NAVAL TRAINING CENTER

SAN DIEGO

*Guidelines for the Treatment of
Historic Properties*

A u g u s t 1, 2 0 0 0

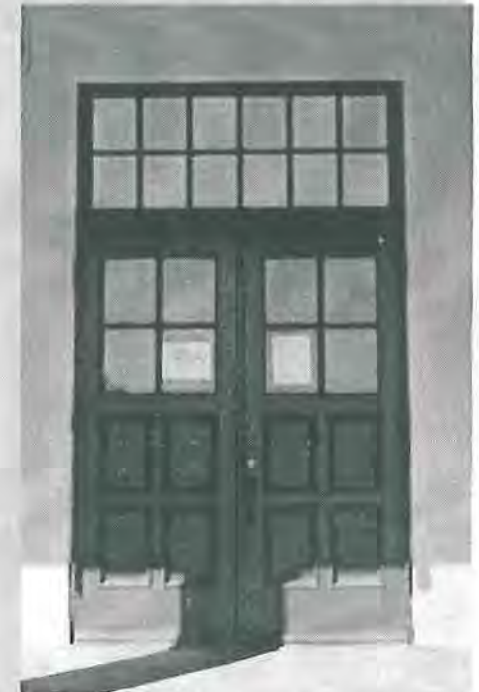
Wood door entry surrounds, when deteriorated, should be replaced "in kind" to exactly match the original material and details. Photograph courtesy of Architect Milford Wayne Donaldson, FAIA, December 21, 1999.

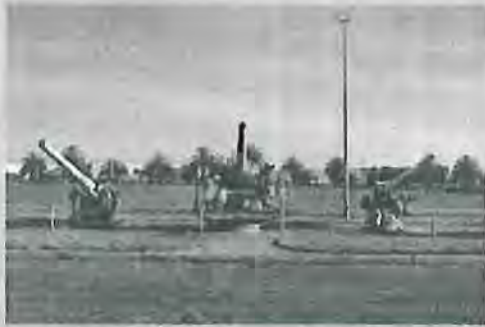
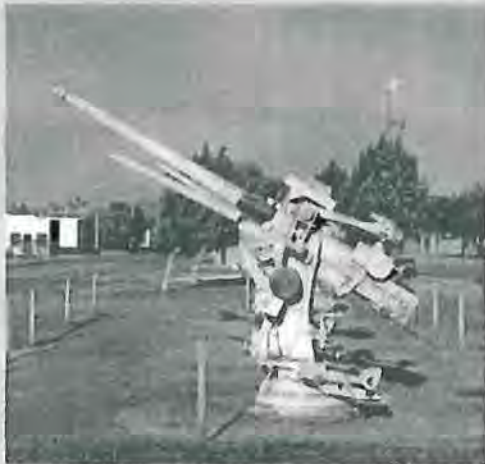
*Gun platforms adjacent to Preble Field.
Photograph courtesy of Architect Milford
Wayne Donaldson, FAIA, January 10, 2000.*

*Gun platforms adjacent to Preble field.
Photograph courtesy of Architect Milford
Wayne Donaldson, FAIA, January 10, 2000.*

NTC Historic District has some unique elements. The USS Recruit is a building made to look like a naval ship and constructed of painted sheet metal with both real and mock-up ships fittings. Gun platforms, anchors and other naval items are located throughout NTC. These historic metal elements must be maintained free of rust and corrosion.

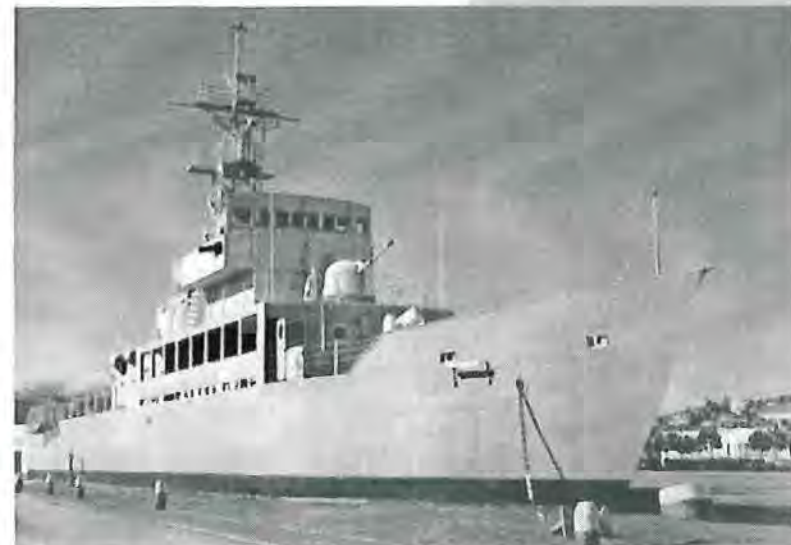
USS Recruit, constructed in 1949 as a simulated full size mock-up of a Destroyer Escort (DE) Class Navy ship was used for classrooms and training. Photograph courtesy of Architect Milford Wayne Donaldson, FAIA. January 4, 2000.

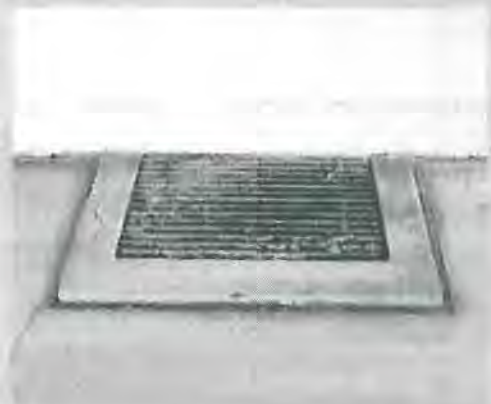
There are several grills that vent the buildings' foundations and should be replaced "in kind" if damaged beyond repair. Photograph courtesy of Architect Milford Wayne Donaldson, FAIA, December 21, 1999.

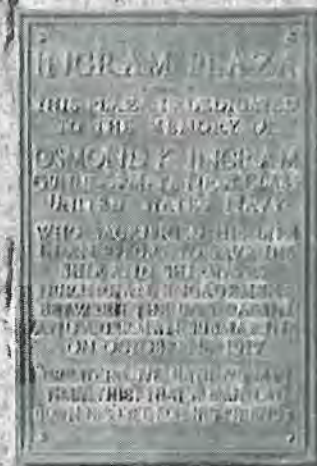
Bronze plaque dedicating Ingram Plaza in the memory of Osmond K. Ingram needs restoration work. Photograph courtesy of Architect Milford Wayne Donaldson, FAIA, December 21, 1999.

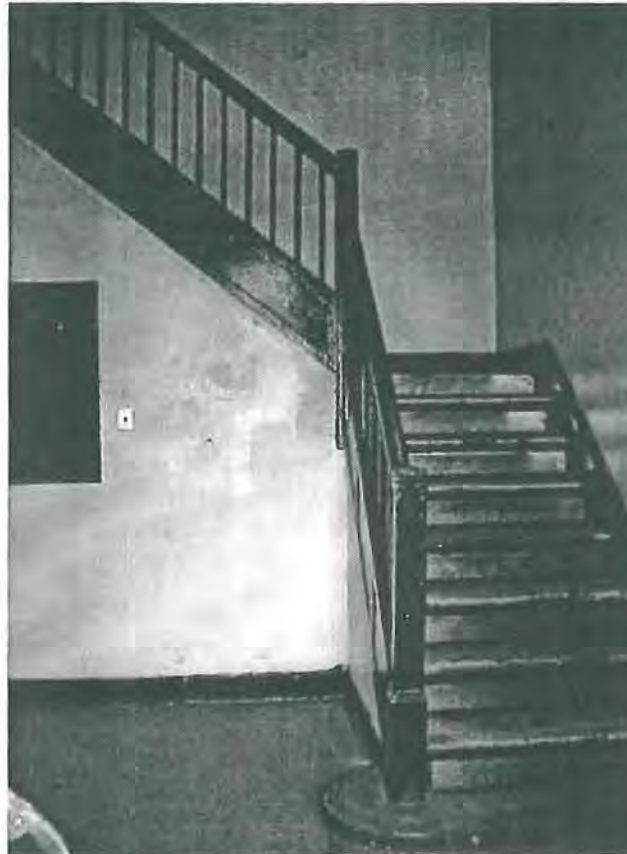
Metal stairs, brackets and balustrades are character defining features in the barracks buildings. Photograph courtesy of Architect Milford Wayne Donaldson, FAIA, February 2000.

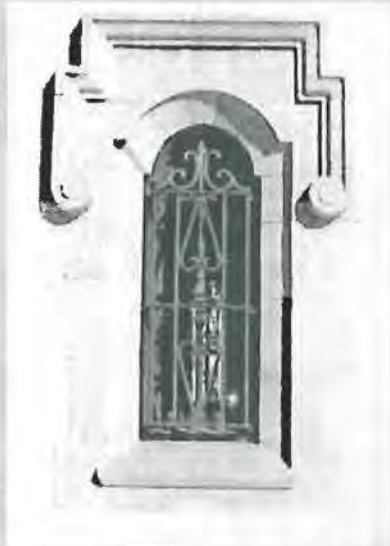
Decorative metal security grills are a common feature at NTC and should be retained. Photograph courtesy of Architect Milford Wayne Donaldson, FAIA, December 21, 1999.

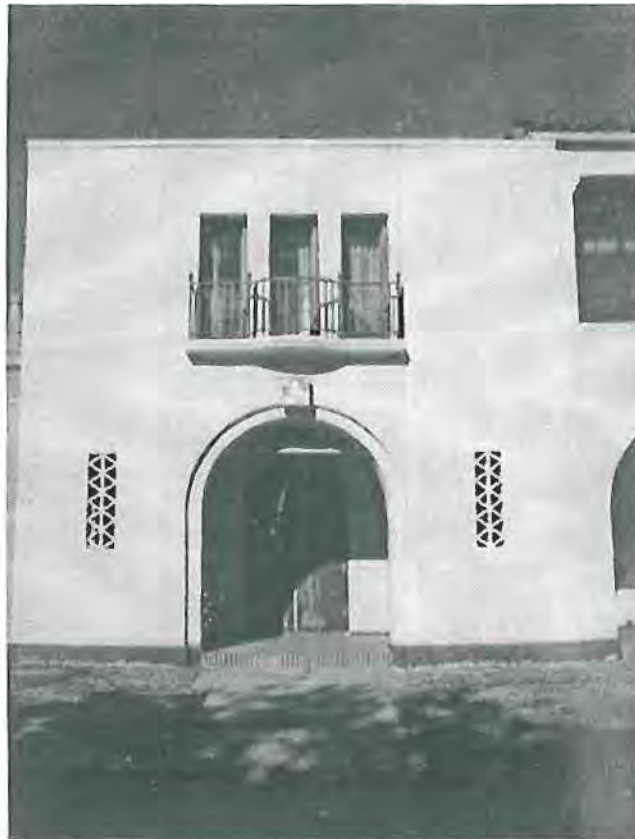
Wrought iron railing at the balcony of barracks Building 27. Photograph courtesy of Architect Milford Wayne Donaldson, FAIA, January 4, 2000.

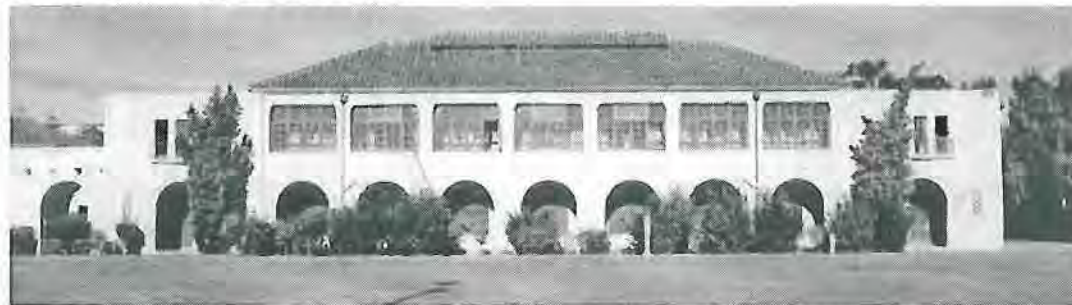
Variegated red tile roofs are very distinctive and a unifying feature at Naval Training Center as seen at barracks Building 29. Photograph courtesy of Architect Milford Wayne Donaldson, FAIA, December 21, 1999.

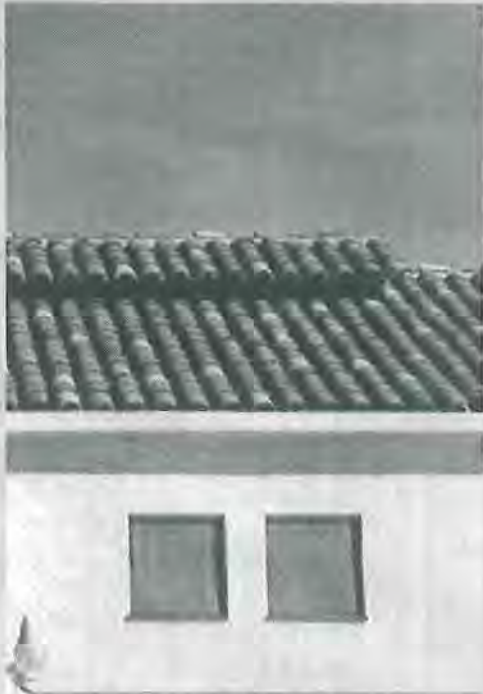
Clay tile roofing, while very durable, may be damaged due to impact or deterioration of substrate and fasteners. This roof can be preserved by repairing its substrate and fasteners as required, and by selectively replacing damaged tiles. Photograph courtesy of Architect Milford Wayne Donaldson, FALA, January 4, 2000.

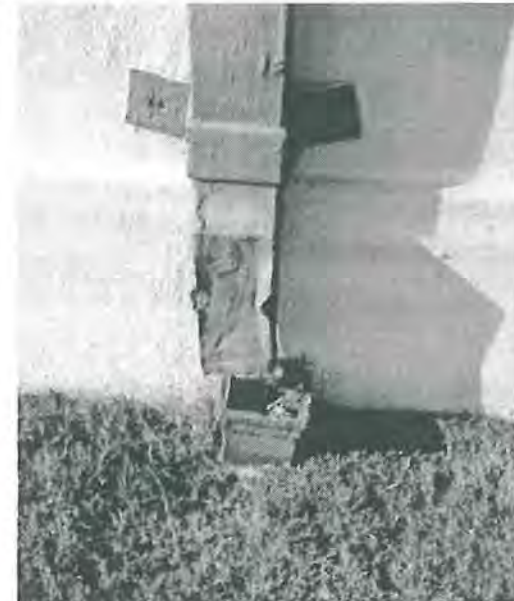
The downspout has been disconnected from the drain. The drain has become clogged with debris. This situation needs to be corrected to prevent water damage to the plaster walls and foundation. Photograph courtesy of Architect Milford Wayne Donaldson, FAIA, January 10, 2000.

Repair damaged, disconnected, and missing gutters and downspouts.

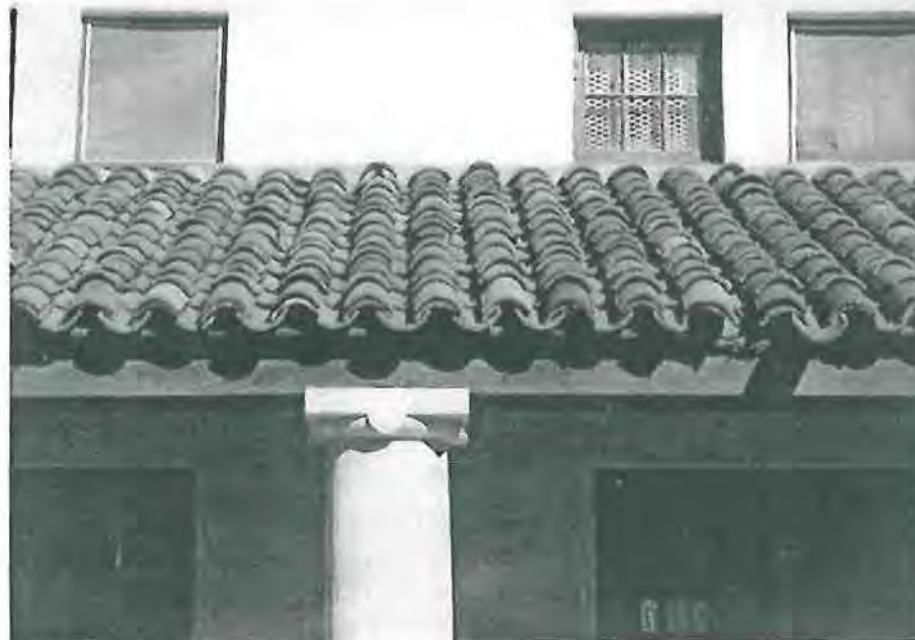
Original barrel tile roof at the rear facade of Building 25. Photograph courtesy of Architect Milford Wayne Donaldson, FAIA, January 4, 2000.

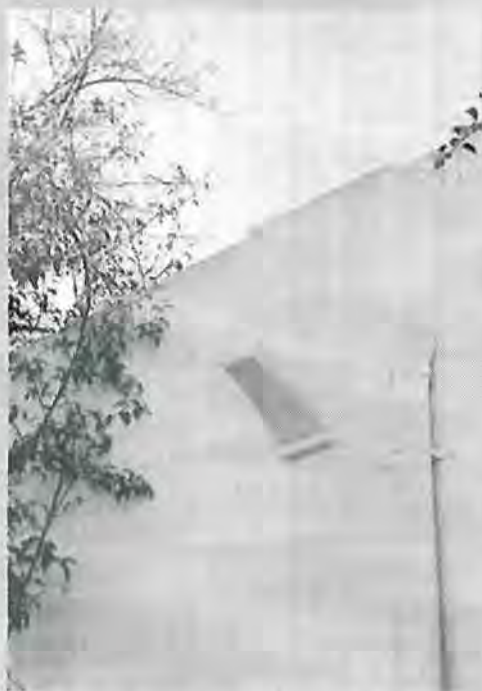
Built-in downspouts are particularly vulnerable to deterioration because they are within the roof or wall structure. Their deterioration can go unnoticed until it leads to serious problems. Adding new exterior roof drain pipes, as shown at Building 30, detracts from the Building's historic appearance. Photograph courtesy of Architect Milford Wayne Donaldson, FAIA, January 4, 2000.

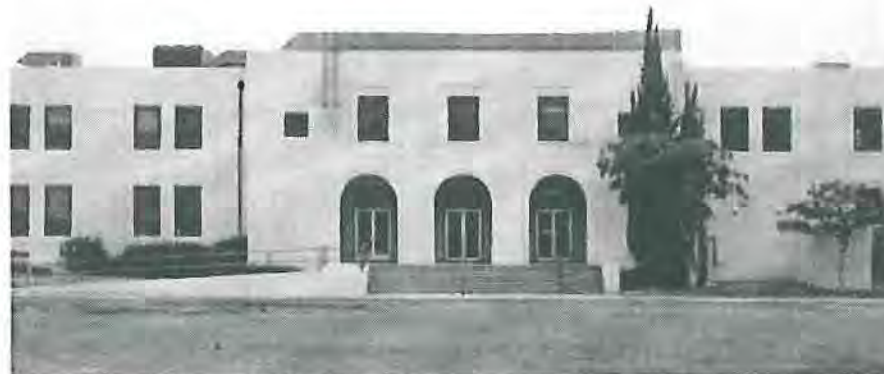
The addition of mechanical equipment that disrupts the clean parapet roof line, should be discouraged within the historic district. Photograph courtesy of Architect Milford Wayne Donaldson, FAIA, January 11, 2000.

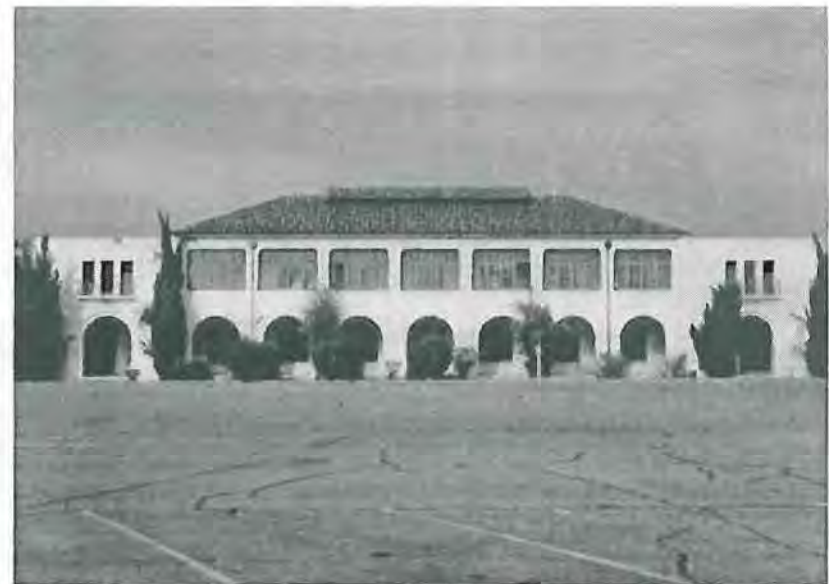
The rhythm and spacing of the wood windows emphasize Goodhue's Spanish Colonial Revival influence and are an essential component of Naval Training Center architecture. Photograph courtesy of Architect Milford Wayne Donaldson, FAIA, January 11, 2000.

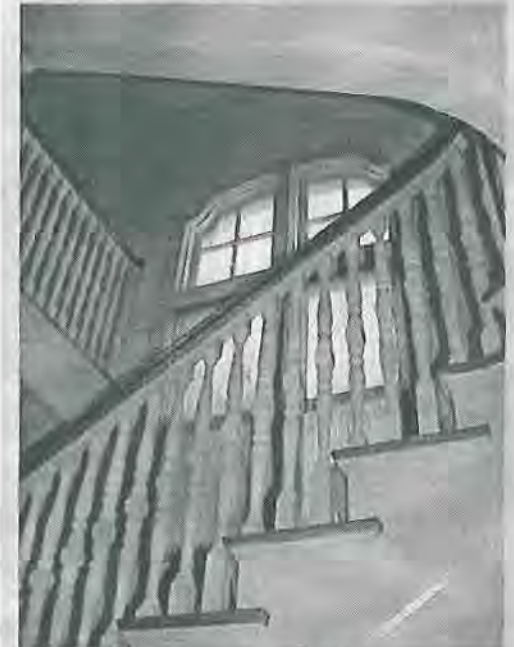
A specially designed wood window at the landing of Officer's Quarters "A" allows a shower of light to flood the interior. Photograph courtesy of Architect Milford Wayne Donaldson, FAIA, March 2, 2000.

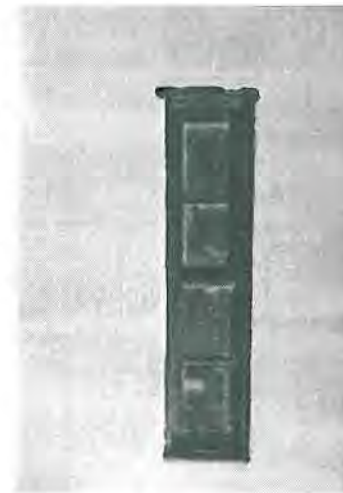
Historic wood window at Building 10, with small double-hung windows should be maintained and not replaced with aluminum windows. Photograph courtesy of Architect Milford Wayne Donaldson, FAIA, January 4, 2000.

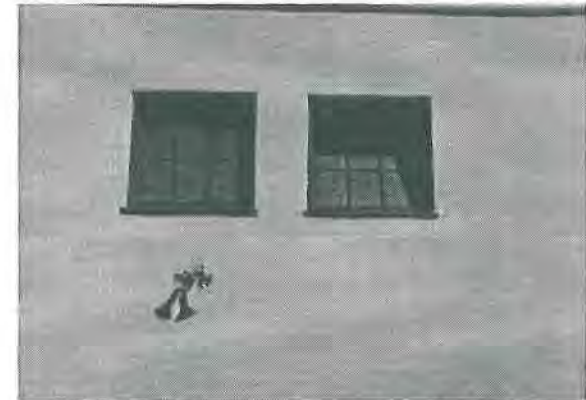
Window glazing has been painted for daylight control. The use of shades, curtains, and other removable devices is preferred. Photograph courtesy of Architect Milford Wayne Donaldson, FAIA, January 4, 2000.

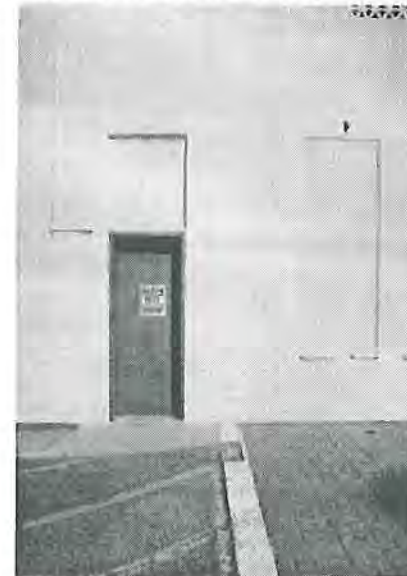
The building reveals an altered window that is now a door. There is clear evidence of the original window style form, materials, and color. Reconstruction of the altered window is appropriate. Photograph courtesy of Architect Milford Wayne Donaldson, FAIA, January 10, 2000.

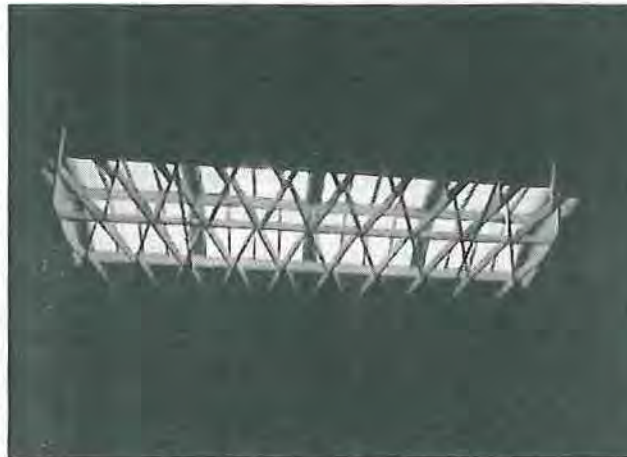
Skylights and clerestory windows allow the interior to receive natural sunlight and should not be covered.

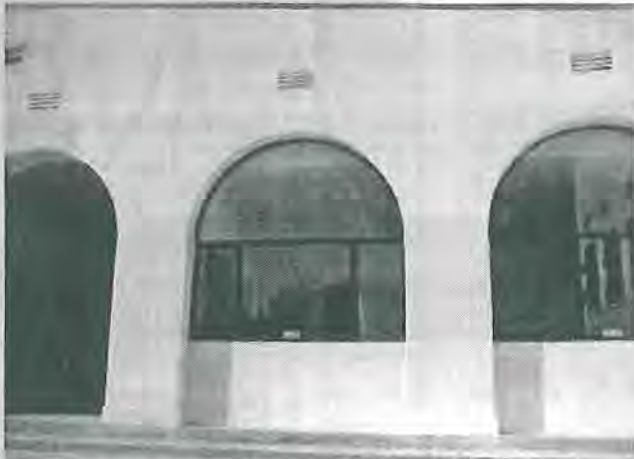
Some arches have been filled with modern aluminum windows, stucco infill, and dropped ceilings visible from the outside. These modifications are not in character with the historic buildings. Photograph courtesy of Architect Milford Wayne Donaldson, FAIA, January 11, 2000.

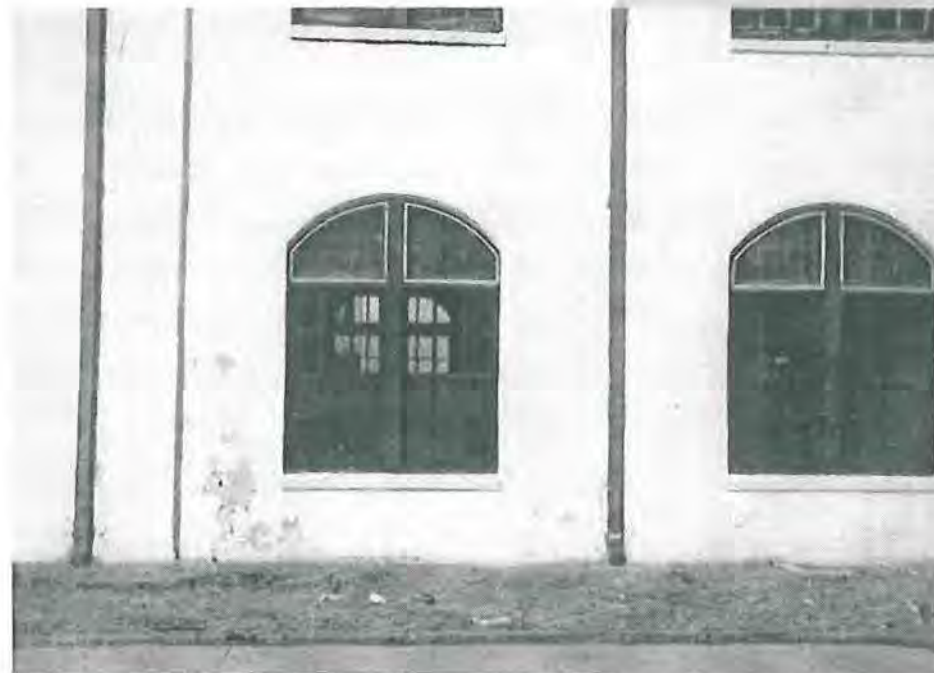
High arched windows allow a large amount of light to the interior of the building and provide a pleasant environment. Photograph courtesy of Architect Milford Wayne Donaldson. FAIA, January 10, 2000.

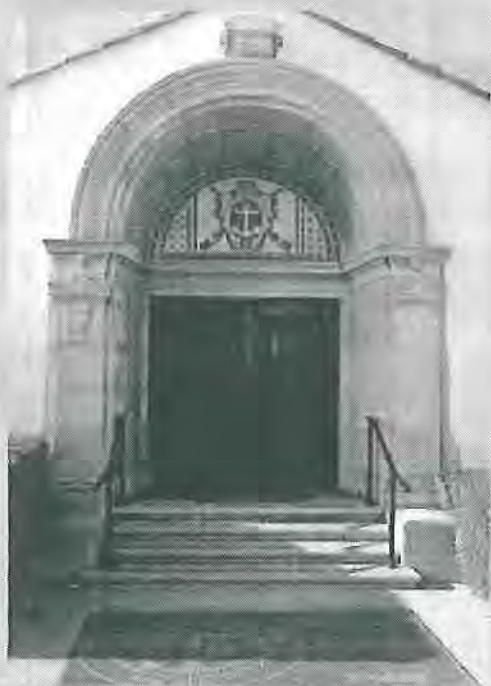
*This decorative door surround at Building 208 is an important character-defining feature for the building entrance.
Photograph courtesy of Architect Milford Wayne Donaldson, FAIA, January 10, 2000.*

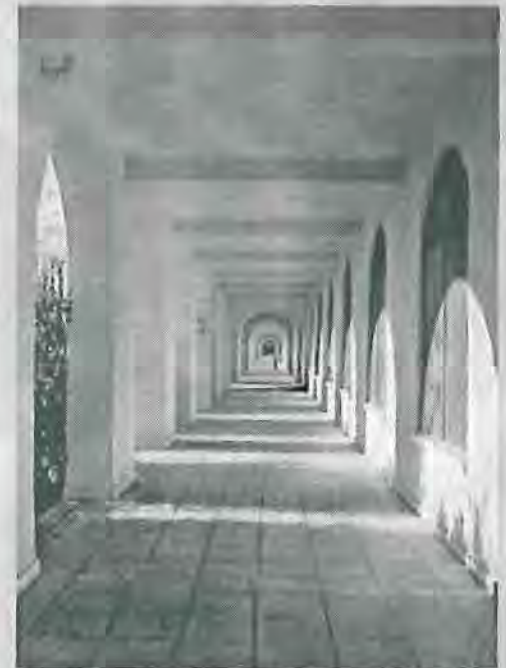
The arcade is an important design feature used to unify the buildings. The arcade constantly receives sunlight providing ever changing shadows through the day. Photograph courtesy of Architect Milford Wayne Donaldson, FAIA, December 21, 1999.

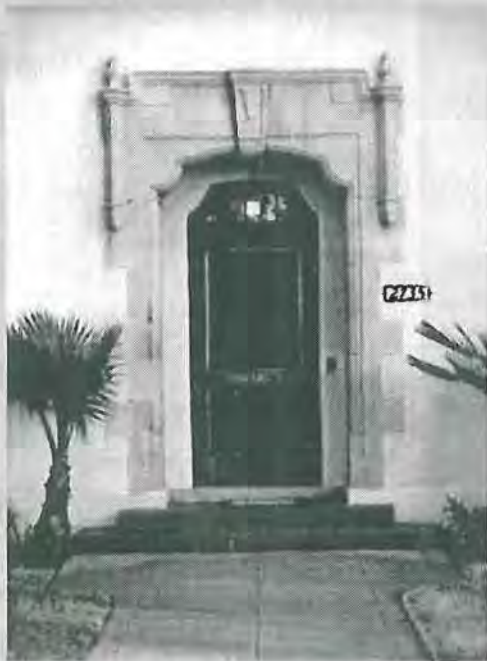
Entrances to the Mess Hall and Officer's Quarters maintain consistent design features throughout Naval Training Center. Photograph courtesy of Architect Milford Wayne Donaldson, FAIA, December 21, 1999.

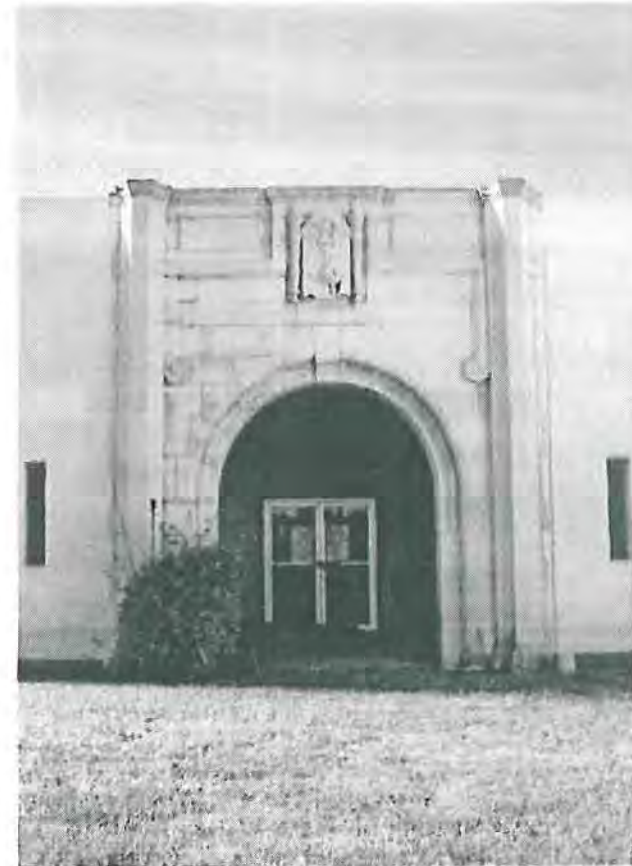
Entrance to the Mess Hall in Building 30. The historic doors have been removed and replaced with aluminum frame doors (this is not recommended). Photograph courtesy of Architect Milford Wayne Donaldson, FAIA, January 11, 2000.

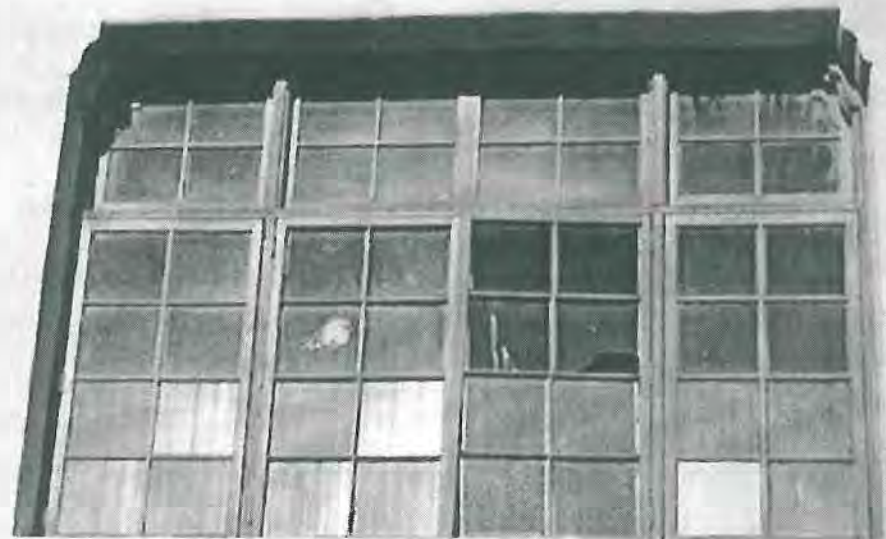
The second story balconies in the barracks Buildings 27, 28, and 29 were enclosed shortly after completion of the buildings. Photograph courtesy of Architect Milford Wayne Donaldson, FALA, December 21, 1999.

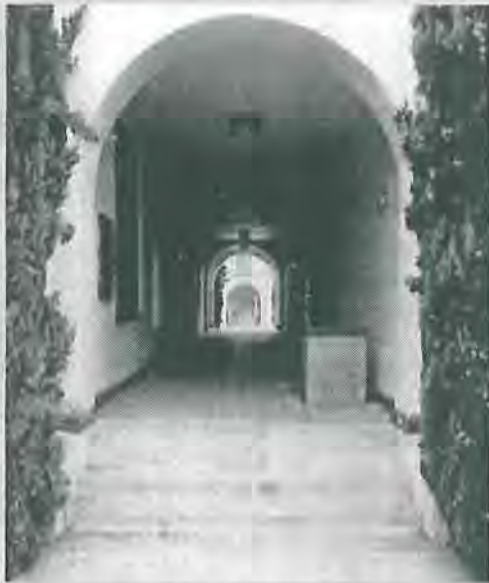
Entrances can be architecturally compromised by the introduction of trash receptacles and other non-complimentary items. Photograph courtesy of Architect Milford Wayne Donaldson, FAIA, January 11, 2000.

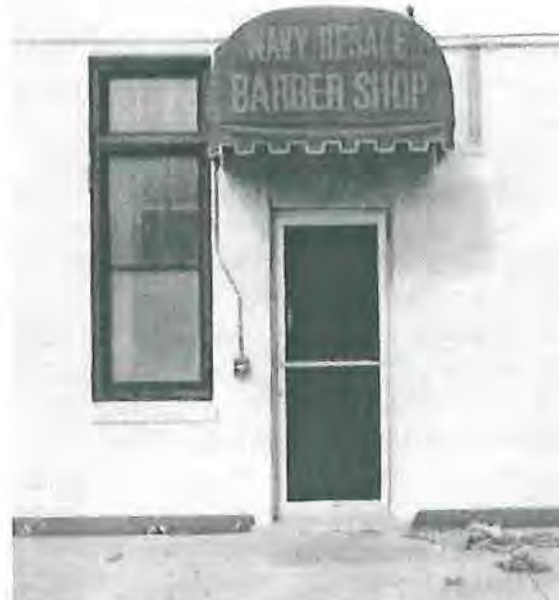
New or contrived entrances are not appropriate. Photograph courtesy of Architect Milford Wayne Donaldson, FAIA, January 11, 2000.

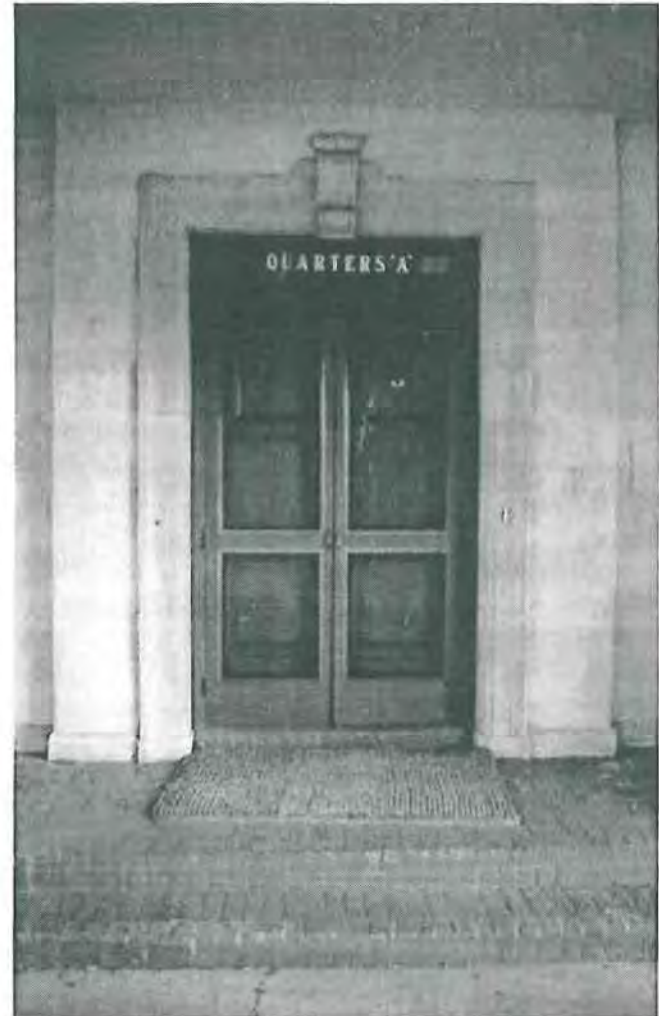
*Many entrances do not allow wheelchair access.
Photograph courtesy of Architect Milford Wayne
Donaldson, FAIA, January 11, 2000.*

Access for persons with disabilities should be designed in a manner which is sensitive to the porches and entrance features. Most NTC buildings will require improved accessibility, to the buildings, the arcades, and through portions of the interior. (See Accessibility Considerations chapter for more information.)

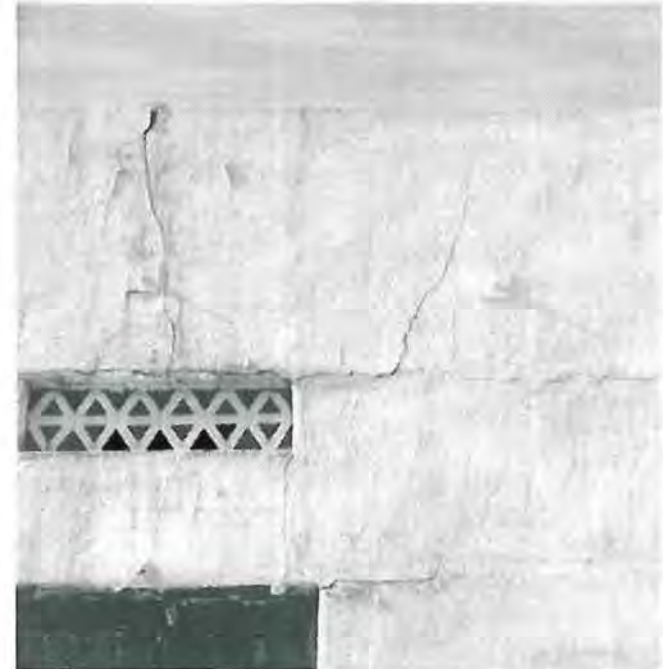
Historic building frequently have rafter ties, bond iron ties or other elements which improve their seismic capacity. A building should be carefully researched and surveyed to locate these elements, and the seismic analysis should take their value into account. Photograph courtesy of Architect Milford Wayne Donaldson, FAIA, January 10, 2000.

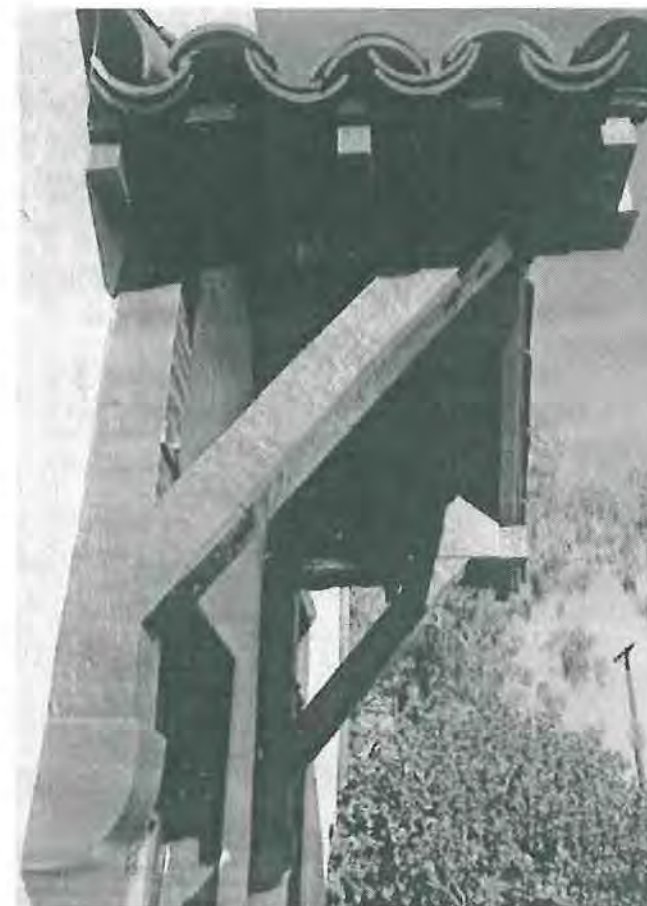
Several wood members are fastened by metal plates and bolts, but need to be seismically analyzed. Photograph courtesy of Architect Milford Wayne Donaldson, FAIA, January 10, 2000.

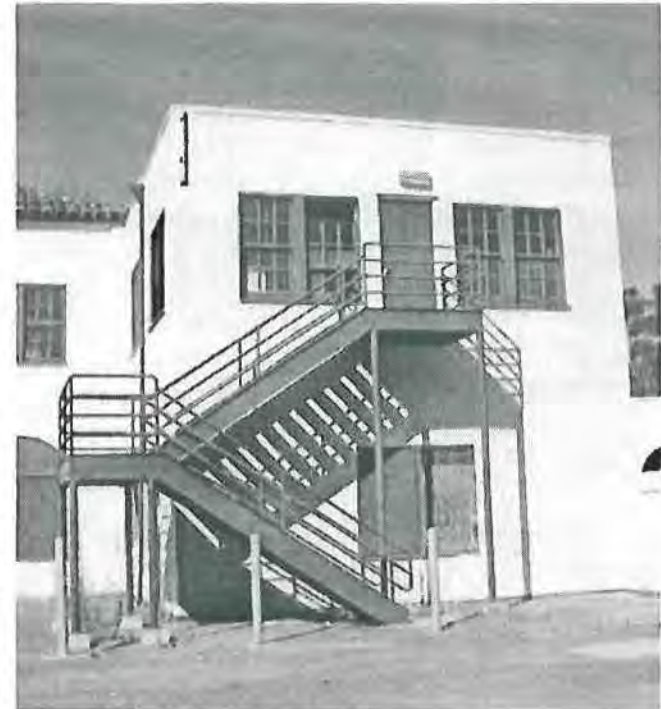
Later additions such as this stairway may need to be reviewed for current seismic upgrading. This addition distracts from the cubic simplicity of the original architecture. Photograph courtesy of Architect Milford Wayne Donaldson, FAIA, December 21, 1999.

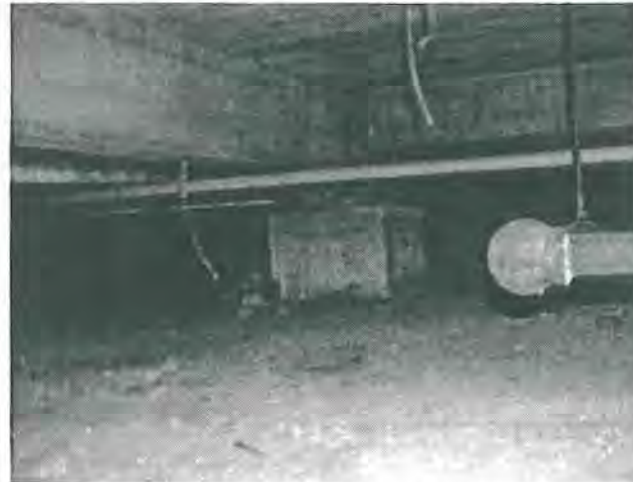
Most of the buildings at NTC have reinforced concrete foundations and require evaluation for seismic strengthening. Any modifications should be accomplished without removal or damage to the existing system.

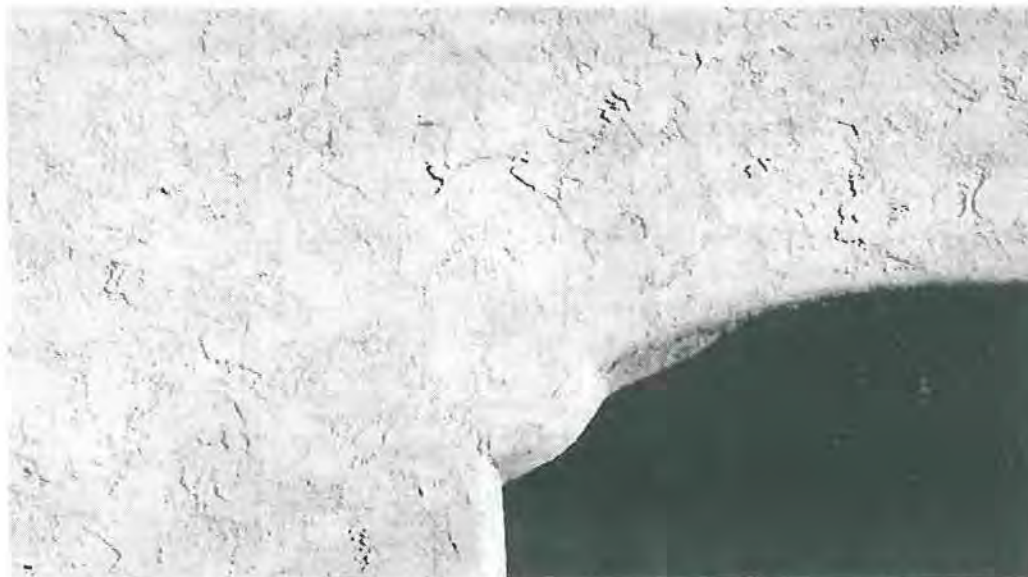
A heavy "skip trowel" stucco skim coating has been applied to Officer's Quarters "A" and has greatly changed the original adobe style finish. Photograph courtesy of Architect Milford Wayne Donaldson, FAIA, January 10, 2000.

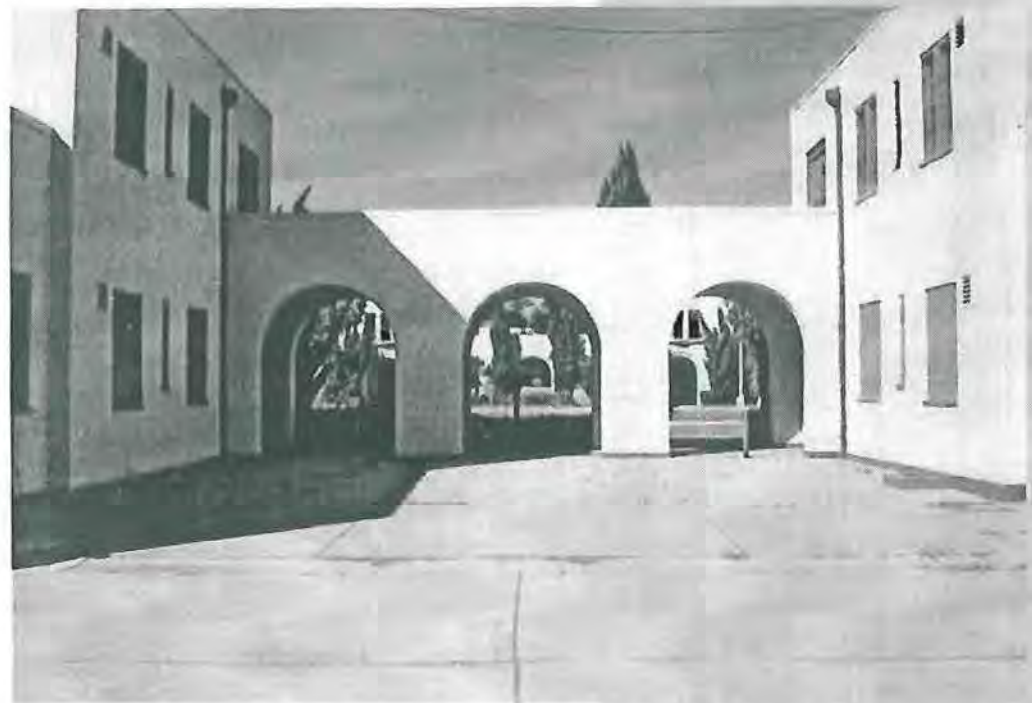
*The stucco texture allows a wide range of color contrast due to shade and shadows.
Photograph courtesy of Architect Milford Wayne Donaldson, FAIA, December 21, 1999.*

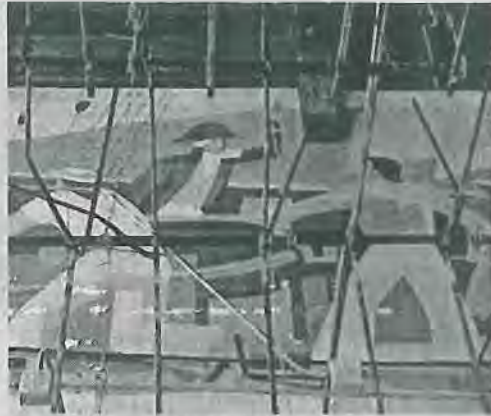
Detail of mural in Building 30. These murals should be conserved and protected in place. Photograph courtesy of Architect Milford Wayne Donaldson, FAIA, February 2000.

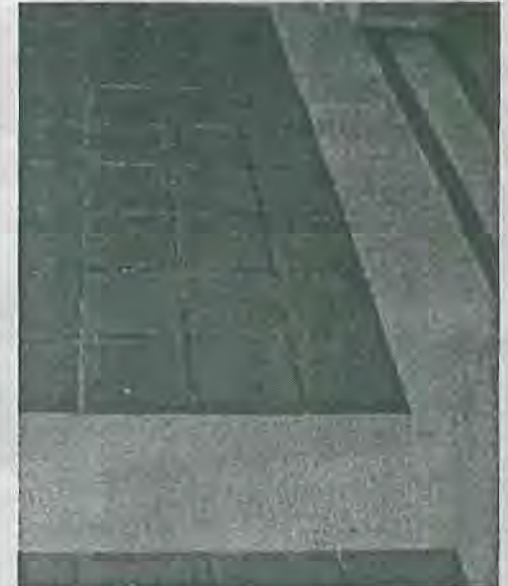
*Care should be taken to protect ceramic tile and terrazzo floors during rehabilitation and remodeling.
Photograph courtesy of Architect Milford Wayne Donaldson, FAIA, February 2000.*

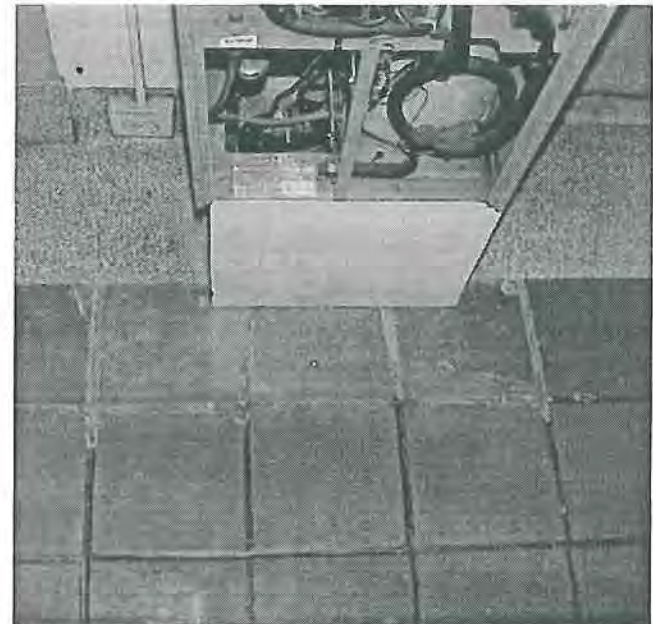
Leaking water cooler discoloring tile and mortar joints should be repaired to match original condition. Photograph courtesy of Architect Milford Wayne Donaldson, FAIA, February 2000.

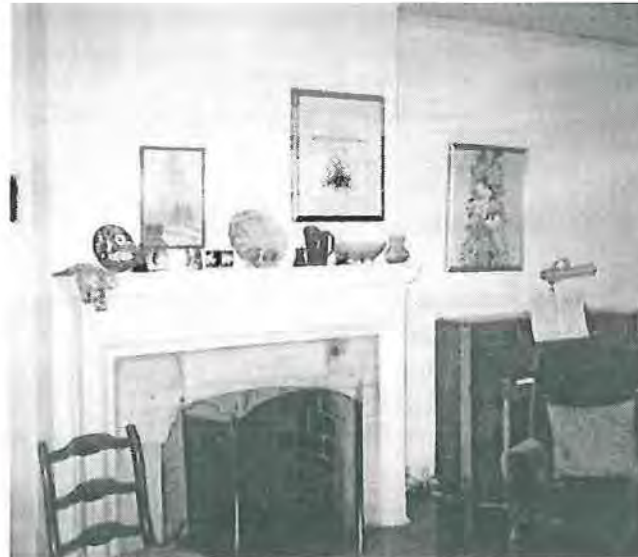
The wood moldings, fireplace, doors, and finish floor materials of the Officer's Quarters are original and should be maintained. Photograph courtesy of Architect Milford Wayne Donaldson, FAIA, January 11, 2000.

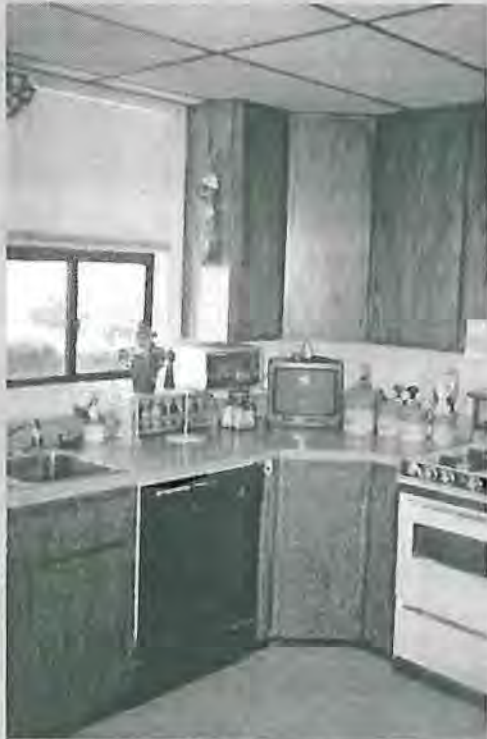
The kitchens in the Officers' Quarters have been remodelled with new cabinets, floor and ceiling materials that are not respective of the historical character of the building. Photograph courtesy of Architect Milford Wayne Donaldson, FAIA, January 11, 2000.

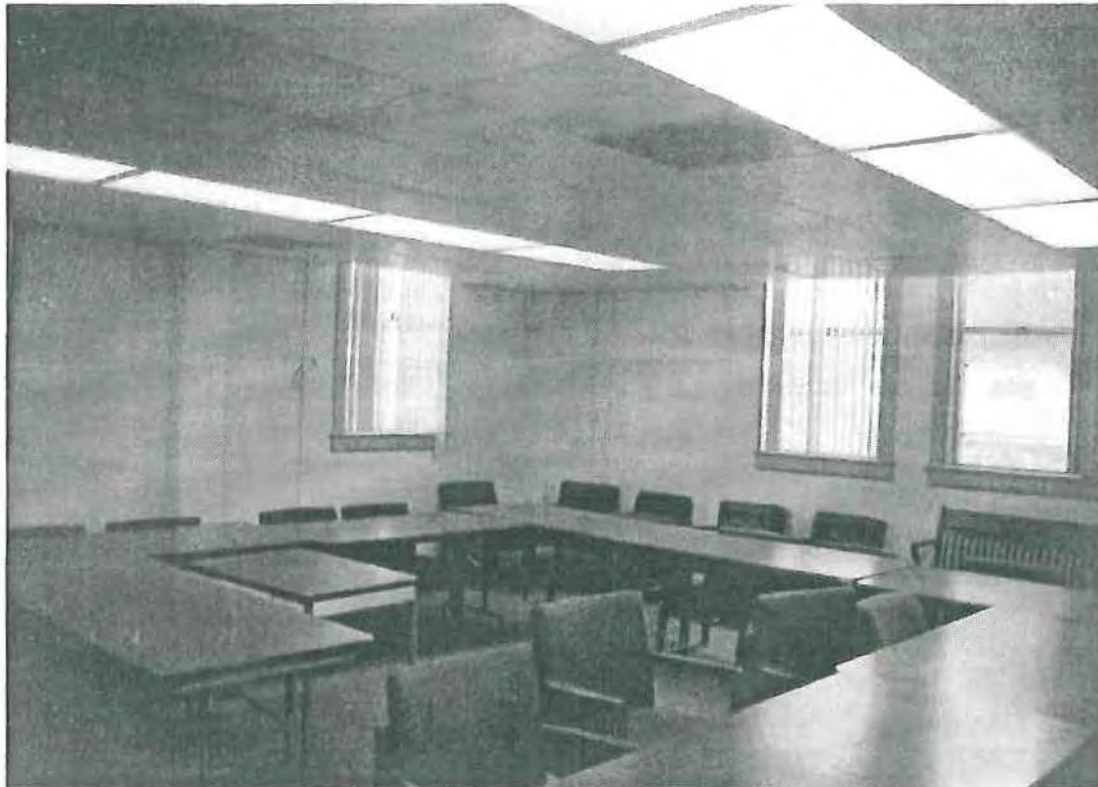
New suspended ceilings should be modified to maintain the perception of the original space and not block off the historic windows. Photograph courtesy of Architect Milford Wayne Donaldson, FAIA, January 11, 2000.

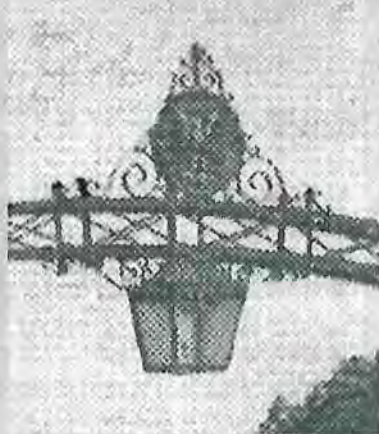
Before: Historic light fixture located at the center of the Naval Training Center gate. Historic postcard collection of Architect Milford Wayne Donaldson, FAIA.

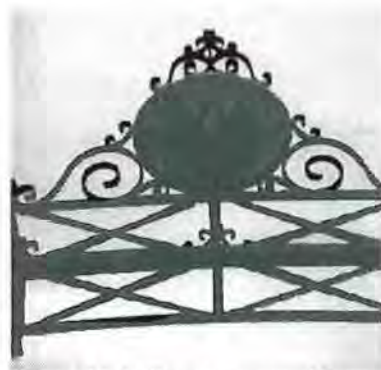
After: Light fixture removed from entry gate. Photograph courtesy of Architect Milford Wayne Donaldson, FAIA, January 11, 2000.

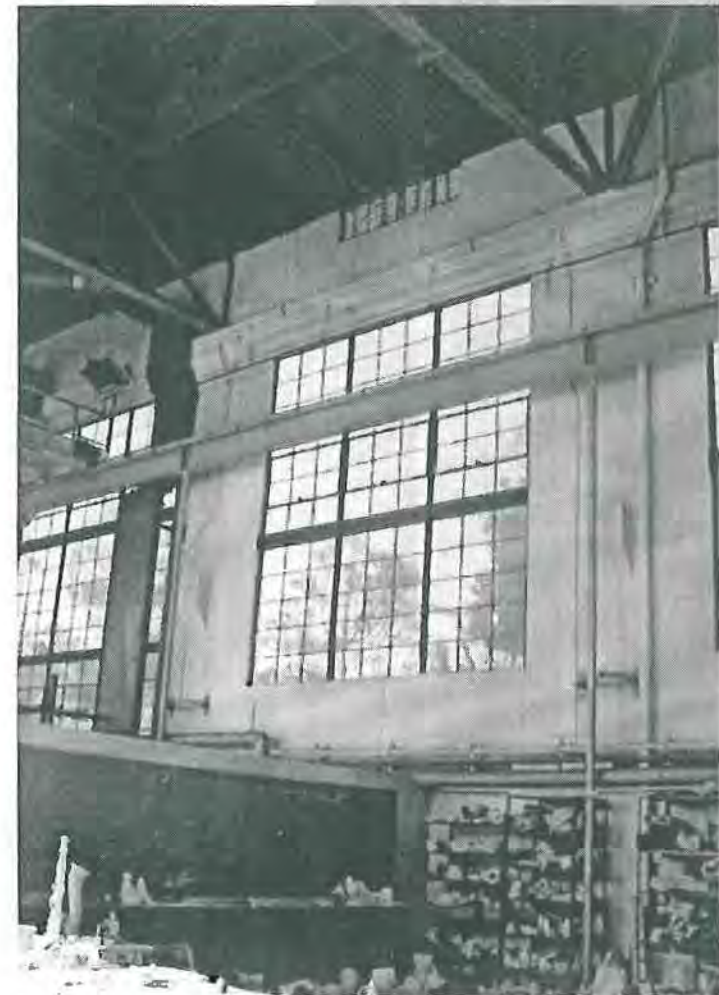
Exposed conduit and other mechanical systems in industrial spaces are appropriate. Photograph courtesy of Architect Milford Wayne Donaldson, FAIA, December 21, 1999.

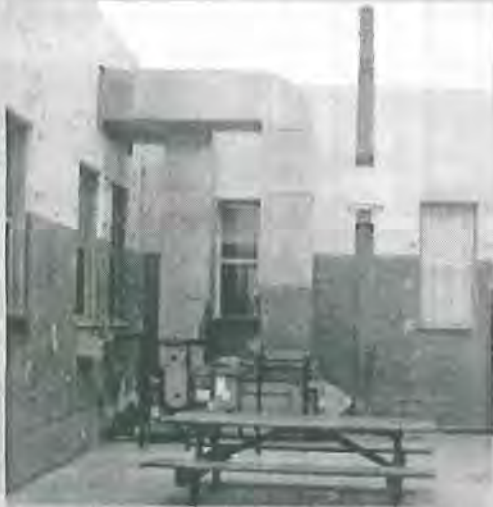
Exposed mechanical units and ductwork on the exterior of the buildings are unsightly and inappropriate. Photograph courtesy of Architect Milford Wayne Donaldson, FAIA, January 11, 2000.

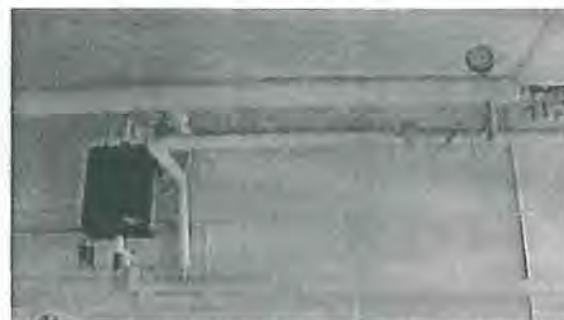
The tangible reminders of earlier mechanical and electrical systems including light fixtures and switchplates contribute to the overall character of a building and should be retained in place, even if the systems themselves are obsolete or need upgrading. Typically these elements can be integrated into upgraded systems and remain functional. Photograph courtesy of Architect Milford dated February 2000.

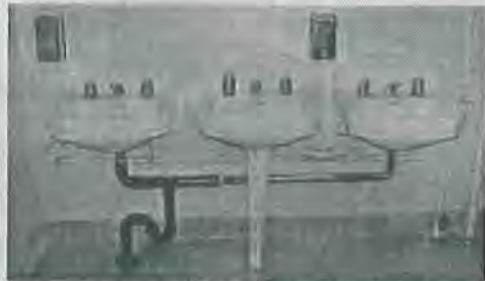
Although built to withstand abuse, some original faucets and sinks have been replaced as shown in this restroom. However, the overall historical integrity of most lavatories remains high. Photograph courtesy of Architect Milford Wayne Donaldson, FAIA, February 2000.

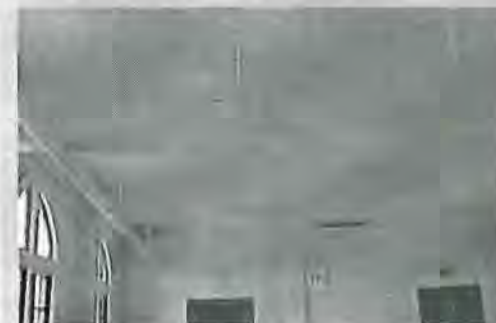
Exposed electrical conduit is not appropriate and should be concealed where possible.

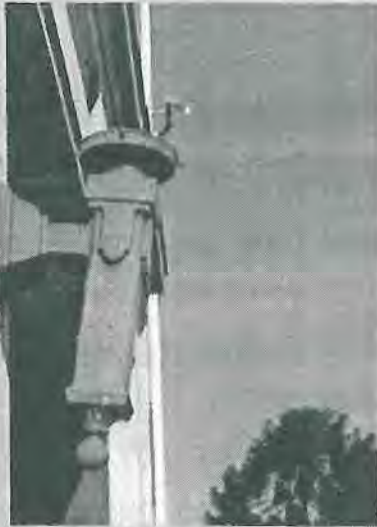
The original light fixture base is still present at Building 8, the Fire Station. The fixture should be restored to its original condition. Photograph courtesy of Architect Milford Wayne Donaldson, FAIA, January 11, 2000.

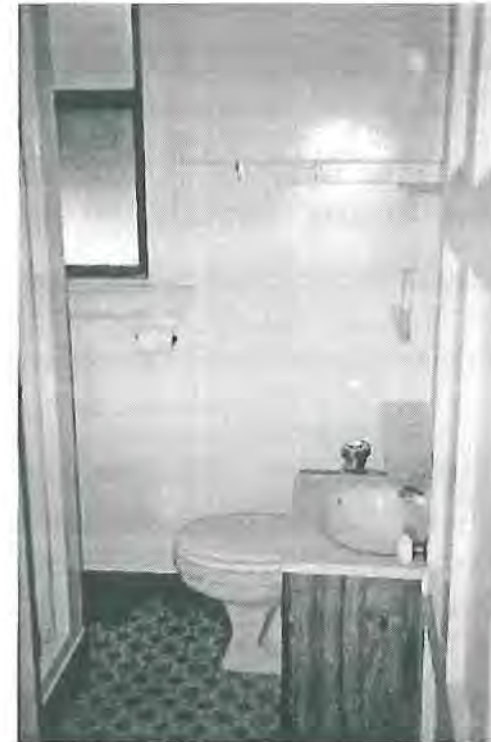
The original bathroom fixtures in the Officers' Quarters have been replaced with inappropriate plastic counters, sinks, toilets, and shower stalls. Photograph courtesy of Architect Milford Wayne Donaldson, FAIA, February 1995.

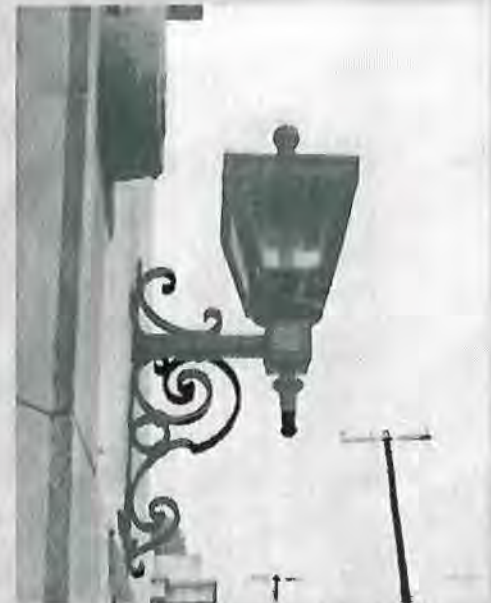
Several light fixtures are original and although the illumination may not meet current code requirements, they should remain and be supplemented with additional compatible light fixtures. Photograph courtesy of Architect Milford Wayne Donaldson, FAIA, January 10, 2000.

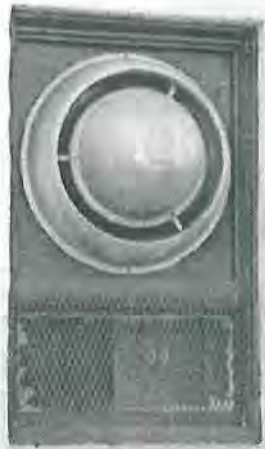
Mechanical units installed in historic windows are inappropriate mechanical units. The units should be removed and windows reconstructed. Photograph courtesy of Architect Milford Wayne Donaldson, FAIA, December 21, 1999.

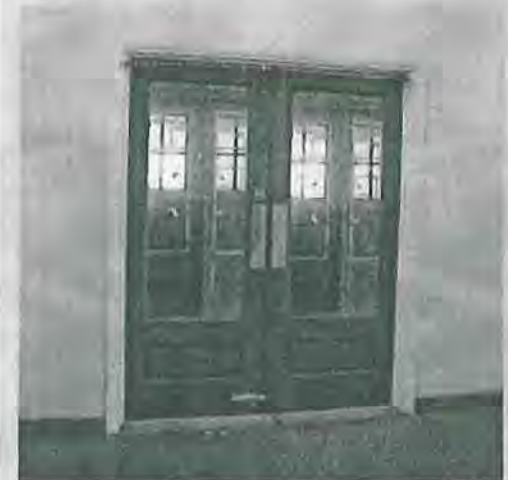
New electrical switches and outlets should be placed to minimize visibility and impact to historic fabric. This photograph shows a typical interior door elevation at Naval Training Center. Existing historic wood trim and molding should not be covered or cut for the installation of new outlets and switches. Photograph courtesy of Architect Milford Wayne Donaldson, FAIA.
