NAVAL TRAINING CENTER

SAN DIEGO

*Guidelines for the Treatment of
Historic Properties*

A u g u s t 1, 2 0 0 0

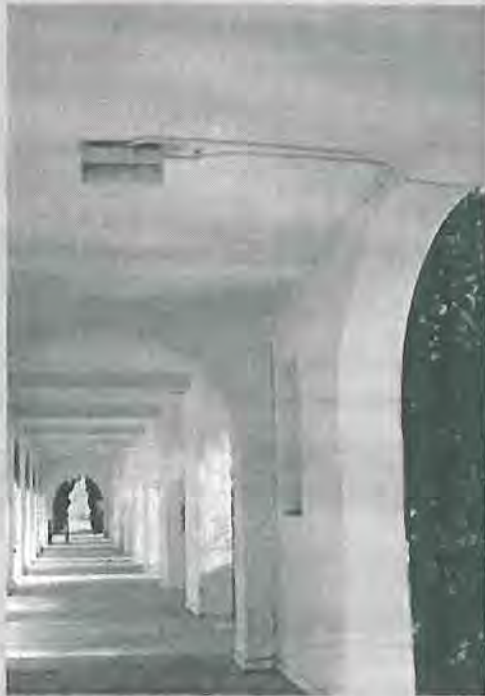
Original cast-in-place conduit has deteriorated and exposed conduit to service light fixture was installed over the archway. Attempts should be made to install new conduit to minimize visibility from public view. Photograph courtesy of Architect Milford Wayne Donaldson, FAIA, December 21, 1999.

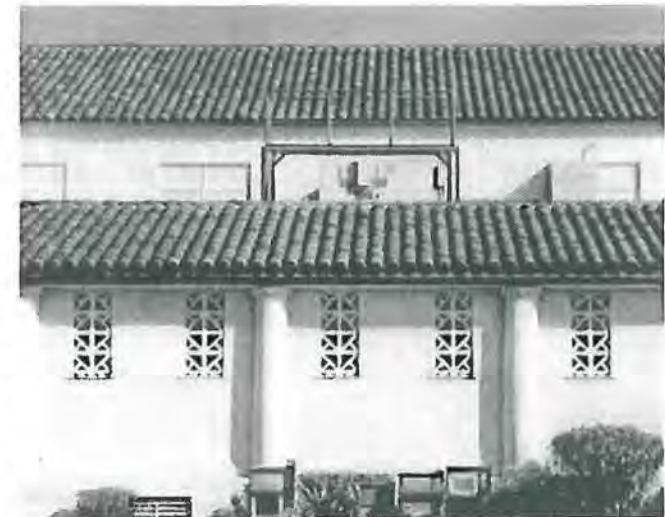
These new mechanical units greatly distract from the architecture of the historic district. Mechanical units have been installed where they are visible from the public realm and are not acceptable. The design and placement of newspaper stands should be considered as to not distract from the historic setting. Photograph courtesy of Architect Milford Wayne Donaldson, FAIA, January 11, 2000.

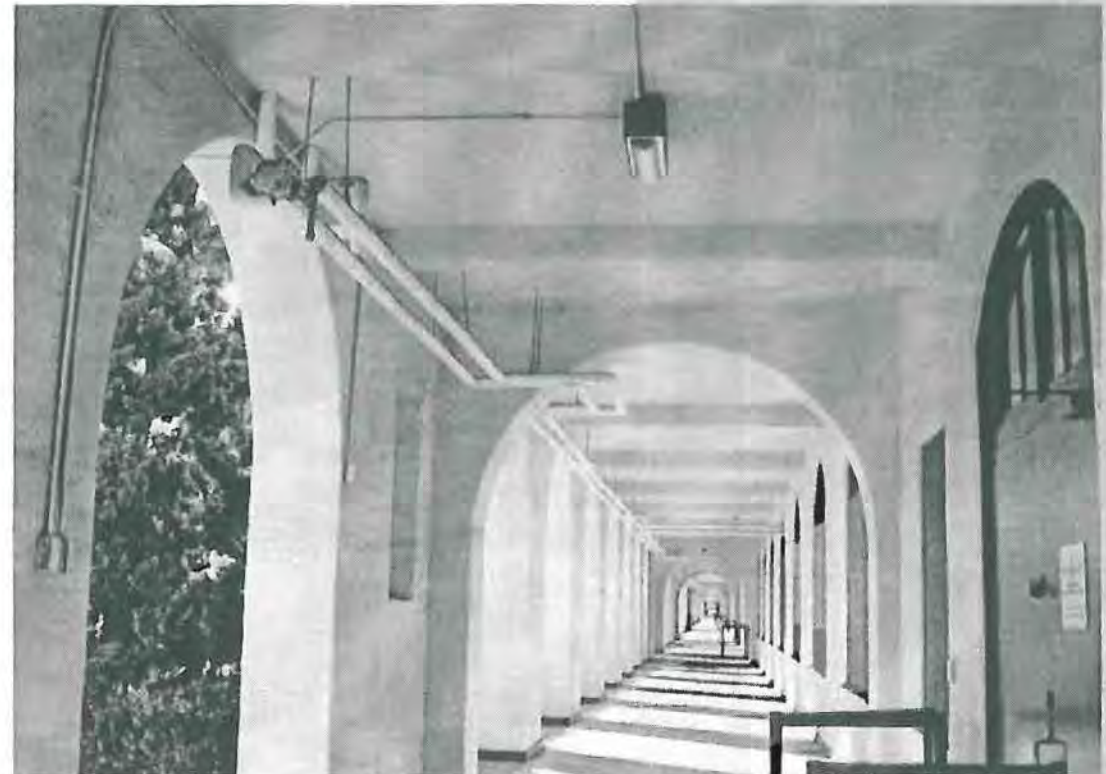
The exterior walls have exposed conduit and steam pipes that should have been installed away from the public view. Photograph courtesy of Architect Milford Wayne Donaldson, FAIA, December 21, 1999.

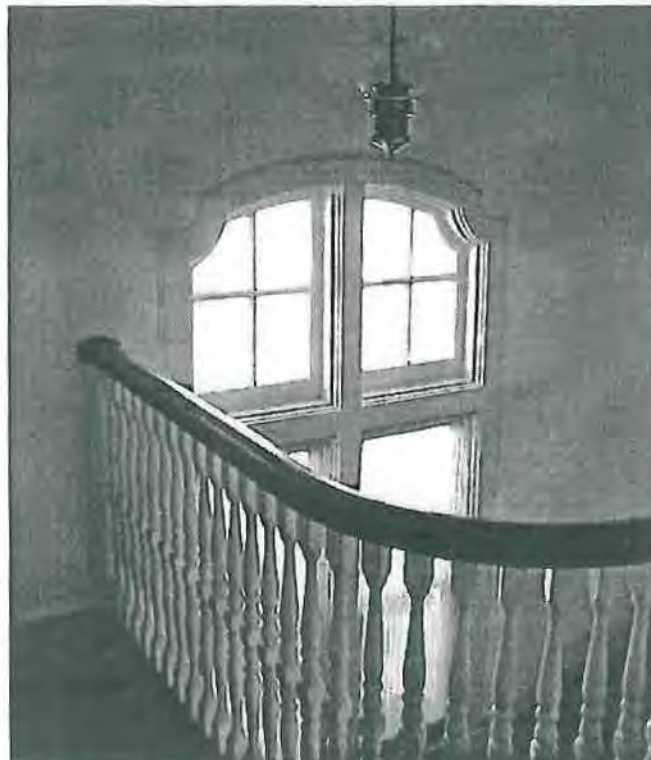
A specially designed wood window at the landing of Officers' Quarters "A" allows a shower of light to flood the interior. Photograph courtesy of Architect Milford Wayne Donaldson, FAIA, March 2, 2000.

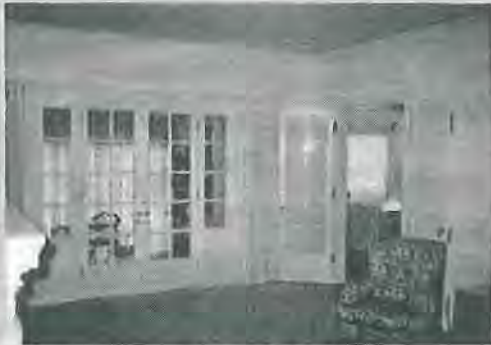
The sun porches found at the Naval Training Center's Officers' Quarters were early energy conserving features. Many porches on residences were later enclosed. Photograph courtesy of Architect Milford Wayne Donaldson, FAIA, January 11, 2000.

Use the inherent energy conserving features of a building; maintain porches in good condition so that they fulfill their original functions, retaining heat, blocking the sun and wind, and providing natural ventilation.

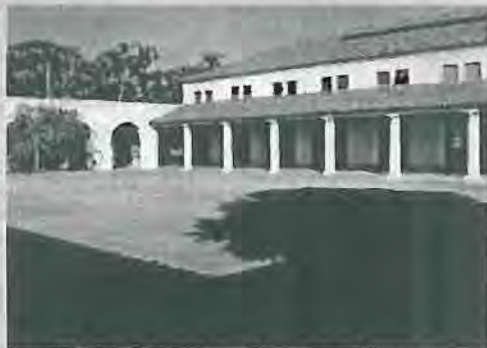
Roofed corridors are a feature of many NTC buildings. They perform a valuable energy conserving function, controlling summer sunlight and allowing windows to be used for ventilation during inclement weather. Photograph courtesy of Architect Milford Wayne Donaldson, FAIA, January 4, 2000.

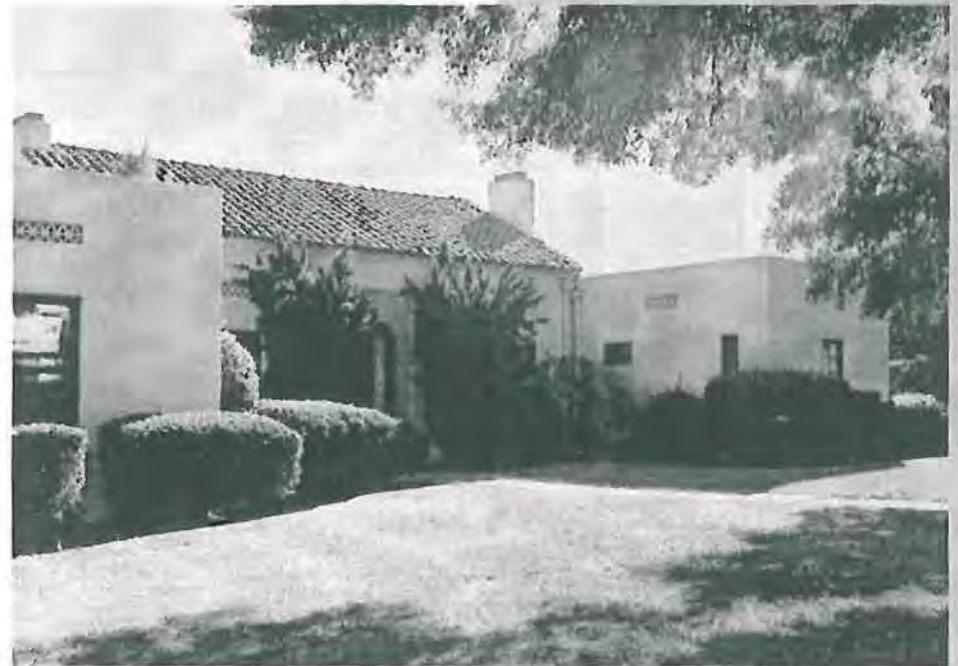
The mature landscaping plays an important role in providing passive control of sunlight and wind. Alteration of such landscaping can radically change the interior environment of nearby buildings and create a need for future energy conservation solutions. Photograph courtesy of Architect Milford Wayne Donaldson, FAIA, December 21, 1999.

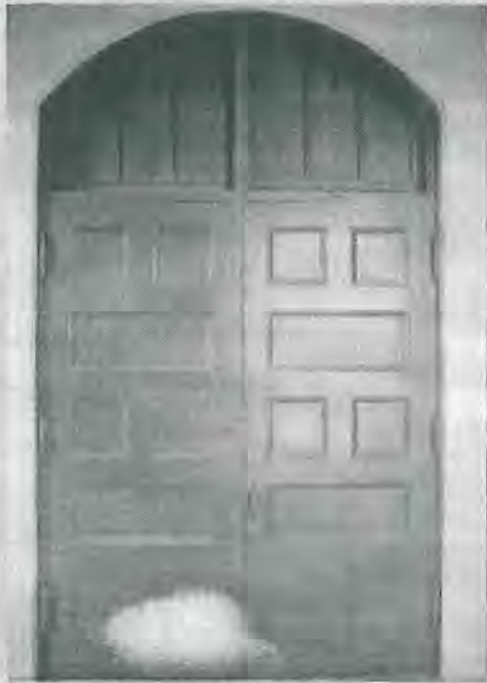
Restoration and maintenance of the arched transom window, shown above, will provide daylight and natural ventilation to the building interior. This will enhance both the internal environment and reduce energy use. Photograph courtesy of Architect Milford Wayne Donaldson, FAIA, December 21, 1999.

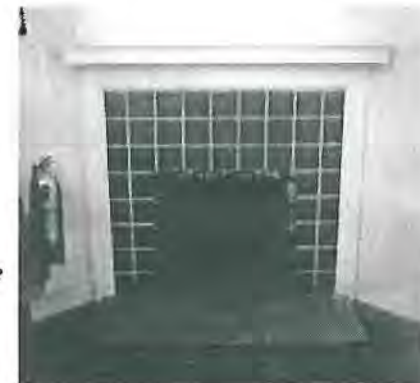
Fireplaces with undampened chimneys are a major source of heat loss. Nonfunctional chimneys should be covered by removable caps. Photograph courtesy of Architect Milford Wayne Donaldson, FAIA, December 21, 1999.

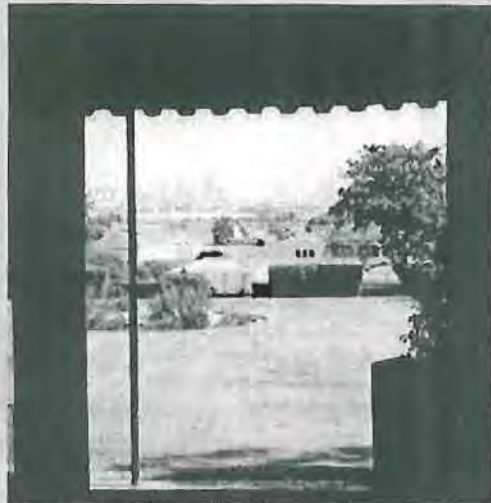
Awnings can be appropriate devices for sunlight control particularly on residences or modest, unornamented structures.

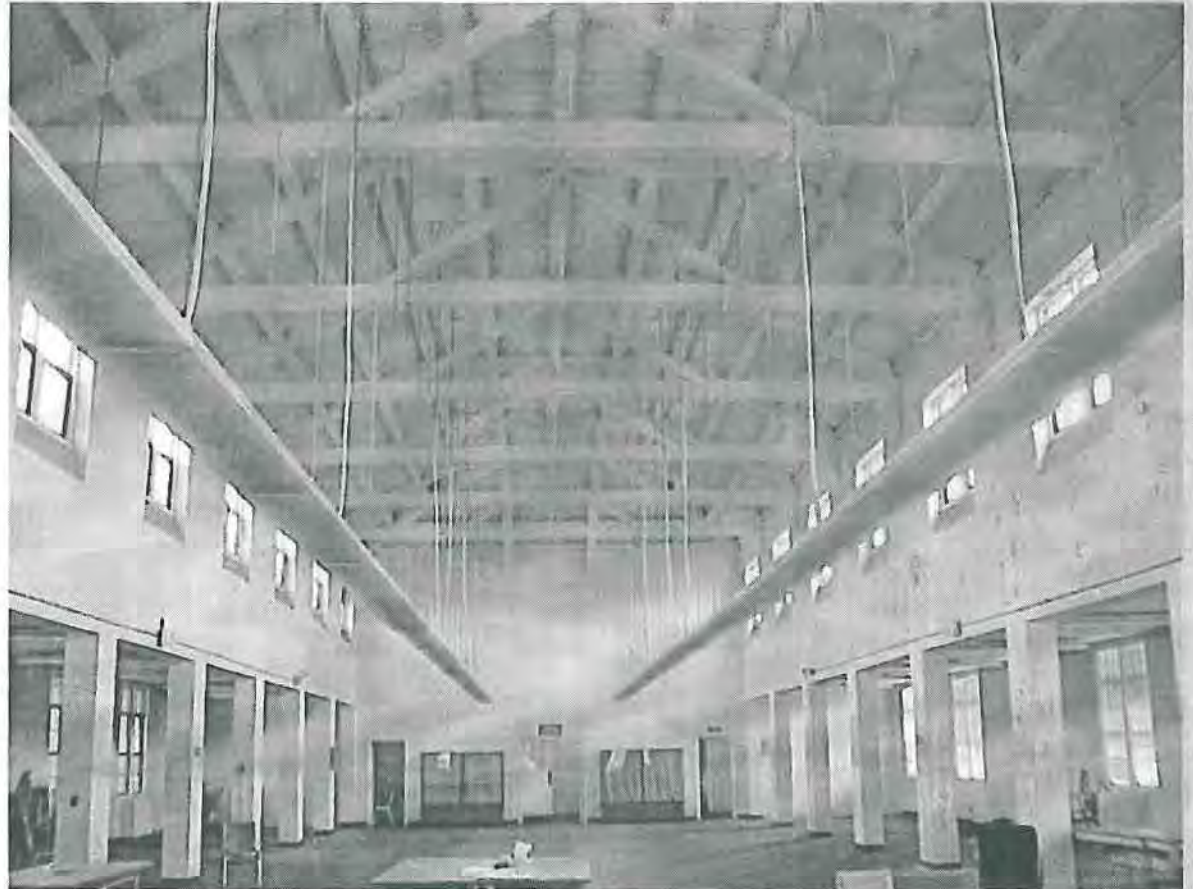
The Library (Building 177) was built with large windows to provide adequate natural light and ventilation into the space. The added fluorescent lights obstruct the high volume of the space. Substitution of task lighting for some of the overhead fixtures will increase efficiency and be more sympathetic to the historic space. Photograph courtesy of Architect Milford Wayne Donaldson, FAIA, February, 2000.

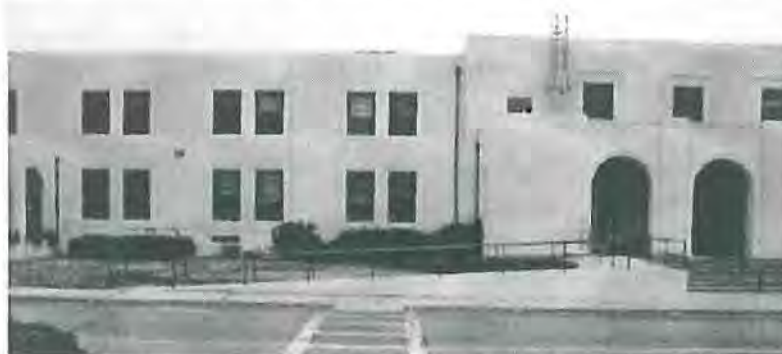
Some pedestrian paths are not clearly signed for wheelchair access across the roadway. Photograph courtesy of Architect Milford Wayne Donaldson, FAIA, January 11, 2000.

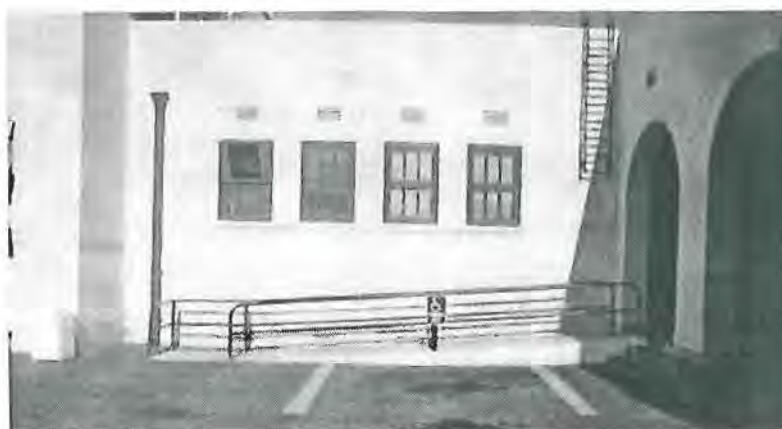
Simple modifications can help create accessibility to historic buildings. This photograph of Building 210 shows accessible parking adjacent to an accessible ramp giving convenient access to the building. Photograph courtesy of Architect Milford Wayne Donaldson, FAIA, January 11, 2000.

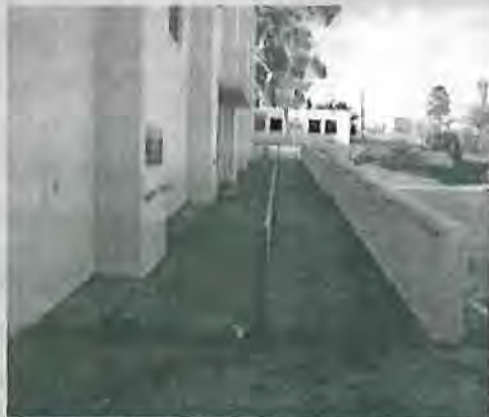
Some buildings are equipped with ramps for moving materials which may serve as wheelchair access with little or no alterations. This ramp occurs at Building #35. Photograph courtesy of Architect Milford Wayne Donaldson, FAIA, January 11, 2000.

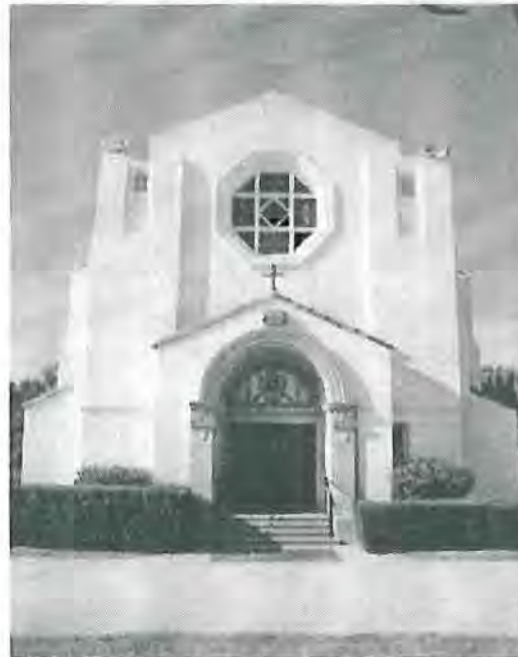
Certain buildings have prominent entrances that are difficult to modify without affecting the historic character of the building such as the North Chapel (Building 208). A wheelchair lift or ramp at a secondary entrance is a possible alternative. Photograph courtesy of Architect Milford Wayne Donaldson, FAIA, January 11, 2000.

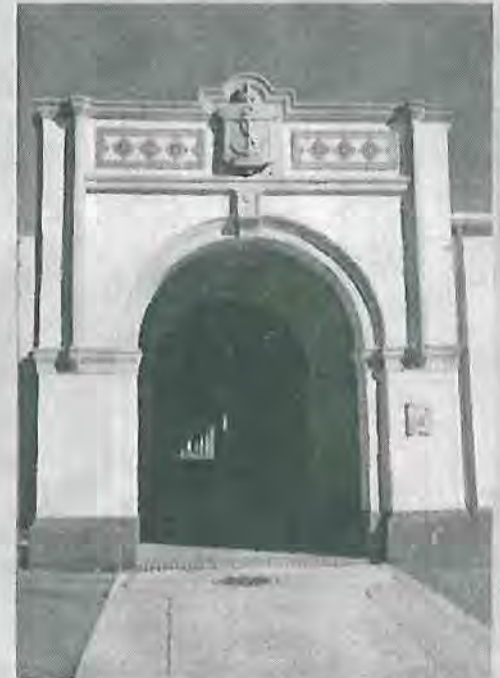
A common condition at the Naval Training Center is a one or two step elevation change at building or arcade entrances, as shown here. In some cases, this can be treated by regrading and constructing a sloped sidewalk. This is preferred because of its reduced impact on the historic appearance of the building. Photograph courtesy of Architect Milford Wayne Donaldson, FAIA, January 4, 2000.

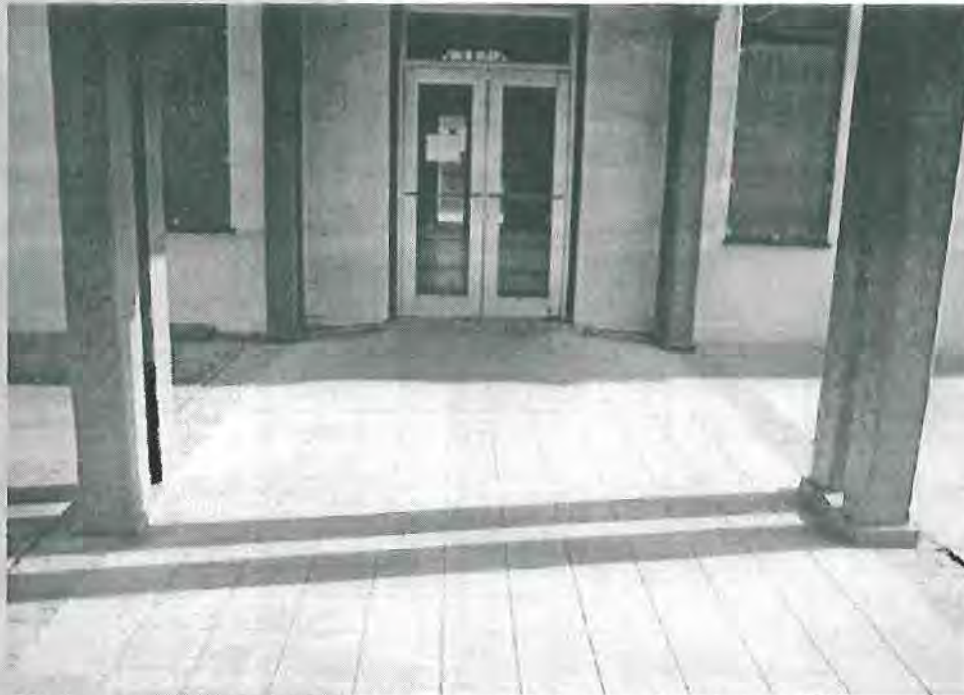
This is an example of a building entrance modified to comply with accessibility requirements. The original scored concrete was removed and new concrete was ramped up to threshold and matched to the existing concrete in color, texture, and scoring. The original brick edging was left unaffected. The entrance doors shown here are not historic. Photograph courtesy of Architect Milford Wayne Donaldson, FAIA, January 11, 2000.

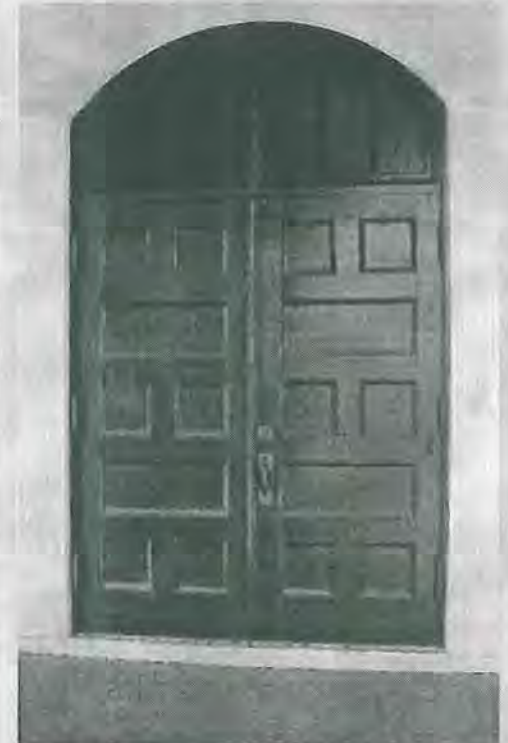
The typical single step into most buildings may be avoided through alternative routes or by installing an appropriate reversible short ramp for wheelchair access.

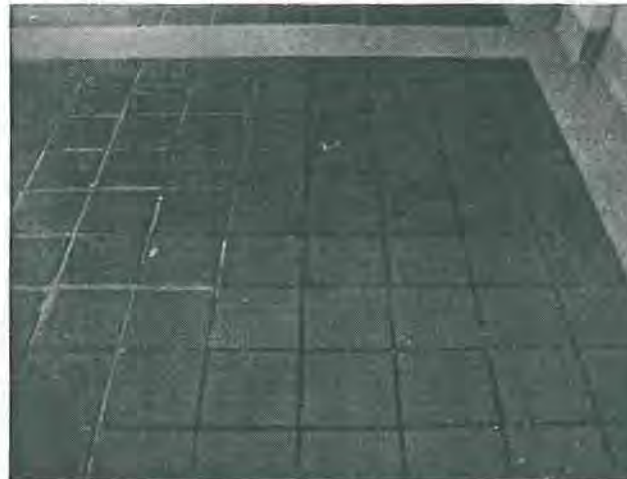
The floor tile should not be waxed to the point that the surface becomes too slippery and poses a threat to persons on crutches or that have other disabilities. Photograph courtesy of Architect Milford Wayne Donaldson, FAIA, February 2000.

Install reversible treatments for slippery surfaces such as vinyl tile, and terrazzo floors, as found in the Commander's Office area, can be refinished to meet accessibility standards.

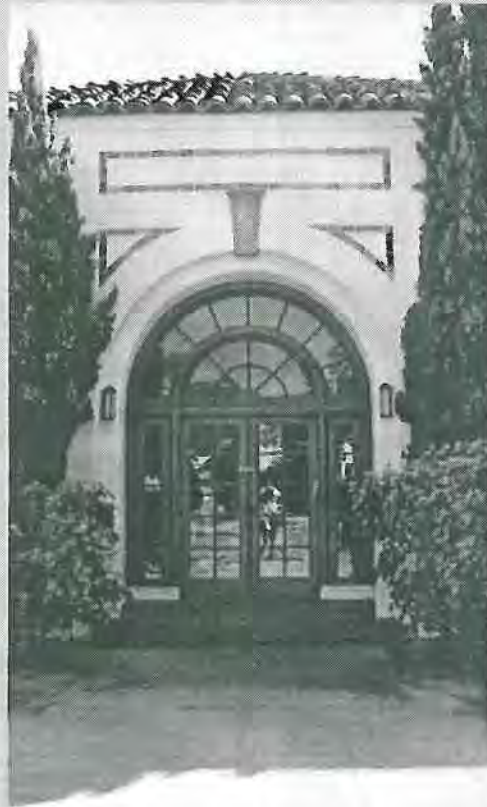
A common condition at the Naval Training Center is the one or two step elevation change at the entrances. In some cases, this can be treated by regrading and constructing a sloped sidewalk. This is preferred because it reduces the visual effect on the historic buildings. Photograph courtesy of Architect Milford Wayne Donaldson, FAIA, December 21, 1999.

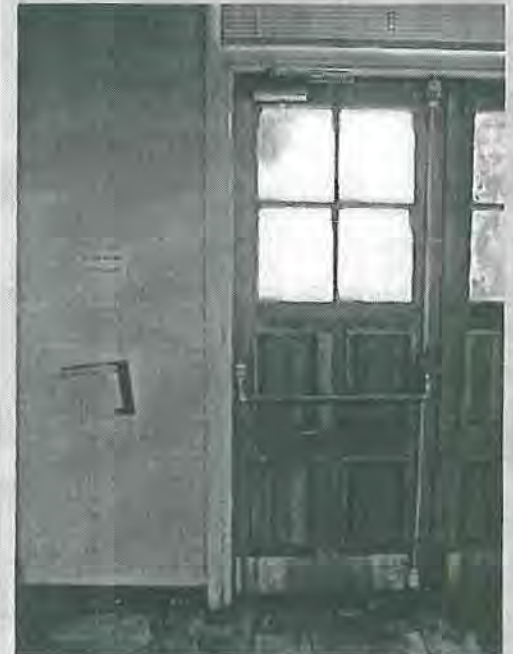
Several exit doors have been retrofitted with panic hardware; however exit signs have not been installed. All exit doors should have illuminated exit signs. Photograph courtesy of Architect Milford Wayne Donaldson, FAIA, February 2000.

Add exit illumination and exit route guidance in a manner that does not damage nor detract from historic details and materials.

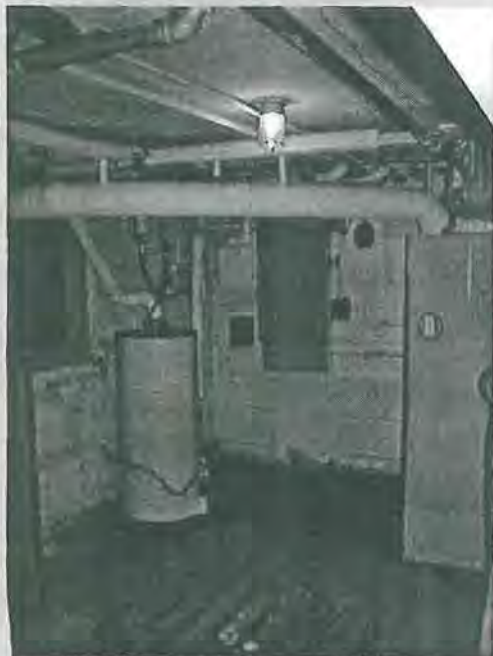
Residential basement areas may contain lead-based paint or asbestos as seen in this basement in Officer's Quarters "A". All such areas should be investigated for hazardous materials. Photograph courtesy of Architect Milford Wayne Donaldson, FAIA, February 2000.

Remove toxic building materials only after thorough testing and only after less invasive abatement methods are determined to be inadequate.

Monitor encapsulated asbestos for any signs of deterioration. If determined asbestos should be removed, utilize trained personnel following prescribed methods.

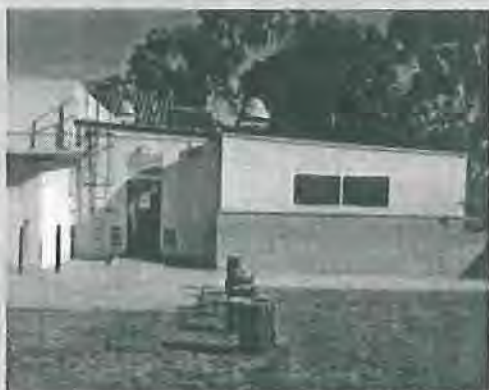
Inappropriate additions not sensitive to the original design in materials, massing, or character should be evaluated for possible demolition. Photograph courtesy of Architect Milford Wayne Donaldson, FAIA, January 4, 2000.

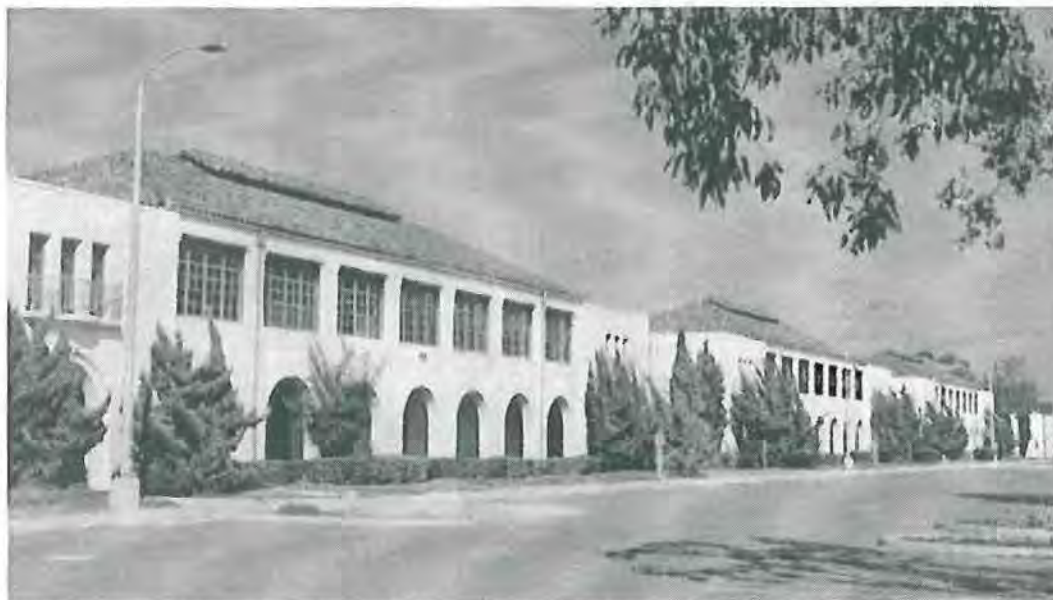
*The simplicity of form, the rhythm of the arches, the variegated tile roofs, the predominate use of plaster and a single exterior wall color present a strong cohesiveness of architectural style.
Photograph courtesy of Architect Milford Wayne Donaldson, FAIA, January 11, 2000.*

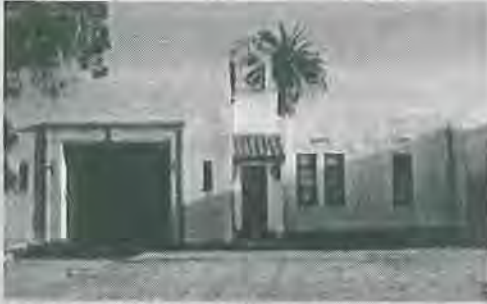
Buildings, like the old fire station, can be adaptively reused for other uses and still maintain their architectural character-defining forms and integrity. Photograph courtesy of Architect Milford Wayne Donaldson, FAIA, January 10, 2000.

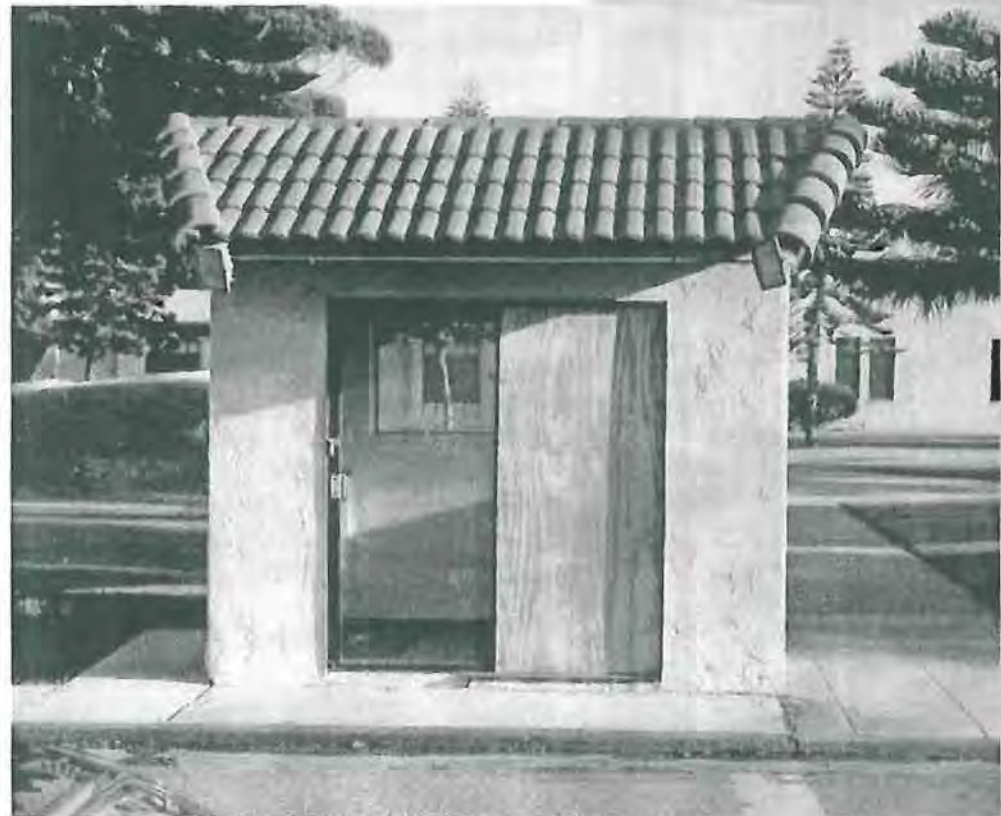
The architecture of this building, although slightly Spanish in character, does not capture the historical elements of the original design and diminishes the historic character of the district. Its placement in sellers plaza disrupts the master plan. Photograph courtesy of Architect Milford Wayne Donaldson, FALA. January 10, 2000.

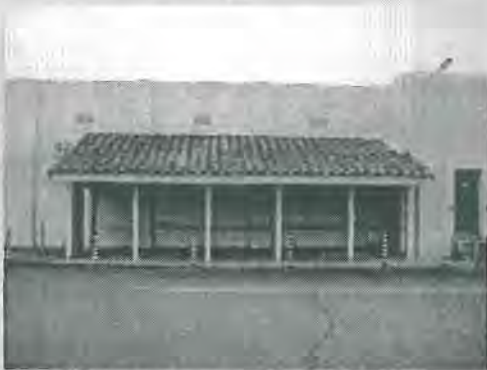
The addition of contrived porch coverings greatly detracts from the historic district. Photograph courtesy of Architect Milford Wayne Donaldson, FAIA, January 11, 2000.

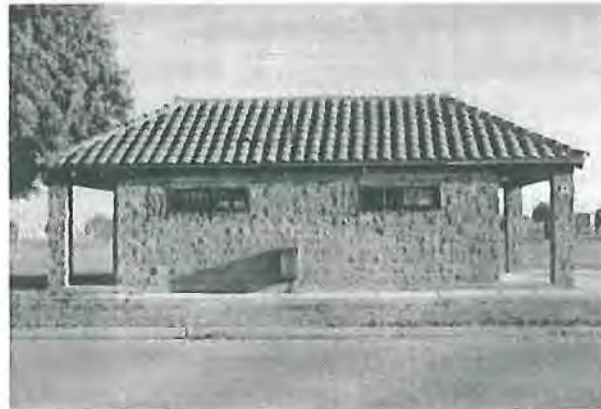
This new restroom building attempted to blend in with the Spanish style of the buildings. However, it is poorly executed in form, design and materials. The structure detracts from the character of the NTC Historic District. Photograph courtesy of Architect Milford Wayne Donaldson, FAIA, January 10, 2000.

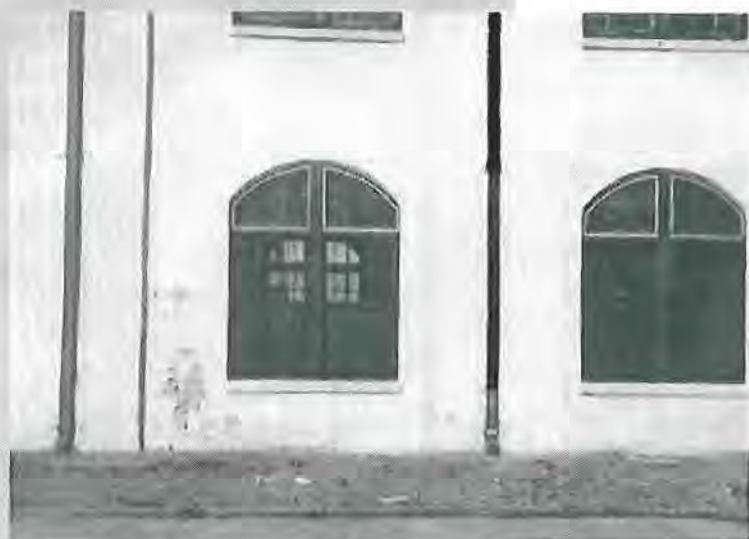
*Stucco texture and color chipping in several buildings.
Photograph courtesy of Architect Milford Wayne Donaldson,
FAIA, January 27, 2000.*

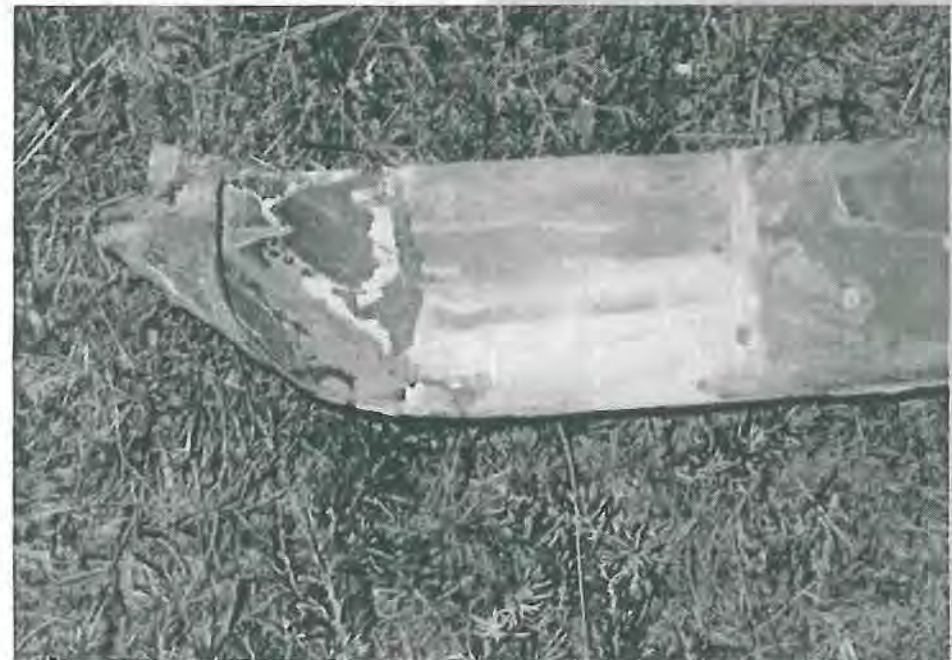
Copper downspout removed from Building 28 showing layers of paint. The downspouts were originally left unpainted. Photograph courtesy of Architect Milford Wayne Donaldson, FAIA, January 27, 2000.

The evidence in the cross-section sample suggests the copper gutter was not originally painted. There appears to be a thin oxidation layer directly above the copper substrate, below fragments of what may be a red lead-based primer. The first generation of paint found in this sample is a green layer which lines up with the second generation of green paint found on samples 1 and 3 from wood trim elements.

There are nine generations of paint in the sample on the downspout. Generations 2 through 7 are off-white and cream-colored paints similar to those found in the stucco samples. The two uppermost (most recent) paints are the same type of blue paint found in the wood trim samples. This paint sequence indicates that although the downspout was not originally painted, it was painted comparatively early on in the life of the building. In generations 1, 8, and 9 it was painted to match the wood trim, and in generations 2 through 7 it was painted to match the body color of the building.

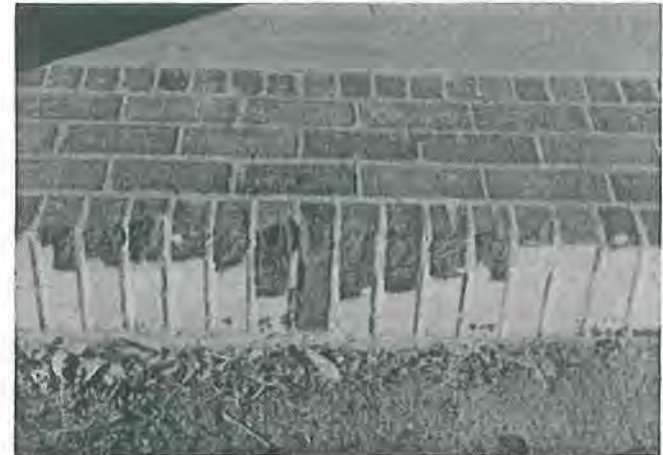
Bricks inappropriately painted and chipped at an arcade entrance. Photograph courtesy of Architect Milford Wayne Donaldson, FAIA, January 27, 2000.
