PLUME TRACKING MONITORING PLAN FOR THE POINT LOMA AND SOUTH BAY OCEAN OUTFALL REGIONS, SAN DIEGO, CALIFORNIA

Progress Report March 2021

Report Period: January – December 2020

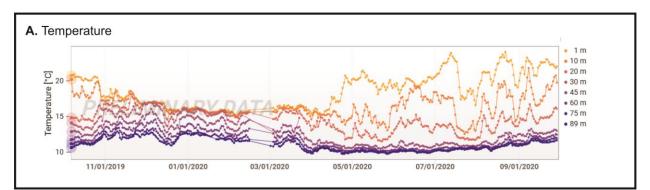
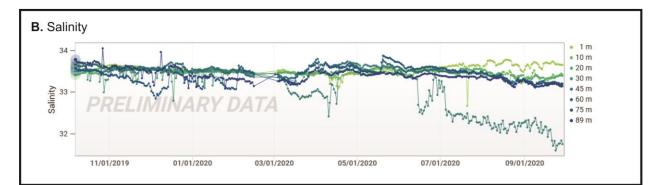
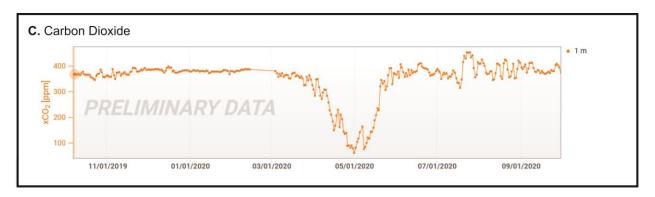
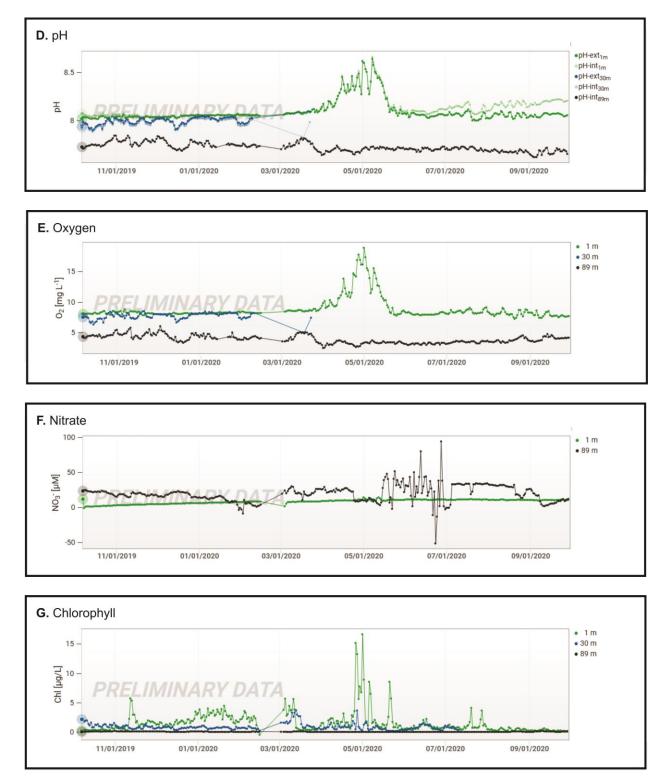
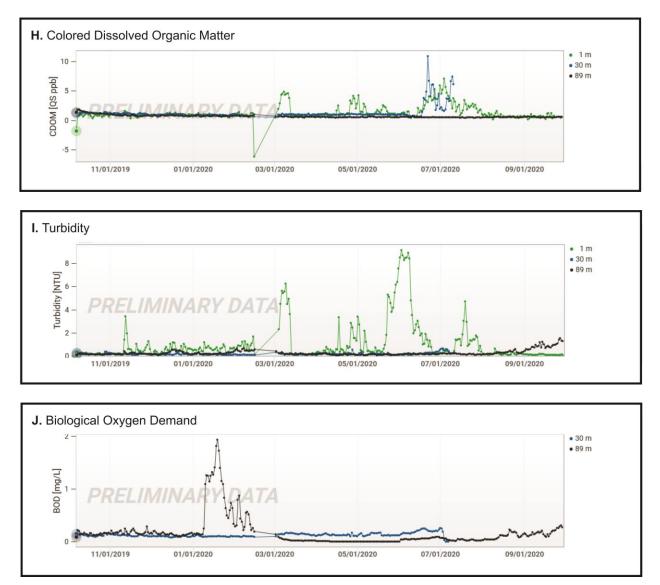
FIGURE 1. Preliminary data from the second deployment of the PLOO real-time oceanographic mooring system from 10/07/2019 – 09/29/2020, shown as daily averages. These raw real-time data have not been reviewed for quality and may include errors. Parameters include, A: Temperature; B: Salinity; C: Carbon Dioxide; D: pH; E: Oxygen; F: Nitrate; G: Chlorophyll; H: CDOM; I: Turbidity; and J: BOD. For real time preliminary data from the PLOO mooring, see http://mooring.ucsd.edu/dev/ploo/

- Further consultation with SIO to develop a plan to transfer data storage and processing responsibilities of RTOMS data to the City of San Diego by the end of the current SIO contract in 2022.
- <u>Second Deployment of PLOO RTOMS</u> (see Figure 1).

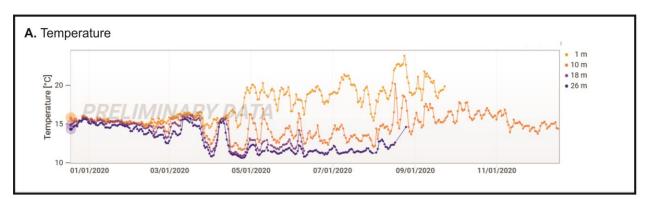
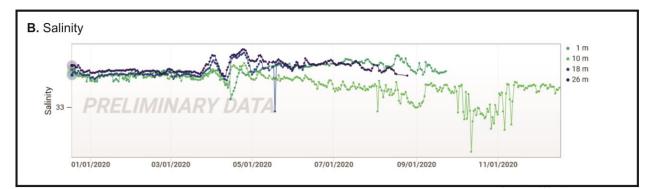
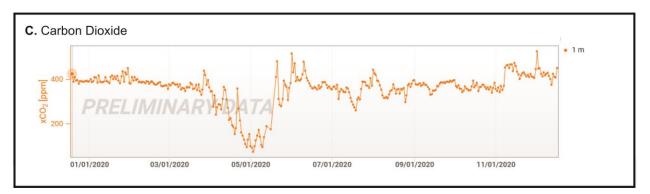
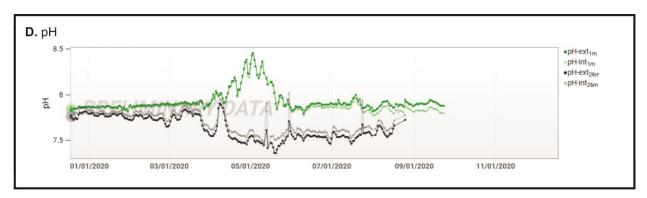
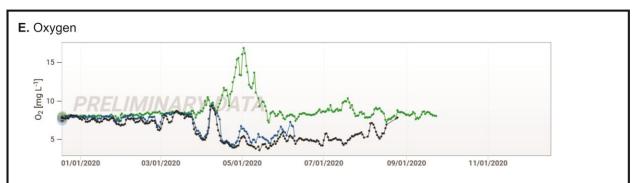
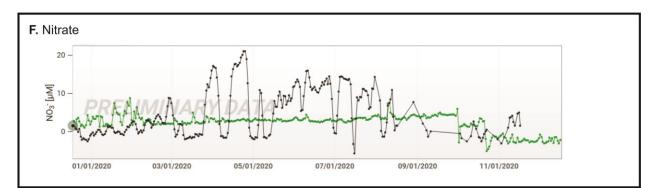
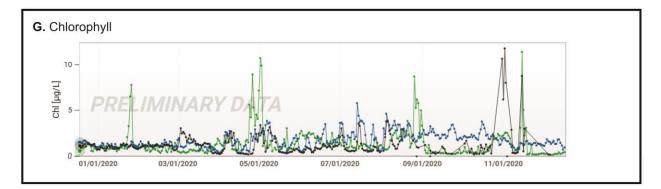
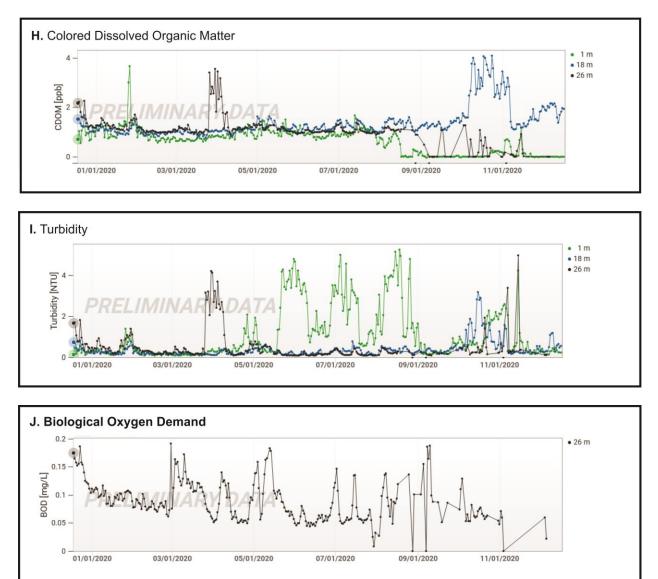
FIGURE 2. Preliminary data from the third deployment of the SBOO real-time oceanographic mooring system from 12/18/2019 – 12/17/2020, shown as daily averages. These raw real-time data have not been reviewed for quality and may include errors. Parameters include, A: Temperature; B: Salinity; C: Carbon Dioxide; D: pH; E: Oxygen; F: Nitrate; G: Chlorophyll; H: CDOM; I: Turbidity; and J: BOD. For real time preliminary data from the SBOO mooring, see http://mooring.ucsd.edu/dev/sboo/

- Work plan for ROTV/CTD quarterly surveys completed (see Plume Tracking Pilot Study, submitted to Regional Board on March 3, 2020).
- <u>Third Deployment of SBOO RTOMS</u> (see Figure 2).

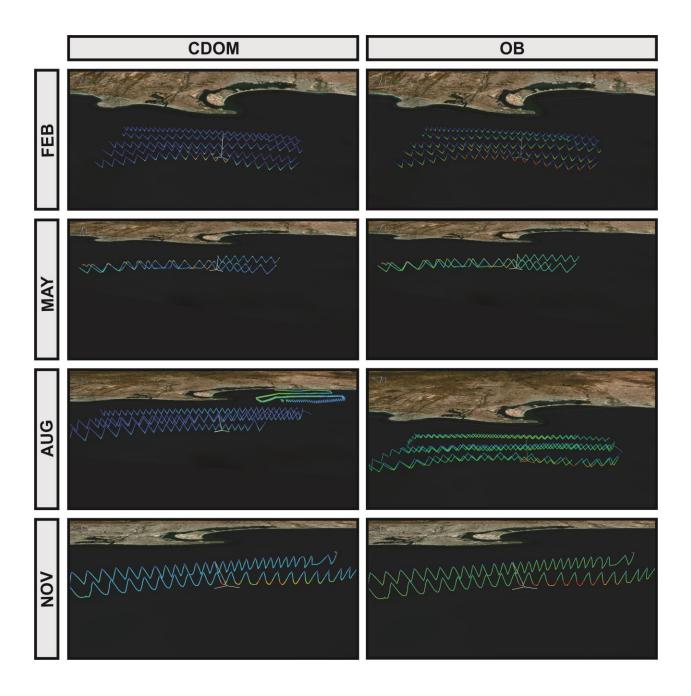
FIGURE 3. Preliminary maps from the PTMP Pilot Study produced from quarterly ScanFish tows in the PLOO region. Maps for the SBOO region are not currently available. Parameters presented include: Colored Dissolved Organic Matter (CDOM); and Optical Brightness (OB). These raw data have not been reviewed for quality and so may include errors.

• PTMP Pilot Study - first quarter testing implemented in PLOO region. ScanFish towed at 60m, 80m, and 100m contours at PLOO water quality stations (see Figure 3).
