# SATELLITE & AERIAL COASTAL WATER QUALITY MONITORING IN THE SAN DIEGO / TIJUANA REGION

13 June 2023

This report summarizes observations made during the period 1/1/2022 – 12/31/2022.

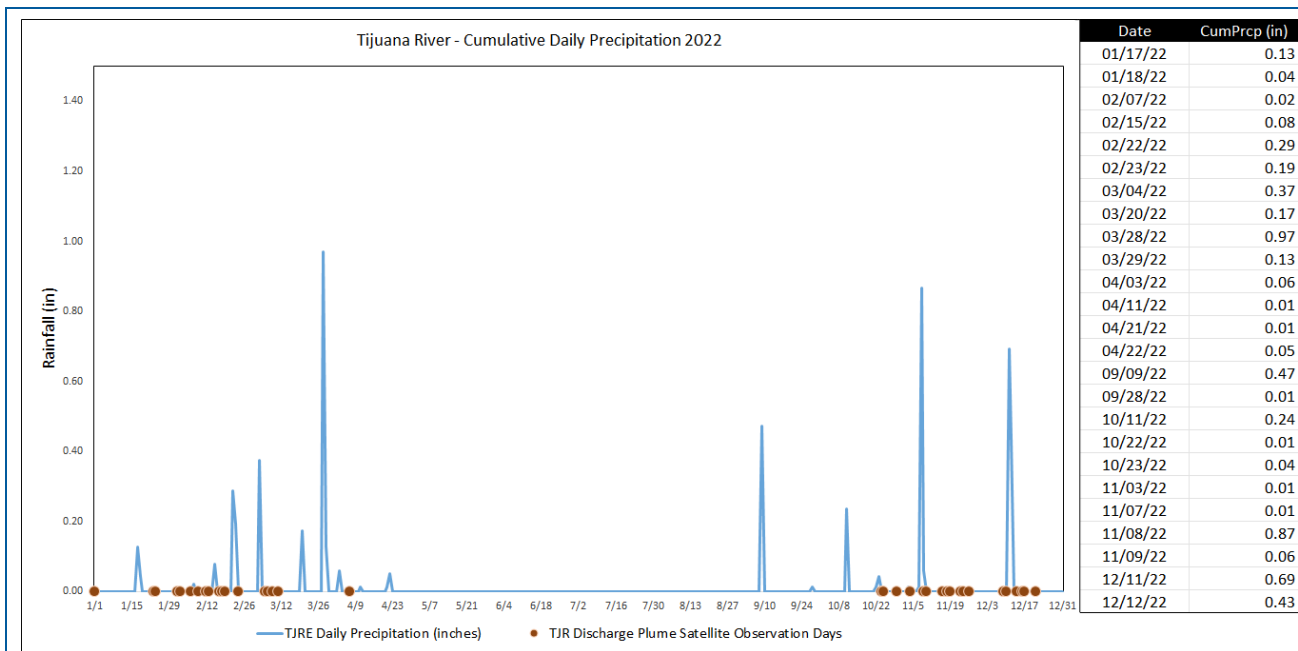
**Figure 3.** Daily accumulated rainfall in the Tijuana Estuary and days on which significant TJR discharge was observed in the high-resolution satellite imagery, including the Sentinel 1 SAR data.

Figure 3 shows cumulative daily precipitation in the Tijuana Estuary. The table to the side of the plot gives the dates for which there was measurable precipitation at that station. As has been noted in the previous reports, the monthly and annual precipitation amounts can differ at times between the two reporting stations. The primary periods of consistent and/or heavy precipitation occurred during the months of February, March, November, and December. All (36 out of 36) significant TJR discharge events observed in the remotely sensed data occurred during the months of January through April and October through December, which is considered to be the Southern California rainy season. Most can be associated with a rainfall event occurring within a few days of the observation (Figure 3).

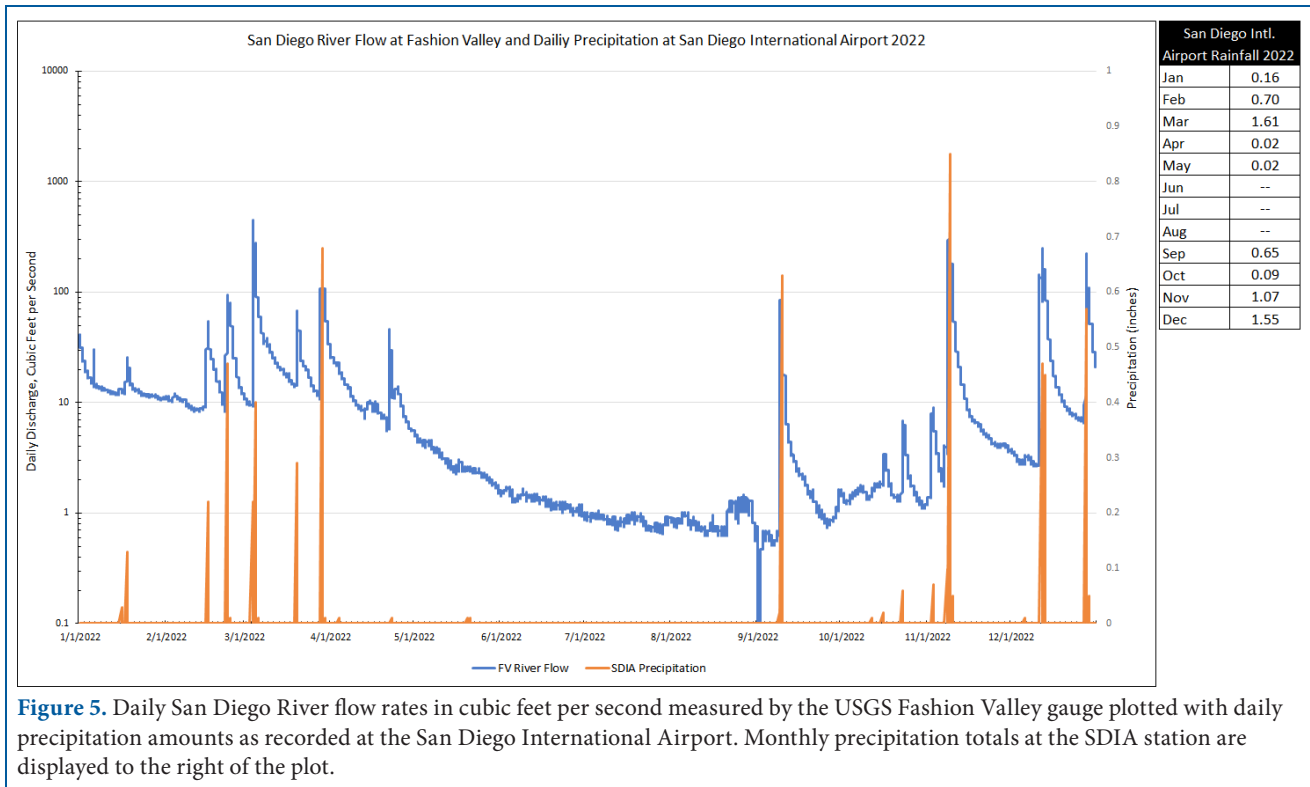
**Figure 5.** Daily San Diego River flow rates in cubic feet per second measured by the USGS Fashion Valley gauge plotted with daily precipitation amounts as recorded at the San Diego International Airport. Monthly precipitation totals at the SDIA station are displayed to the right of the plot.

As noted above, there was almost no precipitation in the San Diego region during the months of May through the first week of September. River flow rates in cubic feet per second (cfs) measured by the United States Geological Survey (USGS) Fashion Valley gauge correspond well with the rainfall data. In Figure 5 daily SDIA precipitation totals are plotted with river flow data and monthly precipitation totals are displayed to the right of the plot. The 2022 the river flow rates matched what would be expected given seasonal rainfall patterns.

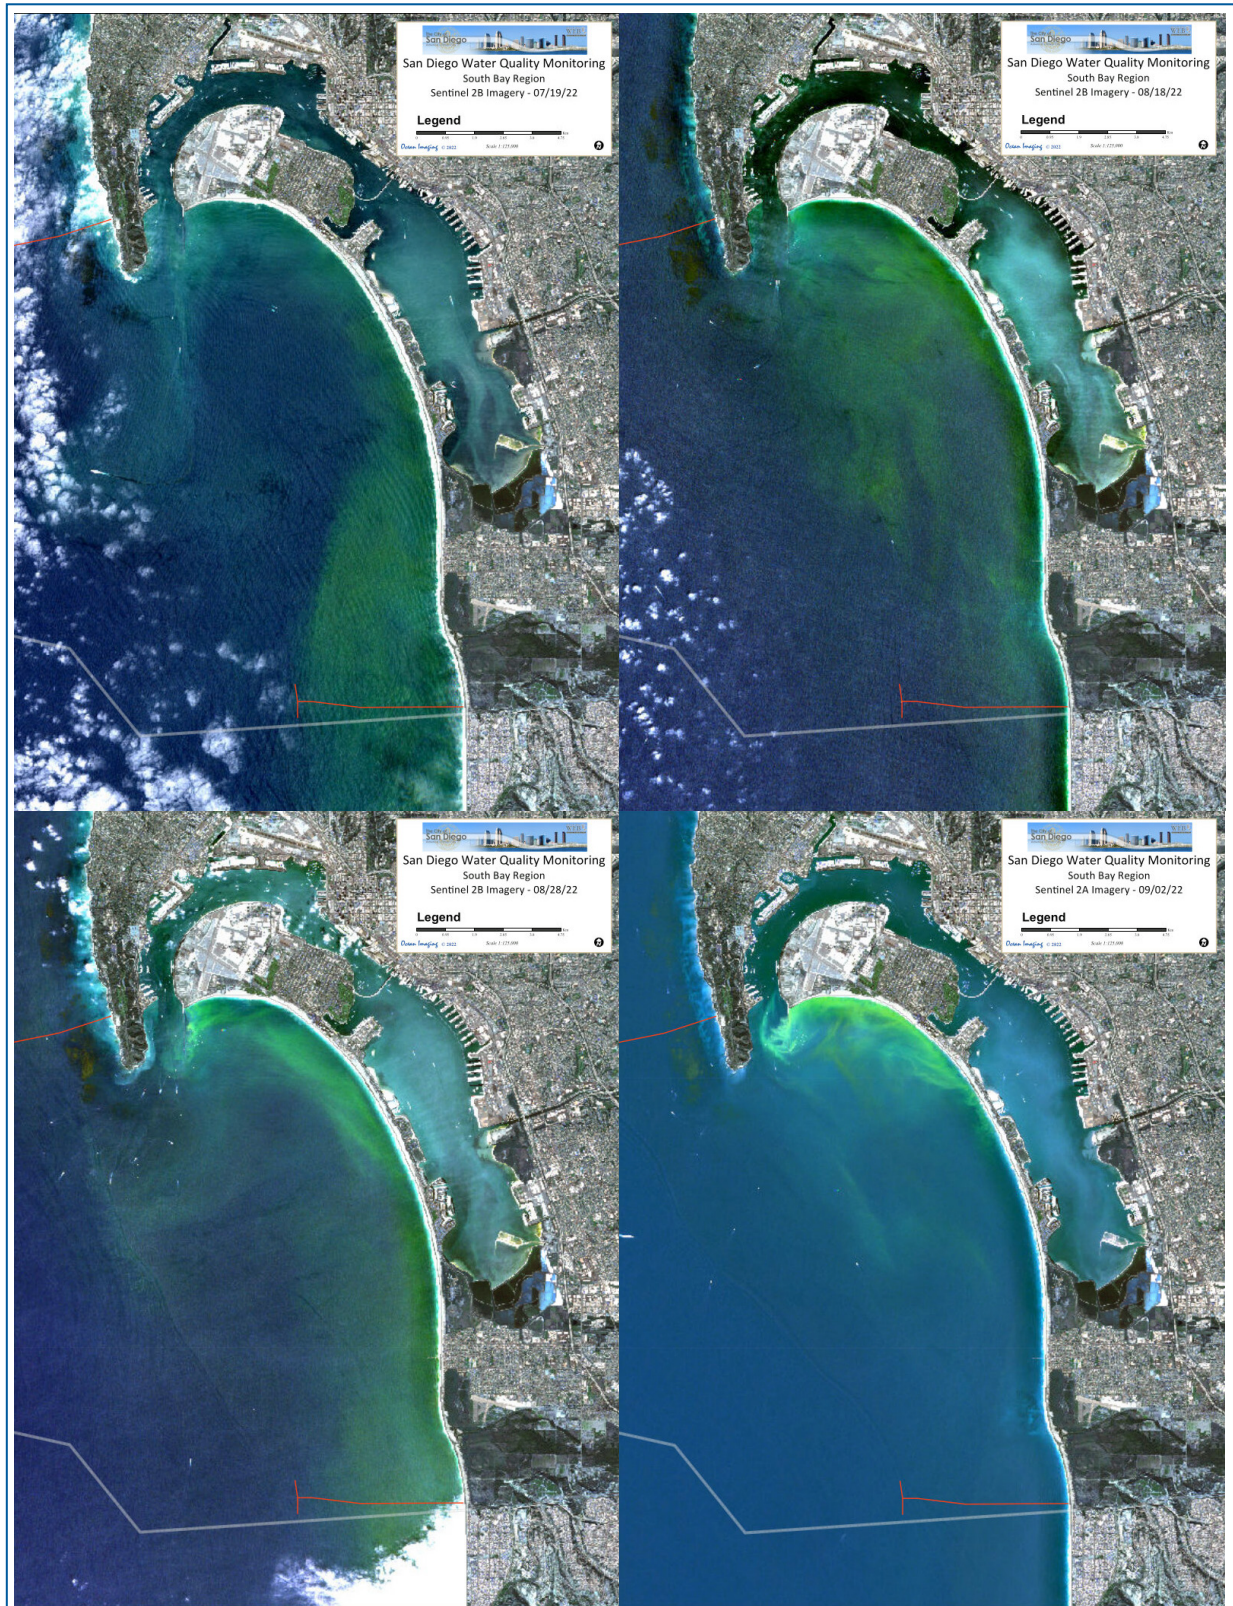
**Figure 6.** Sentinel 2A and 2B data from 07/19/22, 08/18/22, 08/28/22 and 09/02/22 highlighting the strong phytoplankton blooms which occurred in the San Diego South Bay region during July, August, and September.

Despite the dry summer conditions with little coastal runoff measured by the USGS gauge or observed in the satellite data, there were several days during this time period that exhibited strong coastal phytoplankton blooms (Figure 6). This is an indication that the nutrients fueling the blooms likely entered the San Diego region from offshore and/or via upwelling events. Figure 7 shows a summer satellite image with reflectance signatures indicative of a strong red tide event. Also seemingly unrelated to the rainfall and river flow data, November experienced several days late in the month during which the TJR discharge extended far offshore and was documented pushing up past the southern tip of Point Loma - well after the heavy rain event on 11/08/22 (Figure 1 above).

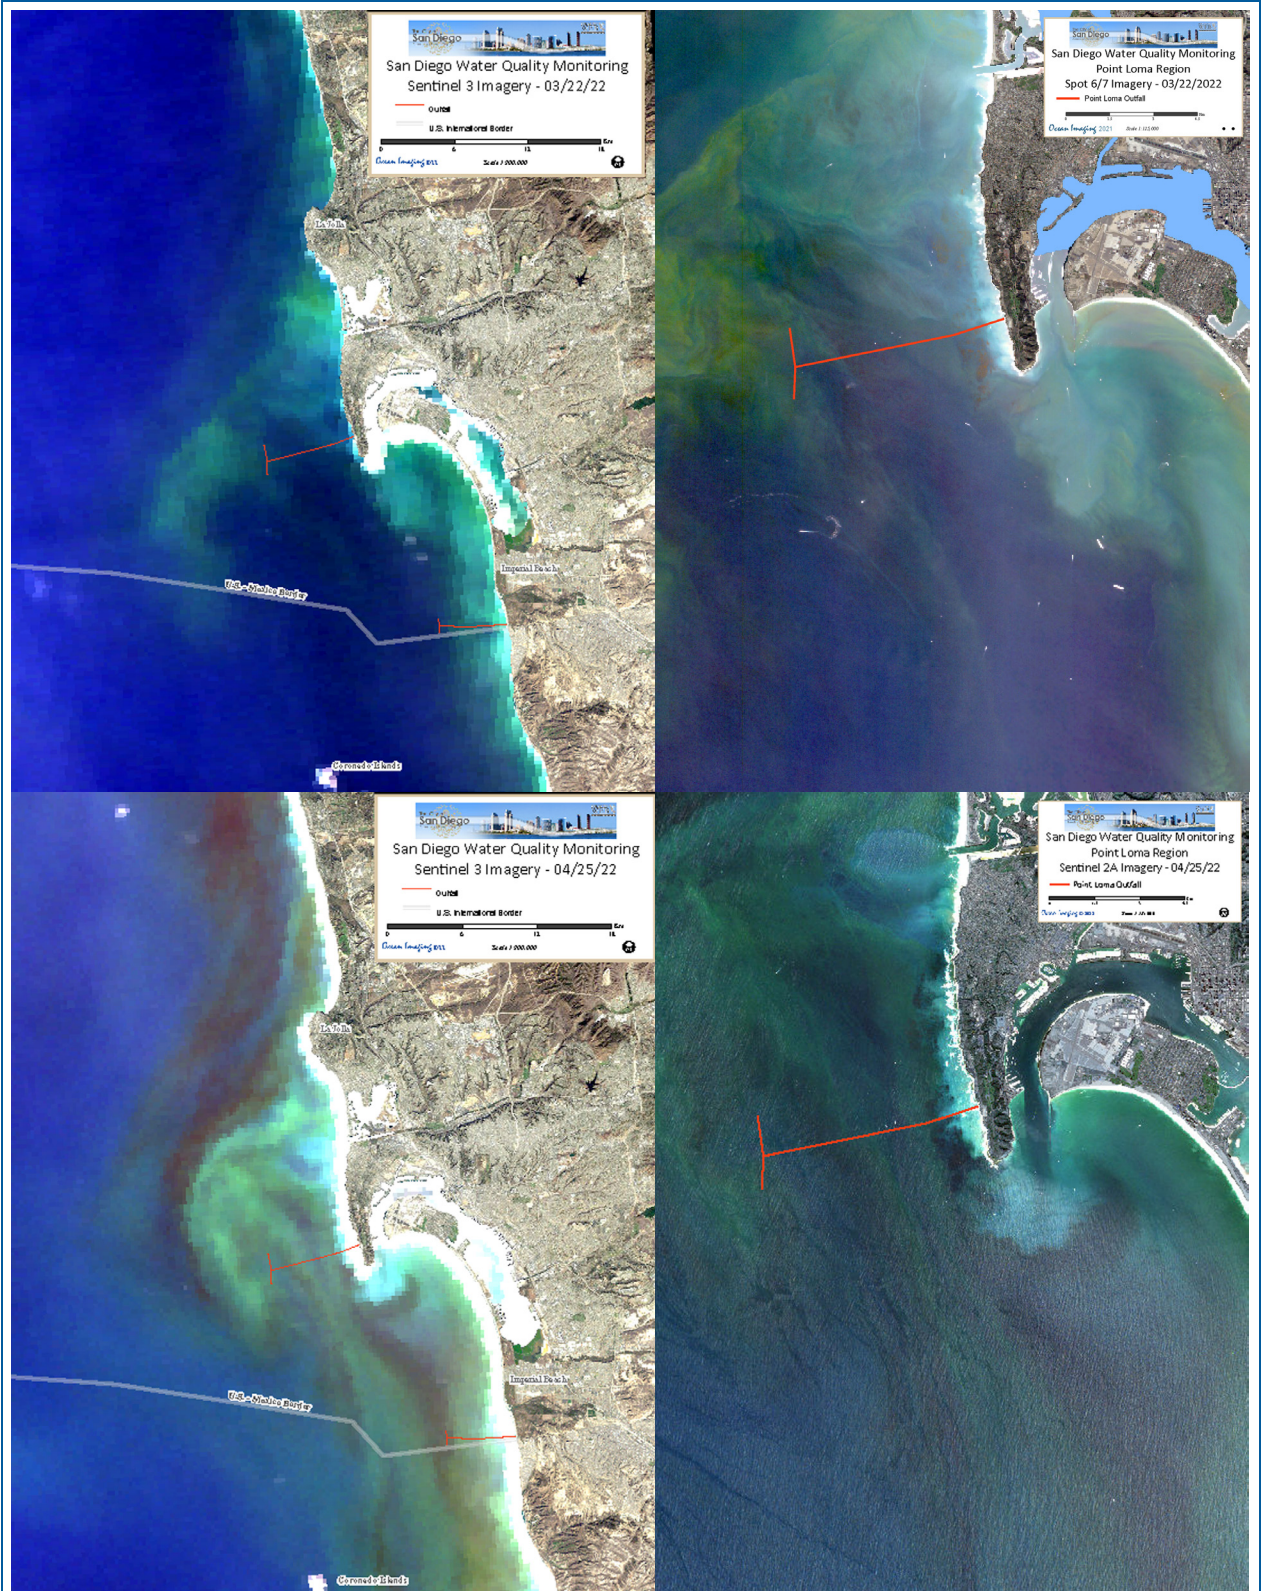
**Figure 10.** Sentinel 3 images (left side) and the higher resolution SPOT and Sentinel 2A images (right side) showing the turbid water flowing out of the Mission Bay entrance and associated plankton blooms on 03/22/22 (top) and 04/25/22 (bottom).
