W:\18187-B-FY18\_Channel\_Prioritization\GIS\Appendix\_F\_Culverts\Map87\_Jeremiah\_04.2018

**Assessment Results**

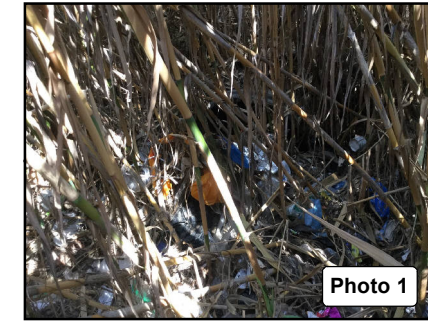
Photo 1

- Channel Prioritization Score: 53.3 out of 100
- Capacity Prior to Maintenance: 50-year storm event
- Capacity After Maintenance (As-built Capacity): 100-year storm event
- Clogging Potential: LOW
- Approximate Invasive Vegetation Coverage: HIGH
- Surrounding Area: Residential
- Infrastructure Failures: Failed side slope
- Site Evaluation Date: February 22, 2018
- Notes/Comments: The portion of the channel near Treat street and 27th street has a dense amount of arundo and is blocking the upstream culvert.
