2016 Substantial Conformance Review for Individual Maintenance Plan (IMP) and Individual Technical Assessments for Tijuana River Pilot Channel and Smuggler's Gulch, City of San Diego Site Development  
Permit No. 1134892, Master Storm Water System Maintenance Program

***Subject: 2016 Condition Verification for the Tijuana River Emergency Channel Maintenance Wetland Mitigation Project, San Diego County, California***

# **Final Wetlands Mitigation and Monitoring Plan for the Tijuana River Valley Channel Maintenance Project**

# Tijuana River Valley Channel Maintenance Mitigation Project

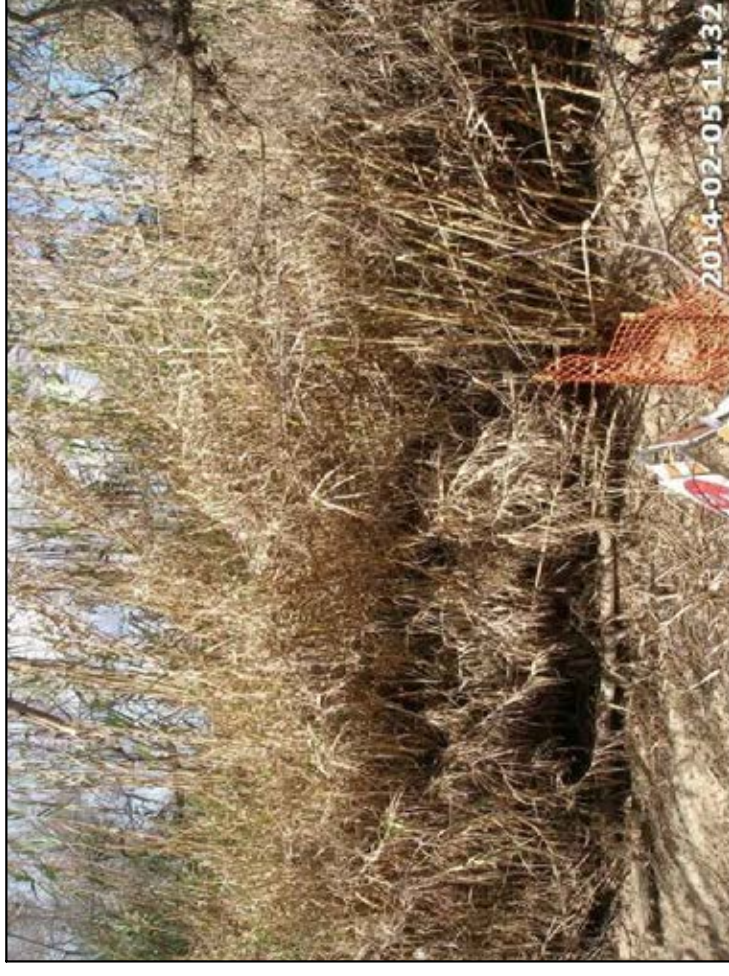
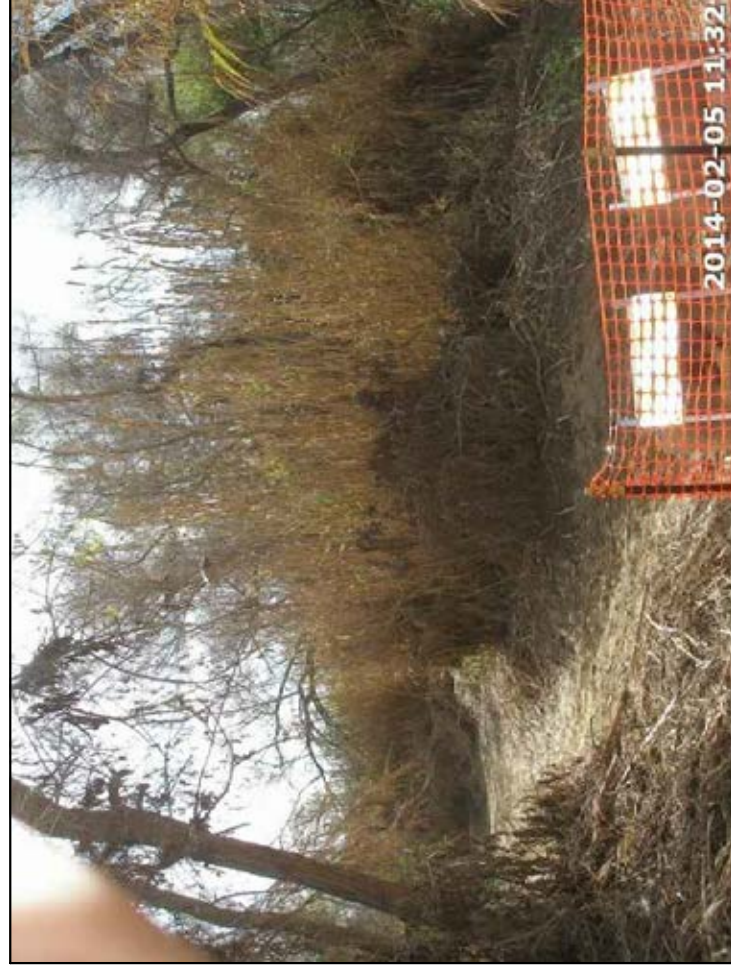
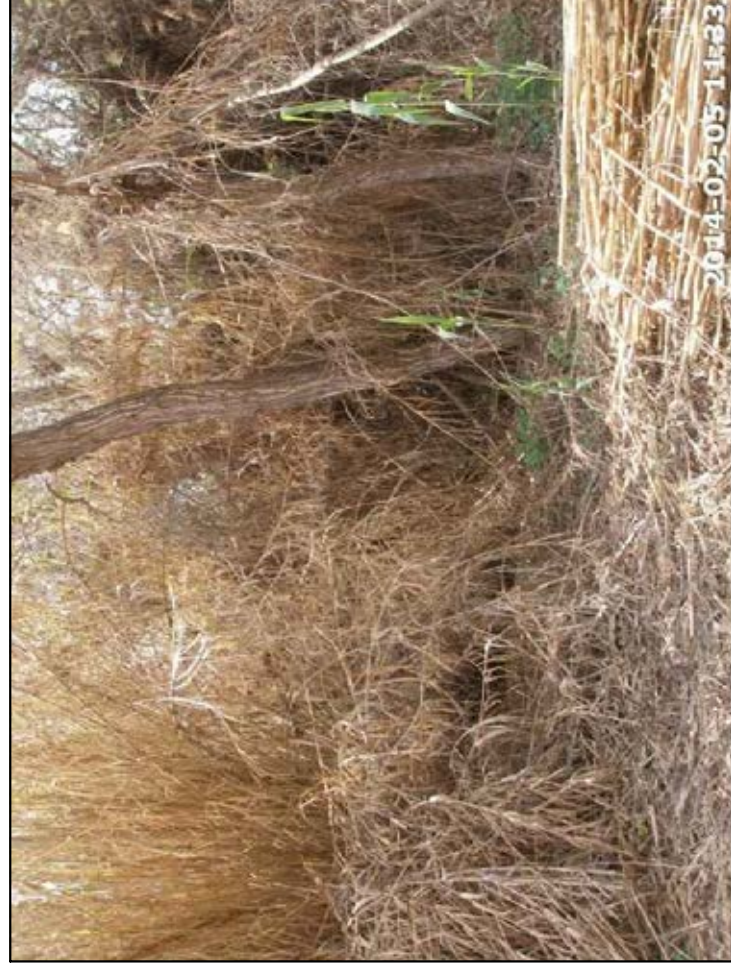
<p>Photo Point #7 (February 5, 2014).</p>	  <p>Photo Point #8 (February 5, 2014).</p>
  <p>Photo Point #9 (February 5, 2014).</p>	  <p>Photo Point #10 (February 5, 2014).</p>
<div><div> <div>8685-01</div></div><div><div>FIGURE A-2</div><div>Established Photo Points - Prior to Initial Weed Control</div></div></div> <div>First Annual Mitigation Monitoring Report for the Tijuana River Valley Channel Maintenance Mitigation Project</div>

Permanent photo-documentation stations were set up throughout the mitigation areas to visually document the site conditions and progress over time. A map of the photo points overlaid on an aerial map, along with photos are presented in Appendix A. Photos documenting the end of the year one monitoring period were taken on December 1, 2014, by Rory Driskell and Christopher Oesch (Dudek). A log of the most recent photopoint collection is shown in Table 3.

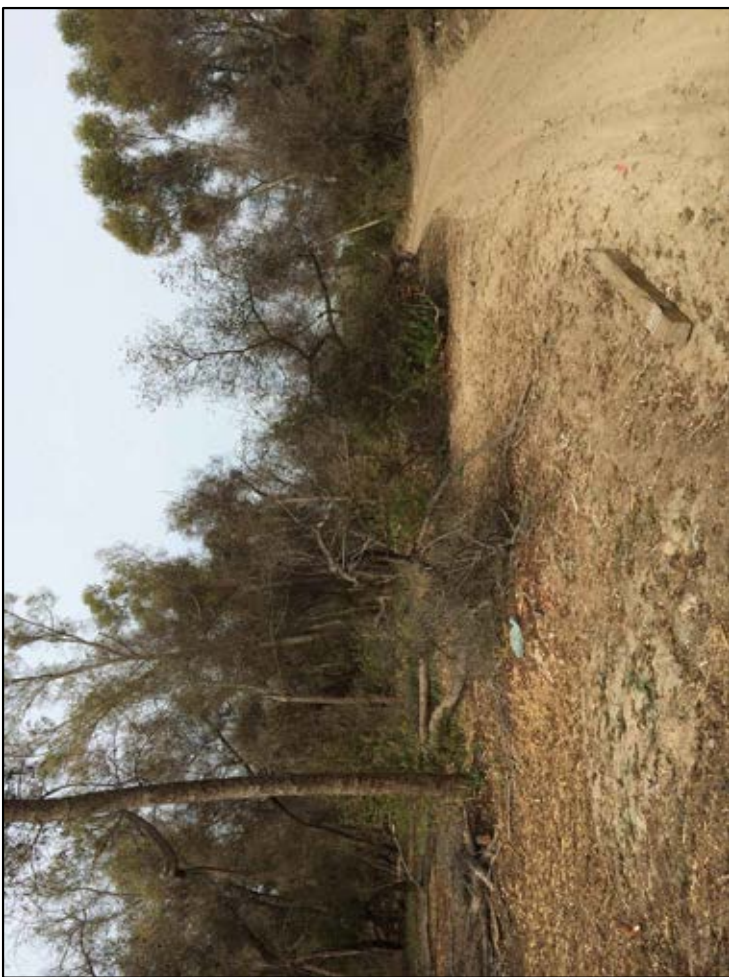
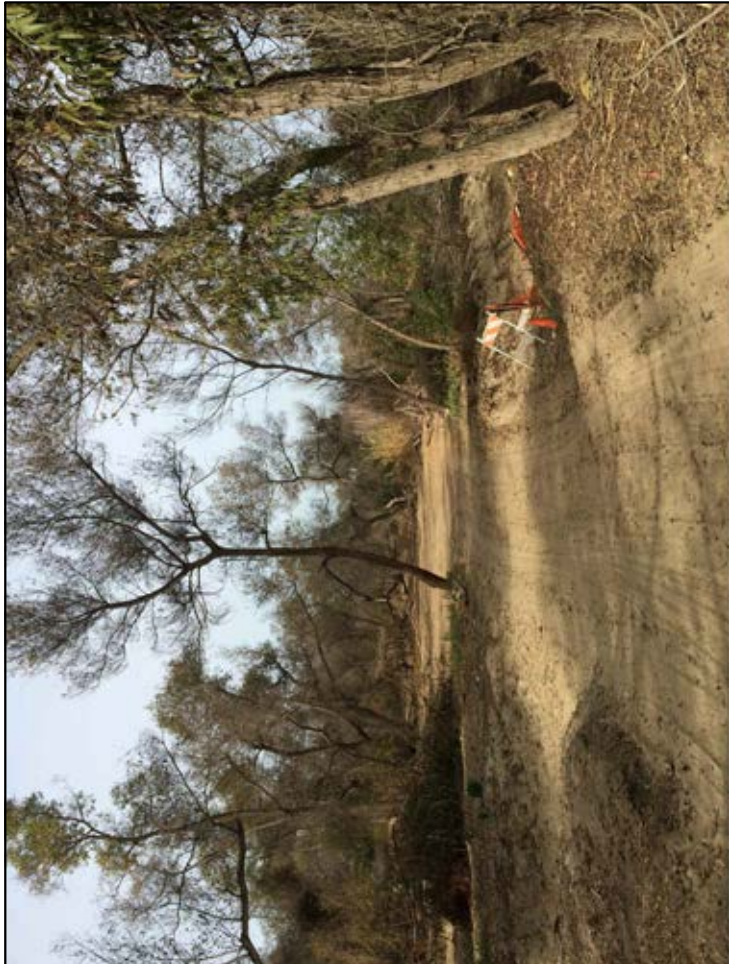
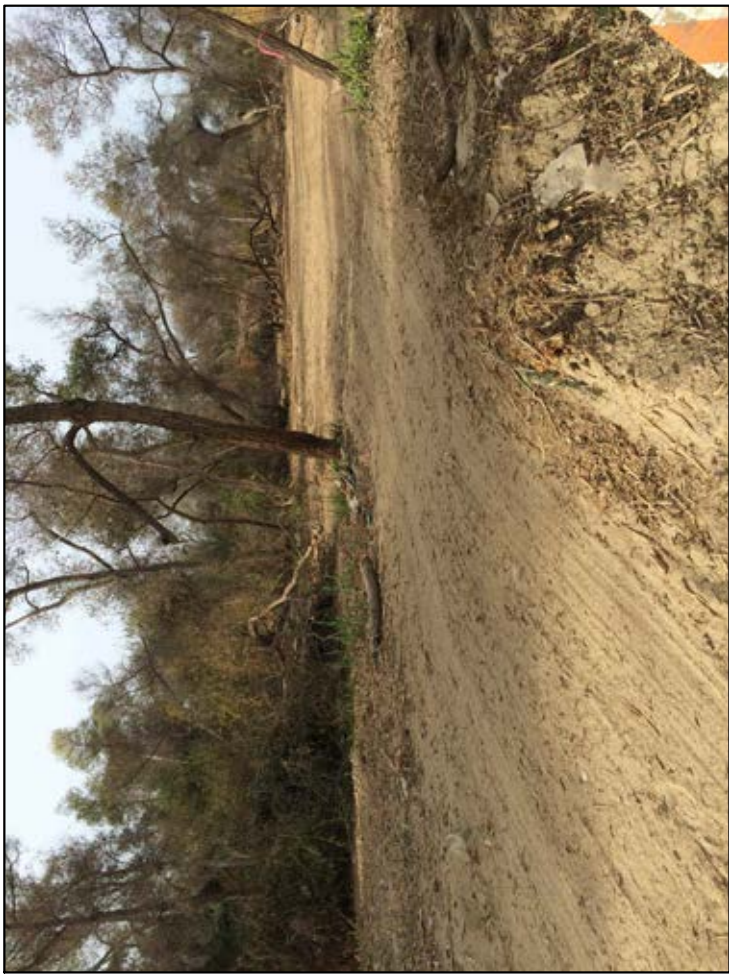
Photo Point #1 (December 1, 2014).	Photo Point #2 (December 1, 2014).	Photo Point #3 (December 1, 2014).

Photo Point #	Date	Time	Coordinates (Lat/Long,)	Direction	Location Description	Notes/Conditions
PP-1	12/1/14	1044	117° 5' 18.73" W 32° 33' 03.70" N	N	View of out-of-channel mitigation area along access road.	Area which received recent invasive non-native removal and control.
PP-2	12/1/14	1050	117° 5' 20.71" W 32° 33' 06.58" N	NW	View of out-of-channel mitigation area along access road at horse trail crossing at northern end of site.	Area which received recent invasive non-native removal and control.
PP-3	12/1/14	1051	117° 5' 20.99" W 32° 33' 06.83" N	W	View of out-of-channel mitigation area along access road at horse trail crossing at northern end of site.	Area which received recent invasive non-native removal and control.
PP-4	12/1/14	1052	117° 5' 21.12" W 32° 33' 06.91" N	W	View of out-of-channel mitigation area looking down the horse trail at cleared area.	Area which received recent invasive non-native removal and control.

1. Dudek recommends regular follow-up herbicide treatment and/or physical removal of target non-native invasive species which may resprout within the in-channel and out-of-channel mitigation areas.
2. Dudek recommends regular periodic trash removal within the mitigation sites.
