HISTORIC RESOURCES INVENTORY

1. Common name: Anderson Apartments
2. Historic name: Anderson Apartments
3. Street or rural address: 1747 5th Avenue
City San Diego Zip 92101 County San Diego
4. Parcel number: 533-303-02
5. Present Owner: Electronics Capital Corp Address: P.O. Box 2429
City San Diego Zip 92112 Ownership is: Public _____ Private X
6. Present Use: Residential Original use: Residential

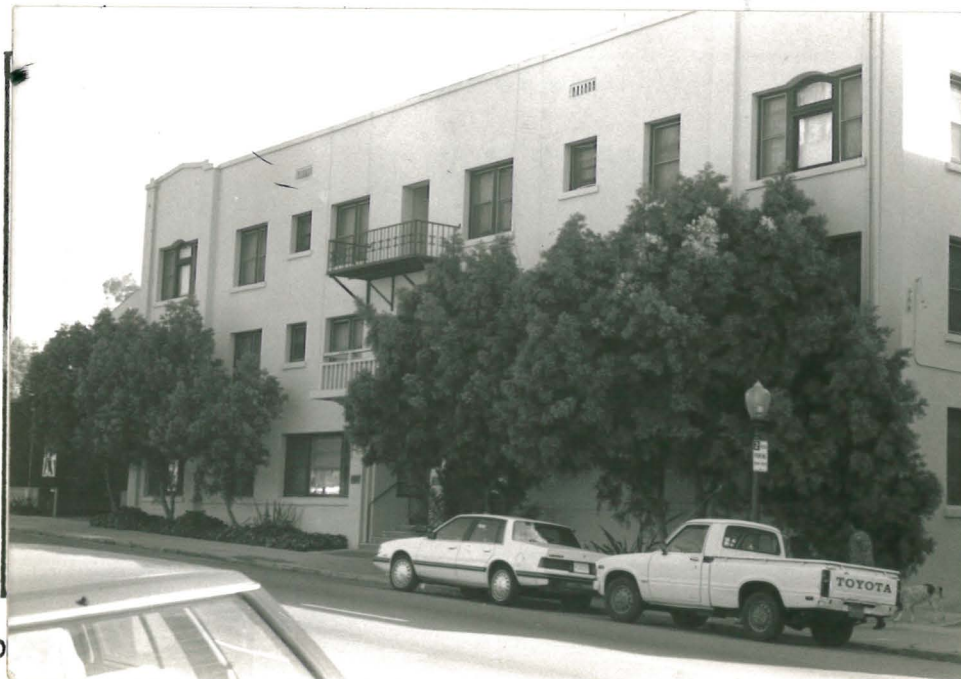
The Anderson Apartments at 1747 Fifth Avenue is a symmetrical 3-story rectangular building of the Mission Revival Style. The siding is stucco; the roof is flat with a parapet, which is stepped at the corners with dual full-length pilasters. Five steps with iron handrails lead to a rectangular entryway with a central recessed door which is wood framed with a single glass panel, brass doorknob, and double-paned transom. Original light fixtures and name plaques are on each side of the entryway. A bracketed 2nd story balcony with wood railing forms a hood for the entryway. The 3rd story balcony, directly above, has a decorative wrought iron railing. An open stairwell provides balcony access. Windows are double-hung pairs on the 2nd and 3rd floors, and central fixed panes with double-hung side panels on the 1st floor. Third floor windows near the corners feature a fixed-pane central window with semi-elliptical transom and double-hung side panels. Two horizontally-grated roof vents are symmetrically placed near the roofline. A fire escape exists on the south side.

13. Condition: Excellent ☒ Good _____ Fair _____ Deteriorated _____ No longer in existence _____
14. Alterations: None
15. Surroundings: (Check more than one if necessary) Open land _____ Scattered buildings _____ Densely built-up ☒
Residential ☒ Industrial _____ Commercial ☒ Other: _____
16. Threats to site: None known ☒ Private development _____ Zoning _____ Vandalism _____
Public Works project _____ Other: _____
17. Is the structure: On its original site? ☒ Moved? _____ Unknown? _____
18. Related features: None

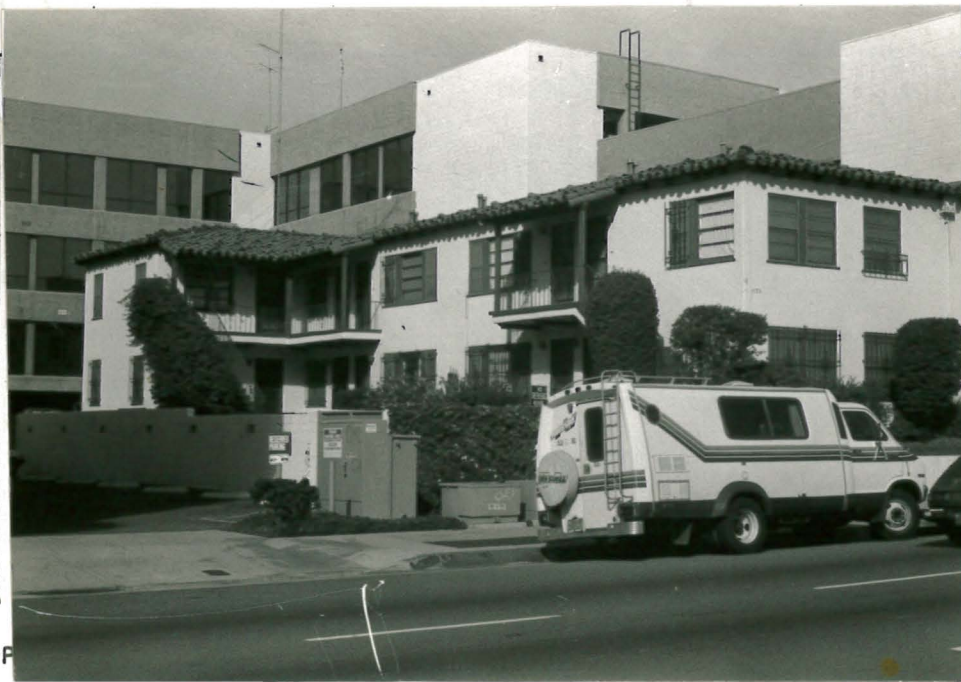
13. Condition: Excellent ☒ Good ☐ Fair ☐ Deteriorated ☐ No longer in existence ☐
14. Alterations: Security doors
15. Surroundings: (Check more than one if necessary) Open land ☐ Scattered buildings ☐ Densely built-up ☒
Residential ☒ Industrial ☐ Commercial ☒ Other: ☐
16. Threats to site: None known ☐ Private development ☐ Zoning ☒ Vandalism ☐
Public Works project ☐ Other: ☐
17. Is the structure: On its original site? ☒ Moved? ☐ Unknown? ☐
18. Related features: None

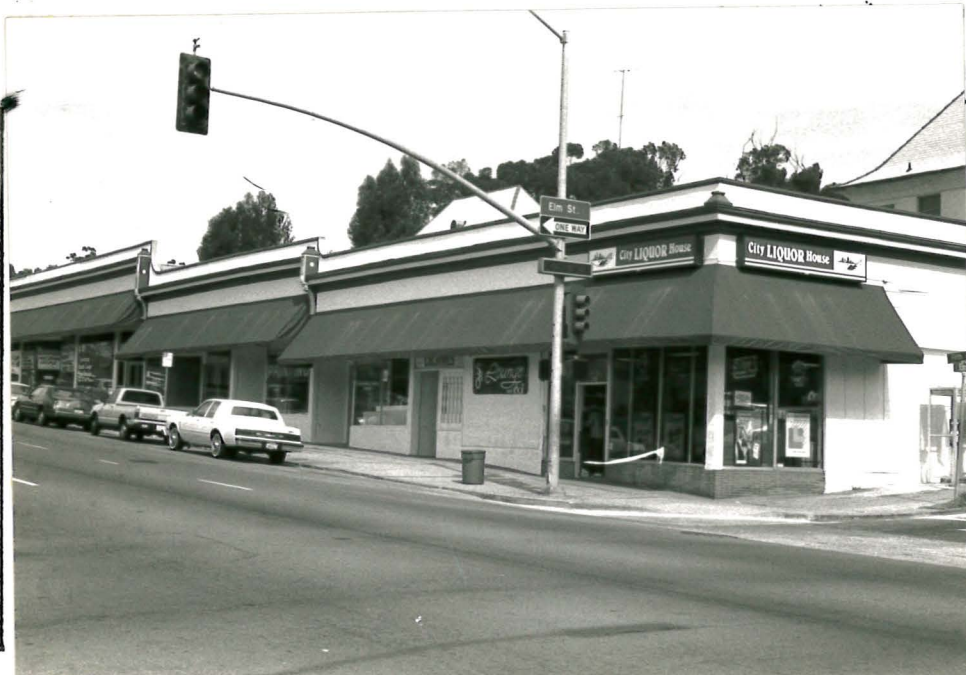
This single story one part commercial block is broken into five stepped sections and has a canvas awning also stepped, which emphasizes the horizontality of the block. The flat roof has a raised parapet and dentiled entablature with corbelled corner. Brackets at each step of the building and at each end. An expanse of plate glass windows runs across the front of the building, typical of 1920's commercial development. Many entry doors have been replaced with wood framed glass doors. Some windows have also been replaced using aluminum frame signage across the facade is an alteration.

13. Condition: Excellent _____ Good _____ Fair X Deteriorated _____ No longer in existence _____

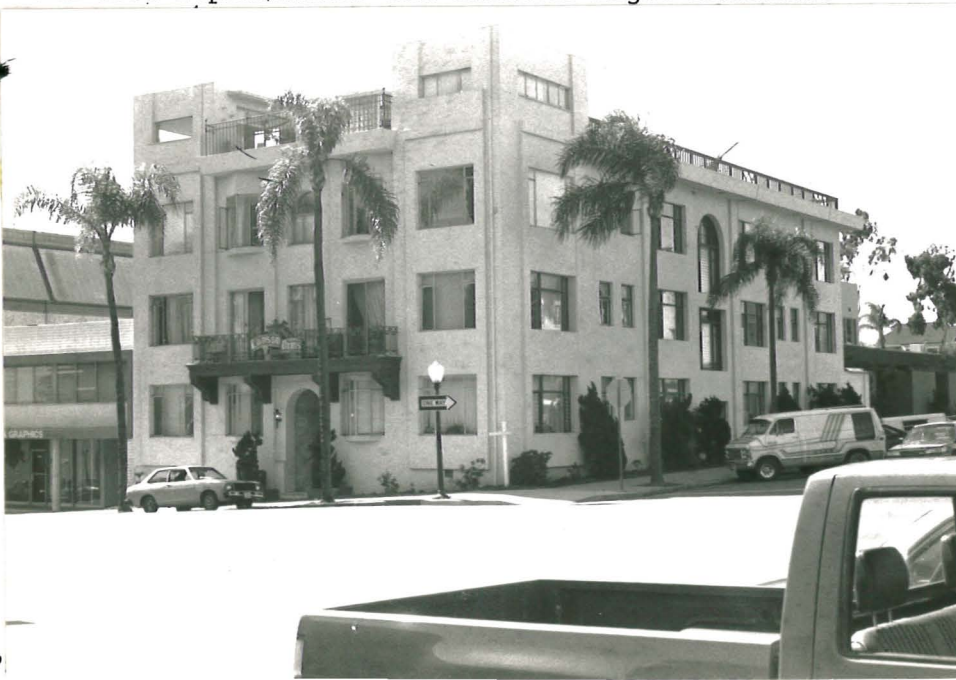
This three story, rectangular shaped apartment building is clad with stucco over pressed brick on a cement foundation. The south facing entrance facade is separated into three sections. Two corner square towers rise one story above the center areas and form covered porch areas and fourth floor living area on the iron balustraded roof garden. The recessed center section contains an arched, multi-paned window on the third floor flanked by projecting, triangularly shaped, multi-paned bay windows to either side. This pattern repeats on the first floor with a recessed, central arched entry between the two triangular $\frac{1}{2}$ bay side panel windows. Above the entry four massive wrought iron balustrade. Sliding glass doors (alterations) now lead out to the balcony. A projecting cornice surrounds the building, broken at the tower sections where vertical sections containing the windows project out. The remaining windows consist of various multi-paned casement groupings. Palms line the building along the street. An exterior light fixture is located just south of the entry and a freestanding lap post is located on the corner of 5th and Grape. Alterations include; The stucco facade, enclosure of tower sections, window and door replacements and exterior light fixtures.

13. Condition: Excellent _____ Good X Fair _____ Deteriorated _____ No longer in existence _____
14. Alterations: Metal Window, door frames, stucco
15. Surroundings: (Check more than one if necessary) Open land _____ Scattered buildings _____ Densely built-up X
Residential X Industrial _____ Commercial x Other: _____
16. Threats to site: None known X Private development _____ Zoning _____ Vandalism _____
Public Works project _____ Other: _____
17. Is the structure: On its original site? X Moved? _____ Unknown? _____
18. Related features: Foundation planting, street palms

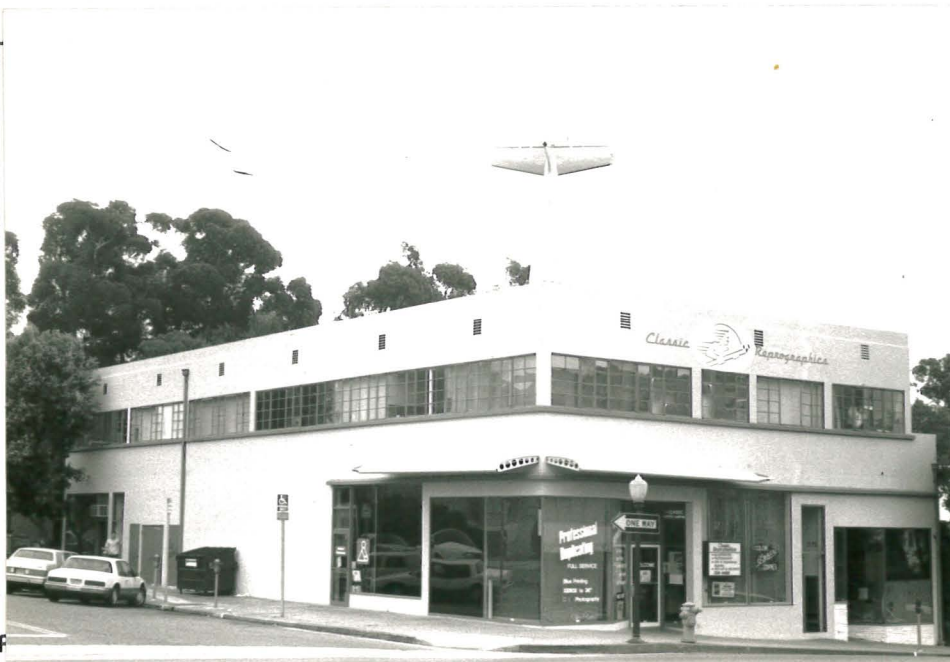
13. Condition: Excellent _____ Good _____ Fair X Deteriorated _____ No longer in existence _____
14. Alterations: Roof decoration, canopy, first story windows
15. Surroundings: (Check more than one if necessary) Open land _____ Scattered buildings _____ Densely built-up X
Residential X Industrial _____ Commercial _____ Other: X
16. Threats to site: None known _____ Private development _____ Zoning _____ Vandalism X
Public Works project _____ Other: _____
17. Is the structure: On its original site? X Moved? _____ Unknown? _____
18. Related features: None

This commercial building was erected in approximately 1937 as a car repair garage. It remained a garage until 1947, when it housed miscellaneous commercial uses. Presumably, some alterations to the building occurred at that time. Despite the alterations, the building is typical of a 1930's commercial structure. It is somewhat of a landmark due to the addition of the airplane on the roof. Its importance is enhanced by its corner location.

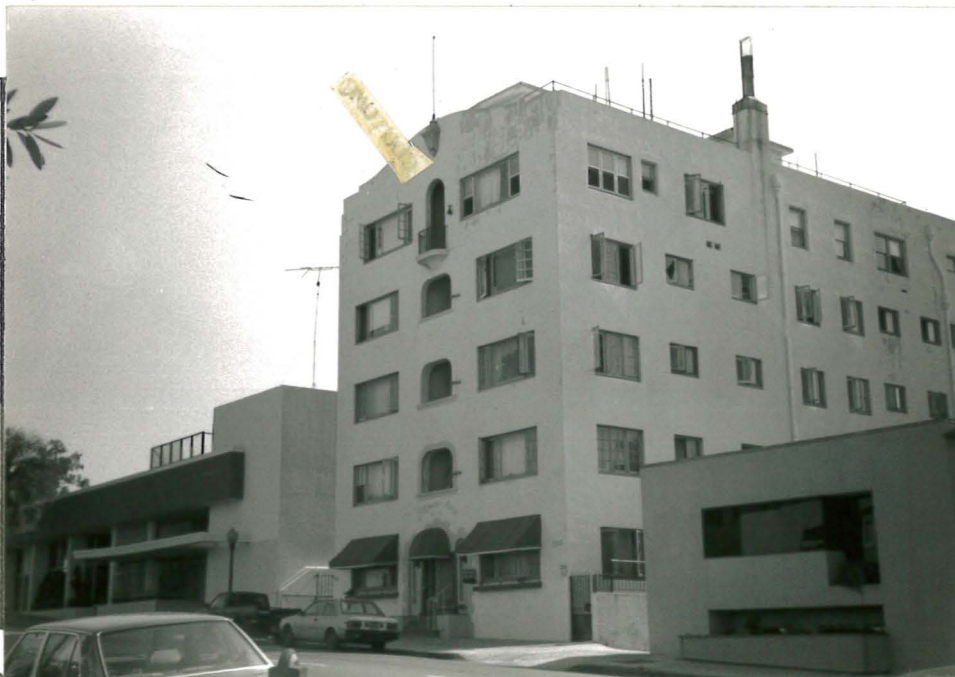
This 5 story stucco clad rectangular building it constructed of brick and concrete and contains a basement used for parking. A flat roof with solarium sets behind the espadana parapet with stepped sides and central ornamental flag pole. The windows are three sash on the facade with a fixed central panel and wooden casement side panels. Casement windows are used throughout the remainder of the building except where replaced by metal framed. The entry is centered on the facade and approached through a recessed semi-circular arch with 3/4 columns to either side and arched side niches. Brick quoining frames the entry. Recessed centred balconies of molded, flat arches with round corners are located on the second and fourth floors. On the top floor a semi circular full length arched balcony with rod iron railing is supported by a corbel bracket. Ownings over first floor windows and entry and security entrance are alterations as are the aluminum framed windows.

13. Condition: Excellent _____ Good X Fair _____ Deteriorated _____ No longer in existence _____
14. Alterations: awnings, aluminum windows
15. Surroundings: (Check more than one if necessary) Open land _____ Scattered buildings _____ Densely built-up _____
Residential X Industrial _____ Commercial X Other: _____
16. Threats to site: None known X Private development _____ Zoning _____ Vandalism _____
Public Works project _____ Other: _____
17. Is the structure: On its original site? X Moved? _____ Unknown? _____
18. Related features: none

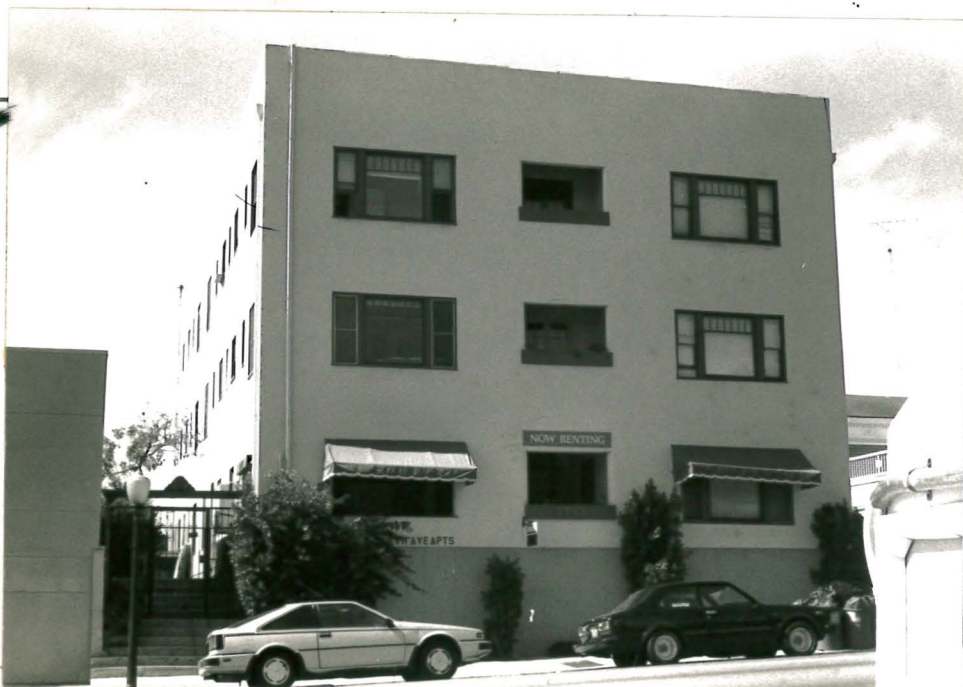
- 7a. Architectural style: Stripped down Mission with Craftsman infl.
- 7b. Briefly describe the present *physical appearance* of the site or structure and describe any major alterations from its original condition: This is a three-story stucco-clad building with a flat roof, unelaborated roofwall junction and symmetrical facade, sitting on a raised block foundation. Windows are three sash consisting of a fixed-pane center panel with multi-pane transom and narrow double-hung side panels. The south-facing side entry is reached from 12 plain steps leading from the street through an iron gate into a covered, boxed entry porch. Two cloth awnings cover both the porch opening and 1st floor window. Recessed balconies are centered on each floor with boxed planter balustrades and French entry doors. Signage and awnings are alterations.

13. Condition: Excellent ☒ Good _____ Fair _____ Deteriorated _____ No longer in existence _____
14. Alterations: Signage and awnings
15. Surroundings: (Check more than one if necessary) Open land _____ Scattered buildings _____ Densely built-up ☒
Residential ☒ Industrial _____ Commercial ☒ Other: _____
16. Threats to site: None known ☒ Private development _____ Zoning _____ Vandalism _____
Public Works project _____ Other: _____
17. Is the structure: On its original site? ☒ Moved? _____ Unknown? _____
18. Related features: None apparent

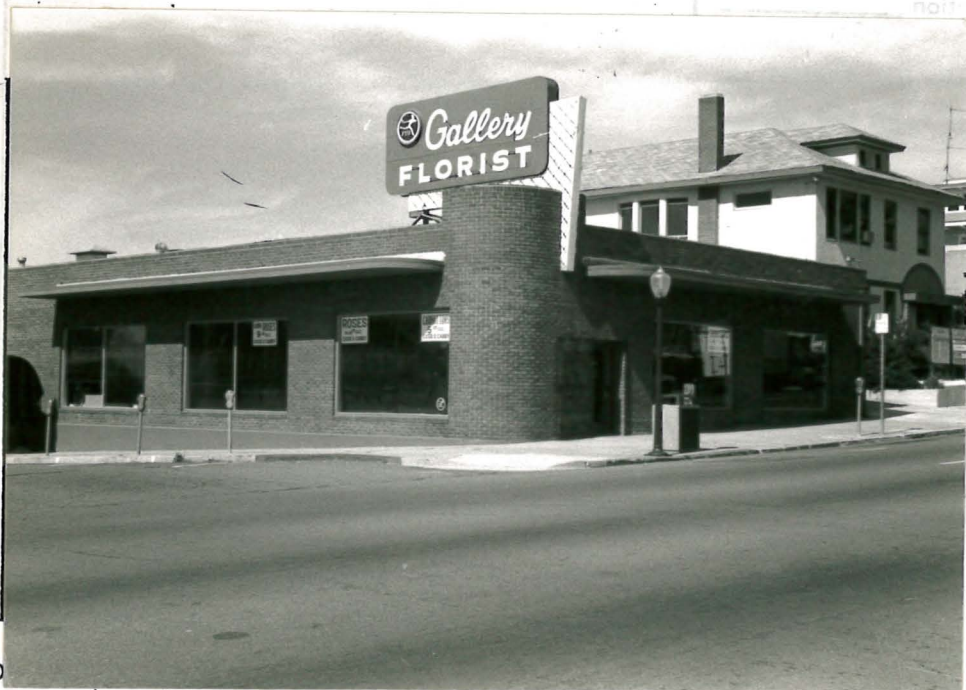
Gallery Florist is a one-story rectangular structure with a red stretcher bond brick facade. The flat roof has a stepped parapet at the rounded corner and a wide rounded cantilevered canopy below over the windows and entry. The windows are large recessed picture windows with a brick slipsill. The entry is recessed with a wood framed glass panel door and a wrought iron screen. Large neon signage extends above the roofline and down the street facade. The Ivy Street facade reveals the concrete foundation which slightly rises to account for the gradual slope. A rolling aluminum garage door provides loading access on the south facade.

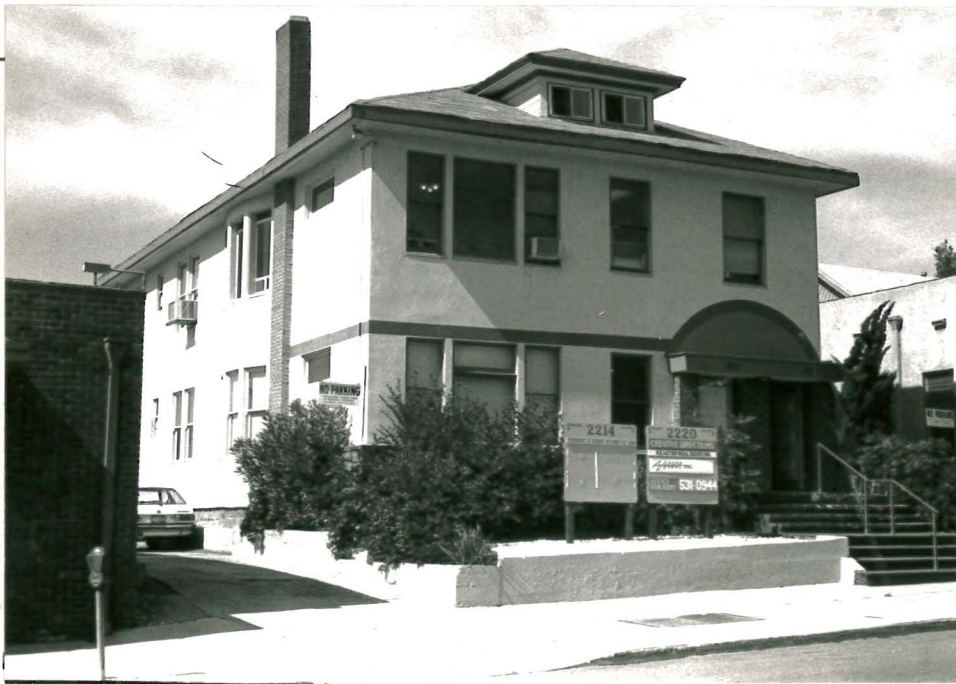
13. Condition: Excellent _____ Good _____ Fair ☒ Deteriorated _____ No longer in existence _____
14. Alterations: Stucco siding, entries, windows
15. Surroundings: (Check more than one if necessary) Open land _____ Scattered buildings _____ Densely built-up ☒
Residential _____ Industrial _____ Commercial ☒ Other: _____
16. Threats to site: None known ☒ Private development _____ Zoning _____ Vandalism _____
Public Works project _____ Other: _____
17. Is the structure: On its original site? ☒ Moved? _____ Unknown? _____
18. Related features: _____

This is a non-contributing structure due to alterations to the original architecture, deterioration, and/or lack of historical significance.

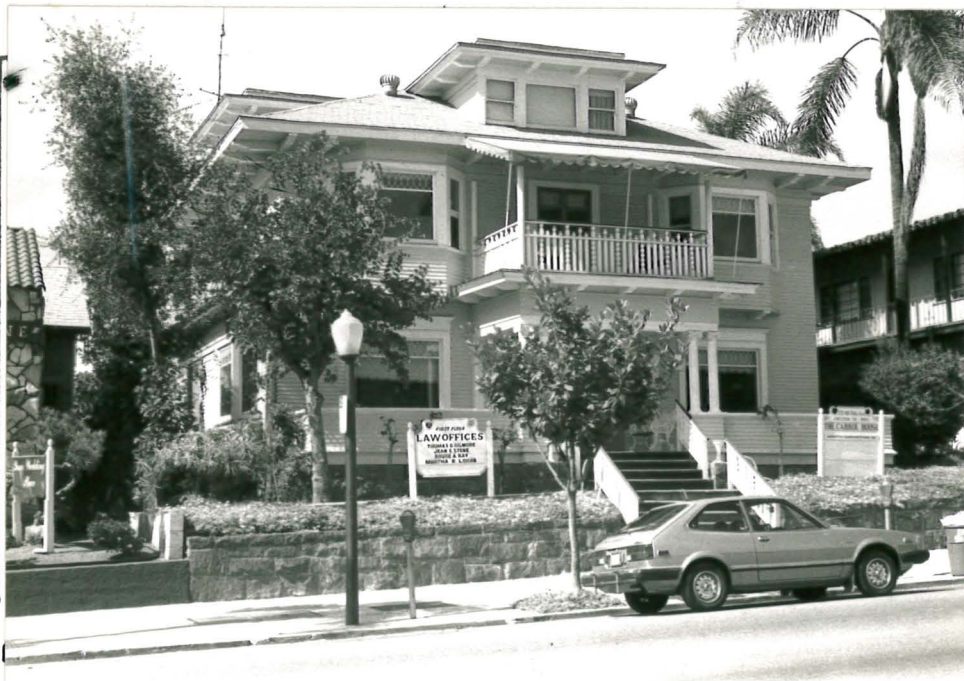
This large, 2 1/2 story building on a raised stone basement foundation is raised above the street level by an ashlar stone retaining wall. The medium pitched hip roof has a wide eave overhang with decorative rafters as do the shed roofed dormer windows on the south and east sides. The porch is open with a flat roof that serves as a 2nd story balcony. Two sets of paired Corinthian columns support the porch entablature with exposed rafters. The balcony above has a spindled wood railing across the front, freestanding columns and canvas awning all appear to be alterations. Second story oriel bay windows are located to either side of the porch with fixed pane center sashes with leaded glass transoms and double-hung side bay windows. Beneath fixed pane with leaded glass transoms and shelf caps. The siding is clapboard as is the solid balustrade extending across the front facade. The wooden entry has a glass oval panel. The carpet on front steps and porch is an alteration.

13. Condition: Excellent ☒ Good _____ Fair _____ Deteriorated _____ No longer in existence _____
14. Alterations: Awning, commercial signage, carpet on steps. & porch
15. Surroundings: (Check more than one if necessary) Open land _____ Scattered buildings _____ Densely built-up ☒
Residential ☒ Industrial _____ Commercial ☒ Other: _____
16. Threats to site: None known ☒ Private development _____ Zoning _____ Vandalism _____
Public Works project _____ Other: _____
17. Is the structure: On its original site? ☒ Moved? _____ Unknown? _____
18. Related features: Ashlar stone retaining wall

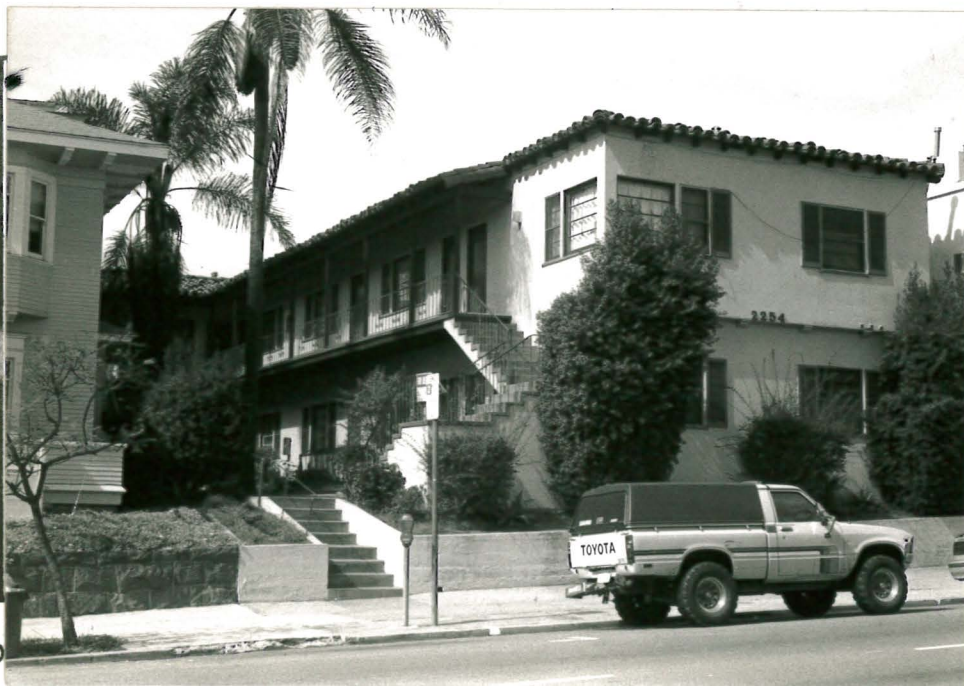
13. Condition: Excellent ☒ Good _____ Fair _____ Deteriorated _____ No longer in existence _____
14. Alterations: None apparent
15. Surroundings: (Check more than one if necessary) Open land _____ Scattered buildings _____ Densely built-up ☒
Residential ☒ Industrial _____ Commercial ☒ Other: _____
16. Threats to site: None known ☒ Private development _____ Zoning _____ Vandalism _____
Public Works project _____ Other: _____
17. Is the structure: On its original site? ☒ Moved? _____ Unknown? _____
18. Related features: None

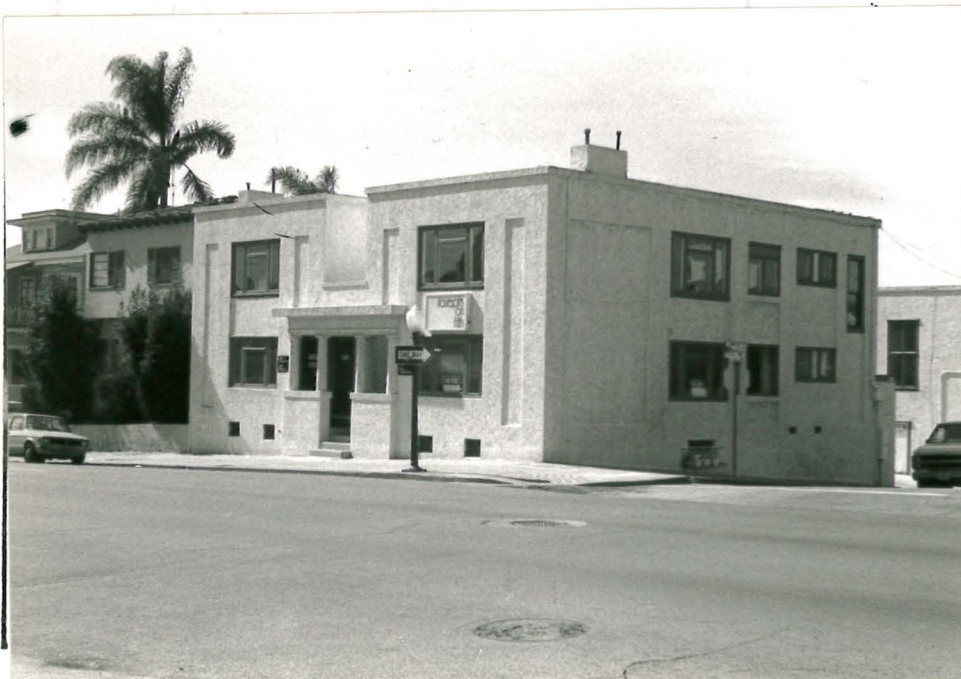
13. Condition: Excellent ___ Good X Fair ___ Deteriorated ___ No longer in existence ___
14. Alterations: restuccoed, signage
15. Surroundings: (Check more than one if necessary) Open land ___ Scattered buildings ___ Densely built-up X
Residential X Industrial ___ Commercial X Other: ___
16. Threats to site: None known X Private development ___ Zoning ___ Vandalism ___
Public Works project ___ Other: ___
17. Is the structure: On its original site? X Moved? ___ Unknown? ___
18. Related features: Courtyard joining buildings

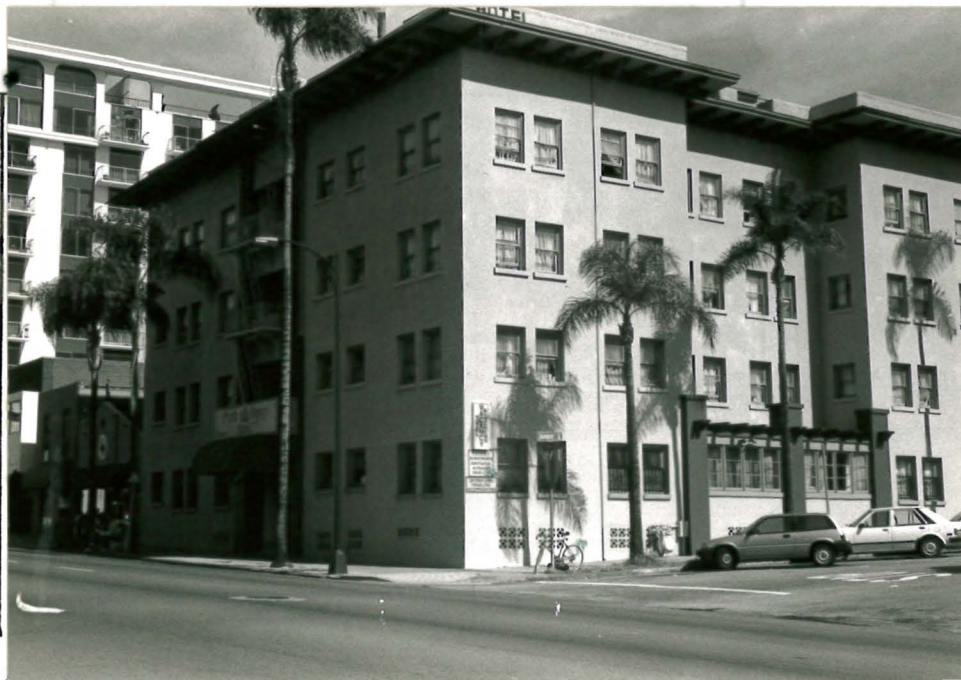
A square wood framed four-story building, the Park Regency Hotel at 2309 Fifth Avenue has a flat roof with a widely overhanging eaves supported by decorative brackets in the Italianate style. Two deep vertically stepped insets are located centrally on the north and south sides. A garden and penthouse are located on the roof. Central recessed balconies with metal railing, fire escapes are located on each floor above the main Fifth Avenue entrance. Flat decorative cement pillars rise the full height of the building. The arched entry is recessed with an awning projecting out over the sidewalk, and two marble steps leading to the double glass pane aluminum framed doors. The windows are symmetrically placed in double hung single pane pairs.

Alterations include: on the Juniper facade an inset enclosed sun porch with multi paned windows and wooden rafters projecting out. Also, signage has been added to the south west corner and security bars have been placed over some First Street floors Juniper Street windows. Side panels at Fifth Street entry have been covered with marble.

13. Condition: Excellent ☒ Good _____ Fair _____ Deteriorated _____ No longer in existence _____
14. Alterations: Interior remodeled, security bars, enclosed porch covered side panels at entry
15. Surroundings: (Check more than one if necessary) Open land _____ Scattered buildings _____ Densely built-up ☒
Residential ☒ Industrial ☒ Commercial ☒ Other: _____
16. Threats to site: None known ☒ Private development _____ Zoning _____ Vandalism _____
Public Works project _____ Other: _____
17. Is the structure: On its original site? ☒ Moved? _____ Unknown? _____
18. Related features: Street Palms

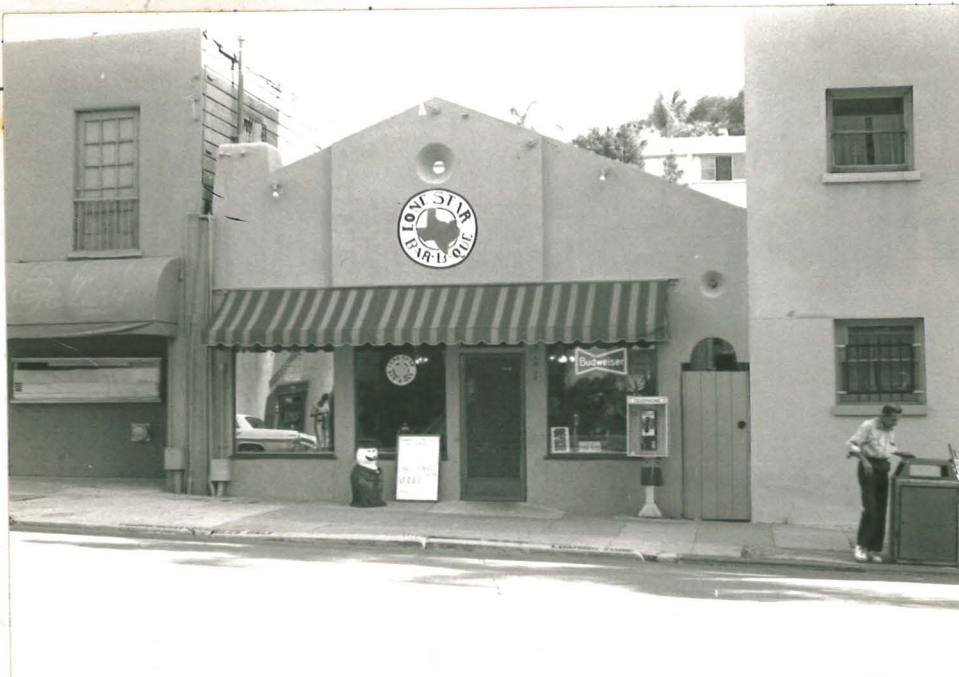
- 7a. Architectural style: Mission Revival
- 7b. Briefly describe the present *physical appearance* of the site or structure and describe any major alterations from its original condition: Leg Desc: Blk 261 Lot E w 90ft of N 1/2 Horton's Add Lockling
This one-story Mission Revival Commercial building at 2321 5th Avenue has a flat roof and stucco siding. A medium-high gabled parapet extends across the facade with a chimney-like step to the north. A conical recessed porthole is centered within the center extended facade panel. Another smaller porthole sits to the south above an arched side alley entrance with vertical wooden panel door. An awning stretches across the facade with 3 large single-sash windows and a single glass-panel entry door below. Neon signage, lighting and a public telephone are alterations.

13. Condition: Excellent ☒ Good ☐ Fair ☐ Deteriorated ☐ No longer in existence ☐
14. Alterations: neon signage, lighting, public telephone
15. Surroundings: (Check more than one if necessary) Open land ☐ Scattered buildings ☐ Densely built-up ☒
Residential ☒ Industrial ☐ Commercial ☒ Other: ☐
16. Threats to site: None known ☐ Private development ☐ Zoning ☒ Vandalism ☐
Public Works project ☐ Other: ☐
17. Is the structure: On its original site? ☒ Moved? ☐ Unknown? ☐
18. Related features: None

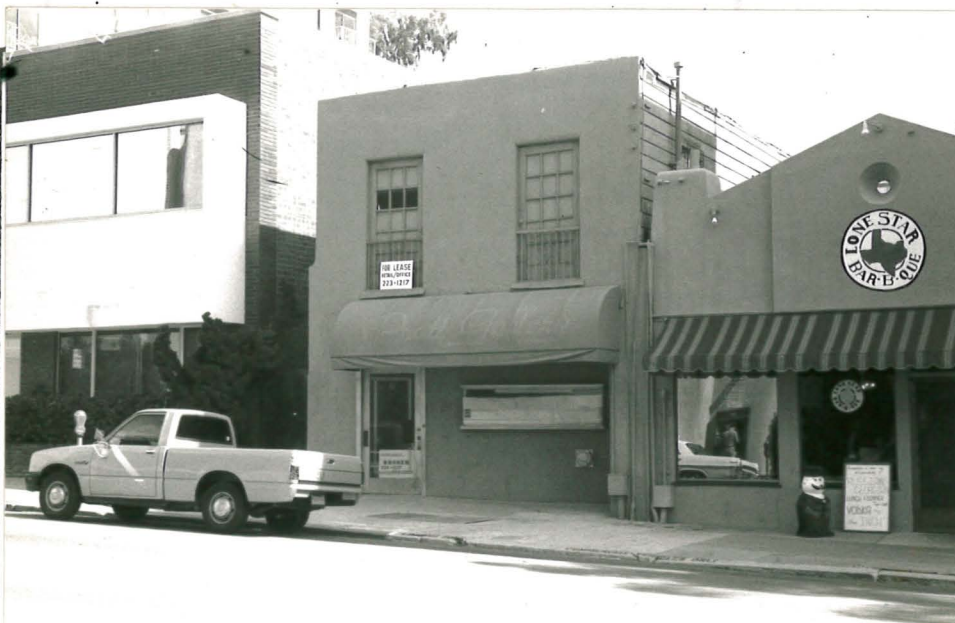
This narrow 2-story building with a flat roof was originally Italianate, but has been severely altered. The roof is slightly stepped at the corners between the 1st & 2nd floors. The front facade is stuccoed; the north and south facades have shiplap siding on the second floor and the north side first floor is cement block. The 1st story of the front facade is angled creating a recessed area. This includes a glass door with aluminum framing and double-pane glass transom and a protruding horizontal display window below four horizontal windows with wood mullions. A utility box is on the north facing wall. The recessed area is covered by an awning. The 2nd floor features 2 French doors with iron balconets. On the north side of the building, a wooden gate leads to a narrow stairway with an iron bannister which culminates in a 2nd floor entrance. Windows on the north facade are double hung with ironwork. Many of the features of this building are alterations including the awning, stucco siding, angled entry, door and window box.

13. Condition: Excellent ____ Good ____ Fair ____ Deteriorated ____ No longer in existence X
14. Alterations: Awning, stucco siding, door, window box, angled front.
15. Surroundings: (Check more than one if necessary) Open land ____ Scattered buildings ____ Densely built-up X
Residential X Industrial ____ Commercial X Other: _____
16. Threats to site: None known X Private development ____ Zoning ____ Vandalism ____
Public Works project ____ Other: _____
17. Is the structure: On its original site? X Moved? ____ Unknown? ____
18. Related features: None

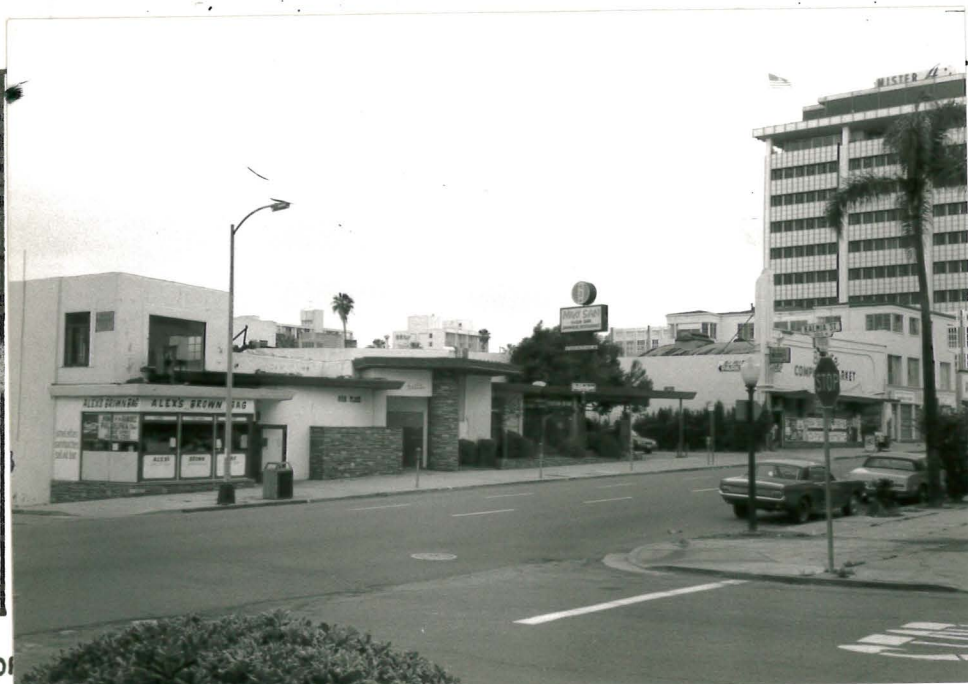
This large commercial structure is primarily 1-story with a 2-story southern facade which connects to a lower 2-story Spanish Colonial Revival extension at 444 Kalmia Street. The siding is stucco with flat, multiple level roofs in front and a flat roof with a boxed red-tile shed on the back extension. Large pane windows are on the 5th Street facade along with fixed panes with transoms and side panels at the rounded northern corner. The three entries are angular and recessed with wide angular overhanging eaves over the 1st level. Flagstone decorates the lower 5th Street facade and covers a tall pilaster and planter in the center entry. The back extension has multi-pane casement windows, some with aluminum awnings. Ionic pilasters decorate the upper level and recessed panels line the street level.

13. Condition: Excellent _____ Good ☒ Fair _____ Deteriorated _____ No longer in existence _____
14. Alterations: None
15. Surroundings: (Check more than one if necessary) Open land _____ Scattered buildings _____ Densely built-up ☒
Residential ☒ Industrial _____ Commercial ☒ Other: _____
16. Threats to site: None known _____ Private development _____ Zoning ☒ Vandalism ☒
Public Works project _____ Other: _____
17. Is the structure: On its original site? ☒ Moved? _____ Unknown? _____
18. Related features: None

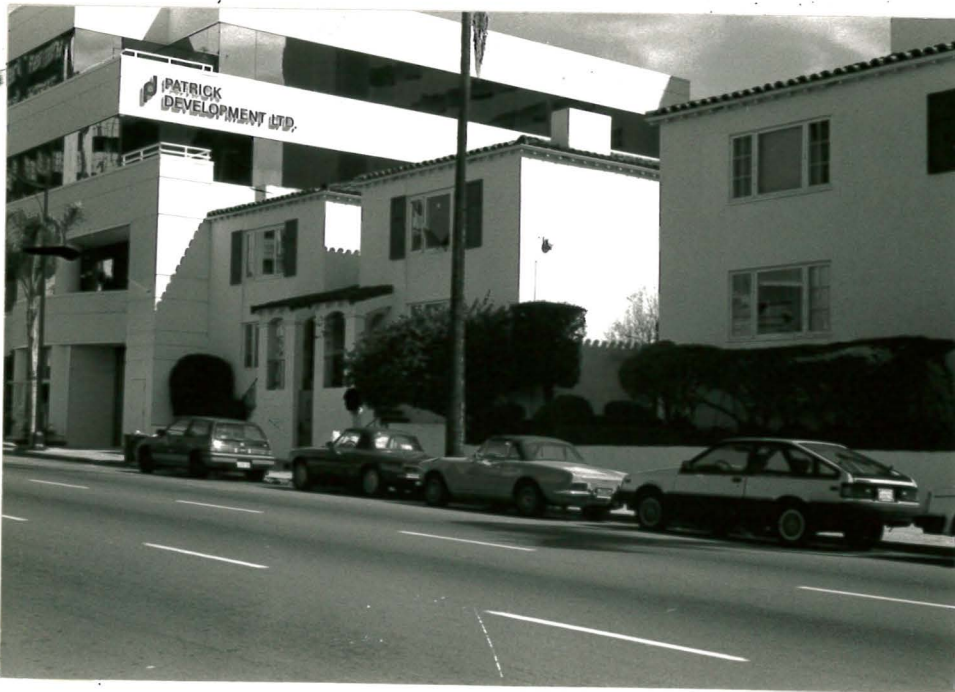
This Spanish Colonial Revival Court apartment complex at 2417 - 2421 5th Avenue consists of three - two story stucco buildings two along the street, one rectangular and one L-shaped and the other behind is rectangular. The red tile roof are hipped with shallow projecting eaves with exposed dentil like brackets. The windows are three-sash wood framed with a central fixed pane and multi paned casement side panels. The second story windows have shutters though one set is missing.

The raised north entrance is reached from straight double stairs covered by a red tile pent roof three arches across the front. The center arch extends to the street level separating the entrances and all have a metal railing. The entry doors are wood framed multi paned french. Stucco chimneys rise a top each building. The narrow court to the south is also raised off the street by six steps with entrance to either side and mature landscaping. A dryer vent below the eave is an alteration.

13. Condition: Excellent ☒ Good _____ Fair _____ Deteriorated _____ No longer in existence _____
14. Alterations: dryer vent window eave
15. Surroundings: (Check more than one if necessary) Open land _____ Scattered buildings _____ Densely built-up ☒
Residential ☒ Industrial _____ Commercial ☒ Other: _____
16. Threats to site: None known ☒ Private development _____ / Zoning ☒ Vandalism _____
Public Works project _____ Other: _____
17. Is the structure: On its original site? ☒ Moved? _____ Unknown? _____
18. Related features: Mature land saping in court and along street

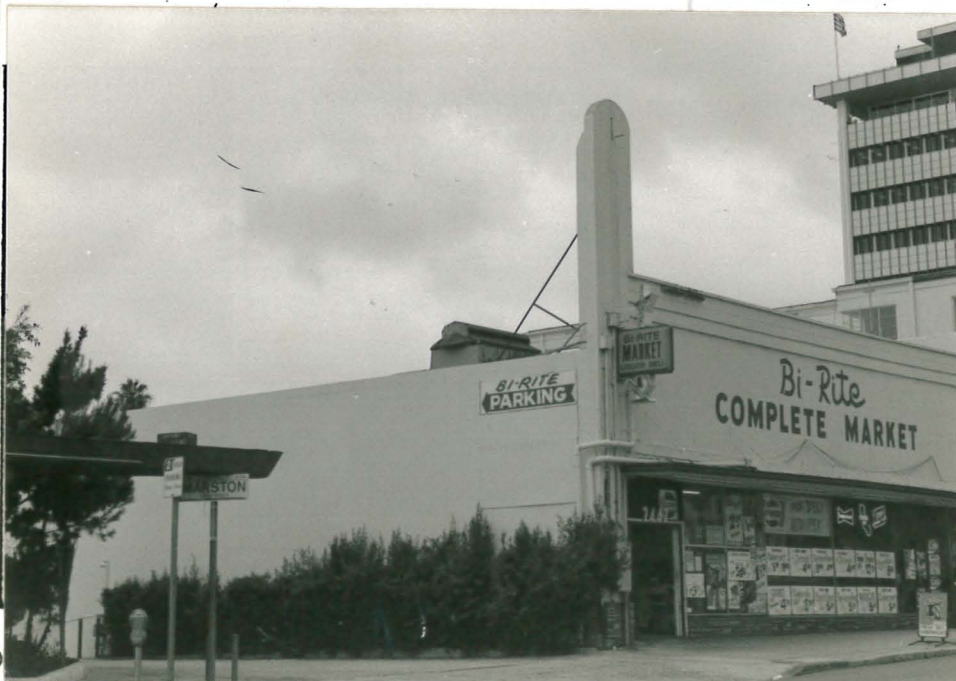
Bi-Rite Market is a rectangular one-story commercial building with a flat roof and tall, flat parapet. The stucco facade has been scored and has recessed panels with a low flagstone skirt decorating the front facade. A tall stucco tower element is now plain while a small marquis is situated below. The street facade features large fixed pane windows with aluminum frames and two sliding wood framed door with a folding metal security gate. Sheltering the street facade is a low cantilevered canopy with added rod supports above.

13. Condition: Excellent _____ Good X Fair _____ Deteriorated _____ No longer in existence _____

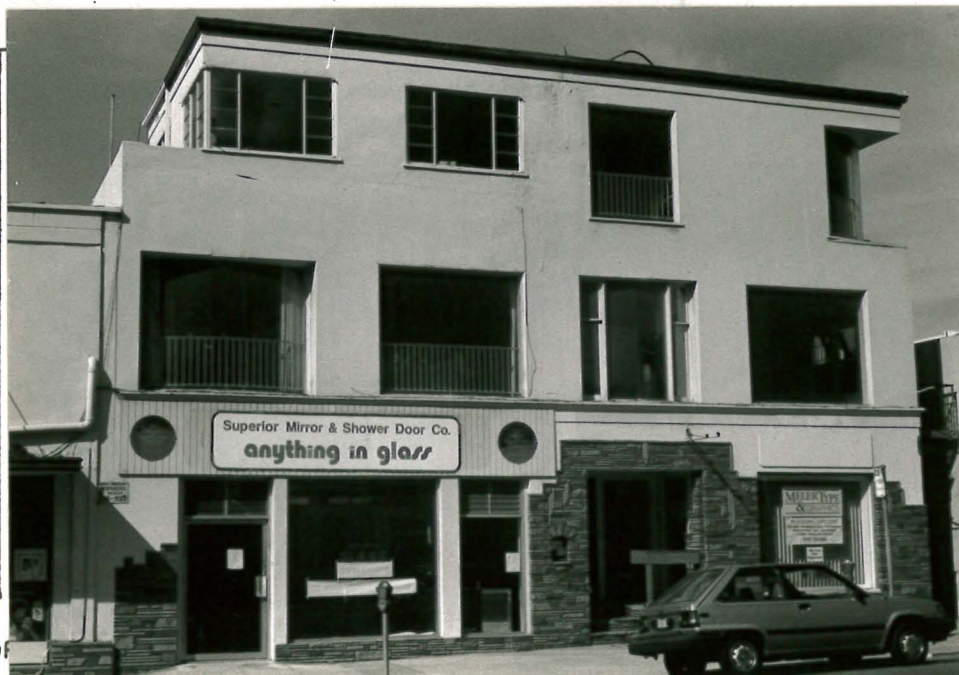
This 3-story rectangular building, stepped at the 3rd story on the SE Corner, has a flat roof with slightly overhanging eaves and a plain frieze. Siding is stucco with ornate stepped flagstone brickwork covering much of the 1st story. The NE corner on the third floor has a rounded recessed fixed-pane window, in sections, within the square corner of the building. Other windows include large fixed pane, fixed pane with casement side panels, and one mirrored window group on the 2nd floor. Second floor windows are deeply recessed. The building houses 2 commercial spaces. One is accessed from a stoop surrounded by flagstone brickwork and reached via 3 flagstone steps. Three entry doors of various types (both wood & metal frame) open onto the stoop. A secondary entrance door to the south is glass with aluminum frame and louvered transom. An arch with radiating bricks and keystone decorates the mailbox. Alterations include windows, a panel between the 1st and 2nd floors for signage, and wood railing around the stoop.

13. Condition: Excellent _____ Good ☒ Fair _____ Deteriorated _____ No longer in existence _____
14. Alterations: Windows, panel between first and second floors, railing around stoop
15. Surroundings: (Check more than one if necessary) Open land _____ Scattered buildings _____ Densely built-up ☒
Residential ☒ Industrial _____ Commercial ☒ Other: _____
16. Threats to site: None known ☒ Private development _____ Zoning _____ Vandalism _____
Public Works project _____ Other: _____
17. Is the structure: On its original site? ☒ Moved? _____ Unknown? _____
18. Related features: None

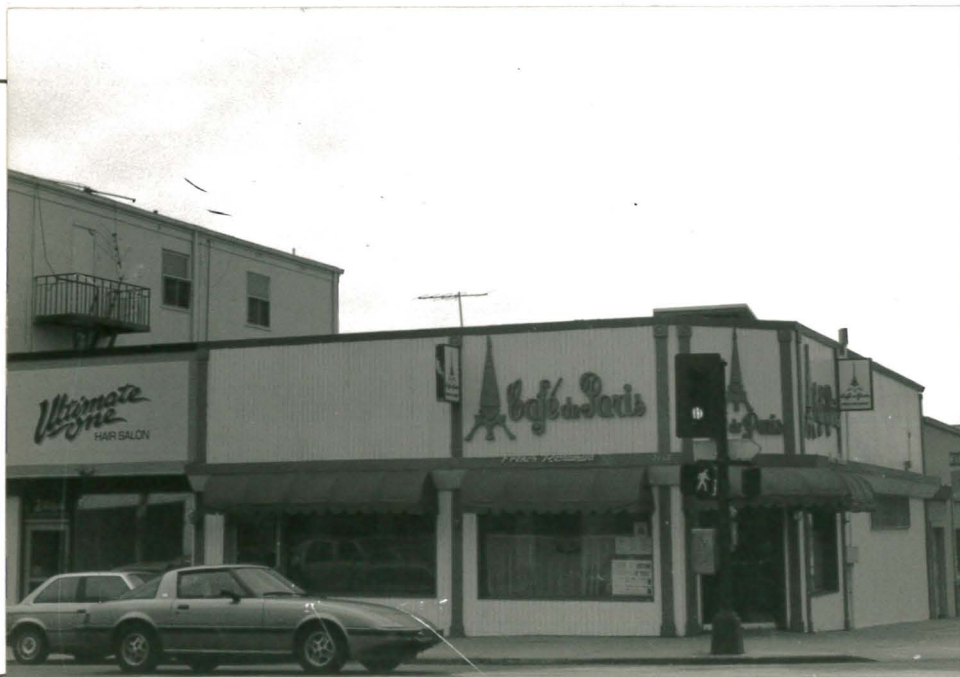
- Architectural style: 30's Modern/Commercial Legal D: Blk 281 Lot L Horton's Add Lockling
- Briefly describe the present *physical appearance* of the site or structure and describe any major alterations from its original condition:
This one-story commercial building occupies the corner of Fifth Avenue and Laurel Street. It has a flat roof with a high flat parapet topped by coping. Vertical tongue and groove siding is evident on the Fifth Avenue facade, and wraps around the corner. The siding on the Laurel Street facade is stucco. Seven fluted capped pilasters at uneven intervals extend the length of the building and are broken by a visor, curved at the bottom, which is located above the level of the windows and doors. Arched awnings are attached to the visor and cover the windows and doors. The entryway, at the truncated corner, contains double glass doors. Windows are large, deeply-recessed fixed panes. A ribbon of shutters is located on the Laurel Street facade. Signage decorates the parapet and two small projecting signs are featured as well. Exterior light fixtures on either side of the doors are alterations, as is the siding above the awnings.

13. Condition: Excellent ☒ Good ☐ Fair ☐ Deteriorated ☐ No longer in existence ☐
14. Alterations: Light fixtures, siding
15. Surroundings: (Check more than one if necessary) Open land ☐ Scattered buildings ☐ Densely built-up ☒
Residential ☒ Industrial ☐ Commercial ☒ Other: ☐
16. Threats to site: None known ☐ Private development ☐ Zoning ☐ Vandalism ☐
Public Works project ☐ Other: ☐
17. Is the structure: On its original site? ☒ Moved? ☐ Unknown? ☐
18. Related features: None

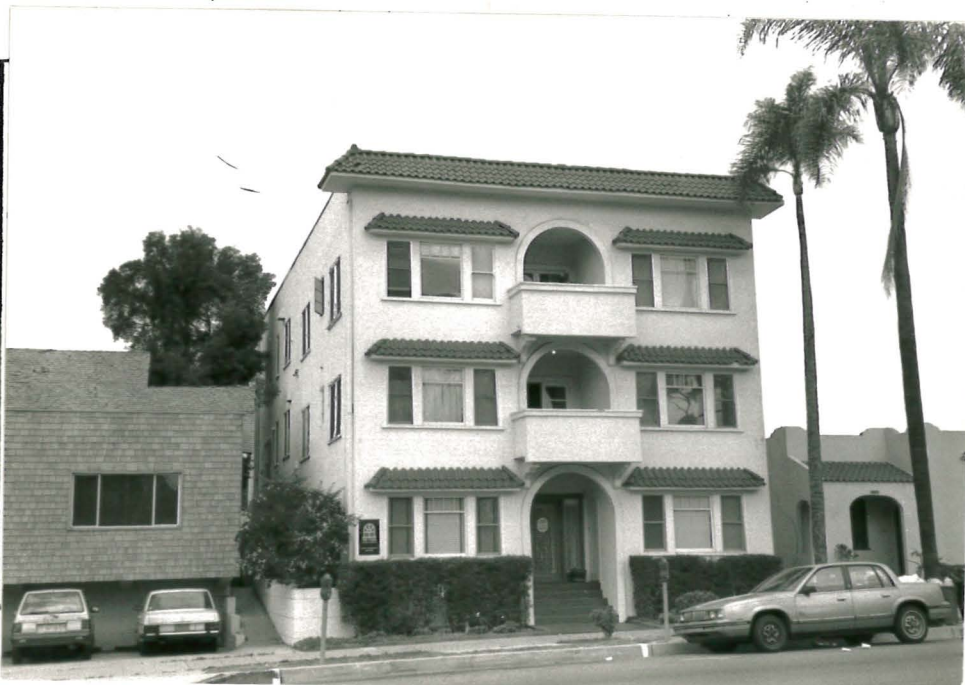
A rectangular three-story, wood-framed structure, this apartment building at 1758 6th Avenue sits on a raised foundation. A flat roof is faced with a red tile low-hip visor roof which cantilevers out the width of the facade with a overhanging boxed eave. The symmetrical facade consists of a central entry window on either side. Each 3-sash group of windows is capped with a red tile pent hood and divided by upright wooden bars. The center sash is fixed with a multi-panel transom, the side panels are double-hung. The centered, arched and recessed entry is repeated in the balconies of the floors above. Five plain steps lead to the first floor entrance where a single-panel glass door with a brass kick plate exists between narrow glass side panels. A side entrance is located left of this door. The two projecting boxed balconies above are supported by exposed rafters with an arched entry behind leading to recessed French doors. Mature shrubbery flanks the stucco siding adding to this Mission Style apartment house. Alteration: sign on south side.

13. Condition: Excellent ☒ Good ☐ Fair ☐ Deteriorated ☐ No longer in existence ☐
14. Alterations: Sign on southeast side
15. Surroundings: (Check more than one if necessary) Open land ☐ Scattered buildings ☐ Densely built-up ☒
Residential ☒ Industrial ☐ Commercial ☒ Other: Balboa Park to the east
16. Threats to site: None known ☒ Private development ☐ Zoning ☐ Vandalism ☐
Public Works project ☐ Other: ☐
17. Is the structure: On its original site? ☒ Moved? ☐ Unknown? ☐
18. Related features: Other Mission Style structures on block

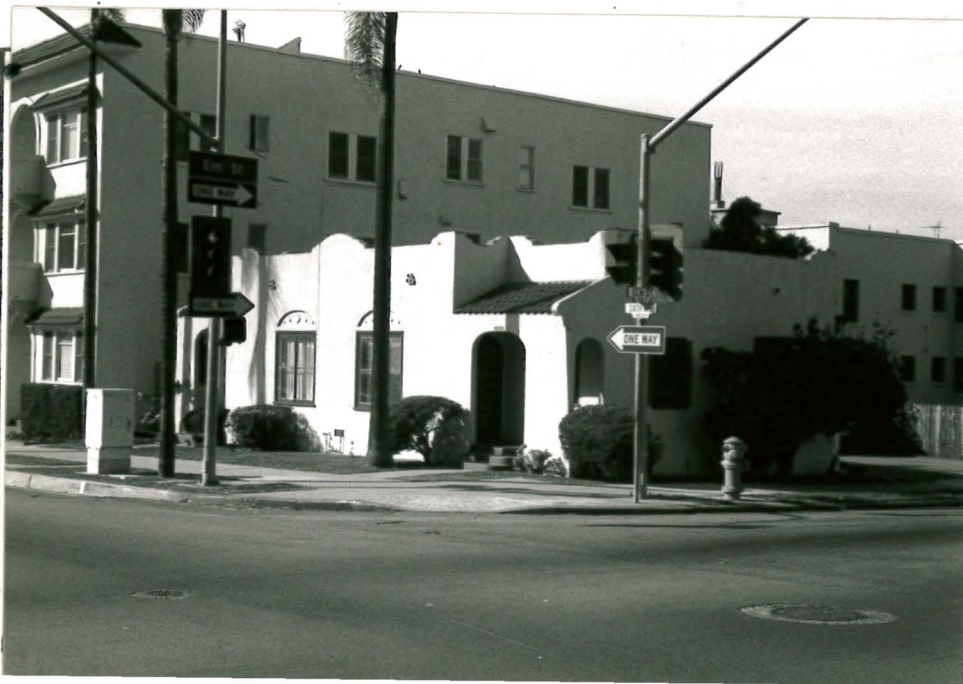
This single-story rectangular duplex is flat roofed with a curving, stepped parapet. Entry porches are located on either side of the facade with dropped red tile shed roofs. The stucco facade contains 2 symmetrically placed double-hung windows with recessed blind fanlight transoms containing diamond pattern reliefs within. Above are decorative cylindrical tile vents. To either side of the facade are porches reached from three plain curved steps. Semi-elyptical arches lead into the covered area where arched, solid wood side entry doors are located with large fixed-pane windows facing the street. Corner buttresses are located under side arches on each porch. This duplex located at 1762-64 Sixth Avenue, with mature palms framing it, characterizes the Mission Revival Style well.

13. Condition: Excellent ___ Good x Fair ___ Deteriorated ___ No longer in existence ___
14. Alterations: None apparent
15. Surroundings: (Check more than one if necessary) Open land ___ Scattered buildings ___ Densely built-up X
Residential ___ Industrial ___ Commercial ___ Other: Balboa Park across street
16. Threats to site: None known ___ Private development ___ Zoning X Vandalism ___
Public Works project ___ Other: ___
17. Is the structure: On its original site? X Moved? ___ Unknown? ___
18. Related features: ___
