HISTORIC RESOURCES INVENTORY

1. Common name: Anderson Apartments
2. Historic name: Anderson Apartments
3. Street or rural address: 1747 5th Avenue
City San Diego Zip 92101 County San Diego
4. Parcel number: 533-303-02
5. Present Owner: Electronics Capital Corp Address: P.O. Box 2429
City San Diego Zip 92112 Ownership is: Public _____ Private X
6. Present Use: Residential Original use: Residential

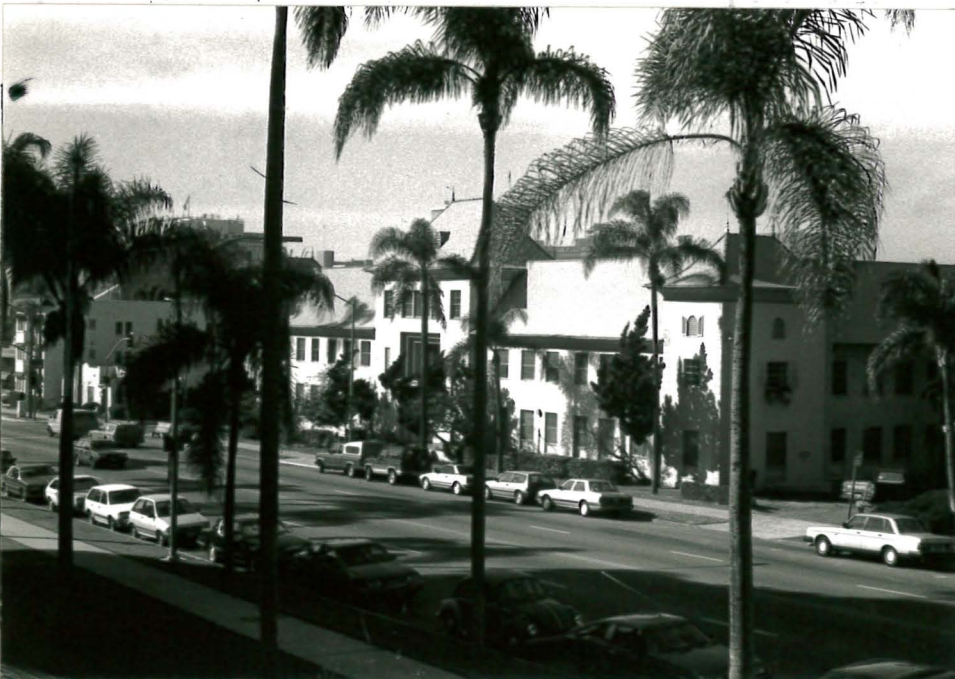
- 7a. Architectural style: French Eclectic
- 7b. Briefly describe the present *physical appearance* of the site or structure and describe any major alterations from its original condition: Leg. D: Blk 228 Lots G-J exc W 62ft lots C-F & all Hortons Add Lockling
The "La Maison" Apartments at 1818 6th Avenue is an example of the French Eclectic style.
A three story rectangular building with three towers, it has a bellcast mansard roof over the main structure with high pitched bellcast hip roof over the towers. Red tile spines run throughout. The towers are placed symmetrically on the stucco facade two corner towers and one, larger central tower all with finials at the hip ends. The windows throughout are multi-paned double hung which are placed in horizontal rows with a horizontal top molding above the second story row and paned slip sash on the first floor.
The central tower contains the entrance consisting of a two story recessed area of three geometric steps. To either side are two story vertical areas of glass block. The entrance is reached from four plain slips on the ground floor below a cantilevered marquee which serves as a second story balcony. Entrance doors are single pane glass french doors with multi-paned side panels. A dormer like vent sits centered in the the central tower roof while the sidetowers have shuttered, arched vents on the third level. Entrance lanterns and metal balcony balustrade are alterations. Palms line the facade.

13. Condition: Excellent ☒ Good _____ Fair _____ Deteriorated _____ No longer in existence _____

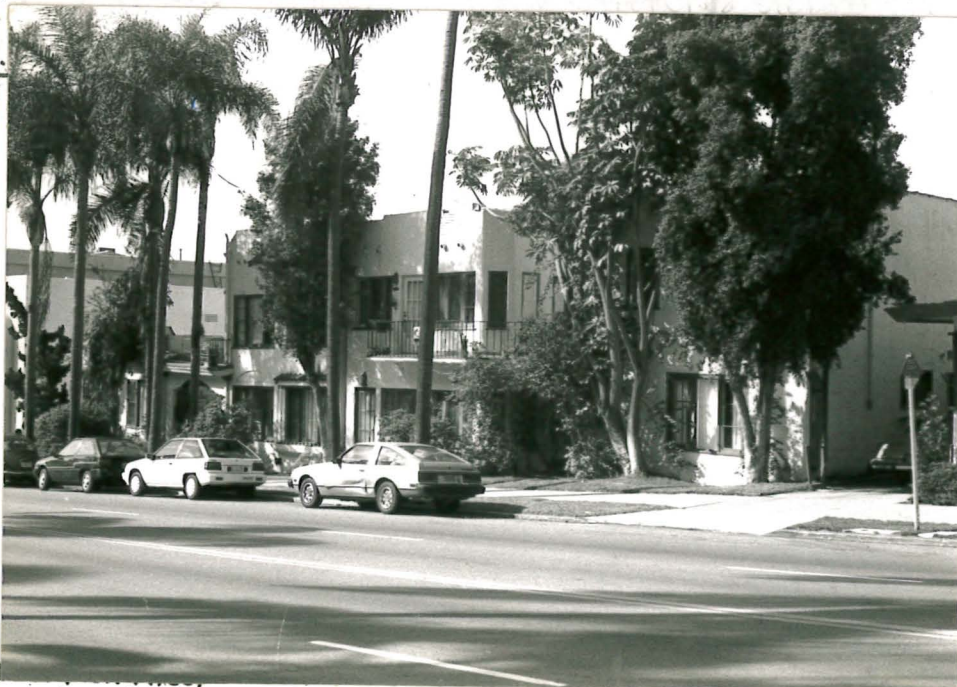
This apartment court consists of four stuccoed buildings, one single story and three two story in a row. Flat roofs have irregular stepped parapets, some with red tile spines. Red tile pipe-like drains are placed throughout. The complex or court stretches from 6th to 5th Avenue, with iron gates placed at the various court entrances. A iron-railed balcony serves as a bridge over the main 6th Avenue entrance and joins the one-story building to one of the 2-story buildings. Another iron balcony stretches across the facade of another building and turns to the north side. Various 1st floor apartments have overhanging porches serving as second story balconies. The windows are three sash multi-paned wooden casement, some with red tile pent hoods. Alterations include an iron gate section added to the upper portion of the main gate and security bars placed on various 6th Avenue windows as well as the entire 2nd floor. Street palms and mature courtyard plantings are located throughout.

13. Condition: Excellent ___ Good X Fair ___ Deteriorated ___ No longer in existence: ___
14. Alterations: New gates
15. Surroundings: (Check more than one if necessary) Open land ___ Scattered buildings ___ Densely built-up X
Residential X Industrial ___ Commercial ___ Other: Balboa Park to the east.
16. Threats to site: None known X Private development ___ Zoning ___ Vandalism ___
Public Works project ___ Other: ___
17. Is the structure: On its original site? X Moved? ___ Unknown? ___
18. Related features: Complex extends from 5th to 6th Avenue.

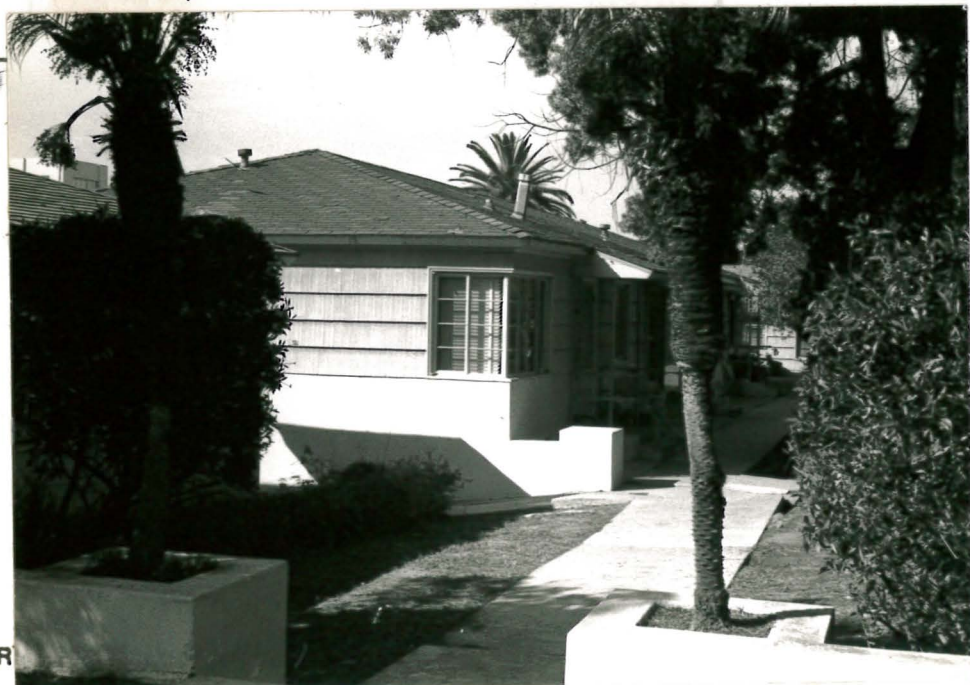
- 7a. Architectural style: 30's - 40's modern
- 7b. Briefly describe the present *physical appearance* of the site or structure and describe any major alterations from its original condition: This group of garden apartments consists of six one-story buildings with composition, medium-hipped roofs and wooden frames. The windows consist of multi-paned casement sashes with some windows that wrap around the corners of the buildings in the art moderne fashion of the 30's and 40's. The siding is two part: stucco on the lower half, one-foot wood clapboard for the upper portions. Entrances consist of overhanging boxed hoods with tubular metal railings and posts below. Entries are reached from two plain cement steps. These lead to plain wooden doors. The complex extends from 6th to 5th Avenue with the buildings enclosing an inner central courtyard with cement sidewalks and mature landscaping including potocarpus.

13. Condition: Excellent ☒ Good _____ Fair _____ Deteriorated _____ No longer in existence _____
14. Alterations: None apparent
15. Surroundings: (Check more than one if necessary) Open land _____ Scattered buildings _____ Densely built-up ☒
Residential ☒ Industrial _____ Commercial ☒ Other: Balboa Park to the east
16. Threats to site: None known _____ Private development _____ Zoning ☒ Vandalism _____
Public Works project _____ Other: _____
17. Is the structure: On its original site? ☒ Moved? _____ Unknown? _____
18. Related features: Balboa Park

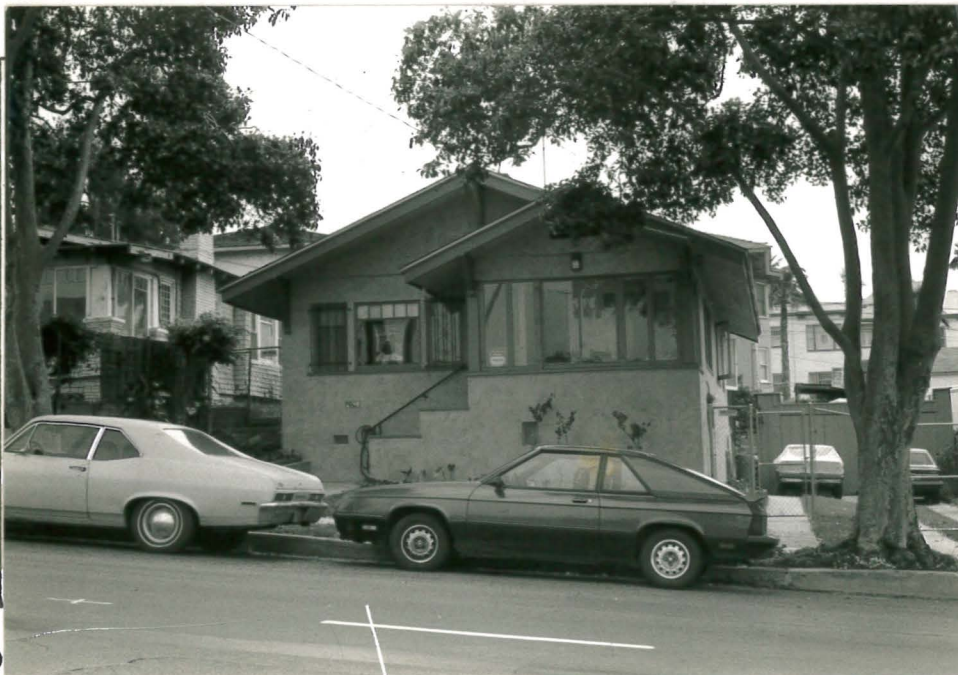
This one-story Craftsman home is on a raised foundations and rectangular in shape. The roof is a low-pitched gable with wide overhanging eaves and knee brackets supporting the gable ends and peaks. A second lower offset gable shelters an enclosed porch with narrow wood-framed hinge windows surrounding the porch. The street facade features a large three-sash window with a fixed center pane, multi-paned transom and hinged side panels. The porch entry is reached by six cement steps from the north and a stepped solid stucco bannister with wooden caps. The north-facing door is now covered with a metal security screen and some windows have iron security bars over them. The siding has been altered with new stucco also. The home has a brick interior chimney and a driveway to the south which leads to a wooden two-car garage.

13. Condition: Excellent _____ Good ☒ Fair _____ Deteriorated _____ No longer in existence _____
14. Alterations: Stucco facade, security screens over windows and door
15. Surroundings: (Check more than one if necessary) Open land _____ Scattered buildings _____ Densely built-up ☒
Residential ☒ Industrial _____ Commercial _____ Other: _____
16. Threats to site: None known _____ Private development _____ Zoning ☒ Vandalism _____
Public Works project _____ Other: _____
17. Is the structure: On its original site? ☒ Moved? _____ Unknown? _____
18. Related features: Detached garage in the rear

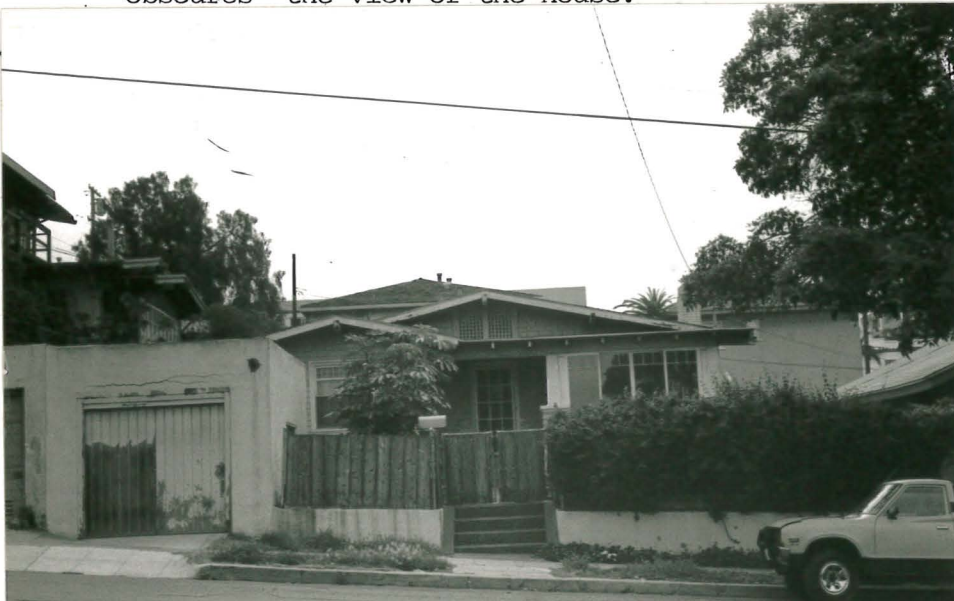
This California Bungalow is a one-story rectangular building with shingle siding, flared at foundation level. It has a low-pitch double-gabled composition roof, overhanging eaves, and exposed rafters. The house sits above street level, behind a retaining wall. A cement stairway leads to a walkway at foundation level. Then three cement steps terminate in an entry porch with shingled balustrade on the south side of the front facade. Elephantine columns and a lintel support a flat porch roof with overhanging eaves and exposed rafters. The porch is enclosed by fixed-pane windows with multi-pane transoms on the south and west sides. Other windows are double-hung, and fixed with multi-pane transoms and double-hung side panels. All windows have narrow wooden surrounds. The door is wood panel with a small rectangular glass upper. A wooden lattice vent is located in the main gable peak. The south facade features a flaring brick chimney and an oriel bay. Alterations include a wooden and crimped wire fence and wooden gate, which surround the property, a mailbox, and a stucco garage at street level, which partially obscures the view of the house.

13. Condition: Excellent _____ Good ☒ Fair _____ Deteriorated _____ No longer in existence _____
14. Alterations: Wooden and crimped wire fence, wooden gate, garage
15. Surroundings: (Check more than one if necessary) Open land _____ Scattered buildings _____ Densely built-up ☒
Residential ☒ Industrial _____ Commercial _____ Other: _____
16. Threats to site: None known _____ Private development _____ Zoning ☒ Vandalism _____
Public Works project _____ Other: _____
17. Is the structure: On its original site? ☒ Moved? _____ Unknown? _____
18. Related features: Stucco garage

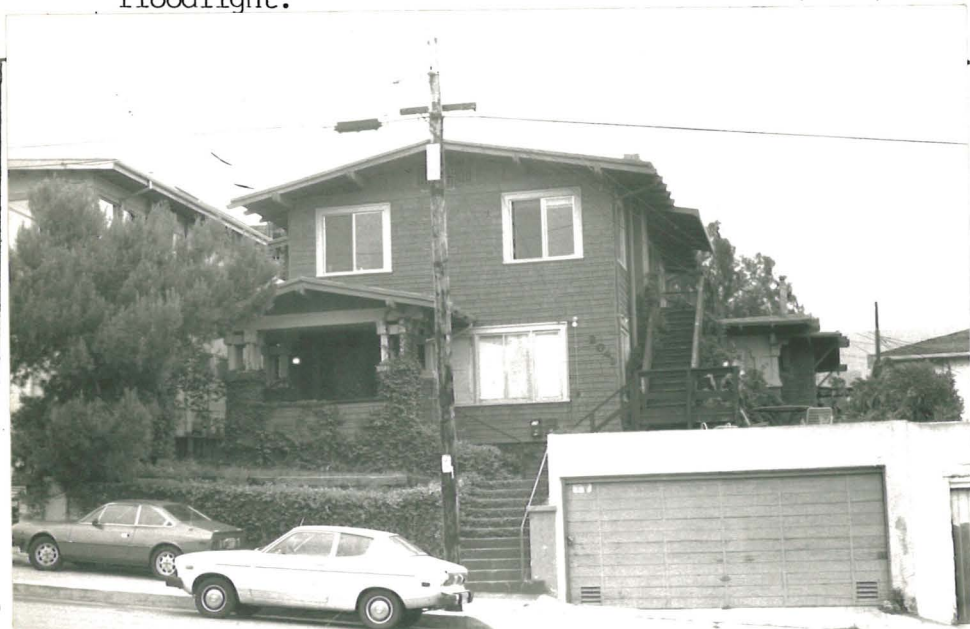
This 2-story irregularly shaped Craftsman style house sits on a raised foundation behind a vine-covered retaining wall. It has a low-pitched, front-gabled roof with overhanging eaves and worked rafters. Siding is shingle, flared at foundation level. The front facade features a horizontal band above the 2nd story, half timbering in the pediment, and wooden grill-work over a vent at the gable peak. Windows are single pane hinged with wood surrounds. The door, flanked by globe lights, is wood paneled with diamond-paned upper, wood surround, and narrow opaque glass side panels. From street level, eleven cement steps with a metal rail lead to a walkway. Straight south-facing stairs, again with metal rail, lead to the entry porch where a shingled balustrade rises to form piers at the corners. Groups of 4 square-worked posts and massive lintel support a gable roof with shingled pediment, overhanging eaves, and worked rafters. A single-story extension on the south side of the house features a double-gabled roof and band of multi-pane windows. Alterations include windows, and a wooden stairway on the south side which leads to a 2nd floor entry with overhanging roof and front floodlight.

13. Condition: Excellent _____ Good ☒ Fair _____ Deteriorated _____ No longer in existence _____
14. Alterations: windows, stairway to south, floodlight
15. Surroundings: (Check more than one if necessary) Open land _____ Scattered buildings _____ Densely built-up ☒
Residential ☒ Industrial _____ Commercial _____ Other: _____
16. Threats to site: None known _____ Private development _____ Zoning _____ Vandalism _____
Public Works project _____ Other: _____
17. Is the structure: On its original site? ☒ Moved? _____ Unknown? _____
18. Related features: None

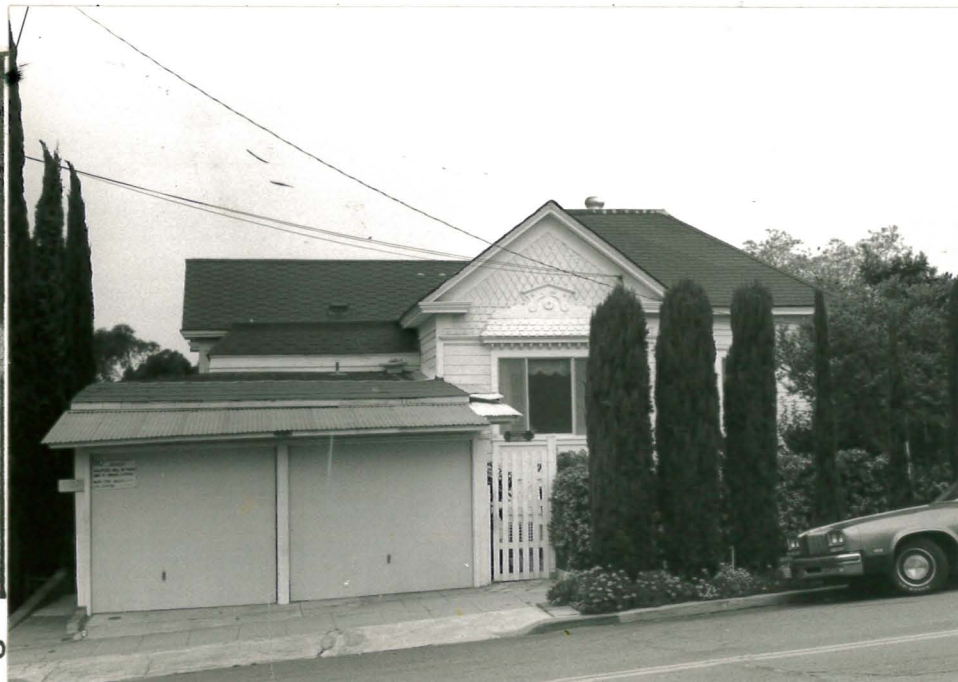
This 1-story Victorian home has a medium-pitched cross-gable roof with a truncated hip to the north. The boxed cornice has a plain frieze below. The front pediment covers the cornice and diamond-shaped shingles. The pediment covers the square bay with a decorative window hood, dentils and fancy crown. The bay windows have been altered and are now 3-sashed with a fixed center pane and louvered side panels. A large shed-roofed 2-car garage has been added to the street facade which completely hides the main entry. A truncated hip roof is visible which possibly sheltered a small porch south of the bay. The siding is shiplap with endboards. A wooden gate serves as the main entry and concrete sidewalk along the southern facade provides access to the rear apartments.

13. Condition: Excellent _____ Good _____ Fair ☒ Deteriorated _____ No longer in existence _____
14. Alterations: 2-car garage structure, windows
15. Surroundings: (Check more than one if necessary) Open land _____ Scattered buildings _____ Densely built-up ☒
Residential ☒ Industrial _____ Commercial _____ Other: _____
16. Threats to site: None known _____ Private development _____ Zoning ☒ Vandalism _____
Public Works project _____ Other: _____
17. Is the structure: On its original site? ☒ Moved? _____ Unknown? _____
18. Related features: garage

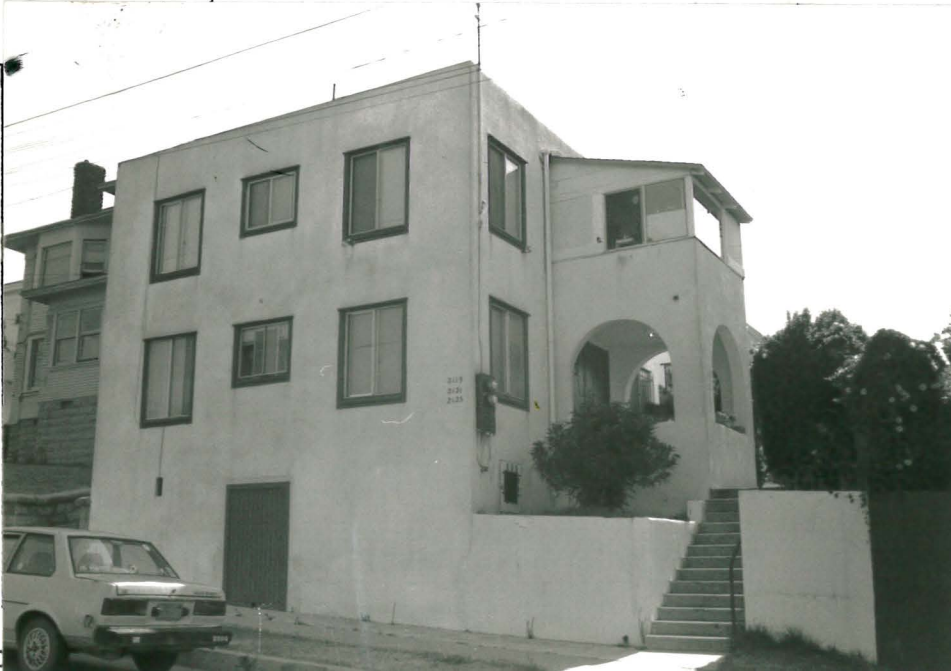
These two rectangular structures have flat roofs and stucco siding. The structure to the west is situated along Albatross Street and is 2 stories in height on a raised foundation with storage space below. The west facade rises up next to the sidewalk with a board & batten door and symmetrically placed windows. The main entry is reached by concrete stairs set within the stucco retaining wall which continues south from the structure's facade. The entry faces south within a boxed stucco porch with large arched openings (Gill's trademark) with the stepped porch entry from the east. Two wood paneled doors face south to provide access to the 2 flats within. Above the porch is a pent roof addition with overhanging eaves and exposed rafters. The siding is wood paneling with aluminum framed windows which wrap around the southwestern corner. The original structure's windows were 2-sashed wooden hinges with a hinged transom above, some still remain in the rear. The majority of the windows are now aluminum framed with a few louvres interspersed. The rear structure is nearly identical to the 2-story front structure, with exception of the west facing main entry, the 1-story height and a few window security bars.

13. Condition: Excellent ____ Good ____ Fair X Deteriorated ____ No longer in existence ____

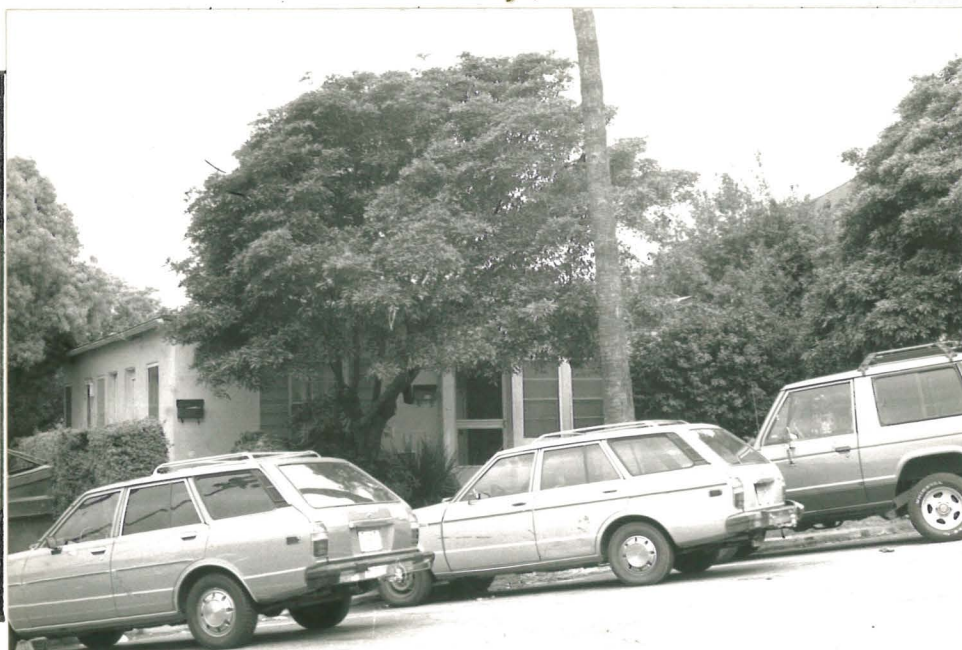
This one-story rectangular building has a low-pitched, asphalt shingle hip roof with a narrow overhang with exposed rafters. Windows consist of horizontal two pane double-hung sashes with wood screens. Doors are four panel wood with the upper two of glass. The entry doors have a gable hood above, one with clapboard and a square vent with narrow side panels to either side of the door. The siding is stucco. A metal-railed walkway leads down the south side where a multi-pane Craftsman appearing door with a wooden screen is located. The stucco siding curves inward at the doors and windows--a possible alteration. Other alterations include window shutters and pedimented entry surround.

13. Condition: Excellent _____ Good ☒ Fair _____ Deteriorated _____ No longer in existence _____
14. Alterations: Shutters, block pedimented entry surround and door
15. Surroundings: (Check more than one if necessary) Open land _____ Scattered buildings _____ Densely built-up ☒
Residential ☒ Industrial _____ Commercial _____ Other: _____
16. Threats to site: None known _____ Private development _____ Zoning ☒ Vandalism _____
Public Works project _____ Other: _____
17. Is the structure: On its original site? ☒ Moved? _____ Unknown? _____
18. Related features: _____

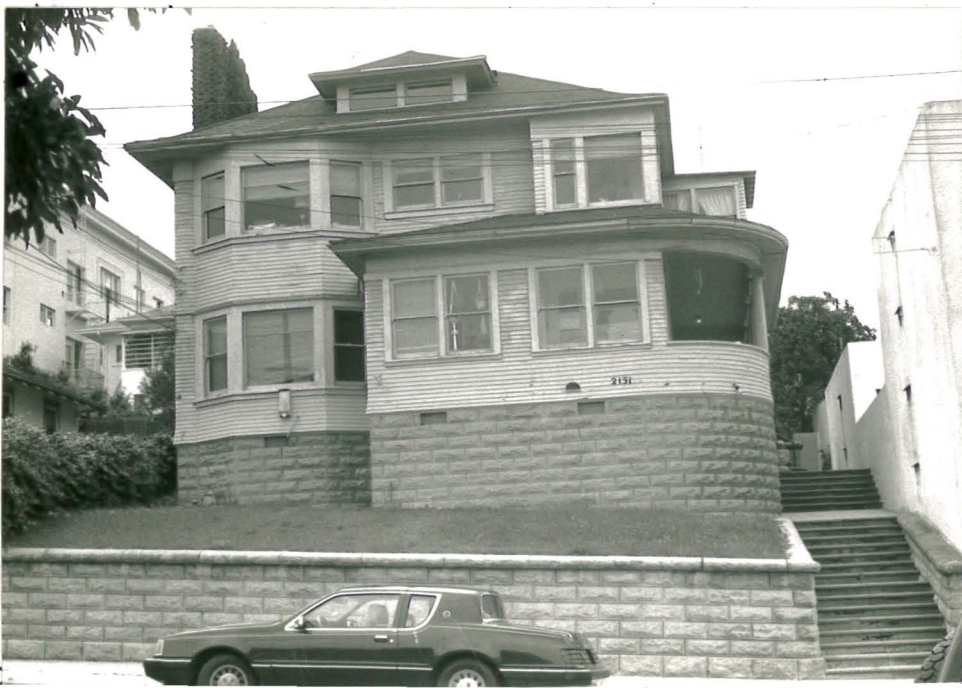
This 2 ½ story home rests on a high curving ashlar foundation reached by a south stairway with matching ashlar bannister and retaining wall. The roof is a low-pitched hip with a slight bellcast and overhanging boxed eaves. Hipped dormers with horizontal windows are on each facade and an unusual brick pattern is on the tall northwestern chimney. The siding is clapboard which flairs at the foundation. The dominant feature of the house is the curving veranda along the southern lower facade. Ionic columns support the hipped roof over the veranda and rest on the solid clapboard balustrade. The western portion of the veranda is enclosed and has pairs of double-hung windows which match the majority of the windows. Three sash windows surround the wide-angled two-story bay on the western facade. The central pane is fixed with a plain transom and double-hung sidepanels. A square bay is situated above the veranda and an addition with exposed rafters is on the southern two-story facade, over the veranda.

13. Condition: Excellent ☒ Good _____ Fair _____ Deteriorated _____ No longer in existence _____
14. Alterations: none
15. Surroundings: (Check more than one if necessary) Open land _____ Scattered buildings _____ Densely built-up ☒
Residential ☒ Industrial _____ Commercial _____ Other: _____
16. Threats to site: None known _____ Private development _____ Zoning ☒ Vandalism _____
Public Works project _____ Other: _____
17. Is the structure: On its original site? ☒ Moved? _____ Unknown? _____
18. Related features: none

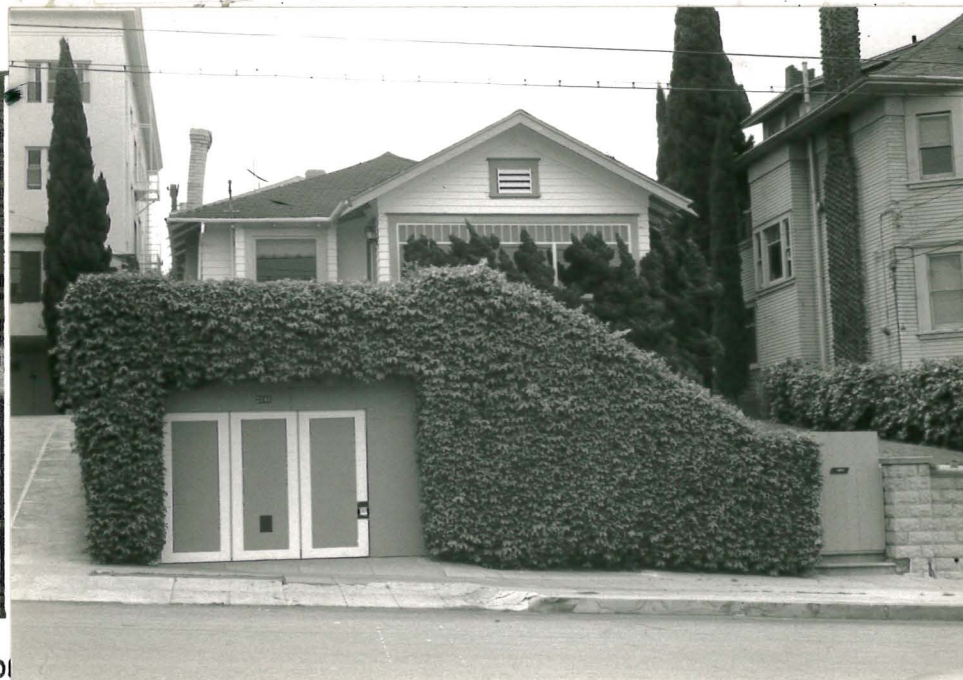
This 1-story, L-shaped Craftsman style house has clapboard siding and sits high above street level on an ashlar block foundation. It has a medium-pitched hipped roof with asphalt shingles and a front gable on the S. side. Overhanging eaves shelter exposed worked and pointed rafters. Under the front gable, a ribbon of fixed-pane windows with multi-pane transom dominates the facade. Other windows are double-hung, some with multi-pane uppers. The door is 2 panel wood with a multi-pane transom. Windows and door have shelf surrounds. The porch, on the north side of the front facade, is hidden from view by a story-high garage with wood doors. An ashlar block wall retains the remainder of the property. Both the wall and the garage are ivy-covered. South of the garage, a wooden gate leads to a stairway which rises to the porch. The house has two brick chimneys and several bays -- single square bays on the west & north facades and a wide-angle bay on the south facade. The gable peak features a square vent with a shelf surround. Alterations include the gate and a fixed-pane window on the west bay.

13. Condition: Excellent ☒ Good _____ Fair _____ Deteriorated _____ No longer in existence _____
14. Alterations: gate, window in west bay
15. Surroundings: (Check more than one if necessary) Open land _____ Scattered buildings _____ Densely built-up ☒
Residential ☒ Industrial _____ Commercial _____ Other: _____
16. Threats to site: None known _____ Private development _____ Zoning ☒ Vandalism _____
Public Works project _____ Other: _____
17. Is the structure: On its original site? ☒ Moved? _____ Unknown? _____
18. Related features: None

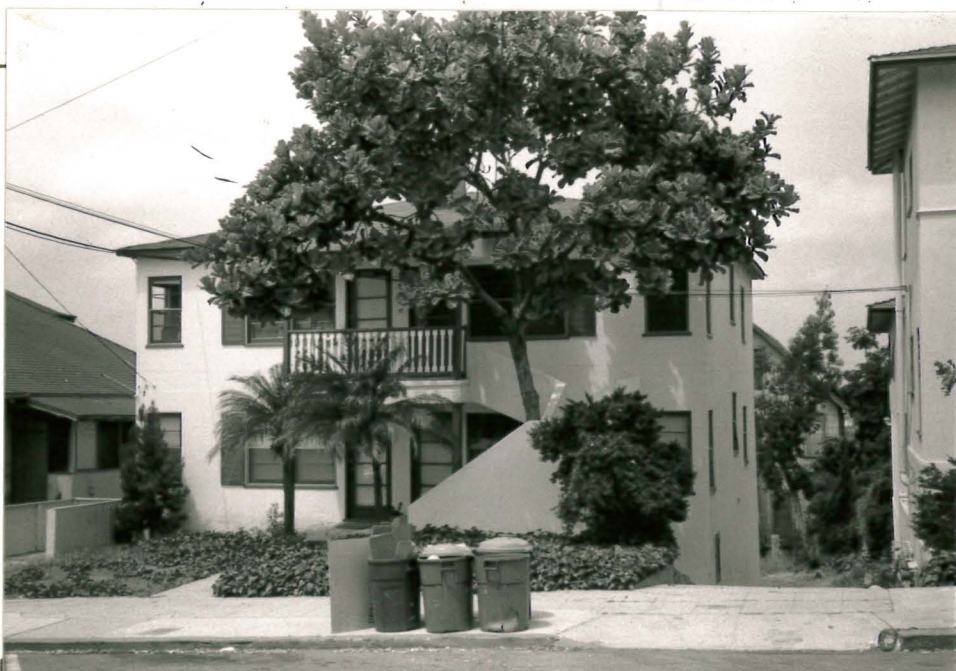
This stucco-sided rectangular two-story apartment building with a basement sits on a steeply sloping lot. The low-pitched hipped roof has composition shingles, overhanging eaves, and worked rafters. Windows are double-hung, multi-horizontally paned, some in pairs and with shutters, particularly on the front facade. The doors are wood frame with four horizontal glass panes. A dominant feature on the front facade is an articulated stairway with a solid bannister, which is located on the north side of the front facade. This stairway leads to second floor entries and a small balcony with a worked wooden balustrade and posts supporting a roof extension. Directly below, the first floor entry doors and stoop are covered by the balcony, which is supported by square wooden posts. This stoop is reached from a walkway from the sidewalk and from a stairway from the north side driveway. The building features an interior brick chimney.

13. Condition: Excellent ☒ Good _____ Fair _____ Deteriorated _____ No longer in existence _____
14. Alterations: _____ None apparent _____
15. Surroundings: (Check more than one if necessary) Open land _____ Scattered buildings _____ Densely built-up _____ X
Residential ☒ Industrial _____ Commercial _____ Other: _____
16. Threats to site: None known ☒ Private development _____ Zoning _____ Vandalism _____
Public Works project _____ Other: _____
17. Is the structure: On its original site? ☒ Moved? _____ Unknown? _____
18. Related features: _____ None _____

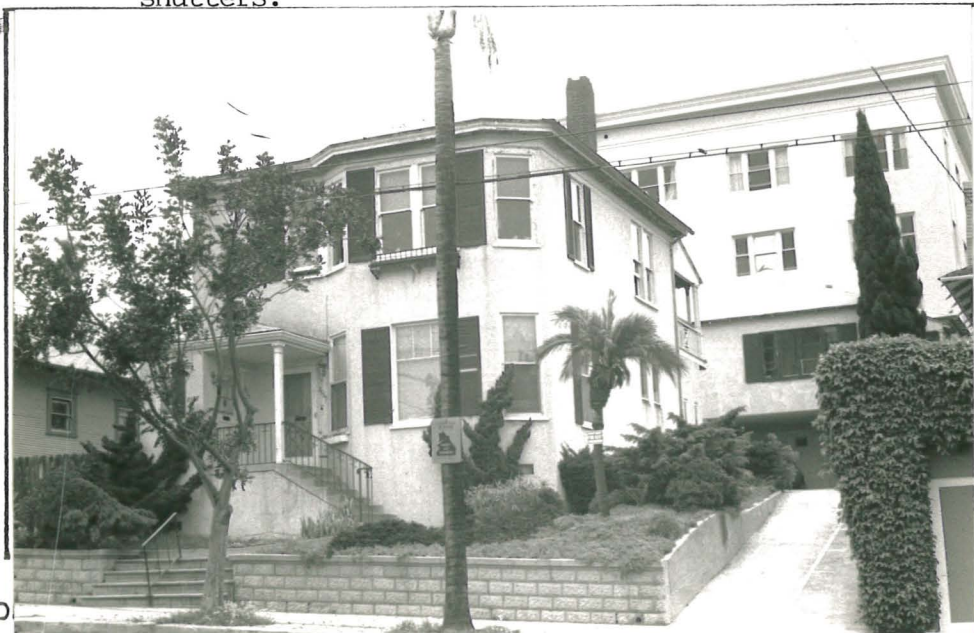
This two-story rectangular Italianate style apartment building sits above street level behind an ashlar block retaining wall. It is stucco-sided, and has an asphalt-shingled, medium-pitched hipped roof with boxed cornice, widely overhanging eaves, and plain frieze. Windows are predominantly double-hung; many have shutters. The main window on the first floor front facade is fixed with a three-pane transom. The building features a full-length wide-angle bay on the south side of the front facade, which is covered by the main roof. Below the second story window is an iron window box supported by worked brackets. A porch on the north side of the front facade is reached via four cement steps with central railing from street level, then a walkway and straight south-facing stairway. The porch, with a wrought iron balustrade, which continues to form a railing for the stairway, has wooden posts and is covered by a hipped roof. The two entry doors, facing south and west, are wood paneled with rectangular glass uppers. The building has an interior brick chimney and a second floor balcony with shed roof, wood balustrade and worked posts on the east side. A driveway to the south leads to a two-story 40's style apartment with garages on the first floor. Alterations include a floating stairway on the northeast corner, new stucco, and possibly the shutters.

13. Condition: Excellent ___ Good ☒ Fair ___ Deteriorated ___ No longer in existence ___
14. Alterations: Floating stairway on northeast corner, new stucco, and possibly shutters
15. Surroundings: (Check more than one if necessary) Open land ___ Scattered buildings ___ Densely built-up ☒
Residential ☒ Industrial ___ Commercial ___ Other: ___
16. Threats to site: None known ☒ Private development ___ Zoning ___ Vandalism ___
Public Works project ___ Other: ___
17. Is the structure: On its original site? ☒ Moved? ___ Unknown? ___
18. Related features: 40's style apartment building to rear.

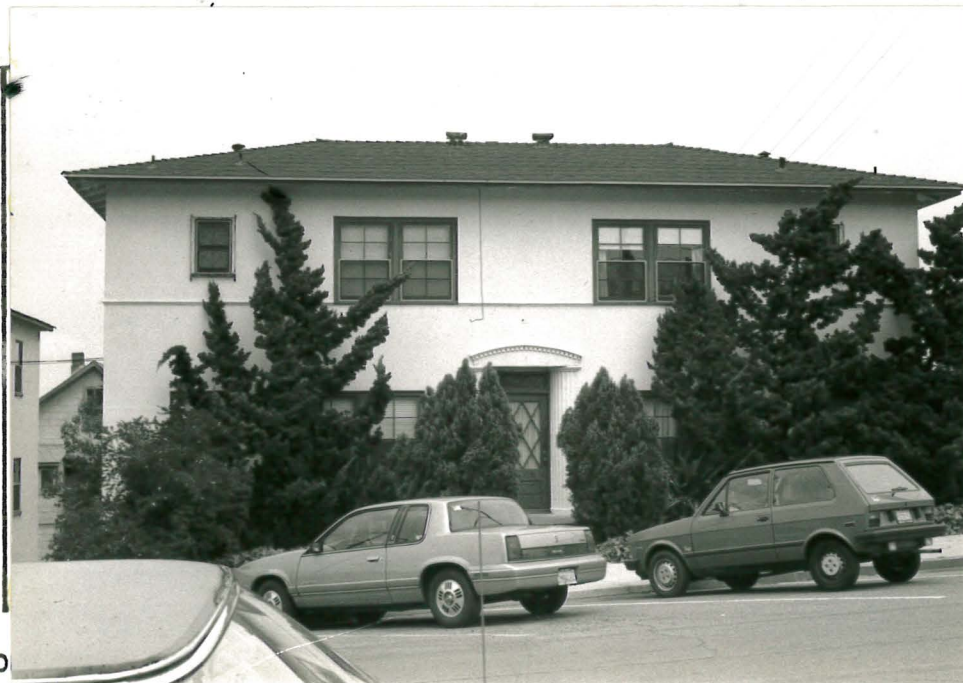
These 2-story apartments with basement are rectangular in shape with smooth stucco siding. The low-pitched hip roof has wide overhanging eaves, exposed rafters and square canalis below. Pairs of double-hung multi-pane windows are placed symmetrically on the structure and two smaller solo windows with iron grillwork are at the 2nd story corners. A water-course surrounds the structure just below the 2nd story windows. The stepped entry is recessed with large fluted pilasters on either side of the door. Above the wood-paneled door with a diamond-paned upper, is a leaded transom and curved crown with dentils. To the rear of the structure is a 2nd story cantilevered balcony with square posts and decorative wood balustrade. It is sheltered by an extension of the roof. The driveway to the rear leads to the basement access and an accompanying 2-story apartment building. Below is a row of 5 garages with wooden doors while a stairway with a wrought iron banister leads to the upper apartments.

13. Condition: Excellent ☒ Good _____ Fair _____ Deteriorated _____ No longer in existence _____
14. Alterations: None
15. Surroundings: (Check more than one if necessary) Open land _____ Scattered buildings _____ Densely built-up ☒
Residential ☒ Industrial _____ Commercial _____ Other: _____
16. Threats to site: None known ☒ Private development _____ Zoning _____ Vandalism _____
Public Works project _____ Other: _____
17. Is the structure: On its original site? ☒ Moved? _____ Unknown? _____
18. Related features: None

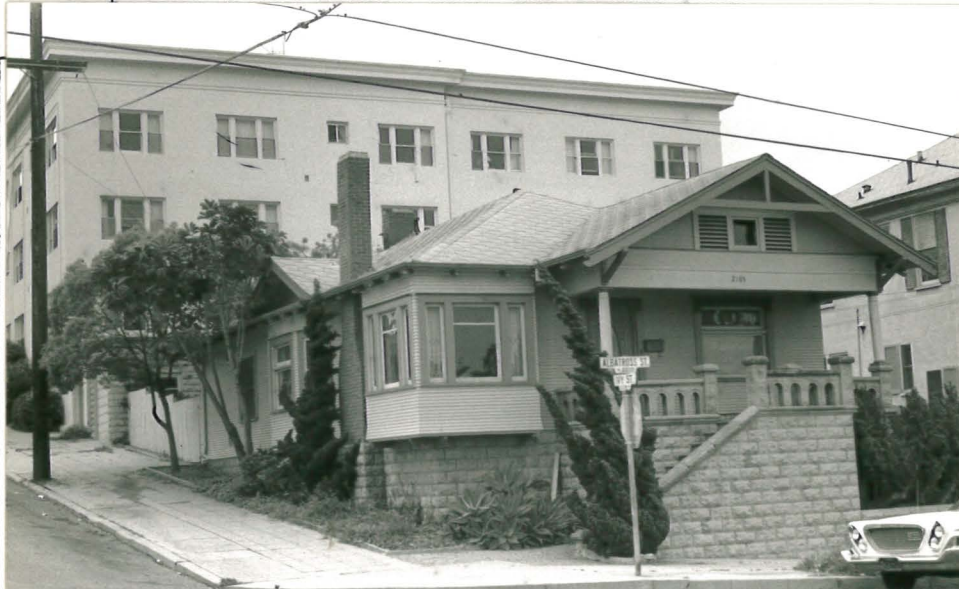
This one-story craftsman home has an irregular roofline with two central medium-pitched hip and gables over the entry and bay. The wide overhanging eaves have exposed worked rafters, knee brackets & stickwork decorate the front pediment. A tall brick chimney is situated along the north wall and connects to the ashlar foundation which rises near the front due to the grade and forms the stepped porch entry and balustrade. The porch is sheltered by the front gable which has a wide plain entablature and is supported by Doric columns which connect to ashlar post. The gable end has horizontal roof vents flanking a small square window. The door is wooden with a single oval pane. To the south of the door is a fixed pane window with a leaded transom. To the north of the porch is a square oriel bay with brackets below and three-sash windows with leaded transom and side panels wrapping around the corner. An angled bay is on the north wall below the gable. The remainder of the windows are double-hung with a shelf surround, except for an altered window on the north facade which has a plain wooden surround. The siding is narrow clapboard which flairs near the foundation.

13. Condition: Excellent ☒ Good _____ Fair _____ Deteriorated _____ No longer in existence _____
14. Alterations: window
15. Surroundings: (Check more than one if necessary) Open land _____ Scattered buildings _____ Densely built-up ☒
Residential ☒ Industrial _____ Commercial _____ Other: _____
16. Threats to site: None known _____ Private development _____ Zoning ☒ Vandalism _____
Public Works project _____ Other: _____
17. Is the structure: On its original site? ☒ Moved? _____ Unknown? _____
18. Related features: an ashlar garage with a wooden door along Front St

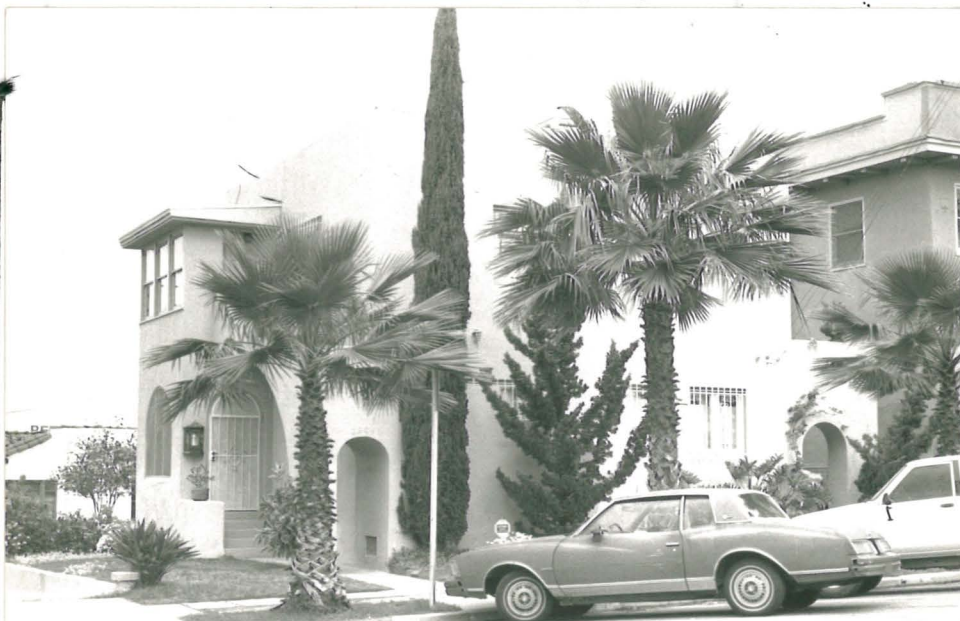
This 2 1/2 story split level Spanish Colonial Style building is irregularly shaped, flat roofed, and stucco sided. Windows are recessed and include pairs of hinged windows with awning transoms and double-hung windows. Some have decorative ironwork. The door is not visible from the street. Instead, a front facing screen door with decorative ironwork and a plain fanlight serves an enclosed entry porch on the south side of the building. A sidewalk with an arcaded wing wall and 5 steps lead to a north side entry. There is a retaining wall with stucco posts on the south side. The building has been greatly altered: an articulated stairway crosses the front facade and rises to a 2nd floor apartment entrance. The stairway covers a large arch on the south facade. The first floor porch has been enclosed and many of the windows are new. A second story addition surrounding a rear roof balcony with Craftsman style pergolas also appears new. There is a garage on the south west corner.

13. Condition: Excellent _____ Good _____ Fair X Deteriorated _____ No longer in existence _____
14. Alterations: Enclosed porch, windows, 2nd story addition surrounding roof balcony stairway
15. Surroundings: (Check more than one if necessary) Open land _____ Scattered buildings _____ Densely built-up X
Residential X Industrial _____ Commercial X Other: _____
16. Threats to site: None known _____ Private development _____ Zoning X Vandalism _____
Public Works project _____ Other: _____
17. Is the structure: On its original site? X Moved? _____ Unknown? _____
18. Related features: None

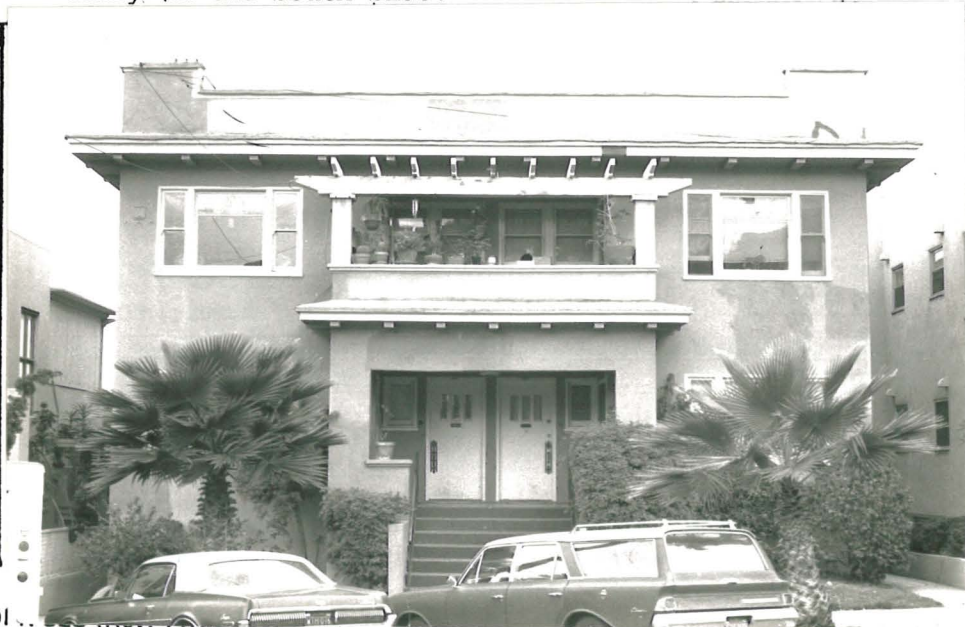
This rectangular, symmetrical Mission style apartment building is two stories in height with a basement in the rear necessitated by the slope of the lot. Siding is stucco; the roof is flat with a boxed cornice and rectangular brackets. A parapet, stepped at the corners and with coping, rises above the roof. The windows are both double-hung and three-sash with fixed central pane, multi-pane transom and narrow double hung side panels. Doors are single panel with three narrow vertical uppers and decorative door handles. Both doors and windows have narrow wood surrounds. From street level eight cement steps with iron railing lead to a porch with a solid stucco balustrade and posts. Door are recessed, two facing the street, flanked by the windows and tow opposing each other on the north and south sides of the porch. The porch is covered by a hipped roof with boxed cornice and rectangular brackets. A second floor recessed balcony with solid balustrades thick wooden posts, and worked lintel supporting a craftsman style worked wood pergola is directly above. Balcony doors open to the north and south. The north and south facades each feature shallow, square two-story oriel bays. There is an entry on the south side.

13. Condition: Excellent _____ Good X Fair _____ Deteriorated _____ No longer in existence _____
14. Alterations: none apparent
15. Surroundings: (Check more than one if necessary) Open land _____ Scattered buildings _____ Densely built-up X
Residential X Industrial _____ Commercial _____ Other: _____
16. Threats to site: None known X Private development _____ Zoning _____ Vandalism _____
Public Works project _____ Other: _____
17. Is the structure: On its original site? X Moved? _____ Unknown? _____
18. Related features: _____

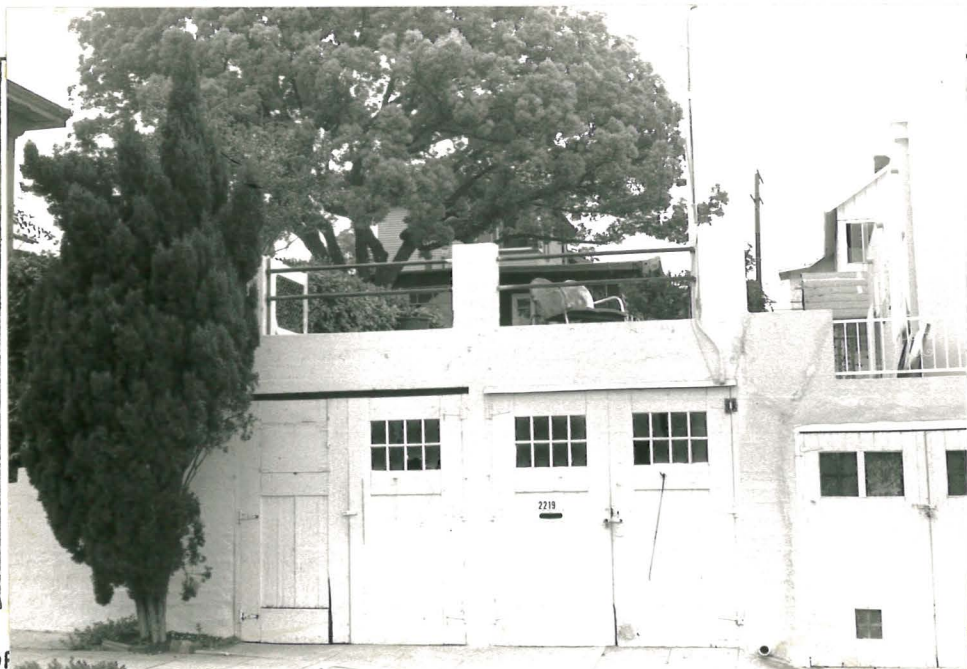
This one-story bungalow is situated high above the street level with a tall retaining wall, and a two-car garage along the street level. Steps are along the wall, which lead to a gate over the garage which has wood doors with hinges and multi-paned uppers. The bungalow has a low-pitch side gable with a wide overhang and exposed rafters. The siding is wood shingle with an enclosed porch on the north-west street facade. On the enclosure, the windows are large fixed panes with multi-pane uppers and a stepped entry is on the southwest side. The remainder of the windows are twin wooden hinged with single glass panes. A mature camphor tree shades the yard and bungalow.

13. Condition: Excellent _____ Good ☒ Fair _____ Deteriorated _____ No longer in existence _____
14. Alterations: _____
15. Surroundings: (Check more than one if necessary) Open land _____ Scattered buildings _____ Densely built-up ☒
Residential ☒ Industrial _____ Commercial _____ Other: _____
16. Threats to site: None known _____ Private development _____ Zoning ☒ Vandalism _____
Public Works project _____ Other: _____
17. Is the structure: On its original site? ☒ Moved? _____ Unknown? _____
18. Related features: _____

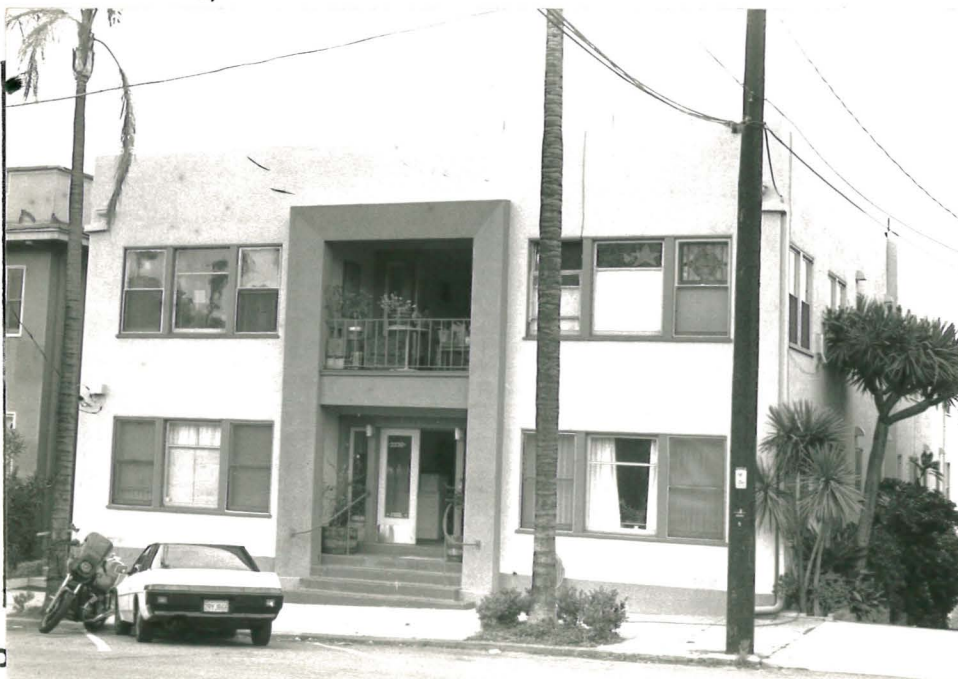
- Architectural style: Mission Revival
- Briefly describe the present *physical appearance* of the site or structure and describe any major alterations from its original condition:
Legal D: Blk 253 Lot I Hortons's Add Lockling
2230 Albatross Street is a 2-story rectangular apartment building. It rests on a slope which allows for a rear basement with an entry along the southern facade. The roof is flat and the siding is smooth stucco. Little ornamentation exists beyond the entry which is the central element. It consists of a wide 2-story rectangular frame around the recessed door and 2nd story balcony. Four steps lead to the door with a curving iron railing. The double doors are wood framed with a single glass pane and 3/4 side panels which are echoed above on the balcony. The windows are 3-sash on the street facade with a center fixed pane and double-hung side panels. The remainder are adjacent pairs of double-hung windows.

13. Condition: Excellent _____ Good X Fair _____ Deteriorated _____ No longer in existence _____
14. Alterations: _____
15. Surroundings: (Check more than one if necessary) Open land _____ Scattered buildings _____ Densely built-up X
Residential X Industrial _____ Commercial _____ Other: _____
16. Threats to site: None known X Private development _____ Zoning _____ Vandalism _____
Public Works project _____ Other: _____
17. Is the structure: On its original site? X Moved? _____ Unknown? _____
18. Related features: _____

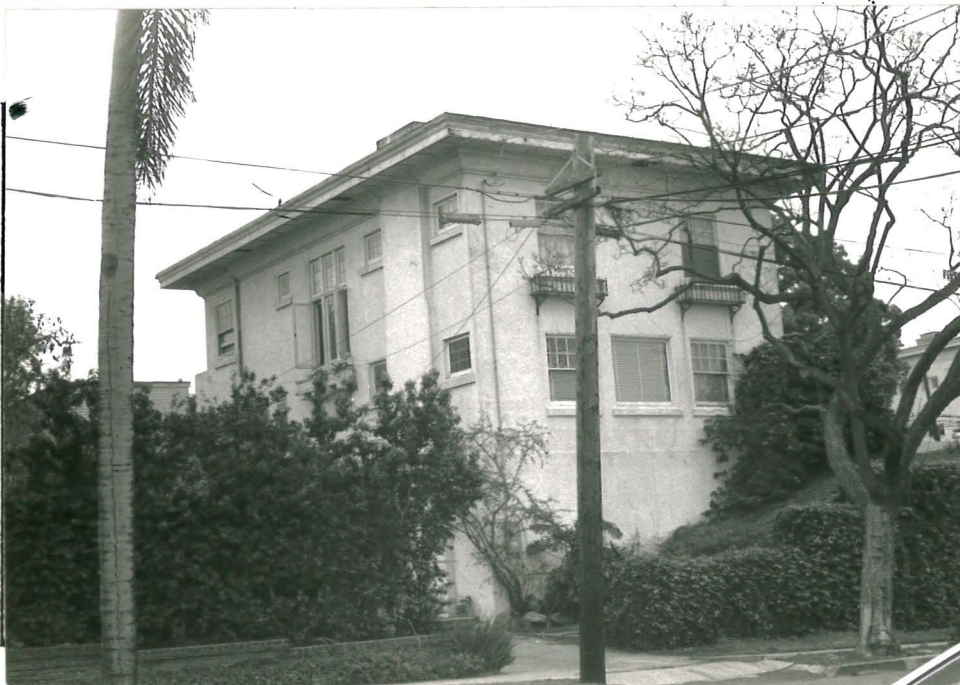
This rectangular three-story home has a flat roof with a molded cornice. The wide overhang eaves have decorative brackets and a wide molded frieze below. An exterior chimney protrudes from the northern facade and is sheathed in stucco as is the rest of the house. The windows are multi-paned and either double hung or hinged in a smaller version. Above the north facing entry with a beautifully landscaped yard are three tall vertical hinged windows with multi-paned transoms. Below the windows is the entry with a large arched overhang with decorative brackets and a center keystone. The door is wood panel with a glass upper. The street facade has decorative wrought iron window boxes on the third story and a fixed center pane below. A two-story addition with a flat roof is lower than the original roofline and is situated along the southern facade. A band of multi-pane windows surround the addition which may have been an original enclosed porch on the first level. A two-story building has been added to the rear with a flat roof, clapboard and stucco siding and double-hung multi-pane windows. The lower level serves as a garage.

13. Condition: Excellent ____ Good X Fair ____ Deteriorated ____ No longer in existence ____
