HISTORIC RESOURCES INVENTORY

1. Common name: Anderson Apartments
2. Historic name: Anderson Apartments
3. Street or rural address: 1747 5th Avenue
City San Diego Zip 92101 County San Diego
4. Parcel number: 533-303-02
5. Present Owner: Electronics Capital Corp Address: P.O. Box 2429
City San Diego Zip 92112 Ownership is: Public _____ Private X
6. Present Use: Residential Original use: Residential

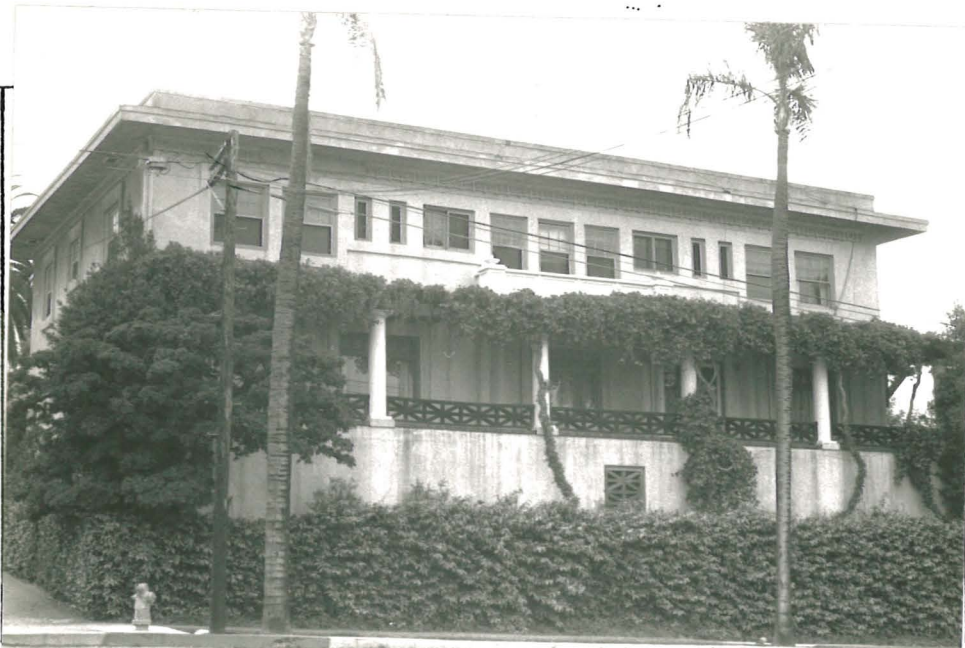
- 7a. Architectural style: Italian Renaissance with Prairie Influence
- 7b. Briefly describe the present *physical description* of the site or structure and describe any major alterations from its original condition: Legal D: Blk 254 Lots A thru C Hortons Add Lockling
This large two-story rectangular home situated on a slope and has a basement below. The roof is flat with a dropped cornice, wide overhanging eaves and a decorated frieze with a greek key pattern. The windows have a horizontal orientation and are in various sizes such as wide double hung with multi-paned uppers, very narrow four paned hinged, and multi-paned sliders along the second story. First story windows along the street facade consist of large fixed panes with multi-paned transoms. The central feature of the symmetrical stucco facade is the large veranda along the western facade. It is high above the street level due to the slope and has four Doric columns supporting an ivy-covered pergola. The balustrade is solid stucco topped with a heavy wooden cross beam pattern. The porch entry are double french doors with a wide stucco surround. Above is a small stucco balconette courtyard while the northern facade has a driveway, single car garage and grand pergola which suggests the primary entrance.

13. Condition: Excellent ☒ Good _____ Fair _____ Deteriorated _____ No longer in existence _____
14. Alterations: none apparent
15. Surroundings: (Check more than one if necessary) Open land _____ Scattered buildings _____ Densely built-up ☒
Residential ☒ Industrial _____ Commercial _____ Other: _____
16. Threats to site: None known _____ Private development _____ Zoning ☒ Vandalism ☒
Public Works project _____ Other: _____
17. Is the structure: On its original site? ☒ Moved? _____ Unknown? _____
18. Related features: none

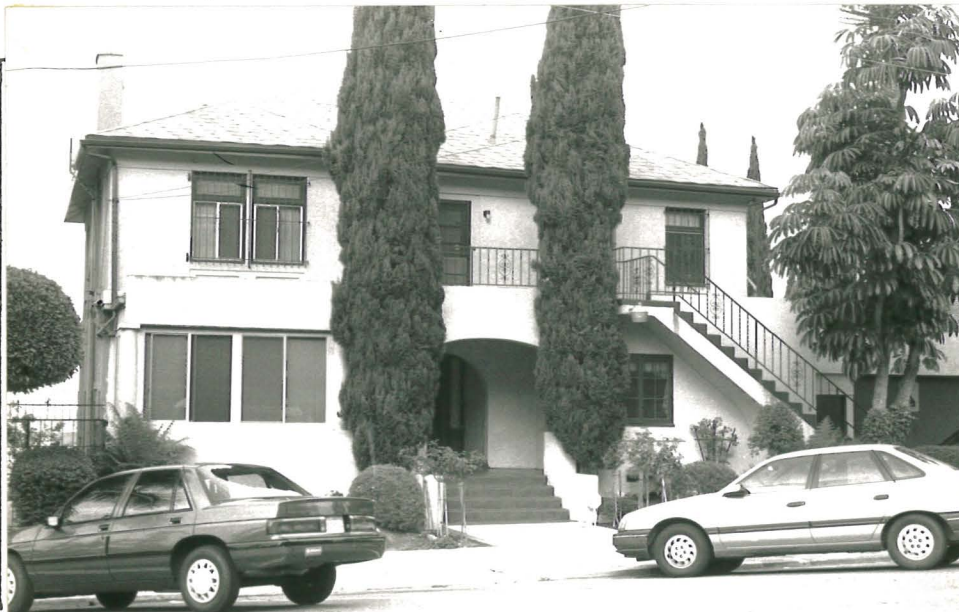
2330 Albatross Street is a rectangular two-story apartment house in the Mission Revival style. The roof is medium-pitched with a truncated hip and boxed overhang. The original three-part windows consist of two multi-pane hinged and single-pane hinged with transoms. A porch on the southeast corner has been enclosed with aluminum sliding windows, a flat roof, and stucco sheathing, as the entire structure is sheathed. The semi-elliptical porch entry has a stucco balustrade and two Tuscan columns, which have been covered with stucco. The recessed door is wood framed with a single glass pane and 3/4 sidepanels. A stucco stairway runs along the street facade (possible addition), and is entered from the north with a wrought iron bannister. It leads to the second floor balcony and door, which is wood framed with horizontal panes. A garage is situated to the north with a flat roof and gated security entrance. Alterations include the second-story window security bars, aluminum windows, and enclosed porch.

13. Condition: Excellent ___ Good ___ Fair X Deteriorated ___ No longer in existence ___
14. Alterations: Windows, enclosed porch, security bars, light fixtures.
15. Surroundings: (Check more than one if necessary) Open land ___ Scattered buildings ___ Densely built-up X
Residential X Industrial ___ Commercial ___ Other: ___
16. Threats to site: None known X Private development ___ Zoning ___ Vandalism ___
Public Works project ___ Other: ___
17. Is the structure: On its original site? X Moved? ___ Unknown? ___
18. Related features: ___

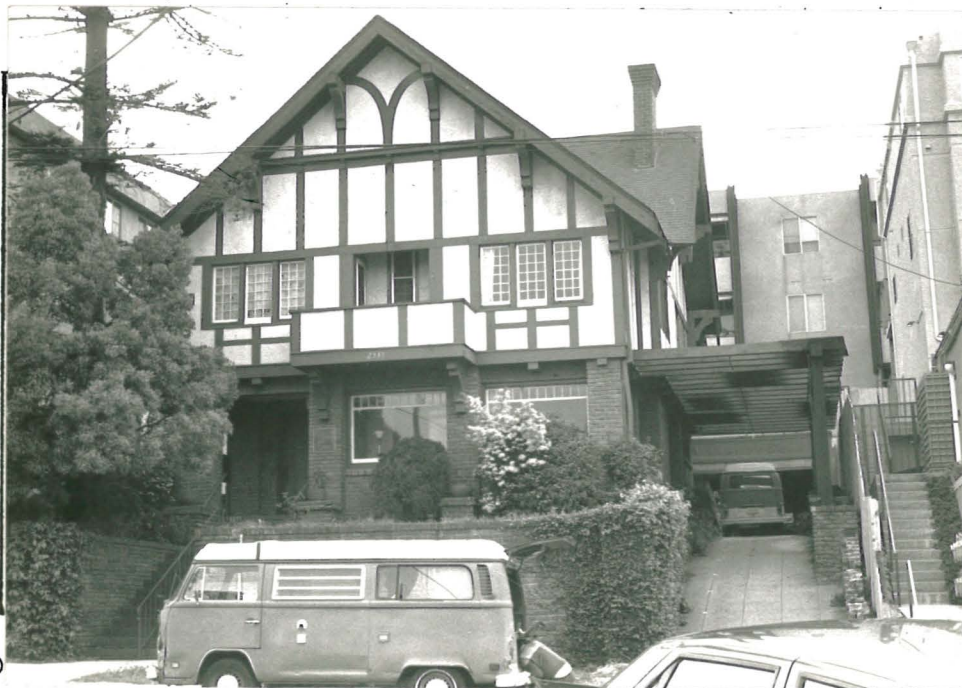
This 2 ½ story Tudor home has a high-pitched cross gable roof with overhanging eaves and massive worked knee brackets. A large brick interior chimney protrudes on the southern side of the roof. The first level is sheathed in brick with brick pilasters while the upper levels are stucco with decorative half-timbering. The house is situated above the street level with a large brick retaining wall and a sloped driveway to the south sheltered by a large arbor supported by thick beams and square brick piers below. The windows are multi-paned in double-hung and casement varieties. Along the first level of the street facade are fixed single panes with multi-paned transoms. The second story has a centered balcony with a solid stucco and timber balustrade and recessed opposing doors with a center window. Below the balcony are large worked bracket, a plain frieze and small square brackets under the second story overhang. The recessed porch entrey has large brick pillars and pilasters with a solid wooden door.

13. Condition: Excellent ☒ Good _____ Fair _____ Deteriorated _____ No longer in existence _____

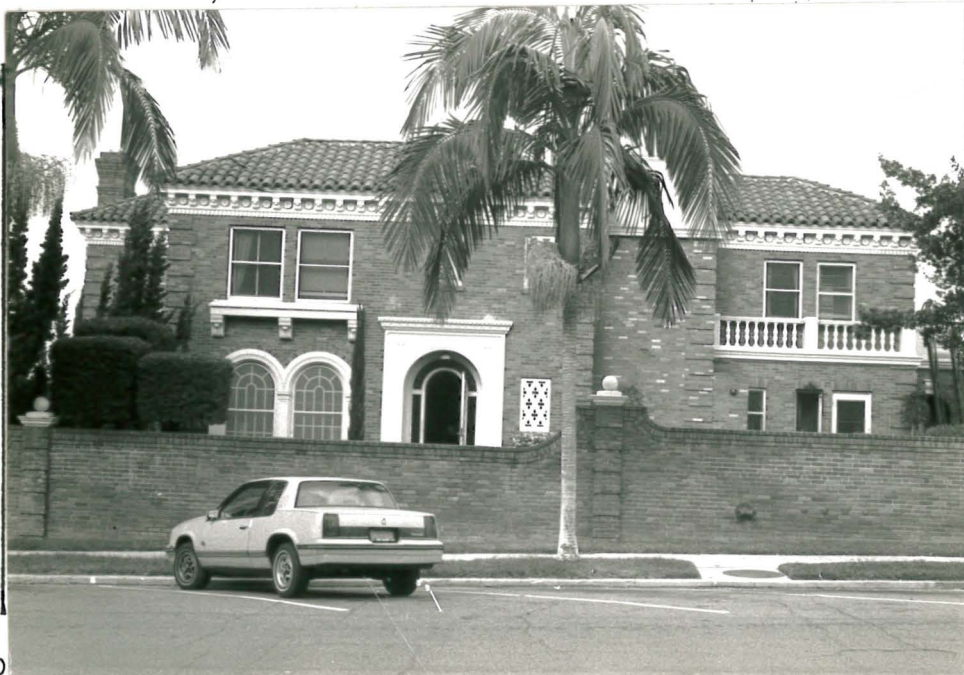
This ornate, three story brick house is irregularly shaped with a trunkated hip roof of mission style red tile. A shallow overhang has exposed, decorative brackets which form along with flower shaped medallians, an elaborate cornice with a dentil like bond below. Windows include double full length arched, some with keystone in reverse-u cap. Entrance is arched with wide surround and entablature above. Arched entry door has transom and side panel which follow the curve of the arch. Wooden spindle balconette faces one window grouping, another has a massive bracketed lugsill. The facade is brick with corner quoining and a stepped brick wall surrounds the entire property. Quoined post with globes atop are placed in intervals along the wall, some with the wall curving up to the globe.

Alterations include a semi-circular, flat roofed hall like addition on the new corner with a continuous ribbon of lg, single pane fixed windows, brick siding on 2nd floor and stucco on the first floor. Also the garage has been converted to living space. Both alterations sensitively constructed in cooperation wiht the main building.

13. Condition: Excellent X Good _____ Fair _____ Deteriorated _____ No longer in existence _____
14. Alterations: home apparent
15. Surroundings: (Check more than one if necessary) Open land _____ Scattered buildings _____ Densely built-up X
Residential X Industrial _____ Commercial _____ Other: _____
16. Threats to site: None known _____ Private development _____ Zoning X Vandalism _____
Public Works project _____ Other: _____
17. Is the structure: On its original site? X Moved? _____ Unknown? _____
18. Related features: home

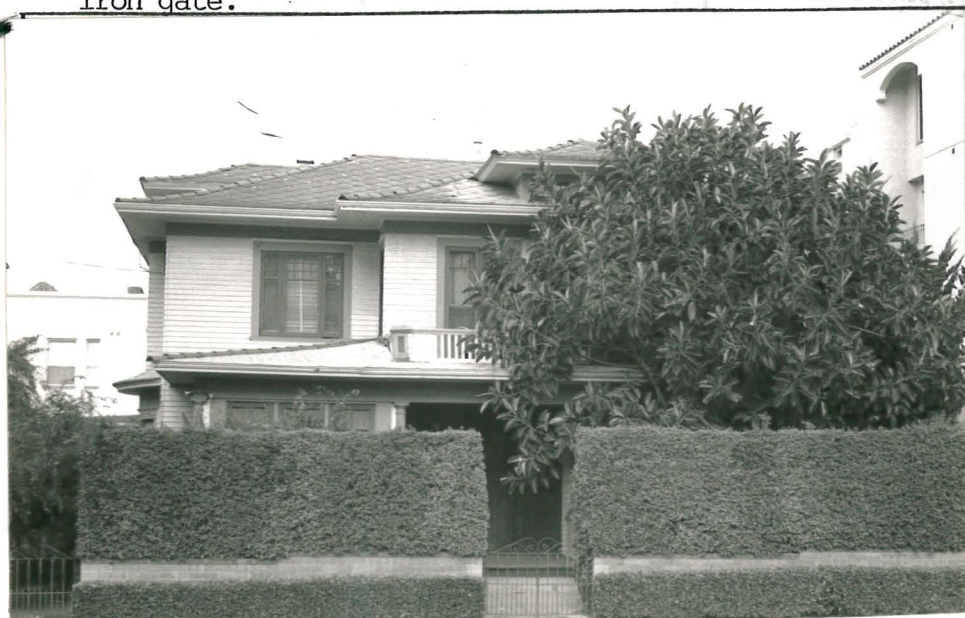
This 2½ story home is rectangular in shape and rest on a slop which allows for 3½ stories to the rear. The roof is a low-pitched multi-hip with a red-tile spine. The widely overhanging boxed eaves are bellcast and a plain frieze wraps around the home below the cornice. Hipped domes project from each facade with horizontal windows. The second-story windows are three-sashed and hinged with multi-paned uppers which are echoed on the first story in a larger version. The remainder of the windows are double-hung with multi-paned uppers. The open entry porch is reached by two wooden steps. Tuscan columns are situated at the corners of the porch, the southern column is engaged within the first story extension while a hip roof with a red tile spine covers them both the entry is recessed with a wide solid wood panel door, original brass fixtures and ½ sidepanels. Above the porch is a small balcony with a stick balustrade and multi-paned french doors. Along the first story of the southern facade is a round bay with a conical roof. To the west is a later addition with a flat roof and exposed rafters. The home is sheathed with clapboard and surrounded by lush landscaping and brick and wrought iron gate.

13. Condition: Excellent X Good _____ Fair _____ Deteriorated _____ No longer in existence _____

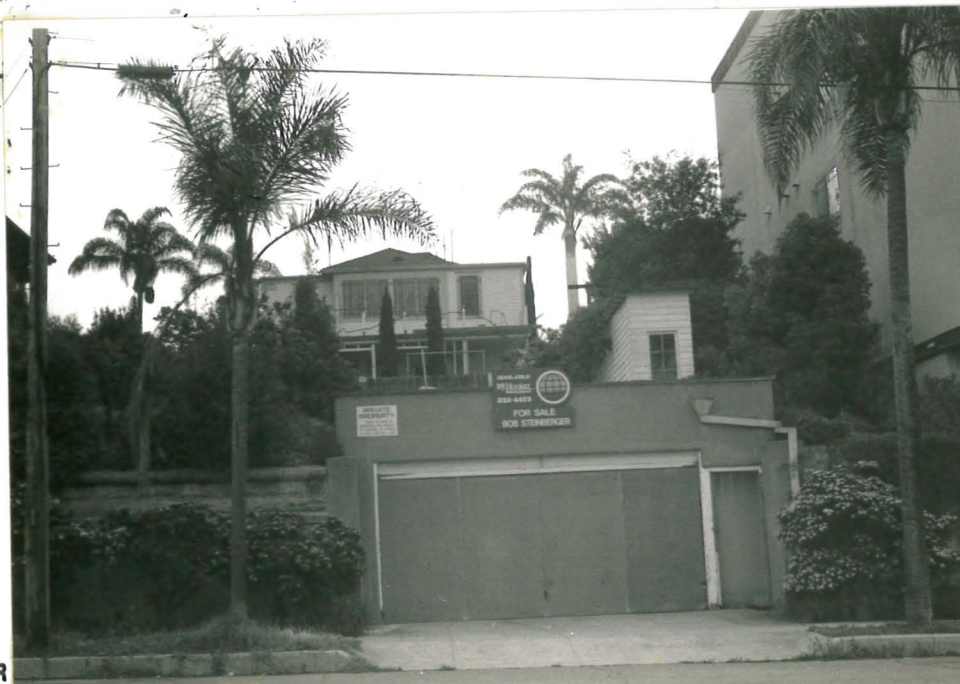
This predominately vacant lot is an architectural remnant which contains mature landscaping and a small structure along the southern boundary. The 1-story structure is very narrow and appears to be in the Craftsman style. The roof is flat with exposed worked rafters. The siding is clapboard and the windows are narrow multi-paned hinged. Along the street level is an ashlar block retaining wall and a stucco 2-car garage with a wooden door.

13. Condition: Excellent _____ Good _____ Fair _____ Deteriorated _____ No longer in existence X
14. Alterations: _____
15. Surroundings: (Check more than one if necessary) Open land _____ Scattered buildings _____ Densely built-up X
Residential X Industrial _____ Commercial _____ Other: _____
16. Threats to site: None known X Private development _____ Zoning _____ Vandalism _____
Public Works project _____ Other: _____
17. Is the structure: On its original site? X Moved? _____ Unknown? _____
18. Related features: _____

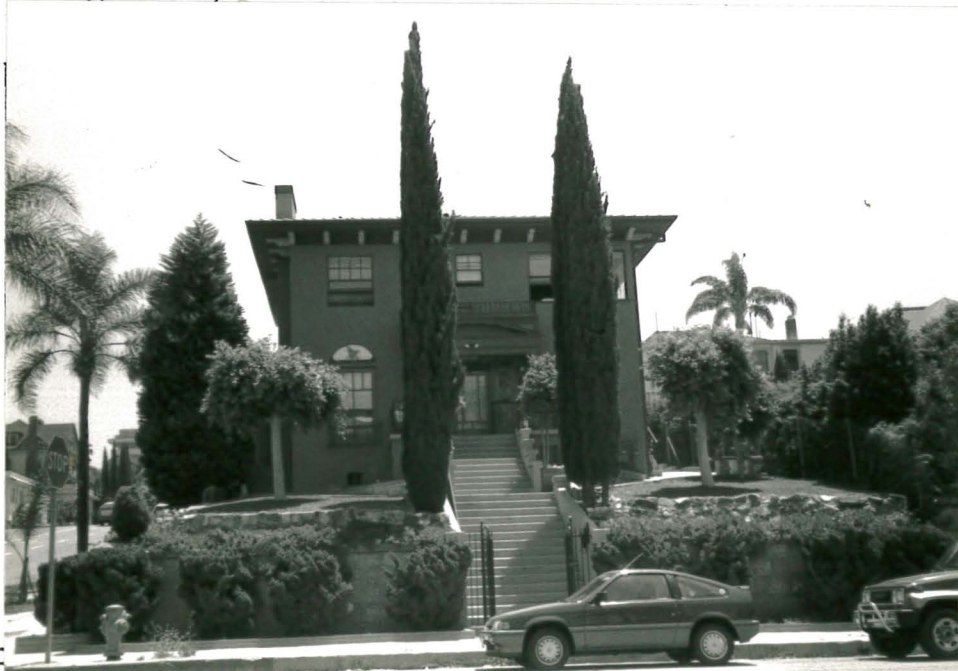
This two story Italianate home is on a raised foundation and is situated high above the street level. The low-pitched hip roof has a red-tile spine, wide overhanging eaves and exposed worked rafters. The siding is stucco which covers the large chimney along the northern facade. Along the second story the windows are wide and double-hung with multi-paned uppers with two altered windows which are now large fixed panes. The lower windows along the street facade are hinged and multi-paned with an unusual fan-shaped mural above the centered entry is accessed by a long stairway from the street. The wide wood framed front door has multi-panes above and carved wooden sidepanels. Above is an eyebrow pediment with a wide entablature, dentils, heavy carved brackets below and a wrought iron balconette above. A tall cement block retaining wall surrounds the yard with an iron gate opening to the front stairs. A square bay is along the northern facade with a three sashed window. Alteration include two flat roofed addition and entrance along Laurel Street, iron window security bars and the large fixed windows. Mature cypress and ficus trees surround the home.

13. Condition: Excellent _____ Good X Fair _____ Deteriorated _____ No longer in existence _____
14. Alterations: some windows, small entry addition
15. Surroundings: (Check more than one if necessary) Open land _____ Scattered buildings _____ Densely built-up X
Residential X Industrial _____ Commercial _____ Other: _____
16. Threats to site: None known _____ Private development _____ Zoning X Vandalism _____
Public Works project _____ Other: _____
17. Is the structure: On its original site? X Moved? _____ Unknown? _____
18. Related features: none

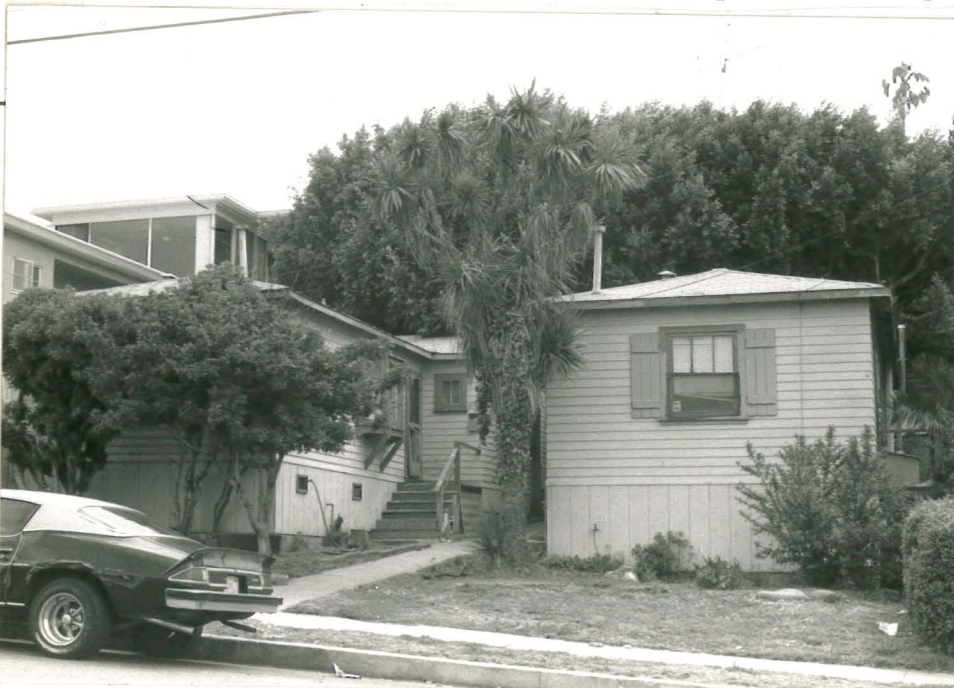
These three bungalows form a quaint center courtyard. The wing units are L-shaped facing inward and the back structure is a shallow U-shape. They are one-story on a raised foundation with clapboard siding. The roofs are low-pitched hips with a slight overhang and exposed rafters. A gable extends to form the L-shape on each wing. The windows are double-hung with vertical multi-pane uppers, some in pairs, and two along the street facade with shutters. Two angled oriel bays with knee brackets below and a multi-pane window with hinged multi-pane side panels face the inner courtyard. They have flat roofs with scalloped edges. Wooden stairs with a wooden banister lead to each entry. The doors are wood panel with a multi-paned upper. Similar entries are on the north and south facades of the wings with new aluminum-framed screen doors, which are the only apparent alterations. A concrete sidewalk and sparse landscaping are within the courtyard.

13. Condition: Excellent ___ Good X Fair ___ Deteriorated ___ No longer in existence ___
14. Alterations: Aluminum screened back doors
15. Surroundings: (Check more than one if necessary) Open land ___ Scattered buildings ___ Densely built-up X
Residential X Industrial ___ Commercial ___ Other: ___
16. Threats to site: None known ___ Private development ___ Zoning X Vandalism ___
Public Works project ___ Other: ___
17. Is the structure: On its original site? X Moved? ___ Unknown? ___
18. Related features: ___

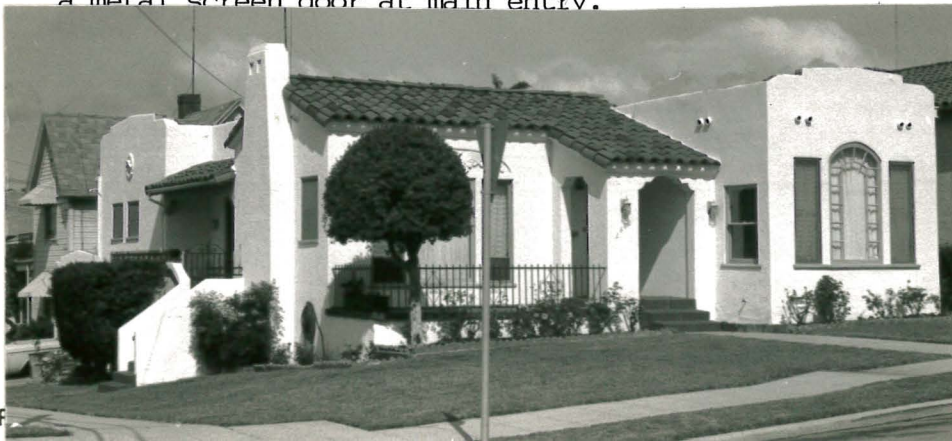
Additional entries are located on the north facade and south-west corner. The house has canales; the south facade features a chimney and quatrefoil vent. A driveway to the south leads to a two-car garage. Alteration include a metal screen door at main entry.

13. Condition: Excellent _____ Good X Fair _____ Deteriorated _____ No longer in existence _____

14. Alterations: metal screen door

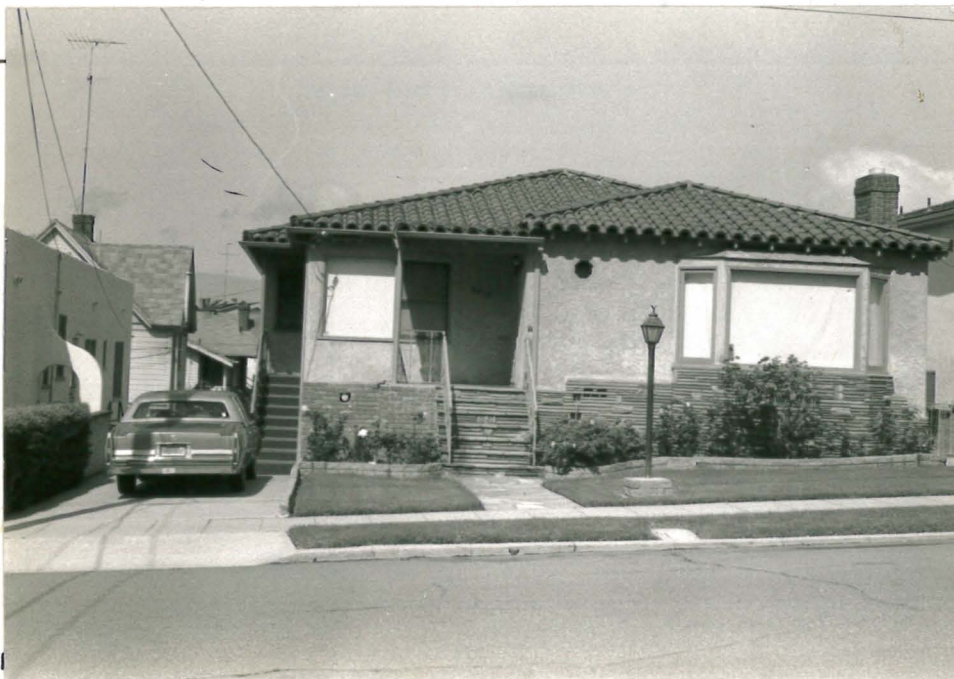
This one-story irregularly-shaped home has a low-pitched red tile hip roof with overhanging eaves and exposed rafters. The home is built on a raised foundation and has a basement to the rear due to the slope of the property. The siding is now rough stucco with the original flagstone skirting to the north and new brick skirting to the south along the street facade. The windows are double-hung along the side facades, while the street facade features a wide-angle bay with a fixed center pane and hinged side panels. Six flagstone steps with a decorative iron bannister lead to the porch sheltered by an extension of the roof. The door faces south and has a metal security screen, which is a recent alteration. A second entry is along the south facade with a tall stairway leading to the sheltered stoop. The door is wooden with a diamond-shaped upper pane. Items of mention are the brick chimney along the north wall and a porthole window between the bay and the entry.

13. Condition: Excellent _____ Good ☒ Fair _____ Deteriorated _____ No longer in existence _____
14. Alterations: Brick skirting, second south entry and steps, security door, stucco siding
15. Surroundings: (Check more than one if necessary) Open land _____ Scattered buildings _____ Densely built-up ☒
Residential ☒ Industrial _____ Commercial _____ Other: _____
16. Threats to site: None known _____ Private development _____ Zoning ☒ Vandalism _____
Public Works project _____ Other: _____
17. Is the structure: On its original site? ☒ Moved? _____ Unknown? _____
18. Related features: _____

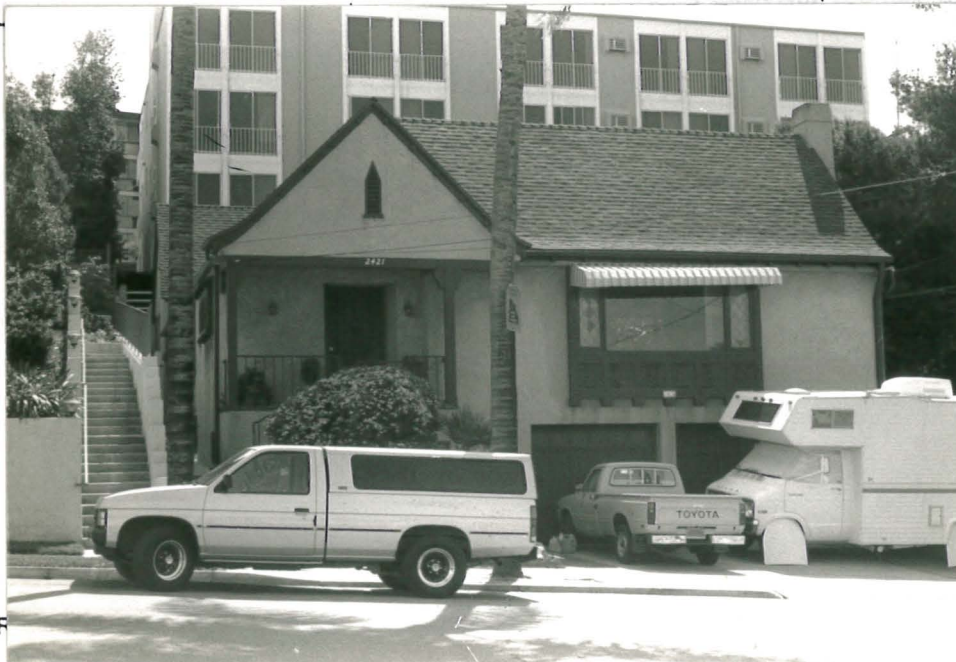
This large two-story home is situated on a rise and becomes one story in the center and becomes two stories again in the rear. The steeply pitched cross-gable roof is bell-cast with asphalt shingles and dentil-like brackets. The siding is stucco and covers the large chimney on the southern facade. The front gable features a roof vent which is a pointed arch as in the Gothic style. Below is the main entry and porch with supporting beams and lentil with corner brackets. The open porch is surrounded by a wrought iron balustrade which provides a banister for the brick articulated stairway from the street level. The door is now covered with a metal security screen. Below the porch is a basement entrance with a French door and 3/4 multi-pane side panels. To the south are two garage doors of multi-paneled wood. Directly above them is a square oriel bay projecting slightly from the facade with massive dentil-like brackets below. Six recessed panels line the lower half of the bay with various carved emblems within them. The large picture window is flanked by leaded side panels and is sheltered by an aluminum awning (alteration). A similar smaller bay is on the northern facade without the carved panels. It is sheltered by a shed roof with exposed rafters and stained glass. Two windows along the northern facade are now louvered and have iron security bars.

13. Condition: Excellent _____ Good X Fair _____ Deteriorated _____ No longer in existence _____
14. Alterations: Entry below porch, aluminum awning, security bars and screens.
15. Surroundings: (Check more than one if necessary) Open land _____ Scattered buildings _____ Densely built-up X
Residential X Industrial _____ Commercial _____ Other: _____
16. Threats to site: None known _____ Private development X Zoning _____ Vandalism _____
Public Works project _____ Other: _____
17. Is the structure: On its original site? X Moved? _____ Unknown? _____
18. Related features: None

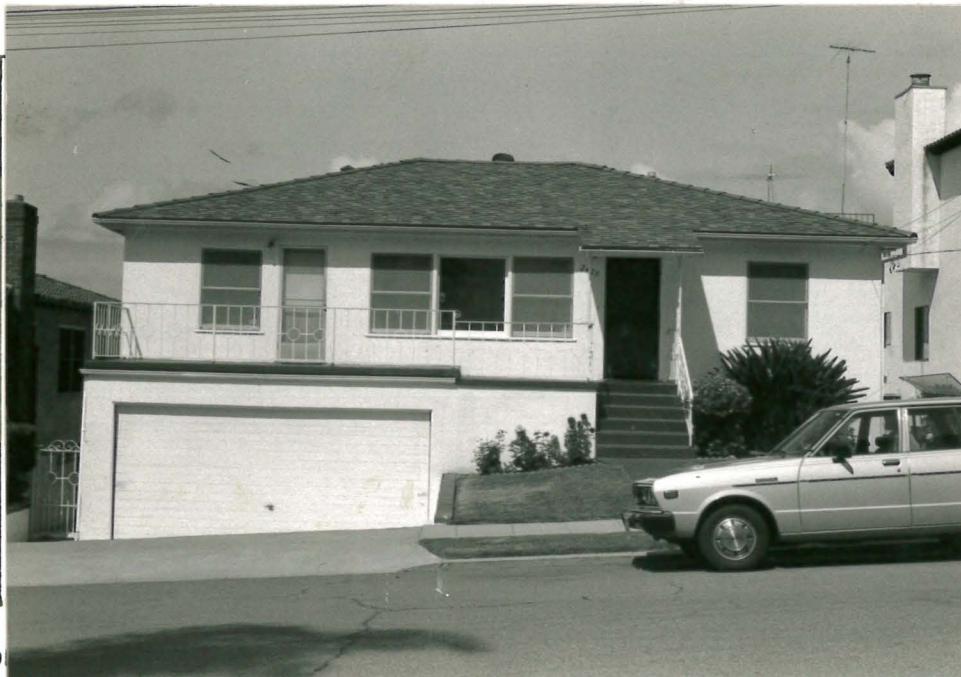
This two-story home was built on a slope allowing visibility of the first level along the southern facade. The home is rectangular in shape with a low-pitched roof, a red-tile spine, asphalt shingles and overhanging boxed eaves. The siding is smooth stucco. The windows are wide and double-hung with a three-sash window with a central fixed pane near the main entry. Six steps with a decorative iron bannister lead to the main entry and porch, which extends south along the street facade. The main doorway is sheltered by an extension of the roof supported by decorative iron posts. A metal security screen now covers the front door. To the south is a second minor entry, which is a more recent alteration. The solid wooden door is covered by an aluminum screen. On the southeast corner, below the porch, is a two-car garage situated slightly below the street level due to the slope of the property.

13. Condition: Excellent ☒ Good ☐ Fair ☐ Deteriorated ☐ No longer in existence ☐
14. Alterations: Second door on porch, garden window
15. Surroundings: (Check more than one if necessary) Open land ☐ Scattered buildings ☐ Densely built-up ☒
Residential ☒ Industrial ☐ Commercial ☐ Other: ☐
16. Threats to site: None known ☐ Private development ☐ Zoning ☒ Vandalism ☐
Public Works project ☐ Other: ☐
17. Is the structure: On its original site? ☒ Moved? ☐ Unknown? ☐
18. Related features: ☐

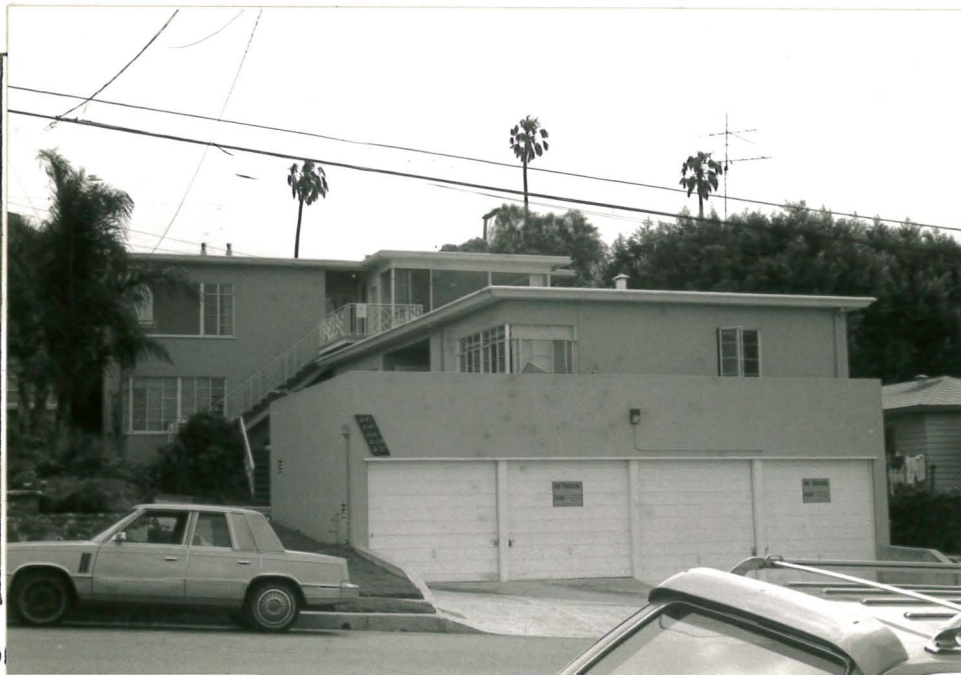
This two-story irregular-shaped structure contains five apartments. A row of four garages with a flat roof provides for a patio along the street facade, enclosing a small courtyard opening to the north. The back section of apartments is two stories in height and steps down to one story, stepping down again to the garages. The roofs are extremely low-pitched hips with a plain boxed cornice and stucco siding. The windows are metal-framed multi-paned casement with multi-paned transoms, some wrapping around the northwestern corners, as in the 1930's style. A few of the windows are large glass panes, which appear to be alterations. To the north of the garages is a sidewalk which leads to the courtyard and apartment entries. An articulated concrete stairway with a decorative iron bannister leads to the second story apartments which face west and have a small stoop. A second story balcony to the south is now enclosed with large picture windows and louvered side panels. The center section faces north and is one-story with a tall crawlspace below. The apartment entries are recessed with solid wood-paneled doors.

13. Condition: Excellent _____ Good ☒ Fair _____ Deteriorated _____ No longer in existence _____
14. Alterations: Louvered windows, enclosed balcony
15. Surroundings: (Check more than one if necessary) Open land _____ Scattered buildings _____ Densely built-up ☒
Residential ☒ Industrial _____ Commercial _____ Other: _____
16. Threats to site: None known ☒ Private development _____ Zoning _____ Vandalism _____
Public Works project _____ Other: _____
17. Is the structure: On its original site? ☒ Moved? _____ Unknown? _____
18. Related features: _____

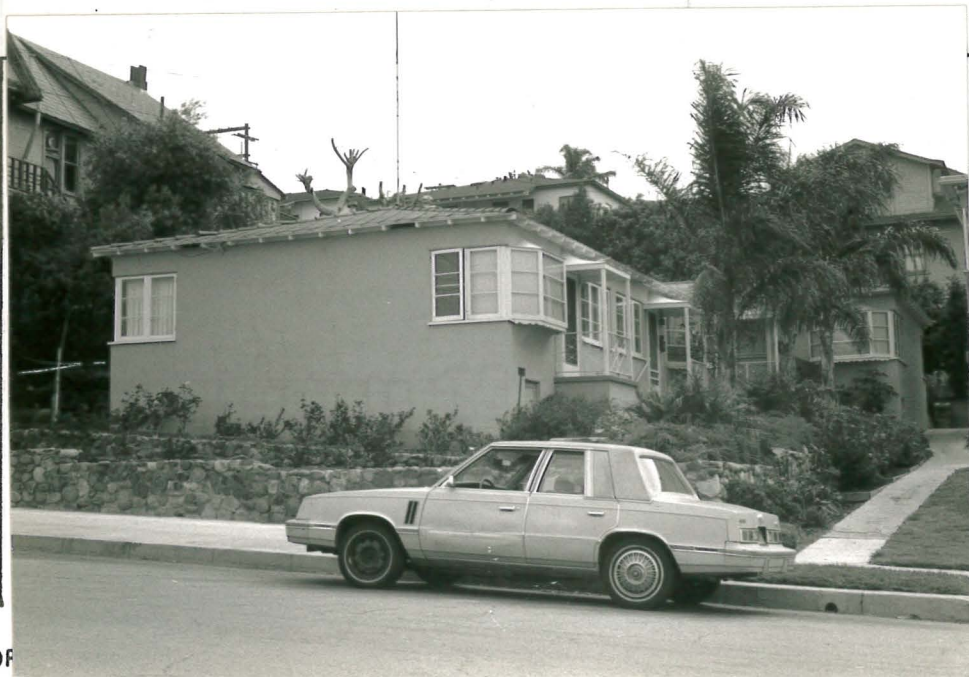
2147-53 Brant Street is two one-story rectangular buildings arranged in an L-shape around a courtyard. The front building has a low-pitched hipped roof and the rear building displays a low-pitched pyramidal hipped roof. Both roofs have asphalt shingles with red tile spines, overhanging eaves, and exposed rafters. Bands of horizontally-paned hinged windows, some three sash, wrap around the corners of the buildings. Four wide-angle bays with corbels, metal hoods, and scalloped sill molding are located at the corners. The entries to the apartments face the courtyards. Each is reached from straight stairways and has a small covered porch with flared metal roof, open metal balustrade, and small wooden posts. Doors are wood panelled. The front of the property features a rock terrace and rock retaining wall. Cement steps lead from street level to the courtyard. On the north side, a walkway leads to stepped entrances.

13. Condition: Excellent ____ Good X Fair ____ Deteriorated ____ No longer in existence ____
14. Alterations: None apparent
15. Surroundings: (Check more than one if necessary) Open land ____ Scattered buildings ____ Densely built-up X
Residential X Industrial ____ Commercial ____ Other: ____
16. Threats to site: None known X Private development ____ Zoning ____ Vandalism ____
Public Works project ____ Other: ____
17. Is the structure: On its original site? X Moved? ____ Unknown? ____
18. Related features: None

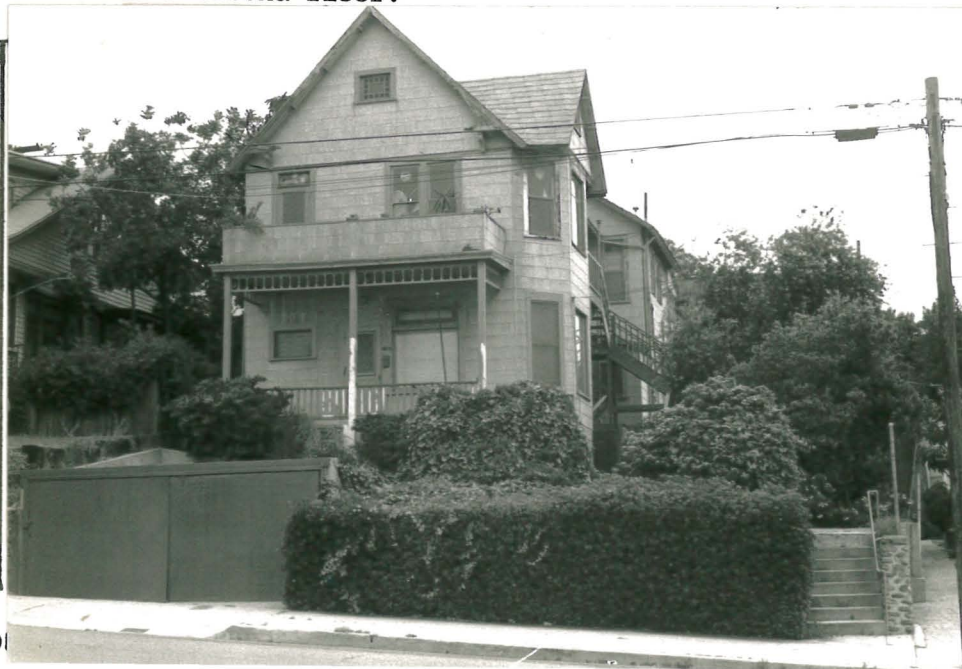
This 2½-story Folk Victorian house with a basement has an irregular shape and a high-pitch multiple cross gable roof with composition shingles and overhanging eaves. The front gable has a gable return with decorative brackets. Windows are double-hung, many in pairs, and fixed pane with single-pane transoms. A front-facing window south of the door is fixed with a multi-pane transom with flashing and square windows are centrally located in the gables. All windows have wood surrounds. Doors are two panel wood with double-hung uppers. A front porch features an open wood balustrade, three turned posts, and an open spindle frieze and molded cap. Above, a boxed balustrade surrounds a second floor balcony. South of the porch is a wide angle bar. The south-facing second floor entry is reached from an articulated wooden stairway with an open wood railing. A cobblestone retaining wall, covered by planting, fronts the property. A cement stairway with pipe rail is to the south. To the north is a cement garage with 2 wooden doors. Alterations include asbestos siding, a louvered window and the wooden stairway to the second floor.

13. Condition: Excellent ___ Good ☒ Fair ___ Deteriorated ___ No longer in existence ___
14. Alterations: Asbestos siding, louvered window, stairway
15. Surroundings: (Check more than one if necessary) Open land ___ Scattered buildings ___ Densely built-up ☒
Residential ☒ Industrial ___ Commercial ___ Other: ___
16. Threats to site: None known ___ Private development ☒ Zoning ___ Vandalism ___
Public Works project ___ Other: ___
17. Is the structure: On its original site? ☒ Moved? ___ Unknown? ___
18. Related features: None

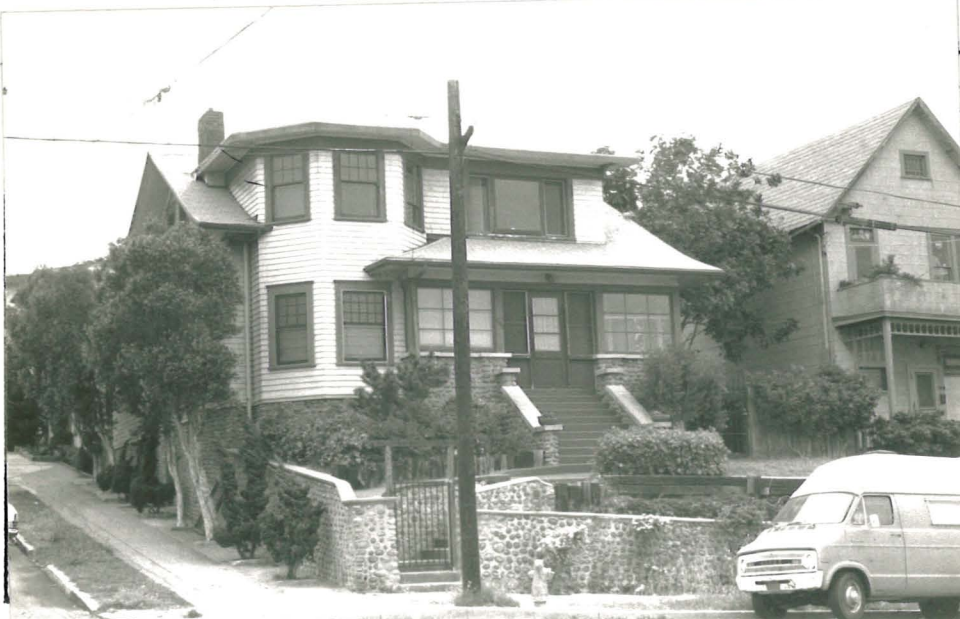
This two-story home with basement is irregular in shape and is situated on a tall cobblestone foundation above the street level. The high pitched side gable roof is bellcast with a boxed cornice, wide overhanging eaves and a plain frieze. Curved brackets decorated the eaves at the corners. The siding is clapboard with a cobblestone skirting which surrounds the front porch and continues down the front stairs forming the banister and retaining wall at the street level. The original windows are double-hung with multi-pane uppers and a shelf surround.

A two-story-wide angled bay projects from the gable roof with a hipped segmented roof. To the south is a shed roofed dormer with altered louvred windows flanking a fixed center pane. Below is a porch which has been enclosed with multi-pane windows and a wood framed door with a horizontal multi-paned upper and louvred sidepanels. Another alteration is an addition on the south facade with an arbor and porch. The windows are aluminum sliding and the addition has an iron gated entry. A first story angled bay is on the southern facade and the northern facade has a shallow square oriel bay with hip roof and brackets below.

13. Condition: Excellent _____ Good _____ Fair X Deteriorated _____ No longer in existence _____
14. Alterations: enclosed porch, aluminum sliding windows, addition to south
15. Surroundings: (Check more than one if necessary) Open land _____ Scattered buildings _____ Densely built-up X
Residential X Industrial _____ Commercial _____ Other: _____
16. Threats to site: None known _____ Private development _____ Zoning X Vandalism _____
Public Works project _____ Other: _____
17. Is the structure: On its original site? X Moved? _____ Unknown? _____
18. Related features: none

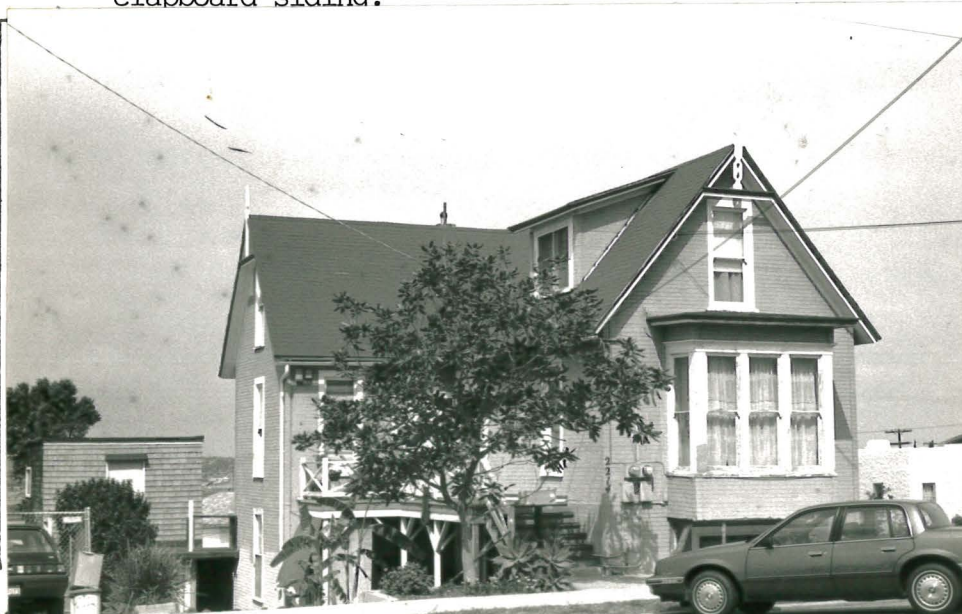
This 2½-story Gothic Revival home is situated on a hillside with the 2½ stories apparent from the rear. The high-pitched offset gable roof has overhanging eaves and finials at the gable ends. A shed-roofed dormer faces the south with altered louvered windows. The original siding has been replaced with sheets of asbestos imitation brick. The windows are tall, narrow and double-hung with a wooden surround. The raised open porch has wooden steps and railing supported by wooden beams below. Two doors serve as entries; the original is a tall, narrow wood-paneled door, while the other is a wide wood-paneled door with plywood surrounding the doorway. Two other doors are on the first level below the porch and appear to be original. A driveway to the south of the house leads to a one-car garage with a room above (alteration). A square oriel bay with a flat roof and brackets below adorn the street facade. Below is a flashed-glass window. A structure was added in the backyard with a gable roof, exposed rafters and clapboard siding.

13. Condition: Excellent ____ Good ____ Fair X Deteriorated ____ No longer in existence ____
14. Alterations: Windows, door, siding
15. Surroundings: (Check more than one if necessary) Open land ____ Scattered buildings ____ Densely built-up X
Residential X Industrial ____ Commercial ____ Other: ____
16. Threats to site: None known ____ Private development ____ Zoning X Vandalism ____
Public Works project ____ Other: ____
17. Is the structure: On its original site? X Moved? ____ Unknown? ____
18. Related features: Garage addition and rear structure (house)

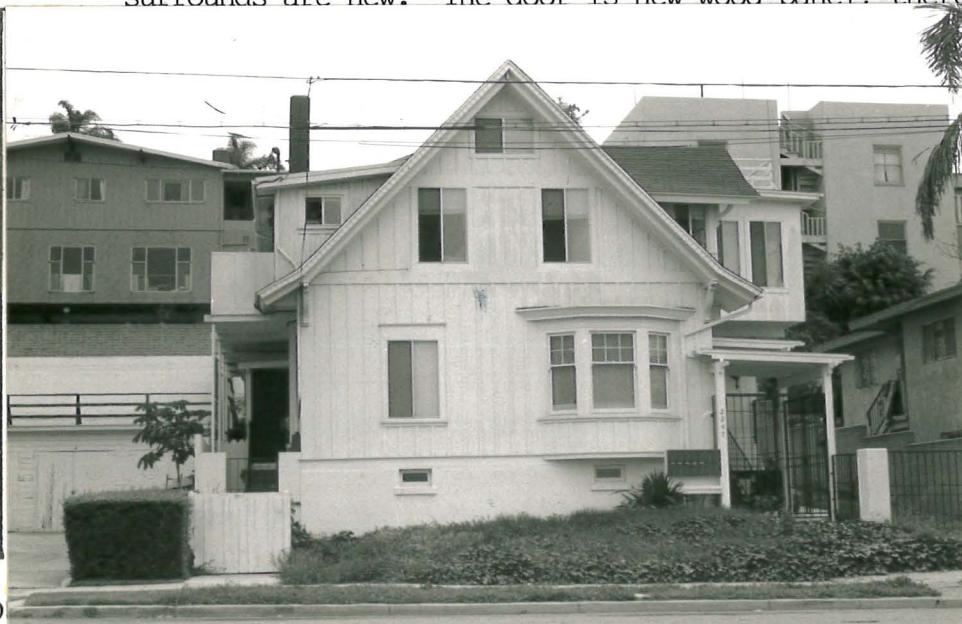
This irregularly-shaped Craftsman style house is 2½ stories with a basement. It has board and batten siding with stucco over the basement and clapboard beneath the window in the middle of the south facade. Horizontal bands run between floors on the front facade. The roof is high-pitched, cross-gabled, flared at the ends with asphalt shingles, overhanging eaves, and a boxed cornice. There are many other rooflines due to additions to the house. Original windows in the first story wide-angled oriel bay in the front facade and sporadically placed elsewhere are double-hung with multi-pane uppers. Other windows are aluminum sliders, which are alterations. The entry porch is on the south side and is reached by a wooden stairway. The south side second story slightly overhangs the first story, and is supported by worked rafters. A driveway to the south leads to a garage. This house has been greatly altered. The porch has been enclosed; a wrought iron gate leads to the porch and wrought iron railing flanks the steps. A pergola has been added over the entry stairs and porch. There have been second story additions on the north and south sides and a second floor balcony supported by galvanized pipes has been added on the north side. There is an addition to the rear and a first story addition on the north. Most windows are new, and some surrounds are new. The door is new wood panel. There is a new roof balcony and a gate to the driveway.

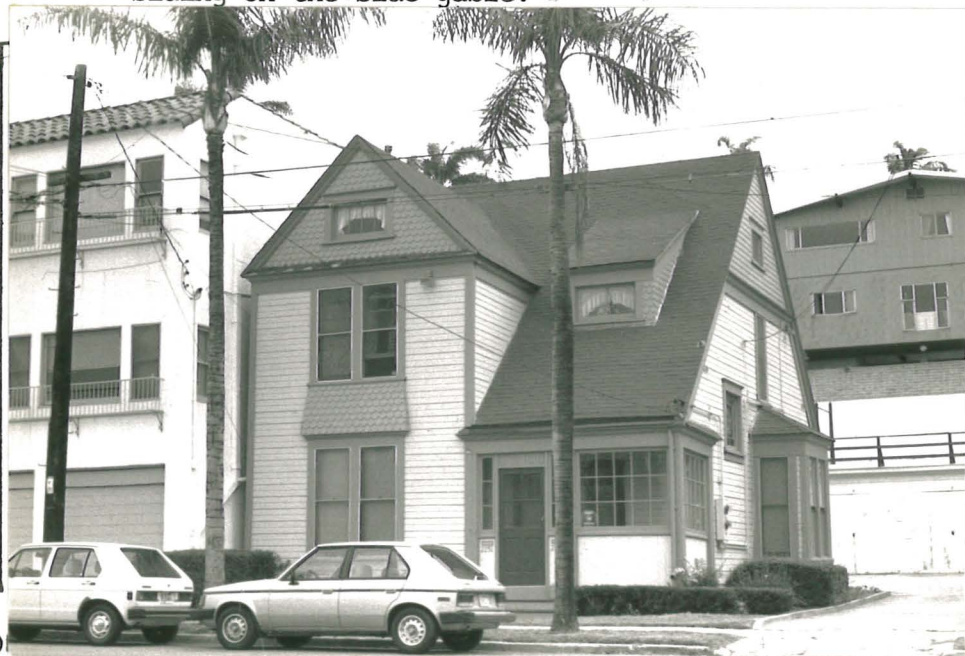
- 7a. Architectural style: Folk Victorian Legal D: Blk 253 Lots A & B Horton's Add Lockling
- 7b. Briefly describe the present *physical appearance* of the site or structure and describe any major alterations from its original condition: This 2½-story Folk Victorian house on a wood foundation is irregularly shaped and has a high-pitched cross gable roof with composition shingles. The side gable, with its front-facing windowed shed dormer, extends to the floor level of the second story above the porch. Pent roofs enclose the gables. Siding is predominantly shiplap with endboards. A fishscale pattern is located in the front gable, between the first and second-story windows on the front facade, and surrounding the dormer. A plain horizontal band extends between the second and third floors and above the porch. Windows are predominantly recessed double-hung, frequently in pairs, many with shelf surrounds. One window on the south facade features flashing. A one-story hip-roofed bay with four narrow double-hung windows faces south. The house is reached from three wooden steps which lead to a porch on the southwest corner, recently enclosed. The porch now exhibits multi-pane fixed windows, a wood panel door with multi-pane upper and multi-pane half side panels, and a shallow pent overhang. A secondary entrance is on the south facade. A driveway to the south leads to garages. Alterations include the enclosed porch and a square third story window, and surrounding siding on the side gable.

13. Condition: Excellent _____ Good ☒ Fair _____ Deteriorated _____ No longer in existence _____
14. Alterations: Enclosed porch, square third story window, and surrounding siding on south side.
15. Surroundings: (Check more than one if necessary) Open land _____ Scattered buildings _____ Densely built-up ☒
Residential ☒ Industrial _____ Commercial _____ Other: _____
16. Threats to site: None known _____ Private development _____ Zoning ☒ Vandalism _____
Public Works project _____ Other: _____
17. Is the structure: On its original site? ☒ Moved? _____ Unknown? _____
18. Related features: Garages

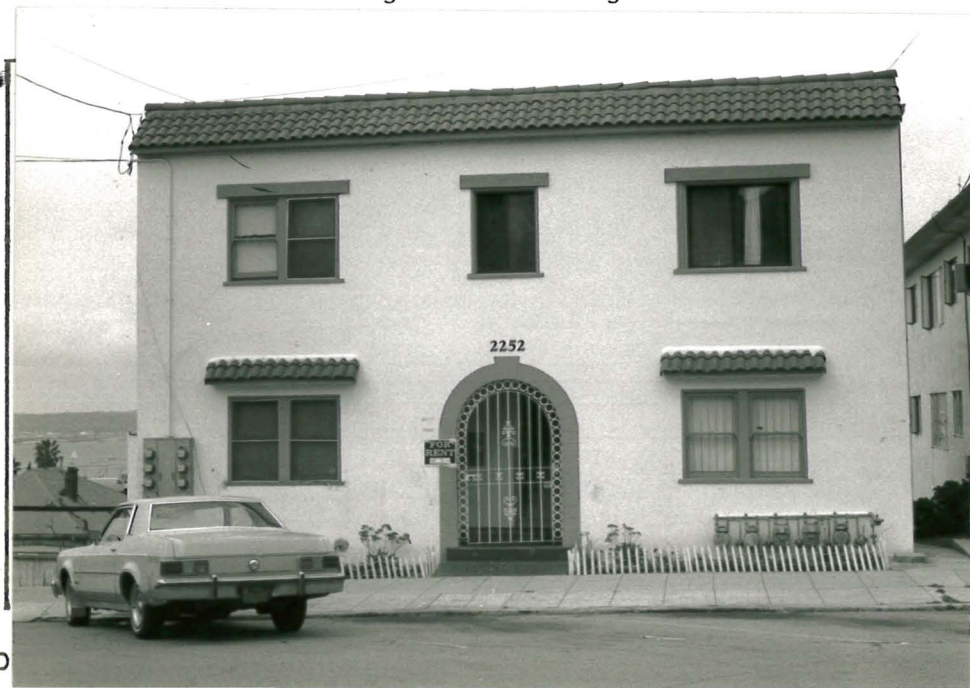
This two-story rectangular apartment building with basement has a flat roof with a red tile pent overhang along the street facade. The facade has stucco siding and is very symmetrical. The windows are double-hung, some in pairs along the street facade. The first floor street facade windows are sheltered by red tile visors, while the second floor windows have a wide plain lintel. The center entrance is a semi-circular arch with a quoin surround and center keystone. A security gate has been added to cover the open stepped entry. Inside are wood paneled doors for the first floor apartments and stairs leading to the upper level. A sloped driveway to the south leads to a detached two-story structure with a flat roof and stepped parapet with espadana Square three-part roof vents are along the roofline as those on the front building. A small garden separates the two structures. Alterations include the metal security gate and one set of aluminum sliding windows along the street facade.

13. Condition: Excellent _____ Good X Fair _____ Deteriorated _____ No longer in existence _____
14. Alterations: Aluminum sliding window, metal security gate
15. Surroundings: (Check more than one if necessary) Open land _____ Scattered buildings _____ Densely built-up X
Residential X Industrial _____ Commercial _____ Other: _____
16. Threats to site: None known X Private development _____ Zoning _____ Vandalism _____
Public Works project _____ Other: _____
17. Is the structure: On its original site? X Moved? _____ Unknown? _____
18. Related features: 2-story building in back

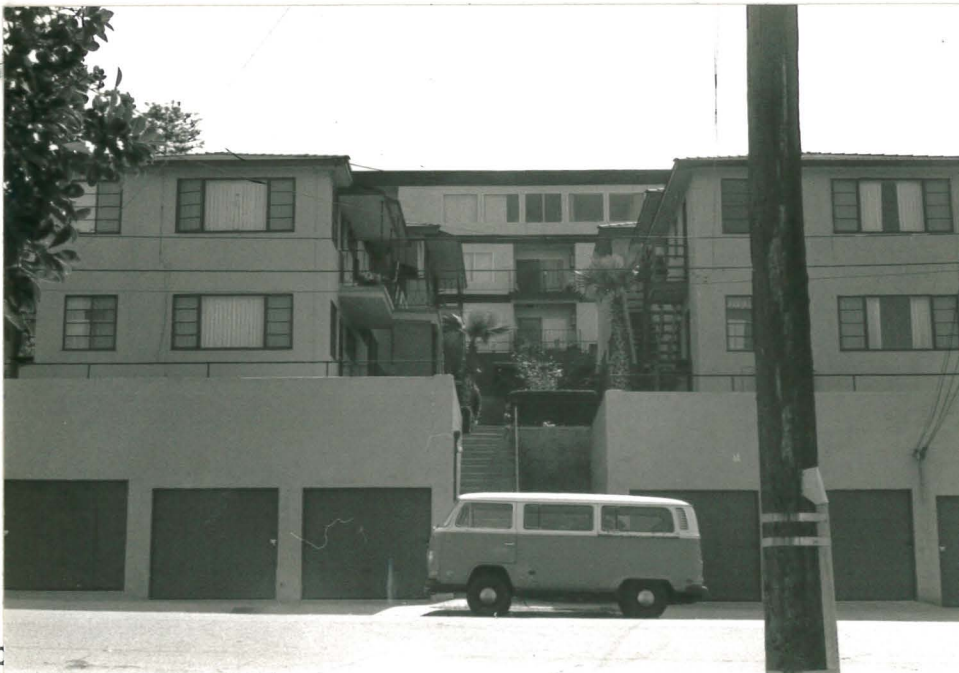
These two rectangular 2½-story apartment buildings form an inner courtyard, which is reached by a tall concrete stairway from the street level. The structures are situated high above the street level on a slope and both face to the south. Along the street level, on either side of the stairway are three wood-doored single-car garages with a flat roof providing a balcony above with iron railing. The roofs of the buildings are low-pitched hips with red-tile spines and overhanging boxed eaves. The windows are multi-paned metal casement, some with a large center fixed pane. The apartment entries are solid wood-paneled doors sheltered by roof extensions on the second story, and second story stoops shelter the lower entries. The second story is accessed by a concrete stairway and balcony with an iron balustrade on the southern facades. The upper northern facades are accessed by a wooden stairway and are not sheltered. The courtyard contains palms and landscaping.

13. Condition: Excellent ☒ Good _____ Fair _____ Deteriorated _____ No longer in existence: _____
14. Alterations: _____
15. Surroundings: (Check more than one if necessary) Open land _____ Scattered buildings _____ Densely built-up ☒
Residential ☒ Industrial _____ Commercial _____ Other: _____
16. Threats to site: None known ☒ Private development _____ Zoning _____ Vandalism _____
Public Works project _____ Other: _____
17. Is the structure: On its original site? ☒ Moved? _____ Unknown? _____
18. Related features: _____
