HISTORIC RESOURCES INVENTORY

1. Common name: Anderson Apartments
2. Historic name: Anderson Apartments
3. Street or rural address: 1747 5th Avenue
City San Diego Zip 92101 County San Diego
4. Parcel number: 533-303-02
5. Present Owner: Electronics Capital Corp Address: P.O. Box 2429
City San Diego Zip 92112 Ownership is: Public _____ Private X
6. Present Use: Residential Original use: Residential

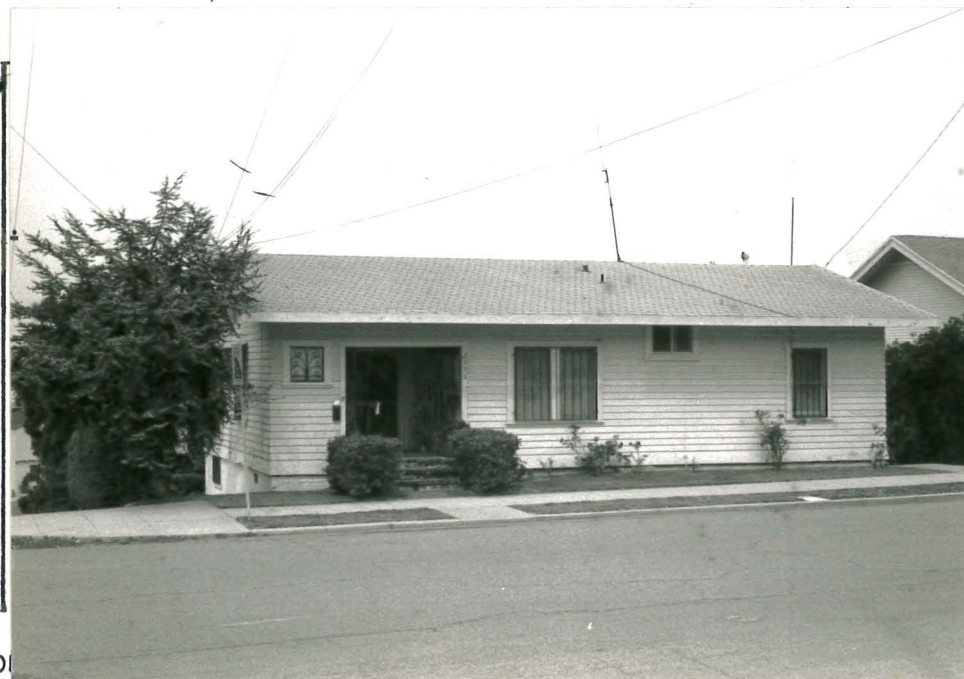
2306 Brant is a one-story rectangular home on a medium grade which allows for a basement with a rear outside entry. The low-pitched side-gable roof has wide overhanging eaves and exposed rafters boxed in by a plain bargeboard. The siding is clapboard which flares at the concrete foundation. Vertical roof vents decorate the gable ends and a large brick chimney extends down the western facade along the driveway. Some of the original double-hung windows have been replaced with aluminum siding and louvred; all have a wide wooden surround. The southwest corner has been altered to contain large picture windows to view the bay. Aluminum awnings cover this window and several others on the southwest facade. The deeply recessed entry near the southeast corner has three brick steps leading to the stoop and a solid wooden door with a metal security screen. The driveway along the west facade leads to an attached one-car garage with a wood door and multi-pane upper. A small door along the driveway allows access to the basement. Security bars have been added to cover the windows.

13. Condition: Excellent ___ Good ___ Fair X Deteriorated ___ No longer in existence ___
14. Alterations: Security window and door treatments, windows
15. Surroundings: (Check more than one if necessary) Open land ___ Scattered buildings ___ Densely built-up ___ X
Residential X Industrial ___ Commercial ___ Other: ___
16. Threats to site: None known ___ Private development ___ Zoning X Vandalism ___
Public Works project ___ Other: ___
17. Is the structure: On its original site? X Moved? ___ Unknown? ___
18. Related features: ___

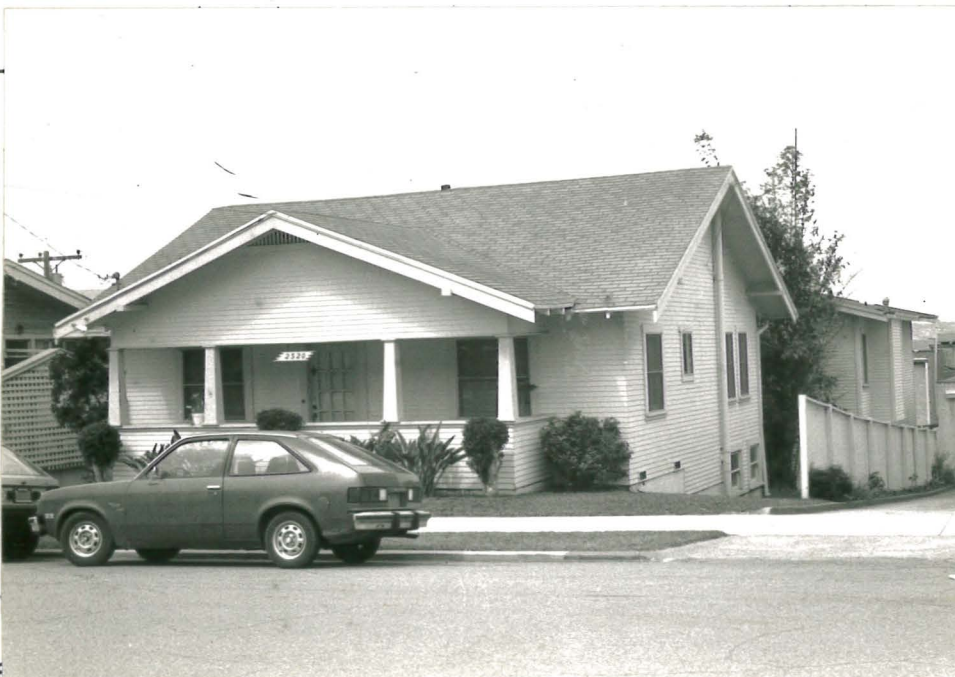
This rectangular California Bungalow on a concrete foundation is one story in height with a second story to the rear due to the slope of the lot. The composition shingled roof is medium pitched and side gabled with a front gable over the protruding porch. Overhanging eaves shelter exposed rafters. Rectangular brackets are located in the gable ends. Siding is clapboard with vertical wood strips at the vents in gable peaks. Windows are double-hung and the door is wood with a multi-pane rectangular upper. Both have wood surrounds. The front entry porch extends almost the full length of the front facade. It is reached from a straight south-facing stairway and has a clapboard balustrade and four elephantine columns which support a clapboard pediment which wraps around the corners under the porch roof. A driveway on the south side leads to garages. There is a detached wood frame dwelling to the rear.

13. Condition: Excellent ☒ Good ☐ Fair ☐ Deteriorated ☐ No longer in existence ☐
14. Alterations: None apparent
15. Surroundings: (Check more than one if necessary) Open land ☐ Scattered buildings ☐ Densely built-up ☒
Residential ☒ Industrial ☐ Commercial ☒ Other: ☐
16. Threats to site: None known ☐ Private development ☐ Zoning ☒ Vandalism ☐
Public Works project ☐ Other: ☐
17. Is the structure: On its original site? ☒ Moved? ☐ Unknown? ☐
18. Related features: Garage, detached dwelling to rear

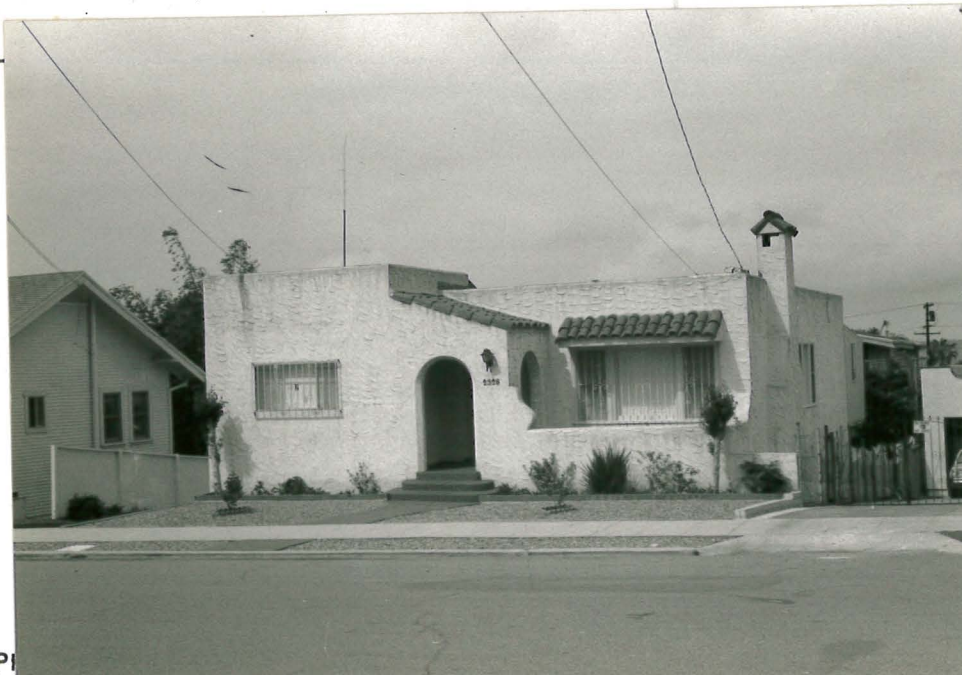
This one-story Mission Style home is irregularly shaped with a flat roof. The southeast corner of the structure is taller than the main structure and has a red tile shed overhang to the north which covers the entry. A chimney is situated along the northern facade and is topped with a red tile gable. Three horizontal roof vents line the southern roofline. The windows are double-hung; some are altered and are now aluminum sliding. A three-sash window is along the street facade with iron security bars and a red tile shed overhang with boxed eaves. To the south is an arcaded porch entry with a decorative lower corner which connects onto a solid stucco balustrade surrounding a small open porch. The porch entry has curving steps which lead to the metal security screened door. A driveway to the south leads to a small detached garage. The siding is rough stucco.

13. Condition: Excellent ____ Good ____ Fair X Deteriorated ____ No longer in existence ____
14. Alterations: Security screens over door and windows, aluminum sliding framed windows, rear addition
15. Surroundings: (Check more than one if necessary) Open land ____ Scattered buildings ____ Densely built-up X
Residential X Industrial ____ Commercial ____ Other: ____
16. Threats to site: None known ____ Private development ____ Zoning X Vandalism ____
Public Works project ____ Other: ____
17. Is the structure: On its original site? X Moved? ____ Unknown? ____
18. Related features: Detached driveway

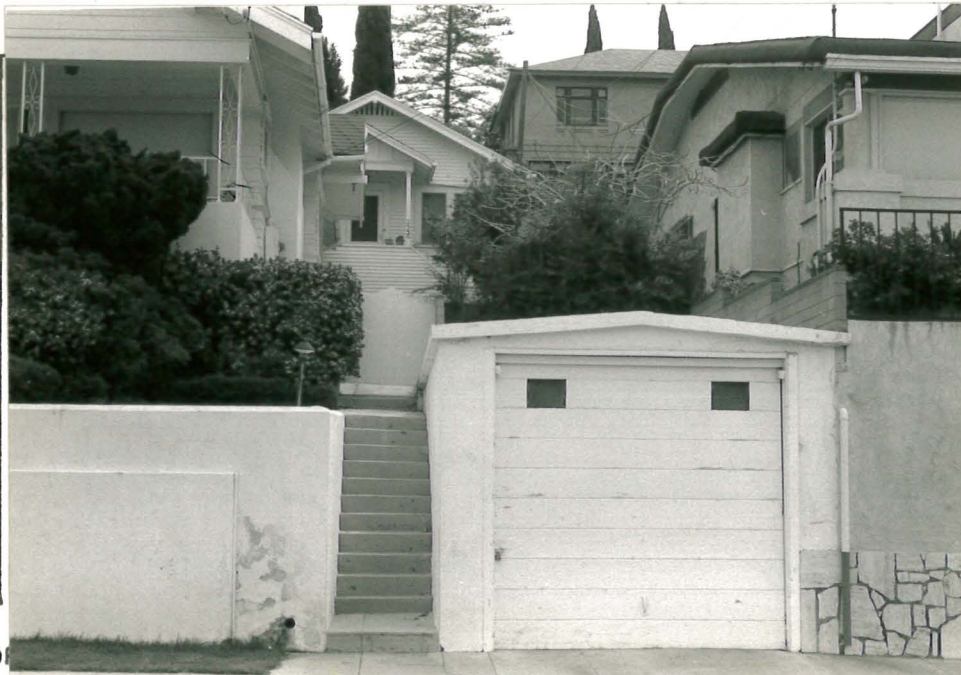
This California bungalow is tightly situated to the rear of another home, high above the street level. A tall concrete stairway leads to the home between the retaining wall and a one-car garage at the street level. The bungalow has a front gable roof with a second lower gable over the porch entry. The roof has wide overhanging eaves with exposed rafters and vertical roof vents at the gable peaks. The siding is clapboard which boxes in the porch with narrow beams to support the molded entablature and gable with board and batten in the pediment. The windows are double-hung in pairs with a wide wooden surround. The door is wood paneled with a wood-framed screen and wide surround.

13. Condition: Excellent _____ Good X Fair _____ Deteriorated _____ No longer in existence _____
14. Alterations: None
15. Surroundings: (Check more than one if necessary) Open land _____ Scattered buildings _____ Densely built-up X
Residential _____ Industrial _____ Commercial _____ Other: _____
16. Threats to site: None known _____ Private development _____ Zoning X Vandalism _____
Public Works project _____ Other: _____
17. Is the structure: On its original site? X Moved? _____ Unknown? _____
18. Related features: One-car garage at the street level

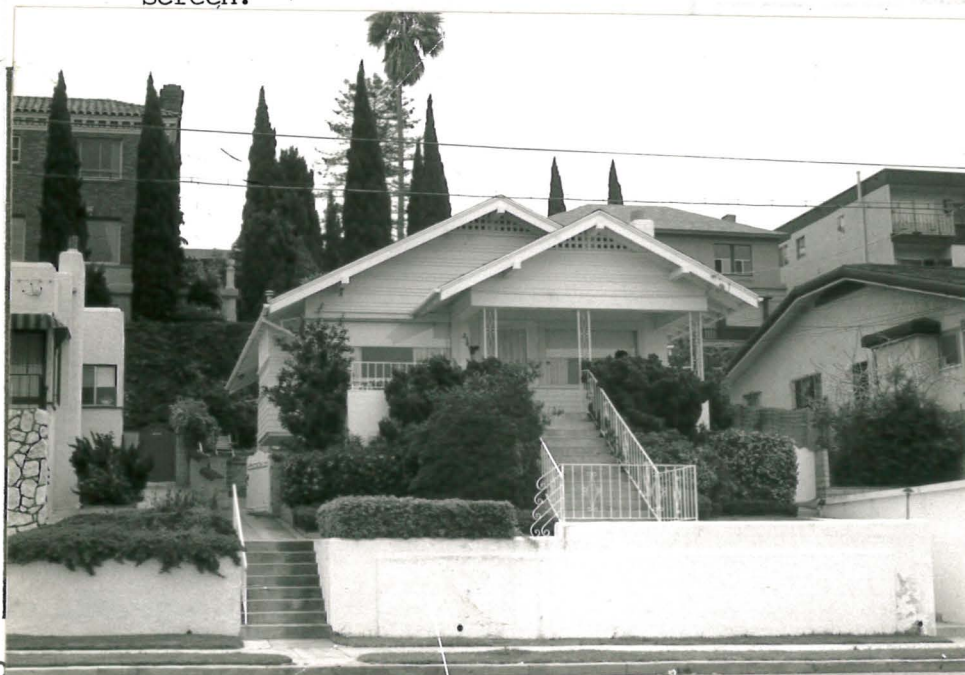
This one-story rectangular California Bungalow sits high above street level behind a stucco retaining wall. The asphalt shingled roof is medium pitch cross gable with two front gables, overhanging eaves, and exposed rafters. Siding is patterned clapboard with shingles below the window level and latticework in the gable peaks. Windows are double-hung on the north and south facades. Fixed-pane windows have been added to the front facade. The door is not visible behind a security screen, which is an alteration. The house is reached via a wide articulated cement stairway which leads to a gabled porch on the south side of the front facade. The porch has decorative iron posts and an iron balustrade which continues as the railing for the stairway. Both are alterations. The house has a square oriel bay on the north facade and a square pedimented bay on the south facade. A stucco chimney is located on the south side. A garage is on street level to the south and a narrow south side stairway leads to a rear house. Alterations include windows, posts, balustrade, and railing and security screen.

13. Condition: Excellent ___ Good ☒ Fair ___ Deteriorated ___ No longer in existence ___
14. Alterations: Windows, security screen, posts, balustrade, and railing
15. Surroundings: (Check more than one if necessary) Open land ___ Scattered buildings ___ Densely built-up ☒
Residential ☒ Industrial ___ Commercial ☒ Other: ___
16. Threats to site: None known ___ Private development ___ Zoning ☒ Vandalism ___
Public Works project ___ Other: ___
17. Is the structure: On its original site? ☒ Moved? ___ Unknown? ___
18. Related features: Garage, rear house

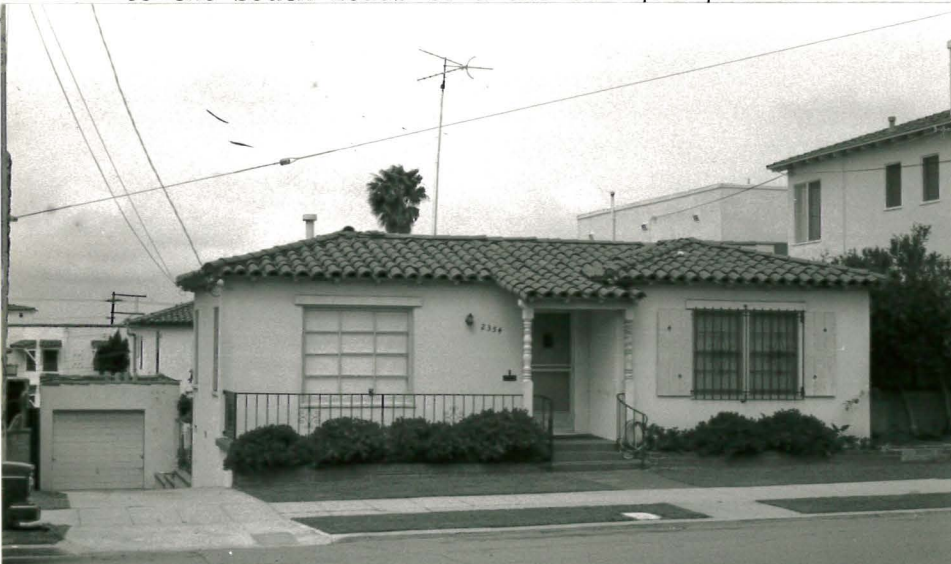
This irregularly-shaped stucco-sided Spanish Colonial style house is one story in the front with a rear basement necessitated by the steep slope of the lot. The roof is red tile, low pitched, double hipped with slightly overhanging eaves and exposed rafters. To the rear, the roof is flat with red tile coping. Windows in the front facade are large multi-pane fixed with lintels. Wrought iron and shutters decorate the window on the north side of the front facade. Side windows are multi-pane double-hung with single pane double-hung to the rear. The door is wood with a small rectangular upper. A stepped entry with curving wrought iron railing leads to an entry porch which extends across the front facade to the southeast corner of the house. The railing continues to form a balustrade on the east and south sides of the porch. The north side is enclosed by one of the walls of the house. A small overhang, which is a continuation of the roof, shelters the entryway and is supported by turned posts and a lintel. The house features canalis under the eaves and a brick retaining wall. A driveway to the south leads to a one-car garage with a flat roof with red tile coping.

13. Condition: Excellent ☒ Good ☐ Fair ☐ Deteriorated ☐ No longer in existence ☐
14. Alterations: None apparent
15. Surroundings: (Check more than one if necessary) Open land ☐ Scattered buildings ☐ Densely built-up ☒
Residential ☒ Industrial ☐ Commercial ☐ Other: ☐
16. Threats to site: None known ☐ Private development ☐ Zoning ☒ Vandalism ☐
Public Works project ☐ Other: ☐
17. Is the structure: On its original site? ☒ Moved? ☐ Unknown? ☐
18. Related features: Garage

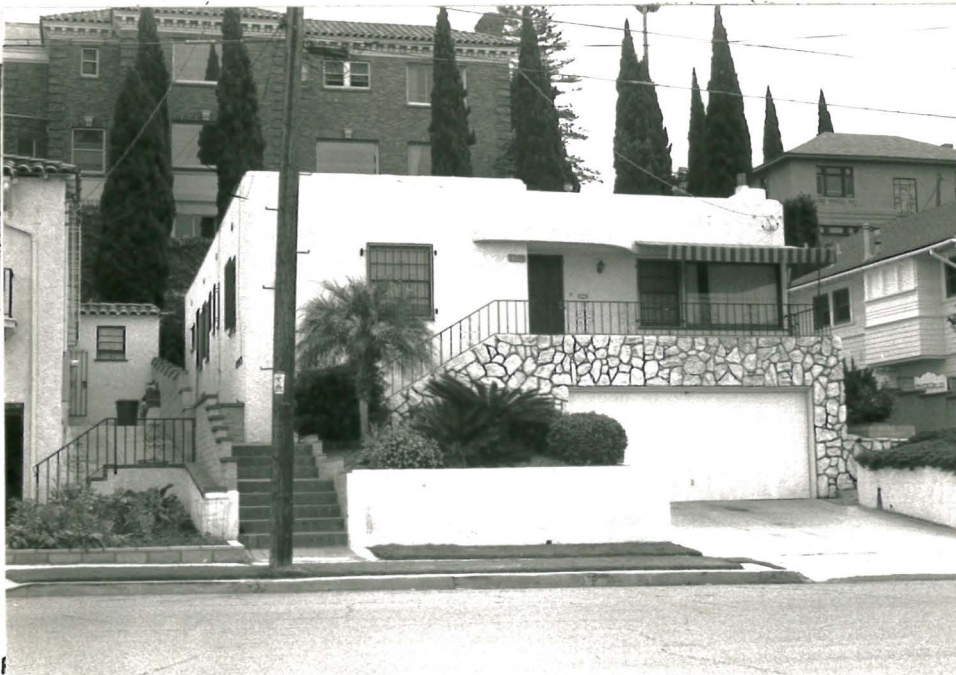
This irregularly-shaped one-story house with a garage below has a flat roof with rounded coping. Siding is primarily stucco, but the garage and stairway are sheathed in decorative rock on the front facade. Windows are predominantly double-hung, four-pane horizontals, with a fixed-pane window south of the entry door. On the north facade is a metal casement window and a small porthole window is located on the south facade. The door is solid wood. Decorative iron-work is evident on many of the windows and on the screen door. A stucco retaining wall surrounds the property and is interrupted by a wide driveway to the south side of the property and a red tile stairway to the north. The stairway turns as it reaches the corner of the house and crosses the front as it rises to the entry porch above the two-car garage. The porch has a decorative iron balustrade which continues to form a railing for the stairway. A rounded cantilevered roof covers the entry area. An awning supported by iron poles shelters the porch windows. A rounded chimney with a decorative chimney pot rises on the south facade and horizontal roof vents are located on the north and south side.

13. Condition: Excellent ☒ Good _____ Fair _____ Deteriorated _____ No longer in existence _____
14. Alterations: Decorative rock facade
15. Surroundings: (Check more than one if necessary) Open land _____ Scattered buildings _____ Densely built-up ☒
Residential ☒ Industrial _____ Commercial _____ Other: _____
16. Threats to site: None known _____ Private development _____ Zoning ☒ Vandalism _____
Public Works project _____ Other: _____
17. Is the structure: On its original site? ☒ Moved? _____ Unknown? _____
18. Related features: None

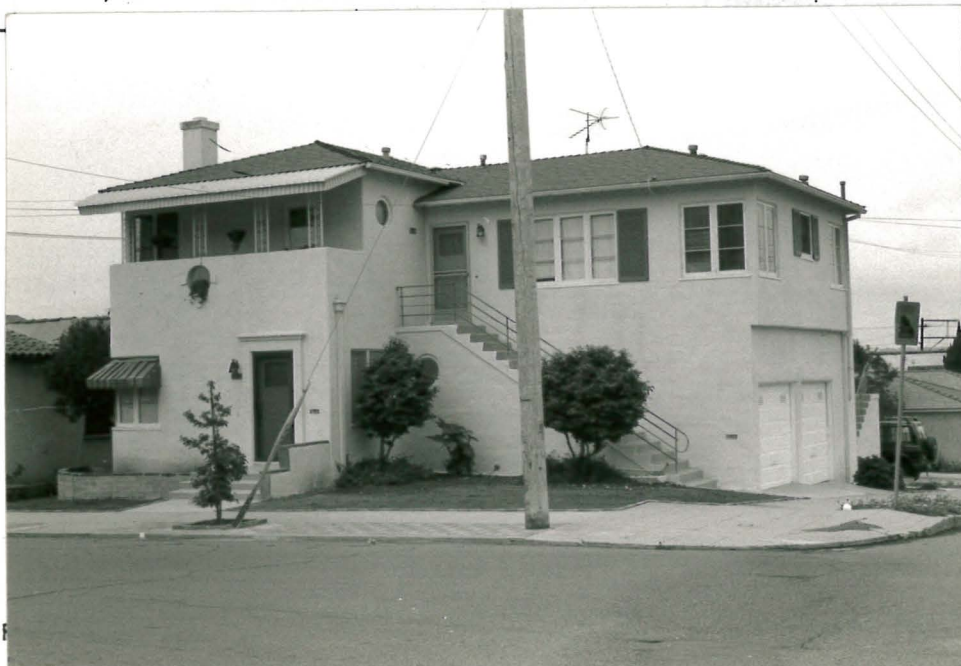
This two-story stucco-sided apartment building is L-shaped with a curving southeast corner. The roof is medium-pitched cross hipped with a boxed cornice, overhanging eaves, and canalis near the roofline. Windows are two and three-sash hinged with multiple horizontal panes, double-hung, and some portholes, one with keystones. Shutters flank some window groups on the second floor. Doors are vertical tongue and groove with square glass uppers and a wide protruding shelf surround on the first floor. Three cement steps lead to a stoop and entry on the front facade. Above, a second floor balcony with a stucco balustrade extends to the southeast corner. North of the first floor entry, a north-facing cement stairway with metal railing crosses the front of the building and rises to a second floor entry. A chimney and a bay with a scalloped frieze are featured on the south facade. Two single-car garages with recessed wooden doors face north below a slightly protruding second story. Metal light fixtures, lighted metal address panels, and mailboxes are original. A companion building with a walkway between faces north and features a cement stairway to a second floor entry, a west-facing balcony, and two garage doors on the west side of the north facade. Alterations include a shed roof over the balcony on the main building, an awning over a first floor window on the front facade, and louvered windows on the south facade.

13. Condition: Excellent ☒ Good ☐ Fair ☐ Deteriorated ☐ No longer in existence ☐
14. Alterations: Shed roof over balcony, awning over window, louvered windows
15. Surroundings: (Check more than one if necessary) Open land ☐ Scattered buildings ☐ Densely built-up ☒
Residential ☒ Industrial ☐ Commercial ☐ Other: ☐
16. Threats to site: None known ☒ Private development ☐ Zoning ☐ Vandalism ☐
Public Works project ☐ Other: ☐
17. Is the structure: On its original site? ☒ Moved? ☐ Unknown? ☐
18. Related features: Companion building to the west

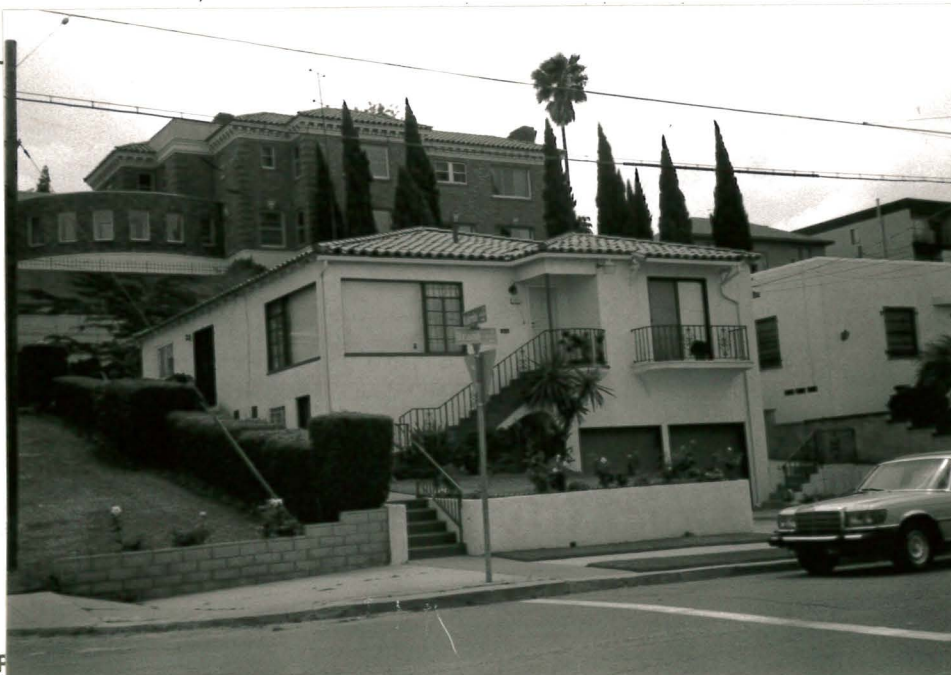
This two-story irregular-shaped home is situated on a rise to the rear to accomodate two visible stories on the street facade. The roof is a low-pitched red tile hip with slightly overhanging eaves and exposed rafters. The main hip extends on the southwest corner to shelter the front extension and entry stoop. An articulated concrete stairway with a wrought iron bannister leads to the second story main entry. The small stoop is sheltered by the corner of the front extension roof with a metal pole for support. The door is now covered by a metal security screen. To the south is an extending balcony with a wrought iron balustrade and sliding glass doors, which are alterations. Below is a two-car garage. To the north of the main entry is a large fixed-pane window, which seems to wrap around the north corner. The outer corners of the pane window are multi-pane casements with a multi-pane transom, as are the remainder of the windows. The siding is stucco matching the retaining wall near the sidewalk. The original driveway along the southern facade is now a walkway with steps and a front garden.

13. Condition: Excellent _____ Good _____ Fair X Deteriorated _____ No longer in existence _____
14. Alterations: Sliding glass doors and windows, two car garage, security screens
15. Surroundings: (Check more than one if necessary) Open land _____ Scattered buildings _____ Densely built-up X
Residential X Industrial _____ Commercial _____ Other: _____
16. Threats to site: None known _____ Private development _____ Zoning X Vandalism _____
Public Works project _____ Other: _____
17. Is the structure: On its original site? X Moved? _____ Unknown? _____
18. Related features: _____

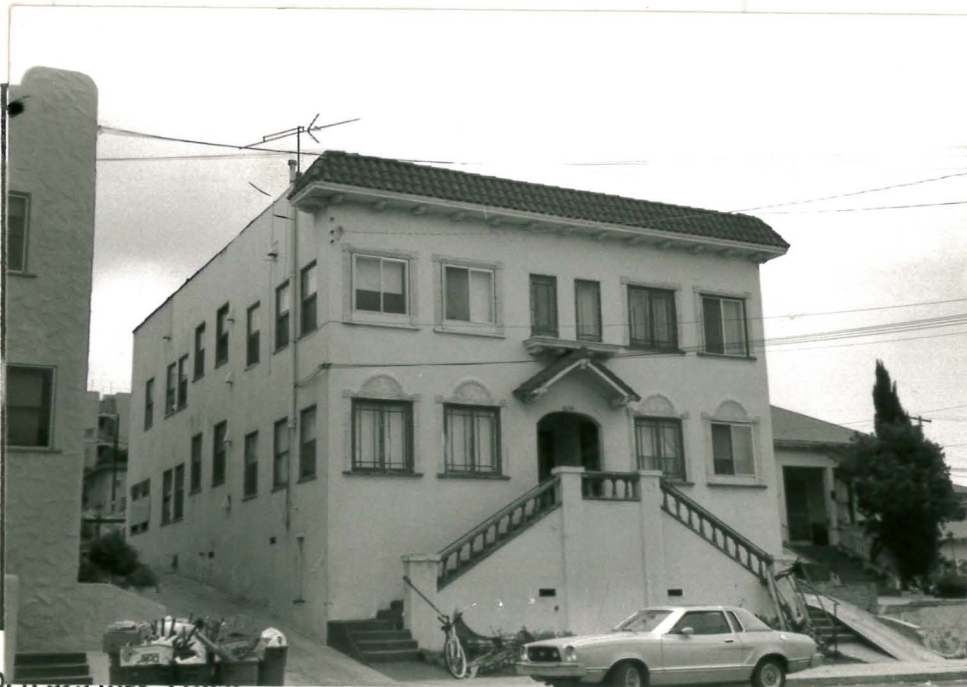
This three-story rectangular-shaped building has a flat roof with a red tile hipped hood across the front facade with a boxed cornice and decorative brackets below. The height to the rear, on the north side, is two stories due to the slope of the lot. The windows are double-hung on the sides and hinged on the front, south facade with geometric patterned panes and elaborately decorated surrounds with corner pieces and stuccoed fan lights on the second level. The center area of the third level has a heavy moulded shelf with decorative brackets. A story high, straight, double stairway with massive square pilasters and a turned wood balustrade with metal pipes above is reached from four steps on either side with iron pipe railing. This leads to a segmental arched entry porch with four French doors, two of which face the street. Alterations include a gable hood of red tile with three supporting brackets over the main entry and abutting against the third level center shelf, a shed to the southeast, and various windows replaced in aluminum sliders.

___ Fair ☒ Deteriorated ___ No longer in existence ___

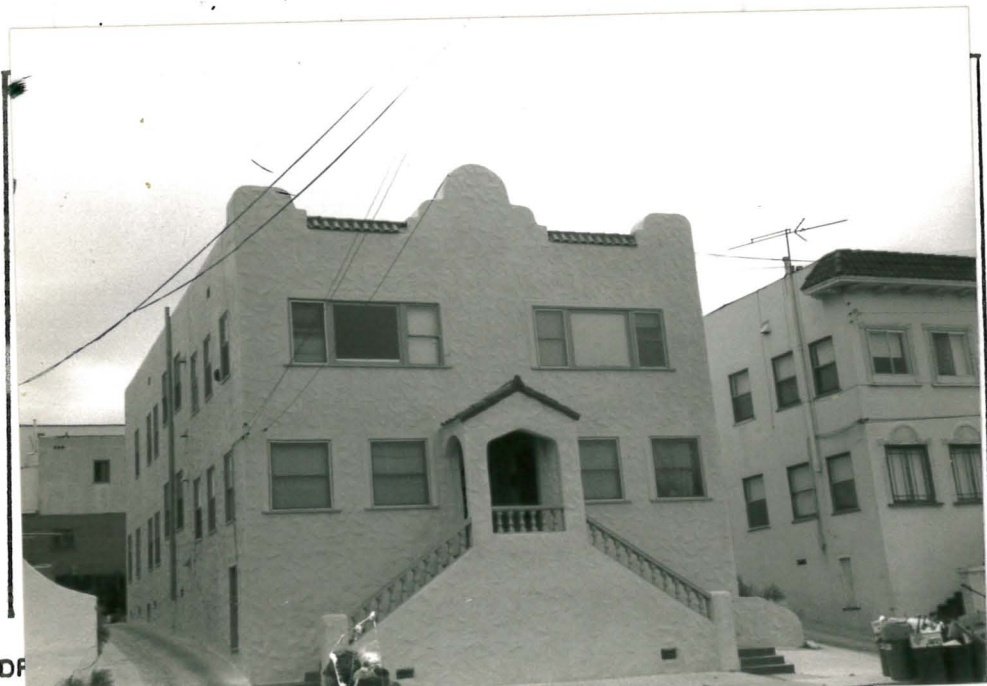
This rectangular building is three stories in height on the front and two on the back, due to the slope of the lot. The flat roof has a centered espadana parapet of curving steps with similar steps at the corners and red tile shed hood sections between. The windows are wide, double-hung, some with three sash with a fixed central pane. The doors are French at the entrances and a multi-panel wood basement door to the north. The entry is covered with a front gable red tile roof projection with a pointed segmental arch on the front and semi-circular arches to the sides, below the gable. The porch is reached from double straight one story high steps with three additional steps from the street. A heavy, open turned wood balustrade runs up the staircase and across the front arch. Alterations include partially covered wide window surrounds on the front facade, new high-texture stucco, aluminum window screens, a shed on the south east corner of the property, possibly the entry gable projection.

13. Condition: Excellent _____ Good ☒ Fair _____ Deteriorated _____ No longer in existence _____
 14. Alterations: Partially covered wood surrounds on windows, high texture stucco, aluminum screens, shed, possibly the entry gables..
15. Surroundings: (Check more than one if necessary) ☒ Open land _____ Scattered buildings _____ Densely built-up ☒
 Residential _____ Industrial _____ Commercial _____ Other: _____
16. Threats to site: None known ☒ Private development _____ Zoning _____ Vandalism _____
 Public Works project _____ Other: _____
17. Is the structure: On its original site? ☒ Moved? _____ Unknown? _____
 None
18. Related features: _____

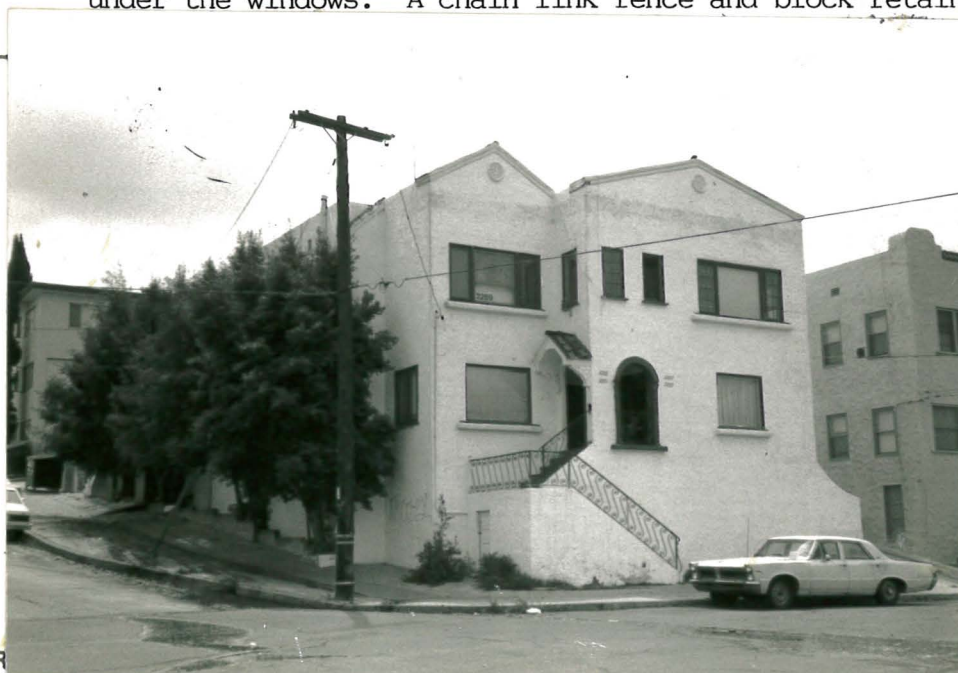
This building, located on a corner is three stories on the front and two stories on the back, due to the slope of the lot. The flat roof has two medium-pitched front-gable parapets with moulded, wood coping running along the top of them and decorative stucco flower patterned rounds beneath. The windows include multi-pane hinged wood, three sash with a fixed center pane and multi-pane hinged side panels and large single-pane fixed, all with lugsills. Doors are single-paned French. The north entrance of the front facade is reached from side-reversed story-high steps with an S-curve wrought iron railing and stucco boxed base with a small multi-paned wood storage door on the north at street level. A small red tile gabled hood with decorative corner knee brackets and segmental arch below acts as the entry to a covered porch with a front-facing arch with the same wrought iron S-curve balustrade within, and a moulded surround with spiral pilasters. A heavy lugsill is located beneath this arch and under the windows. A chain link fence and block retaining wall are located to the south.

13. Condition: Excellent ___ Good X Fair ___ Deteriorated ___ No longer in existence ___
14. Alterations: None
15. Surroundings: (Check more than one if necessary) Open land ___ Scattered buildings ___ Densely built-up ___
Residential X Industrial ___ Commercial ___ Other: ___
16. Threats to site: None known X Private development ___ Zoning ___ Vandalism ___
Public Works project ___ Other: ___
17. Is the structure: On its original site? ___ Moved? ___ Unknown? X
18. Related features: Next to other Mission Style Apartment Buildings.

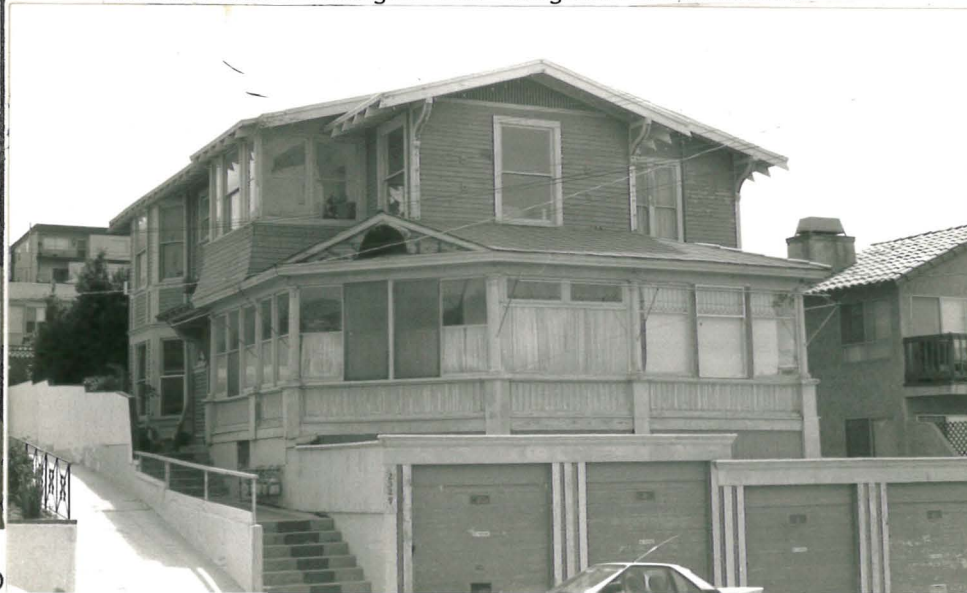
This large 2-story home with basement is high above the street level with a row of four wood-doored garages with flat roofs lining the street facade. The roof is a low-pitched front gable with wide overhanging eaves, exposed rafters and a lower front gable covering the 2nd story square bay. Vertical roof vents are situated at the gable peaks with curved brackets at the gable ends. The siding is clapboard with endboards except for the 2nd story square bay on the north facade which has flared shingle siding. The main entry faces the north along the northern facade and has a shed roof with exposed rafters and curving brackets. Concrete steps along the northern facade lead to the entry. The 2nd story street facade has Craftsman additions including the center square bay and a square bay on the northwest corner which is apparent by the double-hung windows and vertical roof vents. The entire roof has the Craftsman influence also. The remainder of the windows are narrow and double-hung. The central feature is a large veranda with a hip roof wrapping around the west and northwestern facade. It is now enclosed and has large fixed panes, some with leased transoms, while others are double-hung. The wooden balustrade is now enclosed and has square posts with Doric columns above connecting onto a molded cornice. A pediment decorates the northwestern corner of the veranda. The home has not been maintained and many alterations have changed the original character.

13. Condition: Excellent _____ Good _____ Fair ☒ Deteriorated _____ No longer in existence _____
14. Alterations: 2nd story, sq. bay on N. facade, enclosed porch, balustrade, garages added stairway
15. Surroundings: (Check more than one if necessary) Open land _____ Scattered buildings _____ Densely built-up _____
Residential ☒ Industrial _____ Commercial _____ Other: _____
16. Threats to site: None known ☒ Private development _____ Zoning _____ Vandalism _____
Public Works project _____ Other: _____
17. Is the structure: On its original site? ☒ Moved? _____ Unknown? _____
18. Related features: None

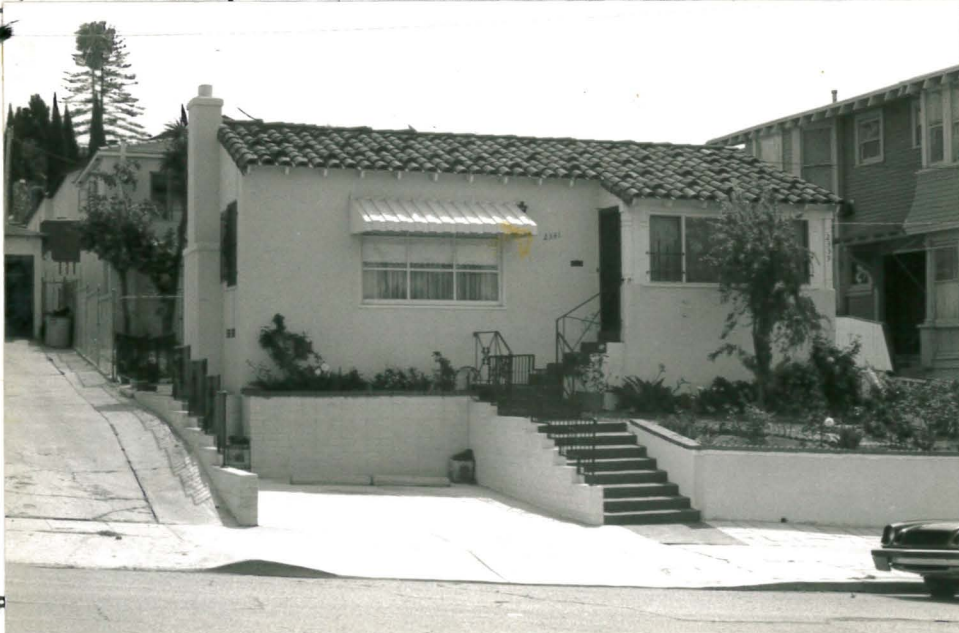
This stucco-sided, irregularly-shaped dwelling is 1-story in height with a basement on the S. side and sits high above street level on a raised foundation. A red tile pent roof with slightly overhanging eaves and exposed rafter caps is located in front of a flat-roofed rear section with a parapet. The front facade has a fixed multi-pane window with a metal awning on the N. side and a fixed-pane window with louvered side panels on the S. side. Other windows are double-hung and some feature decorative iron work. The door is not visible through a security screen. The house is reached via an articulated red cement stairway with an iron railing. There is no porch, but remnants of worked posts are evident where the original porch was enclosed. On the S. facade a red tile pent-roofed bay is located above an entry to the basement. A stepped entry with a pent overhang is also located on the S. side. The N. side features a stucco chimney with decorative chimney pots and a stepped walkway. Canals are located on the N. & S. facades. A retaining wall fronts the property and an iron railing surrounds the N. & S. sides. Brick skirting on the N. end of the front facade wraps around the corner. A driveway is to the south. Alterations include the enclosed porch, the pent-roofed section, and an addition in the rear.

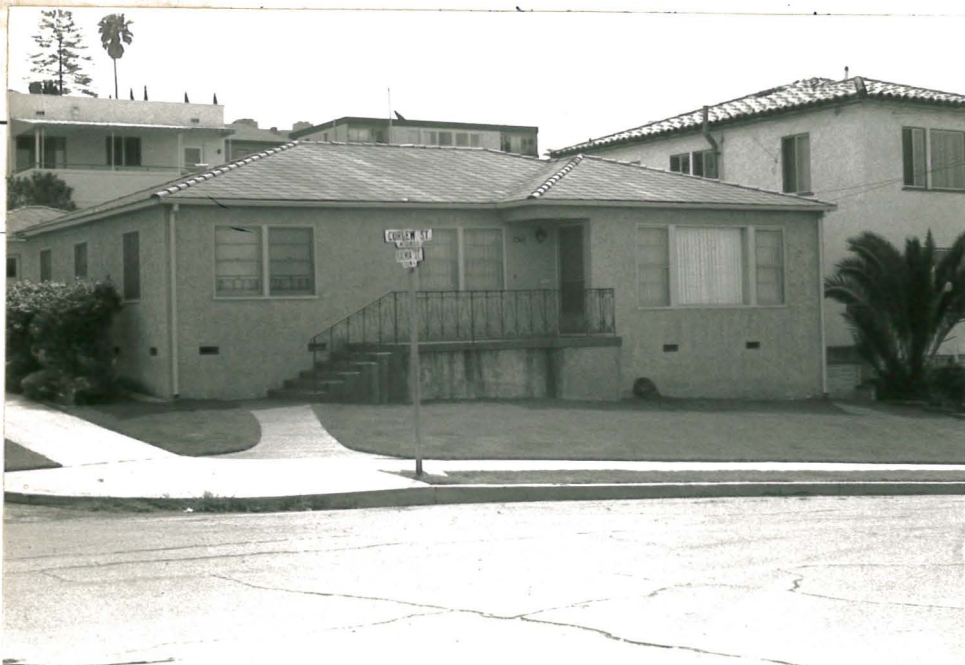
This 1-story rectangular home rests on a raised foundation and has rough stucco siding. The low-pitched hip roof has a red-tile spine and slightly overhanging boxed eaves. The windows have horizontal multiple panes in pairs of double-hung frames. In addition, the front street facade features a fixed center pane with horizontal multi-paned side panels located to the south of the door. The door is reached by stairs along the facade with a wrought iron bannister heading south. The solid wooden door faces north and is sheltered by the corner of the roof overhang. The southwestern facade protrudes to accommodate the north-facing door. A detached 2-car garage along Kalmia Street has a hip roof with matching red-tile spine and stucco siding. The backyard is enclosed by a concrete brick fence. Alterations to the house include new stucco, the wrought iron bannister, and possibly a remodeled entry.

13. Condition: Excellent _____ Good ☒ Fair _____ Deteriorated _____ No longer in existence _____
14. Alterations: New stucco, bannister, possibly a new entry
15. Surroundings: (Check more than one if necessary) Open land _____ Scattered buildings _____ Densely built-up ☒
Residential ☒ Industrial _____ Commercial _____ Other: _____
16. Threats to site: None known _____ Private development _____ Zoning ☒ Vandalism _____
Public Works project _____ Other: _____
17. Is the structure: On its original site? ☒ Moved? _____ Unknown? _____
18. Related features: 2 car detached garage

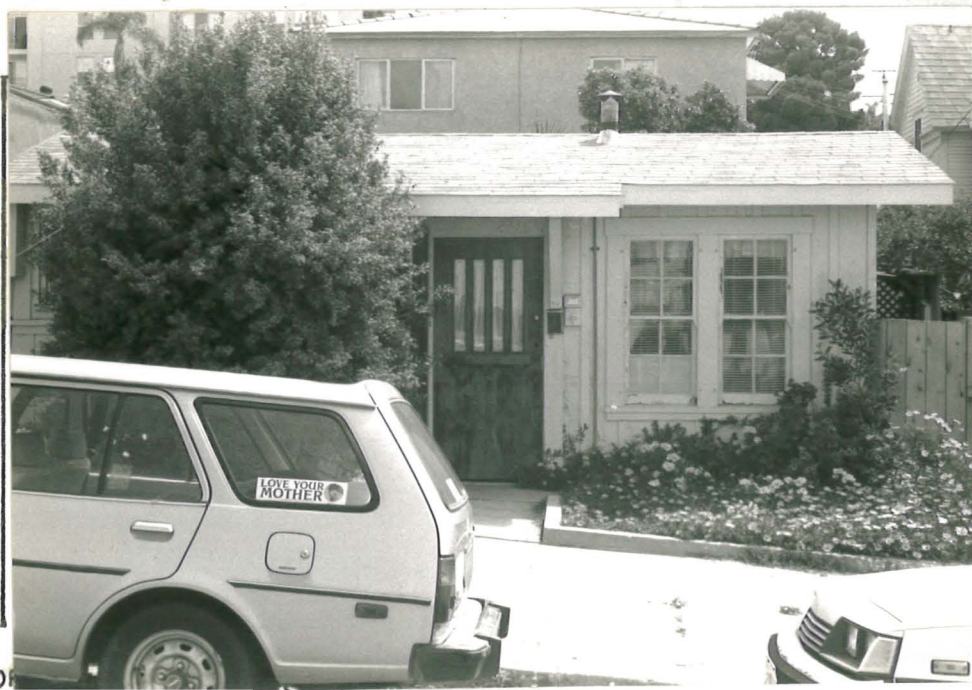
This is a small rectangular one-story structure with board and batten siding, and a medium-pitched side-gable roof with asphalt shingles, exposed rafters, and overhanging eaves. Windows are double-hung multi-paned featured in pairs, and with wooden surrounds. The door, with wood surrounds, is four-panel wood with four vertical rectangular glass uppers located above a horizontal shelf. A roof extension supported by triangular brackets shelter a front stoop. There is a secondary entry on the south side. A garage with a flat roof is on the north. Alterations include a louvered window and a covered patio to the rear. The building is an accessory to 448 Kalmia.

13. Condition: Excellent _____ Good X Fair _____ Deteriorated _____ No longer in existence _____
14. Alterations: Louvered window, covered patio.
15. Surroundings: (Check more than one if necessary) Open land _____ Scattered buildings _____ Densely built-up X
Residential X Industrial _____ Commercial _____ Other: _____
16. Threats to site: None known _____ Private development _____ Zoning X Vandalism _____
Public Works project _____ Other: _____
17. Is the structure: On its original site? _____ Moved? _____ Unknown? X
Garage on north, residence at 448 Kalmia.
18. Related features: _____

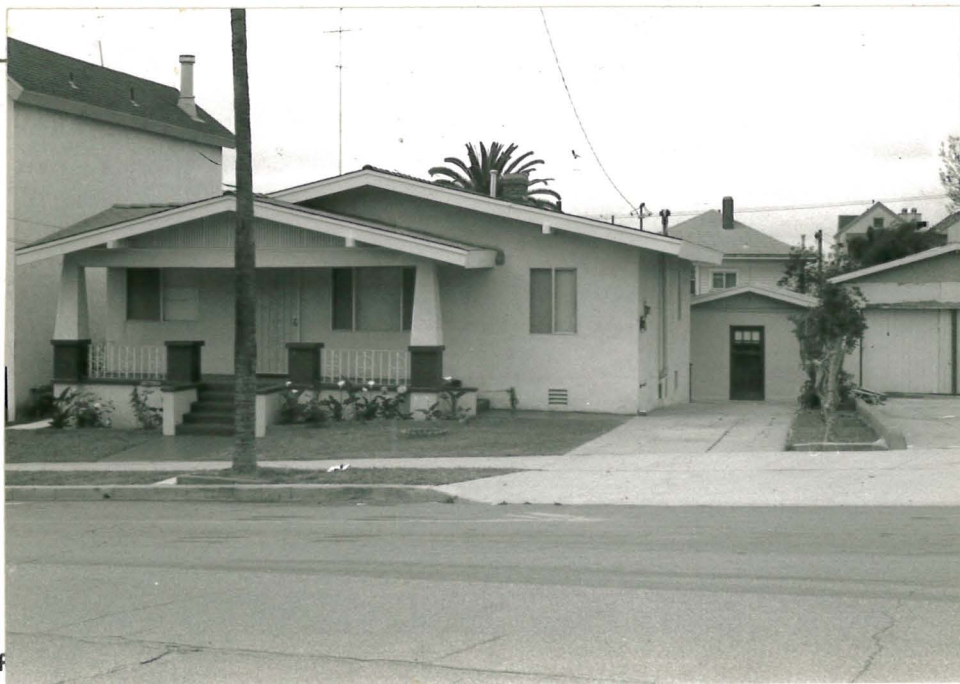
2428 Curlew Street is a one-story rectangular bungalow with basement. The roof is a low-pitched gable with a red-tile spine, wide overhanging eaves, and exposed rafters which are boxed by a plain bargeboard. A second gable roof is offset to the south and shelters the front porch. Within the gable end are vertical roof vents and brackets. Several alterations have occurred on the house, most significantly the windows are now aluminum sliding. The siding has also been altered and is now stucco. Five steps lead to the porch, which has large square brick posts, and decorative iron balustrade and elephantine columns at the outer corners. A security screen now covers the front door. A driveway runs along the northern facade and leads to a small detached garage with a gable roof, stucco siding and wood paneled door with a multi-paned upper.

13. Condition: Excellent ___ Good ___ Fair X Deteriorated ___ No longer in existence ___
14. Alterations: Stucco siding, aluminum sliding windows, security door
15. Surroundings: (Check more than one if necessary) Open land ___ Scattered buildings ___ Densely built-up X
Residential X Industrial ___ Commercial ___ Other: ___
16. Threats to site: None known ___ Private development ___ Zoning X Vandalism ___
Public Works project ___ Other: ___
17. Is the structure: On its original site? X Moved? ___ Unknown? ___
18. Related features: Detached garage

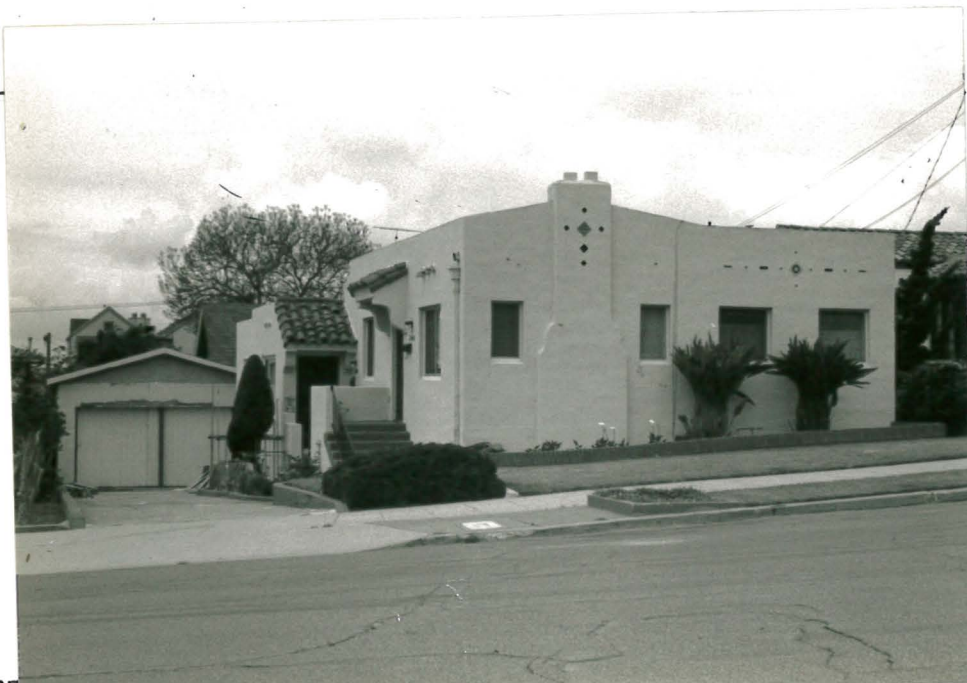
This 1-story, L-shaped Spanish Colonial Style house has stucco siding with tilework on the front facade. The flat roof features a parapet, stepped at intermittent intervals and rising on the front facade to form a gable surrounding a curving chimney with two decorative chimney pots. Windows are deeply recessed with ironwork on the north facade. The doors are not visible behind security screens. The building has two main entrances on the south facade, one facing south and one facing east. The entrances, reached from straight front-facing stairways, have small porches with solid stucco balustrades. Red tile pent hoods supported by massive curving stucco brackets and lintels shelter the entrances. A narrow walkway on the N. side leads to a secondary entry. Spindled vents are located at foundation level. A driveway to the south leads to a garage which has been altered. Other alterations include the windows which are louvered or sliding.

13. Condition: Excellent _____ Good X Fair _____ Deteriorated _____ No longer in existence _____
14. Alterations: Garage, windows
15. Surroundings: (Check more than one if necessary) Open land _____ Scattered buildings _____ Densely built-up X
Residential X Industrial _____ Commercial _____ Other: _____
16. Threats to site: None known _____ Private development _____ Zoning X Vandalism _____
Public Works project _____ Other: _____
17. Is the structure: On its original site? X Moved? _____ Unknown? _____
18. Related features: Garage

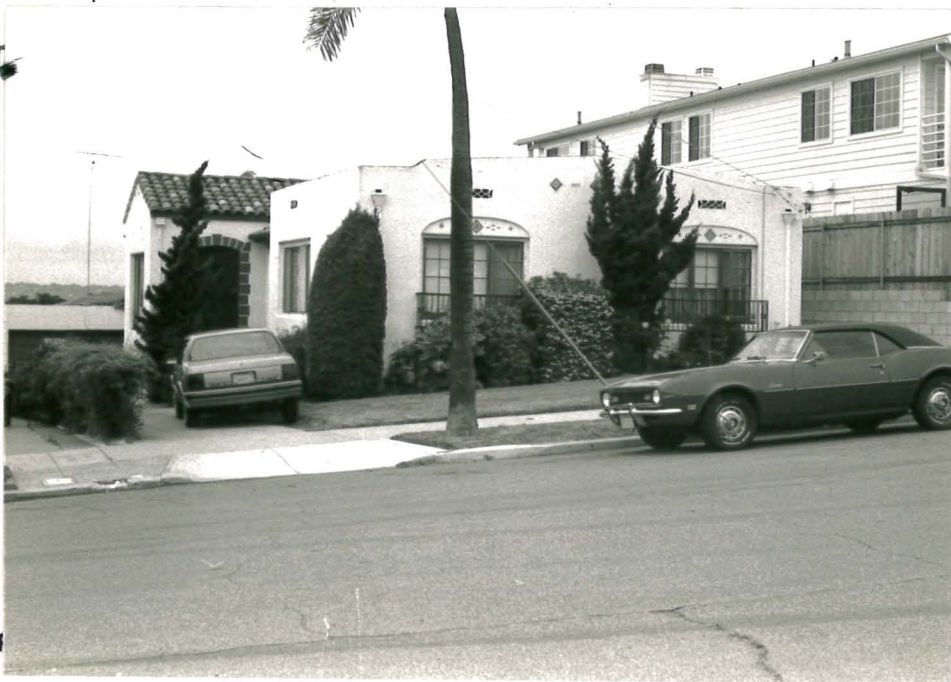
- 7a. Architectural style: Spanish Colonial Revival
- 7b. Briefly describe the present *physical appearance* of the site or structure and describe any major alterations from its original condition: Legal D: Blk 71 Lot 11 Middletown
This L-shaped Spanish Colonial Style dwelling is 1 story in the front with a second story behind due to the slope of the lot. The roof is flat with a stepped, low-pitched gabled parapet in front and to the rear, medium-pitched side gabled with red tile and slightly overhanging eaves. Windows are deeply recessed, 2 & 3 sash hinged with multi-paned and some fixed panes. The 2 windows groups on the front facade have iron balconets and are topped by tilework enclosed in semi-elliptical fanlights. The tiled entry porch which abuts the gabled section of the house is reached from steps decorated with ceramic and terra cotta tile which is an alteration. The south-facing entry doors are flanked by full-length multi-pane side panels and sheltered by a shed roof with exposed rafters. A front-facing wood door also opens on to the porch and is surrounded by quoins which are possibly alterations. A side entry projects on the N. facade and a driveway to the south leads to a flat-roofed garage with vertically panelled doors. Alterations include metal frame windows, a security screen door, quoins, tilework on the steps, and a fanlight over a window on the S. facade which has been enclosed.

13. Condition: Excellent _____ Good X Fair _____ Deteriorated _____ No longer in existence _____
14. Alterations: Metal frame windows, security screen door, tilework on steps, enclosed fanlight
15. Surroundings: (Check more than one if necessary) Open land _____ Scattered buildings _____ Densely built-up X
Residential X Industrial _____ Commercial _____ Other: _____
16. Threats to site: None known _____ Private development X Zoning _____ Vandalism _____
Public Works project _____ Other: _____
17. Is the structure: On its original site? X Moved? _____ Unknown? _____
Garage
18. Related features: _____

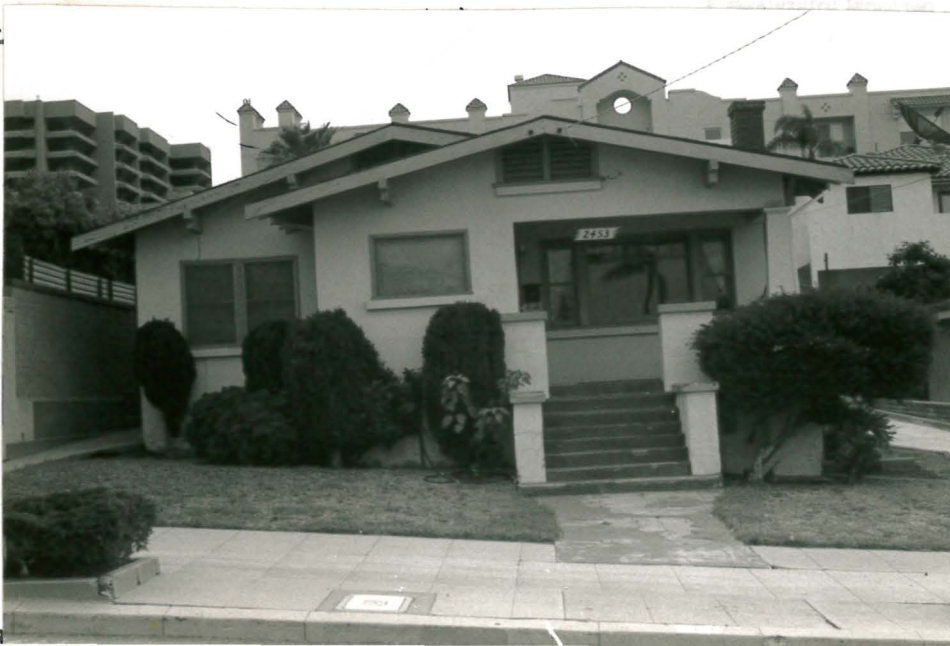
This 1-story rectangular bungalow is on a raised foundation. The roof is a low-pitched gable roof with overhanging eaves, exposed rafters and worked brackets at the gable ends. A second offset gable to the south shelters the front porch extension and has a large horizontal roof vent at the gable peak.

The windows are double-hung with large protruding sills. Within the porch entry is a 3-sash window with a fixed center pane, multi-paned transom and narrow, double-hung side panels. The porch is reached by 8 concrete stairs with a solid stucco banister leading to 2 large square posts. The porch is open to the south with a solid stucco balustrade and a large square post at the southwest corner resting on a square brick post. The southern porch balustrade is decorative open brickwork. The front door faces south from the enclosed north portion of the porch extension and is covered by a metal security screen. The home is sheathed in stucco and the southern facade features a brick chimney, a driveway, and an added cement block patio.

13. Condition: Excellent ☒ Good _____ Fair _____ Deteriorated _____ No longer in existence _____
14. Alterations: Security screen door, patio addition to the rear.
15. Surroundings: (Check more than one if necessary) Open land _____ Scattered buildings _____ Densely built-up ☒
Residential ☒ Industrial _____ Commercial _____ Other: _____
16. Threats to site: None known _____ Private development _____ Zoning ☒ Vandalism _____
Public Works project _____ Other: _____
17. Is the structure: On its original site? ☒ Moved? _____ Unknown? _____
18. Related features: 1- car detached garage
