HISTORIC RESOURCES INVENTORY

1. Common name: Anderson Apartments
2. Historic name: Anderson Apartments
3. Street or rural address: 1747 5th Avenue
City San Diego Zip 92101 County San Diego
4. Parcel number: 533-303-02
5. Present Owner: Electronics Capital Corp Address: P.O. Box 2429
City San Diego Zip 92112 Ownership is: Public _____ Private X
6. Present Use: Residential Original use: Residential

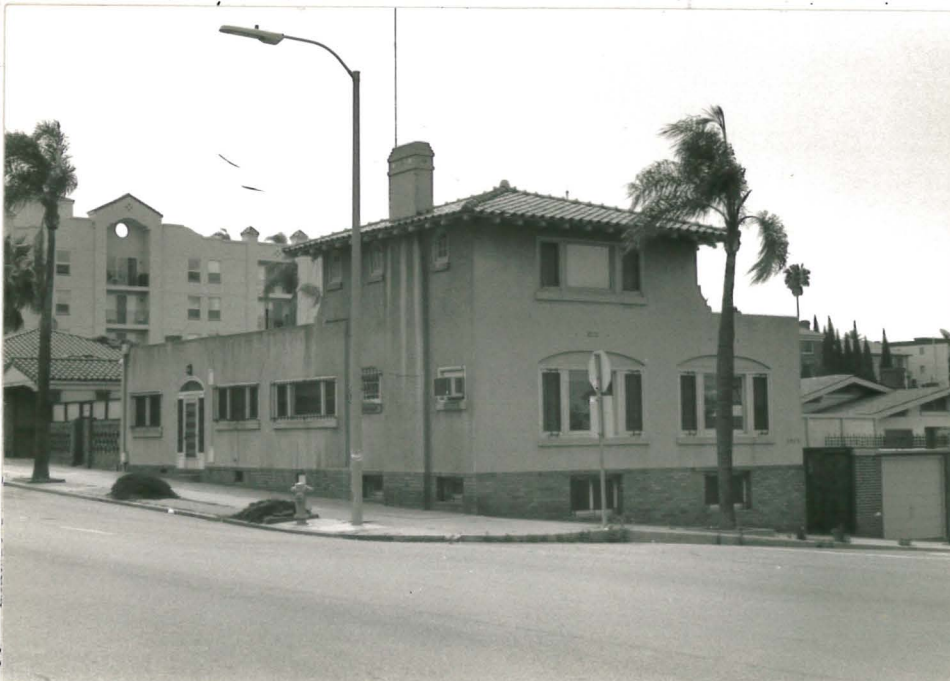
This rectangular home with basement is one story in height and rises to become two stories at the northwest corner. The two story corner has a low pitched red tile hip roof with overhanging eaves and exposed worked rafters. The one story roof is flat. The siding is stucco with decorative inlaid tile above the first story Curlew Street facade. Tile also surrounds the top of the two story chimney along the northern facade. The basement level is sheathed with bricks. The windows are primarily three-sashed along the first story with a fixed center pane and double-hung side panels. Along the west facade the windows have arched niche above and the sidepanels have been altered with louvred windows and iron security bars which also cover the basement windows and the remainder of the first level windows. Some windows have unusual curving iron bars. Along the first story with an arched transom and multi-pane side panels. A second entry is gated on the southwest facade with a red-tile shed roof supported by worked brackets and entablature. A second story balcony is situated above with a solid stucco balustrade.

13. Condition: Excellent _____ Good X Fair _____ Deteriorated _____ No longer in existence _____
14. Alterations: louvered windows, addition on south facade, security bars
15. Surroundings: (Check more than one if necessary) Open land _____ Scattered buildings _____ Densely built-up X
Residential X Industrial _____ Commercial _____ Other: _____
16. Threats to site: None known _____ Private development _____ Zoning X Vandalism _____
Public Works project _____ Other: _____
17. Is the structure: On its original site? X Moved? _____ Unknown? _____
18. Related features: one car garage to south, garage on 427 Laurel also

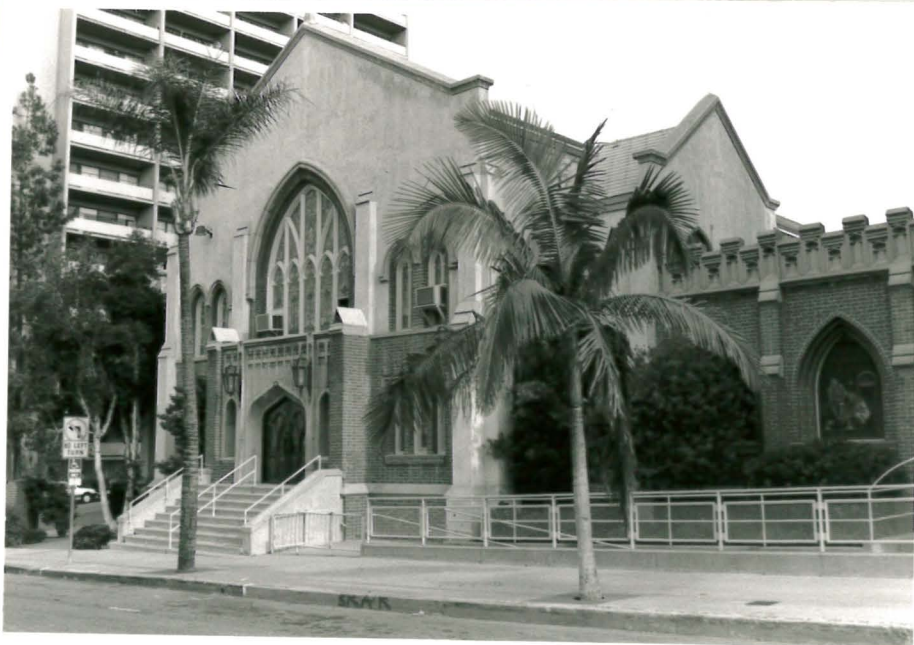
This Gothic Revival church consists of two steeply pitched gabled elements connected by an arcaded walkway which surrounds a garth ten feet below street level. The building is accented by a square tower on the southwest corner of the eastern most gable. The front gables feature molded gable parapets topped by crosses. The eastern gable is four stories in height with three story side gables; the western gable is slightly lower again with lower side gables. The walkway is two stories in height; the tower rises to approximately six stories. Siding is flemish brick concrete and stucco. Deeply recessed windows are prominent on all facades. The church exhibits many Gothic characteristics including corner buttressing Gothic tracery, and stained glass acute arched windows. The western gabled element and the turret house the front entries reached by cement steps. Deeply recessed double doors with a wood panel between are wooden with glass on curving and angular designs. A secondary entrance on the south corner of the east facade is articulated with a one story brick turret with a formed concrete top, buttresses and arched. Alteration include formed concrete atop the main tower, a brick sign holder, pipe railing at main entrance, some brickwork flood lights, chain link fence on the west face. On the west face, some first floor windows have been filled in and a stairway has been added.

13. Condition: Excellent ☒ Good _____ Fair _____ Deteriorated _____ No longer in existence _____
formed concrete atop main turret, brick sign holder, brick wk, chain lind fence, floodlight
iron fencing on w. facade some windows ahve veen filled in and a stairway added.
14. Alterations: _____
15. Surroundings: (Check more than one if necessary) Open land _____ Scattered buildings _____ Densely built-up ☒
Residential ☒ Industrial _____ Commercial ☒ Other: Interstate % _____
16. Threats to site: None known ☒ Private development _____ Zoning _____ Vandalism _____
Public Works project _____ Other: _____
17. Is the structure: On its original site? ☒ Moved? _____ Unknown? _____
18. Related features: Iglesia Presbyterian Hispana, Christian Education cont to the North

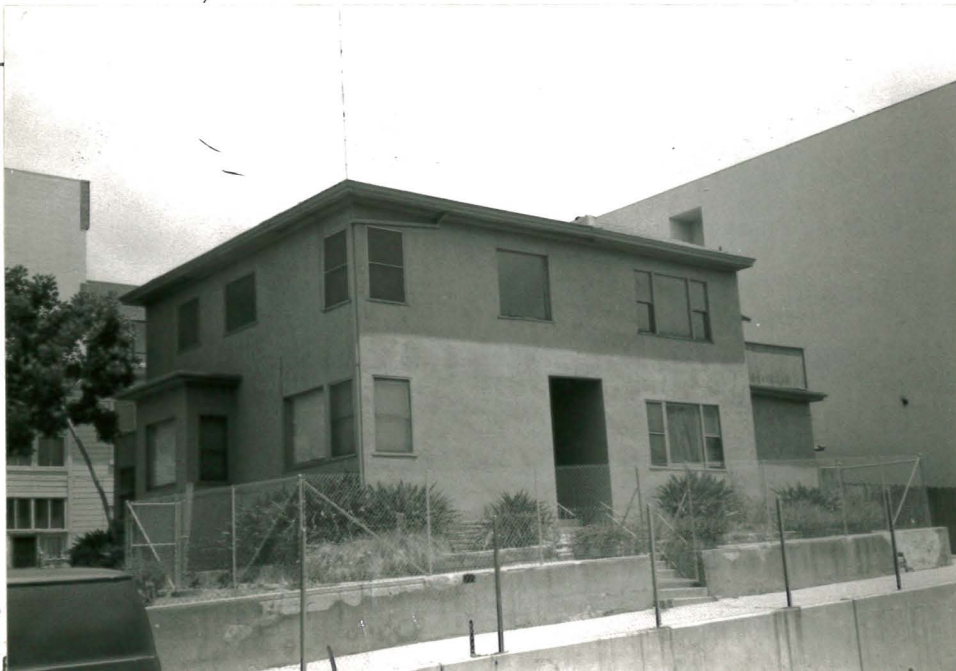
This two-story home is on a raised foundation and has been altered partially due to the construction of the interstate to the south of the property. The roof is a low-pitched truncated hip with overhanging boxed eaves. A brick interior chimney intersects the roofline and a two-story extension to the home is along the eastern facade with a pent roof. The windows are double-hung on large fixed panes with a few three-sashed windows with a fixed center pane and double-hung sidepanels. A square one-story bay with a flat roof projects from the western facade. The original entry is recessed along the southern facade with concrete stairs and a wrought iron barnmaster. The rear entry along the northern facade is now used as the main entry, due to the highway. Surrounding the property is a stuccoed retaining wall and a chain link fence. The home has a recent stucco sheath, which may have altered the original siding.

13. Condition: Excellent _____ Good _____ Fair x Deteriorated _____ No longer in existence _____
14. Alterations: Siding, additions, chain link fence, entry
15. Surroundings: (Check more than one if necessary) Open land _____ Scattered buildings _____ Densely built-up x
Residential x Industrial _____ Commercial X Other: _____
16. Threats to site: None known _____ Private development _____ Zoning X Vandalism _____
Public Works project _____ Other: _____
17. Is the structure: On its original site? _____ Moved? _____ Unknown? x
18. Related features: _____

This is a non-contributing structure due to alterations to the original architecture, deterioration, and/or lack of historical significance.

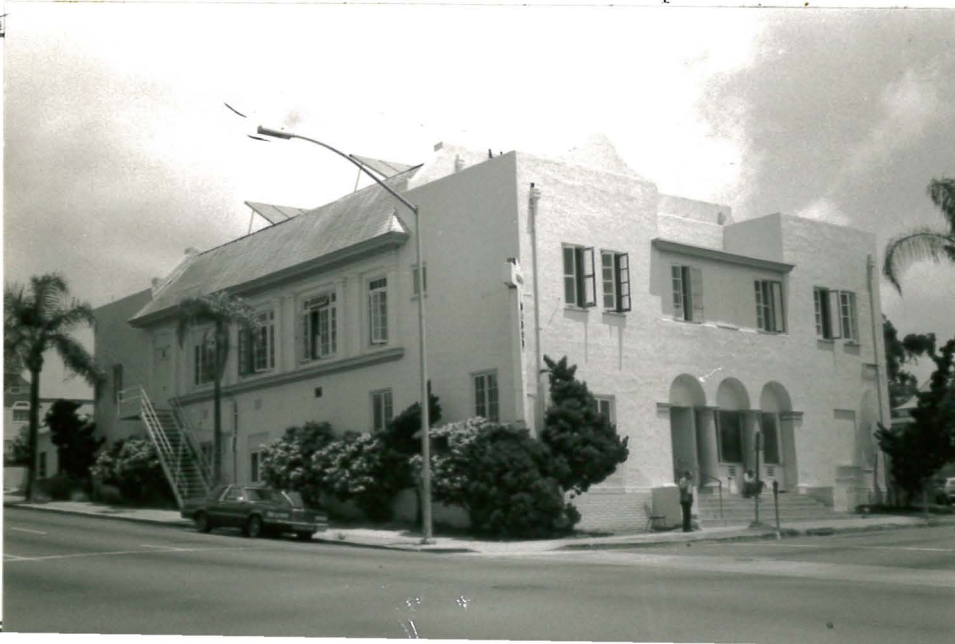
This 2-story stucco rectangular structure is on a raised brick foundation with a basement below. The roof is flat with large pent roofs centered within the east and west facades and large espadana parapets at the pent roof ends. The cornices of the pent roofs are boxed with a decorative molding and frieze. The large northern and southern espadanas contain a recessed area above the 2nd level. The windows are multi-paned, double-sashed and hinged, with multi-paned side panels and transoms below the pent roofs. Separating these larger windows on the second floor are pairs of square pilasters between the pent's frieze and the molded band below the windows. The symmetrical southern facade features 3 arched and columned openings reached by concrete stairs from the street forming the main entry which has been altered to allow access only through the western archway. The other 2 arches have been enclosed with stucco and aluminum-framed pane windows. Above the entry is a recessed panel with 2 windows which also steps down from the corners with a band of molding above. Two entries on each level of the western facade provide alternative accesses.

13. Condition: Excellent ___ Good X Fair ___ Deteriorated ___ No longer in existence ___
14. Alterations: stuccoed window on southeast corner, entry, solar panels on roof stairway on west facade
15. Surroundings: (Check more than one if necessary) Open land ___ Scattered buildings ___ Densely built-up X
Residential X Industrial ___ Commercial X Other: ___
16. Threats to site: None known X Private development ___ Zoning ___ Vandalism ___
Public Works project ___ Other: ___
17. Is the structure: On its original site? X Moved? ___ Unknown? ___
18. Related features: ___

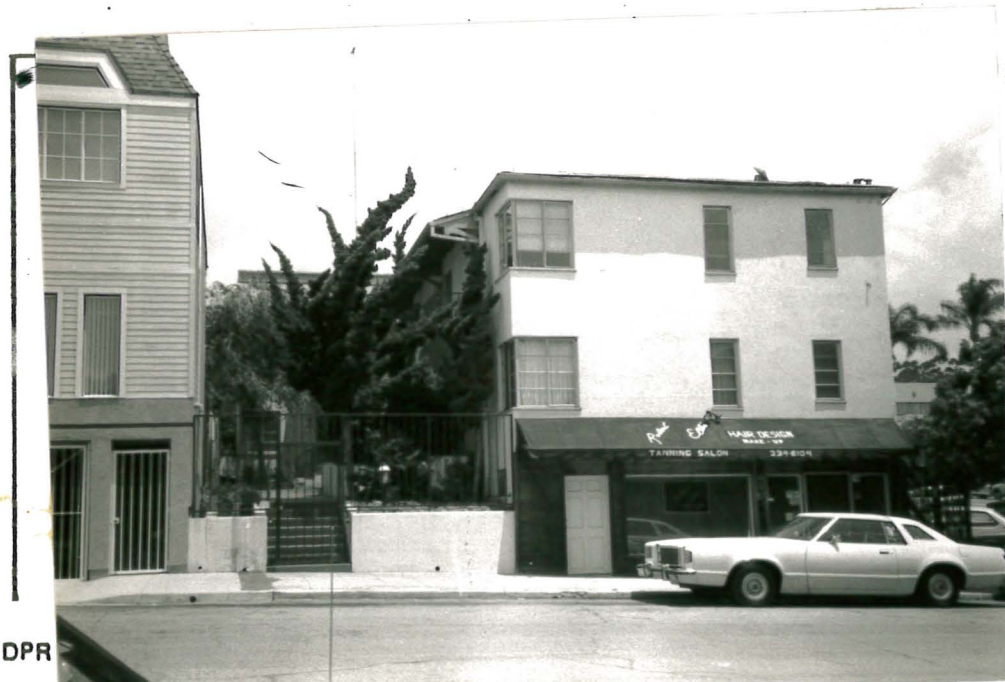
These 2 stucco mixed-use buildings contain apartments on the 2nd & 3rd levels and commercial space on the 1st story of the street facade with basement space in the remainder of the 1st level. The 2 structures form an L-shape and have a low-pitched hip roof with slightly overhanging eaves. Over the 3rd story apartment entries, the roof extends with exposed rafters and curved brackets. The windows are multi-paned casements in various sash sizes, some wrapping around the corners of the structure. The apartment doors are solid wood panels. The 2nd floor entries are reached by concrete stairways with iron banisters which continue upward to access the 3rd level. The inner court contains mature landscaping and is reached by a concrete stairway with an iron security gate. Along the 1st level, the commercial entries are sheltered by a canvas awning. The facade is wood paneling with large fixed-pane windows and 2 solid wood-paneled doors. Alterations include the commercial facade, iron security gate, fire escape on the eastern facade and 2 double-hung windows.

13. Condition: Excellent _____ Good X Fair _____ Deteriorated _____ No longer in existence _____
14. Alterations: Commercial facade, iron security gate & door, fire escape on eastern facade, 2 double hung windows.
15. Surroundings: (Check more than one if necessary) Open land _____ Scattered buildings _____ Densely built-up X
Residential X Industrial _____ Commercial X Other: _____
16. Threats to site: None known X Private development _____ Zoning _____ Vandalism _____
Public Works project _____ Other: _____
17. Is the structure: On its original site? X Moved? _____ Unknown? _____
18. Related features: NONE

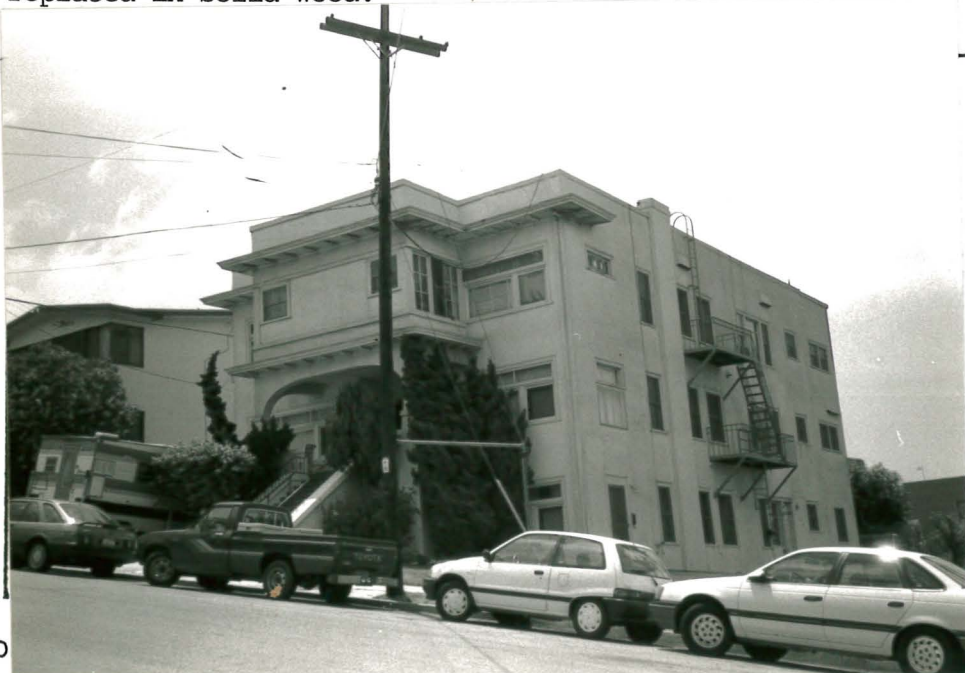
This three story, rectangular shaped building has a flat roof with projecting horizontal coping. On the east parapet at the roof. A flat cornice visor just below the roof line is boxed with exposed, worked brackets. The windows are double hung in horizontal rows. Some windows are fixed with angled curvilinear leaded glass on the north facade wide pairs of single pane hinged windows have the same leaded glass in full width transoms. The center section of the north facade project out the full three stories with two horizontal bands at the third story, the same cornice visor dividing the second and first stories and a wide segmental entry arch beneath supported by massive, story high elephantine pedestal with two horizontal bands at there capitals. A story high centered, concrete staircase, with wrought iron railing running inside a boxed balustrade, leads to the covered, arched entry porch with four solid oak entry doors, each with a large oval glass panel. Two side entries are located on the west facade. Alterations include fire escape on the east and west facades, one aluminum window, some windows replaced in 40s multi pane and one door on the west replaced in solid wood.

13. Condition: Excellent _____ Good ☒ Fair _____ Deteriorated _____ No longer in existence _____
14. Alterations: fire escapes, some windows, one door
15. Surroundings: (Check more than one if necessary) Open land _____ Scattered buildings _____ Densely built-up ☒
Residential ☒ Industrial _____ Commercial _____ Other: Interstate 5
16. Threats to site: None known ☒ Private development _____ Zoning _____ Vandalism _____
Public Works project _____ Other: _____
17. Is the structure: On its original site? ☒ Moved? _____ Unknown? _____
18. Related features: none

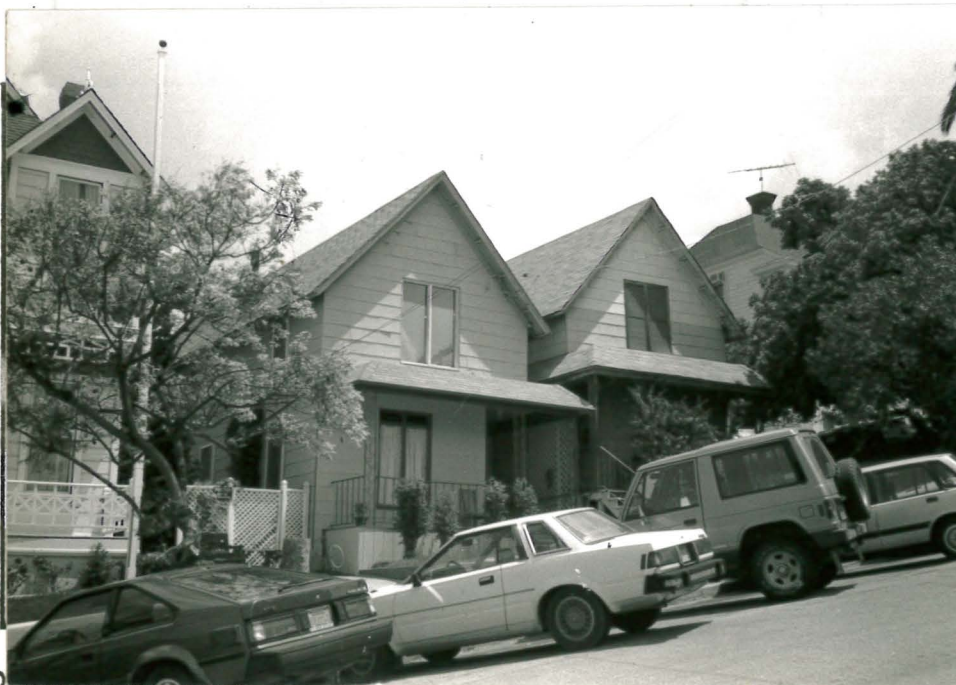
- 7a. Architectural style: Folk Victorian
7b. Briefly describe the present *physical appearance* of the site or structure and describe any major alterations from its original condition: 126 West Fir Street is a property with 2 nearly identical Victorian row houses upon it. The western structure seems to have been moved onto the property and has been maintained better than the eastern row house. The structures are 2 stories in height with high-pitched front gables with overhanging eaves & worked exposed rafters. The siding on both homes has been altered and is now asbestos shingle. The side windows are narrow and double-hung while the front windows have been altered and are pairs of aluminum sliding or fixed on the west building & louvered on the east building. Wooden steps lead to each open front porch sheltered by truncated hip roofs. Wrought iron balustrades have corner posts which rise to the plain porch entablatures. The doors are deeply recessed along the interior sides of the 2 grouped structures with latticework separating the 2 entries. The wood panel doors have a flashed glass upper. Each structure has a square brick interior chimney.

13. Condition: Excellent _____ Good _____ Fair ☒ Deteriorated _____ No longer in existence _____
14. Alterations: Siding, windows, balustrades, bannister
15. Surroundings: (Check more than one if necessary) Open land _____ Scattered buildings _____ Densely built-up ☒
Residential ☒ Industrial _____ Commercial _____ Other: _____
16. Threats to site: None known _____ Private development _____ Zoning ☒ Vandalism _____
Public Works project _____ Other: _____
17. Is the structure: On its original site? _____ Moved? ☒ Unknown? _____
18. Related features: None

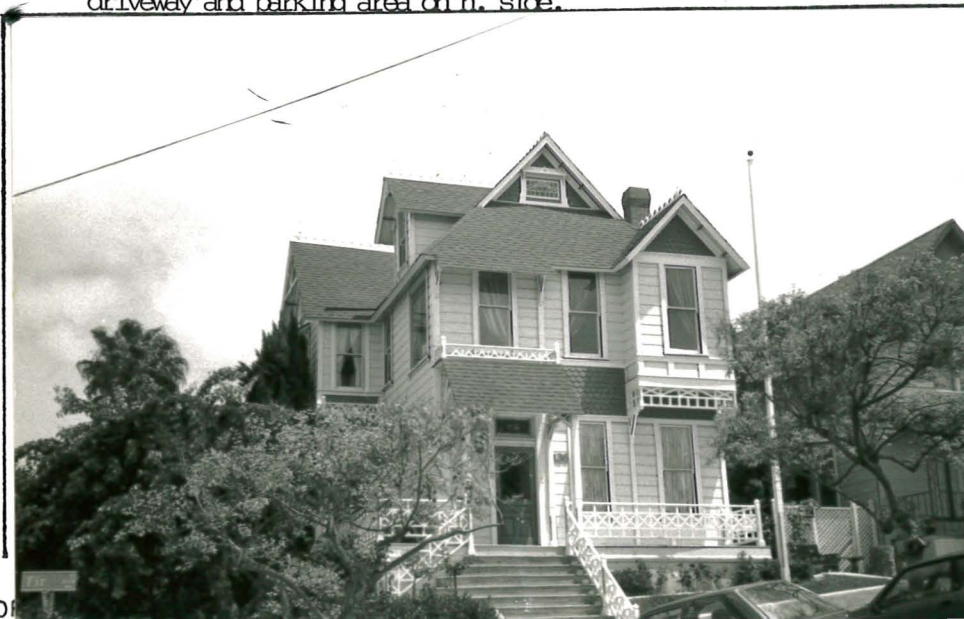
original condition: This 2 $\frac{1}{2}$ story Queen Anne Style house on a raised cement block foundation is Historic Site #104. It sits high above street level behind a cement block retaining wall and commands views on the south and west sides. A steeply pitched hipped roof with multiple gables has roof cresting with turned finials, overhanging eaves, worked rafters and plain frieze. Trusswork ornaments many of the gable peaks. Two gabled dormers are located on the west facade. Siding is predominately shiplap with endboards. There is fish scale siding between stories on a west-facing gabled square bay, between stories on the south facade, and in some of gables. Windows are primarily narrow, double-hung with shelf surrounds, and decorated sill. Some are fixed with flashing or stained glass and some exhibit pent overhangs with decorative brackets. 14 molded cement steps lead a veranda which crosses the south facade and wraps around the west side. A stick balustrade with worked posts continues to form a railing for the stairs. The 2 entry doors off the veranda are wood panel with bevelled glass uppers, one with a stained glass transom. Entry roofs are decorated with horseshoe trusswork, supported by turned posts, and topped with false balconies surrounded by stickwood echoing the balustrade. A prominent feature is a 2nd story gabled oriel bay with panelling and stickwork, supported by worked brackets. On the west facade, north of the bay, a cement stairway leads to a porch with a hipped roof supported by turned posts. The roof wraps around the north side of the building and shelters 1st floor extension, the house has a brick chimney. Restored in 1975-76, has the following alterations the gable dormer, some windows, stained glass transom above west side porch, basement entrances, stairway, 1st floor extension on north side driveway and parking area on n. side.

13. Condition: Excellent _____ Good X Fair _____ Deteriorated _____ No longer in existence _____
 Northside roof&1st floor extension, north side basement entrances, play area basement added, 2 gabled dormer,
 some windows stained glass transom
14. Alterations: _____
15. Surroundings: (Check more than one if necessary) Open land _____ Scattered buildings _____ Densely built-up X
 Residential X Industrial _____ Commercial X Other: _____
16. Threats to site: None known X Private development _____ Zoning _____ Vandalism _____
 Public Works project _____ Other: _____
17. Is the structure: On its original site? X Moved? _____ Unknown? _____
18. Related features: _____
