HISTORIC RESOURCES INVENTORY

1. Common name: None
2. Historic name: None
3. Street or rural address: 1916-1926 Front Street
City San Diego Zip 92101 County San Diego
4. Parcel number: 533-251-05
5. Present Owner: Robert Mellis Address: P.O. Box 2248
City San Diego Zip 92073 Ownership is: Public _____ Private X
6. Present Use: Residential Original use: Residential

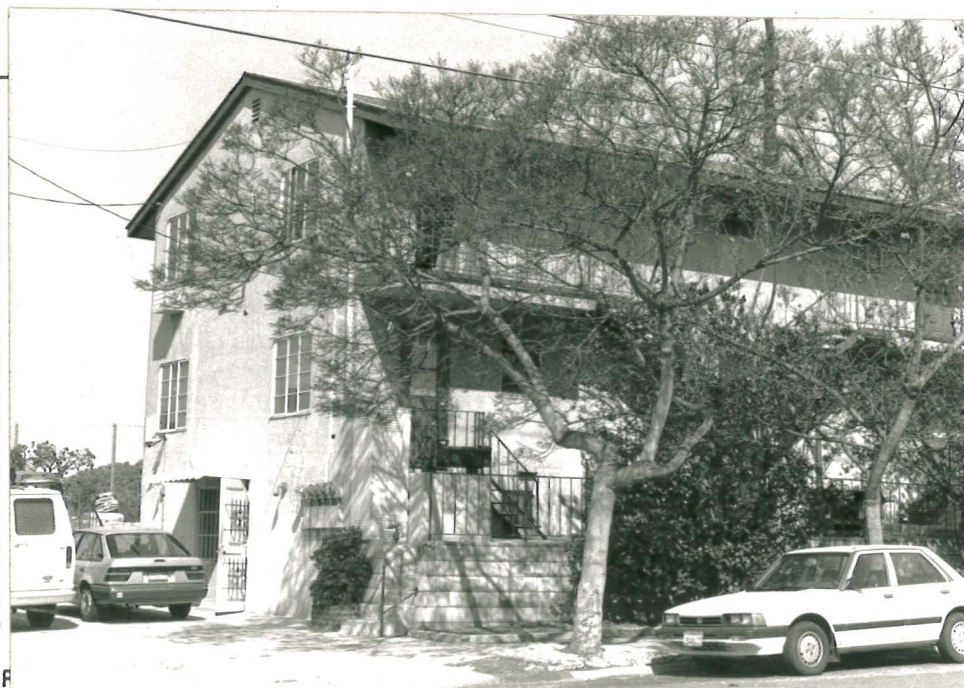
This two-story apartment building with basement contains four dwelling units and additional storage/living space below. The roof is a low-pitched side gable with horizontal roof vents at the gable ends and widely overhanging eaves. The windows along the street facade are now aluminum-framed; however, the original three-sash multi-pane metal casements still exist on the northern and southern facades. The window and door placement within the stucco siding is very symmetrical. Apartment entries are located on each corner of the eastern facade and are reached by floating concrete stairs with simple iron bannisters. The small cantilevered stoops lead to a wooden door with a two-pane metal-framed upper. The raised concrete block porch is entered from the south by a concrete stairway. Also, to the south is a parking area and an entrance to the basement level with an aluminum awning and double wooden doors.

13. Condition: Excellent ☒ Good ☐ Fair ☐ Deteriorated ☐ No longer in existence ☐
14. Alterations: Aluminum-framed windows and aluminum awning.
15. Surroundings: (Check more than one if necessary) Open land ☐ Scattered buildings ☐ Densely built-up ☒
Residential ☒ Industrial ☐ Commercial ☐ Other: ☐
16. Threats to site: None known ☒ Private development ☐ Zoning ☐ Vandalism ☐
Public Works project ☐ Other: ☐
17. Is the structure: On its original site? ☒ Moved? ☐ Unknown? ☐
18. Related features: ☐

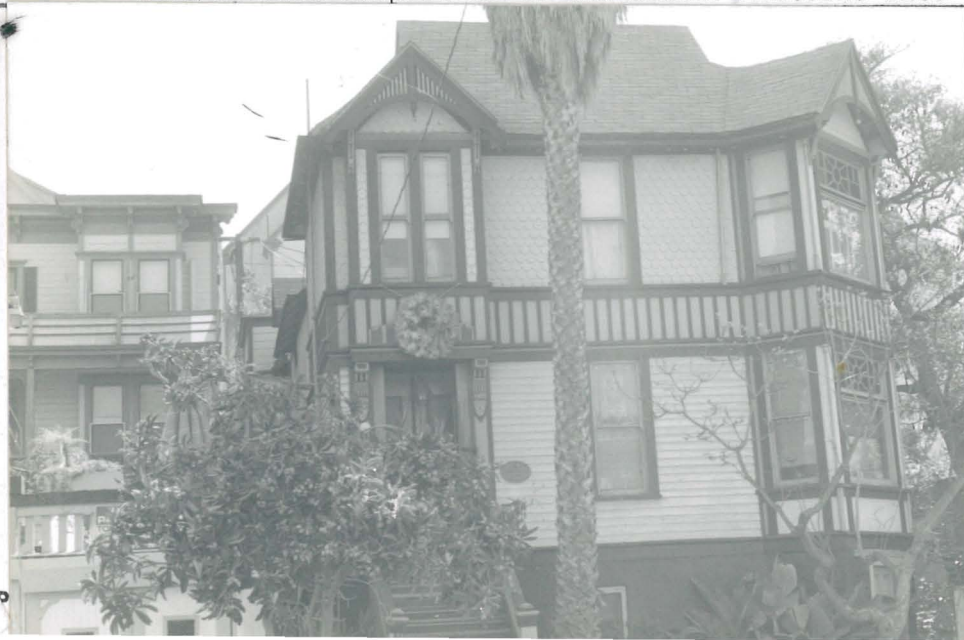
7b. Briefly describe the present *physical appearance* of the site or structure and describe any major alterations from its original condition: This 2-story Queen Anne style house with a basement in front due to the slope of the lot, has a steep multi-gabled asphalt shingled roof with overhanging eaves and exposed rafters. Siding is clapboard on the 1st story and fishscale on the second, with corner boards, a vertically panelled band between the first and second floors, and a watercourse between the 1st & 2nd floors on the north facade. Stucco sheaths the foundation and latticework is located under the stairway. Windows are predominantly double-hung, but in the bay, there are fixed pane windows with transoms of unusual geometric designs. Windows have wood surrounds and some are flanked by spindled pilasters which act as cornerboards. The house is reached from cement steps at street level, then wooden steps with a spindled bannister and square wooden posts lead to an iron gate at the entry to a small porch. The porch has double wooden doors with rectangular glass uppers. A full story gabled overhang with narrow double-hung windows and spindled ornamentation in the gable peak covers the porch. The most striking feature of this house is a full-length square bay, angled on the southwest corner and covered by a gable roof with ornamentation similar to that in the gable above the porch. A basement entry door, with wood surrounds and lintels is located in the bay. A vine-covered carport is to the south. Historic Site #100.

13. Condition: Excellent ☒ Good _____ Fair _____ Deteriorated _____ No longer in existence _____
14. Alterations: None Apparent
15. Surroundings: (Check more than one if necessary) Open land _____ Scattered buildings _____ Densely built-up ☒
Residential ☒ Industrial _____ Commercial _____ Other: _____
16. Threats to site: None known ☒ Private development _____ Zoning _____ Vandalism _____
Public Works project _____ Other: _____
17. Is the structure: On its original site? ☒ Moved? _____ Unknown? _____
18. Related features: Carport

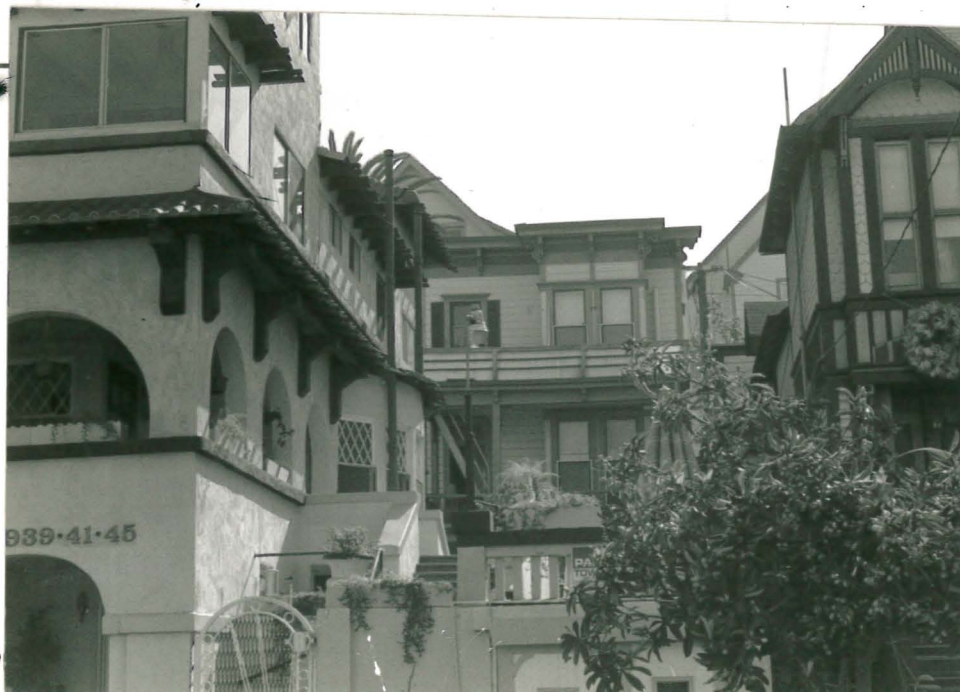
- 7b. Briefly describe the present *physical appearance* of the site or structure and describe any major alterations from its original condition: This rectangular flat-roofed Italianate house sits at the rear of the lot and is partially obscured by a Spanish Colonial/Mission Style apartment building at the front. It is 3 stories high, but only the upper two are visible from the street. A boxed cornice and overhanging eaves shelter decorative brackets, lintelwork, and a plain frieze. Siding is tongue and groove with endboards. Windows are paired double-hung with shelf surrounds. A shuttered window is visible on the 3rd floor. A full length square bay rises on the south side of the front facade. Both the 2nd & 3rd floors feature balconies, each with an open wood balustrade. The 2nd floor balcony has wooden posts with decorative gingerbread work and worked brackets which support the 3rd floor balcony. A stairway which intersects the balcony leads from the 2nd to the 3rd floor. Bamboo surrounding the 3rd floor balcony is an alteration.

13. Condition: Excellent _____ Good ☒ Fair _____ Deteriorated _____ No longer in existence _____
14. Alterations: Bamboo surrounding 3rd floor balcony
15. Surroundings: (Check more than one if necessary) Open land _____ Scattered buildings _____ Densely built-up ☒
Residential ☒ Industrial _____ Commercial _____ Other: _____
16. Threats to site: None known _____ Private development _____ Zoning ☒ Vandalism _____
Public Works project _____ Other: _____
17. Is the structure: On its original site? _____ Moved? ☒ Unknown? _____
18. Related features: Mission Style Apartment in front of lot

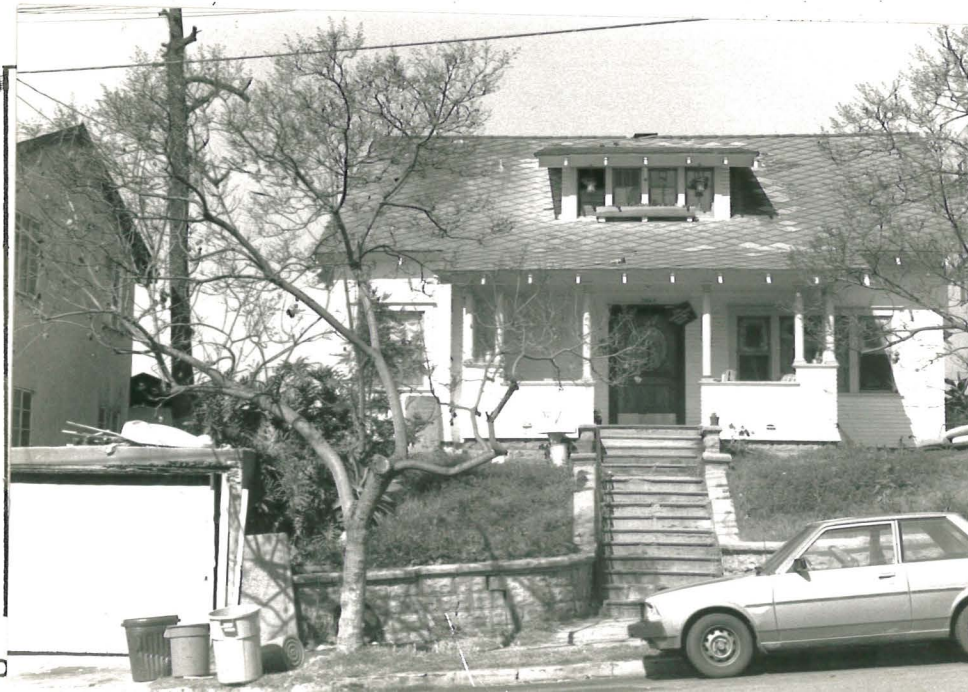
This rectangular, 1½-story Craftsman bungalow sits above street level on an ashlar block foundation. It is sided in shiplap and flared at the foundation level. A high-pitched, side-gabled roof with diamond-shaped composition roofing material extends to cover a central front porch and front square bay south of the porch. Widely overhanging eaves shelter sharply pointed rafters in the gable and knee brackets. A central shed dormer, also with overhanging eaves and pointed rafters, contains a band of multi-paned windows. Other windows, all with shelf surrounds, are predominantly double-hung, with leaded glass uppers featured north of the porch. Fifteen molded concrete steps with an ashlar block bannister lead to the large front porch. A boxed shiplap balustrade, stepped on the corners and columns, support the roof. A central two-panelled wooden door contains a large oval bevelled glass upper. On the north facade, there is a single-story bay with a shed roof. An ashlar block retaining wall surrounds the property and a concrete garage with a wood door abuts the sidewalk to the south.

13. Condition: Excellent ☒ Good _____ Fair _____ Deteriorated _____ No longer in existence _____
14. Alterations: None apparent
15. Surroundings: (Check more than one if necessary) Open land _____ Scattered buildings _____ Densely built-up ☒
Residential ☒ Industrial _____ Commercial _____ Other: _____
16. Threats to site: None known _____ Private development _____ Zoning ☒ Vandalism _____
Public Works project _____ Other: _____
17. Is the structure: On its original site? ☒ Moved? _____ Unknown? _____
18. Related features: Garage

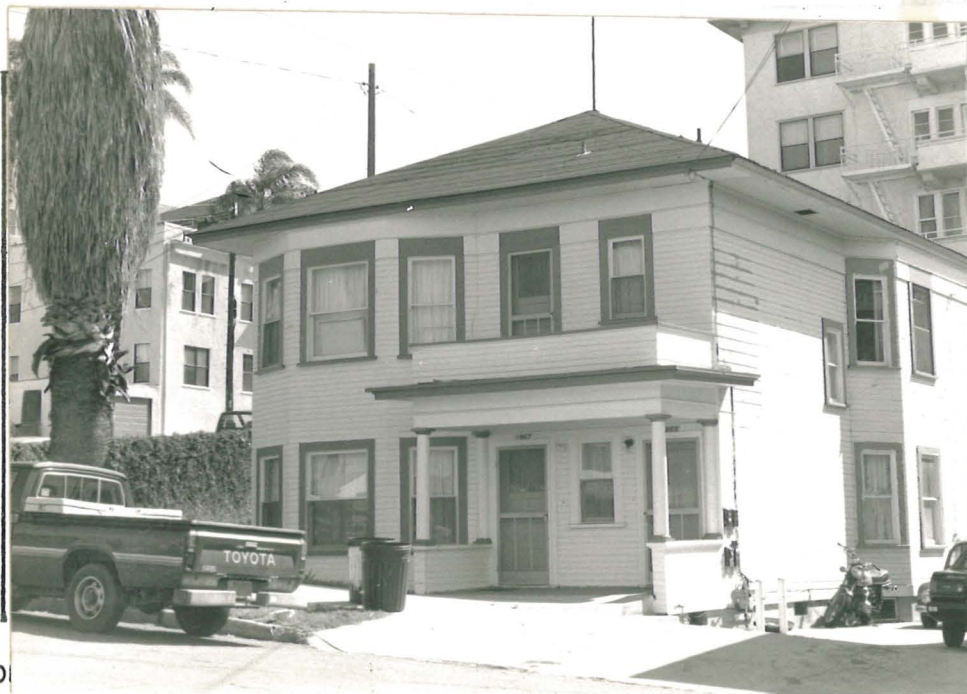
13. Condition: Excellent ☒ Good ☐ Fair ☐ Deteriorated ☐ No longer in existence ☐
14. Alterations: Entry door, new screens on doors and windows.
15. Surroundings: (Check more than one if necessary) Open land ☐ Scattered buildings ☐ Densely built-up ☒
Residential ☒ Industrial ☐ Commercial ☒ Other: ☐
16. Threats to site: None known ☐ Private development ☐ Zoning ☒ Vandalism ☐
Public Works project ☐ Other: ☐
17. Is the structure: On its original site? ☐ Moved? ☒ Unknown? ☐
18. Related features: None

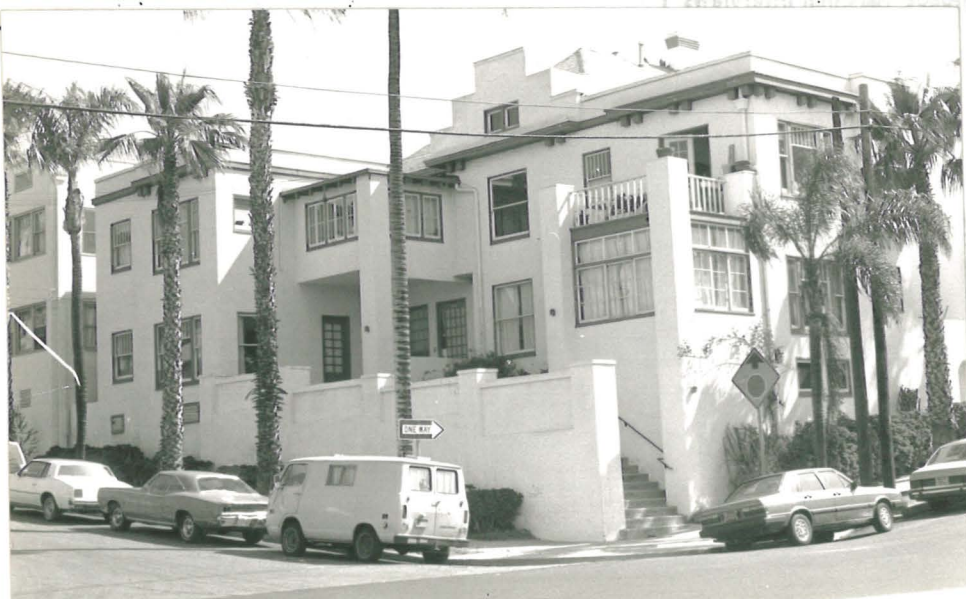
This stucco sided irregularly shaped Spanish Colonial Style apartment building is three and half stories in height and sits on a sloping corner lot. It has a flat roof with a parapet covered by coping and stepped in the center, and a pyramidal hipped roof to the rear. Below the parapet, a protruding horizontal band with square brackets runs across the front facade and wraps around the corners. Windows, all with narrow wooden surrounds, include double-hung with vertical multi-pane uppers, multi-paned wooden casements, and three sash with central fixed panes with vertical multi-pane transoms and narrow double-hung side panels. Door are french, some in pairs. A stepped cement wall with horizontal panels and large square posts extends across the south 2/3 of the front facade. Behind, a straight south facing stairway with metal rail leads to a porch which has three entry doors and is covered by a third story corner extension. On the southwest corner, behind the stairs is a third story balcony with plain wood balustrade and large wooden posts which continue as pilasters to street level. The south facade features an arched entry with a large niche, small third story square bay sit on arched balcony. The building has square vents at ground levels and a chimney.

13. Condition: Excellent X Good _____ Fair _____ Deteriorated _____ No longer in existence _____

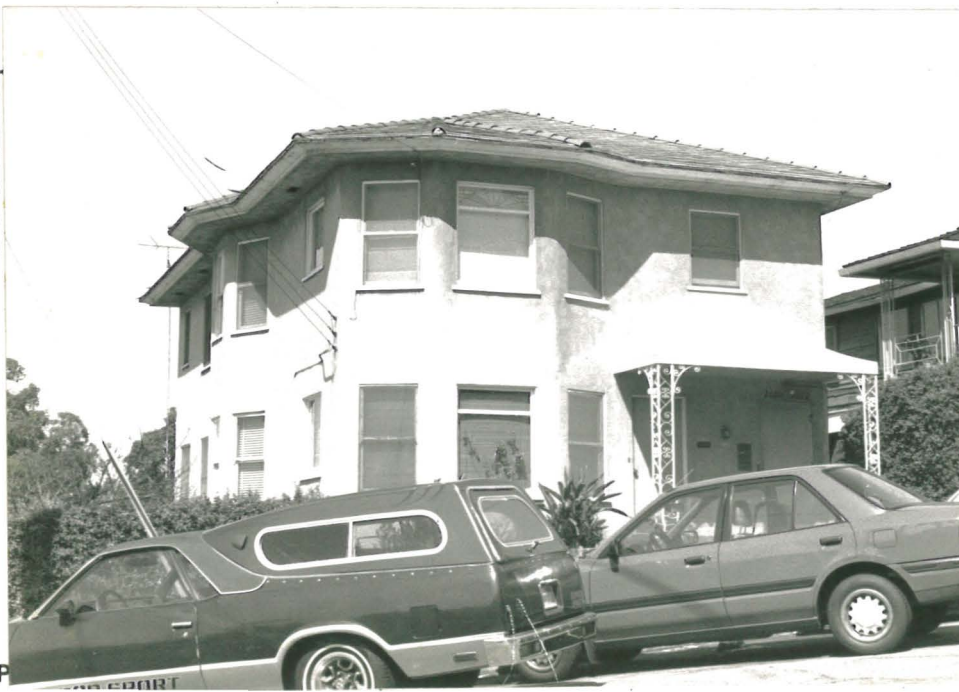
This is a two-story, rectangular, stucco-sided apartment building which sits on a raised foundation. The roof, a medium-pitch hip with composition shingles and a red tile spine, has a boxed cornice and widely overhanging eaves. Windows are double-hung and fixed with horizontal transoms, one with a leaded glass fan pattern. Two two-story wide-angle bays, one at the south corner of the front facade and one on the south facade, are covered by hipped roofs. A cement walkway leads to a raised entry with a metal bellcast entry hood supported by decorated wrought iron posts. Doors are solid wood with aluminum kickplates. A small door on the south facade opens into a basement storage area. The entry hood and posts are possible alterations.

13. Condition: Excellent ____ Good ☒ Fair ____ Deteriorated ____ No longer in existence ____

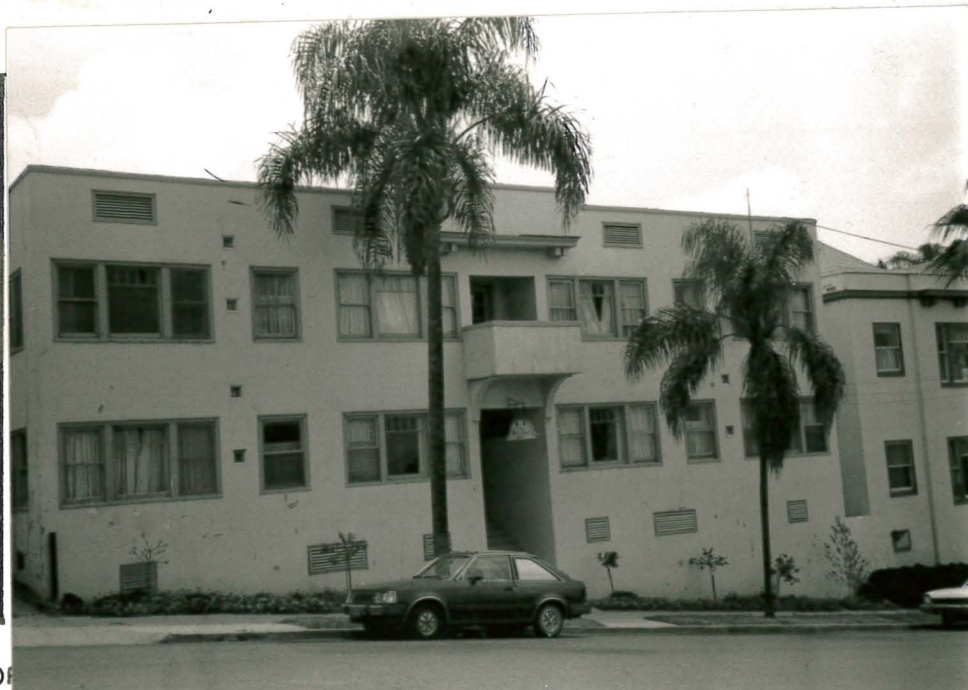
This two-story rectangular apartment building is on a raised foundation which accommodates the sloping terrain. The siding is smooth stucco which compliments the symmetrical Mission architecture. The flat roof has a stepped parapet with a plain stucco coping. Large horizontal roof vents are below the roofline and matching crawlspace vents are situated in the raised foundation. The horizontal bands of wide double-hung windows alternate with three-sash windows with a fixed center pane and a multi-pane transom. The central element is the deeply recessed entry with a long staircase from the street. The single French door has multi-pane side panels and a small marquis hangs above the entry. Directly above is a second story balcony with a solid stucco balustrade and large brackets below. A shallow decorative hood with twin brackets lies above the balcony's recessed French door. Along the northern facade is an unpaved driveway leading to a one-car garage.

13. Condition: Excellent ☒ Good _____ Fair _____ Deteriorated _____ No longer in existence _____
14. Alterations: None apparent
15. Surroundings: (Check more than one if necessary) Open land _____ Scattered buildings _____ Densely built-up _____
Residential ☒ Industrial _____ Commercial _____ Other: _____
16. Threats to site: None known _____ Private development _____ Zoning _____ Vandalism ☒
Public Works project _____ Other: _____
17. Is the structure: On its original site? ☒ Moved? _____ Unknown? _____
18. Related features: One-car garage

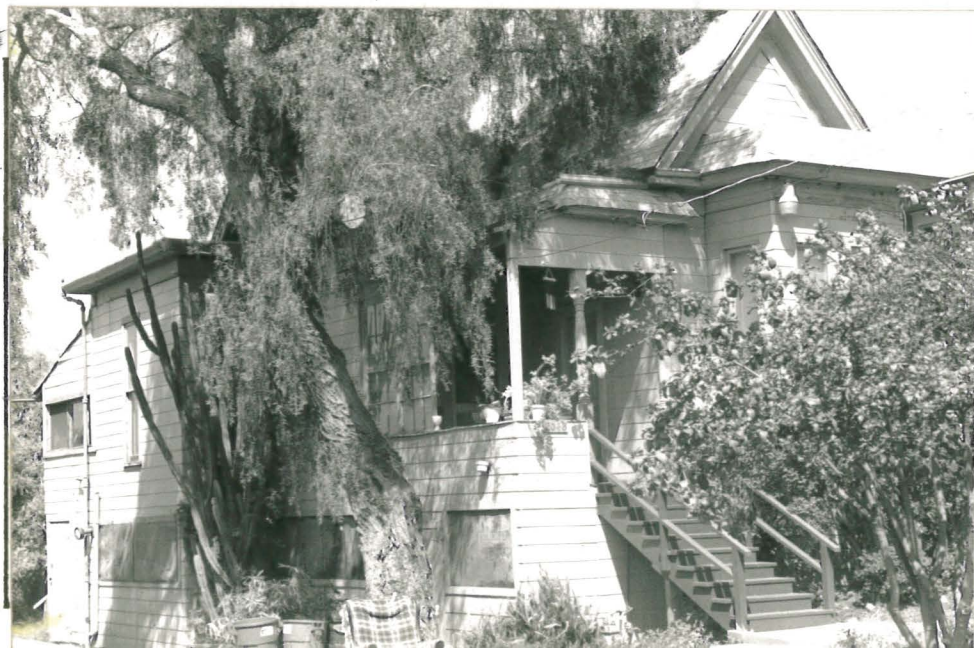
This one-story rectangular Victorian home is situated on a high raised foundation with a large crawlspace providing storage below. The large crawlspace vents are covered with screens and a small wooden door provides access along the southwestern facade. The roof is high-pitched crossed gables with a slight overhang and a plain frieze. The altered siding is now asbestos shingle and the roofing is asphalt shingle. A square bay is situated below the front gable end with a truncated hip roof and narrow double-hung windows. The remainder of the windows are also narrow and double-hung with the exception of the windows on the back addition with a pent roof. On the southeast corner is a tall, wooden stairway which leads to the front porch. The balustrade is clapboard with two turned posts and a multi-pane glass enclosure near the doorway. One post is now a plain beam. The porch is sheltered by a truncated hip roof and contains two doorways, one being an alteration.

13. Condition: Excellent _____ Good ☒ Fair _____ Deteriorated _____ No longer in existence _____
14. Alterations: Screens, siding, asphalt roof, front stairway, back addition
15. Surroundings: (Check more than one if necessary) Open land _____ Scattered buildings _____ Densely built-up ☒
Residential ☒ Industrial _____ Commercial _____ Other: _____
16. Threats to site: None known _____ Private development _____ Zoning ☒ Vandalism _____
Public Works project _____ Other: _____
17. Is the structure: On its original site? ☒ Moved? _____ Unknown? _____
18. Related features: None

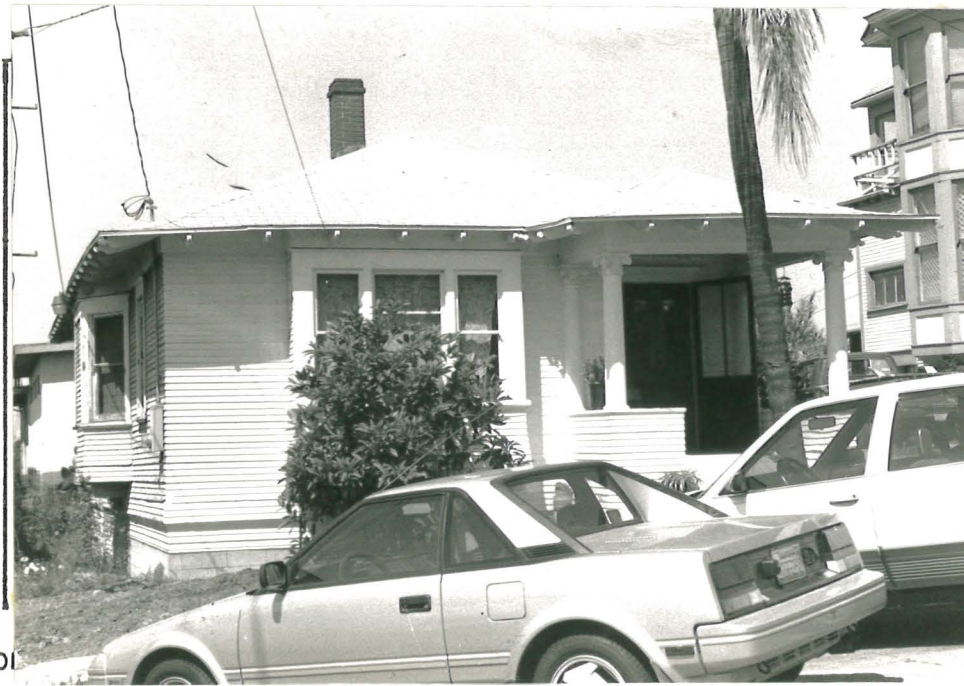
2060 Front Street is a one-story rectangular home on a raised cement block foundation. The medium-pitched hip roof has wide overhanging flared eaves with worked exposed rafters and a plain frieze. Two brick interior chimneys are located to the west of the structure. The siding is clapboard and flares slightly near the foundation. Square oriel bays are on the north and street facades with three-sash windows with a fixed center pane, leaded transom, and double-hung side panels. An angled oriel bay is on the south facade with double-hung windows on each side. The remainder of the windows are double-hung with shelf surrounds similar to the bay surrounds. Four Ionic columns (two engaged) support the hip roof over the offset portico entry. The porch is boxed with a clapboard balustrade and is reached by three concrete steps. The wide wood panel door has a glass upper panel, wood-framed screen and shelf surround. A later addition on the rear has a pent roof and wide clapboard siding.

13. Condition: Excellent _____ Good ☒ Fair _____ Deteriorated _____ No longer in existence _____
14. Alterations: Addition on rear facade with shed roof
15. Surroundings: (Check more than one if necessary) Open land _____ Scattered buildings _____ Densely built-up ☒
Residential ☒ Industrial _____ Commercial _____ Other: _____
16. Threats to site: None known _____ Private development _____ Zoning ☒ Vandalism _____
Public Works project _____ Other: _____
17. Is the structure: On its original site? ☒ Moved? _____ Unknown? _____
18. Related features: None

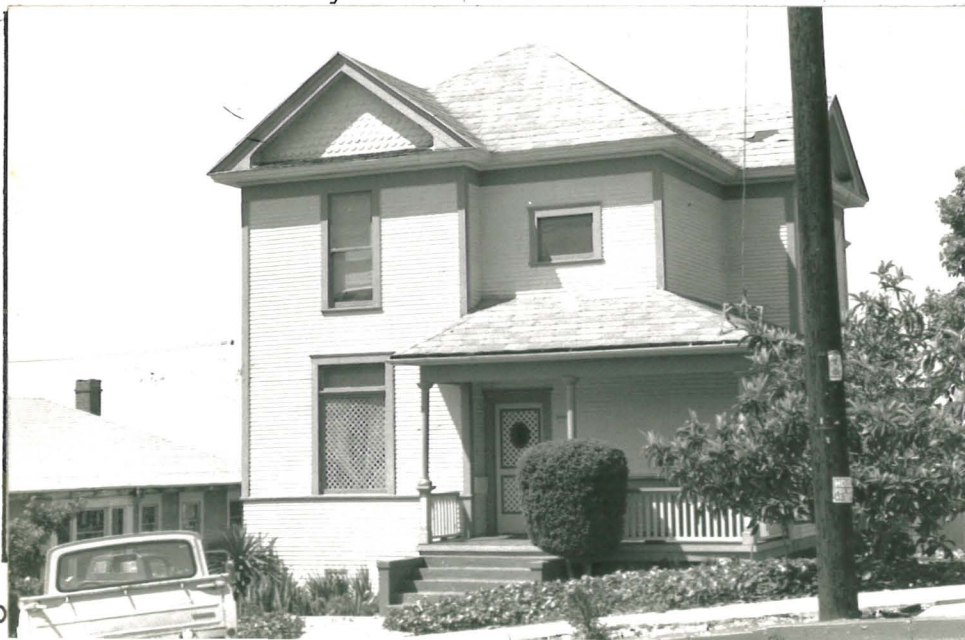
This two-story irregularly-shaped Queen Anne Style house has a high-pitched hipped roof with multiple gables and composition shingles. Pent roofs enclose the gables. Siding is clapboard with fishscale in the gables and endboards. A horizontal band runs between the foundation and first floor. A plain frieze is sheltered by a boxed cornice and overhanging eaves. Windows are predominantly double-hung with shelf surrounds. A fixed-pane window with a transom is located on the south side of the front facade. The door, also with a shelf surround, has a double wood panel with a small oval glass upper. Five cement steps with a low cement bannister lead to a wooden porch on the north side of the front facade. The porch, with an open wood balustrade and square posts, has columns which support a plain entablature and hipped roof with overhanging eaves and boxed cornice. The house sits on a raised brick foundation which is highest on the south and west sides to accommodate the slope of the lot. The foundation features latticework and latticed vents. On the south side, there is an oriel bay with corbel and hipped roof. The north side has a full-length square bay. There is an attached garage at the northwest corner. Alterations include windows and a balcony on the rear. The north section of the porch has been enclosed.

13. Condition: Excellent ___ Good X Fair ___ Deteriorated ___ No longer in existence ___
14. Alterations: North section of porch has been enclosed, latticework over windows balcony at rear.
15. Surroundings: (Check more than one if necessary) Open land ___ Scattered buildings ___ Densely built-up X
Residential X Industrial ___ Commercial ___ Other: ___
16. Threats to site: None known ___ Private development ___ Zoning X Vandalism ___
Public Works project ___ Other: ___
17. Is the structure: On its original site? X Moved? ___ Unknown? ___
18. Related features: None

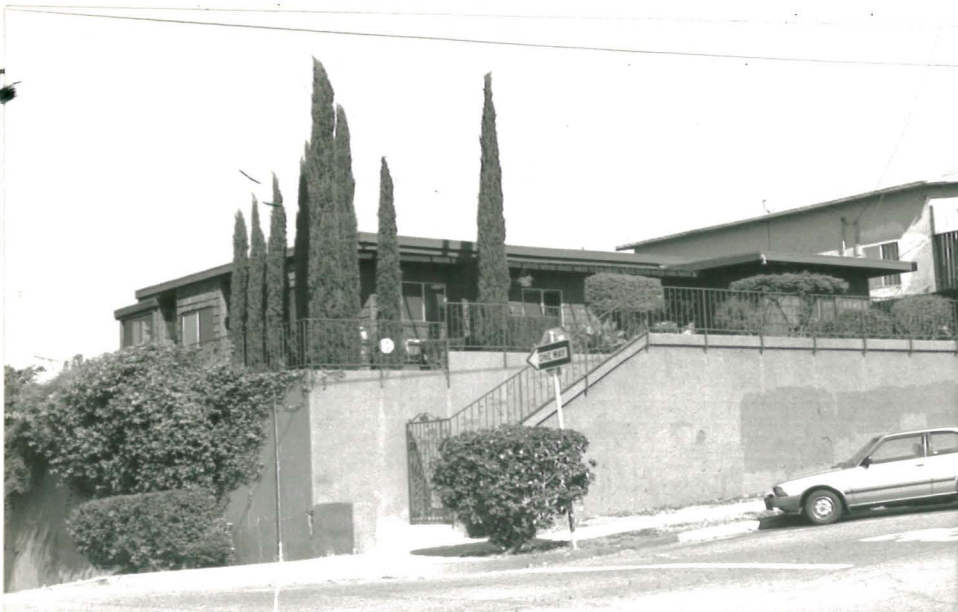
This 1-story cottage is rectangular in shape and has multiple flat rooflines widely overhanging eaves, exposed rafters, and a wide fascia board. The shingle siding is a recent alteration. The cottage features square bays to the south and southwest. Many of the original windows have been replaced with aluminum frames. The cottage sits high above street level and a story-high stucco retaining wall surrounds the property. The cottage is reached from a stairway with a wrought iron rail and security gate at the southeast corner of the property. A pergola faces east. Alterations include aluminum windows, shingle siding, ironwork on pergola.

13. Condition: Excellent _____ Good _____ Fair ☒ Deteriorated _____ No longer in existence _____
14. Alterations: windows, shingle siding, ironwork on pergola
15. Surroundings: (Check more than one if necessary) Open land _____ Scattered buildings _____ Densely built-up ☒
Residential ☒ Industrial _____ Commercial _____ Other: _____
16. Threats to site: None known _____ Private development _____ Zoning ☒ Vandalism _____
Public Works project _____ Other: _____
17. Is the structure: On its original site? ☒ Moved? _____ Unknown? _____
18. Related features: 3 other dwellings designed by Irving Gill

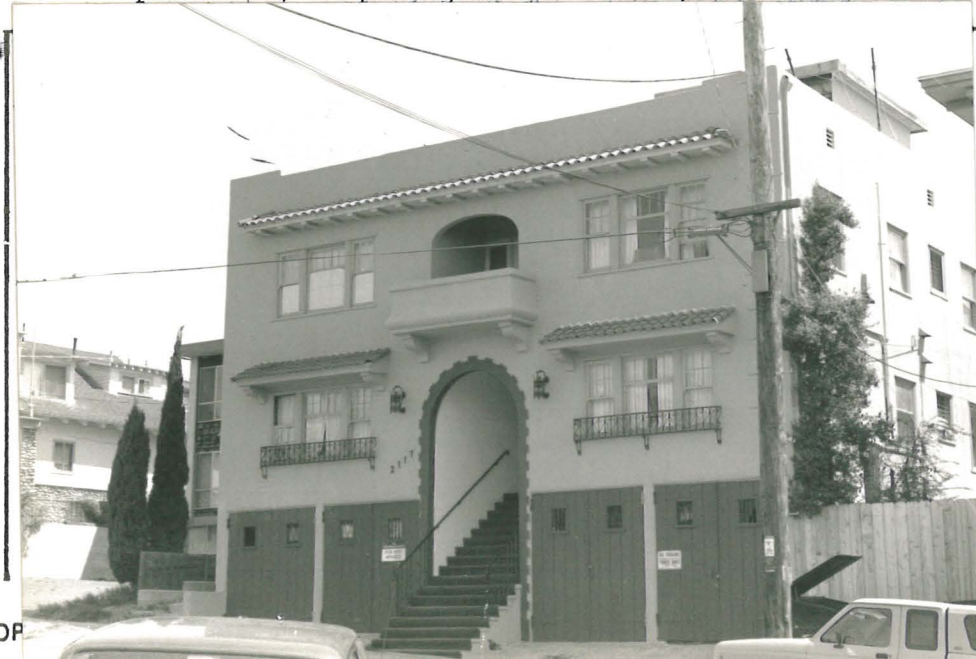
This is a three-story rectangular Mission style apartment building with garages serving as the first story. It is stucco-sided and symmetrical with a flat roof and a parapet, stepped at the corners. A red tile visor with boxed cornice and rectangular brackets is featured above the third story, and red tile pent hoods with boxed cornice and curving brackets extend above the second floor windows. Windows are three sash with a central fixed pane with a multi-pane transom and double-hung side panels with multipane uppers. Second floor windows have iron balconets. Windows on the north and south facades are double-hung. The central section of the building features a third floor balcony with solid balustrade and brackets below an elliptically arched recessed entry with French door and multi-pane side panels. Directly below, an elliptically arched entry with quoins shelters a one-story cement stairway with iron railing. The stairway terminates in a deeply recessed second floor entry, which has a wide French door, multi-pane side panels, and a multi-pane transom. On either side of the entryway are two, two-door side-hinged garages with small rectangular windows. Alterations include a small shingled penthouse, carpeting on the stairs, and window tinting.

13. Condition: Excellent ___ Good ___ X Fair ___ Deteriorated ___ No longer in existence ___
14. Alterations: Penthouse, carpeting on stairs, window tinting
15. Surroundings: (Check more than one if necessary) Open land ___ Scattered buildings ___ Densely built-up X
Residential X Industrial ___ Commercial ___ Other: ___
16. Threats to site: None known X Private development ___ Zoning ___ Vandalism ___
Public Works project ___ Other: ___
17. Is the structure: On its original site? X Moved? ___ Unknown? ___
18. Related features: None

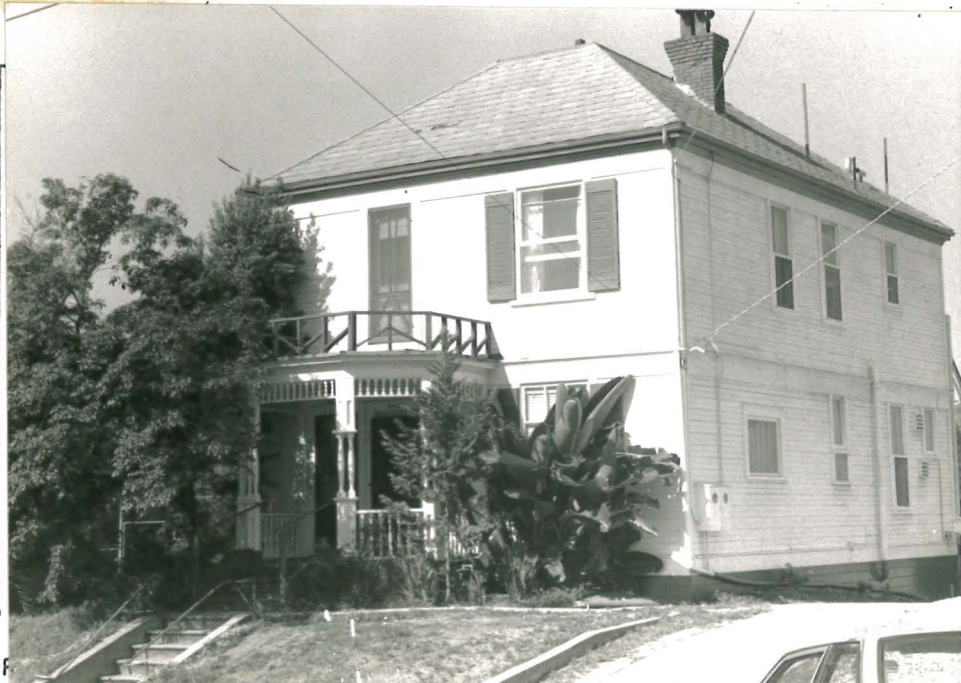
This two-story rectangular residence sits on a concrete block foundation and has a truncated hipped roof with boxed cornice and plain frieze. The siding is shiplap with a horizontal band which runs between the first and second floors. Windows are predominantly double-hung, some have shutters, and the northern first floor window is fixed pane with a multipane transom. Doors are two panel wood with glass uppers. Cement steps lead from street level to foundation level and four wooden steps lead to an entry porch on the south side of the front facade. The porch, which is the dominant feature of the house, has a spindled balustrade and square paneled piers interrupted by pairs of turned posts at midpier. The porch roof features a spindled frieze and dentilwork under a roof which serves as a second floor balcony. The balcony has an open wood balustrade. The house is surrounded by a cement retaining wall and has a brick chimney. Alterations include a second story rear balcony and staircase.

13. Condition: Excellent ☒ Good _____ Fair _____ Deteriorated _____ No longer in existence _____
14. Alterations: Second story rear balcony and staircase.
15. Surroundings: (Check more than one if necessary) Open land _____ Scattered buildings _____ Densely built-up ☒
Residential ☒ Industrial _____ Commercial _____ Other: _____
16. Threats to site: None known _____ Private development _____ Zoning ☒ Vandalism _____
Public Works project _____ Other: _____
17. Is the structure: On its original site? ☒ Moved? _____ Unknown? _____
18. Related features: None

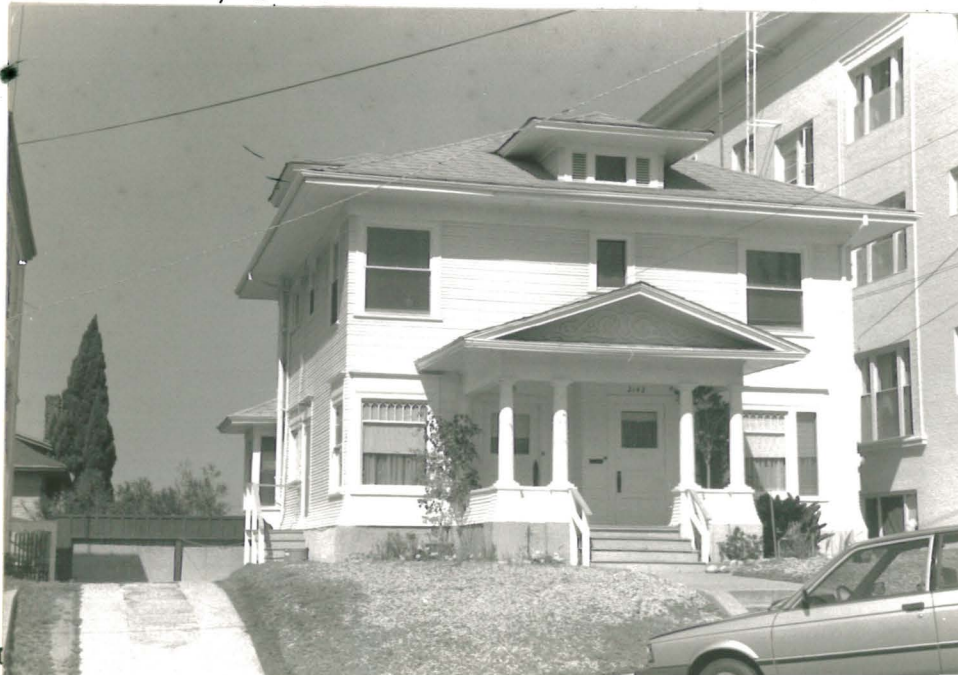
This Neoclassic duplex home is a 2 ½ story rectangular structure on a raised concrete foundation. The hipped roof is medium pitched with wide overhanging boxed eaves and hipped roof dormers on each facade. A plain frieze is situated below the cornice. The siding is clapboard and is slightly flared at the foundation. Square oriel bays with hipped roofs, overhanging eaves and brackets underneath are situated along the southern first stories. The bays have three-sash windows with a fixed center pane, multi-pane transom and altered louvered side-panels. The remainder of the windows are double-hung and fixed center panes with multi-pane transoms with shelf surrounds on the lower level. Above the entry is a small double-hung stained glass window. The offset portico entry is surrounded by a solid clapboard balustrade with four Doric columns. A large gable roof covers the portico with a wide entablature and scrollwork in the pediment similar to that of Robert Adam. Four wooden steps to the porch lead to two doorways which are wood panel with and upper glass panel. A recent addition of a detached garage is situated to the southwest corner of the home.

13. Condition: Excellent ☒ Good ☐ Fair ☐ Deteriorated ☐ No longer in existence ☐
14. Alterations: detached tow-car garage, louvered windows
15. Surroundings: (Check more than one if necessary) Open land ☐ Scattered buildings ☐ Densely built-up ☒
Residential ☒ Industrial ☐ Commercial ☐ Other: ☐
16. Threats to site: None known ☐ Private development ☐ Zoning ☒ Vandalism ☐
Public Works project ☐ Other: ☐
17. Is the structure: On its original site? ☒ Moved? ☐ Unknown? ☐
18. Related features: garage

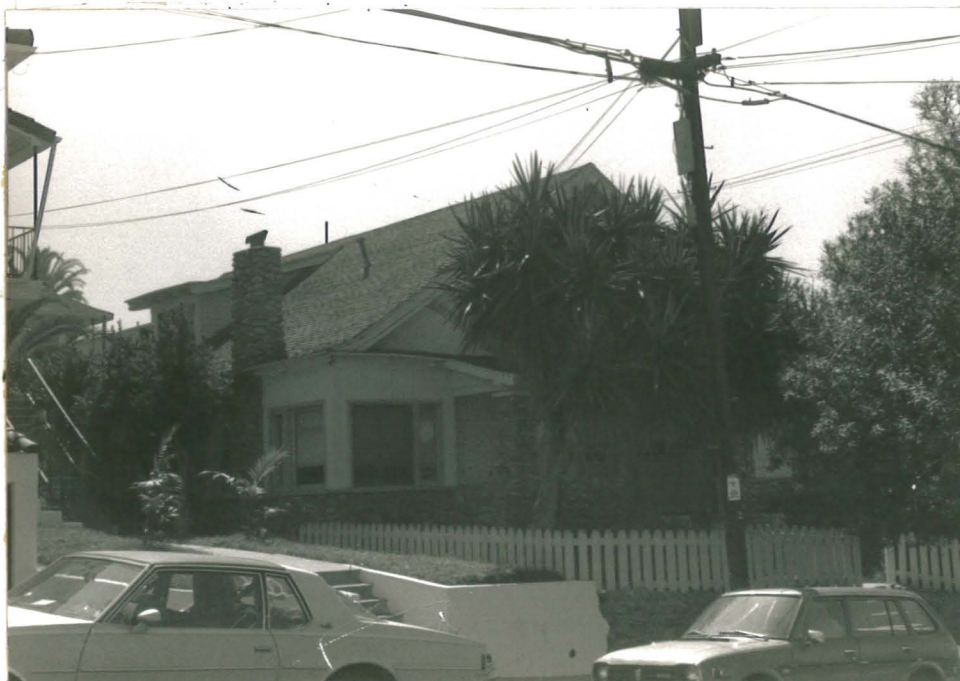
This 1 1/2-story Craftsman home has had many alterations. The roof is a high-pitched gable with flared overhanging eaves and worked rafters. Shed dormers with exposed rafters and shingle siding are on the north and south facades and three additional dormers were added later along the south facade. These additions have aluminum sliding windows and clapboard siding. The front gable end is half-timbered in stucco with an open porch below. The porch is surrounded by a cobblestone balustrade with posts and continues to form a skirt around the entire structure and sheathing the northern chimney. The porch is sheltered by a shed overhang and has been enclosed on the southwest corner with wood paneling and aluminum sliding windows. The entire facade above the cobblestone skirt has been covered with wood paneling and a second alteration is situated to the north of the porch with original large fixed panes and louvered side panels. Above the porch is an added balcony with aluminum sliding doors. Some original windows remain which are double-hung. The front door is now wood with an aluminum framed glass upper. A cobblestone retaining wall and a white picket fence surround the raised lot.

13. Condition: Excellent _____ Good _____ Fair _____ Deteriorated X No longer in existence _____
Porch enclosed, siding, windows, addition to north of porch,
14. Alterations: door, fence
15. Surroundings: (Check more than one if necessary) Open land _____ Scattered buildings _____ Densely built-up X
Residential X Industrial _____ Commercial _____ Other: _____
16. Threats to site: None known X Private development _____ Zoning _____ Vandalism _____
Public Works project _____ Other: _____
17. Is the structure: On its original site? X Moved? _____ Unknown? _____
18. Related features: One-story building in rear with gable roof and clapboard siding

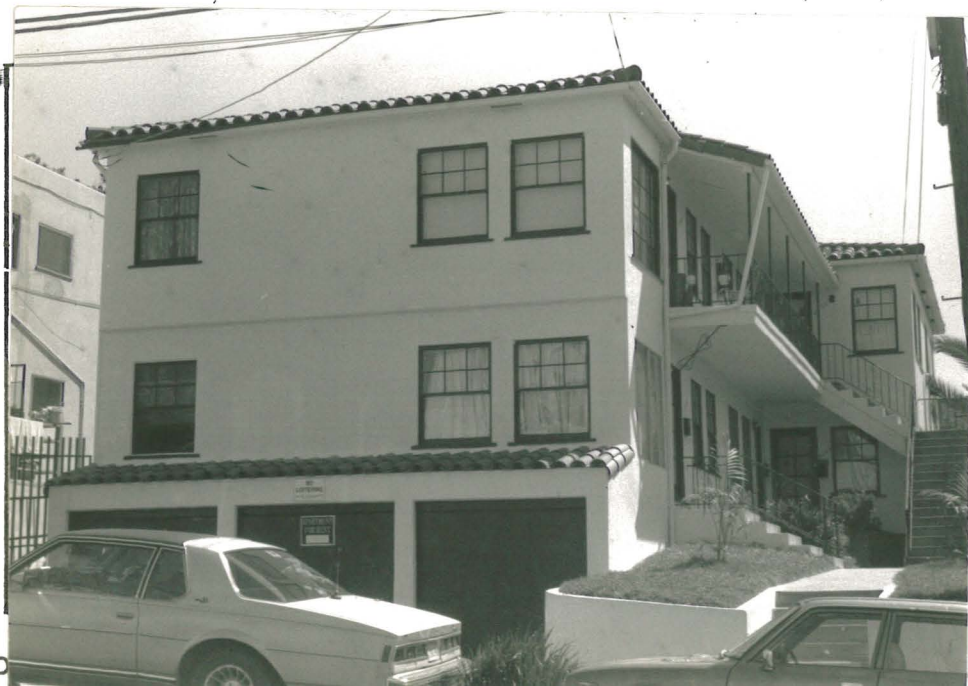
This L-shaped Monterey style apartment building has a medium-pitched red tile hipped roof with overhanging eaves. It is two stories in height but appears to be three stories in front due to front-facing garages below the first story. Windows are double-hung with multi-pane uppers and narrow lugsills. Doors are French. Six cement steps lead from the street to a sidewalk from which two additional cement stairways, one with wrought iron railing, rise to first floor entrances. One entrance has a south-facing stoop and two entrances at the corner of the "L" share an entry porch. Straight reversed steps lead to a second floor balcony with apartment entrances, which serves as an overhang for the first floor. A shed roof supported by metal poles shelters the balcony and a wrought iron balustrade continues to form a railing for the stairway. A cement retaining wall is located in front of the property. Three one-car garages with wooden doors project from the front facade and are covered by a red tile shed roof.

13. Condition: Excellent ☒ Good _____ Fair _____ Deteriorated _____ No longer in existence _____
14. Alterations: None apparent
15. Surroundings: (Check more than one if necessary) Open land _____ Scattered buildings _____ Densely built-up ☒
Residential ☒ Industrial _____ Commercial ☒ Other: _____
16. Threats to site: None known ☒ Private development _____ Zoning _____ Vandalism _____
Public Works project _____ Other: _____
17. Is the structure: On its original site? ☒ Moved? _____ Unknown? _____
18. Related features: None

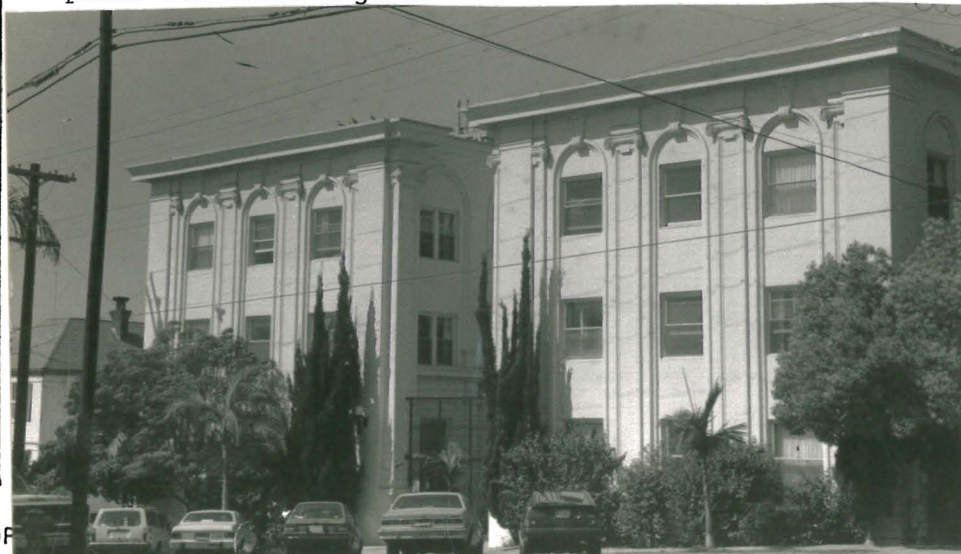
This U-shaped apartment building is three stories in height with a penthouse and a fourth story to the rear due to the slaping lot. It has a flat roof with a boxed cornice which protrudes on the front facade and wraps around the corners. Egg and dart dentilwork runs below the roofline and above the plain frieze. The brick walls on the front facade feature a series of evenly spaced vertical recessed panels with square pilasters capped by Ionic capitals. These alternate with rows of recessed double hung windows surrounded by three story arches which are topped by decorative keystones. Side facades display plain arches over rows of windows. Quoins mark the corners. The interior of the "U" serves as a long narrow courtyard flanked by paired windows and terminating in a porch with oak entry doors with long vertical glass panels, 3/4 side panels surrounded by marble with transoms. Above the entry, a curving espadana-style parapet serves balustrade for a second floor balcony. A third story balcony has an open metal balustrade and metal brackets. An open metal railing crosses the roof and a flat roofed penthouse rises to the northwest. A large arched entry is located on the west side of the north facade. Alterations include a gated entry to the courtyard area with security phone and flood lights.

13. Condition: Excellent X Good _____ Fair _____ Deteriorated _____ No longer in existence _____

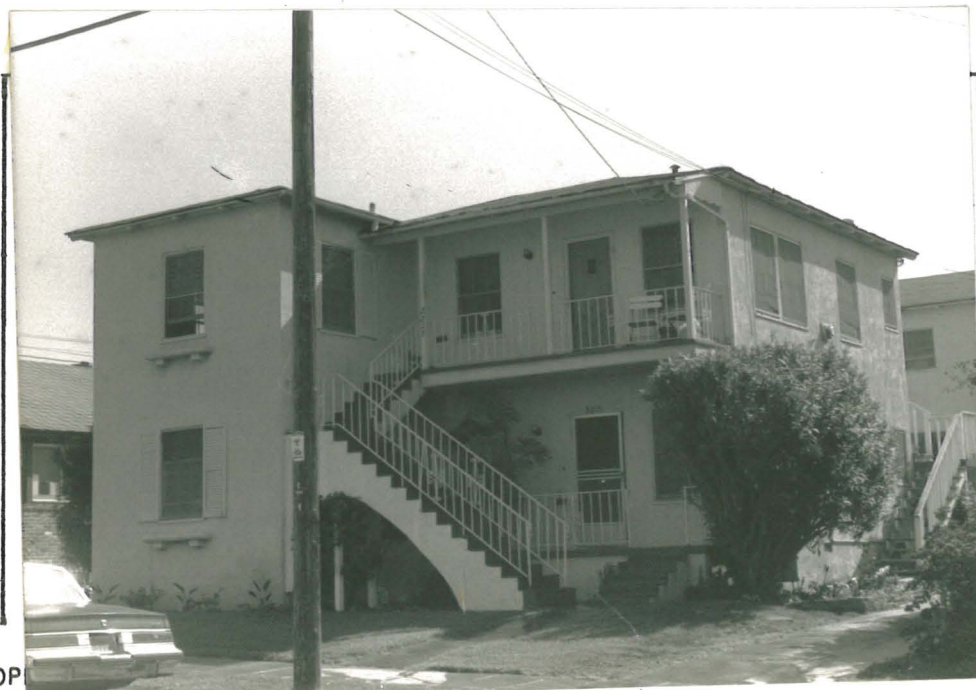
- 7a. Architectural style: 30's Modern Legal D: blk 255 Lot E Horton's Add Lockling
- 7b. Briefly describe the present *physical appearance* of the site or structure and describe any major alterations from its original condition: This two-story apartment complex contains two buildings, the front building almost obscuring the rear building from view. The front building is L-shaped with a medium-pitched truncated hipped roof and a pyramidal hipped roof over the front part of the L. The roof is asphalt shingled with overhanging eaves and exposed rafters. Siding is stucco with vertical shiplap on the south side of the second floor front facade. Windows are multi-paned double-hung, some with shutters. Doors are panelled wood. A cement stairway with an iron railing rests on an arched platform. It crosses the front of the building and leads to the second floor entrance balcony. This is covered by the main roof which is supported by wooden posts. On the south side of the front facade, a straight stairway leads to a first floor entry porch with an iron balustrade. Beneath two of the windows on the front facade are massive-looking rounded stucco shelves with brackets. The back building features deeply recessed first floor garages. Cement stairways on the northwest and southwest corners exhibit wood and stucco banisters and lead to second floor side entrances.

13. Condition: Excellent ☒ Good _____ Fair _____ Deteriorated _____ No longer in existence _____
14. Alterations: None apparent
15. Surroundings: (Check more than one if necessary) Open land _____ Scattered buildings _____ Densely built-up ☒
Residential ☒ Industrial _____ Commercial ☒ Other: _____
16. Threats to site: None known ☒ Private development _____ Zoning _____ Vandalism _____
Public Works project _____ Other: _____
17. Is the structure: On its original site? ☒ Moved? _____ Unknown? _____
18. Related features: None

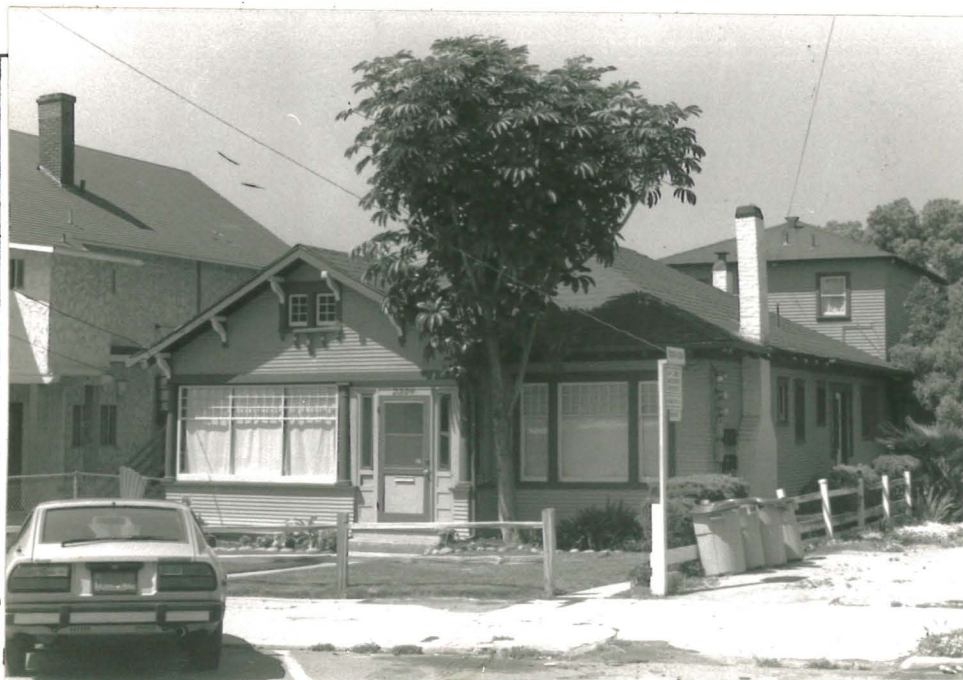
- 7a. Architectural style: Craftsman Legal D: Blk 254 Lot H N 40ft Horton's Add Lockling
- 7b. Briefly describe the present *physical appearance* of the site or structure and describe any major alterations from its original condition: This 1½-story Craftsman bungalow with a basement has a two-story addition in the rear. It has a medium-pitched, composition shingled, hipped roof and a front gable over an enclosed porch. Overhanging eaves shelter worked rafters and a plain frieze. There are knee brackets in the gable. Siding is clapboard. Windows are varied and include double-hung with multi-pane uppers, hoppers, four-pane casements, three-sash with fixed central panel with multi-pane transom and double-hung side panels, and in the gable peak, a pair of fixed multi-panes with brackets below. The front-facing door has a wooden screen and ½ side panels. Doors and windows feature wood surrounds. Windows in the front facade have been added and are fixed pane with multi-pane transoms. The porch is reached from a single cement step. It has been enclosed and features Tuscan columns, which are now engaged. There is a brick chimney to the north and a smaller chimney on the west. Other additions are a wide-angled bay on the south side, mailboxes, and an added basement. The two-story addition to the rear blends well with the main portion of the building.

13. Condition: Excellent _____ Good ^X _____ Fair _____ Deteriorated _____ No longer in existence _____
14. Alterations: Enclosed porch, windows, basement, two-story addition in rear
15. Surroundings: (Check more than one if necessary) Open land _____ Scattered buildings _____ Densely built-up: X
Residential X Industrial _____ Commercial _____ Other: _____
16. Threats to site: None known _____ Private development _____ Zoning X Vandalism _____
Public Works project _____ Other: _____
17. Is the structure: On its original site? X Moved? _____ Unknown? _____
18. Related features: None
