HISTORIC RESOURCES INVENTORY

1. Common name: None
2. Historic name: None
3. Street or rural address: 1916-1926 Front Street
City San Diego Zip 92101 County San Diego
4. Parcel number: 533-251-05
5. Present Owner: Robert Mellis Address: P.O. Box 2248
City San Diego Zip 92073 Ownership is: Public _____ Private X
6. Present Use: Residential Original use: Residential

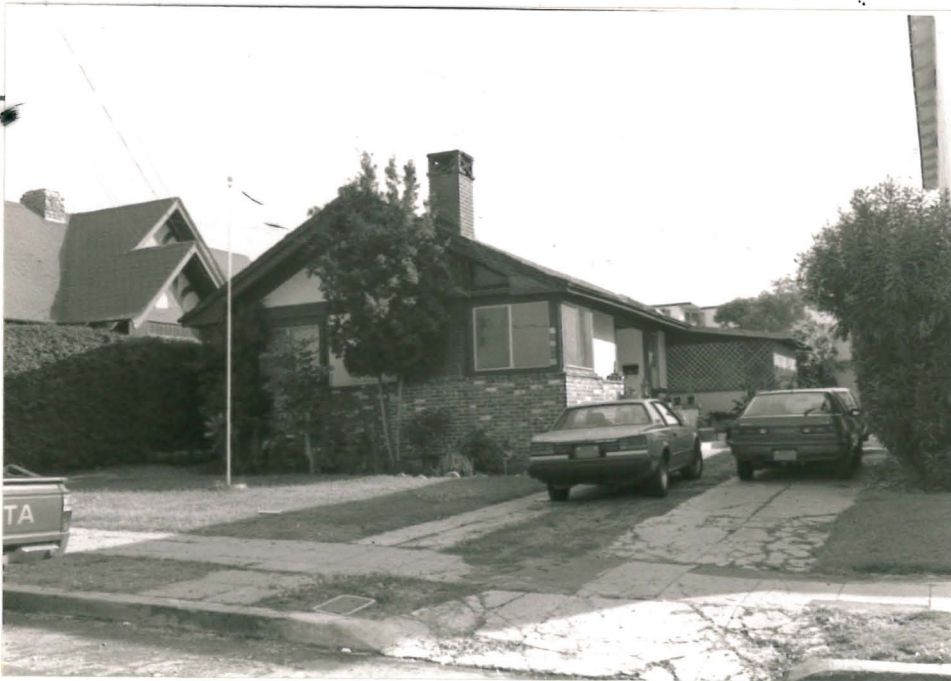
This Craftsman Cottage is 1-story in height with a medium pitch front gable roof with overhanging eaves, exposed rafters, and a fascia board. The eaves are slightly flared. A brick chimney with decorative brick work rises on the front facade. This house has been greatly altered. The entryway on the south facade with cement steps framed by brick walls has been altered. Brick skirting, windows, and a shed roofed addition with lattice work has also been added.

13. Condition: Excellent _____ Good _____ Fair X Deteriorated _____ No longer in existence _____
14. Alterations: Brick skirting, windows, entryway, S. addition
15. Surroundings: (Check more than one if necessary) Open land _____ Scattered buildings _____ Densely built-up X
Residential X Industrial _____ Commercial _____ Other: _____
16. Threats to site: None known _____ Private development _____ Zoning X Vandalism _____
Public Works project _____ Other: _____
17. Is the structure: On its original site? X Moved? _____ Unknown? _____
18. Related features: None

Due to its alterations, this house has lost much of its architectural integrity. Its importance stems from the fact that it was designed by Will S. Hebbard and Irving Gill, two of San Diego's most prominent architects. They worked together from 1887 to 1907. Hebbard was active in professional organizations - a founding member of the California State Board of Architects and charter member of the American Institute of Architects. Irving Gill designed many notable residences in San Diego, including the Klauber house. This building is typical of his style in the middle years, before he developed his simplified Mission style.

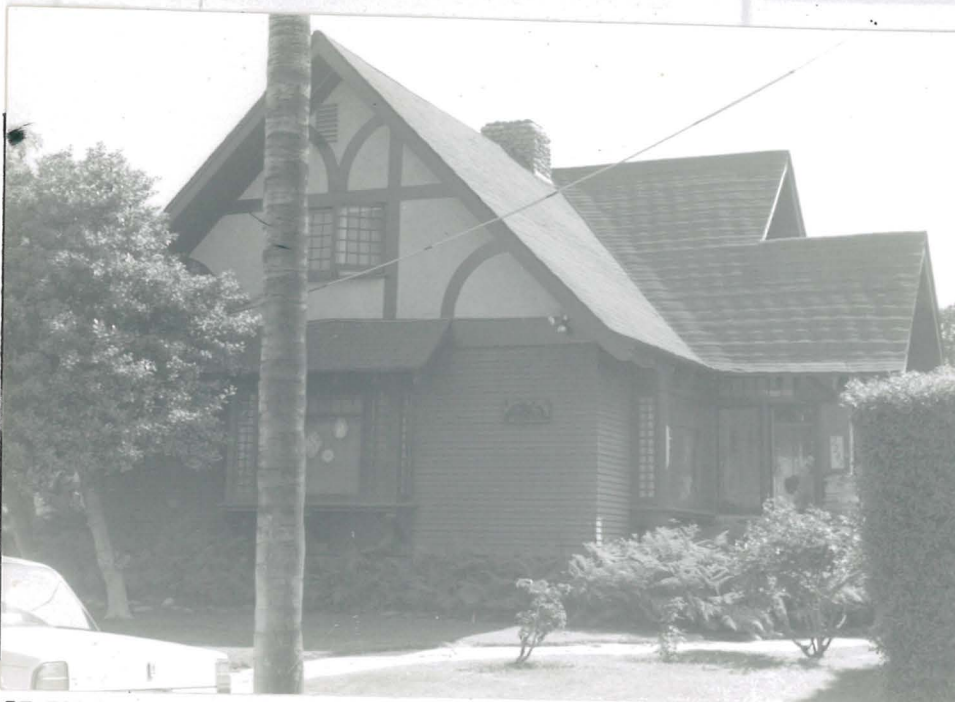
- 7a. Architectural style: Craftsman with Tudor Influence
- 7b. Briefly describe the present *physical appearance* of the site or structure and describe any major alterations from its original condition: This 1 1/2 story Craftsman Style house has a high pitched cross gable roof with an additional gable which protrudes below the main gable to cover the south facing porch. The roof flares at the ends and has worked rafters, wide overhanging eaves, and asphalt shingles. Siding is clapboard on the 1st story and half timbered stucco in the pediments. The fan and interior chimney are cobblestone. A water course runs between the fan and the 1st floor. Windows are varied; some are fixed pane with multi-pane casement side panels and multi-pane uppers. Others are pairs of single panel wooden casements. A pair of multi-pane casements sits above a front facing oriel bay with knee brackets below and shed hood with exposed worked rafters. The house is reached from a curving walkway which leads to steps to an enclosed porch. The porch features a cobblestone balustrade and posts. On the north side, a square bay covered by a gabled roof houses and screen porch.

13. Condition: Excellent ☒ Good _____ Fair _____ Deteriorated _____ No longer in existence _____
14. Alterations: None apparent
15. Surroundings: (Check more than one if necessary) Open land _____ Scattered buildings _____ Densely built-up ☒
Residential ☒ Industrial _____ Commercial _____ Other: _____
16. Threats to site: None known _____ Private development _____ Zoning ☒ Vandalism _____
Public Works project _____ Other: _____
17. Is the structure: On its original site? ☒ Moved? _____ Unknown? _____
18. Related features: None

This large home was built in 1901 for Dr. Edward Grove, a physician who lived here until 1904. The home was designed by Will S. Hebbard and Irving Gill, two of the most prominent architects in San Diego history. They worked together from 1897 to 1907, but both were well-known in their own rights. Hebbard was active in professional organizations - a founding member of the California State Board of Architects and charter member of the American Institute of Architects. Irving Gill designed many notable residences in San Diego including the Klauber House. This building is typical of the style in his middle years, before he developed his simplified Mission style.

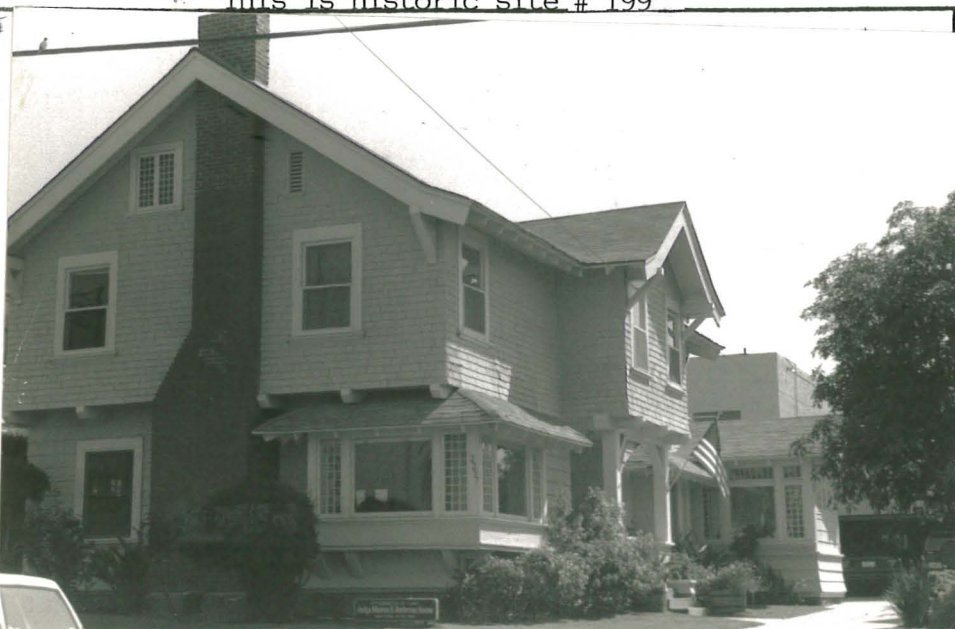
- 7a. Architectural style: Craftsman
- 7b. Briefly describe the present *physical appearance* of the site or structure and describe any major alterations from its original condition: This irregularly shaped 2 1/2 story Craftsman style home has a cross gable roof flared at the ends with widely overhanging eaves and exposed rafters. Both gables feature triangular brackets and plain, wide bargeboard. Siding is wide clapboard on the 1st floor and shingle on the 2nd & 3rd floors. A rake overhang above the first floor is supported by worked brackets. The foundation is granite laid in a random ashlar pattern. Windows are double-hung on the 2nd story with small multi-pane casements in the attic. The 1st floor features fixed pane windows with multi-pane casement side panels. The door is French with multi-pane side panels. The house faces south. Four wooden steps lead to a south facing porch with boxed clapboard balustrade. Massive wooden piers and exposed rafters and lintel support a 2nd floor porch overhang below the cross gabled roof. A prominent element of the house is a 1st story bay which projects at the southeast corner under a sheltering hipped roof. A massive centrally located brick chimney on the west facade rises above the gable end. There is a 1-story rectangular bay east of the porch. A driveway on the south leads to a garage. This is historic site # 199

13. Condition: Excellent ☒ Good _____ Fair _____ Deteriorated _____ No longer in existence _____
14. Alterations: None apparent
15. Surroundings: (Check more than one if necessary) Open land _____ Scattered buildings _____ Densely built-up ☒
Residential ☒ Industrial _____ Commercial _____ Other: _____
16. Threats to site: None known ☒ Private development _____ Zoning _____ Vandalism _____
Public Works project _____ Other: _____
17. Is the structure: On its original site? ☒ Moved? _____ Unknown? _____
18. Related features: garage

The Monroe Anderson House was designed by Will S. Hebbard and Irving Gill two of the most prominent architects in San Diego history. They worked together from 1897 to 1907, but both were well-known in their own rights. Hebbard was active in professional organizations and a founding member of the California State Board of Architects and charter member of the American Institute of Architects. Irving Gill designed many notable residences in San Diego including the Klauber House. This building is typical of his style in the middle years, before he developed his simplified Mission style. The location of this house next to another Hebbard and Gill enhances its significance. Notable features are

bracketed eave supports, decorative use of exposed structural elements, porch treatment and granite foundation. The home is in an area which contains several homes with Craftsman elements.

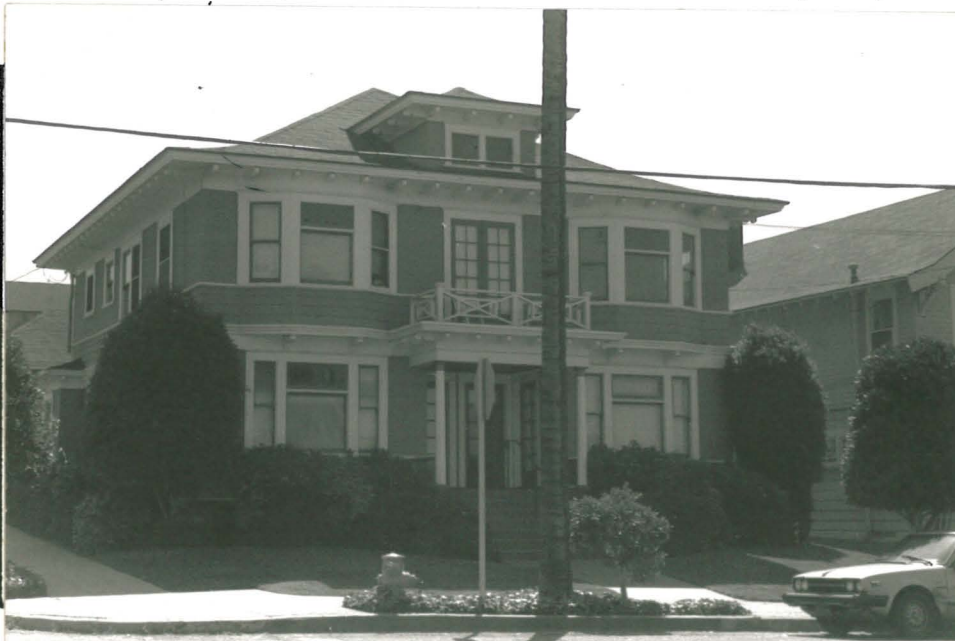
This 2 ½ story rectangular house has a medium pitched hipped roof with flared ends, boxed cornice, overhanging eaves, craftsman style worked brackets plain frieze. Siding is clapboard with bands of wide tongue and groove at foundation level and at the bottom of the second floor. A horizontal band with molding runs between the first and second floors. Windows on the front facade are fixed with angular geometric leaded glass transoms, double-hung side panels, and shelf surrounds. Other windows are double-hung, also with shelf surrounds. The house is symmetrical with a central element consisting of a hipped dormer; second floor balcony with spindle balustrade and double french doors; and a classical open entry porch. The porch features two doors with shelf surrounds. It is reached via seven cement steps with central metal rail. Second story, wide-angle oriel bays are supported by worked rafters and flank the balcony. The south facade has two one story square bays with hipped roofs and worked rafters. A detached garage exhibits a gabled roof with hipped ends.

13. Condition: Excellent ☒ Good _____ Fair _____ Deteriorated _____ No longer in existence _____
14. Alterations: none apparent
15. Surroundings: (Check more than one if necessary) Open land _____ Scattered buildings _____ Densely built-up ☒
Residential ☒ Industrial _____ Commercial _____ Other: _____
16. Threats to site: None known _____ Private development _____ Zoning ☒ Vandalism _____
Public Works project _____ Other: _____
17. Is the structure: On its original site? ☒ Moved? _____ Unknown? _____
18. Related features: detached garage

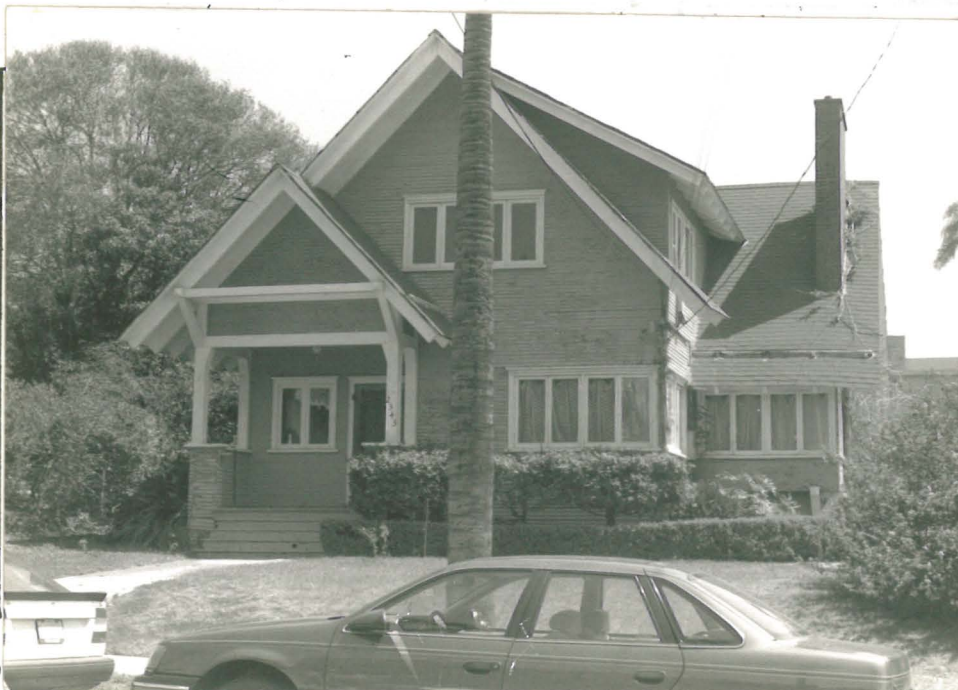
This two-story irregularly-shaped Tudor-style house is sided in narrow clapboard. It has a high-pitched cross-gabled roof with multiple front and side gables at varied pitches and composition shingles. Overhanging eaves shelter Craftsman-style worked rafters. Windows are bands of single-pane casements with shelf surrounds. The door is wood panelled with narrow horizontal glass uppers and a shelf surround. A cement walkway and five wide wooden steps lead to the entry porch on the north side of the front facade. The porch has a clapboard balustrade and square wooden posts which support a gabled pediment. The pediment features horizontal half-timbering, triangular brackets, and an additional horizontal timber which projects at the apex of the brackets and helps to support the roof. A 1½-story bay supported by triangular brackets and covered by a gabled roof with projecting brick chimney distinguishes the south facade. An additional chimney is in the rear. A two-story addition is also in the rear.

13. Condition: Excellent ___ Good X Fair ___ Deteriorated ___ No longer in existence ___
14. Alterations: Two-story addition in rear
15. Surroundings: (Check more than one if necessary) Open land ___ Scattered buildings ___ Densely built-up X
Residential X Industrial ___ Commercial ___ Other: ___
16. Threats to site: None known ___ Private development ___ Zoning X Vandalism ___
Public Works project ___ Other: ___
17. Is the structure: On its original site? X Moved? ___ Unknown? ___
18. Related features: None

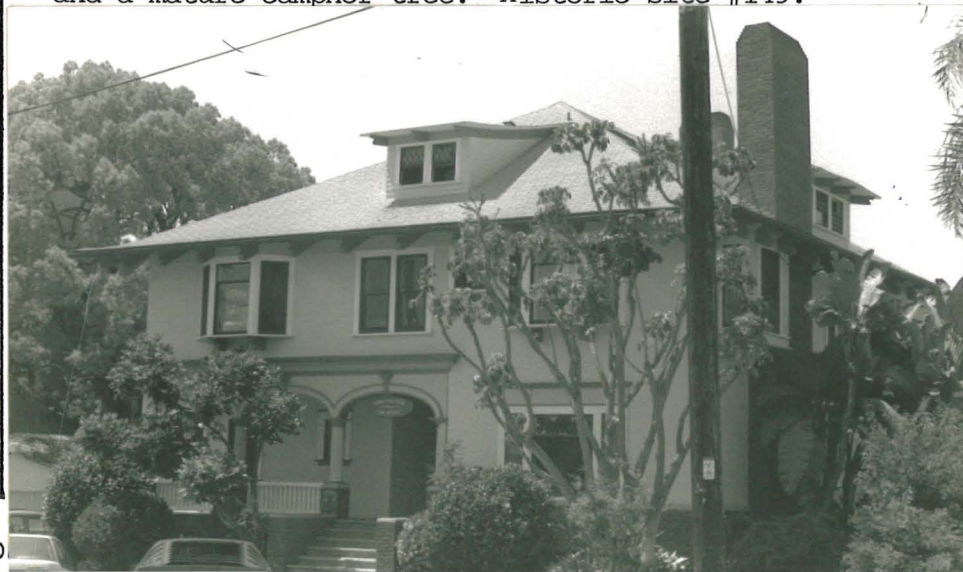
This rectangular 2 1/2 story house with a basement sits on a raised foundation. The roof is medium pitch hipped, slightly flared at the ends and has overhanging eaves which shelter massive worked rafters and a plain frieze. Siding is narrow shiplap with vents decorated with iron work in the brick foundation. Windows are fixed pane with leaded glass transoms in geometric designs and double hung side panels some with diamond paned uppers. Other windows are double hung. A palladian window with an adjacent oval window is featured on the 2nd story of the north facade. The wide deeply recessed door is multi-panelled oak with ornamental trim. All windows have wood surrounds; shelf surrounds decorate the first floor windows and door. Fenestrated shed dormers are centrally located on each of the four sides. There are three brick chimneys with slightly tapered tops, one on the n. facade. The front facade is symmetrical except for an open porch which extends from the central doorway to the s-e corner. The porch reached from a series of molded cement steps has a plain wood balustrade, columns some of which are engaged, square piers, semi-elliptical arches with key stones, and a shelf with dentil work above the arches. There is a rounded bay on the s. facade and a secondary entrance on the sw corner. A low cement retaining wall abuts the sidewalk and wraps around the corner rising on the n. side. A cobblestone driveway to the west has an iron gate. To the s. is a driveway and garages. Attach Photo Envelope Here and a mature camphor tree. Historic site #149.

13. Condition: Excellent ☒ Good _____ Fair _____ Deteriorated _____ No longer in existence _____
14. Alterations: Sign above porch entry
15. Surroundings: (Check more than one if necessary) Open land _____ Scattered buildings _____ Densely built-up ☒
Residential ☒ Industrial _____ Commercial _____ Other: _____
16. Threats to site: None known ☒ Private development _____ Zoning _____ Vandalism _____
Public Works project _____ Other: _____
17. Is the structure: On its original site? ☒ Moved? _____ Unknown? _____
18. Related features: garages to south

The D. F. Garretson house is significant as one of the residences which comprise Bunker's Hill. D. F. Garretson and his family were very prominent in both business and cultural circles in San Diego. David Garretson was a director and president of the First National Bank, founded by his family in 1893. He also served on the City Park Improvement Committee which focused attention on Balboa Park and the Board of Directors of the Panama-California Exposition. Garretson and his wife, Mary Wilson Acheson Garretson, lived at 2366 Front St. until their deaths from an automobile accident in 1932. In 1933-36 "The Barnplayers, a theater group, put on performances in the barn" at the Garretson house. The Barnplayers became the basis of the actors' group at the Old Globe theater. The Garretson house itself, because of its size and fine condition contributes significantly to the historic streetscape of the area.

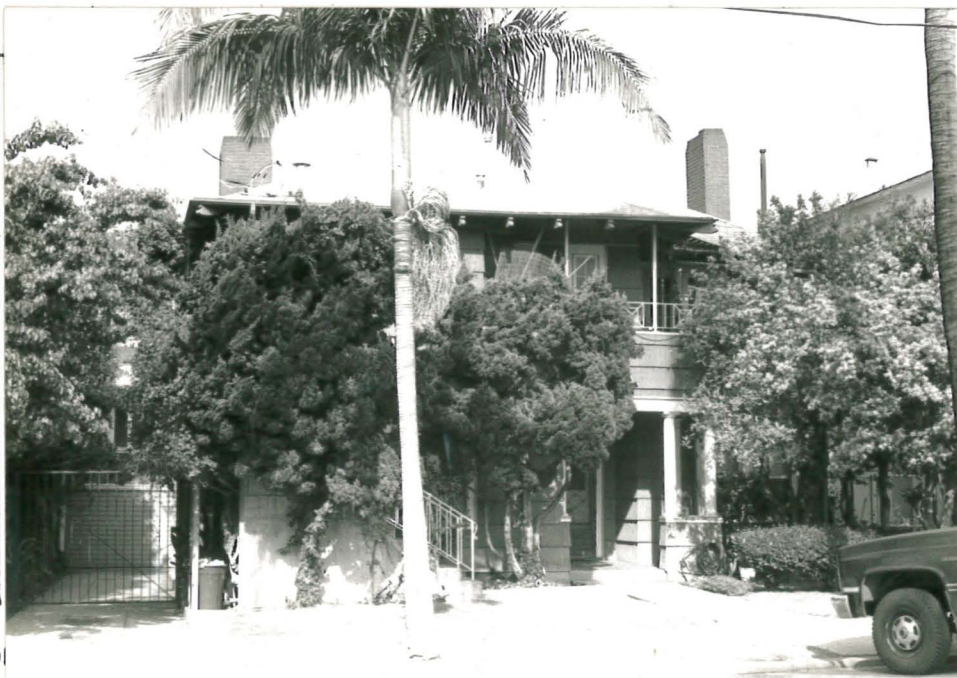
This two-story home has been converted to several apartments with many alterations. The roof is a medium-pitched hip roof with overhanging eaves and exposed worked rafters characteristic of Craftsman architecture. Two brick chimneys, one on the northern facade and the other on the southern facade, protrude from the roofline. The windows are double-hung in adjacent pairs with a shelf surrounds giving it a Neoclassic style. A balcony on the second story street facade corner wraps around to the north and is boxed below with a patterned metal balustrade. It is sheltered by a roof extension and the boxed siding is now asbestos clapboard, as is the rest of the house. Below is the porch entry which is boxed with four Tuscan columns connecting to the plain entablature. To the south of the main entry is a cement stairway which has been added to access the upper apartment. A portion of the southeast upper balcony has been enclosed with metal casement windows. A detached addition is to the rear with a garage below, and living quarters above.

13. Condition: Excellent _____ Good _____ Fair ☒ Deteriorated _____ No longer in existence _____
14. Alterations: Cement stairway, enclosed balcony on southeast facade, casement windows.
15. Surroundings: (Check more than one if necessary) Open land _____ Scattered buildings _____ Densely built-up ☒
Residential ☒ Industrial _____ Commercial _____ Other: _____
16. Threats to site: None known ☒ Private development _____ Zoning _____ Vandalism _____
Public Works project _____ Other: _____
17. Is the structure: On its original site? ☒ Moved? _____ Unknown? _____
18. Related features: Detached addition with garage below and apartment above.

This is a non-contributing structure due to alterations to the original architecture, deterioration, and/or lack of historical significance.

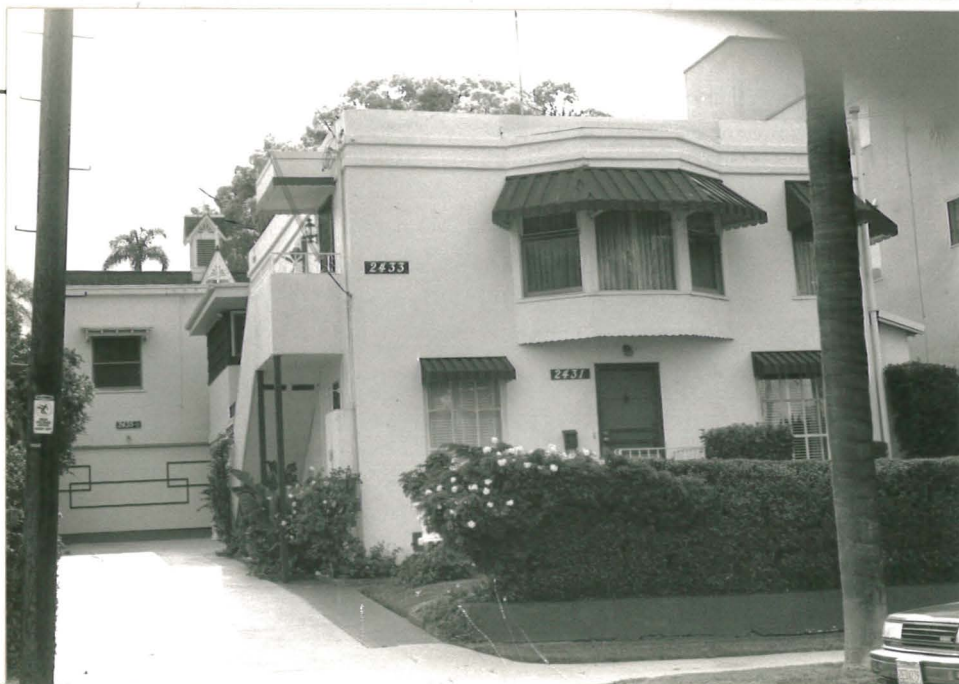
These two-story 40's Modern apartments have a flat roof with two stucco bands wrapping around it, below the cornice line. The siding is smooth stucco. The windows are double-hung and multi-pane fixed on the first story street facade with aluminum awnings. A second story angled oriel bay is over the main entry with a fixed center pane and double-hung side panels sheltered by an aluminum awning. The stepped entry has a metal banister and leads to a wood paneled door with a metal screen. Along the north wall is a driveway and a stucco balustrade staircase leading to the upper apartment. The stoop is sheltered by a small cantilevered overhang. To the rear are two additional structures. One is a later addition to the main structure with a flat roof and wooden shingles on the upper story. The other structure houses a two-car garage below with living quarters above.

13. Condition: Excellent ___ Good ___ Fair X Deteriorated ___ No longer in existence ___
14. Alterations: Windows, metal awnings, screens
15. Surroundings: (Check more than one if necessary) Open land ___ Scattered buildings ___ Densely built-up X
Residential X Industrial ___ Commercial ___ Other: ___
16. Threats to site: None known ___ Private development ___ Zoning X Vandalism ___
Public Works project ___ Other: ___
17. Is the structure: On its original site? X Moved? ___ Unknown? ___
18. Related features: Two two-car garage with apartment above.

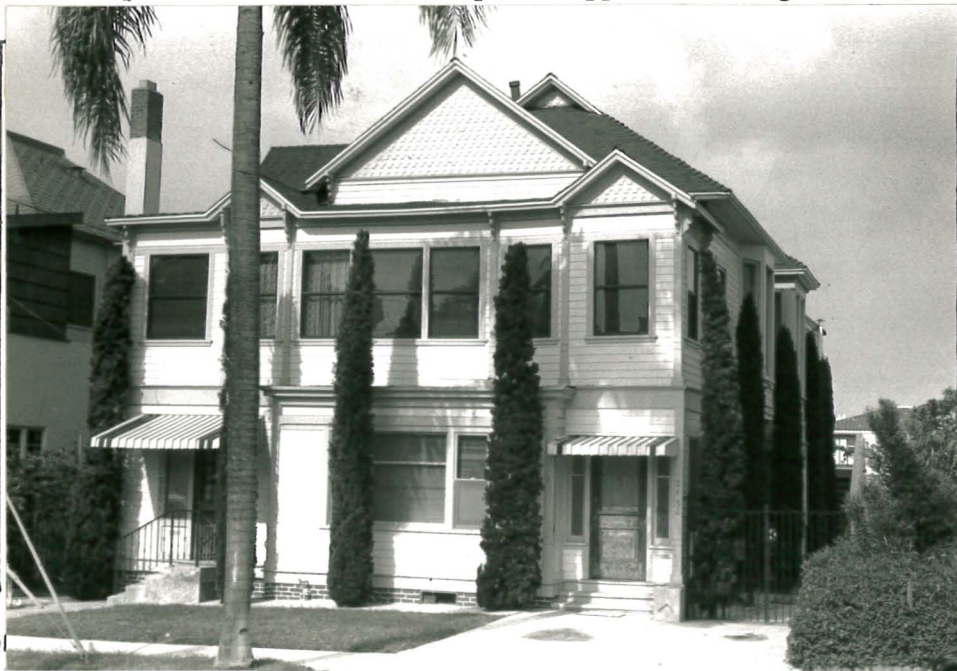
This two-story Queen Anne home has had several alterations. It is difficult to determine what is original, but it appears that two major additions have been built on the original structure. The multiple roof lines are hip, gable and even flat in some areas. The rear portion has a 2-story square bay with a boxed cornice, decorated frieze, and extremely tall, narrow double-hung windows. The central portion has matching shiplap siding; however, the roofline and windows are less decorative. The most recent addition is the entire street facade with clapboard siding and new aluminum-framed double-hung windows, which are much shorter and wider than their counterparts. A large pediment decorates the street facade with patterned shingles, decorative brackets, and two smaller pediments flanking it. Below the large pediment on the first level is an extension with a flat roof and a three-sash window with a center fixed pane, transom, and double-hung side panels. On either side are entries with aluminum awnings. The northern entry is stepped with an old wood-paneled door with a single-pane upper, and 3/4 side-panels. The southern entry is stepped from the side with an iron bannister, wood panel door with multi-paned upper and large side panels.

13. Condition: Excellent _____ Good _____ Fair ☒ Deteriorated _____ No longer in existence _____
14. Alterations: Windows, entire front facade, iron gates on sides
15. Surroundings: (Check more than one if necessary) Open land _____ Scattered buildings _____ Densely built-up ☒
Residential ☒ Industrial _____ Commercial _____ Other: _____
16. Threats to site: None known _____ Private development _____ Zoning _____ Vandalism _____
Public Works project _____ Other: _____
17. Is the structure: On its original site? ☒ Moved? _____ Unknown? _____
18. Related features: Detached garage in back

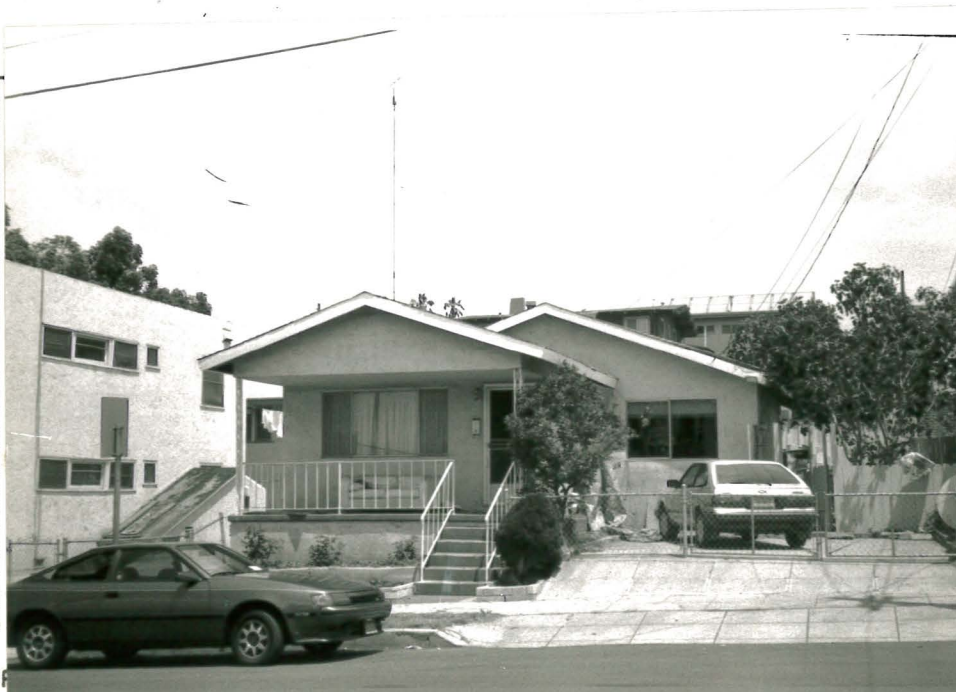
This L-shaped stucco-sided house is one story in height on a raised foundation. The roof is a medium-pitched double front gable with asphalt shingles, overhanging eaves, and exposed rafters. Windows have been altered and are now aluminum sliders. The door, also altered, is hollow core wood. Six cement steps with wrought iron railing lead to a porch, which fills the area under one of the gables. The porch has a wrought iron balustrade and wrought iron posts. On the west side is a stepped entry with wrought iron railing, covered by a metal awning. An additional entry is located on the east side. A driveway to the east leads to a parking area. Alterations are many. They include the windows and door, new stucco, the wrought iron balustrade, posts, and railings. Also, a pergola has been added at the rear, a fence to the east of the house, and a chain link fence across the front. An alarm box has also been added.

13. Condition: Excellent _____ Good _____ Fair _____ Deteriorated ☒ No longer in existence _____
14. Alterations: Pergola, stucco, windows, door, fences, balustrade, railing, posts, alarm box
15. Surroundings: (Check more than one if necessary) Open land _____ Scattered buildings _____ Densely built-up ☒
Residential ☒ Industrial _____ Commercial _____ Other: _____
16. Threats to site: None known _____ Private development _____ Zoning ☒ Vandalism _____
Public Works project _____ Other: _____
17. Is the structure: On its original site? ☒ Moved? _____ Unknown? _____
18. Related features: None

This is a non-contributing structure due to alterations to the original architecture, deterioration, and/or lack of historical significance.

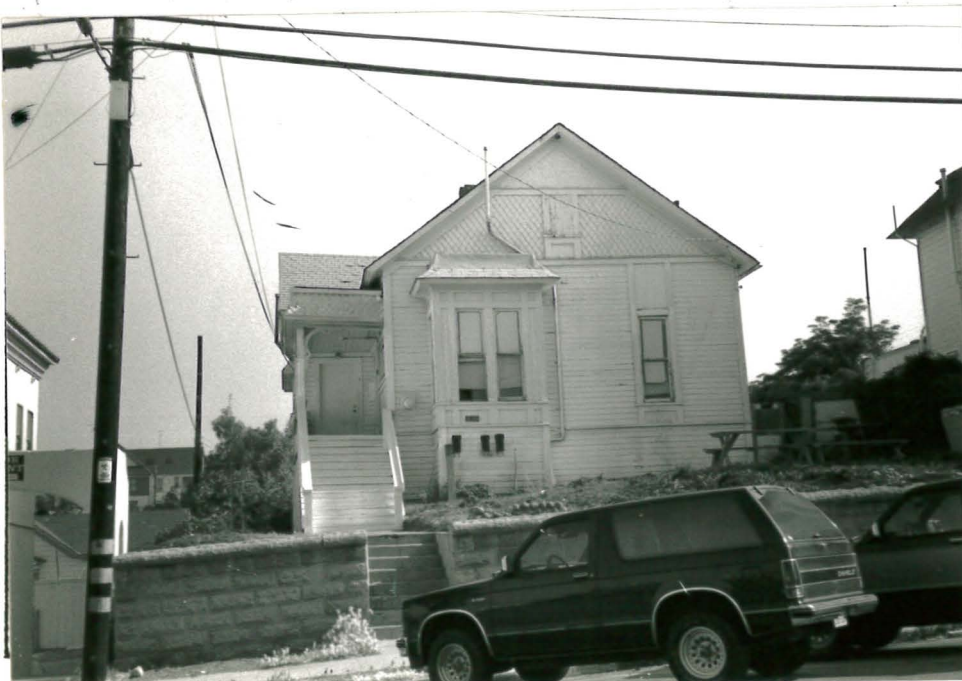
The 1½ story Queen Anne home has a basement below and is situated high above the street level with an ashlar block retaining wall. The home is gable with overhanging eaves. The front gable end has diamond patterned shingles and a center small hinged door. The windows are narrow and double-hung with half-timbering surrounds on the street facade.

A mansard roof covers the square bay to the east of the main entry. The entry porch has a tall stairway leading from the yard with a solid shiplap balustrade. A mansard roof with diamond shaped shingles square posts and curving decorative brackets shelter the open porch. Within the porch is a fixed flashed glass window and two solid wooden doors; one is a replacement of the original while the other may have been a later addition. The porch roof running along the western wall, continues to the rear after being interrupted by the crossing side gable. Alterations include the boxing of the front porch, replacement of the original stairs and the two front doors.

13. Condition: Excellent _____ Good X Fair _____ Deteriorated _____ No longer in existence _____
14. Alterations: boxing of front porch, replacement of front stairs, front doors
15. Surroundings: (Check more than one if necessary) Open land _____ Scattered buildings _____ Densely built-up X
Residential X Industrial _____ Commercial _____ Other: _____
16. Threats to site: None known _____ Private development _____ Zoning X Vandalism _____
Public Works project _____ Other: _____
17. Is the structure: On its original site? _____ Moved? X Unknown? _____
18. Related features: none

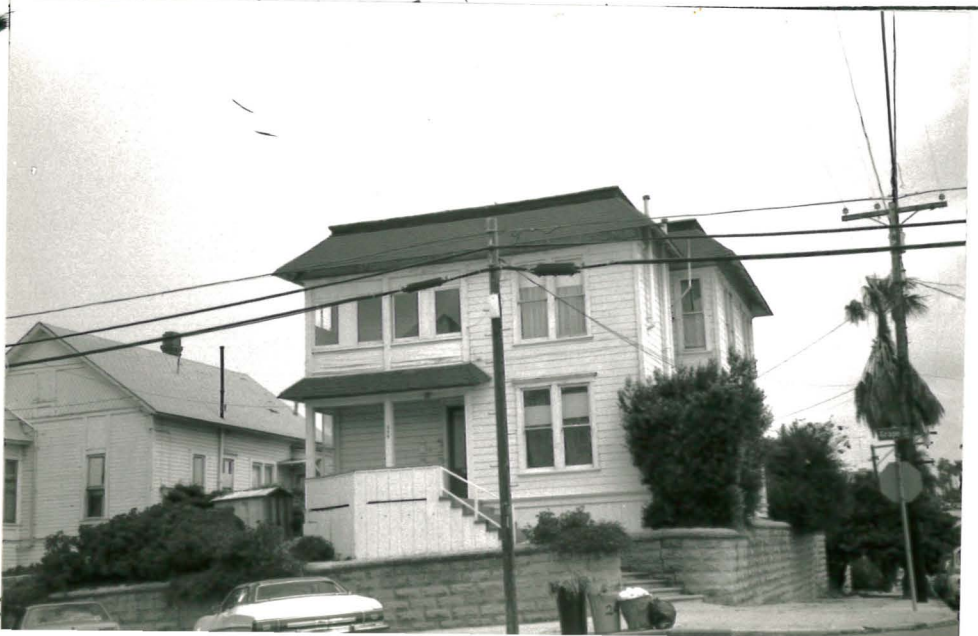
This two story rectangular building is raised off the street by a high ashlar block retaining wall, raising to a story high on the north east orner. The roof is a trunkated hip with a molded cap or parapet with wide overlining eaves with worked craftsman style rafts and a narrow vertical ship-lap beneath. Windows are narrow double-hung with articulated shelf caps on the first level and plain wood surround on the second level. Many windows are located in pairs. The building steps out in a large square bay on the east side. The siding throughout is a wide ship-lap. The entry is reached from the south east corner where seven curving cement steps lined with ashlar block lead to another seven wooden steps which reach the hip roofed entry porched which wraps from the south to the west. A lintel with molding above and the same vertical frieze above that is supported by square wooden posts. The door is two panel wood with a large rectangular glass upper.

Alterations include an enclosed balocony above the porch with wood siding and wooden single pane sliding windows. Also a flat roof one story addition is located on the north side with a ladder leading to the roof of the main building. The foundation is skirted with narrow vertical shiplap with a horizontal molded band above. The wooden steps and porch are enclosed in vertical tongue and groove siding. Westside of porch enclosed in four single pain windows.

13. Condition: Excellent ___ Good ☒ Fair ___ Deteriorated ___ No longer in existence ___
14. Alterations: enclosed balcony, one story additn. foundation skirting
15. Surroundings: (Check more than one if necessary) Open land ___ Scattered buildings ___ Densely built-up ☒
Residential ☒ Industrial ___ Commercial ___ Other: ___
16. Threats to site: None known ☒ Private development ___ Zoning ___ Vandalism ___
Public Works project ___ Other: ___
17. Is the structure: On its original site? ☒ Moved? ___ Unknown? ___
18. Related features: NONE

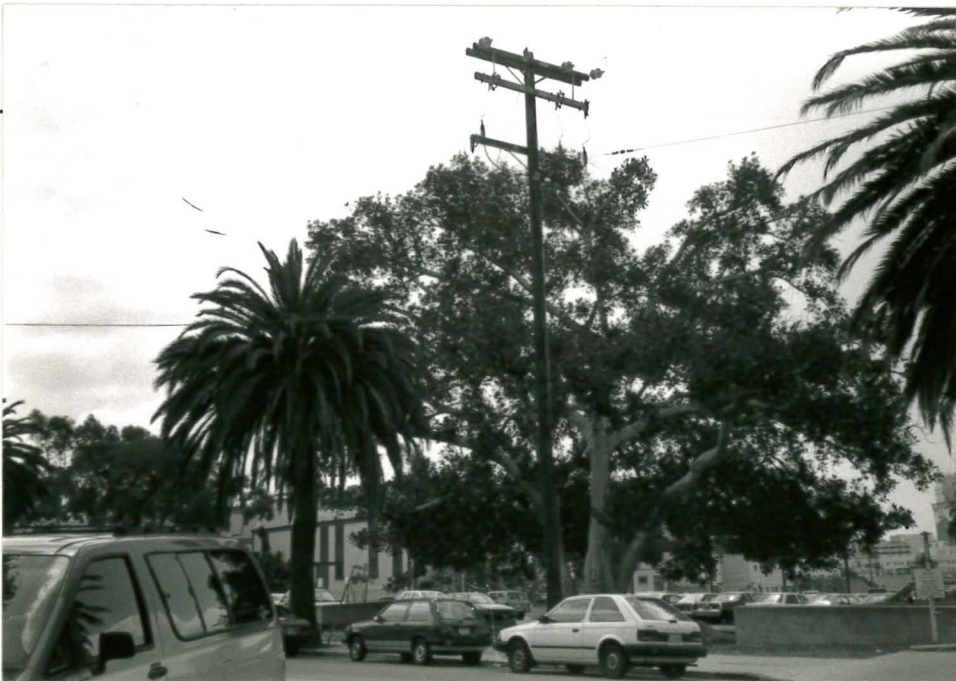
This Moreton Bay Fig Tree is San Diego Historic Site #53. It grows centered between lots A and L near Grape Street. A broken low retaining wall is located to the east and west a sidewalk is located to the north of the tree and the parking lot surrounds it on the east west and south sides.

13. Condition: Excellent ☒ Good _____ Fair _____ Deteriorated _____ No longer in existence _____
14. Alterations: _____
15. Surroundings: (Check more than one if necessary) Open land _____ Scattered buildings _____ Densely built-up ☒
Residential ☒ Industrial _____ Commercial ☒ Other: parking lot
16. Threats to site: None known _____ Private development _____ Zoning ☒ Vandalism _____
Public Works project _____ Other: _____
17. Is the structure: On its original site? ☒ Moved? _____ Unknown? _____
18. Related features: Original site of Florence Hotel

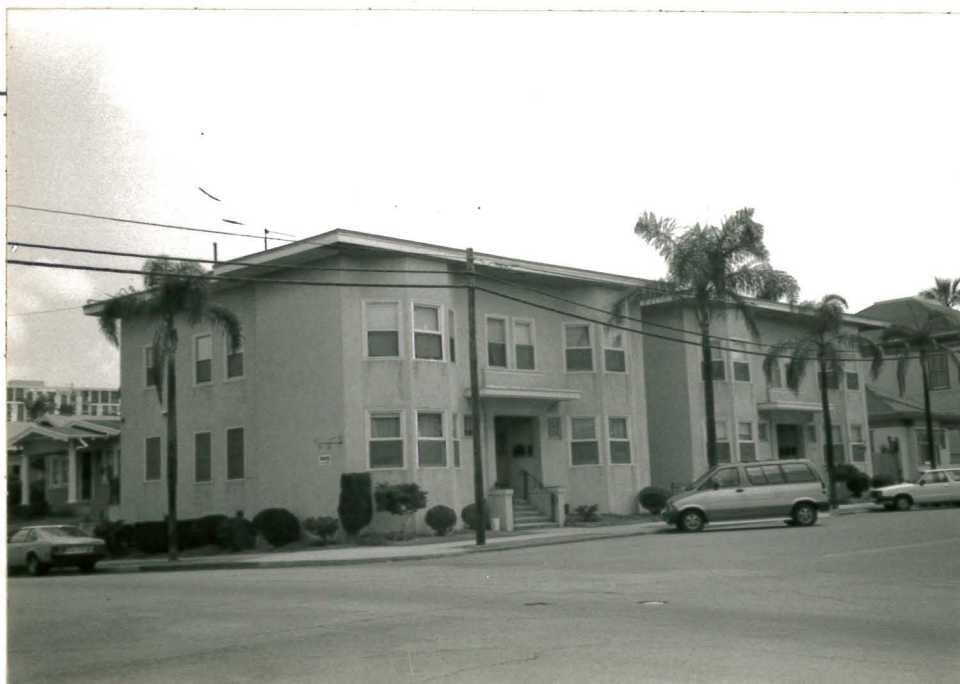
These 2 apartment structures are 2 stories in height on a raised foundation. The roof is flat with wide overhanging eaves and a boxed cornice. The siding is stucco which may be a later alteration of the existing siding. Wide double-hung windows form bands around the structures and surround the 2-story bays on each building corner along Grape Street. The facades are symmetrical with a pair of windows above each cantilevered entry overhang with a flared stucco support below. Each entry is stepped from the sidewalk with a simple iron railing and square posts. Each square recessed porch contains 4 doors. The western structure's doors are solid wood with multi-pane uppers while the eastern structures are single pane. Flanking the entries are 2 small multi-paned windows. Alterations include aluminum-framed windows along the western facade, aluminum awnings over the rear entries (1st & 2nd levels) and the stucco siding.

13. Condition: Excellent _____ Good ☒ Fair _____ Deteriorated _____ No longer in existence _____
14. Alterations: Windows, awnings, siding, railings
15. Surroundings: (Check more than one if necessary) Open land _____ Scattered buildings _____ Densely built-up ☒
Residential ☒ Industrial _____ Commercial _____ Other: _____
16. Threats to site: None known ☒ Private development _____ Zoning _____ Vandalism _____
Public Works project _____ Other: _____
17. Is the structure: On its original site? ☒ Moved? _____ Unknown? _____
18. Related features: None

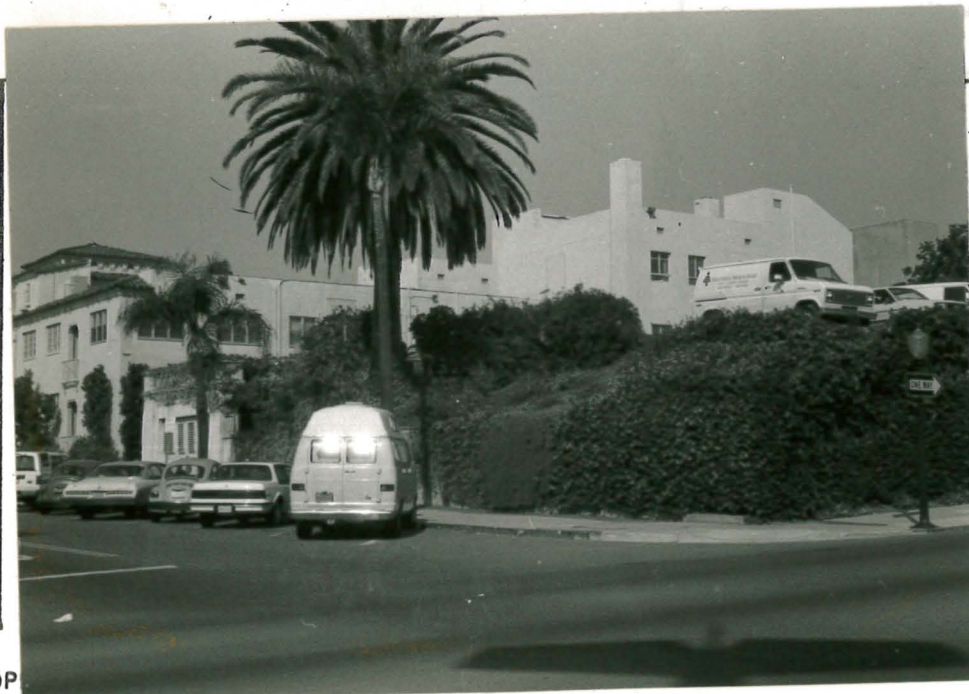
This architectural remnant has a 6 ft. cement block retaining wall which is covered by dense vegetation. Articulated stairways appear on 5th Avenue and Grape Street with a third side stairway at the northeastern corner. The stairway along Grape Street is still utilized to access the upper parking lot. It is covered by mature vines on a decorative pergola made of wooden beams. Along the stairway are solid rough concrete planters with an open concrete banister which continues along the southwestern boundary of the parking lot. Beneath the banister and to the west of the stairway is a large 2-door hinged garage with similar rough concrete siding. The doors are wooden with louvres above and diagonal shiplap panels below. A mature palm is at the upper stair landing. Sidewalks contain the following: Jennings 1907, JC Brockway DS Warstad 1908, and Joseph Kelly Contractor in cement office 864 5th Street.

13. Condition: Excellent ___ Good ___ Fair ___ Deteriorated ___ No longer in existence X
14. Alterations: _____
15. Surroundings: (Check more than one if necessary) Open land ___ Scattered buildings ___ Densely built-up X
Residential X Industrial ___ Commercial X Other: _____
16. Threats to site: None known X Private development ___ Zoning ___ Vandalism ___
Public Works project ___ Other: _____
17. Is the structure: On its original site? X Moved? ___ Unknown? ___
18. Related features: _____

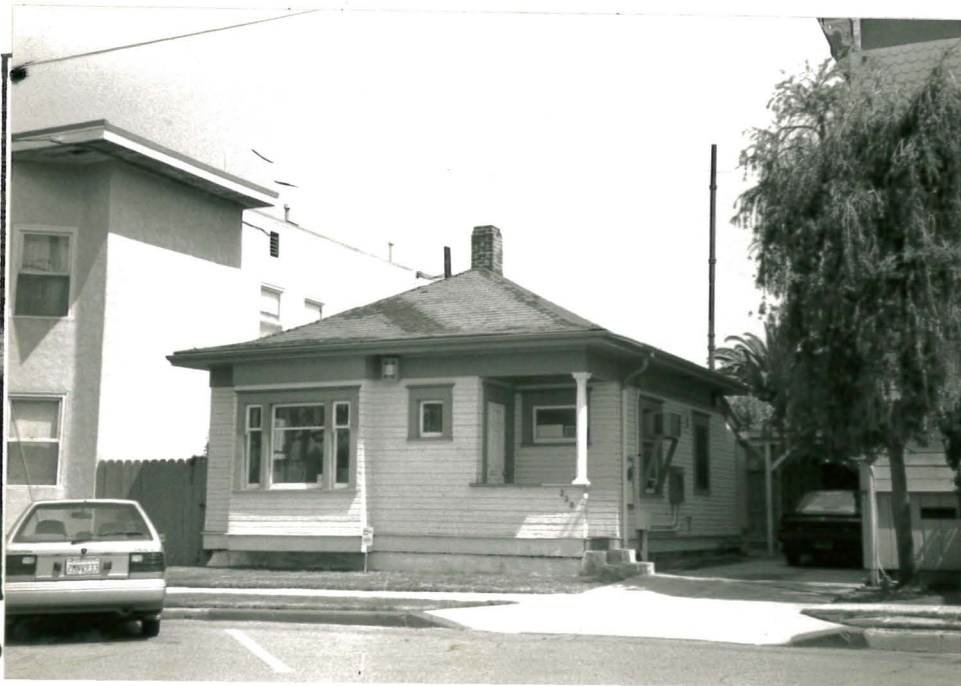
This small neoclassical box is rectangular-shaped on a cement foundation w/shiplap siding and a horizontal band at foundation level. The high-pitched, asphalt-shingled hipped roof which flares at the eaves has a boxed cornice, widely overhanging eaves, and a wide plain frieze. On the front facade, west of the porch, a square oriel bay sheltered by the main roof contains a 3-sash window with a central fixed pane w/a leaded angular geometric transom and narrow double-hung side panels with leaded angular geometric uppers. On the side facades are double-hung windows. All windows have wide shelf surrounds. A porch covered by the main roof and reached by 3 cement steps is located on the east corner of the front facade. An east-facing door is multipaneled wood. The porch balustrade is shiplap, an extension of the house wall. One Corinthian column at the corner supports a lintel which is an extension of the plain frieze. There is a central brick chimney. Alterations include a fence to the west and a shed-roofed addition to the rear.

13. Condition: Excellent _____ Good ☒ Fair _____ Deteriorated _____ No longer in existence _____
14. Alterations: fence, shed-roofed addition to the rear
15. Surroundings: (Check more than one if necessary) Open land _____ Scattered buildings _____ Densely built-up ☒
Residential ☒ Industrial _____ Commercial ☒ Other: _____
16. Threats to site: None known ☒ Private development _____ Zoning _____ Vandalism _____
Public Works project _____ Other: _____
17. Is the structure: On its original site? _____ Moved? _____ Unknown? ☒
18. Related features: None

This neoclassical cottage was moved on to this site prior to 1926. The porch and window surrounds are typical of the Neoclassical Style. This structure is in good condition and contributes to the historic streetscape of the area.

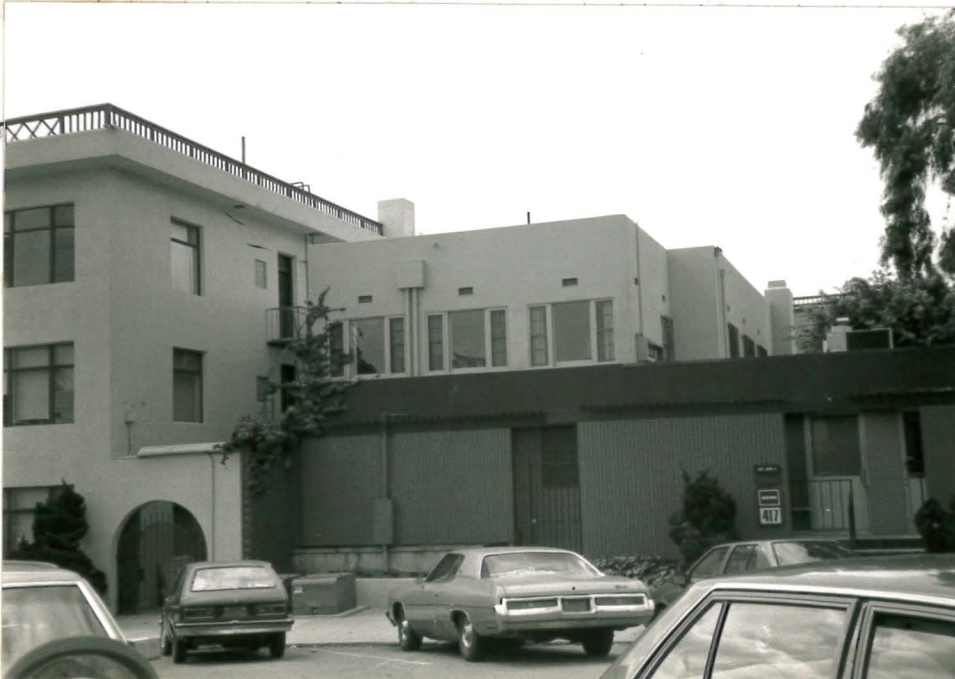
7b. Briefly describe the present *physical appearance* of the site or structure and describe any major alterations from its original condition: This rectangular stucco commercial structure is primarily 1 story and becomes 2 story to the east. The roof is flat with horizontal roof vents above each window. The entire 1st story has been remodeled with a vertical shiplap siding which covers the original architecture. To the rear within the parking lot, the original windows are bands of large multi-paned windows with a pivoting center. The 2nd story windows are 3-sash with a fixed center pane and multi-paned double-hung narrow side panels. Metal awnings cover the southern 2nd story windows. Various commercial entries line the 1st story facade with some brick and some concrete stairs. Some entries feature arbors above, while the extreme east entry has glass block windows to the west. It appears that 2 remodels have been performed on the structure; one occurring in the 1940's and the second occurring in the 1960's or early 1970's.

13. Condition: Excellent _____ Good _____ Fair _____ Deteriorated ☒ No longer in existence _____
14. Alterations: 1st story facade, arbors, brick steps
15. Surroundings: (Check more than one if necessary) Open land _____ Scattered buildings _____ Densely built-up ☒
Residential ☒ Industrial _____ Commercial ☒ Other: _____
16. Threats to site: None known ☒ Private development _____ Zoning _____ Vandalism _____
Public Works project _____ Other: _____
17. Is the structure: On its original site? ☒ Moved? _____ Unknown? _____
18. Related features: _____

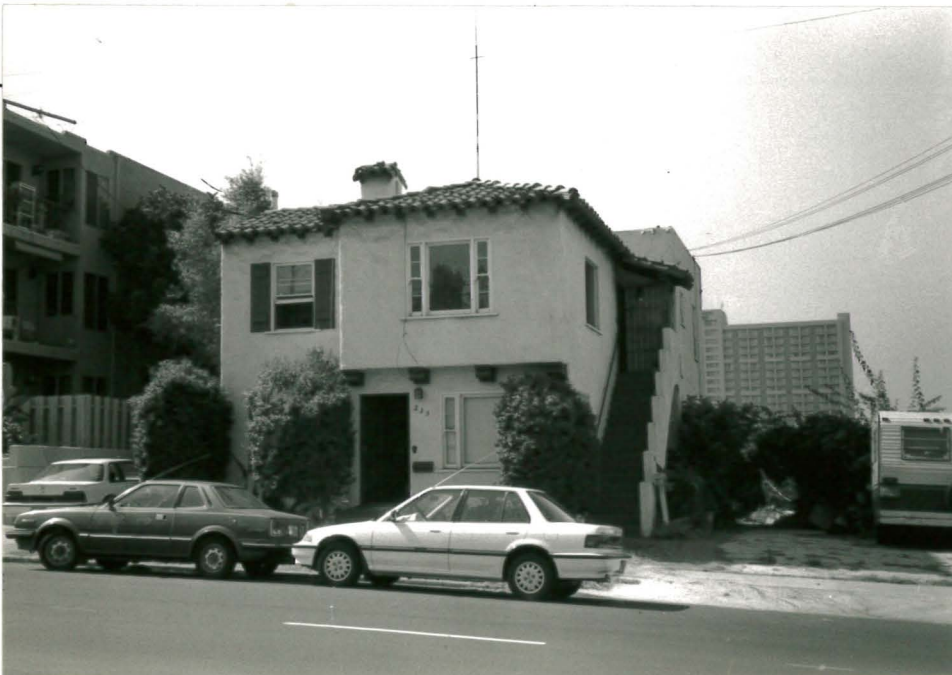
This two-story, irregularly-shaped stucco building has a flat roof except for a red tile hipped section on the north side with exposed, massive cylindrical rafters under overhanging eaves. The windows include double-hung, some of which are two horizontal pane, and three sash with a large fixed center pane and very narrow two pane double-hung side panels. Most windows have shutters. A second story projection facing the north, supported by massive worked brackets, forms a hood for the main entry. The entry door, reached from three irregularly scored cement steps, is vertical paned wood with three large wrought iron hinges. Two additional entries are located on the west side of the building, one is reached through an irregularly shaped arch formed by a staircase to the second floor entry with a stepped boxed stucco balustrade. The entry door below is wood with a narrow horizontal pane and matching paned side panels. A large fixed-pane window is located on the second floor to the west. Canals run just below the roof along the flat section and an interior chimney, within the red tile roof section, has an elaborated top with arches and red tile gable roof.

13. Condition: Excellent _____ Good X Fair _____ Deteriorated _____ No longer in existence _____
14. Alterations: West stairs, large fixed pane window on west
15. Surroundings: (Check more than one if necessary) Open land _____ Scattered buildings _____ Densely built-up X
Residential X Industrial _____ Commercial _____ Other: Interstate 5
16. Threats to site: None known X Private development _____ Zoning _____ Vandalism _____
Public Works project _____ Other: _____
17. Is the structure: On its original site? _____ Moved? _____ Unknown? X
18. Related features: none

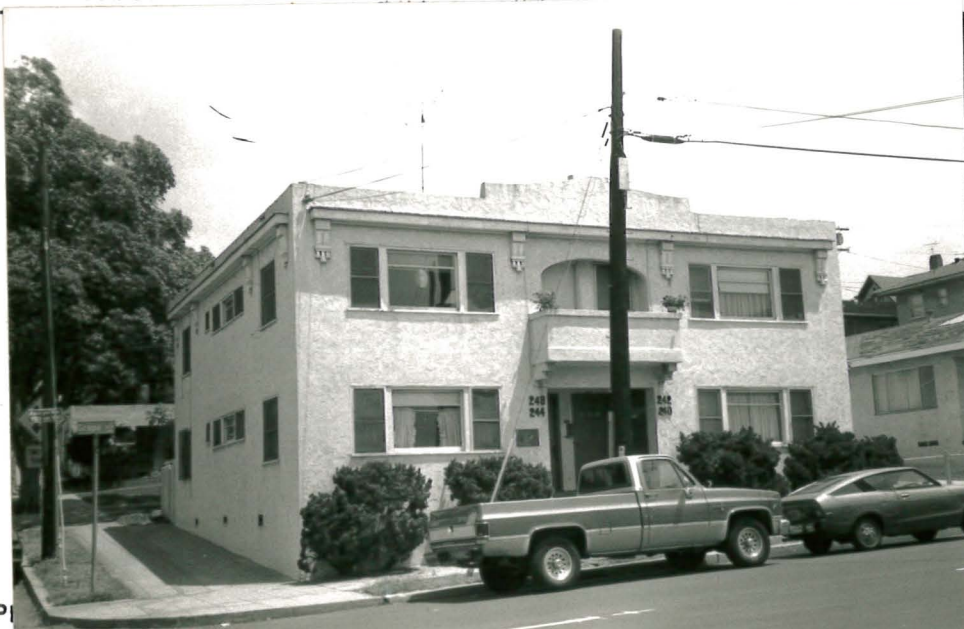
This symmetrical 2-story Mission Style apartment building is rectangular in shape and stucco sided. It has a flat roof with a parapet which is gabled in the center. Windows, all w/narrow wood surrounds, are double-hung or 3-sash with central fixed pane w/glass transoms and double-hung side panels. One window on the west facade and many on the north facade are decorated w/iron work. Six cement steps flanked by a low curving stucco wall lead to a recessed entry porch with four wooden doors, each w/3 small square panes in the upper portion. Two doors face front and two oppose each other. Directly above the porch is a protruding balcony w/a solid stucco balustrade w/coping supported by stepped stucco brackets. Two doors are recessed behind a semi-elliptical arch. A prominent feature of the building is a protruding horizontal band w/decorative brackets which extends almost the full length of the south and west facades below the parapet. The west facade has rectangular roof vents at foundation level. There is a driveway to the east. The rear of the building has two entry doors on each floor and rectangular vents in rows. Alterations include rear doors, a massive stairway to the 2nd floor in the rear, a utility box, a fence on the north side, and a utility shed on the east.

13. Condition: Excellent _____ Good ^X _____ Fair _____ Deteriorated _____ No longer in existence _____
14. Alterations: rear doors, stairway at rear, fence, utility box, utility shed
15. Surroundings: (Check more than one if necessary) Open land _____ Scattered buildings _____ Densely built-up ^X _____
Residential ^X _____ Industrial _____ Commercial _____ Other: Interstate 5
16. Threats to site: None known ^X _____ Private development _____ Zoning _____ Vandalism _____
Public Works project _____ Other: _____
17. Is the structure: On its original site? ^X _____ Moved? _____ Unknown? _____
18. Related features: None
