HISTORIC RESOURCES INVENTORY

1. Common name: None
2. Historic name: None
3. Street or rural address: 1916-1926 Front Street
City San Diego Zip 92101 County San Diego
4. Parcel number: 533-251-05
5. Present Owner: Robert Mellis Address: P.O. Box 2248
City San Diego Zip 92073 Ownership is: Public _____ Private X
6. Present Use: Residential Original use: Residential

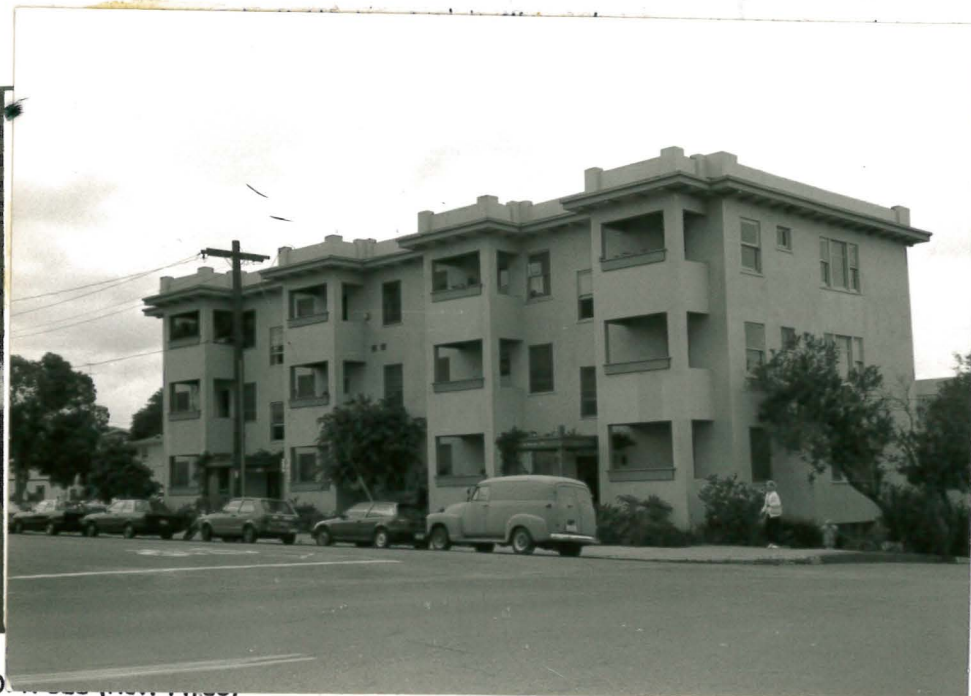
- Architectural style: Mission Revival
- Briefly describe the present *physical appearance* of the site or structure and describe any major alterations from its original condition: This three-story building with a basement to the west is rectangular in shape with a stepped parapet formed at the corners and on the north facade where four three-story balconies project out. A flat cornice visor projects just below the parapet around the entire building, boxed with narrow shiplap with exposed decorative brackets beneath. Windows are double-hung, some three sash with fixed center panels and vertical five-pane transom. There are two main entry pergolas, both formed of plain post and lintel wood with ivy growing up. These lead to two recessed double-door wood entries. Each projecting balcony structure has a balcony on each floor with a square north-facing opening with a built-in wooden planter box and openings to either side. A door leads to each balcony. The facade is stucco and mature landscaping lines the building. Alterations include a security gate on the southwest alley, metal screens and security screens along the basement windows.

13. Condition: Excellent _____ Good ☒ Fair _____ Deteriorated _____ No longer in existence _____
14. Alterations: security gate, metal screens, security screens along basement windows
15. Surroundings: (Check more than one if necessary) Open land _____ Scattered buildings _____ Densely built-up ☒
Residential ☒ Industrial _____ Commercial ☒ Other: _____
16. Threats to site: None known ☒ Private development _____ Zoning _____ Vandalism _____
Public Works project _____ Other: _____
17. Is the structure: On its original site? ☒ Moved? _____ Unknown? _____
18. Related features: _____

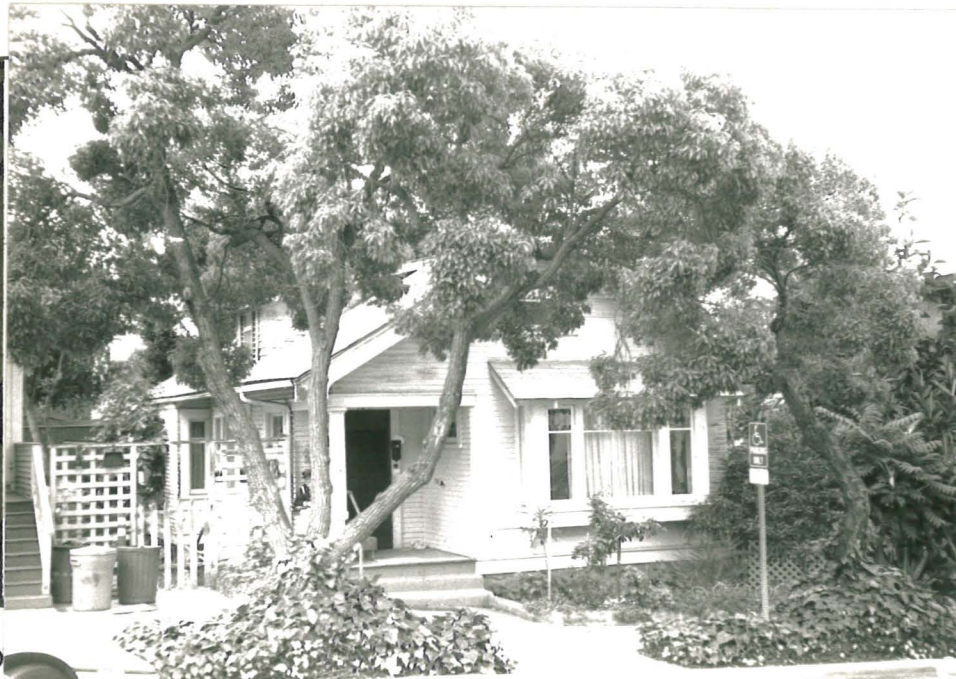
This one-story rectangular California Bungalow sits on a raised cement foundation which is very high in the rear due to the sloping lot. The medium pitched front-gabled roof of composition shingles has overhanging eaves, exposed rafters which are worked at the gable ends, and a plain frieze. Siding is narrow clapboard with endboards; a shed dormer on the east side has shingled siding and a window flanked by horizontal wooden strips. The house has 2 sq. oriel bays, one on the front facade w/a pent roof and exposed rafters, and one on the east facade sheltered by the main roof. The front bay features a 3-sash window w/a central fixed pane and hinged side panels, all with angular geometric upper panes. Other windows, w/shelf surrounds, are varied; some are fixed pane; some have angular geometric designs. Three cement steps w/a single pipe rail lead to a porch on the east side of the front facade. The porch is sheltered by the main roof and has a clapboard balustrade, sq. posts, and a lintel. The door is wood panel. East of the house a lattice fence and a gate leads to steps which descend to a side yard. The security screen door is an alteration.

13. Condition: Excellent ___ Good ☒ Fair ___ Deteriorated ___ No longer in existence ___
14. Alterations: security screen door
15. Surroundings: (Check more than one if necessary) Open land ___ Scattered buildings ___ Densely built-up ☒
Residential ☒ Industrial ___ Commercial ☒ Other: ___
16. Threats to site: None known ___ Private development ___ Zoning ☒ Vandalism ___
Public Works project ___ Other: ___
17. Is the structure: On its original site? ☒ Moved? ___ Unknown? ___
18. Related features: none

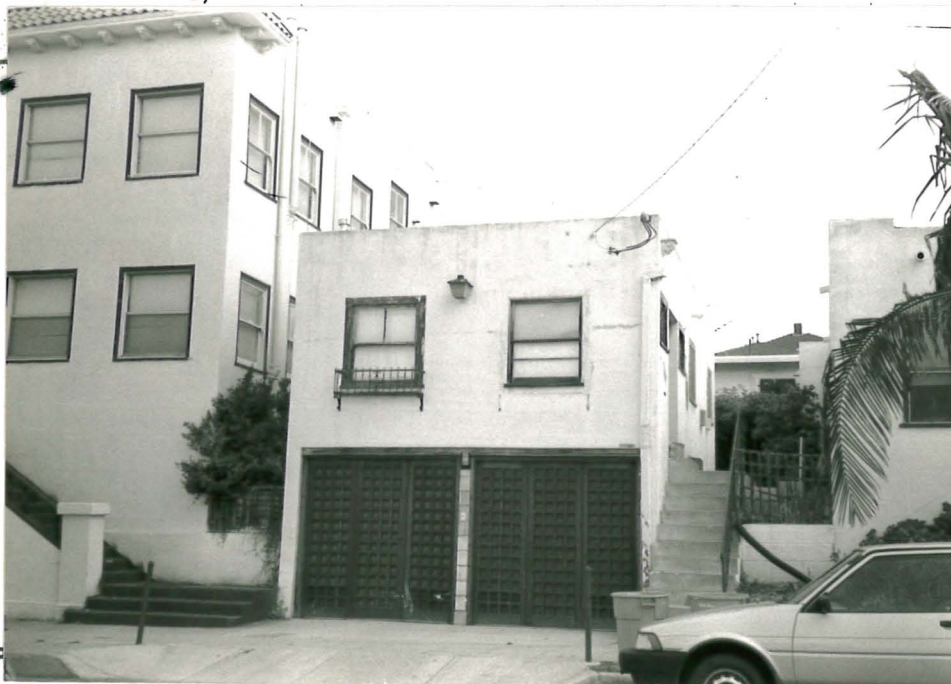
140 East Hawthorn Street is a simple rectangular apartment building with a flat roof. The structure is two stories in height, situated on a rise to the rear which accommodates a 2-car garage along the street level. The doors have been altered and are now latticed wood with wood backing in 3 panels with the center opening as an entry door. The stucco siding contains canalis along the west and east facades. Two wide double-hung windows are situated above the garage doors; one has two vertical upper panes with a decorative iron balconet and wooden surround while the other has two horizontal lower panes with the decorative accents removed. Tall concrete stairs run along the eastern facade with a wrought iron banister. The recessed apartment entries face the east and have large glass panes set within a wooden frame door. The structure faces a similar structure to form a narrow courtyard between. Alterations include the garage door conversions and street facade windows.

13. Condition: Excellent _____ Good _____ Fair ☒ Deteriorated _____ No longer in existence _____
14. Alterations: Garage doors, windows.
15. Surroundings: (Check more than one if necessary) Open land _____ Scattered buildings _____ Densely built-up ☒
Residential ☒ Industrial _____ Commercial _____ Other: _____
16. Threats to site: None known ☒ Private development _____ Zoning _____ Vandalism _____
Public Works project _____ Other: _____
17. Is the structure: On its original site? ☒ Moved? _____ Unknown? _____
18. Related features: Similar structure to the east

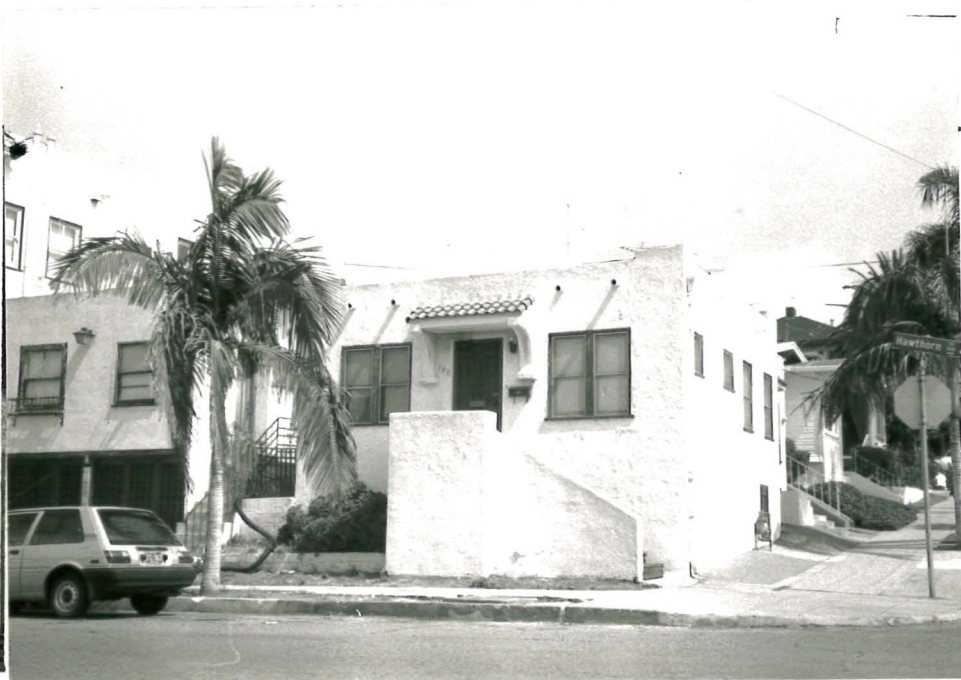
7b. Briefly describe the present *physical appearance* of the site or structure and describe any major alterations from its original condition: This one story irregularly shaped building has a flat roof with a stepped parapet. Windows are single and double-hung, some in pairs. The entries are reached from the south and east. Red tiled entry hoods rest on Massive curving worked brackets. The east facing door has geometric multi-pane large panel with a wooden screen. The south entry is reached from multiple wooden steps encased within a high stucco boxed balustrade and entry stoop. A small half door is located at the foundation level on the east side. Siding is stucco with a low stucco planter box on the south wall. Painted canales run just below the roof line. Alterations include a metal security screen door and aluminum window screens.

13. Condition: Excellent _____ Good ☒ Fair _____ Deteriorated _____ No longer in existence _____
14. Alterations: Metal security screen door, aluminum window screens
15. Surroundings: (Check more than one if necessary) Open land _____ Scattered buildings _____ Densely built-up ☒
Residential ☒ Industrial _____ Commercial _____ Other: _____
16. Threats to site: None known ☒ Private development _____ Zoning _____ Vandalism _____
Public Works project _____ Other: _____
17. Is the structure: On its original site? ☒ Moved? _____ Unknown? _____
18. Related features: None

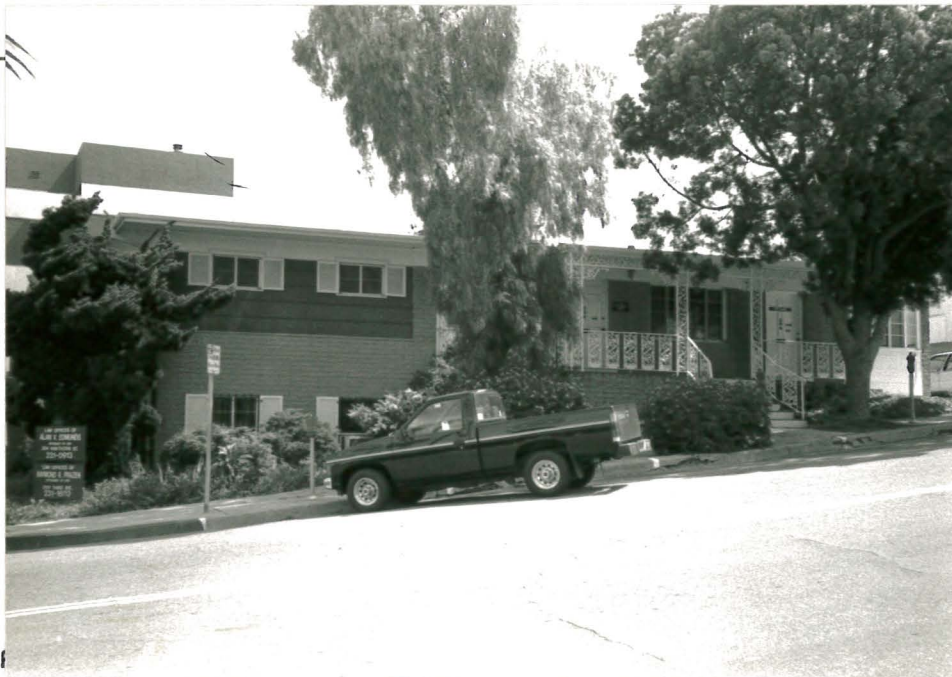
- 7a. Architectural style: 40's Modern
- 7b. Briefly describe the present *physical appearance* of the site or structure and describe any major alterations from its original condition: Legal Desc: Blk 246 Lot F, S $\frac{1}{2}$ Lot E and all Horton's Add Lockling
This two-story, rectangularly-shaped office building is situated on a rise to the east, which covers the eastern lower level. The roof is a low-pitched hip with overhanging eaves, plain frieze, and boxed cornice. A small square turret rises from the center of the roof with a copper pyramidal roof and finial. The structure is sheathed with ashlar brick on the first level, which becomes asbestos shingle above. The windows are multi-paned metal casements with wooden shutters, with the exception of the fixed windows on the shallow curving bays, which flank the open porch. The bannister, posts, and balustrade are ornate wrought iron and the porch is sheltered by a roof extension. Two doorways within the porch are solid wood panel with a large multi-paned window between.

The Third Avenue first level entry has a curving metal canopy with a decorative wrought iron lintel and posts. Two wooden doors lie within with multi-paned uppers. To the rear of the structure is a wooden staircase and a large parking lot.

13. Condition: Excellent _____ Good _____ ☒ Fair _____ Deteriorated _____ No longer in existence _____
14. Alterations: _____
15. Surroundings: (Check more than one if necessary) Open land _____ Scattered buildings _____ Densely built-up ☒
Residential ☒ Industrial _____ Commercial _____ ☒ Other: _____
16. Threats to site: None known _____ ☒ Private development _____ Zoning _____ Vandalism _____
Public Works project _____ Other: _____
17. Is the structure: On its original site? _____ ☒ Moved? _____ Unknown? _____
18. Related features: _____

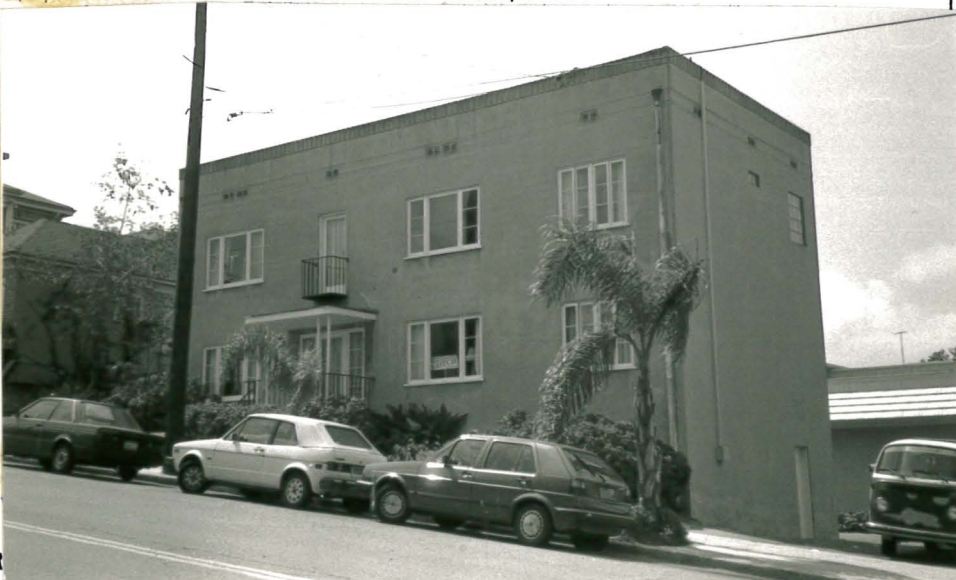
This rectangular 2-story apartment building has lower level garages and storage on the S. & W. sides necessitated by a steeply sloping lot. The building is stucco sided. Near the roofline is a wide horizontal band which encloses rectangular roof vents. This is surrounded by narrow recessed horizontal bands. A flat roof is capped by a fluted parapet. The windows are bands of paired hinged multi-panes and 3 sash windows with fixed central panes and multi-pane hinged side panels. A cement stairway with an iron railing leads from the east to an off-center porch surrounded by an iron balustrade which is a continuation of the railing. The porch is sheltered by a rounded roof supported by 4 poles in pairs. The door is wood-framed with a large rectangular glass pane and multi-paned side panels, interrupted by a mailbox on the east. Above the porch, a narrow door opens on to a small balconet with an iron railing. East of the porch is a cement planter and glass blocks are featured on the West & South facades. There is a door on the west side. On the south facade are 4 entry doors and a wrought iron fire escape. An overhang supported by large timbers shelters two lower level garages with wooden doors and an entry door between. West of the garages is another entry door. A driveway to the south leads to a parking area and the garages. Alterations include the fire escape, rain gutter and door on west facade. Another building with a stepped shape abutted this one on the west side at one time.

13. Condition: Excellent _____ Good X Fair _____ Deteriorated _____ No longer in existence _____
14. Alterations: rain gutter and west side door, fire escape
15. Surroundings: (Check more than one if necessary) Open land _____ Scattered buildings _____ Densely built-up X
Residential X Industrial _____ Commercial X Other: _____
16. Threats to site: None known X Private development _____ Zoning _____ Vandalism _____
Public Works project _____ Other: _____
17. Is the structure: On its original site? X Moved? _____ Unknown? _____
18. Related features: _____

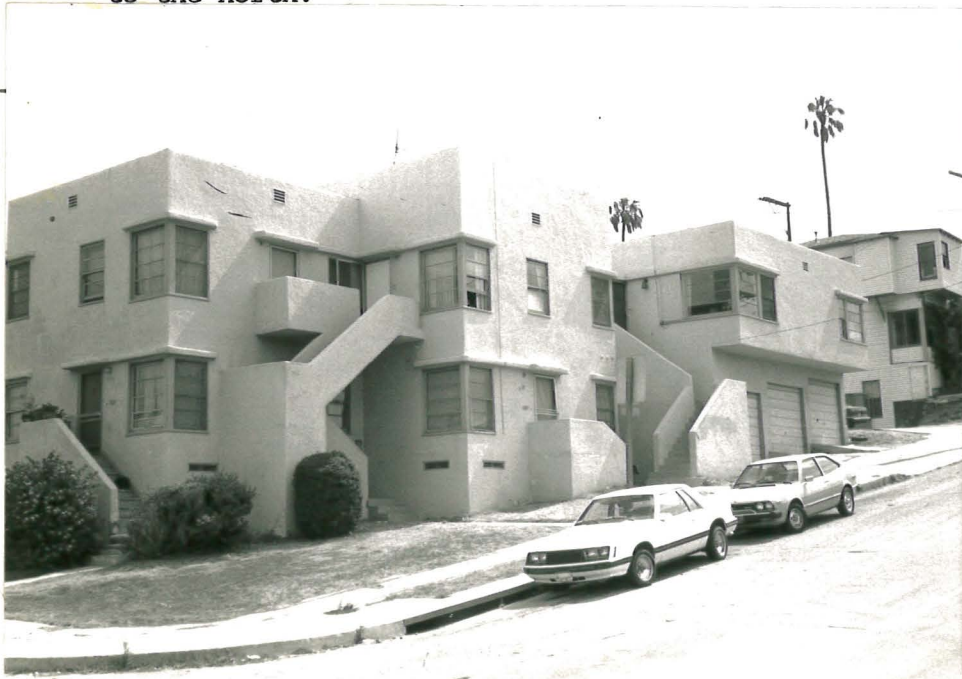
This two-story apartment complex consists of two buildings, one rectangularly shaped, the other L-shaped, both with flat roofs. The placement of the buildings, with the L-section of the west building projecting south and the rectangular building projecting beyond, lends a prominent stepped effect to the structures. Also, the projecting L-section roof rises above the other section. Windows are double-hung, horizontally-paned wood with fixed "wrap around" sashes at the corners. Doors are plain wood. Square vents are centrally located on each stuccoed facade near the roofline. Entries are reached from boxed stuccoed staircases with boxed balustrades at the porches. Three stepped one-car garages are located on the southeast side, the second floor cantilevered over them. Horizontal crawlspace vents run along the foundation area of the stucco facades. Alterations include aluminum entry door screens and a SW entry of the east building enclosed with lattice and corrugated plastic with a balcony extension to the north.

13. Condition: Excellent _____ Good ☒ Fair _____ Deteriorated _____ No longer in existence _____
 Aluminum door screen, lattice entry enclosure balcony
14. Alterations: _____
15. Surroundings: (Check more than one if necessary) Open land _____ Scattered buildings _____ Densely built-up ☒
 Residential ☒ Industrial _____ Commercial _____ Other: _____
16. Threats to site: None known ☒ Private development _____ Zoning _____ Vandalism _____
 Public Works project _____ Other: _____
17. Is the structure: On its original site? ☒ Moved? _____ Unknown? _____
18. Related features: _____

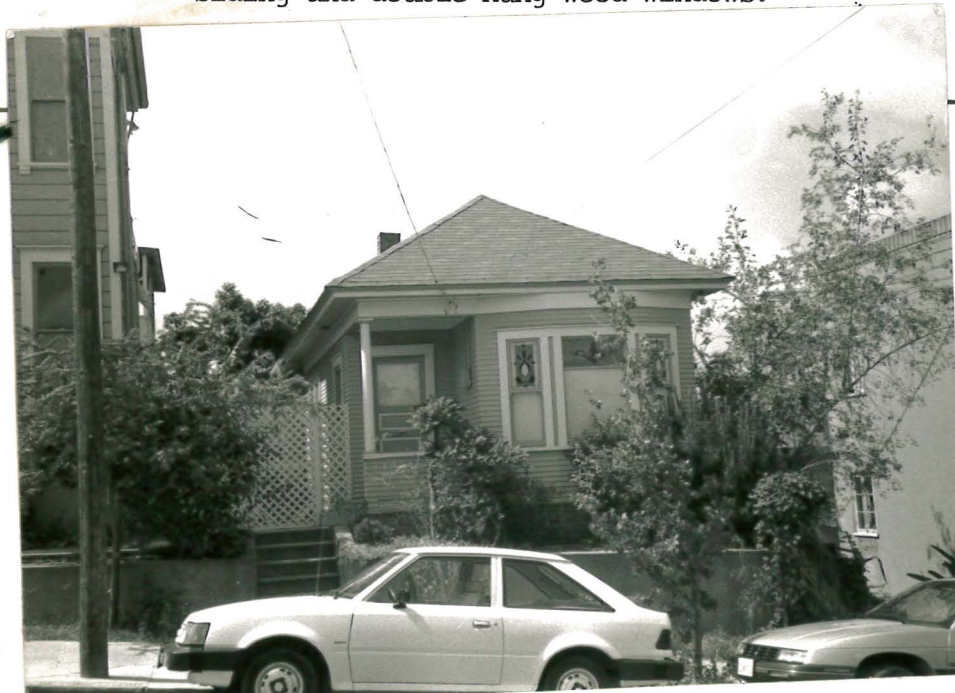
This one-story rectangular house sits on a raised cement foundation and has a high-pitched hip roof of composition shingle. The overhanging eaves are boxed with a plain frieze below. The front bay window is three sash with narrow double-hung side panels with abstract leaded-glass uppers and a fixed center pane with the same leaded glass in the transom. Other windows are double-hung with exception of one awning window of leaded glass in the square west-facing bay. The entry door is four-panel wood with a large glass upper. Eight steps lead to the entry door which is covered by a recessed porch supported by a narrow column resting on a boxed clapboard balustrade. The siding is also clapboard. The foundation is skirted with narrow vertical paneling and faced with brick along the north side. A scored concrete retaining wall raises the building above the street level. Alterations include a lattice fence and gate to the east of the entry, and a shed-roof addition to the south with vertical tongue and groove siding and double-hung wood windows.

13. Condition: Excellent ☒ Good _____ Fair _____ Deteriorated _____ No longer in existence _____
14. Alterations: Fence, addition in rear
15. Surroundings: (Check more than one if necessary) Open land _____ Scattered buildings _____ Densely built-up ☒
Residential ☒ Industrial _____ Commercial _____ Other: _____
16. Threats to site: None known ☒ Private development _____ Zoning _____ Vandalism _____
Public Works project _____ Other: _____
17. Is the structure: On its original site? ☒ Moved? _____ Unknown? _____
Large apartment building on same lot to east
18. Related features: _____

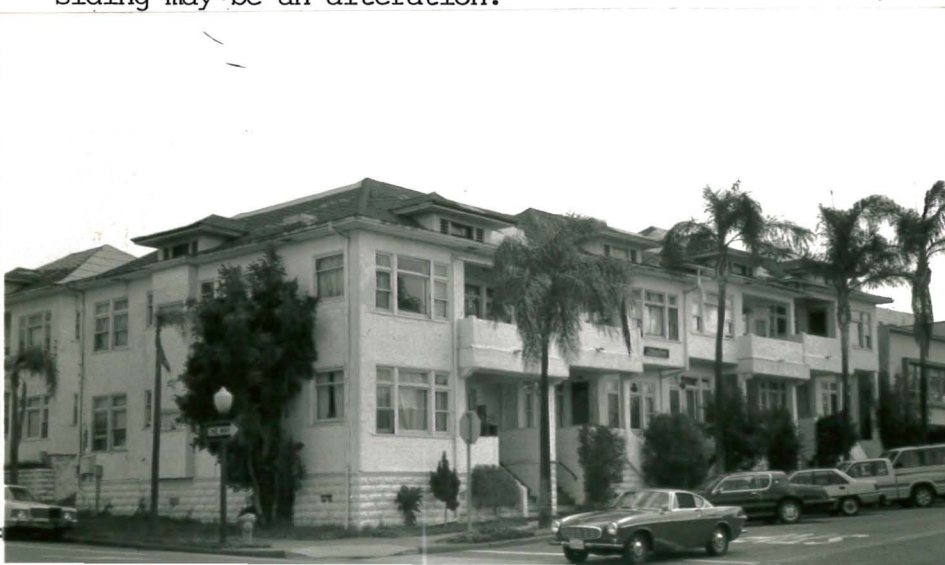
The Markeen apartment building is an irregularly shaped, stucco sided two story apartment building on a raised ashlar block foundation. It is closely related to the apartments at 2115-21 Fourth Avenue, directly to the north. Four nearly identical elements, stepped back and up from the west to east comprise the building. Each element is capped by a hipped roof, flared at the ends, with widely overhanging eaves, a boxed cornice, and a windowed hipped dormer, also with flared eaves. Each elements also contains an open recessed porch reached by a cement stairway with metal railing and surrounded by a stucco balustrade. Doors are wood and have glass uppers with dentil work below. Above the porches are protruding stucco balconies supported by square piers, lintels, and scrolled or square brackets. Three sash window grouping alternately to the east and west of the porches and balconies on both floors feature fixed central panes and narrow double hung side panels with tri-partite glass transoms. Intermittant long narrow stairways with metal or wood rails led from street level to first and second floor apartments entrances. On the west facade, a square two story oriel bay rises below a hipped dormer. Four hipped dormers face north. Side windows are predominantly double-hung with glass transoms. The north or rear facade contains porches which are reached from wooden stairways. Stucco siding may be an alteration.

13. Condition: Excellent _____ Good X Fair _____ Deteriorated _____ No longer in existence _____

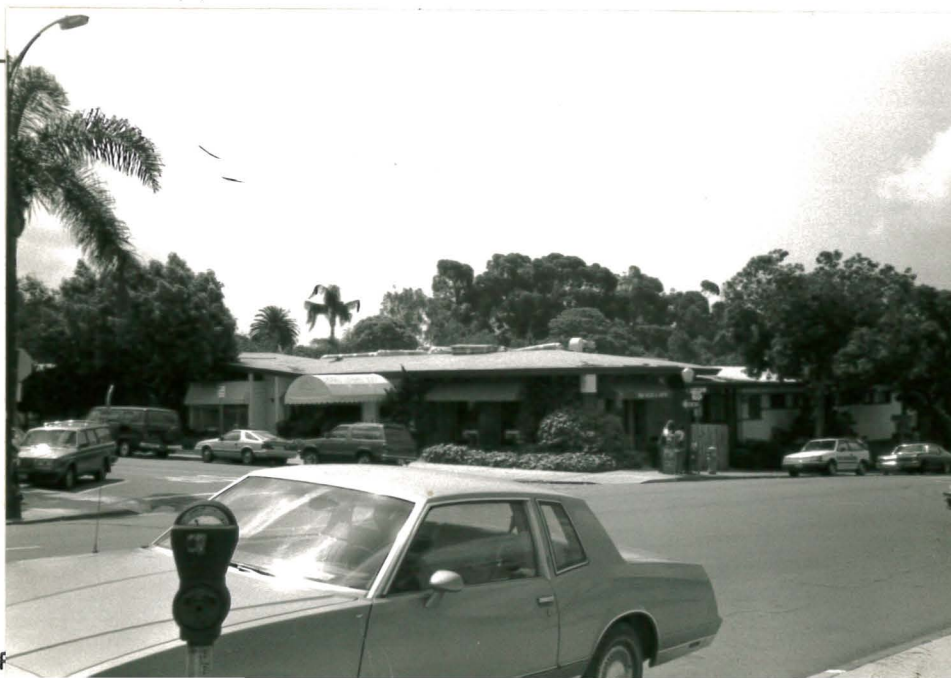
- 7a. Architectural style: 50's Modern
- 7b. Briefly describe the present *physical appearance* of the site or structure and describe any major alterations from its original condition: Legal Desc: Blk 243 Lots A, B, L & K Hortons Add Lockling
This 1-story commercial building covers the entire block of 500 Hawthorn Street. The low-pitched hip roofs have overhanging eaves and step down to the rear due to the slight grade of the property. A large low-pitched front gable covers the center block entry to a commercial court with mature landscaping. A full-height geometrically-latticed gate covers the court entry. The windows are placed high within the stucco facade in bands with horizontal half-timbering surrounds along the east and west facades. The northern facade contains the main entries with awnings covering the western restaurant entry and the large single-paned windows. The double doors are 2-paneled wood with 3/4 single upper panes and fixed single-paned transom. A second set of double doors are aluminum-framed glass panes.

13. Condition: Excellent ____ Good X Fair ____ Deteriorated ____ No longer in existence ____
14. Alterations: Awnings, front windows, aluminum framed doors
15. Surroundings: (Check more than one if necessary) Open land ____ Scattered buildings ____ Densely built-up X
Residential X Industrial ____ Commercial X Other: ____
16. Threats to site: None known X Private development ____ Zoning ____ Vandalism ____
Public Works project ____ Other: ____
17. Is the structure: On its original site? X Moved? ____ Unknown? ____
18. Related features: None

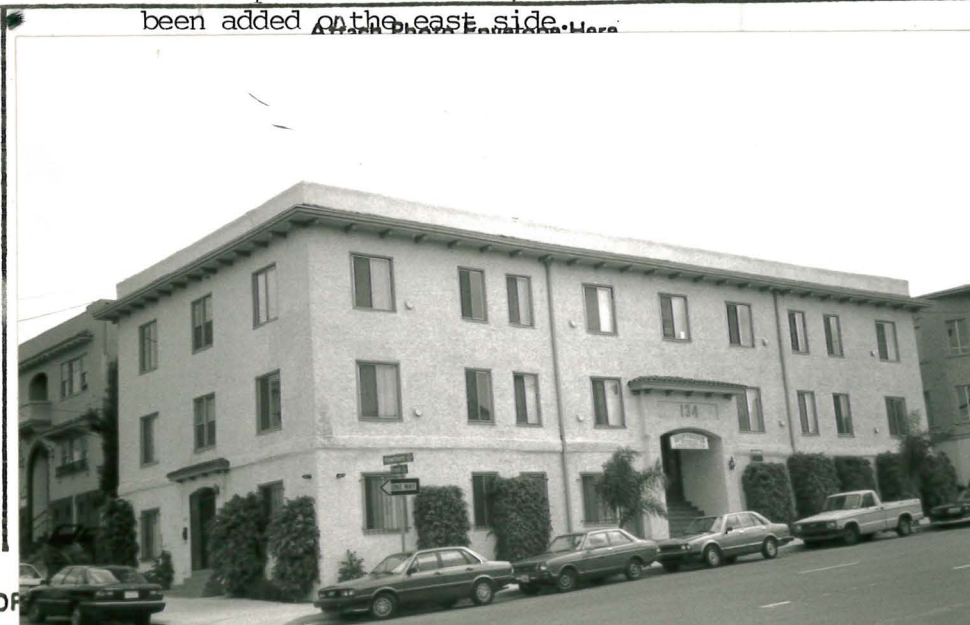
This 3-story rectangular Mission Style apartment building has a flat roof with a parapet and a dropped cornice supported by square rafters. It is stucco-sided and features a protruding horizontal band between the first and second floors. The building is symmetrical with a central recessed entry way with 10 recessed steps enclosed in a segmented arch with buttressing. A recessed panel above the arch contains the building's address. A flat roofed red tile visor with building brackets is located directly above. Double entry doors with rectangular glass panels have wooden side panels with rectangular glass panes, wood surrounds, and dentilwork on a wood transom. Rain gutters are evenly spaced on either side of the entry. On the west facade a control entry with articulation similar to that of the main entry, but more subdued, is reached from 4 cement steps. The recessed entry porch has a front-facing, double-hung window and wood doors which oppose each other. Windows on the building are in bands with narrow wood surrounds. Most have been altered & are now aluminum sliding windows. There is a secondary wood door west of the main entry and an entry door on the east side. Alterations include a security gate on the W. entry, new stucco below the dropped cornice, windows, carpeting on the porch and stairs, floodlights, and mailboxes. A shed-roofed utility shed has been added on the east side.

13. Condition: Excellent _____ Good _____ Fair ☒ Deteriorated _____ No longer in existence _____
Security gate on W. entry, new stucco, windows, carpeting on stairs and porch, floodlights, shed-roofed utility shed on E. side.
14. Alterations: _____
15. Surroundings: (Check more than one if necessary) Open land _____ Scattered buildings _____ Densely built-up ☒
Residential ☒ Industrial _____ Commercial _____ Other: _____
16. Threats to site: None known ☒ Private development _____ Zoning _____ Vandalism _____
Public Works project _____ Other: _____
17. Is the structure: On its original site? ☒ Moved? _____ Unknown? _____
18. Related features: NONE

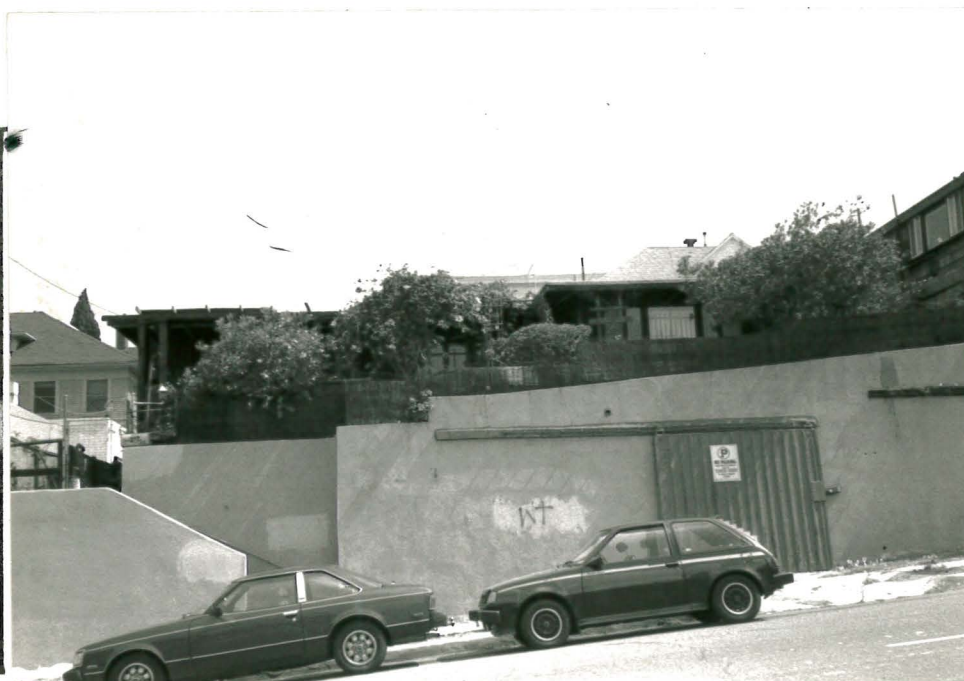
The visibility of this structure is impaired by the lush landscaping and height above the street level. It is a 1-story L-shaped home in the Prairie style. Situated high above the street, the home has a high stuccoed retaining wall which has an articulated stairway to the west and a sliding wooden 1-car garage door to the east. The roof is flat with wide overhanging eaves and exposed rafters which are boxed in some areas. The windows are large fixed panes, some with hinged side panels and some with wooden shutters. Along the street facade is a large porch, now enclosed along the west facade with glass panes and an original pergola overhead. The balustrade is solid vertical board and batten which also sheaths the entire home.

13. Condition: Excellent ___ Good X Fair ___ Deteriorated ___ No longer in existence ___
14. Alterations: pergola over porch, enclosed porch
15. Surroundings: (Check more than one if necessary) Open land ___ Scattered buildings ___ Densely built-up X
Residential X Industrial ___ Commercial ___ Other: ___
16. Threats to site: None known ___ Private development ___ Zoning X Vandalism ___
Public Works project ___ Other: ___
17. Is the structure: On its original site? X Moved? ___ Unknown? ___
18. Related features: 3 other dwellings designed by Irving Gill

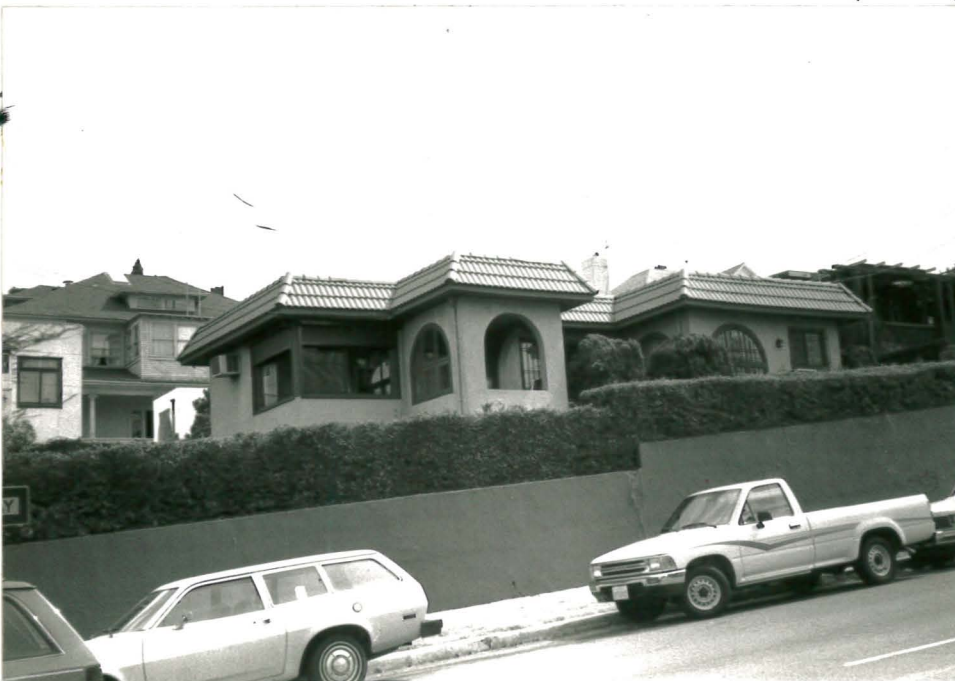
7b. Briefly describe the present *physical appearance* of the site or structure and describe any major alterations from its original condition: This one story flat roofed building is irregularly shaped with stucco siding. A red tile hipped parapet has been added to the street facade which significantly alters the original architecture. The cornice is boxed and the eaves have a wide overhang. The street facade features 2 rectangular projections with arched 6-sectioned hinged windows. The southeast corner projection is enclosed and also features 2-sashed rectangular hinged windows with metal security bars (alteration). The 2nd offset projection contains the main entry with arched openings to the south and east and an arched 6-section window on the western facade. To the west of the entry are large rectangular windows which wrap around the corner with rolling aluminum security panels above, indicating that this section is a later addition. A stucco interior chimney is visible to the rear. The home is situated high above the street level with a stuccoed retaining wall and tall hedge. Cement steps lead to the home at the southeast corner of the retaining wall with a stucco banister.

13. Condition: Excellent ____ Good ____ Fair ☒ Deteriorated ____ No longer in existence ____
14. Alterations: addition to the west, red tile hopped parapet, windows
15. Surroundings: (Check more than one if necessary) Open land ____ Scattered buildings ____ Densely built-up ☒
Residential ☒ Industrial ____ Commercial ____ Other: ____
16. Threats to site: None known ____ Private development ____ Zoning ☒ Vandalism ____
Public Works project ____ Other: ____
17. Is the structure: On its original site? ☒ Moved? ____ Unknown? ____
18. Related features: 3 other dwellings designed by Irving Gill

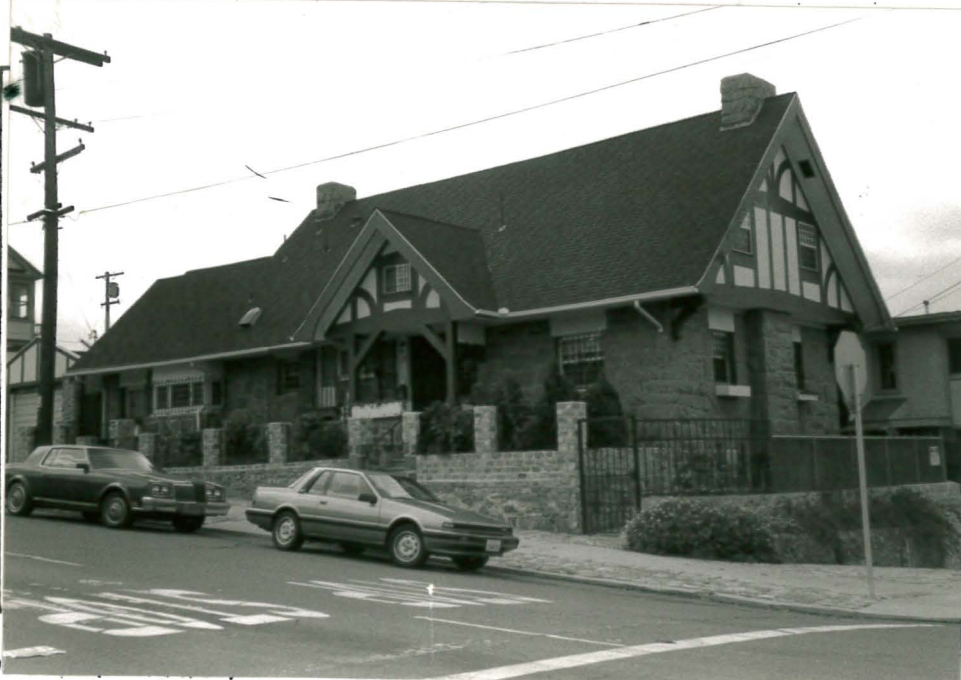
The Granite Cottage is a rectangular 1 1/2 story residence in the Tudor style. The steeply pitched side gabled roof is shingled with widely overhanging eaves, a boxed cornice, and a plain frieze. A lower front gable shelters the entry. The most striking features of the house are the rough hewn granite walls. The gable ends are half-timbered. Windows are hinged multi-panes, some in pairs, many with decorative ironwork. Nine cement steps, enclosed by a stone wall and posts lead to the open front entry porch. The gabled roof is supported by large posts and brackets and a lintel. The house has 2 granite chimneys, a wrought iron fence with massive square granite posts and a granite planter surrounds the property. There is a driveway and garage to the south. Alterations include new shingles on the roof, the boxed cornice, flower boxes under some windows, wrought iron on the windows, a security screen on the door, a chain link fence, iron fencing and a gate between the house and the garage. The yard has been paved with stones and the garage has been topped with a gabled parapet. A shed roofed addition is at the rear.

13. Condition: Excellent _____ Good ☒ Fair _____ Deteriorated _____ No longer in existence _____
 Shed roofed addition at rear, gable above garage, new shingles on roof, boxed
 14. Alterations: cornice, wrought iron on windows, window boxes, chain link fence, iron gate &
 fence, paving in yard, security screen on door.
 15. Surroundings: (Check more than one if necessary) Open land _____ Scattered buildings _____ Densely built-up ☒
 Residential ☒ Industrial _____ Commercial _____ Other: _____
 16. Threats to site: None known ☒ Private development _____ Zoning _____ Vandalism _____
 Public Works project _____ Other: _____
 17. Is the structure: On its original site? ☒ Moved? _____ Unknown? _____
 18. Related features: None

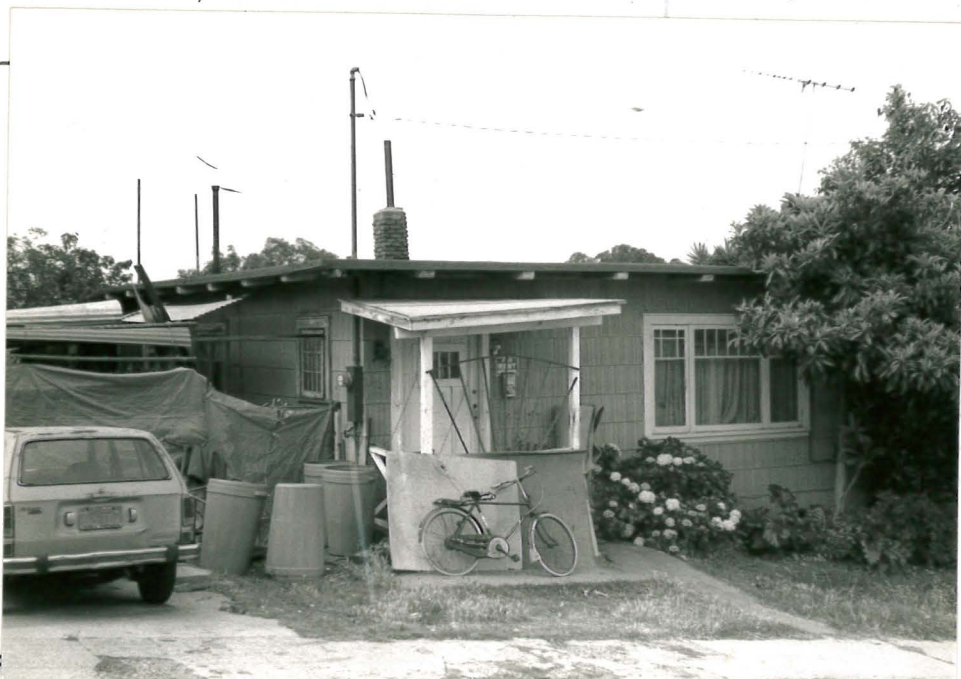
This one-story bungalow is rectangular in shape with a flat composition roof. The wide overhanging eaves have simple exposed rafters. Two brick chimneys intersect the roofline; one is a smaller interior chimney while the other is larger and is along the western facade. The windows are wood-framed multi-paned hinge with wide wooden surrounds. A three-sash window adorns the street facade with multi-paned uppers. The entry is situated at the northeast corner with a shed roof supported by a lentil and square posts which connect onto a cross-beam open balustrade. The wooden door is vertical board and batten with a vertical multi-paned upper. A wide-angle oriel bay is along the western facade and a corrugated plastic and aluminum shelter has been added to the eastern facade. The siding has been altered and is now asbestos shingle.

13. Condition: Excellent ___ Good ___ Fair ___ Deteriorated X No longer in existence ___
14. Alterations: Siding, shed added along eastern facade, roofing material
15. Surroundings: (Check more than one if necessary) Open land ___ Scattered buildings ___ Densely built-up X
Residential X Industrial ___ Commercial ___ Other: ___
16. Threats to site: None known ___ Private development ___ Zoning X Vandalism ___
Public Works project ___ Other: ___
17. Is the structure: On its original site? X Moved? ___ Unknown? ___
18. Related features: ___

This is a non-contributing structure due to alterations to the original architecture, deterioration, and/or lack of historical significance.

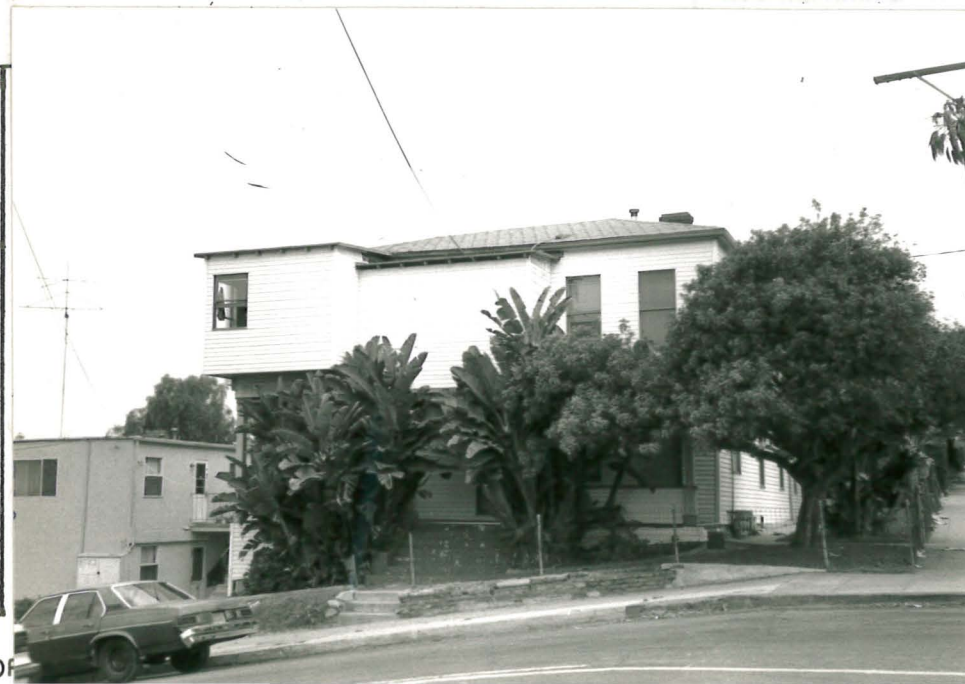
- 7a. Architectural style: Neoclassical Legal D: Blk 251 Lot H E 50 ft of Lot G/EXC N 15 ft/
very altered E 50 ft Horton's Add Lockling
- 7b. Briefly describe the present *physical appearance* of the site or structure and describe any major alterations from its original condition: This three-story home is rectangular in shape and has been altered to provide several apartments. The foundation is brick and concrete and is situated on a rise, which covers the lower east facade. The low-pitched hip roof has slightly overhanging eaves with a boxed cornice, while the third story addition along the street facade has a shed roof with exposed rafters. A tall brick interior chimney intersects the northeastern roofline. The windows are tall and double-hung with vertical multi-panes on the first story. Some windows have been altered and are now large fixed panes or wide double-hung. The front porch extends the length of the first story Hawthorn Street facade. The boxed balustrade has aluminum clapboard siding, which is an alteration on the entire structure. Square beams support the flat porch overhang. Within the porch are three entries. The center entry is original wood panel with narrow 3/4 twin panes. Flanking the center entry are two doors, which are solid wood and wood panel. Two entries are situated along the western driveway on the first level. The home is surrounded by mature landscaping.

13. Condition: Excellent ___ Good x Fair ___ Deteriorated ___ No longer in existence ___
14. Alterations: Third story addition, windows, siding, entry additions
15. Surroundings: (Check more than one if necessary) Open land ___ Scattered buildings ___ Densely built-up x
Residential x Industrial ___ Commercial ___ Other: ___
16. Threats to site: None known x Private development ___ Zoning ___ Vandalism ___
Public Works project ___ Other: ___
17. Is the structure: On its original site? x Moved? ___ Unknown? ___
18. Related features: ___

This is a non-contributing structure due to alterations to the original architecture, deterioration, and/or lack of historical significance.

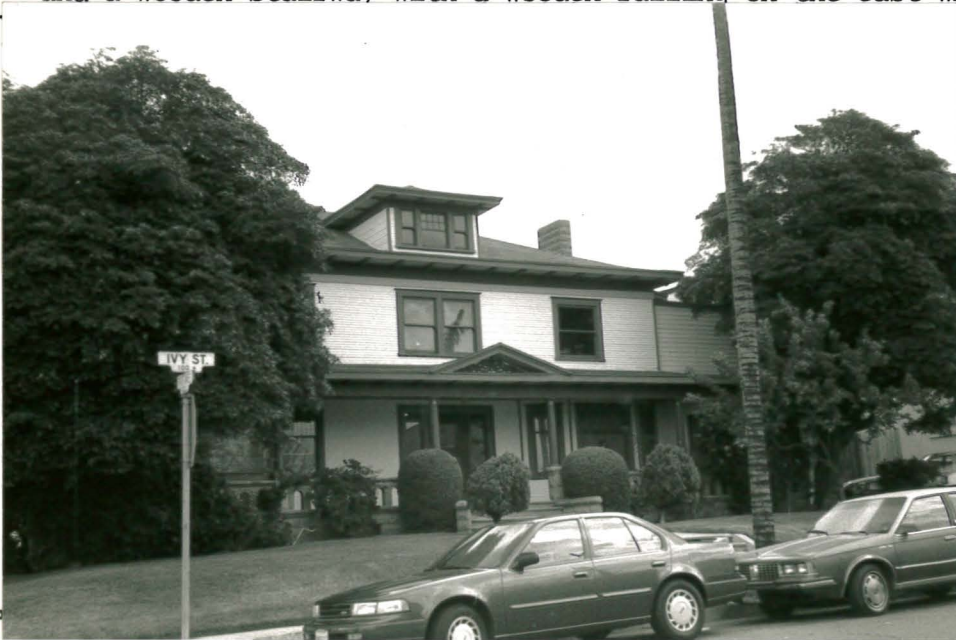
This imposing two story neoclassical house has an ashlar block foundation. It is irregularly shaped and features a high pitched hipped roof with flared ends, asphalt siding, widely over hanging eaves with decorative worked brackets and a plain frieze with a horizontal band below. A hipped corner with flared ends and roof treatment identical to the main roof is centrally located on front facade. Siding is narrow clapboard with endboards, windows are double-hung with shelf surrounds some in pairs. First floor windows have leaded angular geometric uppers; the corner window is 3-sash with a central fixed pane and narrow double hung side panels. A series of molded cement steps flanked by a low curving ashlar wall leads to a veranda which once extended the entire length of the front facade. An open ashlar block balustrade, tuscan columns, and a lintel support a hipped roofed overhang with a central decorative gabled pediment with recessed scrollwork. The entry door, located directly below, is wood with a square bevelled glass upper and 3/4 etched glass side panels. The wood surround has dentil work. East of the door is a one story wide angled bay. The east and west sides of the porch have been enclosed. The house has a square bay on the west facade and ashlar block chimney on the east and west. Alterations include second floor additions on the northeast and northwest corners and a wooden stairway with a wooden railing on the east which leads to the second floor.

13. Condition: Excellent _____ Good X Fair _____ Deteriorated _____ No longer in existence _____
 porch has been enclosed on east and west corners, second floor addition
 14. Alterations: at ne & nw corners, wooden stairway to the east
15. Surroundings: (Check more than one if necessary) Open land _____ Scattered buildings _____ Densely built-up _____
 Residential X Industrial _____ Commercial X Other: _____
16. Threats to site: None known X Private development _____ Zoning _____ Vandalism _____
 Public Works project _____ Other: _____
17. Is the structure: On its original site? X Moved? _____ Unknown? _____
18. Related features: none

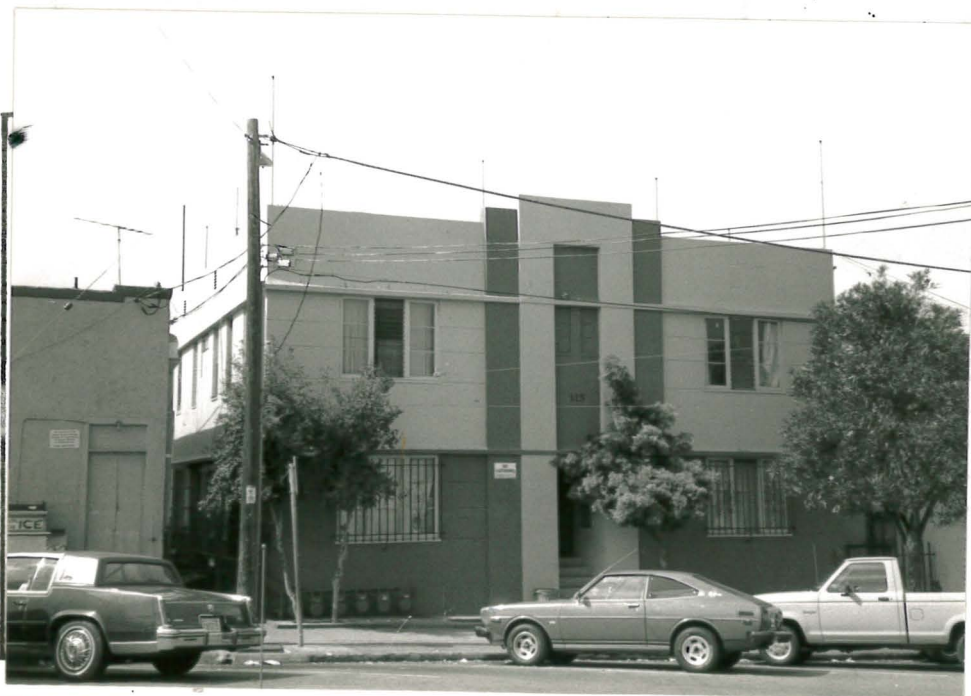
This 2-story rectangular apartment building is situated on a rise which reveals a basement to the rear. The roof is flat with a stepped center parapet which forms 2 pairs of pilasters down the structure to the ground level framing the centered entry. The siding is stucco which has 3 scored bands around each level near the windows. Watercourses top each level directly above the windows. The street facade windows are 3-sash wood hinged with horizontal multi-panes. Some center panes have been replaced with louvred windows and some windows now have iron security bars. Two narrow windows within the central element above the entry have been painted over. The side windows are wood hinged horizontal multi-panes. The center entry is deeply recessed with concrete stairs leading to the 1st story stoops with opposing doorways and continuing on to the 2nd-story apartments. An iron security gate has been added to the main entry.

13. Condition: Excellent _____ Good _____ Fair X Deteriorated _____ No longer in existence _____
14. Alterations: Security screens, windows.
15. Surroundings: (Check more than one if necessary) Open land _____ Scattered buildings _____ Densely built-up X
Residential X Industrial _____ Commercial X Other: _____
16. Threats to site: None known X Private development _____ Zoning _____ Vandalism _____
Public Works project _____ Other: _____
17. Is the structure: On its original site? X Moved? _____ Unknown? _____
18. Related features: None

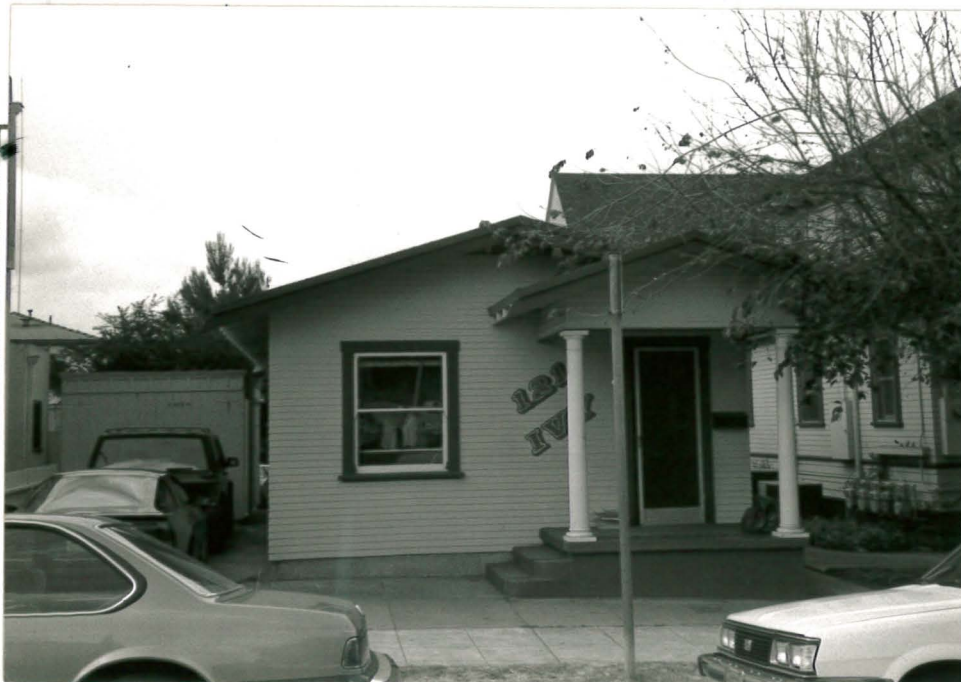
7b. Briefly describe the present *physical appearance* of the site or structure and describe any major alterations from its original condition: This one story rectangular building sits on a concrete foundation and has a low pitched front gable roof of composition shingle with overhanging eaves and exposed rafters. A second front gable forms the entry porch. The windows are double hung, some horizontally oriented, some vertical. The siding is clapboard. Two rounded concrete side steps lead to the entry porch where the gable is clapboard and rests a top two tuscan columns. A side entry on the south west is reached from three concrete steps and stoop. A flat roof one car garage is located to the north with vertical tongue and groove siding and a driveway leading from the street.

13. Condition: Excellent ☒ Good _____ Fair _____ Deteriorated _____ No longer in existence _____
14. Alterations: _____
15. Surroundings: (Check more than one if necessary) Open land _____ Scattered buildings _____ Densely built-up ☒
Residential ☒ Industrial _____ Commercial ☒ Other: _____
16. Threats to site: None known _____ Private development ☒ Zoning _____ Vandalism _____
Public Works project _____ Other: _____
17. Is the structure: On its original site? ☒ Moved? _____ Unknown? _____
18. Related features: _____
