HISTORIC RESOURCES INVENTORY

1. Common name: None
2. Historic name: None
3. Street or rural address: 1916-1926 Front Street
City San Diego Zip 92101 County San Diego
4. Parcel number: 533-251-05
5. Present Owner: Robert Mellis Address: P.O. Box 2248
City San Diego Zip 92073 Ownership is: Public _____ Private X
6. Present Use: Residential Original use: Residential

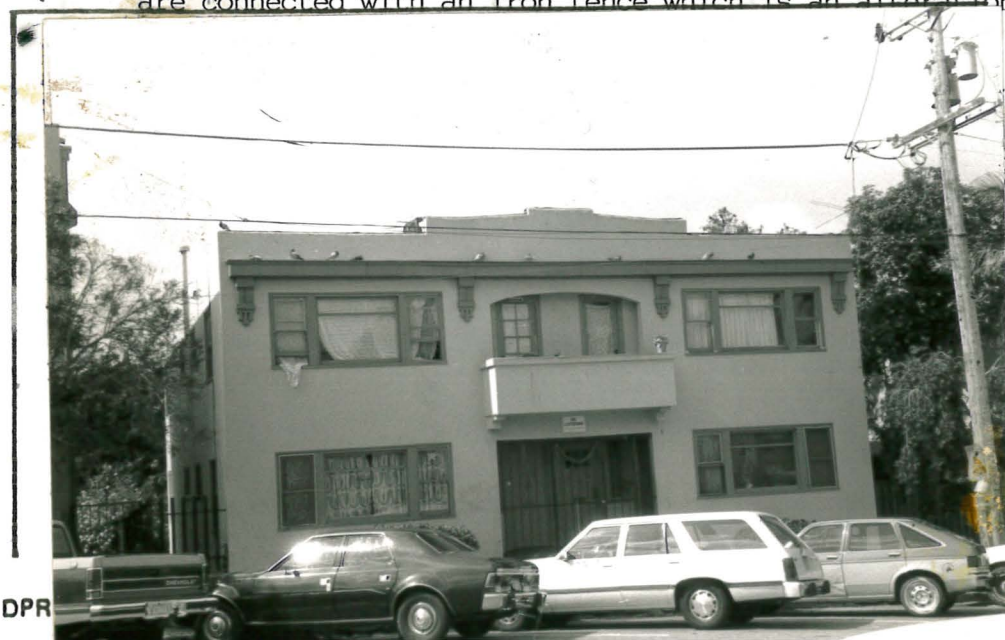
This Mission Style apartment building sits on a sloping lot. It is 2 stories in height w/a rear basement, stucco sided, and rectangular in shape. The flat roof has a parapet which is gabled in the center. The building is symmetrical w/a central recessed entry porch reached via 4 cement steps. The doors, 2 facing and 2 opposing each other are wood panel with 6 small rectangular glass panes in the upper portion. 3/4 glass side panels flank the front-facing doors. Directly above the entry porch is a protruding balcony supported by stepped brackets and featuring stucco balustrades w/coping. One French door and one wood frame door w/a large glass pane serve the balcony. Flanking the central element on both floors are wide 3-sash windows with central fixed panes, narrow glass transoms, and double-hung side panels. Other windows are double-hung. A striking feature of the building is a protruding horizontal band with 4 decorative brackets which runs almost the full length of the first facade below the parapet. Wooden stairways at the rear lead to the 1st floor entrances w/latticework above. Alterations include some doors and the iron security gate in front of the entrances. This building is almost identical to the building at 141-47 West Ivy, directly to the west. The two buildings are connected with an iron fence which is an alteration.

13. Condition: Excellent ___ Good ☒ Fair ___ Deteriorated ___ No longer in existence ___
14. Alterations: doors security gate, iron fencing
15. Surroundings: (Check more than one if necessary) Open land ___ Scattered buildings ___ Densely built-up ☒
Residential ☒ Industrial ___ Commercial ☒ Other: ___
16. Threats to site: None known ☒ Private development ___ Zoning ___ Vandalism ___
Public Works project ___ Other: ___
17. Is the structure: On its original site? ☒ Moved? ___ Unknown? ___
18. Related features: nearly identical building at 141-147 West Ivy Street 240-48 West Grape

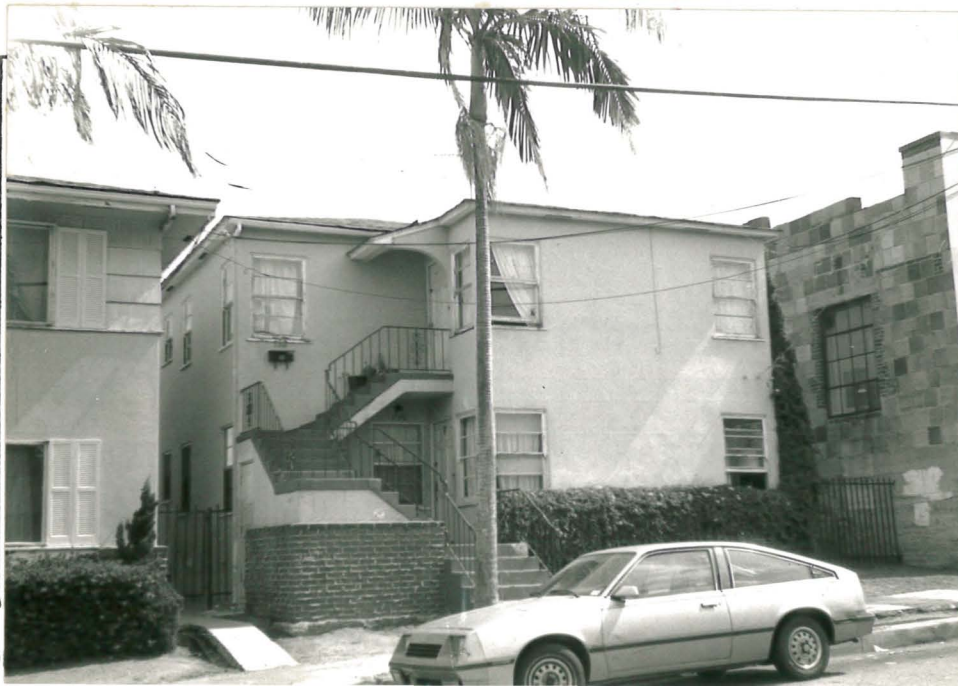
This L-shaped, two-story building has a low-pitched hip roof of composition shingle. The shallow overhanging eaves are boxed. Windows are double-hung, horizontally-paned in pairs constructed of wood, and doors are multi-panel wood. The first floor entry is reached from six plain cement steps lined with a double, open wrought iron railing. The stairs and stoop for the second floor entry serve as a hood to the first floor entry. This stepped, turning staircase leads to the second floor entry covered with a shed hood supported by curving, boxed, stuccoed brackets. The remainder of the building is also stuccoed. A plain wood door is located beneath the staircase. Alterations include brick skirting on the staircase and one window minus the horizontal panes.

13. Condition: Excellent _____ Good ☒ Fair _____ Deteriorated _____ No longer in existence _____
14. Alterations: Brick skirting, window minus horizontal pane
15. Surroundings: (Check more than one if necessary) Open land _____ Scattered buildings _____ Densely built-up ☒
Residential ☒ Industrial _____ Commercial _____ Other: _____
16. Threats to site: None known ☒ Private development _____ Zoning _____ Vandalism _____
Public Works project _____ Other: _____
17. Is the structure: On its original site? ☒ Moved? _____ Unknown? _____
18. Related features: Newer apartment building on lot

This is a non-contributing structure due to alterations to the original architecture, deterioration, and/or lack of historical significance.

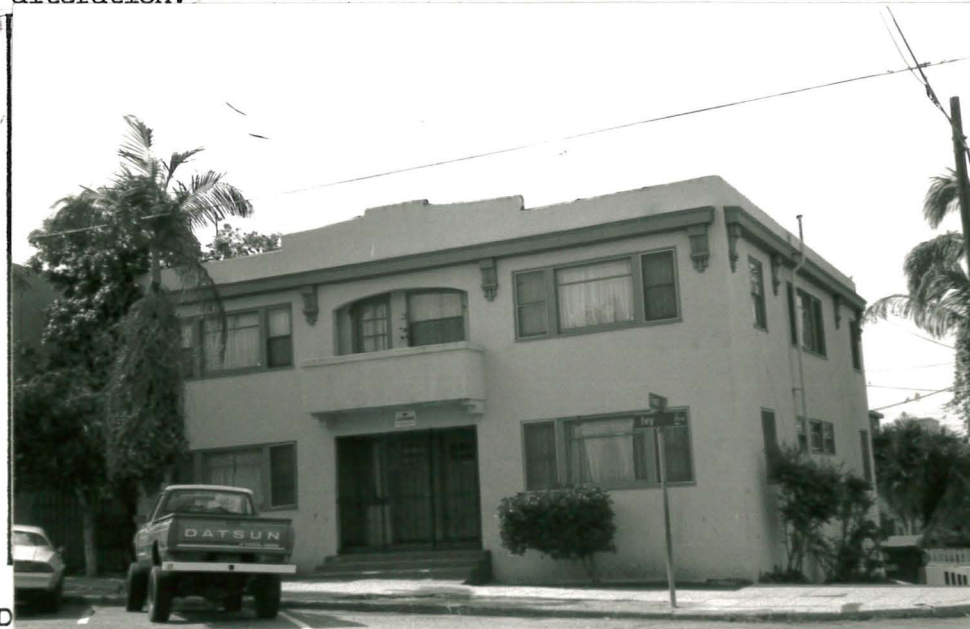
This Mission Style apartment building sits on a sloping corner lot. It is 2 stories in height w/a rear basement, stucco sided, and rectangular in shape. The flat roof has a parapet which is gabled in the center. The building is symmetrical w/a central recessed entry porch reached via 4 cement steps. The doors, 2 facing front, 2 opposing each other, are wood panel w/6 small rectangular glass panels in the upper portion. 3/4 glass side panels flank the front facing doors. Directly above the entry porch is a protruding balcony supported by stepped brackets and featuring stucco balustrades w/coping. A French door and a large double-hung window serve the balcony. Flanking the central element on both floors are wide 3-sash windows with central fixed panes, narrow glass transoms, and double-hung side panels. This window grouping also occurs on the west facade. Other windows are double-hung. A striking feature of the building is protruding horizontal bands w/four decorative brackets which run almost the full length of the front and west facades below the parapet. Wooden stairways at the rear lead to 1st floor entrance w/latticework above. The west facade has rectangular vents at the foundation level. Alterations include some doors, the iron security gate in front of the entrances, and a fence and gate on the SW corner. This building is almost identical to the building at 127-33 West Ivy, directly to the east. The two buildings are connected w/an iron fence which is an alteration.

13. Condition: Excellent _____ Good X Fair _____ Deteriorated _____ No longer in existence _____
14. Alterations: Some doors, security gate in front of entrances, iron fencing and gate
15. Surroundings: (Check more than one if necessary) Open land _____ Scattered buildings _____ Densely built-up X
Residential X Industrial _____ Commercial X Other: _____
16. Threats to site: None known X Private development _____ Zoning _____ Vandalism _____
Public Works project _____ Other: _____
17. Is the structure: On its original site? X Moved? _____ Unknown? _____
18. Related features: nearly identical building adjacent to structure

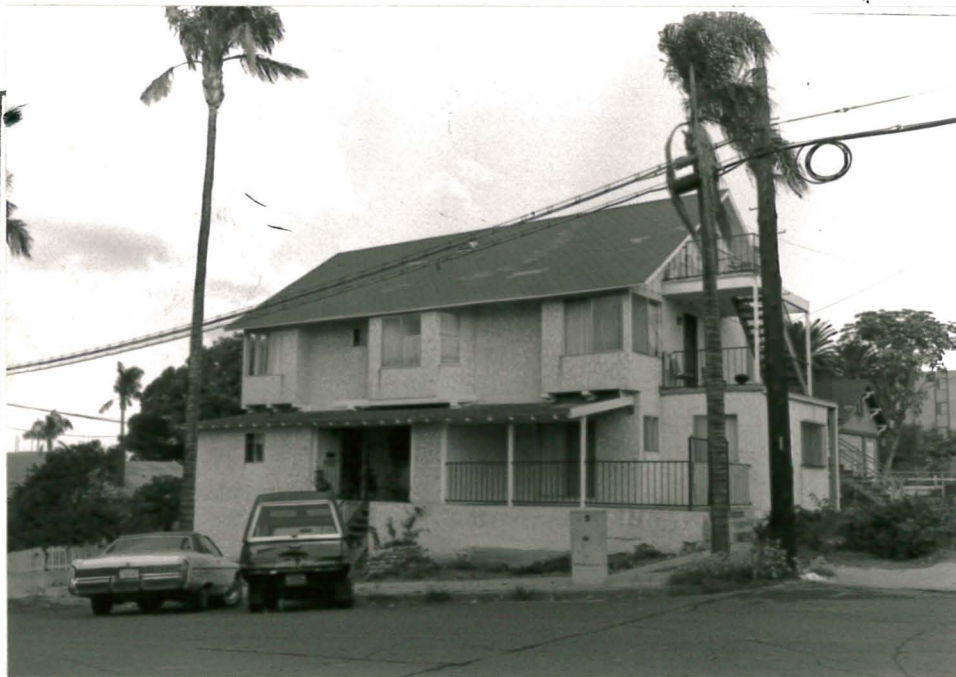
This 2 1/2 story home has been severely altered. Originally, the structure was stucco with decorative half-timbering above the bricked 1st story. The siding today is textured stucco. The windows were wooden framed with hinges and multipanes, some with fixed center panes and transoms which have been replaced with aluminum sliding windows and doors. The medium pitched gable roof had a shed roofed dormer and exposed rafters all of which have been removed. Three bays on the southern 2nd story still exhibit their original form. Below is a porch addition which is enclosed to the west. Balconies have been added to the eastern upper levels which are reached by a wooden stairway. The large 2nd story balcony is above the rectangular eastern 1st story addition. The gable ends contain board & batten siding, replacing the decorative stucco & half-timbering.

13. Condition: Excellent _____ Good _____ Fair _____ Deteriorated ☒ No longer in existence _____
14. Alterations: Siding, windows, security bars, 1st & 2nd story addition.
15. Surroundings: (Check more than one if necessary) Open land _____ Scattered buildings _____ Densely built-up ☒
Residential ☒ Industrial _____ Commercial _____ Other: _____
16. Threats to site: None known ☒ Private development _____ Zoning _____ Vandalism _____
Public Works project _____ Other: _____
17. Is the structure: On its original site? ☒ Moved? _____ Unknown? _____
18. Related features: _____

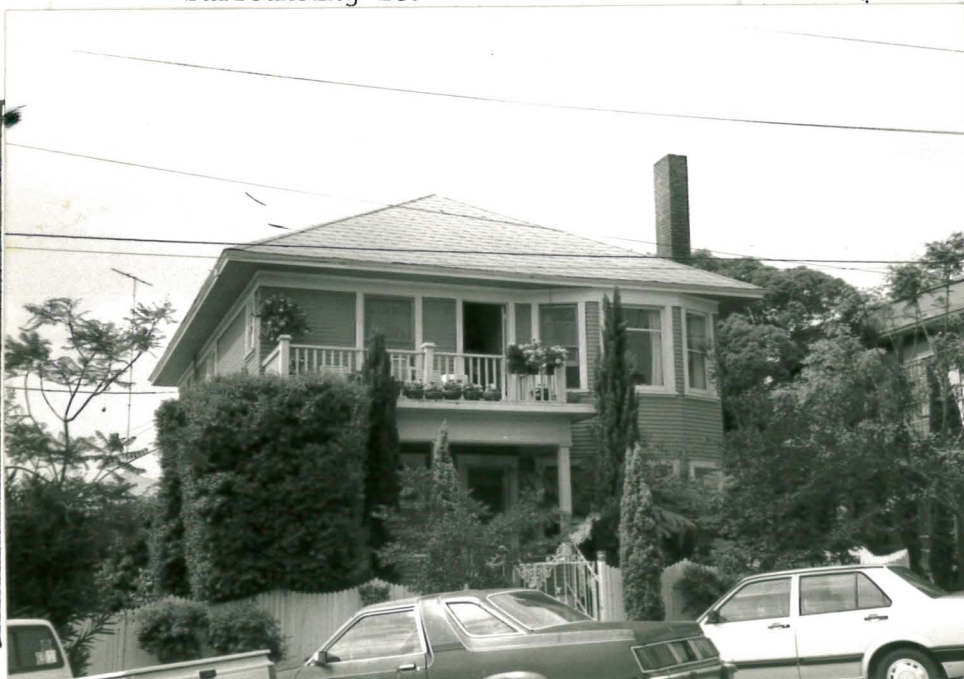
This 2-story rectangular house on a raised cement foundation has a high pitched hipped roof with asphalt shingles, a boxed cornice, widely overhanging eaves, and a plain frieze. It has clapboard siding and a horizontal band which runs around the house between the foundation and the 1st floor. A prominent porch, typical of Colonial Revival homes, is located on the eastern 2/3 of the front facade. It is reached from 5 cement stairs. The porch has a clapboard balustrade with coping. Three square wooden posts and a wide lintel supports a 2nd floor balcony with open wood balustrade and square posts. 2 front-facing doors are panelled wood with rectangular glass uppers and shelf surrounds. West of the porch, a 2-story wide angled bay is covered by the main roof. Windows are double-hung and fixed pane with leaded angular geometric transoms. Two chimneys, one interior, are located on the west side of the house. There is a driveway to the west. Alterations include a wrought iron gate and railing in front of the house and a wood fence surrounding it.

13. Condition: Excellent ☒ Good _____ Fair _____ Deteriorated _____ No longer in existence _____
14. Alterations: Wrought iron gate & railing, wooden fence
15. Surroundings: (Check more than one if necessary) Open land _____ Scattered buildings _____ Densely built-up ☒
Residential ☒ Industrial _____ Commercial _____ Other: _____
16. Threats to site: None known ☒ Private development _____ Zoning _____ Vandalism _____
Public Works project _____ Other: _____
17. Is the structure: On its original site? ☒ Moved? _____ Unknown? _____
18. Related features: None

This Colonial Revival flats were constructed in approximately 1903. Research indicates that they were built for Ida D. Chappell as investment property and designed by Irving John Gill. Gill was a prominent San Diego architect who has gained national recognition. He is credited with developing a simplified Mission Revival/Modern architectural style. This structure's architecture is typical of Gill during his early years as a professional architect. Gill began developing his individualistic style several years later. This structure is in excellent condition.

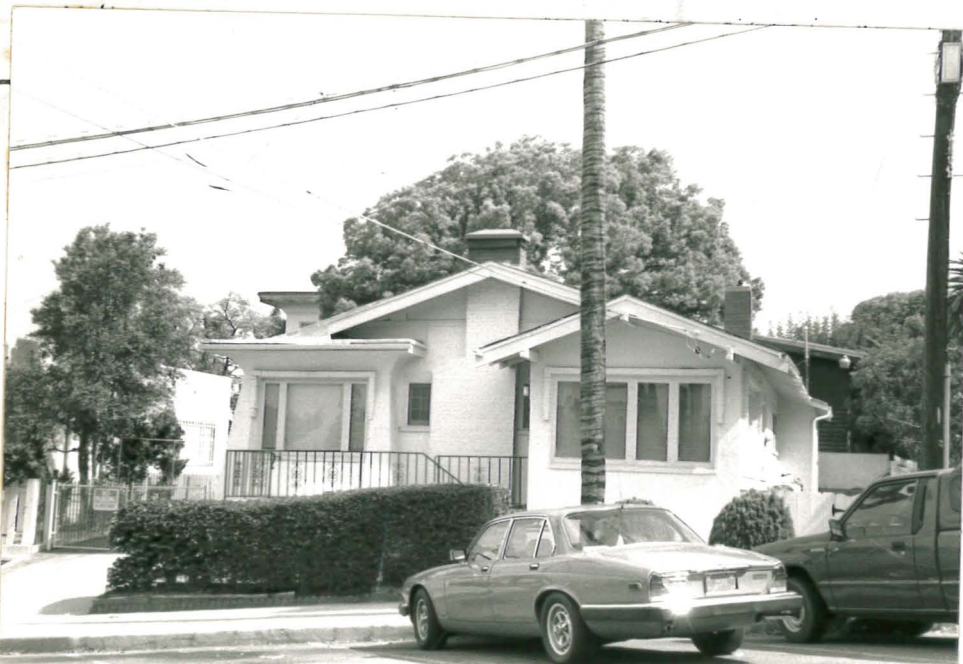
- 7a. Architectural style: California Bungalow
- 7b. Briefly describe the present *physical appearance* of the site or structure and describe any major alterations from its original condition: 232 West Ivy Street is a California Bungalow with alterations. The 1-story structure with basement is on a raised foundation and has smooth stucco siding. The medium-pitched front-gable roof has overhanging eaves and exposed rafters. A lower offset gable along the street facade extends to cover the main entry facing west with a row of 4 hinged windows with a brick lintel surround facing the street. The unusual brick surround is echoed on a 2nd extension on the western corner. The extension has a flat roof which flares from below and flares again down the sides giving the appearance of elephantine columns. The 3-sash extension window has a fixed center pane with narrow hinged sidepanels. The structure's side windows are wide & double-hung. The open front porch is stepped from the sidewalk with an iron banister. Centered between the 2 front extensions is a large brick chimney flanked by multi-paned hinged windows. The door is covered by a new metal security screen. Alterations include the front porch, the west corner extension and aluminum sliding windows on the east and west facades.

13. Condition: Excellent ___ Good ___ Fair X Deteriorated ___ No longer in existence: ___
14. Alterations: Front extension, porch, windows.
15. Surroundings: (Check more than one if necessary) Open land ___ Scattered buildings ___ Densely built-up ___
Residential X Industrial ___ Commercial ___ Other: ___
16. Threats to site: None known ___ Private development ___ Zoning X Vandalism ___
Public Works project ___ Other: ___
17. Is the structure: On its original site? X Moved? ___ Unknown? ___
18. Related features: ___

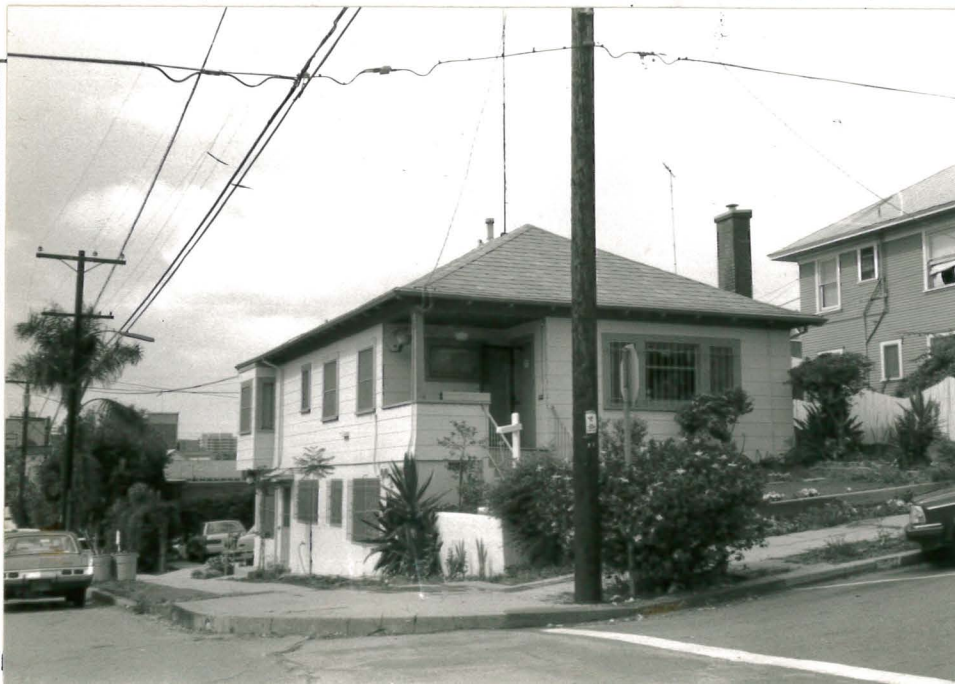
- 7a. Architectural style: Neoclassical Legal Desc: Blk 247 Lots K & L E 35 ft Horton's Add
- 7b. Briefly describe the present *physical appearance* of the site or structure and describe any major alterations from its Lockling original condition: This two-story Neoclassical home is situated on a rise to the west which covers the western and northern first level. The roof is a high-pitched hip with overhanging eaves and exposed worked rafters. A plain frieze surrounds the home which is now sheathed with asbestos shingle on the second story flaring slightly and becoming stucco on the first level. A tall brick chimney runs up the western facade. The windows are wide and double-hung with wide wooden surrounds and iron security bars on those that are accessible. The lower level windows are in pairs with a small wooden surround. The Ivy Street facade features a three-sash window with a fixed center pane and louvered side panels, which were originally multi-paned hinged windows matching those in the rear. The entrance is stepped from the sidewalk with an iron bannister leading to a small porch on the northeast corner. The porch is boxed with asbestos shingle and a square beam provides support for the roof corner. The door faces east and is solid wood with an iron security screen. Along Second Avenue is another entry with a cantilevered overhang and wood paneled door. Diagonally above is a square oriel bay on the southeast corner.

13. Condition: Excellent ___ Good ___ Fair X Deteriorated ___ No longer in existence ___
14. Alterations: Some windows, metal security screens, siding
15. Surroundings: (Check more than one if necessary) Open land ___ Scattered buildings ___ Densely built-up X
Residential X Industrial ___ Commercial X Other: ___
16. Threats to site: None known ___ Private development ___ Zoning X Vandalism ___
Public Works project ___ Other: ___
17. Is the structure: On its original site? X Moved? ___ Unknown? ___
18. Related features: ___

This is a non-contributing structure due to alterations to the original architecture, deterioration, and/or lack of historical significance.

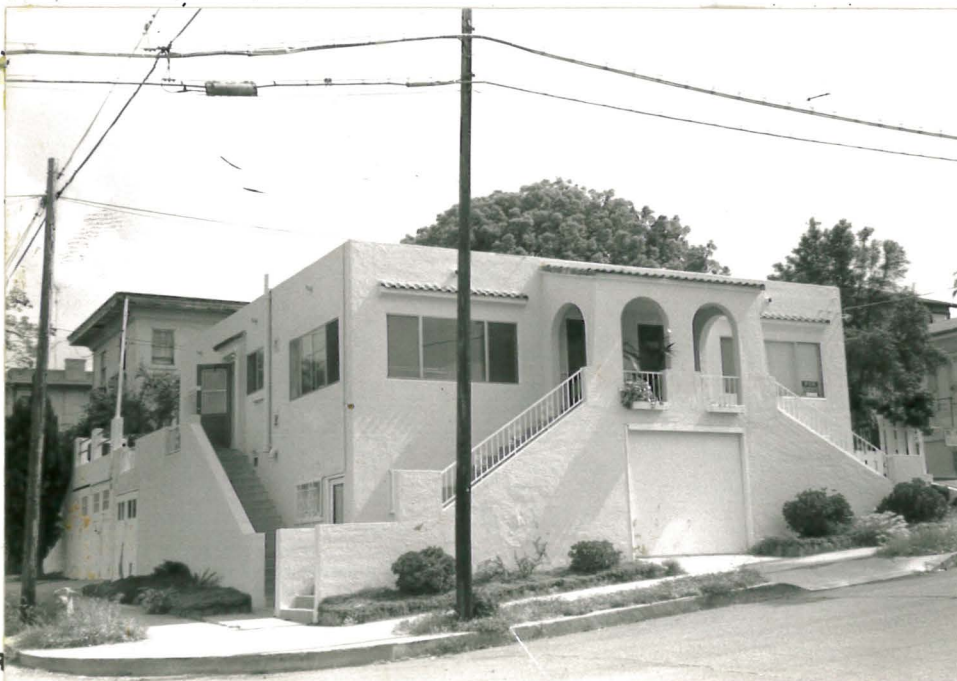
This rectangular stucco-sided Mission style house is two stories in height with a garage which acts as the first story in the front. It has a flat roof with a parapet and canalis near the roofline. Original windows on the first floor are hoppertype; second floor windows have been altered and are aluminum sliding windows, some with security bars. Doors, original on the 1st floor, are wood paneled with rectangular glass uppers. The two 2nd floor doors which are alterations are wood paneled. The front facade features a straight double stairway with stucco posts and wrought iron balustrades which rises to the 2nd floor entry porch. The porch is arcaded and covered by a red tile pent roof. A garage with new doors is directly below. Original wood window surrounds have been stuccoed over. Pent hoods are located above some of the windows. Cement stairways on the west and east sides lead to entries and stoops. Original garage doors on the west facade are wood paneled with rectangular glass uppers.

13. Condition: Excellent ___ Good X Fair ___ Deteriorated ___ No longer in existence ___
14. Alterations: Windows, New garage doors, window surrounds have been stuccoed over.
15. Surroundings: (Check more than one if necessary) Open land ___ Scattered buildings ___ Densely built-up X
Residential X Industrial ___ Commercial ___ Other: ___
16. Threats to site: None known X Private development ___ Zoning ___ Vandalism ___
Public Works project ___ Other: ___
17. Is the structure: On its original site? X Moved? ___ Unknown? ___
18. Related features: None

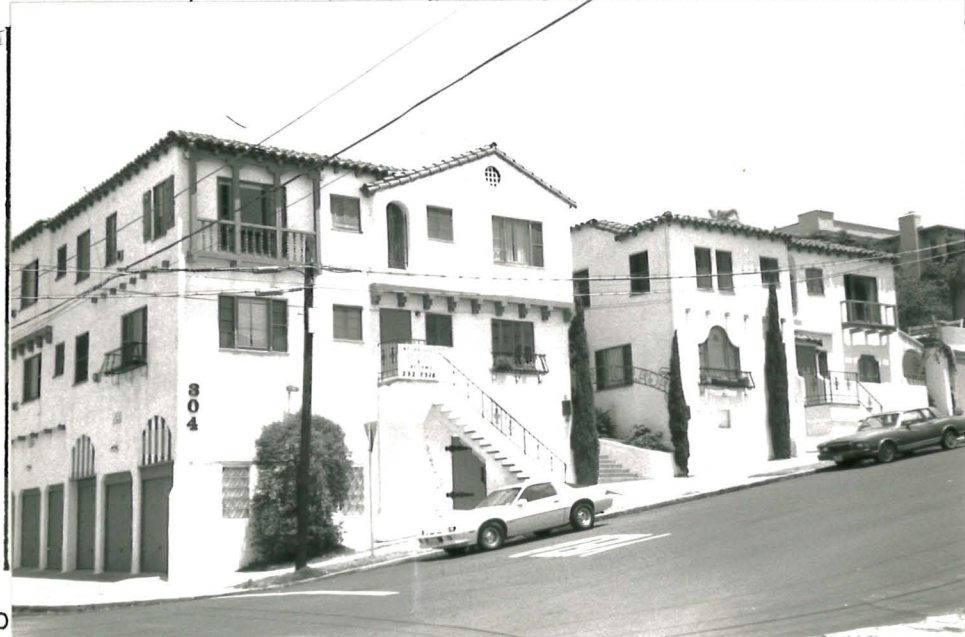
This three story stucco apartment building is situated on a rise to the east. A four story round turret with a red tile conical roof has been added and is visible from within the center courtyard. The red tile roof has slightly overhanging eaves and exposed rafters and has various shapes including hip, pent and gable with a latticed round roof vent. The stucco facade has various decorative features such as protruding walls with massive lentils and brackets below exposed rafters between levels and turned half timbering in recessed arches above the first story band of one car garages along the western facade. The windows are hinged multi-panes in various sash sizes and numbers. Some windows are arched or have curvilinear shapes with curving wrought iron balconettes, massive wooden balconettes with turned balustrades and shutters also providing ornamentation. The center courtyard is reached by a concrete stairway with a stucco banister and curving wrought iron sign above. The entry is arched with a half-timbered upper of worked balusters. Two entries on the southern wings are reached by stuccoed stairways from the east with iron banisters. Alterations include the center turret with aluminum sliding windows, ironwork and possibly the southwestern facade stairway and entry.

13. Condition: Excellent _____ Good X Fair _____ Deteriorated _____ No longer in existence _____
14. Alterations: turret addition, metal slider windows, iron work, stairs & entry
15. Surroundings: (Check more than one if necessary) Open land _____ Scattered buildings _____ Densely built-up X
Residential X Industrial _____ Commercial _____ Other: _____
16. Threats to site: None known X Private development _____ Zoning _____ Vandalism _____
Public Works project _____ Other: _____
17. Is the structure: On its original site? X Moved? _____ Unknown? _____
18. Related features: _____

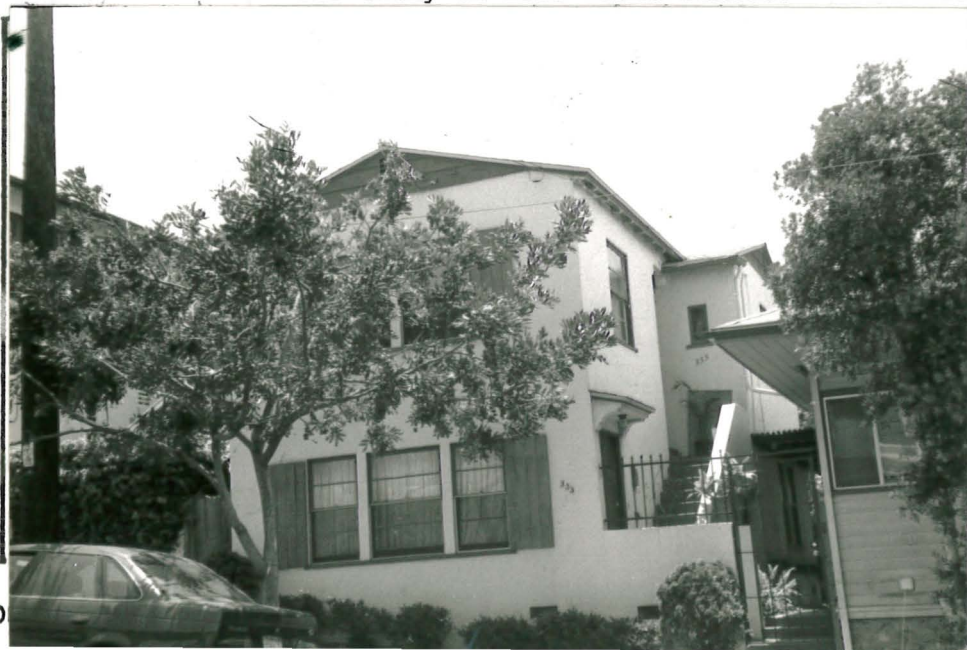
This 2-story L-shaped apartment building is situated on a rise which slopes to the west. The siding is stucco and the foundation rises from the ground level to the west with rectangular crawl space vents. The roof is a low-pitched cross gable with slightly overhanging eaves and exposed rafters. At the peaks of the gable ends are sections of shiplap siding with horizontal roof vents within. The windows exhibit 30's architecture with their horizontal multi-panes which are double-hung, with wooden shutters along the street facade.

An iron gate has been added to the main entry along West Ivy Street and opens to the apartment entries which face west along the western facade. Articulated stairs lead to the 1st story solid wood panel door with a shed roof overhang, boxed cornice and solid worked brackets. The steps continue from the 1st story stoop to the 2nd story apartment entry which is not visible from the street. The banister is solid stucco with a small narrow hinged window at the 1st stair landing. The gated entry is shared with the rear entry of 2169 Brant Street.

13. Condition: Excellent ___ Good X Fair ___ Deteriorated ___ No longer in existence ___
14. Alterations: Iron security gate.
15. Surroundings: (Check more than one if necessary) Open land ___ Scattered buildings ___ Densely built-up X
Residential X Industrial ___ Commercial ___ Other: ___
16. Threats to site: None known X Private development ___ Zoning ___ Vandalism ___
Public Works project ___ Other: ___
17. Is the structure: On its original site? X Moved? ___ Unknown? ___
18. Related features: None

This apartment building was built in 1936. It is in good condition and represents the building style of the time. Notable features are the bands of shuttered windows and the wood siding on the gable ends. This structure contributes to the variety of historic homes on this block of Ivy Street.

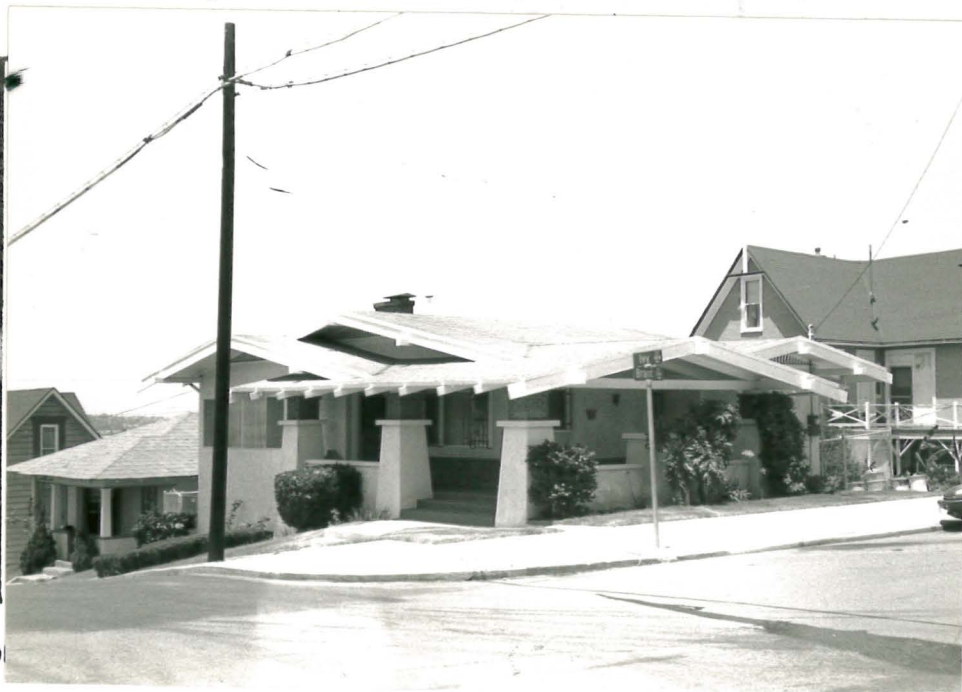
7b. Briefly describe the present *physical appearance* of the site or structure and describe any major alterations from its original condition: This irregularly-shaped California Bungalow is 1 story in height with a 2nd floor on the west side due to the slope of the lot. It is stucco sided and flared at foundation level, with a stepped brick skirting. The roof is low-pitch multi-cross-gabled of composition shingles with overhanging eaves and exposed rafters. Gable peaks contain decorative angled wood strips. Windows have been altered and are louvered, aluminum sliders, and aluminum casements, some with decorative ironwork. The door, also altered, is hollow-core wood. A series of cement steps leads to a porch with a stucco balustrade which wraps around the southeast corner of the house. Massive elephantine posts, square brick columns and a lintel support the side-gabled porch roof. A windowless square bay is located on the east porch facade. The house has a brick chimney; a driveway is to the north. Alterations include a shed-roofed addition to the north, the brick skirting, brick columns, windows, door stucco siding, mailbox, and porch light fixtures.

13. Condition: Excellent _____ Good _____ Fair X Deteriorated _____ No longer in existence _____
14. Alterations: Shed-roofed addition, brick skirting, brick columns, windows, door, stucco siding, mailbox, porch light fixtures.
15. Surroundings: (Check more than one if necessary) Open land _____ Scattered buildings _____ Densely built-up X
Residential X Industrial _____ Commercial _____ Other: _____
16. Threats to site: None known _____ Private development _____ Zoning X Vandalism _____
Public Works project _____ Other: _____
17. Is the structure: On its original site? X Moved? _____ Unknown? _____
18. Related features: None

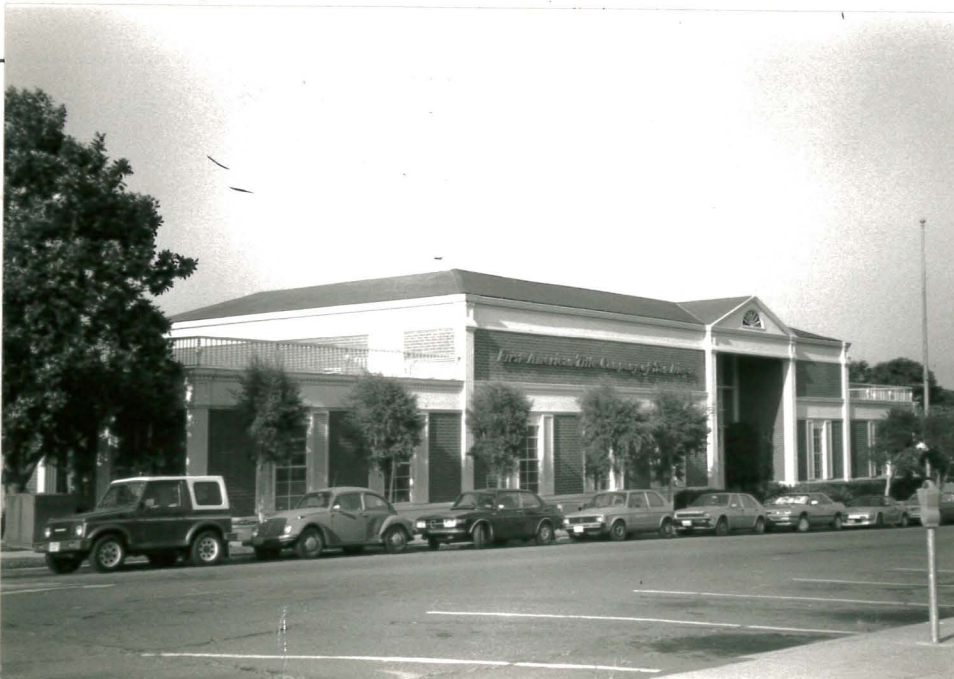
This two-story rectangular-shaped commercial structure covers the entire block of Ivy Street. The center two stories have a low-pitched truncated hip roof with a gable over the main entry. The eaves slightly overhang with molding, dentilwork and an enormous frieze below. The center two stories step down to one story on both sides with a patio above. The patio balustrade is open stickwork with turned posts. The windows are tall multi-paned metal casements with transoms and wooden shutters. The two-story recessed entry porch is sheltered by the front gable with a spindled fanlight within the pediment. Fluted pilasters on pedestals flank the entry porch and are echoed at each corner of the structure. The double wood-paneled doors have multi-paned sidepanels and a fanlight above with spindels and a large golden eagle statue in the center. The siding is brick with a cement block foundation. Wide bands similar to the upper frieze wrap around between the first and second floors and again near the foundation. The structure is surrounded by landscaping with a garden to the east and a parking lot to the south.

13. Condition: Excellent ☒ Good _____ Fair _____ Deteriorated _____ No longer in existence _____
14. Alterations: None
15. Surroundings: (Check more than one if necessary) Open land _____ Scattered buildings _____ Densely built-up ☒
Residential ☒ Industrial _____ Commercial ☒ Other: _____
16. Threats to site: None known ☒ Private development _____ Zoning _____ Vandalism _____
Public Works project _____ Other: _____
17. Is the structure: On its original site? ☒ Moved? _____ Unknown? _____
18. Related features: None

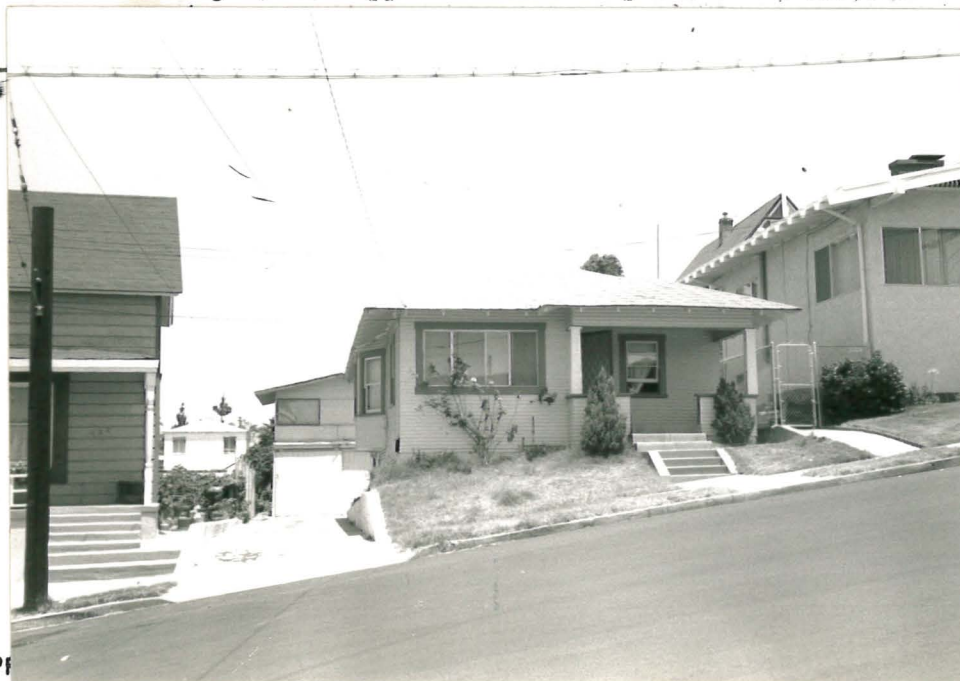
This 1-story rectangular-shaped home rests on a raised foundation with a basement below. The roof is a medium-pitched hip with an extension of the hip sheltering the front porch. The wide overhanging eaves have exposed rafters. Double-hung windows with wide wooden surrounds are placed among the clapboard sheathing and surround a wide-angled oriel bay along the western facade. The center window of the bay is fixed with a multi-paned transom. A large 3-sash window along the street facade has been replaced with an aluminum sliding window. The main entry is stepped from the sidewalk and leads to the front porch. The porch is boxed with a solid clapboard balustrade and has two square posts supporting the hip-roof extension and wide clapboard entablature. The solid wooden door faces east from inside the porch with a wide wooden surround, metal security screen and small vertical pane covered with iron bars. A narrow driveway to the west leads to a newer 2-car wood-doored garage with an apartment upstairs. The windows are aluminum sliding which supports the assumption that the rear structure is a later addition.

13. Condition: Excellent _____ Good ☒ Fair _____ Deteriorated _____ No longer in existence _____
Aluminum sliding windows, security doors
14. Alterations: _____
15. Surroundings: (Check more than one if necessary) Open land _____ Scattered buildings _____ Densely built-up ☒
Residential ☒ Industrial _____ Commercial _____ Other: _____
16. Threats to site: None known _____ Private development _____ Zoning ☒ Vandalism _____
Public Works project _____ Other: _____
17. Is the structure: On its original site? ☒ Moved? _____ Unknown? _____
Rear structure with garage below and apartment above
18. Related features: _____

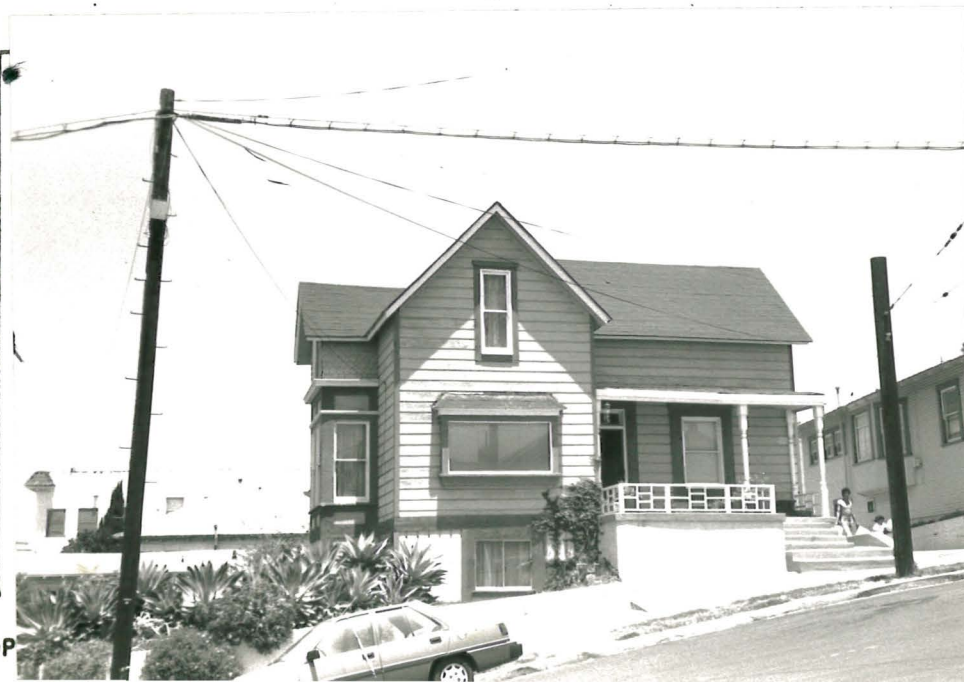
This irregularly-shaped Folk Victorian house sits on a sloping lot and is 1½ stories in height with a basement. It has a high-pitched cross-gabled roof with asphalt shingles, overhanging eaves, and a boxed cornice. An additional smaller gable is located over a square west-facing box. Siding is shiplap paneling with endboards. Fishscale and shingle siding with a protruding molding below is located on the 2nd story of a gabled bay on the west facade. Vertical shiplap, an alteration, covers the basement and a horizontal band, also an alteration, runs between the basement and the first floor. Original windows are narrow, double-hung. Altered windows include a protruding fixed-pane window with a hipped hood west of the entry way and some sliding windows. Wood window surrounds are alterations. The door is hidden by a security screen which is also an alteration. On the east side of the front facade, cement steps lead to a porch with a decorative open wood balustrade. Spindled posts support a porch roof. Of the porch elements, only the posts are original. On the W. side of the property, a cement retaining wall, a wooden gate, and a wooden fence are located. Alterations include the porch, windows, wood surrounds, siding, and security screen. The house was probably moved to the site.

13. Condition: Excellent _____ Good _____ Fair ☒ Deteriorated _____ No longer in existence _____
14. Alterations: Porch, windows, window surrounds, security screen, siding.
15. Surroundings: (Check more than one if necessary) Open land _____ Scattered buildings _____ Densely built-up ☒
Residential ☒ Industrial _____ Commercial _____ Other: _____
16. Threats to site: None known _____ Private development _____ Zoning ☒ Vandalism _____
Public Works project _____ Other: _____
17. Is the structure: On its original site? _____ Moved? ☒ Unknown? _____
18. Related features: None

This Folk Victorian home dates from the 1890's and was moved to this site, probably in 1921. Charles and Frank Midgely of Midgely Auto Repair lived in the home for several years. The building retains many design features which add to the historic character of the neighborhood.

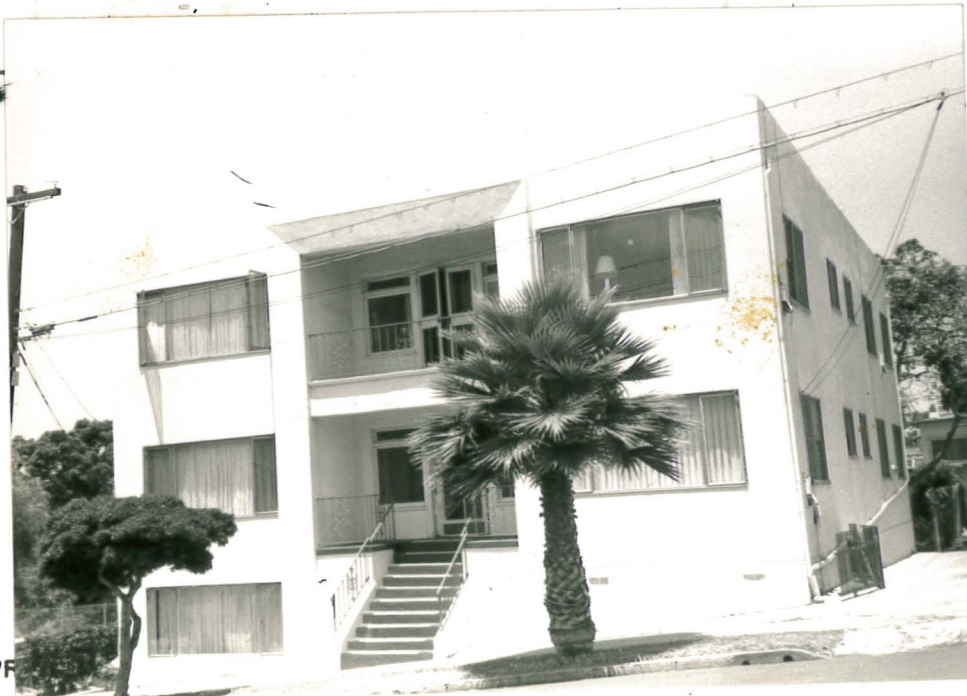
This 3-story rectangular apartment building is situated on a rise to the east. The stucco facade features symmetrical window and door placement with a flat roof. The windows are wood-framed and double-hung in pairs along the sides, however, the street facade windows have been altered. The 3-sash wood-framed windows are now metal casement with a fixed center pane. Centered between the windows is a massive 2-story entry and balcony surround which frames the recessed doorways. Both the 2nd story entry porch and 3rd story balcony have wrought iron balustrades & center doorways which are flanked by large fixed panes with glass transoms. The balcony contains double French doors while the main entry contains a wide wooden-frame door with a center pane. The main entry porch is reached by a tall carpeted stairway from the sidewalk with an iron banister. Two apartment entries are located along the west facade which are flanked by double-hung windows.

13. Condition: Excellent ___ Good X Fair ___ Deteriorated ___ No longer in existence ___
14. Alterations: 3-sash windows are now metal casement
15. Surroundings: (Check more than one if necessary) Open land ___ Scattered buildings ___ Densely built-up X
Residential X Industrial ___ Commercial ___ Other: Interstate 5
16. Threats to site: None known X Private development ___ Zoning ___ Vandalism ___
Public Works project ___ Other: ___
17. Is the structure: On its original site? X Moved? ___ Unknown? ___
18. Related features: None

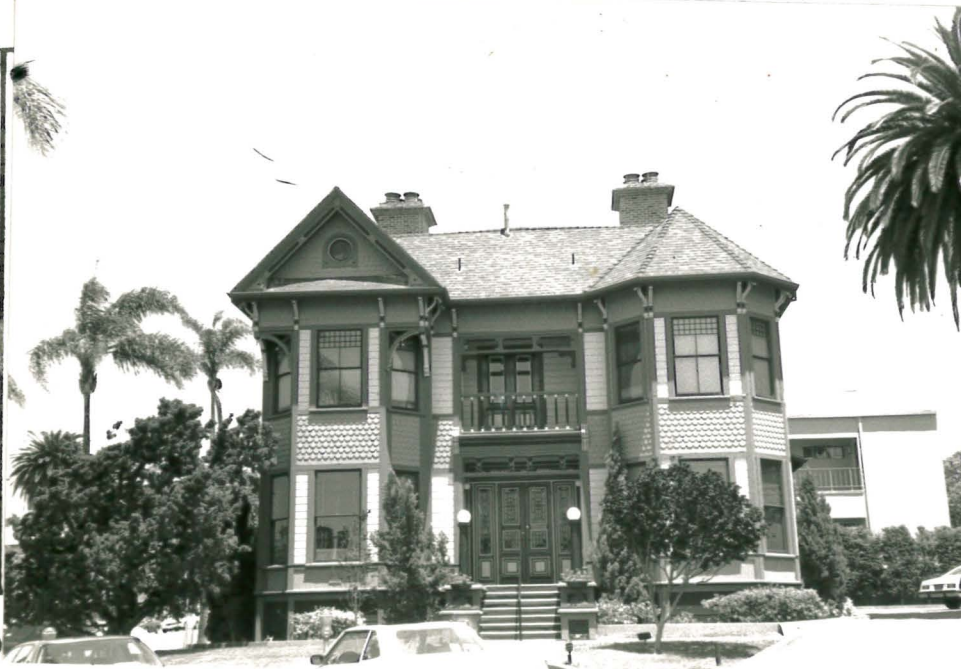
110 Juniper Street is a beautiful Queen Anne structure which is 2½ stories in height on a raised foundation. The roof is a steeply pitched multiple gable with overhanging eaves and decorative brackets below. The southwest corner is a wide-angled bay sheltered by a front gable with an enclosed pediment and round porthole window. Below are curving spindlework brackets which square off the upper portion of the rectangular bay. The southeast corner is a second 2-story bay with a segmented hip roof. Two massive square brick chimneys oppose each other at the gable peak. The windows are tall double-hung wooden windows with a half-timbering surround, while the upper windows have multi-paned uppers. The siding is shiplap with half-timbering and a band of fish-scale shingles between levels and within the front pediment. From the street, a new brick sidewalk leads to the center entry between the two bays. The entry is stepped and recessed with square posts, decorative urns and columns (alterations) with globe light fixtures atop. The double doors are wooden with ¾ leaded sidepanels. Above is a balcony with a worked balustrade and double wooded recessed doors. A large addition extends from the rear with the same sheathing, large pane windows and a flat roof.

13. Condition: Excellent _____ Good ☒ Fair _____ Deteriorated _____ No longer in existence _____
14. Alterations: extension on rear, brick sidewalk, lightposts
15. Surroundings: (Check more than one if necessary) Open land _____ Scattered buildings _____ Densely built-up ☒
Residential ☒ Industrial _____ Commercial ☒ Other: _____
16. Threats to site: None known ☒ Private development _____ Zoning _____ Vandalism _____
Public Works project _____ Other: _____
17. Is the structure: On its original site? ☒ Moved? _____ Unknown? _____
18. Related features: None

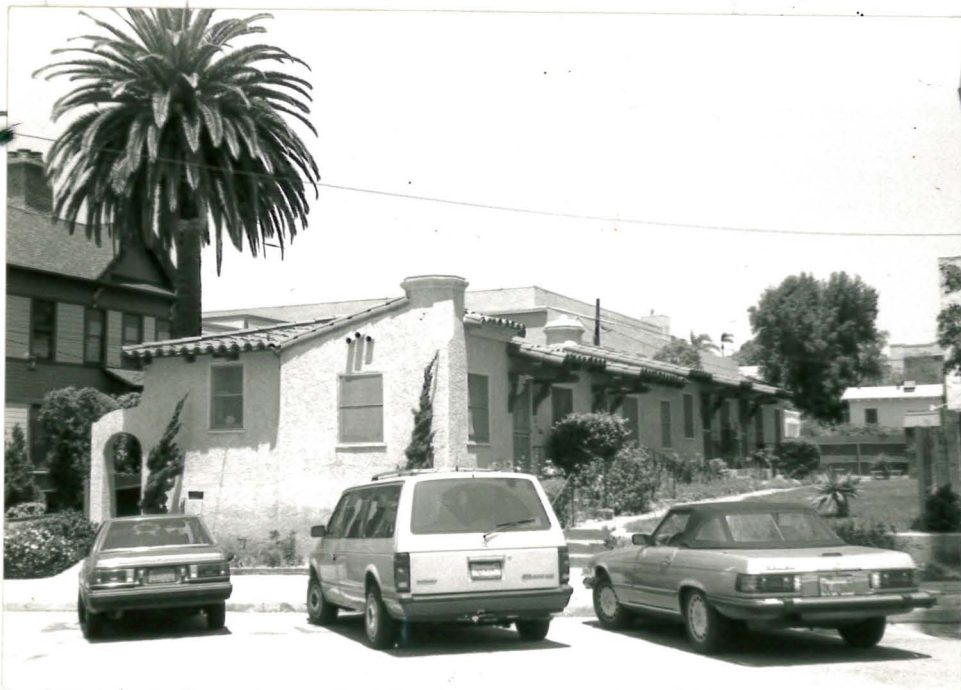
7b. Briefly describe the present *physical appearance* of the site or structure and describe any major alterations from its original condition: This 1-story rectangular apartment building has a stepped red tile hip roof with overhanging eaves and exposed rafters. Round and square canales are near the roofline along the stucco facades. The southeast corner protrudes slightly with an octagonal tower at the corner's edge which is repeated to the north within the hip roof. Portions of the roof extend to shelter the lintels. Many of the windows are louvred, which are possible alterations, while the remainder are double-hung. A courtyard to the east is faced by the apartment entries which are stepped with an iron banister leading to a single french door. An arched wing wall extends from the southern facade and is now covered with an iron security gate.

13. Condition: Excellent ___ Good X Fair ___ Deteriorated ___ No longer in existence: ___
14. Alterations: Security gate
15. Surroundings: (Check more than one if necessary) Open land ___ Scattered buildings ___ Densely built-up X
Residential X Industrial ___ Commercial X Other: ___
16. Threats to site: None known ___ Private development ___ Zoning X Vandalism ___
Public Works project ___ Other: ___
17. Is the structure: On its original site? X Moved? ___ Unknown? ___
18. Related features: ___

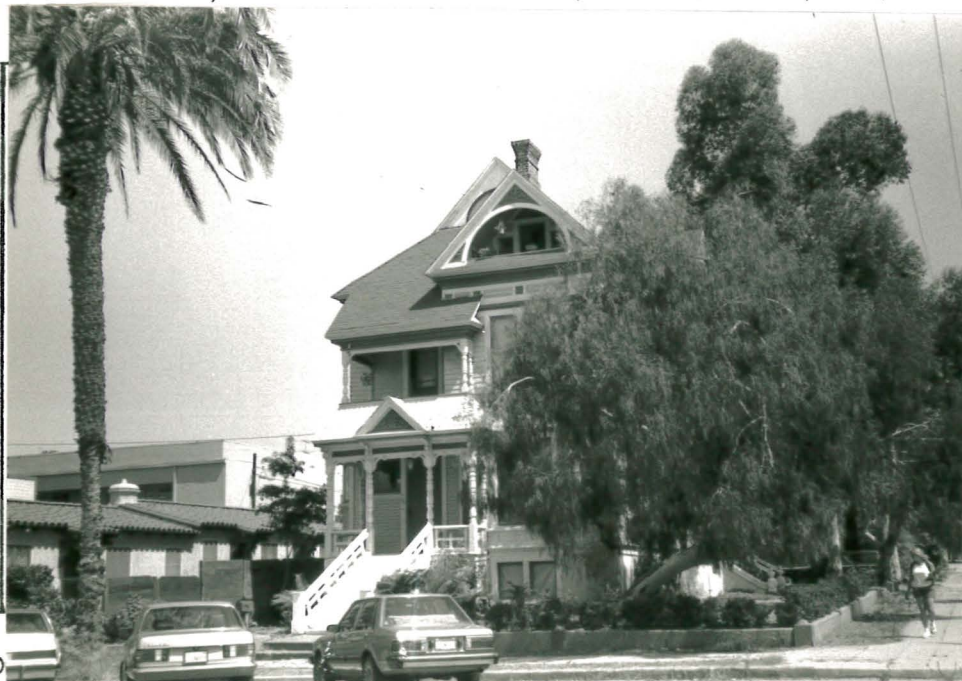
This 2½-story Queen Anne home is on a raised foundation with a basement entry along 2nd Street. The roof is a high-pitched hip with a gable roof and tall brick chimney at the peak and multiple hip with half-circle recessed porches or arched windows. The cornices are boxed with decorative friezes. The windows are tall and double-hung with bands of molding running above and below. Some are nearly square fixed windows with flashed leaded glass. The southern facade contains a 2nd story porch with turned posts, a boxed fishscale shingle balustrade, and a multi-pane wooden door within. Below is the main entry which is sheltered by a hip roof with a small center gable with decorative pediment. The wide ornate entablature is supported by turned posts which connect onto a stick balustrade. Wooden stairs lead to the porch with an altered banister and lattice work below the door is solid wood panel. Along the eastern facade is a second porch with a double-door entry. Bays are situated along the east and west facades, with paladian and curved double-hung windows. The siding is clapboard with bands of fishscale shingles and half-timbering.

13. Condition: Excellent ☒ Good _____ Fair _____ Deteriorated _____ No longer in existence _____
14. Alterations: none apparent
15. Surroundings: (Check more than one if necessary) Open land _____ Scattered buildings _____ Densely built-up ☒
Residential ☒ Industrial _____ Commercial _____ Other: _____
16. Threats to site: None known ☒ Private development _____ Zoning _____ Vandalism _____
Public Works project _____ Other: _____
17. Is the structure: On its original site? ☒ Moved? _____ Unknown? _____
18. Related features: none

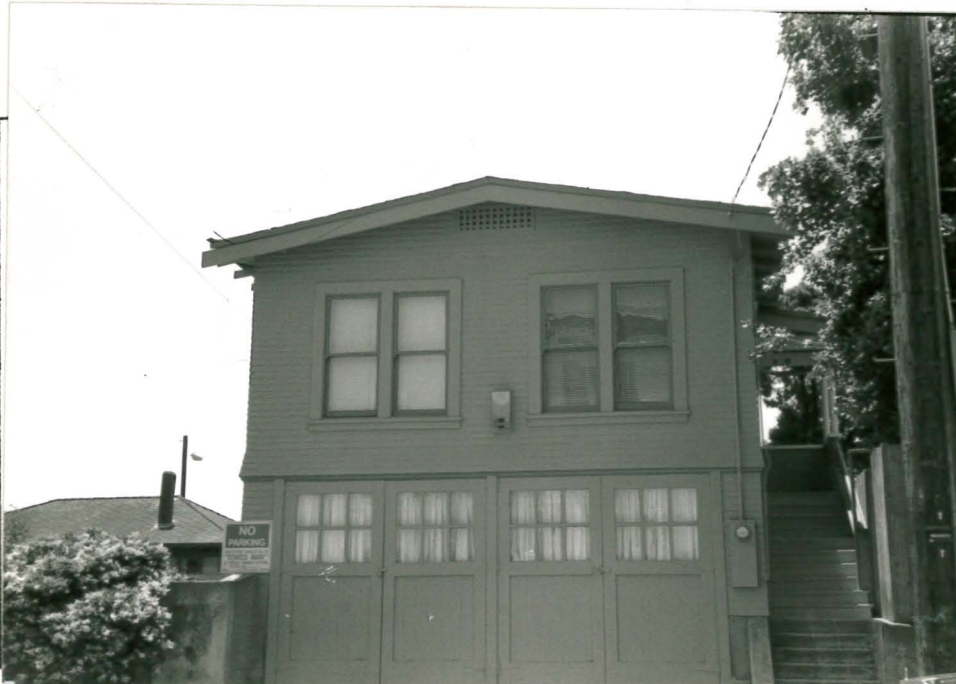
This 2-story structure accompanies the home at 2265 2nd Ave. The roof is a low pitched front gable with overhanging eaves and exposed rafters. The clapboard siding contains a latticed roof vent at the gable peak and flares slightly between the 1st and 2nd stories. The 1st story consists of 2 double door hinged garages with multi-paned uppers. The 2nd story is a possible 1915 Exposition addition to provide living space above. Indications include the wooden band just above the garage doors, the roof style and the 1st story windows placement along the edge of the cement stairway. The stairway leads to a small porch with 2 classical columns, plain entablature and extension of roof which provides shelter. The porch is boxed with solid clapboard. The windows are double-hung in pairs with wide surrounds over the front garage doors. Alterations include a louvred window along the east facade & the metal security screen over the entry.

13. Condition: Excellent ____ Good X Fair ____ Deteriorated ____ No longer in existence ____
14. Alterations: louvred window, metal security screen
15. Surroundings: (Check more than one if necessary) Open land ____ Scattered buildings ____ Densely built-up X
Residential X Industrial ____ Commercial ____ Other: ____
16. Threats to site: None known ____ Private development ____ Zoning X Vandalism ____
Public Works project ____ Other: ____
17. Is the structure: On its original site? X Moved? ____ Unknown? ____
18. Related features: accompanies home on 2265 2nd Ave.
