HISTORIC RESOURCES INVENTORY

1. Common name: None
2. Historic name: None
3. Street or rural address: 1916-1926 Front Street
City San Diego Zip 92101 County San Diego
4. Parcel number: 533-251-05
5. Present Owner: Robert Mellis Address: P.O. Box 2248
City San Diego Zip 92073 Ownership is: Public _____ Private X
6. Present Use: Residential Original use: Residential

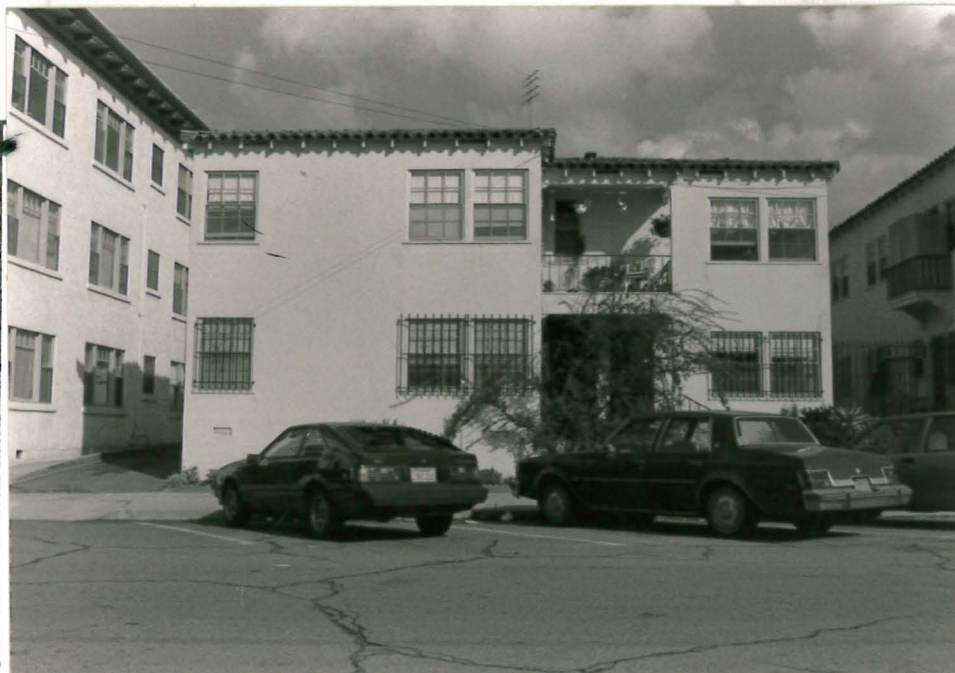
7b. Briefly describe the present *physical appearance* of the site or structure and describe any major alterations from its original condition: This 2 story Spanish Colonial Revival building has a medium pitch red tile hipped roof with slightly overhanging eaves and exposed rafters. It is L-shaped & stucco sided with rectangular vents at foundation level. Windows wrap the corners and are multi-pane double-hung, some with decorative wrought iron. Doors are multi-panel wood. A red tile stairway with a wrought iron railing leads to a front entry porch with 2 entry doors. Above the porch a balcony with a wrought iron balustrade & a red tile overhang is supported to a square wooden post. A lintel is located under the overhang. The west facade features a secondary entry with a cement stoop. The wooden stairway leads to the 2nd floor. Alterations include some aluminum sliding windows. A driveway to the west leads to a flat roofed garage. A related building to the east is connected by a wrought iron gate and fence.

13. Condition: Excellent ☒ Good _____ Fair _____ Deteriorated _____ No longer in existence _____
14. Alterations: Some aluminum framed windows.
15. Surroundings: (Check more than one if necessary) Open land _____ Scattered buildings _____ Densely built-up ☒
Residential ☒ Industrial _____ Commercial ☒ Other: _____
16. Threats to site: None known ☒ Private development _____ Zoning _____ Vandalism _____
Public Works project _____ Other: _____
17. Is the structure: On its original site? ☒ Moved? _____ Unknown? _____
18. Related features: Flat roofed garage to west; related building to east

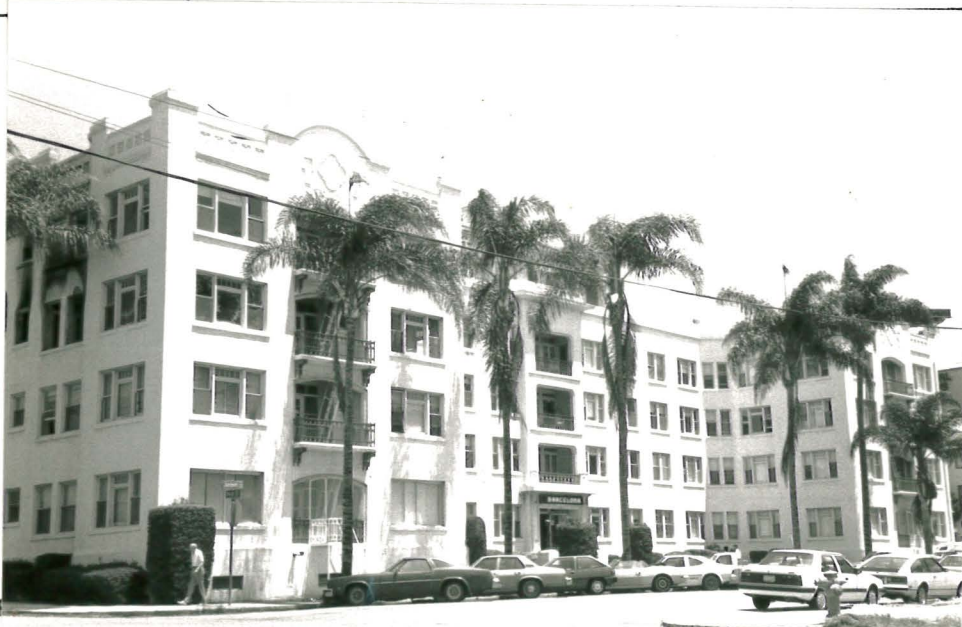
The Barcelona Apartments is a four story structure in a symmetrical U-shape with angled inner corners. The roof is flat with decorative end units consisting of fenestrated balustrades, square posts and espadana parapets with quatrefoils and key shapes within the stucco sheathing. The windows are double-hung usually in pairs along with three sash windows with a fixed center pane, multi-paned transom and double hung sidepanels. Balconies line the end units and line the center section. The balustrade are decorative wrought iron with twin iron brackets below the balcony extensions. The recessed doorways on the wing balconies are wood framed with two glass panes flanked by hinged multi-paned windows. The center balcony doors are recessed also with three pairs of double french doors and multi-paned transoms. The main entry is stepped with an iron railing which leads to the pair of aluminum framed glass doors with glass sidepanels and transom. Fire escape stairs run down the wind balconies to the first level balcony which is enclosed by metal screen (alteration). Additional alterations include the pent-house on the roof, neon signage and aluminum sliding windows on the southwestern wing unit.

13. Condition: Excellent _____ Good X Fair _____ Deteriorated _____ No longer in existence _____
14. Alterations: Penthouse, windows, signage, security screens
15. Surroundings: (Check more than one if necessary) Open land _____ Scattered buildings _____ Densely built-up X
Residential X Industrial _____ Commercial X Other: _____
16. Threats to site: None known X Private development _____ Zoning _____ Vandalism _____
Public Works project _____ Other: _____
17. Is the structure: On its original site? X Moved? _____ Unknown? _____
18. Related features: _____

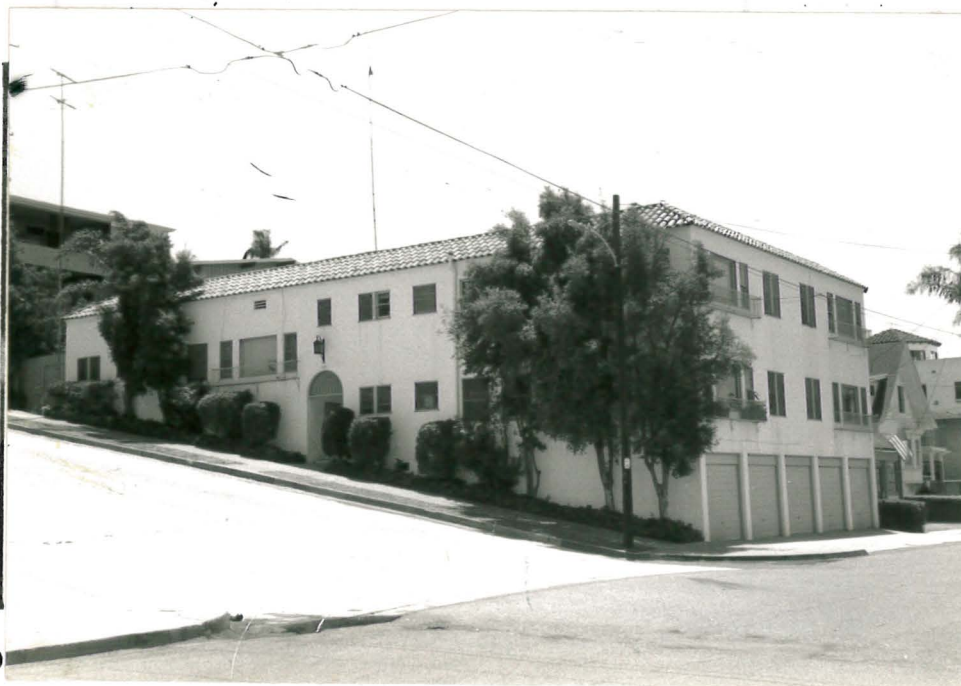
This rectangular two-story flat-roofed building has a red tile hip visor surrounded with shallow boxed overhanging eaves. Five garages of horizontal panel wood form a third story on the westside due to the slope on the lot. Windows consist of double-hung, fixed and some three sash with fixed center pane and double-hung side panels faced with balconets of wrought iron. The north-facing entry is arched with spindle work in the upper arch section. The recessed entry door is multi-panel wood reached from two cement block steps. A wrought iron light fixture is centered above the entry and rectangular vents are placed just below the roof line. The building is fenced and gated with a side entry on the northeast corner.

13. Condition: Excellent ☒ Good _____ Fair _____ Deteriorated _____ No longer in existence _____
14. Alterations: fenced, gated side entry
15. Surroundings: (Check more than one if necessary) Open land _____ Scattered buildings _____ Densely built-up _____
Residential ☒ Industrial _____ Commercial _____ Other: _____
16. Threats to site: None known ☒ Private development _____ Zoning _____ Vandalism _____
Public Works project _____ Other: _____
17. Is the structure: On its original site? ☒ Moved? _____ Unknown? _____
18. Related features: _____

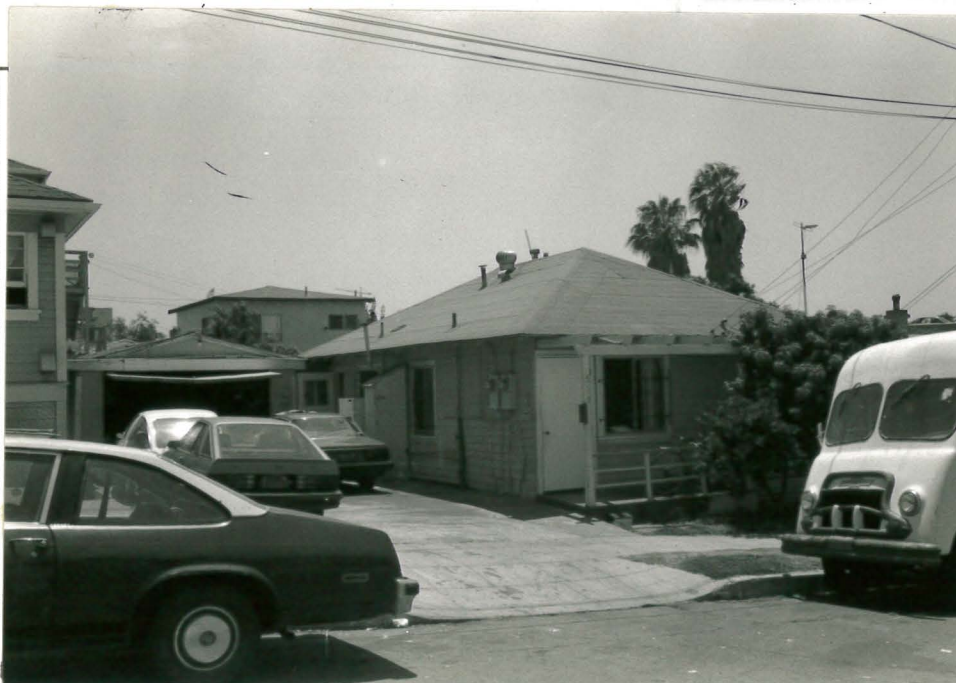
This one-story Neoclassical Cottage has a high-pitched hipped roof with asphalt sheeting, widely overhanging eaves, and shingle siding. The raised foundation on the west side is covered with plastic corrugated siding. Most of the windows have been altered and are aluminum sliding windows with wood surrounds. There are two unaltered hopper windows on the west facade. The doors, also altered, are hollow core wood in front and hollow core wood with a sliding aluminum upper on the east side. The slightly raised front porch has an open wood balustrade, square wooden posts, and lintel, which support a porch roof above extended exposed rafters. Alterations include windows, doors, and siding on the foundation. There is a driveway to the east.

13. Condition: Excellent ___ Good ___ Fair X Deteriorated ___ No longer in existence ___

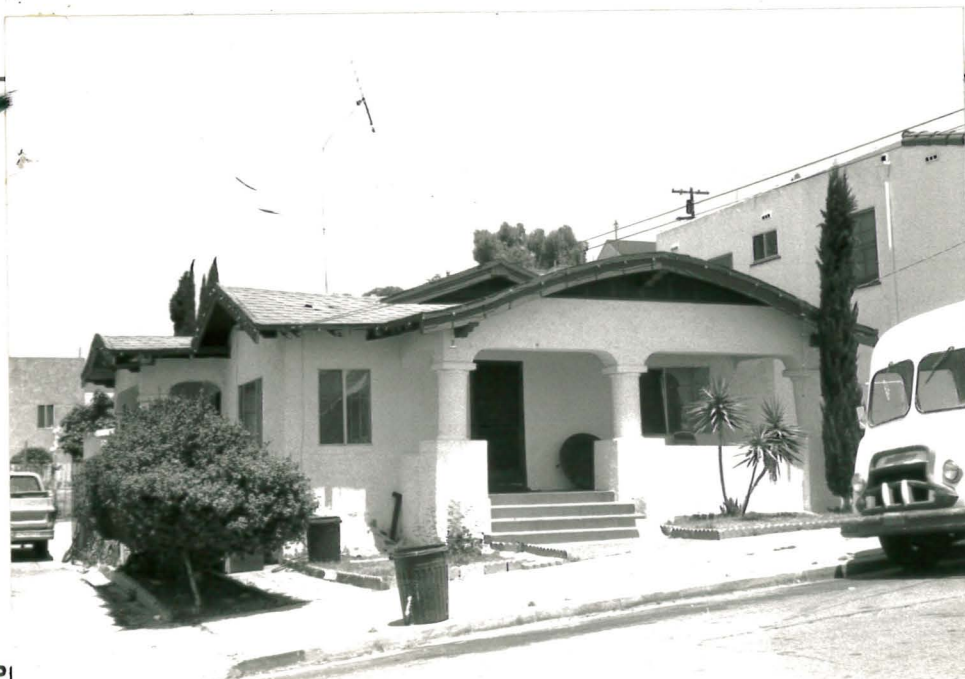
This one-story, irregularly-shaped building has a medium-pitched, multi-cross gable roof of composition shingle with exposed rafters beneath overhanging eaves. A recessed front gable roof sits within a side gable roof recessed behind an eyebrow-shaped front gable at the south entry. Worked knee brackets join the gable to a wide stuccoed lintel area supported by massive, straight, capped columns separating two semi-elliptical arches. Four plain cement steps lead to the covered porch beneath, with boxed, stucco balustrade and multi-panel wood entry door. A smaller, west-facing entry porch has the same eyebrow-like gable above, columns and arches of the main entry. However, the door is French with multi-paned side panels -- the last two remaining original windows. All other windows have been replaced in aluminum sliders. Wide bands of vertical slotted vents run the width of the gables at the top. Alterations include new stucco, a metal gate on the east side and a small one-story shed-roof addition on the northwest side.

13. Condition: Excellent ___ Good ___ Fair ___ Deteriorated X No longer in existence ___
14. Alterations: Stucco, metal slider windows, columns, gate, addition.
15. Surroundings: (Check more than one if necessary) Open land ___ Scattered buildings ___ Densely built-up X
Residential X Industrial ___ Commercial ___ Other: ___
16. Threats to site: None known ___ Private development ___ Zoning X Vandalism ___
Public Works project ___ Other: ___
17. Is the structure: On its original site? X Moved? ___ Unknown? ___
18. Related features: None

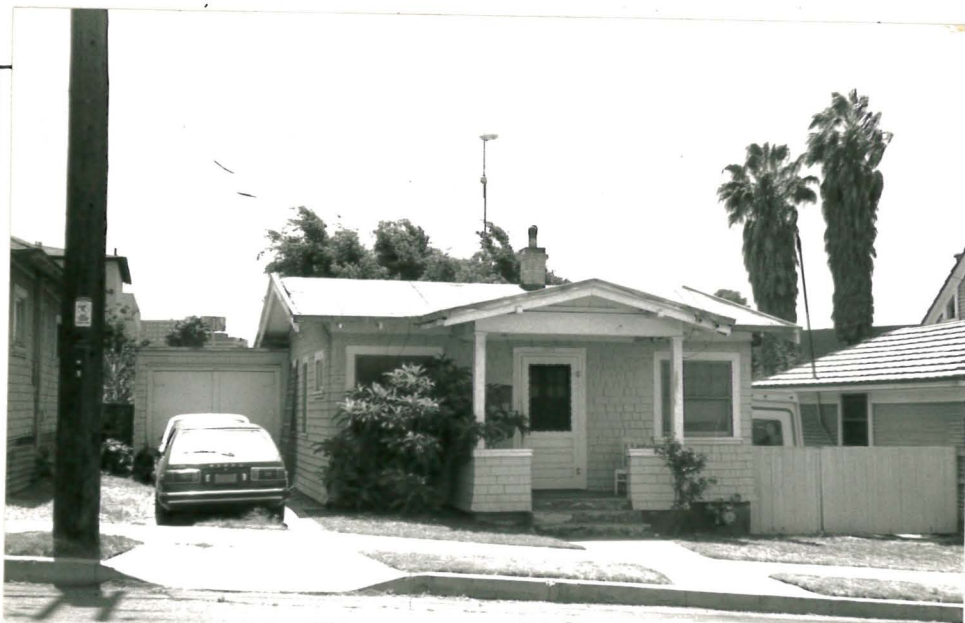
This one-story rectangular building has a centered cross-gable roof of composition sheeting, wide overhanging eaves with exposed rafters and a plain frieze running beneath. The windows are double-hung with multi-pane uppers. Three cement steps lead from the street to a covered porch which forms the front gable. A boxed balustrade lines the steps and porch with square, wooden corner posts and lintel above. A plain wooden door with a multi-pane upper stands behind a wooden screen door with plain wide surround. The shingle siding flairs at the foundation and an interior chimney is centered behind the front gable. An alteration to the building is a single-car shed-roof garage on the east side of the building with shingle siding and center opening plain, hinged garage doors.

13. Condition: Excellent _____ Good ☒ Fair _____ Deteriorated _____ No longer in existence _____

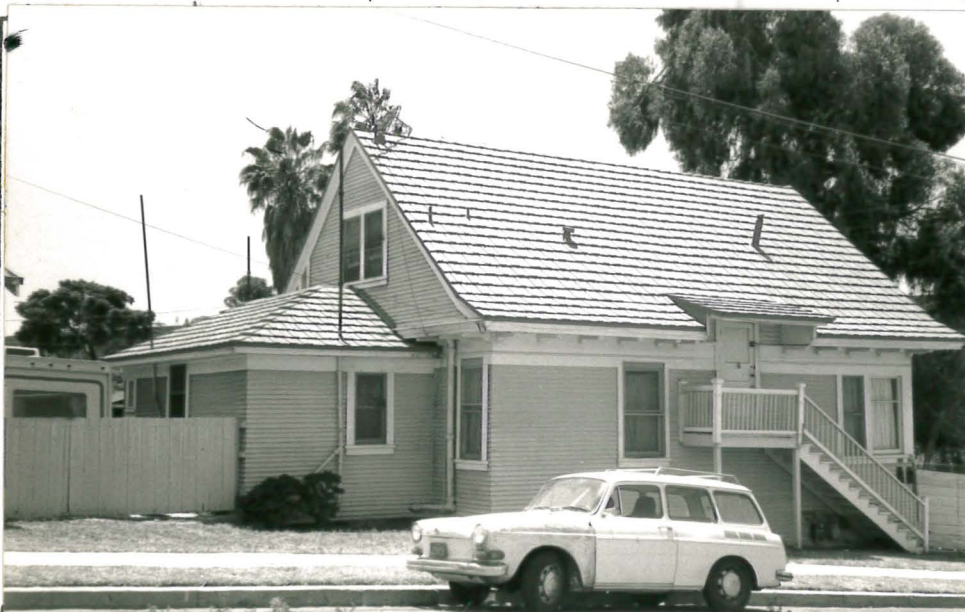
7b. Briefly describe the present *physical appearance* of the site or structure and describe any major alterations from its original condition: This 2-story Colonial Revival home previously faced State St. prior to the construction of Interstate 5 which is located directly to the west of the structure. The roof is a high-pitched belicast side gable with widely overhanging eaves, a boxed cornice, square brackets and plain frieze. The 2nd story is situated entirely within the gable roof and a large hip dormer with a 3 sashed window protrudes on the southern facade. The windows are double-hung with wide wooden surrounds. Paired windows are within the gable ends and a 4-sashed window with fixed center panes, transoms and double-hung side panels wraps around the northwest corner. The southern facade contains the original entry porch with a hipped roof, boxed clapboard balustrade, wide entablature and square posts. The wide door has wooden panels with a glass upper pane. The northern entry along West Juniper is an alteration and is reached by a tall wooden stairway which leads to a stoop between the 2 levels with a stick banister and balustrade. The door is wood paneled with a glass upper sheltered by a raised pent roof extending from the roof. The west facade features a square oriel bay with brackets below. The eastern facade features a 1920's-story hip roof addition with clapboard siding and recent roofing identical to that of the

main structure.

13. Condition: Excellent ___ Good X Fair ___ Deteriorated ___ No longer in existence ___
14. Alterations: East addition, roofing.
15. Surroundings: (Check more than one if necessary) Open land ___ Scattered buildings ___ Densely built-up X
Residential X Industrial ___ Commercial ___ Other: ___
16. Threats to site: None known ___ Private development ___ Zoning X Vandalism ___
Public Works project ___ Other: ___
17. Is the structure: On its original site? X Moved? ___ Unknown? ___
18. Related features: None

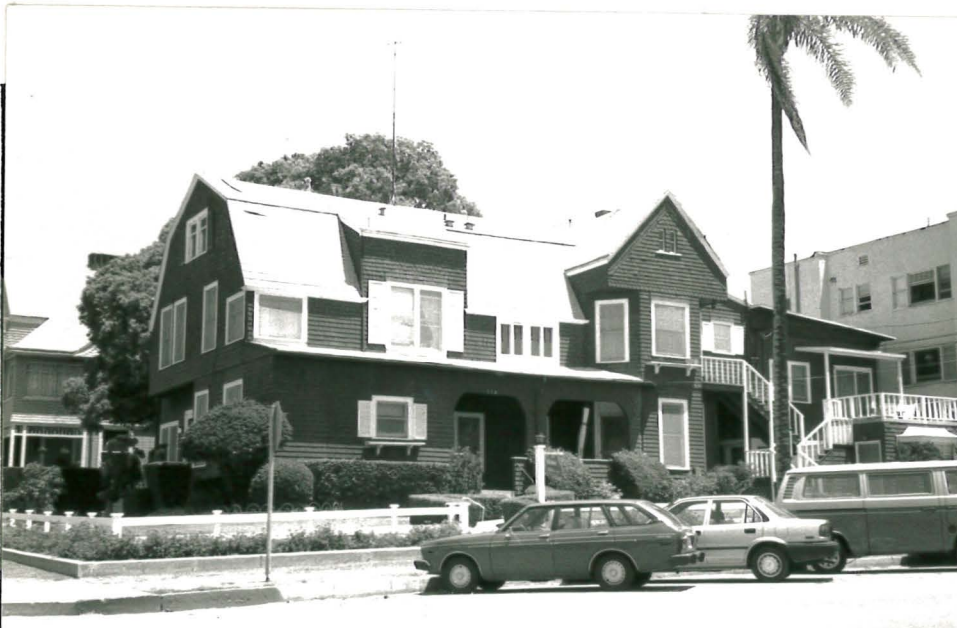
This 2½ story irregular shaped colonial revival building has an asphalt shingled gambrel roof with a cross gable peak and angled shingles over the recessed arches surrounding the porch. Windows are double hung, some with multi-pane angular geometric uppers, some with shutters, and some with bracketed shelves below. All windows have wood surrounds, cement steps and curving walkways which lead to three wooden steps which lead to an arcaded porch enclosed in the east and west sides. A shingled balustrade and shingled posts support a pent roof which extends over the first story from the northwest corner of the building to a second story cutaway bay, located under the gable. East of the bay, an articulated wooden stairway with an open wood railing leads to a second floor entrance. East of the stairway is a roofed addition with a second floor balcony. The west facade has a stepped entry with a stoop, which is sheltered by a second floor overhang. The house has an interior chimney. The north addition, a second addition with a gabled roof to the north, the enclosure of the second floor balcony on the north facade, and a stairway to the second floor, on the north.

13. Condition: Excellent ___ Good ___ Fair X Deteriorated ___ No longer in existence ___
 14. Alterations: pent roofed addition to east, two story additions to north enclosure of second floor balcony on north, wooden stairwall to 2nd floor on the north.
15. Surroundings: (Check more than one if necessary) Open land ___ Scattered buildings ___ Densely built-up X
 Residential X Industrial ___ Commercial X Other: ___
16. Threats to site: None known X Private development ___ Zoning ___ Vandalism ___
 Public Works project ___ Other: ___
17. Is the structure: On its original site? X Moved? ___ Unknown? ___
18. Related features: none

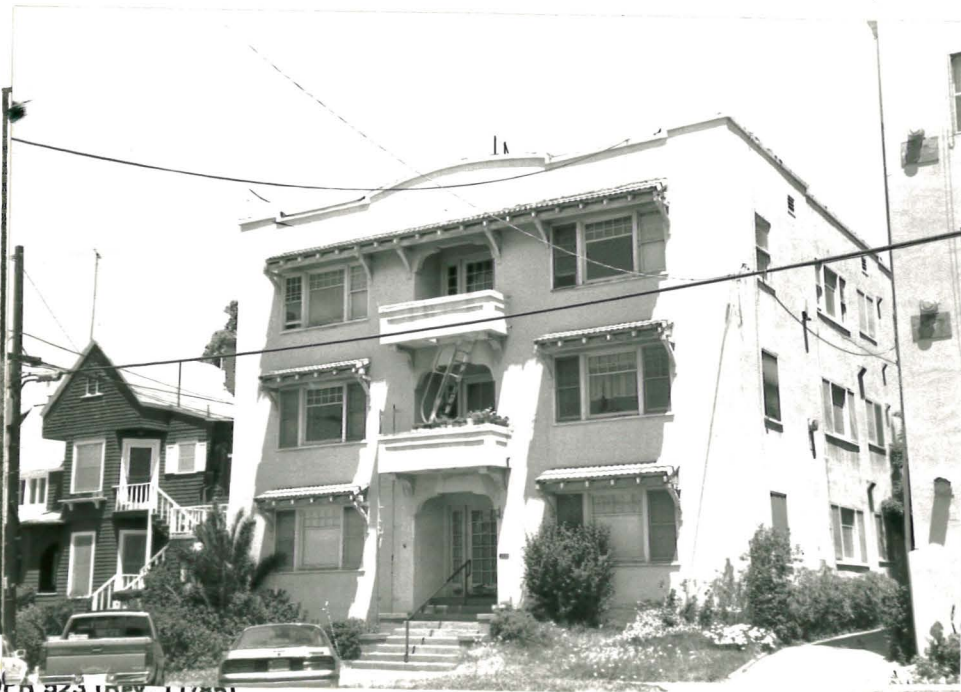
- 7a. Architectural style: Mission Revival
- 7b. Briefly describe the present *physical appearance* of the site or structure and describe any major alterations from its original condition: 128 East Kalmia Street is a 3-story stucco apartment building which is rectangular in shape on a raised foundation. The roof is flat with a low stepped curving parapet with a stucco coping. Three sash windows with a fixed center pane, multi-paned transom and multi-paned double-hung sidepanels are symmetrically placed along the street facade. The side windows are also double-hung in single, double and triple sashed varieties. Above the street facade windows are red-tile shed roofs with exposed rafters, lintels and knee brackets. The central element is a series of centered recessed balconies along the street facade. The balcony balustrades are solid stucco and extend outward from the facade, supported by large curving brackets. The balcony a Spanish-style arch. The main entry door is a wider variety of the balcony door which is stepped from the street with a metal banister and square stepped concrete posts. The structure is sheathed in stucco with recessed panels on the balcony balustrades and fire escape ladders extending down the facade through the balconies. Alterations include the 2nd story balcony door which is now a 2-paned wood framed door with 2-paned sidepanels.

13. Condition: Excellent _____ Good X Fair _____ Deteriorated _____ No longer in existence _____
14. Alterations: 2nd story balcony door
15. Surroundings: (Check more than one if necessary) Open land _____ Scattered buildings _____ Densely built-up X
Residential X Industrial _____ Commercial _____ Other: _____
16. Threats to site: None known X Private development _____ Zoning _____ Vandalism _____
Public Works project _____ Other: _____
17. Is the structure: On its original site? X Moved? _____ Unknown? _____
18. Related features: Small rear wooden garage reached by the east driveway.

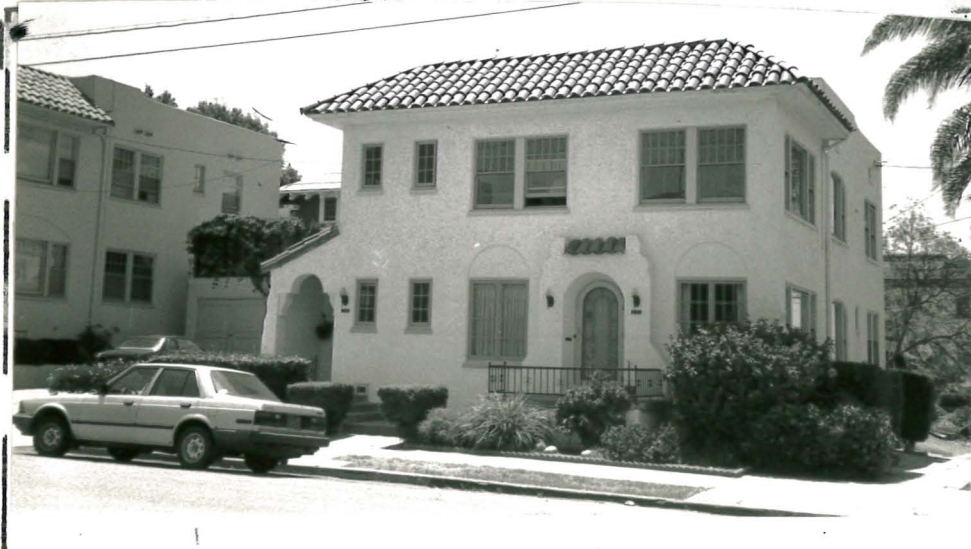
This irregularly shaped stucco sided Spanish Colonial apartment building is two stories in height. The roof is predominantly flat with a hipped red tile section in the front, which has widely overhanging eaves and wraps around the corners. Windows are varied. On the front facade, small multi-pane casements are featured to the east and to the west pairs of second story double-hung windows with multi-pane uppers are located above long multi-pane casement windows in recessed arches. The west facade has elliptically arched window groups with fixed central pane and multi-pane, double-hung side panels. Entryways are prominent. To the east, cement stairs lead to an entry porch deeply recessed behind a curving Spanish Colonial style archway and beneath a red tile pent roof. Near the center of the front facade, another stairways leads to a small entry porch with a wrought iron balustrade. The entry door is recessed in an arched and buttressed surround with a red tile hood. The door itself, flanked by light fixtures, is elliptically arched with a wood frame and glass panels. Other doors are wood panel and wood with rectangular glass uppers. The west facade has a square roof vents. A second floor entry is reached from a wood staircase on the east. A driveway to the east leads to a two-car garage with doors that roll horizontally to open. The garage roof serves as a balcony with a stucco balustrade. Alterations include new stucco and the wood stairway.

13. Condition: Excellent ☒ Good _____ Fair _____ Deteriorated _____ No longer in existence _____
14. Alterations: New stucco, wood stairway
15. Surroundings: (Check more than one if necessary) Open land _____ Scattered buildings _____ Densely built-up ☒
Residential ☒ Industrial _____ Commercial ☒ Other: _____
16. Threats to site: None known ☒ Private development _____ Zoning _____ Vandalism _____
Public Works project _____ Other: _____
17. Is the structure: On its original site? ☒ Moved? _____ Unknown? _____
18. Related features: garage

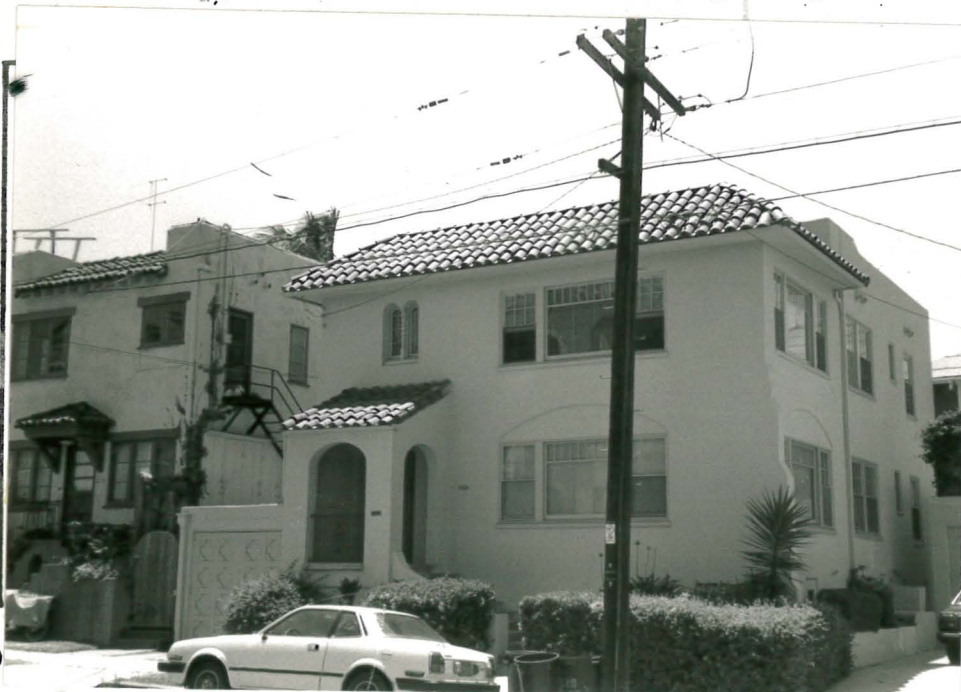
- 7a. Architectural style: Spanish Colonial Revival
- 7b. Briefly describe the present *physical appearance* of the site or structure and describe any major alterations from its original condition: This 2-story irregular-shaped structure is situated on a raised foundation. The asymmetrical facade, stucco siding arched windows and entries are typical of the Spanish Colonial style. The roof is flat to the rear with a truncated red-tile hip roof with a boxed cornice on the front 1/2 of the structure. The flat portion of the roof rises near the hip roof and has pairs of canales along the side facades. The windows are primarily 3-sash with a center fixed pane, multi-paned transom and double-hung side panels with multi-paned uppers. Side windows vary from 1-3 sashes in the double-hung variety. The entry is arcaded and stepped from the sidewalk. The porch is sheltered by a red-tile shed roof and protrudes from the northeast corner. The porch contains a simple iron balustrade and 2 deeply recessed wooden framed doors with inner multi-paned arches. Above the entry are 2 narrow arched windows with multiple panes. To the east & west of the structure are 1-car garages with flat roofs and decorative wood-paneled hinged doors. The stucco sheathing features semi-elliptical niches above the 3-sash windows, square niches around the porch foundation and buttressing along the northern street facade corners.

13. Condition: Excellent ☒ Good _____ Fair _____ Deteriorated _____ No longer in existence _____
14. Alterations: _____
15. Surroundings: (Check more than one if necessary) Open land _____ Scattered buildings _____ Densely built-up ☒
Residential ☒ Industrial _____ Commercial _____ Other: _____
16. Threats to site: None known ☒ Private development _____ Zoning _____ Vandalism _____
Public Works project _____ Other: _____
17. Is the structure: On its original site? ☒ Moved? _____ Unknown? _____
18. Related features: _____ None _____

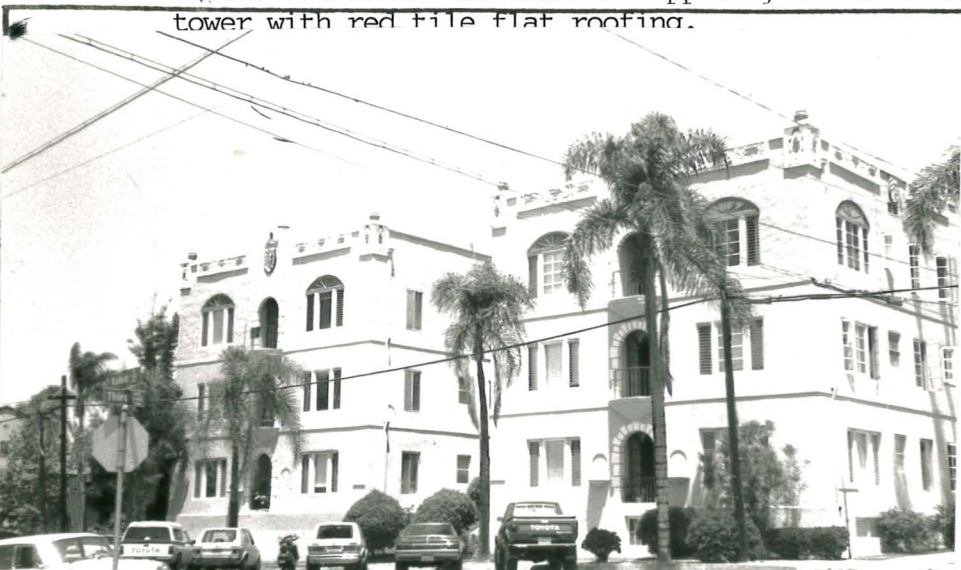
- 7a. Architectural style: Spanish Colonial Revival
- 7b. Briefly describe the present *physical appearance* of the site or structure and describe any major alterations from its original condition: This 3-story apartment court with basement is on a raised foundation with stucco siding. The building is U-shaped with a narrow landscaped center court leading to the main entry. The roof is flat with a decorative parapet consisting of centered espadan's with plaster shields and decorative bands of plaster leading to square corner posts topped by urns. The windows are placed symmetrically in bands of 3, 2 and single sash varieties. The original windows are multi-pane wooden hinged or double-hung many of which have been replaced with single fixed panes, louvred and aluminum framed. Above the 3rd story 3-sash windows are decorative fanlights. Arched windows line the center section while arched oriel balconies line each floor of the end units. The recessed balconies have stepped corbeling below with an iron balustrade and quoin surround. Flanking each 1st story balcony is an arched shelf of plaster. Within the balconies are arched multi-paned double doors. The center court is stepped from the sidewalk with a center statue of a woman holding a globe lamp. The main doorway consists of double french doors with an arched fanlight above. The center section is topped by a 4th story sunroom with a tower with red tile flat roofing.

13. Condition: Excellent ___ Good ___ ☒ Fair ___ Deteriorated ___ No longer in existence ___
14. Alterations: Some windows replaced with louvered & aluminum
15. Surroundings: (Check more than one if necessary) Open land ___ Scattered buildings ___ Densely built-up ☒
Residential ☒ Industrial ___ Commercial ___ Other: ___
16. Threats to site: None known ☒ Private development ___ Zoning ___ Vandalism ___
Public Works project ___ Other: ___
17. Is the structure: On its original site? ☒ Moved? ___ Unknown? ___
18. Related features: _____

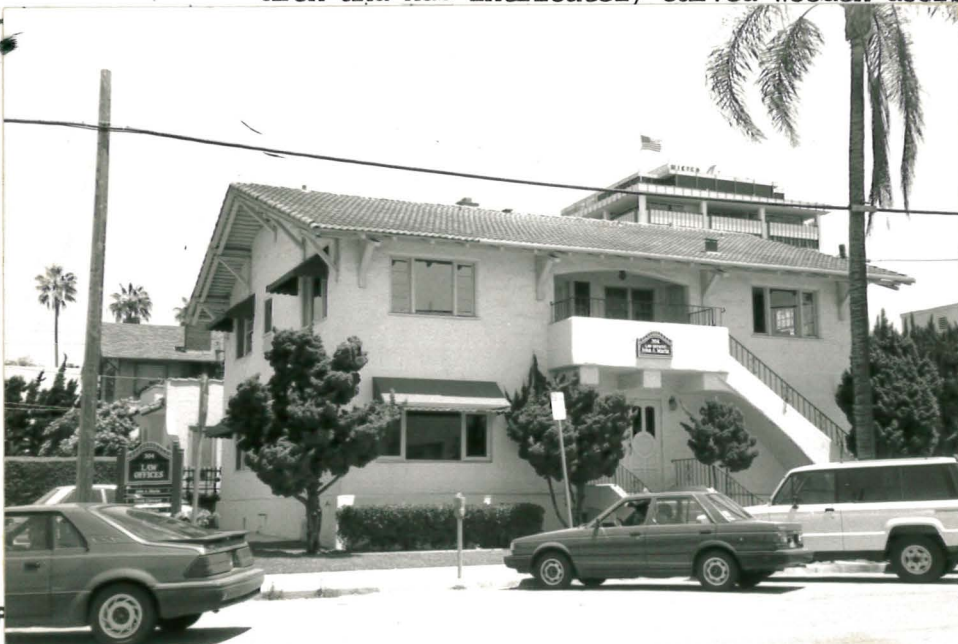
This 2-story rectangular home is on a raised foundation with a basement below. The roof is a low-pitched side gable with a red tile spine, overhanging eaves, exposed rafters and knee brackets. Vertical roof vents are situated at the gable peaks which is often a characteristic of Craftsman architecture. The windows are usually in multi-panel double-hung pairs or 3-sashed with a fixed center pane and multi-pane casement side panels. Some windows are now covered with canvas awnings including the 3-sashed 1st story window near the entry with a semielliptical multi-paned transom. The central element contains 6 red-tile steps with a wrought iron banister leading to 2 carved wooden doors with twin-paned uppers. The doors appear to be an alteration. To the east is a later addition of an articulated stucco stairway with enameled tile inlays and wrought iron banister which leads to the 2nd story balcony over the main entry. The balustrade is boxed with stucco with an iron railing on top and massive square brackets below. The recessed balcony doorway lies beyond a semielliptical arch and has intricately carved wooden doors. The stucco sheathing is an alteration.

13. Condition: Excellent _____ Good _____ Fair X Deteriorated _____ No longer in existence _____
14. Alterations: Siding, windows, awnings, staircase, doors.
15. Surroundings: (Check more than one if necessary) Open land _____ Scattered buildings _____ Densely built-up X
Residential X Industrial _____ Commercial _____ Other: _____
16. Threats to site: None known _____ Private development _____ Zoning X Vandalism _____
Public Works project _____ Other: _____
17. Is the structure: On its original site? X Moved? _____ Unknown? _____
18. Related features: None

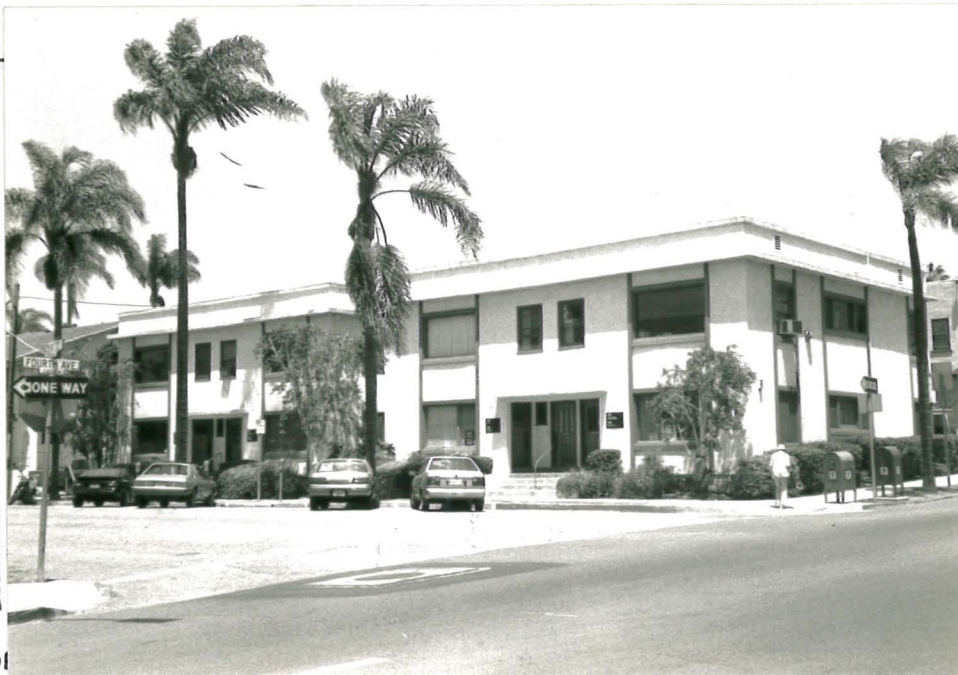
The property at 330-46 E. Kalmia Street contains two identical Mission style buildings which are two stories in height, stucco-sided, and symmetrical. Roofs are flat with flat parapets topped by coping. A dropped cornice extends around the buildings, except on the sides, which face each other. Four central cement steps with a central pipe rail lead from street level to a recessed porch sheltered by a shallow overhang. The four doors, two facing the street, and two opposing each other, are wood panel with narrow vertical bevelled glass uppers. Above the porch are two second story double-hung windows. Flanking the porch on both floors are large picture windows with wood surrounds. The vertical elements of the surrounds continue the length of the building to form half-timbering. On the side facades are double-hung and three-sash windows with fixed central panes, multi-pane transoms, and double-hung side panels. The east side of the east building displays half-timbering similar to that on the front facade. The rear of the buildings feature rows of rectangular vents and a central entry door. Alterations include new stucco, the half-timbering, and picture windows.

13. Condition: Excellent ___ Good ___ Fair X Deteriorated ___ No longer in existence ___
14. Alterations: Picture windows, half-timbering, new stucco.
15. Surroundings: (Check more than one if necessary) Open land ___ Scattered buildings ___ Densely built-up X
Residential X Industrial ___ Commercial X Other: ___
16. Threats to site: None known X Private development ___ Zoning ___ Vandalism ___
Public Works project ___ Other: ___
17. Is the structure: On its original site? X Moved? ___ Unknown? ___
18. Related features: None

This is a non-contributing structure due to alterations to the original architecture, deterioration, and/or lack of historical significance.

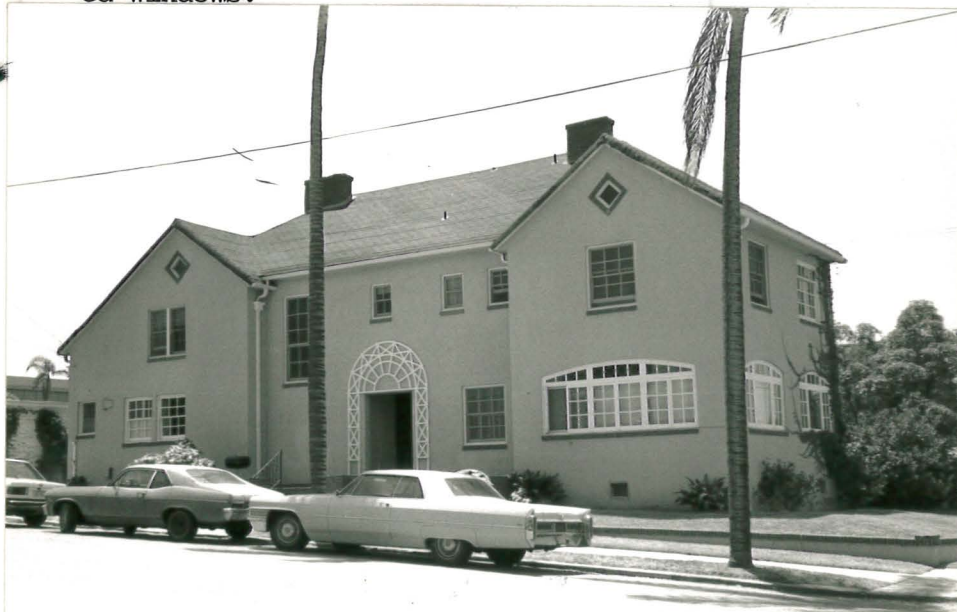
135 West Kalmia is a 2 ½ story structure with basement on a raised foundation. The structure forms a modified H-shape with its central hip roof and two front gables on either end. The roof is steeply pitched with overhanging rounded eaves and two massive brick chimneys at the central hip ends. The windows and their placement are asymmetrical with a variety of shapes and styles. The first floor western section features groups of multi-paned hinged windows with a semi-elliptical multi-paned transom. The remainder of the windows are various sizes of multi-paned windows with exception of the two diamond-shaped windows at the upper gable ends. These windows have a brick surround which is also used as a sill for the rest of the windows. The entry is reached with an arched latticed surround. A wide wood paneled door lies within with a beveled multi-pane upper and 3/4 beveled multi-pane sidepanels. Alterations include a fixed pane window on the northeast corner and corrugated plastic which shelters a two story balcony in the rear. A guest house is situated within the landscaped backyard with a flat roof, exposed rafters and narrow hinged windows.

13. Condition: Excellent ____ Good X Fair ____ Deteriorated ____ No longer in existence ____
14. Alterations: Addition on the east facade, rear balcony shelter
15. Surroundings: (Check more than one if necessary) Open land ____ Scattered buildings ____ Densely built-up X
Residential X Industrial ____ Commercial ____ Other: ____
16. Threats to site: None known ____ Private development ____ Zoning X Vandalism ____
Public Works project ____ Other: ____
17. Is the structure: On its original site? X Moved? ____ Unknown? ____
18. Related features: none

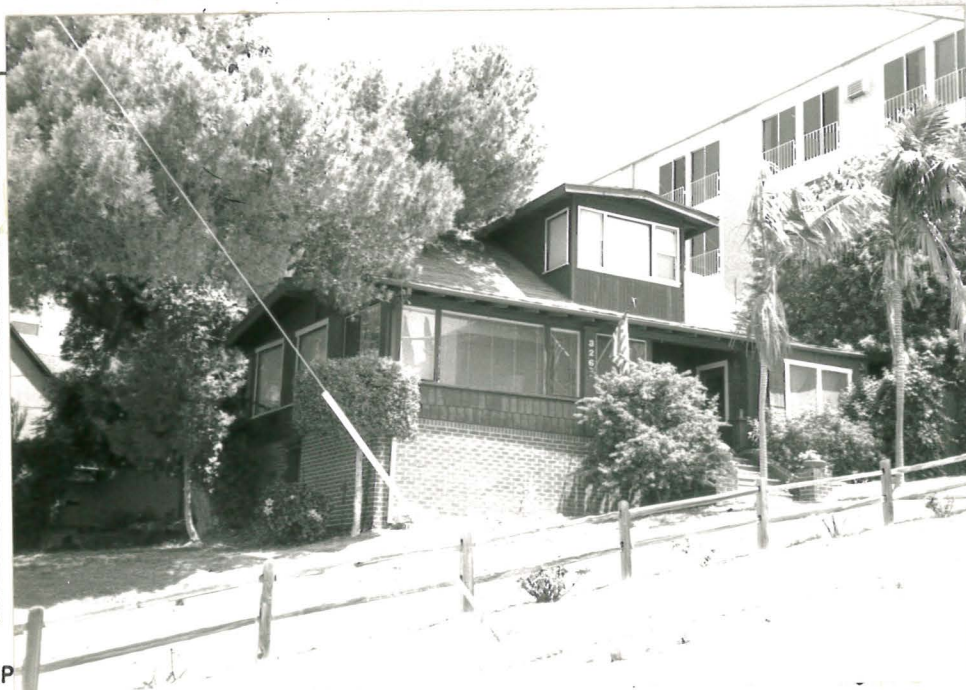
This is a rectangular, 1½-story Craftsman Style home with a basement on the west side due to the steep slope of the lot. The roof is steeply pitched and side gabled with a lower medium-pitched gable on the west side. The roofs have composition shingles, overhanging eaves, and exposed rafters; the upper roof has knee brackets. Siding is shingle. Brick skirting on the basement and wood panelling on the house are alterations. Windows, also altered, are aluminum sliding windows, louvered windows, or three-sash with central fixed panes and diamond side panels. The door is wood panel with vertical multi-pane glass uppers. A sidewalk leads to a cement and wood stairway flanked by brick posts and a low wall, which leads in turn to a deeply recessed entry porch with a lintel. The porch has been enclosed to the west and the remains of the original posts are visible. East of the door is a stained glass window. A tall gabled dormer located directly above the porch is an addition. North of the house is a driveway and cement block single-car garage with a wooden door. There is a wooden gate east of the house and a narrow stairway with a pipe railing south of the garage. Alterations include the windows, some siding, the dormer, and partial enclosure of the porch.

13. Condition: Excellent ___ Good ___ Fair X Deteriorated ___ No longer in existence ___
14. Alterations: Windows, some siding, dormer, porch enclosure.
15. Surroundings: (Check more than one if necessary) Open land ___ Scattered buildings ___ Densely built-up X
Residential X Industrial ___ Commercial ___ Other: ___
16. Threats to site: None known ___ Private development ___ Zoning X Vandalism ___
Public Works project ___ Other: ___
17. Is the structure: On its original site? X Moved? ___ Unknown? ___
18. Related features: Garage

This is a non-contributing structure due to alterations to the original architecture, deterioration, and/or lack of historical significance.

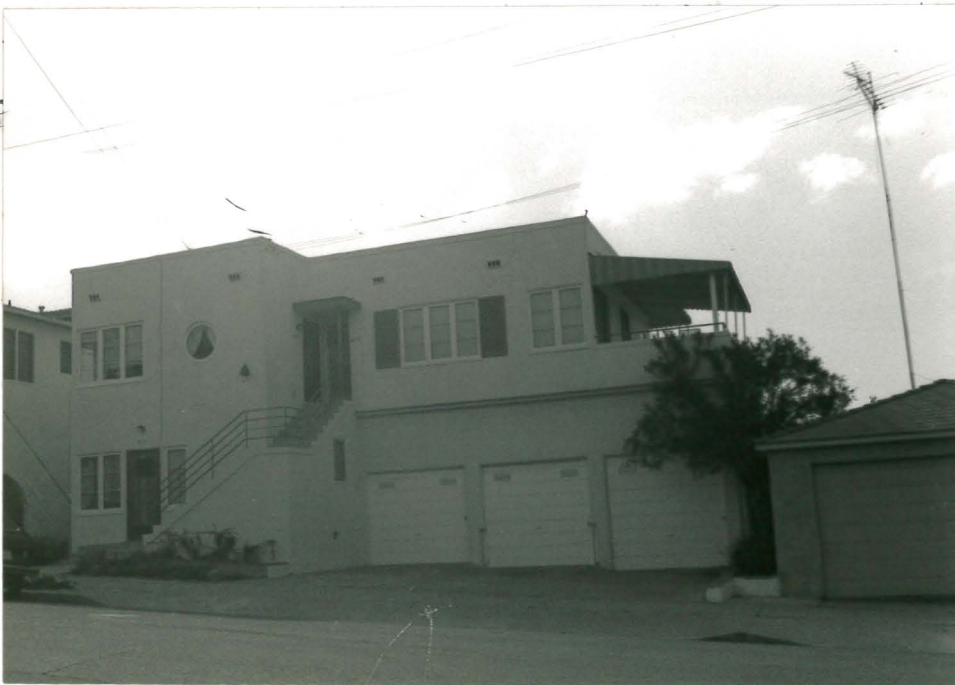
original condition: This 2-story L-shaped apartment building contains 3 dwelling units. The roof is flat with square canalis in triplets which are set within the stucco siding. The 1st level consists of an apartment to the east and 3 single-car garages to the west. The second level is reached by an articulated concrete and stucco stairway with metal railing leading to the stoop for 2 apartments with a flat canopy supported by a thin pole. The doors are wooden with a single-pane upper and the screens are aluminum with exception of the metal security screen on the 1st level. The windows are wood framed and hinged with horizontal multi-panes & often 3 or 2 sashed. Above the far west garage is a balcony with a canvas awning and a solid stucco balustrade. Alterations include wooden shutters and a round porthole window along the street facade, the metal security screen, and aluminum sliding and louvered window along the side facades.

13. Condition: Excellent ☒ Good ☐ Fair ☐ Deteriorated ☐ No longer in existence ☐
14. Alterations: Windows, security screen, shutters
15. Surroundings: (Check more than one if necessary) Open land ☐ Scattered buildings ☐ Densely built-up ☒
Residential ☒ Industrial ☐ Commercial ☐ Other: ☐
16. Threats to site: None known ☐ Private development ☐ Zoning ☒ Vandalism ☐
Public Works project ☐ Other: ☐
17. Is the structure: On its original site? ☒ Moved? ☐ Unknown? ☐
18. Related features: None

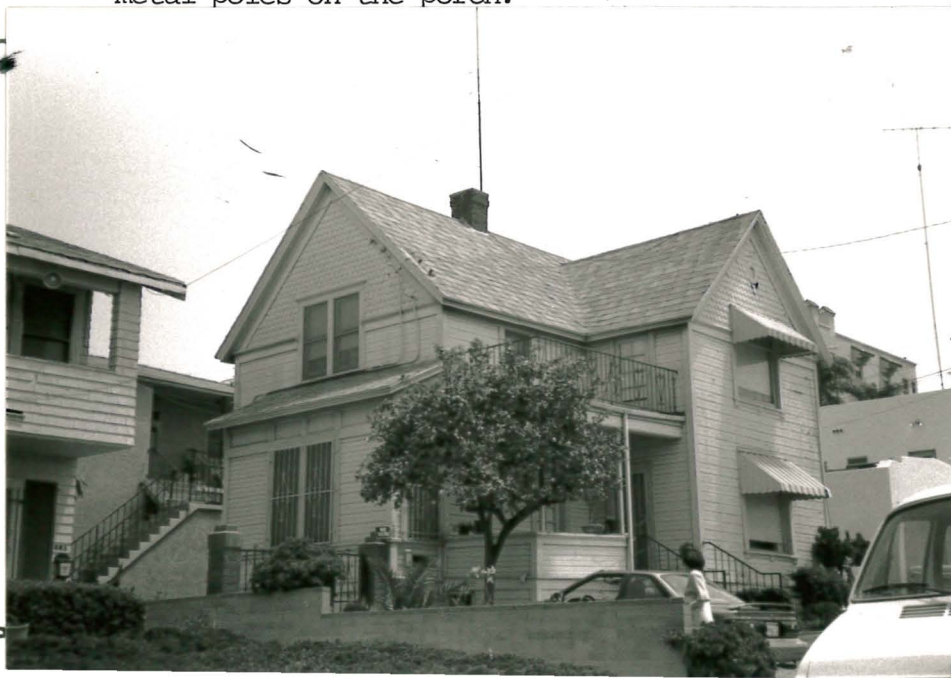
7b. Briefly describe the present *physical appearance* of the site or structure and describe any major alterations from its original condition: This 2-story L-shaped Folk Victorian house sits on a raised cement foundation. It has a steeply-pitched cross-gable roof with asphalt shingles, overhanging eaves, a boxed cornice, and a plain frieze. Siding is shiplap with end-boards. Fishscale is located in the pediments and wide shiplap covers the foundation. Windows are double-hung with wood surrounds and decorative bracketed sills. A 2nd floor front window is fixed with a multi-pane transom. A walkway leads to 7 cement steps with a wrought iron rail which lead in turn to a porch on the western half of the house. Doors are French; one faces west and one faces south. The porch has a shiplap balustrade and metal poles which support a 2nd floor balcony with a wrought iron balustrade. A west-facing French door opens on to the balcony. The house has an interior brick chimney and there are square vents at foundation level. A driveway to the west leads to a separate residence. The house has been greatly altered. A 1-story shed-roofed addition on the west side of the building has a panelled frieze. Fronting the driveway, an iron gate with brick imposts has been added. Other alterations include metal awnings over front windows, wrought iron railing and balustrade, iron work over some windows, a security screen door, and metal poles on the porch.

13. Condition: Excellent Good Fair X Deteriorated No longer in existence
14. Alterations: Addition on the west side, gate fronting driveway, awnings over front-facing windows, iron balustrade & railing, metal poles, iron work over windows raingutters.
15. Surroundings: (Check more than one if necessary) Open land Scattered buildings Densely built-up X
Residential X Industrial Commercial Other:
16. Threats to site: None known X Private development Zoning Vandalism
Public Works project Other:
17. Is the structure: On its original site? X Moved? Unknown?
18. Related features:

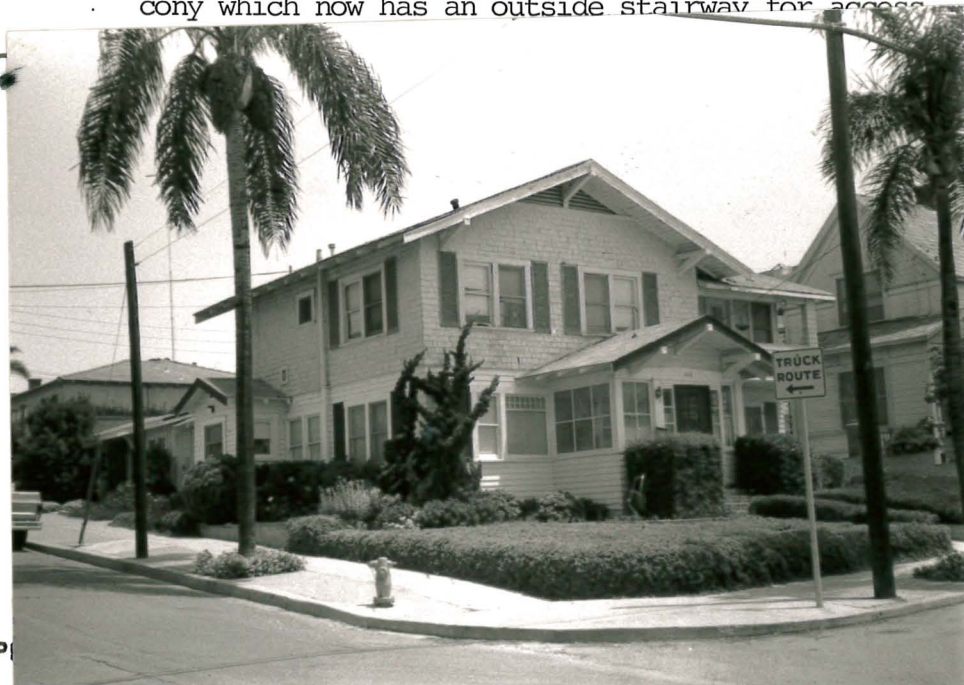
- 7a. Architectural style: Craftsman
- 7b. Briefly describe the present *physical appearance* of the site or structure and describe any major alterations from its original condition: This 2-story irregular-shaped home is situated on a raised foundation with clapboard siding on the 1st level and shingle siding on the 2nd story. The medium-pitched cross-gable roof has wide overhanging eaves, exposed rafters, knee brackets and horizontal roof vents at the gable ends. The windows are double-hung primarily in pairs with wooden shutters. Three and two-sashed windows are situated along the 1st story with a center fixed pane with multi-paned transom and double-hung side panels. Below the large front gable is an enclosed porch sheltered by a lower gable roof with knee brackets and rafters. The entry is reached by concrete stairs and the French door is now covered by a metal security screen with multi-pane side panels. Multi-paned windows surround the porch with clapboard sheathing below. To the east of the main entry is an open porch which has been added to the portion of the home sheltered by the side gable. A new French door has been added to the porch. Above the open porch is a 2nd story balcony which is boxed with a clapboard balustrade. The narrow balcony French door is flanked by 2 double-hung windows. Additional features include a tall brick chimney along the northern facade, a small gabled extension along the western facade and a large rear 2nd story balcony which now has an outside stairway for access.

13. Condition: Excellent _____ Good X Fair _____ Deteriorated _____ No longer in existence _____
14. Alterations: Stairs on east facade, French door on front porch, window on northern facade, metal security screen.
15. Surroundings: (Check more than one if necessary) Open land _____ Scattered buildings _____ Densely built-up X
Residential X Industrial _____ Commercial _____ Other: _____
16. Threats to site: None known _____ Private development _____ Zoning X Vandalism _____
Public Works project _____ Other: _____
17. Is the structure: On its original site? _____ Moved? _____ Unknown? X
18. Related features: _____

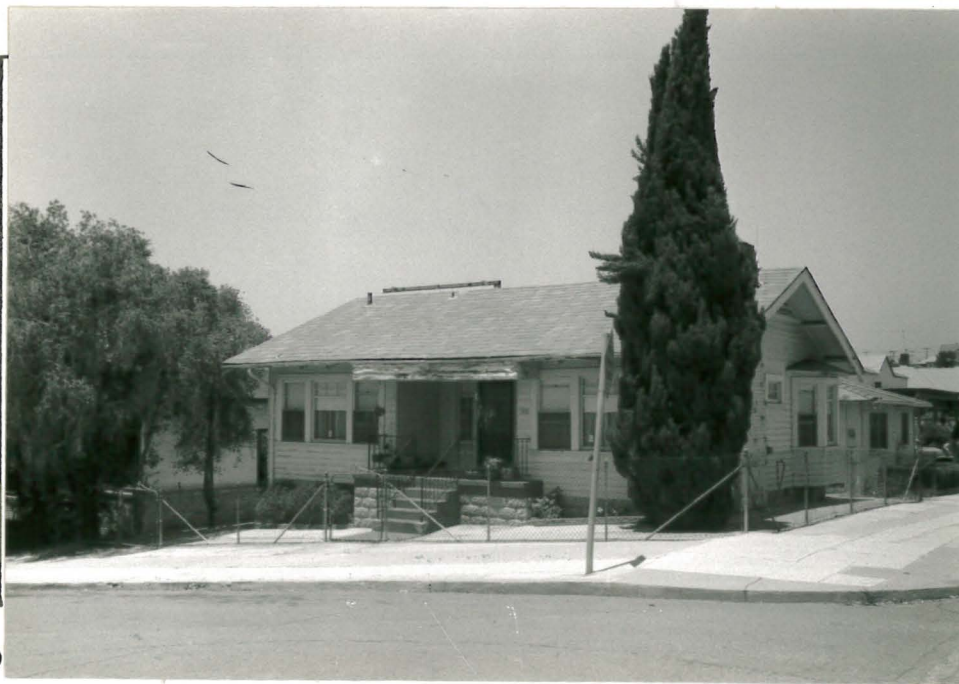
This one-story, rectangular building, with a medium-pitch side-gable roof of composition shingle with exposed rafters beneath overhanging eaves, sits on raised foundation of ashlar block. The windows are double-hung, some three-sash with multi-transoms above a fixed center pane. An oriel bay on the east facade has a hip roof. The centered south-facing entry is reached from five cement steps. Underneath the boxed, flat hood is a wood, multi-panel entry door with a wood screen and multi-pane 3/4 side panels. The siding is clapboard and an internal brick chimney is located on the east side. Alterations include a fully-cemented sand area, wrought iron railing on the entry steps, the entry hood, a shed-roof addition with an entry door on the northeast corner, a cyclone fence with gates, an enclosed porch to the west, and a one-car, flat-roofed garage on the southwest.

13. Condition: Excellent _____ Good _____ Fair _____ Deteriorated X No longer in existence _____
 Railing, hood entry, shed roof addition, fence, enclosed porch,
14. Alterations: one car garage
15. Surroundings: (Check more than one if necessary) Open land _____ Scattered buildings _____ Densely built-up _____
 Residential X Industrial _____ Commercial _____ Other: Interstate 5
16. Threats to site: None known _____ Private development _____ Zoning X Vandalism _____
 Public Works project _____ Other: _____
17. Is the structure: On its original site? _____ Moved? _____ Unknown? X
18. Related features: _____

19. Briefly state historical and/or architectural importance (include dates, events, and persons associated with the site.)
 This is a non-contributing structure due to alterations to the original architecture, deterioration, and/or lack of historical significance.
