HISTORIC RESOURCES INVENTORY

1. Common name: ---
2. Historic name: John S. Hawley Residence
3. Street or rural address: 205 Laurel Street
City San Diego Zip 92101 County San Diego
4. Parcel number: 533-093-01
5. Present Owner: Violet Vanhorne Address: P.O. Box X-1013
City San Diego Zip 92112 Ownership is: Public --- Private X
6. Present Use: Residential Original use: Residential

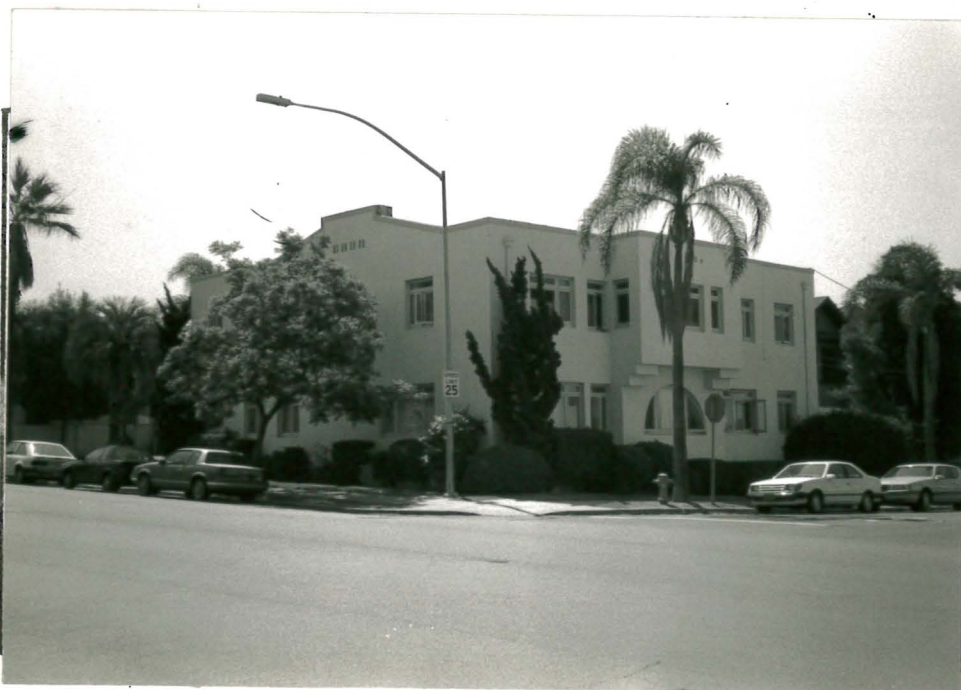
- 7a. Architectural style: Mission Revival/Modern
- 7b. Briefly describe the present *physical appearance* of the site or structure and describe any major alterations from its original condition: This two story stucco building, with a full basement, sits on a raised foundation. It has a flat roof with low, stepped truncated gable parapets on the east and west sides, both with geometric groups of vents below. A flat band of wood coping runs around the structure. A second story square bay with stepped, massive corner corbeling protrudes from the west facade over a large arched, half circles segmental hinged wood window centered on the facade. Bands of hinged wood windows, most with transoms run along each floor level, some grouped, forming a geometric pattern on each facade. The east-facing main entry is recessed behind an arch, centered between two wrought iron light fixtures. The four-foot-wide door is solid oak with a large glass upper. A side entry is accessed from a private garden area on the south, one wall of which helps to form a three-car garage with a flat roof, once a carriage house. A stucco and wood wall lines the east property line, part of an original front garden enclosure now removed. Alterations include some first floor interior security screens, a cement floor in the private garden, and the removal of the original garden enclosure.

13. Condition: Excellent ☒ Good _____ Fair _____ Deteriorated _____ No longer in existence _____
14. Alterations: Interior window security screens, cemented garden floor, removal of garden enclosure.
15. Surroundings: (Check more than one if necessary) Open land _____ Scattered buildings _____ Densely built-up ☒
Residential ☒ Industrial _____ Commercial ☒ Other: _____
16. Threats to site: None known ☒ Private development _____ Zoning _____ Vandalism _____
Public Works project _____ Other: _____
17. Is the structure: On its original site? ☒ Moved? _____ Unknown? _____
18. Related features: None

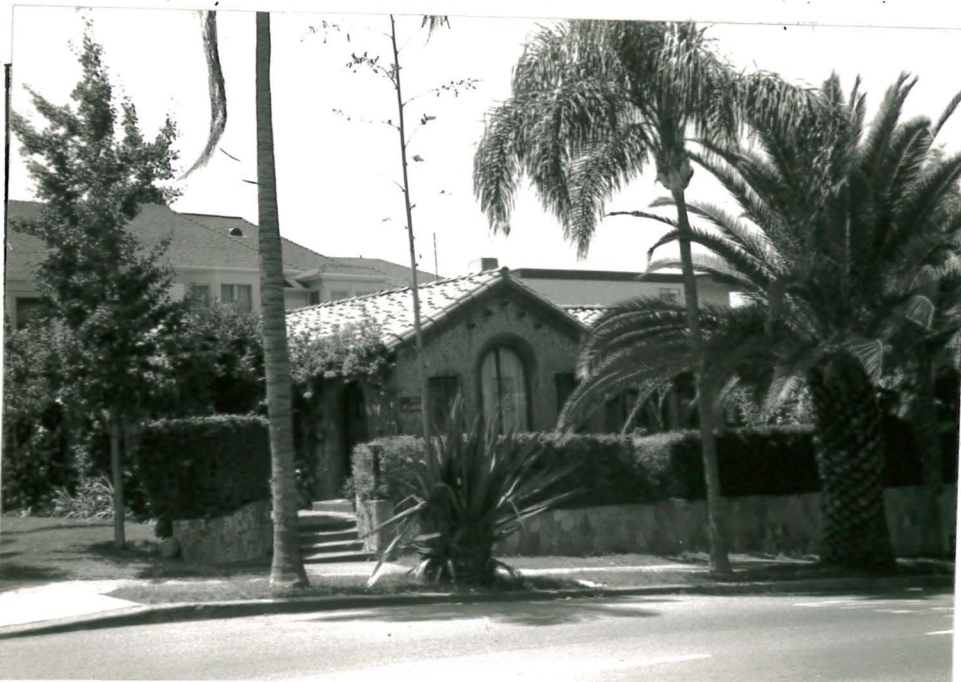
This one story irregular shaped home has rough stucco siding and multiple rooflines. Near the street corner is a medium pitched red tile cross gable with a rounded roof section which connects to a western large rectangular section with a flat roof. The windows and doors are deeply recessed within the stucco siding. Beneath the Laurel Street gable end is a large fixed arched pane flanked by two multi-pane hinged windows with wrought iron bars. Along the front L-shaped patio are three arched windows in a palladian formation with multi-paned quoining. To the south of the windows are french double doors while to the north is the main entry with its heavy arched wooden doors, large exposed hinges and small upper pane with wrought iron bars. The patio is reached by three curving steps within the curving stucco retaining wall. To the west of the home is an attached two-car garage and a rear entry. The home is very unusual with its large arched openings and mature landscaping.

13. Condition: Excellent X Good _____ Fair _____ Deteriorated _____ No longer in existence _____

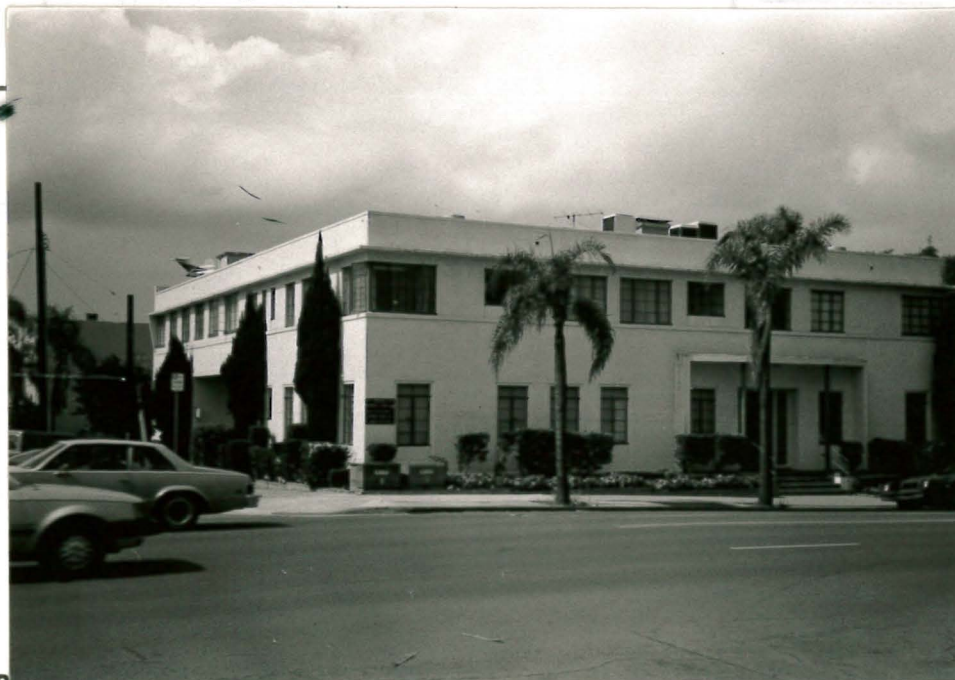
7b. Briefly describe the present *physical appearance* of the site or structure and describe any major alterations from its original condition: This 2-story rectangular stucco building sits on a corner and has a flat roof with a parapet topped by coping. A dropped cornice runs around the building and angles to form a vertical window surround at the SE corner. A protruding horizontal band is located below the 2nd floor windows. Bands of windows are metal pane casements with 2-pane transoms. The 1st floor windows are recessed in a rectangular panel and 2nd floor windows wrap around the corners. 4 brick steps with planters to the sides lead to an entry porch accented by a curved fluted hood and narrow fluted pilasters. The door is recessed solid wood with multi-pane frosted glass side panels. The east side of the building has a large 1st floor opening with a molded surround which serves as a driveway and leads to a parking area behind. South of the opening, 8 steps with a metal rail lead to a 1st floor wooden entry door. Behind the opening & to the north are opposing cement stairways. The west facade has a stairway with a stucco bannister which leads to a 2nd floor walkway with a stucco balustrade. A garage with a metal door is located below the 1st floor on the SE corner. The building has circular canales at fan level.

13. Condition: Excellent _____ Good ☒ Fair _____ Deteriorated _____ No longer in existence _____
14. Alterations: None
15. Surroundings: (Check more than one if necessary) Open land _____ Scattered buildings _____ Densely built-up ☒
Residential ☒ Industrial _____ Commercial ☒ Other: _____
16. Threats to site: None known ☒ Private development _____ Zoning _____ Vandalism _____
Public Works project _____ Other: _____
17. Is the structure: On its original site? ☒ Moved? _____ Unknown? _____
18. Related features: None

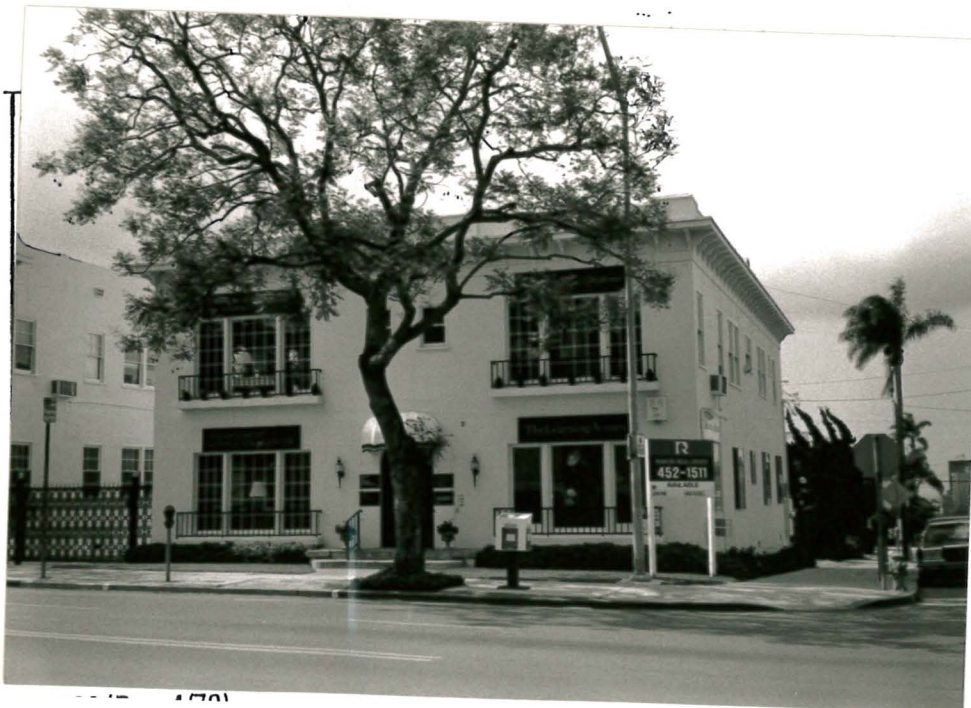
13. Condition: Excellent ☒ Good ☐ Fair ☐ Deteriorated ☐ No longer in existence ☐
14. Alterations: Awning, fixed pane windows, aluminum sliding windows, iron gate & door
15. Surroundings: (Check more than one if necessary) Open land ☐ Scattered buildings ☐ Densely built-up ☒
Residential ☐ Industrial ☐ Commercial ☒ Other: ☐
16. Threats to site: None known ☐ Private development ☐ Zoning ☒ Vandalism ☐
Public Works project ☐ Other: ☐
17. Is the structure: On its original site? ☒ Moved? ☐ Unknown? ☐
18. Related features: ☐

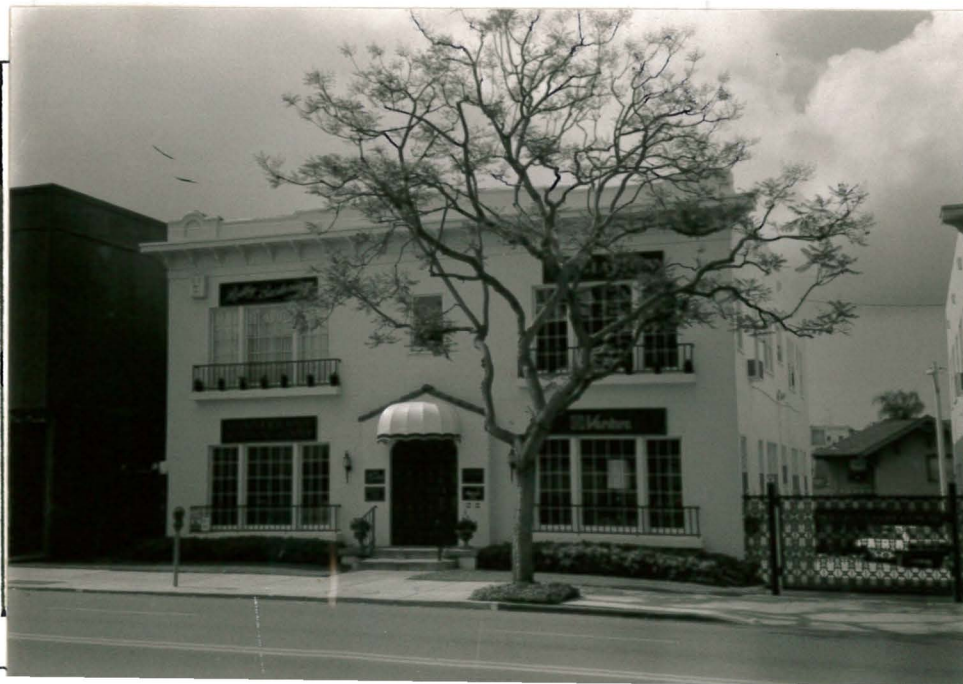
- 7a. Architectural style: Italian Renaissance With Mission Revival Influence
- 7b. Briefly describe the present *physical description* of the site or structure and describe any major alterations from its original condition: Legal D: Blk 280 Lots A & B W 1/2 Hortons Add Lockling

13. Condition: Excellent ☒ Good _____ Fair _____ Deteriorated _____ No longer in existence _____
14. Alterations: awning, signage, security door, entry gable, casement windows
15. Surroundings: (Check more than one if necessary) Open land _____ Scattered buildings _____ Densely built-up ☒
Residential _____ Industrial _____ Commercial ☒ Other: _____
16. Threats to site: None known _____ Private development _____ Zoning ☒ Vandalism _____
Public Works project _____ Other: _____
17. Is the structure: On its original site? ☒ Moved? _____ Unknown? _____
18. Related features: Nearly identical structure to the east

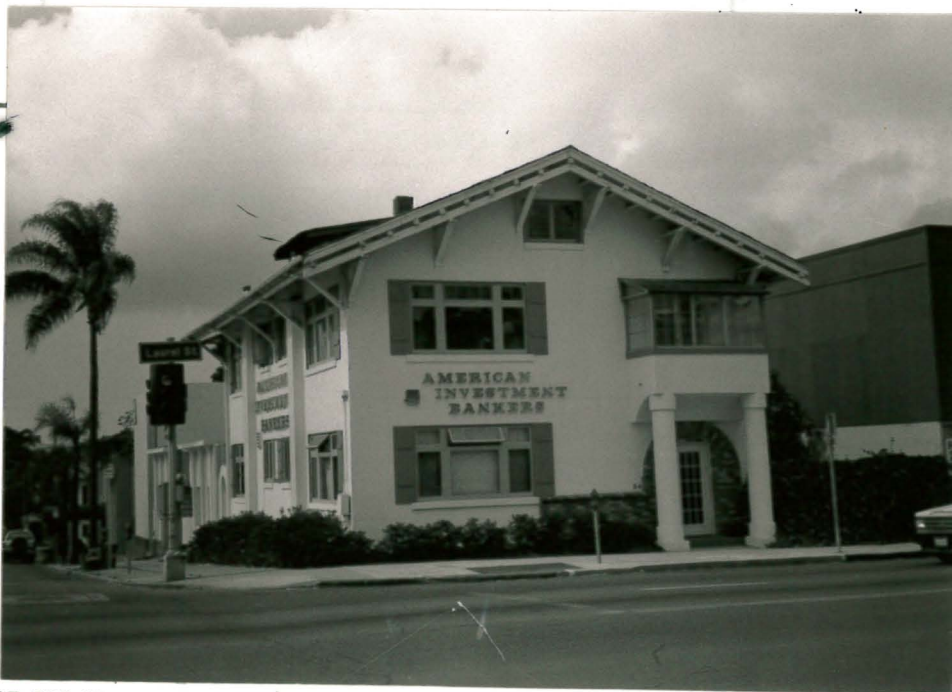
13. Condition: Excellent _____ Good ☒ Fair _____ Deteriorated _____ No longer in existence _____
14. Alterations: Entry, columns & 2nd floor porch, signage; light on west facade.
15. Surroundings: (Check more than one if necessary) Open land _____ Scattered buildings _____ Densely built-up ☒
Residential ☒ Industrial _____ Commercial ☒ Other: _____
16. Threats to site: None known ☒ Private development _____ Zoning _____ Vandalism _____
Public Works project _____ Other: _____
17. Is the structure: On its original site? ☒ Moved? _____ Unknown? _____
18. Related features: None

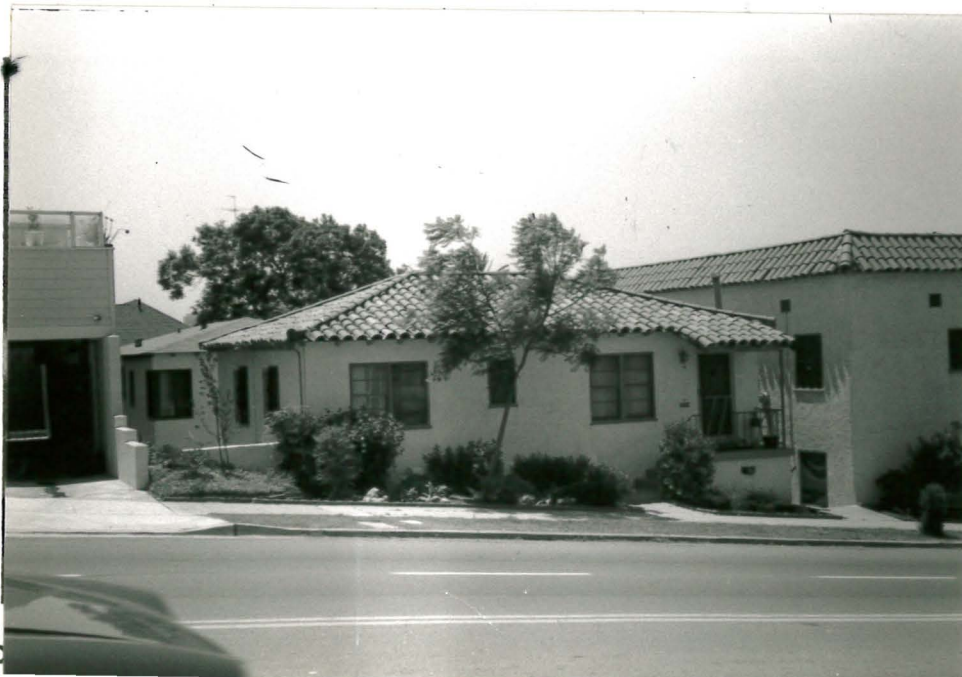
- 7a. Architectural style: 40's Modern
- 7b. Briefly describe the present *physical appearance* of the site or structure and describe any major alterations from its original condition: This 1-story rectangular-shaped home is situated on a rise which exposes the basement to the rear. The roof is a medium-pitched red-tile hip with slightly overhanging eaves and exposed rafters. Square canalis are hidden within the eaves and the stucco sheathing. The windows are horizontal, multi-paned, and double-hung, often in sets of two. The entry is located at the northwest corner beneath a pent roof extension. A small stoop is reached by stairs from the east with a wrought iron banister and balustrade with metal pole supports. The door is solid wood panel with an aluminum screen door cover. The only apparent alterations are the metal security bars over the windows.

13. Condition: Excellent _____ Good ☒ Fair _____ Deteriorated _____ No longer in existence _____
14. Alterations: Window bars
15. Surroundings: (Check more than one if necessary) Open land _____ Scattered buildings _____ Densely built-up ☒
Residential ☒ Industrial _____ Commercial _____ Other: _____
16. Threats to site: None known _____ Private development _____ Zoning ☒ Vandalism _____
Public Works project _____ Other: _____
17. Is the structure: On its original site? ☒ Moved? _____ Unknown? _____
18. Related features: _____

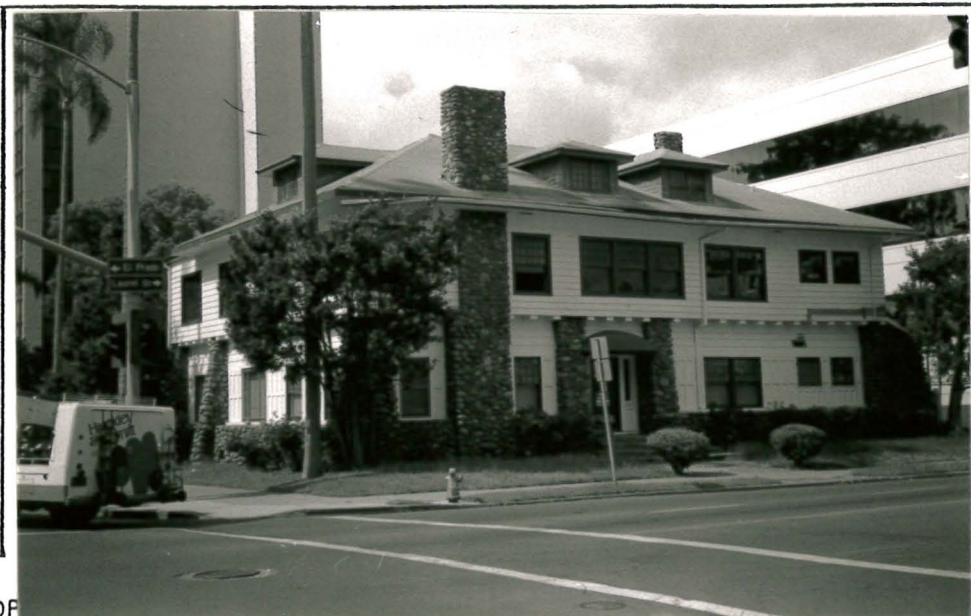
- Architectural style: Prairie with Craftsman influence
- Briefly describe the present *physical appearance* of the site or structure and describe any major alterations from its original condition: Legal D: bkl 282 Lots J thru L, Hortons addition Lockling
The large 2 1/2-story home has a medium pitched hip roof with overhanging boxed eaves and a plain frieze. Within the roof are two massive cobblestone chimney and several hipped dormers with composition shingle siding and multi-paned pairs of windows. The siding is clapboard with dentil-like brackets below the second story overhang and a cobblestone skirting which rises to form one story pilasters at the corner and near the entry. The windows are often in pairs of double-hung sashes with multi-paned uppers. Between the first story windows, the siding changes to wooden panels. A few windows have been altered including large fixed panes on the southeast facade and northeast corner, a louvered window on the northwest facade and three multi-pane casement windows in the rear. Four concrete steps lead to the main entry with a half-dome hood and wooden gate extending from the east facade which surrounds the south garden and guest house. Several alterations have occurred on the western and southern facades. Floating concrete stairs have been added to access the second story and new basement entry with patio is located along the western facade. A large fountain and fish pond were added with an articulated stairway behind providing additional outside access to the second story. Presently the house has been gutted and awaits sale.

13. Condition: Excellent _____ Good X Fair _____ Deteriorated _____ No longer in existence _____

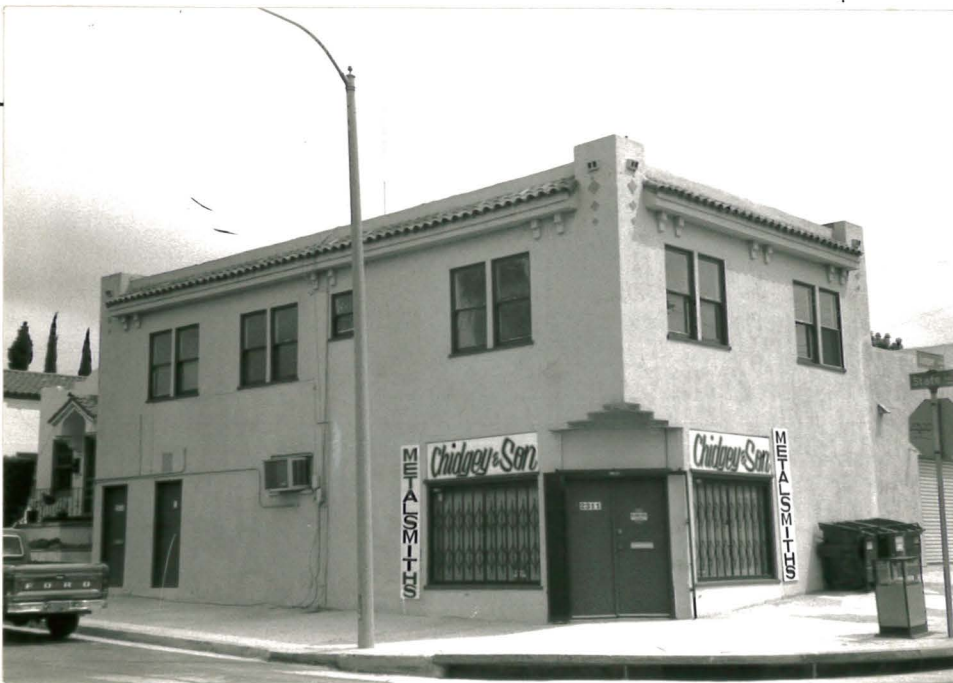
13. Condition: Excellent _____ Good X Fair _____ Deteriorated _____ No longer in existence _____
14. Alterations: Security bars, doors, garage
15. Surroundings: (Check more than one if necessary) Open land _____ Scattered buildings _____ Densely built-up X
Residential X Industrial _____ Commercial X Other: Interstate 5
16. Threats to site: None known X Private development _____ Zoning _____ Vandalism _____
Public Works project _____ Other: _____
17. Is the structure: On its original site? X Moved? _____ Unknown? _____
18. Related features: None

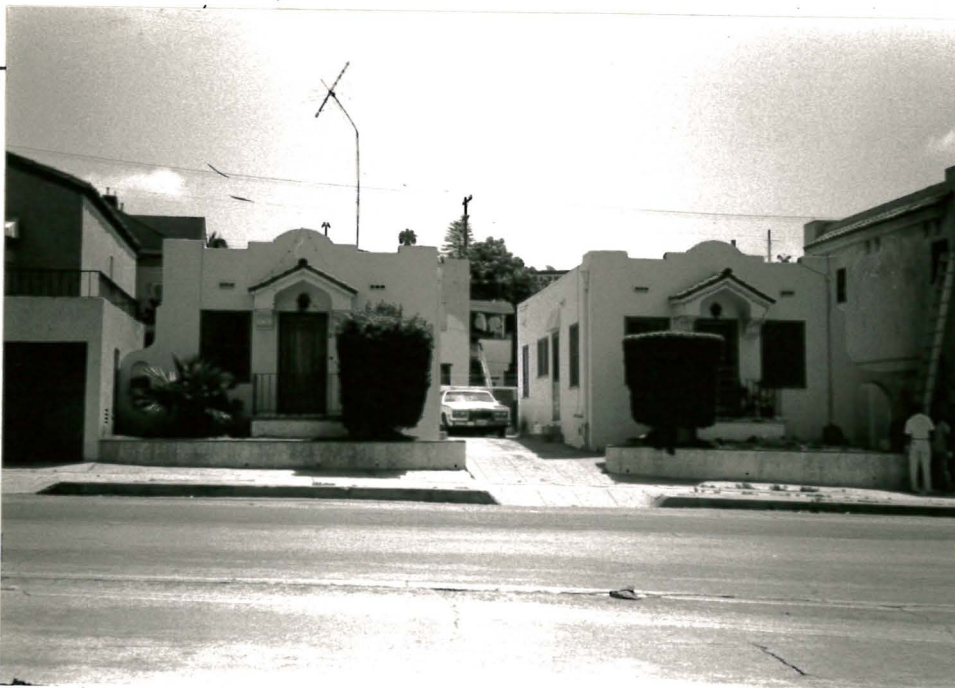
These two nearly identical Mission Style apartment buildings sit side by side with a driveway between them. The buildings are symmetrical, stucco-sided, and rectangular shape and have flat roofs with parapets which are stepped at the corners and curved at the centers. Rectangular roof canals are evenly spaced on the front and side facades. Centrally located entries with small entry porches surrounded by wrought iron balustrades are reached from the straight cement stairways from the driveway. The entries are sheltered by pedimented red tile hoods with massive stucco brackets and a single ogee arch. Within the arches are decorative lamps. The entry doors are wood frame with multi-pane glass in unusual designs. Windows are double-hung with multi-pane uppers and wood surrounds. The S. side of the S. building and the N. side of the N. building feature arched and stepped wing walls. The northern one is solid. Side entries facing the driveway have small stucco hoods and are reached from cement steps. A low stucco retaining wall is located in front of the building.

13. Condition: Excellent _____ Good ☒ Fair _____ Deteriorated _____ No longer in existence _____
14. Alterations: None Apparent
15. Surroundings: (Check more than one if necessary) Open land _____ Scattered buildings _____ Densely built-up ☒
Residential ☒ Industrial _____ Commercial ☒ Other: Interstate 5
16. Threats to site: None known _____ Private development _____ Zoning ☒ Vandalism _____
Public Works project _____ Other: _____
17. Is the structure: On its original site? ☒ Moved? _____ Unknown? _____
18. Related features: None

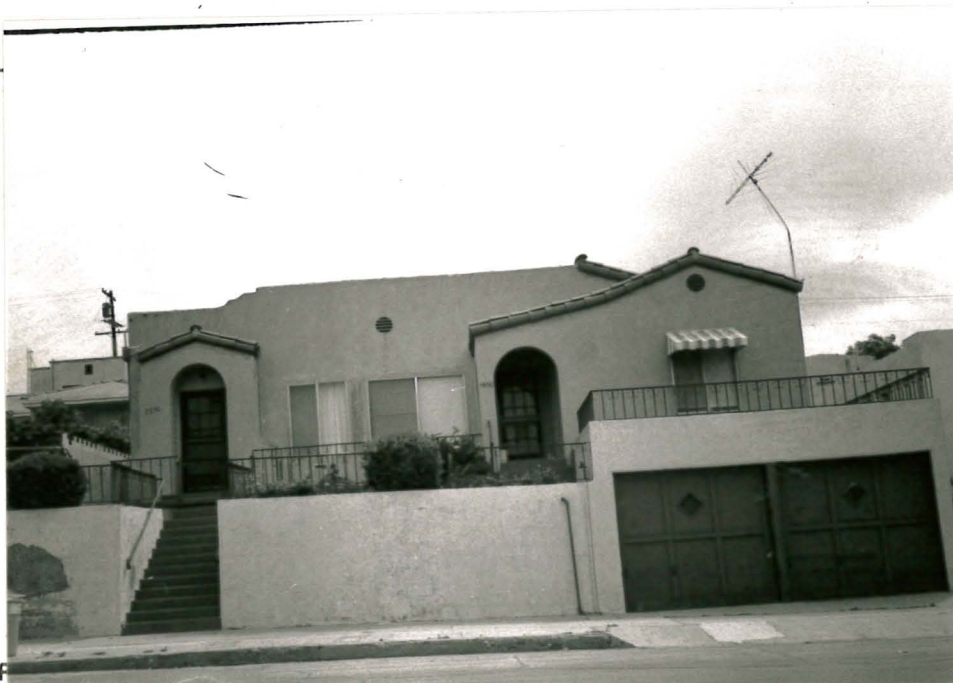
13. Condition: Excellent _____ Good ☒ Fair _____ Deteriorated _____ No longer in existence _____
14. Alterations: Aluminum awning and windows
15. Surroundings: (Check more than one if necessary) Open land _____ Scattered buildings _____ Densely built-up ☒
Residential ☒ Industrial _____ Commercial _____ Other: _____
16. Threats to site: None known _____ Private development _____ Zoning ☒ Vandalism _____
Public Works project _____ Other: _____
17. Is the structure: On its original site? ☒ Moved? _____ Unknown? _____
18. Related features: _____

This is a non-contributing structure due to alterations to the original architecture, deterioration, and/or lack of historical significance.

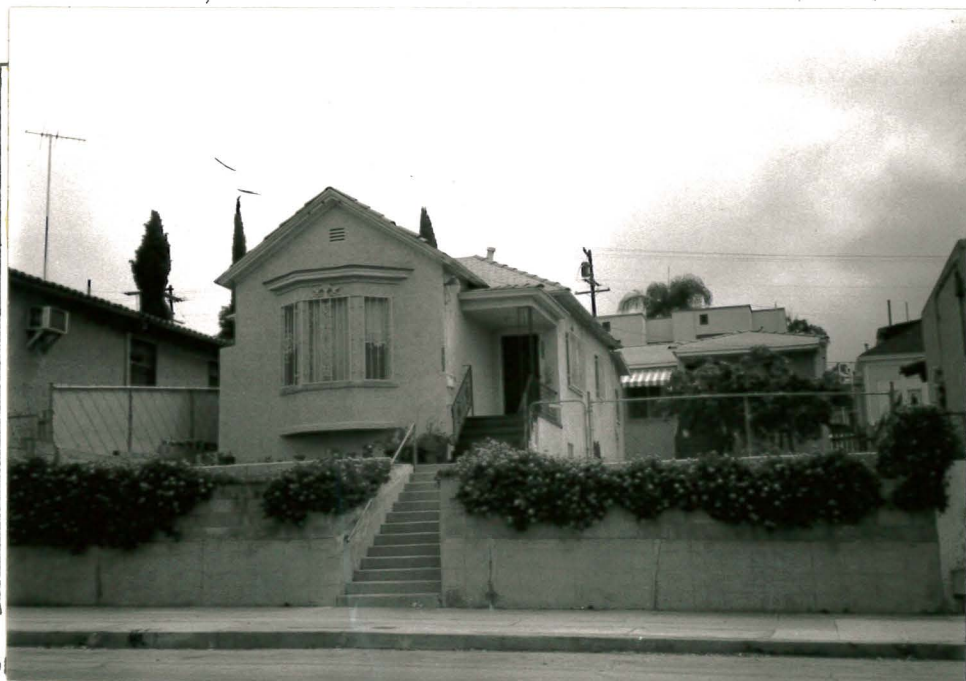
This one-story rectangular home rests on a raised foundation high above the street level with a tall concrete block retaining wall. The medium-pitched truncated hip roof has an extending front gable with horizontal roof vents. The roof has a red-tile spine, boxed cornice and slightly overhanging eaves. The siding has been altered and is now rough stucco. The windows have also been altered and are now sliding aluminum framed with ornate iron security bars. Below the extending front gable is a wide-angled oriel bay with a flat roof. The entry is stepped from the street with an iron bannister leading to the offset southern porch. The porch is sheltered by a hipped roof with a wrought iron corner support. The door is not visible due to the addition of a metal security screen. An addition to the northwestern wall exhibits a different architectural style with its wide overhanging eaves and exposed rafters. To the rear is an L-shaped home similar to the front structure with the same alterations. The address is 2333 State Street.

13. Condition: Excellent ___ Good ___ Fair X Deteriorated ___ No longer in existence ___
14. Alterations: Windows, siding, security screens, roof
15. Surroundings: (Check more than one if necessary) Open land ___ Scattered buildings ___ Densely built-up X
Residential X Industrial ___ Commercial ___ Other: ___
16. Threats to site: None known ___ Private development ___ Zoning X Vandalism ___
Public Works project ___ Other: ___
17. Is the structure: On its original site? X Moved? ___ Unknown? ___
18. Related features: Home to the rear

This is a non-contributing structure due to alterations to the original architecture, deterioration, and/or lack of historical significance.

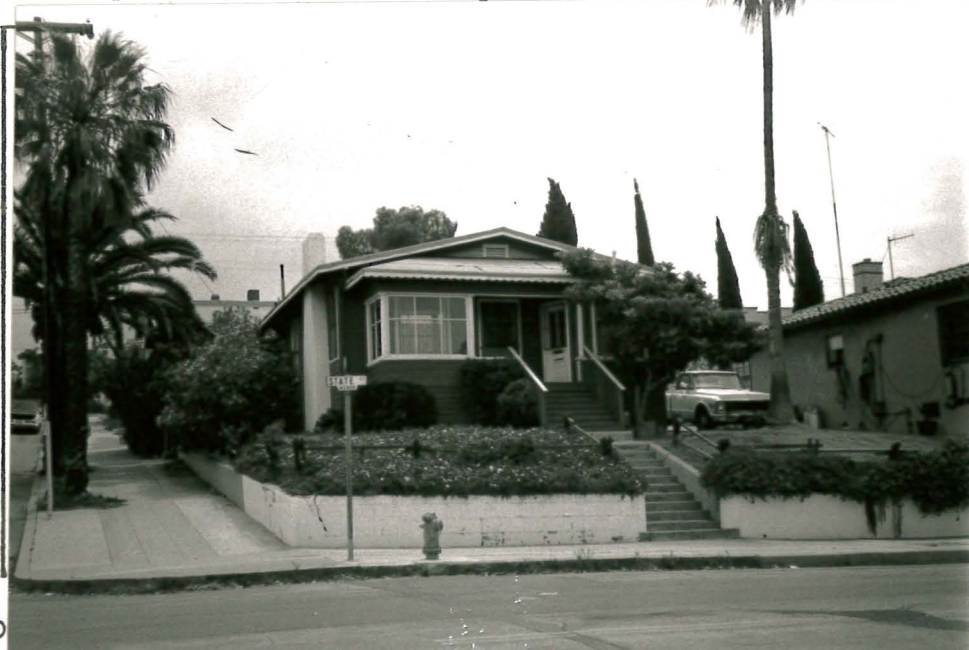
This 1-story California Bungalow sits on a corner lot behind a cement retaining wall and split rail fence. It is high above street level on a raised cement foundation. Siding is clapboard with endboards; paneled shiplap covers the porch. The roof is medium-pitched front-gable with overhanging eaves and patterned bargeboard. A hipped roof with exposed rafters covers the porch. Windows are double-hung, with leaded glass uppers on the front facade. They feature iron bars and plain wood surrounds. Eleven cement steps lead from the sidewalk to a wooden stairway with a wood rail and lattice work below. The stairway leads to a porch which has been enclosed with a multi-pane window on the NW corner. Engaged columns rise from a shiplap balustrade and support a lintel and the hipped roof. An original entry door faces west and is 2-panel wood with a rectangular glass upper. A square bay and a stepped entry with a gabled hood are located on the S. facade. There is a stucco chimney on the N. side. Alterations include the S. side entry, a water heater shed, bars on the windows, false door, roof over porch and enclosure of porch. A 1-story dwelling with a gable roof is to the east.

13. Condition: Excellent _____ Good ☒ Fair _____ Deteriorated _____ No longer in existence _____
14. Alterations: Porch has been altered, S. side entry, water heater shed, bars on window, False door.
15. Surroundings: (Check more than one if necessary) Open land _____ Scattered buildings _____ Densely built-up ☒
Residential ☒ Industrial _____ Commercial ☒ Other: _____
16. Threats to site: None known _____ Private development _____ Zoning ☒ Vandalism _____
Public Works project _____ Other: _____
17. Is the structure: On its original site? ☒ Moved? _____ Unknown? _____
18. Related features: 1-story dwelling to the east

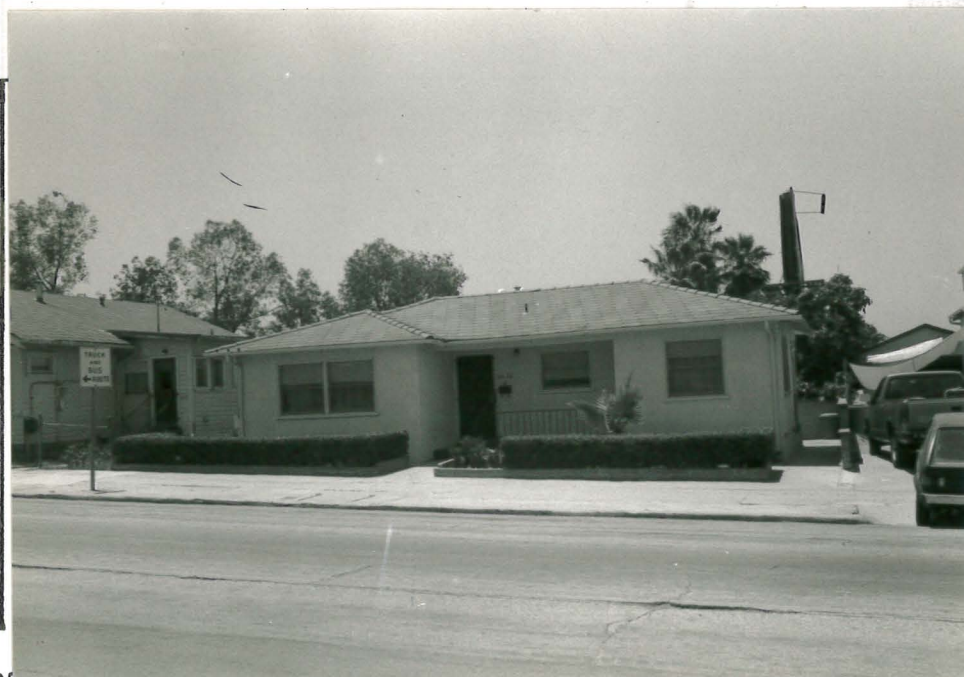
2420 State Street is a one-story home sheathed in stucco. The roof is a medium-pitched hip roof with a red-tile spine, overhanging eaves, and exposed rafters. A hipped extension protrudes on the southwest corner. The windows are very wide with a wooden double-hung frame; some are double-sashed. The entry is located within a rectangular recessed porch reached by one step with a wrought iron balustrade. The door is now covered by a metal security screen and is no longer visible.

13. Condition: Excellent ☐ Good ☒ Fair ☐ Deteriorated ☐ No longer in existence ☐
14. Alterations: _____
15. Surroundings: (Check more than one if necessary) Open land ☐ Scattered buildings ☐ Densely built-up ☒
Residential ☒ Industrial ☐ Commercial ☒ Other: _____
16. Threats to site: None known ☐ Private development ☐ Zoning ☒ Vandalism ☐
Public Works project ☐ Other: _____
17. Is the structure: On its original site? ☒ Moved? ☐ Unknown? ☐
18. Related features: _____

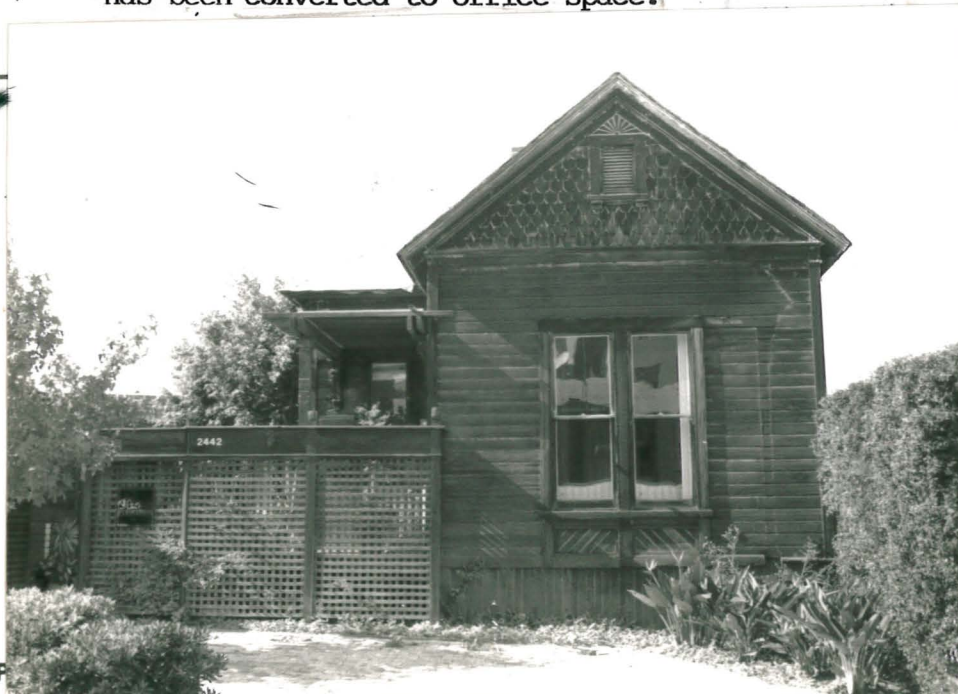
2442 State Street is a 1-story Queen Anne home with a high-pitched front gable connecting onto 2 truncated hips as the structure stretches to the rear of the property and finally becomes flat with exposed rafters and clapboard siding over a later addition. The shiplap siding has been stripped of paint, including the vertical shiplap along the foundation and the molded horizontal band separating the two. The windows are tall and narrow double-hung with various features such as ornate shelflike crowns, squeezed pediments and lower wooden paneling. The rear addition windows are wide & double-hung. Within the front gable are patterned shingles with a sunburst at the peak and roof vents below. A pair of narrow windows lie below. The entry has a latticed gate from the street with a brick walkway (both are alterations). Two entries are within the courtyard. One faces south along the wall of the front gable with tall double wooden doors and brick steps. The second faces the street and is an alteration with a new wood-paneled door, brick steps and pediment. A wide-angled bay with segmented hip roof separates the two entries. The front garage has been converted to office space.

13. Condition: Excellent _____ Good X Fair _____ Deteriorated _____ No longer in existence _____
 14. Alterations: Widow's New porch, widow's walk removed, new siding, new entry, foundation was brick until the house was moved.
15. Surroundings: (Check more than one if necessary) Open land _____ Scattered buildings _____ Densely built-up X
 Residential X Industrial _____ Commercial X Other: Interstate 5
16. Threats to site: None known _____ Private development _____ Zoning X Vandalism _____
 Public Works project _____ Other: _____
17. Is the structure: On its original site? _____ Moved? X Unknown? _____
18. Related features: Garage

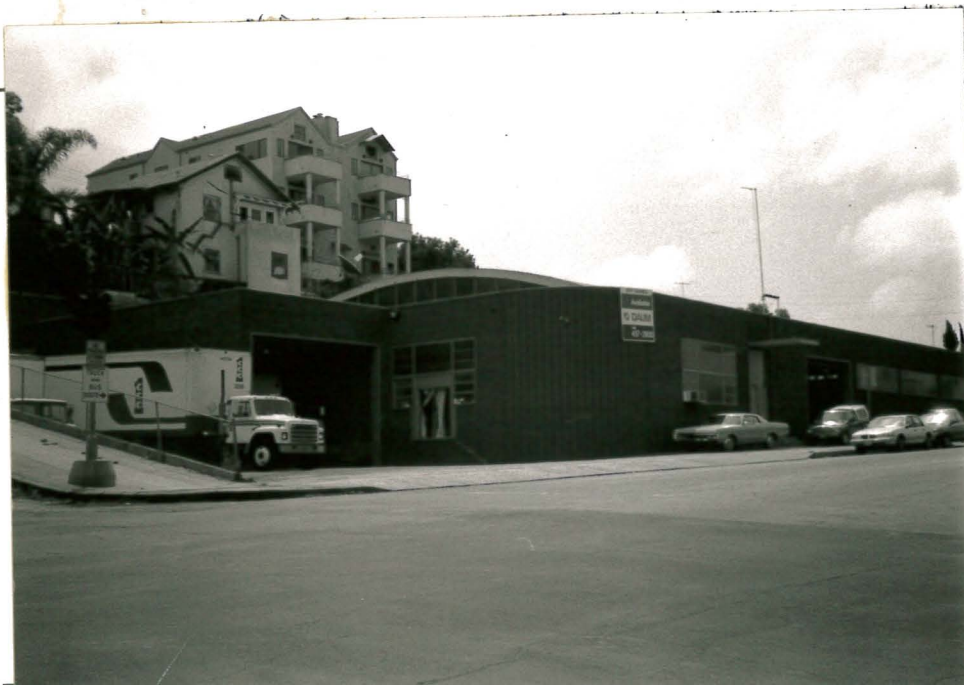
This large 1-story industrial building is rectangular in shape with a curving north-west corner indicative of the 1930's architecture. The roof is flat with a large vaulted curving wooden truss in the center with multi-pane windows on each end. Along the northern facade is a large garage for loading purposes with a cement driveway. The windows are metal framed hopper style with 3 horizontal translucent panes forming a horizontal band around the structure. Some windows have center fixed panes. The main entry features 3 cement steps to the stoop and solid wooden door with a wooden side panel, large square transom and metal hood suspended by guy wires above. Originally, the door was aluminum-framed glass with a glass side panel. To the south of the door is a second large garage with a metal pull-down door. The siding is stretch-bond with small vents along the foundation.

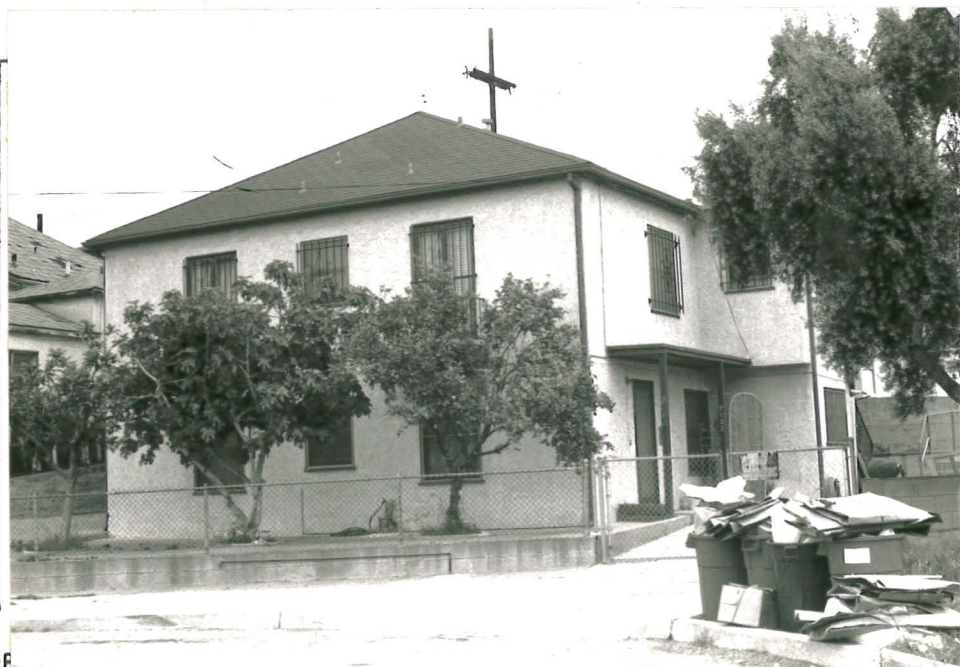
This two-story stucco-sided apartment building is irregularly shaped and has a medium-pitched hipped roof with asphalt shingles, a boxed cornice, and overhanging eaves. The building faces Union Street, but extends the width of the lot to Brant Street, where a second story entrance is at street level. Windows are wide double-hung with wrought ironwork and two balconets on the second floor. The two main entry doors face south. They are sheltered by a flat roof supported by square wooden posts. Entry porches are one step above ground level. A second floor entry is located on the south facade, and is reached via cement steps supported by square wooden posts, and displaying an iron bannister. The Brant Street entry, also on the second floor, has a porch with an iron balustrade and square wooden posts, which support an extension of the main roof. The first floor is located below the porch. There is a driveway on the south side. Alterations include a corrugated overhang on the south facade, and possibly the stuccoed exterior.

13. Condition: Excellent _____ Good _____ Fair ☒ Deteriorated _____ No longer in existence _____
14. Alterations: Corrugated overhang
15. Surroundings: (Check more than one if necessary) Open land _____ Scattered buildings _____ Densely built-up ☒
Residential ☒ Industrial _____ Commercial _____ Other: _____
16. Threats to site: None known ☒ Private development _____ Zoning _____ Vandalism _____
Public Works project _____ Other: _____
17. Is the structure: On its original site? ☒ Moved? _____ Unknown? _____
18. Related features: None

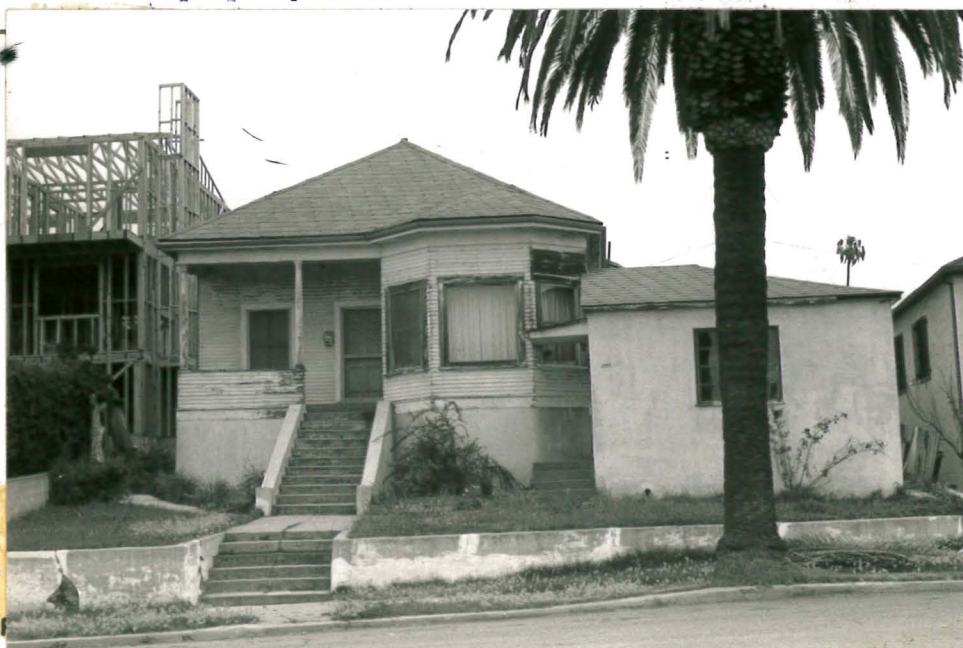
This dwelling is a 1-story irregularly-shaped wood-frame structure on a 1/2-story cement foundation on the north side attached to a single-story addition with stucco siding on the south side. The north side structure is a Neoclassical box with clapboard siding and a high-pitched hipped roof with composition shingles and boxed shallow overhanging eaves with a plain frieze below. Windows are double-hung with wood surround. South of the porch, a wide-angle bay has a large central fixed-pane window with double-hung side panels. The door is multi-panel wood. Six cement steps lead from street level to a sidewalk which leads in turn to 13 cement steps with stucco bannister rising to a covered porch. The porch features a clapboard balustrade & two narrow Tuscan columns. Built on to the south side of this dwelling is a lower structure with a low hipped roof and composition shingles identical to the main structure. A stepped north side entry has a shed hood and a door with a single glass pane. Windows are two and three sash multi-pane casements. A secondary entrance is located on Brant Street. A stuccoed block wall surrounds the property. Alterations include the entire south side structure.

13. Condition: Excellent ____ Good ____ Fair ____ Deteriorated X No longer in existence ____
14. Alterations: A south side addition, new foundation.
15. Surroundings: (Check more than one if necessary) Open land ____ Scattered buildings ____ Densely built-up X
Residential X Industrial ____ Commercial ____ Other: ____
16. Threats to site: None known ____ Private development ____ Zoning X Vandalism ____
Public Works project ____ Other: ____
17. Is the structure: On its original site? ____ Moved? ____ Unknown? X
18. Related features: ____

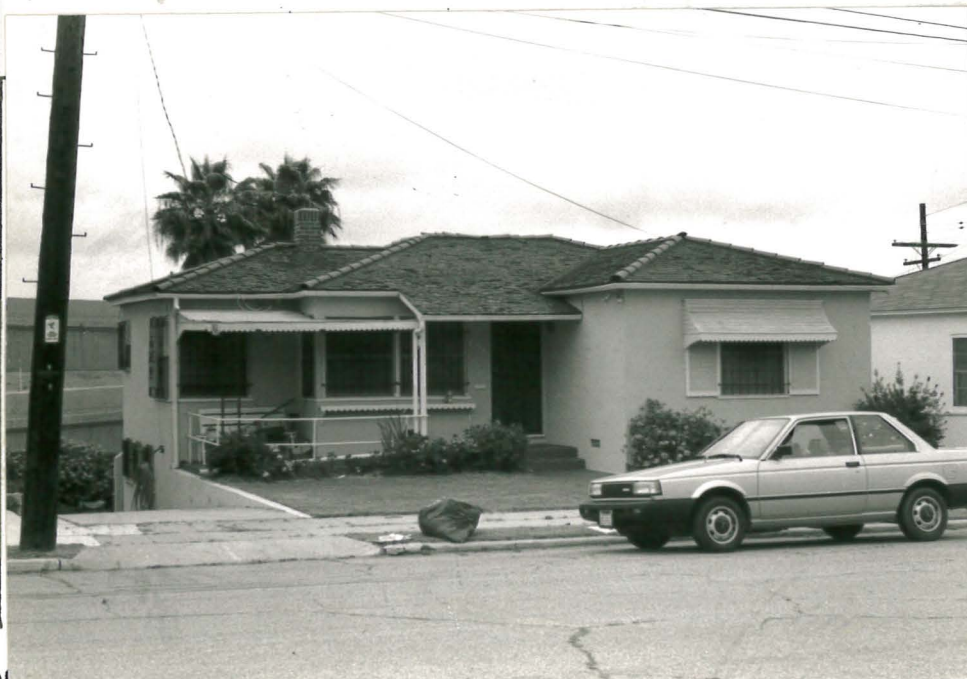
This irregularly-shaped stucco-sided house is one story in height with a basement in the rear to accommodate the steeply sloping lot. The medium-pitched multihipped roof has wood shingles with a red tile spine, boxed cornice, and overhanging eaves. A band of horizontally-paned double-hung windows wraps around the southeast corner of the building. On the north side of the front facade a single window features shutters and a metal awning decorated with scallops. All windows have decorative ironwork. A sidewalk and two cement steps lead to a porch and wood panel door. The porch extends to the southeast corner of the house and features a pipe balustrade and decorative iron and square wooden posts, which support a flat roof with scalloped bargeboard. The roof projects below the level of the main roof and shelters the corner of the porch. A hipped roof extension covers the remainder of the porch, including the entryway. A rear entry is reached via a stairway with a stucco bannister. There is an interior brick chimney and driveway to the south. Alterations include the flat porch roof, balustrade, and posts.

13. Condition: Excellent _____ Good ☒ Fair _____ Deteriorated _____ No longer in existence _____
14. Alterations: Flat porch roof, balustrade, posts.
15. Surroundings: (Check more than one if necessary) Open land _____ Scattered buildings _____ Densely built-up ☒
Residential ☒ Industrial _____ Commercial _____ Other: _____
16. Threats to site: None known _____ Private development _____ Zoning ☒ Vandalism _____
Public Works project _____ Other: _____
17. Is the structure: On its original site? ☒ Moved? _____ Unknown? _____
18. Related features: None

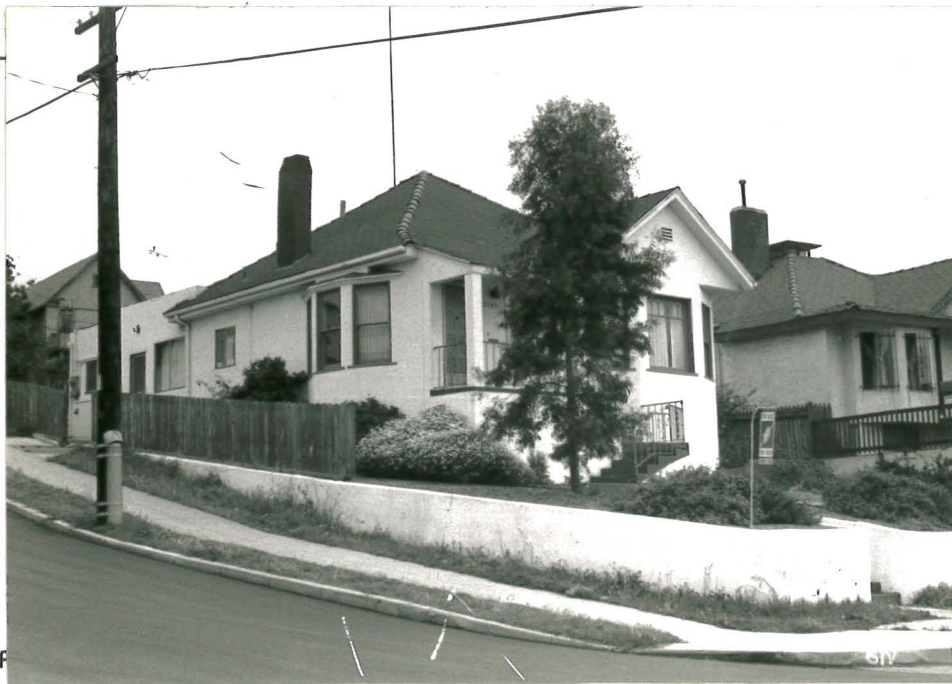
This irregularly-shaped, one-story building has a high-pitched pyramidal roof with cross gable and a flat-roofed addition to the north-east. The roof is composition shingle with a red tile spine. Windows are single-pane double-hung, except on west facing bay beneath a front gable, where a central pane with a leaded glass, pointed arched transom between double-hung panels. Another bay is located on the north side, a possible addition. Ten steps lead from a raised foundation level with a stucco retaining wall on the west side. Metal railing lines the steps and porch, where square wooden posts support a shed roof. A brick chimney is located on the north side, and a square vent rests high in the front gable. Alterations include the flat sliding window on the addition, metal screen door, stucco siding, possibly a classical column was once located where a square post currently is standing.

13. Condition: Excellent ___ Good ___ Fair X Deteriorated ___ No longer in existence: ___
14. Alterations: Flat roof addition, garage, metal sliders, screen door, stucco siding.
15. Surroundings: (Check more than one if necessary) Open land ___ Scattered buildings ___ Densely built-up X
Residential X Industrial ___ Commercial ___ Other: ___
16. Threats to site: None known ___ Private development ___ Zoning X Vandalism ___
Public Works project ___ Other: ___
17. Is the structure: On its original site? X Moved? ___ Unknown? ___
18. Related features: ___

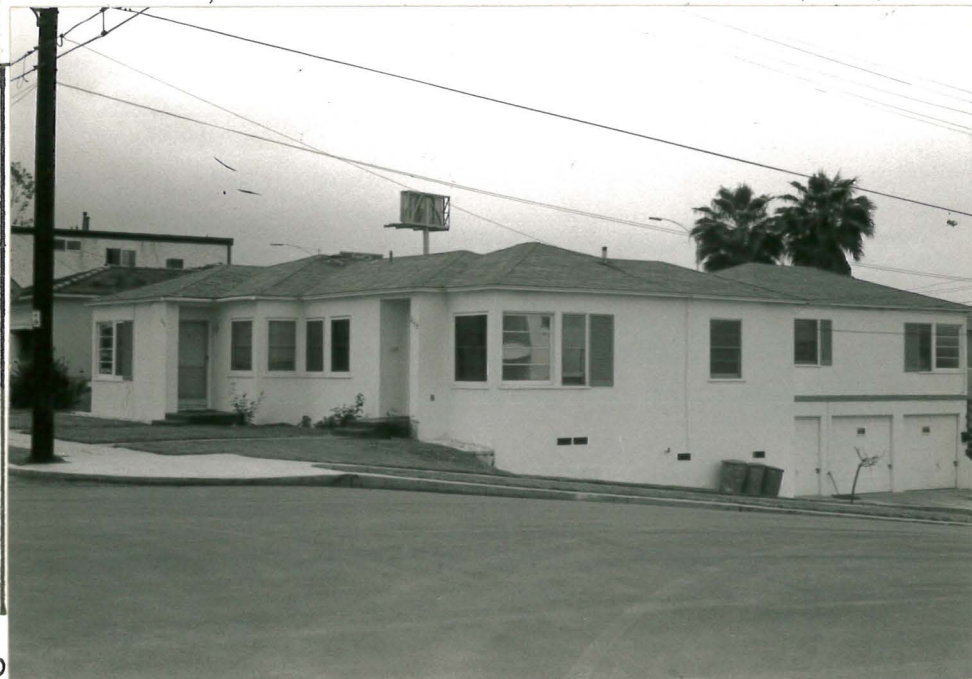
This irregularly-shaped stucco-sided apartment building is one story in height with a basement in the rear to accommodate the steep slope of the lot. The medium-pitched multiple-hipped roof has asphalt shingles and a boxed cornice with overhanging eaves. A band of horizontally-paned double-hung windows crosses the front facade and wraps around the corner. A shutter is located on the south window of the front facade and the east window of the north facade. There are two deeply recessed wood panel entry doors, one facing east and one facing west. The doors are reached from separate sidewalks, and two steps which terminate in stoops partially covered by roof overhangs. The front facade of the building is quite irregular. Rectangular vents are located at the foundation level on the north facade. A rear entry is reached via a wooden stairway with a pipe railing. The dwelling at 519 Ivy Street is a companion. It is a two-story, hip-roofed apartment building, with three garages on the first floor. A horizontal band runs between the first and second floors, and a cement stairway on the west leads to a second floor entrance.

13. Condition: Excellent ☒ Good _____ Fair _____ Deteriorated _____ No longer in existence _____
14. Alterations: None apparent.
15. Surroundings: (Check more than one if necessary) Open land _____ Scattered buildings _____ Densely built-up ☒
Residential ☒ Industrial _____ Commercial _____ Other: _____
16. Threats to site: None known ☒ Private development _____ Zoning _____ Vandalism _____
Public Works project _____ Other: _____
17. Is the structure: On its original site? ☒ Moved? _____ Unknown? _____
18. Related features: Dwelling at 519 Ivy Street
