HISTORIC RESOURCES INVENTORY

1. Common name: ---
2. Historic name: John S. Hawley Residence
3. Street or rural address: 205 Laurel Street
City San Diego Zip 92101 County San Diego
4. Parcel number: 533-093-01
5. Present Owner: Violet Vanhorne Address: P.O. Box X-1013
City San Diego Zip 92112 Ownership is: Public --- Private X
6. Present Use: Residential Original use: Residential

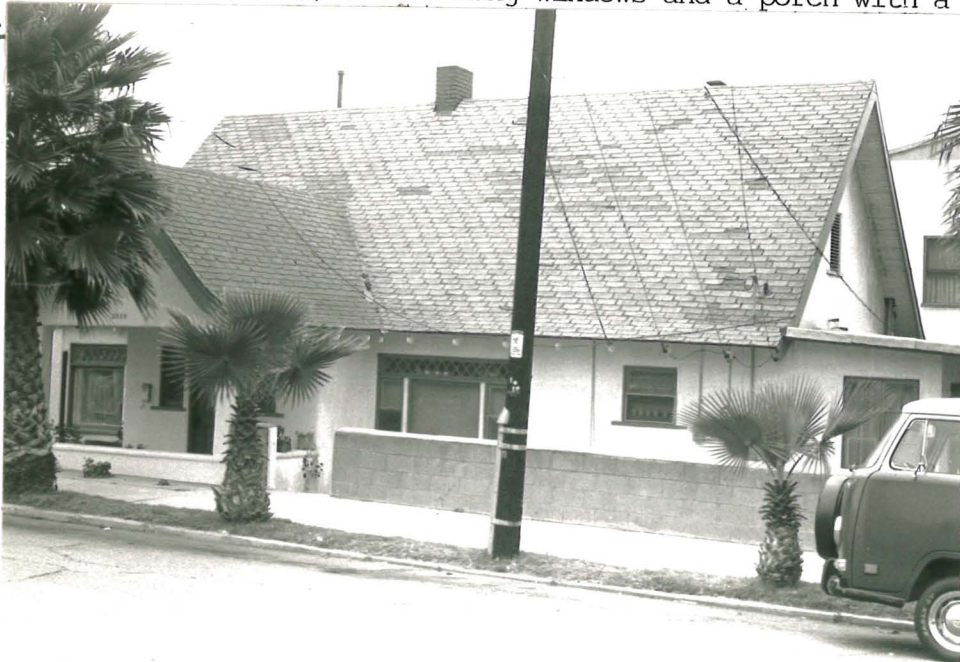
- 7a. Architectural style: Craftsman
7b. Briefly describe the present physical appearance of the site or structure and describe any major alterations from its original condition: Legal D: Blk 60 E H of Lots 7 & 8 in Hortons Add Lockling
This 1-story stucco-sided irregularly-shaped house is in the Craftsman style. It has a high-pitched cross-gable roof with flared ends, asphalt shingles, overhanging eaves, and worked rafters. The front gable which covers the porch is lower than the main gable, but both gables have rectangular roof vents. Prominent additions appear on the N & S sides of the house. The original house has recessed 3-sash windows with central fixed sashes, narrow double-hung side panels, and diamond-paned transoms above all 3 sashes. Some windows are double-hung with extended lugsills. The door, behind a wood-framed screen is wood paneled with a square glass upper and diamond-paned 1/2 side panels with extended lugsills. The front porch with its boxed stucco balustrade with coping is reached from two descending steps and a walkway which leads to the S. side of the porch. Two stucco posts support the gabled porch roof. South of the porch an oriel bay with triangular brackets below wraps around the corner. The house has an interior brick chimney. The addition to the north has a shed roof, multi-pane hinged windows and a stepped entry. To the south, the addition includes a gabled roof which ends before it joins the main roof, double-hung windows and a porch with a shed roof overhang.

13. Condition: Excellent _____ Good X Fair _____ Deteriorated _____ No longer in existence _____
14. Alterations: N & S additions
15. Surroundings: (Check more than one if necessary) Open land _____ Scattered buildings _____ Densely built-up X
Residential X Industrial _____ Commercial _____ Other: _____
16. Threats to site: None known _____ Private development _____ Zoning X Vandalism _____
Public Works project _____ Other: _____
17. Is the structure: On its original site? _____ Moved? _____ Unknown? X
18. Related features: _____

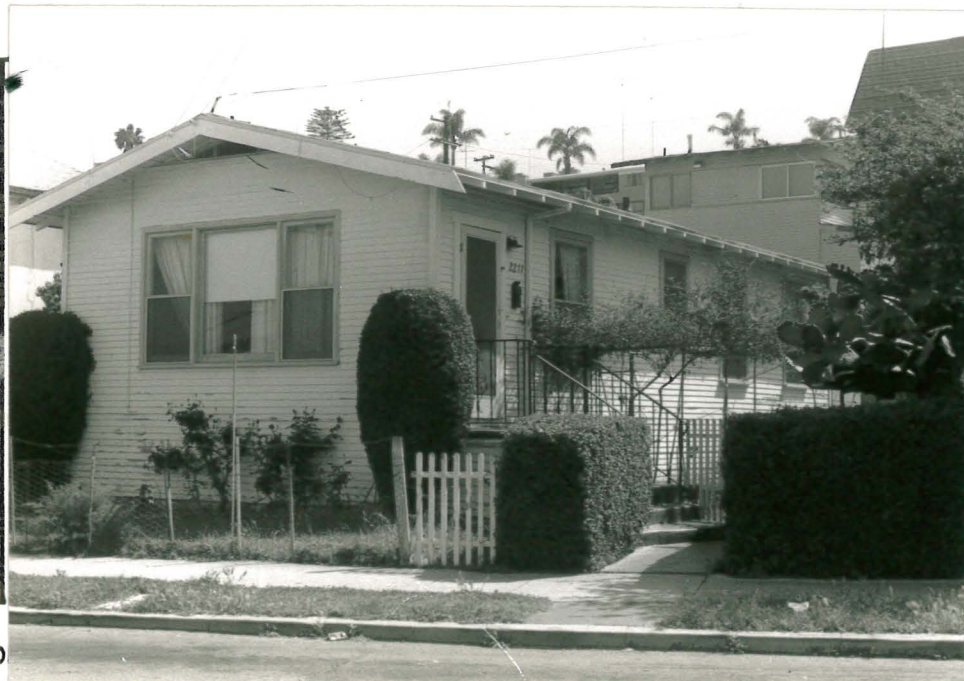
This one story, rectangular building has a low-pitch, front-gable roof of composition shingle with overhanging eaves and exposed rafters. The windows are double-hung with wood surrounds. A three-sash window with a fixed, recessed center pane and double-hung side panels is located on the street facade. The building sits on a concrete foundation and has clapboard siding. The south-facing entry is reached from five, curving cement steps with a wrought iron balustrade which extends around the entry stoop. The entry door is plain wood with a wooden screen and surround. A mature cactus garden is located on the north end of the property. Alterations include the partial picket and chicken wire fence.

13. Condition: Excellent _____ Good ☒ Fair _____ Deteriorated _____ No longer in existence _____
14. Alterations: Fence
15. Surroundings: (Check more than one if necessary) Open land _____ Scattered buildings _____ Densely built-up ☒
Residential ☒ Industrial _____ Commercial _____ Other: _____
16. Threats to site: None known _____ Private development _____ Zoning ☒ Vandalism _____
Public Works project _____ Other: _____
17. Is the structure: On its original site? ☒ Moved? _____ Unknown? _____
18. Related features: _____

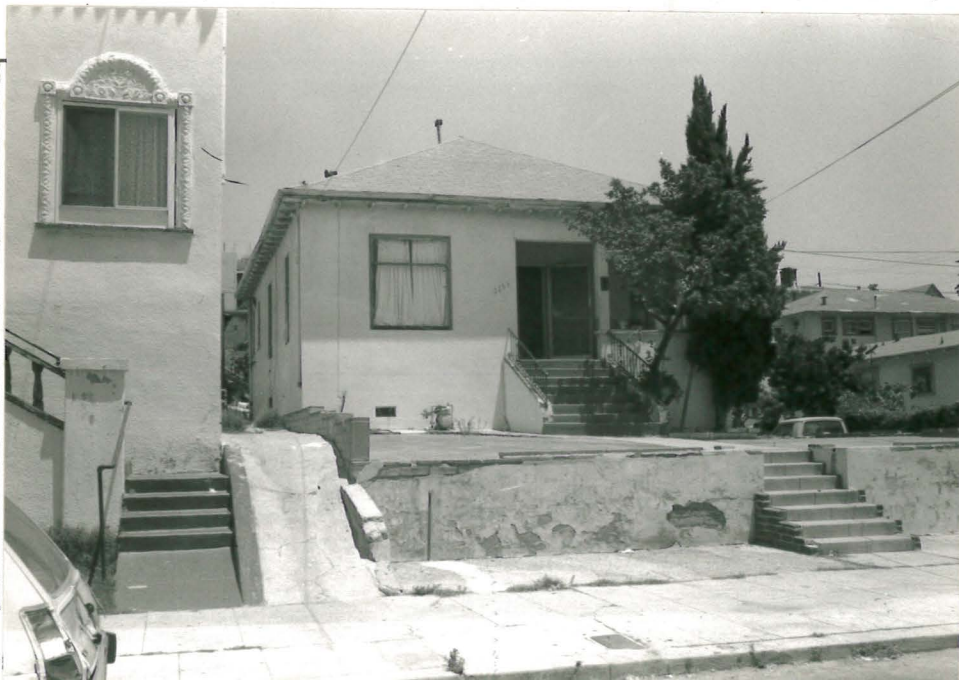
This building is one story in the front and two stories in the back due to the slope of the lot. Rectangular in shape, the building has a medium-pitch hip roof of composition shingle with overhanging eaves and exposed rafters. Windows are recessed double-hung. The building is raised above street level by a block retaining wall. Seven steps lead from the street to this level, then eight steps lead up to a covered porch with a stucco-covered balustrade extending to the foundation, two square wooden posts and two recessed multipanel entry doors with glass uppers. A square recessed entry is located on the south side, below the front porch, and has a wood paneled entry door, entry and door recessed below ground level. A south driveway leads to a two-car garage.

Alterations include the cementing over of the raised front yard area in front of the entry porch and a two car garage with flat roof with stepped parapet on the southeast corner.

13. Condition: Excellent _____ Good _____ Fair ☒ Deteriorated _____ No longer in existence _____
14. Alterations: Stucco over raised front yard.
15. Surroundings: (Check more than one if necessary) Open land _____ Scattered buildings _____ Densely built-up ☒
Residential ☒ Industrial _____ Commercial _____ Other: _____
16. Threats to site: None known _____ Private development _____ Zoning ☒ Vandalism _____
Public Works project _____ Other: _____
17. Is the structure: On its original site? ☒ Moved? _____ Unknown? _____
18. Related features: _____

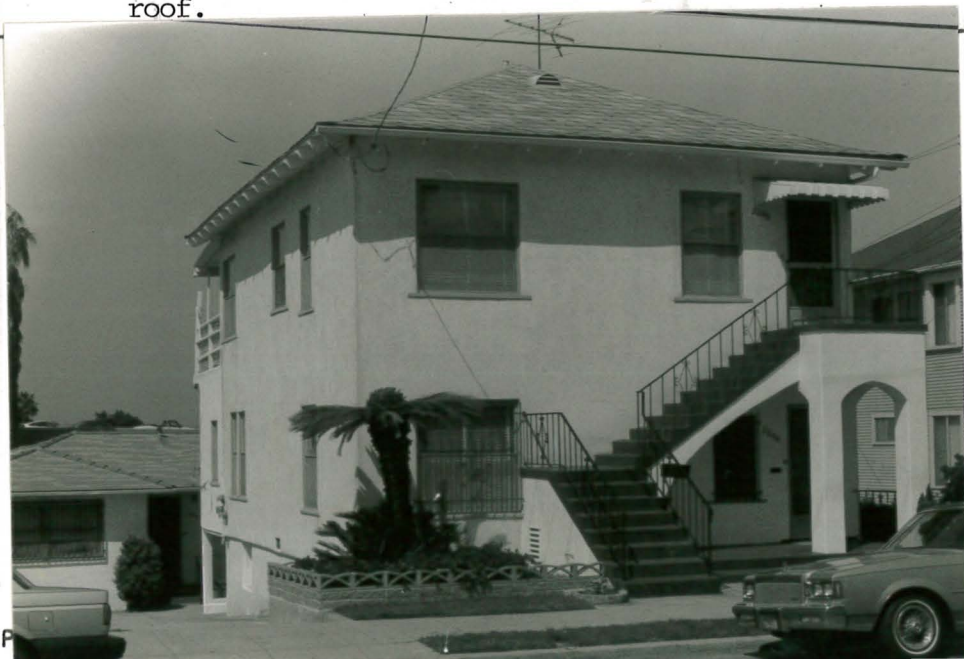
This rectangular, stucco-sided building is two stories in height with a basement in the rear due to the slope of the lot. It has a medium-pitched hipped roof with overhanging eaves and worked rafters. Windows are double-hung with narrow lugsills. Some are wide, with horizontal panes and many are decorated with wrought iron. One of the windows on the north facade has a multi-vertical paned upper. Doors are multiple panel wood. The second floor door has a glass upper and a metal overhang. The building has been greatly altered by the addition of a front cement stairway with an iron railing. The stairway, which is straight and then north-turning, leads to the upper-floor entry and covers the northern half of the front facade. The lower portion of the stairway is curved and forms a roof for the first floor entry porch. A segmented arch with massive posts supports the roof. On the north side of the porch is a wrought iron balustrade. Other alterations are new stucco, metal screens over the doors, and a shed roof and balustrade of open wood and corrugated plastic surrounding a west-facing balcony. To the south, a driveway leads to a one-story house with a multi-hipped roof.

13. Condition: Excellent _____ Good _____ Fair ☒ Deteriorated _____ No longer in existence _____
14. Alterations: Stairway, stucco, screen, roof and balustrade for balcony.
15. Surroundings: (Check more than one if necessary) Open land _____ Scattered buildings _____ Densely built-up ☒
Residential ☒ Industrial _____ Commercial _____ Other: _____
16. Threats to site: None known _____ ☒ Private development _____ Zoning _____ Vandalism _____
Public Works project _____ Other: _____
17. Is the structure: On its original site? ☒ Moved? _____ Unknown? _____
18. Related features: Multihip roofed one story house

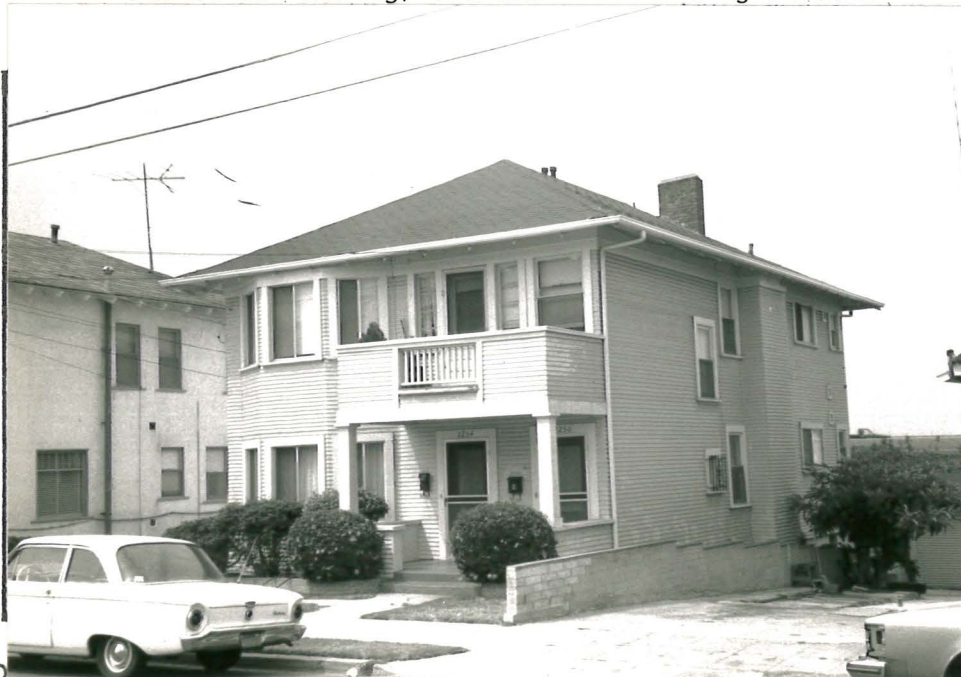
This two-story rectangular duplex is situated on a rise with a basement below. The clapboard siding flares slightly at the concrete foundation. The medium-pitched hip roof has wide overhanging eaves and exposed pointed rafters with a plain frieze below. The windows are double-hung with wooden surrounds; however, sliding aluminum replacements are on the two-story bay along the street facade and along the southern facade bay. To the north of the front bay is the entry porch with a balcony above. The balcony is boxed with a clapboard balustrade which opens in the center with a stick railing. The door is wood framed with horizontal panes and horizontal multi-paned side panels. Below the balcony is the open entry porch with a boxed balustrade and square posts to support the balcony above. Within the porch are two entries with wood-paneled doors, glass uppers, and wide wooden surrounds. A tall brick interior chimney intersects the hip roof and a narrow driveway runs along the southern wall. To the rear is a recent addition of a two-story apartment with a low hip roof, exposed rafters, and stucco siding, and aluminum sliding windows.

13. Condition: Excellent ___ Good ___ X Fair ___ Deteriorated ___ No longer in existence ___
14. Alterations: Windows, shed roof on rear wall first level
15. Surroundings: (Check more than one if necessary) Open land ___ Scattered buildings ___ Densely built-up ___ X
Residential X Industrial ___ Commercial ___ Other: ___
16. Threats to site: None known ___ X Private development ___ Zoning ___ Vandalism ___
Public Works project ___ Other: ___
17. Is the structure: On its original site? ___ X Moved? ___ Unknown? ___
18. Related features: Two-story apartment building in rear.

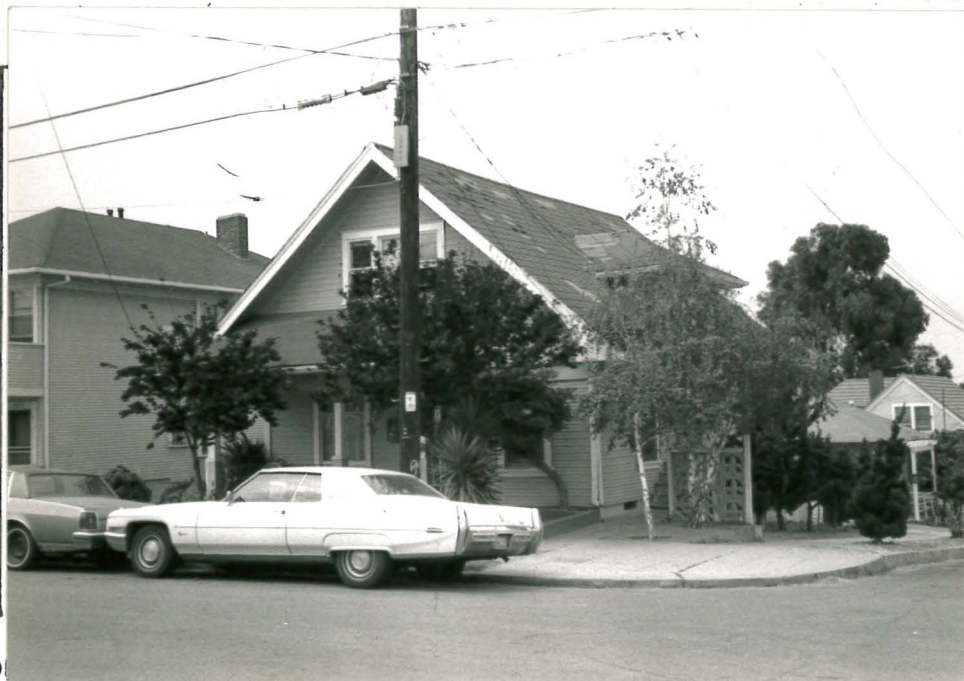
This two-story home with basement is rectangular in shape on a slight grade rising to the east. The roof is a high-pitched front gable with wide overhanging eaves, a boxed cornice, and plain frieze. The gable completely encompasses the second story and a hipped dormer extends from the southern and northern facades. The windows are narrow and double-hung with a three-sashed row within the front gable with shelf surrounds. Some panes are fixed with a leaded transom. The door is wood paneled with a glass upper, which has been replaced with an aluminum frame. Surrounding the door is a molded lugsill and shelf surround with dentils. The front porch is sheltered by a hipped roof with exposed rafters, wide lenthil and square posts separating the wrought iron balustrade. The siding is clapboard with corner boards. Alterations include a hip-roofed addition on the western facade a shed-roofed bay between two original square oriel bays on the southwestern facade, and a stairway with access into the northern second floor dormer.

13. Condition: Excellent ____ Good ____ Fair X Deteriorated ____ No longer in existence ____
14. Alterations: Stairway and access to north dormer, additions on west and southern facades.
15. Surroundings: (Check more than one if necessary) Open land ____ Scattered buildings ____ Densely built-up X
Residential X Industrial ____ Commercial ____ Other: ____
16. Threats to site: None known ____ Private development ____ Zoning X Vandalism ____
Public Works project ____ Other: ____
17. Is the structure: On its original site? X Moved? ____ Unknown? ____
18. Related features: Gable-roofed garage to the west

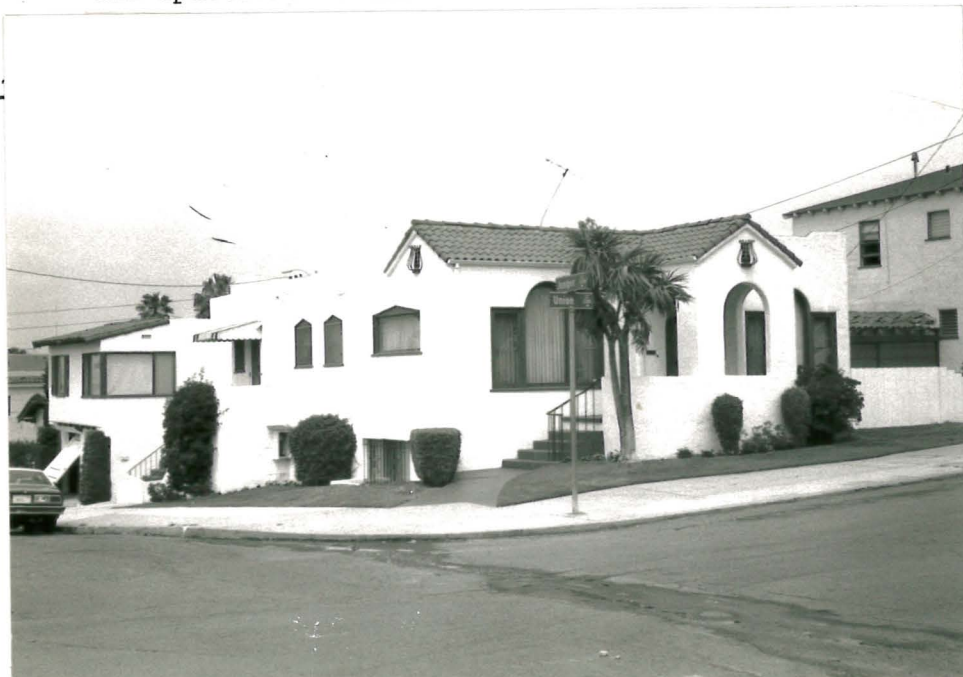
2306 Union Street is a one-story rectangular home in the Mission Revival Style. The stucco facade is symmetrical. The roof is primarily flat with a red-tile side gable along Union Street. The home is situated on a rise which slopes to the rear exposing a basement below. The windows along Union Street are large palladian-style with double-hung side panels. The side windows are various styles due to alterations and include double-hung, 3-sashed multi-pane hinged, fixed, louvered and aluminum sliding, some with decorative pedimented crowns. The front entry is stepped from the side with a curving iron banister leading to an arcaded porch sheltered by a red-tile gable extending from the main gable. Within the gable ends are roof vents covered by curving iron grills. The wooden door is arched with three vertical stepped panes. The side entry on the southern facade has wooden steps with a solid stucco balustrade leading to a small stoop. The wooden door is sheltered by an aluminum awning. To the rear is an accompanying building added later with a flat roof, stucco siding two-car garage below and apartment above.

13. Condition: Excellent _____ Good X Fair _____ Deteriorated _____ No longer in existence _____
14. Alterations: Windows, aluminum awning, iron security bars
15. Surroundings: (Check more than one if necessary) Open land _____ Scattered buildings _____ Densely built-up X
Residential X Industrial _____ Commercial _____ Other: _____
16. Threats to site: None known _____ Private development _____ Zoning X Vandalism _____
Public Works project _____ Other: _____
17. Is the structure: On its original site? X Moved? _____ Unknown? _____
18. Related features: accompanying two-story apartment structure

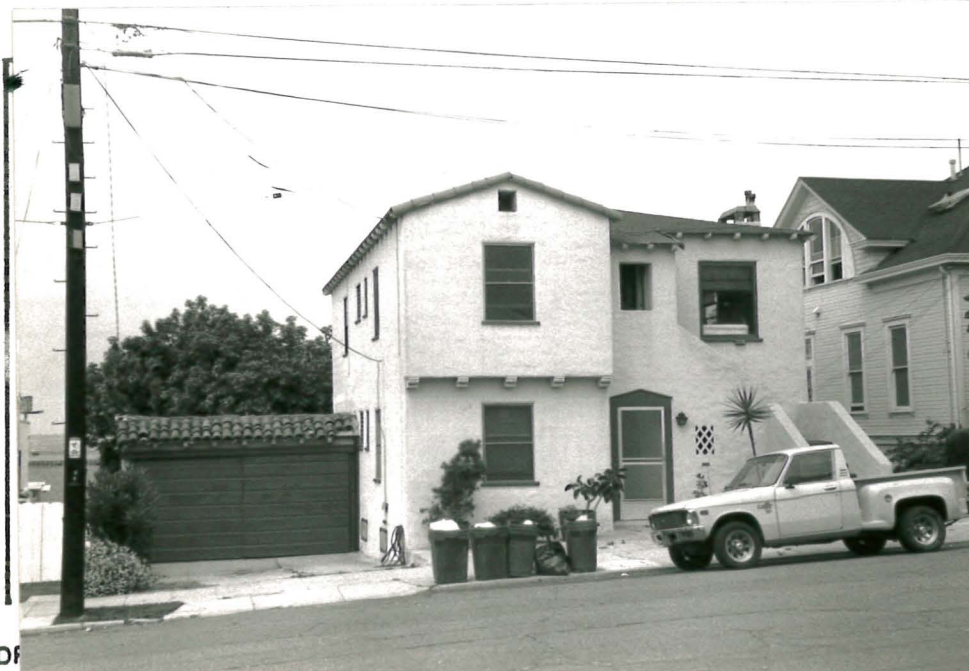
This L-shaped, two-story building has a medium hipped roof of composition shingle, overhanging eaves and exposed worked rafters. An east-facing front gable is capped in red tile with a deeply recessed square vent high in the gable. The windows are single-pane and double-pane double-hung, and multi-pane. The main arched entry door with a vertical glass upper is recessed behind a metal screen door with a wide surround and pediment cap. Straight, south-turning stairs with a boxed, stuccoed balustrade, lead to a second floor entry porch with a square front opening and arched entry. Siding is newly textured stucco with rounded corners and edges. A stuccoed chimney is located to the north with an elaborated brick and tile top. A decorative diamond pattern vent is located just north of the first floor entry beneath the stairs. Worked, exposed brackets support the slightly projecting second floor beneath the gabled section. A flat roof, two-car attached garage on the south side has a red tile shed hood and horizontal wood-plank doors. Alterations include metal window screens, louvered windows, and the new stucco.

13. Condition: Excellent _____ Good X Fair _____ Deteriorated _____ No longer in existence _____
14. Alterations: Metal window, entry screens, louvered windows, new stucco.
15. Surroundings: (Check more than one if necessary) Open land _____ Scattered buildings _____ Densely built-up X
Residential X Industrial _____ Commercial _____ Other: _____
16. Threats to site: None known X Private development _____ Zoning _____ Vandalism _____
Public Works project _____ Other: _____
17. Is the structure: On its original site? X Moved? _____ Unknown? _____
18. Related features: _____

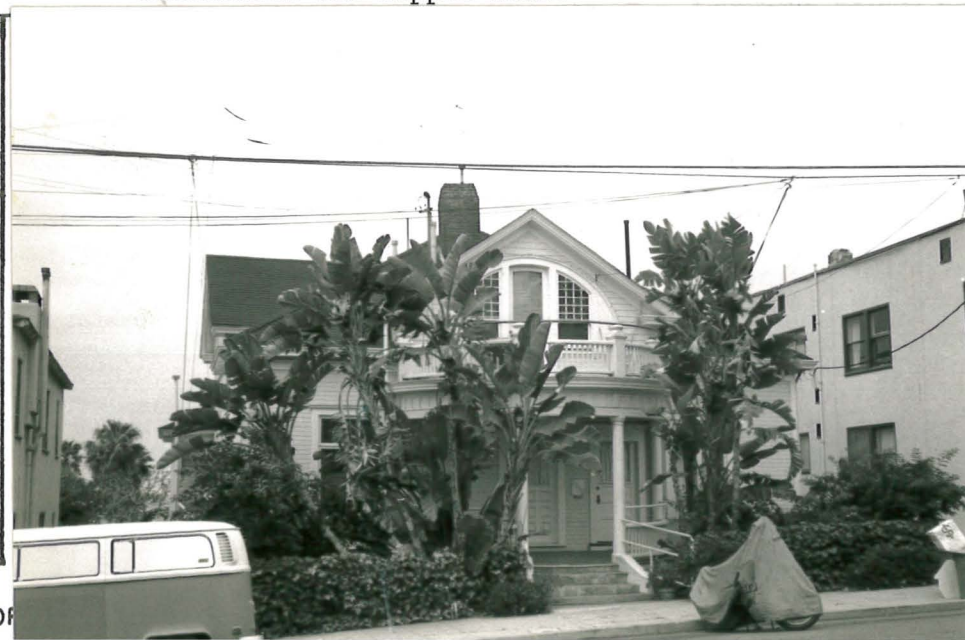
This three-story Colonial home has a steeply-pitched pyramidal roof with large gabled dormers facing east and south, and two shed dormers facing north. The overhanging eaves feature a boxed cornice with a plain frieze below. One shed dormer is sheathed with shingles, while the other is a later addition with shiplap siding and an aluminum sliding window. The two gabled dormers have a raking cornice and three-sashed $\frac{1}{2}$ -circular windows with multi-paned side panels and a center fixed pane, which serves as a door along the street facade balcony. The balcony is semicircular in shape with a simple wood balustrade and large square posts with a metal bar above (alteration). Below is a classical entablature with a decorative frieze supported by Tuscan columns, which surround the semicircular entry porch. The porch is reached by four curving cement steps with an added iron bannister. The door is wood paneled with a glass upper and wide shelf surround. A second more simple door has been added to the north. The windows are primarily hinged, some with leaded transoms, and some altered, now aluminum sliding. Concrete stairs along the northern facade lead downward to the first story apartment entries. A metal stairway leads upward to provide access to the third story apartments. The siding is clapboard and a large brick interior chimney intersects the hipped roof.

13. Condition: Excellent ___ Good X Fair ___ Deteriorated ___ No longer in existence: ___
14. Alterations: Shed dormer, some windows, metal stairway and railing, and door
15. Surroundings: (Check more than one if necessary) Open land ___ Scattered buildings ___ Densely built-up: X
Residential ___ Industrial X Commercial ___ Other: ___
16. Threats to site: None known ___ Private development ___ Zoning: X Vandalism ___
Public Works project ___ Other: ___
17. Is the structure: On its original site? ___ Moved? X Unknown? ___
18. Related features: ___

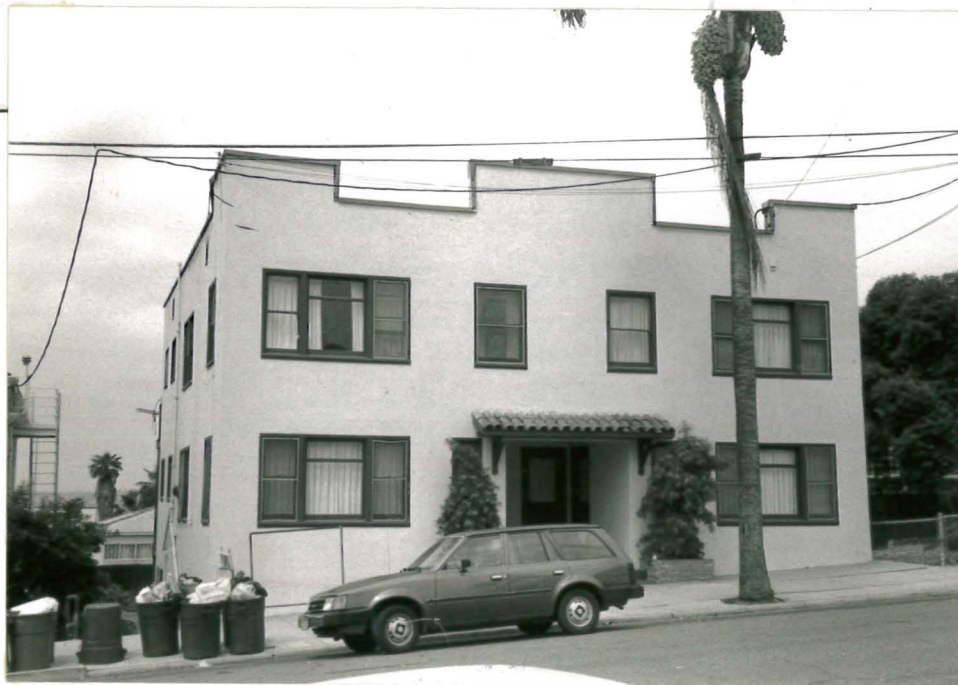
This 2-story apartment building is situated on a rise becoming 3 stories in the rear. It is rectangular in shape and has stucco siding. The roof is flat with a stepped parapet which rises at the corners and center along the street facade. The street facade windows are 3-sash with a fixed center pane, transom and double-hung side panels which are symmetrically placed. The remainder of the windows are double-hung, however, some have been replaced with louvered and aluminum sliding windows. The central element features 2 double-hung windows on the 2nd story with a red-tiled shed roof supported by knee brackets below. The entry is deeply recessed with four wooden doors with single-paned uppers providing access to the apartments. Two small hinged windows flank the recessed entry. Steps along the southern facade lead to the lower apartment entries. Alterations include the windows, a rear balcony with a wooden balustrade and patio below.

13. Condition: Excellent _____ Good X Fair _____ Deteriorated _____ No longer in existence _____
14. Alterations: Windows, rear balcony & patio
15. Surroundings: (Check more than one if necessary) Open land _____ Scattered buildings _____ Densely built-up X
Residential X Industrial _____ Commercial _____ Other: _____
16. Threats to site: None known X Private development _____ Zoning _____ Vandalism _____
Public Works project _____ Other: _____
17. Is the structure: On its original site? X Moved? _____ Unknown? _____
18. Related features: None

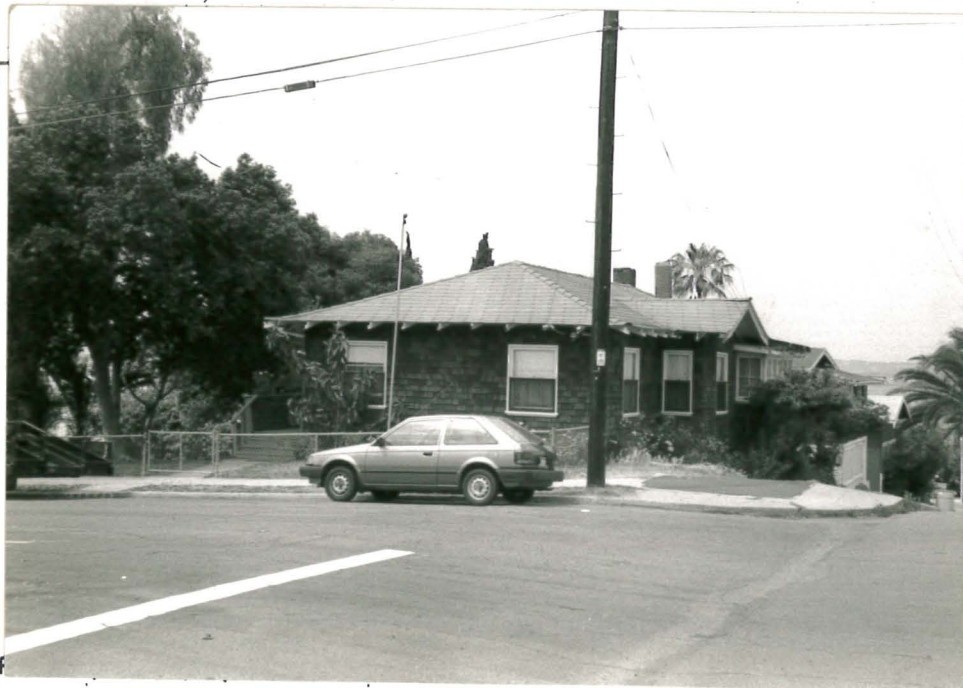
This 1-story bungalow is irregular in shape and situated on a rise which accommodates a basement to the west. The roof is a medium-pitched hip with a red-tile spine, overhanging flaring eaves and exposed rafters. The siding is wood shingle with clapboard around the foundation and basement level. The windows are wide and double-hung along with a multi-paned band of hinged windows around the northern square bay with a shed roof. Two brick chimneys rise along the western facade, one being an addition. The main entry is on the southern facade and is reached by a wooden porch with steps from the eastern facade. The open porch is boxed by a shingle balustrade and the recessed doorways are wooden with a beveled 3/4 glass pane. A side entry on the western sidewall of the bay is reached by articulated wooden stairs. An accompanying building, 621 Kalmia Street, is a 2-story apartment with a 2-car garage below. The gable roof has a red tile spine and exposed rafters. The siding matches the original house, however, some windows are now aluminum framed. A mature oak to the south of the home shades much of the property.

13. Condition: Excellent _____ Good ☒ Fair _____ Deteriorated _____ No longer in existence _____
14. Alterations: One chimney, aluminum framed windows
15. Surroundings: (Check more than one if necessary) Open land _____ Scattered buildings _____ Densely built-up ☒
Residential ☒ Industrial _____ Commercial _____ Other: Interstate 5
16. Threats to site: None known _____ Private development _____ Zoning ☒ Vandalism _____
Public Works project _____ Other: _____
17. Is the structure: On its original site? ☒ Moved? _____ Unknown? _____
18. Related features: None

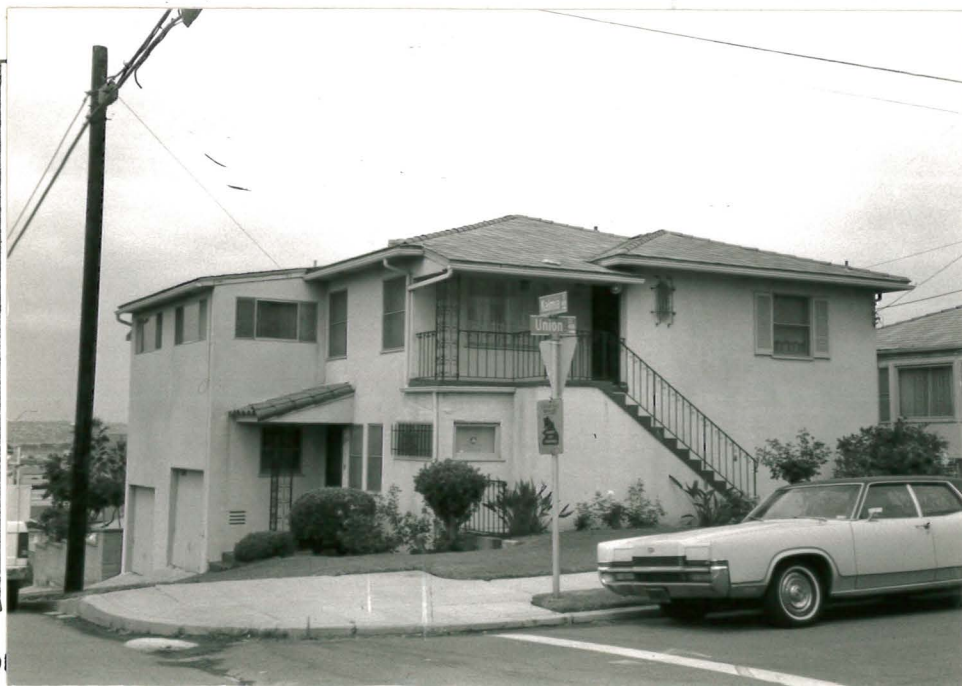
This corner located house is two-story to the east and three-story to the west and south due to the slope of the lot. The multi-hipped medium-pitched roof has a red tile spine and boxed overhanging eaves. The windows are double-hung, some in pairs, others single pane large fixed. One window on the east facade is an elongated octagonal fixed pane. The east entry is reached from cement side steps on a boxed stucco base with an open metal railing and post on the covered porch. The door has a security screen. An entry to the south has a red tile shed roofed hood with an open metal post. The wood door with metal screen is reached from four cement steps. Two wooden, stepped garage doors of vertical panel wood are located west of this entry as part of a two-story addition. Additional stucco boxed steps and balcony are located on the west facade, the balcony enclosed in glass. The siding on the house is stucco with security bars on some windows, an alteration. Other alterations include new exterior aluminum windows, a metal-gated side entry to the west, a stepped shed to the northwest of the property.

13. Condition: Excellent _____ Good _____ Fair ☒ Deteriorated _____ No longer in existence _____
14. Alterations: Southwest addition, security bars, metal gate entry, block wall.
15. Surroundings: (Check more than one if necessary) Open land _____ Scattered buildings _____ Densely built-up _____
Residential ☒ Industrial _____ Commercial _____ Other: _____
16. Threats to site: None known _____ ☒ Private development _____ Zoning _____ Vandalism _____
Public Works project _____ Other: _____
17. Is the structure: On its original site? ☒ Moved? _____ Unknown? _____
18. Related features: _____

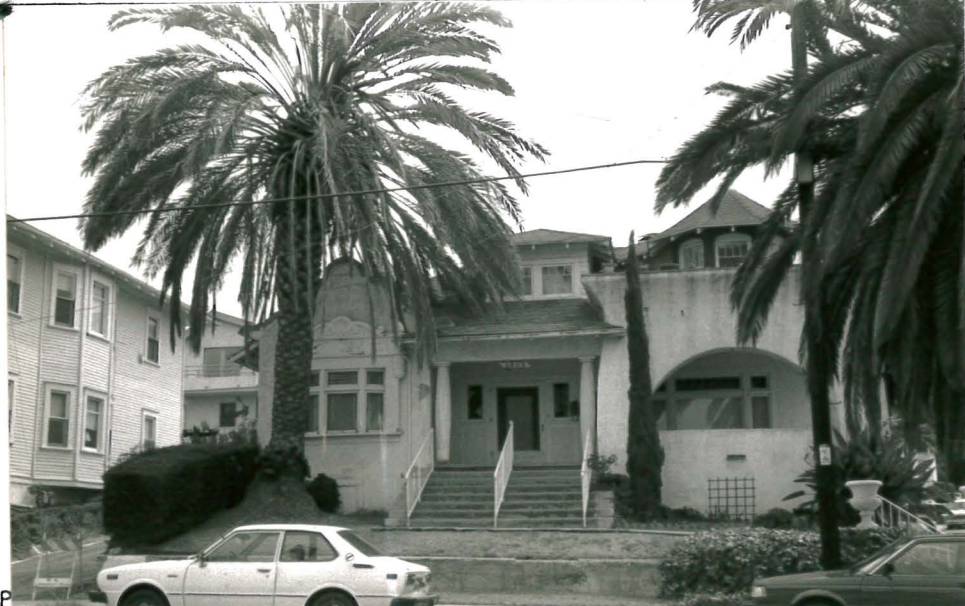
This one story rectangular house has multi-hipped roof with asphalt shingles and a central hipped dormer. Overhanging eaves shelter exposed rafters with additional slats under the eaves and a plain frieze. The house is sided in heavily grained stucco with a wooden band at foundation level. The dormer and turret have shingle siding windows are double-hung hopper, or fixed with glass or colored glass transoms. Dormer windows are hinged with a band of multi-panes across the top. The door is wood frame with a large single glass rectangular pane and 1/2 side panels of diamond shaped colored leaded glass. Both doors and windows have wood surrounds. The house is divided into three elements. The central element consists of eight wide cement steps with metal rails which lead to a recessed entry flanked by moorish columns. A massive lintel supports the roof. A south element features a massive stucco wall with a large 1/2 circle arched opening to the porch which extends from the entry area. The wall flares outward in moorish fashion at the corners and the top of the wall forms a balcony which serves a turret typical of the shingle style. The turret has a finial and fanlight areas above the window which are enclosed in shingles. The north element is composed of a Mission Style espadana above a bay window. The window is enclosed in a massive decorative wooden surround with a shelf, a carved panel and an additional espadana. The house has two chimneys, two wide angled priel bays on the south side and one wide angled bay on the north six stairs. There is a second entry off of Kalmia Street. Both entries are marked by raised pedestals with urns. The house is surrounded by a concrete retaining wall. There is a driveway on the east side. Alterations include new stucco, some windows on the south side and metal railing. The main steps have been widened at each end

13. Condition: Excellent ____ Good X Fair ____ Deteriorated ____ No longer in existence ____
14. Alterations: new stucco, some south side windows, metal rails, steps have been widened
15. Surroundings: (Check more than one if necessary) Open land ____ Scattered buildings ____ Densely built-up X
Residential X Industrial ____ Commercial ____ Other: ____
16. Threats to site: None known ____ Private development ____ Zoning X Vandalism ____
Public Works project ____ Other: ____
17. Is the structure: On its original site? X Moved? ____ Unknown? ____
18. Related features: none

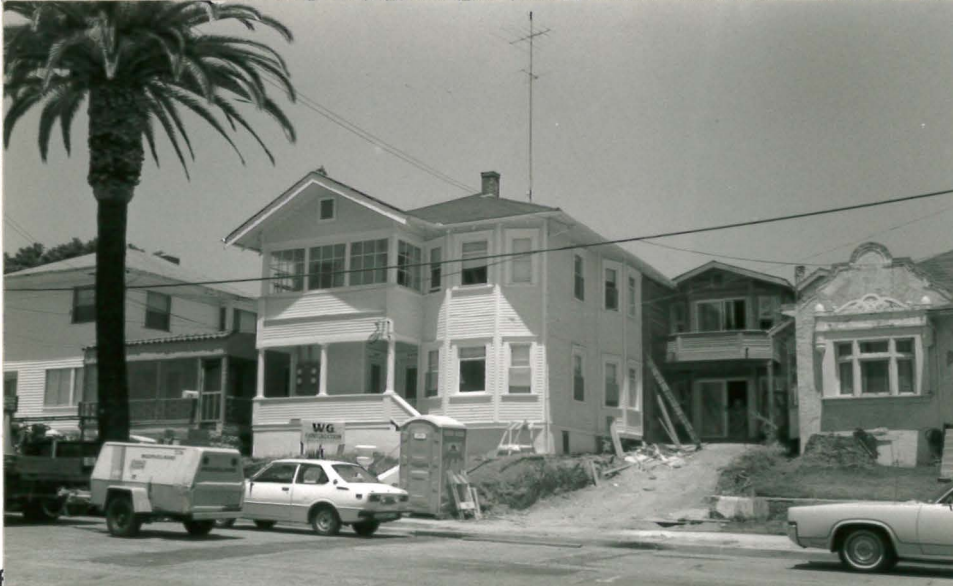
This is a two-story rectangular Colonial Revival house on a raised cement foundation. The house sits above street level behind a scored concrete retaining wall. Siding is clapboard with endboards and full-length vertical bands flanking the bays and between windows in the bays. A horizontal band runs around the building at the foundation level. The low-pitched hipped roof with a front gable over the porch has widely overhanging eaves, exposed rafters and a plain frieze. The gable features a rectangular roof vent in its peak. A prominent porch covers the north half of the front facade and is surrounded by a clapboard balustrade. It features 3 Tuscan columns and a lintel which support a second floor enclosed porch with engaged Tuscan columns at the corners. The doorway is recessed and contains one south-facing and one west-facing entry door. The doors are wood framed with large rectangular bevelled glass panes and shelf surrounds. The west-facing door has narrow glass half-side panels. The porch is reached via an articulated cement stairway marked by urns on pedestals. Near the porch, the stairway has a clapboard bannister. Windows are double-hung or fixed pane with angular geometric transoms. All have shelf surrounds. Windows on the enclosed second story porch are a band of multipaned fixed windows which wrap the corners. The house features two 2-story angled oriel bays, one south of the porch on the front facade and one on the south facade. There is an interior chimney.

13. Condition: Excellent ☒ Good ☐ Fair ☐ Deteriorated ☐ No longer in existence ☐
14. Alterations: Porch has been enclosed, addition to the south
15. Surroundings: (Check more than one if necessary) Open land ☐ Scattered buildings ☐ Densely built-up ☒
Residential ☒ Industrial ☐ Commercial ☐ Other: ☐
16. Threats to site: None known ☒ Private development ☐ Zoning ☐ Vandalism ☐
Public Works project ☐ Other: ☐
17. Is the structure: On its original site? ☒ Moved? ☐ Unknown? ☐
18. Related features: None

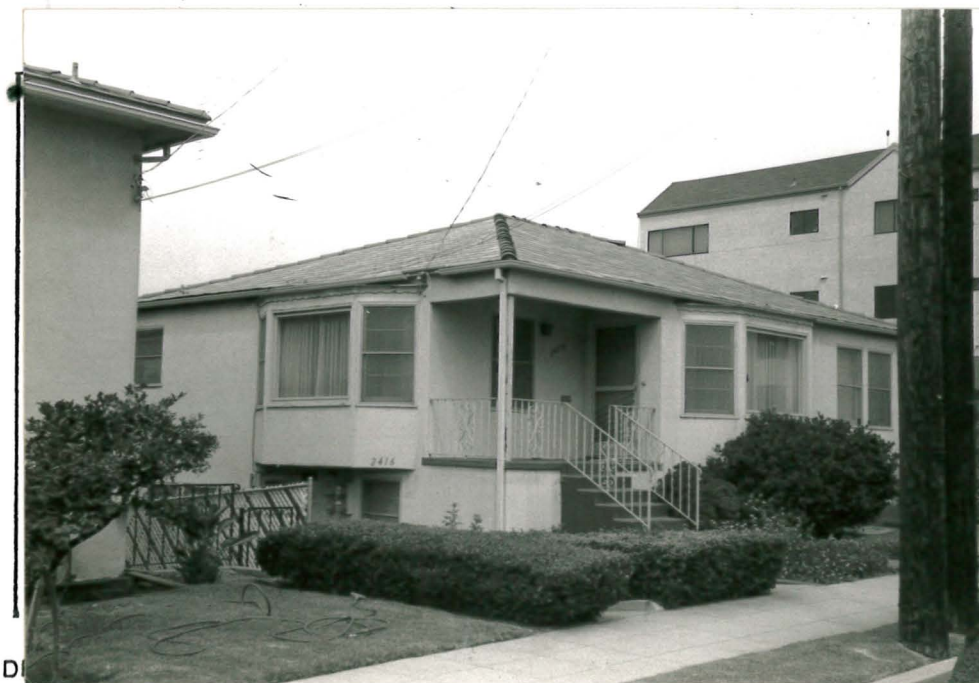
This two-story building, one story from Union Street due to the slope of the lot, is rectangular in shape and has a medium-pitch hipped roof with a red tile spine over composition shingle. The windows are double-hung, each sash with two horizontal panels. A cantilevered, south-facing bay projects over an entry below. Like the northeast bay, it has a fixed center pane and double-hung, horizontal pane, side panels. The main entry is reached, from the south side of the east facade, from six plain cement steps with a wrought iron railing which continues onto a covered porch supported by one square post. The entry door is multi-panel wood with a mutual screen in front.

Condition: Excellent ___ Good X Fair ___ Deteriorated ___ No longer in existence ___

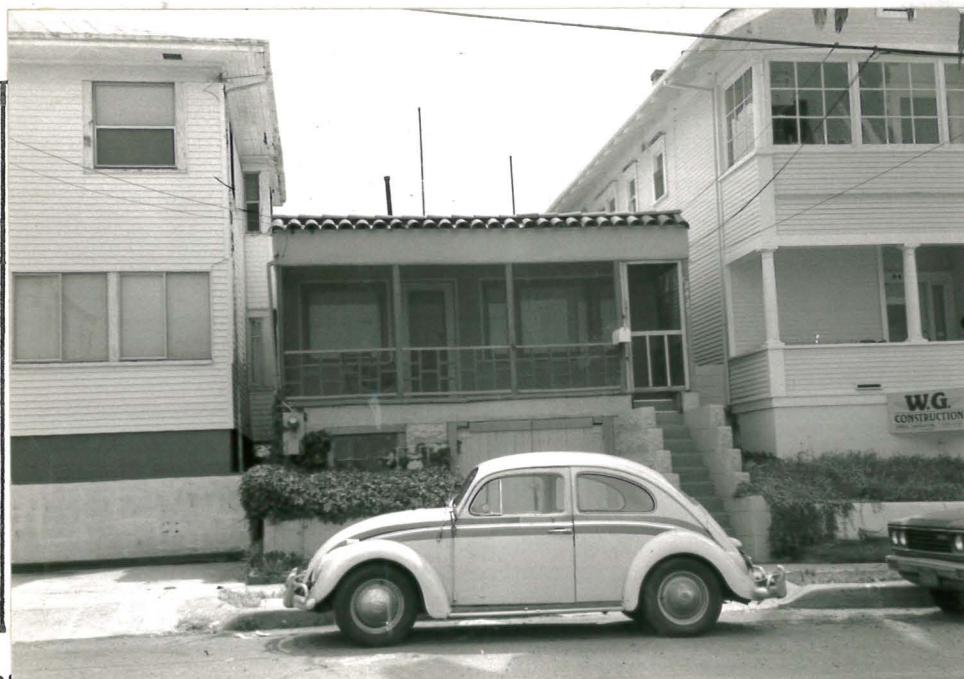
This small two-story building has a flat roof with the addition of a red tile pent-roof porch across the west facade. Windows are large single pane and three sash with a large center pane and hinged side panels. On the south side are double-hung windows. The entry door is two-paned wood with a large glass upper and a wooden screen. The foundation is constructed of ashlar block, as is the retaining wall and stepped top half of the twelve narrow step boxed surround of concrete block. The porch is supported by narrow wooden posts with an open wooden balustrade and net surround. The porch floor consists of plywood, as are the last two of the twelve entry steps. Level with the street is a one-car garage with narrow vertical paneled doors, which open to the center and north of this horizontally-paneled window. Alterations include the entire porch and stairs. The building appears to have been relocated to this site.

13. Condition: Excellent _____ Good _____ Fair _____ Deteriorated X No longer in existence _____
14. Alterations: Entire porch, stairs
15. Surroundings: (Check more than one if necessary) Open land _____ Scattered buildings _____ Densely built-up _____
Residential X Industrial _____ Commercial _____ Other: _____
16. Threats to site: None known X Private development _____ Zoning _____ Vandalism _____
Public Works project _____ Other: _____
17. Is the structure: On its original site? _____ Moved? _____ Unknown? X
18. Related features: _____

This is a non-contributing structure due to alterations to the original architecture, deterioration, and/or lack of historical significance.

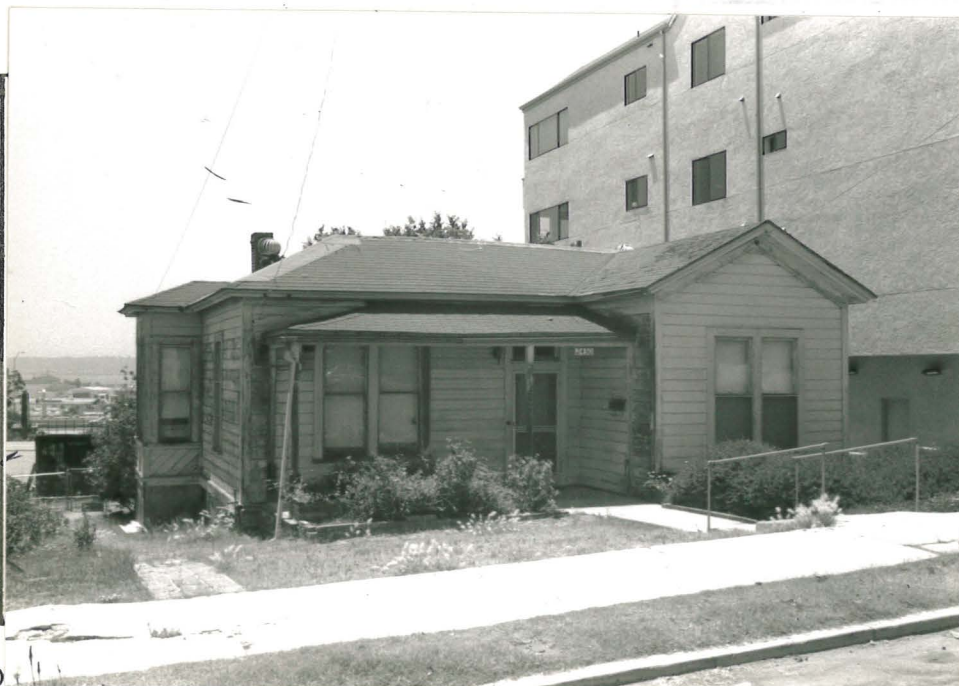
This 1-story L-shaped Folk Victorian house is on a raised foundation to the rear due to the slope of the lot. Siding is shiplap with endboards and a horizontal band at foundation level. The multi-hipped medium-pitched roof with a front gable on the north side has asphalt shingles, overhanging eaves, a boxed cornice, and a plain frieze. Windows are narrow double-hung with wood surrounds. The door is wood panel with a rectangular glass upper, a wood surround, and a double-paned glass transom. Two cement steps with an iron pipe railing lead down to a cement sidewalk which leads, in turn, to a porch on the south side of the front facade. Turned posts and a lintel with a scalloped decoration support a hipped porch roof. The south facade features a square bay with a hipped roof. There is an interior chimney.

13. Condition: Excellent _____ Good X Fair _____ Deteriorated _____ No longer in existence _____
14. Alterations: None apparent
15. Surroundings: (Check more than one if necessary) Open land _____ Scattered buildings _____ Densely built-up X
Residential X Industrial _____ Commercial _____ Other: _____
16. Threats to site: None known _____ Private development _____ Zoning X Vandalism _____
Public Works project _____ Other: _____
17. Is the structure: On its original site? _____ Moved? _____ Unknown? X
18. Related features: None

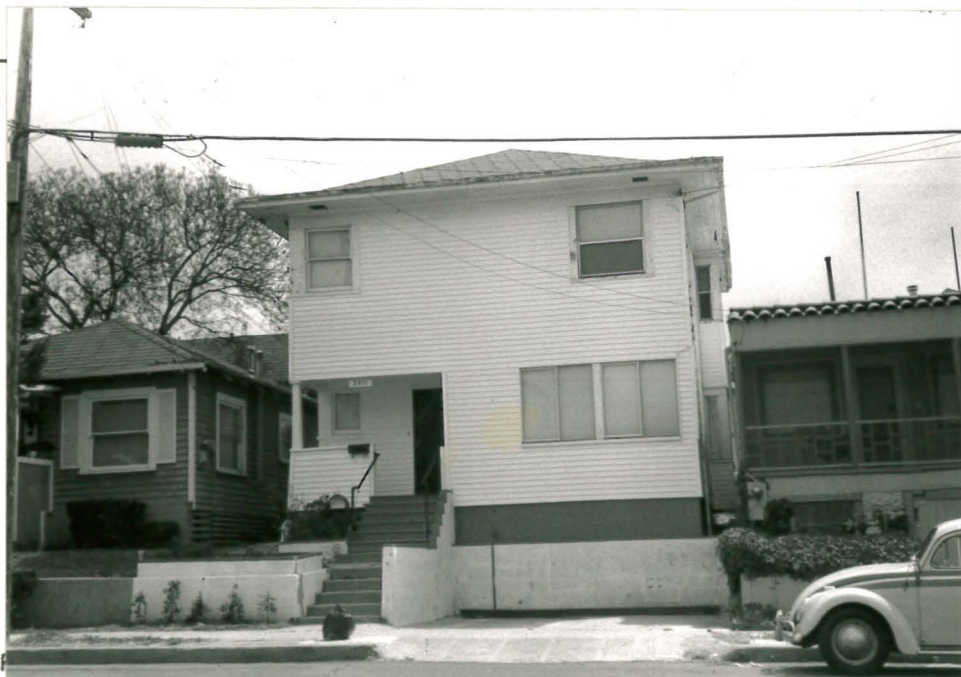
This two-story home appears to have been moved to the site and has had significant alterations. The roof is a low-pitched hip with flared overhanging boxed eaves and a plain frieze. It rests on a raised concrete foundation and has clapboard siding, which has been replaced with a vinyl substitute along the street facade. Some windows and their placement have been altered, however. The original windows were wide and double-hung with wide shelf surrounds. An open recessed porch is on the northwest corner with a boxed clapboard balustrade and a square corner post. Wooden stairs lead to the porch with a simple iron bannister. The door is now covered with a metal security screen and a small fixed window is to the north. A two-story square oriel bay is on the southern facade with narrow multi-paned windows; some have been replaced with aluminum frames. To the rear is a one-story addition with a flat roof.

13. Condition: Excellent _____ Good _____ Fair ☒ Deteriorated _____ No longer in existence _____
14. Alterations: Vinyl clapboard siding on street facade, windows, security bars.
15. Surroundings: (Check more than one if necessary) Open land _____ Scattered buildings _____ Densely built-up ☒
Residential ☒ Industrial _____ Commercial _____ Other: _____
16. Threats to site: None known _____ ☒ Private development _____ Zoning _____ Vandalism _____
Public Works project _____ Other: _____
17. Is the structure: On its original site? _____ Moved? _____ Unknown? ☒
18. Related features: _____

This is a non-contributing structure due to alterations to the original architecture, deterioration, and/or lack of historical significance.

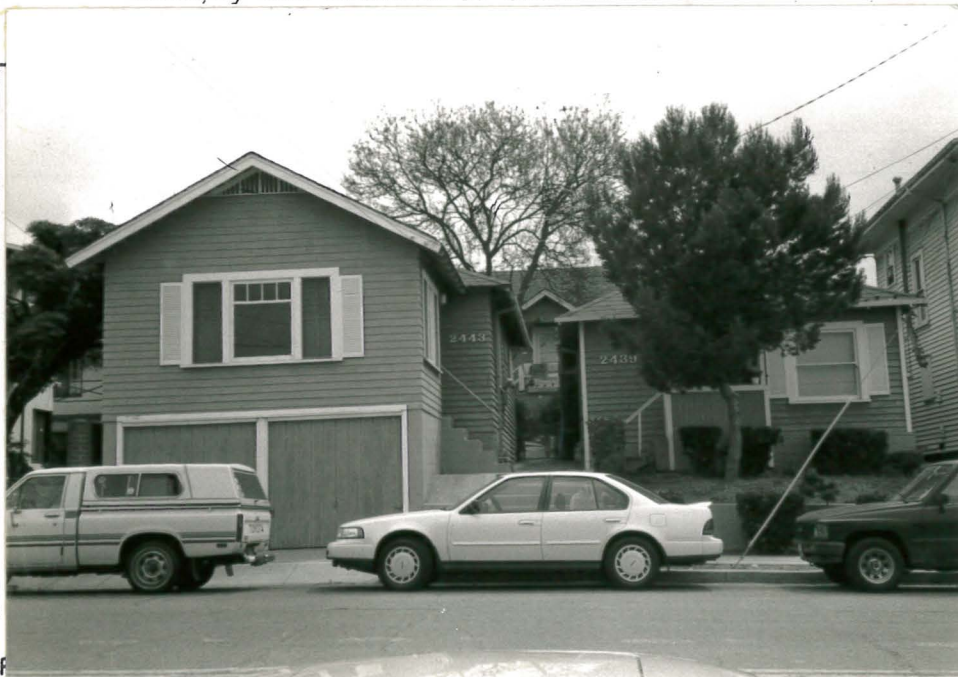
This U-shaped Bungalow Court is made up of two front buildings with hipped roofs, and a north building with a front-gabled two-story garage addition. The back building has a side gable roof with a pedimented front gable porch hood. The roofs are of composition shingle with exposed rafters beneath overhanging eaves. The windows, shuttered on the west facing front facades, are double-hung, some large and wide, some smaller double hinged and others of three sash with a fixed center pane and transom of four vertical panes and louvered side panels. The doors of these clap-board-sided bungalows are two panel wood with a large glass upper and wood screen, French in the back building with a raised open wood balustraded porch. The front south entry has a shed hood covering the entry with wooden side steps leading to the porch with wooden posts and boxed balustrade. The front north entry is reached from cement steps, which lead to a covered porch with metal pipe railing. The two west facing garage doors are vertical paned wood. Central cement steps lead past a block retaining wall from the street to the court. A brick retaining wall and chimney are located to the north.

13. Condition: Excellent _____ Good ☒ Fair _____ Deteriorated _____ No longer in existence _____
14. Alterations: Northeast front addition, louvered windows
15. Surroundings: (Check more than one if necessary) Open land _____ Scattered buildings _____ Densely built-up _____
Residential ☒ Industrial _____ Commercial _____ Other: _____
16. Threats to site: None known ☒ Private development _____ Zoning _____ Vandalism _____
Public Works project _____ Other: _____
17. Is the structure: On its original site? ☒ Moved? _____ Unknown? _____
18. Related features: _____

This is a non-contributing structure due to alterations to the original architecture, deterioration, and/or lack of historical significance.
