HISTORIC RESOURCES INVENTORY

1. Common name: ---
2. Historic name: John S. Hawley Residence
3. Street or rural address: 205 Laurel Street
City San Diego Zip 92101 County San Diego
4. Parcel number: 533-093-01
5. Present Owner: Violet Vanhorne Address: P.O. Box X-1013
City San Diego Zip 92112 Ownership is: Public --- Private X
6. Present Use: Residential Original use: Residential

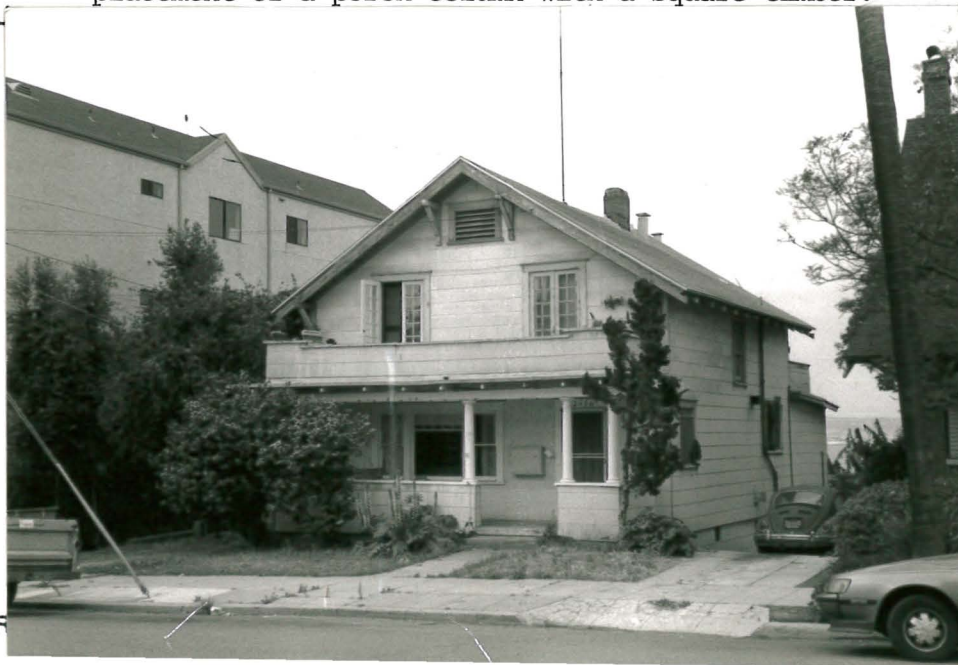
This 2-story rectangular house sits on raised foundation which is high in the rear due to the slope of the lot. A medium-pitched front-gable roof with asphalt shingles shelters overhanging eaves, Craftsman-style worked brackets, and triangular brackets in the gable. Siding is asbestos shingles. The first floor front window is fixed with a multi-pane transom, double-hung side panels, and a shelf surround. Side windows, also with shelf surrounds, are double-hung. A sidewalk leads to a slightly raised porch with a shingled balustrade. The porch extends the length of the house. Colonial Revival style classic columns, two of which are engaged, a lintel, and worked brackets support a 2nd floor balcony. The balcony has a shingled balustrade, stepped at the corners, and is reached from 2 narrow double French doors with shelf surrounds. The main entry door is wood frame with glass panels separated by wide wood mullions. There is an interior brick chimney and a large horizontally-grilled vent with a shelf surround in the gable peak. The south side of the building has an irregular roofline. On the north, a driveway leads to a double garage with living quarters above. Alterations include a rear addition with a balcony, mailboxes, asbestos siding, and the replacement of a porch column with a square timber.

13. Condition: Excellent _____ Good X Fair _____ Deteriorated _____ No longer in existence _____
14. Alterations: Asbestos siding, rear addition with balcony, mailboxes, columns replaced
15. Surroundings: (Check more than one if necessary) Open land _____ Scattered buildings _____ Densely built-up X
Residential _____ Industrial _____ Commercial _____ Other: _____
16. Threats to site: None known _____ Private development _____ Zoning X Vandalism _____
Public Works project _____ Other: _____
17. Is the structure: On its original site? X Moved? _____ Unknown? _____
18. Related features: garage with living quarters above

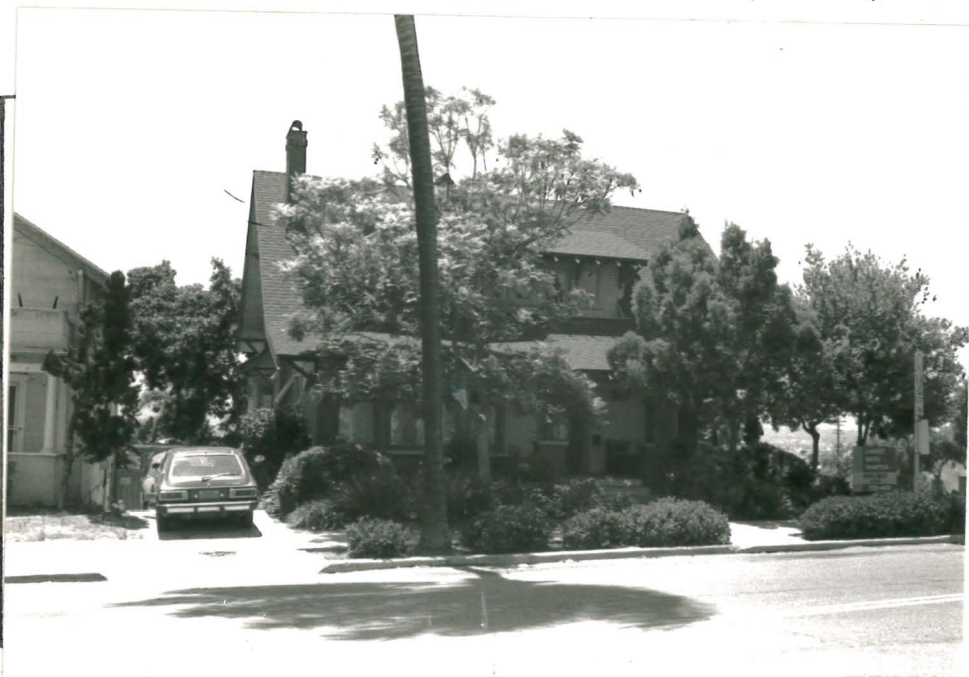
This two story Craftsman home is situated on a rise to the east which exposes the basement to the west. The roof is steeply pitched bellcast side gable which covers the entire second story with a tall brick chimney on the southern facade. The wide overhanging eaves have exposed worked rafters and knee brackets at the gable ends. A gabled dormer projects on the east while a shed roofed dormer projects to the west. The front gable dormer contains a decorative trusses with brackets and three sashed window consisting of a center double hung flanked by wooden hinged windows. The remainder of the windows are primarily double-hung with a wide shelf surround with exception of the few wooden sliders and large fixed panes on the front bay with leaded transoms. The front oak door is within the front porch with a large oval pane. The porch is surrounded by a solid brick balustrade with square brick post and a shallow arched lintel. Small square oriel bays with pent roofs appear on the north and south facades. The siding is clapboard which becomes shingle siding at the foundation and basement level.

13. Condition: Excellent ☒ Good ☐ Fair ☐ Deteriorated ☐ No longer in existence ☐
14. Alterations: _____
15. Surroundings: (Check more than one if necessary) Open land ☐ Scattered buildings ☐ Densely built-up ☒
Residential ☒ Industrial ☐ Commercial ☐ Other: _____
16. Threats to site: None known ☒ Private development ☐ Zoning ☐ Vandalism ☐
Public Works project ☐ Other: _____
17. Is the structure: On its original site? ☒ Moved? ☐ Unknown? ☐
18. Related features: driveway to southeast with carport
