San Diego MWWD Facility Information Sheet

SWIM Workorder

Nature of Complaint
TELEVISE

Street #	Fr	Predir	Street Name	Sfx	Suite #	Juris
5715			SOLEDAD MTN	RD		SD

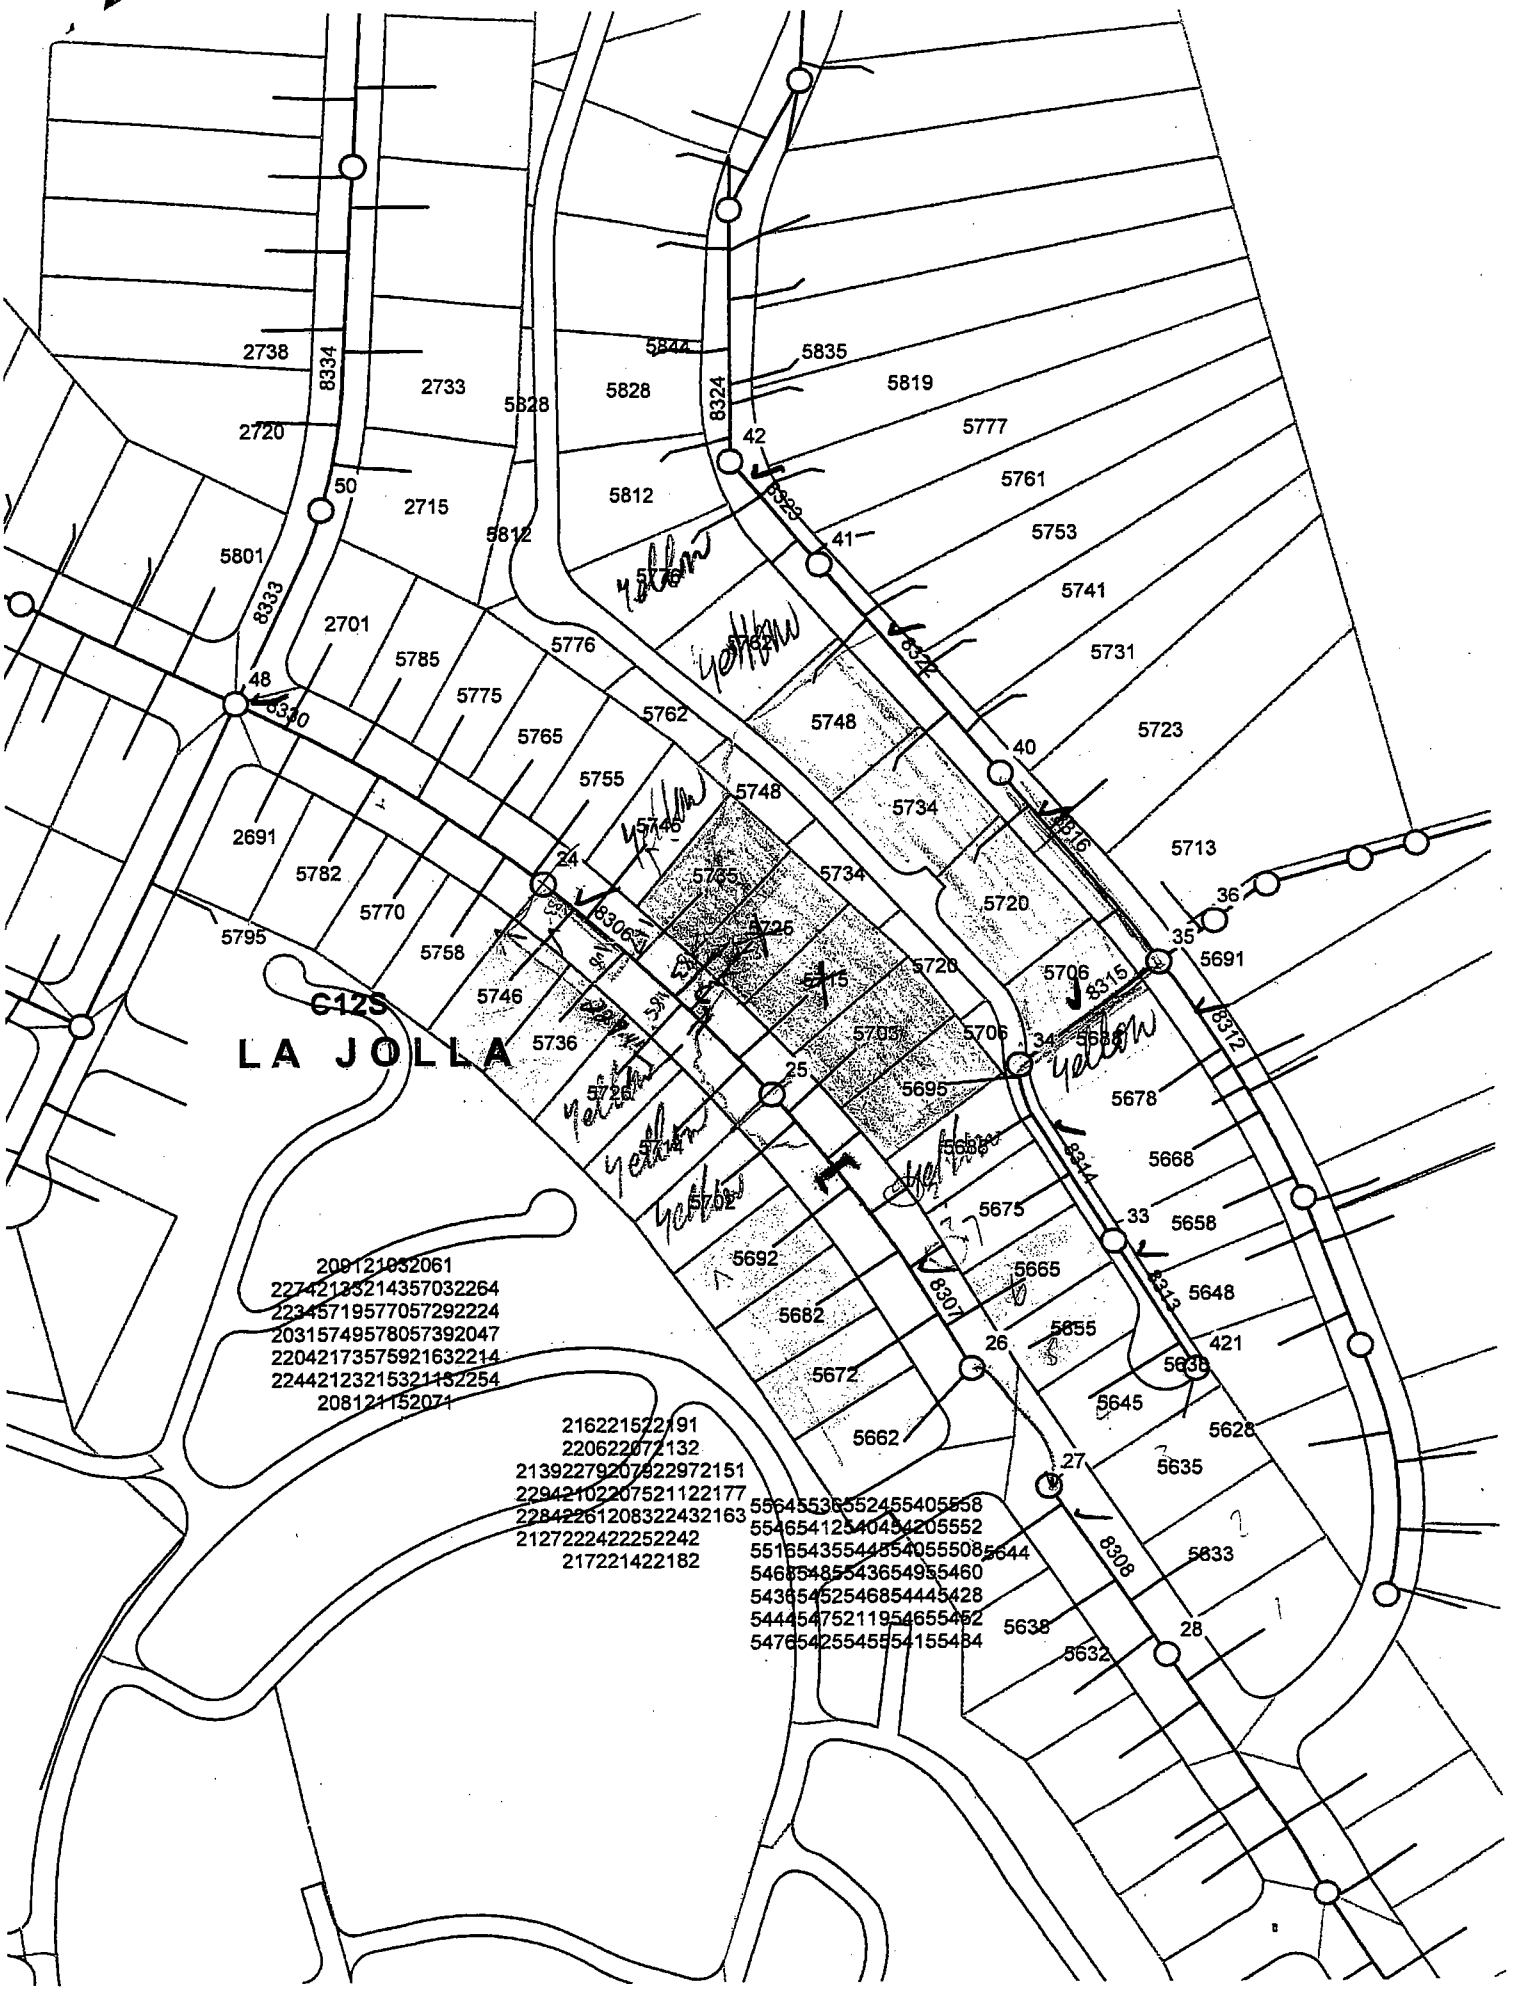
NOTE: THIS IS WHERE LAND IS SINKING NEED CREWS ASAP
