INDOOR AIR QUALITY EVALUATION FOR:

COMMERCIAL-RETAIL SHOPPING CENTER
Decker's Dog & Cat
3055 Clairemont Drive
San Diego, California 92117

Wednesday, July 5, 2023
EAI Project No.: 01.CVQUAD1.23

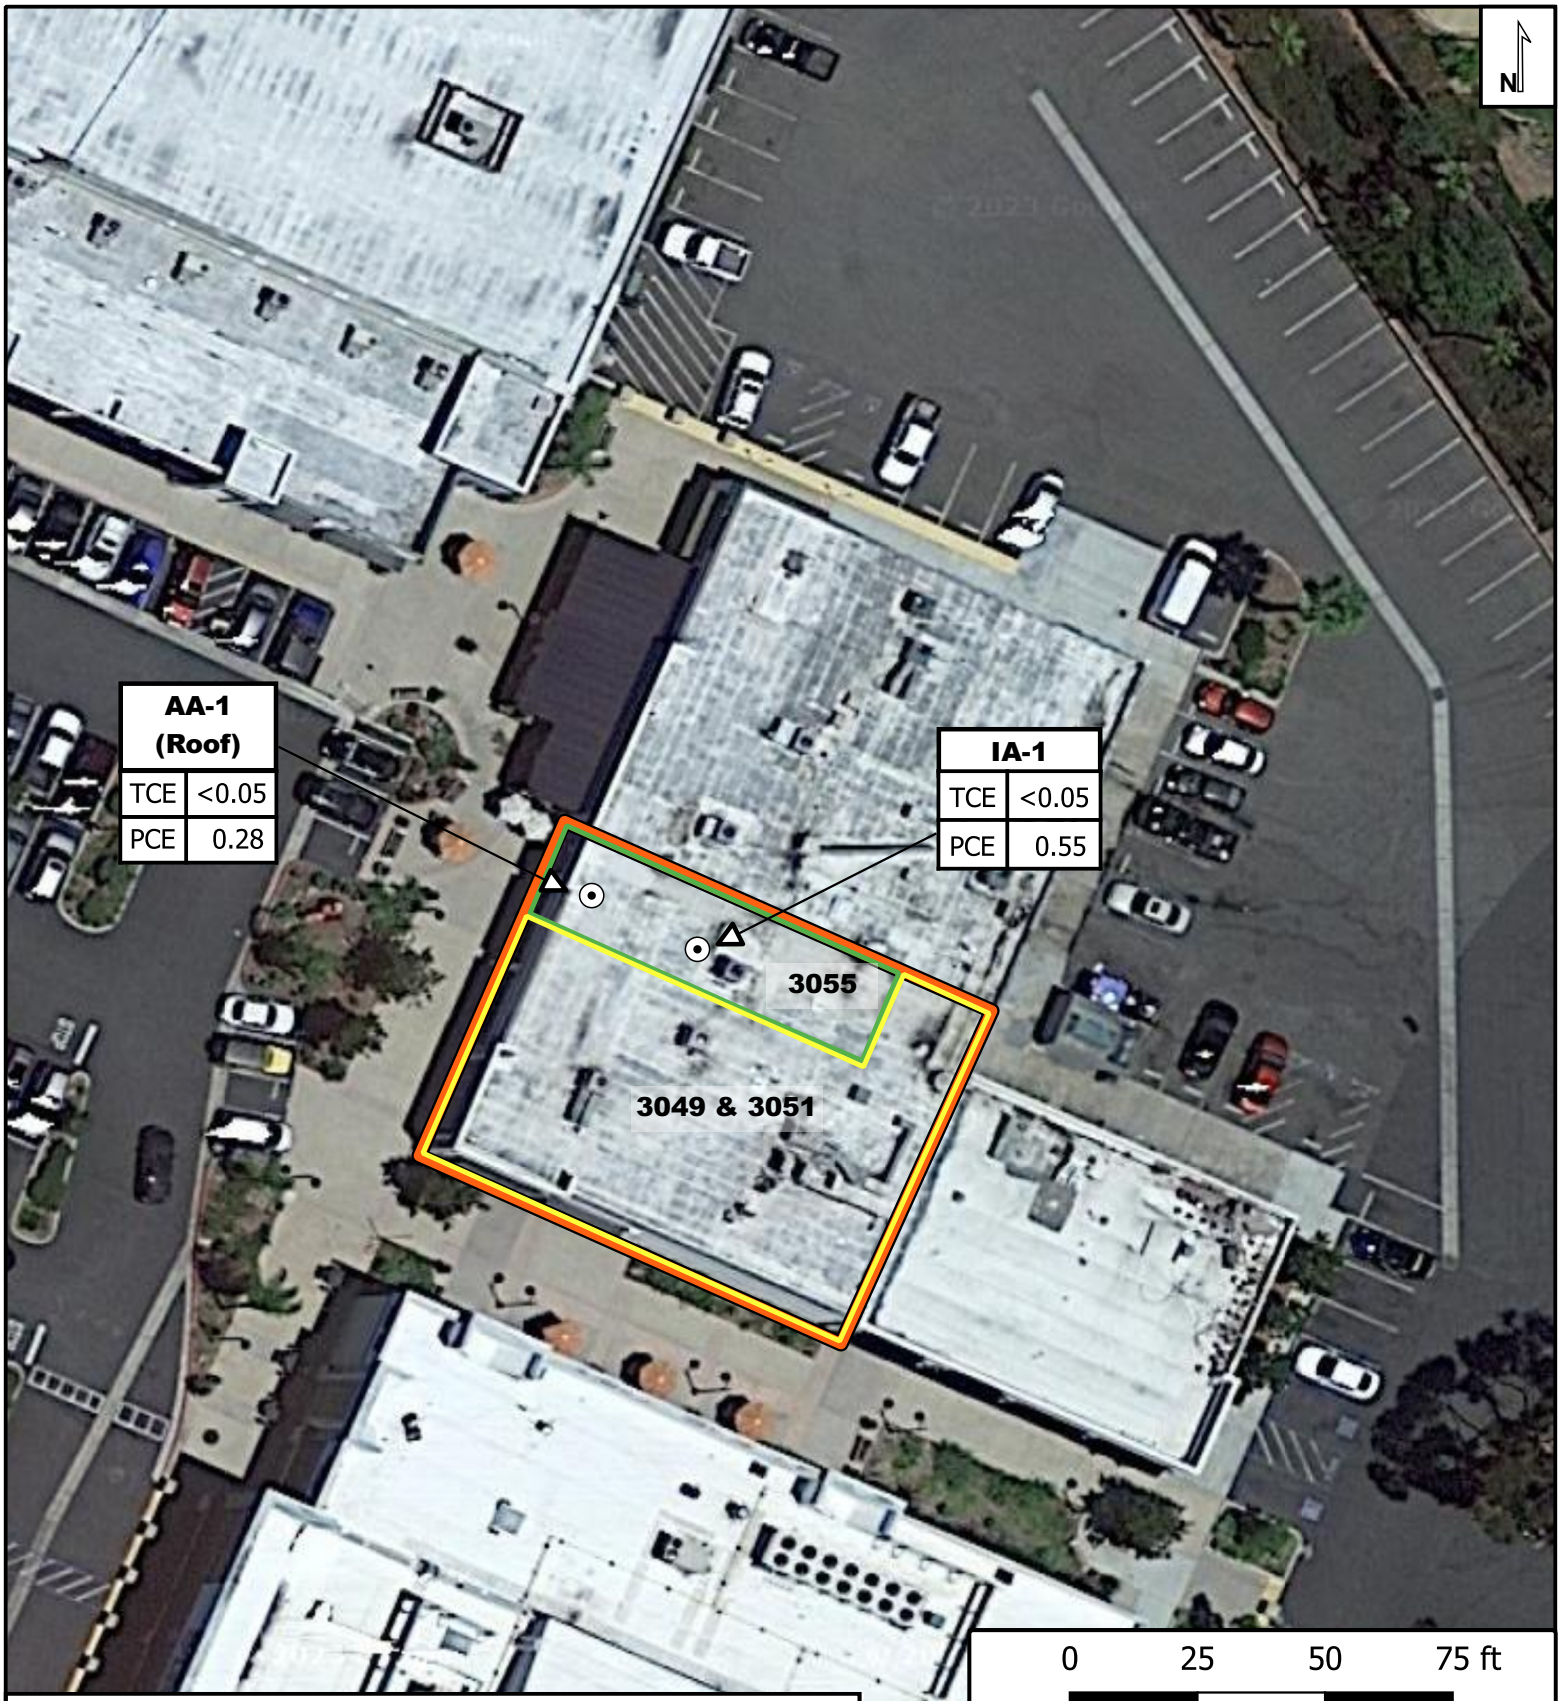
San Diego	June 2023	Figure 1

No targeted VOC concentrations were detected in the samples collected in this most recent 2023 sampling event with concentrations exceeding the commercial/industrial DTSC SLs and SFRWQCB ESLs for ambient air. PCE was detected in the indoor air sample below the regulatory SL (2 µg/m^3), at a concentration of 0.55 µg/m^3. PCE was also detected in the outdoor air sample at a concentration of 0.28 µg/m^3. TCE was not detected above the laboratory reporting limits in either the indoor or outdoor air sample collected.

Site Plan With Pertinent Ambient Air Results
