Preliminary Engineering Report Mission Bay Improvement Zone Deferred Maintenance

June, 2024

Rick Engineering Company
5620 Friars Road
San Diego, CA 92110

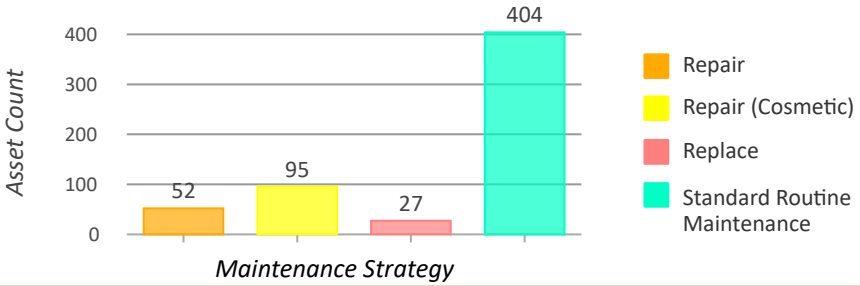
Asset	Quantity	Replacement Timeframe	Issue Notes	Photo Name
Hot Coal Disposal	1 EA	Immediately	Cracked concrete and exposed rebar may be a hazard	#07090025.jpg
Bike Rack	1 EA	Immediately	Badly rusted and bent. Potential for serious injury	#07030013.jpg
Drinking Fountain	1 EA	Within 1-2 Years	Worn down and spout has been removed	#07040001.jpg
ADA Facility	23 EA	Immediately	ADA Non-Compliant	#07120114.jpg

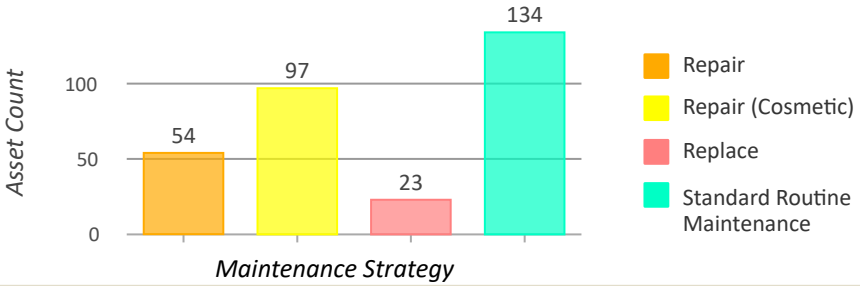
Asset	Quantity	Replacement Timeframe	Issue Notes	Photo Name
Hot Coal Disposal	1 EA	Immediately	Concrete is cracked. Exposed rebar is a danger.	#11090005.jpg
Picnic Table	1 EA	Immediately	Picnic table has been removed, only pad remains	#11130039.jpg
Playground Equipment	1 EA	Immediately	Paint and plastic have faded. Slide is out of order	N/A
ADA Facility	8 EA	Immediately	ADA Non-Compliant	#11120018.jpg #11120020.jpg

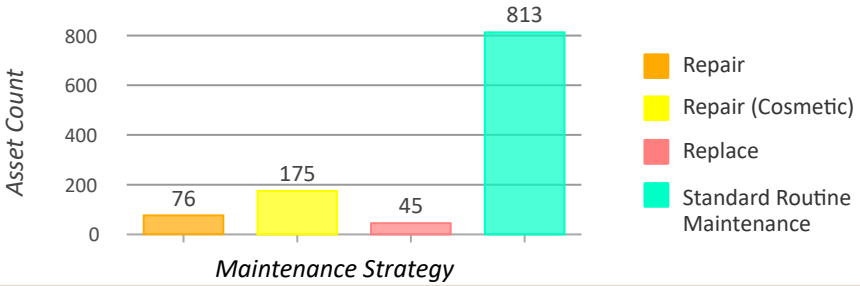
Asset	Quantity	Replacement Timeframe	Issue Notes	Photo Name
Gazebo/ Bandstand	1 EA	Immediately	Metal frame badly rusted	#01080011.jpg
Retaining Wall / Non-Retaining Wall	1 EA	Immediately	Concrete is badly cracked, may be a hazard	#01120190.jpg
Paved Parking Lot	97,090 SF	Within 1-2 Years	Some cracked asphalt and root damage	#01400114.jpg
ADA Facility	36 EA	Immediately	ADA Non-Compliant	#01120187.jpg

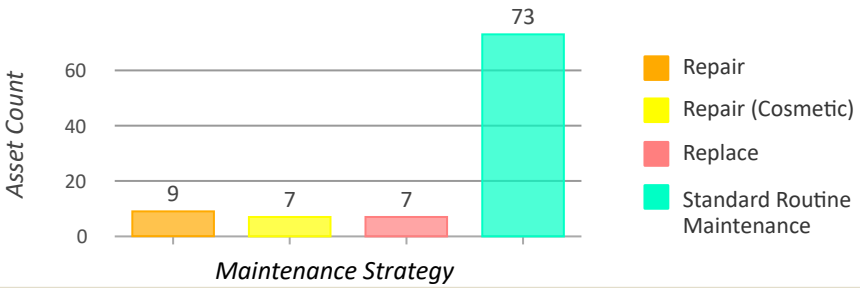
Asset	Quantity	Replacement Timeframe	Issue Notes	Photo Name
Curb	1 EA	Within 1-2 Years	Traffic circle curb badly worn	N/A
Paved Parking Lot	18770 SF	Within 1-2 Years	Cracked asphalt and potholes	#05400071.jpg
Paved Parking Lot	29,380 SF	Within 1-2 Years	Cracked asphalt and potholes	#05400072.jpg
ADA Facility	6 EA	Immediately	ADA Non-Compliant	#05120078.jpg #05120079.jpg

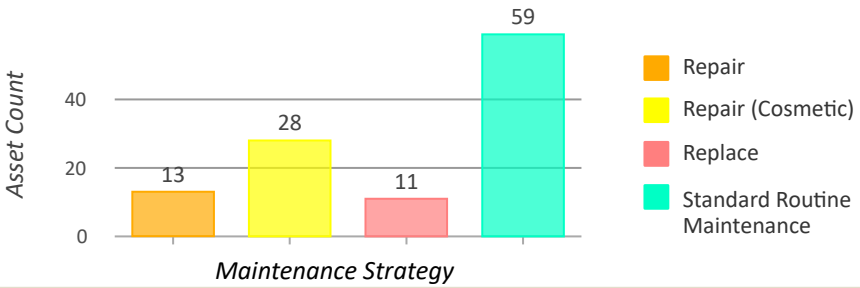
Asset	Quantity	Replacement Timeframe	Issue Notes	Photo Name
Storm Drain Structure	1 EA	Within 1-2 Years	Flume is undercut and badly broken	#08170065.jpg
Storm Drain Structure	1 EA	Within 1-2 Years	Undercut and badly broken	#08170067.jpg
Comfort Station	1 EA	Immediately	Closed for construction	#08500004.jpg
ADA Facility	8 EA	Immediately	ADA Non-Compliant	#08120086.jpg
