2010- 2011

ANNUAL REPORT

September 15 – October 15, 2017 Pre- Diligence / LOI Period Package Addendum 2October 10, 2017

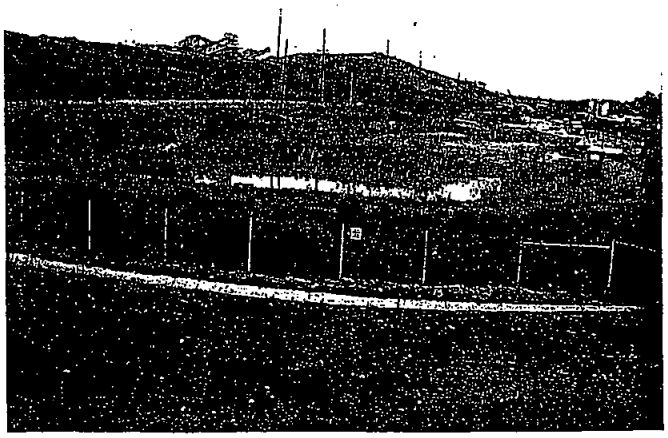
4. Fiber rolls appear to have been dislodged by storm water flows.

5. North bank of Carroll Canyon Creek.

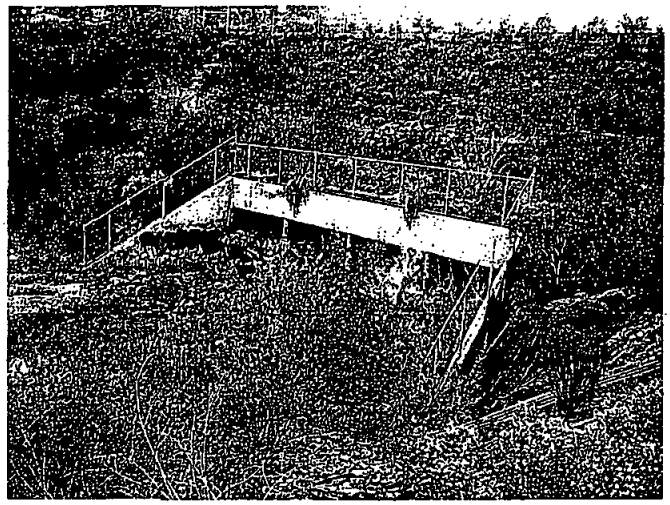
6. Sediment basin located below the quarry area. A brow ditch next to the chain link fence conducts water from off-site to Carroll Canyon Creek.

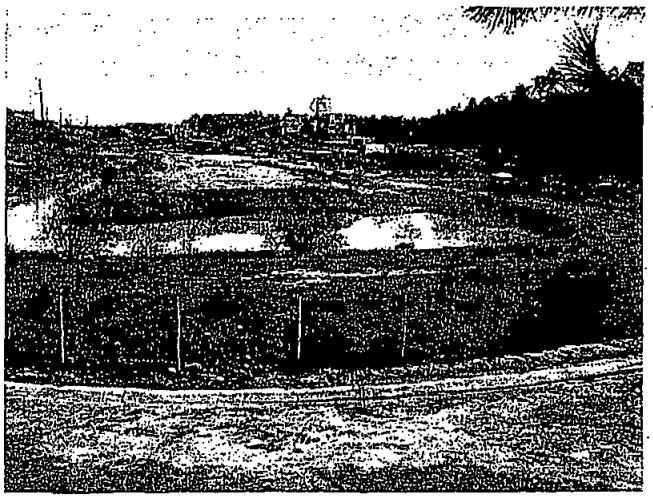
1. View of the facility, looking east from Camino Santa Fe. Highly turbid water is evident in the sediment basin.

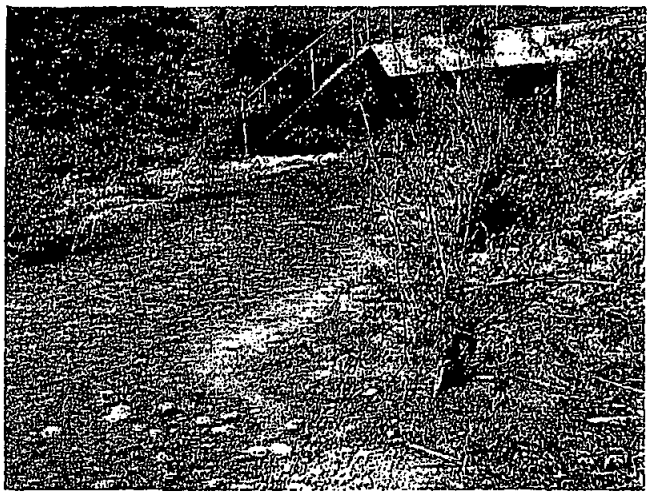
4. Turbidity plume where water discharged from the outfall enters Carroll Canyon Creek.

5. Another view of the turbidity plume resulting from the sediment discharge.

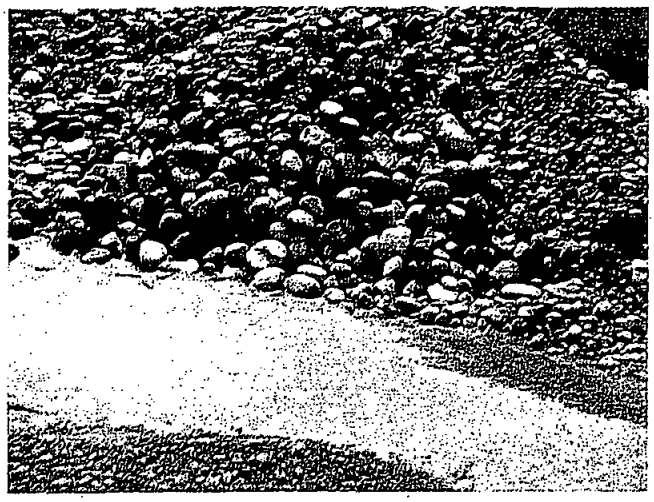
10. Another view of the runoff that is discharging to the creek in front of the administrative office.

11. Location where turbid water shown in Photo 9 enters the bank area of Carroll Canyon Creek
