Master Storm Water System Maintenance Program Annual Report

Transportation & Storm Water Department
Storm Water Division

SEPTEMBER 2016

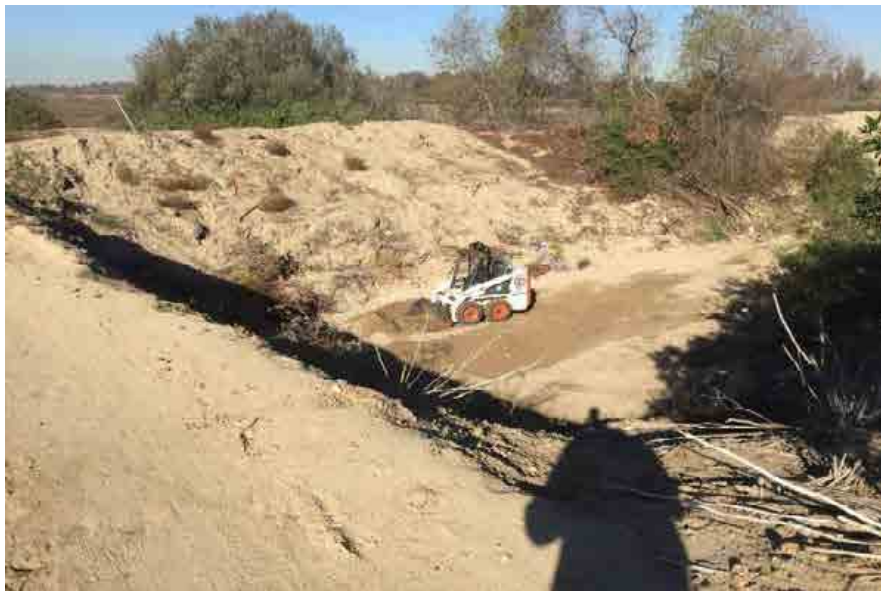
Photo 4. Tijuana River Valley Pilot Channel and Smuggler's Gulch During Maintenance 12/3/15

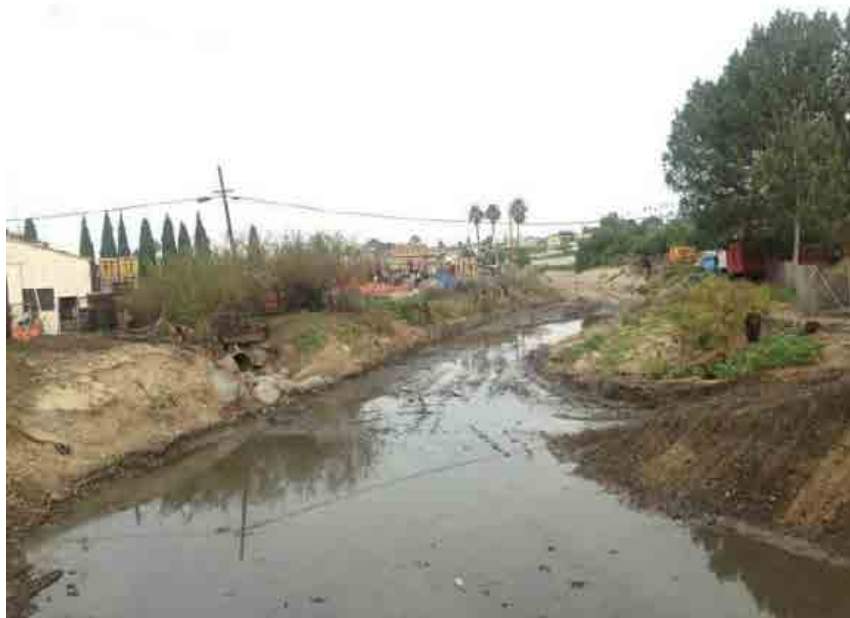
Photo 18. Chollas Creek Channel (MMP Map 93) Post-Maintenance 01/18/16

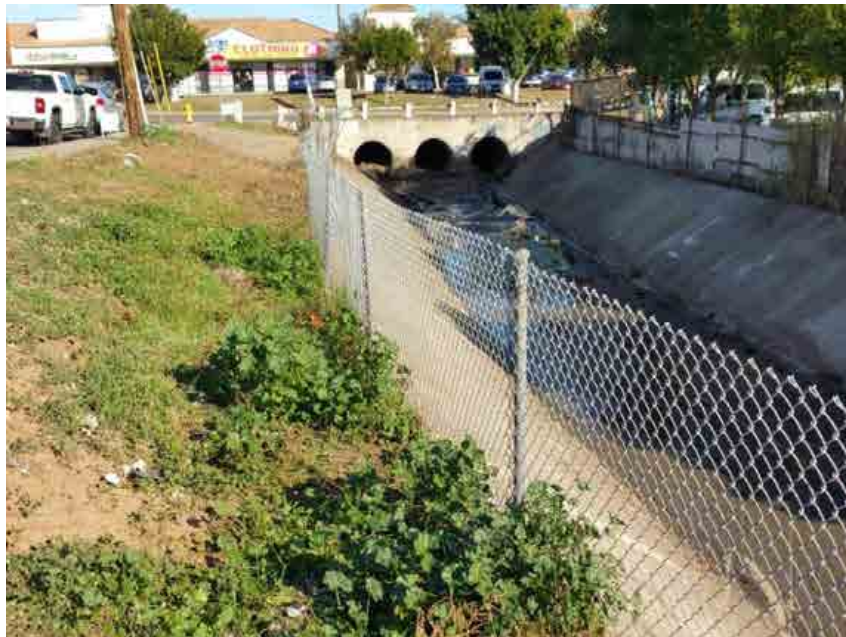
Photo 20. Cottonwood Channel (MMP Maps 120-121) Post-Maintenance 1/1/16

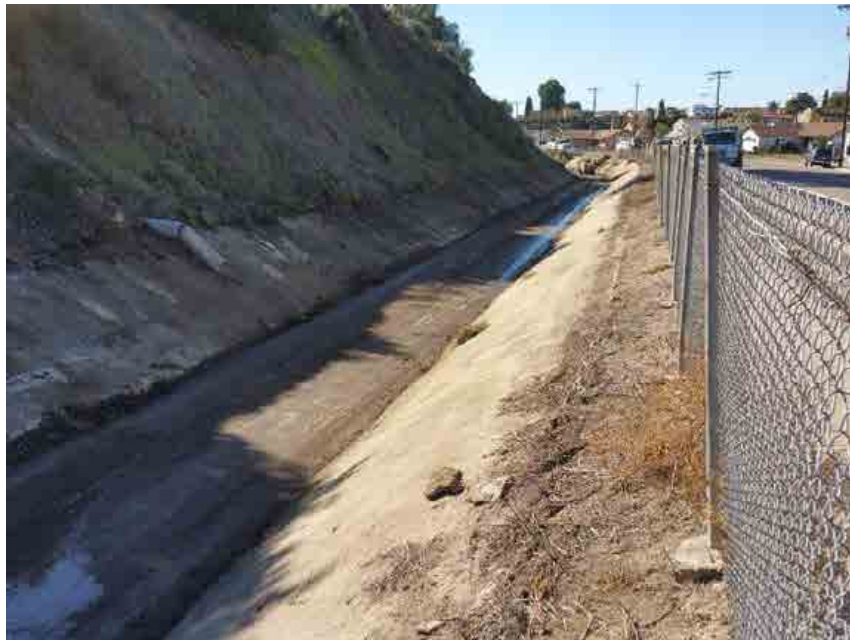
Photo 26. Parkside Channel Post-Maintenance 12/26/15
