CHAPTER 3 – SOLIDS TREATMENT FACILITIES

3.1 Solids Process Facilities

3.2.1 Condition Assessment -“Capacity Limiters”

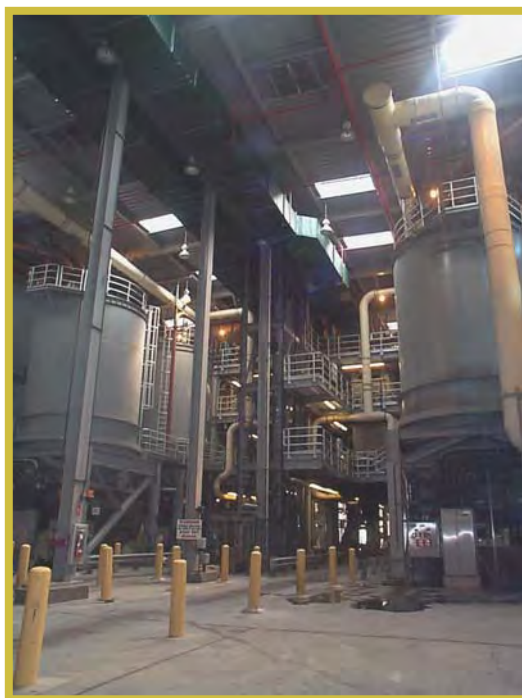
DEWATERED BIOSOLIDS STORAGE BINS
AND TRUCK LOADOUT STATIONS

1. *Inadequate storage capacity for dewatered solids.* The MBC cake load-out facility was designed for a continuous 24 hours per day and 7 days per week operation. However, as landfill operations only allow 9 hours per day for truck delivery, the MBC loadout operation is restricted likewise. Dewatered solids storage silos normally fill up during weekends when no truck hauling is done. Therefore, any repair or maintenance work on the storage silos and loadouts after the weekend will lengthen unloading time for the stored cake. As haul trucks need to be loaded past the regular hours and landfills would have closed by those late hours, loaded trucks would need to park in the facility overnight and wait until next day to travel to the landfills. Parking loaded trucks overnight at MBC results in the emission of fugitive odors and odor complaints. The limited hours for disposal further compound capacity issues when O&M work is required on the cake feed piping system. This work can result in shutting down nearly half of the cake silo system. Thus a half-capacity loadout operation severely limits the dewatering and loadout capacity.

- c. In addition to, if a lime mixer plugs, then cake feed to the 2 loadout bins is cut in half.
3. *Inaccessible frequently failing valve actuators*: Frequent failure of valves is compounded by the lack of access to many of the valve actuators for servicing and position determination. Depending on the valve position at time of failure, several silos and dewatering centrifuges could be forced out of service significantly reducing process capacity.

4. *Potential piping leak damage to electrical equipment*: Chilled water valves and piping for Air Handling Units. 7 and 8 are dangerously located above MCCs and pose risk of damaging electrical equipment in the event of a leak or spill from these assets during repair/maintenance work.

3. Evaluate valve accessibility conditions. Either provide access platforms or catwalks to subject valves or relocate where easily accessible. Overhead valves with motorized operators need to be furnished with chain operators.
4. Relocate valves away from problem area. Piping may have to be rerouted to do this.
5. The installation of two new, totally independent, manually- operated emergency truck loadout stations with direct-feed cake piping from the existing centrifuges or storage silos and built next to the existing loadout bays is recommended to provide capability to increase loadout capacity during peak biosolids production hours,

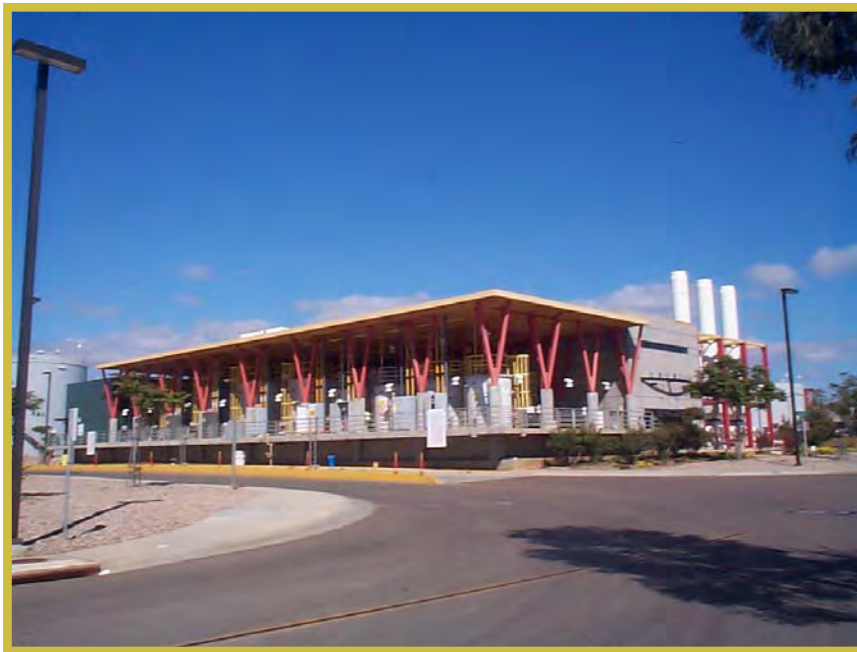
CHEMICAL BUILDING

1. *Inaccessible motorized tank valves*: Motorized isolation valves of bulk storage tanks and pumps are located at floor level in the spill containment cells. In the event of chemical or rain flooding, these valves get submerged and damaged in the flooded containment cell. Many of these motorized isolation valves are inaccessible for repair during flooding.

2. *Complex tandem piping and valves*: Dual bulk storage tanks are piped in tandem such that if a valve on one tank fails or leaks and needs service, both tanks would require shutdown. Repair of a single valve requires that the entire chemical feed system be shutdown and drained.

3. *Potential tank spills*: All chemical transfers from the Chemical Building occur via transfer pipes routed through the pipe gallery located below grade. A break or leak in the transfer pipe can empty out the bulk storage tank(s). In addition, a valve failure in the transfer line can overflow a day tank and cause a chemical spill.

5. *Electrical damage from flooding*: Electrical conduits are routed thru the floor of the containment cells and connect to motorized operators of tank valves on the bulk storage tanks. Containment cell flooding has resulted in chemicals entering into the conduits and damaging the wiring and other electrical equipment.

6. *Containment cell flooding*: In the event of heavy rains, the perforated roofing above the bulk storage tanks has resulted in flooding of the containment cells and caused flooding alarms.
