SUNSET CLIFFS NATURAL PARK

Final Drainage Study

**SUNSET CLIFFS NATURAL PARK
DRAINAGE STUDY**

MAY 2012

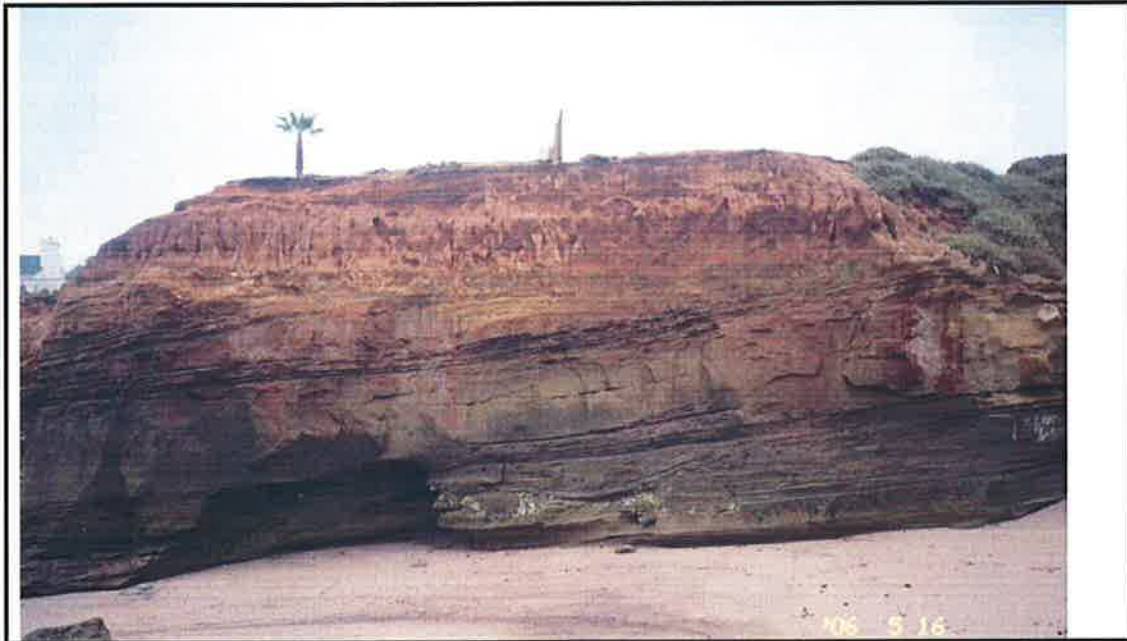
Figure 4A - Bluff face in front of parking lot south of Adair Street. Terrace deposits seen overlying Point Loma Formation. Terrace deposits of Bay Point Formation form moderate slope and erodible. Minor sea cave at base in Point Loma Formation.

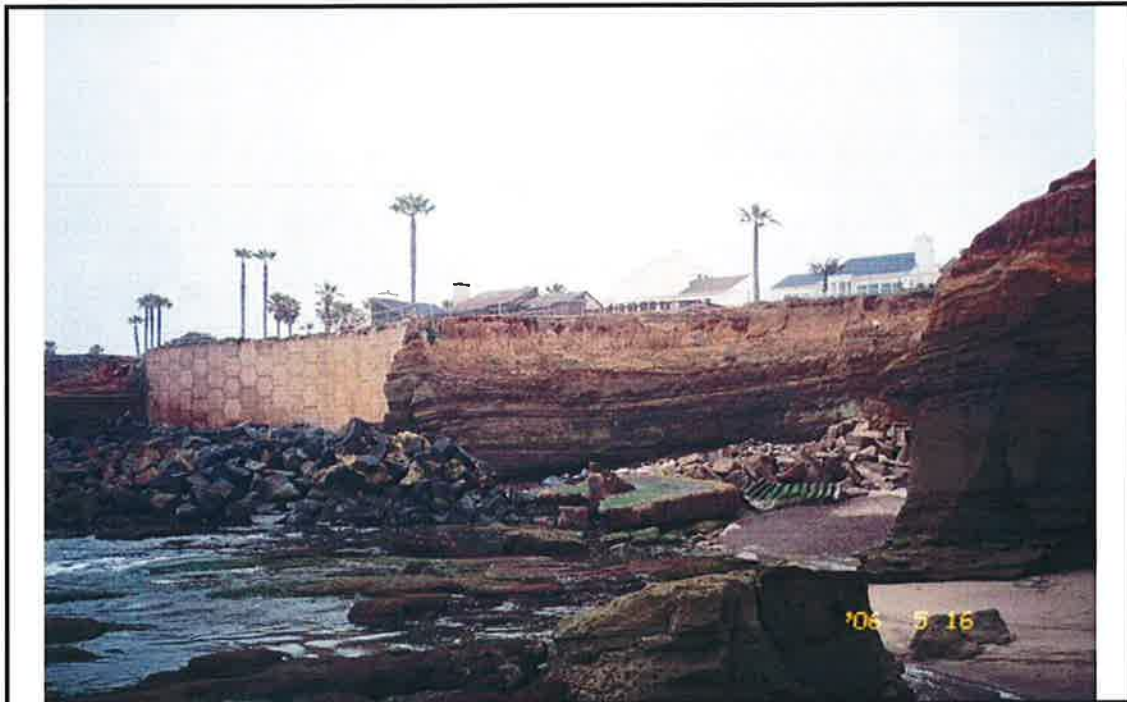
Figure 4B: MSE wall for bluff stabilization along with rip-rap at base near Adair Street. Terrace deposits of Bay Point Formation seen overlying Point Loma Formation.

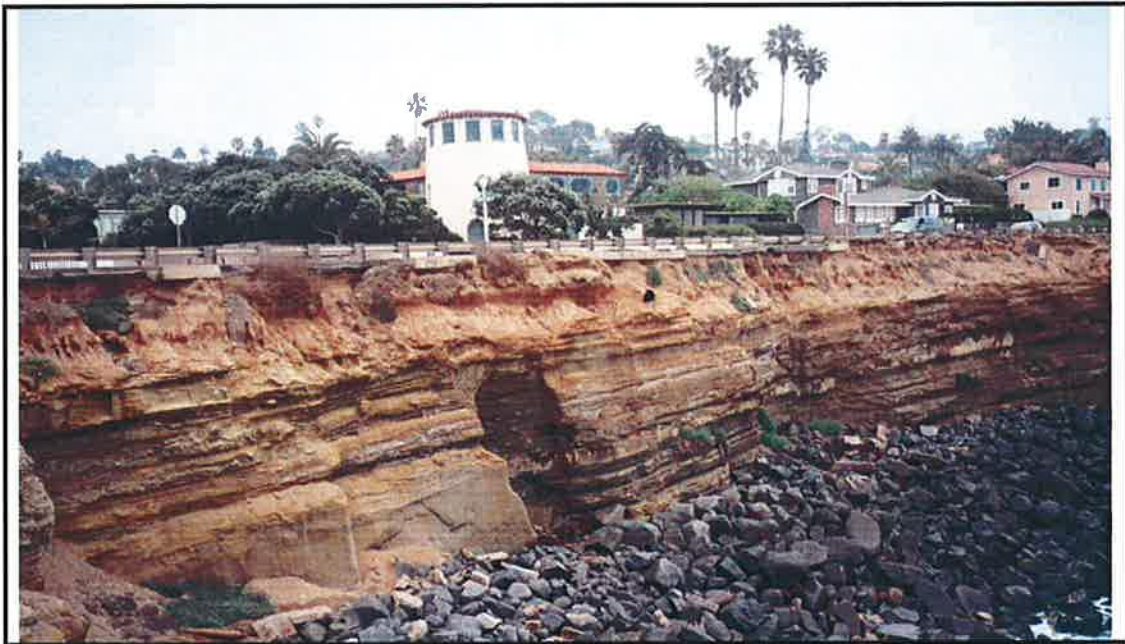
Figure 4C: Bluff face in front of Froude Street intersection. Moderately sloping and eroding terrace deposits of Bay Point Formation overlying sedimentary rock of Point Loma Formation with rip-rap protecting base of bedrock.

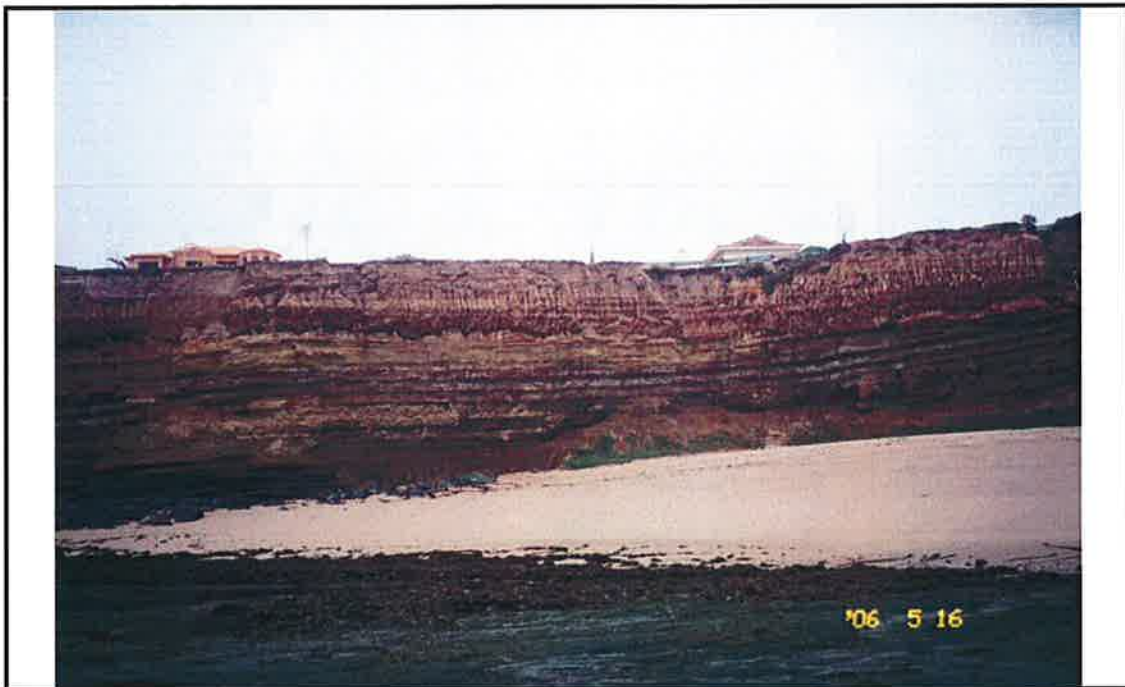
Figure 4D: Bluff face behind beach at Cordova Street intersection. Large sand beach and shore platform exposed. Terrace deposits of Bay Point Formation overlying northeast dipping layers of Point Loma Formation overlying beach..

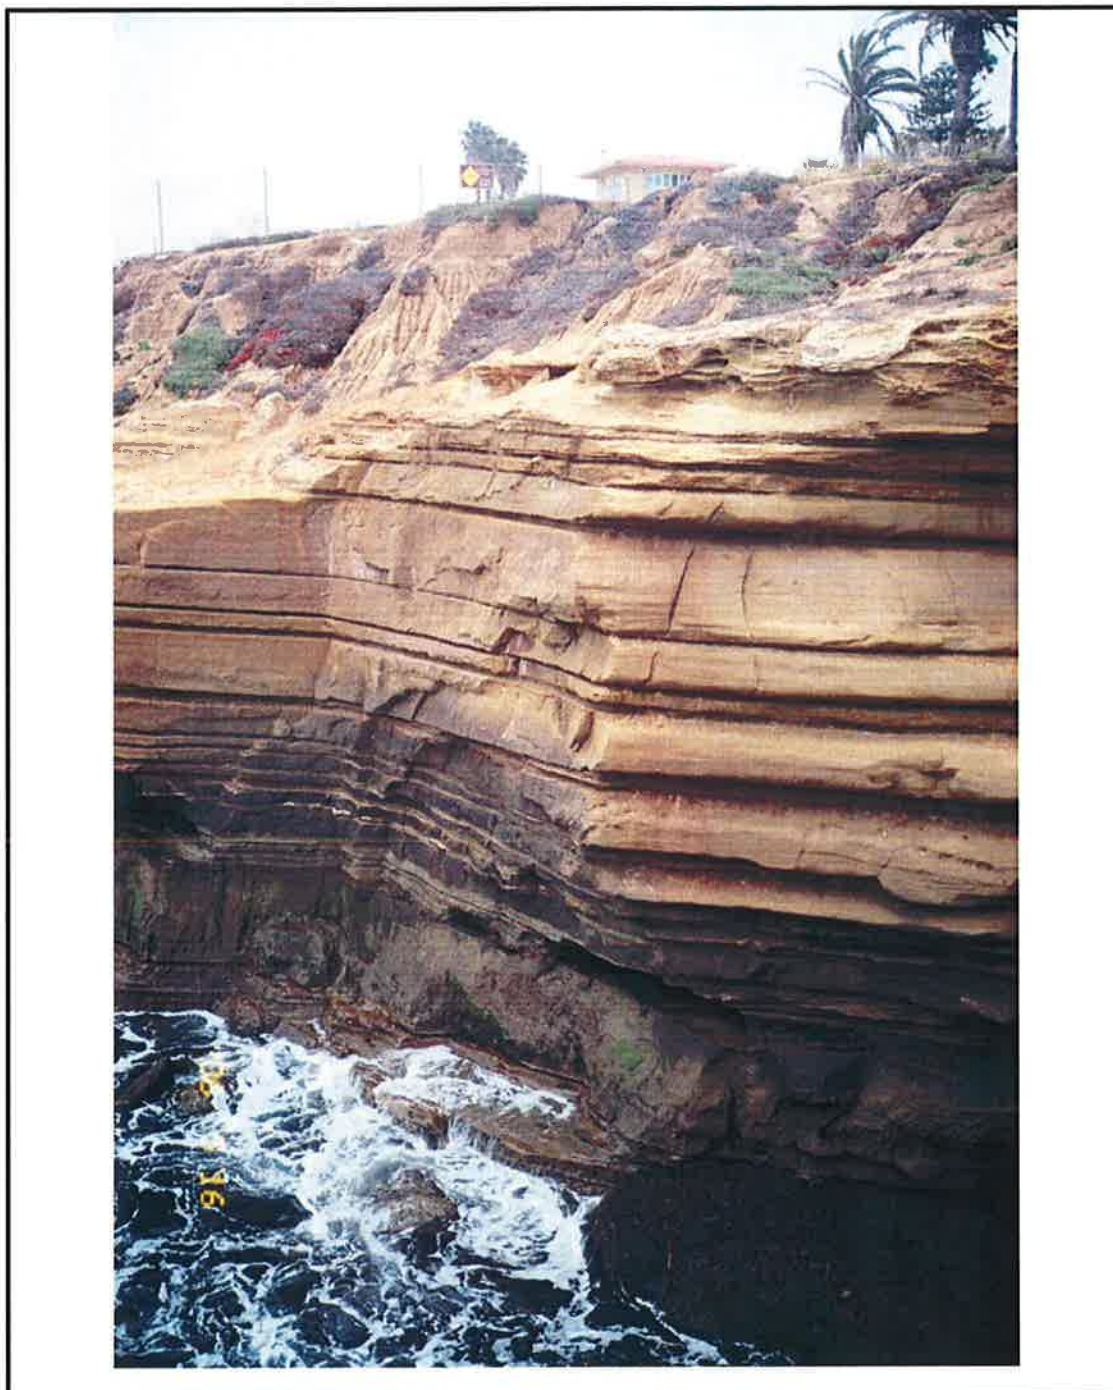
Figure 4E: Bluff face in front of Monaco Street and north of Pump Station No. 35. Sandstone with irregularly weathered with evidence of seepage at mid-cliff face.

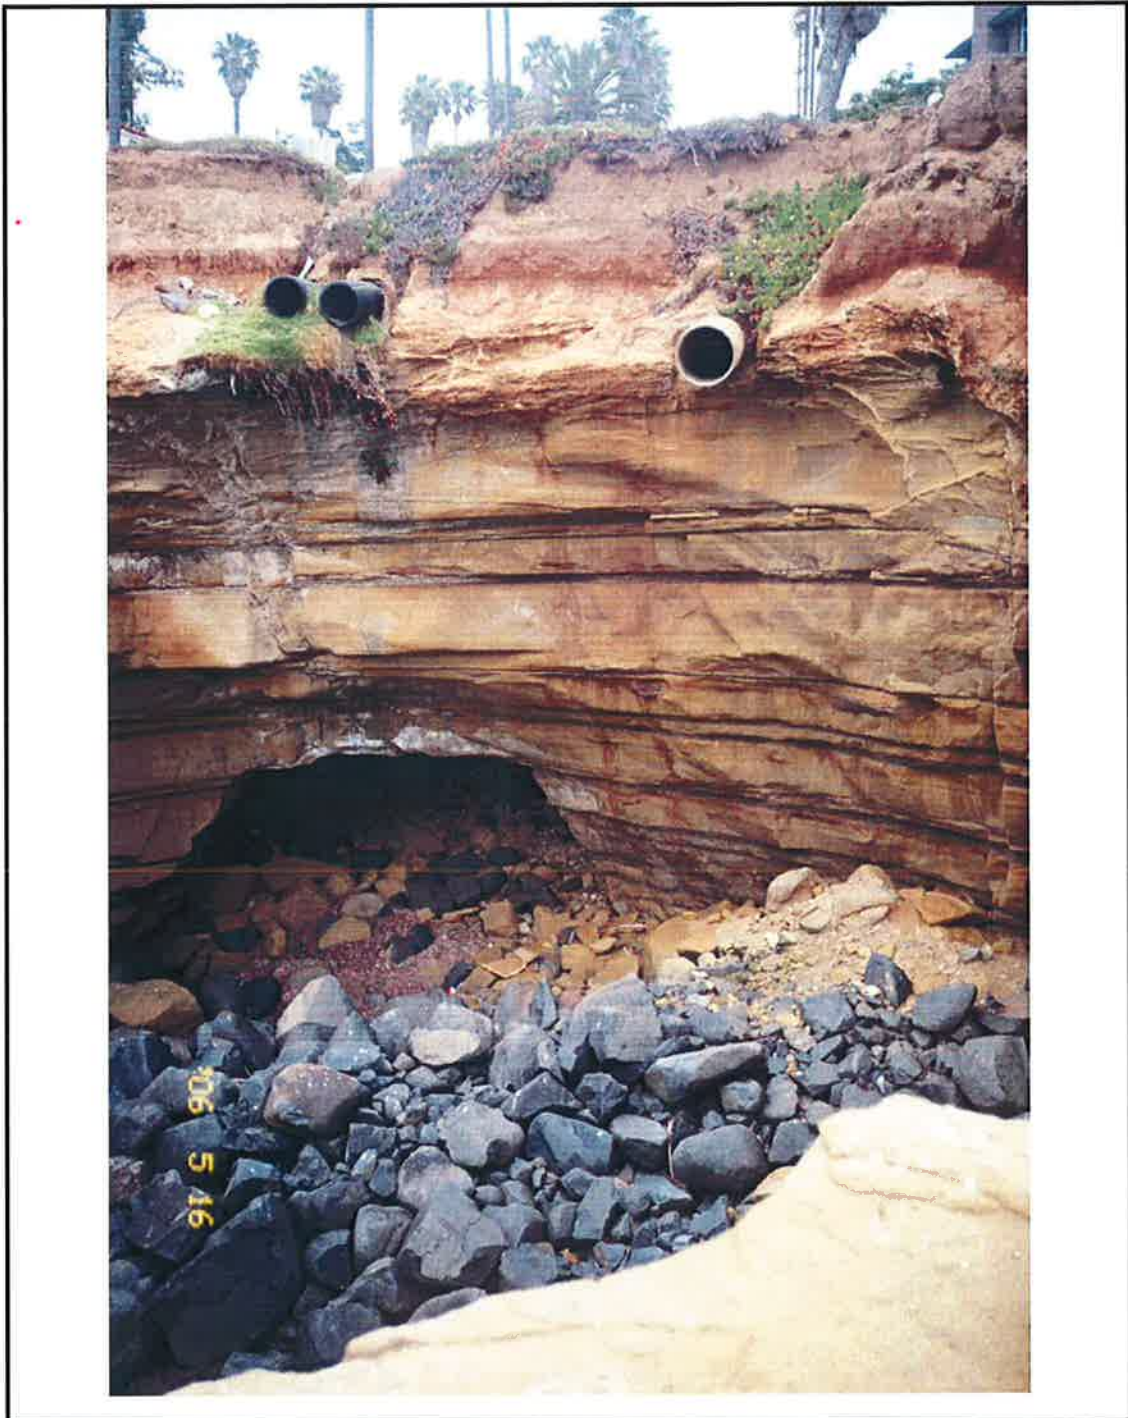
Figure 4F: Storm drain outfalls north of Pump Station 35 at Monaco Street. Sea cave exposed at base with rip rap placed for cliff protection. Terrace deposits of Bay Point Formation and fill overlying Point Loma Formation just above level of outfalls.

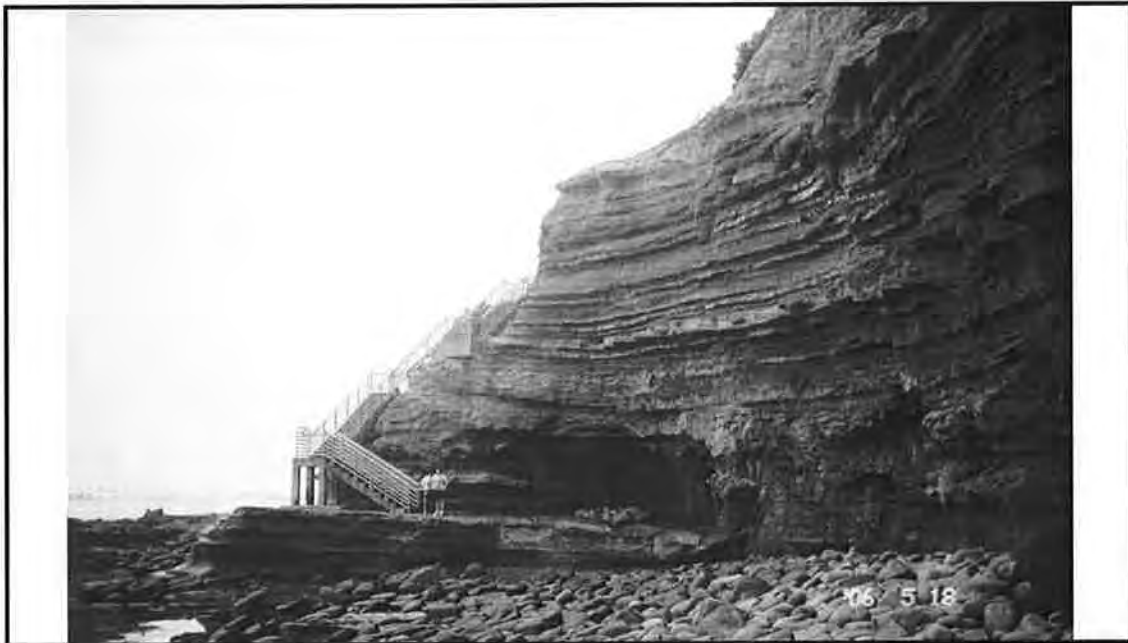
Figure 4G: Bluff Face just south of Ladera Street stairway. Cobble beach in area of high wave energy. Seeps and stratification in Point Loma Formation observed to overlying terrace deposits of Bay Point Formation.

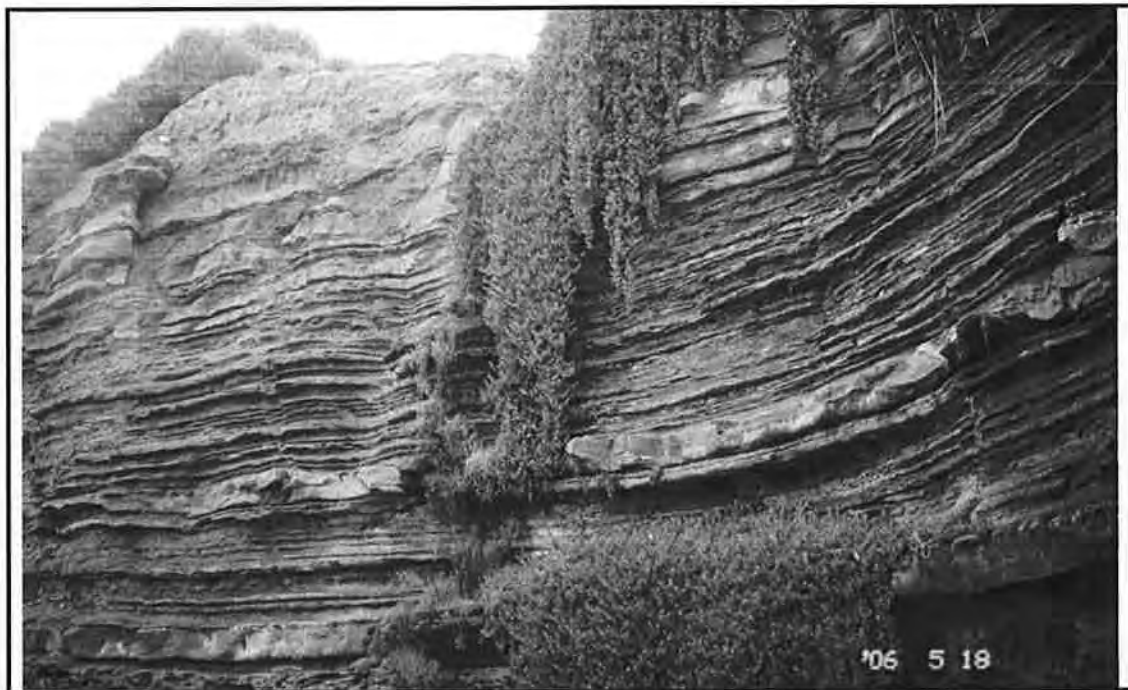
Figure 4H: Seepage in bluff face supporting vegetation. Stratification and weathering of Point Loma Formation with overlying terrace deposits of Bay Point Formation

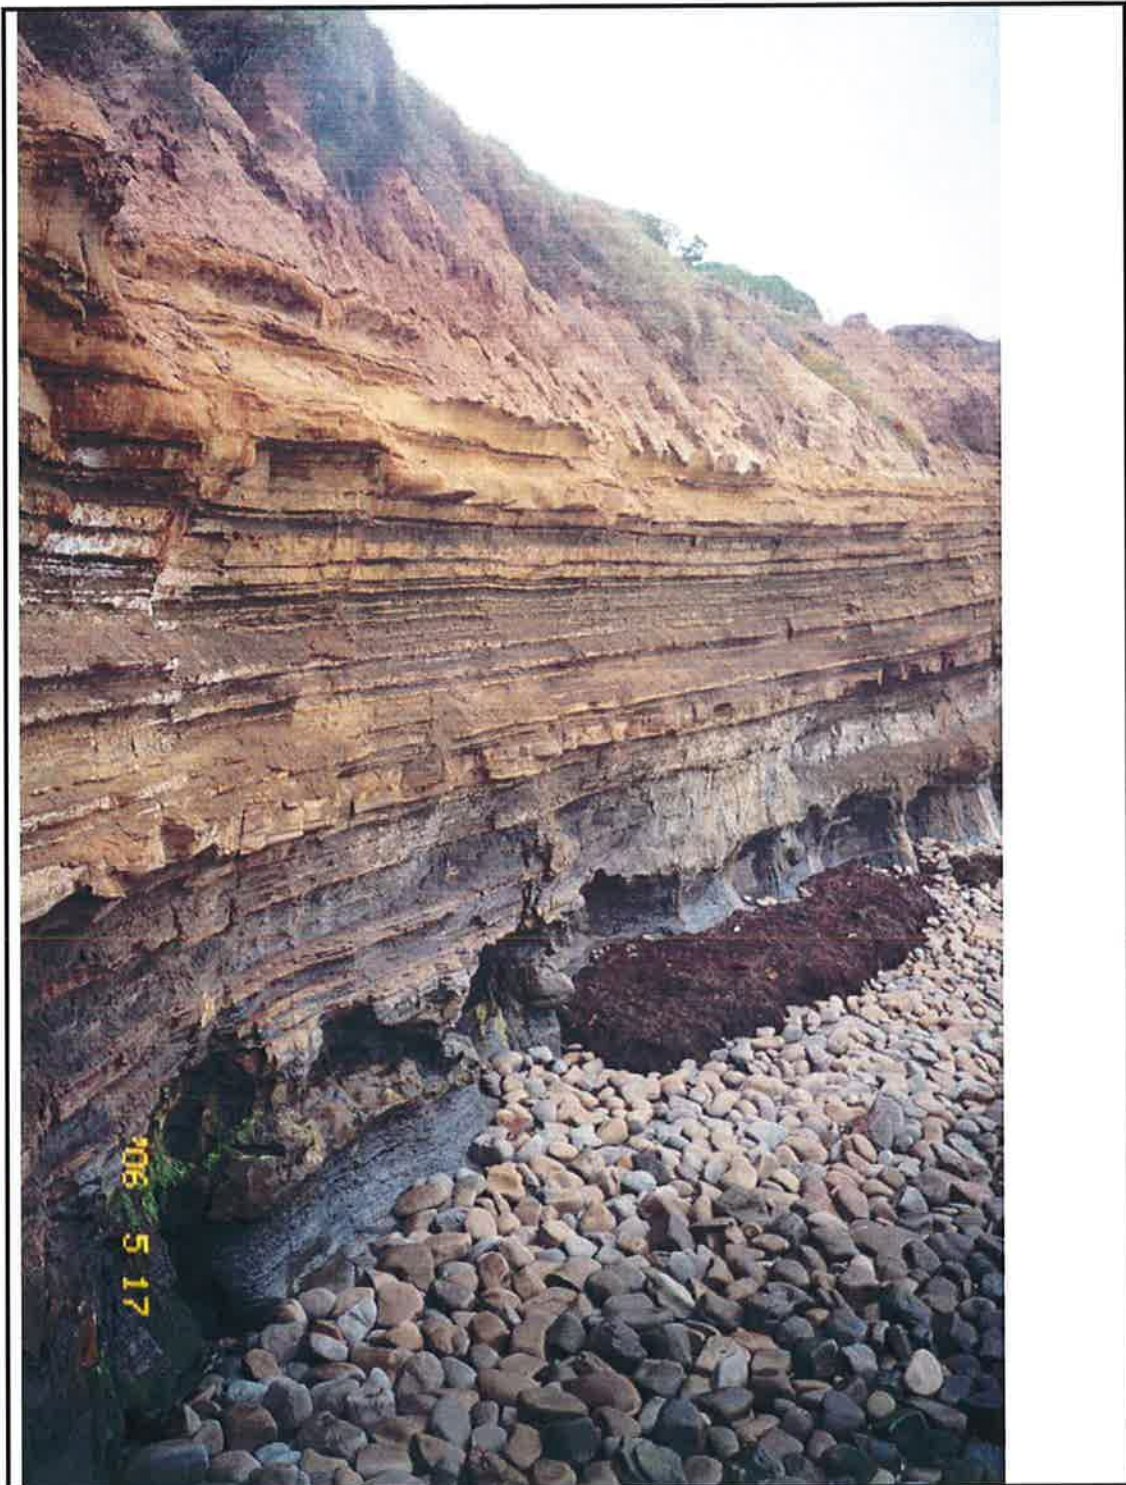
Figure 4I: Bluff face just south of Ladera Street. Significant water seepage throughout lower levels of cliff. Relatively moderately sloped terrace deposits of Bay Point Formation overlying near vertical sedimentary bedrock of Point Loma Formation.

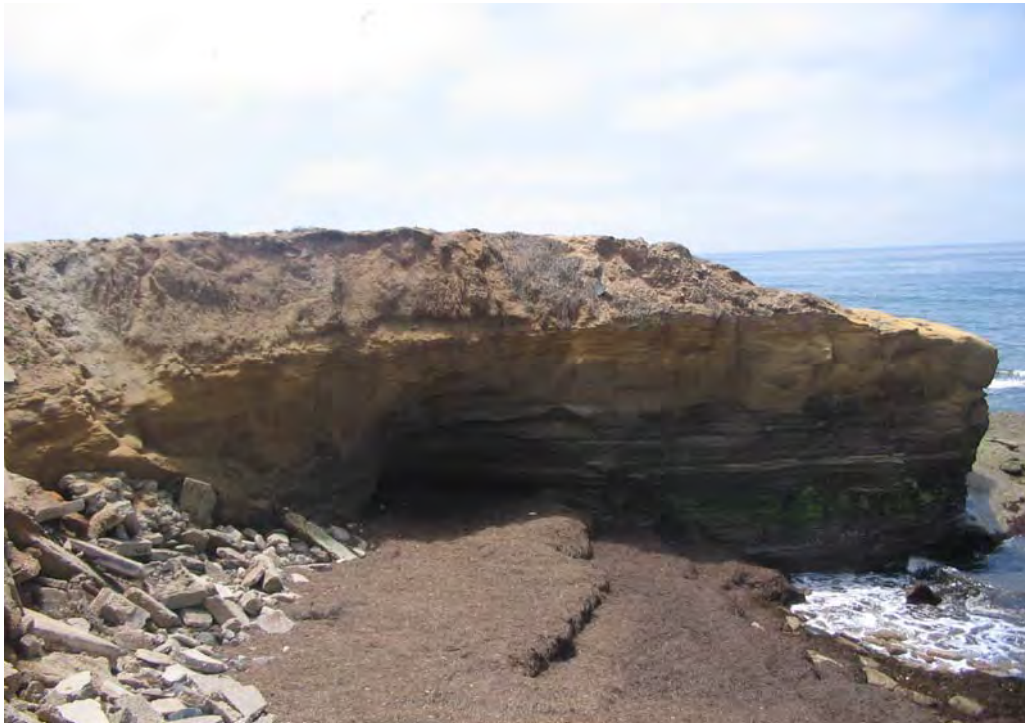
Photo 2 –At northern boundary of SCNP, looking south, Site 10.

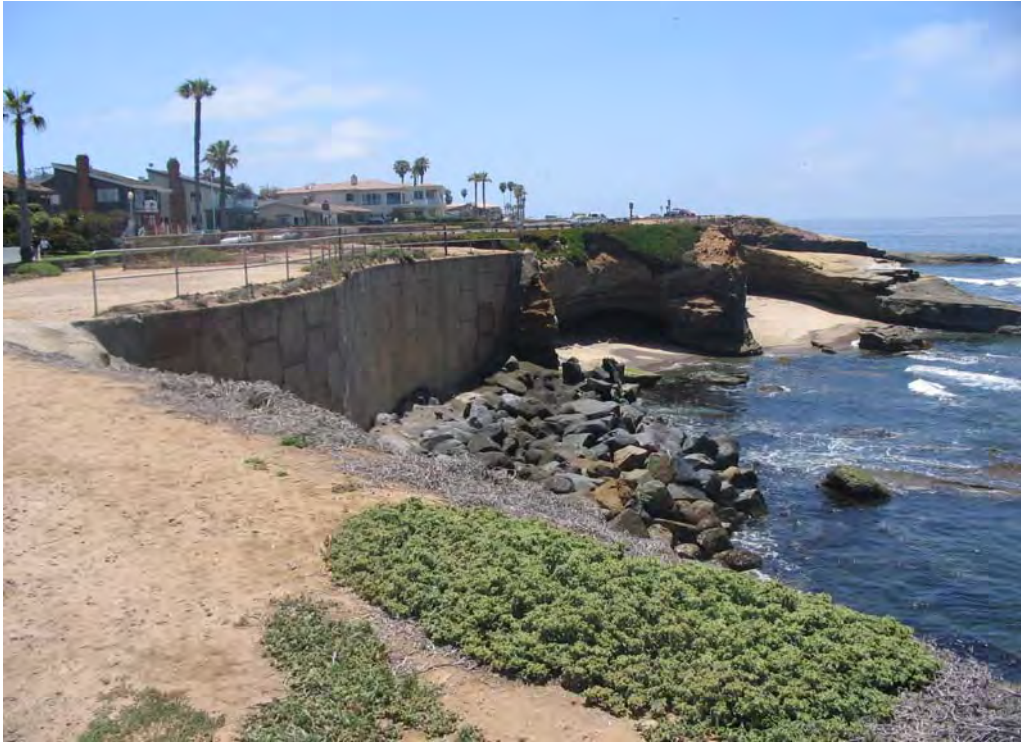
Two seawalls currently exist along the reach. Generally, the walls are performing well. Some repair needs to be considered along the abutments. These existing seawalls could be modified and tiered to a lower elevation, and colored and textured to appear more like the natural bluff formation. A new seawall could be constructed in the area just south of the northern seawall. These two walls could be tied together to create a more uniform structure. The seawall could be colored and textured to blend with the natural bluff face.

Photo 3 –Southern seawall, just north of Spaulding Point, Site 9.

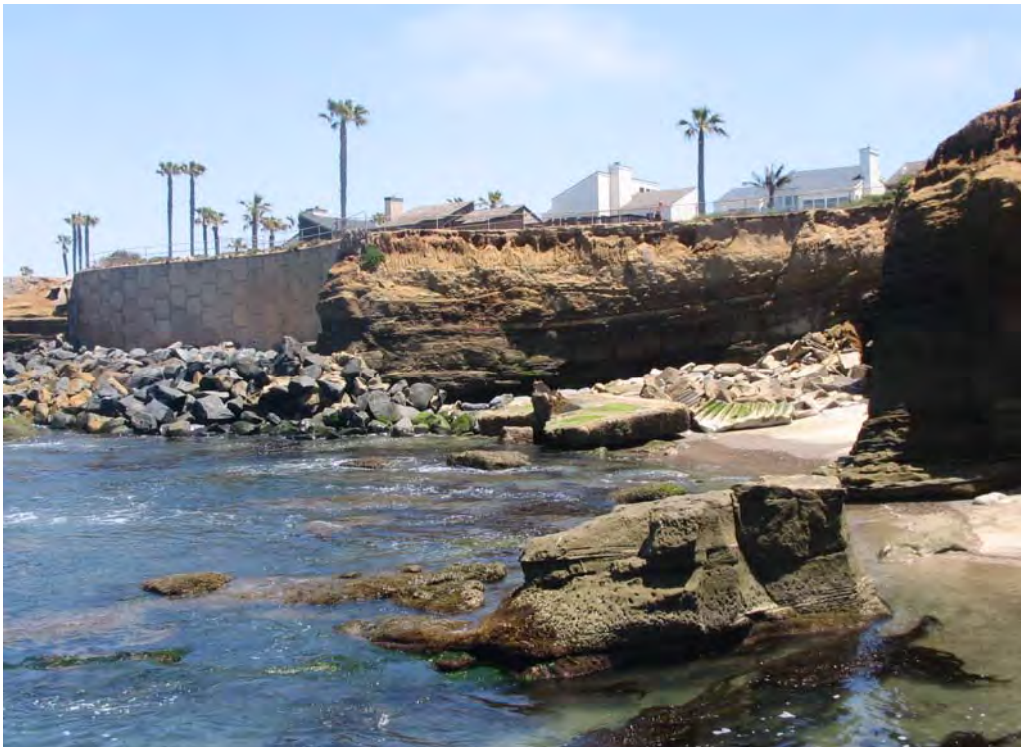
Photo 4 –Northern seawall showing location where a new seawall could be implemented, Site 9.

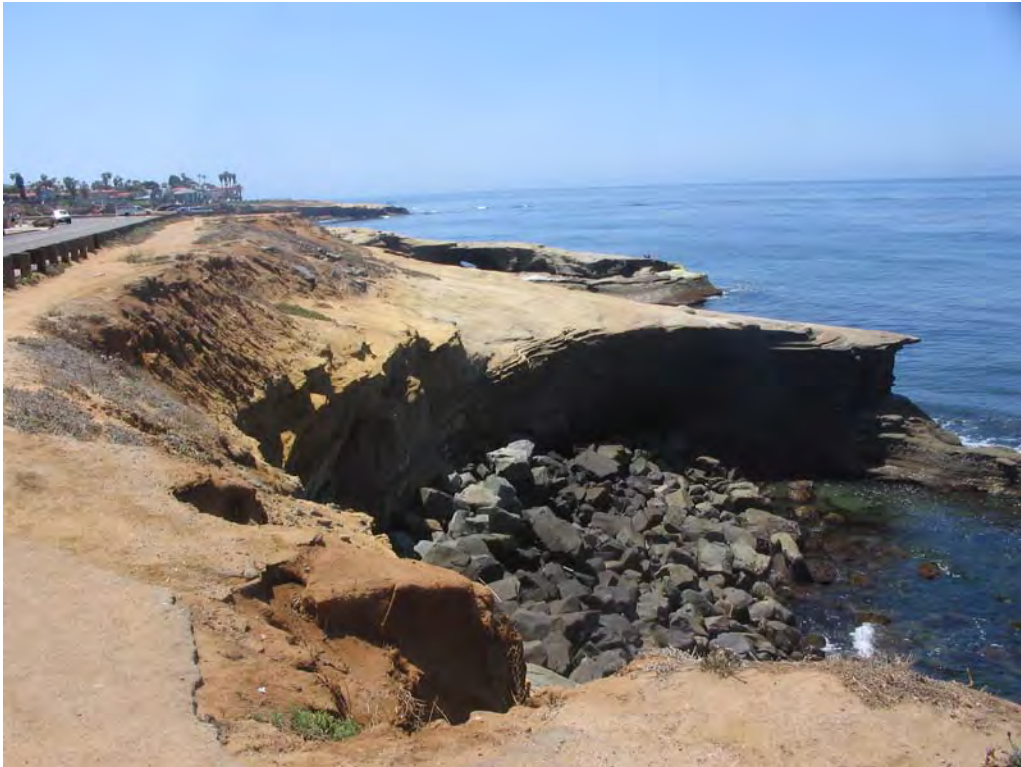
Photo 5 – From northern parking area, looking south along Site 8.

No seawalls are proposed along this reach, but upper bluff stability is recommended. This could include an injected grout or resin product as described in the previous sections.

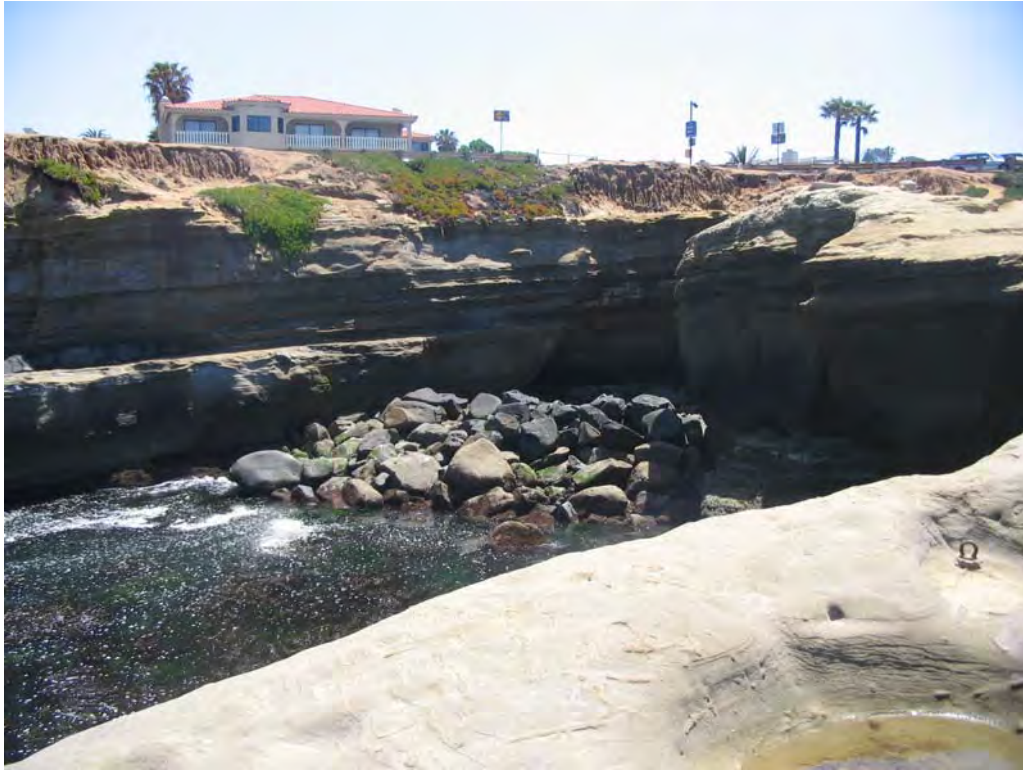
Photo 6 –At southern parking area, looking landward toward cave entrance, Site 8.

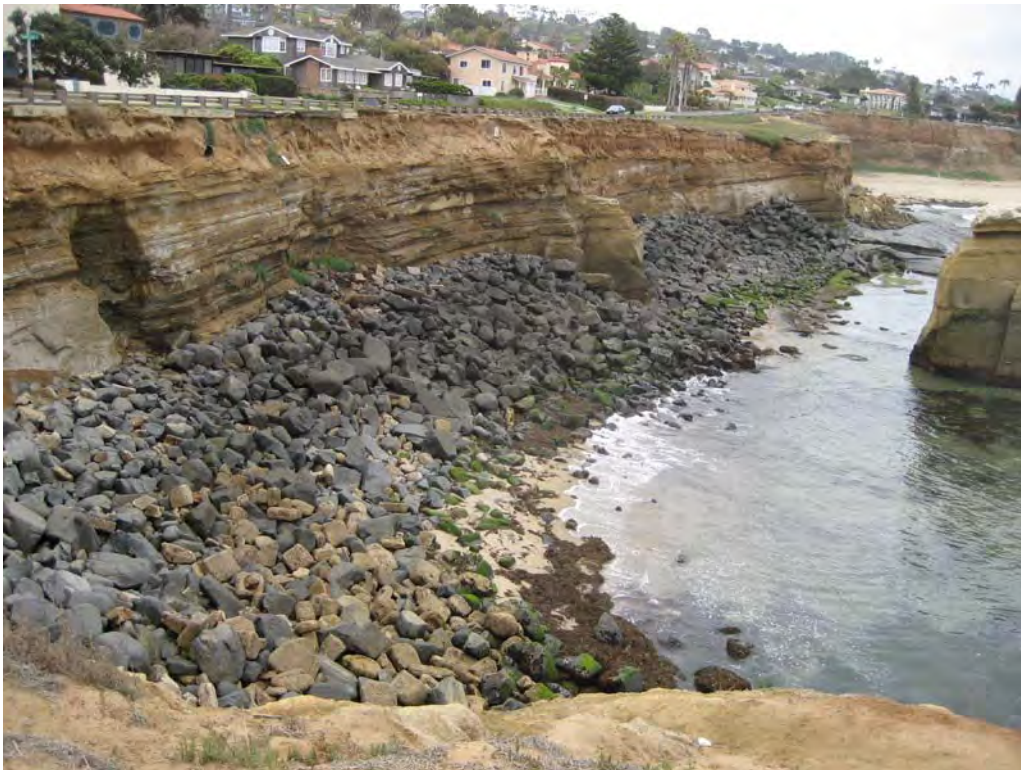
A seawall is another alternative that could be considered along this site because of the critically eroded upper bluff face. Similar to Site 6, there are areas where the bluff has eroded under Sunset Cliffs Boulevard, and public access is directed into the road. A seawall could reclaim a little of that needed public access route along the bluff top. The seawall would need to extend from the base to the top of the bluff and could be colored and textured to blend with the natural bluff face. A less intrusive alternative to a seawall would be to provide some upper bluff stabilization, such as an injected grout or resin product. This would slow the upper bluff erosion, but would not restore the bluff face. This product would need to be reapplied every one to two years and would not hold up well to extensive foot traffic.

Photo 7 – Looking South at Site 7.

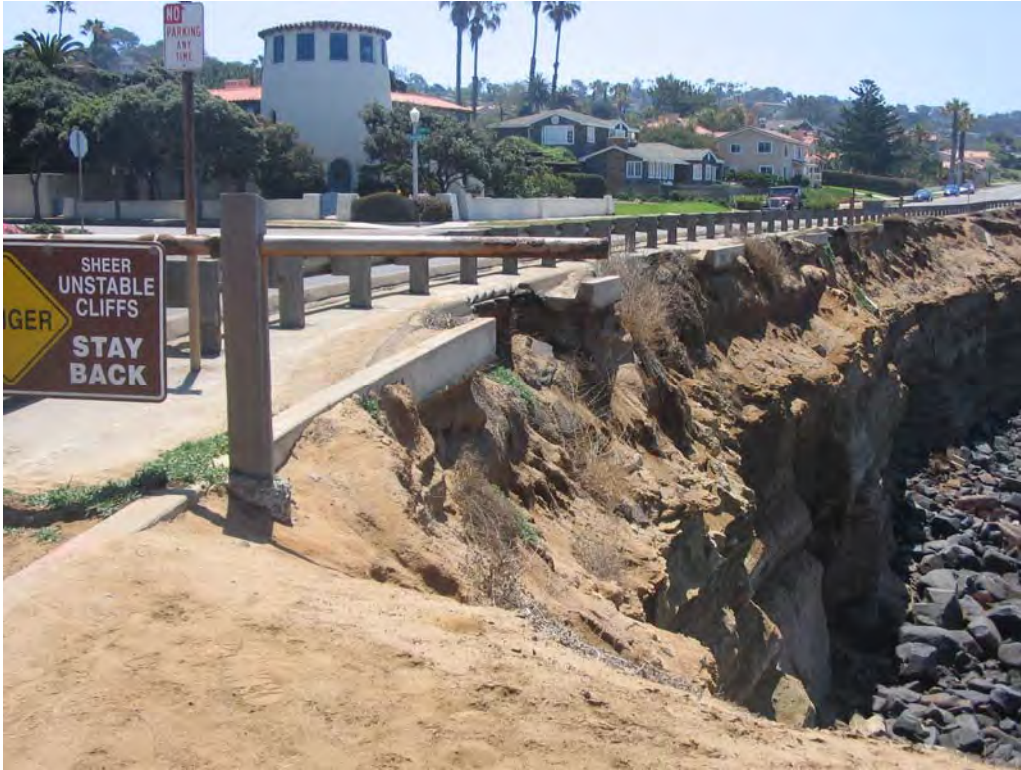
Photo 8 – Top of Bluffs, showing damage to curb, Site 7.

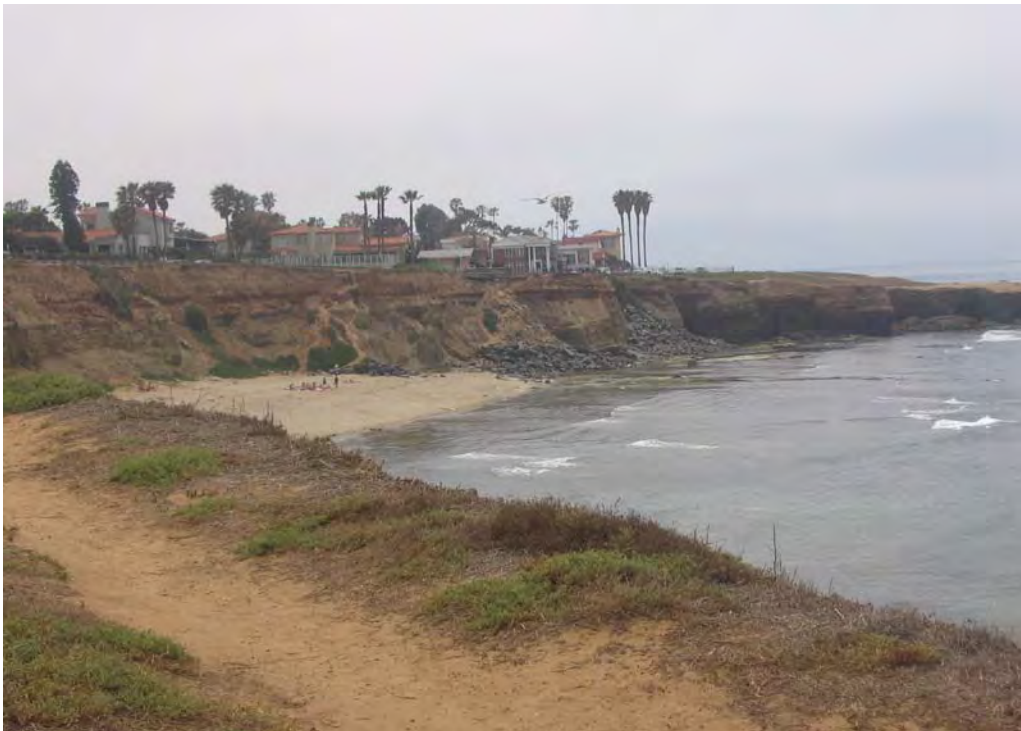
Photo 9 – No Surf Beach, Site 6.

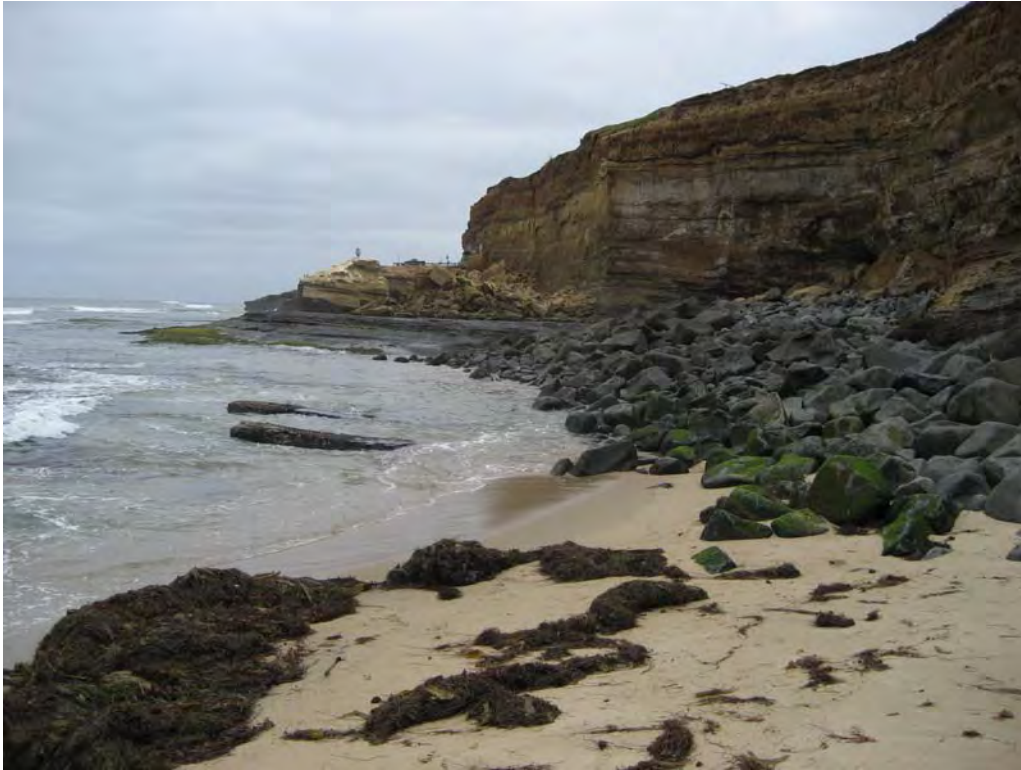
Photo 10 – North end of Surf Beach, Site 6.

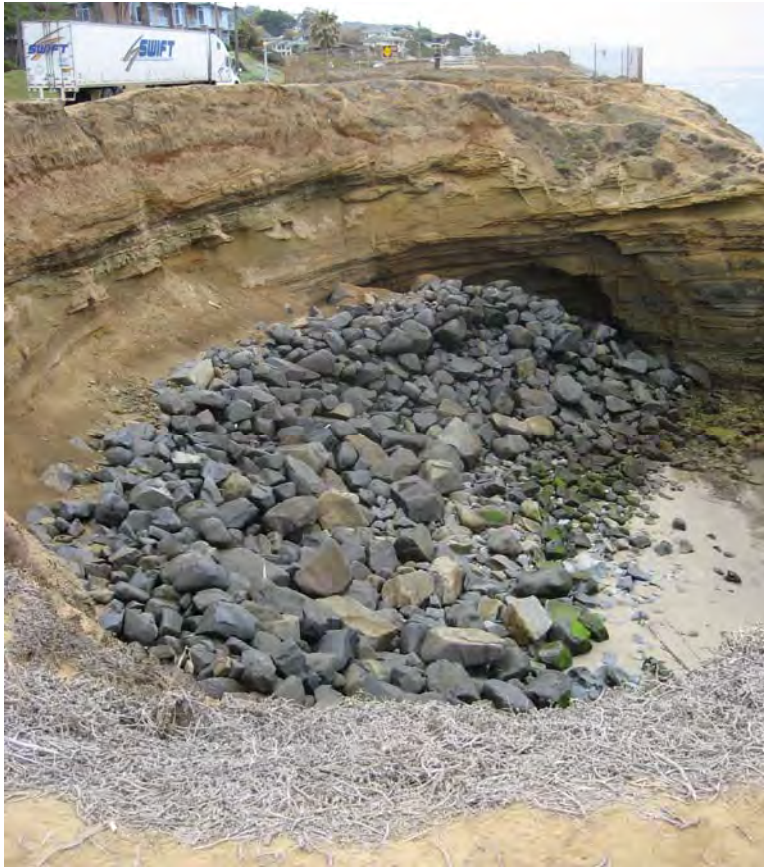
Photo 11 – Small pocket beach just south of Luscomb’s Point, Site 5.

The smaller pocket beach area south of the collapsed sea cave whole could also support a beach fill, nearshore reef, or perched beach. However, the sea arch cutting through the southern headland would need to be filled with rock or concrete to prevent any sand placed in the pocket beach area from being swept out by waves and tides through the arch.

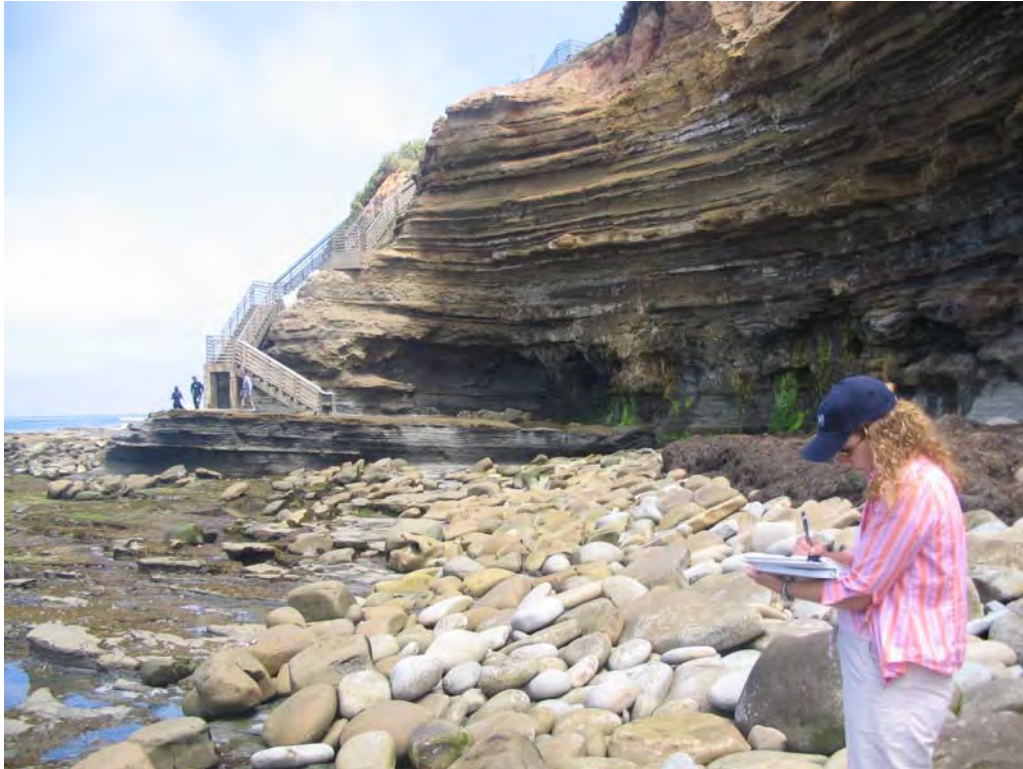
Photo 14 – Site 2, Access Stairway at Ladera Street

This site is the small area directly around the Ladera Street stairway (Figure 6-5). A new stairway is proposed as part of the SCNP Master Plan and therefore the existing stairway would need to be demolished and removed. Any new stairway may require a small, site-specific protective device to ensure its design life and stability. This could be a small seawall structure

that could be incorporated into the stair structure design and not a stand-alone structure. The stairway external face could be colored and textured to match the existing bluff face, but this is probably not practical at this location since the prime vantage point of the stairs is from the top of the bluff.

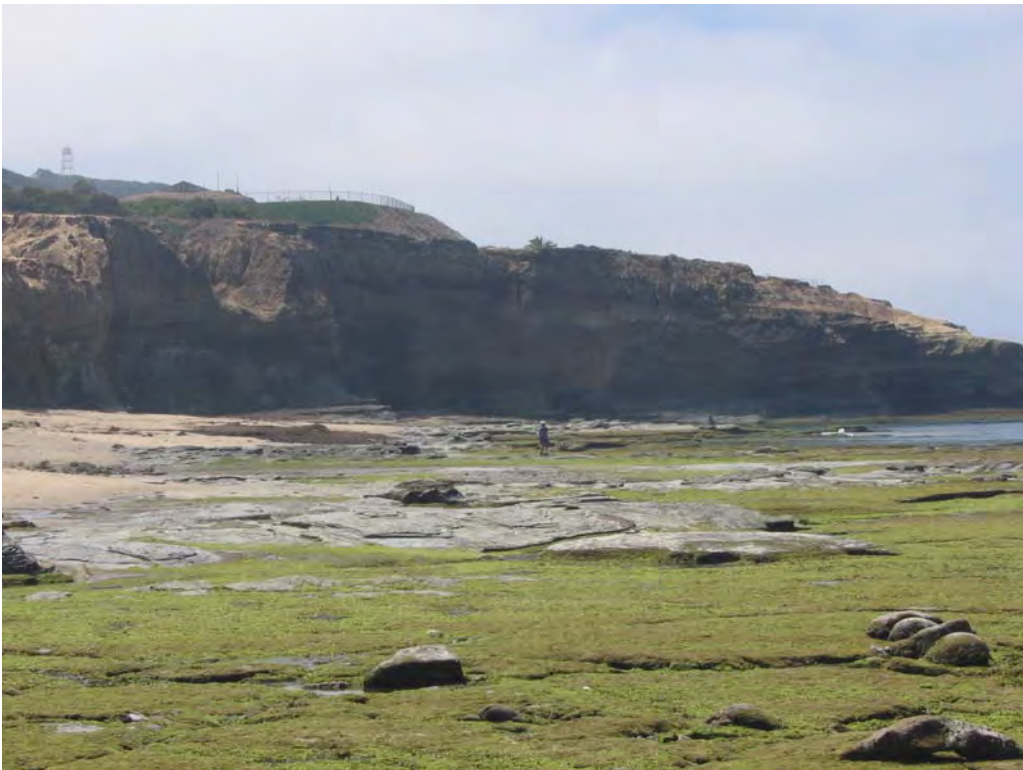
This section extends from Ladera Street to the southern boundary of SCNP (Figures 6-5 to 6-7) and has an overall risk rating of Low. Photographs 1 and 2 are from Site 1. The City’s Coastal Assessment does not contain any recommended action items. The majority of the erosion of the bluffs along this reach is from storm water discharge. Coastal processes are present, but do not contribute to the majority of the erosion issues present. Once the upland storm water system is redesigned and constructed, the bluff erosion will slow significantly. No shore- or bluff-protection alternatives are recommended for this site. The only structures that should be incorporated into this site are public access and properly designed storm drain outfall structure(s). The public access should be designed to prevent further bluff erosion from foot traffic.

Photo 16 - View South of Site 1

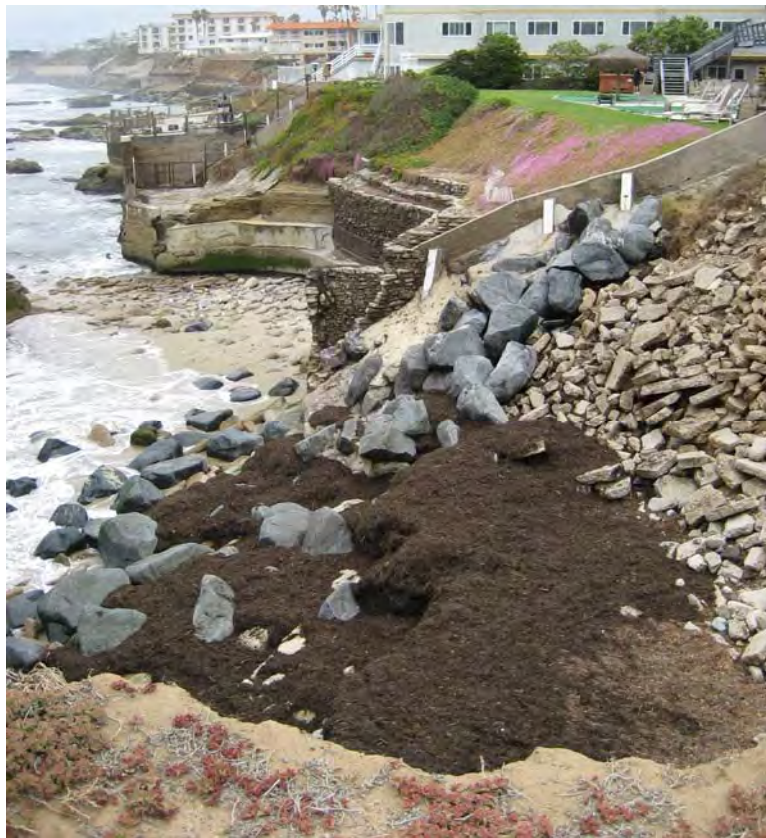
Photo 17 – Adair Street street end.

Because the pocket beach is narrow, the alternative best suited would be to extend the outfall pipe into the nearshore, past the southern headland. This would prevent any storm water flow to erode the headland to the south. The outfall pipe could be buried under the existing sand and covered with a textured surface to blend with the natural sandy and nearshore rocks.

Riprap or concrete dissipating structures could also be constructed here, but would need to be designed to ensure that the high-energy flow did not contribute to erosion of the headland area.

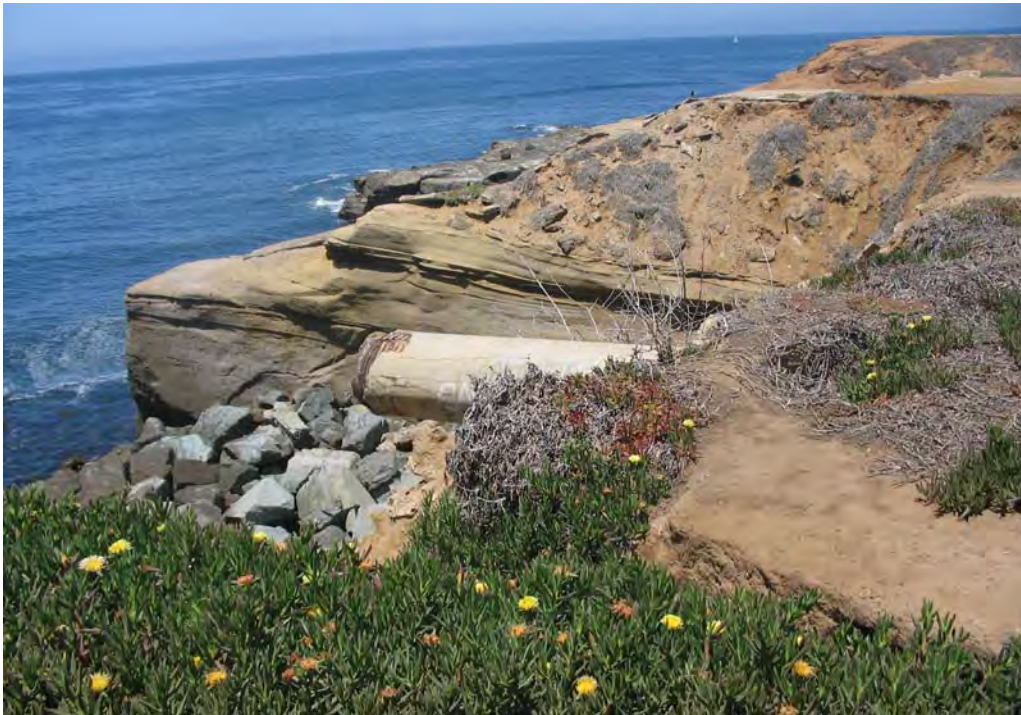
Photo 18 – Osprey Street street end.

Outfall #2 is located at the Osprey Street street end. This site is similar to Adair street, in that it appears to be a good location from a constructability stand point and also may provide an opportunity to remove some of the riprap at the base of the bluffs, depending on the type and design of the outfall structure. The parking area to the south would be an ideal location for staging and equipment storage.

Alternatives that could be applied that this location include a riprap apron or concrete dissipating structure and extending the outfall into the nearshore area. Internal dissipation may be applicable at this site because of the longer length between the catch basin location and the outfall location. Some of the existing riprap could be used to construct a riprap dissipating apron, however the structure should be constructed as far seaward as possible to prevent scour erosion at the base of the bluffs to the north and south. The eroded bluff could be restored with backfill material. Public access impacts resulting from an outfall structure are not an issue at this site, because public access to the beach is currently limited under existing conditions. The outfall should be aligned to minimize aesthetical impacts from viewers up- and down-coast and appropriate color and texturizing would help minimize any visual impacts.
