SUNSET CLIFFS NATURAL PARK

Final Drainage Study

**SUNSET CLIFFS NATURAL PARK
DRAINAGE STUDY**

MAY 2012

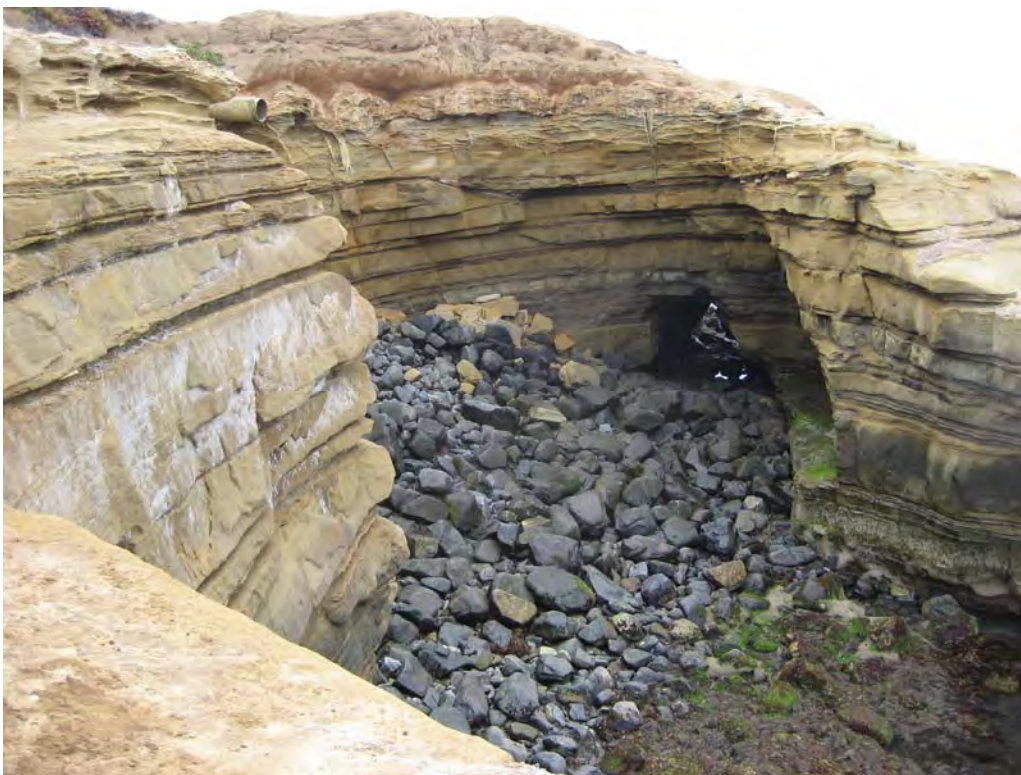
Photo 19 – Monaco Street street end.

located at the base of the bluff and some could be removed during the construction of an outlet at this location. However, it may require a crane operation to move, remove, or realign the riprap. Some of the existing riprap could be re-used for a riprap apron dissipation structure at the base of the bluff.

However, there is concern that an outfall located at the base of the bluff could create flow conditions that can contribute to the erosion of the headland area to the south of the cove (see Photo below). It may be best to situate the outfall structure further seaward, near this headland to minimize erosion from storm water flow. The site may be better suited to extend the outfall pipe into the nearshore, past the southern headland. This would prevent any storm water flow from increasing the erosion to the bluff face and headland. The outfall pipe could be buried and covered with a textured surface to blend with the natural seascape.

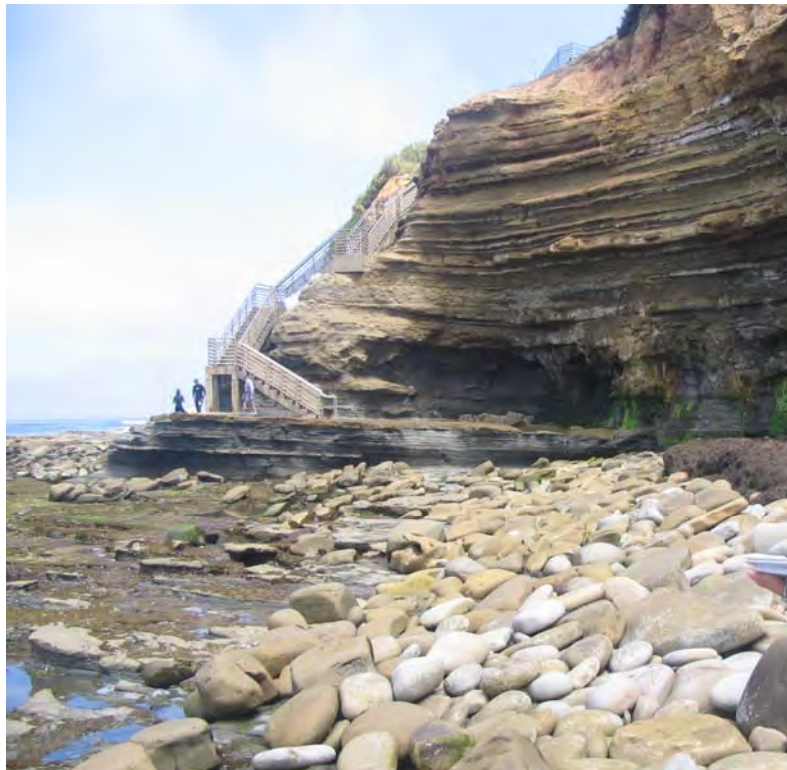
Photo 20 – Ladera Street street public stairway.

The Ladera Street Access Stairway is the proposed location for Outfall #4. This is the most-difficult location along Linear Park for construction access and staging. The bluffs here are near vertical and higher than the locations to the north. It would be best to incorporate the outfall structure into the proposed new stair structure to minimize the number of structures in the coastal environment. This site would be best suited with a riprap apron or concrete dissipating structure that can be incorporated into the base of the new stairway design. Some of the existing rock located at the bluff base could be incorporated into the structure, if needed.

Extending the outfall into the nearshore area is not advised at this location because of the public safety impact this may pose to the surfers and other beach users accessing this location.

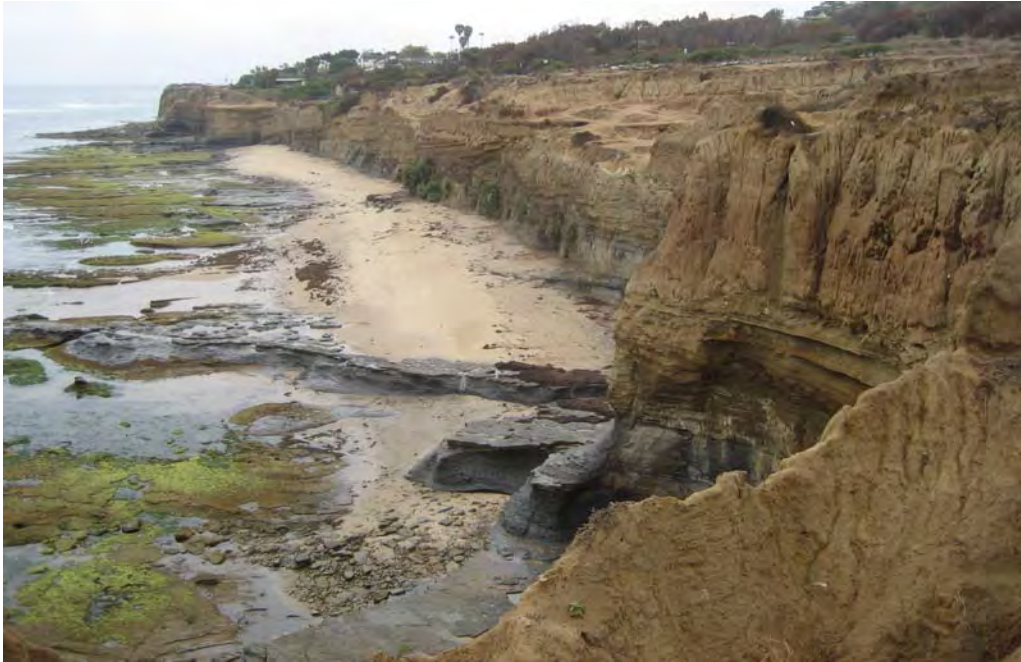
Photo 21 – Photo showing Garbage Beach (Outfall 5 location on S. end).

Outfall #5 is located toward the end of the sandy beach area of Garbage Beach and shown in Photo 21 and Outfall #6 is located around the headland point, and approximately 450 feet north of the SCNP southern property boundary (Photo 21). Both of these locations are similar in that there is a sandy beach below a very high bluff. Access to the beach would be extremely difficult from either location. A very large crane or helicopter may be required to bring equipment and supplies to the beach for construction of an outfall structure.

An outfall extending into the nearshore is not recommended because of the risk of the pipe being exposed during times of low sand deposition. This could create a public safety hazard and would not be very aesthetically pleasing or publicly acceptable.

A concrete or riprap dissipation structure would be the two better alternatives for an outfall at either of these sites. If a beach-access route is incorporated into either of these locations, then the outfall structure could be incorporated into the design, minimizing the number of structures along the coastline. It is noted, that during times of high flow velocity, beach scour may occur from the outfall across the beach to the waterline. The southern end of Garbage Beach has some exposed bedrock that could help serve as a natural scour prevention surface, but some of the sandy beach area around the outfall structure and to the waterline will scour unless the apron is

adequately designed. To minimize the risk of beach scour, the dissipating structure should be designed adequately, which may result in a larger structure along the bluff base. Incorporating internal energy dissipators in the outfall pipe can reduce the velocity of the pipe and may help in reducing the size of the structure.

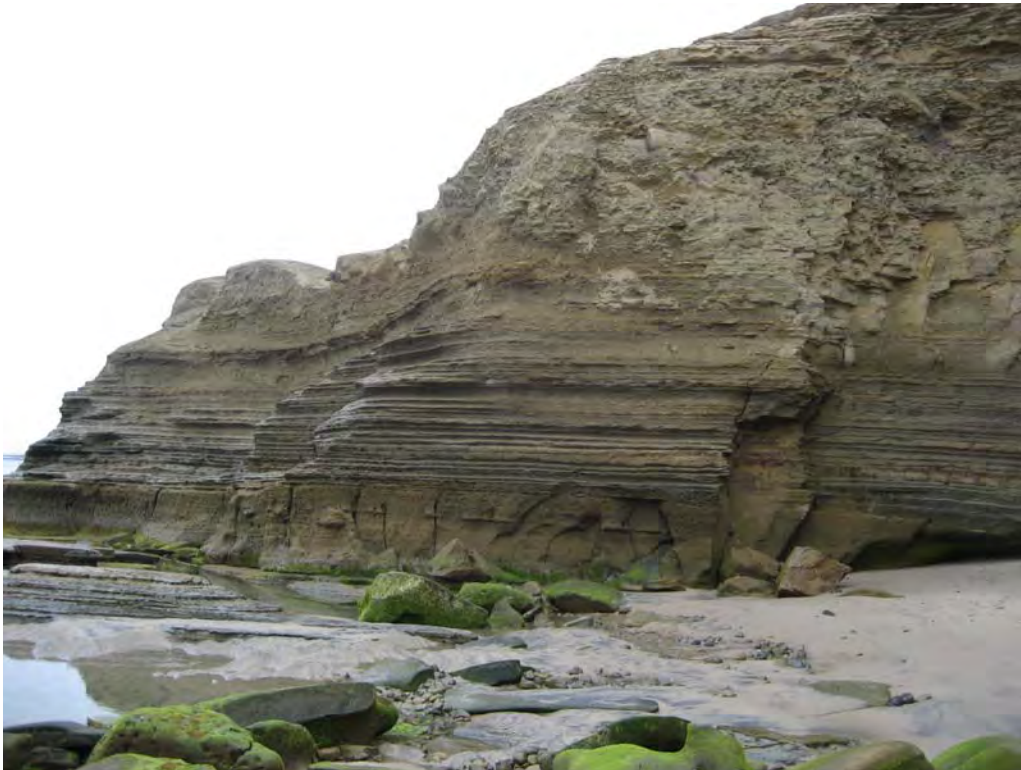
Photo 23 – Site for Proposed Outfall 5/6 Alternative.

This is a combined outfall to replace #5 and #6 and is proposed at the headland area at the south end of Garbage Beach. Although constructability, cost, and construction access access may be more of an issue because the headland extends further into the Pacific, it may be a more suitable location from environmental, aesthetic, public acceptance, and public beach access aspects.

An outfall structure could be constructed into the base of the headland which would direct the storm flow out toward the ocean and minimize any beach scour impacts from the storm flows. The flows could be slowed using internal dissipating devices inside the discharge pipe before it gets to the outfall structure, which may result in smaller design for the outfall dissipating structure. Either a concrete or riprap apron structure could be incorporated into this outfall location. The structure could be colored and textured to match the existing seascape.

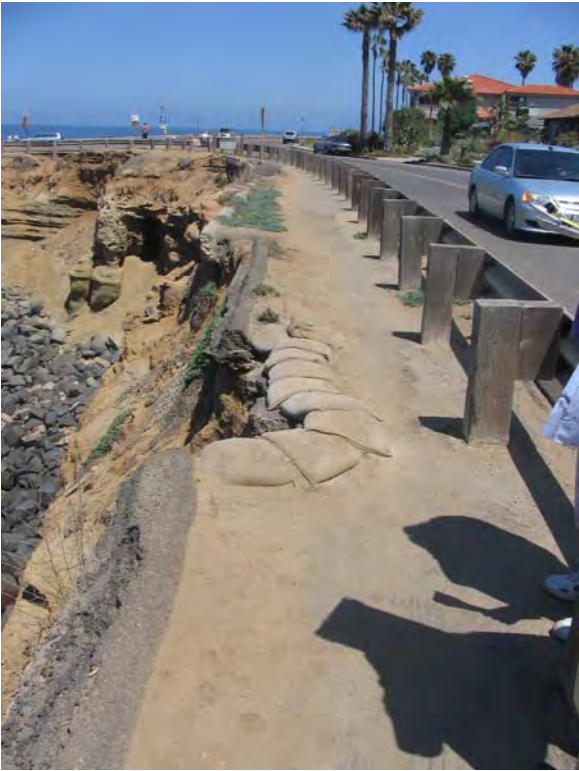
PH1: Sandbags at the end of Fronde Street to prevent runoff over cliffs

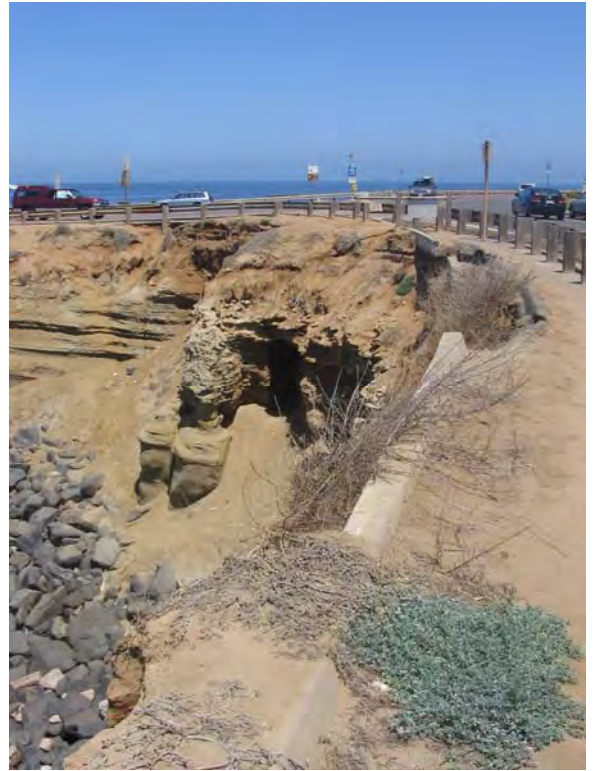
PH2: New (<10 year) cave forming.

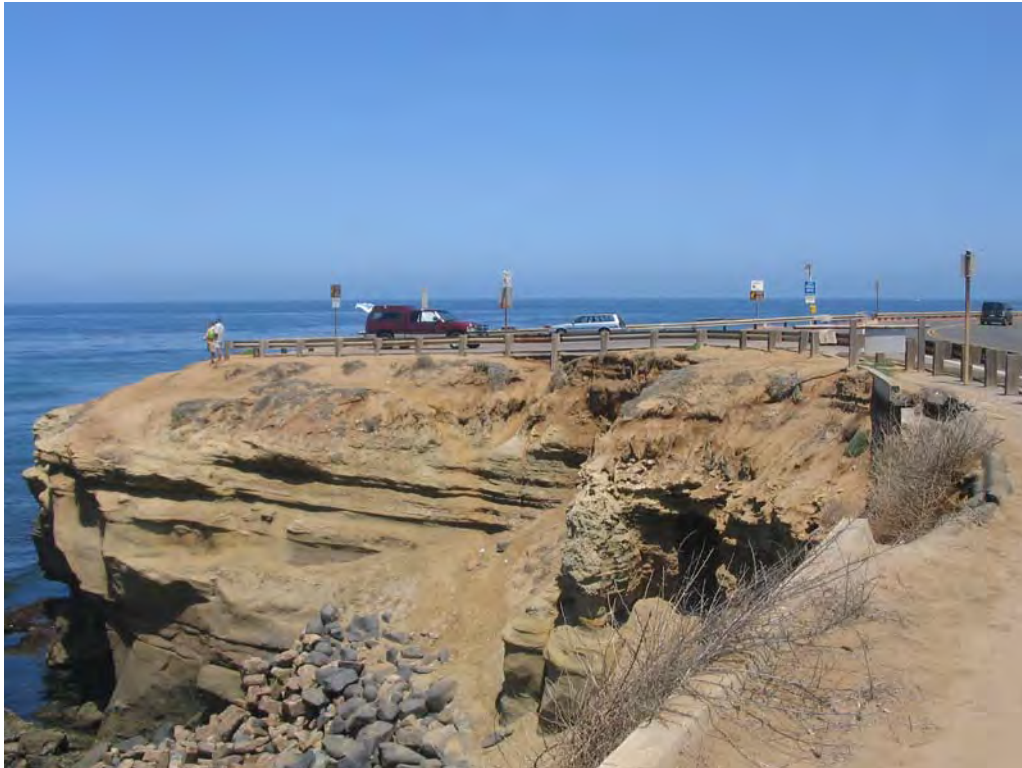
PH3: Parking at Froude Street slopes seaward; therefore all drainage runs over cliff. Concrete stairs used to exist to get to the cave and were replaced in the 1940s (these lasted 10-15 years). In 1915, near the corner of the parking, there was a little building there (this is where there was a lot of bluff erosion).

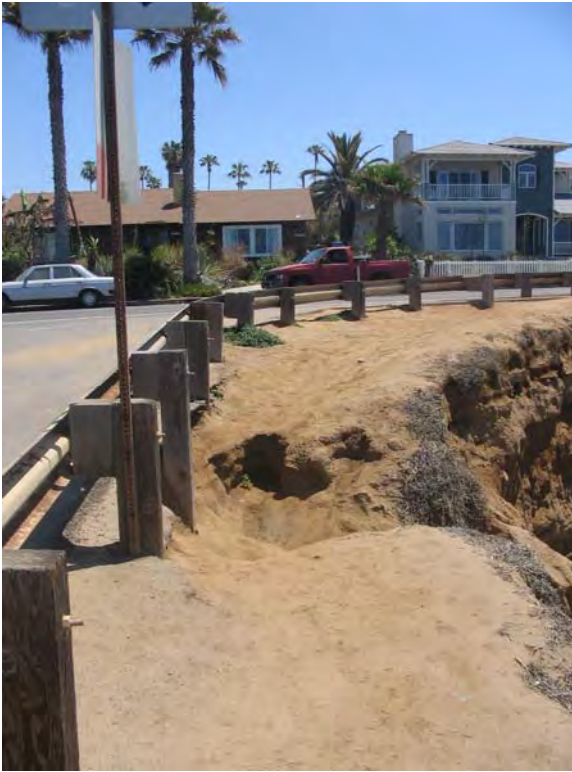
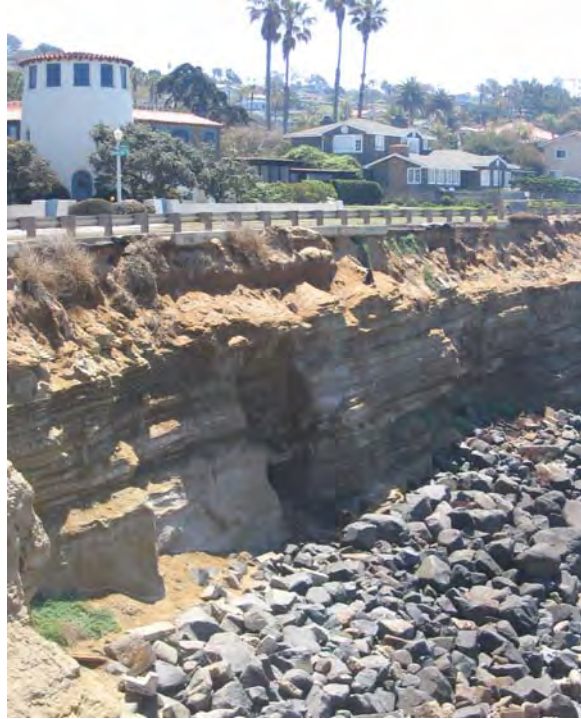
PH6 &7: Bluff Top erosion. 5 years ago this was very small and now it is large and you cant walk over it anymore. 5 years to create this hole.

- There is a cave under the parking lot (pics 6 and 7). There was a whole looking down into/up through the cave and was filled with concrete on top to cover the whole in cave.
- Squirrels are a big problem and seem to be a large factor in increasing runoff-induced cliff erosion.
- Note: Need to differentiate between Natural Cliff Retreat and Non-Natural.

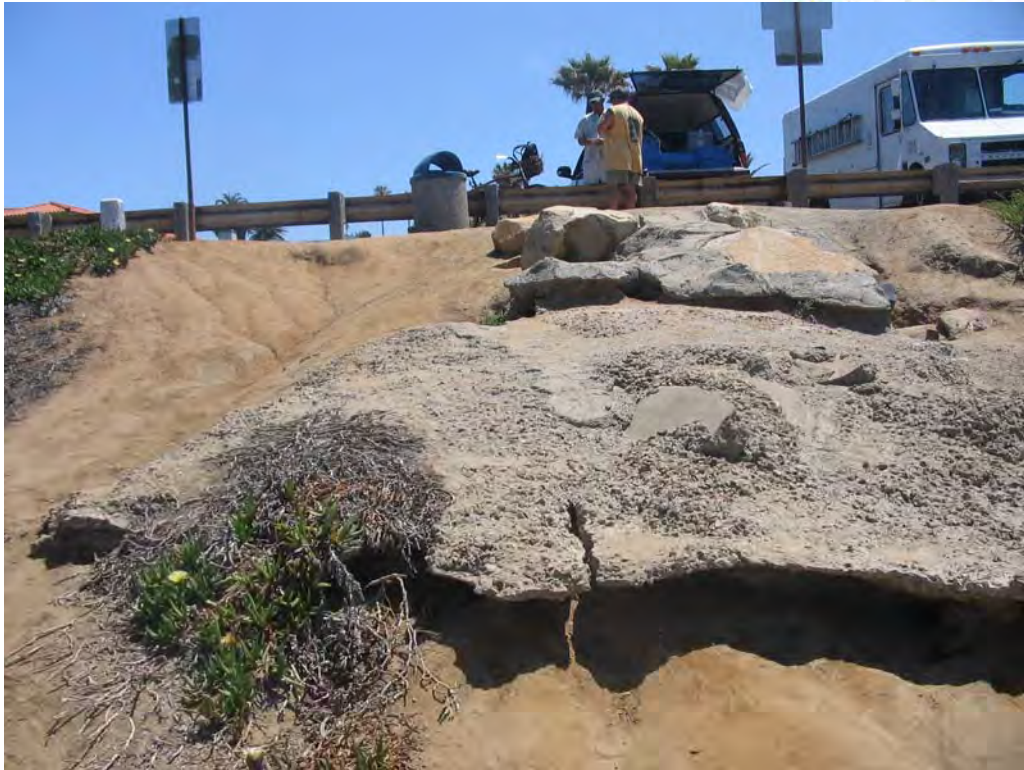
PH8: showing concrete and eroded gullies from rain run-off from the parking lot.

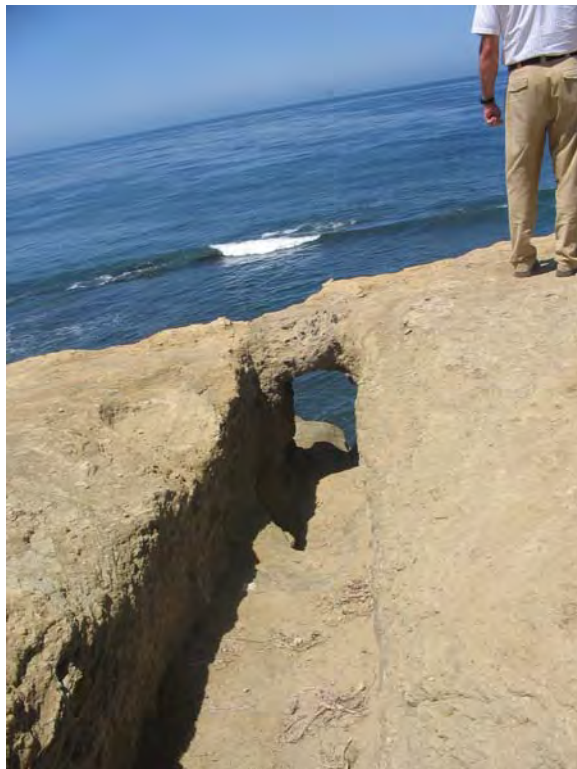
PH9: Remnants from a 1915 wooden drainage structure.

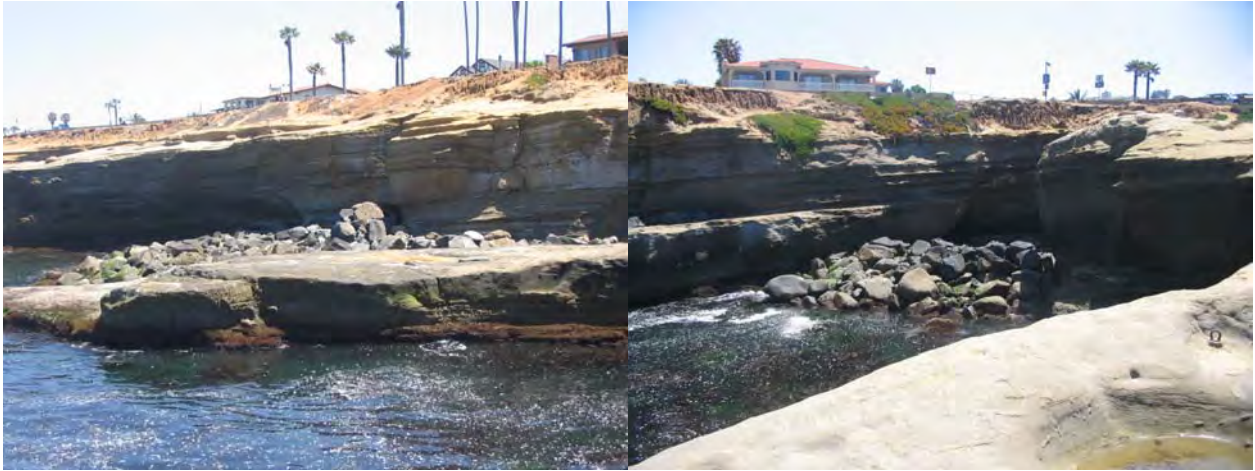
PH10/11: Riprap to fill coves. In 1984, the Corps filled in all the crevices and eroded areas along entire SCB stretch.

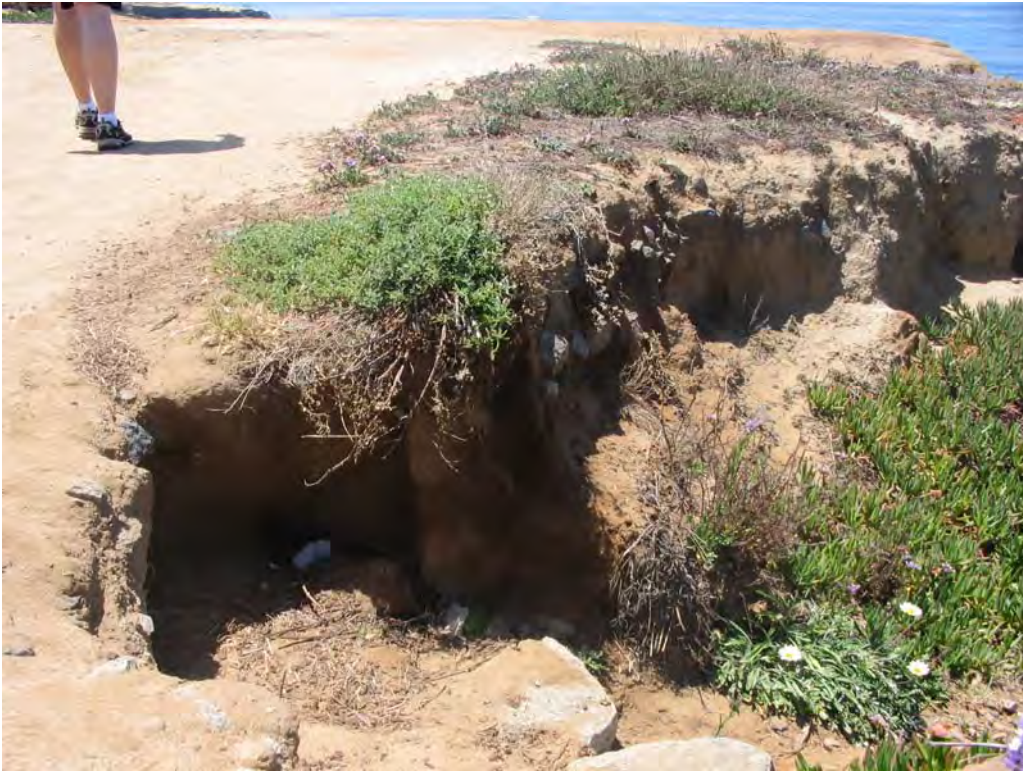
PH 12: There is un-natural fill material placed on the top of the bluffs from the Corps during the same 1984?

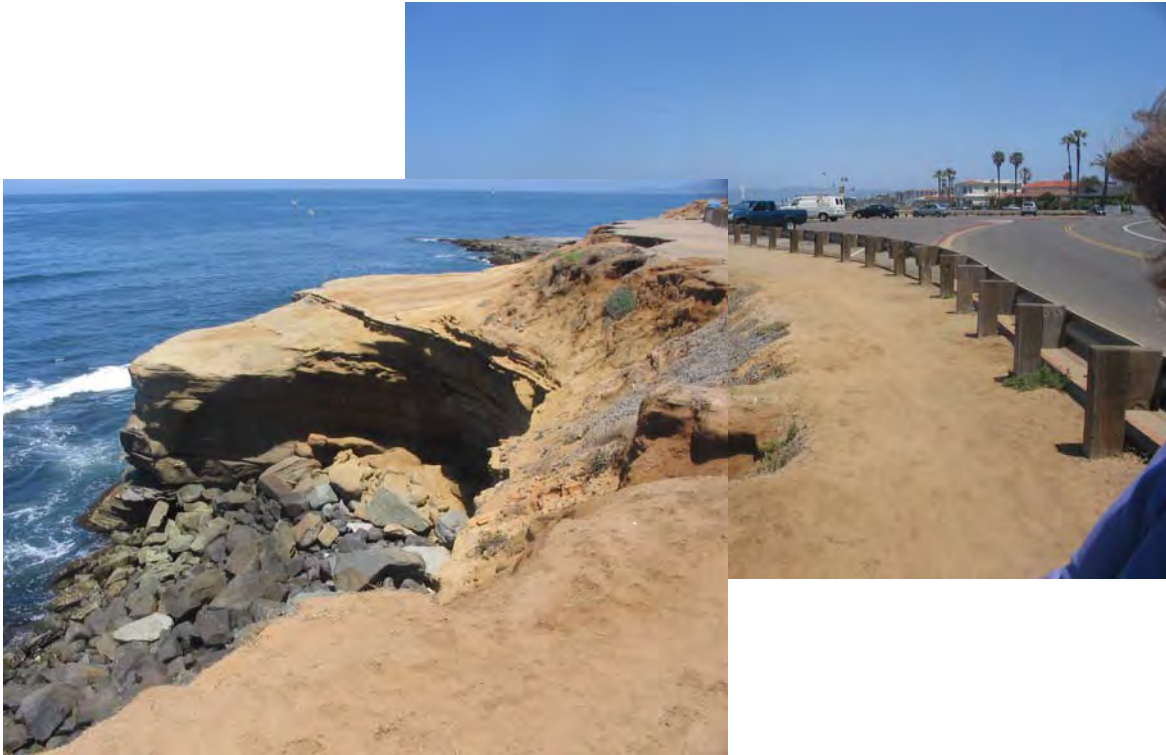
PH13/14: riprap placed by the Corps in 84/86. Parking lot at Osprey.

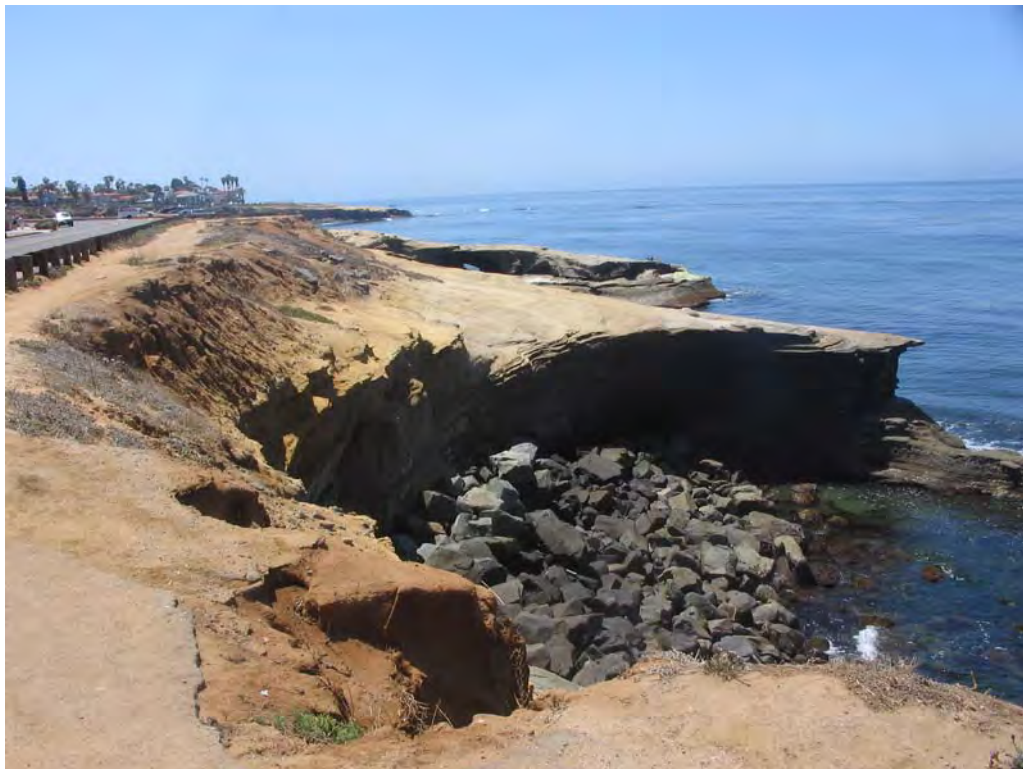
PH15: (From parking lot at Osprey). Dedi used to walk across these two points as a kid, it used to be straight across. It has since eroded into a small cove area and rip-rap has been placed at foot of bluff in cove.

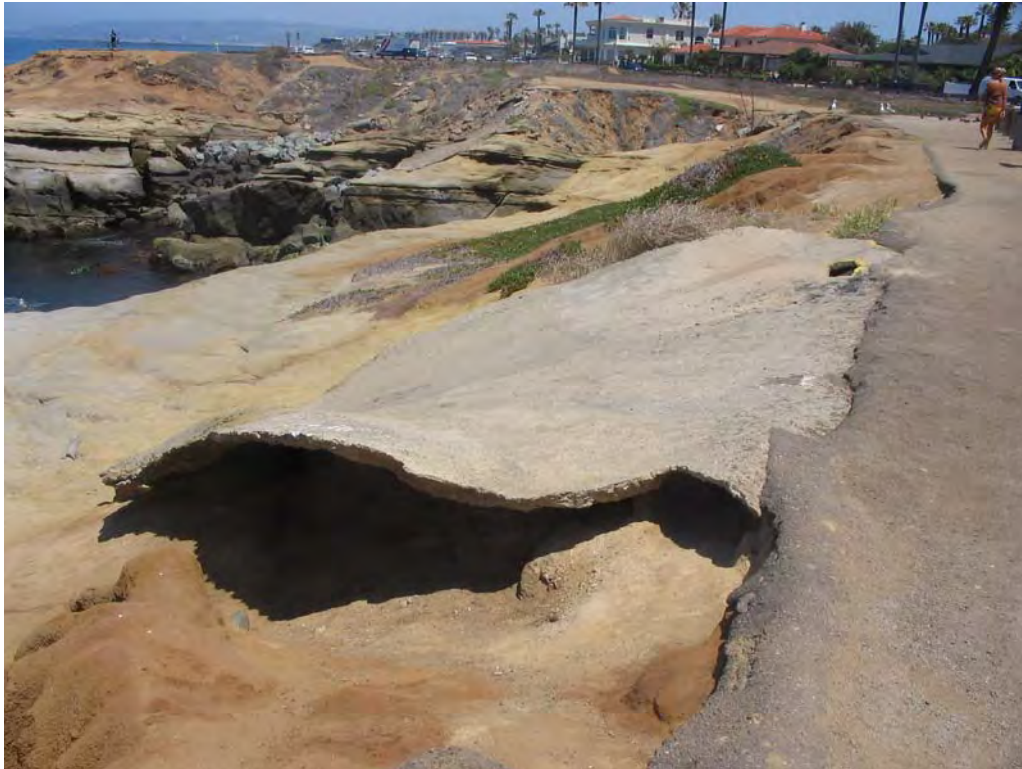
PH16: Concrete slab placed as a (failed) attempt to control run-off erosion (at Osprey). Flow was supposed to go over it, but as shown, it has scoured around it. Rodents live under these structures as they provide extra protection.

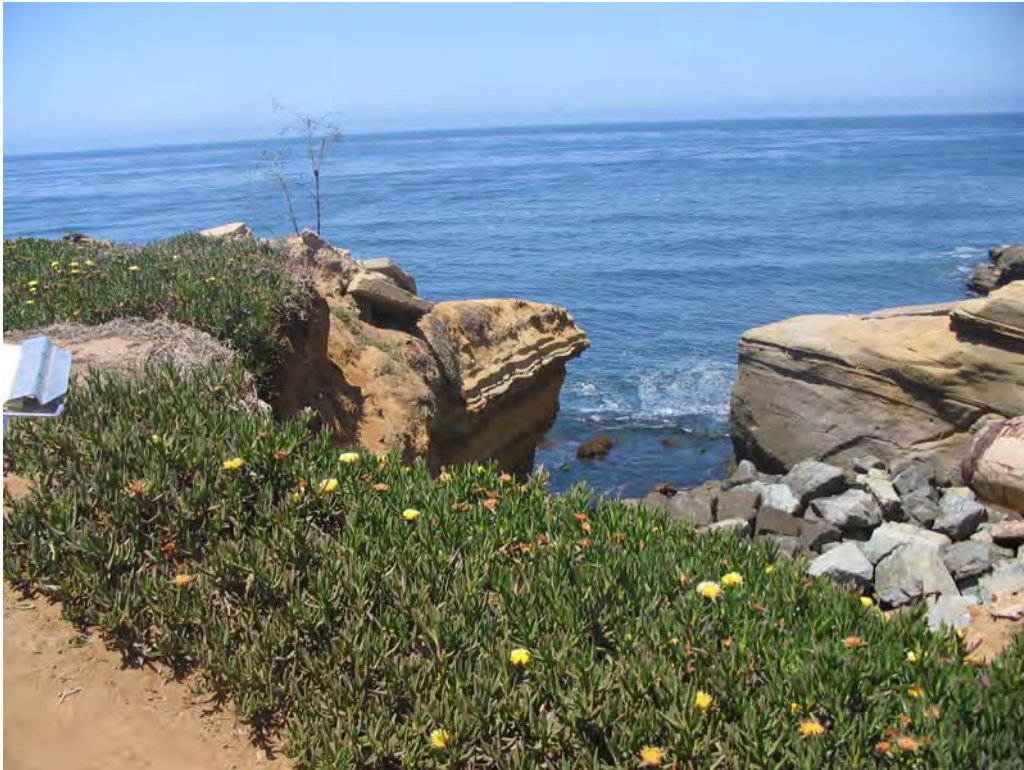
PH19: at Osprey street: rubble at the end of the point. Needs to be removed.
Does this increase erosion from the added weight of riprap/rubble on top of the bluff?

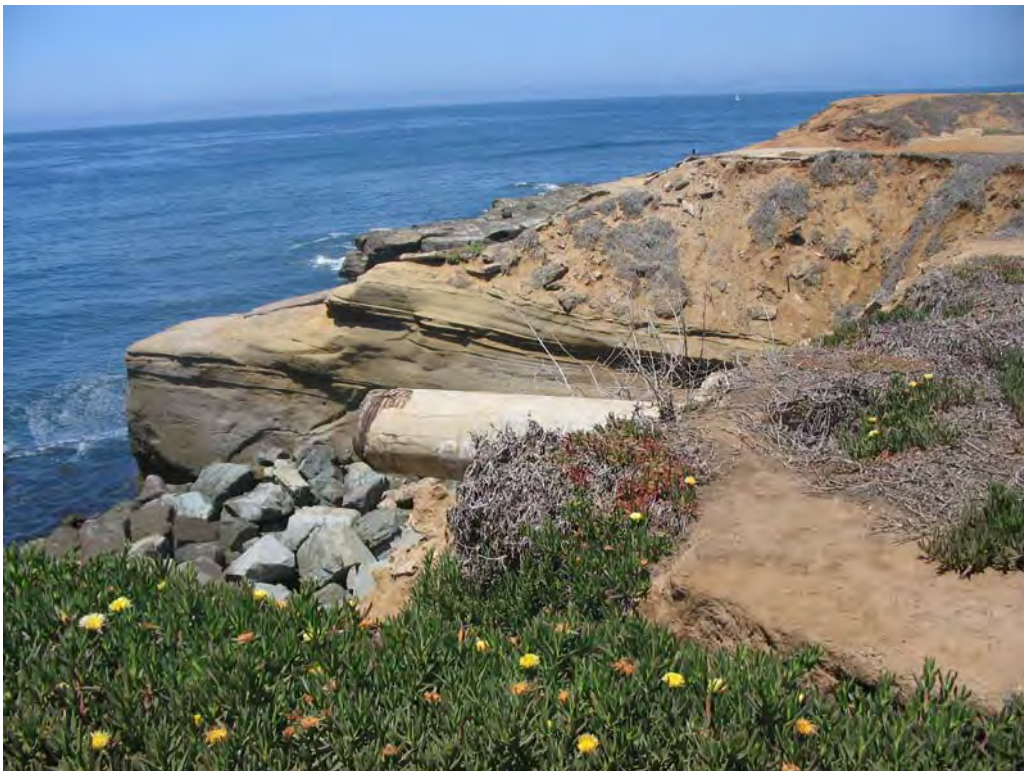
PH20: Osprey drain pipe filled below with rip-rap. Drain pipe to be removed with new plan.

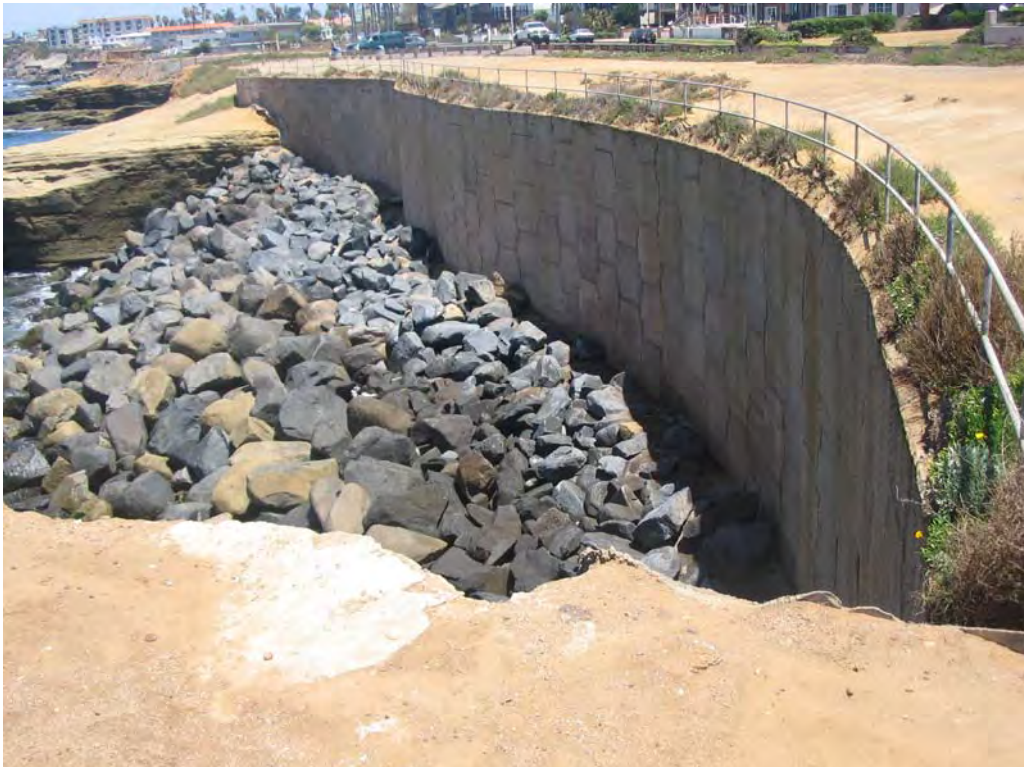
PH24: USACE sea wall/riprap. There was a cove behind it that extended close to the road. The Corps built the wall farther seaward and filled behind it. The fill appears to be quarry rock and dirt. ***Dedi would prefer to see this are be used as a parking area, since it is 'man made' and it would be hard to restore this are to natural conditions. Natural vegetation would have a hard time growing over the fill material.***

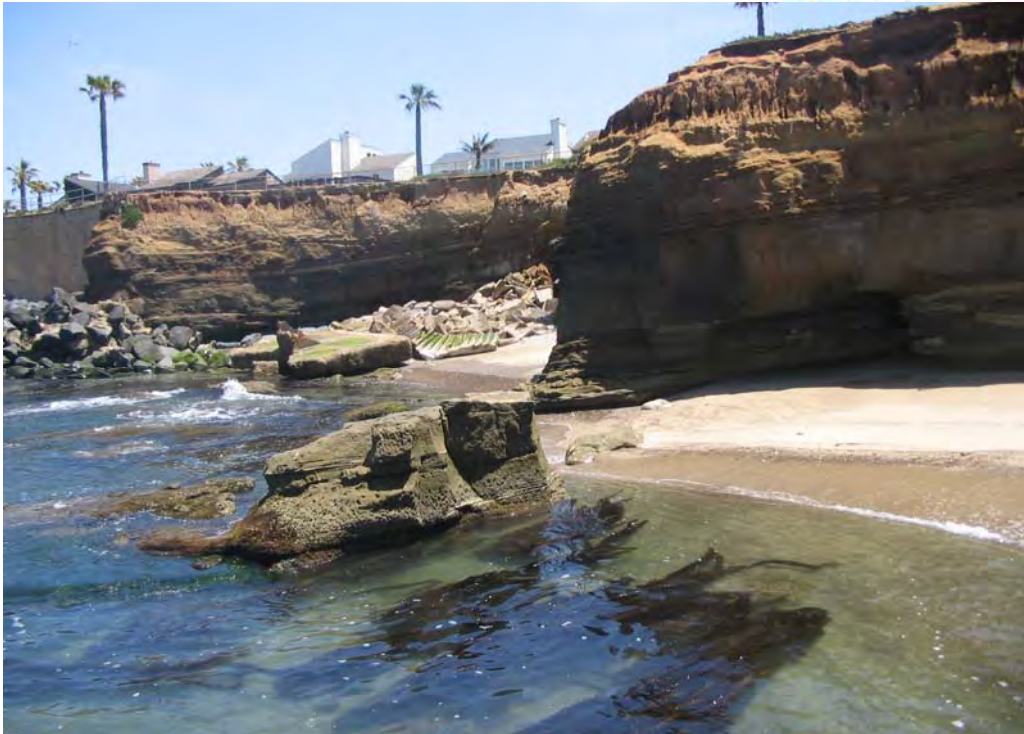
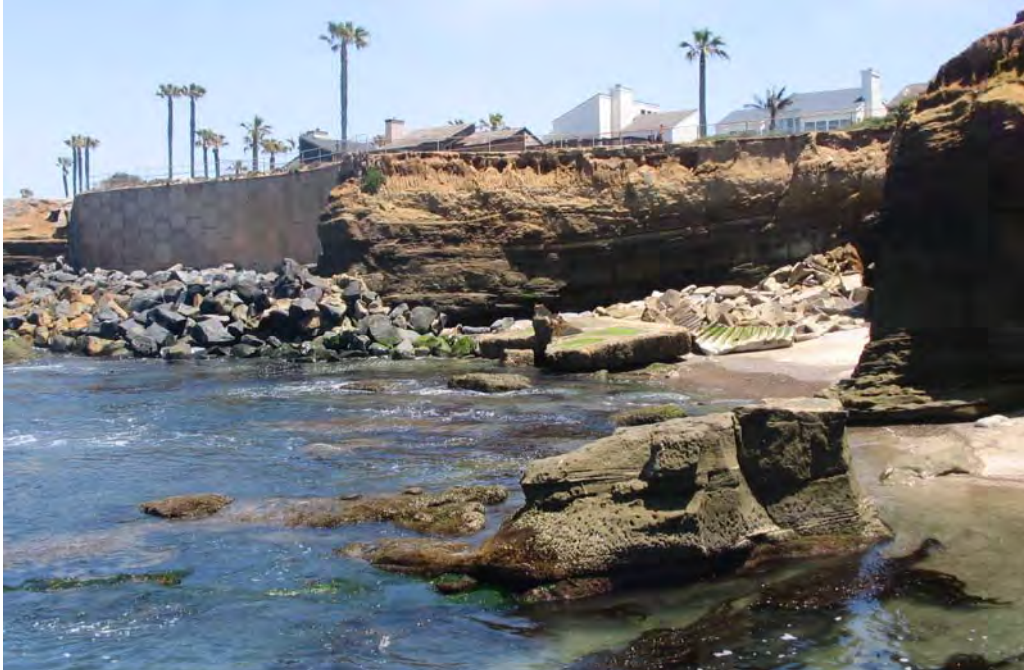
PH25/26: (Spalding Point) This arch fell about 10 years ago. In 1915 there was a seawall and viewing platform. This collapsed because the seawall failed (Dedi suspects that this is indirect erosion caused by the seawall/shore protection scouring around it).

*****Dedi Recommended that this area could benefit from a newly created cove beach and use the rubble (to the north) to create a small groin on the north end, fill with sand, and provide access to beach (or use the point that we are standing on to get to the two cove beaches). She also said that this is one area that a textured seawall would be good solution and restore the cove beach.***

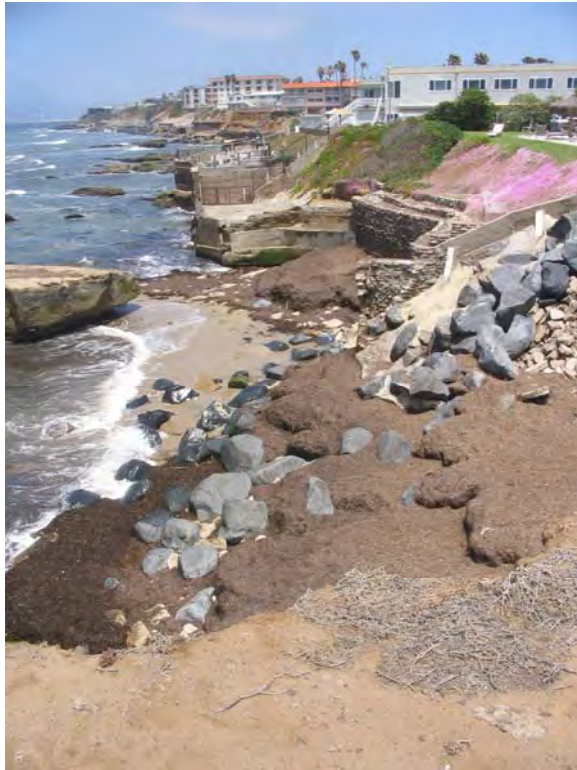
PH29: This shows 'unnatural' erosion caused by failing and settling rubble.
Dedi would like to see a set of terraces/stairs at this point to view the entrance of the park.

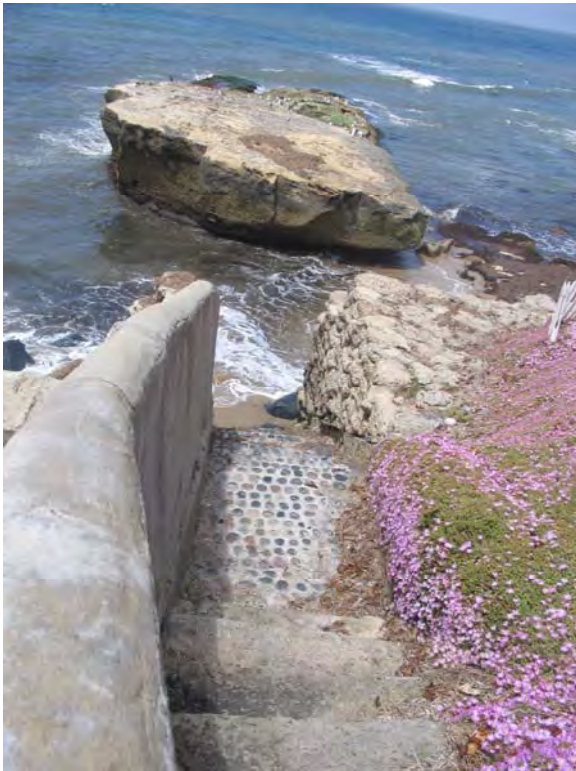
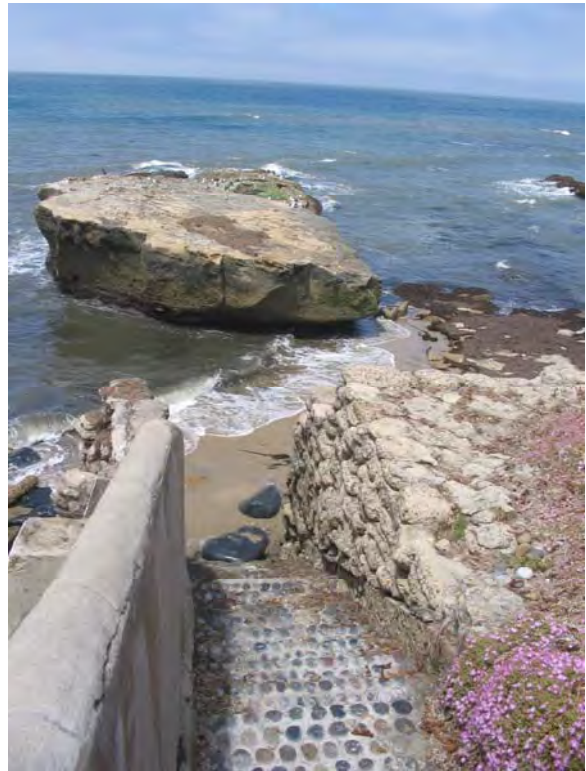
PH30/31: historical steps (1915), ended on sand to walk across to large rock. Now there is a big drop down and no sand along this reach. (Man-made 'swimming' hole in rock)

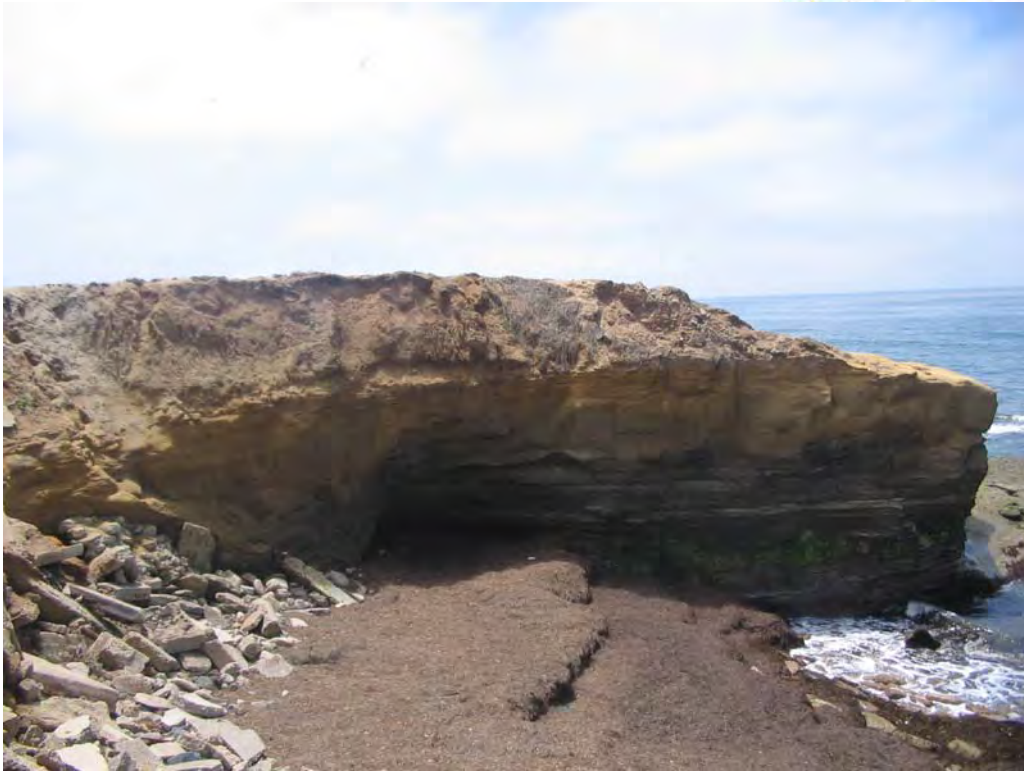
PH32: Construction rubble over bluff.

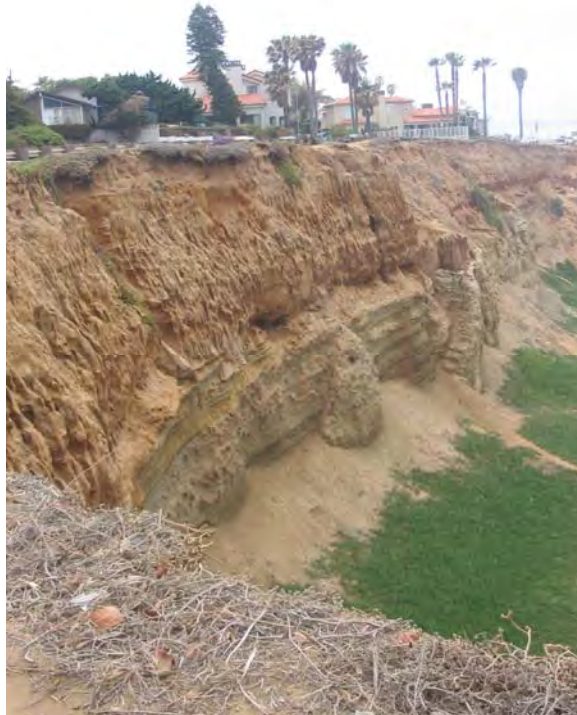
P34: Cordova/Guzot, source of erosion? Bluff top is higher than road, so it is not surface water runoff. Waves rarely reach the base of these cliffs, so it is not wave-induced erosion. Wind? Rodents?

Fill crevices with fill on top of bluff for trail? Probably would need compacted soils → can't grow plants on compacted fill very easily.

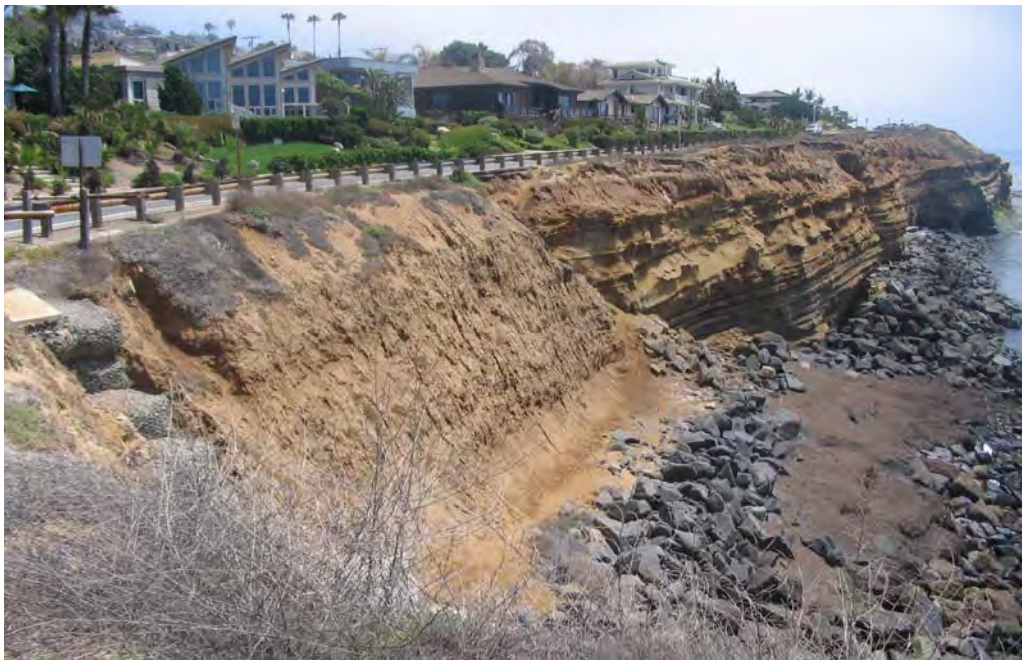
PH35: South of Monaco: No stratification along cliff face; The road was built on cove and filled it with rock and fill. The gabions need to go before they break and spill small rock all over the beach.
