SUNSET CLIFFS NATURAL PARK

Final Drainage Study

**SUNSET CLIFFS NATURAL PARK
DRAINAGE STUDY**

MAY 2012

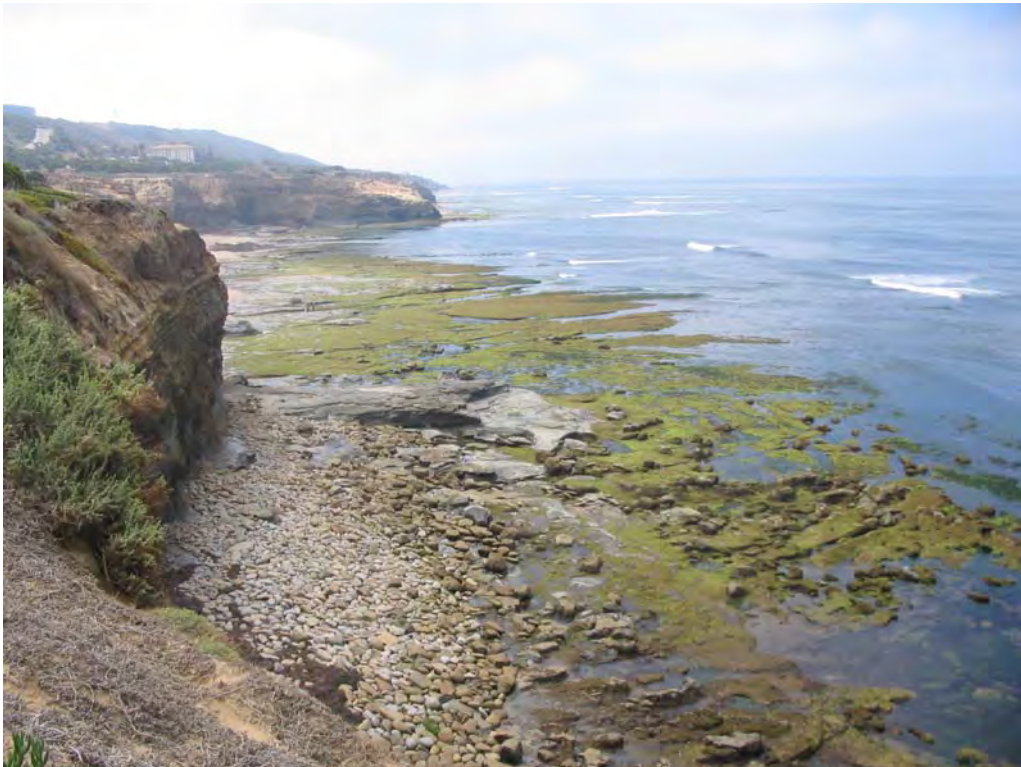
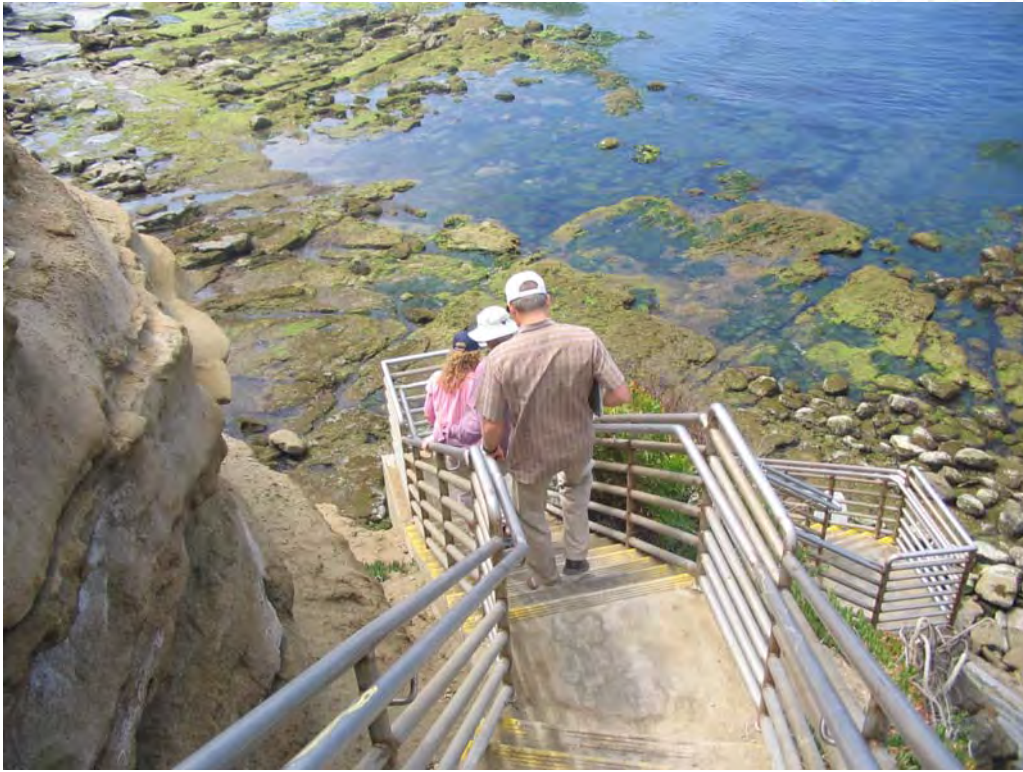
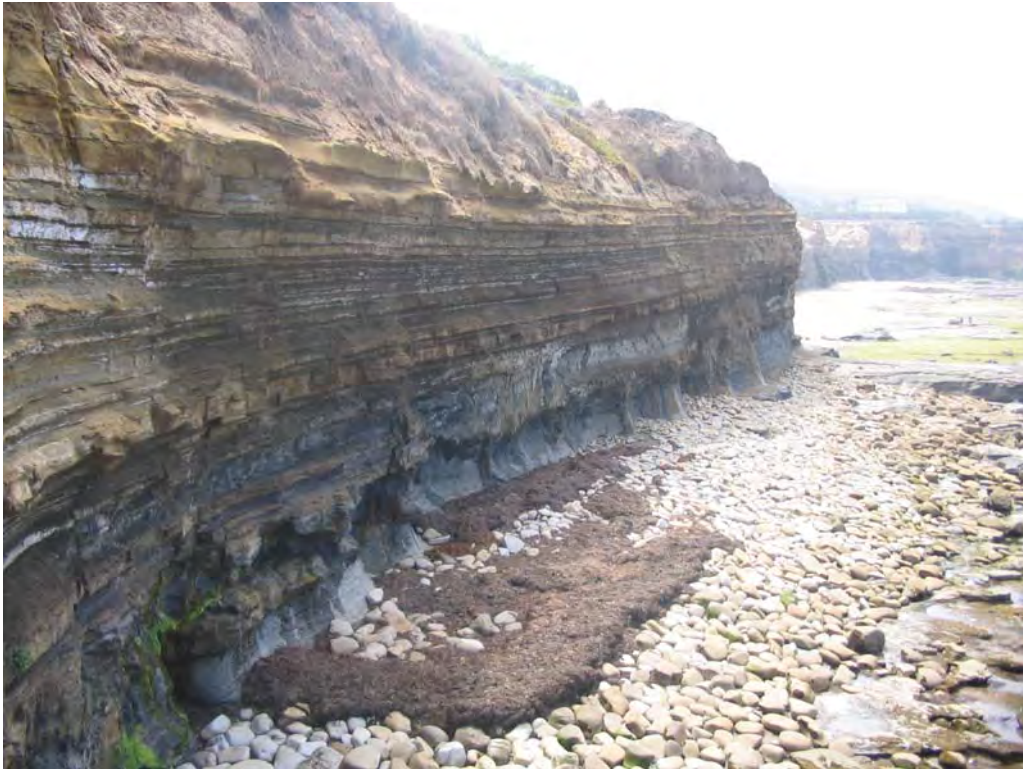
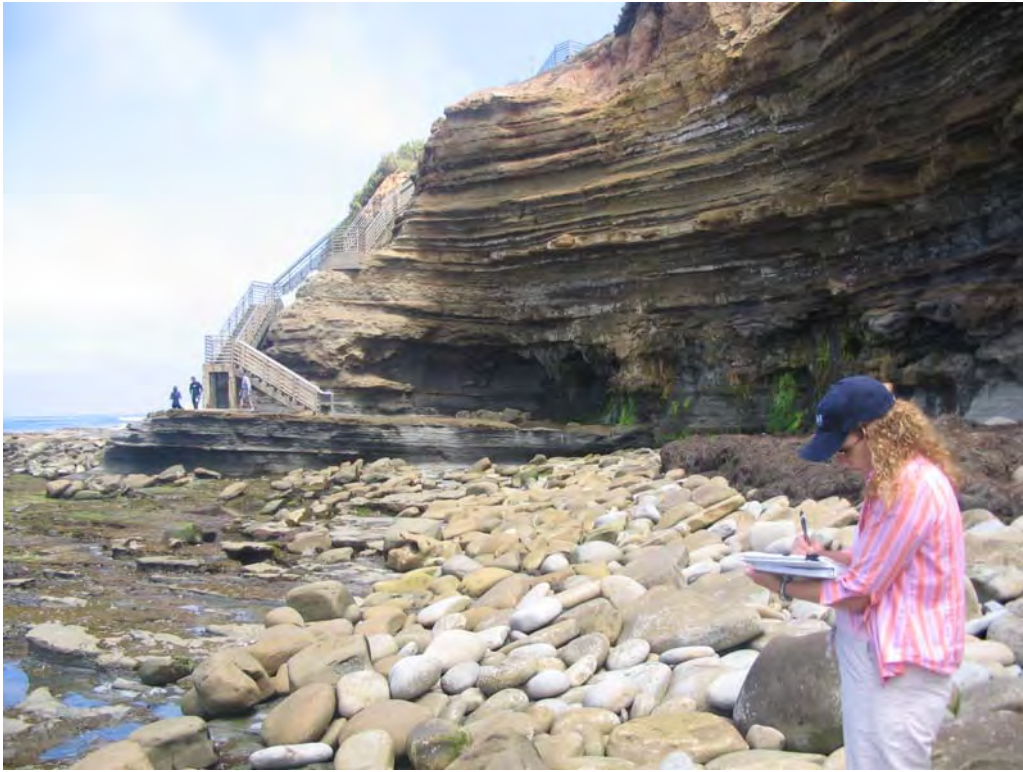
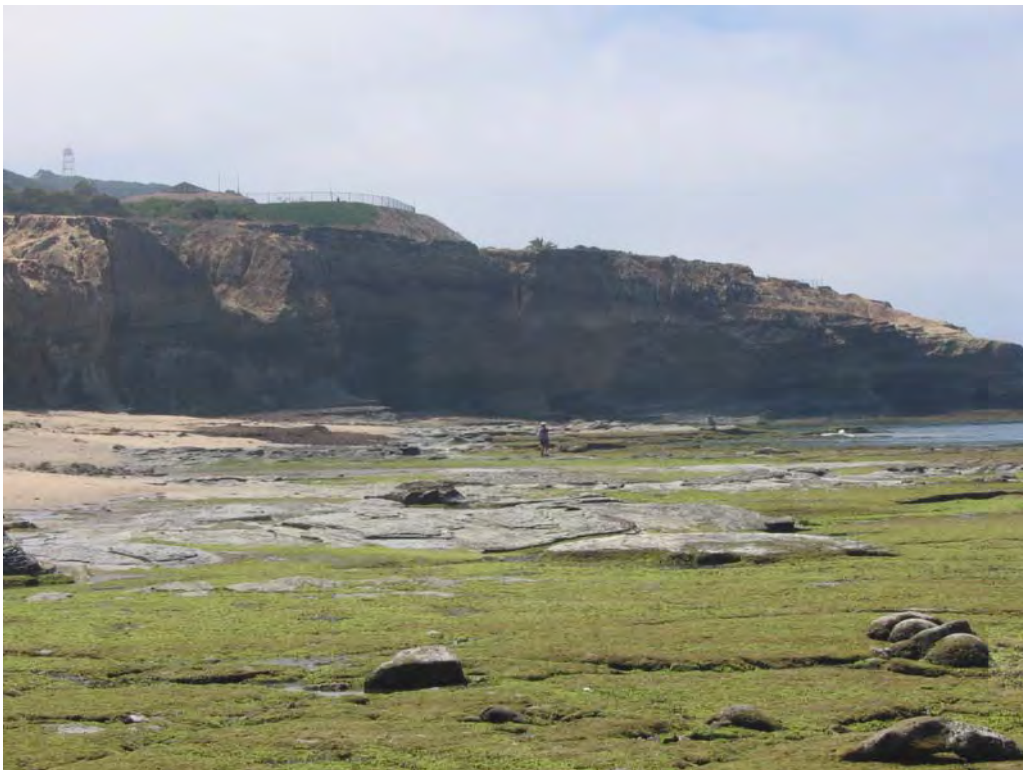
Ladera Street Stairs:

- Storm Drain: shortly after they worked on it in the 1990's, the bluffs collapsed. Coincidence or Cause?
- Cavern forming by the stairs.
- Rocks naturally placed. Not armor
- 1904 maps show a straight shoreline at Garbage Beach (now it is a pocket beach).
- What are the causes of erosion in Garbage Beach; the waves rarely reach bluff face. Runoff from parking lot? Seepage/piping to lower cliff face? Foot traffic? Wind? Incremental wave erosion from when it is exposed?

- Shear face on the bluffs look like they will soon fall.
- Water dripping on lower section of the cliff.
- Sinkhole on upper Park – The City filled it with riprap, and then it sank and disappeared. Was this sinkhole caused by piping? Did this increase the erosion?: riprap settles with the flow of runoff then it is too low to remove it. Does the weight of armor cause/increase failures?
- Are life estates contributing to the problem?

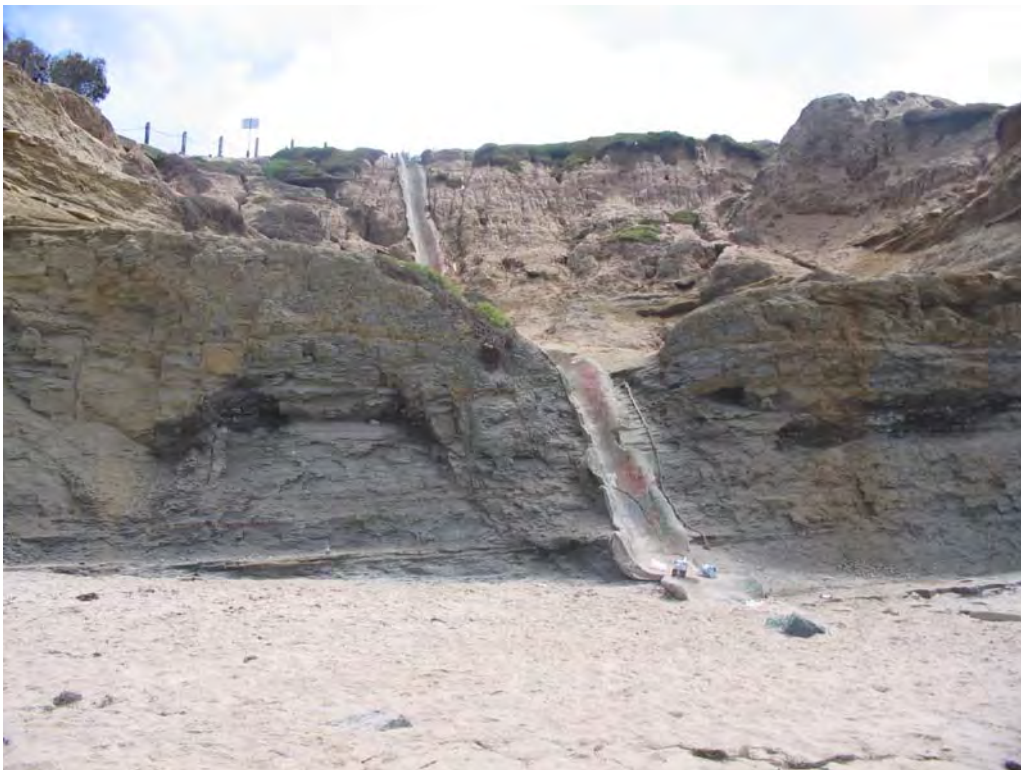
- Public access in mid Garbage Beach near concrete drain. Incorporate public stairs into plan for drainage structure
- This has been used as an Amphitheater area: was it created or used because of its natural configuration?

- University Ball Field on top of cliff is contributing to erosion.

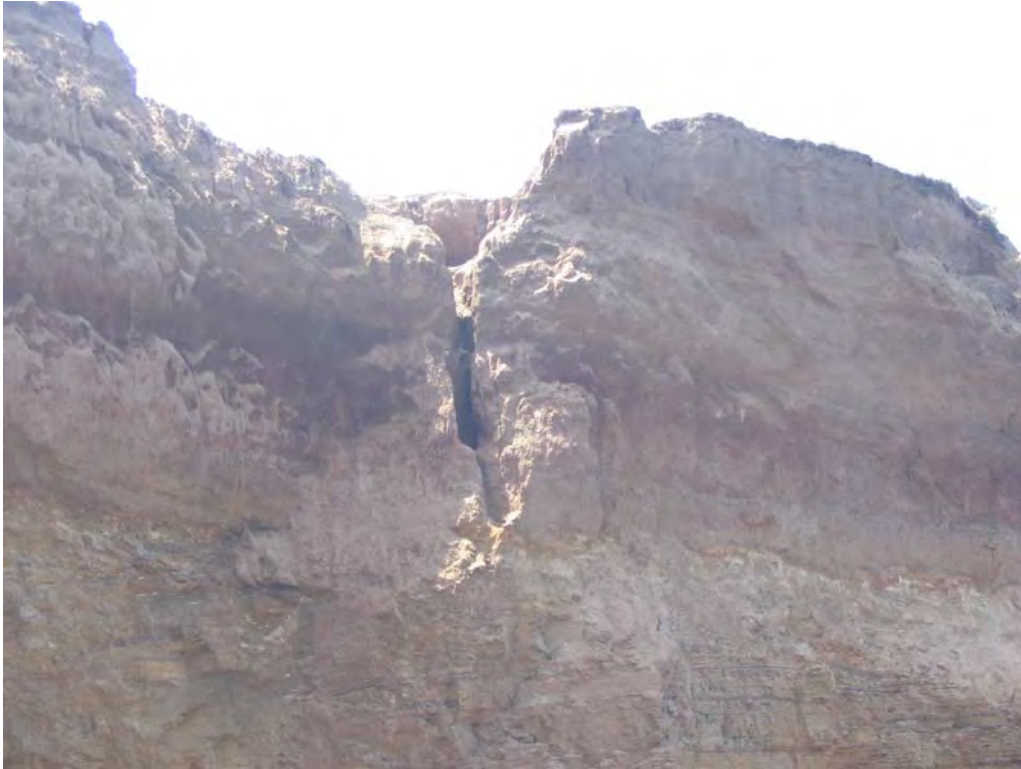
- The pits on the cliffs at the south end of Garbage Beach, are these caused by piping? Or is it another contribution by the ball field/upland irrigation?

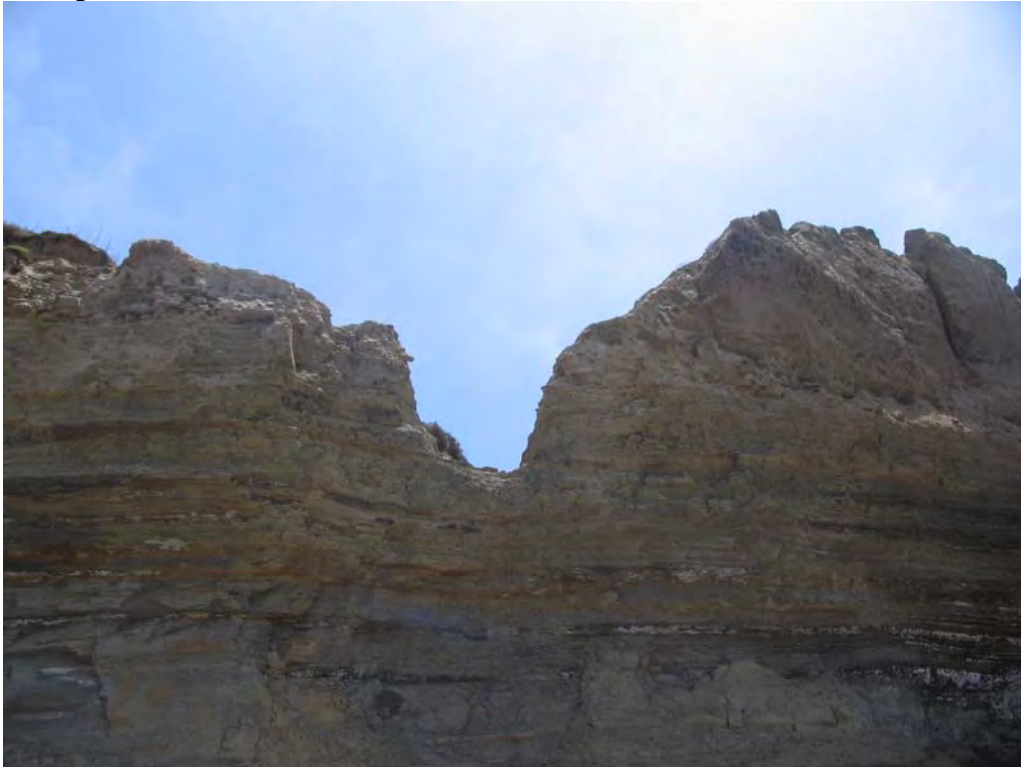
- End of the Grand Canyon: can't get through the lower formation and has completely eroded the upper formation.
- In 1988 there was a massive block fall in the south end of Garbage Beach in the curved area near the end.
- What is causing the caves at the end of Garbage Beach? Waves rarely reach here. Could be slow process only occurring during high tides/storm conditions.

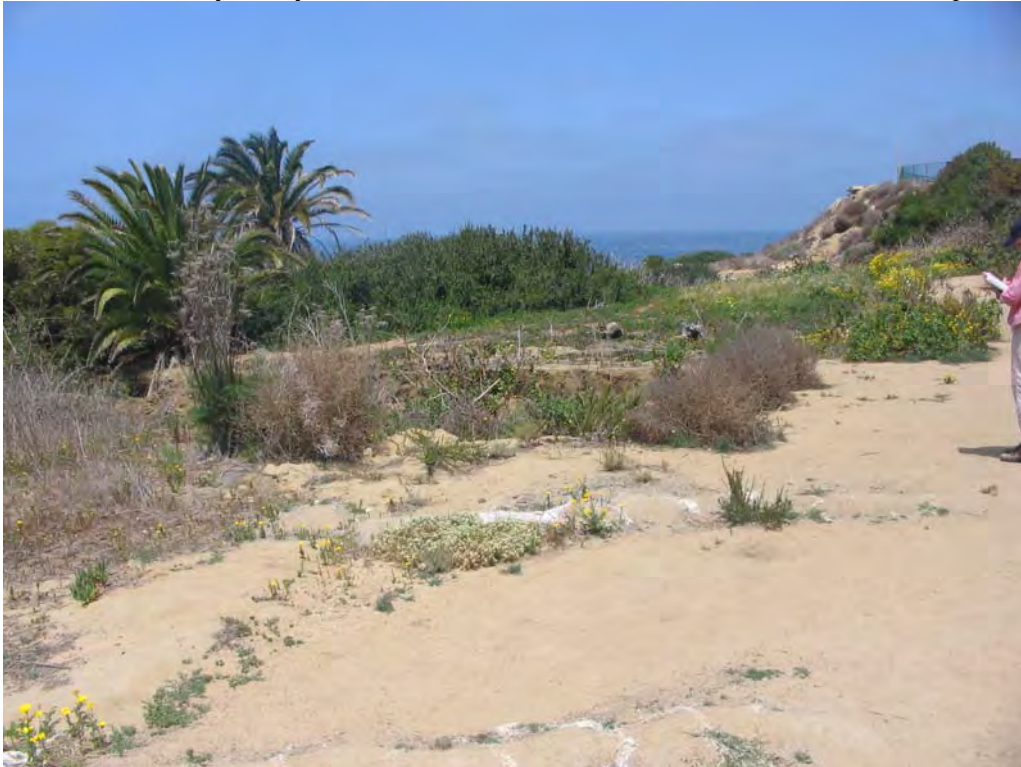
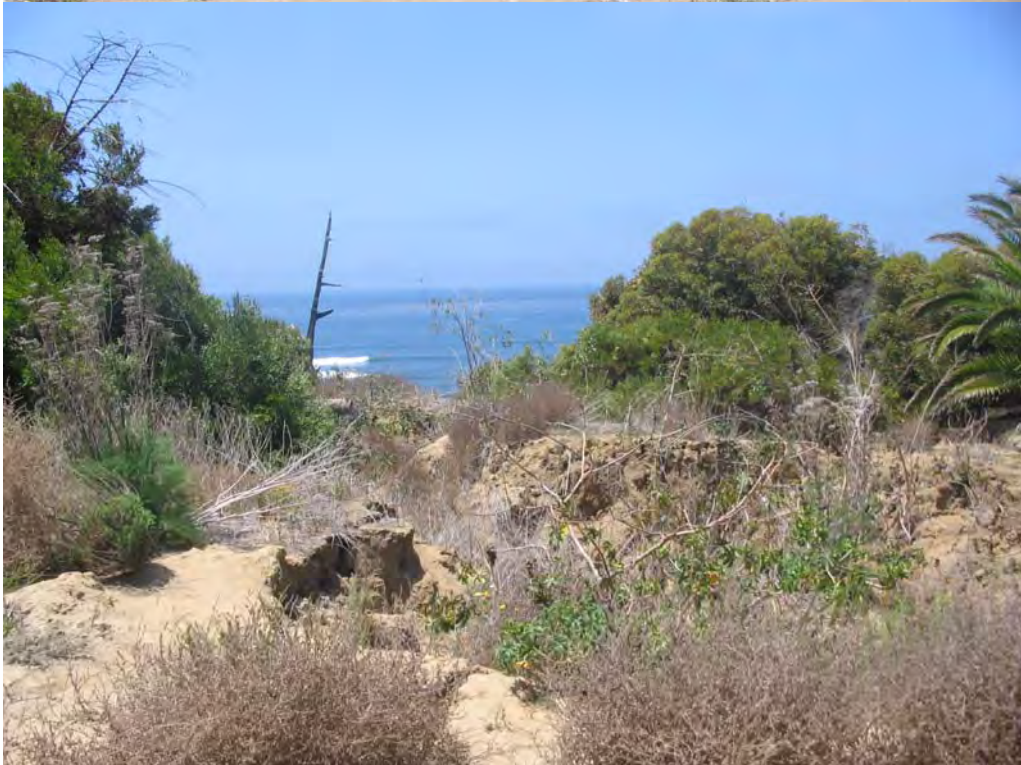
- Surface erosion is coming close to the affluent line. (Sink area to the left of the top photo above)
- Major increase in the surface erosion over the last 10 years.
- Sink area: surface runoff. Used fiberglass sandbags by Young Hall Parking lot.
 - a. Subterranean seepage? What causes this? Rodent hole causes a spot for water to seep in and through under and top layers.
 - b. Soil is too hard for seepage through it without a way in (rodent hole)

- c. Coyotes present.
- d. Rodent control.

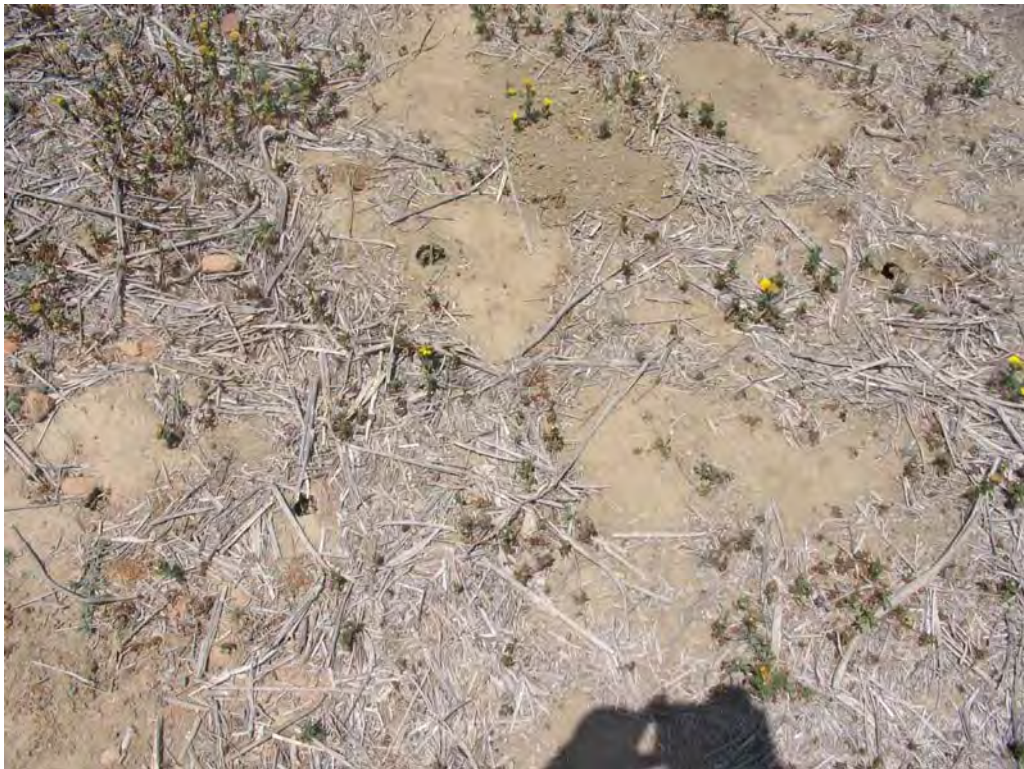
Shows extent of rodent burrows

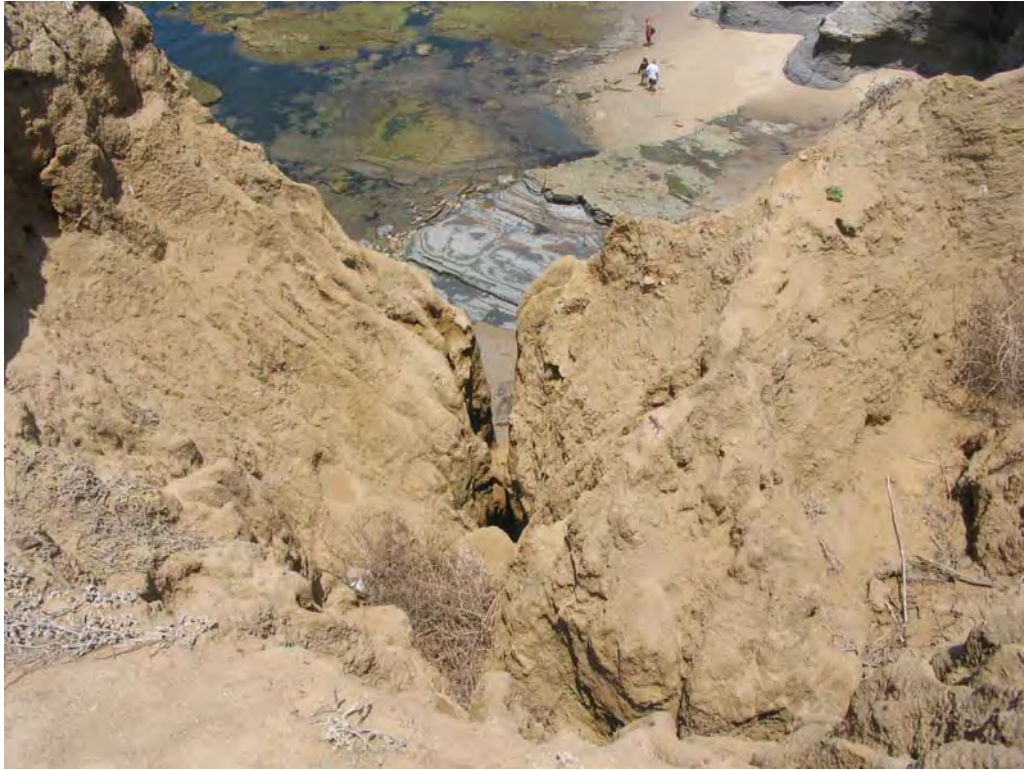
Top of “V” that is shown in previous pictures from Garbage beach. This has eroded significantly over the last 5 years.

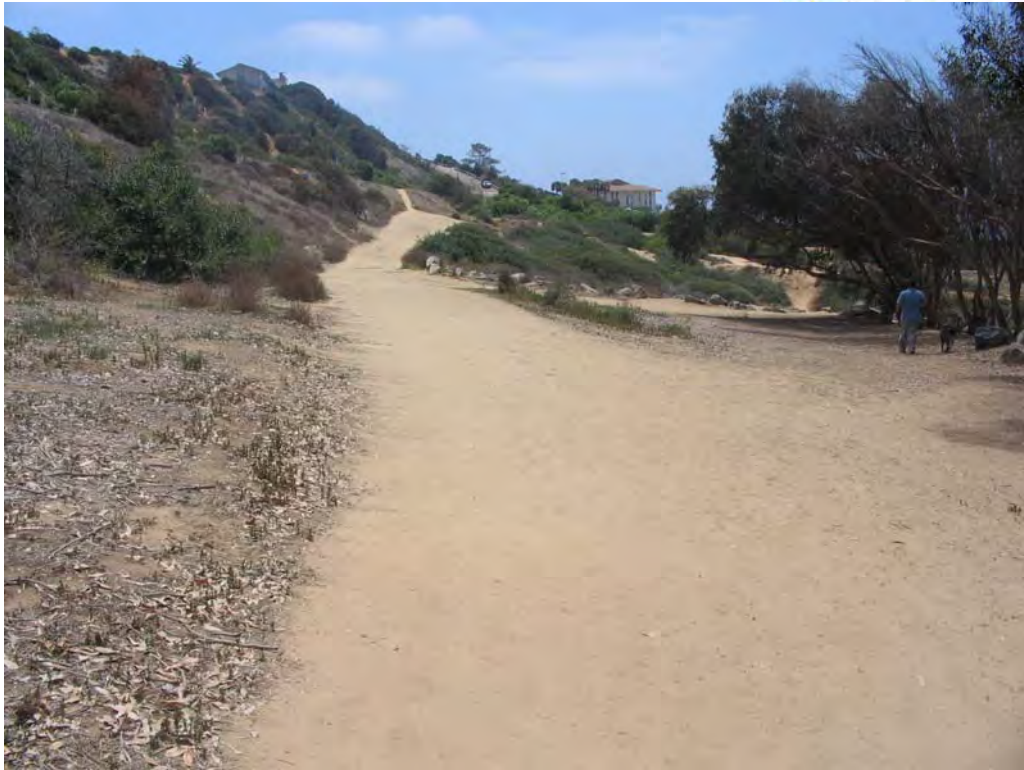
Easement for the City's Wastewater Effluent line. Use this as the ADA path.

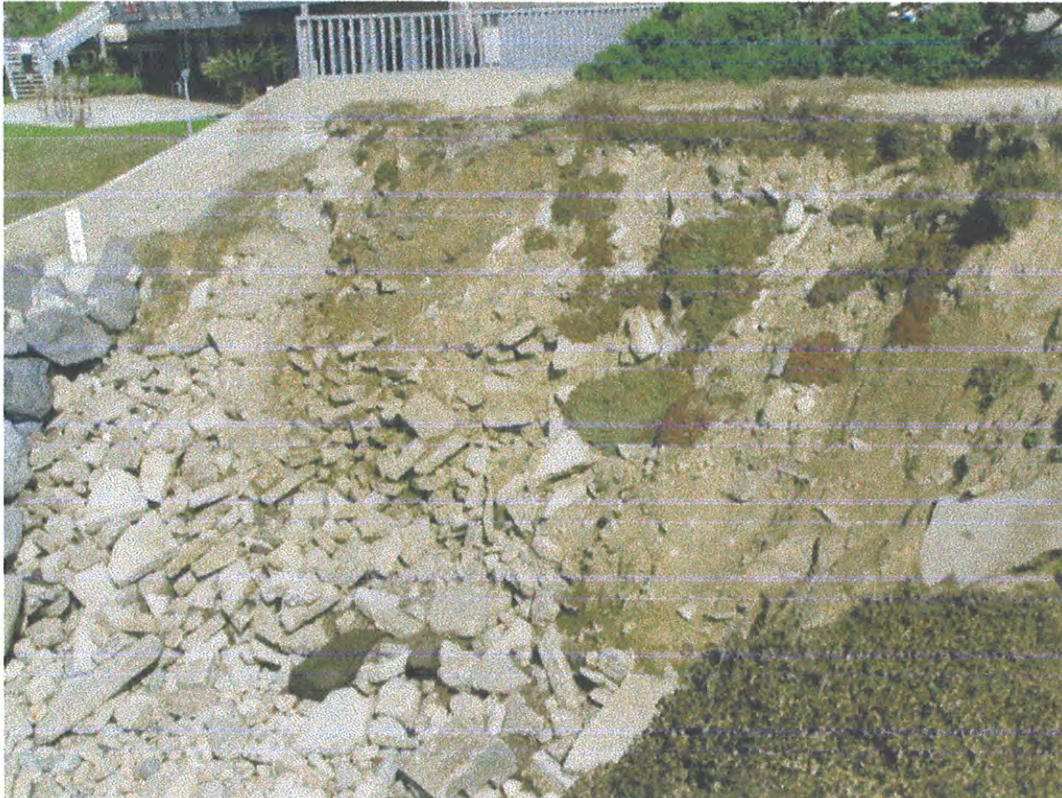
Location 1 (see Northern Linear Park map)

Condition: Subaerial erosion of fill material is due to run off from the soil above it that has been compacted by pedestrian traffic. Lack of erosion control measures, such as revegetation to increase the permeability of the soil to water and not sloping the soil towards Sunset Cliffs Boulevard, is creating runoff degradation and contamination of adjacent nearshore waters. Marine erosion is also eroding the toe of this material in the figure below and contributes to nearshore water contamination.

Recommendation: Revegetation, sloping the soil towards Sunset Cliffs Boulevard so it doesn't erode seaward structures such as seawalls, and trail construction and maintenance using standard methods to prevent erosion are needed.

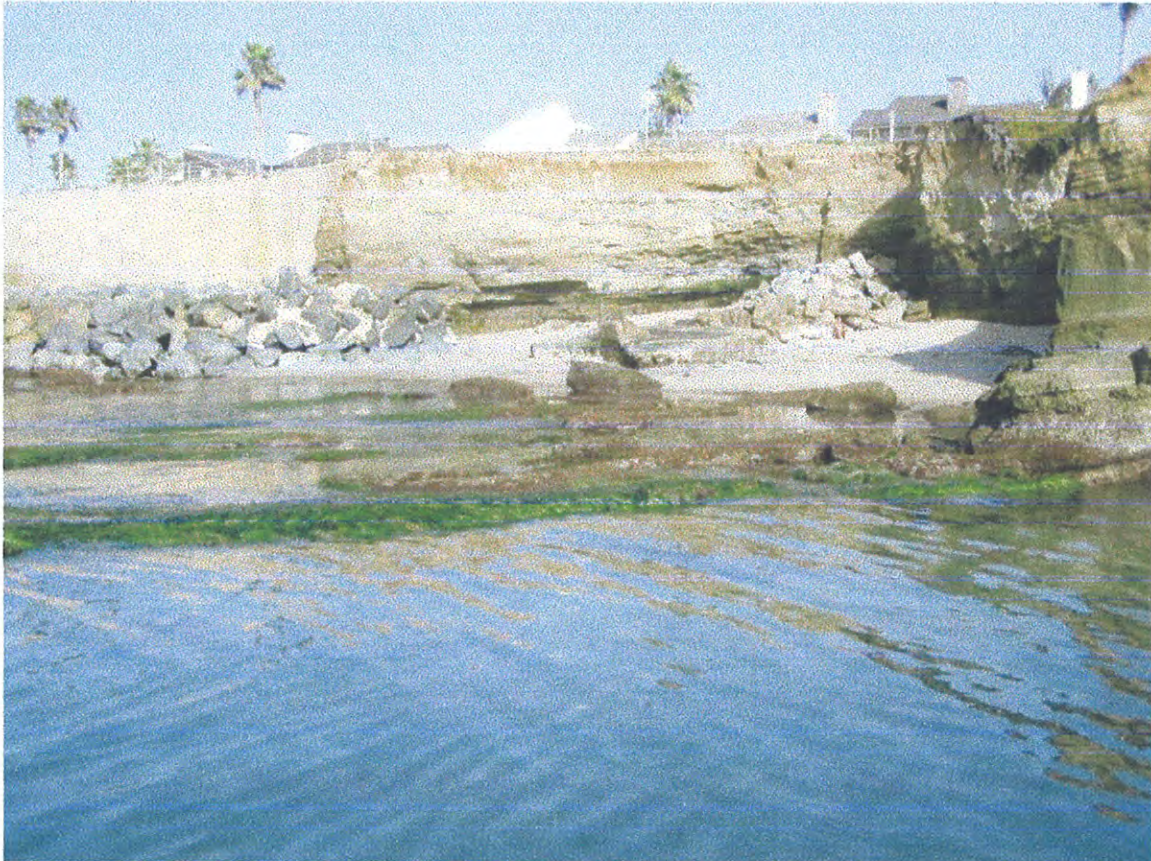
Location 2 (see Northern Linear Park map)

Condition: Marine, subterranean seepage, and subaerial erosion are all threatening both Sunset Cliffs Blvd., and the north wall of the cove that is just south of the Adair Street Seawall. If the north wall of the cove fails, the filled material behind the seawall will be exposed and expensive emergency repairs will be needed. Erosion problems at this site are discussed in an August 31, 2001 Moffett and Nichol report [5] that covers environmental, permitting, construction, and cost issues.

Recommendation: Review the seven alternatives described in the Moffatt & Nichol report as part of Task 3. The seven alternatives the report presented included: no project, beach nourishment, nearshore reef, perched reef, two tie-back wall alternatives, and a revetment. The Sunset Cliffs Natural Park Recreation Council (SCNPRC) on April 7, 2003 recommended that a tie-back retaining/seawall be constructed to prevent further surface water slumping and long-term marine erosion at Location 2 in a manner that conforms to the criteria established in the SCNPRC Erosion Committee April 7, 2003 recommendations.

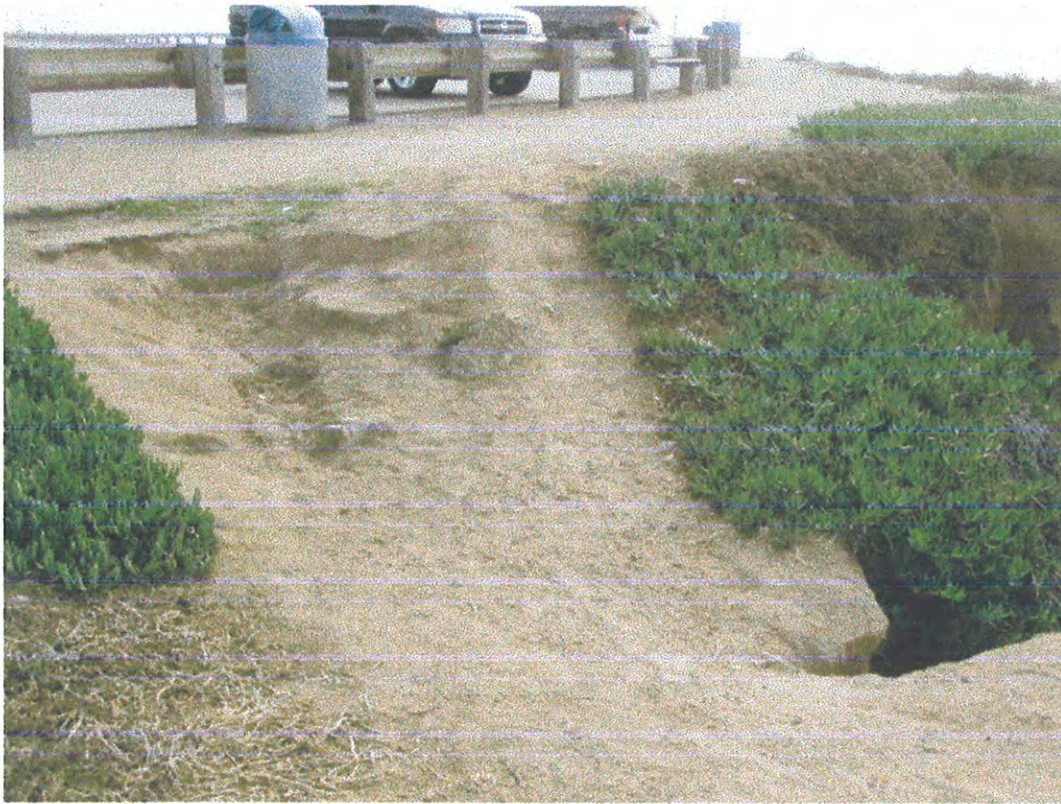
Location 3 (see Northern Linear Park map)

Condition: Runoff from Parking Lot # 1 and areas of compacted soil and paving around it are responsible for erosion and piping that is destroying the cliffs, causing a safety hazard, and is contaminating the adjacent nearshore water with fine grained material that increases turbidity above natural levels.

Recommendation: Install curbs around the parking lot to insure that all water from it drains towards Sunset Cliffs Boulevard. Scarify the soil and plant native vegetation on it to increase it's permeability and minimize seaward runoff.

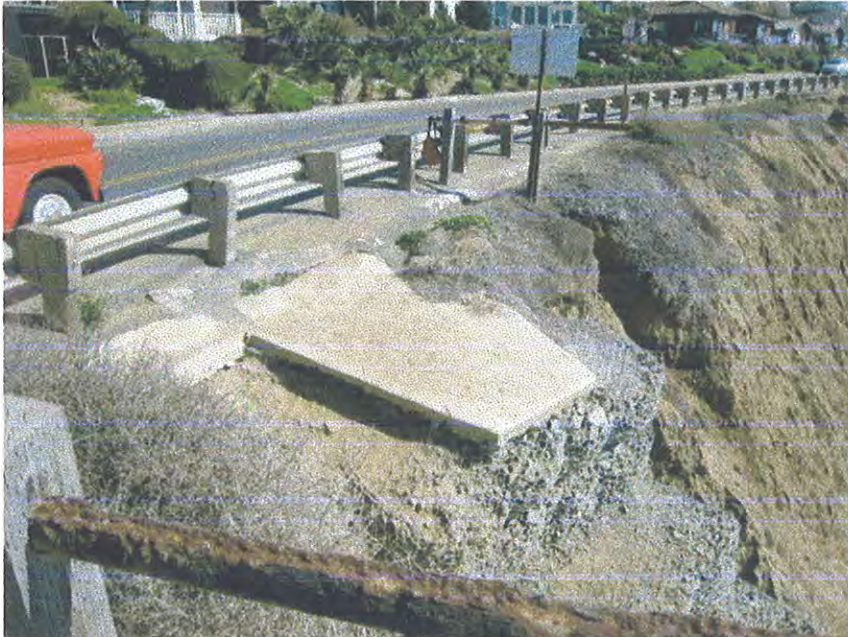
Location 11 (see Southern Linear Park map)

Condition: Rick Engineering lists Location 11 shown below as Outlet 5 which they describe: “This outlet consists of a concrete spillway that discharges over the cliff onto gabion slope protection. Approximately 2.2 acres are tributary to Outlet 5.” Observations of the concrete spillway and gabion structures indicate there is bypass around the spillway due to settling in the area causing cracking of the concrete. Also, there is bypass around the gabion based on erosion of the cliffs adjacent to the gabion. The draft DUDEK Report calculates that the concrete spillway is capable of handling 5.3 cfs and that of the 22 cfs of flow generated within the basin tributary to it, only 4 cfs reaches it because most of the runoff that would otherwise reach it “- - - will flow over the berm and cliff” in Drainage Basin C2 unless the curbs along the west side of Sunset Cliffs for Location 12 are built up. Because building up the curbs along Sunset Cliffs as described below for Location 12 would direct flows to the spillway at Location 11 that it can’t handle, fixes for the runoff conditions at Locations 11 and 12 need to be considered together.

Recommendation: Conduct detailed flow studies for Locations 11 and 12 to determine the size of a storm drain that would be needed to replace the concrete spillway and gabion protection device at Location 11. Alternatively, perhaps the road could be built up along the west side so water bypasses the spillway discharge and runs to the storm drain at the end of Monaco street. The discrepancy of the capacity of the Monaco Street storm drain being at or near capacity based on the Rick Engineering Report, and over capacity in the DUDEK Report, needs to be resolved before any action is taken.

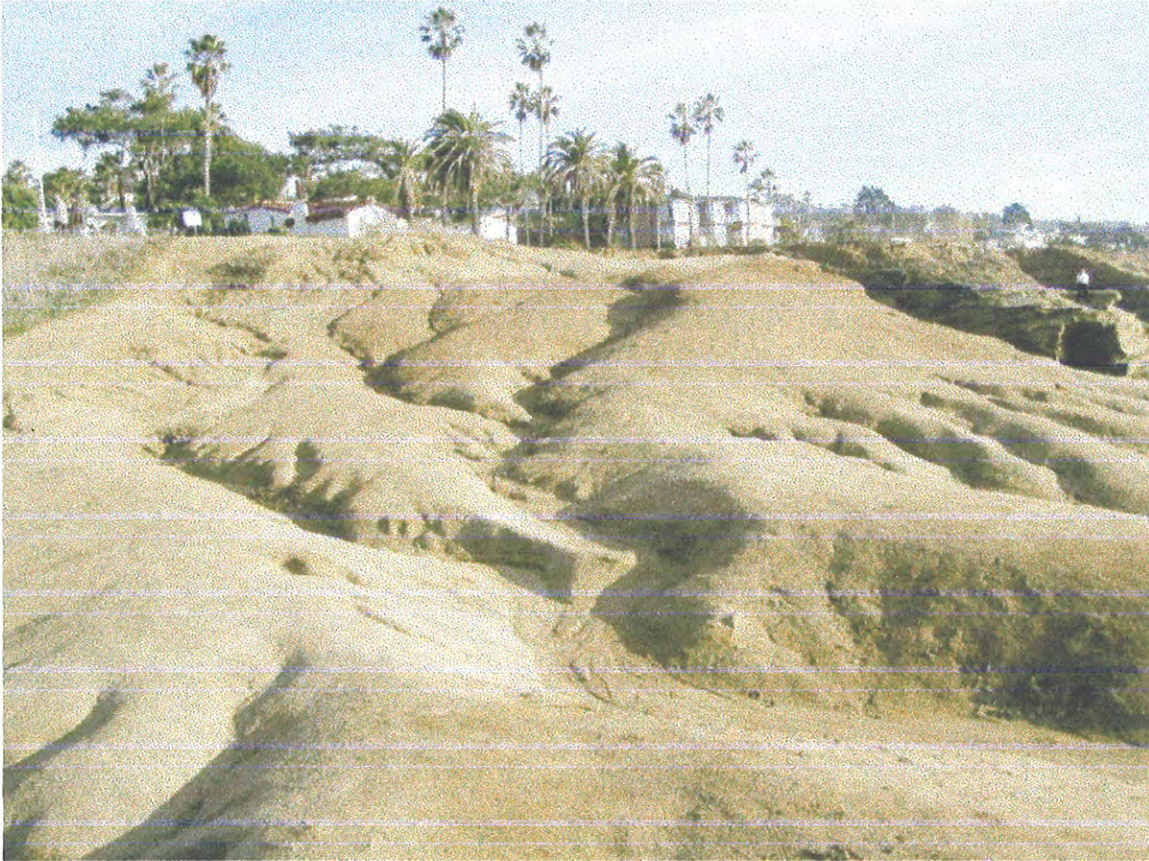
Location 10 (see Southern Linear Park map)

Condition: Heavy pedestrian traffic has compacted the Luscomb's Point (Location 10), soil, and the runoff from this compacted soil has caused extensive erosion rills to form. Silt from the eroded soil is increasing the turbidity in adjacent nearshore waters.

Recommendation: Trails designed to minimize runoff, and revegetation, are both needed to prevent the erosion and contamination of nearshore waters.

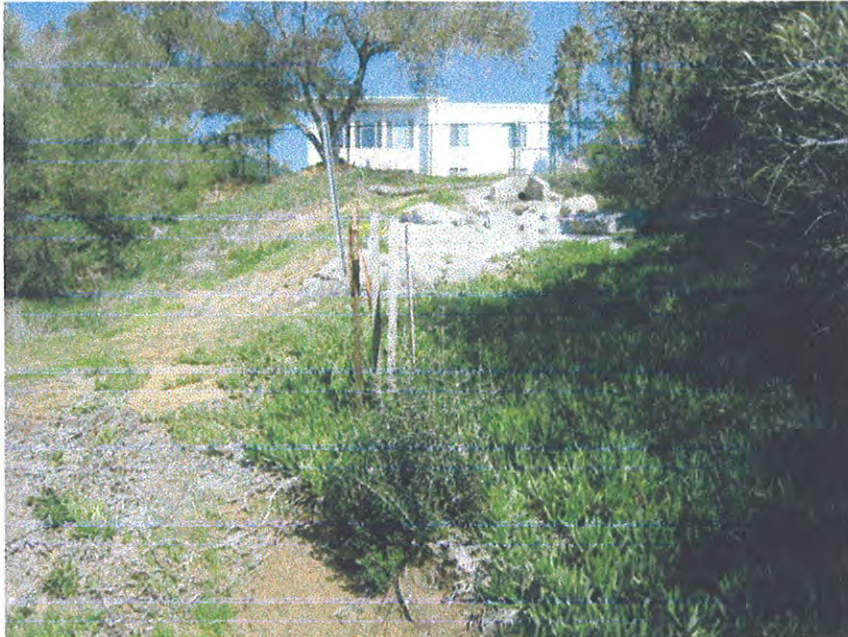
Hillside Park Watercourse A (see Hillside Park map)

Condition: Watercourse A (Location 29) is a 24 inch diameter pipe that receives runoff from the most northerly portion of the Hillside Park, and then conveys it to a driveway off Cornish Drive. The runoff from Location 29 is generated by the surfaces of the land in Drainage Basin D2 [2], and point source discharges from PLNU storm drain outfalls such as those shown in the pictures below, and PLNU parking lots.

Recommendation: Monitor runoff discharges into Basin D2 from the PLNU storm drain system for erosion, and where possible direct the runoff away from Watercourse A by either storing it on the PLNU campus for use in irrigation, or piping it to the nearby brow drainage system ditch that runs along the PLNU west property line in the vicinity of Goodwin Dormitories, and discharges down Monaco Street.

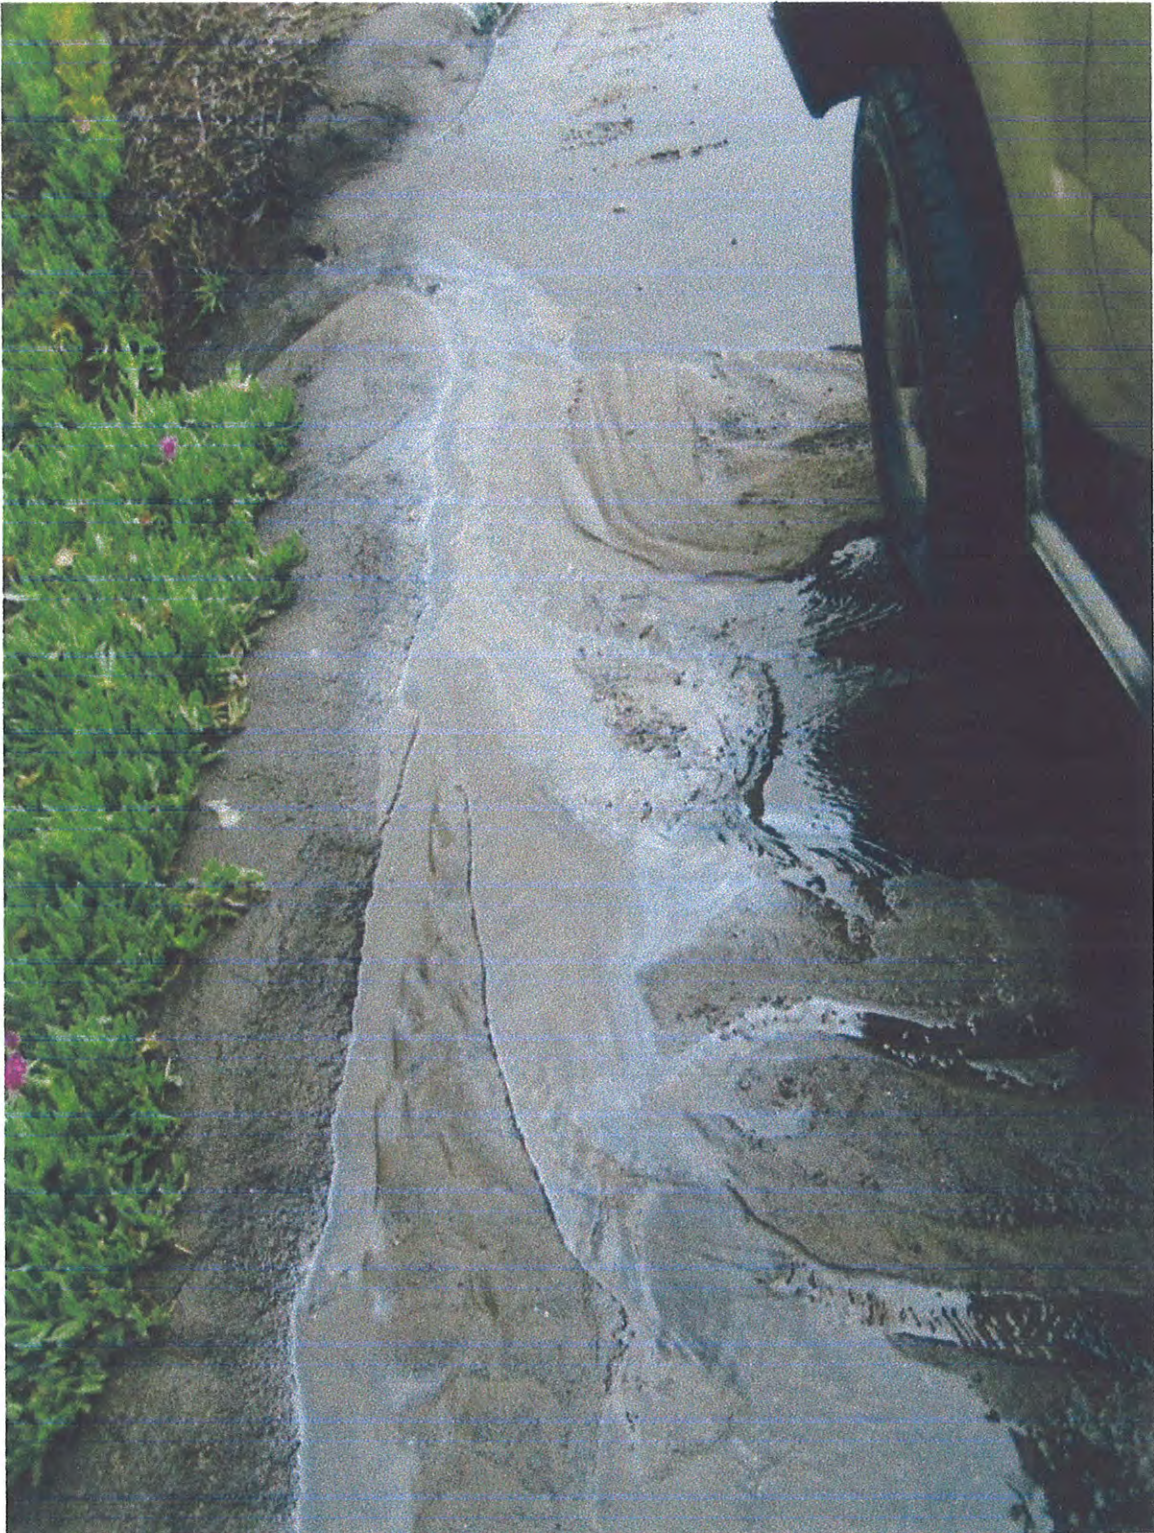
Hillside Park Watercourse D (see Hillside Park map)

Condition: Watercourse D in Drainage Basin J originates at the spillway shown below in the northwest corner of the Upper Parking Lot. A clearly eroded watercourse can be traced from the vicinity of the parking lot spillway shown in the picture below, where dense vegetation makes determining exact watercourses very difficult, to the sludge line trail where the water spreads out before it travels down the slope without any major erosion until it reaches the badly eroded area where rocks have been displaced at Location 18. The clearly visible sheen on the runoff before it discharges from the Upper Parking Lot and into Watercourse D indicates the Park is receiving contamination from this runoff when it rains.

Recommendation: The runoff from the Upper Parking Lot should be captured by a surge dam or tank where it leaves the parking lot spillway, treated to remove contaminants, and

then either discharged down slope at a rate that will not cause erosion or channeled to infrastructure that discharges to a storm drain. With the constraints noted for Location 14 to prevent overflows of the storm drain structure at the corner of Ladera Street and Sunset Cliffs Blvd., runoff could be disposed of there along with flows from other watercourses to storm drain infrastructure that terminates at Location 14. Alternatively, flows from Watercours D could be diverted to the treatment and ocean disposal outfall that will be needed to handle runoff from the PLNU drainage system that drains Drainage Basin M2.

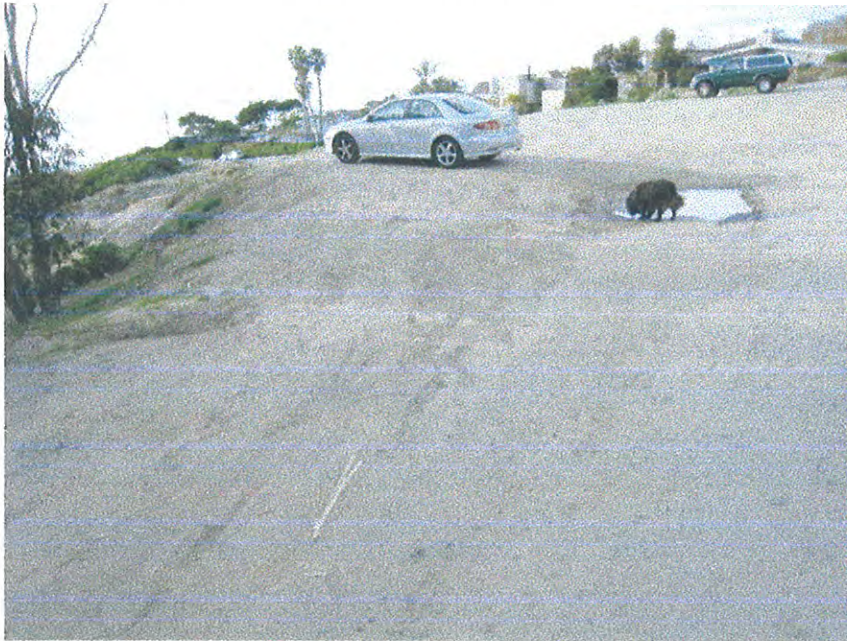
Hillside Park Watercourse I (see Hillside Park map)

Condition: Runoff from the access road to the Park's Lower Parking Lot and the compacted soil parking area shown in the picture below have resulted in the formation of Watercourse I. I runs along the northern edge of the *Eucalyptus* before it runs over the edge of the canyon that is just south of Ladera Street, and then joins the anatomizing minor watercourses where the canyon terminates at the edge of the cliff.

Recommendation: Watercourse I runoff should be channeled to the storm drain at Location 17 along with the runoff from Watercourse C.

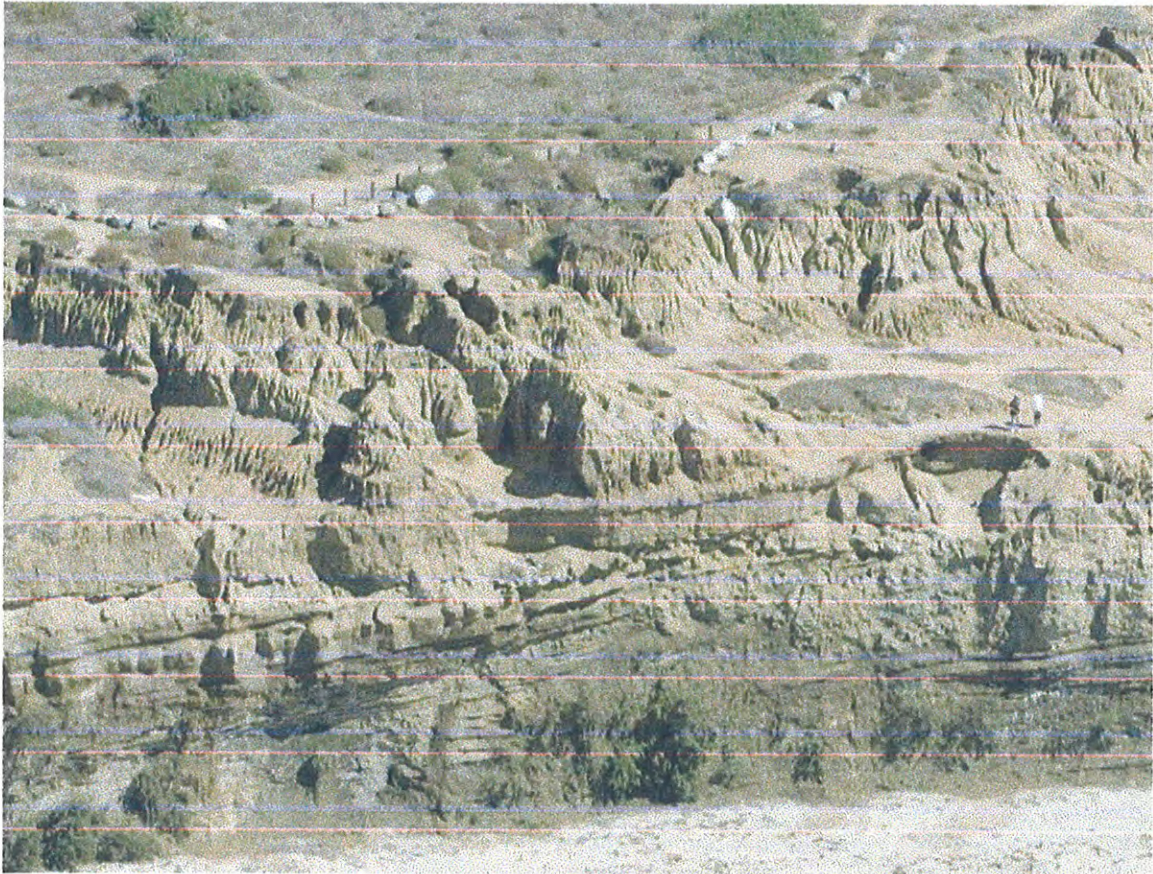
Location 18 (see Hillside Park map)

Condition: The major erosion shown in the photograph is the result of Location 18 receiving runoff from Watercourses D and E. An appreciation for the dynamics of the erosion degradation near Location L can be gained by viewing how much the trail boulders in this area, that were put in place during the early 1990s, have been undercut and moved down slope.

Recommendation: Minimize the runoff from Watercourses D and E following SCA recommendations provided for them. Remaining runoff flowing to Location 18 within Drainage Basin J, and maybe the north part of Basin K, should be controlled with spreading and revegetation.

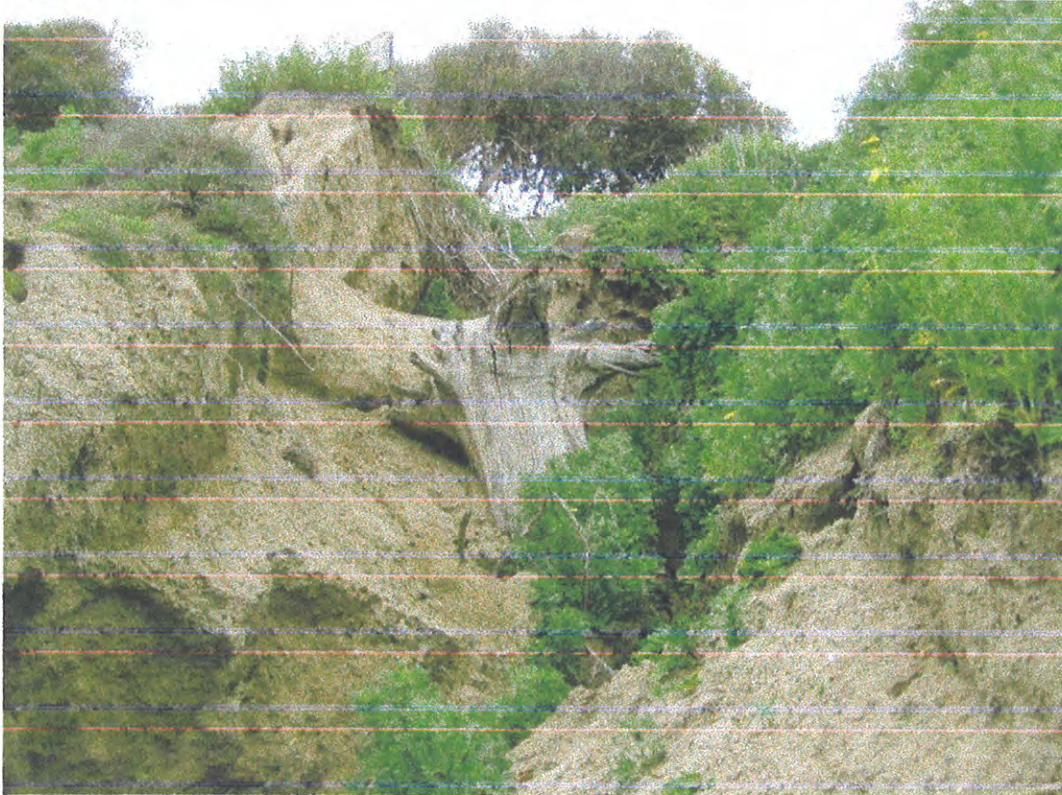
Location 20 (see Hillside Park map)

Condition: Location 19 is a large sinkhole at head of a 10 foot, or more, deep erosion gully that is part of major erosion feature that is called “The Badlands” in the Park Master Plan. Boulders have been placed into the sinkhole to keep it from eroding further to the east, but the erosion gully shown in the photograph below is still getting deeper and more extensive.

Recommendation: After repairing the curbs on the Western Loop Road and properly channeling the runoff from the road itself and the runoff from the 18 inch diameter storm drain at location 28 is properly directed so it doesn't flow down Water Course E, use water spreading and revegetation to minimize runoff that reaches location 20.
