SUNSET CLIFFS NATURAL PARK

Final Drainage Study

**SUNSET CLIFFS NATURAL PARK
DRAINAGE STUDY**

MAY 2012

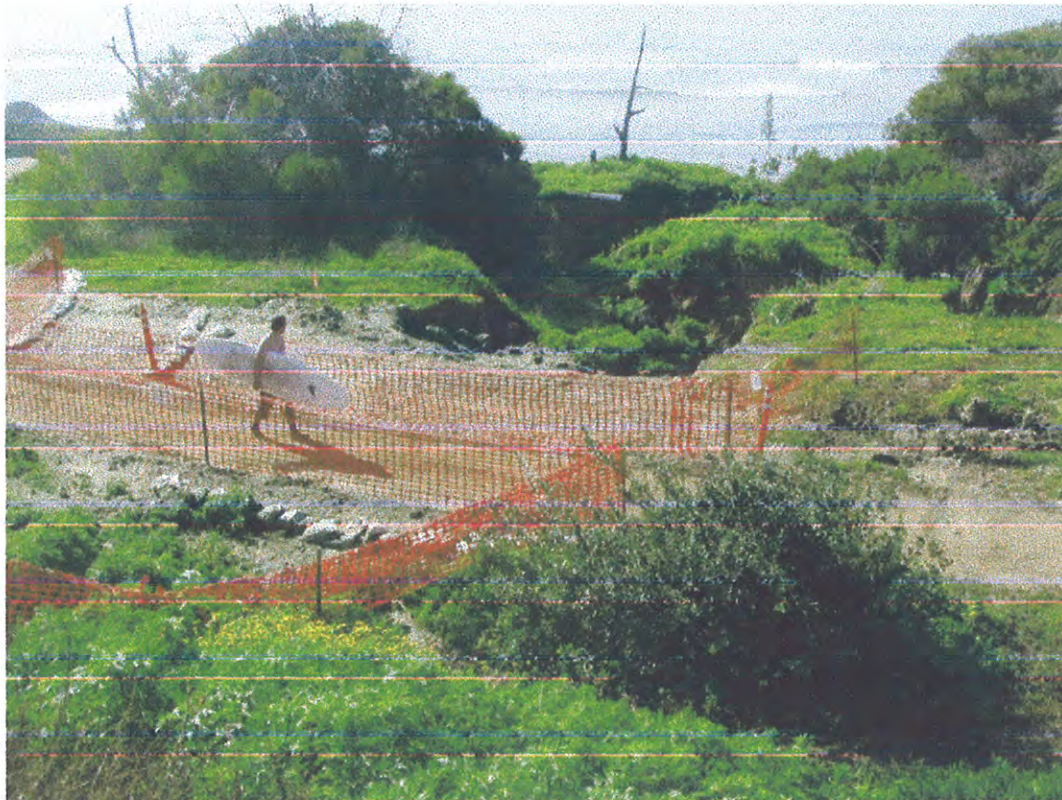
Location 23 (see Hillside Park map)

Condition: Location 23 is at the northwest corner of the lower parking lot for the Young Hall dormitory, where there was drainage spillway that is now in total disrepair and undermining the parking lot pavement. Runoff from both the upper and lower Young Hall parking lots is channeled to Location 23. Through temporary measures by PLNU, Location 23 runoff it is kept from destroying the major north-south trail (shown in the picture below) that provides access to the Ab Reef access location (Location 25). These temporary measures also protect the 23 mile long sludge line that connects the Point Loma wastewater treatment plant with sludge processing facilities near the Miramar Marine Corp Air Station. Location 23 runoff is a major cause of erosion degradation below the Young Hall parking lots.

Recommendation: Direct the Location 23 runoff into the drainage system that is used to dispose of runoff from Basin M2 for the PLNU campus.

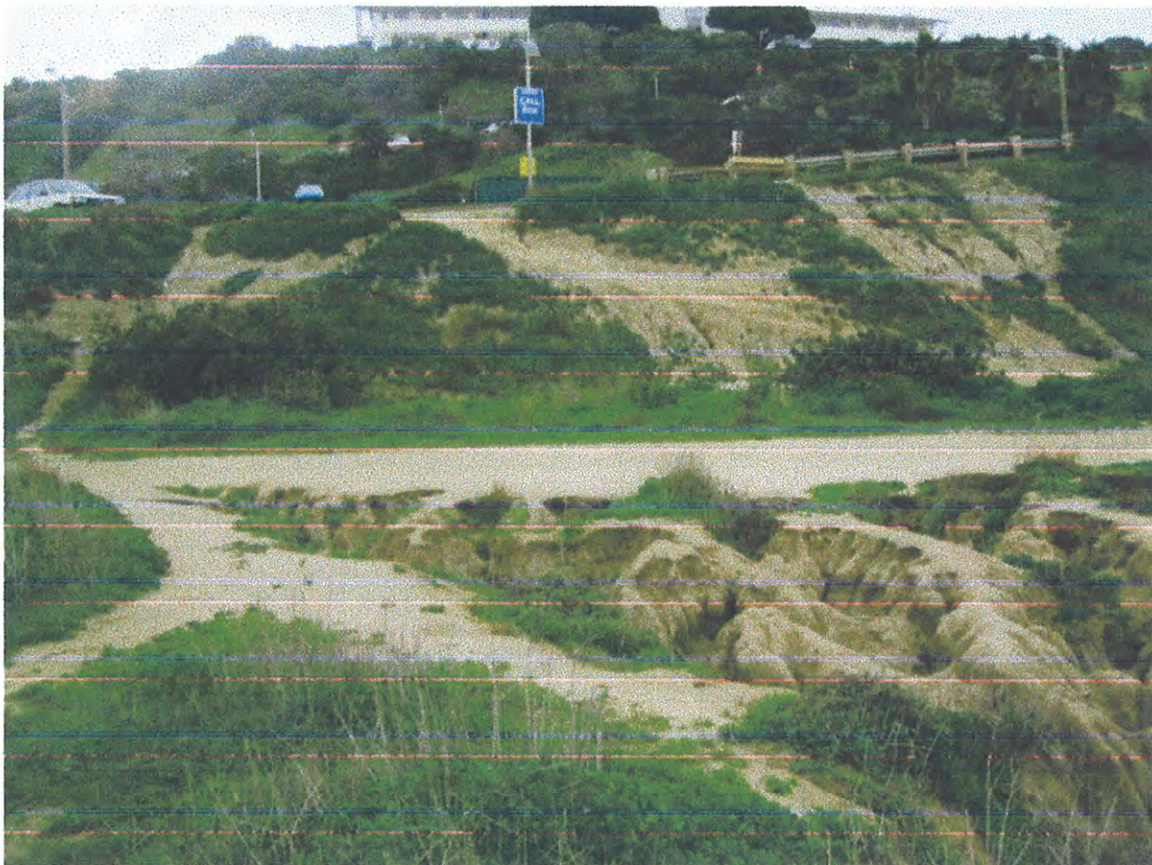
Location 24 (see Hillside Park map)

Condition: There seem to be several sources of runoff at Location 24 that are contributing to the erosion feature shown in the picture below that almost cut through the major north-south trail that is shown in the photograph below just below the toe of the embankment. It is not clear which source contributes the most. These sources include: the compacted soil of trails in the area, runoff coming down areas without vegetation on the Lower Parking Lot embankment, the trail that many use to traverse the embankment from the lower parking lot to the Ab Reef access trail, and parking lot runoff along the western curb that may jump the curb during periods of heavy rainfall.

Recommendation: Improve and maintain the trail from the parking lot so it doesn't generate runoff, and revegetate the area around Location 24 so it maximizes rainfall absorption.

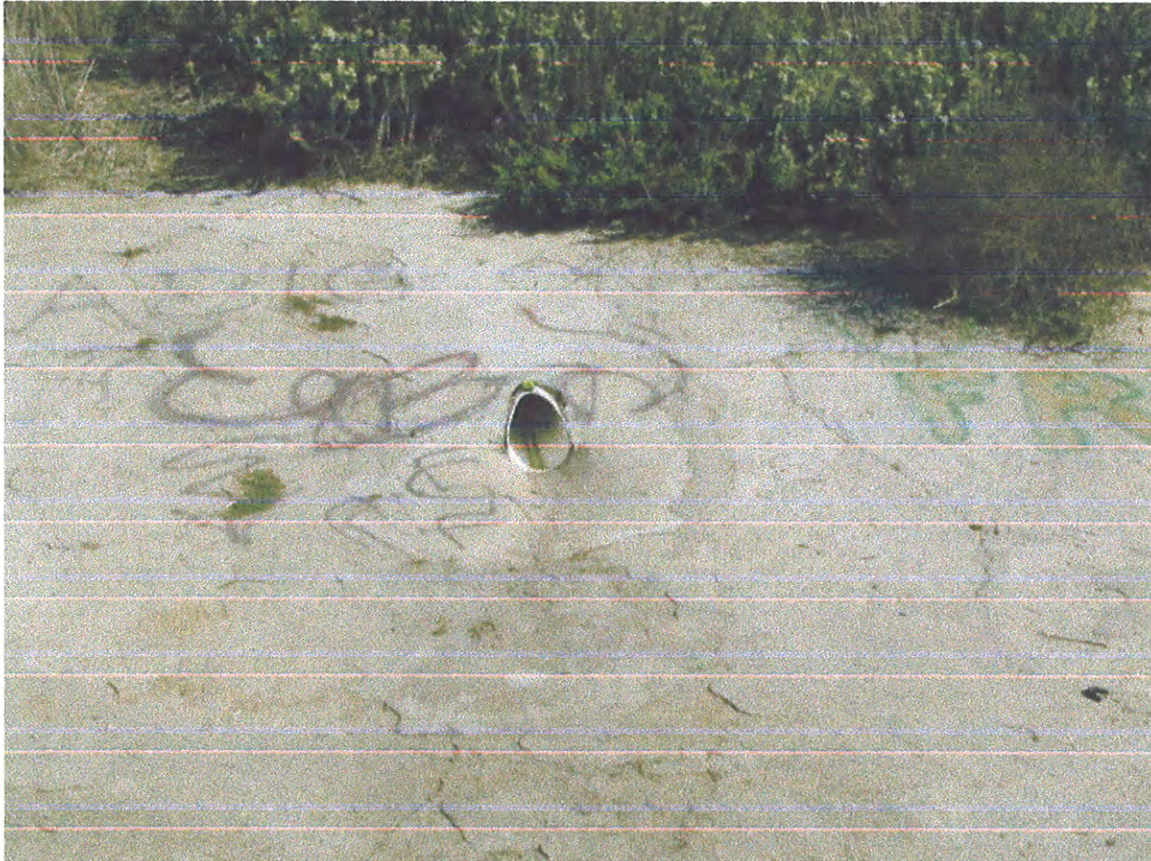
Location 26 (see Hillside Park map)

Condition: Location 26 is a 10 inch diameter outfall pipe that drains the southern area of Drainage Basin M2 in the vicinity of the PLNU track and soccer field, and discharges into the catch basin that is just upstream of the Arizona crossing with the culvert that is at the head of Watercourse G that includes Culvert Canyon.

Recommendation: Flows from this outfall should be directed into the Hillside Park drainage system for ocean disposal of runoff along with runoff from: Drainage Basin M2, Young Hall Parking lots, and other drainage basins and locations in the Park.

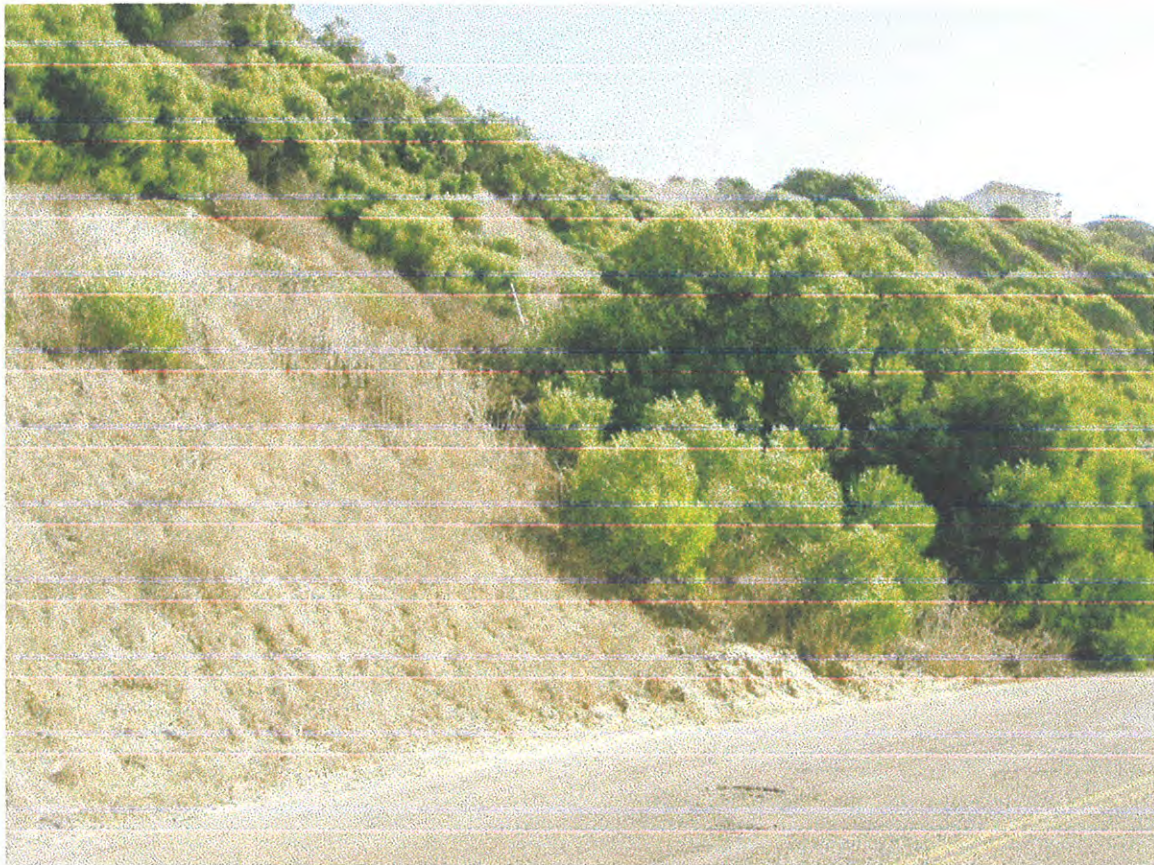
During periods of heavy rain, the 24 inch diameter outfall pipe, that is located where the white piece of pipe can be seen in the picture below, discharges over the pond and into the non-native shrubbery below that should be removed per the Master Plan.

Recommendation: Flows from the outfall at Location 27 should be directed into the Park drainage system for ocean disposal along with runoff from drainage Basin M2, Young Hall Parking lots, and other drainage basins and locations in the Park. Dry weather flows from this outfall should be monitored for contamination and perhaps treated to remove any agricultural chemicals that are used to maintain the PLNU athletic fields and happen to enter the storm drain system.

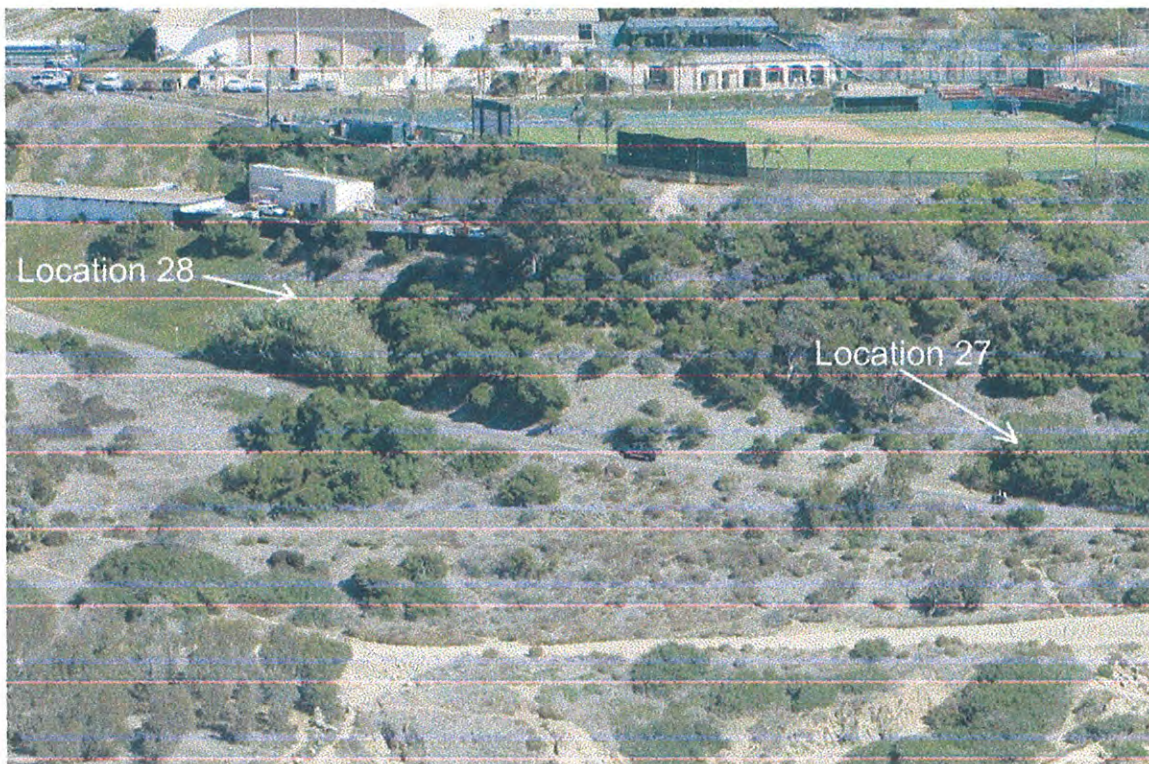
Location 28 (see Hillside Park map)

Condition: Location 28, that is pointed out in the photograph below, is the location of an 18 inch diameter outfall from the PLNU drainage system that terminates and discharges onto Park property. “Dry weather” flow can be heard trickling down inside the broken cement structure at the end of the outfall pipe, but a pool or stream leading away from it has not been found due to the dense grove of extremely invasive non-native weed *Arundo donax* that is growing around the terminus of the outfall pipe. Since *Arundo donax* burns explosively, it should be removed so it doesn’t pose a fire hazard to the nearby PLNU Physical Plant buildings. Location 27 shown in the photograph is the terminus of a 24 inch diameter outfall from the PLNU drainage system.

Recommendation: The effluent from the drainage outfall at Location 28 should be plumbed into the same ocean outfall storm drain system that is used for the disposal of runoff from Basin M2 and other runoff sources that impinge on the Hillside Park. The dry weather flows from this outfall should be monitored and perhaps treated before ocean disposal.

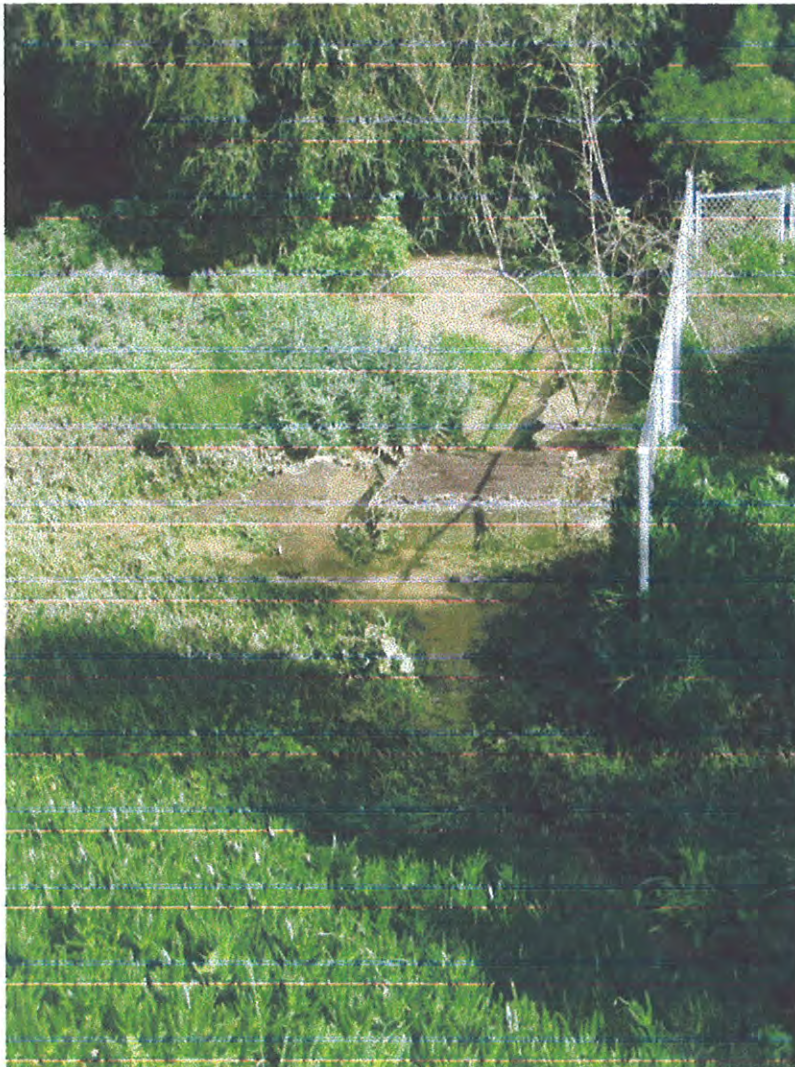
Location 29 (see Hillside Park map)

Condition: Location 29 is a pipeline that connects the northern part of the Hillside Park (DUDEK Report Drainage Basin D2, with an outfall that discharges down an alley way just east of Cornish Drive and into Drainage Basin D1. A cleanout in a depression near the western end of Park Property in the northern part of the Hillside Park that is the input structure to the pipeline that is Location 29, is shown in the photograph below. During the heavy rainfall period from October 2004 through February 2005, this depression was filled with a considerable amount of soil due to erosion in drainage basin D2. Muddy water was also observed in the streets below where the Location 29 pipeline discharged.

Recommendation: Monitor Drainage Basin D2 and the drainage system outfall for evidence of erosion, and correct conditions when evidence of erosion is found. New drainage system outfalls from the PLNU that discharge onto Park property and were installed in 2005 or at a later date (see location 30 and Water should

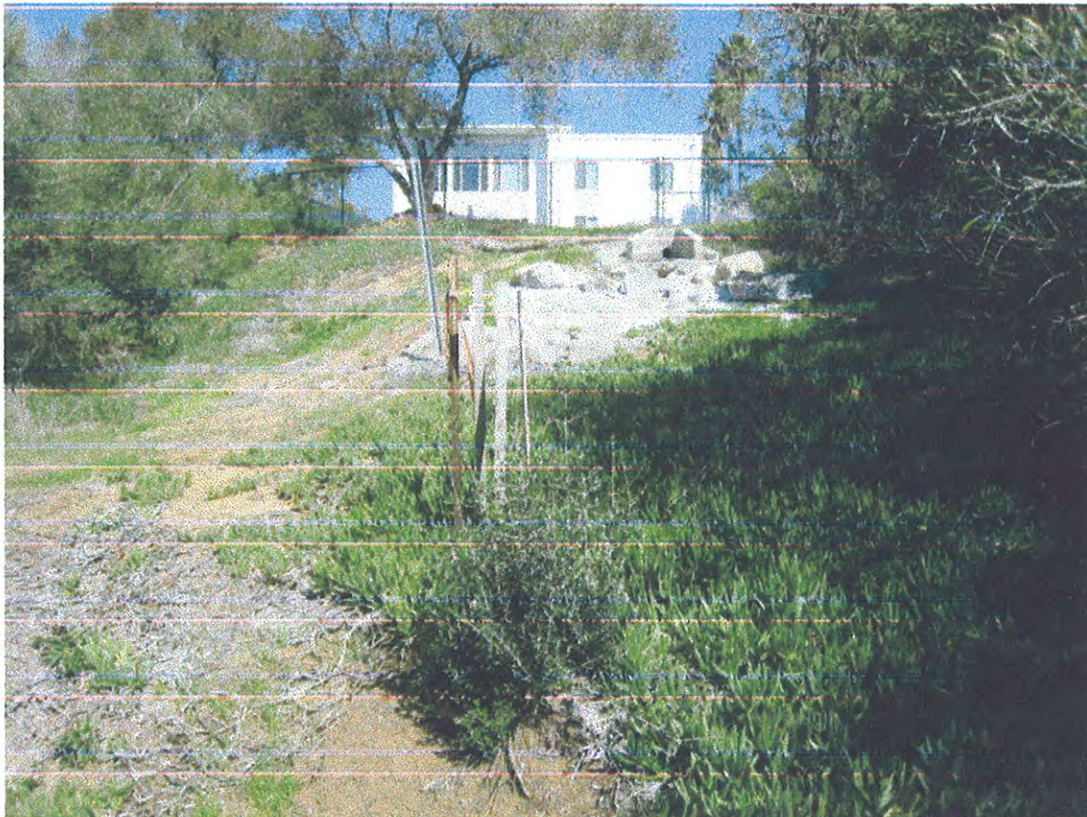
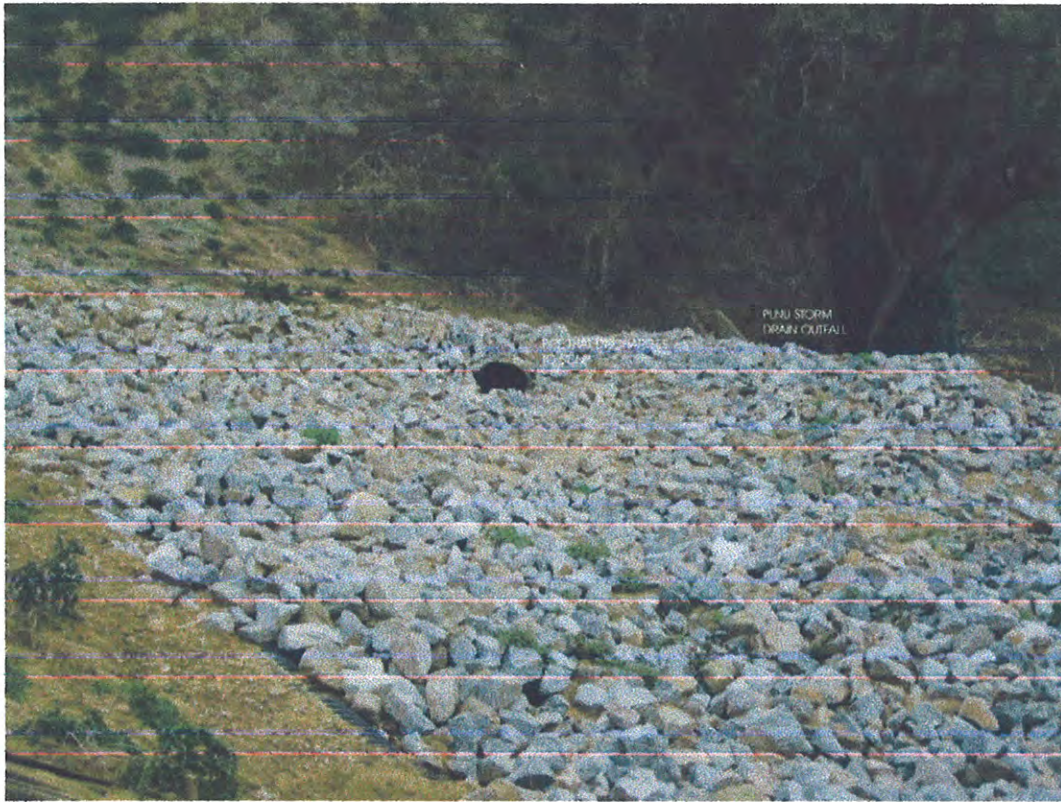
Location 30 (see Hillside Park map)

Condition: Location 30 is a 6 inch drainage outfall and spreading structure in the vicinity of the westernmost PLNU Nease Hall dormitory complex as shown in the picture below, and a nearby discharge into rip-rap shown in the second photograph. These outfall were constructed in 2006 and 2005 respectively, and they discharges into DUDEK Report Drainage Basin D2.

Recommendation: Monitor areas around PLNU outfall structure to see if runoff from them is responsible for erosion in DUDEK Report Drainage Basin D2. A possible action that could be taken to either prevent erosion from occurring or eliminate it if it is found, would be for PLNU to collect the runoff and use it for irrigation during the dry season.

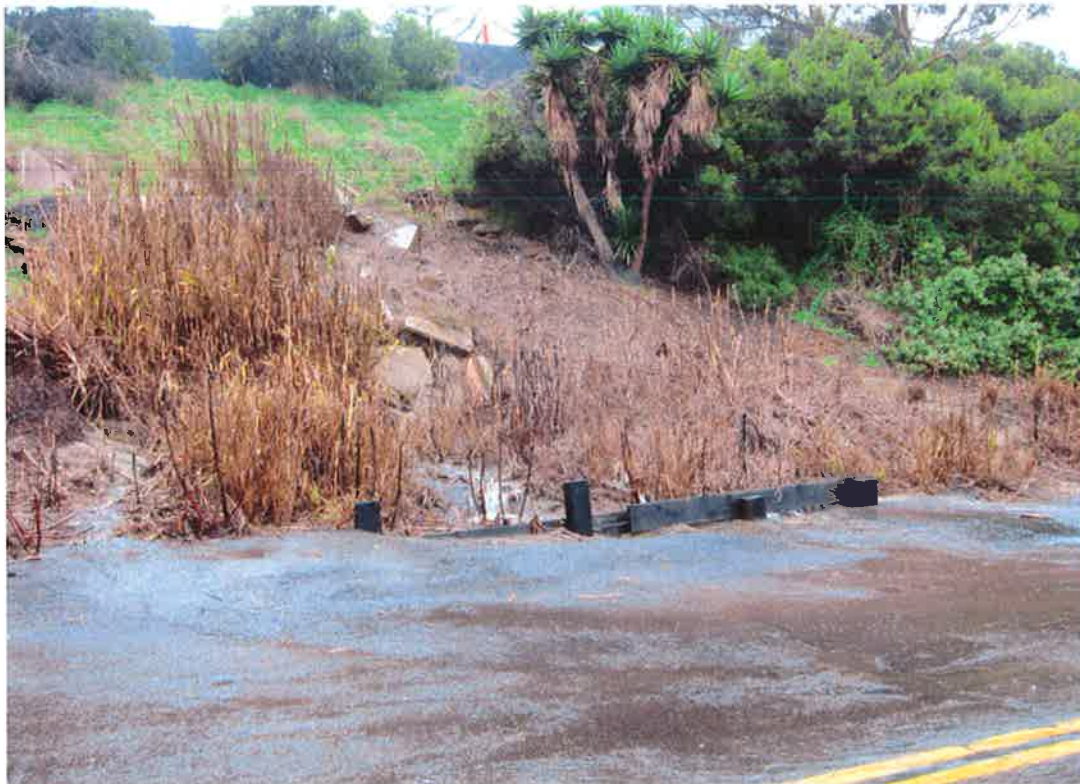
Figure 7. The 18" pipe discharges on this slope among the concrete rubble and dead Arundo plants. Runoff from the 18" pipe mostly stays on the road until the asphalt curb on the western side of the road decreases from approximately 6" in height to 3" and then is nonexistent.

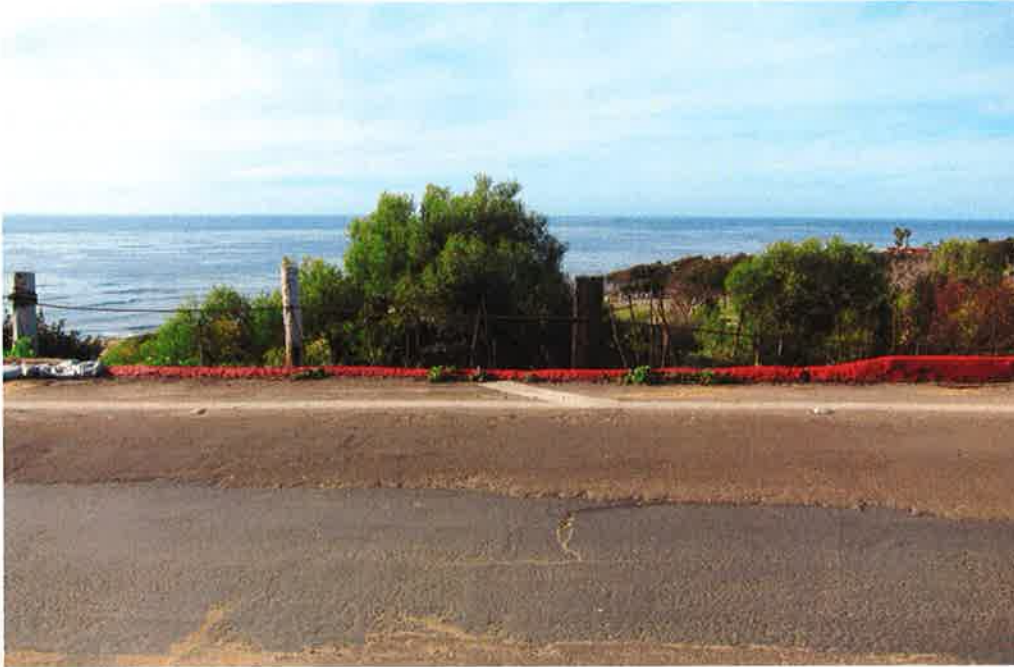
Figure 9. The curb height changes from 6" to 3" allowing storm water to run off between the two Acacia trees by the unpainted wood post, as well as, where the curb is missing, down slope from the sand bags.

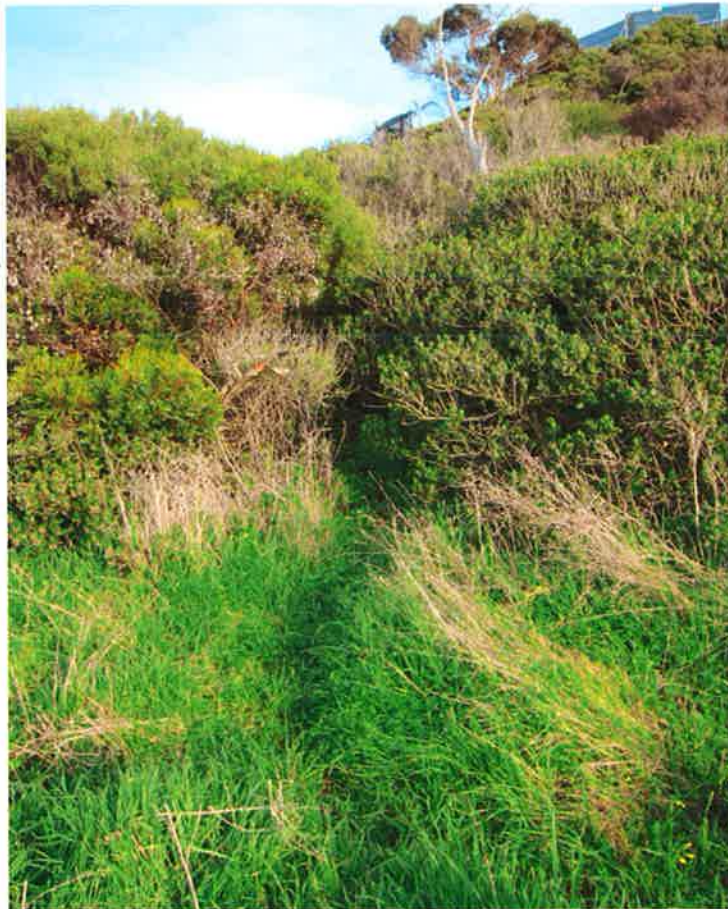
Figure 10. Runoff from the 18" drain goes over the edge of the Loop Road where the curb is 3" or less in height, and it then flows under the bushes and follows the "trail" down the hill, shown by laid down weeds.

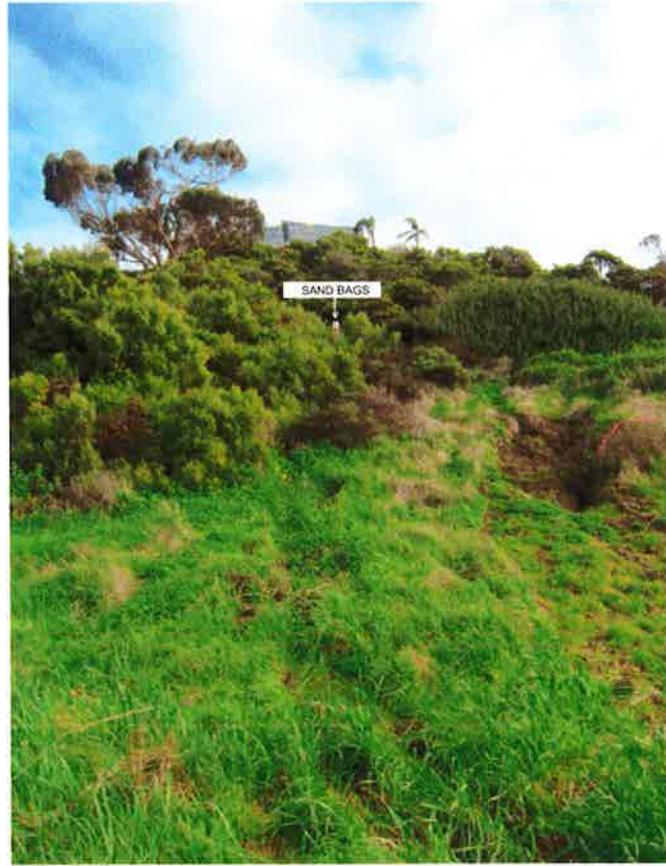
Figure 11A. This runoff course, due to the 18" pipe, is slightly further down the Loop Road than is the one shown in Figure 10. The runoff caused the "trail" and the slump and erosion to the right.

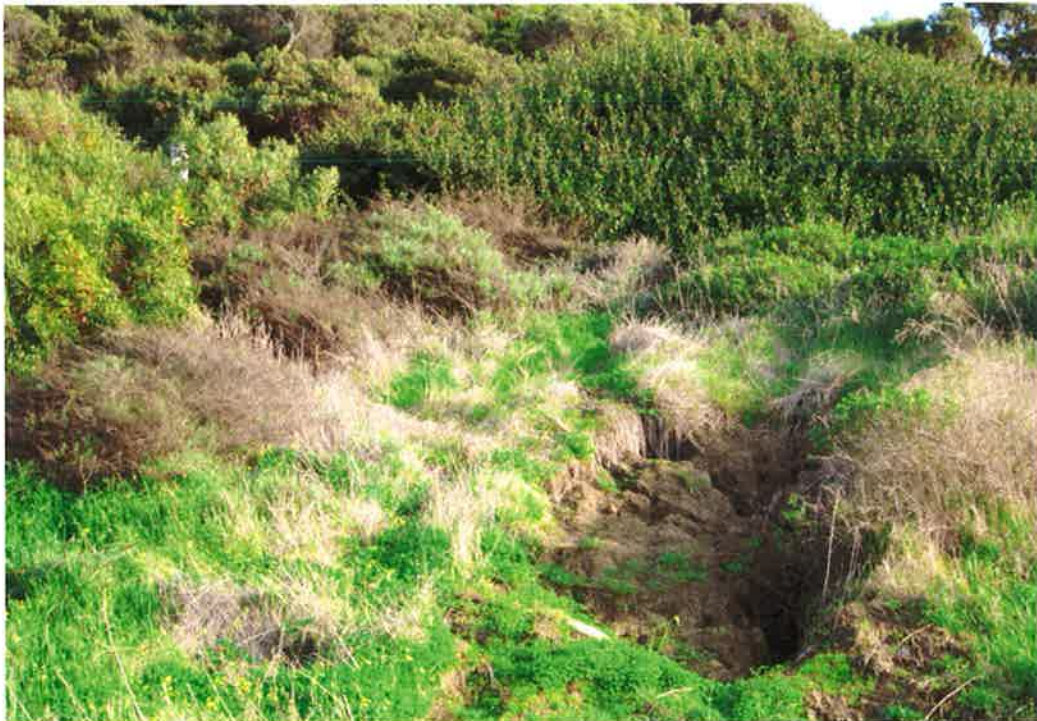
Figure 11B. Close-up of the erosion/mass wasting/mud hole due to runoff from the Loop Road. Those who use this trail to access surfing areas on an almost daily basis did not observe this damage to the Park prior to the December 2010 storm.

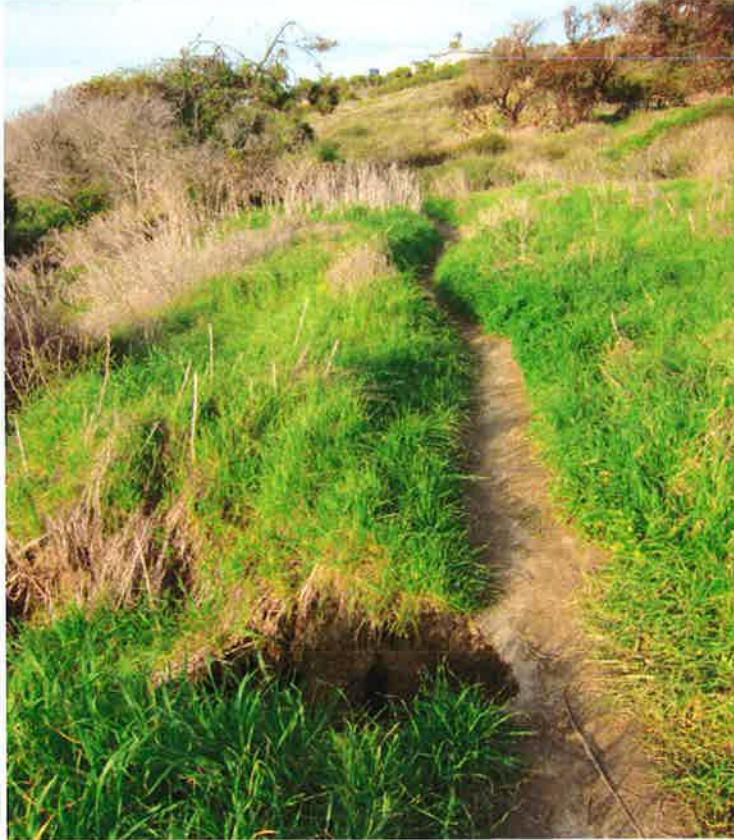
The runoff from the 18" pipe as it goes on down the hill is causing a significant collapse of a trail that is planned to become part of the Park formal trail system.

Figure 12A. Runoff from the 18" pipe is undercutting this trail that is being considered as a secondary trail for the Park, and has caused a significant collapse of the trail and the slope adjacent to it.

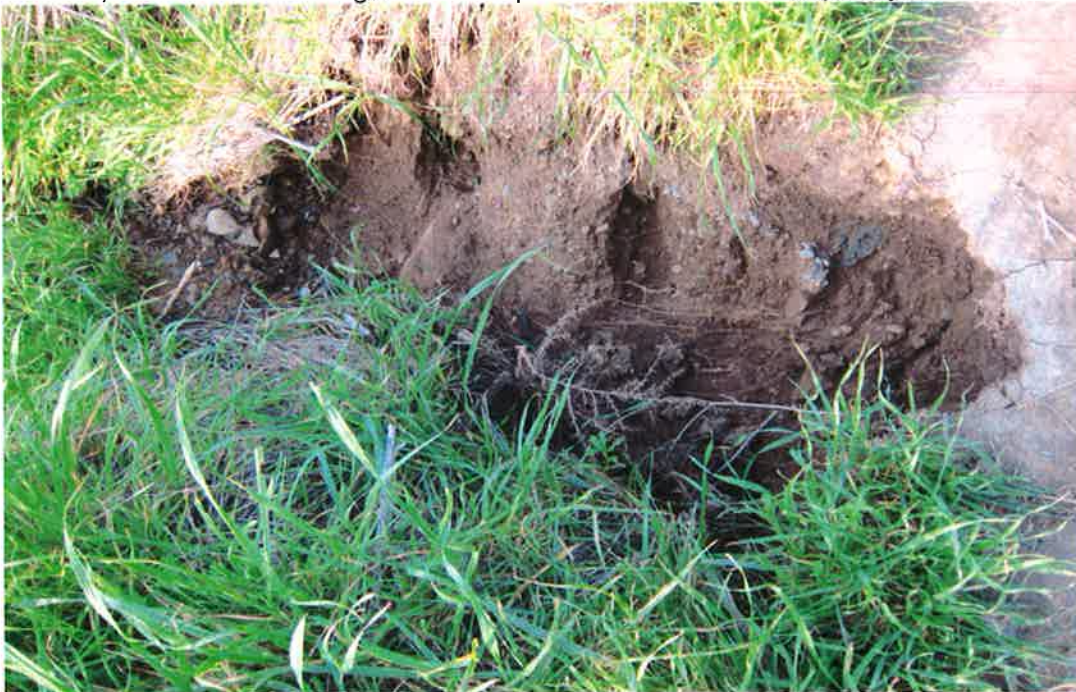
Figure 12B. Close up of erosion washing out the path. 6" curbs along the Loop Road could easily eliminate the runoff causing this washout and allow this trail to be part of the permanent trail system.

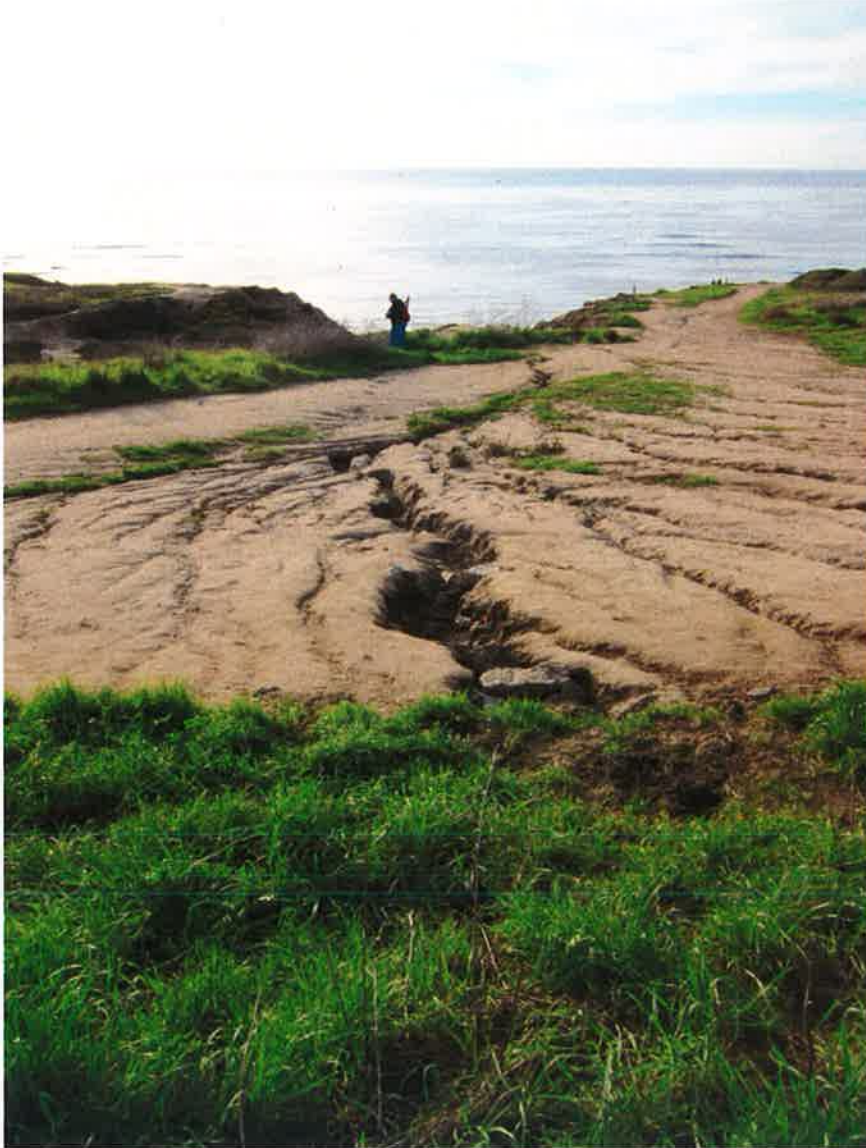
The runoff from the 18" pipe (Figures 13 & 14) continues down the slope, crosses the sludge line where it formed a 4-6 inch deep erosion rill, and then continues westward where it has started a new erosion gully on the northeast side of the badlands (Figure 15). This runoff is also exacerbating existing erosion gullies down slope along the northern edge of the Badlands and westward including extensive erosion between the Lower Parking Lot and the Badlands.

Figure 13. Runoff, mostly from the 18" drain pipe, crosses the sludge line trail, where it has cut this major erosion rill that is 4-6 inches in depth as well as the minor ones, before running into the Badlands along portions of the northern edge. From the Badlands, the runoff runs into Culvert Canyon where it is mixed with flows from Drainage Basins M1 and M2 that can total up to 50 cubic feet per second for a 10-year storm, like the December 2010 storm, before discharging over the cliffs to the ocean. A new erosion gully was formed where the person is standing in the photograph. 6" curbs along the Loop Road could eliminate the runoff causing erosion of the sludge line trail, based on preliminary designs for the Park comprehensive drainage system and observations of their effectiveness when used along parts of the Loop Road after the 2004-2005 rains. This should be done so the trail and sludge line will not require costly repairs.

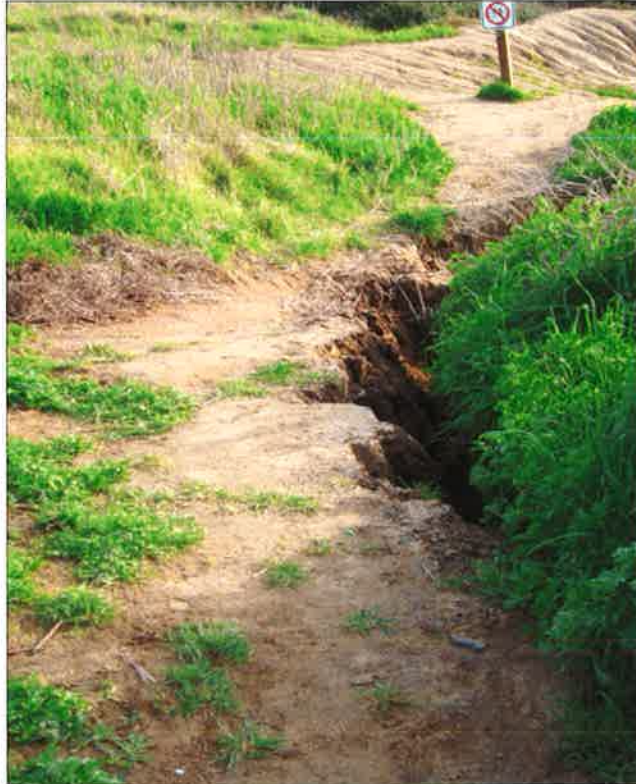
Figure 14. This new erosion gully from runoff from the 18" drain coming off the Western Loop Road was first noticed after the major December 2010 storm. The upper, southward running portions of this recently formed gully should be filled in and stabilized to prevent it from enlarging.

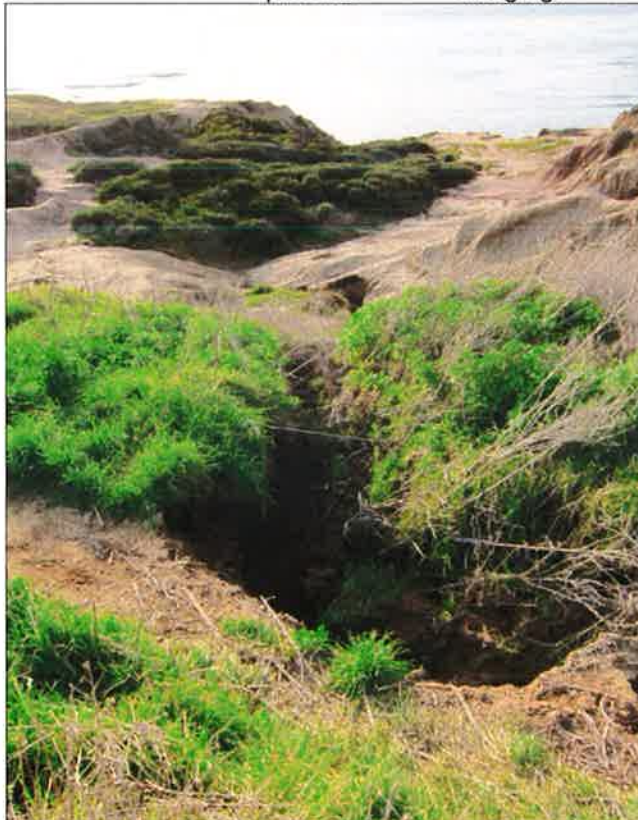
Figure 15. Southern part of the new erosion gully formed by runoff from the 18" drain where it runs into the Badlands. This runoff flows into Culvert Canyon and into the nearshore waters.

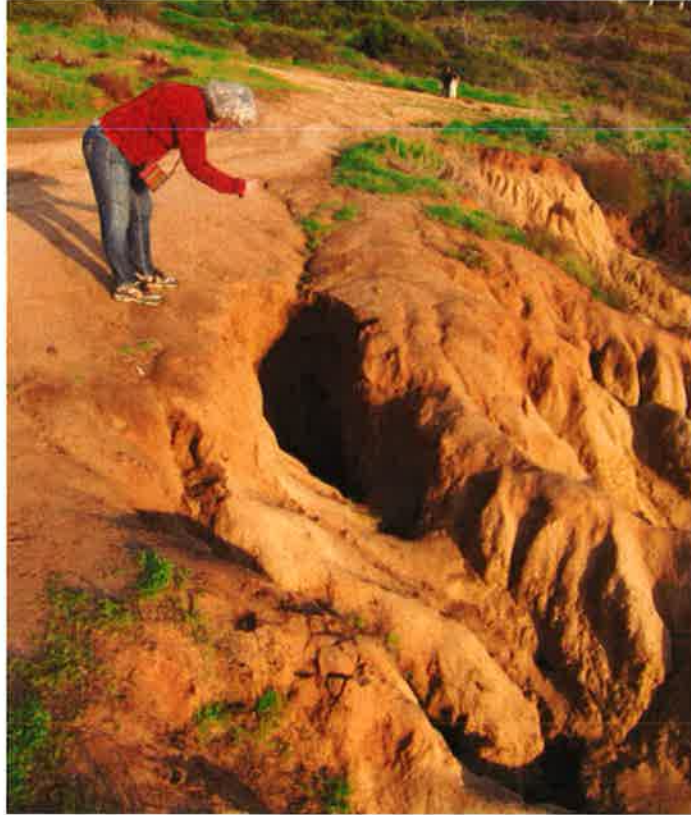
Figure 16. Additional erosion caused by discharges from the 18" pipe along the northern edge of the Badlands. 6" curbs on the Loop Road could easily control this erosion.

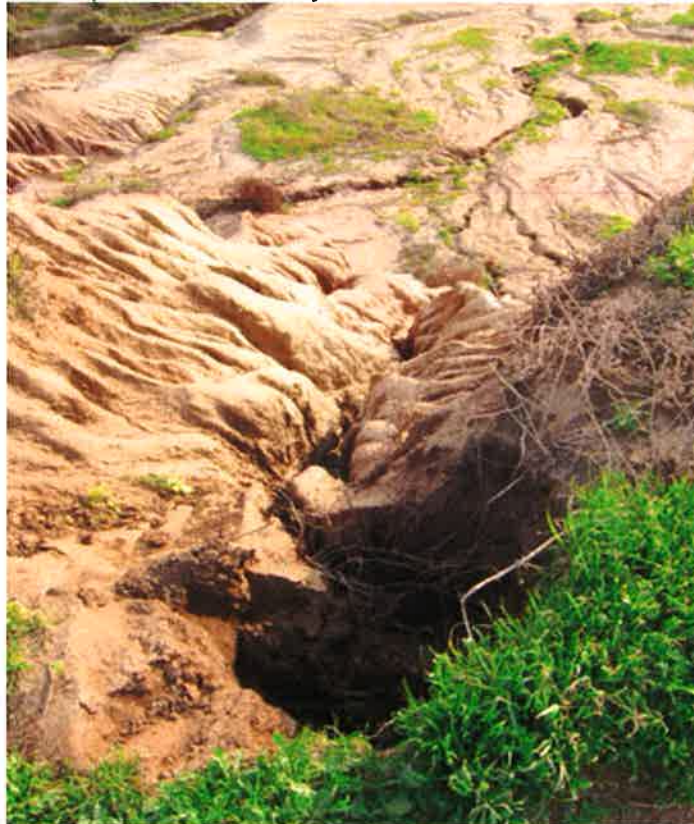
Figure 17. One of many sinkholes next to the trail in the Badlands that pose a clear danger to people and pets, because they are over 10" in depth. These are caused by runoff from the 18" pipe.

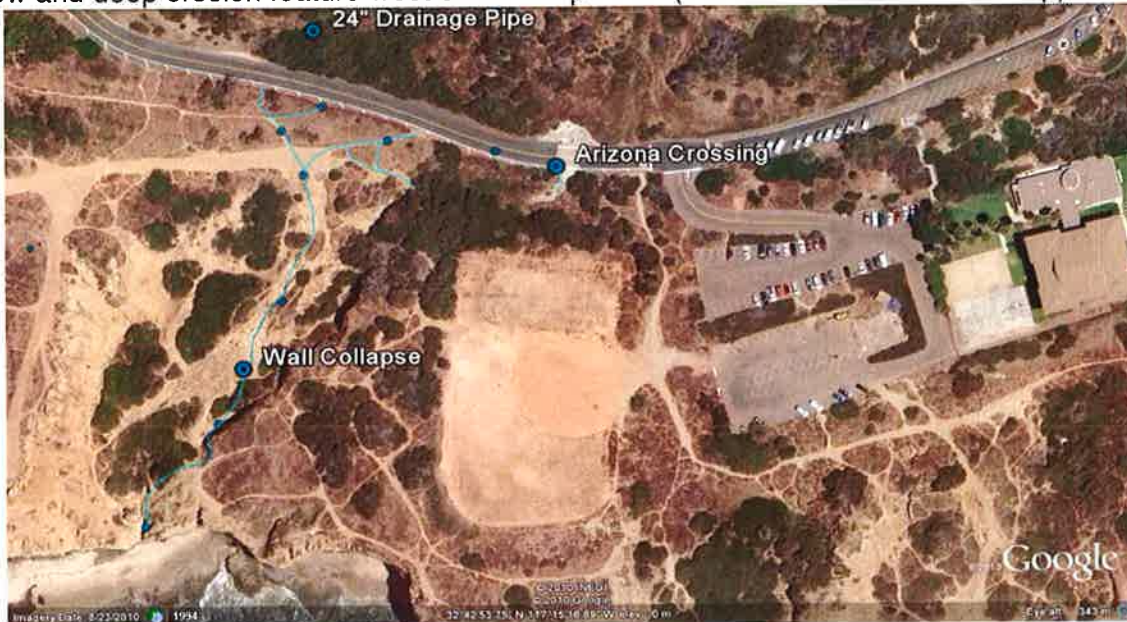
Figure 20. Erosion Caused by Discharges from the 24" Pipe to the Western Loop Road. For reference, the Badlands are on the left, Culvert Canyon is the deep feature to the left of center, and the old ball field is to the right. Runoff from the 24" pipe flows over the Loop Road curb and into the southeast corner of the Badlands and Culvert Canyon at locations indicated by blue dots. Runoff across the Park roughly follows the blue streamlines showing the linkage between erosion on the sludge line trail and the wall collapse area in Culvert Canyon. During periods of high flow the runoff also flows over vegetated areas.

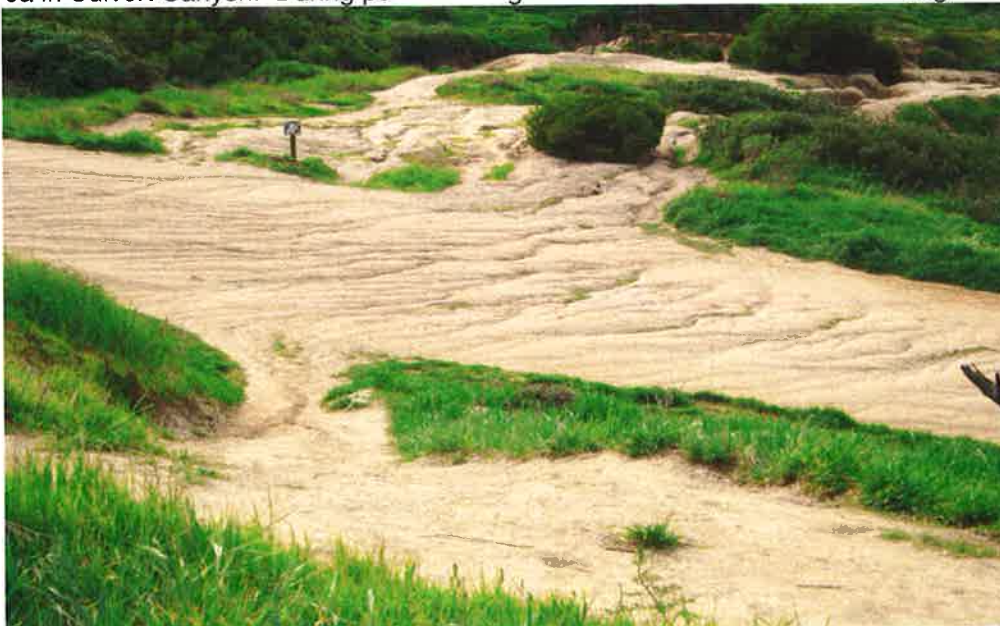
Figure 21. Erosion rills cause by runoff from the Loop Road, predominantly from the 24" pipe.

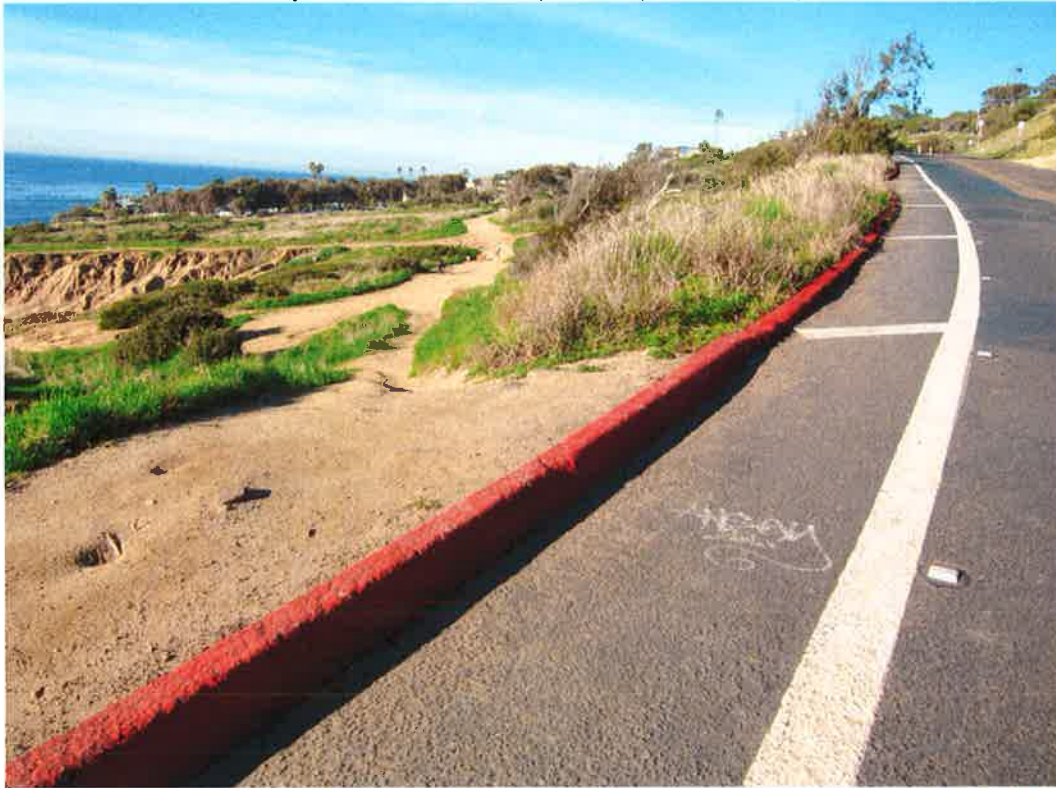
Figure 22A & 22B. Low curbs transition to 6" high curbs where the ramp from the sludge line trail joins the Loop Road (Figure 22A). The low curbs enable road runoff, made up in large part by discharges from the 24" pipe, to flow down the transition trail (Figure 22B) and into Culvert Canyon where it contributes to

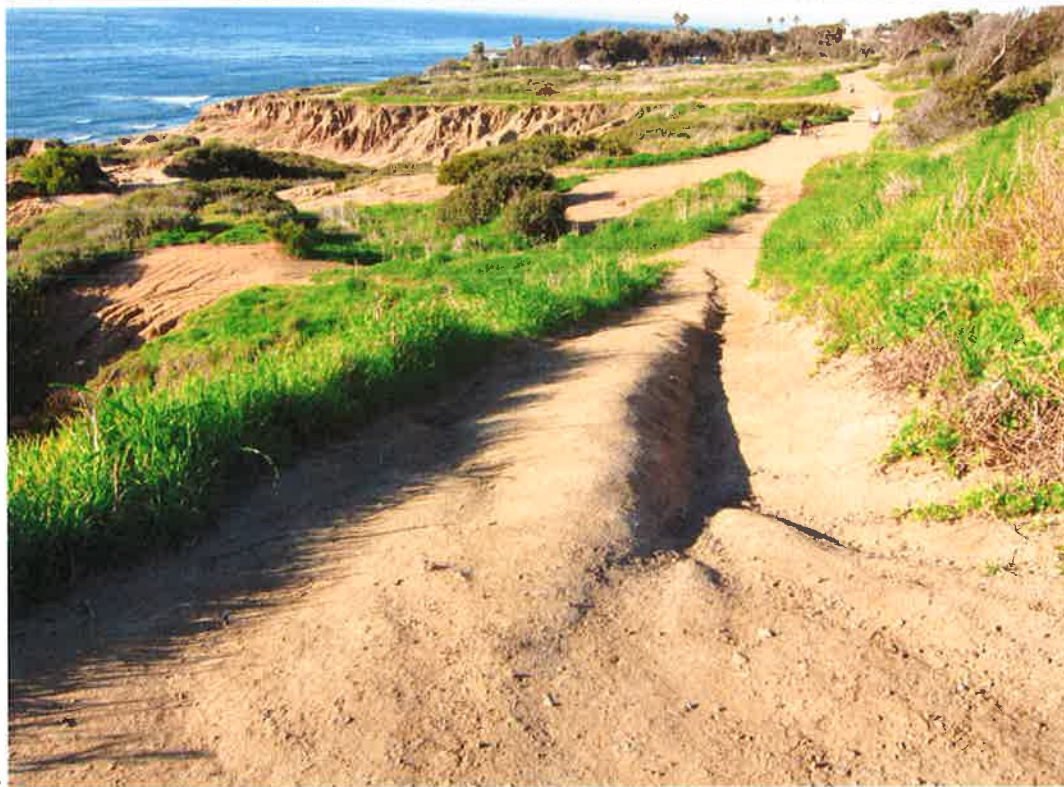
22B

mass wasting on the northeast wall of Culvert Canyon as shown in the next figure. This major section of the proposed Park trail system is being compromised by runoff from the 24" pipe.

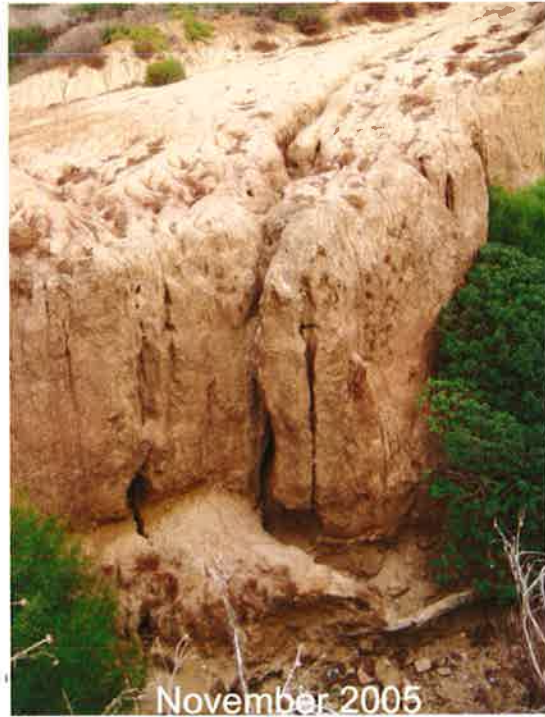
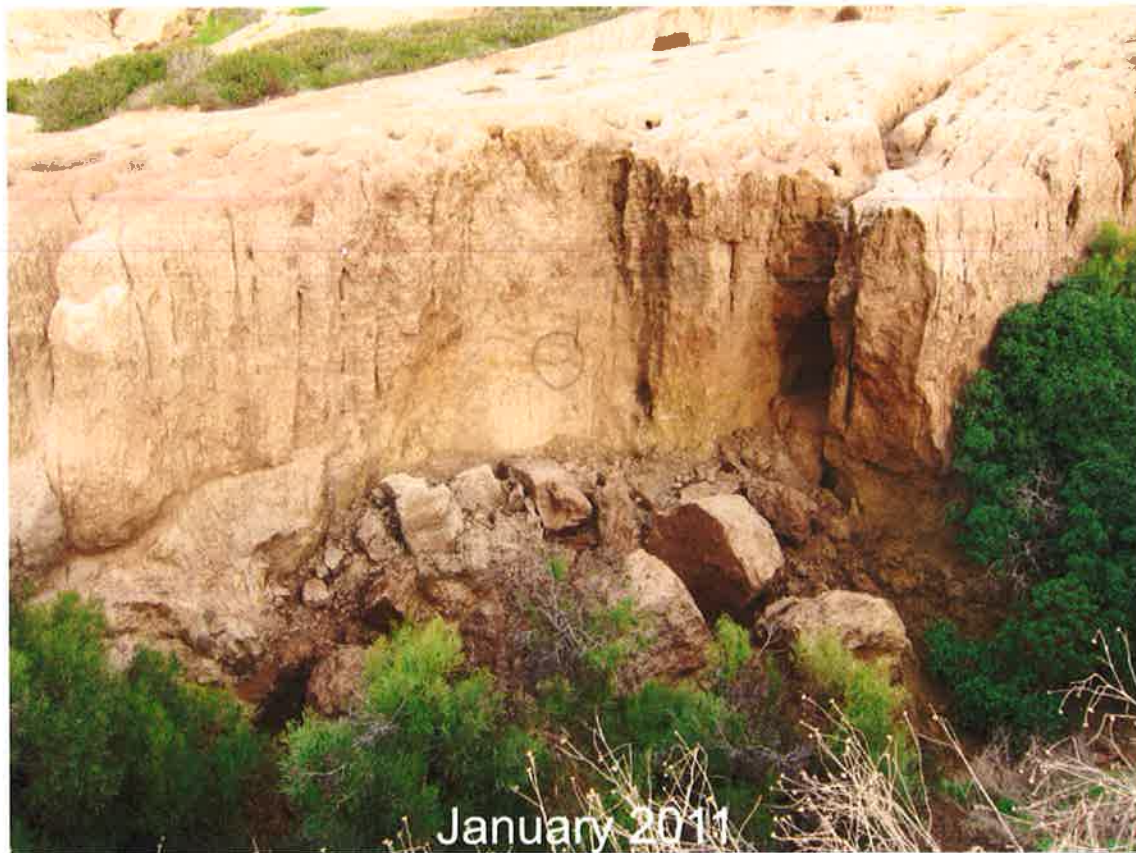
Figure 23. Culvert Canyon wall collapse where runoff from 24" pipe and other sources crosses the Loop Road and continues down erosion gullies in Drainage Basin M1 until it reaches the north wall of Culvert Canyon causing the wall to fail by the erosion process called mass wasting.
