SUNSET CLIFFS NATURAL PARK

Final Drainage Study

**SUNSET CLIFFS NATURAL PARK
DRAINAGE STUDY**

MAY 2012

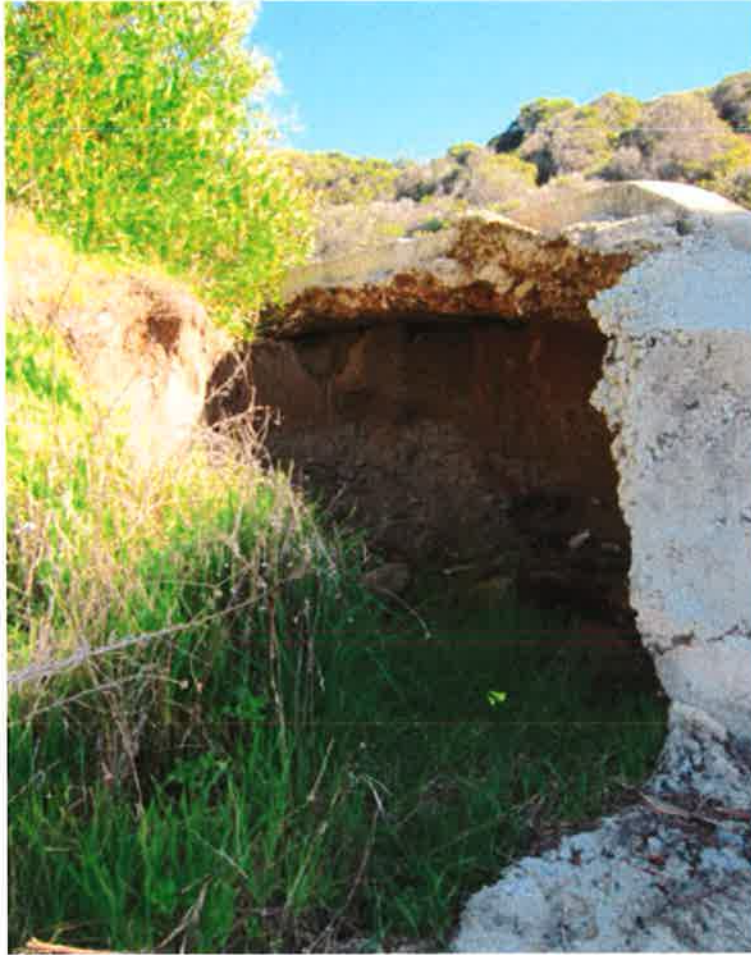
Figure 25A. Undermining of the Loop Road Arizona Crossing by runoff that flows over the western curb (primarily from the 24" pipe). An adequate height curb could eliminate this maintenance problem.

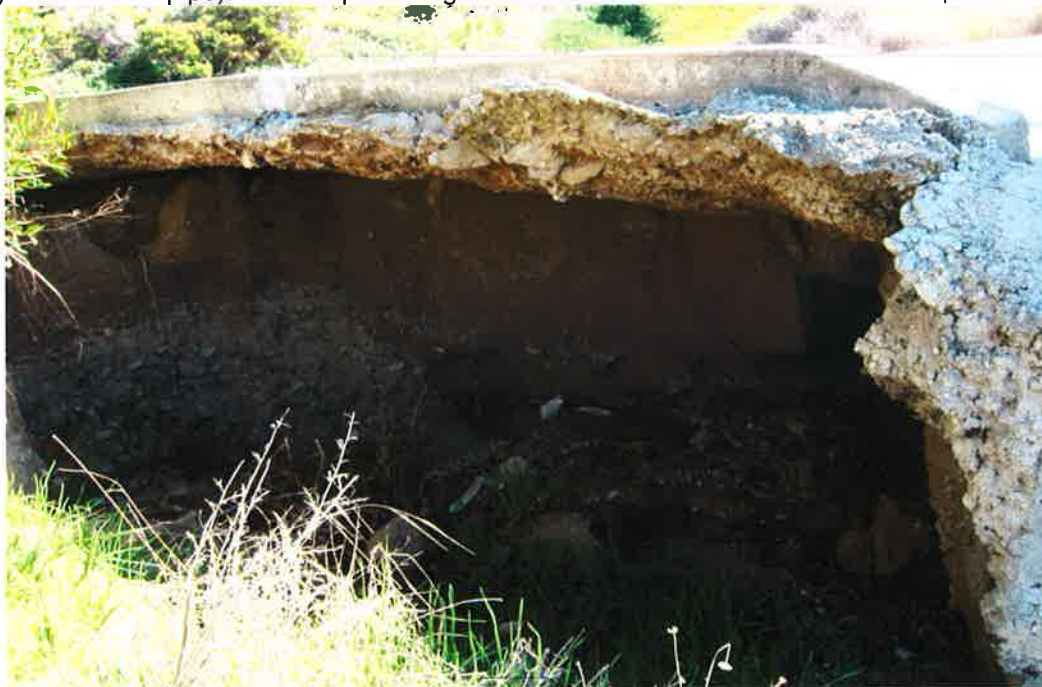
Figure 25B. Close up of the undermining of the Loop Road Arizona Crossing. Most of the water causing this damage is from the 24" drain.

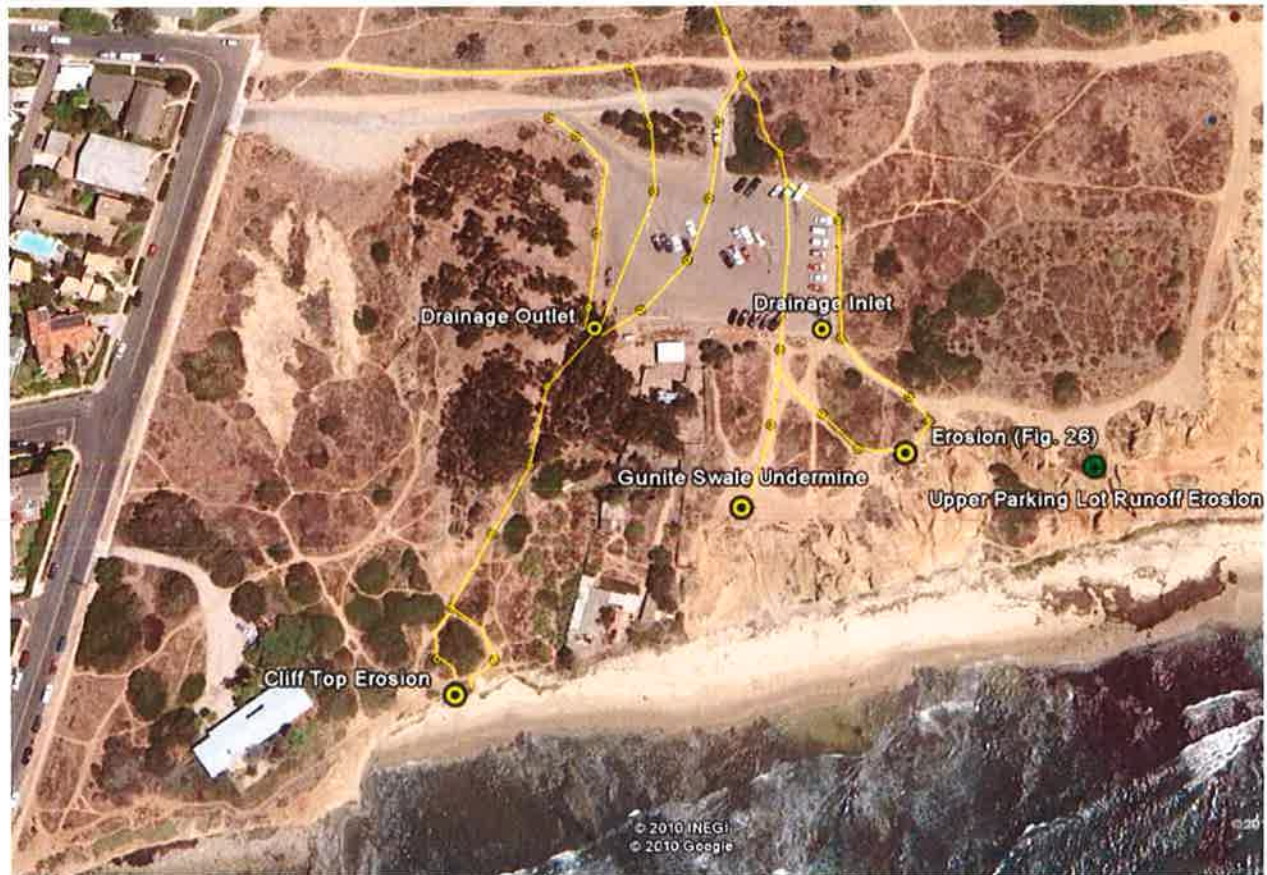
Due to improper grading of the Lower Parking lot, little, if any of the rain and runoff that falls onto or goes into the parking lot from the hillside above it, leaves it through the existing storm drain in the southwest corner of the lot. As a consequence of improper grading, major erosion problems can be found down slope of outlets at both the southwest and northwest corners of the lot.

Figure 26. Pathways runoff follows (shown in yellow) before runoff enters and after it leaves the Lower Parking Lot. Very little parking lot runoff passes through the existing Lower Parking Lot drainage system (in the southwest corner). This drain should carry the runoff to the discharge and the Gunite swale, seen as a light colored feature running across the bowl shaped area in the center of the picture.

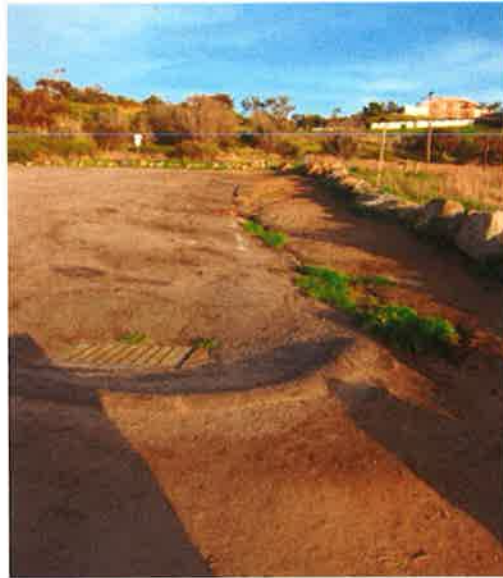
Runoff from Drainage Basin I flows into the Lower Parking Lot along the south side. About mid-way down the south side of the lot, the runoff leaves the lot creating an erosion rill. The runoff does not enter the parking lot storm drain inlet in the southwest corner of the Lower Parking Lot, because the southern side of the parking lot lacks curbing that would keep runoff on the lot until it entered the storm drain inlet. The Master Plan calls for reconstruction of the Lower Parking Lot so it drains properly into whatever drainage system is finally built.

Figure 28. The south side of the Lower Parking Lot, showing both the storm drain inlet and an erosion gully to the south of the storm drain inlet. Clearly, runoff from Drainage Basin I flows along the south side of the lot, causing rill and gully erosion before it discharges over the cliff (Figure 24).

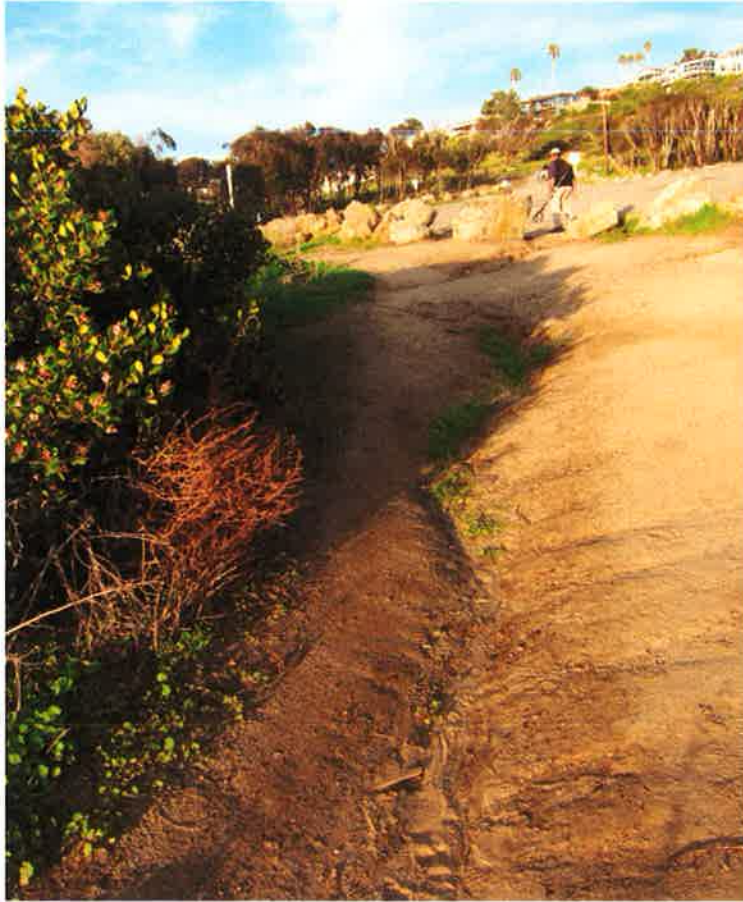
Figure 30. Runoff from the southwest corner of the Lower Parking Lot, that has bypassed the storm drain, mostly follows this trail that runs southwest. This trail is planned as ADA. If the runoff is not abated, a raised walkway will need to be installed to provide an adequate surface for an accessible path.

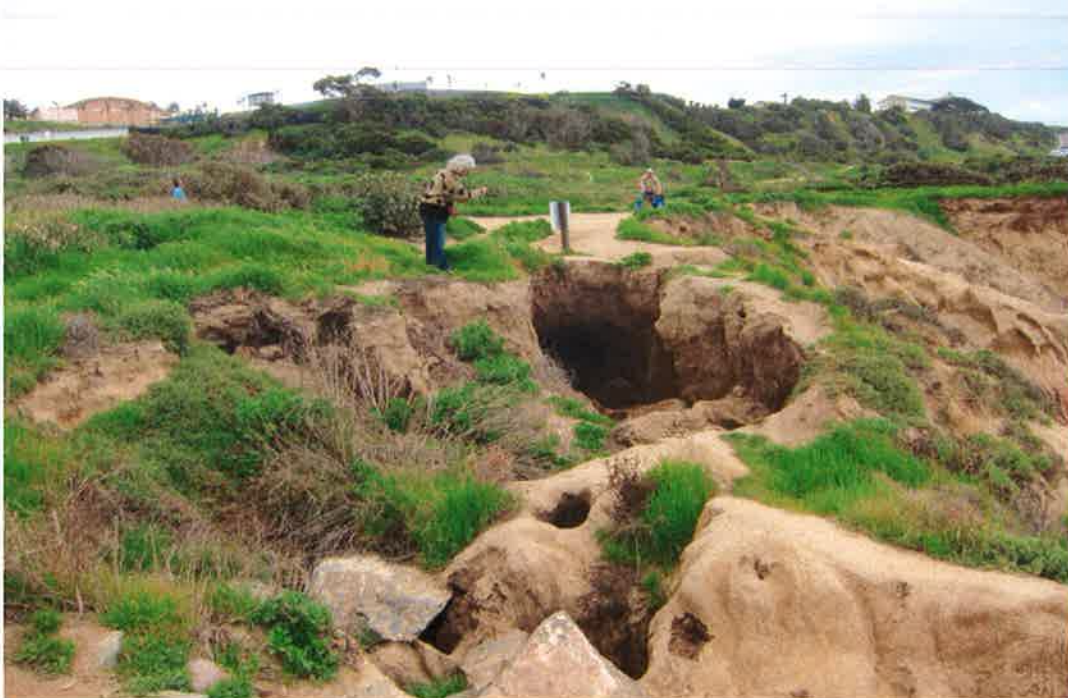
Figure 31. Bluff erosion caused mainly by runoff from the southwest corner of the Lower Parking Lot.

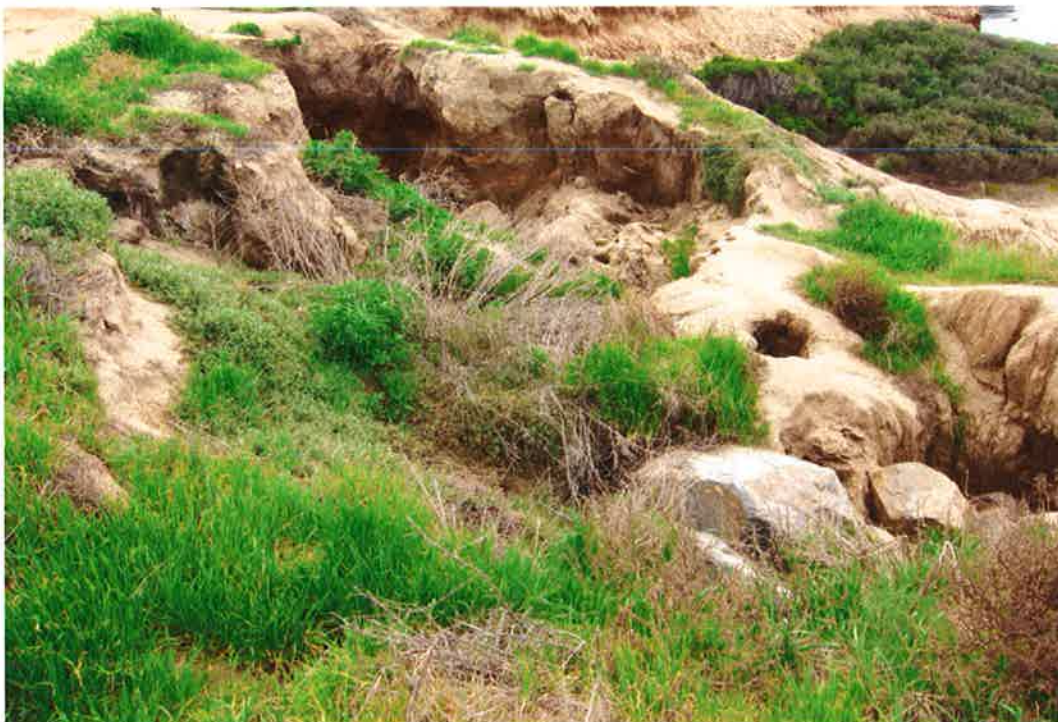
Figure 32. Bluff erosion caused mainly by runoff from the southwest corner of the Lower Parking Lot.

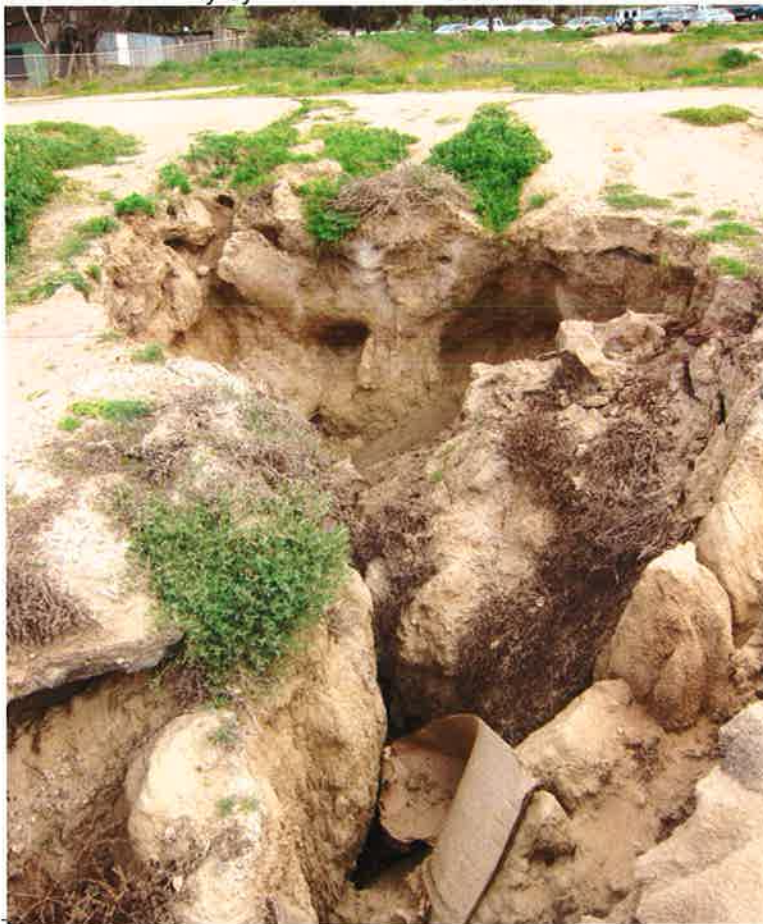
Figure 33. Bluff erosion caused mainly by runoff from the southwest corner of the Lower Parking Lot. This erosion and that shown in the previous figures could be eliminated by putting curbs and berms in the southwest portion of the Lower Parking Lot.

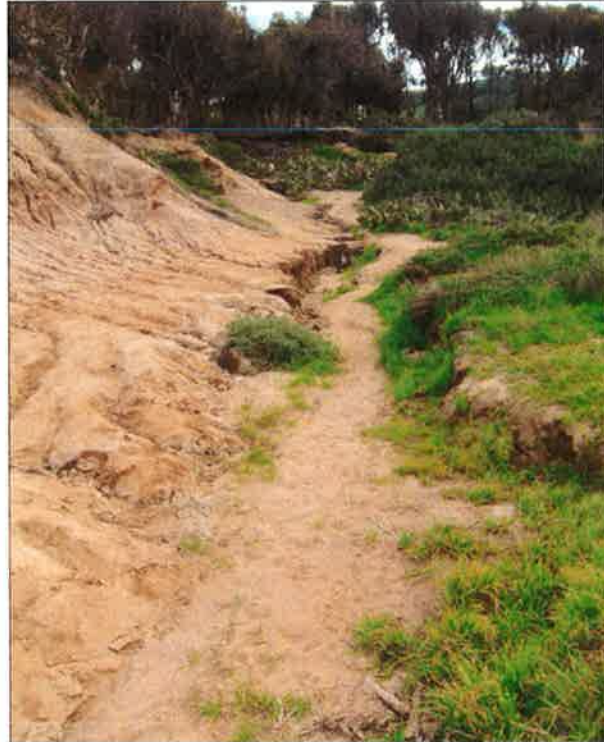
Figure 35. Erosion gully that receives runoff from the northwest corner of the Lower Parking Lot after it has run through the *Eucalyptus* grove (Figure 32).

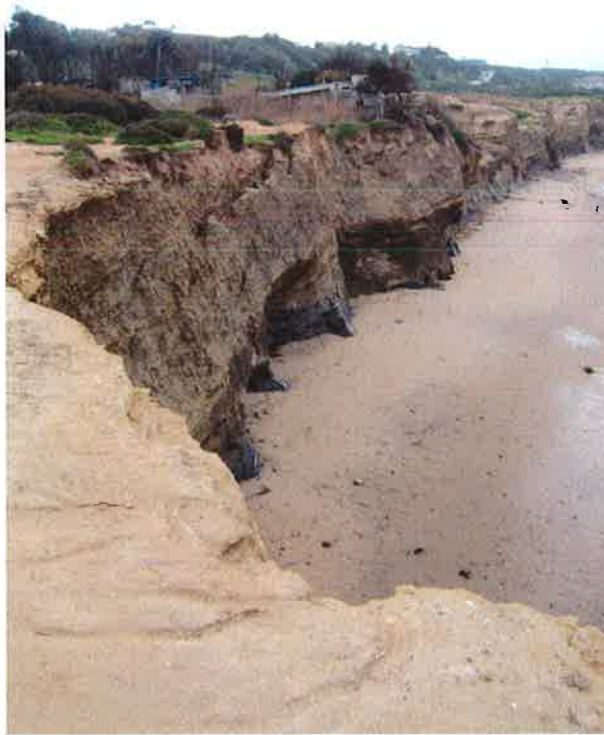
Figure 36. Runoff discharge from the NW corner of the Lower Parking Lot occurs all along this cliff above Garbage Beach. This dangerous cliff loss could be eliminated by diverting as much runoff as possible in the northern portion of the parking lot to the drain inlet in the southwest corner. Wattles and trail bars in the *Eucalyptus* grove should be used to build soil, and slow and spread the runoff so it isn't concentrated in one watercourse as it is now.

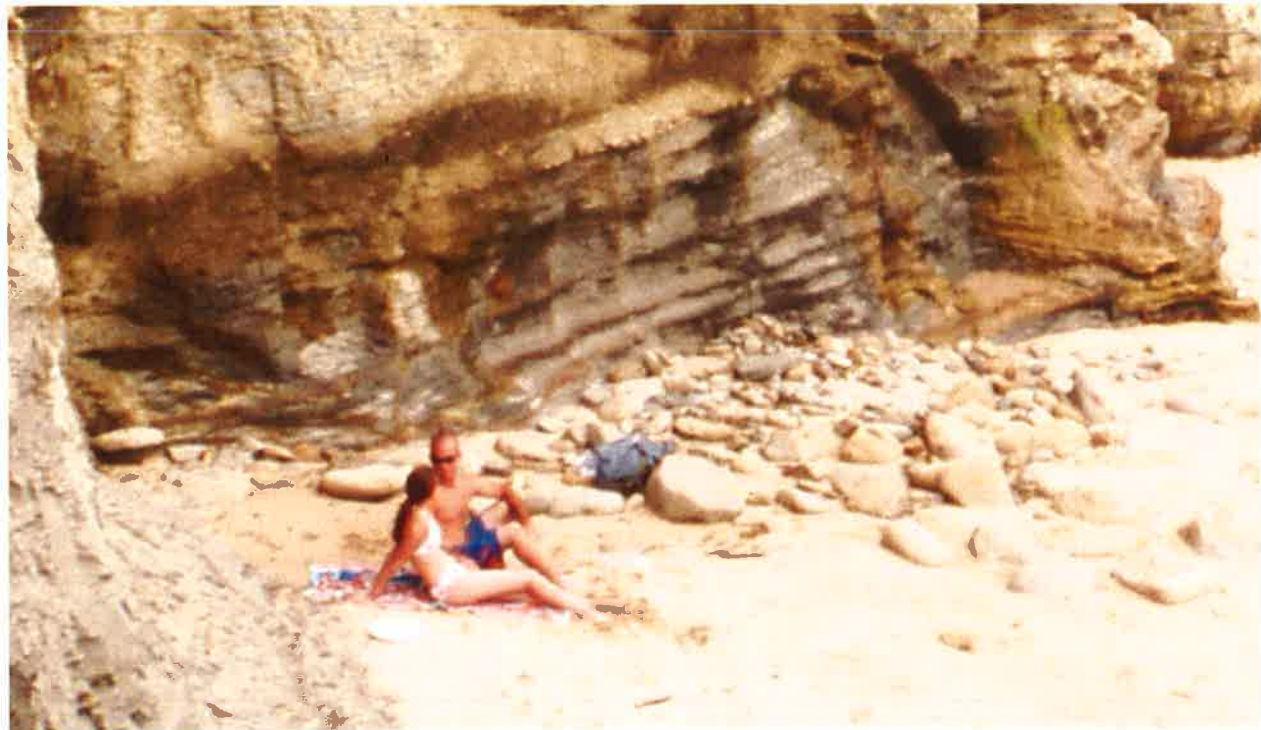
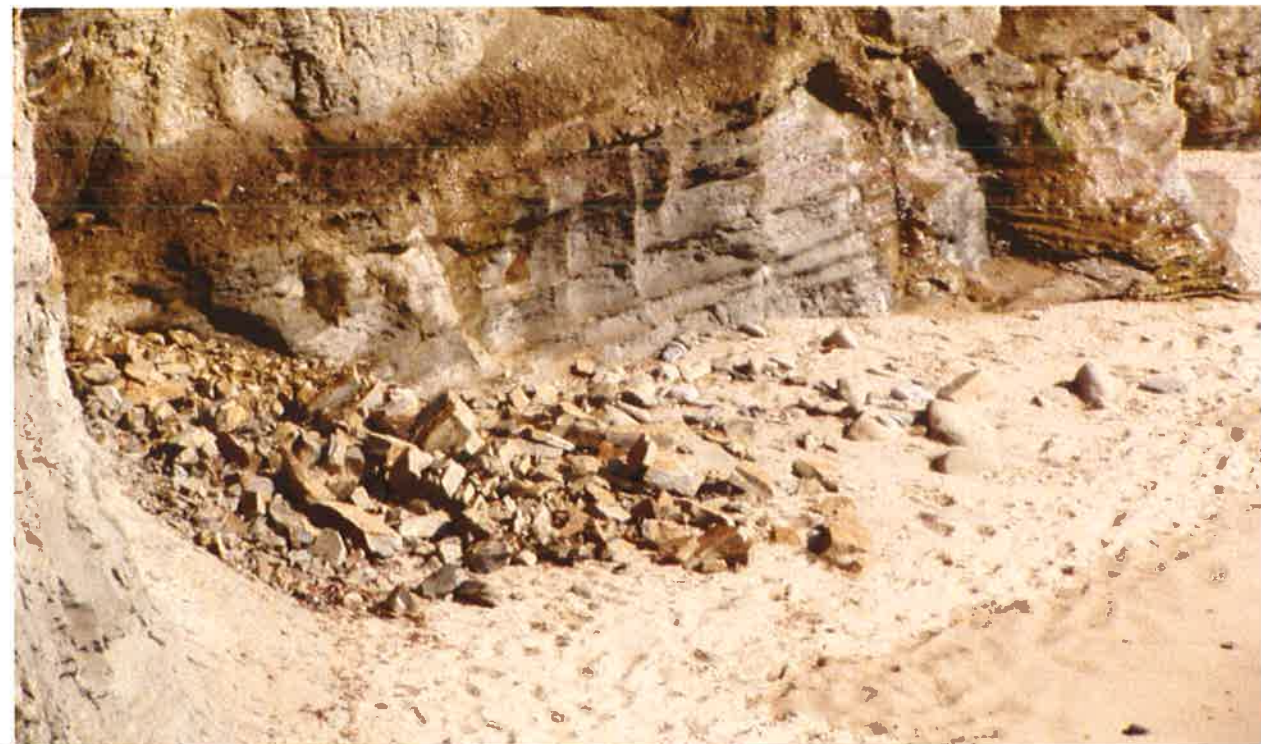
Figure 37. Northern end of Garbage Beach where runoff from the northwest corner of the Lower Parking Lot discharges over the cliff. Cliff block falls in this area pose a clear danger to beach users below as illustrated by these two photos taken 2 weeks apart.

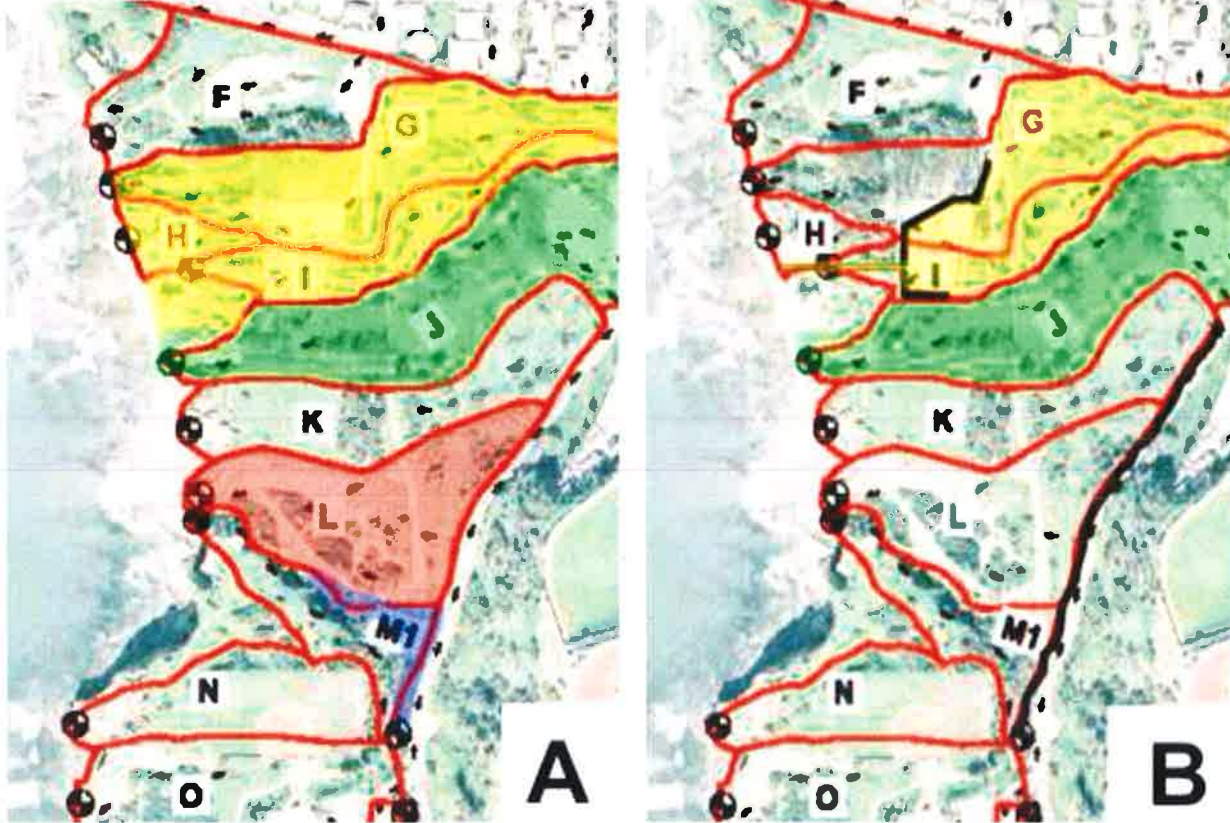
Figures 38 A and B. Figure A shows the drainage basins and areas of the Park where erosion damage due to runoff from the Lower Parking Lot and the Loop Road is occurring. Figure B shows where simple measures, such as building asphalt curbs and berms, can be placed to control runoff that will eliminate or reduced substantially the erosion caused by this runoff.

Runoff from the Lower Parking Lot is creating massive erosion features on the cliffs in Drainage Basins G, H, I, and parts of J. There is a storm drain in the southwest corner of the Lower Parking Lot, but due to lack of curbs and a low berm, almost no runoff enters the storm drain, flowing around it and taking various paths to flow over the cliffs causing massive erosion and dangerous conditions for people on Garbage Beach (bluff collapse).

The Western Loop Road presently acts as an above ground storm drain channeling runoff from the road, and the 18" and 24" drains from Point Loma Nazarene University. These pipes carry runoff from approximately half the campus. By raising the curb along the west side of the Loop Road to a minimum of 6" in height, the runoff will stay on the road and go into Culvert Canyon. This will not eliminate the erosion occurring within Culvert Canyon and the bluff, but at least the damage to the park will be limited to this feature. Presently multiple areas within Drainage Basins K, L, and M1 are suffering massive erosion that could be corrected by putting in a curb.

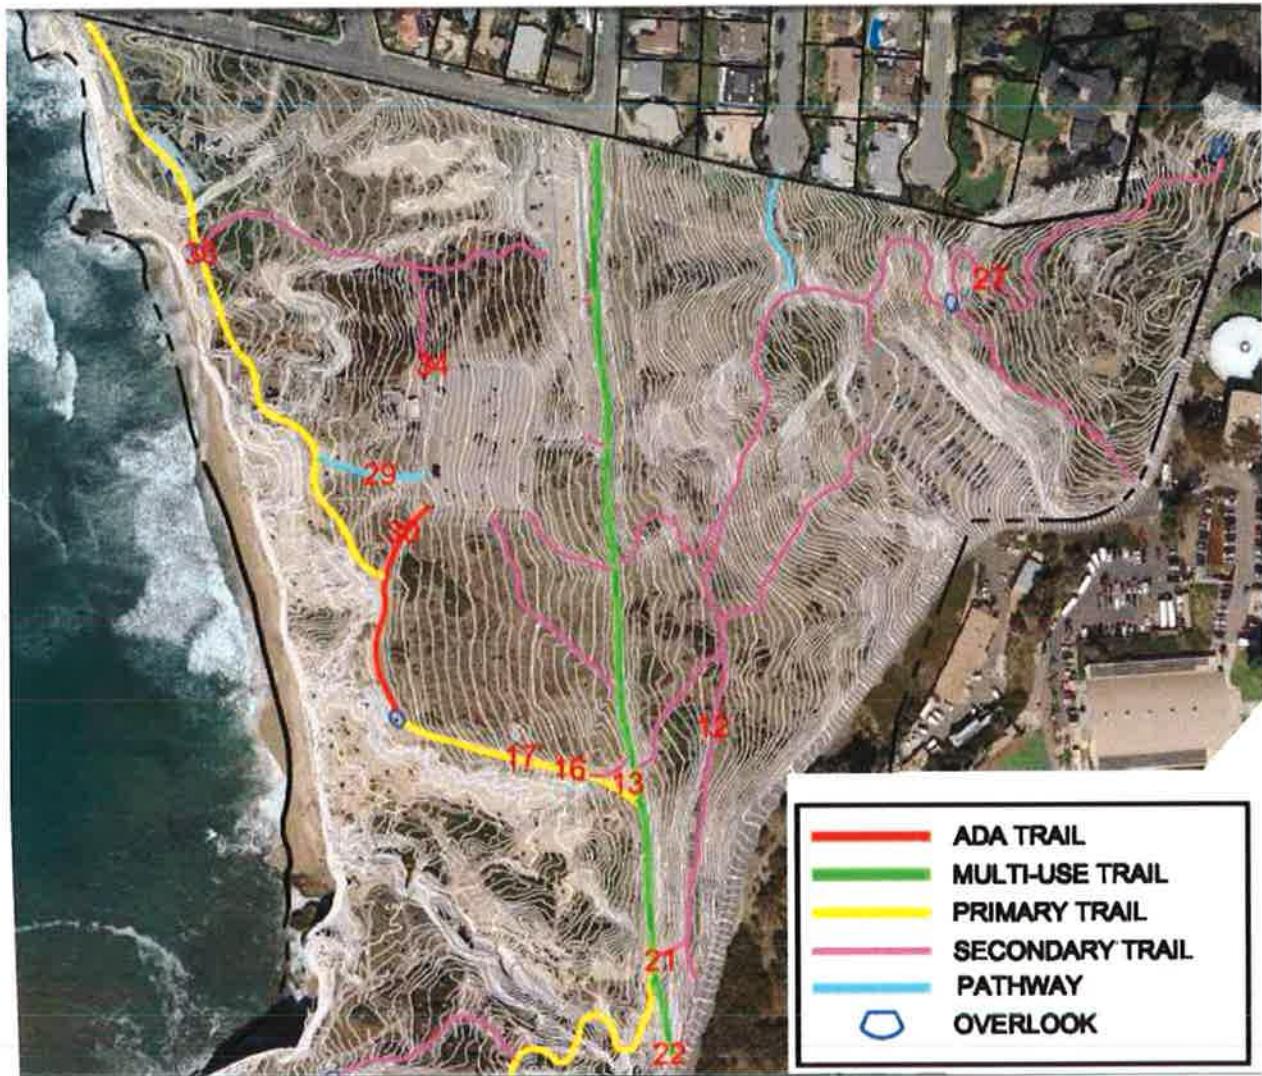
Figure 39. Shows preliminary Park Trails and the locations of erosion that will affect the Park Trails. The red numbers refer to Figures that discuss and show the erosion problems. The effects of erosion need to be considered in trail design and engineering.

If the simple measures discussed above are not implemented, the Park Trail system will continue to be negatively impacted. In order to spend the Coastal Conservancy and private grant funds for trails in the Hillside Park wisely, a relatively small investment needs to be made now to prevent further damage due to uncontrolled runoff.
