## SUNSET CLIFFS NATURAL PARK

Drainage Study

September 2012

**PREPARED BY**  
Dudek  
605 Third Street  
Encinitas, CA 92024  
800.450.1818  
[www.dudek.com](http://www.dudek.com)

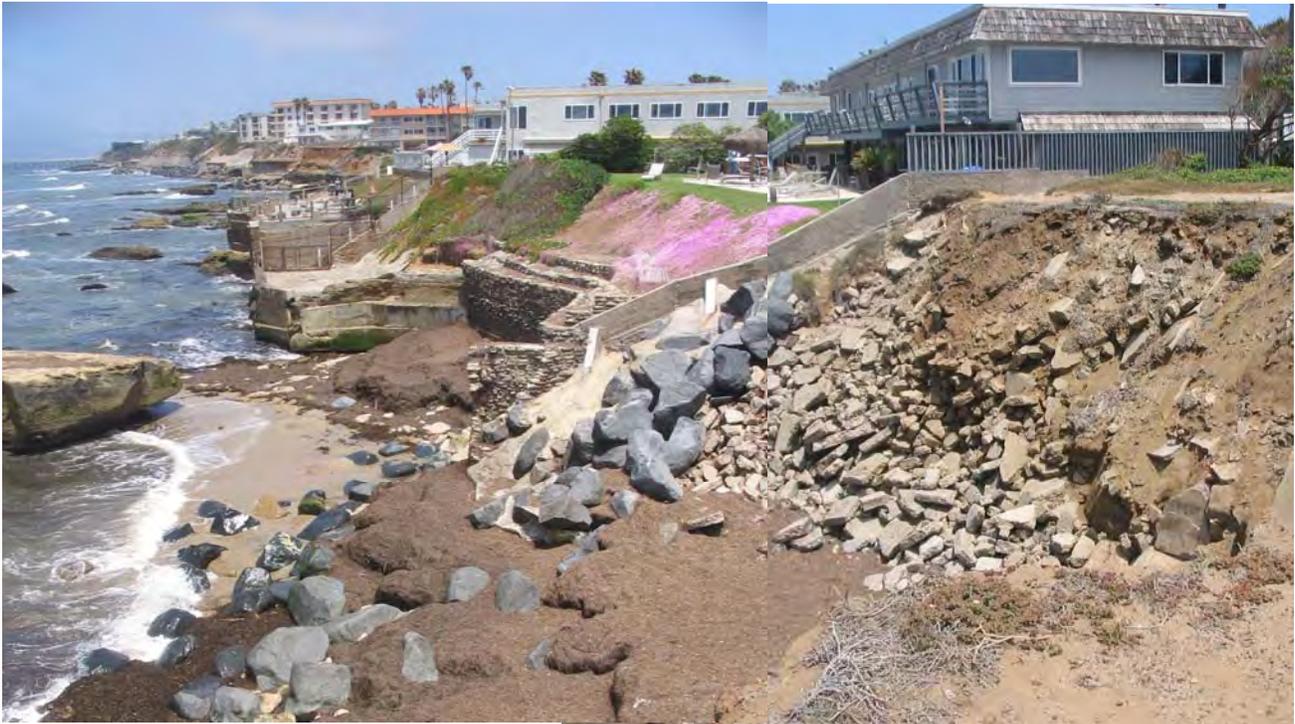
A new outfall structure is proposed in this location, and removal of the existing rubble may be needed to properly install the outfall. This could be an opportunity to restore this site to a more natural appearing coastline.

**Photo 1 –Looking north at the Adair Street street end rubble, Site 10.**

A small beach fill, nearshore reef, or perched beach could also be implemented in this small pocket beach. The beachfill could be used to cover some of the rubble, creating a natural looking pocket. Because of the pocket beach shape, the sand may be retained longer during normal wave conditions. However, if a strong storm came, the cross-shore transport could erode the beach fill material and expose the reef or rock riprap structure of the perched beach.

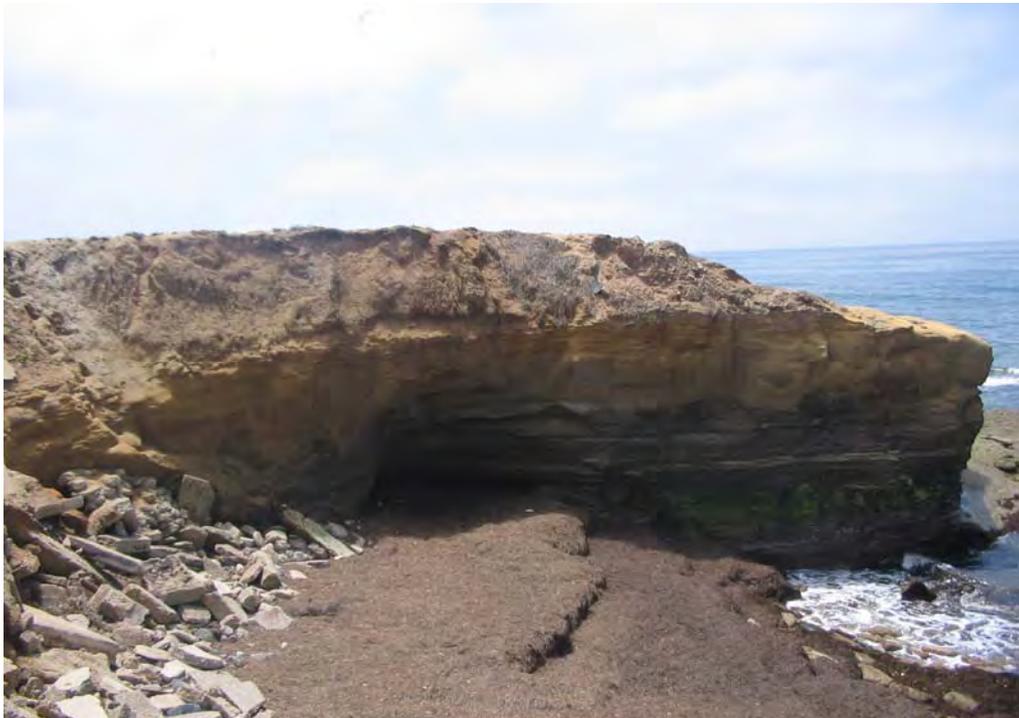
**Photo 2 –At northern boundary of SCNP, looking south, Site 10.**

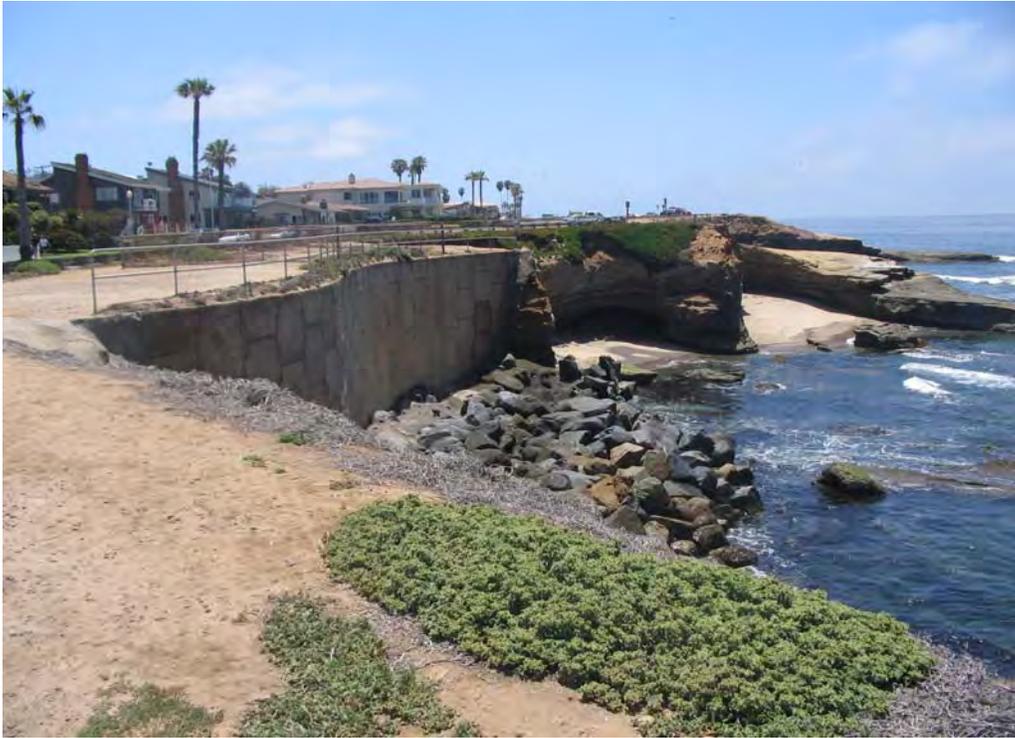
Two seawalls currently exist along the reach. Generally, the walls are performing well. Some repair needs to be considered along the abutments. These existing seawalls could be modified and tiered to a lower elevation, and colored and textured to appear more like the natural bluff formation. A new seawall could be constructed in the area just south of the northern seawall. These two walls could be tied together to create a more uniform structure. The seawall could be colored and textured to blend with the natural bluff face.

Photo 3 –Southern seawall, just north of Spaulding Point, Site 9.

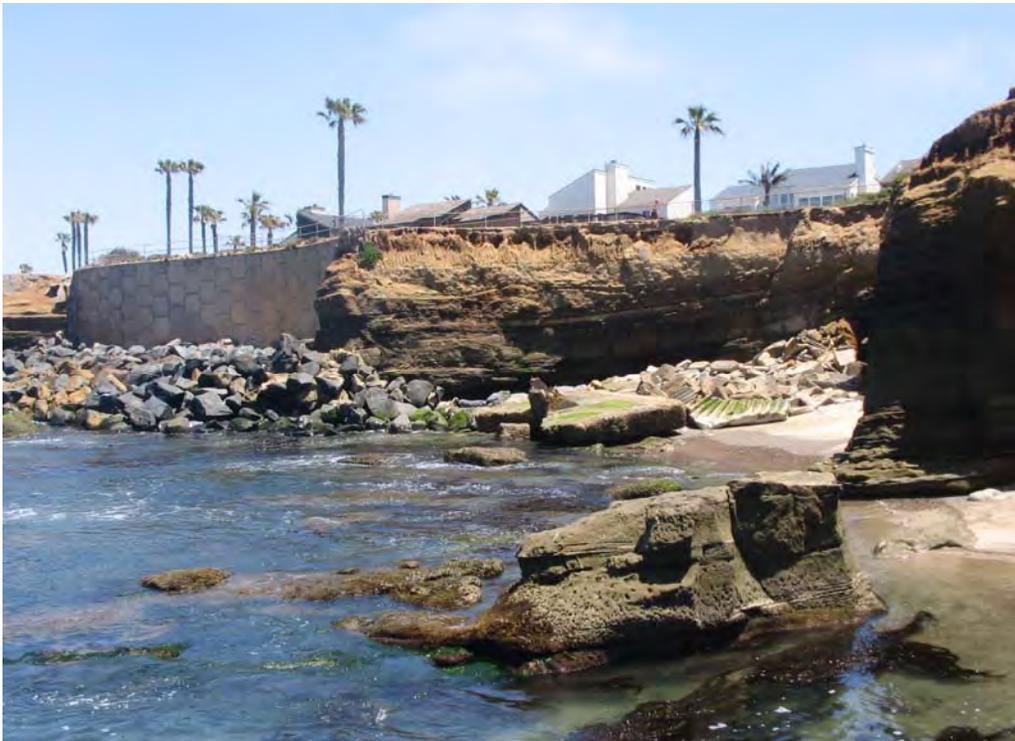
Photo 4 –Northern seawall showing location where a new seawall could be implemented, Site 9.

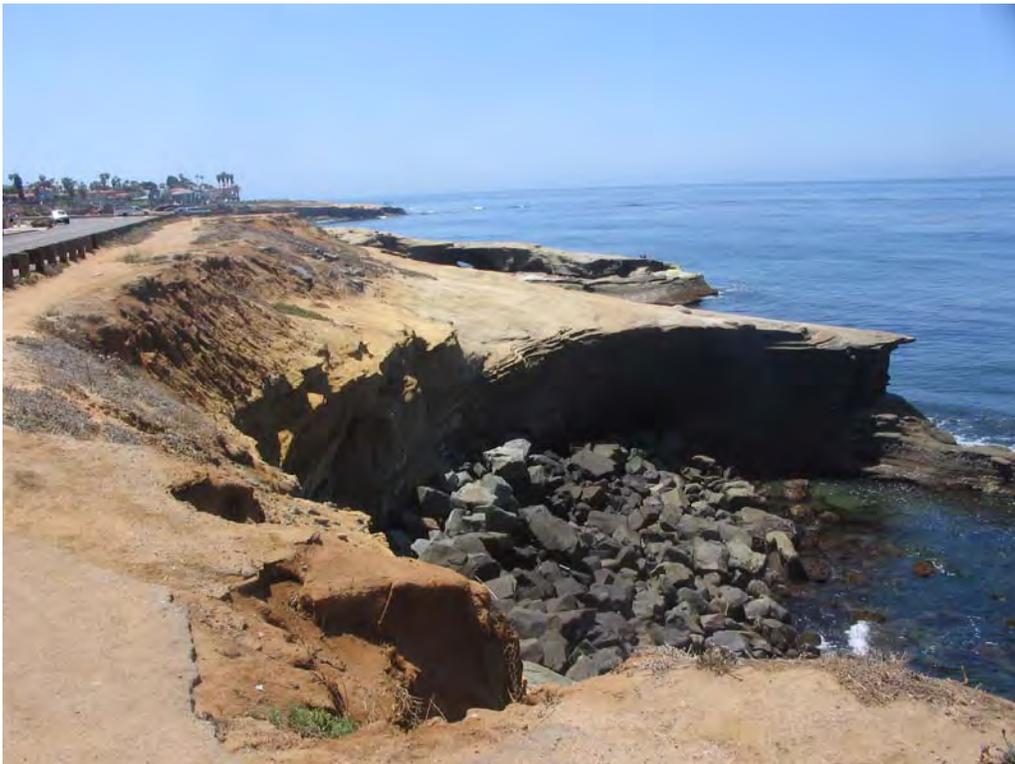
Photo 5 – From northern parking area, looking south along Site 8.

No seawalls are proposed along this reach, but upper bluff stability is recommended. This could include an injected grout or resin product as described in the previous sections.

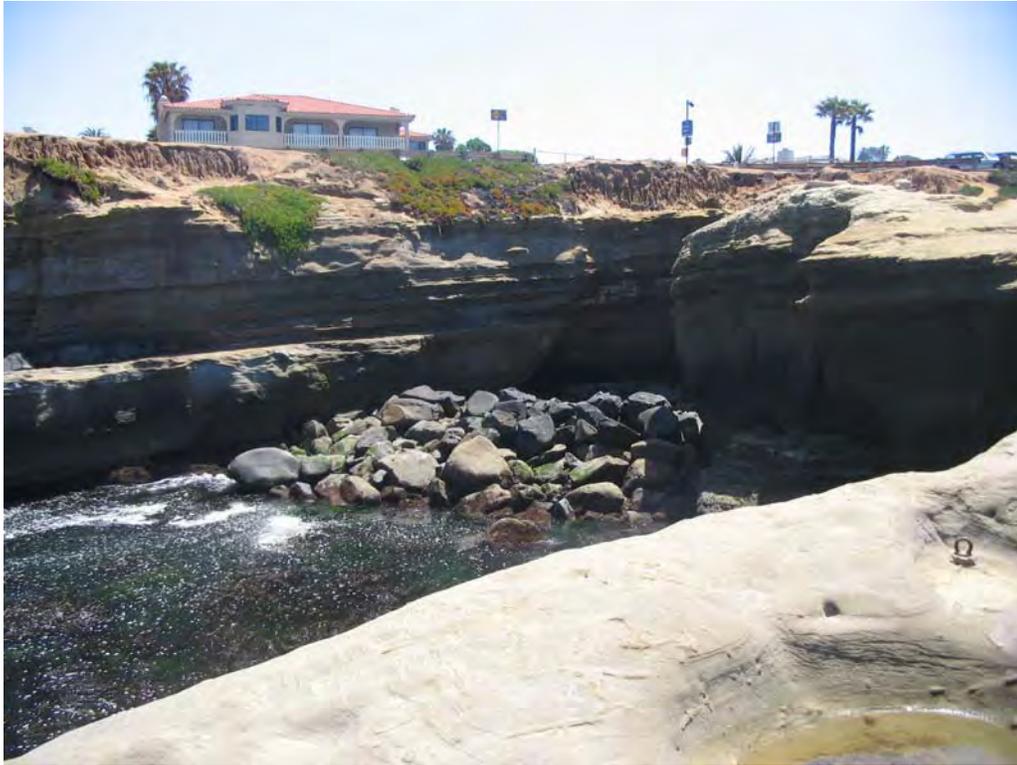
Photo 6 –At southern parking area, looking landward toward cave entrance, Site 8.

- There is a cave under the parking lot (pics 6 and 7). There was a whole looking down into/up through the cave and was filled with concrete on top to cover the whole in cave.
- Squirrels are a big problem and seem to be a large factor in increasing runoff-induced cliff erosion.
- Note: Need to differentiate between Natural Cliff Retreat and Non-Natural.

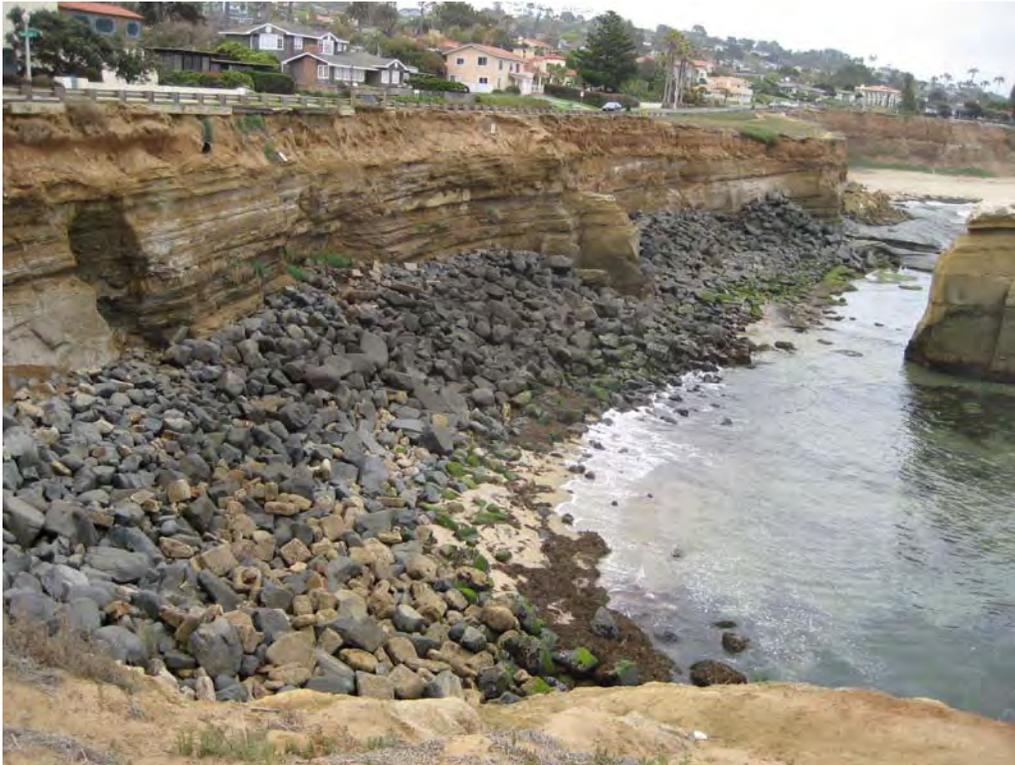
A seawall is another alternative that could be considered along this site because of the critically eroded upper bluff face. Similar to Site 6, there are areas where the bluff has eroded under Sunset Cliffs Boulevard, and public access is directed into the road. A seawall could reclaim a little of that needed public access route along the bluff top. The seawall would need to extend from the base to the top of the bluff and could be colored and textured to blend with the natural bluff face. A less intrusive alternative to a seawall would be to provide some upper bluff stabilization, such as an injected grout or resin product. This would slow the upper bluff erosion, but would not restore the bluff face. This product would need to be reapplied every one to two years and would not hold up well to extensive foot traffic.

**Photo 7 – Looking South at Site 7.**

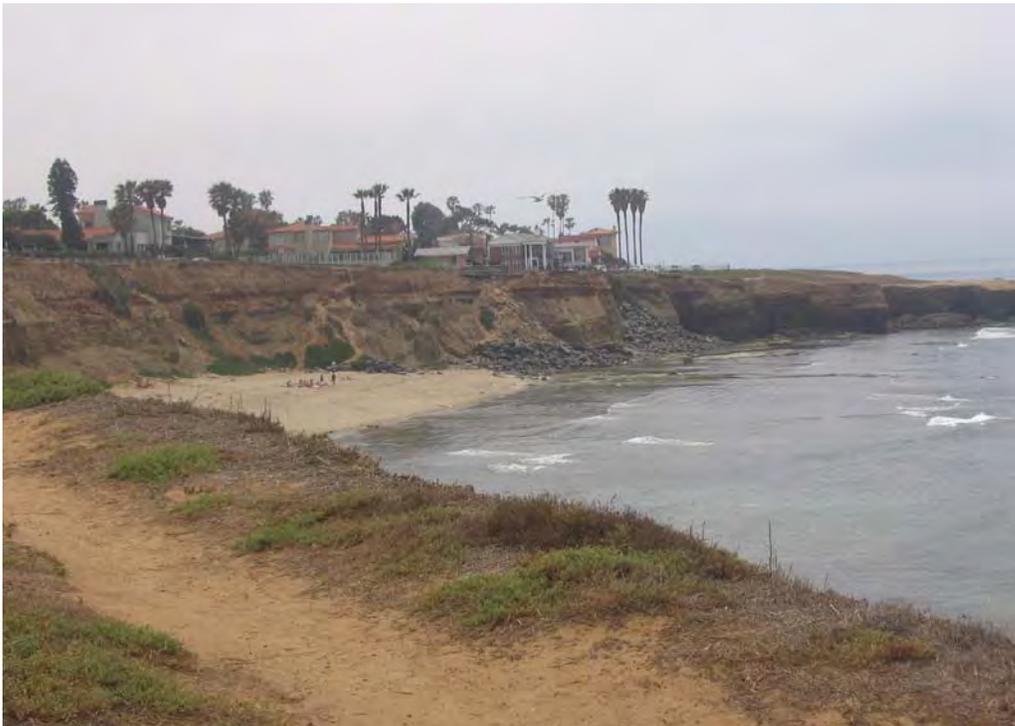
Seawalls are another potential alternative because of the critically eroded upper bluff face. There are many areas where the bluff has eroded under Sunset Cliffs Boulevard, and public access is directed into the road. A seawall could reclaim a little of that needed public access route along the bluff top. The seawall would need to extend from the base to the top of the bluff and could be colored and textured to blend with the natural bluff face. A less intrusive alternative to a seawall would be to provide some upper bluff stabilization, such as an injected grout or resin product. This would slow the upper bluff erosion, but would not restore the bluff face. This product would need to be reapplied every one to two years and would not hold up well to extensive foot traffic.

**Photo 9 – No Surf Beach, Site 6.**

Alternatives for this site include a beach fill and seawall. Since there is already an existing sandy beach area, creating additional sandy beach is feasible. It would be recommended to extend the sandy beach area to the north, over the existing revetment riprap and into Site 7. Extending the beach fill to the south is not recommended due to the extensive nearshore rocky reef area. The nearshore reef and perched beach alternative are not recommended for this site because they can create a public safety hazard since this beach site is used extensively by the public and because they can impact the rocky reef habitat area.

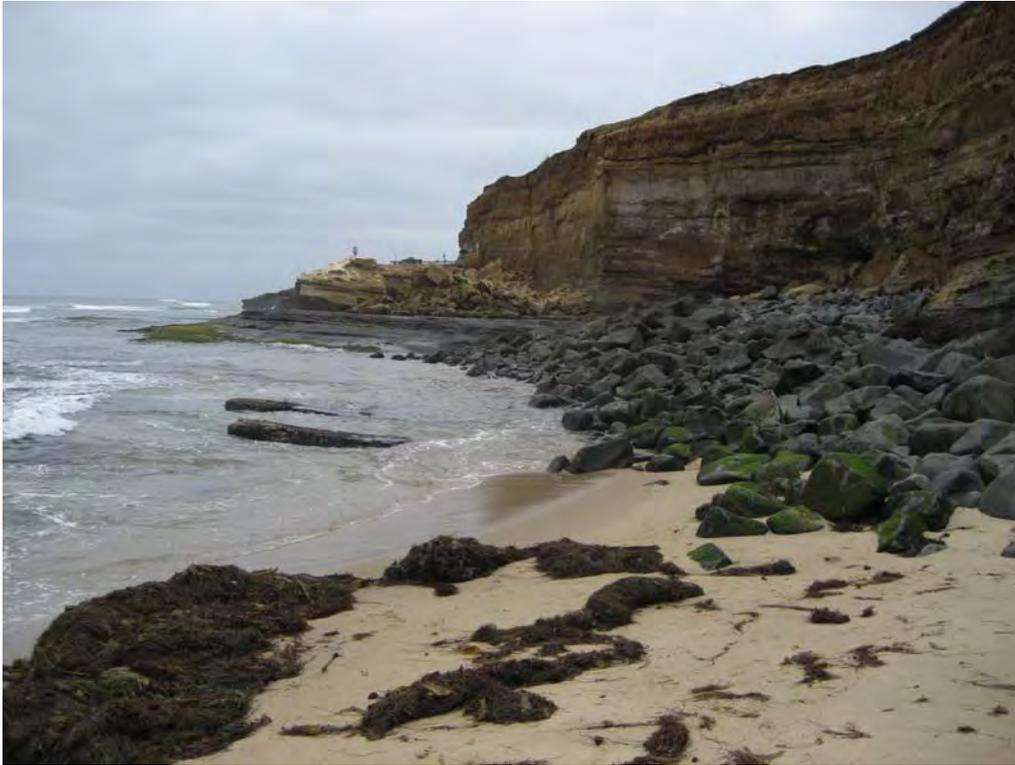
**Photo 10 – North end of Surf Beach, Site 6.**

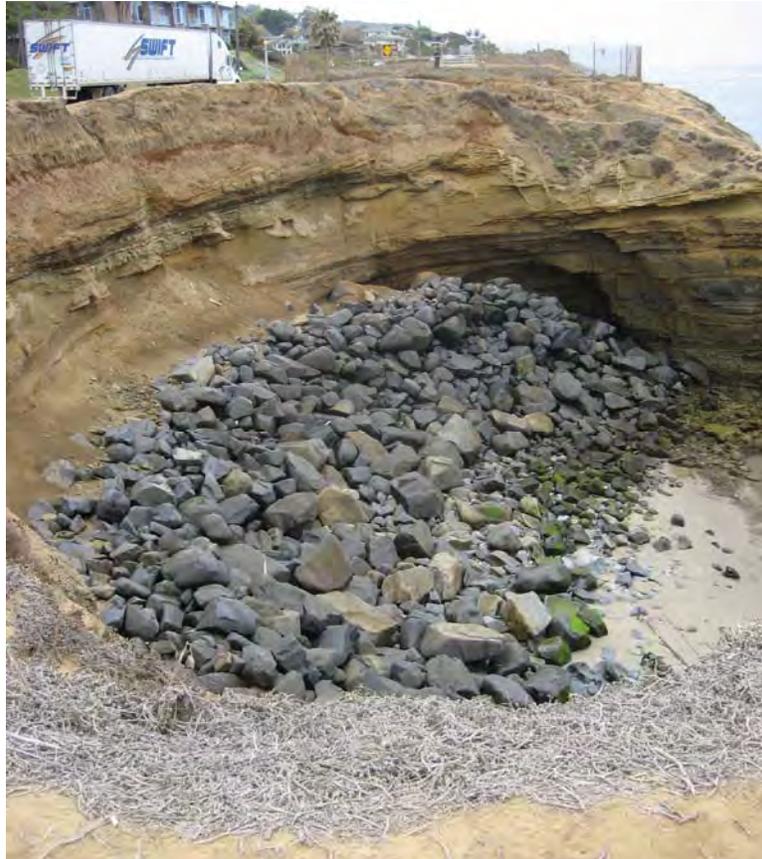
**Photo 11 – Small pocket beach just south of Luscomb’s Point, Site 5.**

The smaller pocket beach area south of the collapsed sea cave whole could also support a beach fill, nearshore reef, or perched beach. However, the sea arch cutting through the southern headland would need to be filled with rock or concrete to prevent any sand placed in the pocket beach area from being swept out by waves and tides through the arch.

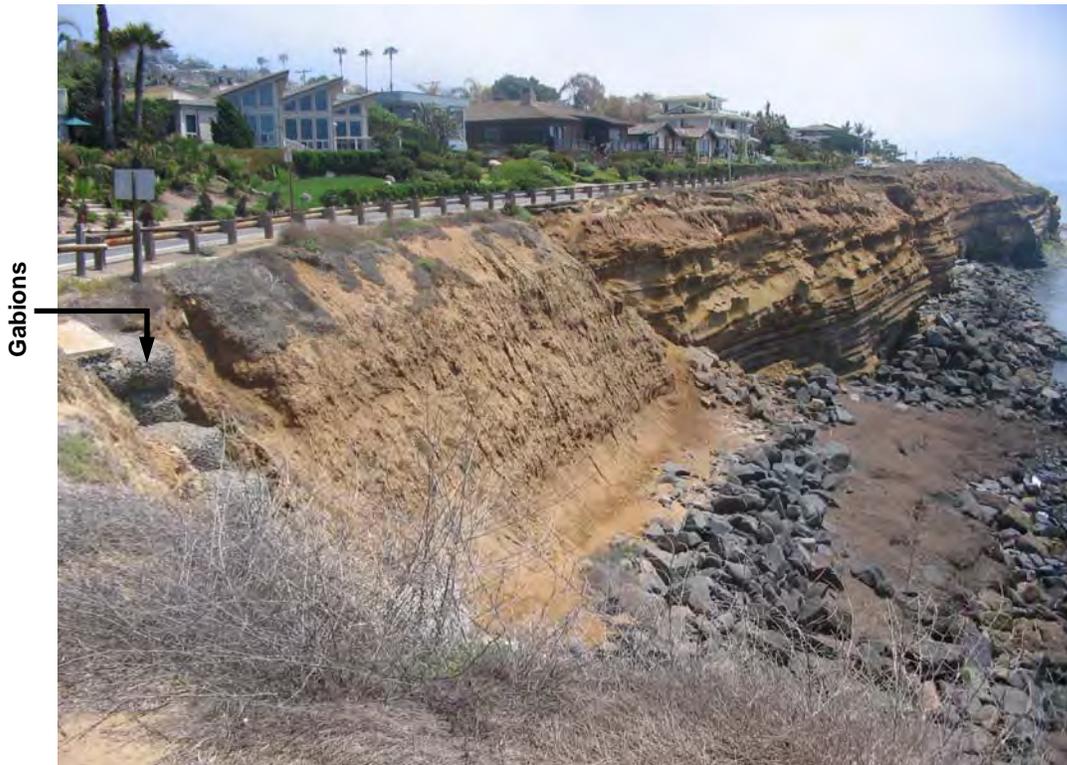
A seawall could be constructed along this reach, mainly because of the very narrow bluff top. In some areas, the bluff top is encroaching within the road way and public access is directed into the road. A seawall could reclaim a little of that needed public access route along the bluff top. The seawall would need to extend from the base to the top of the bluff and could be colored and textured to blend with the natural bluff face. A less intrusive alternative to a seawall would be to provide some upper bluff stabilization, such as a injected grout or resin product. This would slow the upper bluff erosion, but would not restore the bluff face. This product would need to be reapplied every one to two years and would not hold up well to extensive foot traffic.

**Photo 12 – Site 4 view south of Monaco Street**

A beach fill or nearshore reef could be constructed along the reach over the existing revetment structure. Because of the long and straight coastal alignment, the beach fill alternative would not be expected to retain sand for long periods and frequent renourishment would be required. A nearshore reef along this area would be extensive, but could create a good surfing environment. Either alternative, although feasible, would be difficult to permit due to the extensive nearshore rocky reef that exists just offshore. A perched beach is not recommended at this site because of the site's long reach. Constructing a perched structure would be extremely expensive for such a long reach.

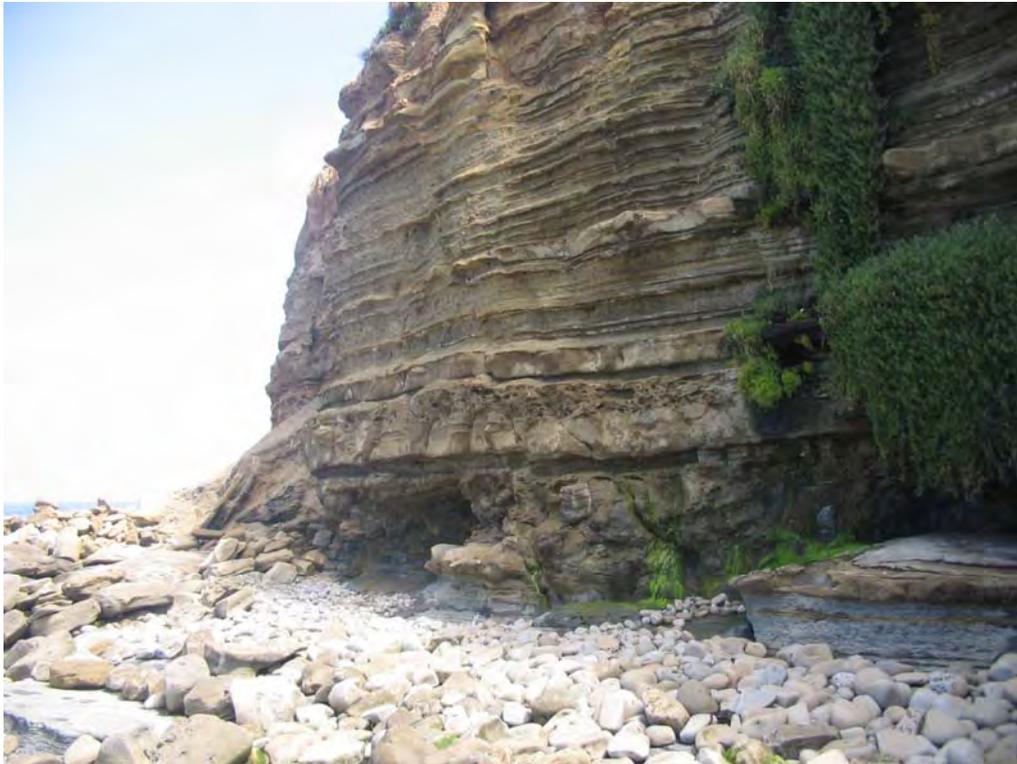
Site 3 extends from Ladera Street north to Carmelo Street and includes a high and narrow bluff top fronted by armor and rock at the toe (Photo 4). Figure 6-5 illustrates the extent of the reach. This site has a risk rating of Low and the only recommendation is to fill the sea cave just south of Carmelo Street with either riprap or concrete, as recommended in the City’s Coastal Assessment. Although no other alternatives are considered for this reach, the recommendation of the Coastal Assessment should still be considered because this seacave extends under Sunset Cliffs Boulevard. However, this is low-priority because of the slow rate of marine erosion. No other alternatives are considered viable for this section of coast. This is the only location where a revetment is considered applicable.

Photo 13 – Site 3 view north from Ladera Street Stairway

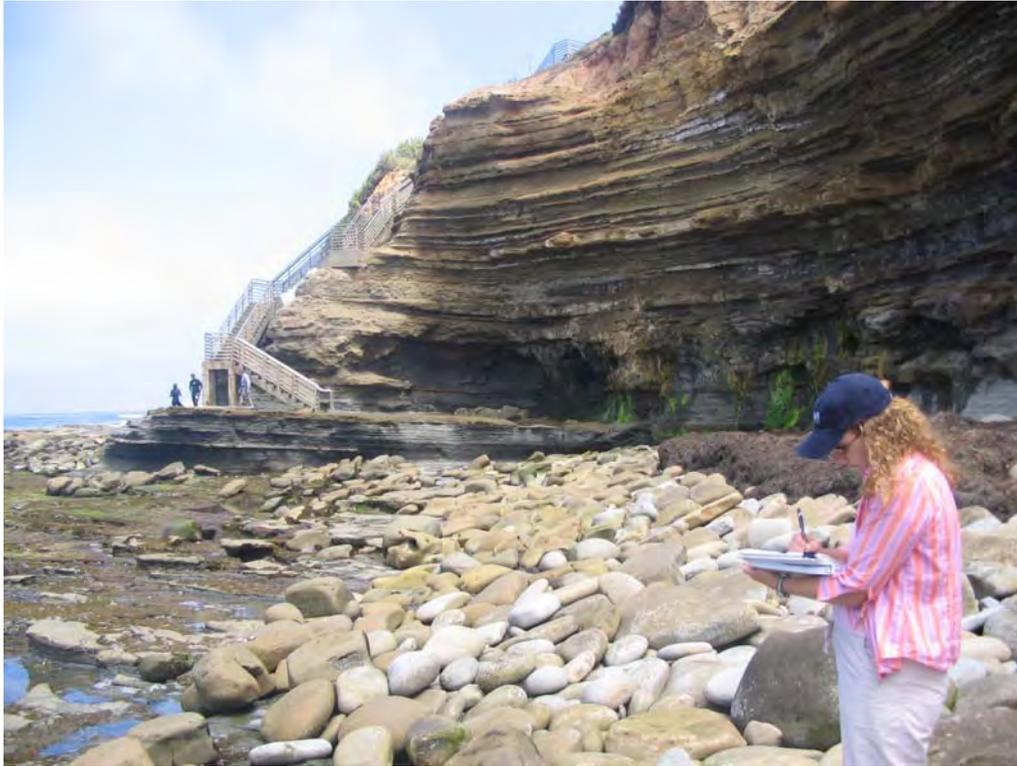
This site is the small area directly around the Ladera Street stairway (Figure 6-5). A new stairway is proposed as part of the SCNP Master Plan and therefore the existing stairway would need to be demolished and removed. Any new stairway may require a small, site-specific protective device to ensure its design life and stability. This could be a small seawall structure

**Photo 14 – Site 2, Access Stairway at Ladera Street**

that could be incorporated into the stair structure design and not a stand-alone structure. The stairway external face could be colored and textured to match the existing bluff face, but this is probably not practical at this location since the prime vantage point of the stairs is from the top of the bluff.

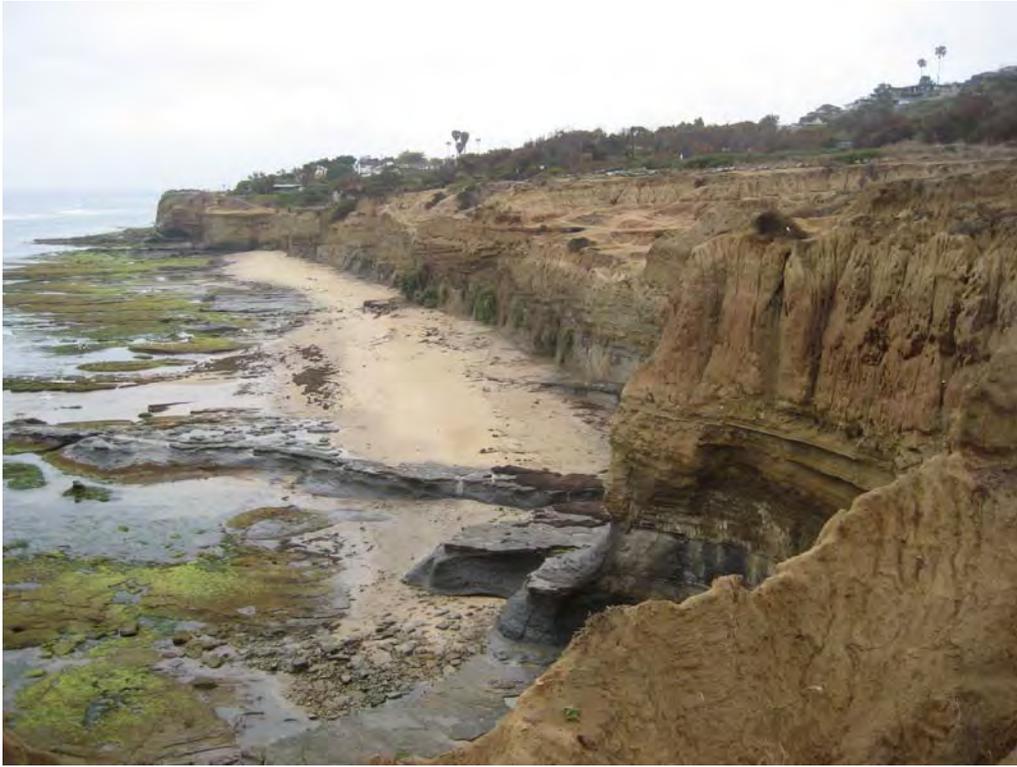
This section extends from Ladera Street to the southern boundary of SCNP (Figures 6-5 to 6-7) and has an overall risk rating of Low. Photographs 1 and 2 are from Site 1. The City’s Coastal Assessment does not contain any recommended action items. The majority of the erosion of the bluffs along this reach is from storm water discharge. Coastal processes are present, but do not contribute to the majority of the erosion issues present. Once the upland storm water system is redesigned and constructed, the bluff erosion will slow significantly. No shore- or bluff-protection alternatives are recommended for this site. The only structures that should be incorporated into this site are public access and properly designed storm drain outfall structure(s). The public access should be designed to prevent further bluff erosion from foot traffic.

**Photo 15 - View North at Garbage Beach, Site 1.**

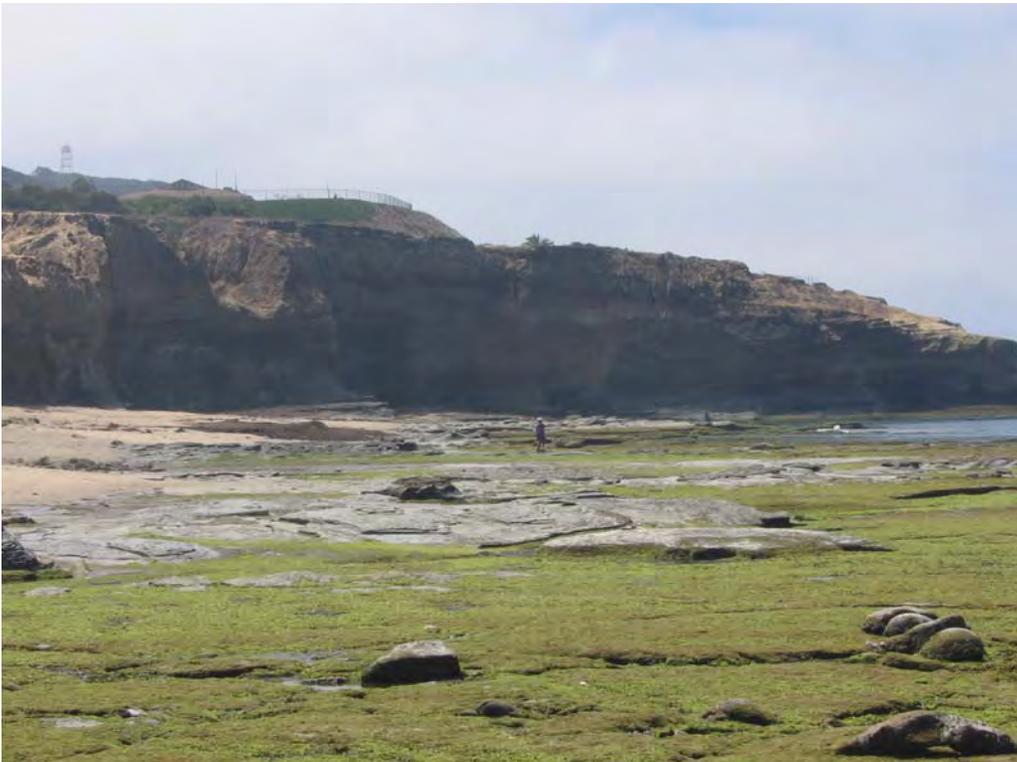
**Photo 16 - View South of Site 1**

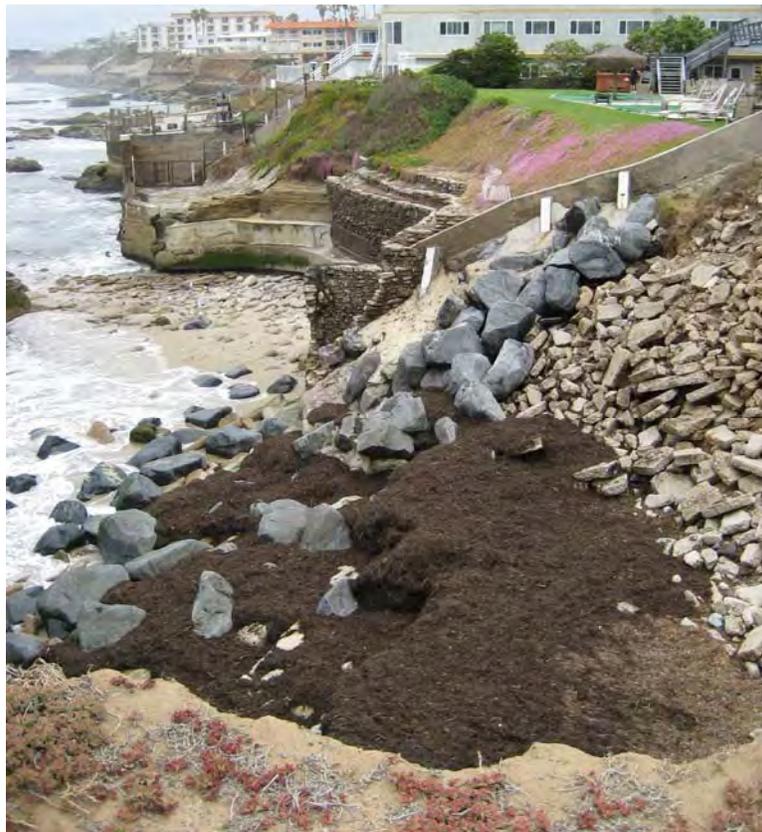
Photo 17 – Adair Street street end.

Because the pocket beach is narrow, the alternative best suited would be to extend the outfall pipe into the nearshore, past the southern headland. This would prevent any storm water flow to erode the headland to the south. The outfall pipe could be buried under the existing sand and covered with a textured surface to blend with the natural sandy and nearshore rocks.

Riprap or concrete dissipating structures could also be constructed here, but would need to be designed to ensure that the high-energy flow did not contribute to erosion of the headland area.

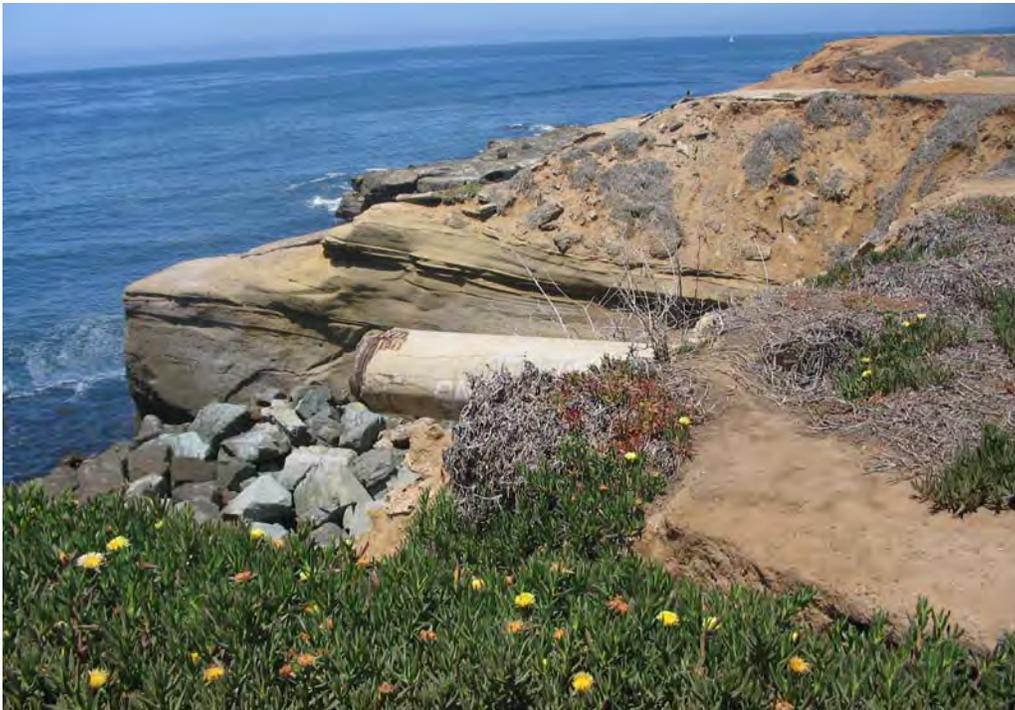
**Photo 18 – Osprey Street street end.**

Alternatives that could be applied that this location include a riprap apron or concrete dissipating structure and extending the outfall into the nearshore area. Internal dissipation may be applicable at this site because of the longer length between the catch basin location and the outfall location. Some of the existing riprap could be used to construct a riprap dissipating apron, however the structure should be constructed as far seaward as possible to prevent scour erosion at the base of the bluffs to the north and south. The eroded bluff could be restored with backfill material. Public access impacts resulting from an outfall structure are not an issue at this site, because public access to the beach is currently limited under existing conditions. The outfall should be aligned to minimize aesthetical impacts from viewers up- and down-coast and appropriate color and texturizing would help minimize any visual impacts.

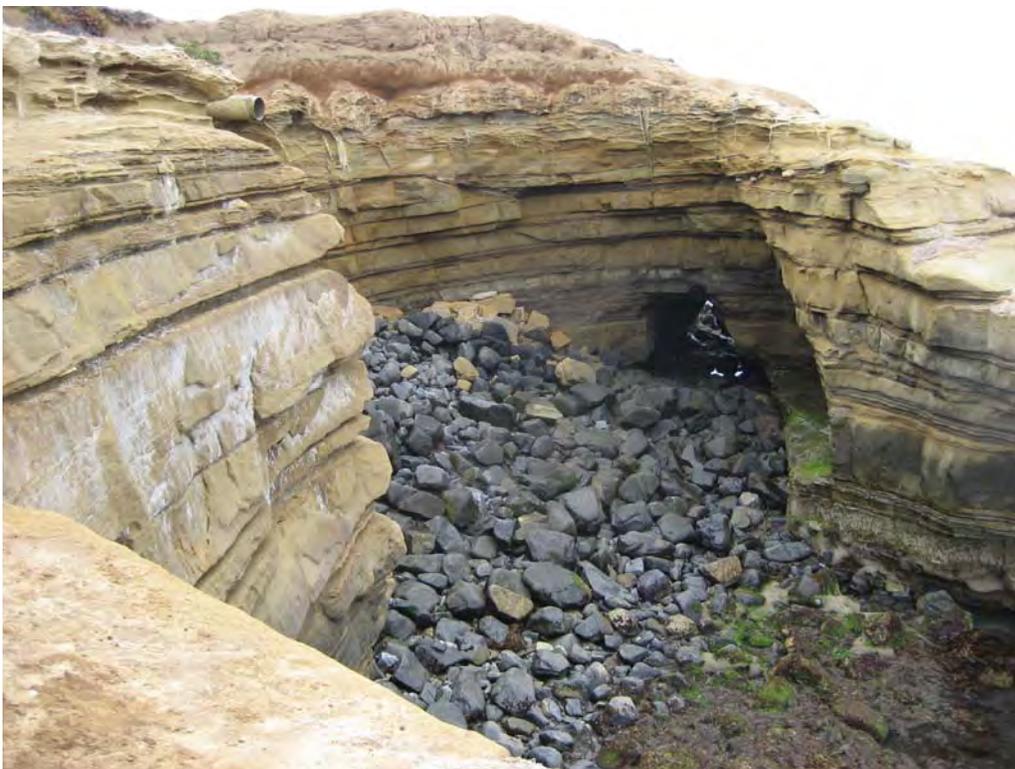
However, there is concern that an outfall located at the base of the bluff could create flow conditions that can contribute to the erosion of the headland area to the south of the cove (see Photo below). It may be best to situate the outfall structure further seaward, near this headland to minimize erosion from storm water flow. The site may be better suited to extend the outfall pipe into the nearshore, past the southern headland. This would prevent any storm water flow from increasing the erosion to the bluff face and headland. The outfall pipe could be buried and covered with a textured surface to blend with the natural seascape.

**Photo 19 – Monaco Street street end.**

located at the base of the bluff and some could be removed during the construction of an outlet at this location. However, it may require a crane operation to move, remove, or realign the riprap. Some of the existing riprap could be re-used for a riprap apron dissipation structure at the base of the bluff.

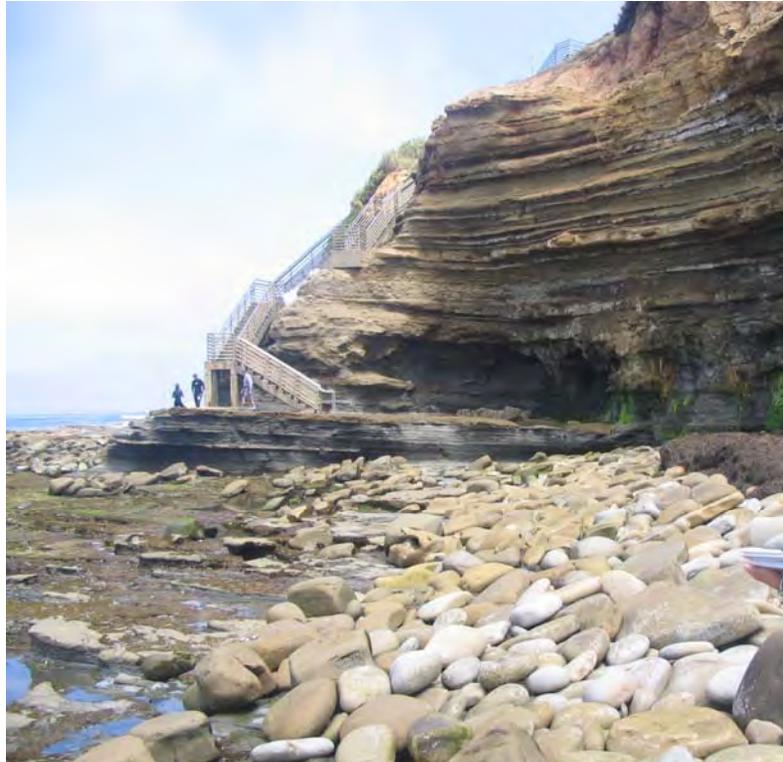
**Photo 20 – Ladera Street street public stairway.**

The Ladera Street Access Stairway is the proposed location for Outfall #4. This is the most-difficult location along Linear Park for construction access and staging. The bluffs here are near vertical and higher than the locations to the north. It would be best to incorporate the outfall structure into the proposed new stair structure to minimize the number of structures in the coastal environment. This site would be best suited with a riprap apron or concrete dissipating structure that can be incorporated into the base of the new stairway design. Some of the existing rock located at the bluff base could be incorporated into the structure, if needed.

Extending the outfall into the nearshore area is not advised at this location because of the public safety impact this may pose to the surfers and other beach users accessing this location.

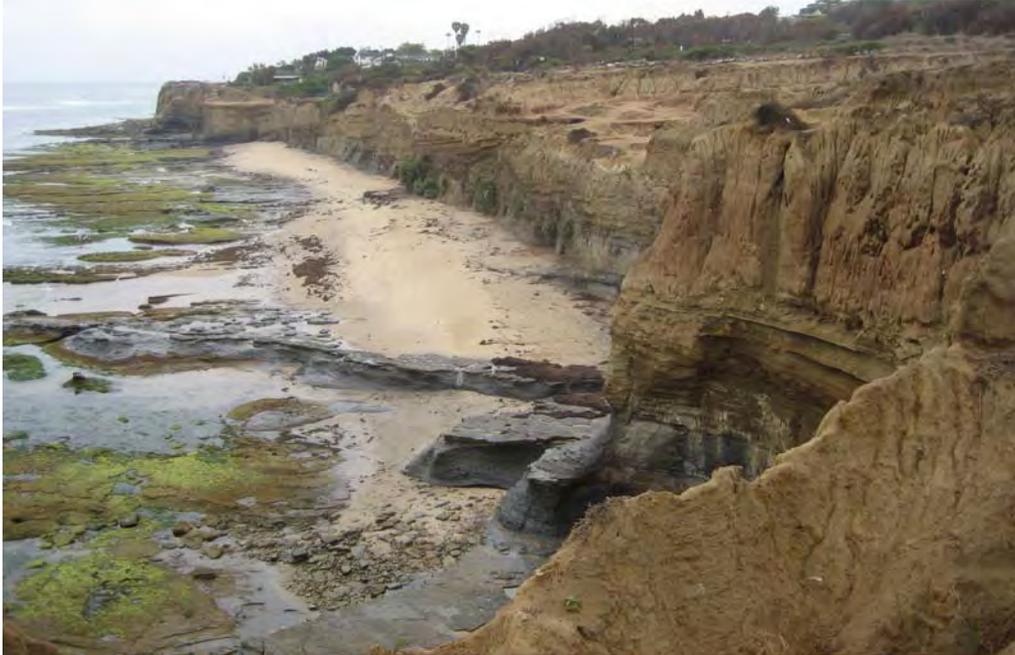
Outfall #5 is located toward the end of the sandy beach area of Garbage Beach and shown in Photo 21 and Outfall #6 is located around the headland point, and approximately 450 feet north of the SCNP southern property boundary (Photo 21). Both of these locations are similar in that there is a sandy beach below a very high bluff. Access to the beach would be extremely difficult from either location. A very large crane or helicopter may be required to bring equipment and supplies to the beach for construction of an outfall structure.

**Photo 21 – Photo showing Garbage Beach (Outfall 5 location on S. end).**

A concrete or riprap dissipation structure would be the two better alternatives for an outfall at either of these sites. If a beach-access route is incorporated into either of these locations, then the outfall structure could be incorporated into the design, minimizing the number of structures along the coastline. It is noted, that during times of high flow velocity, beach scour may occur from the outfall across the beach to the waterline. The southern end of Garbage Beach has some exposed bedrock that could help serve as a natural scour prevention surface, but some of the sandy beach area around the outfall structure and to the waterline will scour unless the apron is

adequately designed. To minimize the risk of beach scour, the dissipating structure should be designed adequately, which may result in a larger structure along the bluff base. Incorporating internal energy dissipators in the outfall pipe can reduce the velocity of the pipe and may help in reducing the size of the structure.

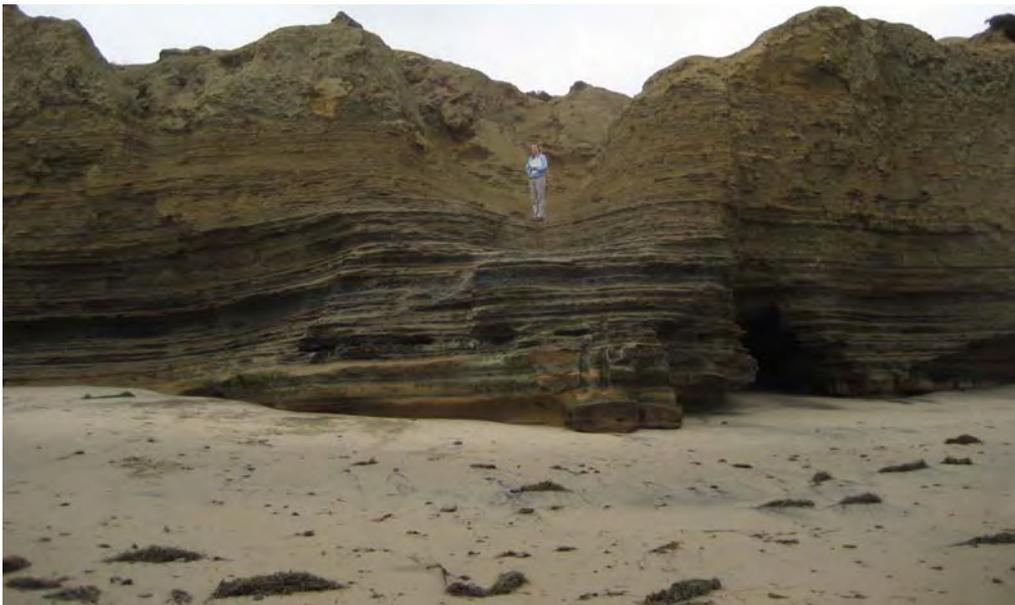
**Photo 22 – Site for Proposed Outfall 6.**

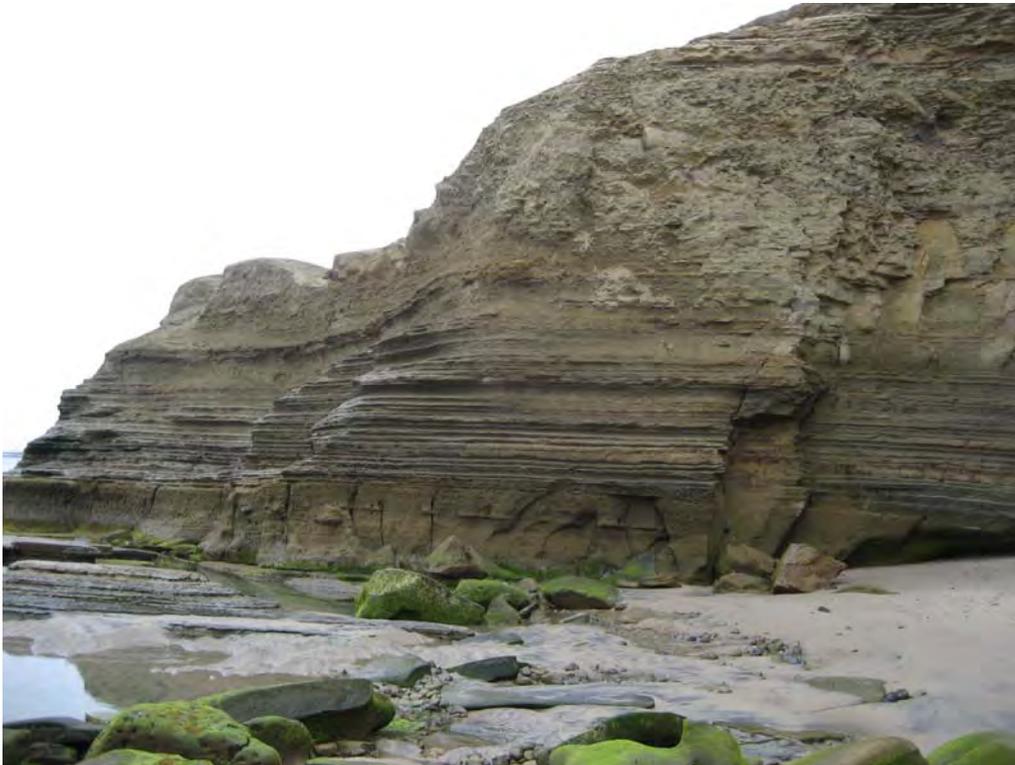
**Photo 23 – Site for Proposed Outfall 5/6 Alternative.**

This is a combined outfall to replace #5 and #6 and is proposed at the headland area at the south end of Garbage Beach. Although constructability, cost, and construction access access may be more of an issue because the headland extends further into the Pacific, it may be a more suitable location from environmental, aesthetic, public acceptance, and public beach access aspects.

An outfall structure could be constructed into the base of the headland which would direct the storm flow out toward the ocean and minimize any beach scour impacts from the storm flows. The flows could be slowed using internal dissipating devices inside the discharge pipe before it gets to the outfall structure, which may result in smaller design for the outfall dissipating structure. Either a concrete or riprap apron structure could be incorporated into this outfall location. The structure could be colored and textured to match the existing seascape.

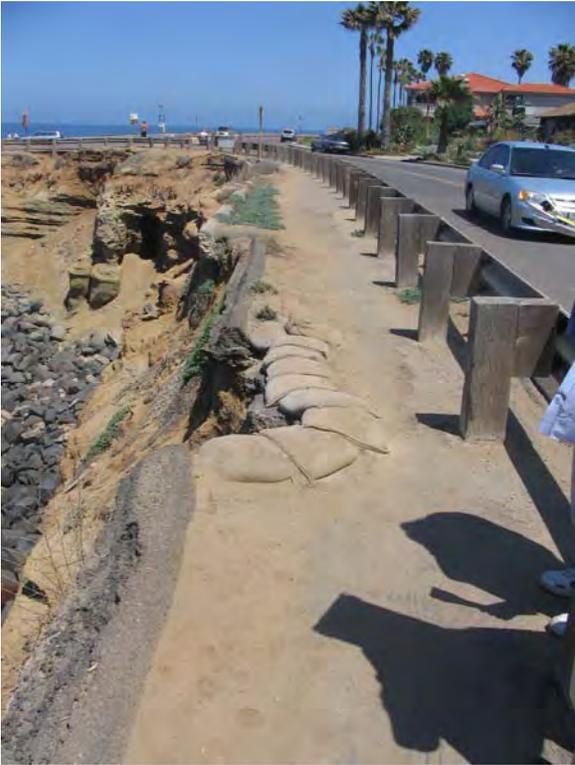
PH1: Sandbags at the end of Fronde Street to prevent runoff over cliffs

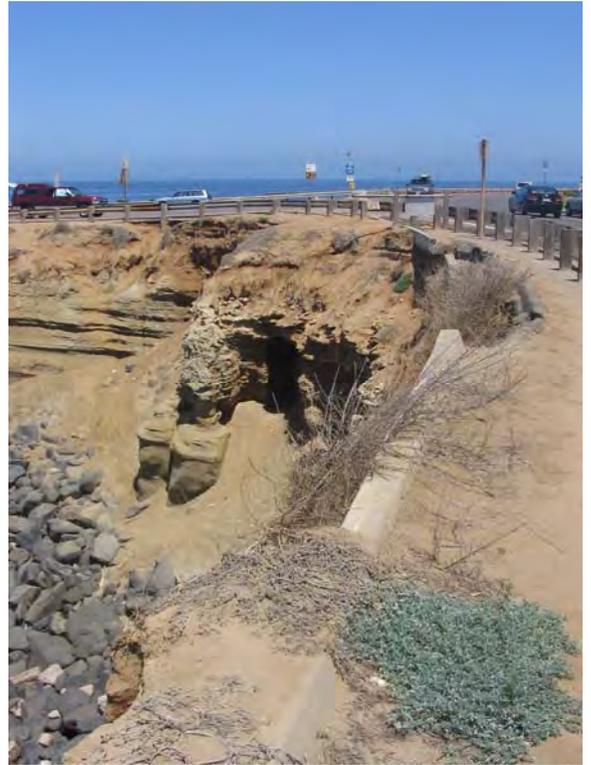
PH2: New (<10 year) cave forming.

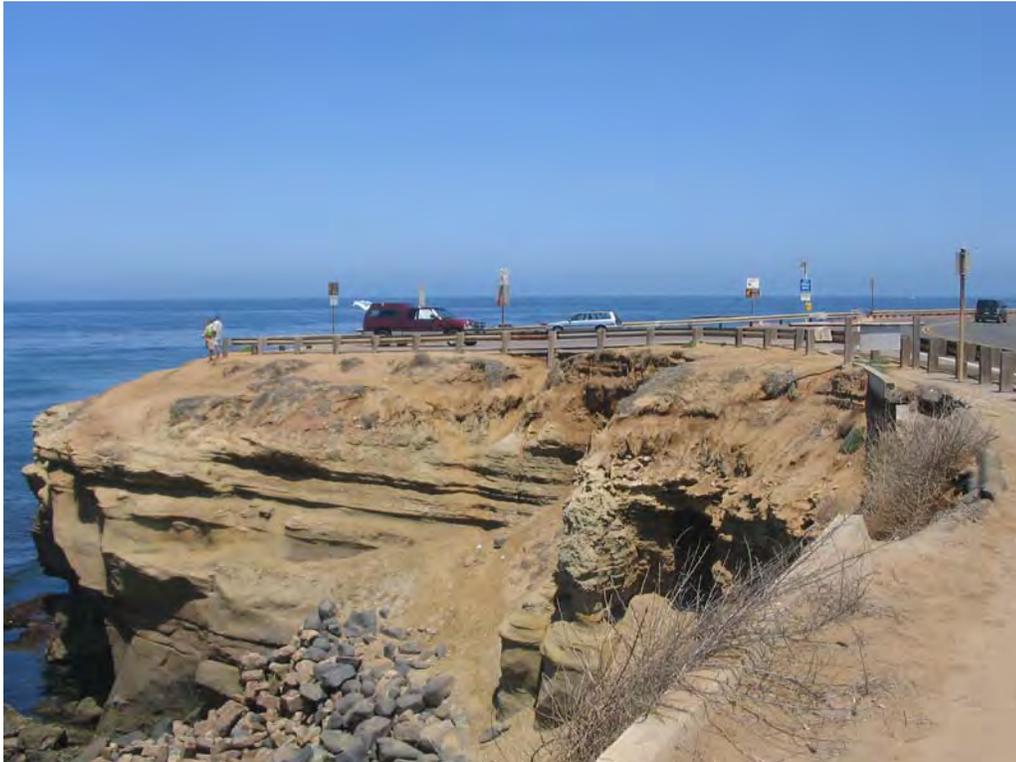
PH3: Parking at Froude Street slopes seaward; therefore all drainage runs over cliff. Concrete stairs used to exist to get to the cave and were replaced in the 1940s (these lasted 10-15 years). In 1915, near the corner of the parking, there was a little building there (this is where there was a lot of bluff erosion).
