## SUNSET CLIFFS NATURAL PARK

Drainage Study

September 2012

**PREPARED BY**  
Dudek  
605 Third Street  
Encinitas, CA 92024  
800.450.1818  
[www.dudek.com](http://www.dudek.com)

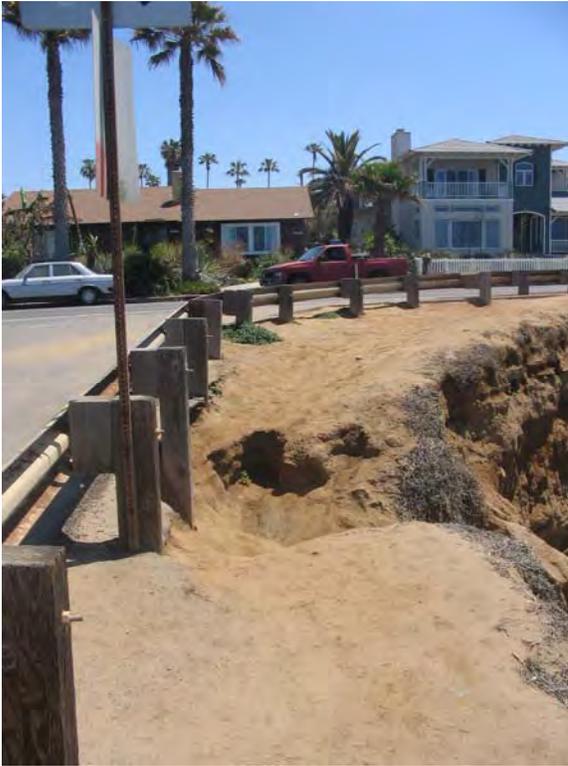
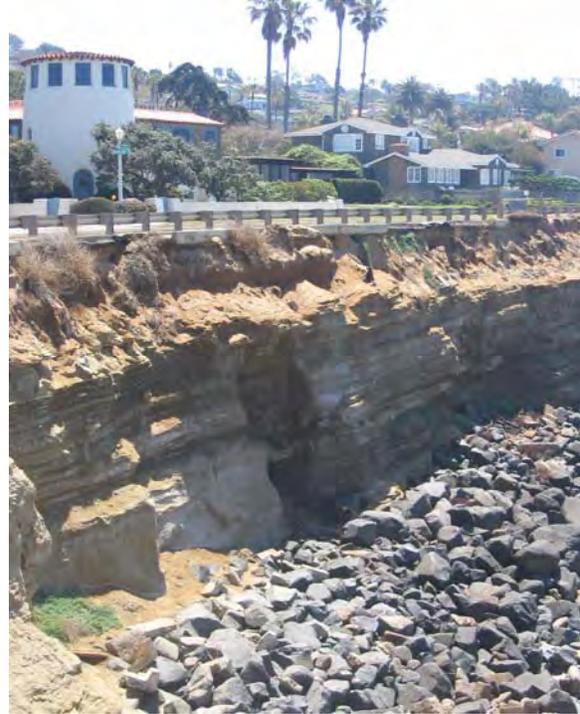
PH6 &7: Bluff Top erosion. 5 years ago this was very small and now it is large and you cant walk over it anymore. 5 years to create this hole.

- There is a cave under the parking lot (pics 6 and 7). There was a whole looking down into/up through the cave and was filled with concrete on top to cover the whole in cave.
- Squirrels are a big problem and seem to be a large factor in increasing runoff-induced cliff erosion.
- Note: Need to differentiate between Natural Cliff Retreat and Non-Natural.

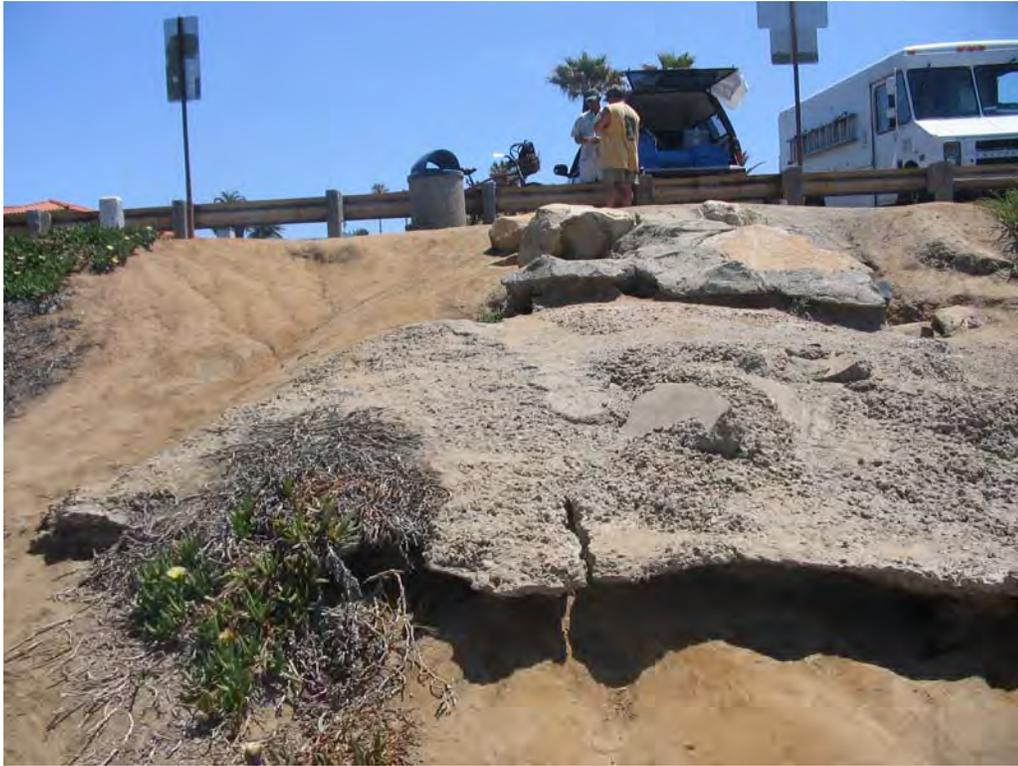
PH8: showing concrete and eroded gullies from rain run-off from the parking lot.

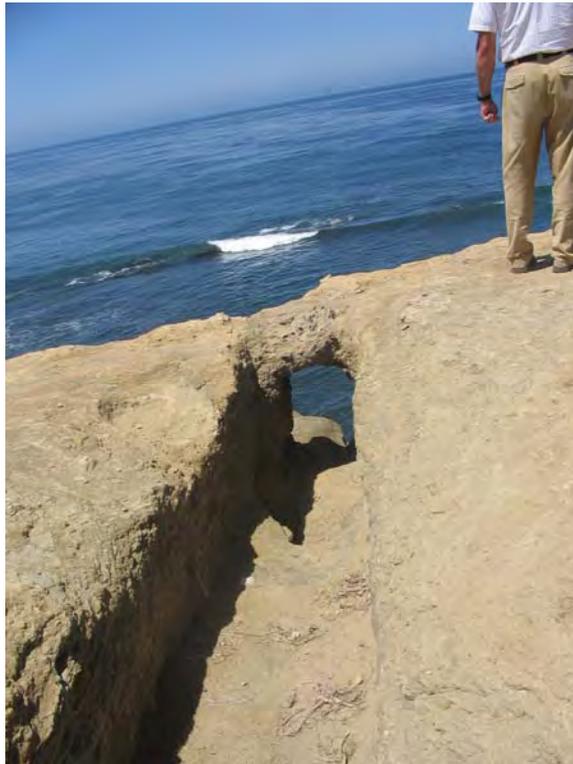
PH9: Remnants from a 1915 wooden drainage structure.

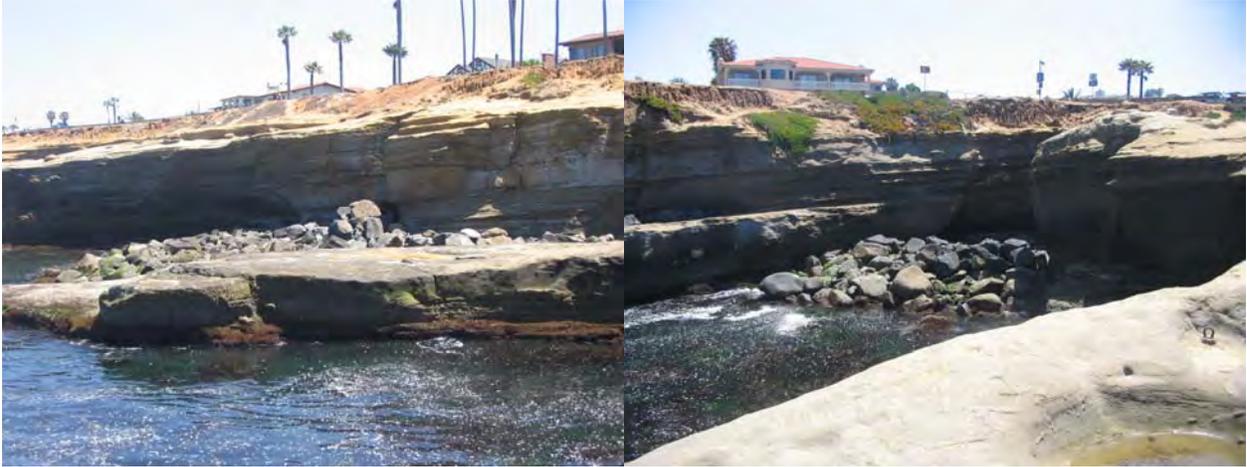
PH10/11: Riprap to fill coves. In 1984, the Corps filled in all the crevices and eroded areas along entire SCB stretch.

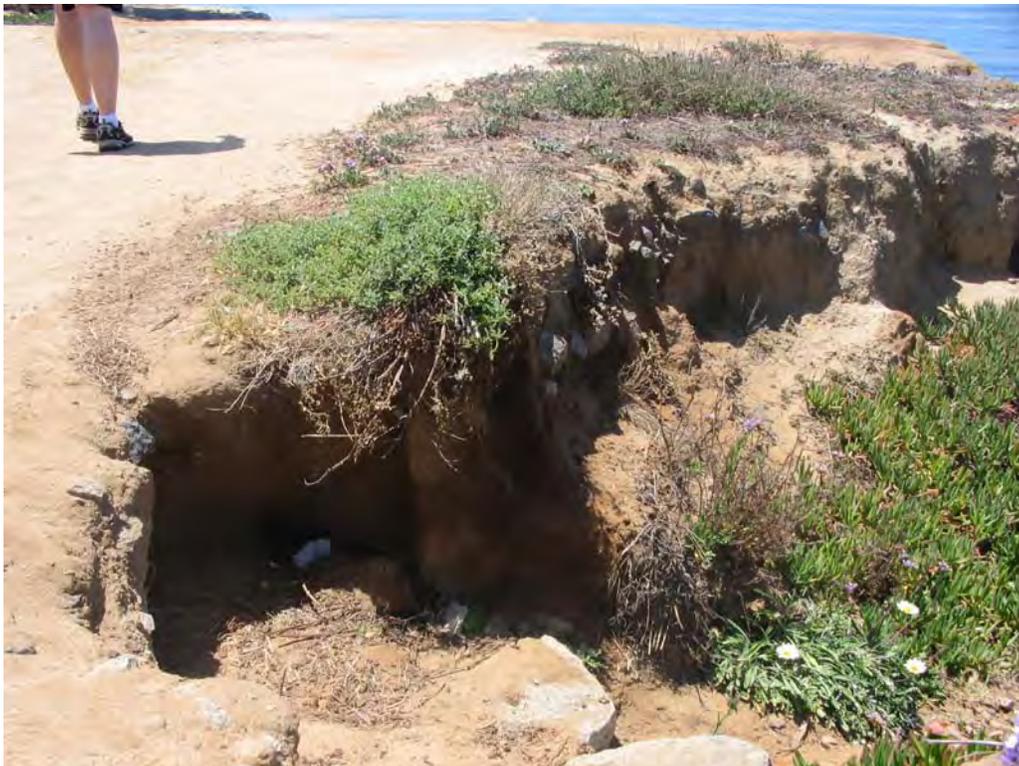
PH 12: There is un-natural fill material placed on the top of the bluffs from the Corps during the same 1984?

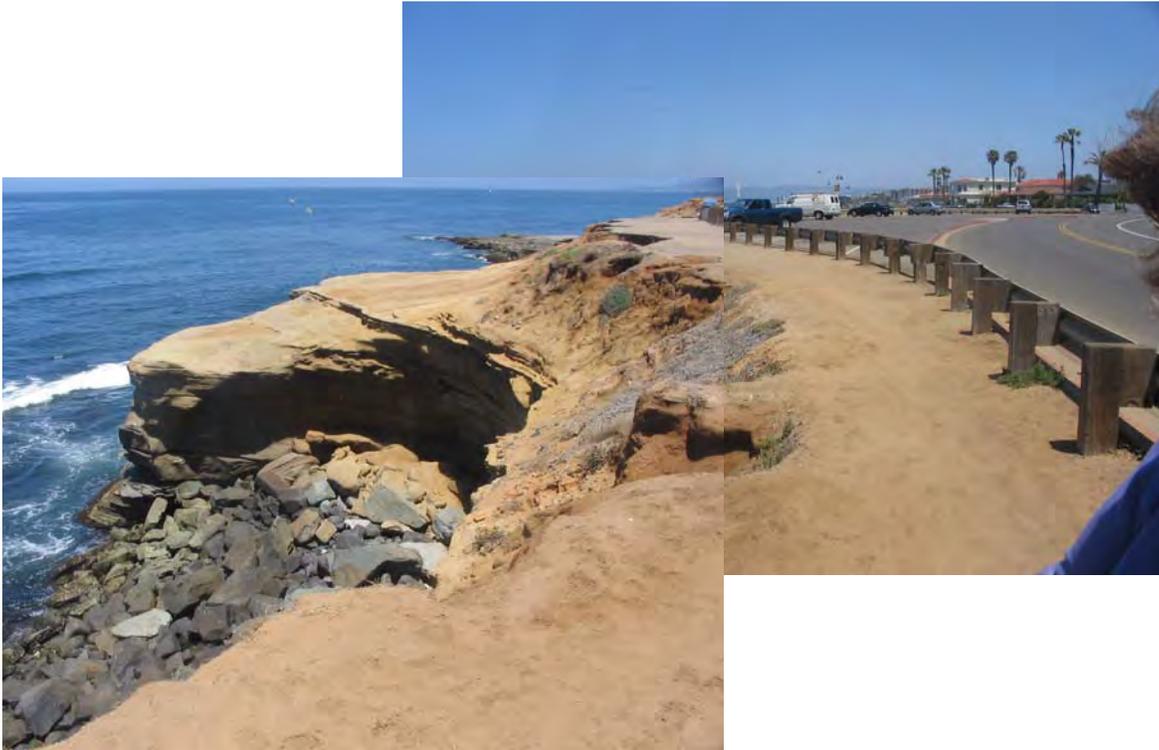
PH13/14: riprap placed by the Corps in 84/86. Parking lot at Osprey.

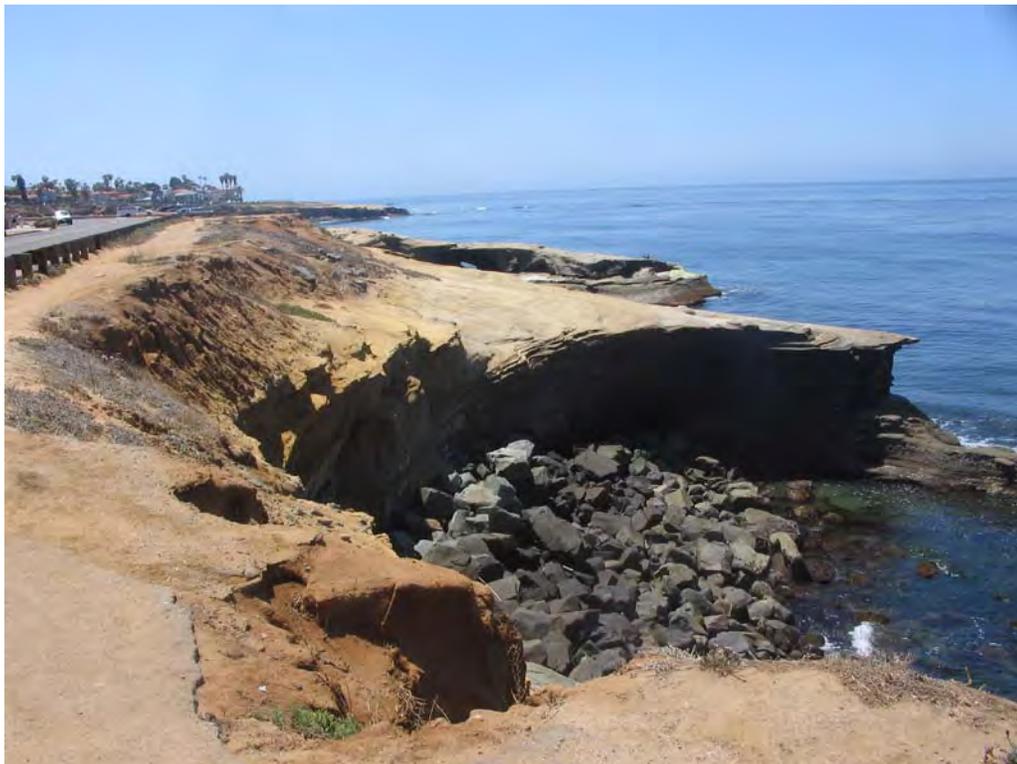
PH15: (From parking lot at Osprey). Dedi used to walk across these two points as a kid, it used to be straight across. It has since eroded into a small cove area and rip-rap has been placed at foot of bluff in cove.

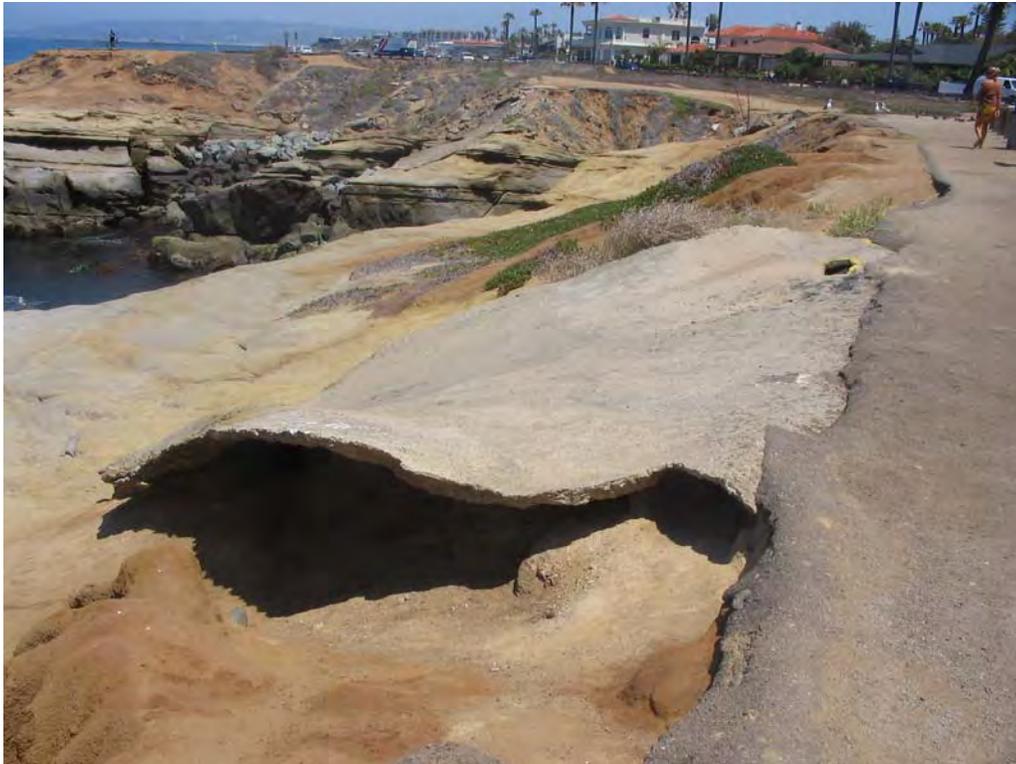
PH16: Concrete slab placed as a (failed) attempt to control run-off erosion (at Osprey). Flow was supposed to go over it, but as shown, it has scoured around it. Rodents live under these structures as they provide extra protection.

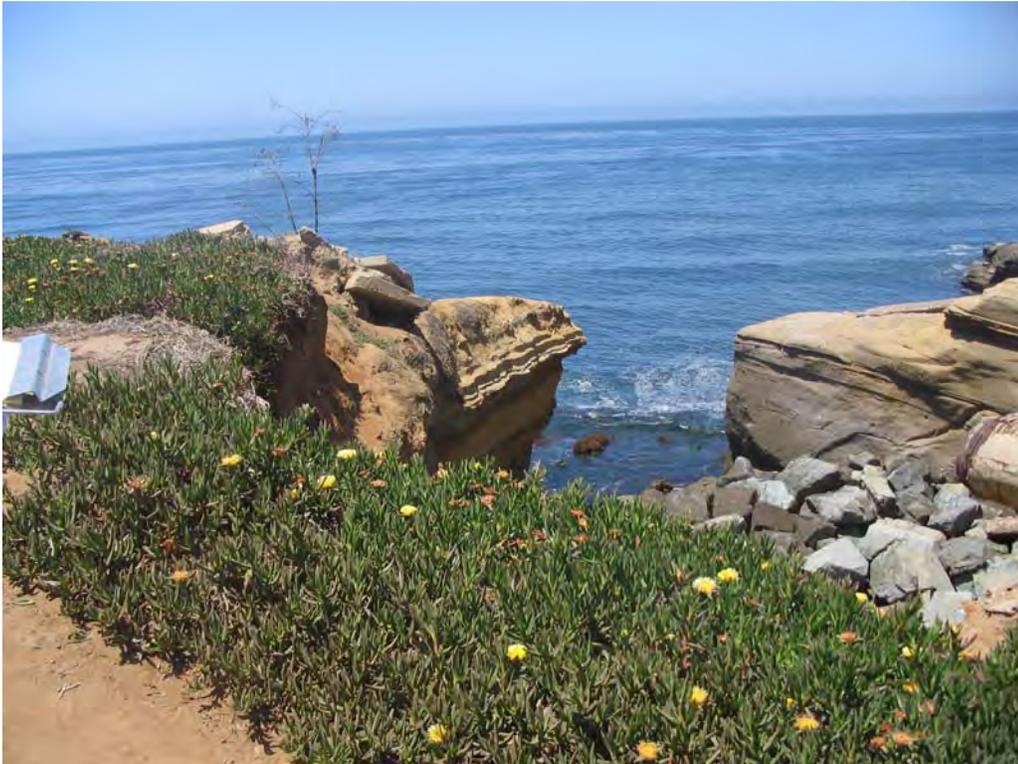
PH19: at Osprey street: rubble at the end of the point. Needs to be removed.  
*Does this increase erosion from the added weight of riprap/rubble on top of the bluff?*

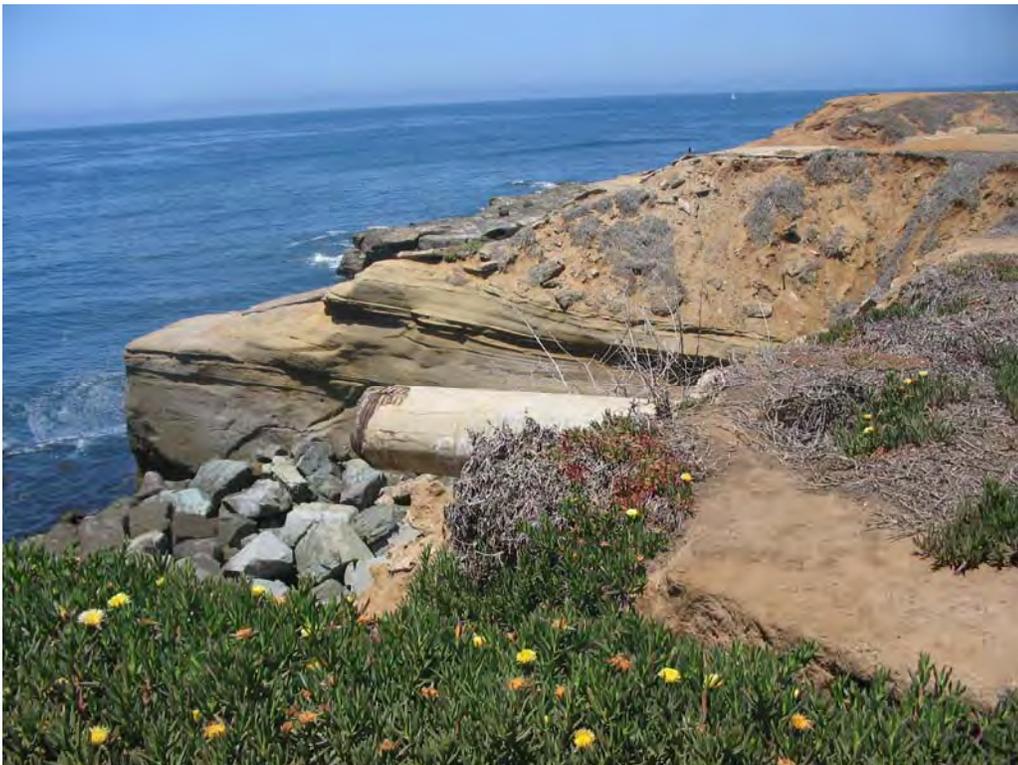
PH20: Osprey drain pipe filled below with rip-rap. Drain pipe to be removed with new plan.

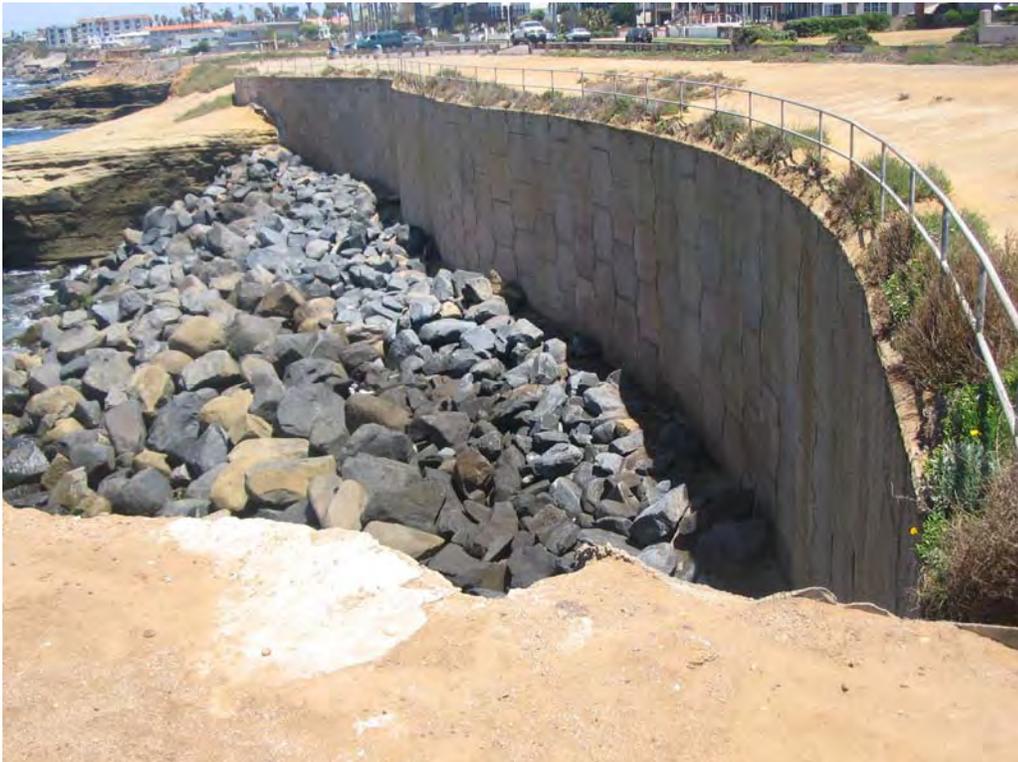
PH24: USACE sea wall/riprap. There was a cove behind it that extended close to the road. The Corps built the wall farther seaward and filled behind it. The fill appears to be quarry rock and dirt. ***Dedi would prefer to see this are be used as a parking area, since it is 'man made' and it would be hard to restore this are to natural conditions. Natural vegetation would have a hard time growing over the fill material.***

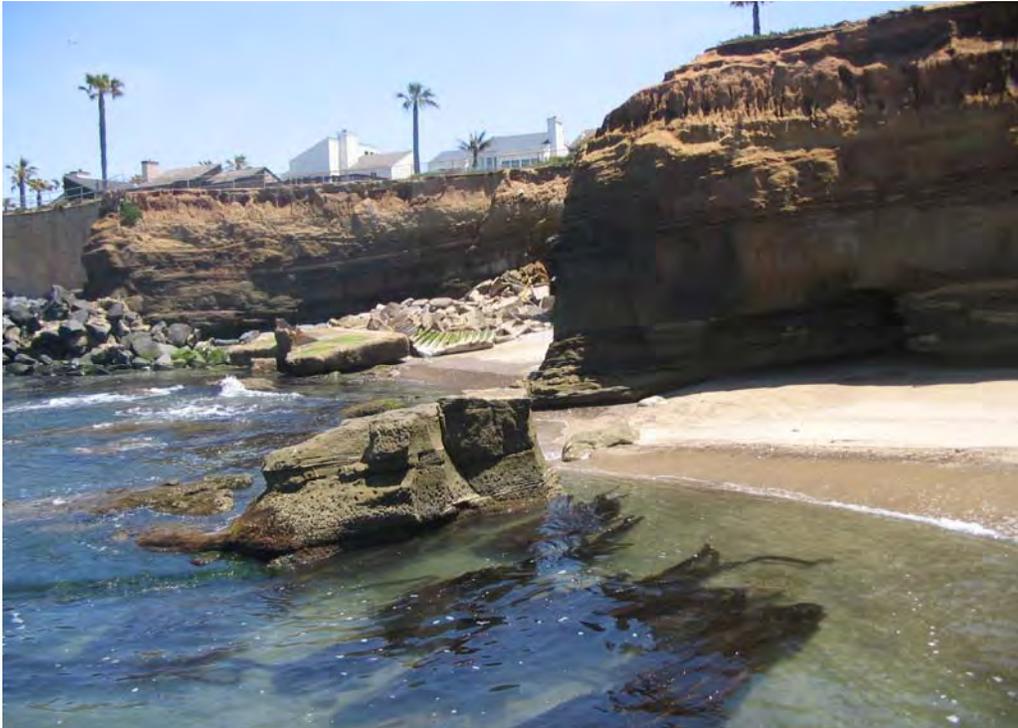
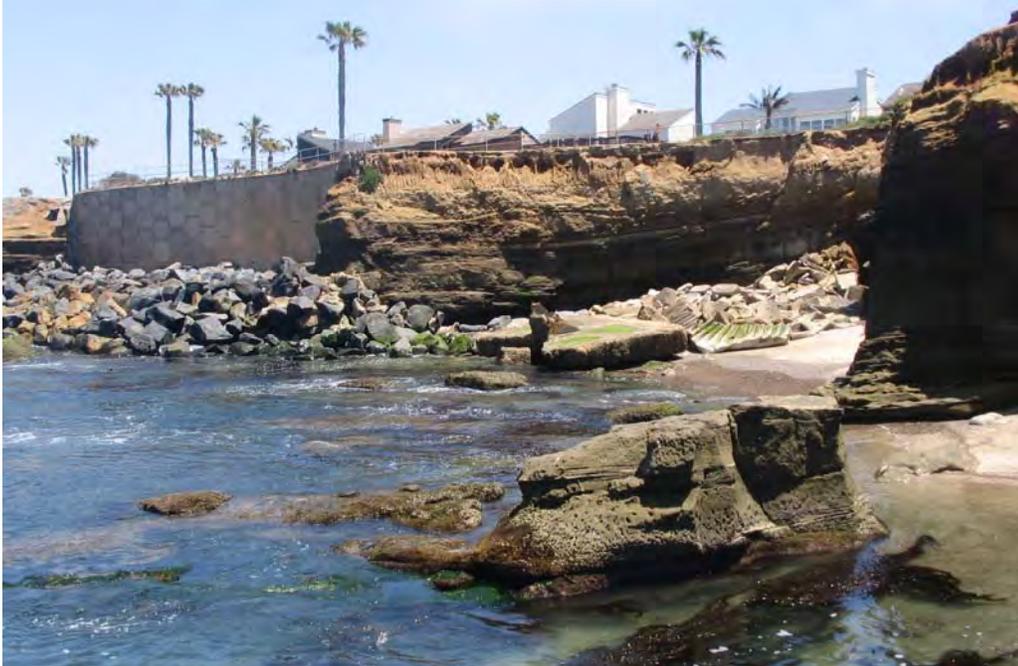
PH25/26: (Spalding Point) This arch fell about 10 years ago. In 1915 there was a seawall and viewing platform. This collapsed because the seawall failed (Dedi suspects that this is indirect erosion caused by the seawall/shore protection scouring around it).

***\*\*Dedi Recommended that this area could benefit from a newly created cove beach and use the rubble (to the north) to create a small groin on the north end, fill with sand, and provide access to beach (or use the point that we are standing on to get to the two cove beaches). She also said that this is one area that a textured seawall would be good solution and restore the cove beach.***

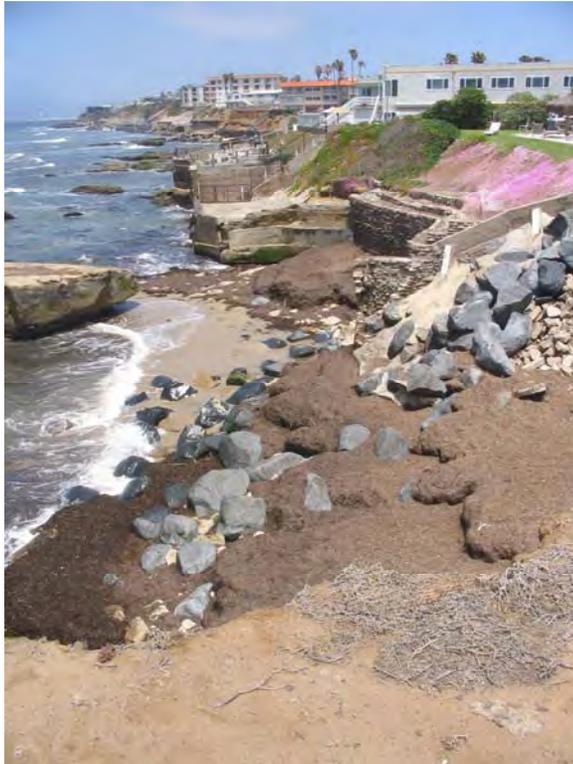
PH29: This shows 'unnatural' erosion caused by failing and settling rubble.  
***Dedi would like to see a set of terraces/stairs at this point to view the entrance of the park.***

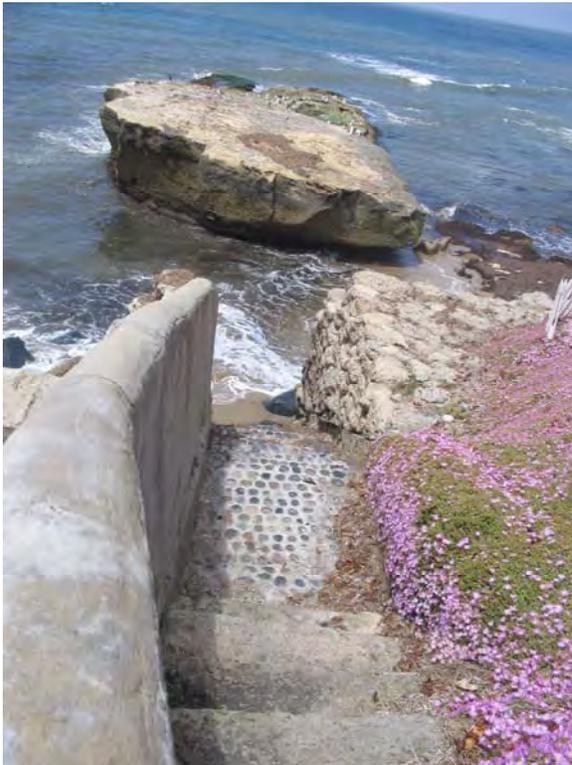
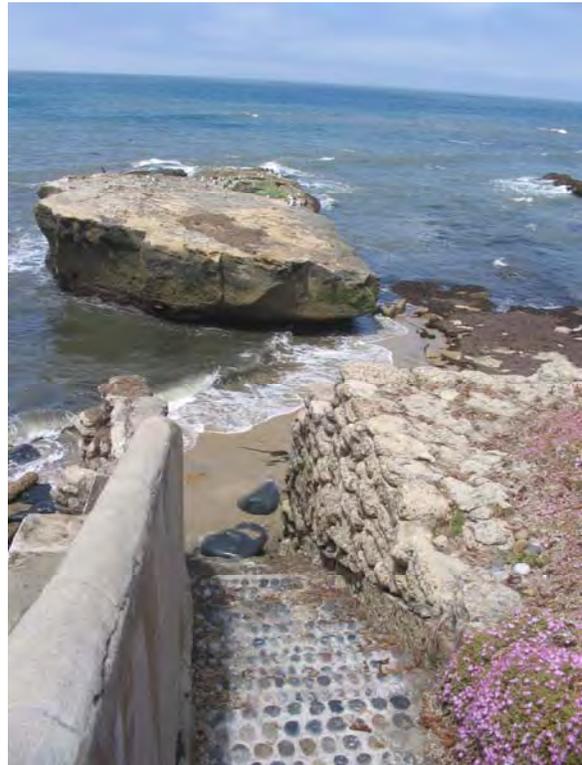
PH30/31: historical steps (1915), ended on sand to walk across to large rock. Now there is a big drop down and no sand along this reach. (Man-made 'swimming' hole in rock)

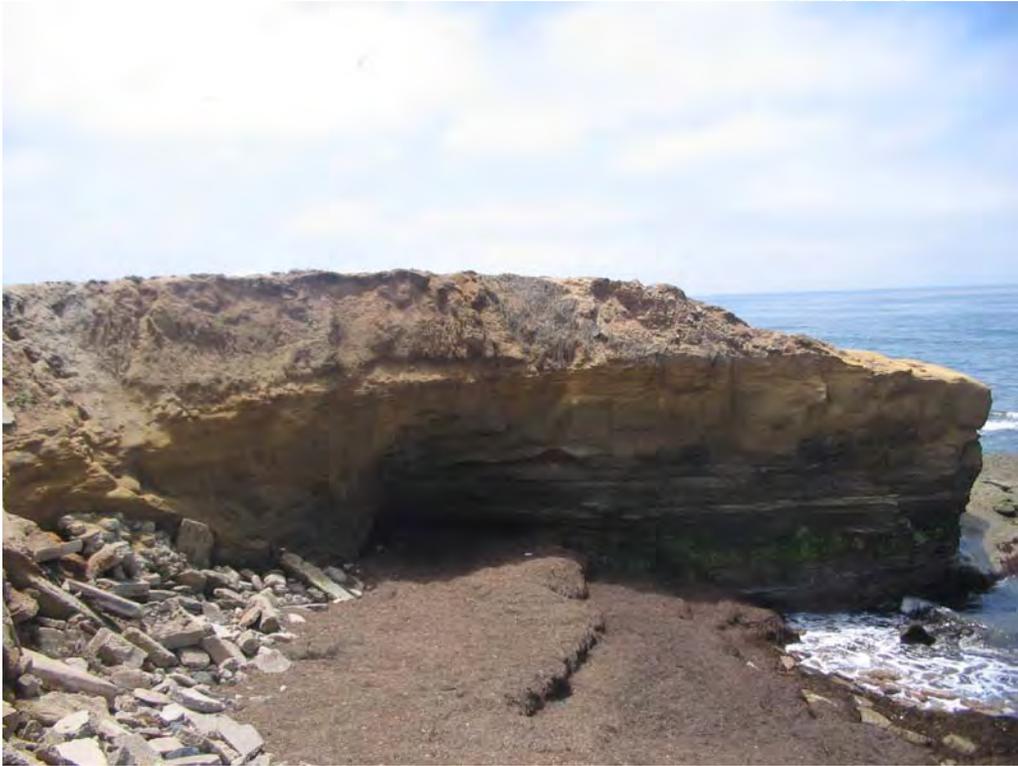
PH32: Construction rubble over bluff.

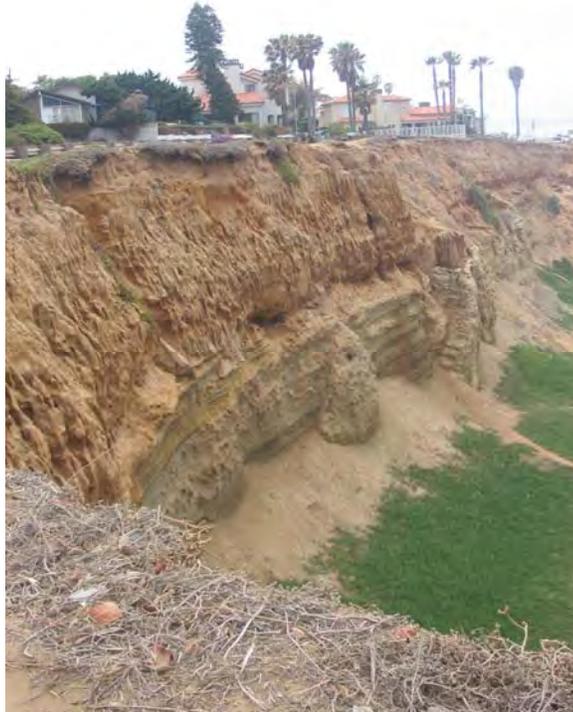
P34: Cordova/Guzot, source of erosion? Bluff top is higher than road, so it is not surface water runoff. Waves rarely reach the base of these cliffs, so it is not wave-induced erosion. Wind? Rodents?

Fill crevices with fill on top of bluff for trail? Probably would need compacted soils → can't grow plants on compacted fill very easily.

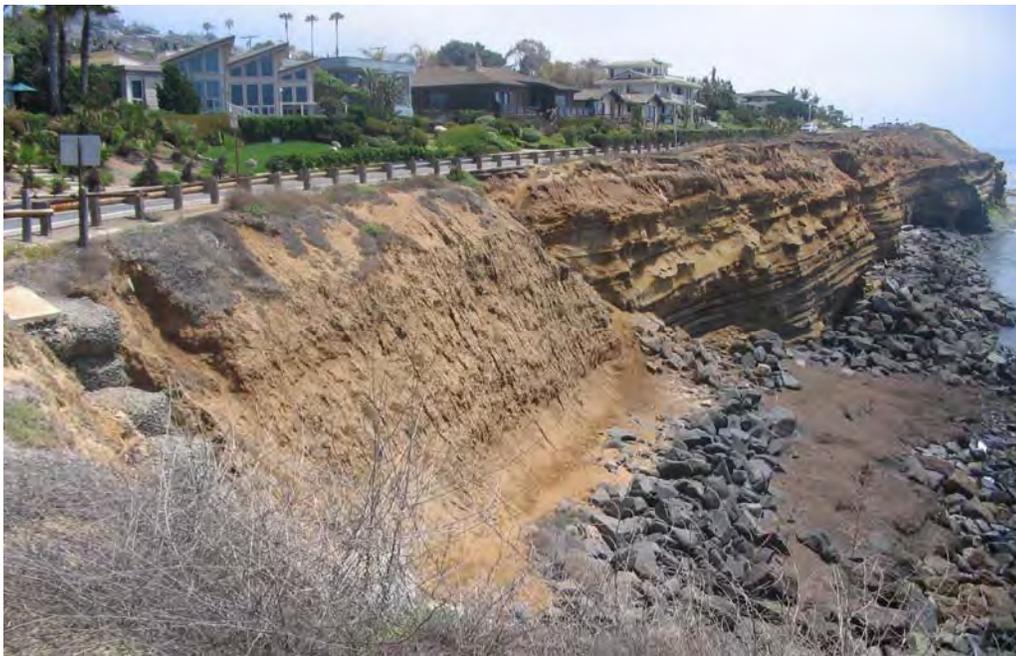
PH35: South of Monaco: No stratification along cliff face; The road was built on cove and filled it with rock and fill. The gabions need to go before they break and spill small rock all over the beach.

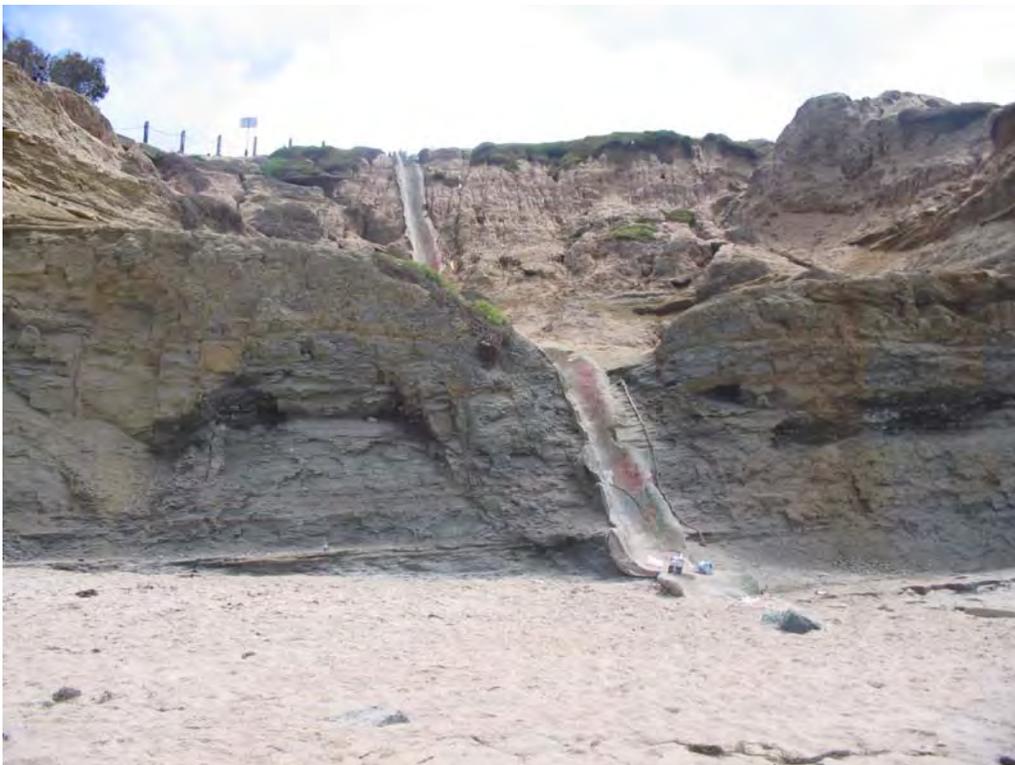
- Public access in mid Garbage Beach near concrete drain. Incorporate public stairs into plan for drainage structure
- This has been used as an Amphitheater area: was it created or used because of its natural configuration?

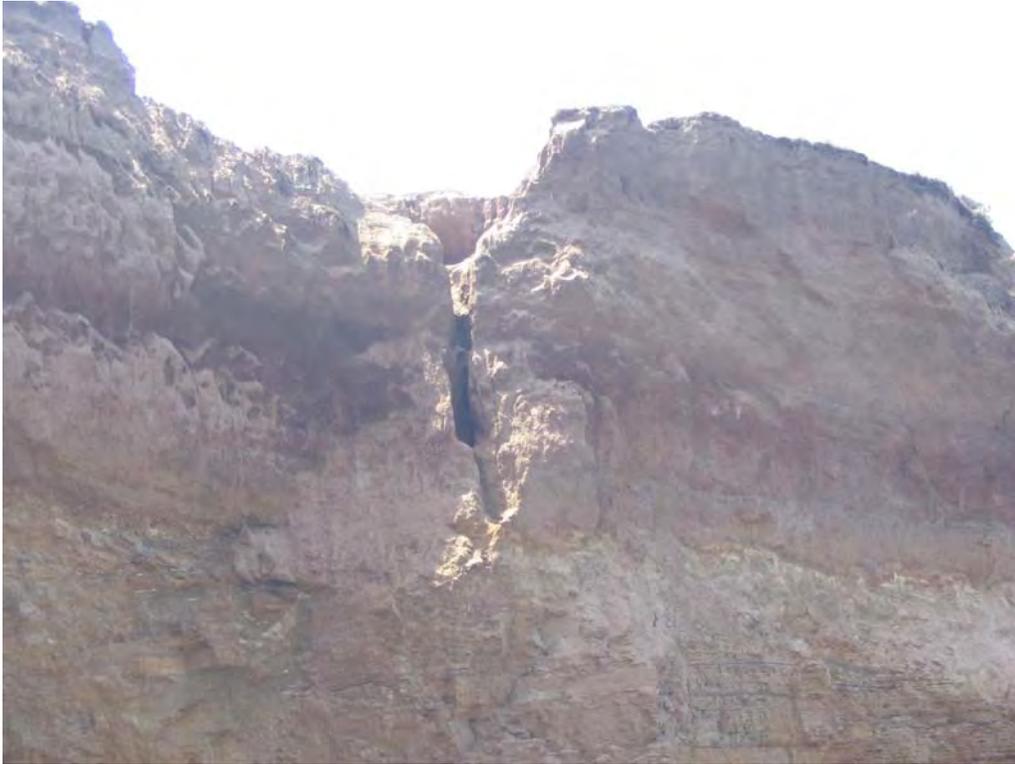
- The pits on the cliffs at the south end of Garbage Beach, are these caused by piping? Or is it another contribution by the ball field/upland irrigation?

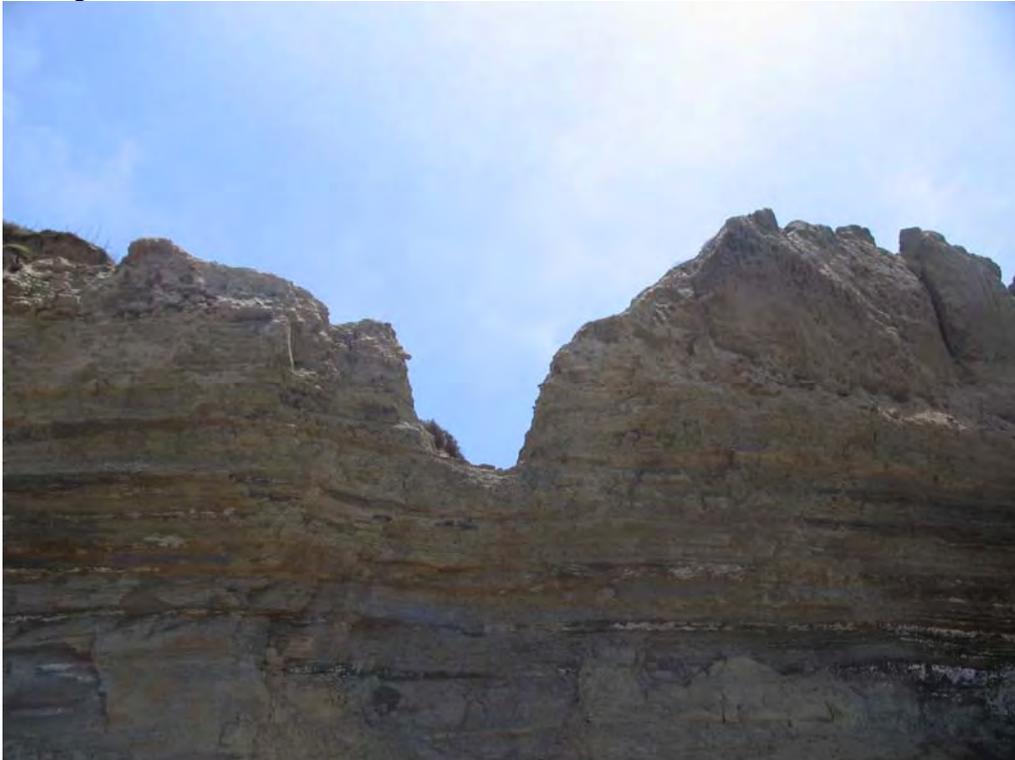
- End of the Grand Canyon: can't get through the lower formation and has completely eroded the upper formation.
- In 1988 there was a massive block fall in the south end of Garbage Beach in the curved area near the end.
- What is causing the caves at the end of Garbage Beach? Waves rarely reach here. Could be slow process only occurring during high tides/storm conditions.

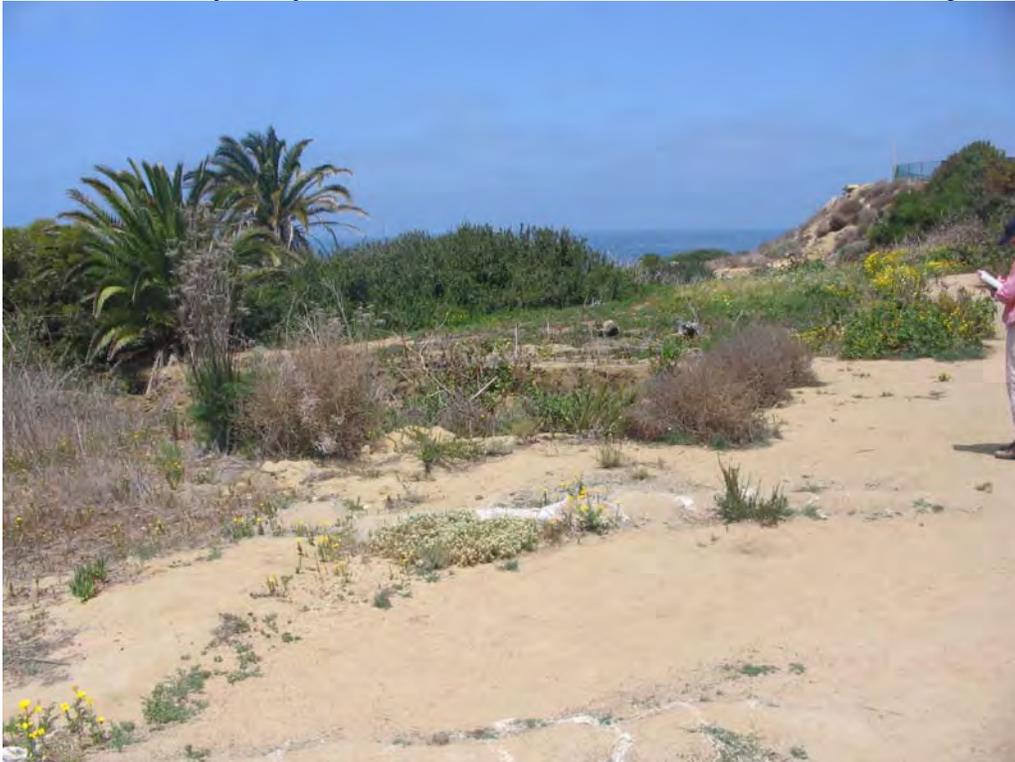
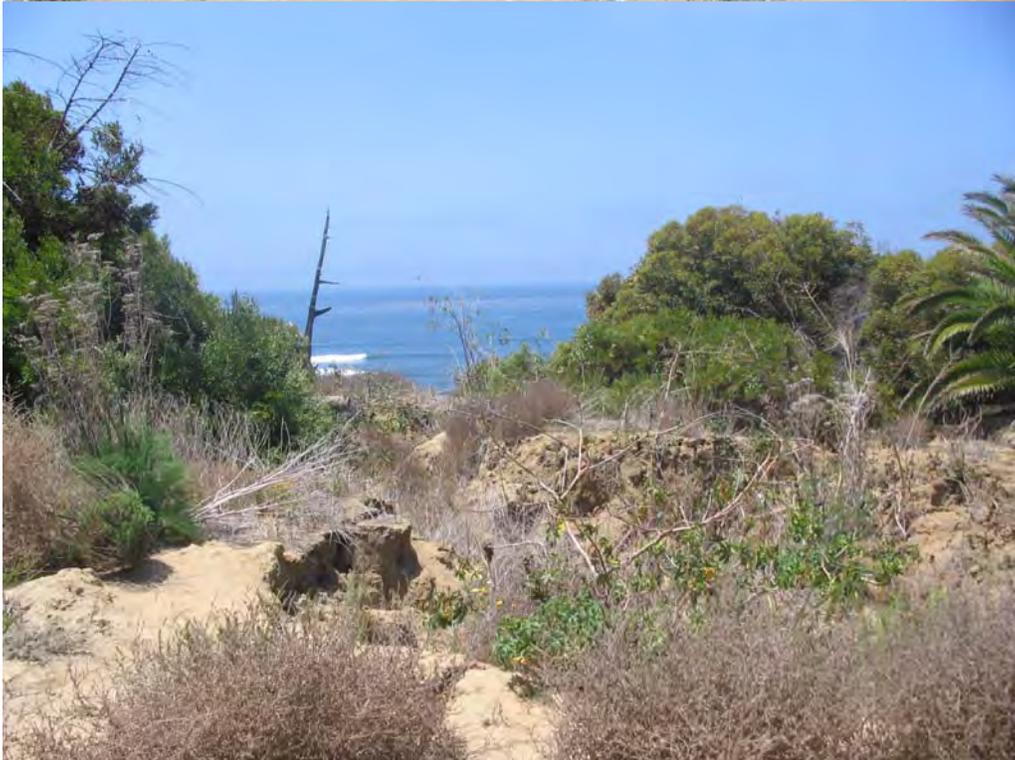
- Surface erosion is coming close to the affluent line. (Sink area to the left of the top photo above)
- Major increase in the surface erosion over the last 10 years.
- Sink area: surface runoff. Used fiberglass sandbags by Young Hall Parking lot.
  - a. Subterranean seepage? What causes this? Rodent hole causes a spot for water to seep in and through under and top layers.
  - b. Soil is too hard for seepage through it without a way in (rodent hole)

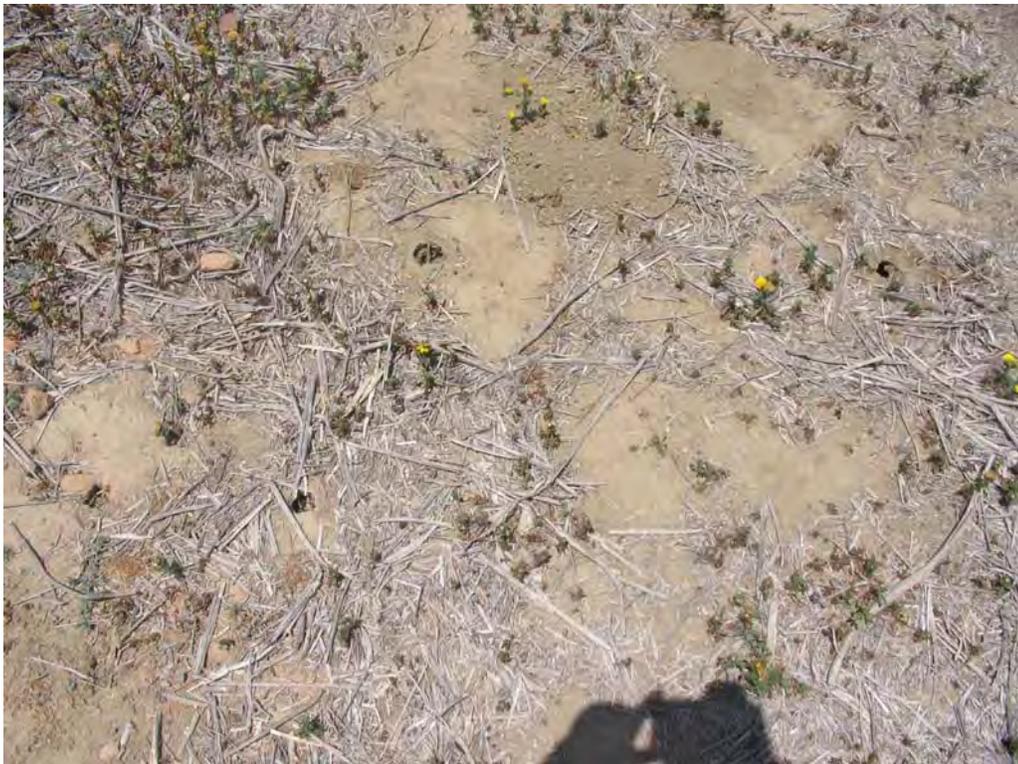
Shows extent of rodent burrows

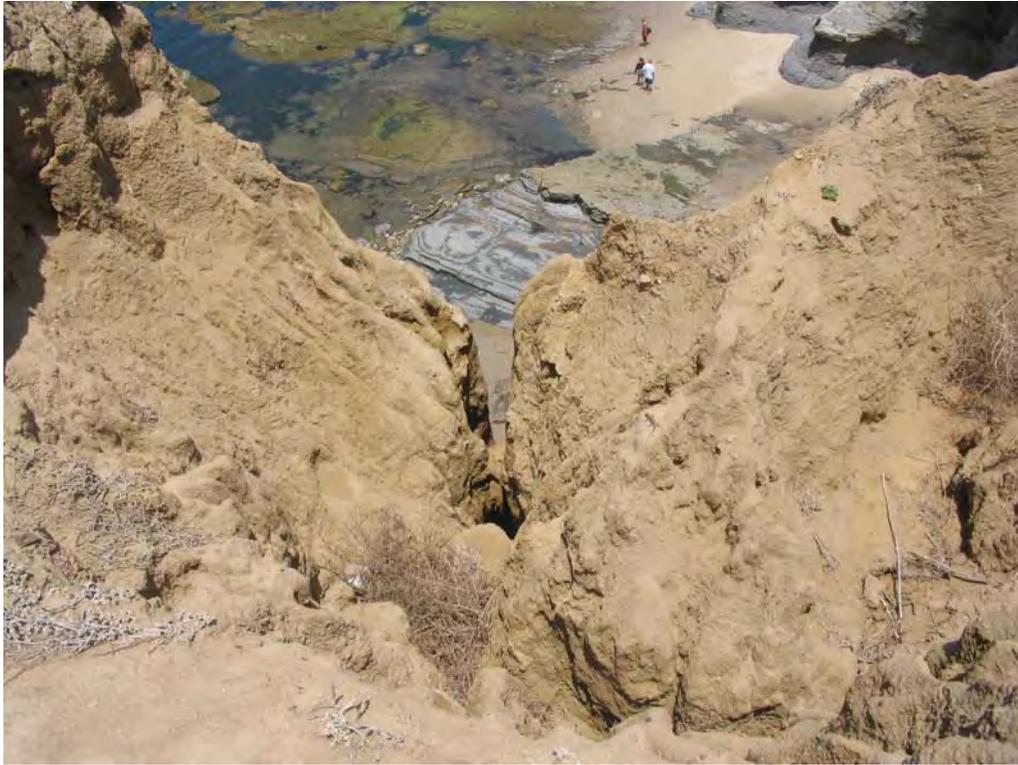
Top of “V” that is shown in previous pictures from Garbage beach. This has eroded significantly over the last 5 years.

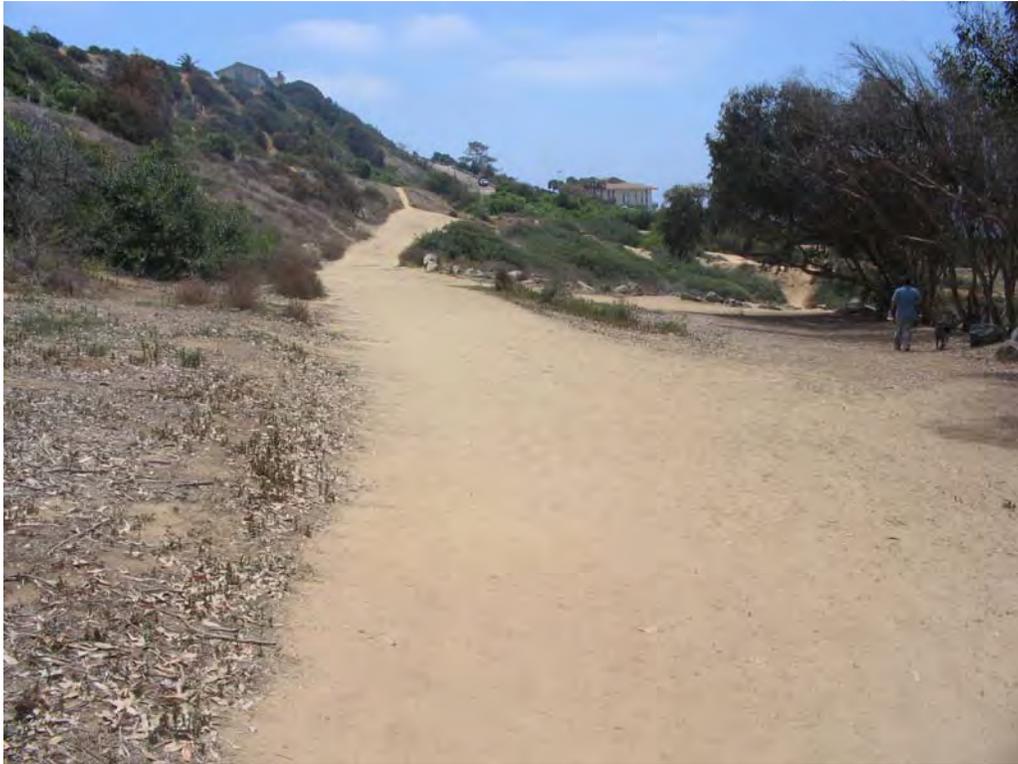
Easement for the City's Wastewater Effluent line. Use this as the ADA path.

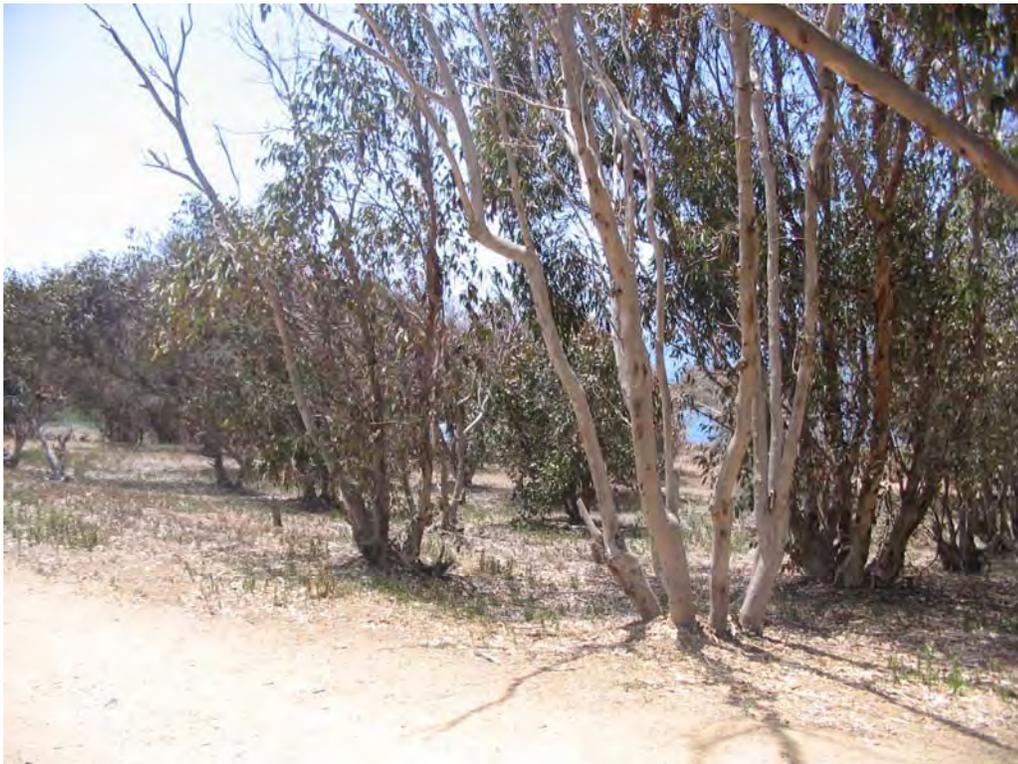
These eucalyptus trees were planted long ago. Need to be removed and replaced with natural vegetation.

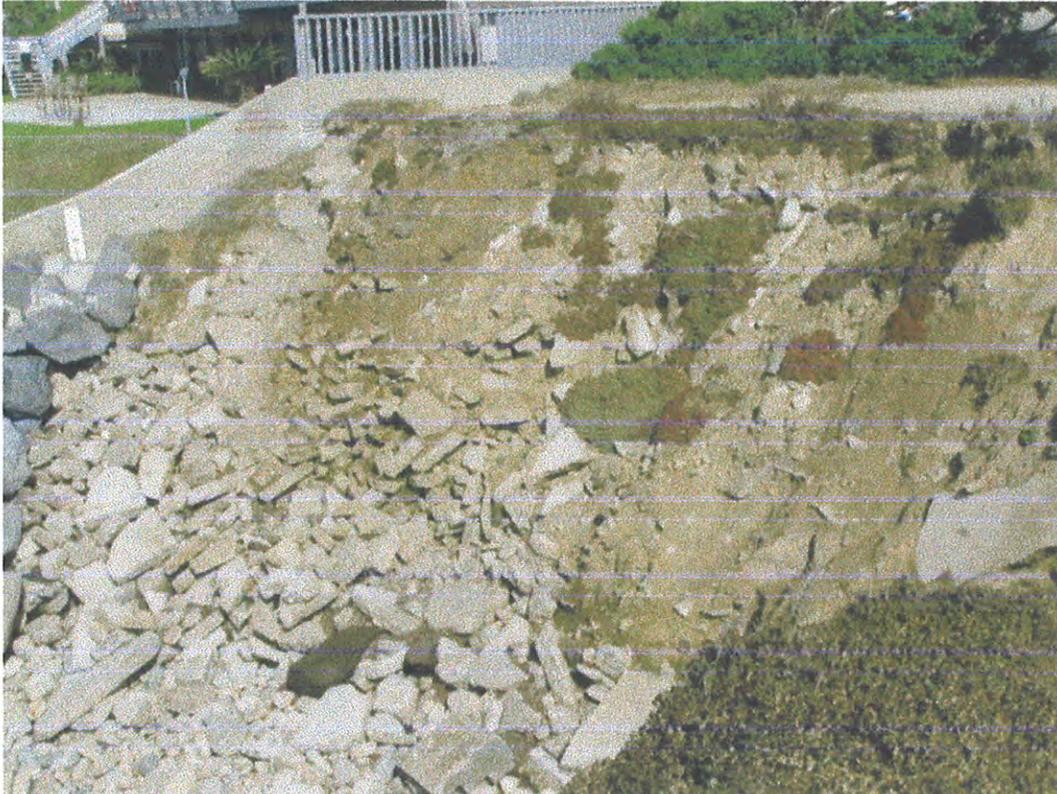
### Location 1 (see Northern Linear Park map)

**Condition:** Subaerial erosion of fill material is due to run off from the soil above it that has been compacted by pedestrian traffic. Lack of erosion control measures, such as revegetation to increase the permeability of the soil to water and not sloping the soil towards Sunset Cliffs Boulevard, is creating runoff degradation and contamination of adjacent nearshore waters. Marine erosion is also eroding the toe of this material in the figure below and contributes to nearshore water contamination.

**Recommendation:** Revegetation, sloping the soil towards Sunset Cliffs Boulevard so it doesn't erode seaward structures such as seawalls, and trail construction and maintenance using standard methods to prevent erosion are needed.
