## SUNSET CLIFFS NATURAL PARK

Drainage Study

September 2012

**PREPARED BY**  
Dudek  
605 Third Street  
Encinitas, CA 92024  
800.450.1818  
[www.dudek.com](http://www.dudek.com)

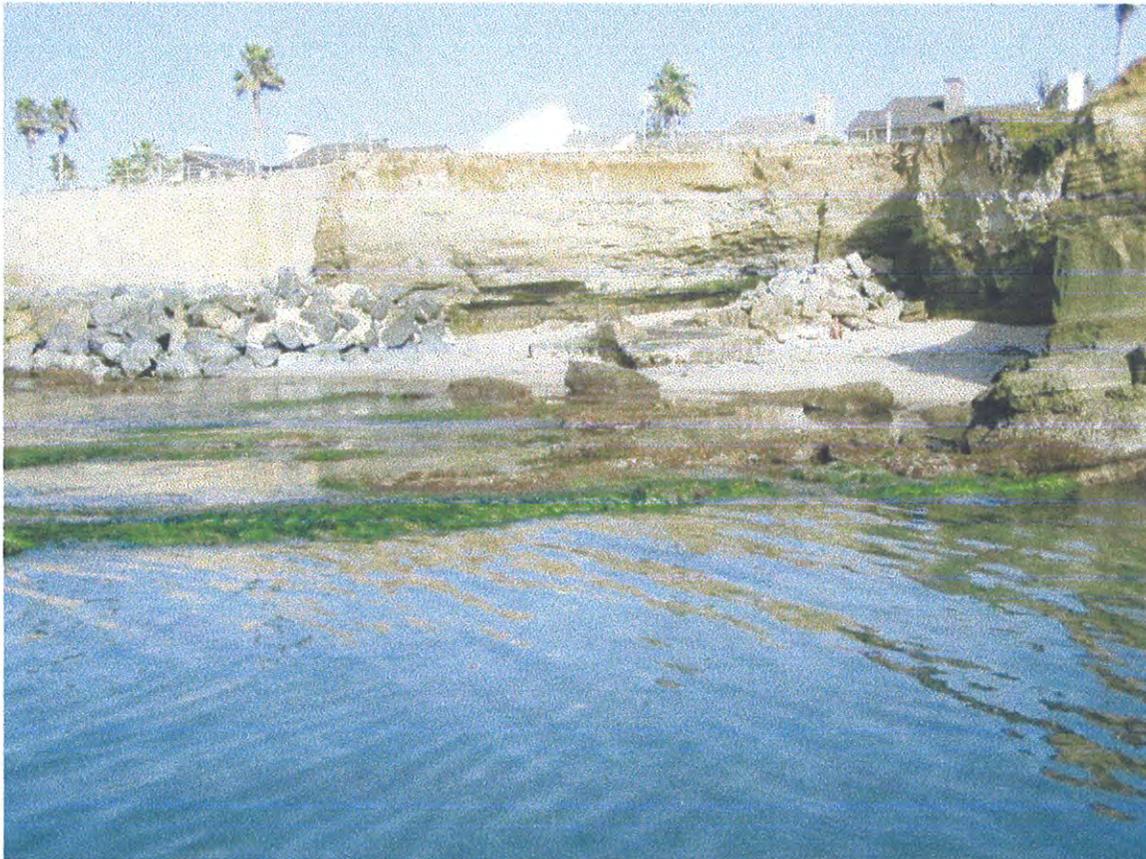
**Location 2 (see Northern Linear Park map)**

**Condition:** Marine, subterranean seepage, and subaerial erosion are all threatening both Sunset Cliffs Blvd., and the north wall of the cove that is just south of the Adair Street Seawall. If the north wall of the cove fails, the filled material behind the seawall will be exposed and expensive emergency repairs will be needed. Erosion problems at this site are discussed in an August 31, 2001 Moffett and Nichol report [5] that covers environmental, permitting, construction, and cost issues.

**Recommendation:** Review the seven alternatives described in the Moffatt & Nichol report as part of Task 3. The seven alternatives the report presented included: no project, beach nourishment, nearshore reef, perched reef, two tie-back wall alternatives, and a revetment. The Sunset Cliffs Natural Park Recreation Council (SCNPRC) on April 7, 2003 recommended that a tie-back retaining/seawall be constructed to prevent further surface water slumping and long-term marine erosion at Location 2 in a manner that conforms to the criteria established in the SCNPRC Erosion Committee April 7, 2003 recommendations.

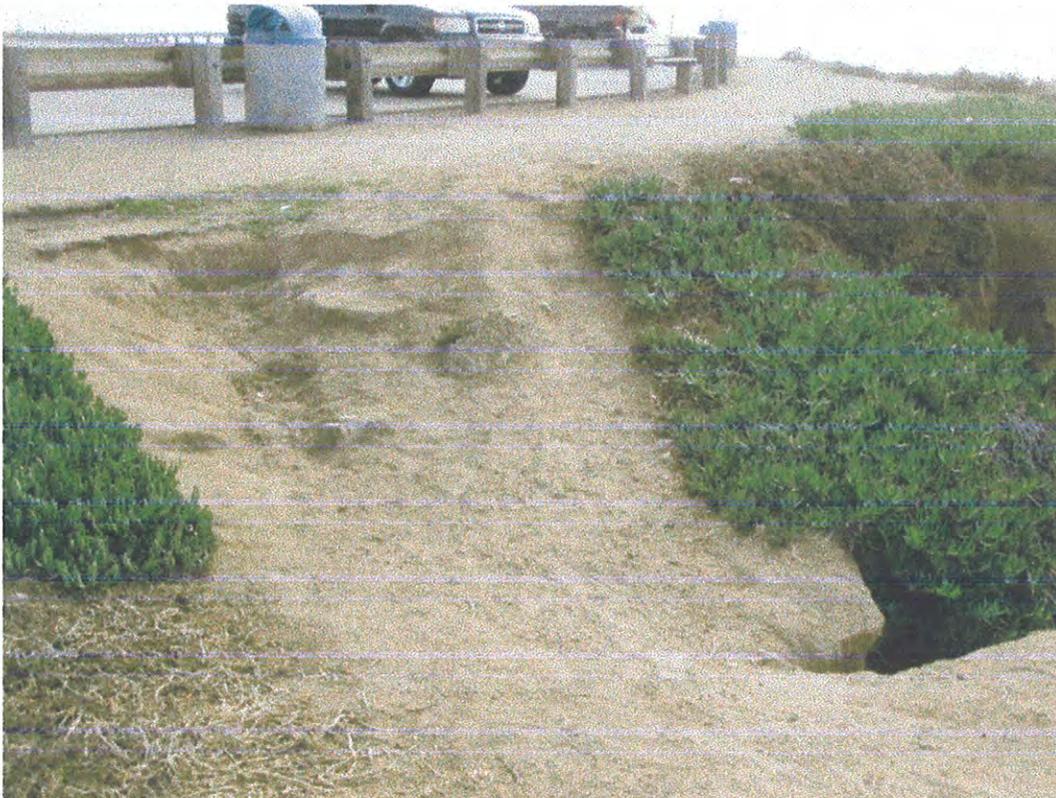
**Location 3 (see Northern Linear Park map)**

**Condition:** Runoff from Parking Lot # 1 and areas of compacted soil and paving around it are responsible for erosion and piping that is destroying the cliffs, causing a safety hazard, and is contaminating the adjacent nearshore water with fine grained material that increases turbidity above natural levels.

**Recommendation:** Install curbs around the parking lot to insure that all water from it drains towards Sunset Cliffs Boulevard. Scarify the soil and plant native vegetation on it to increase it's permeability and minimize seaward runoff.

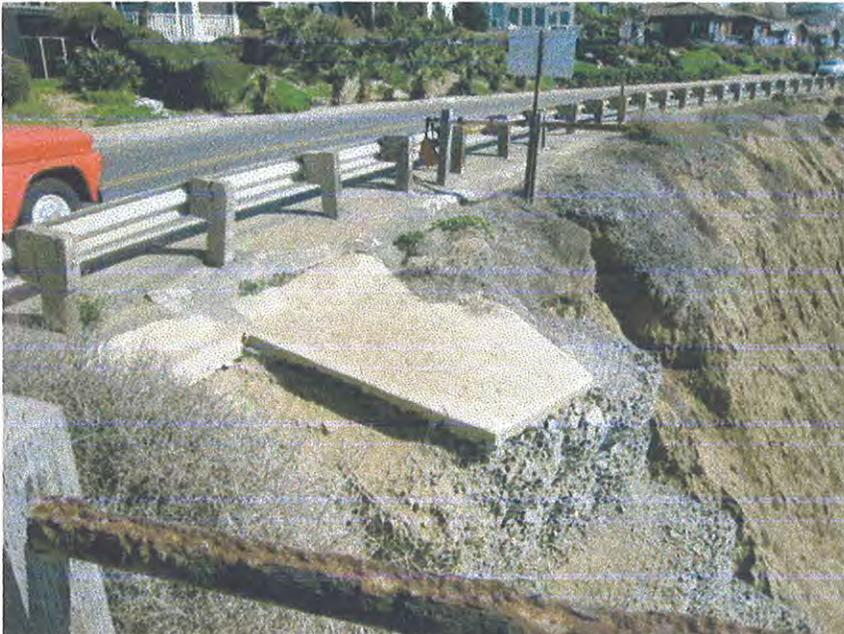
**Location 11 (see Southern Linear Park map)**

**Condition:** Rick Engineering lists Location 11 shown below as Outlet 5 which they describe: “This outlet consists of a concrete spillway that discharges over the cliff onto gabion slope protection. Approximately 2.2 acres are tributary to Outlet 5.” Observations of the concrete spillway and gabion structures indicate there is bypass around the spillway due to settling in the area causing cracking of the concrete. Also, there is bypass around the gabion based on erosion of the cliffs adjacent to the gabion. The draft DUDEK Report calculates that the concrete spillway is capable of handling 5.3 cfs and that of the 22 cfs of flow generated within the basin tributary to it, only 4 cfs reaches it because most of the runoff that would otherwise reach it “- - - will flow over the berm and cliff” in Drainage Basin C2 unless the curbs along the west side of Sunset Cliffs for Location 12 are built up. Because building up the curbs along Sunset Cliffs as described below for Location 12 would direct flows to the spillway at Location 11 that it can’t handle, fixes for the runoff conditions at Locations 11 and 12 need to be considered together.

**Recommendation:** Conduct detailed flow studies for Locations 11 and 12 to determine the size of a storm drain that would be needed to replace the concrete spillway and gabion protection device at Location 11. Alternatively, perhaps the road could be built up along the west side so water bypasses the spillway discharge and runs to the storm drain at the end of Monaco street. The discrepancy of the capacity of the Monaco Street storm drain being at or near capacity based on the Rick Engineering Report, and over capacity in the DUDEK Report, needs to be resolved before any action is taken.

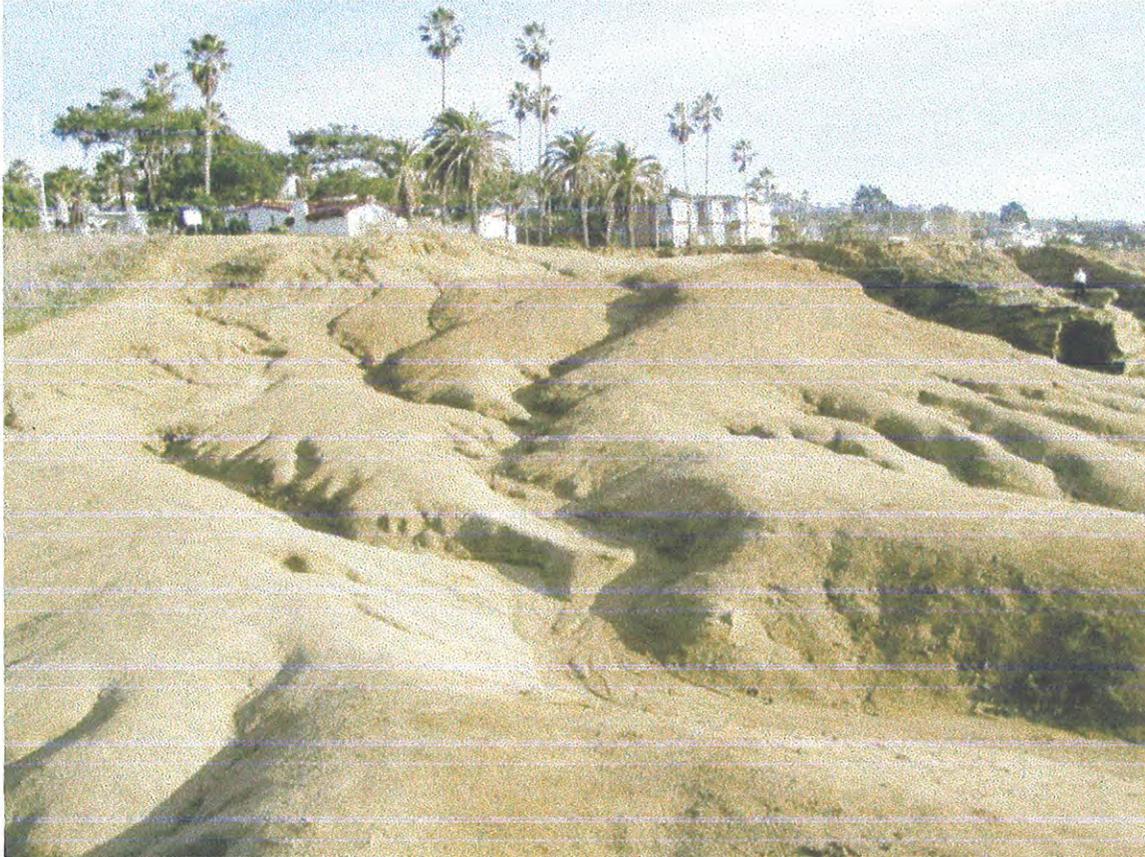
**Location 10 (see Southern Linear Park map)**

**Condition:** Heavy pedestrian traffic has compacted the Luscomb's Point (Location 10), soil, and the runoff from this compacted soil has caused extensive erosion rills to form. Silt from the eroded soil is increasing the turbidity in adjacent nearshore waters.

**Recommendation:** Trails designed to minimize runoff, and revegetation, are both needed to prevent the erosion and contamination of nearshore waters.

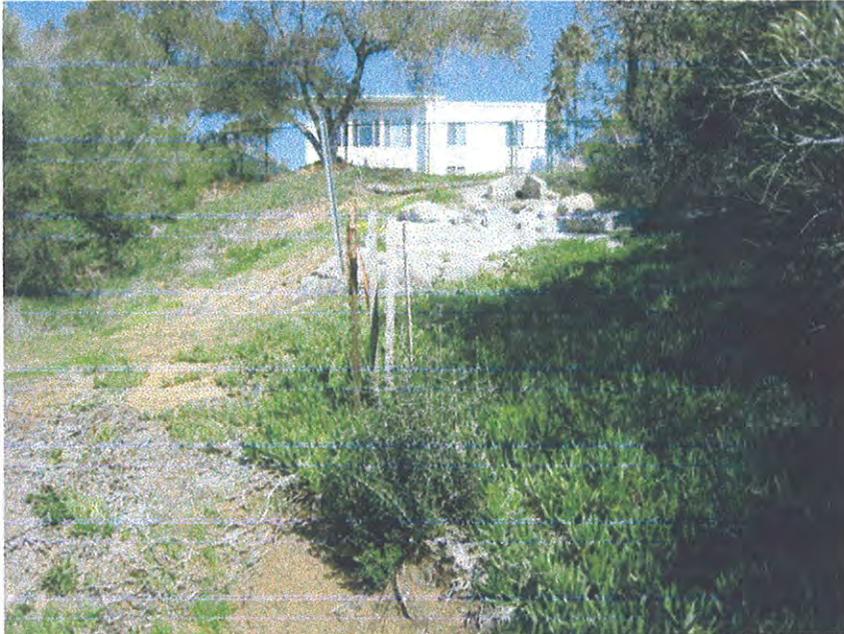
### Hillside Park Watercourse A (see Hillside Park map)

**Condition:** Watercourse A (Location 29) is a 24 inch diameter pipe that receives runoff from the most northerly portion of the Hillside Park, and then conveys it to a driveway off Cornish Drive. The runoff from Location 29 is generated by the surfaces of the land in Drainage Basin D2 [2], and point source discharges from PLNU storm drain outfalls such as those shown in the pictures below, and PLNU parking lots.

**Recommendation:** Monitor runoff discharges into Basin D2 from the PLNU storm drain system for erosion, and where possible direct the runoff away from Watercourse A by either storing it on the PLNU campus for use in irrigation, or piping it to the nearby brow drainage system ditch that runs along the PLNU west property line in the vicinity of Goodwin Dormitories, and discharges down Monaco Street.

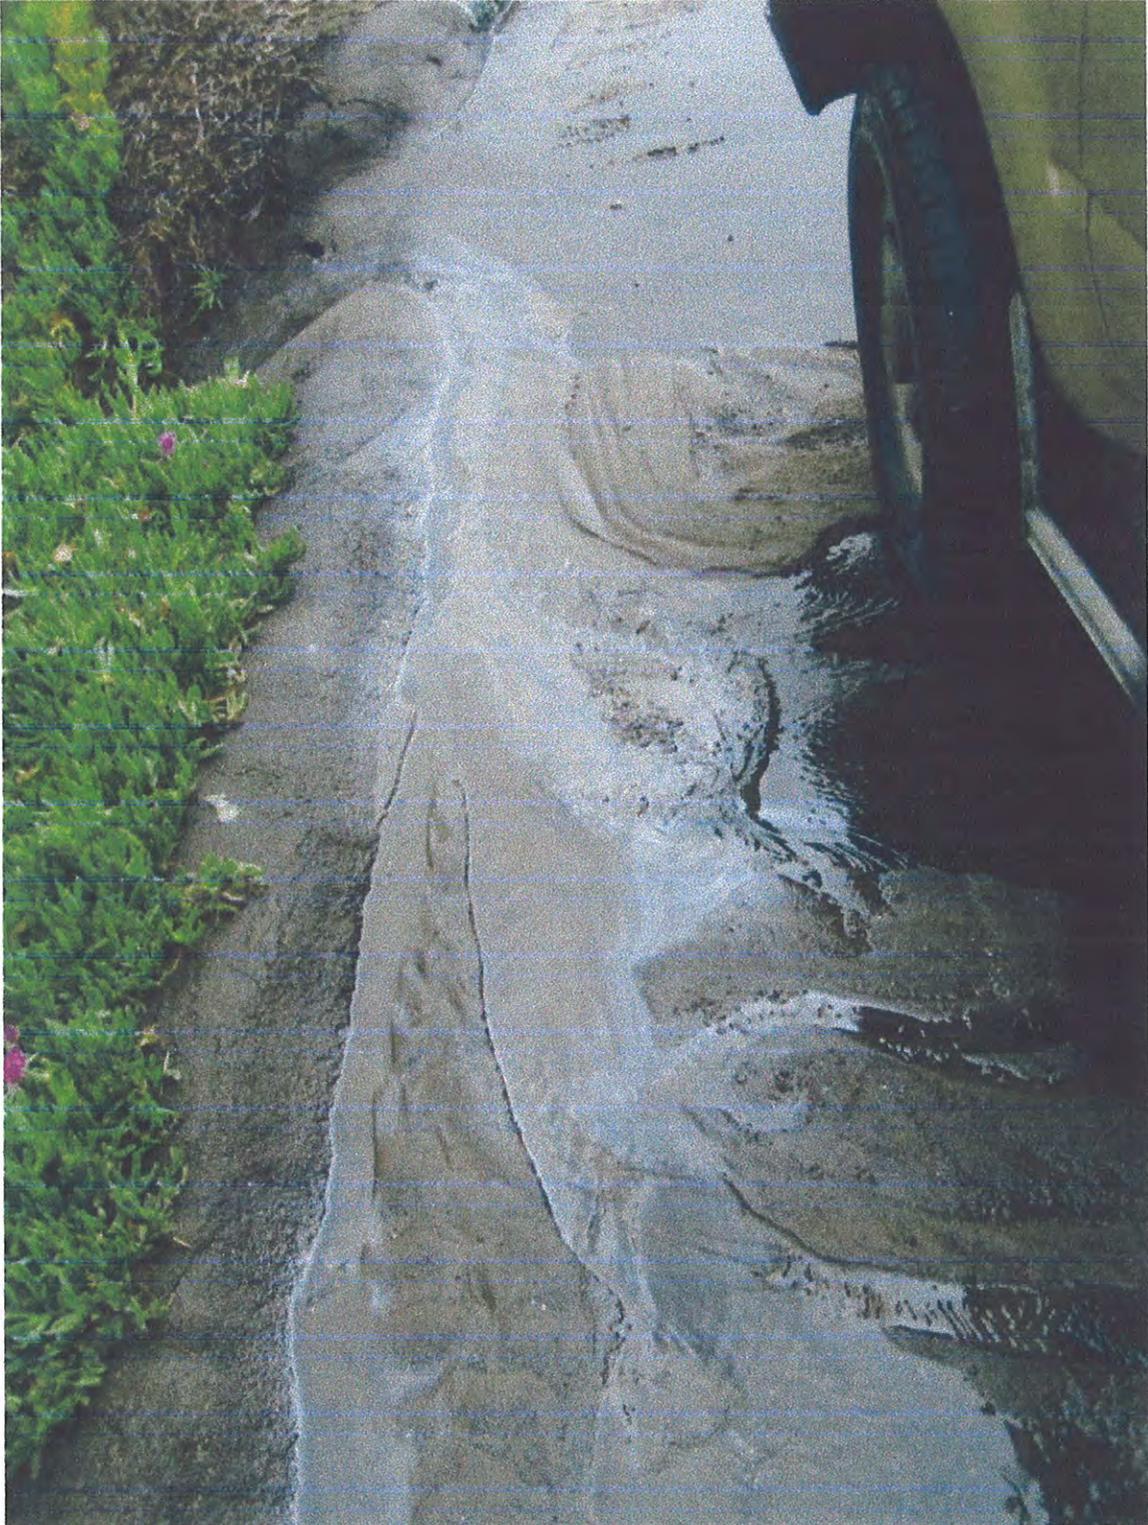
**Hillside Park Watercourse D (see Hillside Park map)**

**Condition:** Watercourse D in Drainage Basin J originates at the spillway shown below in the northwest corner of the Upper Parking Lot. A clearly eroded watercourse can be traced from the vicinity of the parking lot spillway shown in the picture below, where dense vegetation makes determining exact watercourses very difficult, to the sludge line trail where the water spreads out before it travels down the slope without any major erosion until it reaches the badly eroded area where rocks have been displaced at Location 18. The clearly visible sheen on the runoff before it discharges from the Upper Parking Lot and into Watercourse D indicates the Park is receiving contamination from this runoff when it rains.

**Recommendation:** The runoff from the Upper Parking Lot should be captured by a surge dam or tank where it leaves the parking lot spillway, treated to remove contaminants, and

then either discharged down slope at a rate that will not cause erosion or channeled to infrastructure that discharges to a storm drain. With the constraints noted for Location 14 to prevent overflows of the storm drain structure at the corner of Ladera Street and Sunset Cliffs Blvd., runoff could be disposed of there along with flows from other watercourses to storm drain infrastructure that terminates at Location 14. Alternatively, flows from Watercours D could be diverted to the treatment and ocean disposal outfall that will be needed to handle runoff from the PLNU drainage system that drains Drainage Basin M2.

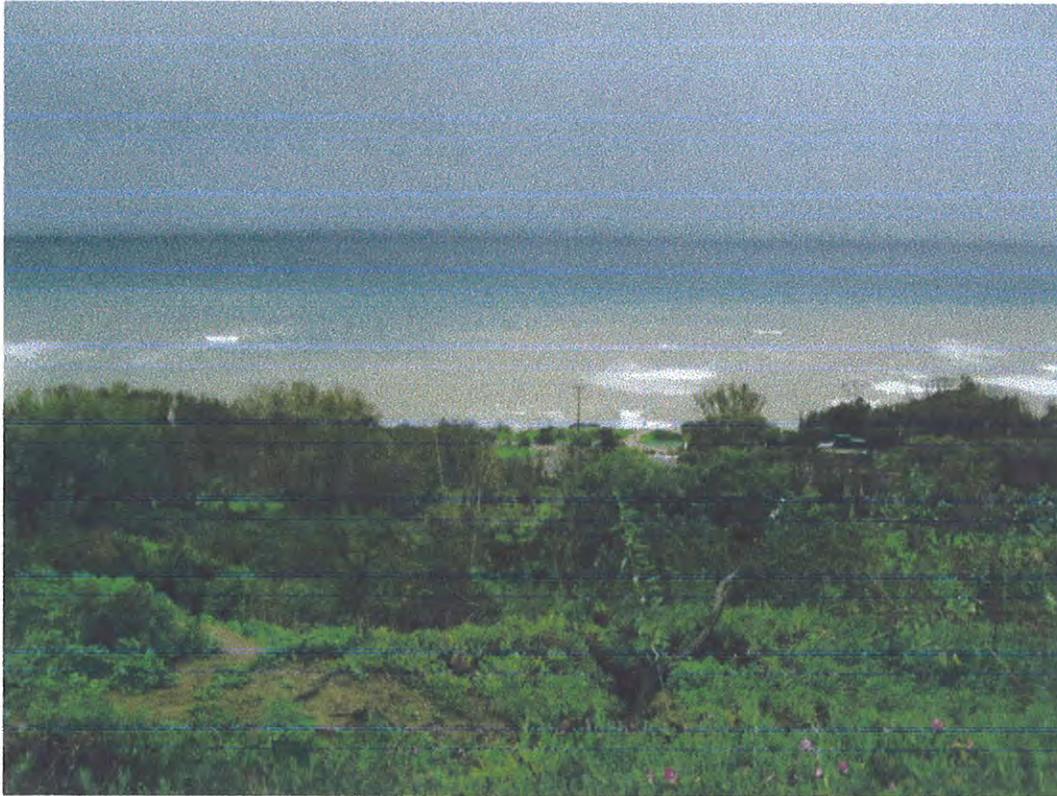
### **Hillside Park Watercourse G (see Hillside Park map)**

**Condition:** Watercourse G is the largest erosion degradation feature in the Park, and besides causing major problems for traversing the Hillside Park in a north-south direction, the eroded material is a major source of turbidity pollution in the adjacent nearshore water as shown in the photograph below. Watercourse G receives most of the runoff from drainage Basin M2 that is discharged either through 18, 24 and 12 inch outfalls at Locations 28, 27 and 26 respectively, or directly down the Western Loop road. Watercourse G starts at Location 26, where there is a catch basin and an Arizona crossing of the Western Loop Road, that are designed to handle 76 cfs of runoff. The runoff then traverses the Hillside Park terrace before discharging over the cliff above the south end of Garbage Beach. Watercourse G was mostly formed by erosion and mass wasting after 1960 based on aerial photos of the Hillside Park, and in some place it is 30 feet or more deep.

**Recommendation:** Once the runoff that created Watercourse G and is still enlarging it has been diverted into a drainage system that conveys it to the ocean for disposal, the Master Plan recommendation for “filling to more natural finish grade (following contours of the natural canyon) and revegetate with native shrubs and groundcover plants.” should be implemented. Perhaps fill material from the adjacent ball field when it is removed under provisions of the Park Master Plan could be used since it is native soil.

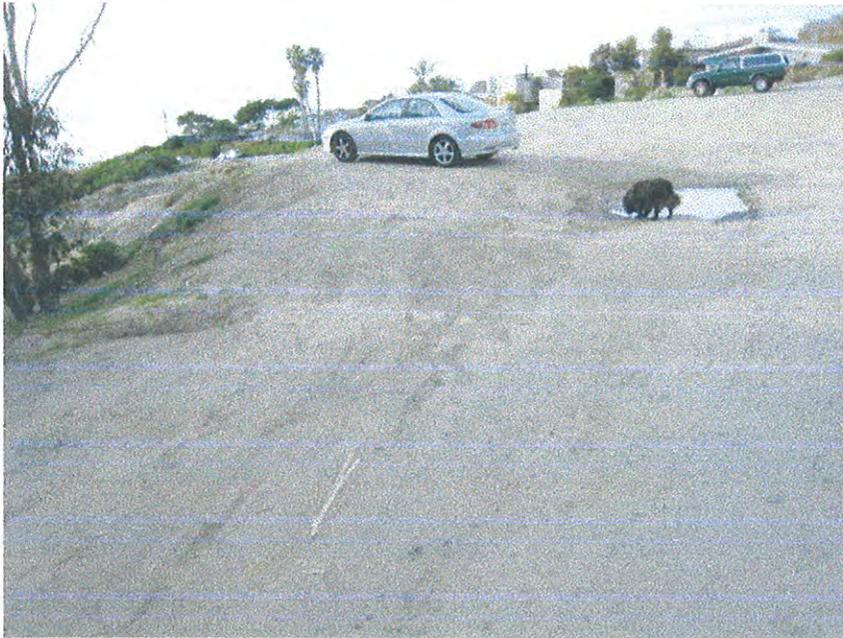
**Hillside Park Watercourse I (see Hillside Park map)**

**Condition:** Runoff from the access road to the Park's Lower Parking Lot and the compacted soil parking area shown in the picture below have resulted in the formation of Watercourse I. I runs along the northern edge of the *Eucalyptus* before it runs over the edge of the canyon that is just south of Ladera Street, and then joins the anatomizing minor watercourses where the canyon terminates at the edge of the cliff.

**Recommendation:** Watercourse I runoff should be channeled to the storm drain at Location 17 along with the runoff from Watercourse C.

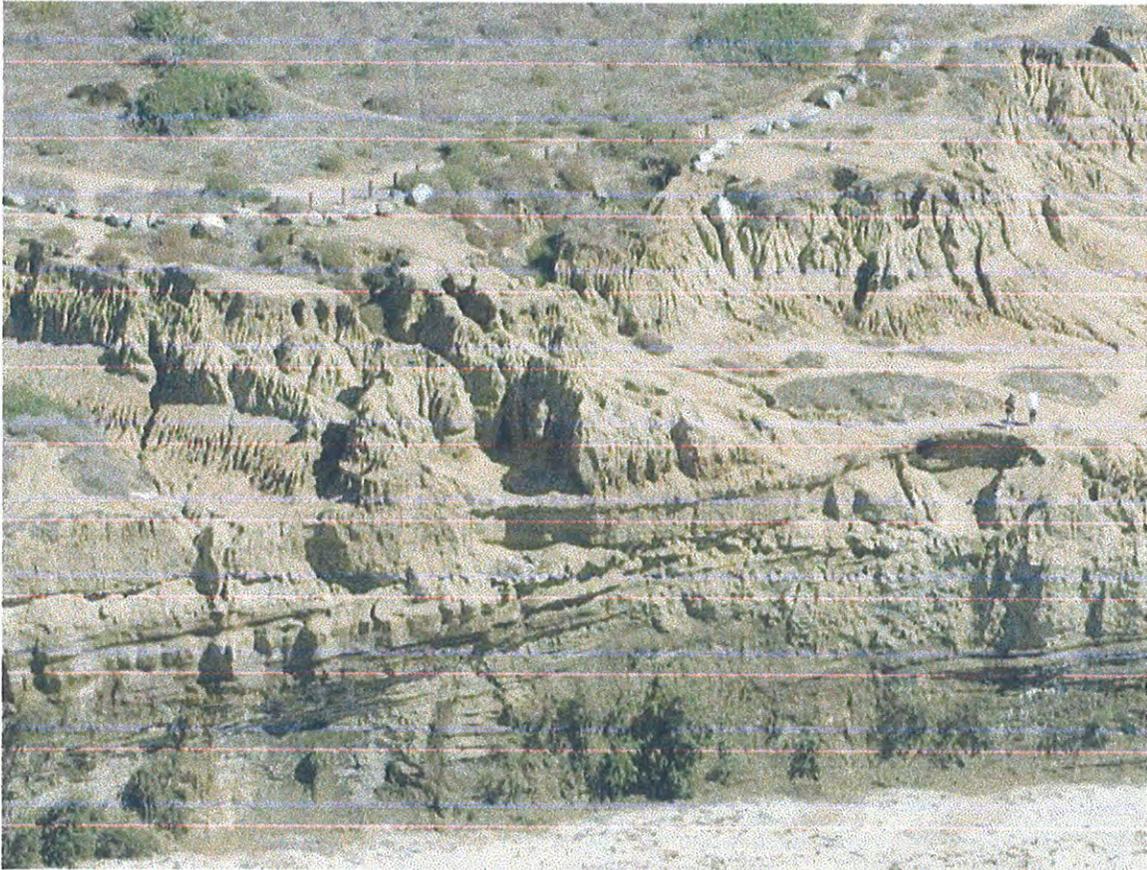
**Location 18 (see Hillside Park map)**

**Condition:** The major erosion shown in the photograph is the result of Location 18 receiving runoff from Watercourses D and E. An appreciation for the dynamics of the erosion degradation near Location L can be gained by viewing how much the trail boulders in this area, that were put in place during the early 1990s, have been undercut and moved down slope.

**Recommendation:** Minimize the runoff from Watercourses D and E following SCA recommendations provided for them. Remaining runoff flowing to Location 18 within Drainage Basin J, and maybe the north part of Basin K, should be controlled with spreading and revegetation.

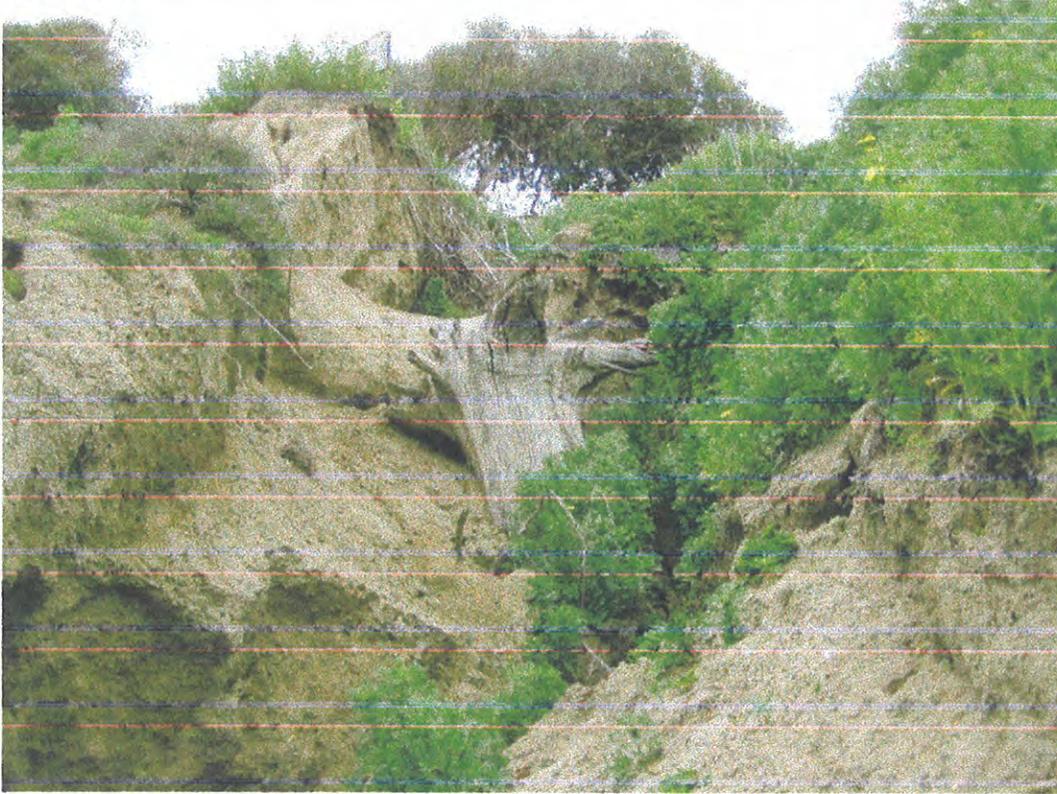
**Location 20 (see Hillside Park map)**

**Condition:** Location 19 is a large sinkhole at head of a 10 foot, or more, deep erosion gully that is part of major erosion feature that is called “The Badlands” in the Park Master Plan. Boulders have been placed into the sinkhole to keep it from eroding further to the east, but the erosion gully shown in the photograph below is still getting deeper and more extensive.

**Recommendation:** After repairing the curbs on the Western Loop Road and properly channeling the runoff from the road itself and the runoff from the 18 inch diameter storm drain at location 28 is properly directed so it doesn't flow down Water Course E, use water spreading and revegetation to minimize runoff that reaches location 20.

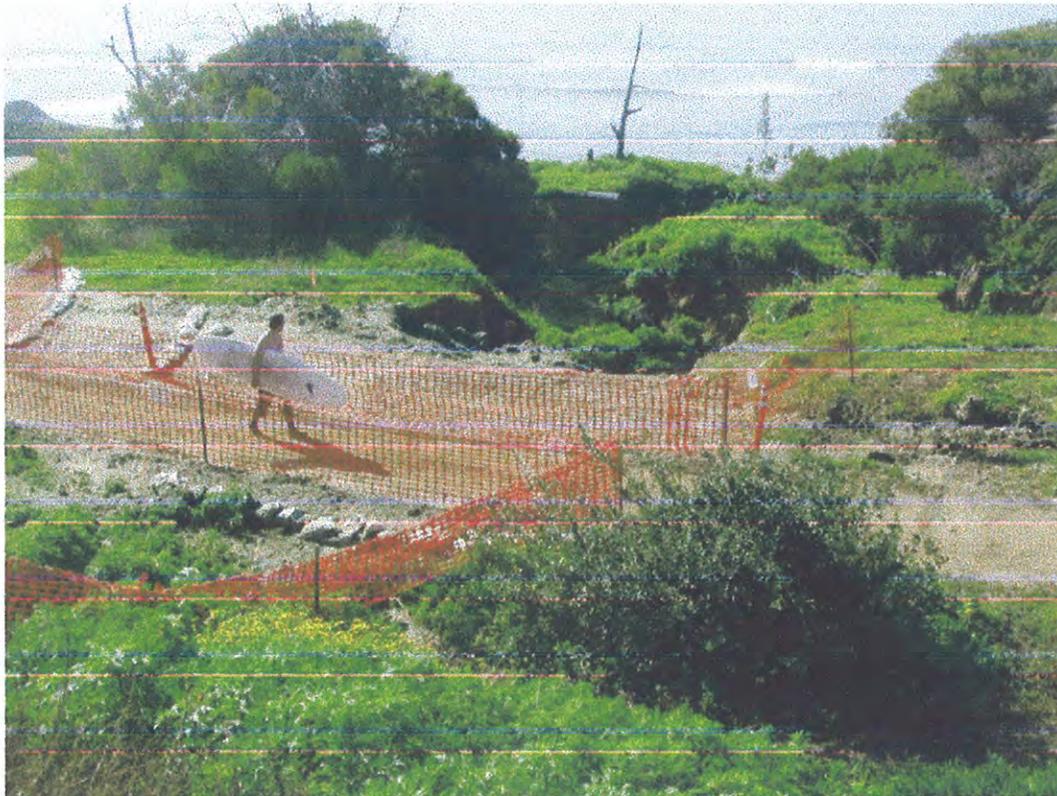
**Location 23 (see Hillside Park map)**

**Condition:** Location 23 is at the northwest corner of the lower parking lot for the Young Hall dormitory, where there was drainage spillway that is now in total disrepair and undermining the parking lot pavement. Runoff from both the upper and lower Young Hall parking lots is channeled to Location 23. Through temporary measures by PLNU, Location 23 runoff it is kept from destroying the major north-south trail (shown in the picture below) that provides access to the Ab Reef access location (Location 25). These temporary measures also protect the 23 mile long sludge line that connects the Point Loma wastewater treatment plant with sludge processing facilities near the Miramar Marine Corp Air Station. Location 23 runoff is a major cause of erosion degradation below the Young Hall parking lots.

**Recommendation:** Direct the Location 23 runoff into the drainage system that is used to dispose of runoff from Basin M2 for the PLNU campus.

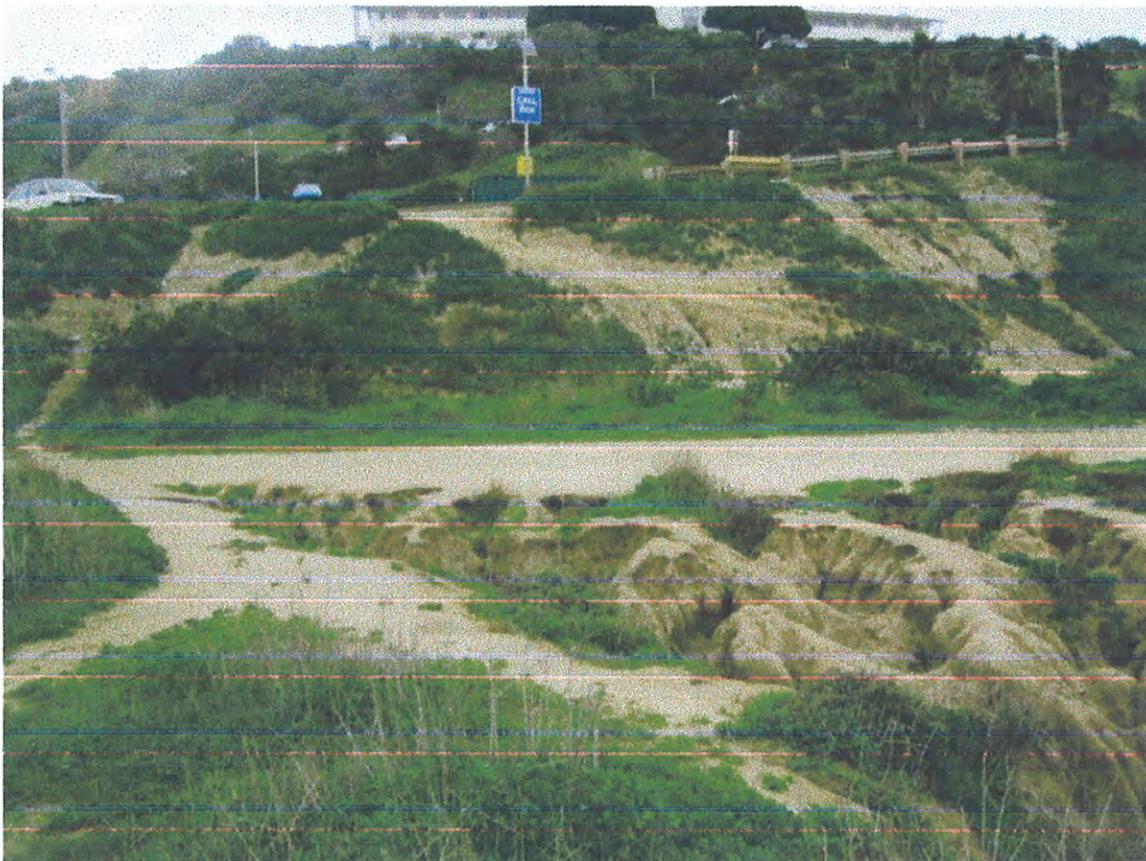
**Location 24 (see Hillside Park map)**

**Condition:** There seem to be several sources of runoff at Location 24 that are contributing to the erosion feature shown in the picture below that almost cut through the major north-south trail that is shown in the photograph below just below the toe of the embankment. It is not clear which source contributes the most. These sources include: the compacted soil of trails in the area, runoff coming down areas without vegetation on the Lower Parking Lot embankment, the trail that many use to traverse the embankment from the lower parking lot to the Ab Reef access trail, and parking lot runoff along the western curb that may jump the curb during periods of heavy rainfall.

**Recommendation:** Improve and maintain the trail from the parking lot so it doesn't generate runoff, and revegetate the area around Location 24 so it maximizes rainfall absorption.

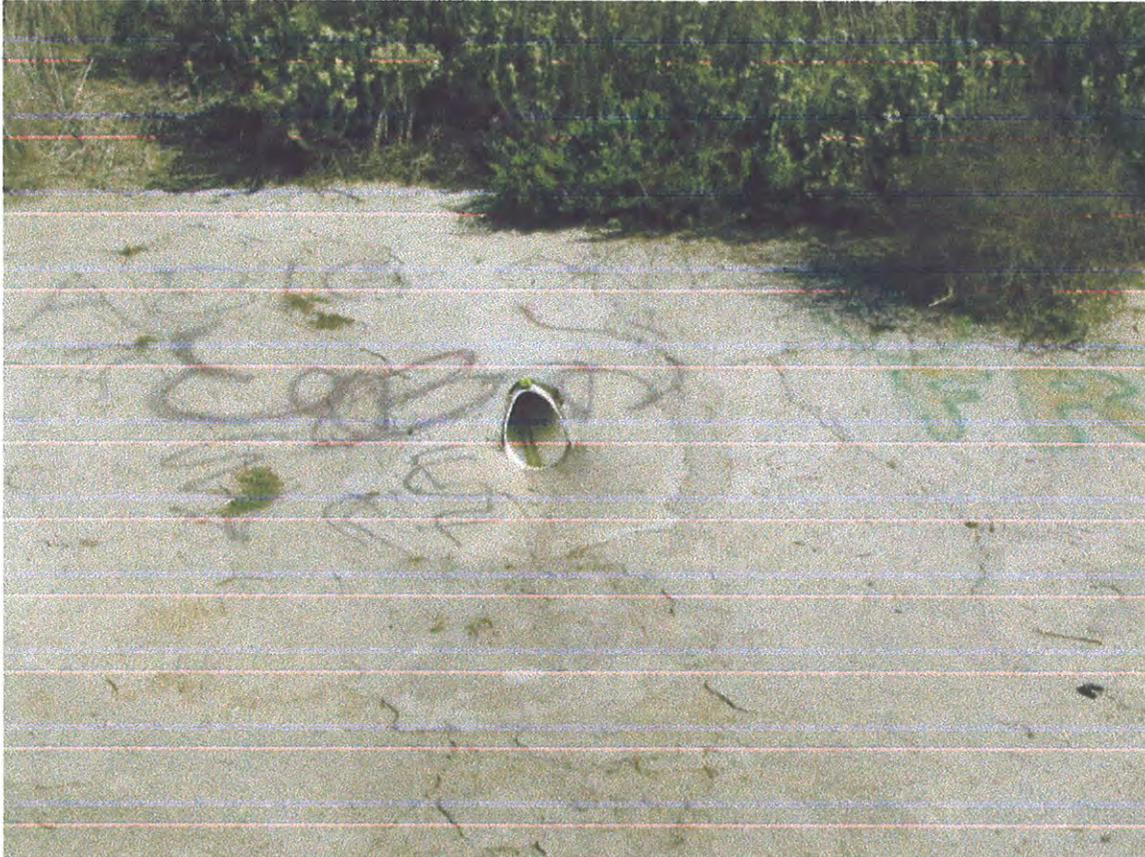
**Location 26 (see Hillside Park map)**

**Condition:** Location 26 is a 10 inch diameter outfall pipe that drains the southern area of Drainage Basin M2 in the vicinity of the PLNU track and soccer field, and discharges into the catch basin that is just upstream of the Arizona crossing with the culvert that is at the head of Watercourse G that includes Culvert Canyon.

**Recommendation:** Flows from this outfall should be directed into the Hillside Park drainage system for ocean disposal of runoff along with runoff from: Drainage Basin M2, Young Hall Parking lots, and other drainage basins and locations in the Park.

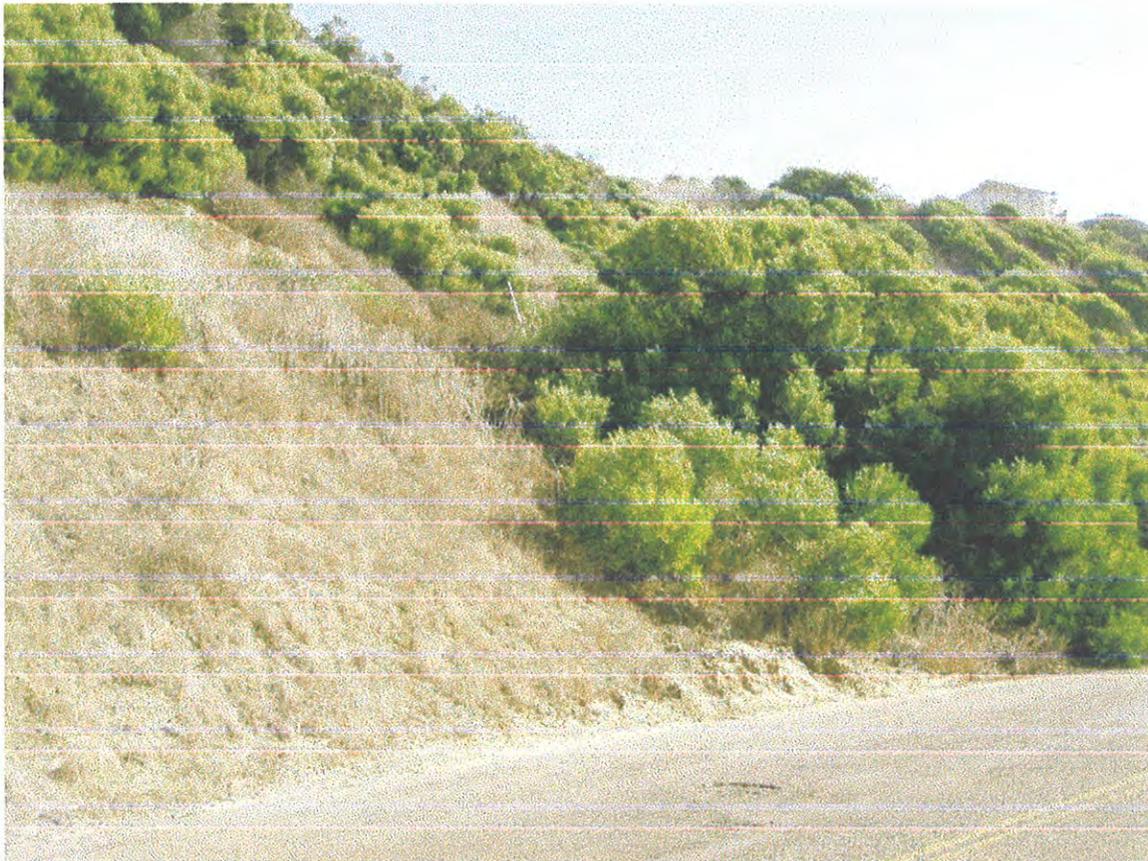
**Location 27 (see Hillside Park map)**

**Condition:** A 24 inch diameter outfall pipe that drains Drainage Basin M2, discharges at Location 27 into a pool on SCNP property shown in the picture below that has been constructed to catch “dry weather” flows. This pool poses a hazard to wildlife, because any animals that drink from it will be exposed to any contaminants that might be washed into it from irrigation runoff.

During periods of heavy rain, the 24 inch diameter outfall pipe, that is located where the white piece of pipe can be seen in the picture below, discharges over the pond and into the non-native shrubbery below that should be removed per the Master Plan.

**Recommendation:** Flows from the outfall at Location 27 should be directed into the Park drainage system for ocean disposal along with runoff from drainage Basin M2, Young Hall Parking lots, and other drainage basins and locations in the Park. Dry weather flows from this outfall should be monitored for contamination and perhaps treated to remove any agricultural chemicals that are used to maintain the PLNU athletic fields and happen to enter the storm drain system.

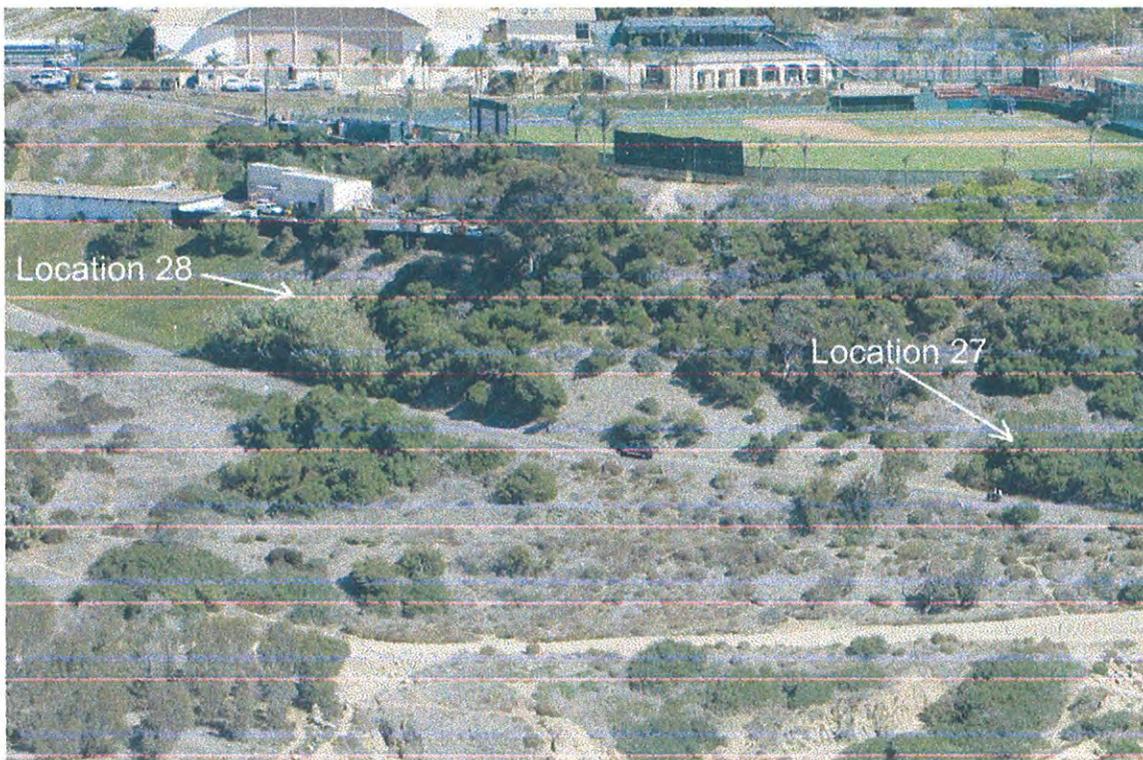
**Location 28 (see Hillside Park map)**

**Condition:** Location 28, that is pointed out in the photograph below, is the location of an 18 inch diameter outfall from the PLNU drainage system that terminates and discharges onto Park property. “Dry weather” flow can be heard trickling down inside the broken cement structure at the end of the outfall pipe, but a pool or stream leading away from it has not been found due to the dense grove of extremely invasive non-native weed *Arundo donax* that is growing around the terminus of the outfall pipe. Since *Arundo donax* burns explosively, it should be removed so it doesn’t pose a fire hazard to the nearby PLNU Physical Plant buildings. Location 27 shown in the photograph is the terminus of a 24 inch diameter outfall from the PLNU drainage system.

**Recommendation:** The effluent from the drainage outfall at Location 28 should be plumbed into the same ocean outfall storm drain system that is used for the disposal of runoff from Basin M2 and other runoff sources that impinge on the Hillside Park. The dry weather flows from this outfall should be monitored and perhaps treated before ocean disposal.

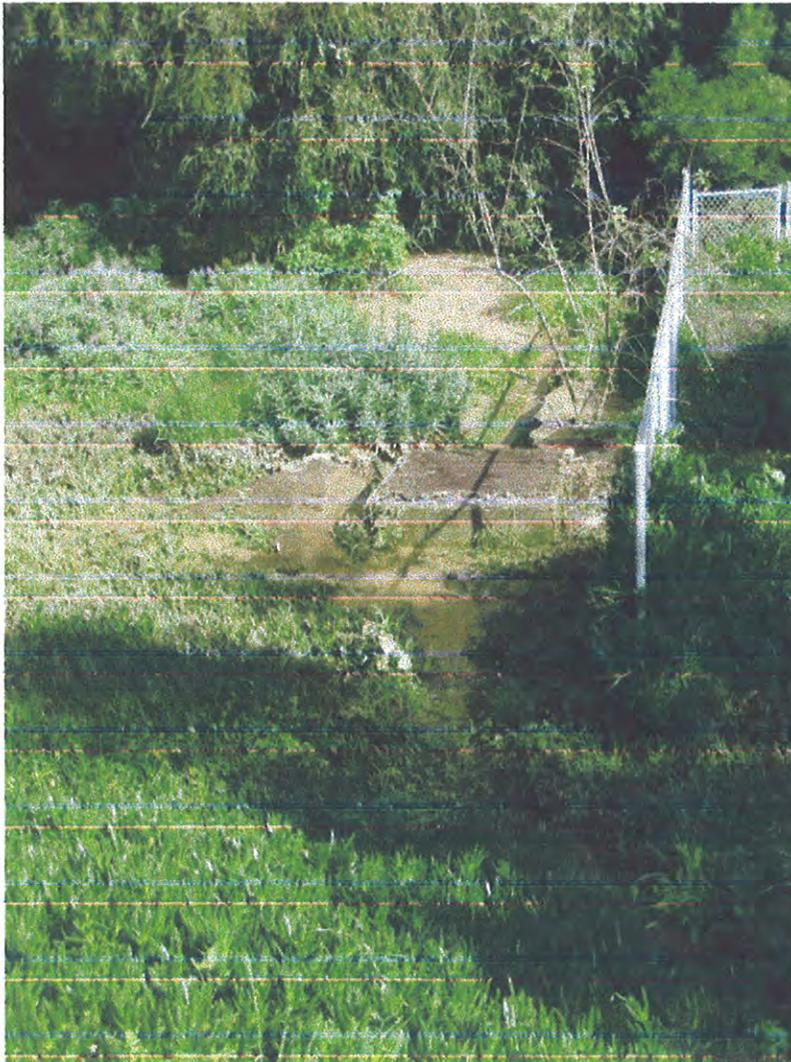
**Location 29 (see Hillside Park map)**

**Condition:** Location 29 is a pipeline that connects the northern part of the Hillside Park (DUDEK Report Drainage Basin D2, with an outfall that discharges down an alley way just east of Cornish Drive and into Drainage Basin D1. A cleanout in a depression near the western end of Park Property in the northern part of the Hillside Park that is the input structure to the pipeline that is Location 29, is shown in the photograph below. During the heavy rainfall period from October 2004 through February 2005, this depression was filled with a considerable amount of soil due to erosion in drainage basin D2. Muddy water was also observed in the streets below where the Location 29 pipeline discharged.

**Recommendation:** Monitor Drainage Basin D2 and the drainage system outfall for evidence of erosion, and correct conditions when evidence of erosion is found. New drainage system outfalls from the PLNU that discharge onto Park property and were installed in 2005 or at a later date (see location 30 and Water should

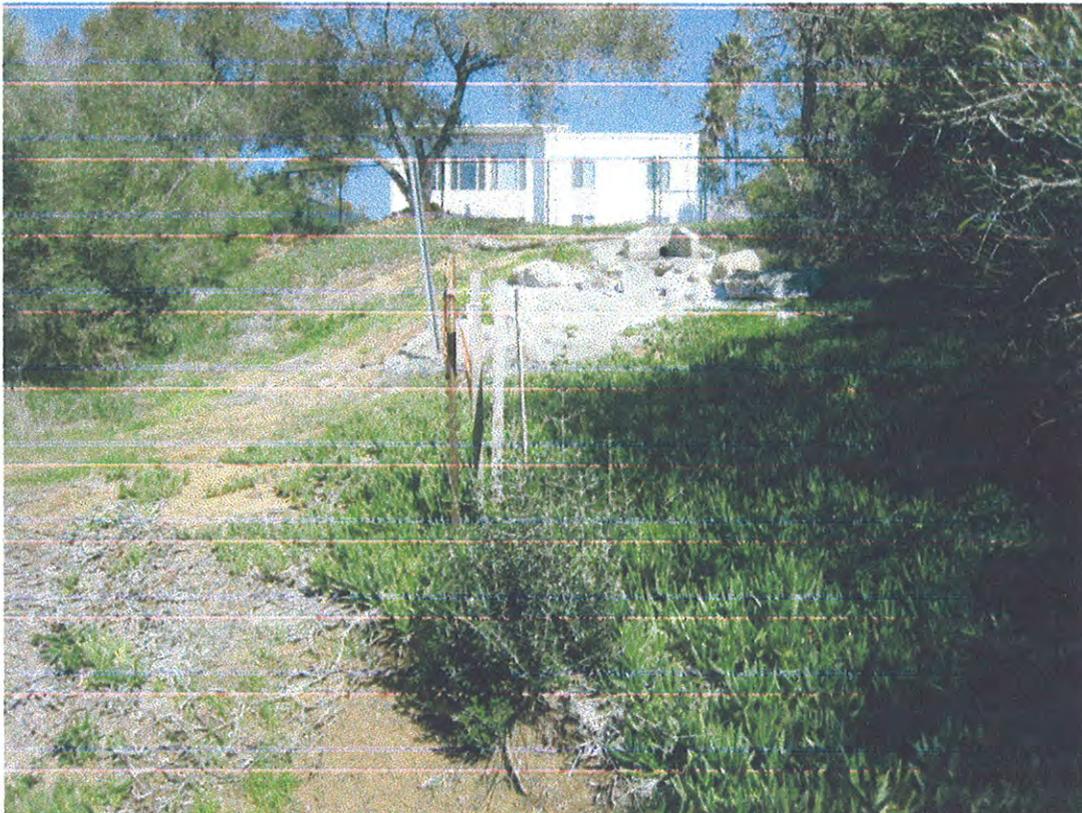
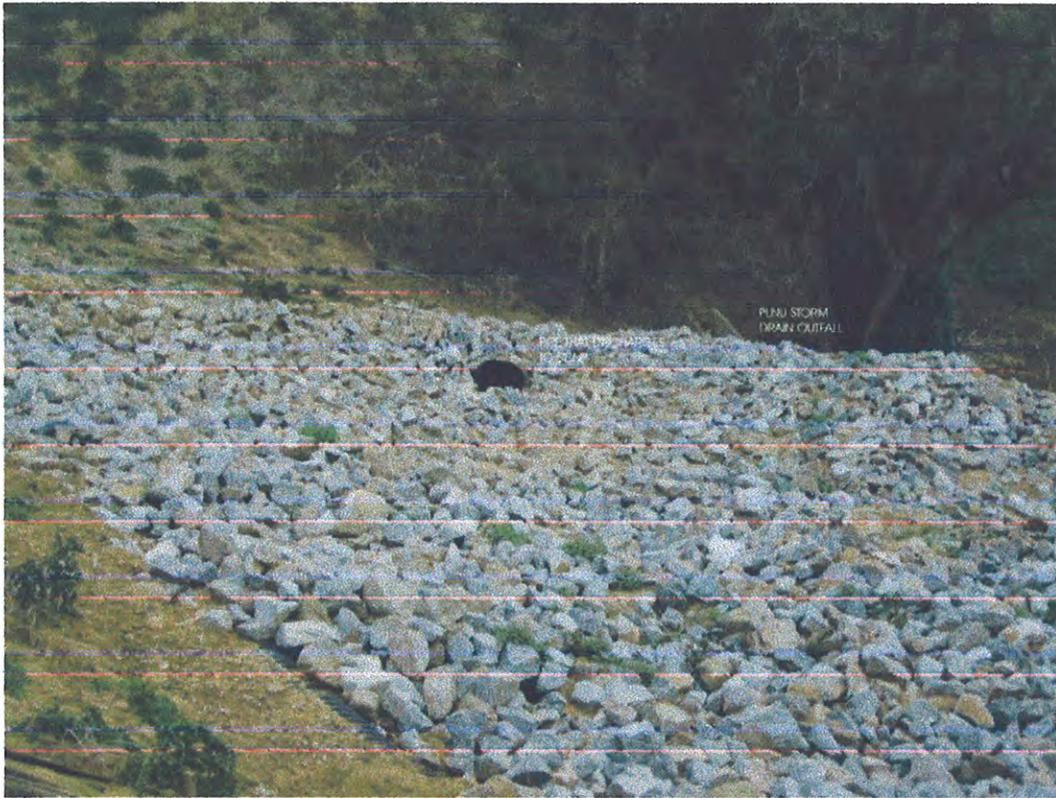
**Location 30 (see Hillside Park map)**

**Condition:** Location 30 is a 6 inch drainage outfall and spreading structure in the vicinity of the westernmost PLNU Nease Hall dormitory complex as shown in the picture below, and a nearby discharge into rip-rap shown in the second photograph. These outfall were constructed in 2006 and 2005 respectively, and they discharges into DUDEK Report Drainage Basin D2.

**Recommendation:** Monitor areas around PLNU outfall structure to see if runoff from them is responsible for erosion in DUDEK Report Drainage Basin D2. A possible action that could be taken to either prevent erosion from occurring or eliminate it if it is found, would be for PLNU to collect the runoff and use it for irrigation during the dry season.

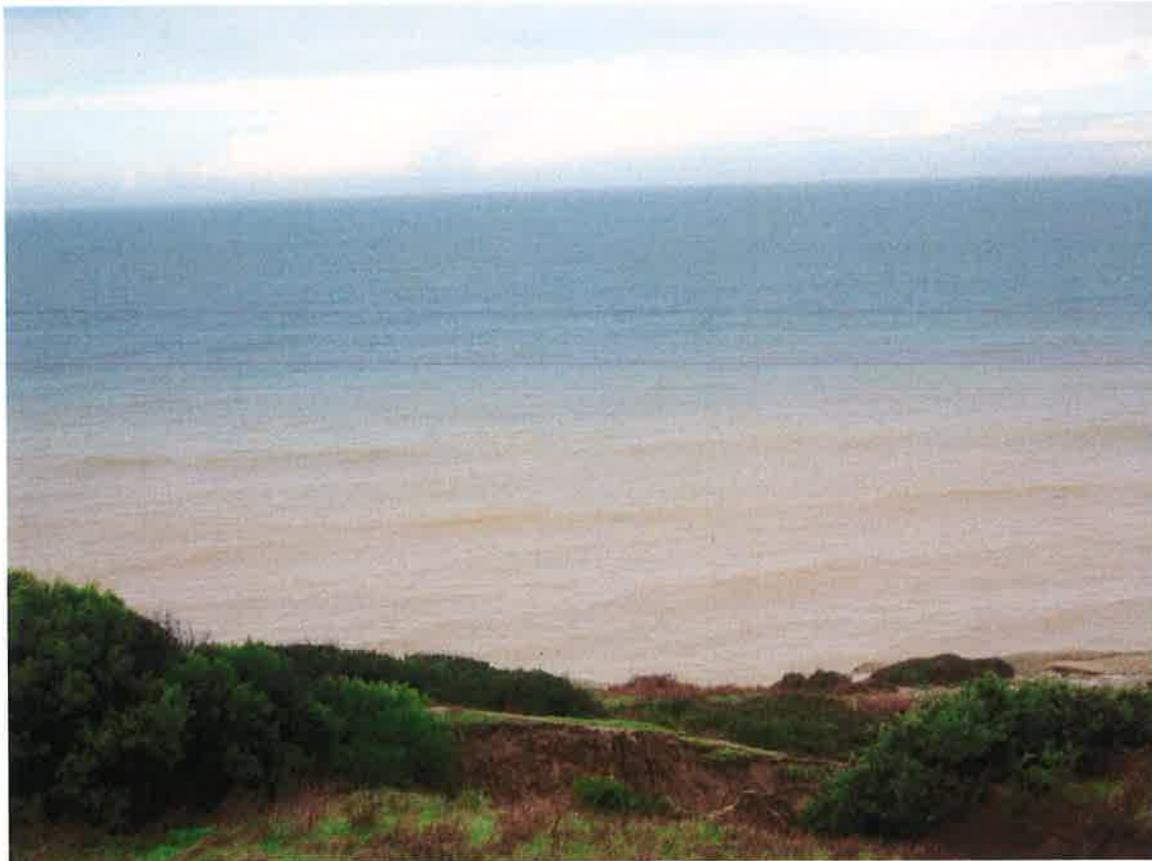
**Figure 1.** Turbid nearshore waters adjacent to the Sunset Cliffs Natural Park December 22, 2010 visually alerts the public to the contaminants and massive erosion from the Park. Turbid waters, due to erosion from the Park, can be seen off the Park after every storm.

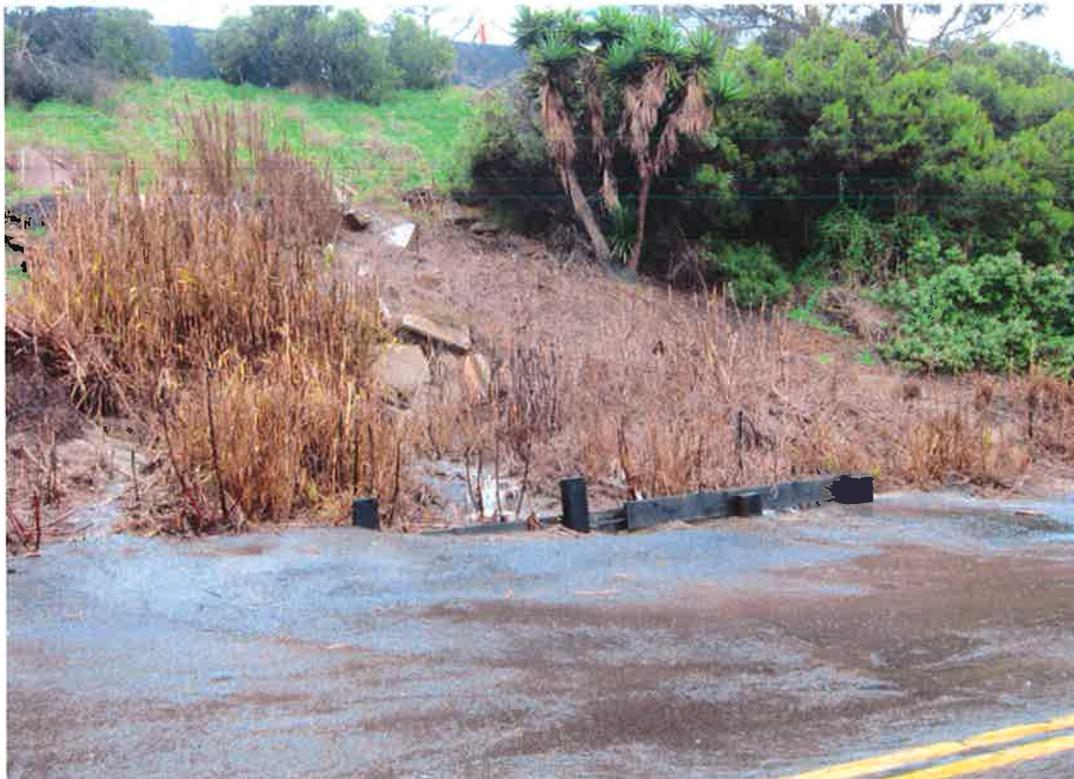
**Figure 7.** The 18" pipe discharges on this slope among the concrete rubble and dead Arundo plants. Runoff from the 18" pipe mostly stays on the road until the asphalt curb on the western side of the road decreases from approximately 6" in height to 3" and then is nonexistent.
