## SUNSET CLIFFS NATURAL PARK

Drainage Study

September 2012

**PREPARED BY**  
Dudek  
605 Third Street  
Encinitas, CA 92024  
800.450.1818  
[www.dudek.com](http://www.dudek.com)

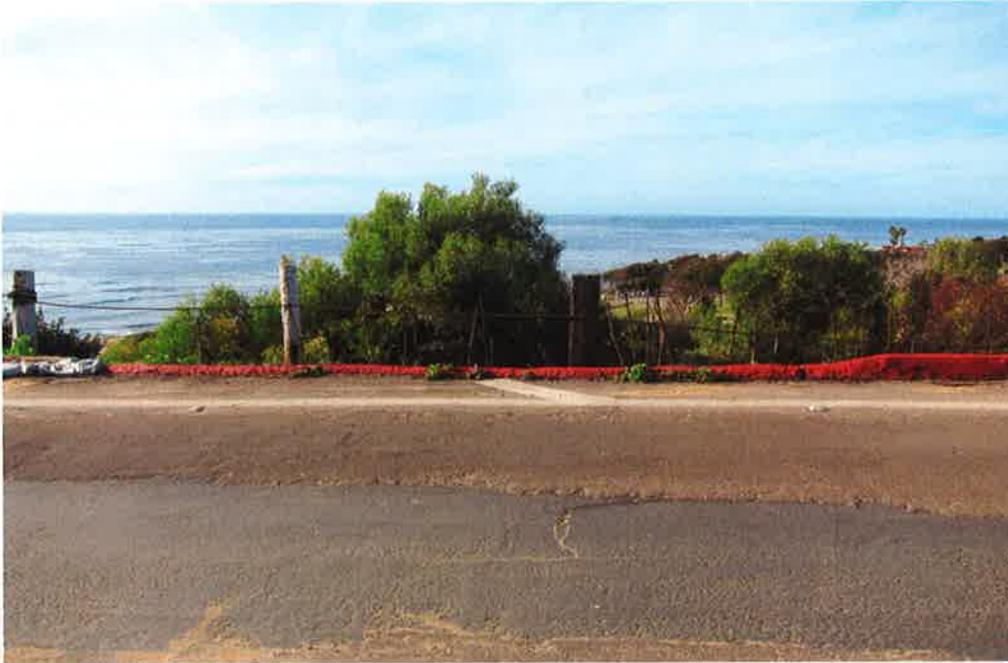
**Figure 9.** The curb height changes from 6" to 3" allowing storm water to run off between the two Acacia trees by the unpainted wood post, as well as, where the curb is missing, down slope from the sand bags.

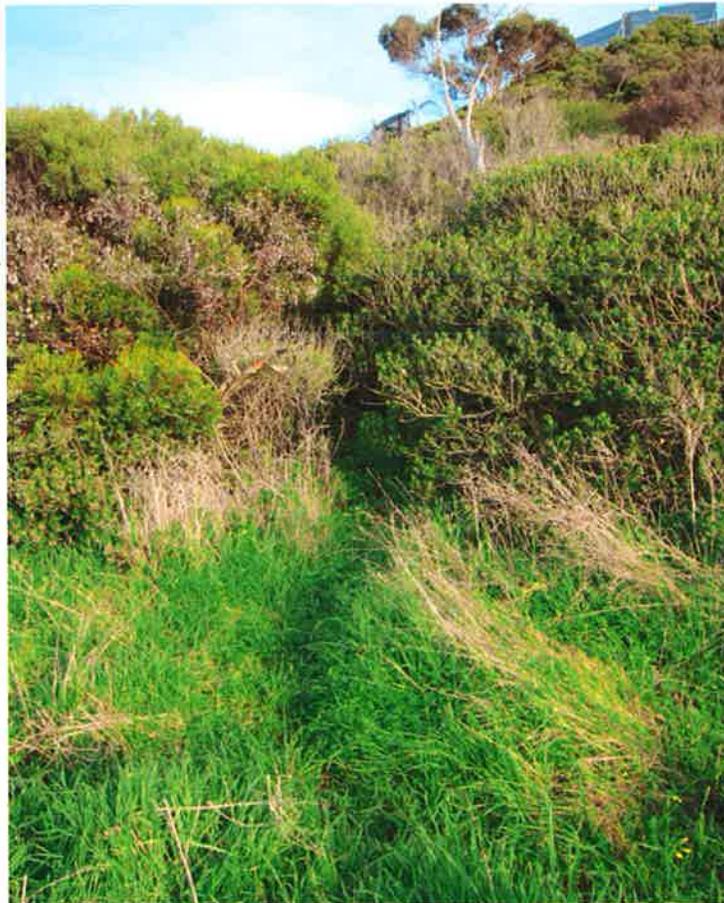
**Figure 10.** Runoff from the 18" drain goes over the edge of the Loop Road where the curb is 3" or less in height, and it then flows under the bushes and follows the "trail" down the hill, shown by laid down weeds.

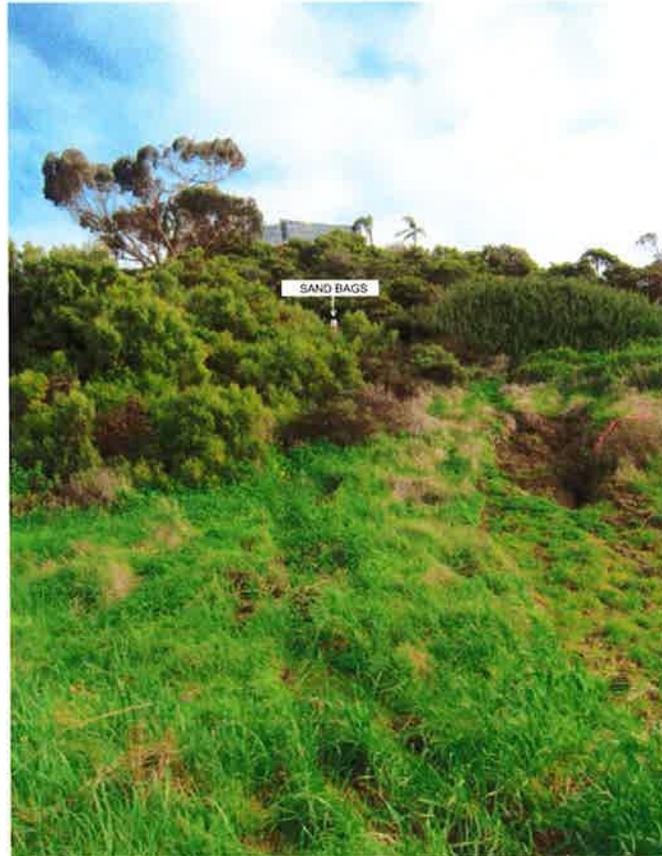
**Figure 11A.** This runoff course, due to the 18" pipe, is slightly further down the Loop Road than is the one shown in Figure 10. The runoff caused the "trail" and the slump and erosion to the right.

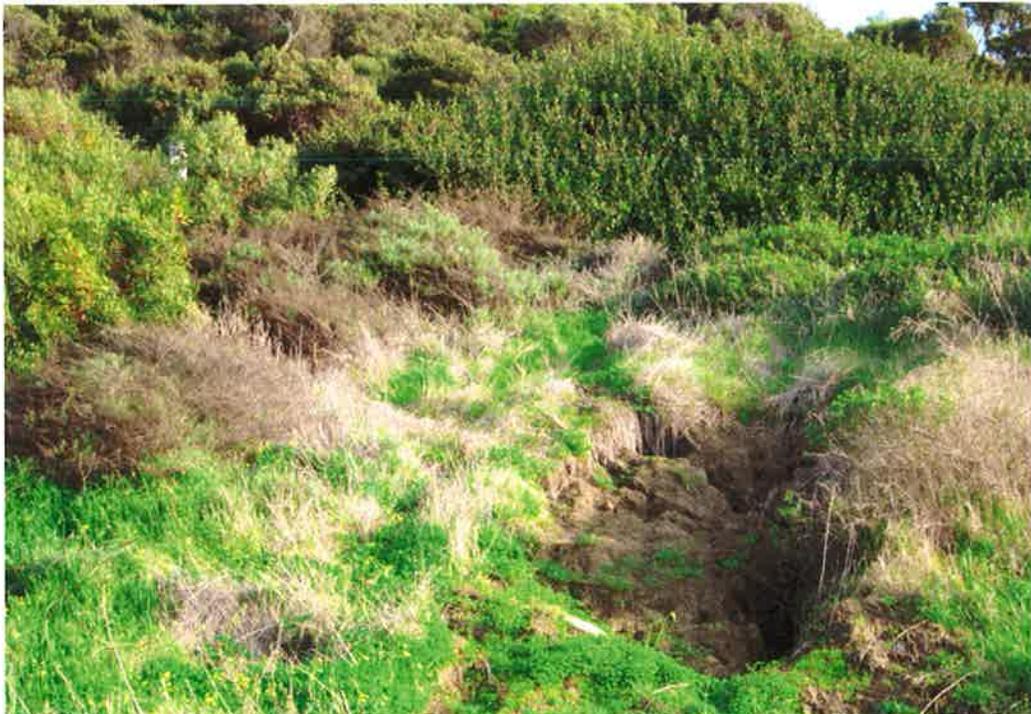
**Figure 11B.** Close-up of the erosion/mass wasting/mud hole due to runoff from the Loop Road. Those who use this trail to access surfing areas on an almost daily basis did not observe this damage to the Park prior to the December 2010 storm.

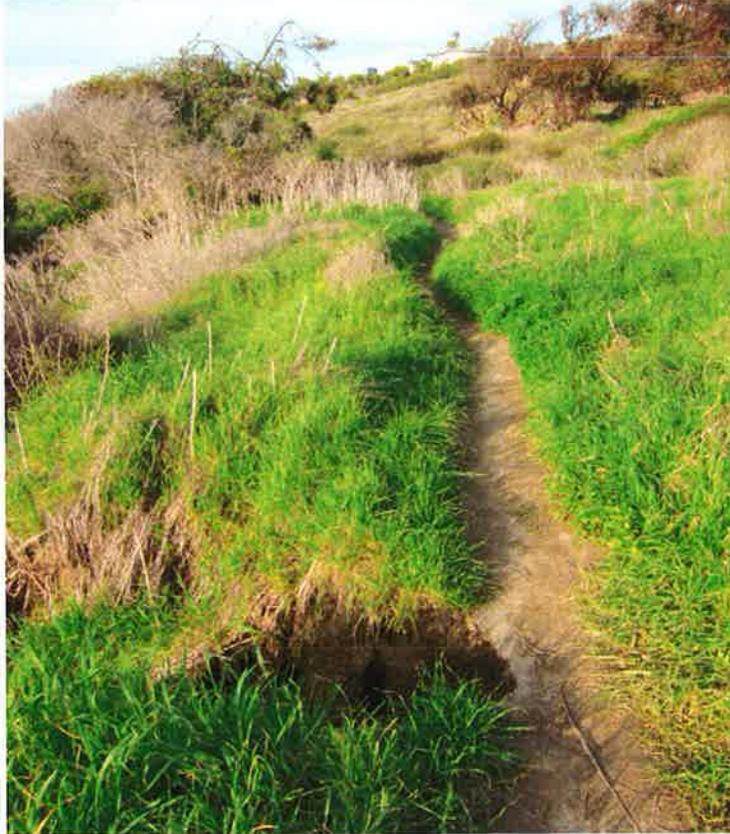
The runoff from the 18" pipe as it goes on down the hill is causing a significant collapse of a trail that is planned to become part of the Park formal trail system.

**Figure 12A.** Runoff from the 18" pipe is undercutting this trail that is being considered as a secondary trail for the Park, and has caused a significant collapse of the trail and the slope adjacent to it.

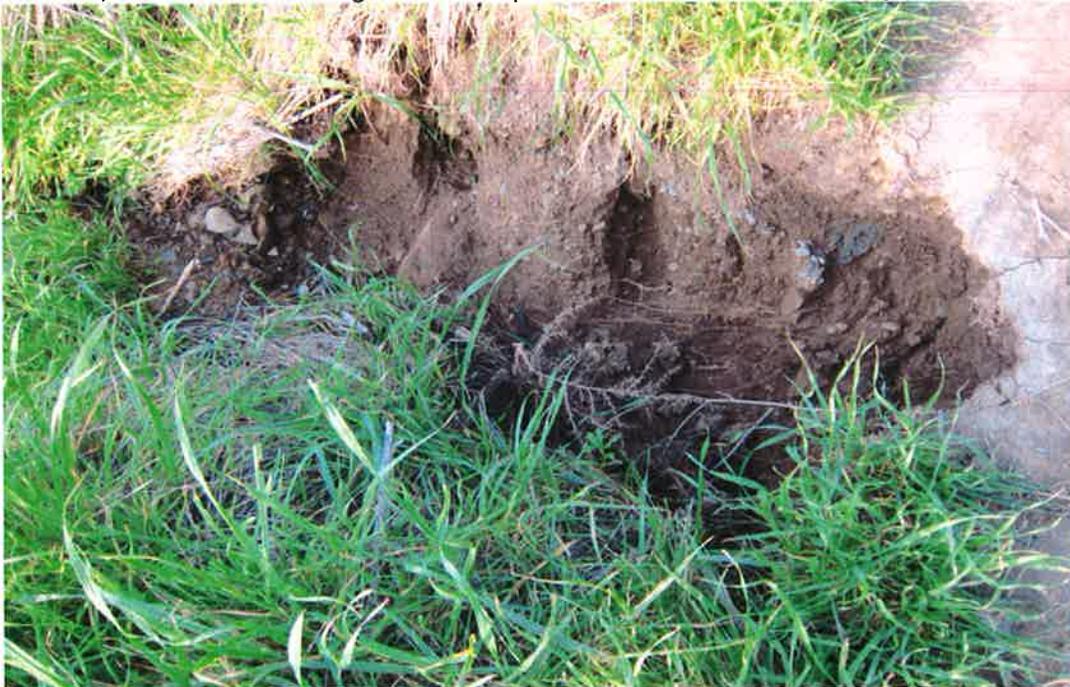
**Figure 12B.** Close up of erosion washing out the path. 6" curbs along the Loop Road could easily eliminate the runoff causing this washout and allow this trail to be part of the permanent trail system.

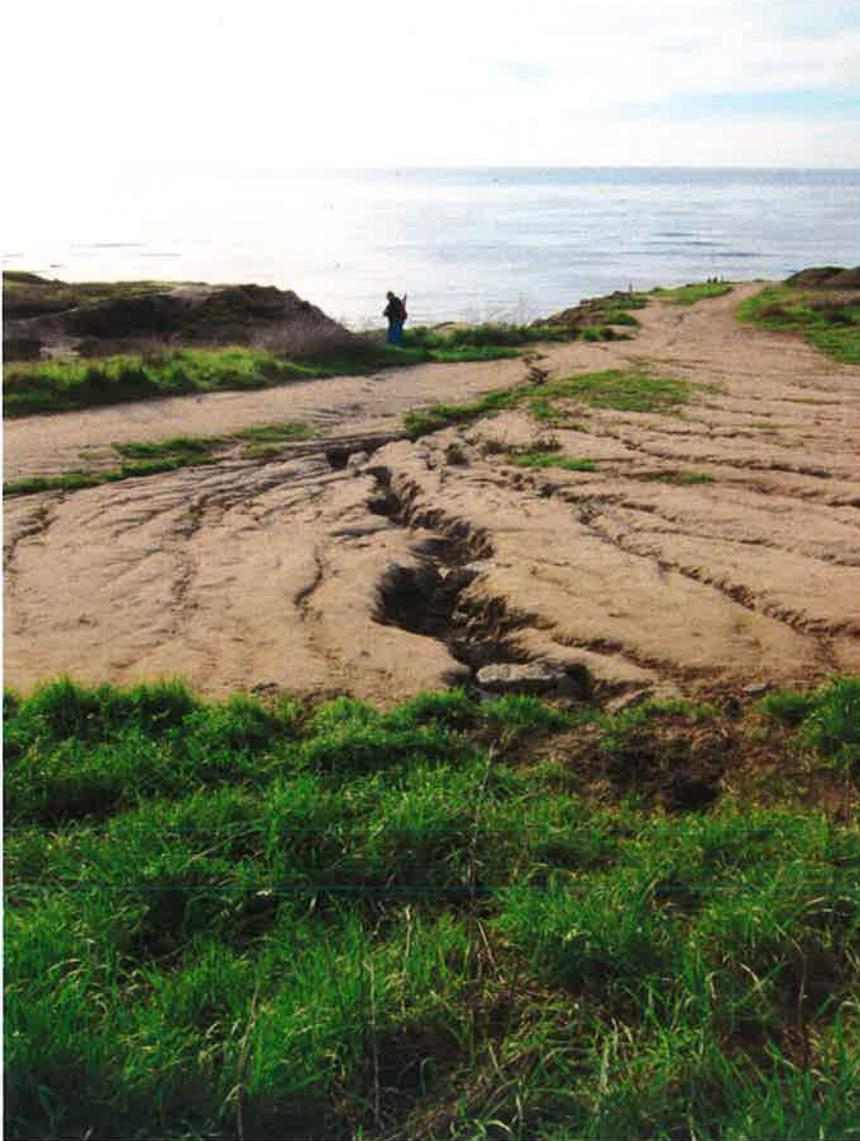
The runoff from the 18" pipe (Figures 13 & 14) continues down the slope, crosses the sludge line where it formed a 4-6 inch deep erosion rill, and then continues westward where it has started a new erosion gully on the northeast side of the badlands (Figure 15). This runoff is also exacerbating existing erosion gullies down slope along the northern edge of the Badlands and westward including extensive erosion between the Lower Parking Lot and the Badlands.

**Figure 13.** Runoff, mostly from the 18" drain pipe, crosses the sludge line trail, where it has cut this major erosion rill that is 4-6 inches in depth as well as the minor ones, before running into the Badlands along portions of the northern edge. From the Badlands, the runoff runs into Culvert Canyon where it is mixed with flows from Drainage Basins M1 and M2 that can total up to 50 cubic feet per second for a 10-year storm, like the December 2010 storm, before discharging over the cliffs to the ocean. A new erosion gully was formed where the person is standing in the photograph. 6" curbs along the Loop Road could eliminate the runoff causing erosion of the sludge line trail, based on preliminary designs for the Park comprehensive drainage system and observations of their effectiveness when used along parts of the Loop Road after the 2004-2005 rains. This should be done so the trail and sludge line will not require costly repairs.

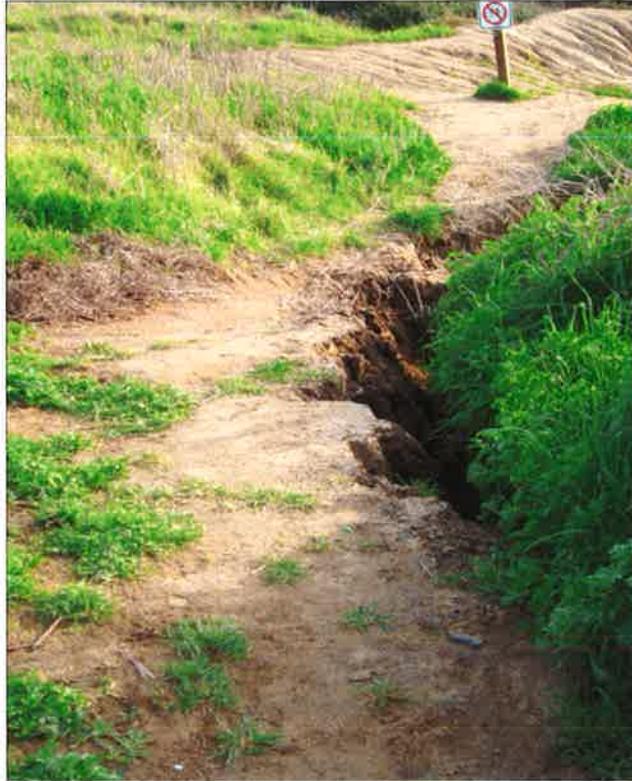
**Figure 14.** This new erosion gully from runoff from the 18" drain coming off the Western Loop Road was first noticed after the major December 2010 storm. The upper, southward running portions of this recently formed gully should be filled in and stabilized to prevent it from enlarging.

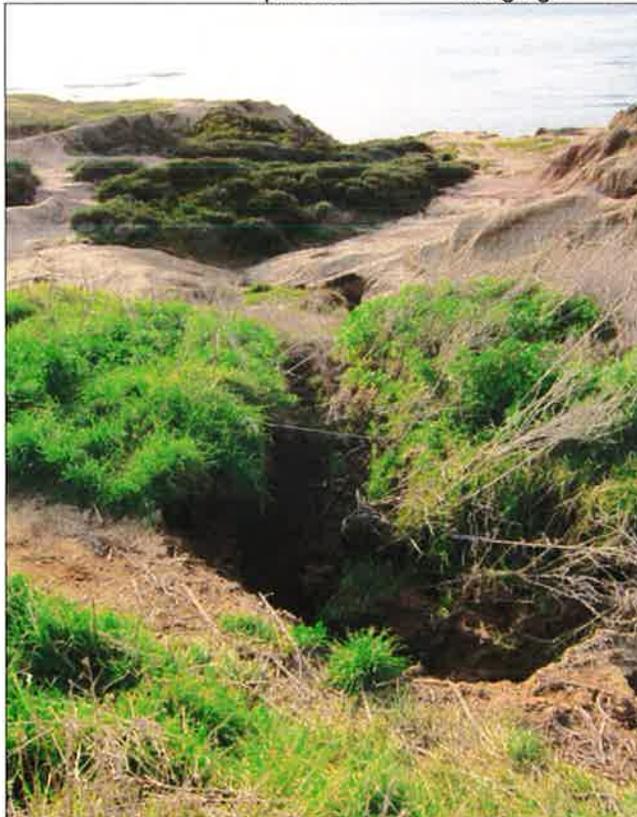
**Figure 15.** Southern part of the new erosion gully formed by runoff from the 18" drain where it runs into the Badlands. This runoff flows into Culvert Canyon and into the nearshore waters.

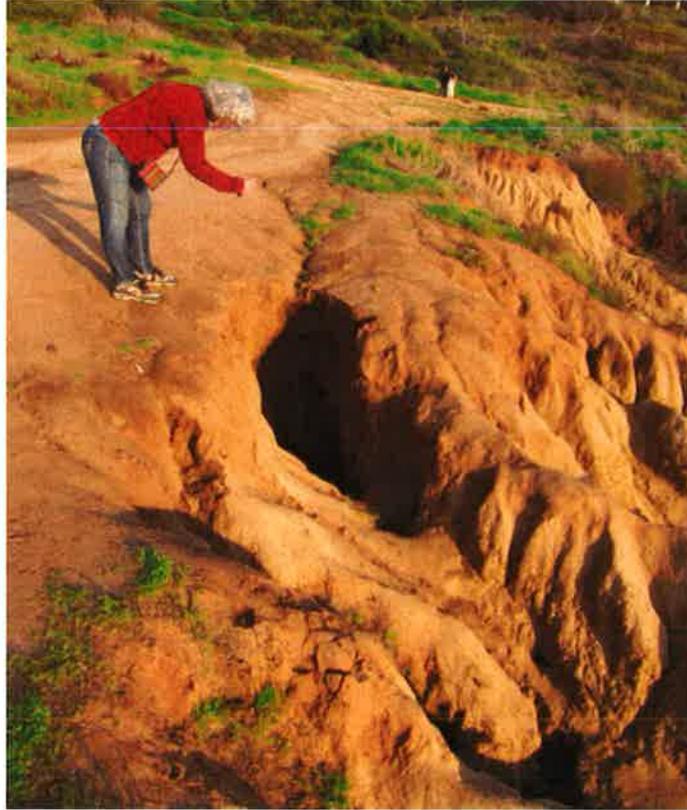
**Figure 16.** Additional erosion caused by discharges from the 18" pipe along the northern edge of the Badlands. 6" curbs on the Loop Road could easily control this erosion.

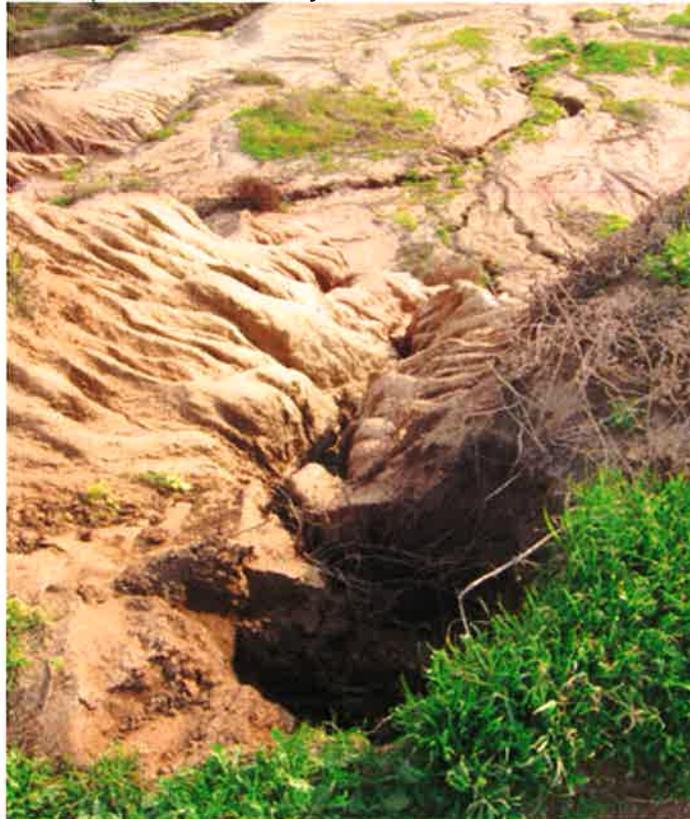
**Figure 17.** One of many sinkholes next to the trail in the Badlands that pose a clear danger to people and pets, because they are over 10" in depth. These are caused by runoff from the 18" pipe.

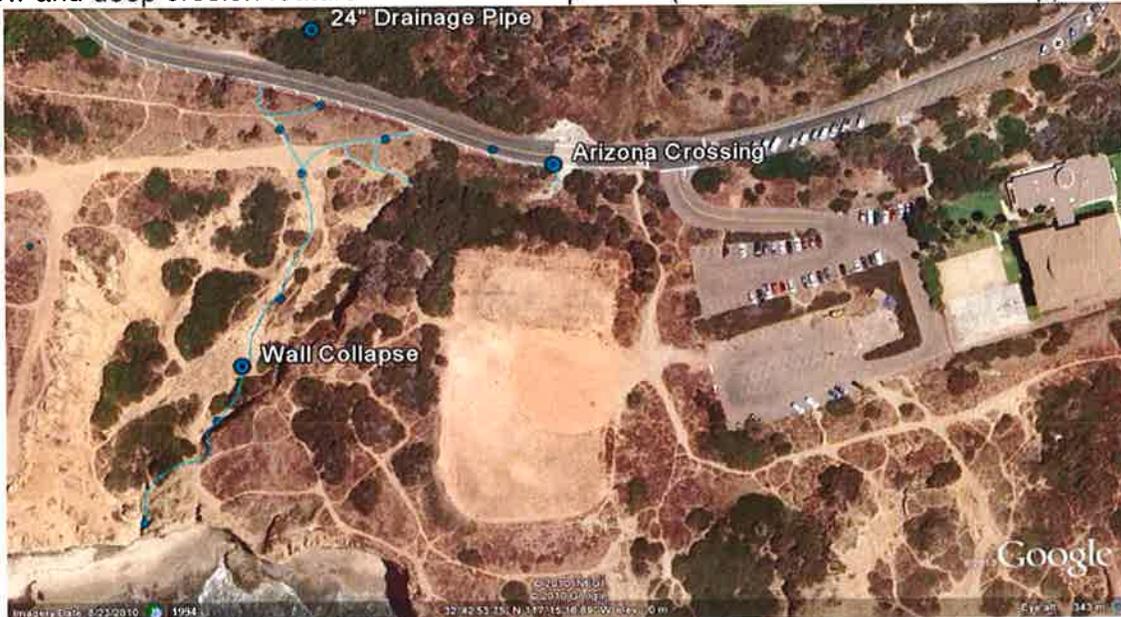
The 24" drainage pipe from PLNU discharges onto Park hillside above the Loop Road, about 500 feet south of the PLNU maintenance building. Even without rain, there is dry-weather flow from this pipe, evidenced by a persistent pond on the slope. This discharge combines with runoff from other sources on the Loop Road, including the 18" pipe, to create ponding on the road. After the December 2010 storm, the water courses this runoff follows were obvious (Figure 18), making it possible to link runoff to erosion rills along the sludge line trail to the resulting failure of the northern wall of Culvert Canyon from mass wasting. Culvert Canyon is a narrow and deep erosion feature west of the Loop Road (estimated 10 to 30 feet deep).

**Figure 20.** Erosion Caused by Discharges from the 24" Pipe to the Western Loop Road. For reference, the Badlands are on the left, Culvert Canyon is the deep feature to the left of center, and the old ball field is to the right. Runoff from the 24" pipe flows over the Loop Road curb and into the southeast corner of the Badlands and Culvert Canyon at locations indicated by blue dots. Runoff across the Park roughly follows the blue streamlines showing the linkage between erosion on the sludge line trail and the wall collapse area in Culvert Canyon. During periods of high flow the runoff also flows over vegetated areas.

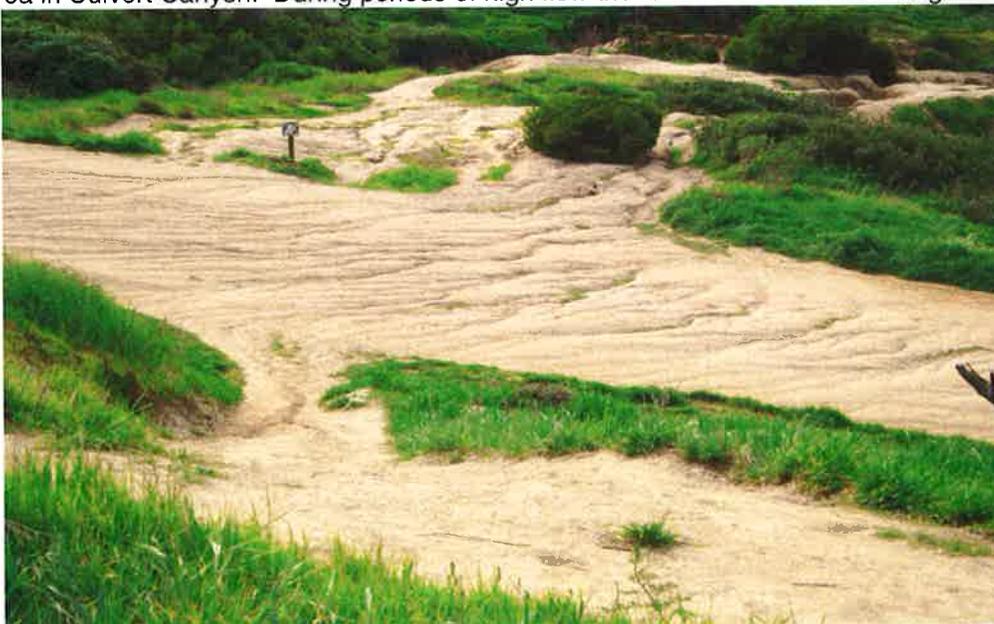
**Figure 21.** Erosion rills cause by runoff from the Loop Road, predominantly from the 24" pipe.

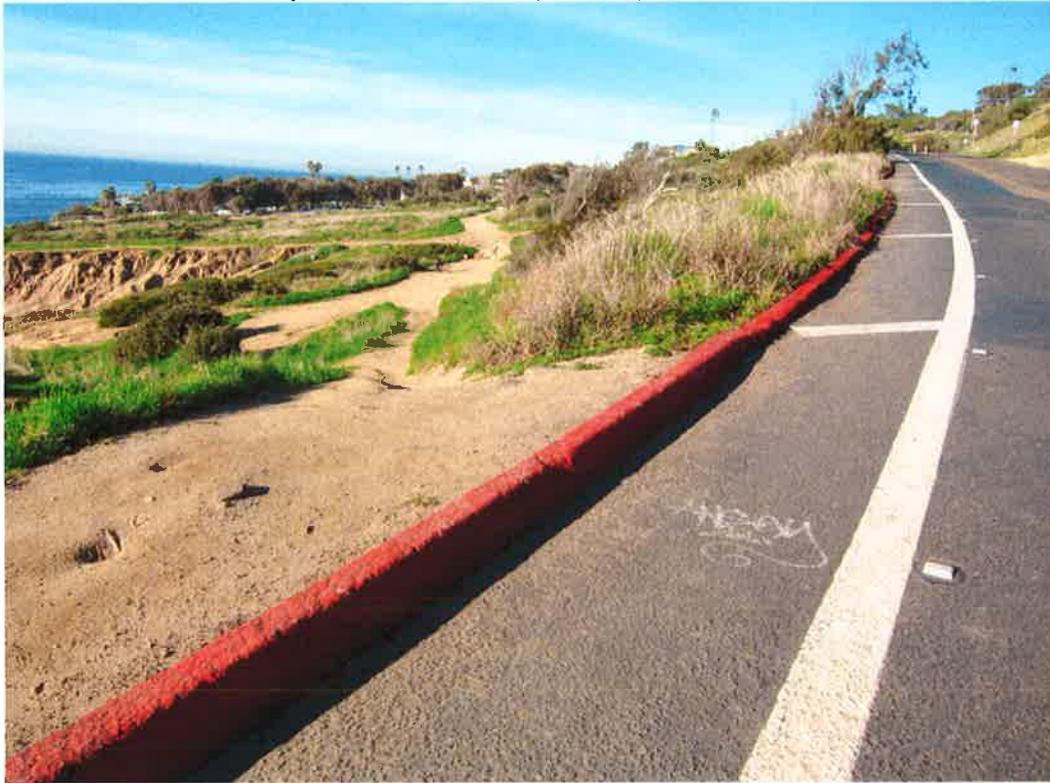
**Figure 22A & 22B.** Low curbs transition to 6" high curbs where the ramp from the sludge line trail joins the Loop Road (Figure 22A). The low curbs enable road runoff, made up in large part by discharges from the 24" pipe, to flow down the transition trail (Figure 22B) and into Culvert Canyon where it contributes to

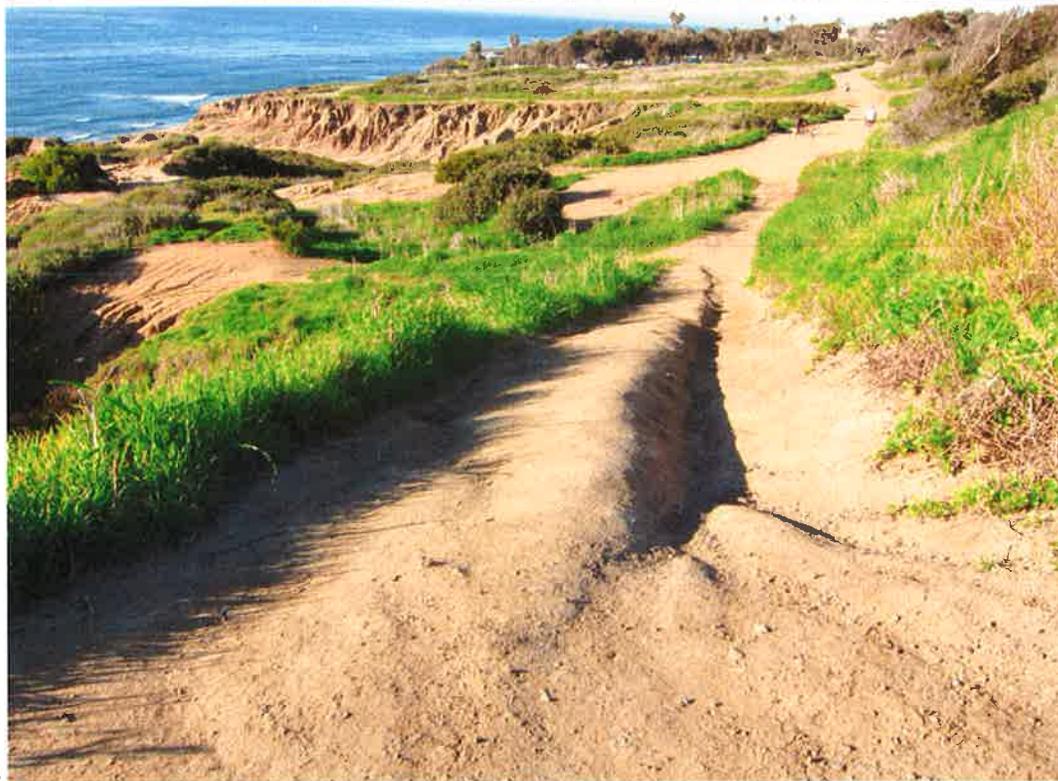
22B

mass wasting on the northeast wall of Culvert Canyon as shown in the next figure. This major section of the proposed Park trail system is being compromised by runoff from the 24" pipe.

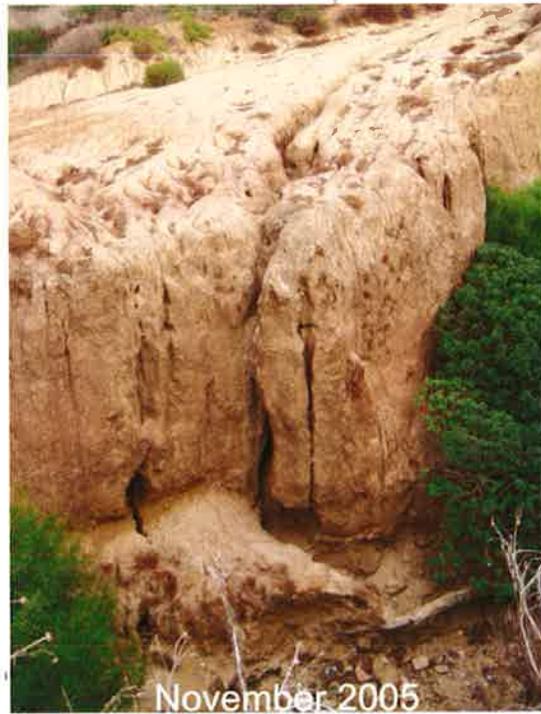
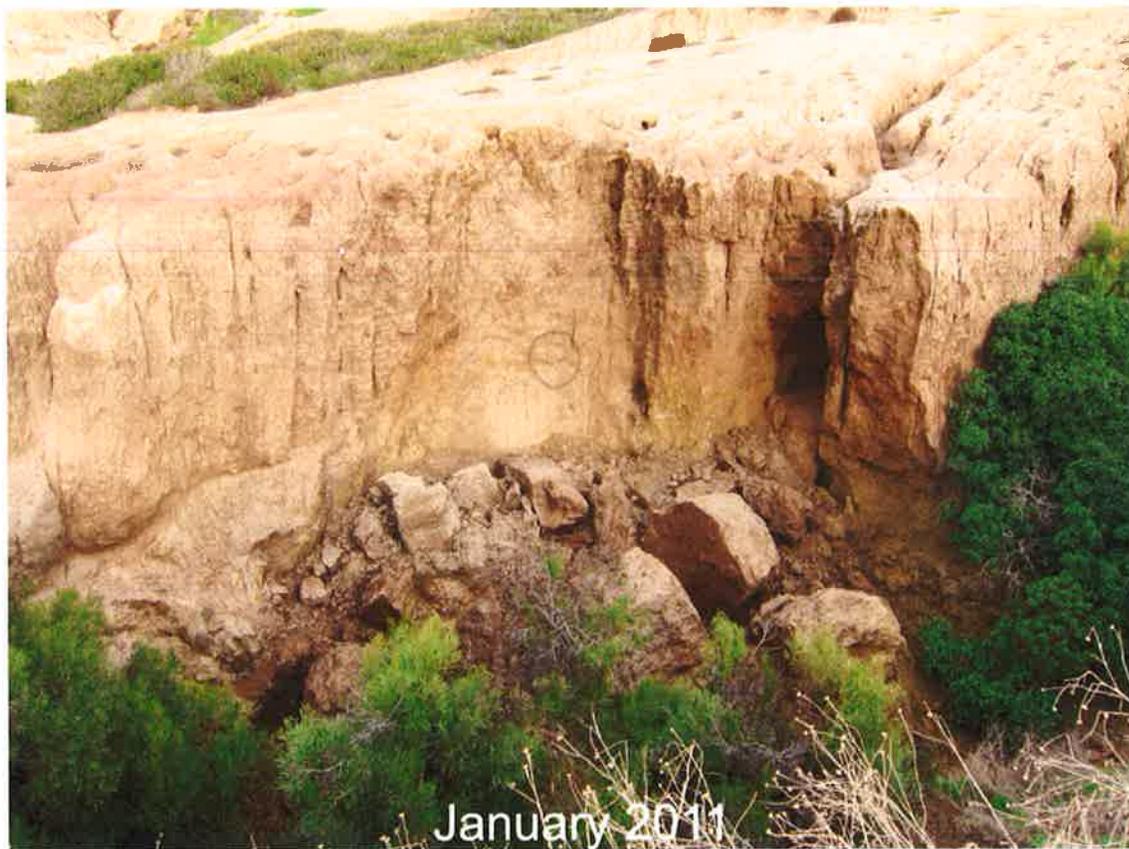
**Figure 23.** Culvert Canyon wall collapse where runoff from 24" pipe and other sources crosses the Loop Road and continues down erosion gullies in Drainage Basin M1 until it reaches the north wall of Culvert Canyon causing the wall to fail by the erosion process called mass wasting.

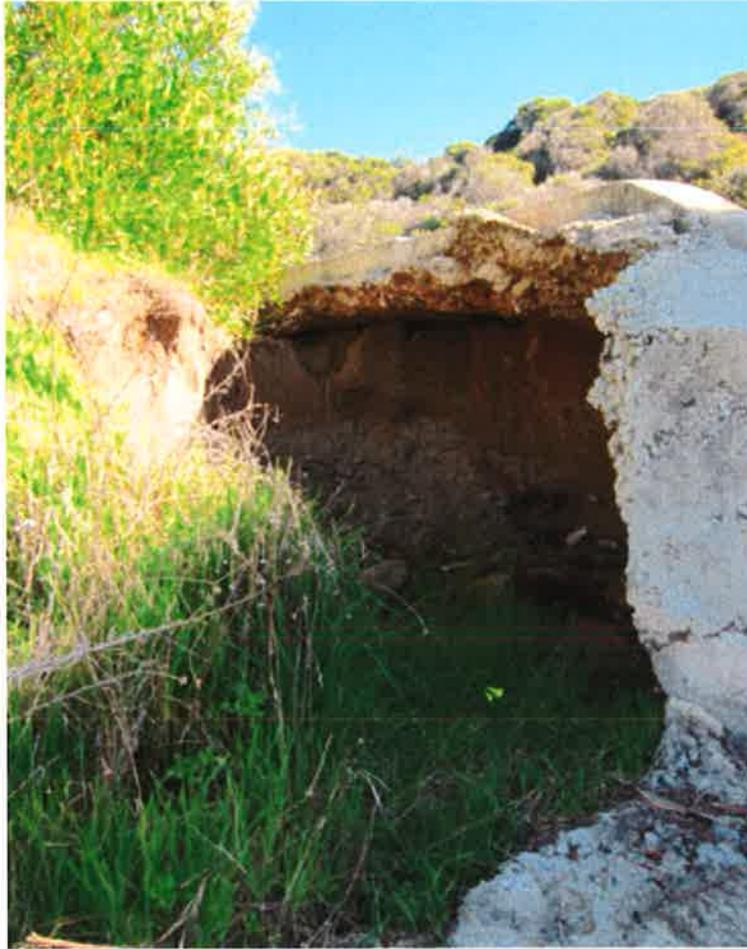
Just north of the Arizona Crossing (the lighter colored concrete in Figure 22) runoff goes over the curb and is undermining the Arizona Crossing (Figures 23A and 23B) and is exacerbating erosion in the area of the concrete swale. This will cause the failure of the Arizona Crossing if it is not attended to. The runoff from the Loop Road to the Arizona Crossing goes into a concrete swale, which then empties onto riprap, and then onto unprotected parkland. Culvert Canyon is an unnatural feature created by runoff from the Loop Road and is the largest drainage/erosion feature in the Park. Most of the contaminants and sediments seen in Figure 1 are carried to the nearshore waters through Culvert Canyon, making this a highly significant source of marine pollution.

**Figure 25A.** Undermining of the Loop Road Arizona Crossing by runoff that flows over the western curb (primarily from the 24" pipe). An adequate height curb could eliminate this maintenance problem.

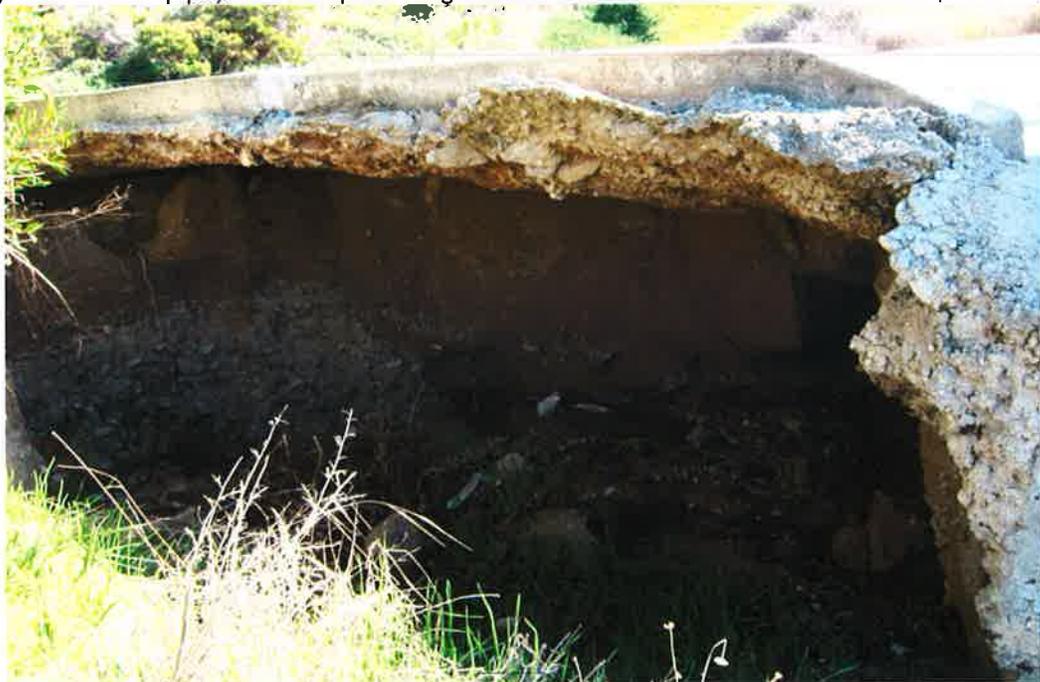
**Figure 25B.** Close up of the undermining of the Loop Road Arizona Crossing. Most of the water causing this damage is from the 24" drain.

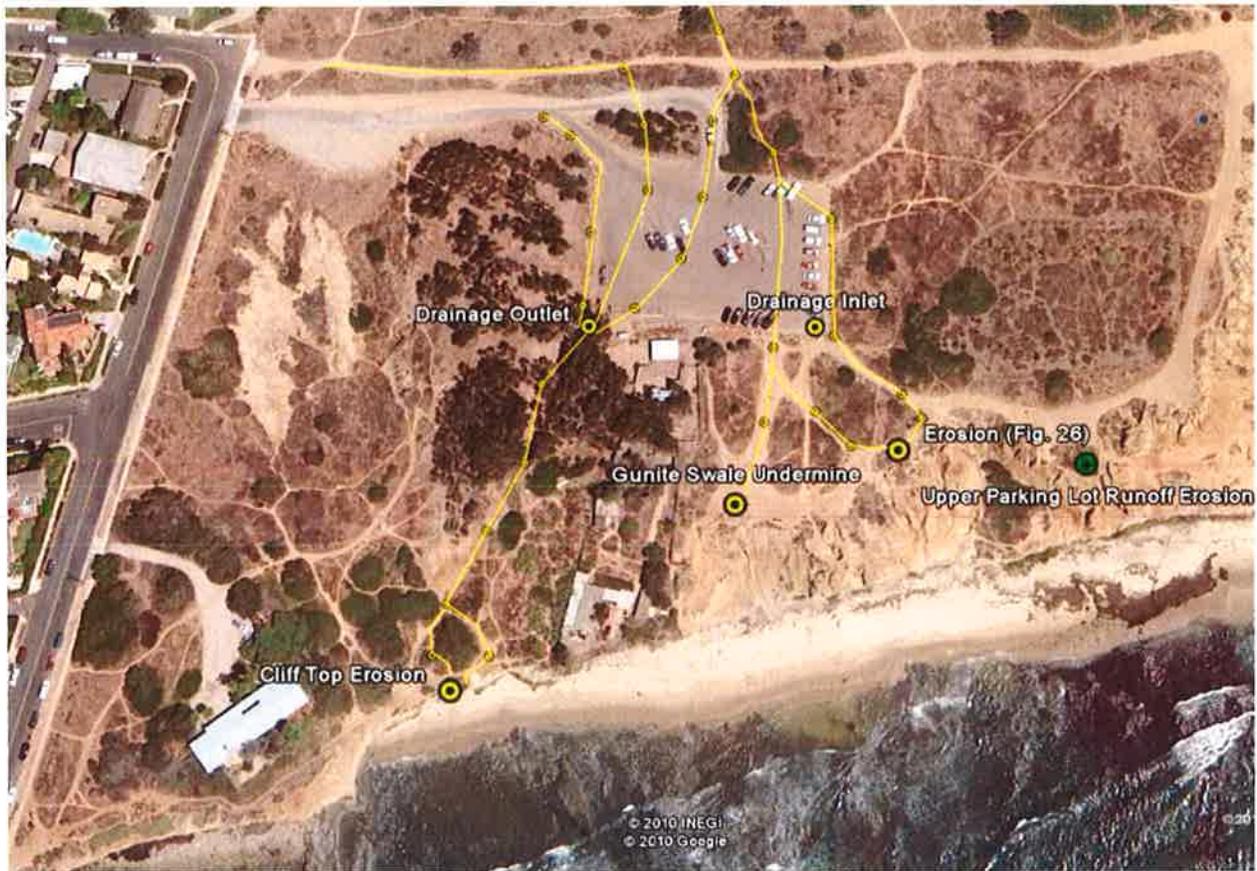
Due to improper grading of the Lower Parking lot, little, if any of the rain and runoff that falls onto or goes into the parking lot from the hillside above it, leaves it through the existing storm drain in the southwest corner of the lot. As a consequence of improper grading, major erosion problems can be found down slope of outlets at both the southwest and northwest corners of the lot.

**Figure 26.** Pathways runoff follows (shown in yellow) before runoff enters and after it leaves the Lower Parking Lot. Very little parking lot runoff passes through the existing Lower Parking Lot drainage system (in the southwest corner). This drain should carry the runoff to the discharge and the Gunite swale, seen as a light colored feature running across the bowl shaped area in the center of the picture.

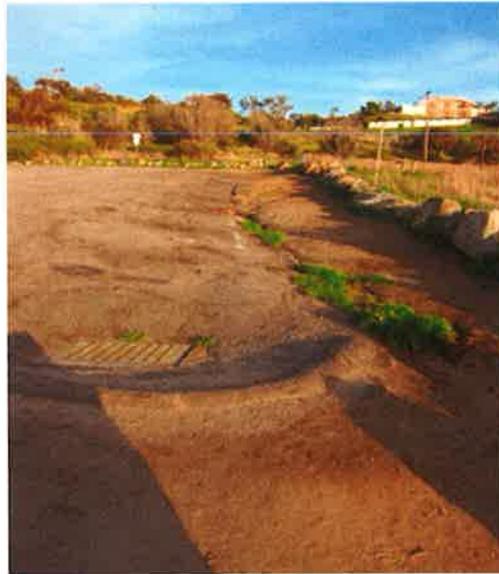
Runoff from Drainage Basin I flows into the Lower Parking Lot along the south side. About mid-way down the south side of the lot, the runoff leaves the lot creating an erosion rill. The runoff does not enter the parking lot storm drain inlet in the southwest corner of the Lower Parking Lot, because the southern side of the parking lot lacks curbing that would keep runoff on the lot until it entered the storm drain inlet. The Master Plan calls for reconstruction of the Lower Parking Lot so it drains properly into whatever drainage system is finally built.

**Figure 28.** The south side of the Lower Parking Lot, showing both the storm drain inlet and an erosion gully to the south of the storm drain inlet. Clearly, runoff from Drainage Basin I flows along the south side of the lot, causing rill and gully erosion before it discharges over the cliff (Figure 24).

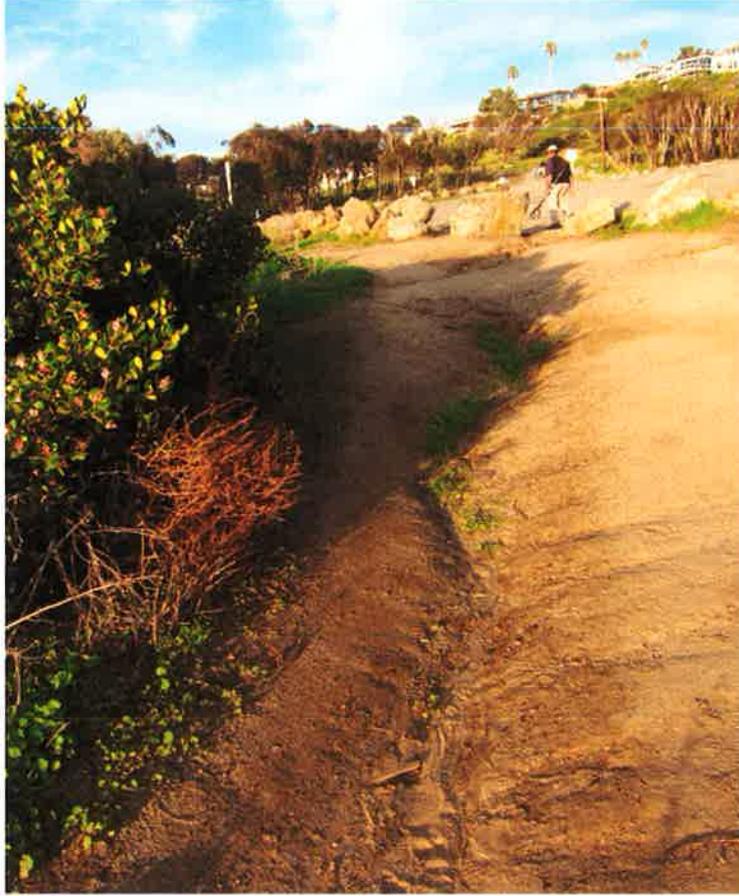
**Figure 30.** Runoff from the southwest corner of the Lower Parking Lot, that has bypassed the storm drain, mostly follows this trail that runs southwest. This trail is planned as ADA. If the runoff is not abated, a raised walkway will need to be installed to provide an adequate surface for an accessible path.

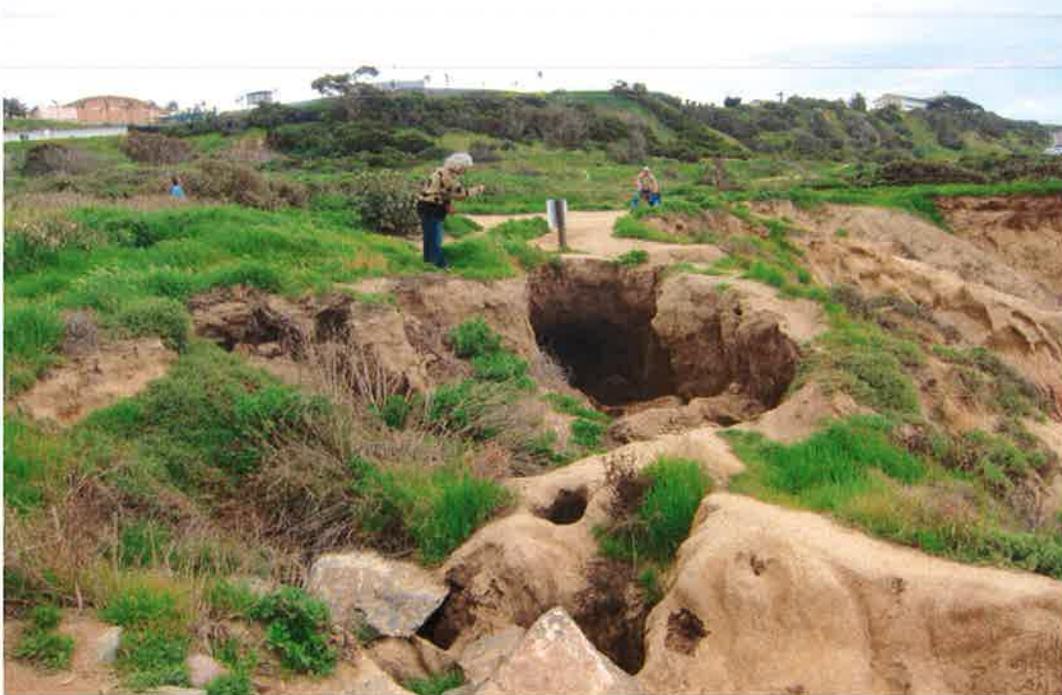
The storm drain in the southwest corner of the lower parking lot is part of an old storm drain system. It was supposed to collect Lower Park Lot runoff through the grated inlet and then channel this runoff through an underground pipe that discharges into a Gunite swale that carries the runoff approximately to the center of Garbage Beach. Lack of berms or curbs on the edge of the parking lot, has resulted in very little water going into this storm drain. As a result, runoff flows onto native soil, causing erosion gullies that bypass the drain inlet. Installation of these simple fixes on the south and west side of the Lower Parking Lot would allow the existing storm drain system to function as designed. This simple repair would prevent runoff from causing the massive erosion to the terrace and cliff below (see Figures 31, 32 & 33).

**Figure 31.** Bluff erosion caused mainly by runoff from the southwest corner of the Lower Parking Lot.

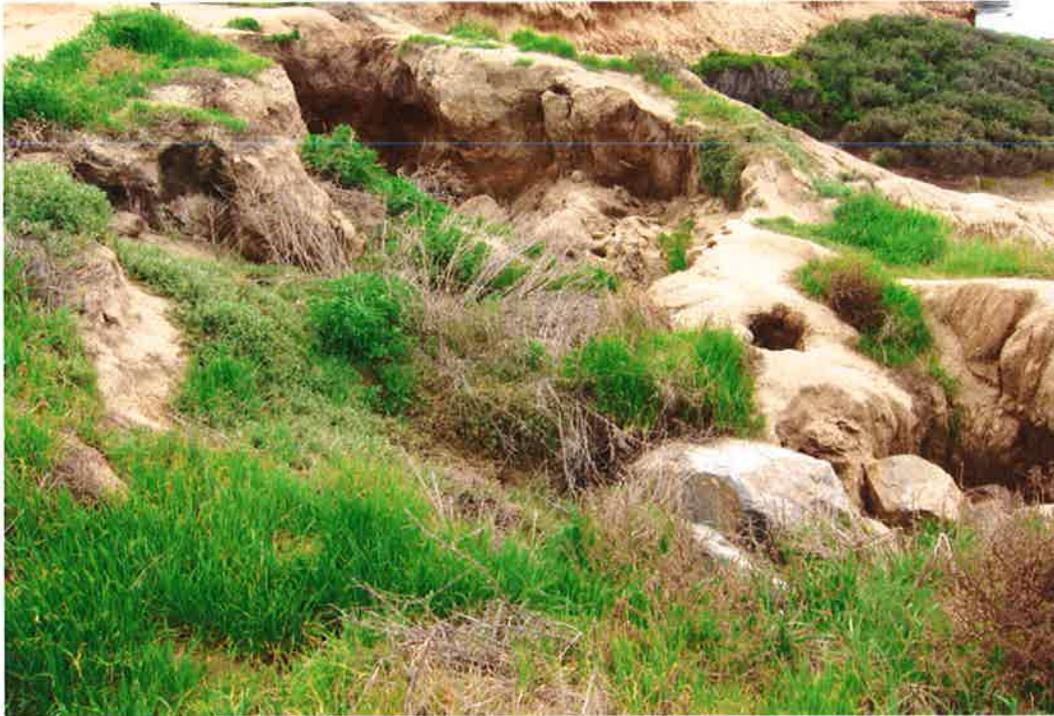
**Figure 32.** Bluff erosion caused mainly by runoff from the southwest corner of the Lower Parking Lot.

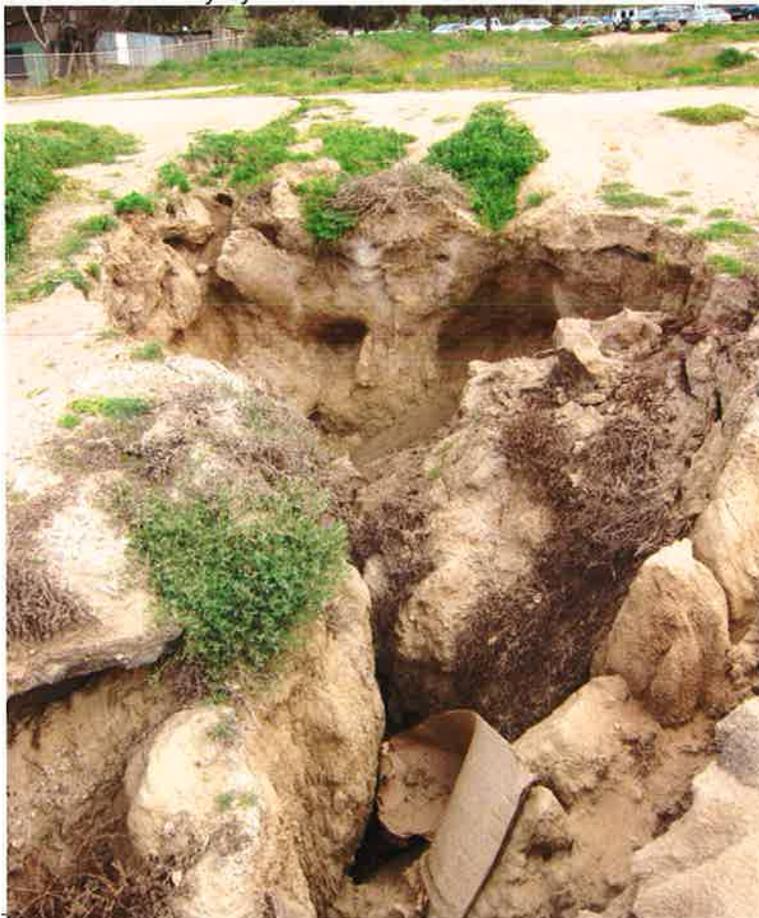
**Figure 33.** Bluff erosion caused mainly by runoff from the southwest corner of the Lower Parking Lot. This erosion and that shown in the previous figures could be eliminated by putting curbs and berms in the southwest portion of the Lower Parking Lot.

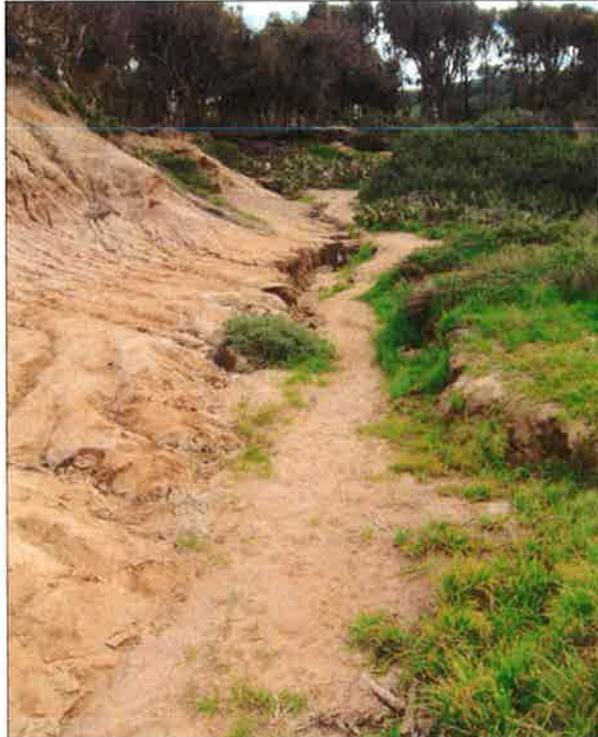
**Figure 35.** Erosion gully that receives runoff from the northwest corner of the Lower Parking Lot after it has run through the Eucalyptus grove (Figure 32).

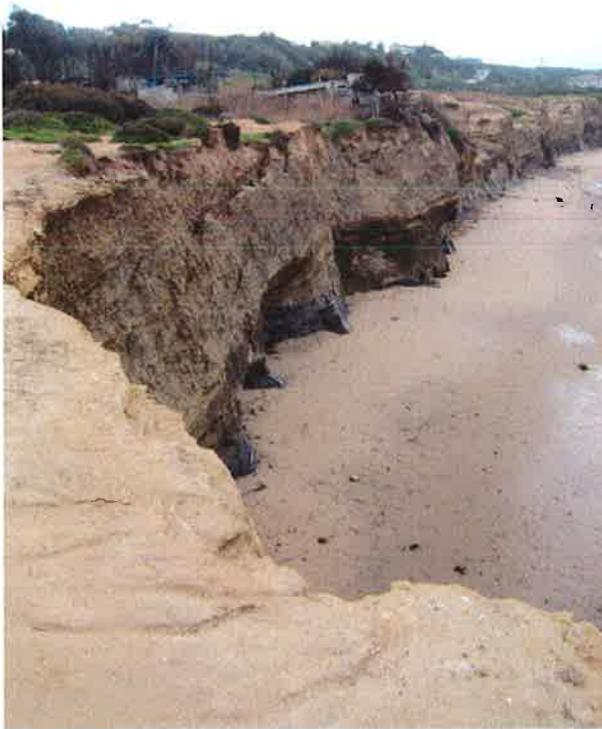
**Figure 36.** Runoff discharge from the NW corner of the Lower Parking Lot occurs all along this cliff above Garbage Beach. This dangerous cliff loss could be eliminated by diverting as much runoff as possible in the northern portion of the parking lot to the drain inlet in the southwest corner. Wattles and trail bars in the *Eucalyptus* grove should be used to build soil, and slow and spread the runoff so it isn't concentrated in one watercourse as it is now.
