## SUNSET CLIFFS NATURAL PARK

Drainage Study

September 2012

**PREPARED BY**  
Dudek  
605 Third Street  
Encinitas, CA 92024  
800.450.1818  
[www.dudek.com](http://www.dudek.com)

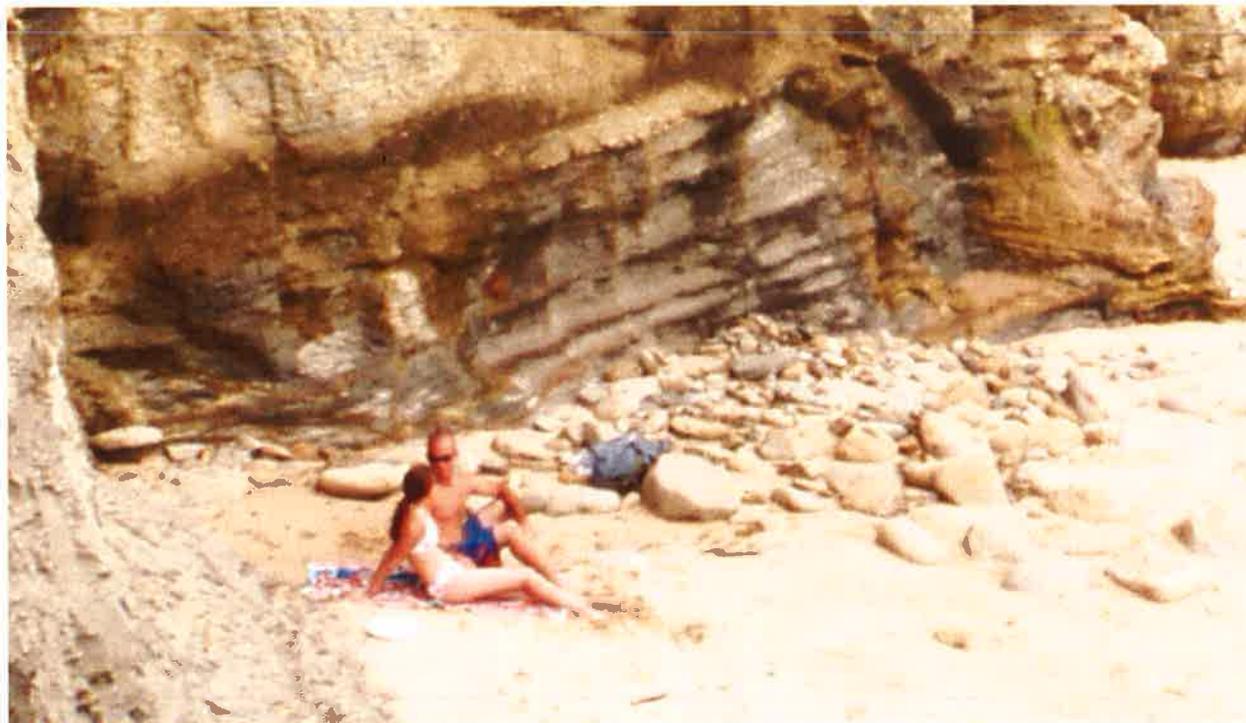
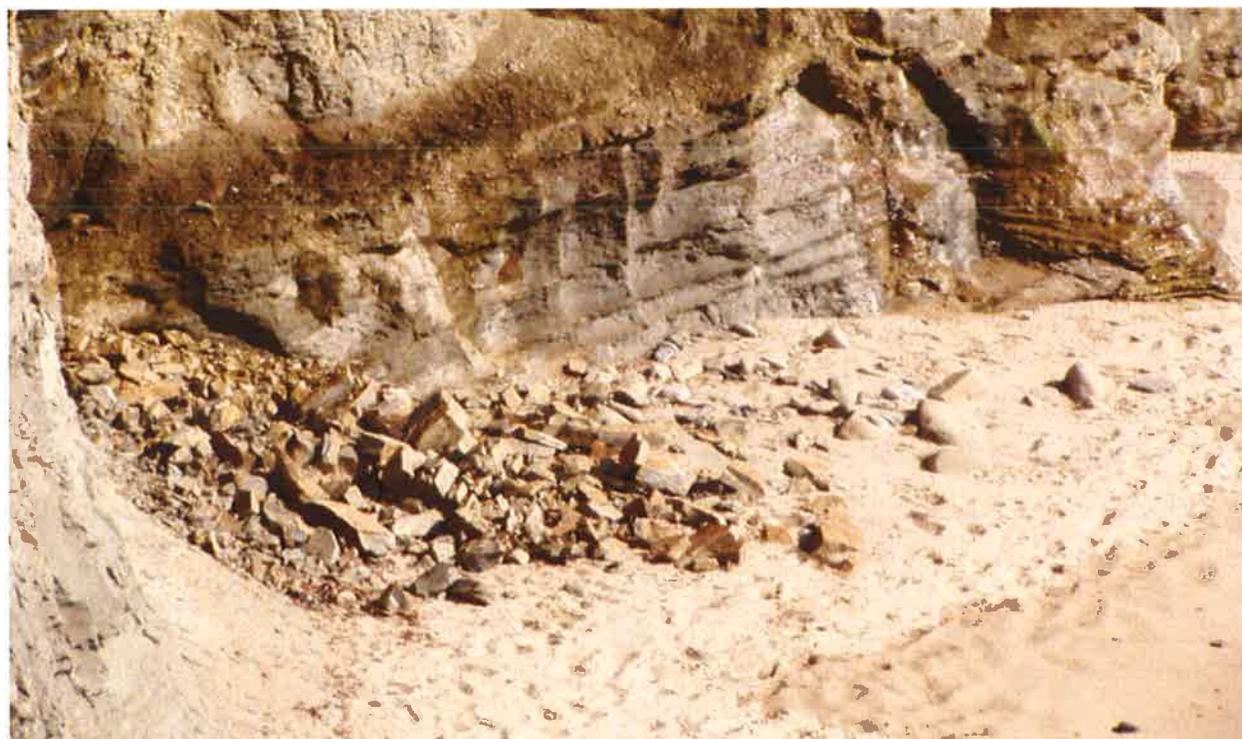
Runoff from Drainage Basins G and H drains onto the northern two thirds of the Lower Parking Lot, and along with runoff generated by the impervious surface of the Lower Parking Lot, exits at the northwest corner of the lot. None of this water runs to the drain in the southwest corner due to improper grading of the parking lot. Instead the runoff drains through the *Eucalyptus* grove that is northwest of the Lower Parking Lot and down an erosion gully before going over the cliffs at the north end of Garbage Beach to a site that is very prone to cliff failure.

**Figure 37.** Northern end of Garbage Beach where runoff from the northwest corner of the Lower Parking Lot discharges over the cliff. Cliff block falls in this area pose a clear danger to beach users below as illustrated by these two photos taken 2 weeks apart.

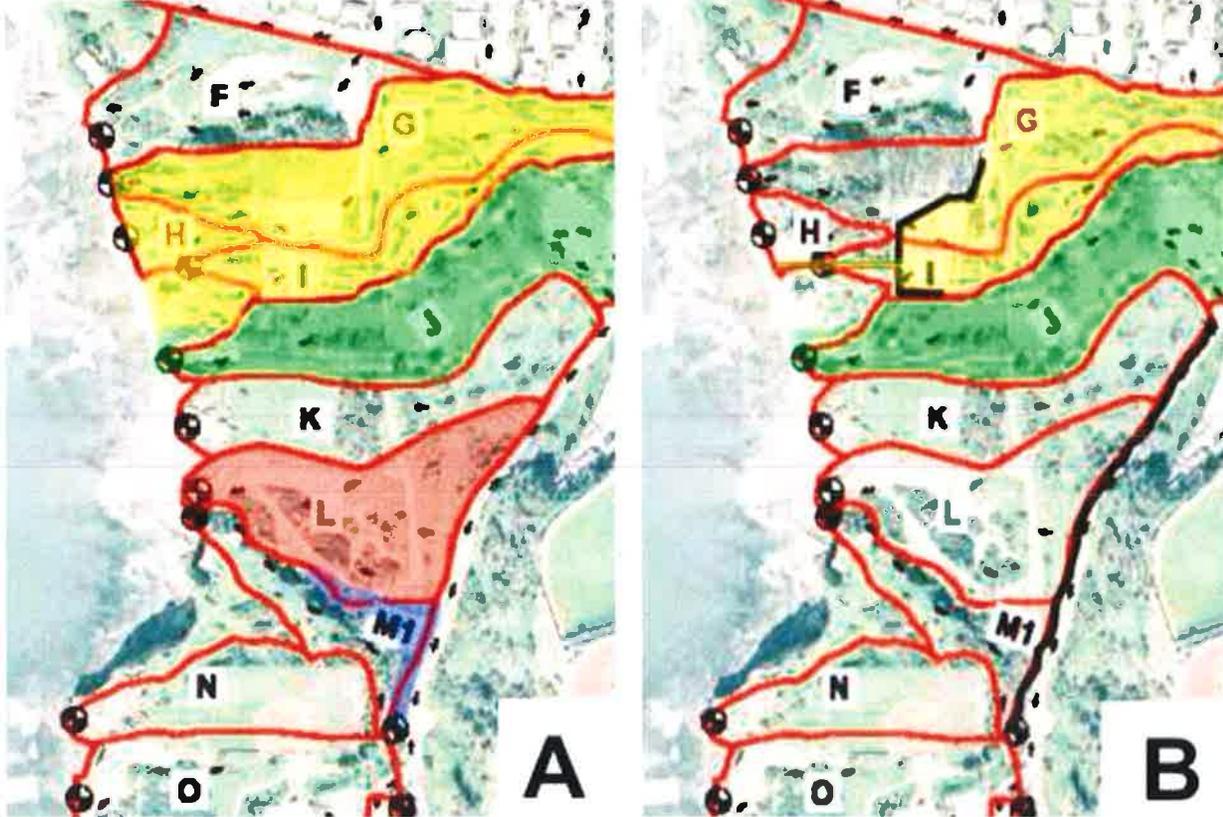
The Western Loop Road presently acts as an above ground storm drain channeling runoff from the road, and the 18" and 24" drains from Point Loma Nazarene University. These pipes carry runoff from approximately half the campus. By raising the curb along the west side of the Loop Road to a minimum of 6" in height, the runoff will stay on the road and go into Culvert Canyon. This will not eliminate the erosion occurring within Culvert Canyon and the bluff, but at least the damage to the park will be limited to this feature. Presently multiple areas within Drainage Basins K, L, and M1 are suffering massive erosion that could be corrected by putting in a curb.

**Figures 38 A and B.** Figure A shows the drainage basins and areas of the Park where erosion damage due to runoff from the Lower Parking Lot and the Loop Road is occurring. Figure B shows where simple measures, such as building asphalt curbs and berms, can be placed to control runoff that will eliminate or reduced substantially the erosion caused by this runoff.

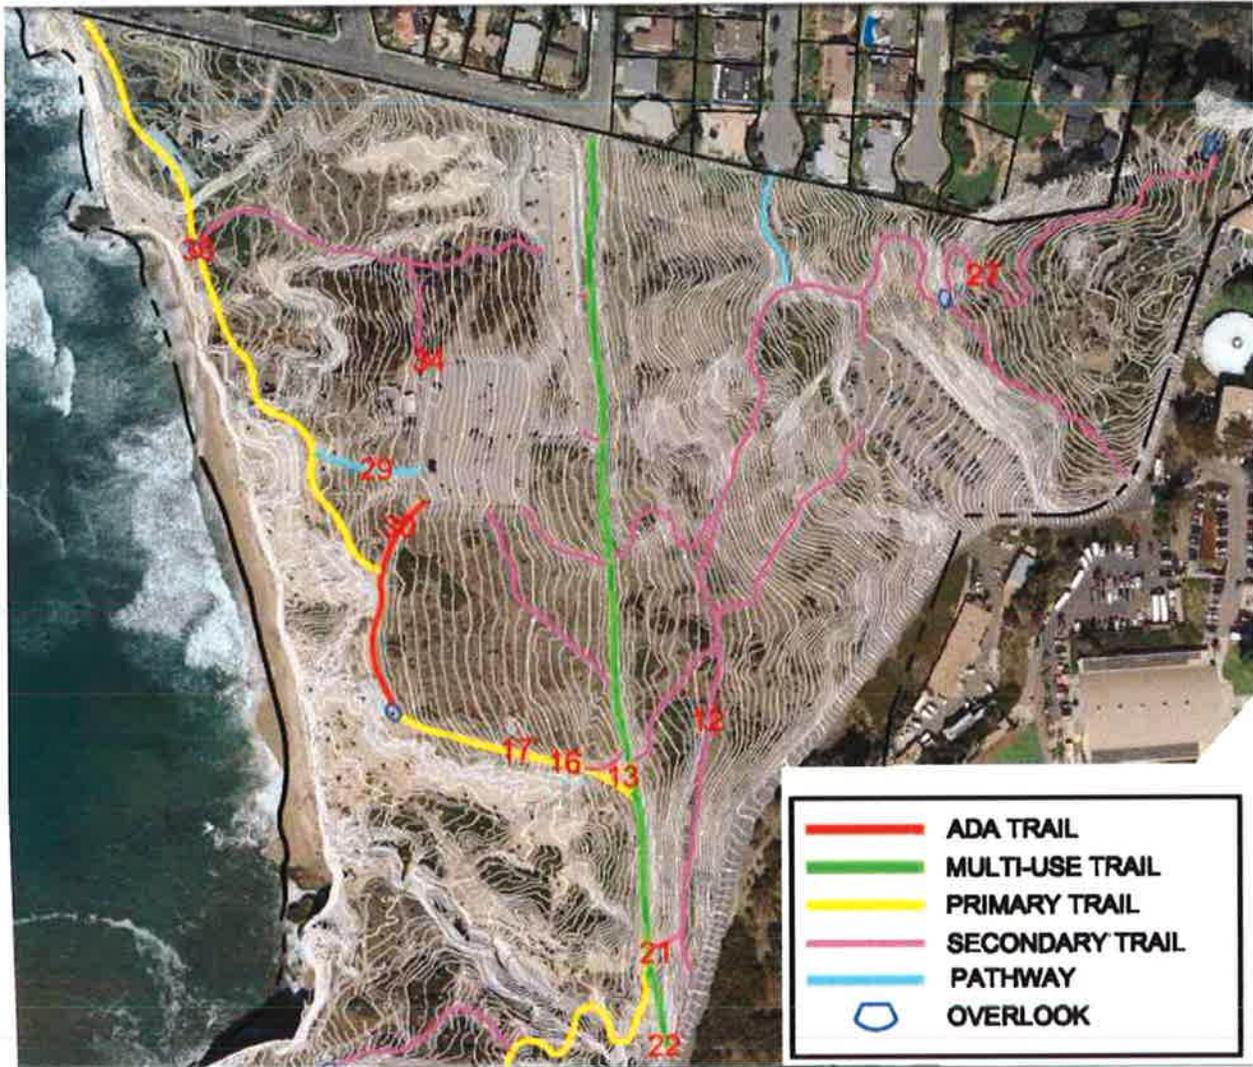
**Figure 39.** Shows preliminary Park Trails and the locations of erosion that will affect the Park Trails. The red numbers refer to Figures that discuss and show the erosion problems. The effects of erosion need to be considered in trail design and engineering.
