THE CITY OF SAN DIEGO
Historical Resources Board

DATE ISSUED: July 11, 2013 REPORT NO. HRB-13-038

SUBJECT: **ITEM #9 – 1515 West Lewis Street**

Photo Exhibit – Porch Alterations Observed by Staff – 1515 West Lewis Street

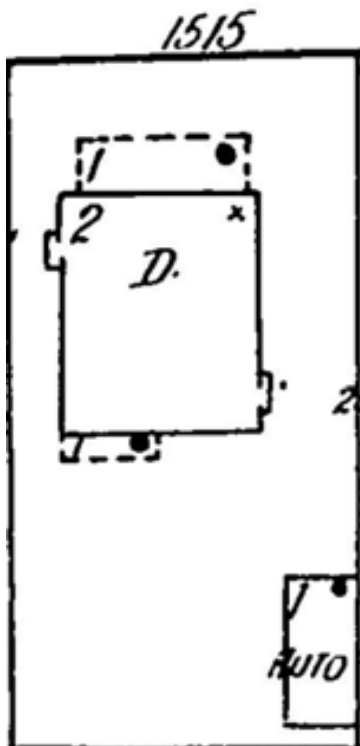
Although not addressed in the applicant's report, historic photographs and field conditions observed by staff that include scarring and replacement siding reveal a significant alteration to the front elevation that drastically impacts the building's integrity as it relates to the 1910 date of construction and period of significance (Attachment 1). The front porch has been modified at least twice – once between the 1940s and 1951, and again after the late 1960s. The original front porch was in fact much wider and covered a greater portion of the front elevation than the porch that exists presently. Originally, the front porch covered a portion of both of the first story windows in the front, and spanned nearly the entire length of the 28-foot façade. Today, the porch no longer covers the front windows and only covers half the length of the façade. The 1921 Sanborn Map also shows the original front porch with a much longer footprint. Furthermore, the porch headers originally sat lower and the balustrade was of wood lap siding rather than of a more open design as seen today. Although likely, it can only be speculated that a second floor balcony originally existed above the front porch. The alteration of the front porch footprint and design is a significant adverse impact to integrity of design, materials, workmanship and feeling.

The loss of the original front porch is an alteration to a character defining feature that significantly impairs the design, materials, workmanship and feeling aspects of integrity as it relates to the 1910 date of construction. The front porch of the subject building is integral to its design, and the proportions and massing of the façade are now considerably different from their historical appearance. As a result, the building can no longer convey its historic significance. Therefore, staff does not recommend designation of the subject property under HRB Criterion C due to a lack of integrity.
