Rain Barrel Downspout Disconnect Best Management Practice Effectiveness Monitoring and Operations Program

Final Report

June 11, 2010

**Weston Solutions, Inc.
2433 Impala Drive
Carlsbad, California 92010**

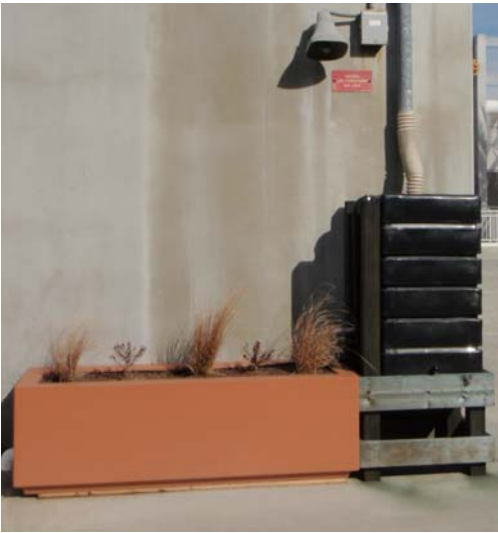
<i>Plants may be vandalized and require regular watering. Consider enhanced iron/zeolite soils with decorative rock instead of plants to reduce O&M costs while improving treatment.</i></p>

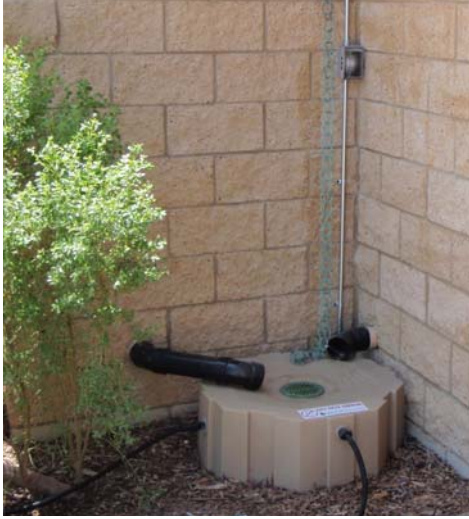
<i>Automated systems have the most moving parts and greatest motivation for theft. Manual timers powered by 12-volt DC photovoltaics are recommended rather than 120-volt AC ground fault circuit interrupt (GFCI) systems. Algae and adverse odors were present in translucent tan barrels.</i></p>

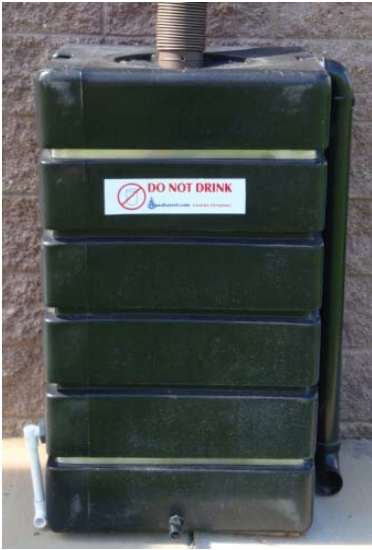
<i>Gravity-flow systems act like miniature detention basins. Roof runoff is attenuated and a volume, up to six times the capacity of the original barrel, is infiltrated to existing landscaping eliminating discharges to the storm water conveyance system.</i></p> <p>LOAD

<i>100% load reduction for runoff is attenuated and infiltrated.</i></p> <p>O&M

<i>Allows for the easiest, fastest, and cheapest repairs. This configuration was vandalized the least. Use opaque barrels to eliminate potential algae growth.</i></p>

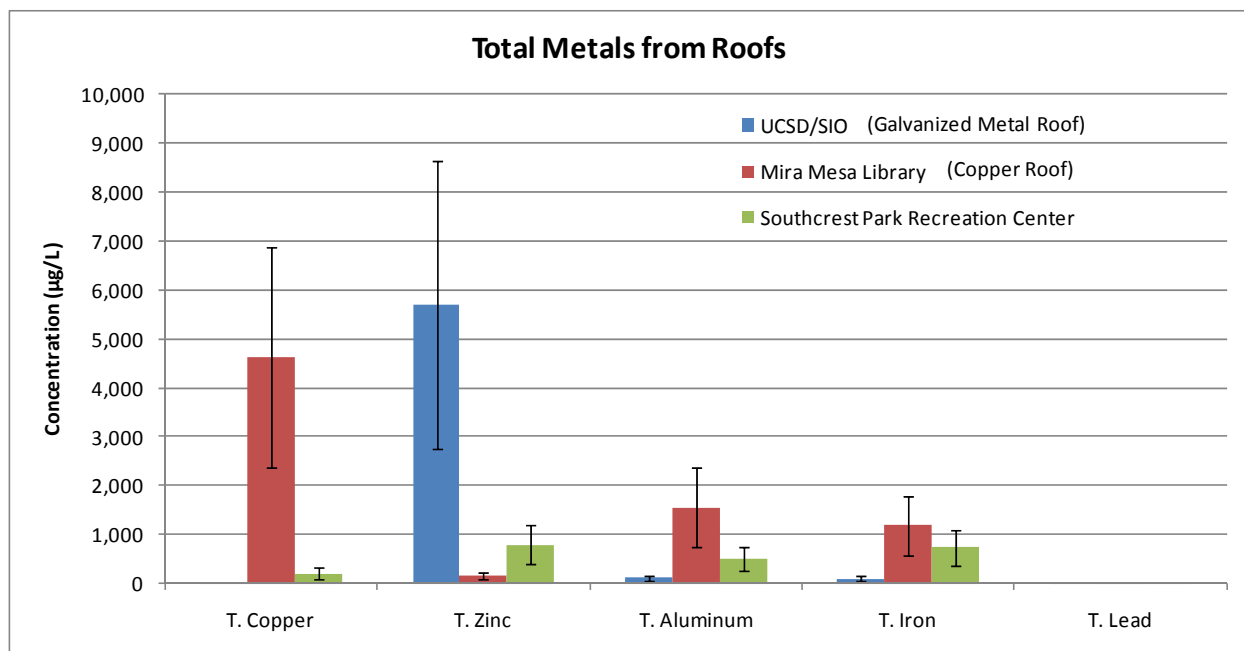
Figure 7-1. Average (Total) Metals Concentrations ± Standard Error from Roofs and Downspouts of Known Building Materials

According to the monitoring data (Figure 7-1), buildings with roof area and runoff conveyance systems composed of copper or galvanized metal were observed to result in higher measurable copper and zinc concentrations. The copper roof at Mira Mesa Library had total copper concentrations up to 12,450 µg/L and typical concentrations of approximately 700 µg/L. Concentrations at Mira Mesa Library were over 20 times larger than facilities without known sources of over (e.g. 26 µg/L at San Ysidro Library). Galvanized downspouts had an average zinc concentration of 1,440 µg/L at the Rancho Bernardo Recreation Center, and hits as high as 15,800 µg/L at the SIO metalshop. The asphalt shingles which make up the roof for the Southcrest Recreation Center translated levels of total copper, zinc, aluminum, and iron greater than 200 µg/L. The data indicates that building materials are not a source of lead, as shown by total lead results consistently less than 20 µg/L, and no higher than 65 µg/L

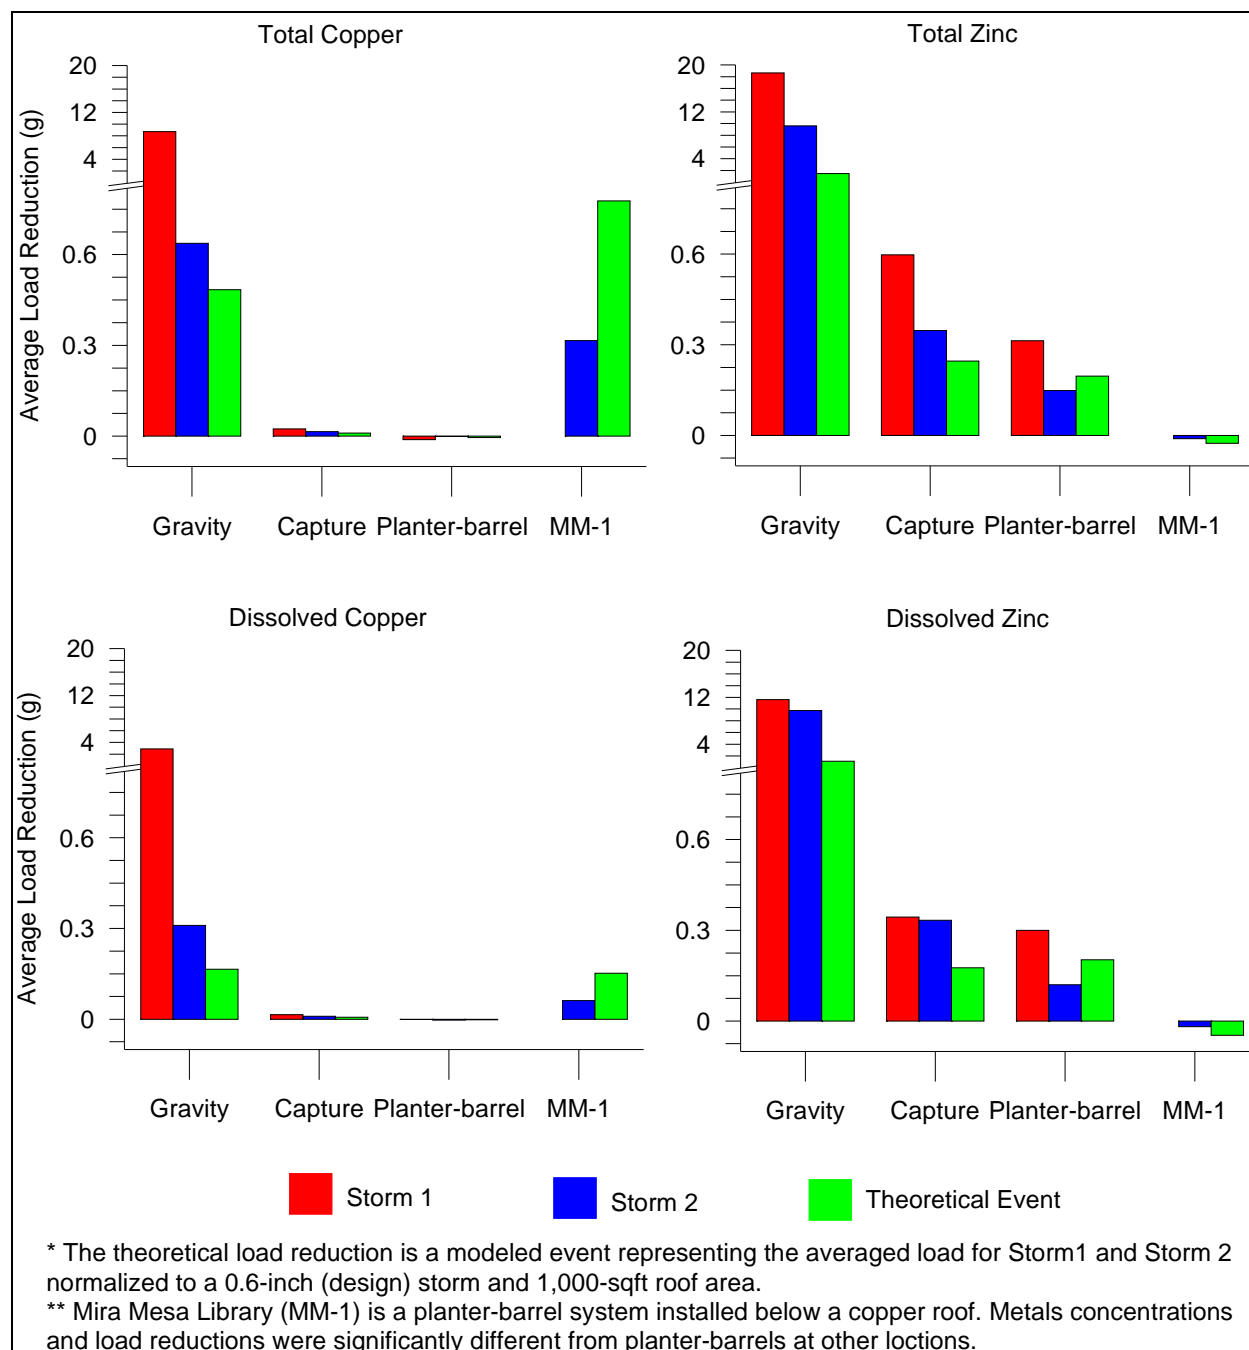
Figure 7-2. Average Load Reductions (grams) for Three Different System Configurations and Mira Mesa Library (planter-barrel system with known source of copper)

Due to current and pending TMDLs, an average load reduction for the three RBDD system configurations was calculated for metals, TSS, and bacteria. Load reductions from RBDD systems were determined by multiplying the influent pollutant concentration by the site-specific storm flow (Storm 1 or Storm 2 only). An average load reduction for each system configuration (gravity-flow, planter-barrel, and automated) was based on system-specific load reductions. Given the variability of the data and small number of sample repetitions, percent load reductions were not calculated. The average load reductions for each RBDD configuration are presented on Table 7-3. Since the rainfall and roof area for each system was variable, the average total and dissolved copper and zinc load reductions for storm 1 and storm 2 were compared to a “theoretical” event (Figure 7-2). The “theoretical” event was modeled for runoff from a 1,000 sq-ft roof during a 0.6-inch, 24-hour storm. Assumptions and load reduction calculations for these tables and figures are presented in Appendix H.

During the first post-installation storm event monitoring, staff observed discharge from the planter effluent pipe, which was designed to discharge treated roof runoff. During the first storm, it was assumed that the systems captured and treated 100% of the flow. Load reductions specific to the planter-barrel configuration were monitored during the second storm by comparing constituent concentrations influent to the RBDD system and effluent from the planter. A load reduction was determined for each constituent by multiplying the difference between the influent
