Phase III Draft Final Report District 3 Sidewalk Study

March 21, 2006

Prepared for:
City of San Diego

Prepared by:
Kimley-Horn and Associates, Inc.

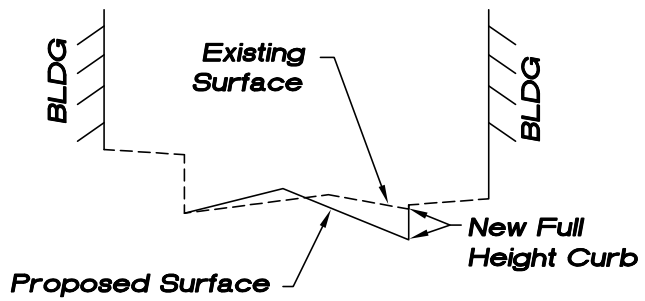
Figure 10

To close the gap in the upgraded streetscape here, and to provide for safe and proper sidewalk drainage, a small area of pavement replacement along with a new storm drain connection have been proposed. See **Figure 10, Ray Street Improvements**.
