TORREY PINES ROAD PRELIMINARY ENGINEERING STUDY

TECHNICAL MEMORANDUM FOR

FENCE CONSIDERATIONS

TRAN CONSULTING ENGINEERS

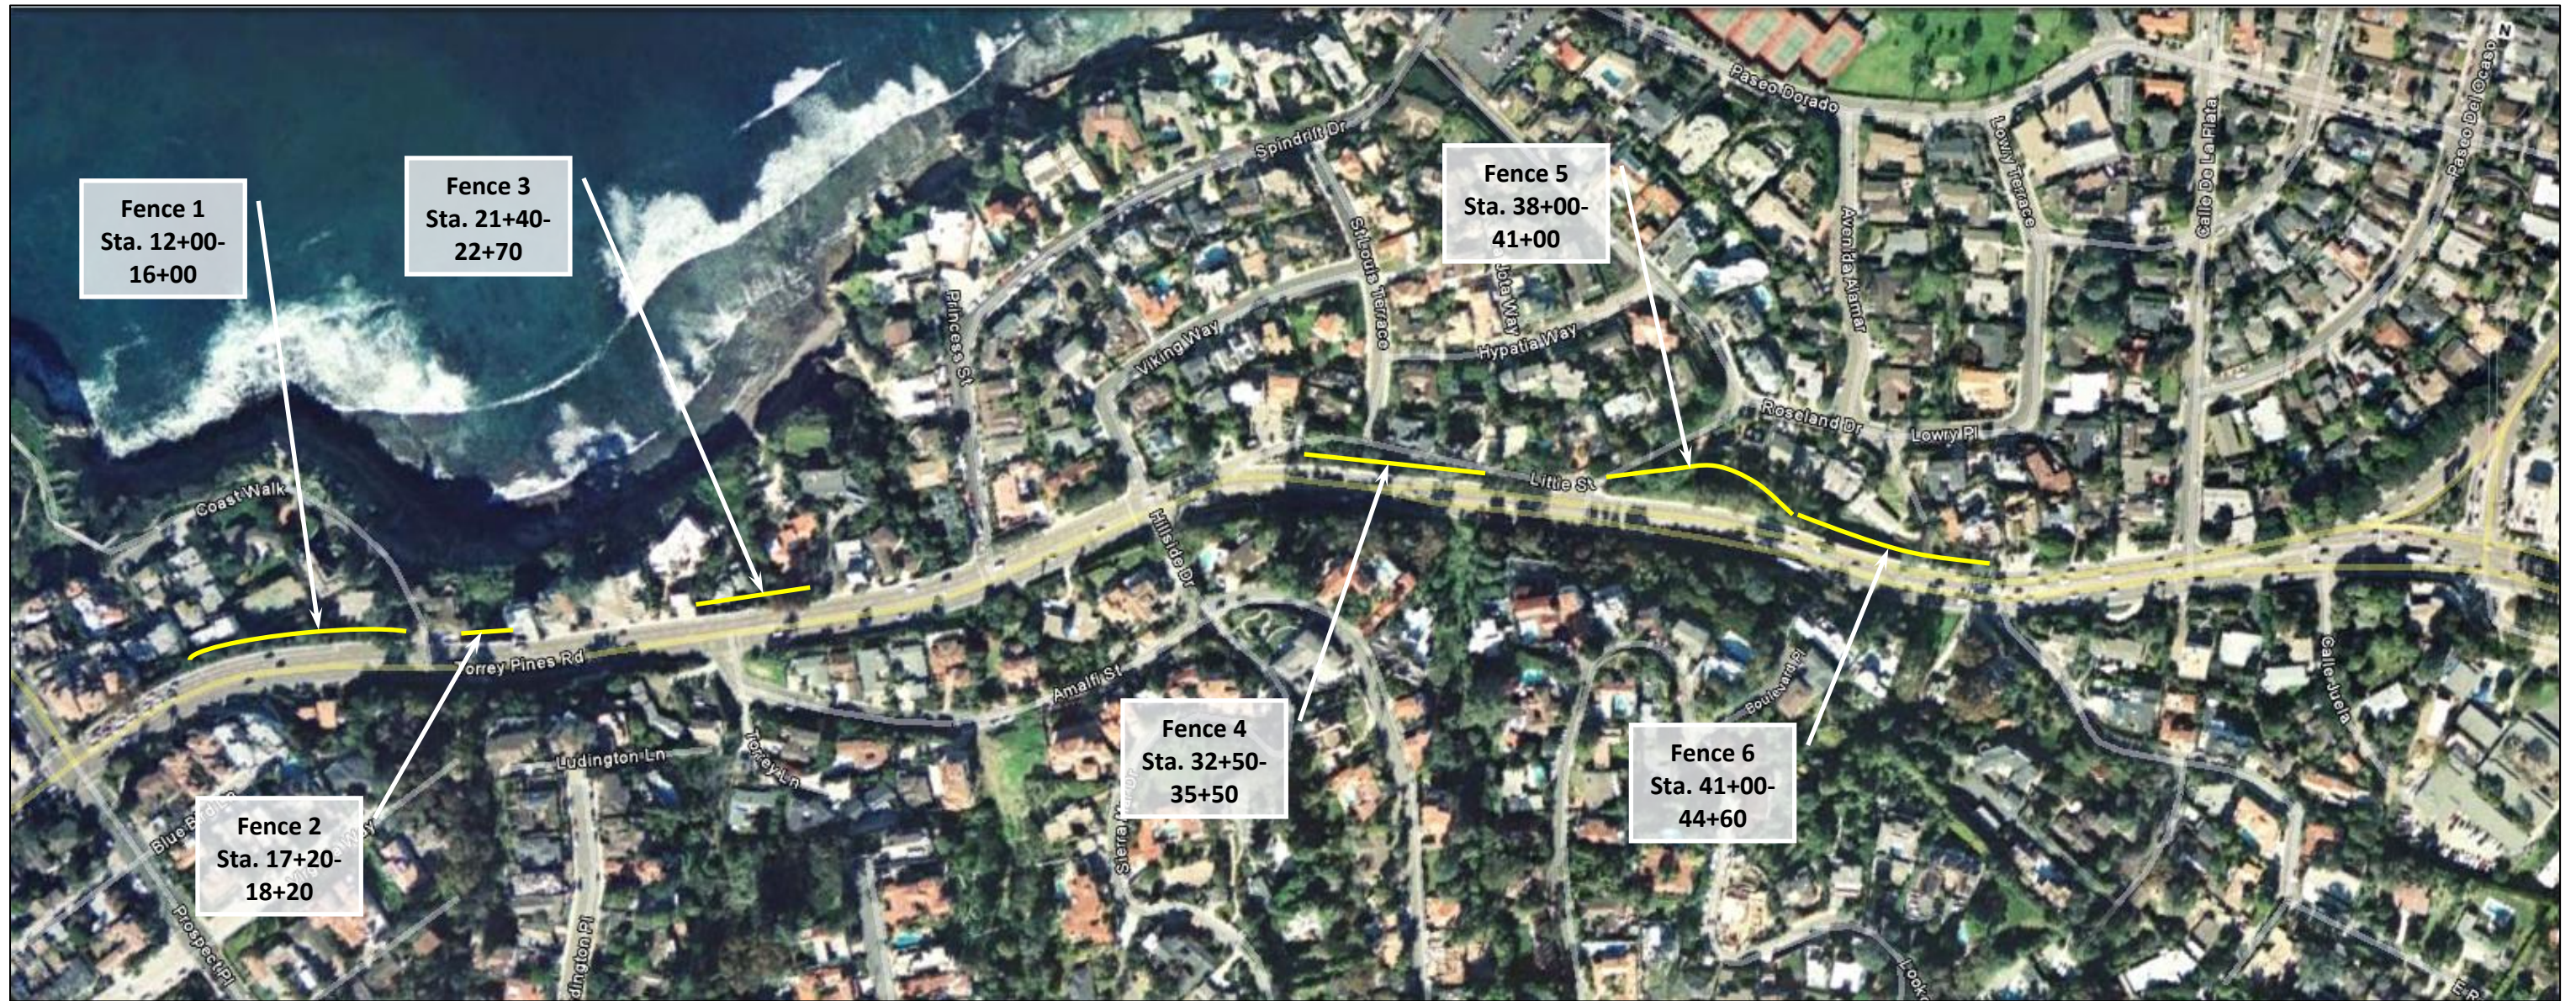
FIGURE 1

Aerial View of Project Showing Proposed Locations of Fences

(Yellow lines represent locations of proposed fences. Line locations are approximate and line widths are not intended to represent the wall size)

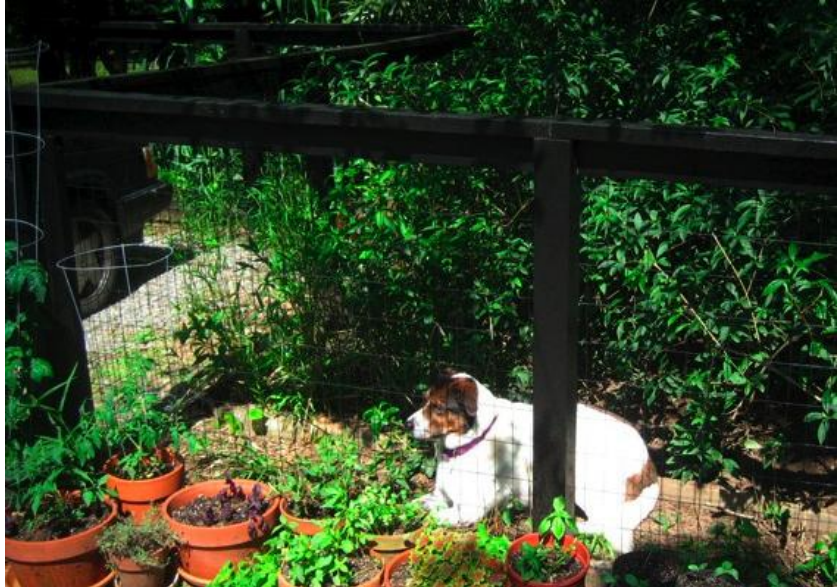
Example of a 42-Inch High Wood Fence with Wire Fabric

described as a wood and wire fabric fence, this fence should be constructed from a material that will last longer than typical wood fences to reduce maintenance and prolong the life of the fence. Coating of the wire is vital to increase the life of the wire fabric because of the proximity to the ocean. A hot dipped galvanized coating topped with a plastic coating would be best.

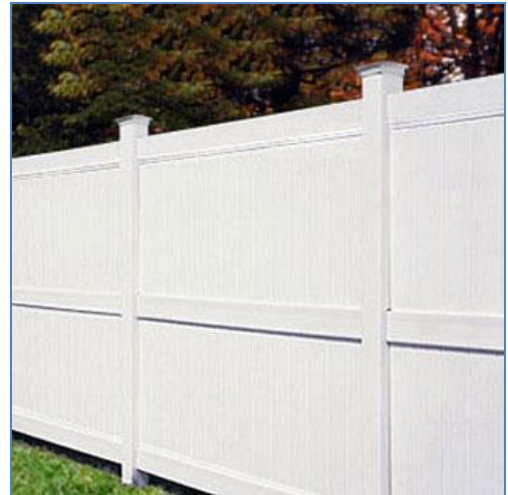
Example of a privacy fence

In instances where a wood barrier or privacy fence is required such as where a view is not available and homes are located at grade with the fence, a plastic fence such as the one shown at right is suggested. Colors should be suitable to the application.

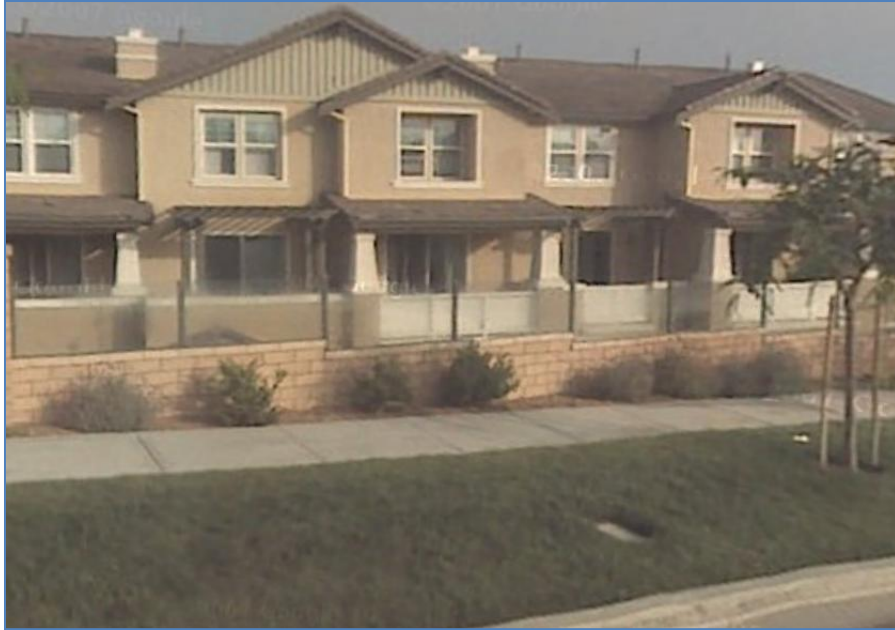
Example of cement block wall parapet with Plexiglas top. Parapet is on top of a retaining wall in 4S Ranch area

In some fence locations guardrail has been recommended in the corridor study because of past instances where cars have driven off the road at lower speeds, such as across Torrey Pines Road from the intersection with Amalfi Street, a decorative parapet approximately 3 to 3.5 feet high may be constructed in these locations. The parapet wall would be topped with either a railing or, to provide an added barrier, a piece of clear Plexiglas material, from 1 to 3 feet high. The Plexiglas would afford a clear view while providing a barrier to lessen littering and trespassing. The parapet could be designed like a decorative guardrail. Two examples of this type of fence approach are shown below. A concrete or concrete block parapet would replace the stucco parapet shown in the picture

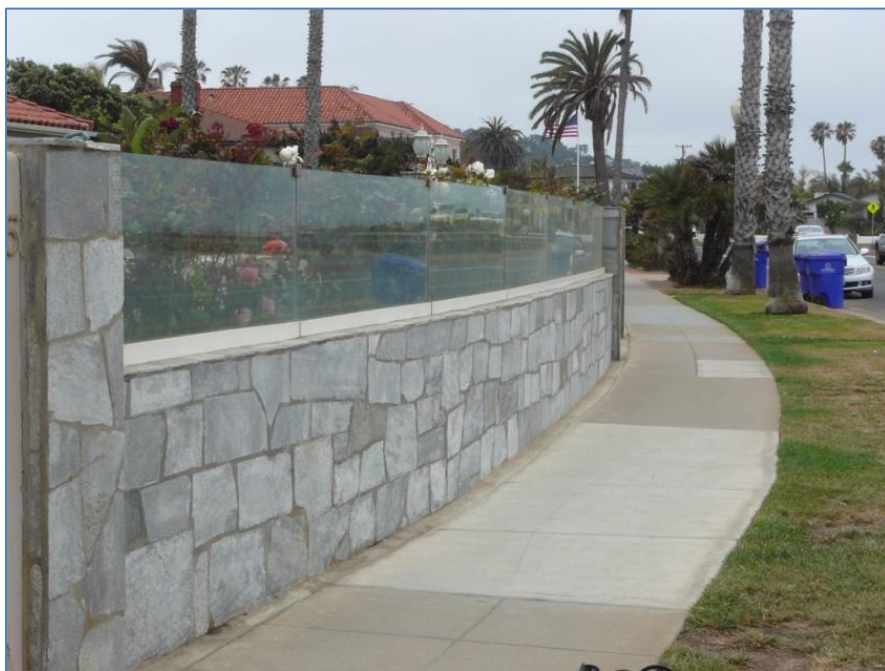
Example of cement block wall with surface treatment and Plexiglas top in Point Loma overlooking Sunset Cliffs
