APPENDIX A-1

Channel and Ditch FMPs

Facility Maintenance Plan

Green Valley Creek - Pomerado Facility Group

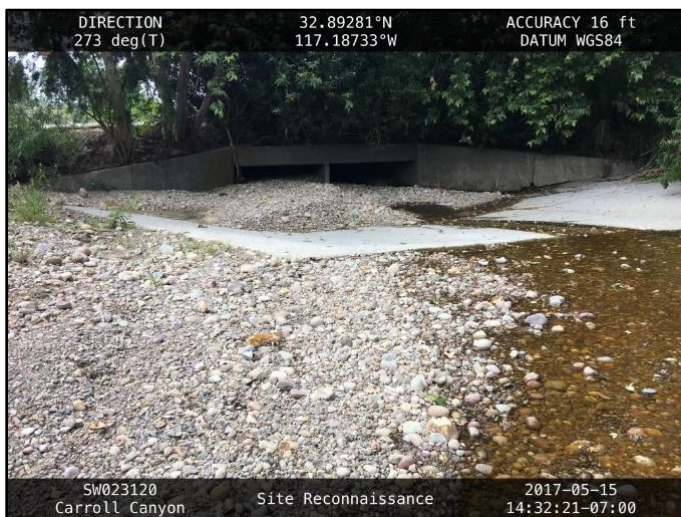
Figure 1: May 2017, sediment and cobbles accumulated on concrete inlet apron upstream of the culvert

Current Conditions Affecting Facility Capacity	The segment was observed to have minimal vegetation and up to 2.2 feet of sediment and cobble in the channel and the culvert
---	--

Maintenance Recommendation	Remove accumulated sediment, debris, and overgrown vegetation from channel bottom and temporary diversion berm from Station 58 to 178 and from Station 497 to Station 561. Remove sediment and debris in culvert from Station 178 to Station 497.
-----------------------------------	---

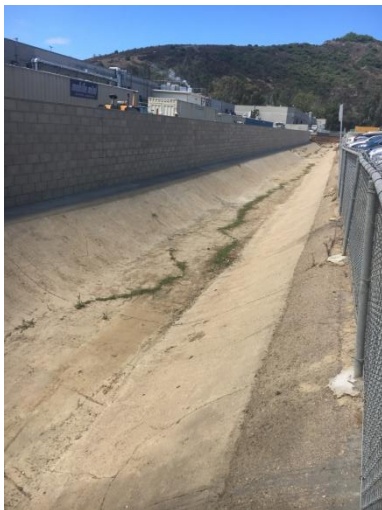
Figure 1: June 2018, taken from Roselle Street looking southwest

In April 2013, the ditch was observed to have vegetation varying from clear to dense and the sediment deposition was estimated to be 1.25 feet. Current conditions were reviewed in relation to the hydraulic analysis for this segment in 2018 and documented in the current conditions assessment memorandum in Appendix A of the Hydrology and Hydraulics Technical Report.

Current Capacity	60 cfs
Proposed MWMP Maintained Capacity	80 cfs
Maintenance Recommendation	Remove accumulated sediment, debris, and vegetation from Station 50 to Station 300 and Station 383 to Station 1125. Remove accumulated sediment and debris in culvert from Station 300 to Station 383.
In-Stream Post-Maintenance Erosion Control Recommendation	None

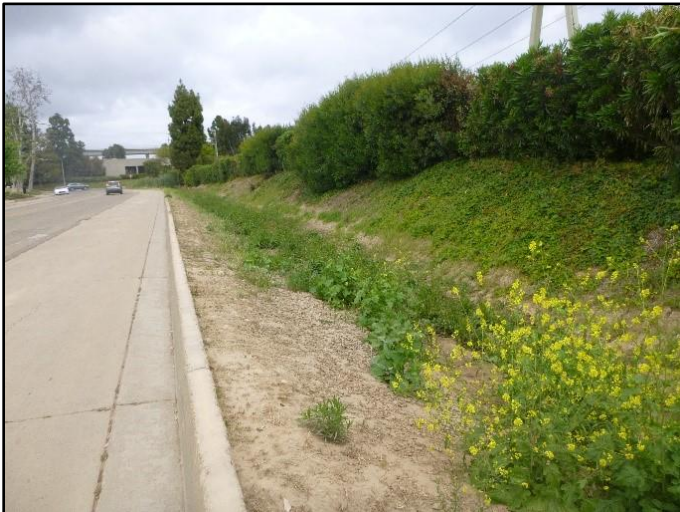
Figure 1: May 2017, looking downstream at vegetation and sediment in Dunhill segment

Current Conditions Affecting Facility Capacity The vegetation was observed to range from light to dense and sediment deposition was estimated to range from 6 inches to 3 feet

Remove accumulated sediment, debris, and vegetation from bottom of the facility from Station 329 to Station 759.
Repair bank at approximately from Station 715 to Station 759 on the north (street) side.
Maintain/repair existing debris fence as needed.

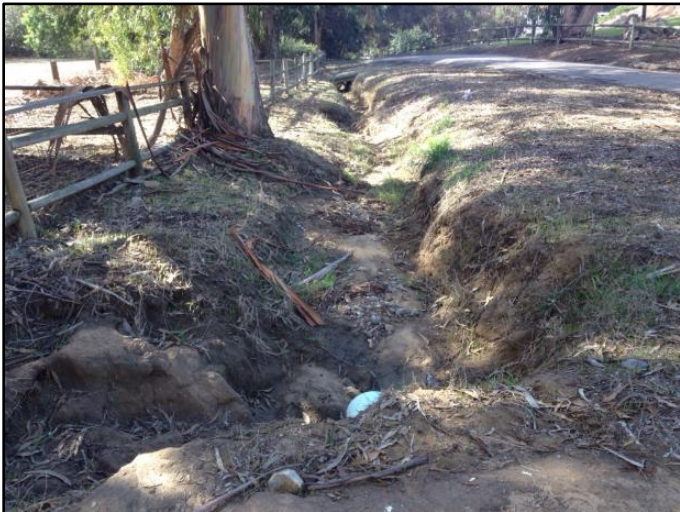
Figure 1: April 2017, representative of light weeds in the channel segment

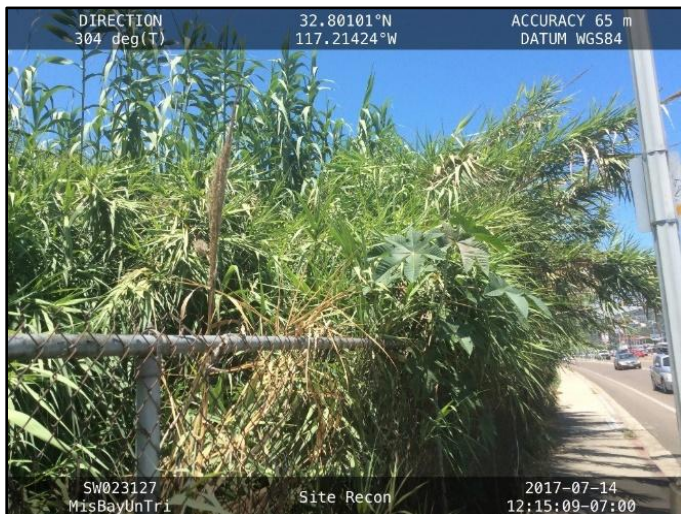
Figure 1: July 2017, representative downstream channel segment with dense vegetation

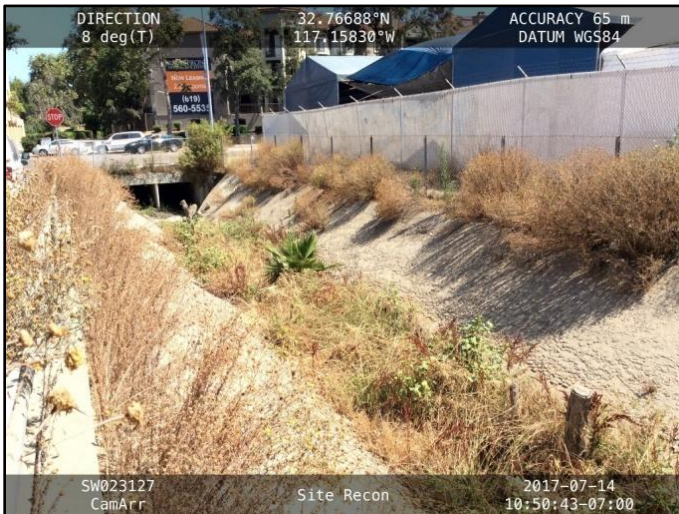
Figure 1: July 2017, looking downstream

Current Conditions Affecting Facility Capacity The amount vegetation was observed to vary from light to dense within the segment and the area in front of the culvert outlet was mostly clean. Sediment deposition was estimated to range from 2 feet at the upstream end to 0.5 feet within the left outlet.

Maintenance Recommendation Remove accumulated sediment, debris, and vegetation from Station 581 to Station 1223

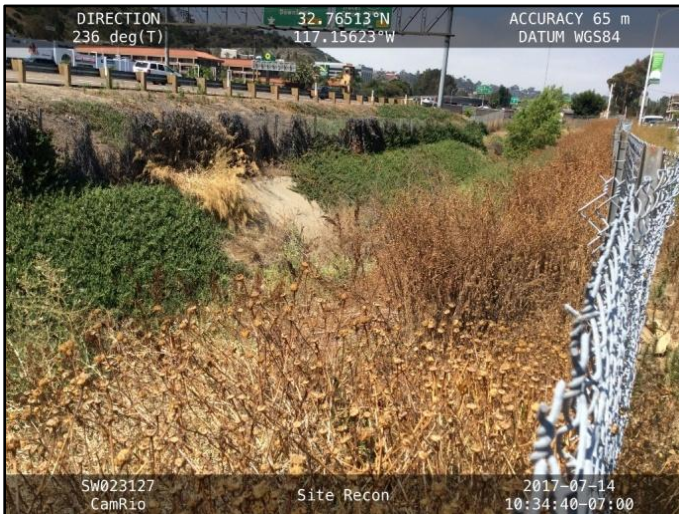
Figure 1: July 2017, looking downstream

Current Conditions Affecting Facility Capacity The amount of vegetation was observed to be dense with sediment accumulation ranging from 4 feet at the upstream end to 3 feet at the downstream end. The culvert at the downstream end was estimated to have 2.5 feet of accumulated sediment.

Maintenance Recommendation Remove accumulated sediment, debris, and overgrown vegetation from Station 1380 to Station 2399.
Remove accumulated sediment and debris in culvert from Station 1223 to Station 1380.

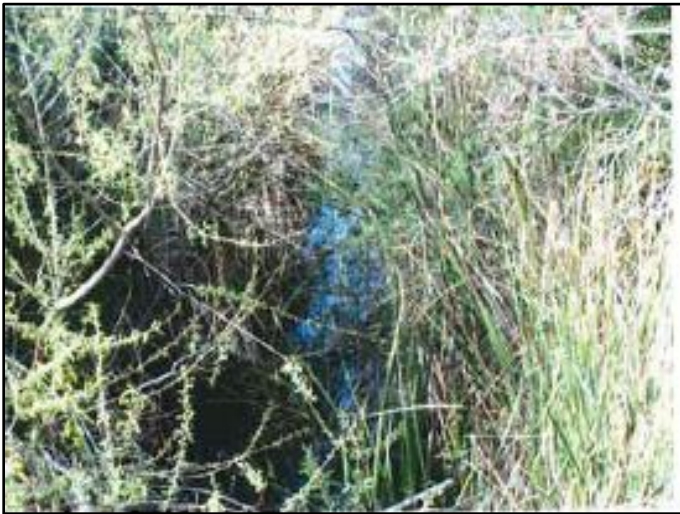
Figure 1: March 2013, heavily vegetated channel bottom near the downstream end of the facility group

Sediment deposition of 1 to 3 feet was found through a majority of the channel, however in one location, the sediment depths were estimated to be as high as 6 to 7 feet. Vegetation ranged from dense to moderately dense throughout the segment length. Current conditions were reviewed in relation to the hydraulic analysis for this segment in 2018 and documented in the current conditions assessment memorandum in Appendix A of the Hydrology and Hydraulics Technical Report.

Current Capacity	<510 cfs
Proposed MWMP Maintained Capacity	1,050 cfs
Maintenance Recommendation	Remove accumulated sediment, debris, and vegetation from Station 119 to Station 1780
In-Stream Post-Maintenance Erosion Control Recommendation	None

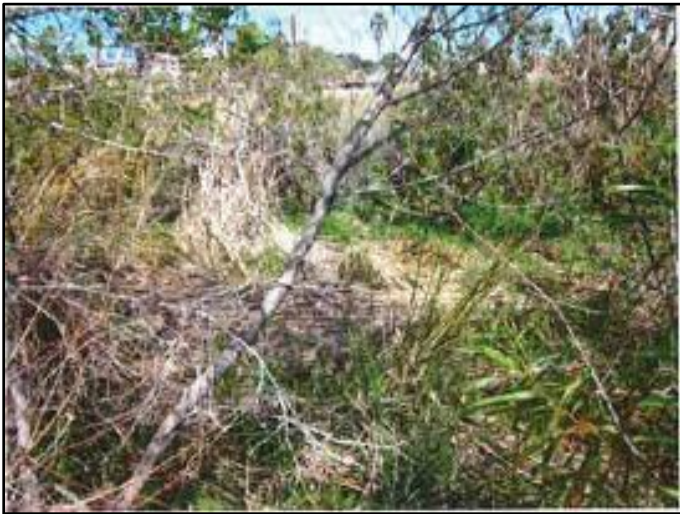
Figure 1: March 2013, looking upstream near area of recommended maintenance

Current Conditions Affecting Facility Capacity	Fairly dense vegetation was observed and sediment deposition was estimated to be 1 foot. Current conditions were reviewed in relation to the hydraulic analysis for this segment in 2018 and documented in the current conditions assessment memorandum in Appendix A of the Hydrology and Hydraulics Technical Report.
---	---

Maintenance Recommendation	Remove accumulated sediment, debris, and vegetation from Station 1780 to Station 1987
-----------------------------------	---

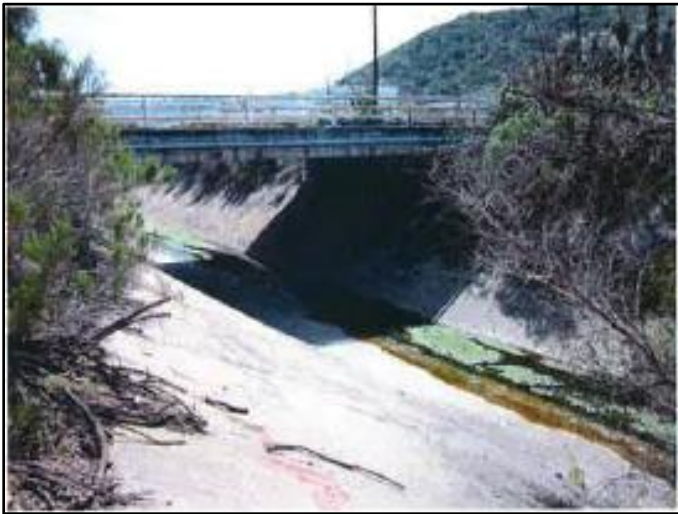
Figure 1: March 2013, looking downstream towards access road bridge near the upstream limit of concrete channel lining

Current Conditions Affecting Facility Capacity In March 2013, the channel was observed to have light vegetation and little to no sediment deposition throughout the segment. Current conditions were reviewed in relation to the hydraulic analysis for this segment in 2018 and documented in the current conditions assessment memorandum in Appendix A of the Hydrology and Hydraulics Technical Report.

Maintenance Recommendation No maintenance currently proposed; however vegetation, sediment and debris removal, or concrete repair/replacement activities should be performed if the conditions change

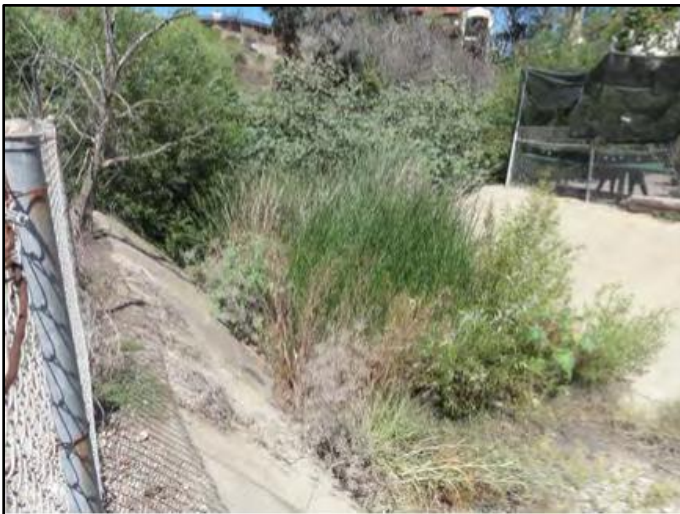
Figure 1: August 2014, from east side of channel, directly upstream of State of California maintenance boundary, looking downstream

In August 2014, the amount of vegetation was observed to range from light to moderate, and sediment deposition was estimated to range from 0.2 to 1.7 feet. Current conditions were reviewed in relation to the hydraulic analysis for this segment in 2018 and documented in the current conditions assessment memorandum in Appendix A of the Hydrology and Hydraulics Technical Report.

Current Capacity	1,700 cfs
Proposed MWMP Maintained Capacity	<3,400 cfs
Maintenance Recommendation	Remove accumulated sediment, debris, and vegetation from channel bottom from Station 2317 to Station 3419. Previously designed post-maintenance erosion control measure at Station 2335 to be installed and maintained as necessary.
In-Stream Post-Maintenance Erosion Control Recommendation	Yes; see Appendix A-4 Location: Station 2537

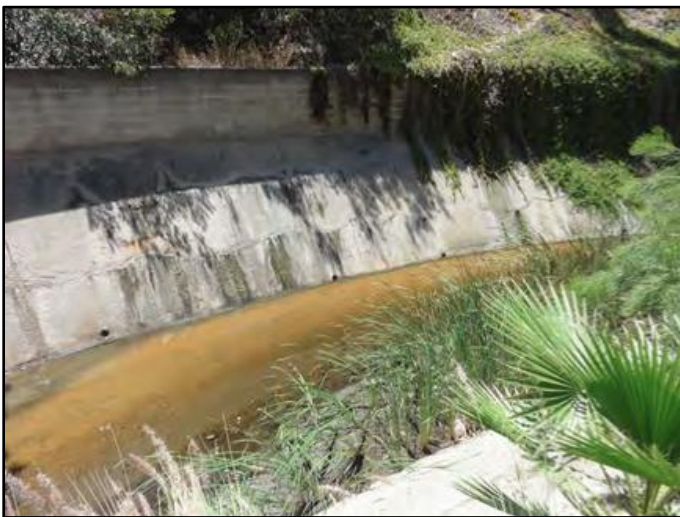
Figure 1: August 2014, from north side of the channel within 100% concrete portion of channel at 90-degree bend, looking downstream

Current Conditions Affecting Facility Capacity In August 2014, the channel was relatively clean with very little evidence of vegetation or sediment deposition. Current conditions were reviewed in relation to the hydraulic analysis for this segment in 2018 and documented in the current conditions assessment memorandum in Appendix A of the Hydrology and Hydraulics Technical Report.

Maintenance Recommendation No maintenance currently proposed; however vegetation, sediment and debris removal, or concrete repair/replacement activities should be performed if the conditions change

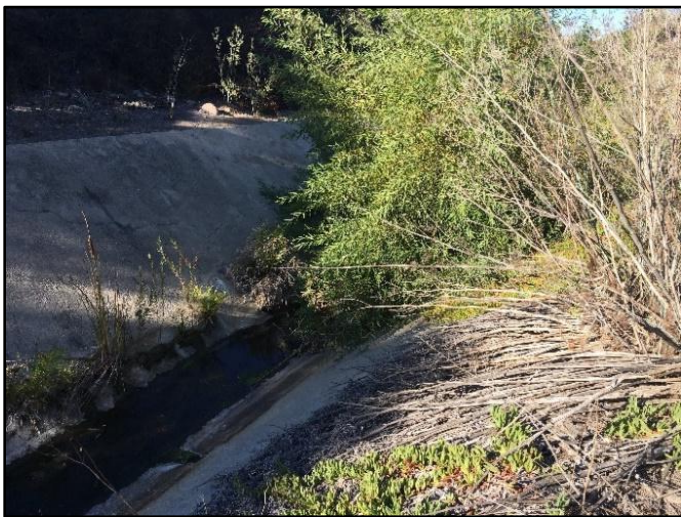
Figure 1: October 2018, upstream of culvert

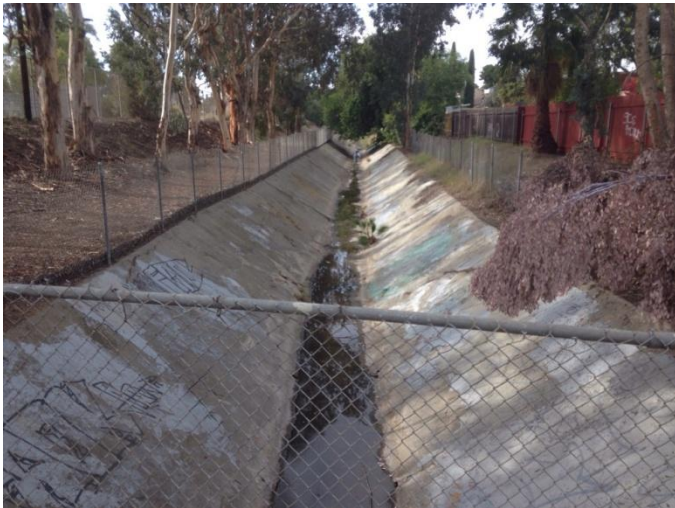
Figure 1: December 2016, above inlet culvert on the Boulder Lake end of channel

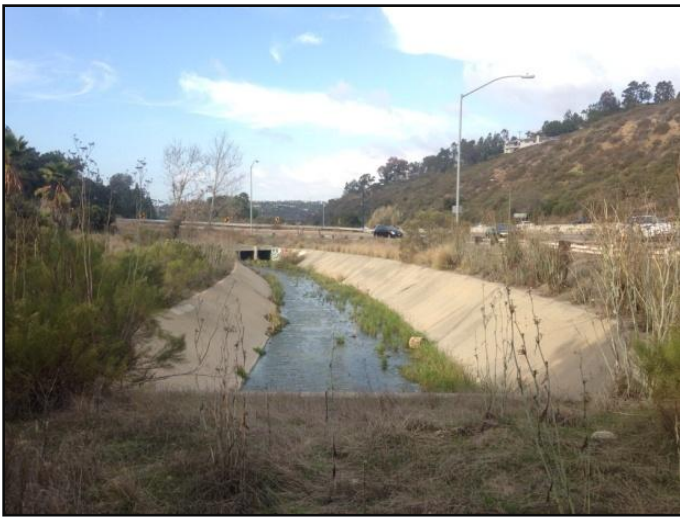
Figure 1: April 2017, looking downstream at concrete channel

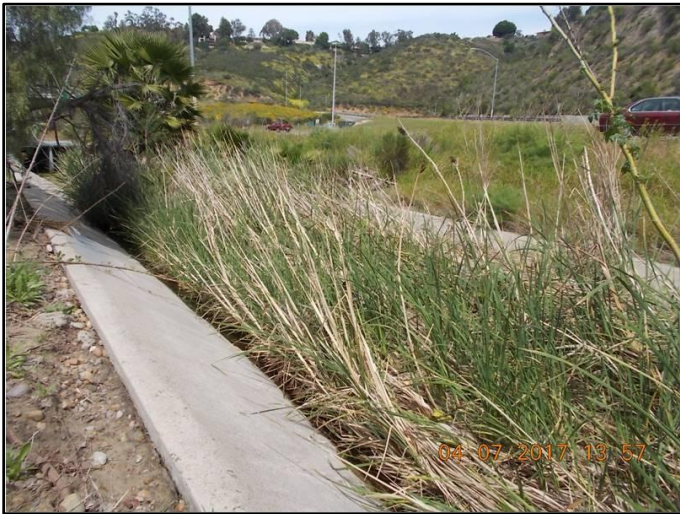
Figure 1: April 2017, looking downstream at vegetation concrete ditch

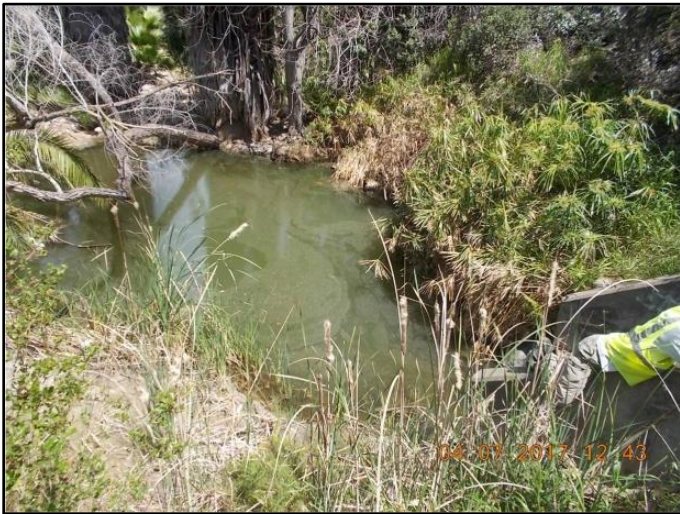
Figure 1: April 2017, looking downstream at scour pool at channel outfall

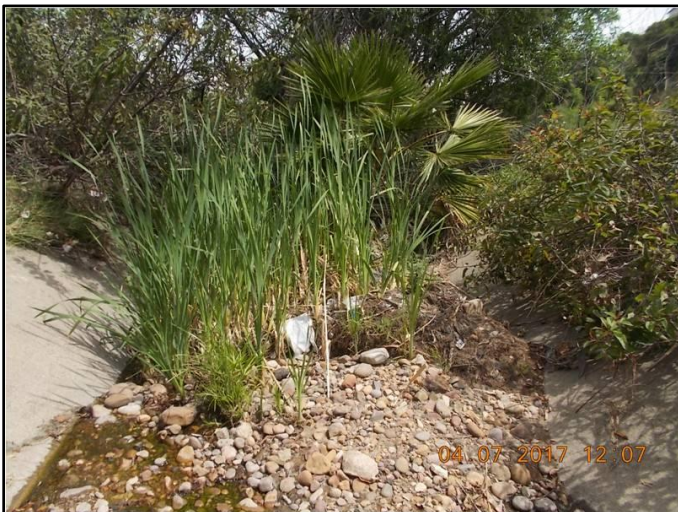
Figure 1: April 2017, looking downstream at sediment, debris and vegetation in concrete ditch

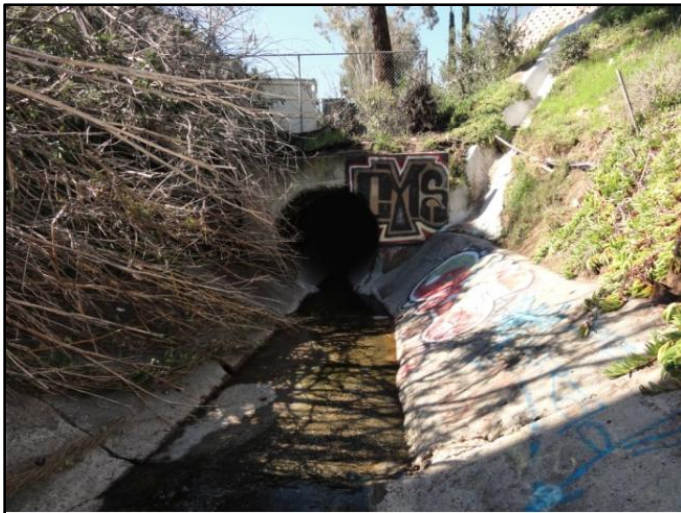
Figure 1: November 2016, facing downstream end of facility group; towards 60-inch-diameter RCP culvert beneath the Collwood Villas Apartments and Collwood Boulevard

Current Conditions Affecting Facility Capacity		In November 2016, the amount of vegetation was observed to vary from light to heavy and broken concrete lining was noted				
Hydrologic Peak Flows						
Storm Event	2-year	5-year	10-year	25-year	50-year	100-year
Q (cubic feet per second [cfs])	593	730	867	958	1,049	1,232
Hydraulic Capacity of Facility						
Current Capacity				250 cfs		
Proposed MWMP Maintained Capacity				250 cfs		
Maintenance Recommendation			<p>From Station 6 to Station 281: No maintenance currently proposed; however vegetation, sediment and debris removal, or concrete repair/replacement activities should be performed if the conditions change.</p> <p>From Station 281 to Station 589: Partially remove vegetation; cut down existing palm trees, leaving 2-foot-tall stumps with root balls intact in the ground. Stumps should be left in place to help mitigate velocities. Remove all fallen palm tree trunks and debris. Leave all other existing vegetation and sediment in place.</p> <p>From Station 589 to Station 646: Remove palm tree growing out of a crack in the concrete lining and repair/replace the broken and missing concrete lining to match the existing flow line. Previously designed post-maintenance erosion control measures at Station 281 and Station 488 to be installed and maintained as necessary.</p> <p>Repair/replacement of broken concrete lining from Station 281 to Station 646.</p> <p>From Station 788 to Station 1507: No maintenance currently proposed; however vegetation, sediment and debris removal or concrete repair/replacement activities should be performed if the conditions change.</p>

In-Stream Post-Maintenance Erosion Control Recommendation			Yes; see Appendix A-4 Location: Station 281 and Station 488
