Facility Maintenance Plan

Green Valley Creek -Pomerado Facility Group

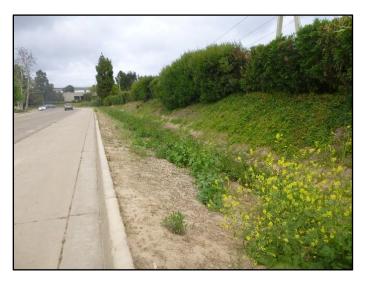
Figure 1: May 2017, looking downstream at vegetation and sediment in Dunhill segment

Current Conditions	S Affecting	The vegetation was observed to range from light to dense and sediment				
Facility Capacity		deposition was estimated to range from 6 inches to 3 feet				
Hydrologic Peak Flows						
Storm Event	2-year	5-year	10-year	25-year	50-year	100-year
Q (cubic feet per	248	321	372	445	486	521
second [cfs])						
Hydraulic Capacity of Facility						
Curr	ent Capacity	120 cfs				
Proposed MWM	Proposed MWMP Maintained Capacity 125 cfs					
Maintenance Recommendation Remove accumulate			ated sediment, o	debris, and veg	getation from	
		bottom of the facility from Station 329 to Station 759.				
			Repair bank at approximately from Station 715 to Station 759 on			
		the north (street) side.				
			Maintain/repair	existing debris fe	nce as needec	l.
In-Stream Post-Maintenance Erosion Control		sion Control	Yes; see Appendix A-4			
Reco	mmendation		Location: Station to be determined

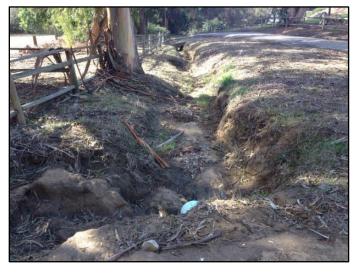
Figure 1: April 2017, representative of light weeds in the channel segment

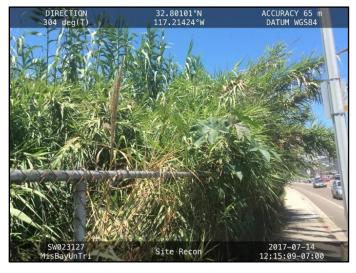
Figure 1: July 2017, representative downstream channel segment with dense vegetation

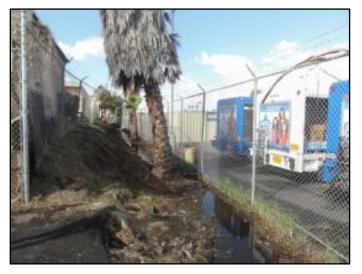
Figure 1: November 2015, upstream portion of reach facing west, showing sediment and vegetation in ditch

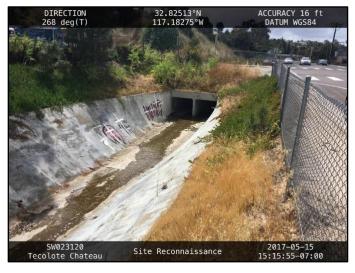
Figure 1: May 2017, upstream of double 5-foot-wide by 4-foot-high RCB culvert beneath Derrick Drive

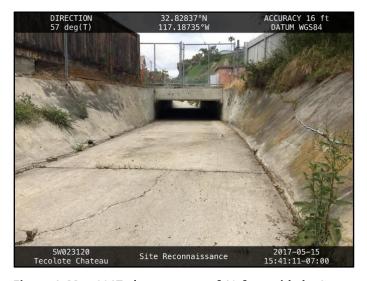
Figure 1: May 2017, downstream of 10-foot-wide by 3-foot-high RCB culvert beneath Chateau Drive

Current Conditions Facility Capacity	S Affecting	The channel was observed to be relatively clean with minor sediment, debris and vegetation in some locations				
Hydrologic Peak Flo	ows					
Storm Event	2-year	5-year	10-year	25-year	50-year	100-year
Q (cubic feet per	236	295	354	387	442	491
second [cfs])						
Hydraulic Capacity of Facility						
Curr	Current Capacity 196 cfs					
Proposed MWM	IP Maintained	Capacity 435 cfs				
Maintenance Recommendation		Station 0 to Sta	ition 105 and Stand Standard	nt, debris, and ve ation 165 to Stat nt and debris in o	ion 1117.

-	to the center of Chateau segment 1
Coastal Zone	No
MWMP Proposed Maintenance	Maintenance of concrete-lined channel per as-built dimensions and
•	Hydrology and Hydraulics recommendations
Hydrology and Hydraulics	Remove accumulated sediment, debris, and vegetation from Station 0 to
Recommendation ²	Station 105 and Station 165 to Station 1117.
	Remove accumulated sediment and debris in culverts from Station 105 to

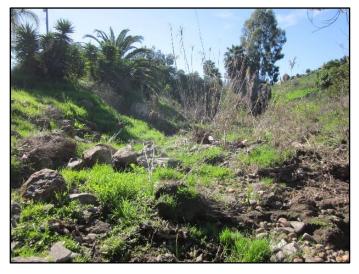
Figure 1: April 2017, looking downstream at sediment, debris, and vegetation

Facility Group	Tecolote Creek - Genesee			
Segment Name	Genesee 1			
Facility No.	3-04-160			
Facility Location	From outlet of culvert near an apartment complex to culvert under			
	Marlesta Drive			
Coastal Zone	No			
MWMP Proposed Maintenance	Maintenance of earthen channel per estimated original design dimension			
	and Hydrology and Hydraulics recommendations			
Hydrology and Hydraulics	Remove accumulated sediment, debris, and vegetation from bottom of the			
Recommendation ²	channel from Station 1592 to Station 2359.			
	Stabilize bank erosion on west bank at Station 1592.			
Maintenance Activities	Vegetation grubbing, trimming, and removal			
	Invasive plant species treatment and removal			
	Sediment removal			
Maintenance Method	Excavation; mechanized equipment inside and outside the channel			
	Temporary access/loading			
	Temporary staging			
	Temporary stockpiling			
	Temporary diversions			
	Vegetation trimming

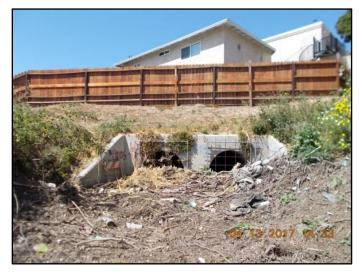
Figure 1: April 2017, looking downstream at dual 54-inch diameter RCP culvert inlet

_		The vegetation was observed to range from moderate to dense and evidence of sediment deposition was noted				
Hydrologic Peak Flo)WS					
Storm Event	2-year	5-year	10-year	25-year	50-year	100-year
Q (cubic feet per	227	290	339	407	456	505
second [cfs])						
Hydraulic Capacity of Facility						
Current Capacity			120 cfs			
Proposed MWMP Maintained Capacity		Capacity	339 cfs			
Maintenance Recommendation		Remove accumulated sediment, debris, and vegetation from bottom of earthen ditch near entrance of culvert from Station 118 to Station 234				
In-Stream Post-Maintenance Erosion Control Recommendation		sion Control		No	ne

Facility Group	San Diego River - Nimitz			
Segment Name	Nimitz 1			
Facility No.	4-01-103			
Facility Location	From the downstream end of Nimitz 2 segment to 200 feet south of the			
	intersection of W Point Loma Boulevard and Nimitz Boulevard			
Coastal Zone	No			
MWMP Proposed Maintenance	Maintenance of earthen ditch per as-built dimensions and Hydrology and			
	Hydraulics recommendations			
Hydrology and Hydraulics	Remove accumulated sediment, debris, and vegetation from bottom of			
Recommendation ²	earthen ditch near entrance of culvert from Station 118 to Station 234			
Maintenance Activities	Vegetation grubbing, trimming, and removal			
	Sediment removal			
	Invasive plant species treatment and removal			
Maintenance Method	Excavation; mechanized equipment inside and outside the ditch			
	Temporary access/loading			
	Temporary staging			
	Temporary stockpiling			
	Temporary diversions			
	Hand removal of vegetation

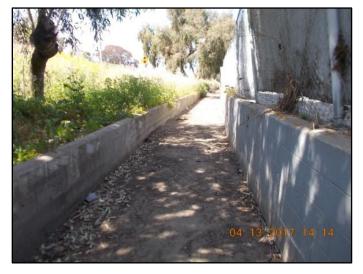
Figure 1: April 2017, looking downstream at sediment and debris at upstream end of concrete ditch

Current Conditions	s Affecting	The segment was observed to be mostly clean with sediment, debris			t, debris	
Facility Capacity		accumulation occurring at the transition to Nimitz 1				
Hydrologic Peak Flows						
Storm Event	2-year	5-year	10-year	25-year	50-year	100-year
Q (cubic feet per	227	290	339	407	456	505
second [cfs])						
Hydraulic Capacity of Facility						
Current Capacity 15 cfs						
Proposed MWMP Maintained Capacity 80 cfs						
Maintenance Recommendation		Remove accumulated sediment, debris, and vegetation from				
			Station 234 to Station 525			
In-Stream Post-Maintenance Erosion Control		ion Control	None			
Recommendation

Facility Group	San Diego River - Nimitz		
Segment Name	Nimitz 2		
Facility No.	4-01-105		
Facility Location	From the downstream end of Nimitz 3 segment to the upstream end of Nimitz 1 segment		
Coastal Zone	No		
MWMP Proposed Maintenance	Maintenance of concrete-lined ditch, per as-built dimensions and Hydrology and Hydraulics recommendations		
Hydrology and Hydraulics	Remove accumulated sediment, debris, and vegetation from Station 234 to		
Recommendation ²	Station 525		
Maintenance Activities	Vegetation grubbing, trimming, and removal Invasive plant species treatment and removal Sediment removal Concrete repair		
Maintenance Method	Excavation; mechanized equipment inside and outside the ditch Temporary access/loading Temporary staging Temporary stockpiling Temporary diversions Hand removal of vegetation		
Bank Repair	No		
Concrete Repair	Yes; see Appendix A-4		
Concrete/Gabion Structure Repair	No		
and Maintenance

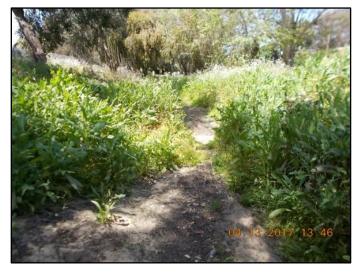
Figure 1: April 2017, looking downstream near upstream end of facility

Current Conditions	s Affecting	In March 2016, the vegetation was observed to range from moderate to dense				
Facility Capacity		with little evidence of sediment deposition				
Hydrologic Peak Flows						
Storm Event	2-year	5-year	10-year	25-year	50-year	100-year
Q (cubic feet per	227	290	339	407	456	505
second [cfs])

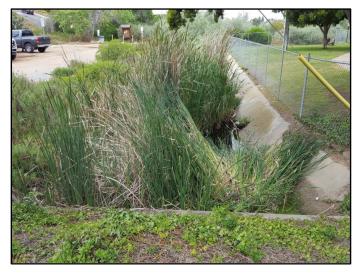
Figure 1: April 2017, looking downstream over headwall and 48-inch-diameter and 30-inch-diameter diameter RCP culvert outlet

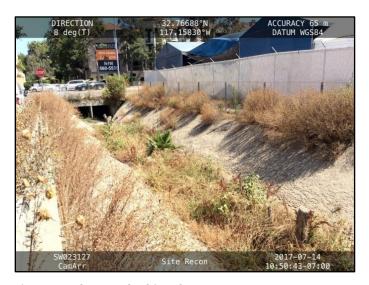
Figure 1: July 2017, looking downstream

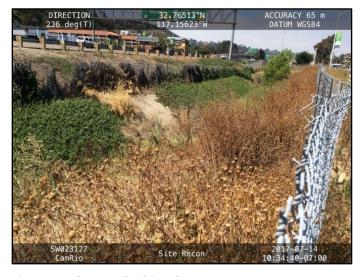
Figure 1: July 2017, looking downstream

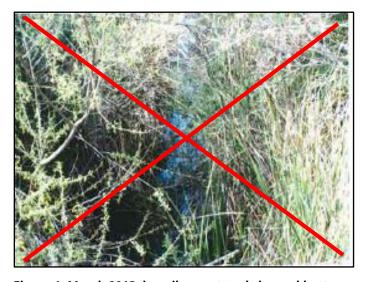
Figure 1: March 2013, heavily vegetated channel bottom near the downstream end of the facility group

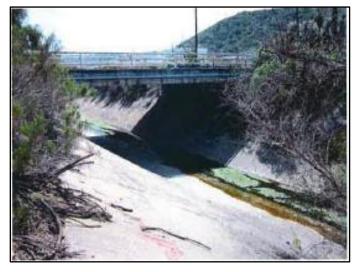
Figure 1: March 2013, looking downstream towards access road bridge near the upstream limit of concrete channel lining

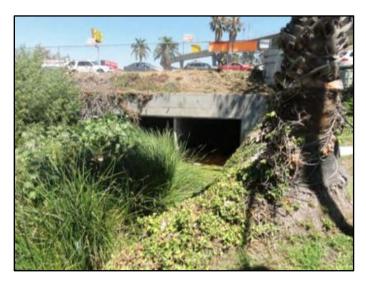
Figure 1: August 2014, looking upstream at the triple 12-foot-wide by 8-foot-tall RCB culvert beneath Fairmount Avenue

to dense vegetation was observed in the channel bottom with deposition ranging from 0.2 to 0.9 feet. Current conditions were				
racinty capacity		•	0 0				
			reviewed in relation to the hydraulic analysis for this segment in 2018 and documented in the current conditions assessment memorandum in Appendix				
		A of the Hydro	Irology and Hydraulics Technical Report.				
Hydrologic Peak Flo	ows						
Storm Event	2-year	5-year	10-year	25-year	50-year	100-year	
Q (cubic feet per	1,180	2,050	2,700	3,800	4,500	5,100	
second [cfs])							
Hydraulic Capacity	of Facility						
Current Capacity 1,250 cfs							
Proposed MWMP Maintained Capacity			1,800 cfs				
Maintenance Recommendation			Remove accumulated sediment, debris, and overgrown				
			vegetation from Station 819 to Station 1156 and Station 1305 to				
			Station 1686.				
			Remove accumulated sediment and debris in culvert from				
			Station 1156 to Station 1305.

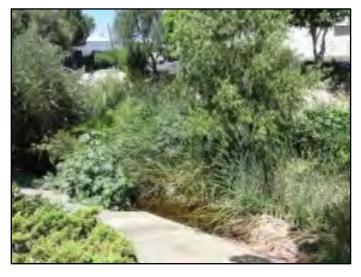
Figure 1: August 2014, looking downstream from the south side

The amount of vegetation in the channel bottom ranged from light to heavy and sediment accumulation varied from 0.25 to 1.1 feet. Current conditions were reviewed in relation to the hydraulic analysis for this segment in 2018 and documented in the current conditions assessment memorandum in Appendix A of the Hydrology and Hydraulics Technical Report.

Maintenance RecommendationRemove accumulated sediment, debris, and overgrownvegetation from Station 3006 to Station 3527

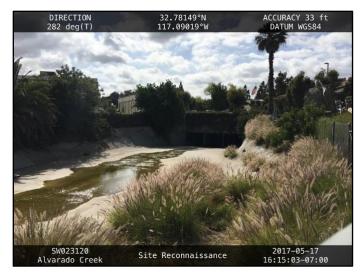
Figure 1: May 2017, looking at the downstream end of segment, towards the triple 9-foot wide by 8-foot high RCB culvert beneath Mission Gorge Place

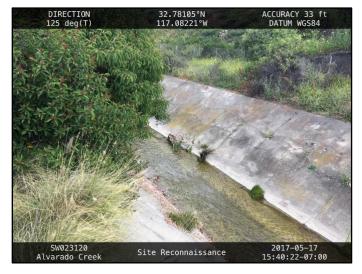
Figure 1: May 2017, looking downstream from the upstream end

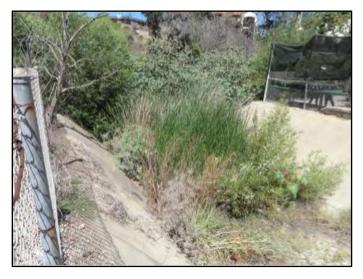
Figure 1: August 2014, from east side of channel, directly upstream of State of California maintenance boundary, looking downstream

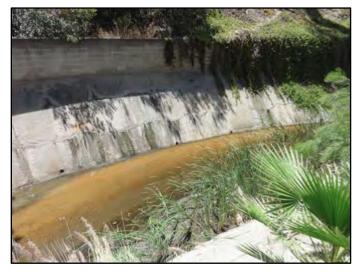
Figure 1: August 2014, from north side of the channel within 100% concrete portion of channel at 90-degree bend, looking downstream

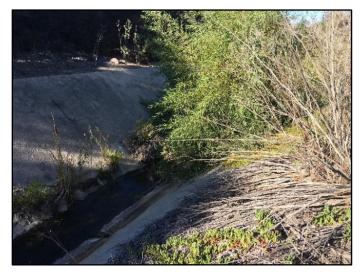
Figure 1: October 2018, upstream of culvert

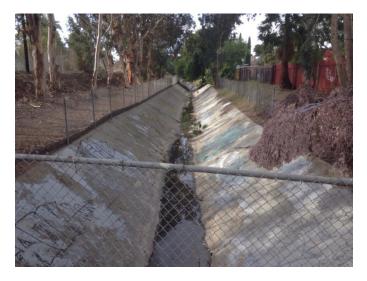
Figure 1: December 2016, above inlet culvert on the Boulder Lake end of channel

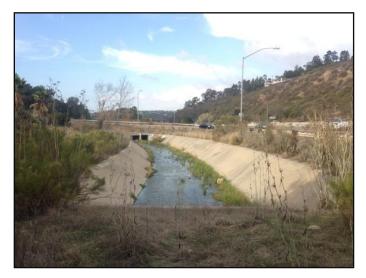
Figure 1: April 2017, looking downstream at concrete channel

Current Conditions Affecting The segment was observed to be mostly clean with a film of algae/moss alo			algae/moss along				
Facility Capacity		the bottom					
Hydrologic Peak Flo	Hydrologic Peak Flows						
Storm Event	2-year	5-year	5-year 10-year 25-year 50-year 100-year				
Q (cubic feet per	390	499	583	699	784	868	
second [cfs])							
Hydraulic Capacity	of Facility						
Curr	ent Capacity	Capacity 600 cfs					
Proposed MWMP Maintained Capacity N/A							
Maintenance Recommendation		No maintenance currently proposed; however vegetation,					
			sediment and debris removal, or concrete repair/replacement				
			activities should be performed if the conditions change				
In-Stream Post-Maintenance Erosion Control		None					
Recommendation

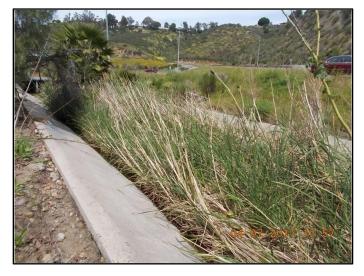
Figure 1: April 2017, looking downstream at vegetation concrete ditch

ccumulation of up to 4 feet was observed in portions of the ong with vegetation growth ranging from light to heavy					
Hydrologic Peak Flows							
Storm Event 2-year	5-year	5-year 10-year 25-year 50-year 100-year					
Q (cubic feet per 390	499	583	699	784	868		
second [cfs])							
Hydraulic Capacity of Facility							
Current Capacity 50 cfs							
Proposed MWMP Maintained Capacity 563 cfs							
Maintenance Recommendation Remove accumulated sediment, debris, and vegetation from				getation from			
		Station 1300 to Station 1875.					
	Remove accumulated sediment and debris in culvert from						
Station 655 to Station 1300.							
In-Stream Post-Maintenance Erosion Control		None					
Recommendat

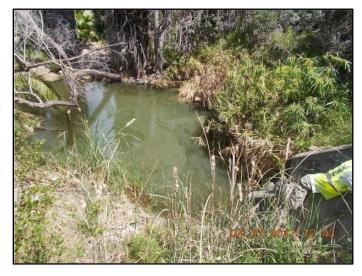
Figure 1: April 2017, looking downstream at scour pool at channel outfall

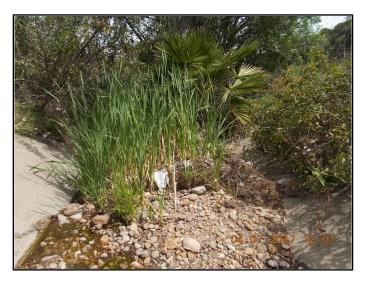
Figure 1: April 2017, looking downstream at sediment, debris and vegetation in concrete ditch

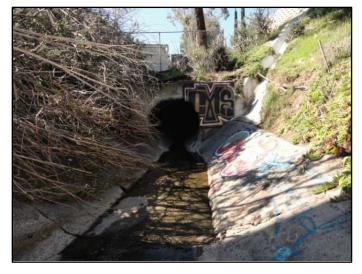
Figure 1: November 2016, facing downstream end of facility group; towards 60-inch-diameter RCP culvert beneath the Collwood Villas Apartments and Collwood Boulevard
