Facility Maintenance Plan

Washington Canyon Creek - Washington Facility Group

Segment Names (Facility numbers):
Washington 1 (5-02-151)
Washington 2 (5-02-153)

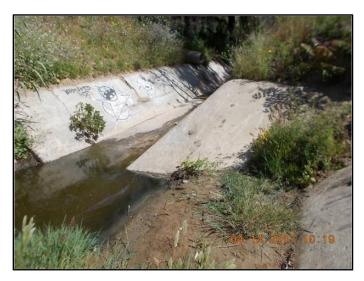
Figure 1: April 2017, looking upstream at transition from Washington 2

Current Conditions	Affecting	Vegetation was observed to be light to dense with up to 1 foot of sediment				
Facility Capacity		deposition				
Hydrologic Peak Flo	ws					
Storm Event	2-year	5-year	10-year	25-year	50-year	100-year
Q (cubic feet per	82	105	123	147	165	183
second [cfs])						
Hydraulic Capacity of Facility						
Curre	ent Capacity	162 cfs				
Proposed MWM	P Maintained	ned Capacity 162 cfs				
Maintenance Recommendation Remove accumulated sediment, debris, and vegetation fr		getation from				
		Station 89 to Station 306.				
			Maintain/repair existing debris fence as needed.			
In-Stream Post-Ma	intenance Ero	sion Control	Yes; see Appendix A-4			
Recor	nmendation		Location: Station to be determined

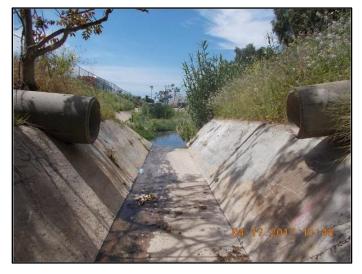
Figure 1: April 2017, looking downstream at transition to Washington 1

Current Conditions Facility Capacity	Affecting	Vegetation was observed to be light to dense with up to 1 foot of sediment deposition						
Hydrologic Peak Flo	ows							
Storm Event	2-year	5-year	10-year	25-year	50-year	100-year		
Q (cubic feet per	82	105	123	147	165	183		
second [cfs])								
Hydraulic Capacity	of Facility							
Curr	ent Capacity		-	70 cfs				
Proposed MWM	IP Maintained	l Capacity	pacity 183 cfs					
Maintenance Recommendation			Remove accumulated sediment, debris, and vegetation in					
			concrete ditch from Station 306 to Station 2516					
In-Stream Post-Ma	intenance Ero	osion Control	None					
Reco	mmendation

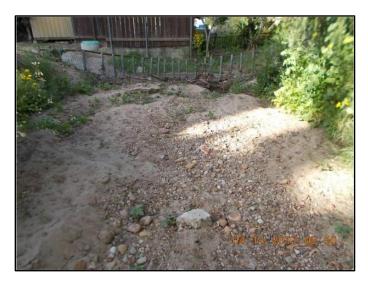
Figure 1: April 2017, looking downstream at sediment and debris accumulated at debris fence

Current Conditions	Affecting	Little vegetation was observed and sediment deposition was estimated to be 3				
Facility Capacity		feet upstream of the debris fence				
Hydrologic Peak Flows						
Storm Event	2-year	5-year	10-year	25-year	50-year	100-year
Q (cubic feet per	52	66	77	92	104	115
second [cfs])

Maintenance Recommendation Remove accumulated sediment and debris from Station 110 to

Maintain/repair existing debris fence as needed.

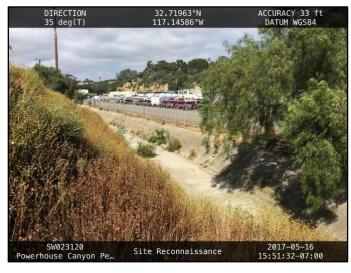
Figure 1: May 2017, Looking upstream near the downstream end of the segment

Current Conditions Affecting The segment Facility Capacity		t was observed	to vary from cle	an concrete to d	ense vegetation	
Hydrologic Peak Flo)WS					
Storm Event	2-year	5-year	10-year	25-year	50-year	100-year
Q (cubic feet per	386	554	675	1,048	1,540	1,870
second [cfs])						
Hydraulic Capacity of Facility						
Current Capacity		630 cfs				
Proposed MWMP Maintained Capacity		633 cfs				
Maintenance Recommendation		Remove accumulated sediment, debris, and vegetation from				
			Station 332 to Station 1930			
In-Stream Post-Maintenance Erosion Control		None				
Recommendation

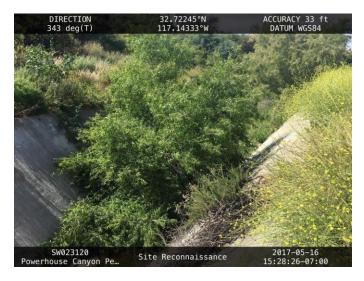
Figure 1: May 2017, looking upstream from the Pershing Drive bridge

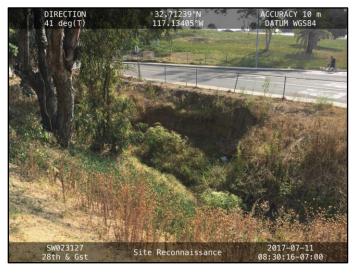
Figure 1: July 2017, looking upstream towards the eroded eastern sidewall

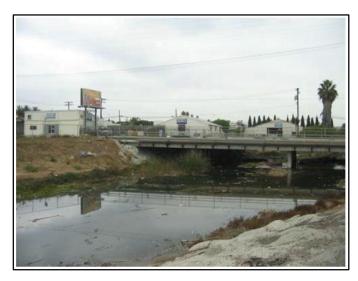
Figure 1: October 2009, looking upstream where the channel crosses under National Avenue, representative of low vegetation

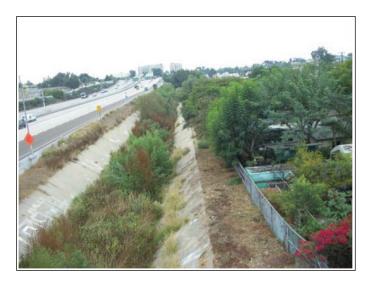
Figure 1: October 2009, looking downstream, representative of medium to dense vegetation

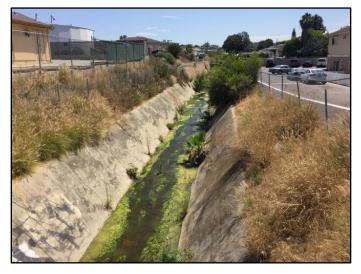
Figure 1: July 2017, looking upstream from downstream end segment

Current Conditions Facility Capacity	Affecting	The segment was observed to be relatively clean and light vegetation was observed in some locations			egetation was	
Hydrologic Peak Flo	ws					
Storm Event	2-year	5-year	10-year	25-year	50-year	100-year
Q (cubic feet per	577	707	793	943	986	1,157
second [cfs])						
Hydraulic Capacity	of Facility					
Curre	ent Capacity	829 cfs				
Proposed MWM	P Maintained	Capacity	pacity 829 cfs			
Maintenanc	e Recommend	ation	Remove accumulated sediment, debris, and vegetation from segment bottom from Station 6272 to Station 6646. Remove accumulated sediment and debris in culvert from Station 6222 to Station 6272.			
In-Stream Post-Ma Reco	intenance Eros mmendation	sion Control	N one

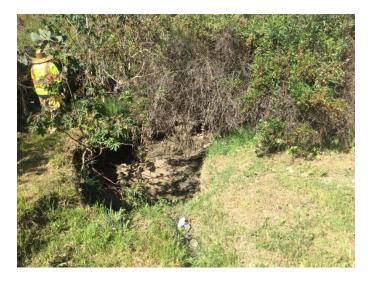
Figure 1: July 2017, looking downstream at scoured ditch bed

Current Conditions Facility Capacity	Affecting	The vegetation observed ranged from light to medium with no evidence of sediment deposition. A scoured area was identified during the site visit.				
Hydrologic Peak Flo	ws					
Storm Event	2-year	5-year	10-year	25-year	50-year	100-year
Q (cubic feet per	118	151	176	211	237	262
second [cfs])						
Hydraulic Capacity	Hydraulic Capacity of Facility					
Current Capacity 228 cfs						
Proposed MWM	WMP Maintained Capacity 228 cfs					
Maintenance Recommendation		Repair and restabilize scoured ditch bed between Station 496 to				
			Station 616			
In-Stream Post-Maintenance Erosion Control		Yes; see Appendix A-4				
Recommendation		Location: Station to be determined

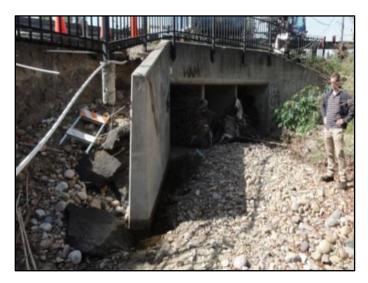
Figure 1: February 2017, standing along east bank of segment, looking southwest at erosion behind east wing wall at downstream end

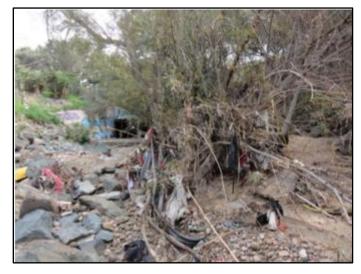
Figure 1: March 2016, looking upstream at the vegetation and displaced riprap downstream of the double 7-foot wide by 6-foot tall RCB culvert

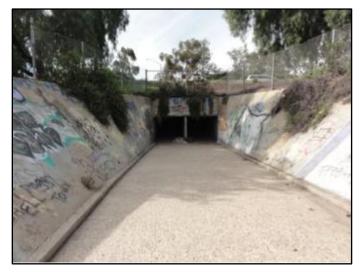
Figure 1: March 2016, looking downstream towards 7-foot wide by 6-foot tall double RCB culvert. Note clean channel.

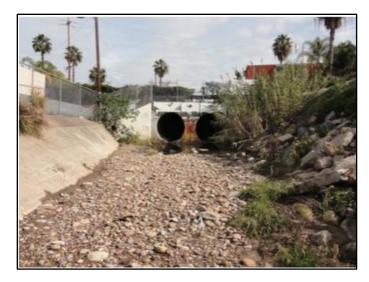
Figure 1: March 2016, looking upstream at the double-barrel 74-inch-diameter RCP culvert

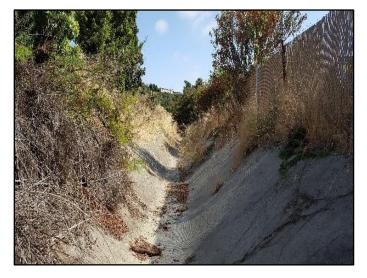
Figure 1: July 2017, looking upstream at concrete ditch

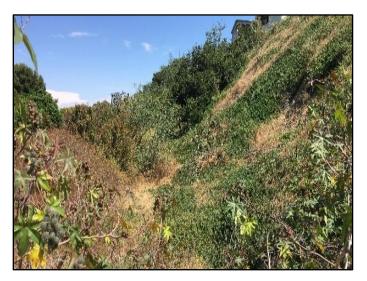
Figure 1: July 2017, looking upstream near upstream end at vegetation

Facility Capacity		the ditch mainly unobstructed. At the transition to the concrete ditch, sediment deposition was noted within the earthen ditch flowline as well as failure of a portion of the earthen bank.				
Hydrologic Peak Flo	ows					
Storm Event	2-year	5-year	10-year	25-year	50-year	100-year
Q (cubic feet per	106	204	239	286	321	355
second [cfs])						
Hydraulic Capacity	of Facility					
Current Capacity 355 cfs						
Proposed MWM	IP Maintaine	Maintained Capacity 355 cfs				
Maintenance RecommendationRemove accumulated sediment and vegetation froside (left bank) of the ditch between Stations 851 areturn the ditch flow path to originally designed co		51 and 913 to				
In-Stream Post-Maintenance Erosion Control			Yes; see	Appendix A-4

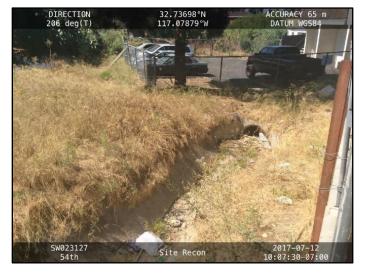
Figure 1: July 2017, looking downstream towards the culvert; conveys flows beneath parking lot, then discharges back into ditch

Current Conditions Facility Capacity	Affecting	Accumulated sediment and patches of dense vegetation in the bottom of the ditch were observed and sediment deposition was estimated to be 2 inches within the ditch and up to 2 feet within the culvert				
Hydrologic Peak Flo)WS					
Storm Event	2-year	5-year	10-year	25-year	50-year	100-year
Q (cubic feet per second [cfs])	73	93	108	130	146	163
Hydraulic Capacity	of Facility					
Curre	Current Capacity 40 cfs					
Proposed MWMP Maintained Capacity 93 cfs						
Maintenanc	e Recommend	ation	Remove accumulated sediment, debris, and vegetation from Station 34 to Station 135, and Station 217 to 380. Remove accumulated sediment and debris in the culvert from Station 135 to 217, and at Station 34.			
In-Stream Post-Maintenance Erosion Control Recommendation			None

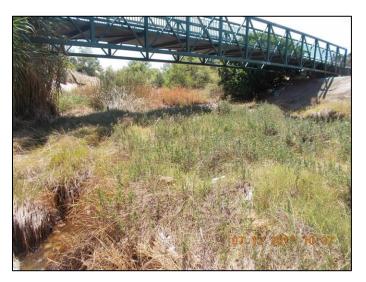
Figure 1: July 2017, looking downstream under the pedestrian bridge located just east of I-5

Current Conditions Facility Capacity	S Affecting	The vegetation observed ranged from light to dense with evidence of sedim deposition			dence of sediment	
Hydrologic Peak Flows						
Storm Event	2-year	5-year	10-year	25-year	50-year	100-year
Q (cubic feet per	550	1,300	2,000	3,000	3,900	5,300
second [cfs])						
Hydraulic Capacity of Facility						
Curr	ent Capacity		550 cfs			
Proposed MWMP Maintained Capacity 1,300 cfs						
Maintenance Recommendation		Remove accumulated sediment, debris, and overgrown vegetation from Station 4788 to Station 5135, Station 5613 to Station 5734, and Station 6195 to 6277. Trim vegetation from Station 5135 to Station 5316. Perform bank repair on the earthen bank from Station 5456 to Station 5556.				
			Private segme	o Station 6195 a	nd Station 6277	property owners to Station 6580).
In-Stream Post-Ma	iintenance Ero	osion Control		Yes; see	Appendix A-4

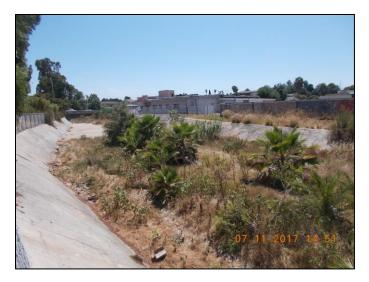
Figure 1: July 2017, looking downstream toward the start of the concrete bottom channel

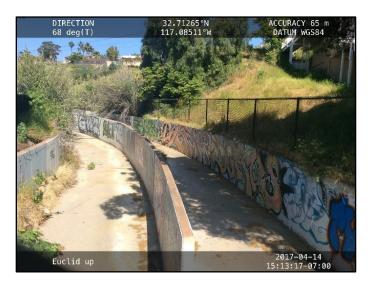
Figure 1: April 2017, representative of concrete portion of channel

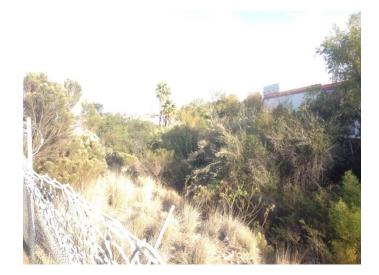
Figure 1: December 2016, looking upstream

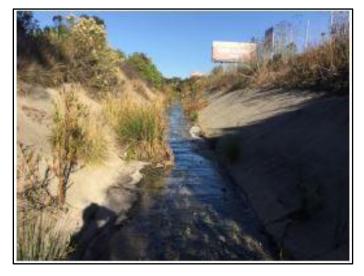
Figure 1: November 2016, looking northeast at the concrete-lined ditch. Note the minimal vegetation established within the ditch.

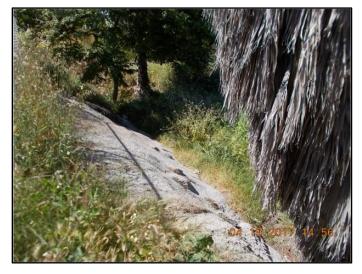
Figure 1: April 2017, looking downstream at vegetation and gunite lining on left bank

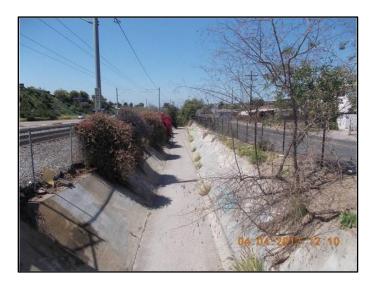
Figure 1: April 2017, looking downstream at concrete channel near 60th Street

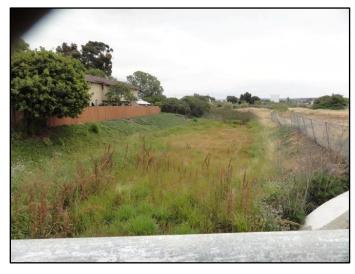
Figure 1: April 2015, looking upstream at the downstream end of the segment

Current Conditions	Affecting	In April 2015	, the vegetation	was observed to	o be light to den	se and there was		
Facility Capacity		evidence of sediment deposition						
Hydrologic Peak Flo)WS							
Storm Event	2-year	5-year	r 10-year 25-year 50-year 100-year					
Q (cubic feet per	215	260	330	470	640	796		
second [cfs])								
Hydraulic Capacity	of Facility							
Curr	Current Capacity 340 cfs							
Proposed MWMP Maintained Capacity 420 cfs								
Maintenanc	Maintenance Recommendation Remove accumulated sediment, debris, and vegetation from				getation from			
channel bottom from Station 3057 to Station 3197 and Statio			197 and Station					
			4167 to Station 5494.					
			Remove accum	ulated sedimen	t and debris fro	m the culvert at		
			Station 2260 to Station 3057.					
			The remainder of Cerissa 1 is recommended to be maintained by			be maintained by		
			the private property owners to remove accumulated sediment,			ulated sediment,

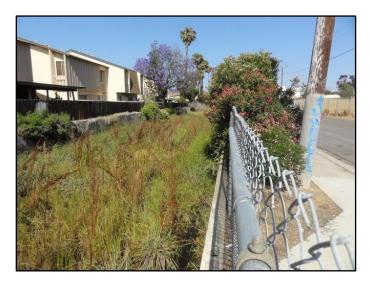
Figure 1: May 2015, looking upstream at the downstream portion of the segment

Current Conditions Facility Capacity	Affecting	In May 2015, the vegetation was observed to be moderate with little evidence of sediment deposition			ith little evidence	
Hydrologic Peak Flo)WS					
Storm Event	2-year	5-year	10-year	25-year	50-year	100-year
Q (cubic feet per second [cfs])	20	88	180	270	365	456
Hydraulic Capacity	of Facility					
Curr	ent Capacity	456 cfs				
Proposed MWM	Proposed MWMP Maintained Capacity 456 cfs					
Maintenanc	e Recommend	ation	Remove accumulated vegetation from channel bottom from Station 8660 to Station 9228, and Station 9261 to Station 9732. Remove accumulated sediment, debris, and vegetation from the culverts from Station 9228 to Station 9261, and Station 9732 to Station 9802.			to Station 9732. getation from the
In-Stream Post-Ma Reco	intenance Ero mmendation	sion Control	rol None

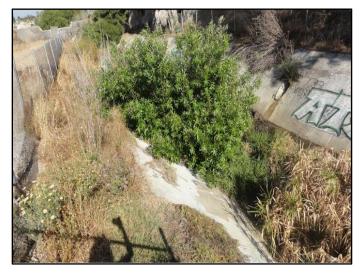
Figure 1: May 2015, looking upstream from a location downstream of the 42-inch-diameter RCP culvert

Current Conditions Facility Capacity	Affecting	In May 2015, dense vegetation and sediment deposition was observed throughout the segment length						
Hydrologic Peak Flows								
Storm Event	2-year	5-year	rear 10-year 25-year 50-year 100-year					
Q (cubic feet per second [cfs])	20	88	180	270	365	456		
Hydraulic Capacity	of Facility							
Curr	ent Capacity	140 cfs						
Proposed MWM	osed MWMP Maintained Capacity 165 cfs							
Maintenanc	e Recommend		Remove accumulated sediment, debris, and vegetation f segment channel from Station 10653 to Station 11830. Remove accumulated sediment, debris, and vegetation f culverts from under gabion dam and at Station 10680 ar Station 11830. Perform bank repair on the north concrete bank near Station 11547.			n 11830. getation from n 10680 and at		
In-Stream Post-Ma Reco	intenance Eros mmendation	sion Control	n Control None

-	Hydrology and Hydraulics recommendations
Hydrology and Hydraulics	Remove accumulated sediment, debris, and vegetation from segment
Recommendation ³	channel from Station 10653 to Station 11830.
	Remove accumulated sediment, debris, and vegetation from culverts from
	under gabion dam and at Station 10680 and at Station 11830.
	Perform bank repair on the north concrete bank near Station 11547.
Maintenance Activities	Vegetation grubbing, trimming, and removal
	Invasive plant species treatment and removal
	Sediment removal
	Concrete repair
Maintenance Method	Excavation; mechanized equipment inside and outside the channel
	Temporary access/loading
	Temporary staging
	Temporary diversions
	Hand removal of vegetation
Bank Repair	Yes (multiple options); see Appendix A-4
Concrete Repair	Yes; see Appendix A-4
Concrete/Gabion Structure Repair	Yes; see Appendix A-4
and Maintenance	
Culvert Maintenance	Yes; see Appendix A-4

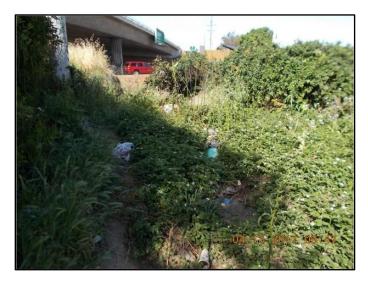
Figure 1: April 2017, looking downstream at vegetation downstream of Outer 1 and Outer 2 junction

Current Conditions Facility Capacity	Affecting	The vegetation observed ranged from medium to dense and there was little evidence of sediment deposition				
Hydrologic Peak Flo	ows					
Storm Event	2-year	5-year	10-year	25-year	50-year	100-year
Q (cubic feet per	106	135	158	190	212	236
second [cfs])						
Hydraulic Capacity of Facility						
Current Capacity		53 cfs				
Proposed MWMP Maintained Capacity		80 cfs				
Maintenance Recommendation		Trim vegetation from Station 228 to Station 613				
In-Stream Post-Maintenance Erosion Control Recommendation			No	one

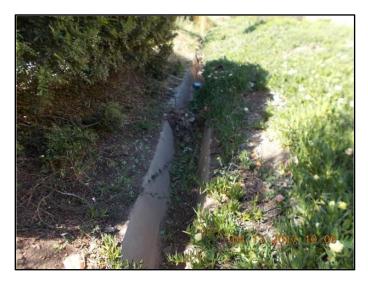
Figure 1: April 2017, looking downstream at sediment, debris and overhanging vegetation upstream of Outer 1 and Outer 2 junction

Current Conditions Facility Capacity	Affecting	Approximately 2 inches of accumulated sediment, debris was observed in the segment including vegetation hanging down into ditch				
Hydrologic Peak Flo	ws					
Storm Event	2-year	5-year	10-year	25-year	50-year	100-year
Q (cubic feet per second [cfs])	5	6	7	9	10	11
Hydraulic Capacity of Facility						
Curre	ent Capacity		4.7 cfs			
Proposed MWM	IP Maintained	Capacity	5 cfs			
Maintenanc	e Recommend	ation	Remove accumulated sediment and debris and removal of			
			overhanging vegetation from bottom and sides of concrete ditch from Station 0 to Station 176			
In-Stream Post-Ma Reco	intenance Eros mmendation	sion Control	ontrol None

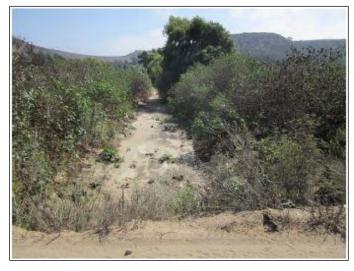
Figure 1: September 2012, looking south (upstream) from atop the Disney Crossing. Vegetation is very thick on the side slopes, while the streambed is mainly unvegetated.

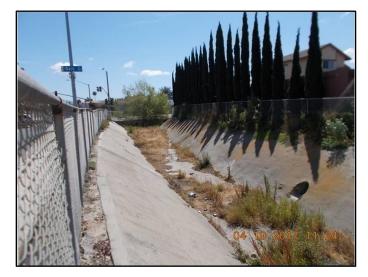
Figure 1: April 2017, looking upstream at vegetation

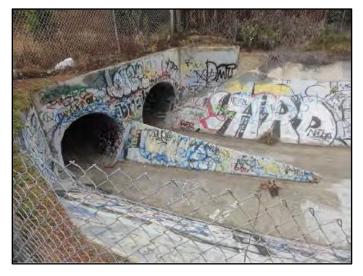
Figure 1: April 2015, entrance to double-barrel 72-inchdiameter RCP culvert under Vista Lane

Current Conditions Facility Capacity	Affecting	In April 2015, the channel was observed to be relatively clean with patches of vegetation, sediment, and debris				
Hydrologic Peak Flo	WS					
Storm Event	2-year	5-year	10-year	25-year	50-year	100-year
Q (cubic feet per	610	793	976	1,037	1,098	1,220
second [cfs])						
Hydraulic Capacity	Hydraulic Capacity of Facility					
Curre	ent Capacity	610 cfs				
Proposed MWM	IP Maintained	Capacity	y 610 cfs			
Maintenance Recommendation		Remove accumulated sediment and vegetation from bottom and				
			sides of segment from Station 1876 to Station 2762			2762
In-Stream Post-Maintenance Erosion Control		None				
Recommendation

•	Hydrology and Hydraulics recommendations
Hydrology and Hydraulics	Remove accumulated sediment and vegetation from bottom and sides of
Recommendation ³	segment from Station 1876 to Station 2762
Maintenance Activities	Vegetation grubbing, trimming, and removal
	Invasive plant species treatment and removal
	Sediment removal
	Concrete repair
Maintenance Method	Excavation; mechanized equipment inside and outside the channel
	Temporary access/loading
	Temporary staging
	Temporary diversions
	Hand removal of vegetation
Bank Repair	No
Concrete Repair	Yes; see Appendix A-4
Concrete/Gabion Structure Repair	No
and Maintenance	
Culvert Maintenance	No
Post-Maintenance Erosion Control	No
Recommendation	
Trash/Debris Fence Repair and	No
Maintenance	
Facility Type	Earthen and concrete channel
Existing Plans and/or As-Builts?	Yes; 19218-D, 11-086034, 16916-D, & 14427-D
Substrate Detail ³	Stations 1876-2612: Concrete bottom and banks

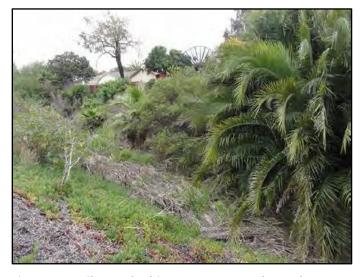
Figure 1: April 2015, looking upstream at channel

The vegetation was observed to vary from light to dense with evidence of

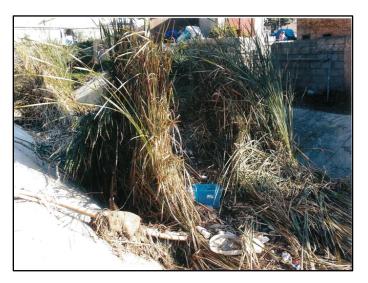
Figure 1: December 2014, looking upstream at dense vegetation, and sediment and debris within ditch

Current Conditions Affecting	In December 2014, the amount of vegetation was observed to be dense with
Facility Capacity	many large trees. Sediment deposition was estimated to be 2 feet. Current
	condition: relatively clean loaf debris

Maintenance RecommendationRemove accumulated sediment and vegetation from bottom and sides of concrete ditch from Station 1418 to Station 2134.

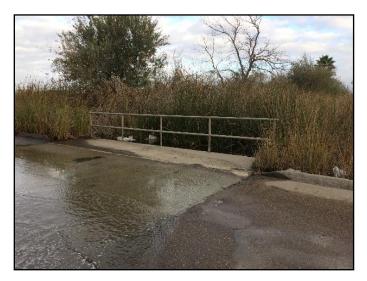
Figure 1: April 2017, looking upstream at conservation area from Airway Road
