101 ASH STREET

BUILDING CONDITION ASSESSMENT

FINAL REPORT

JULY 28, 2020

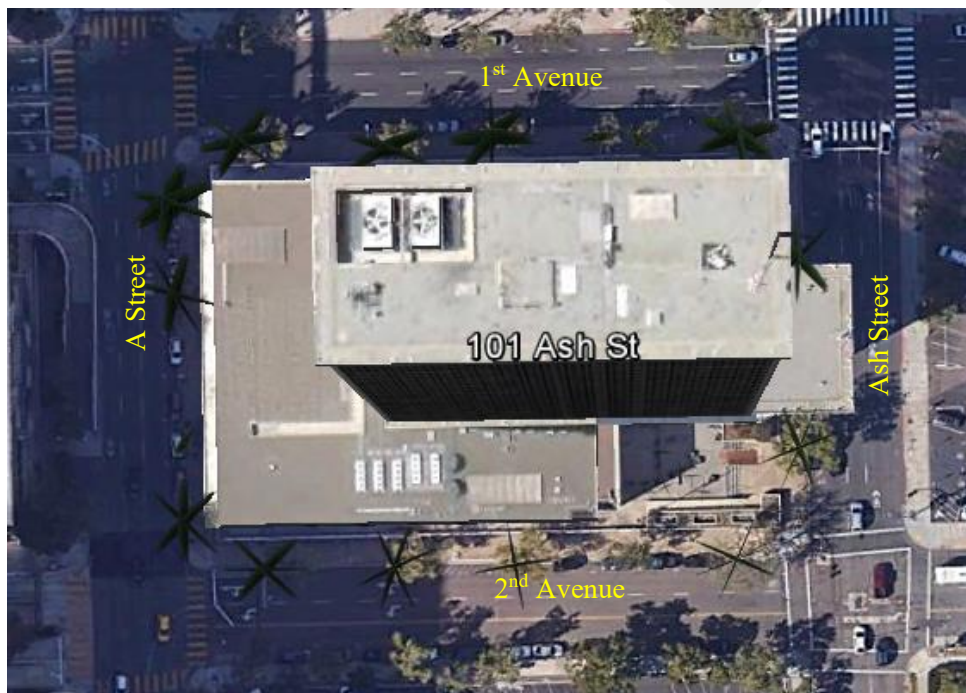
Figure 2. Tower building

The steel-framed tower investigated is located at 101 Ash Street, San Diego, CA; see Figure 2. Measured from basement, the tower is a 23-story steel moment frame building constructed in 1966. The building has a plan dimension of 180 x 70 ft, with individual bays measuring 30x35 ft. The building is rectangular in plan. Typical floors measure 13.5 ft in height, whereas, the first floor is 17 ft tall. The overall height of the building from the basement to the roof is approximately 315 ft.

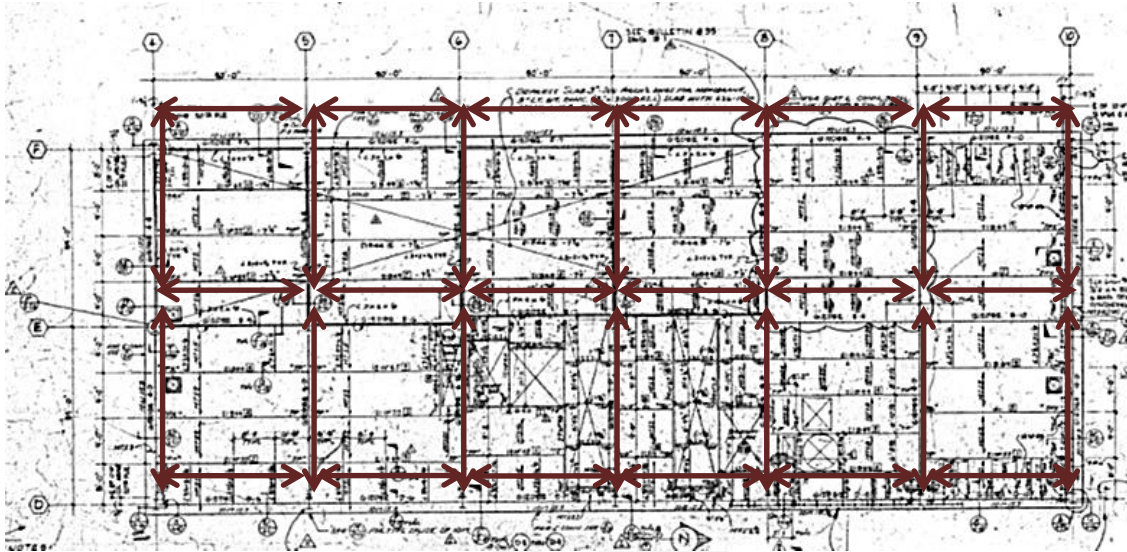
Figure 3. Lateral load resisting system

The lateral load is resisted by a system of steel space moment frames. Figure 3 presents the plan view of a typical floor and the location of the lateral load resisting system. In the longitudinal direction, there are six 30-ft long bays along each grid (18 bays total), and in the transverse direction, there are two 35-ft long bays along each grid (14 bays total). All columns are oriented such that their strong axis aligns in the transverse direction.

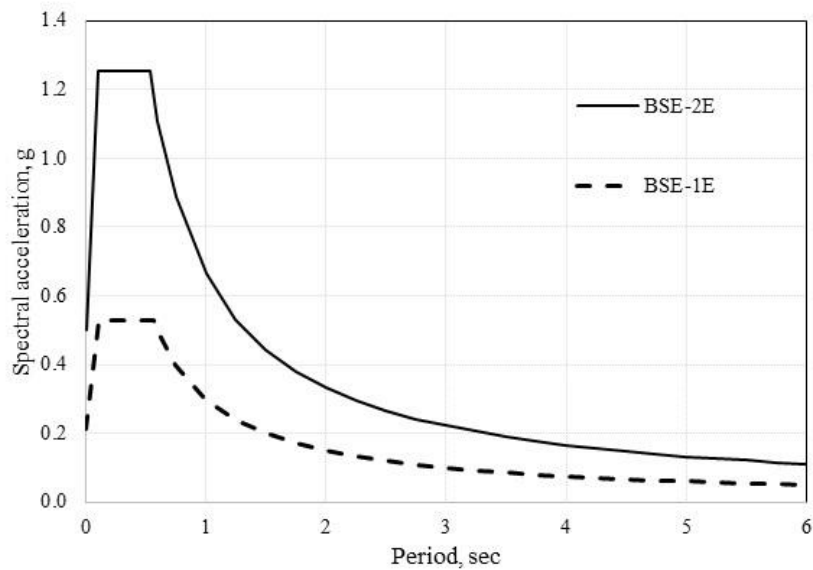
Figure 4. Seismic hazard for the site

The building site is classified as Class D. For the building site and soil conditions, the BSE-1E and BSE-2E seismic hazard can be developed based on the response spectrum plots; see Figure 4. The seismicity at the site is moderately high and falls in the seismic design category (SDC) D.

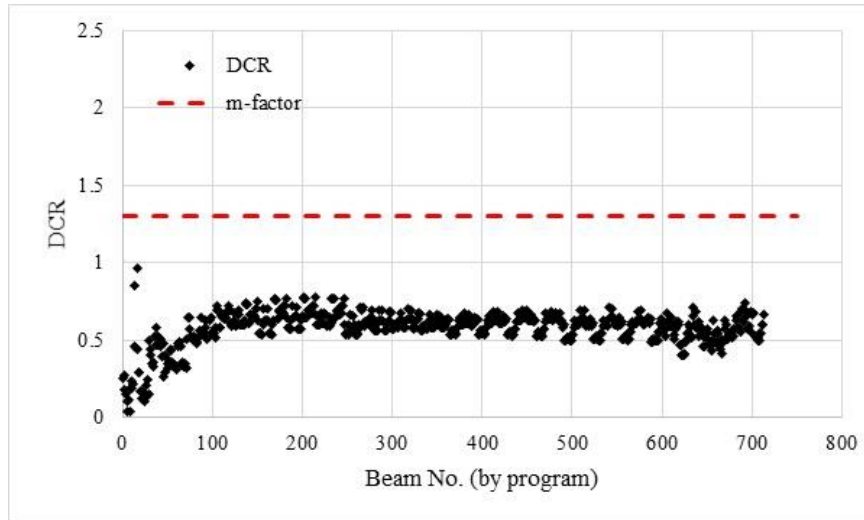
Figure 7. Performance of beams (connections), existing BSE 1E

to absorb the earthquake energy) and thus it is critical to keep DCR values low. The computed DCR for the moment frame connections is less than 1.0 and less than 1.6 for the 225-year and 975-year earthquakes, respectively. In other words, for the expected event, the connections will be undamaged and for rare earthquake they will experience damage, but at an acceptable level

Figure 7 presents the performance of connections at BSE-1E. Note the following:

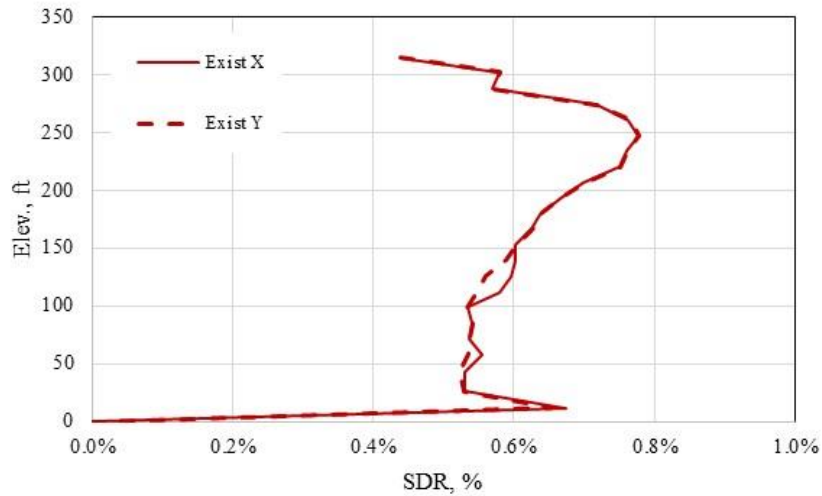
Figure 9. SDR, existing BSE 1E

Figure 9 presents SDR. Note that the maximum drift ratio is less than 0.8% and thus cladding damage is not anticipated.

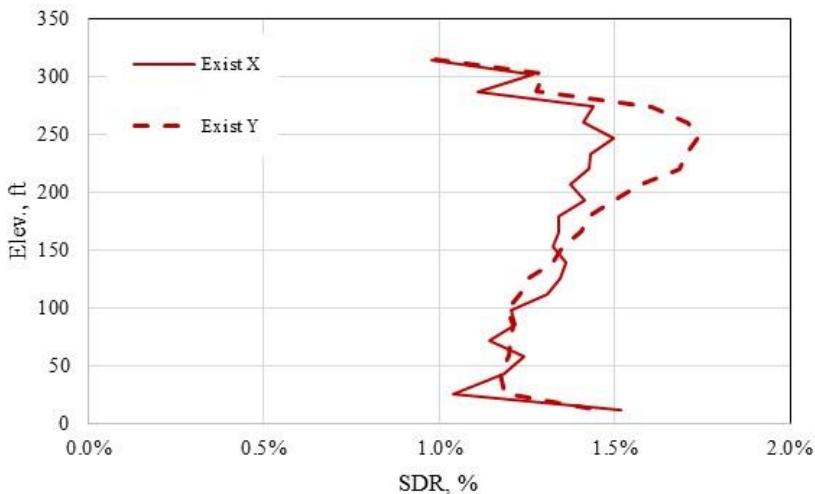
Figure 13. SDR, existing BSE 2E

Figure 13 presents SDR. Note that the drift ratio exceeds 1.2% along the building height for a number of levels and as such cladding damage is expected. Figure 14 presents the peak floor acceleration (PFA) along the building height. Note that the high PFA at the upper levels could result in damage to the cladding

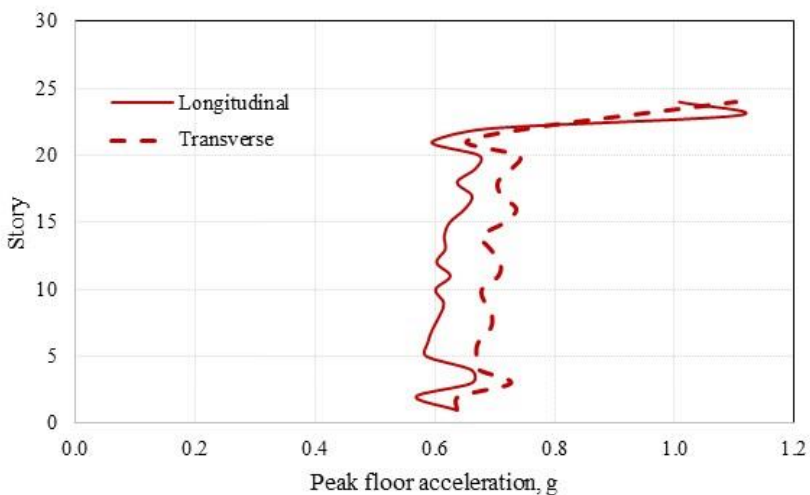
Figure 14. Peak floor accelerations, existing BSE 2E

anchorage and other acceleration-sensitive nonstructural components such as the items located at the mechanical level.

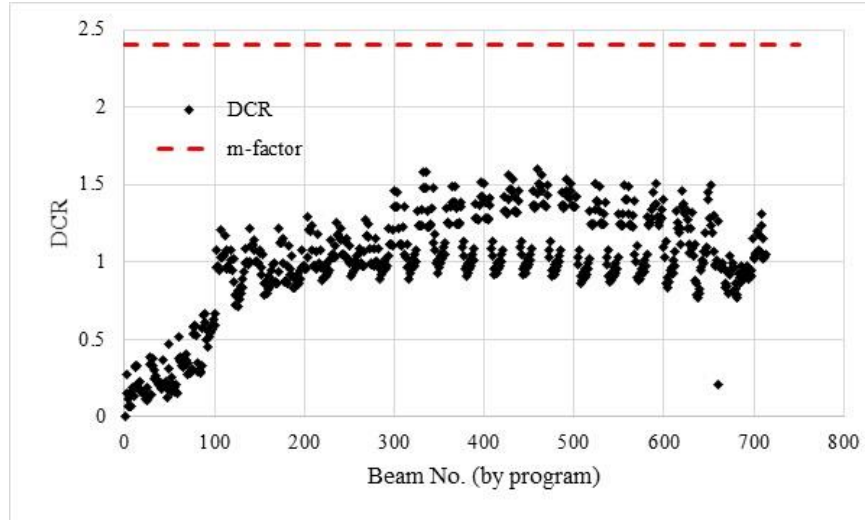
Figure 20. Performance of beams (connections), retrofitted BSE 2E

Figure 20 presents the performance of connections at BSE-2E. Note the following:

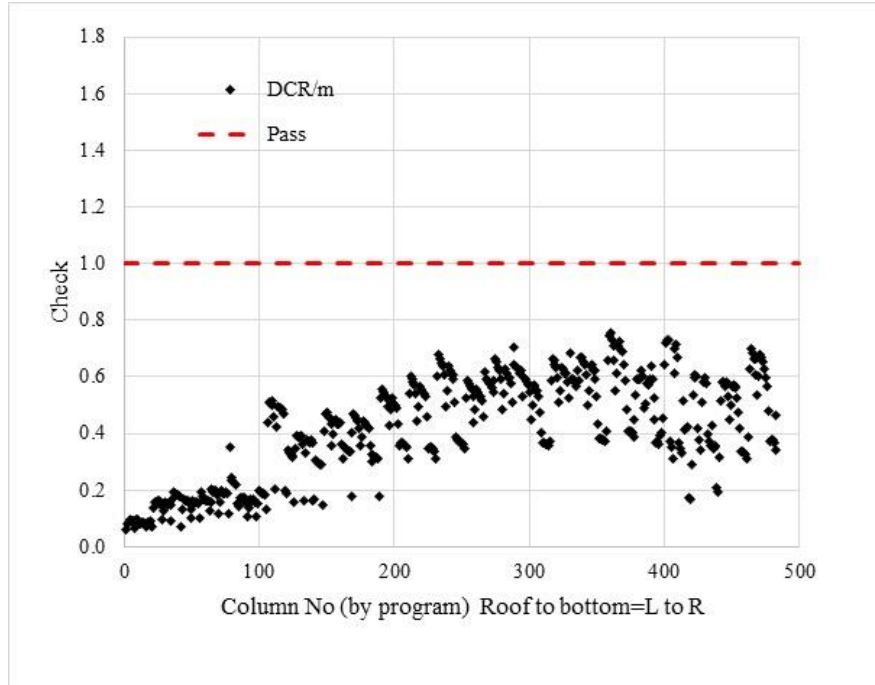
Figure 22. Performance of columns, retrofitted BSE 2E

Figure 22 presents the performance of columns at BSE-2E. Note the following:

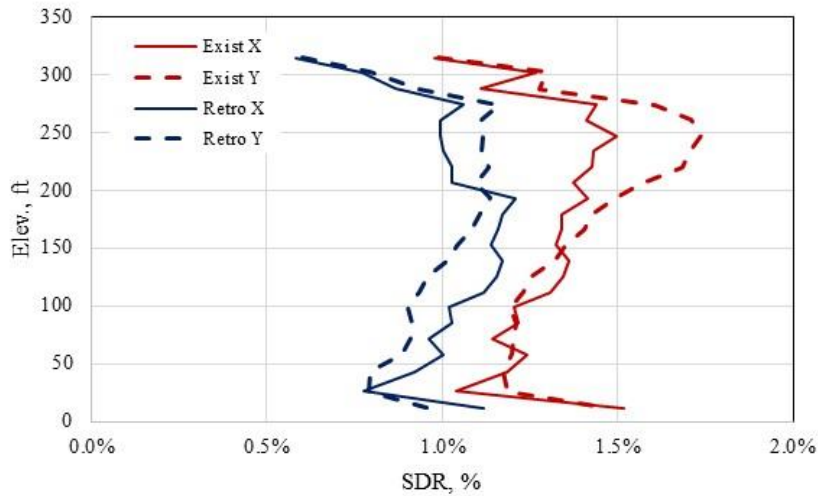
Figure 24. SDR, retrofitted BSE 2E

Figure 24 presents SDR for existing and retrofitted buildings. Note that the drift ratios are reduced by an average of approximately 30% and for the retrofitted building, the maximum SDR is 1.2%. In other words, cladding damage has been mitigated. Figure 25 presents PFA along the building height for existing and retrofitting structures. Note that the PFA is reduced by close to 50%. The reduced PFA will mitigate damage to cladding anchorage and other nonstructural components.
