## INDIVIDUAL WATER QUALITY ASSESSMENT REPORT

Site Name/Facility:	Nestor Creek Channel
Master Program Map No.:	Map Number 131, 132, 133, 134
Date:	October 9, 2015; Revised January 11, 2017; Revised April 21, 2017; Revised May 2, 2017
<b>Civil Engineer</b> (name, company, phone number):	Rick Engineering Company 5620 Friars Road San Diego, California 92110 (619) 688-1448
<b>Register Civil Engineer Number &amp;</b> <b>Expiration Date</b> (place stamp here):	RCE # 70649 Exp. 06/2017
<b>Instructions</b> . This form must be completed for each	facility prior to the completion of the Individual

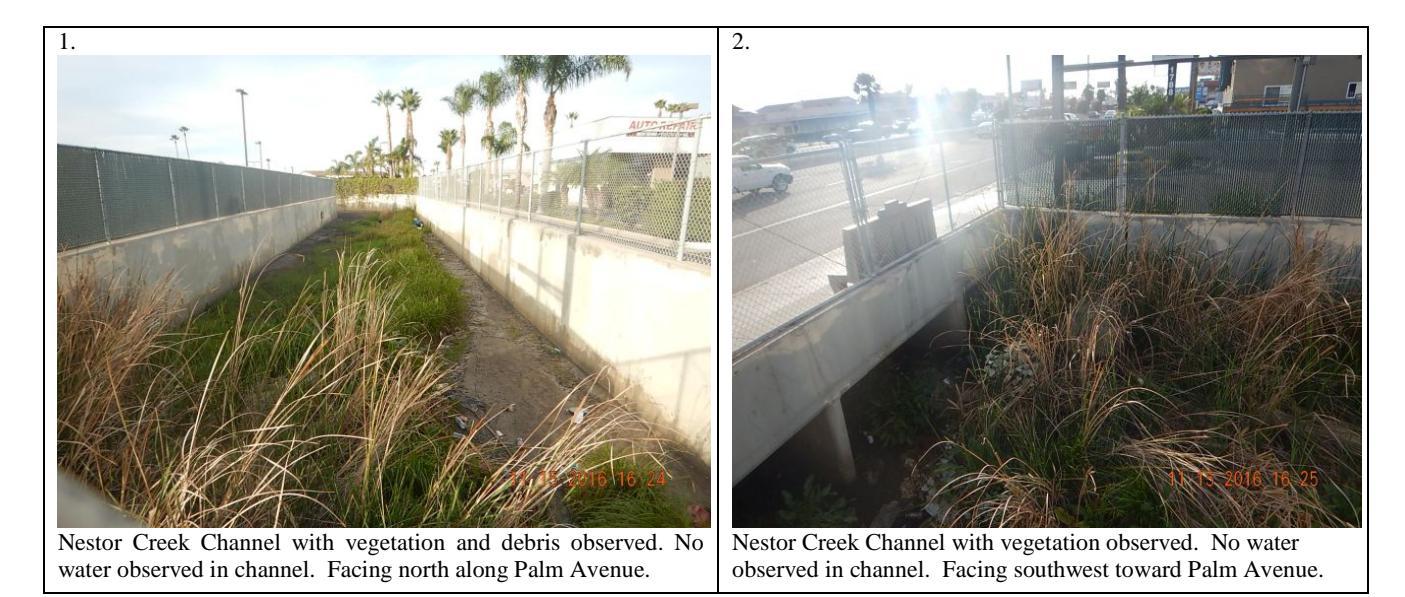
Nestor Creek Channel with vegetation and no dry weather flow observed. Facing northeast from parking lot near Pam Avenue.
