**REPORT OF PRELIMINARY GEOTECHNICAL INVESTIGATION
AND COASTAL BLUFF EDGE EVALUATION**

Princess Street Coastal Trail
7957 Princess Street
La Jolla, California

JOB NO. 22-13797
28 September 2023

Environmental Center of San Diego

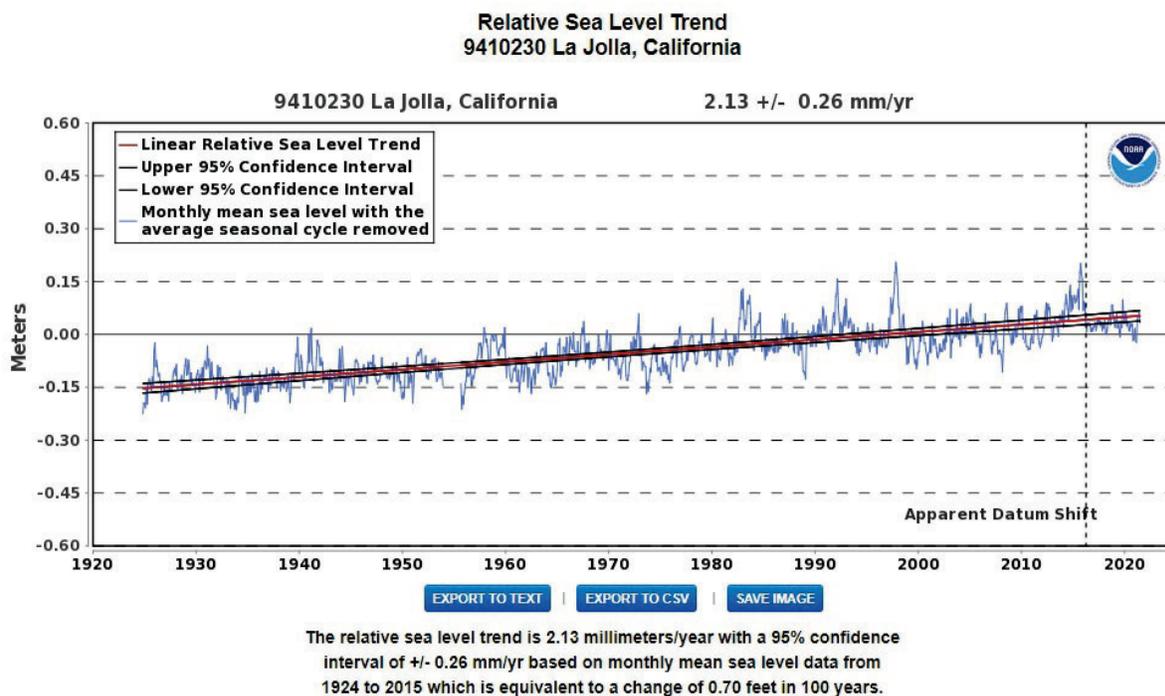
Figure 5. Latest measure SLR at La Jolla from NOAA.

NOAA has been measuring SLR globally, and specifically in La Jolla, which is the closest NOAA tide station to Beach Road. The NOAA La Jolla SLR rate is 2.13 mm/yr as shown in Figure 5. The rate can be used to calculate a sea level rise of 46.9mm (0.15ft) over the last 22 years (2000 through December 2021). If the La Jolla rates do not change significantly in the next 8 years (which is likely), the amount of La Jolla SLR to the year 2030 will be about 0.21 feet.

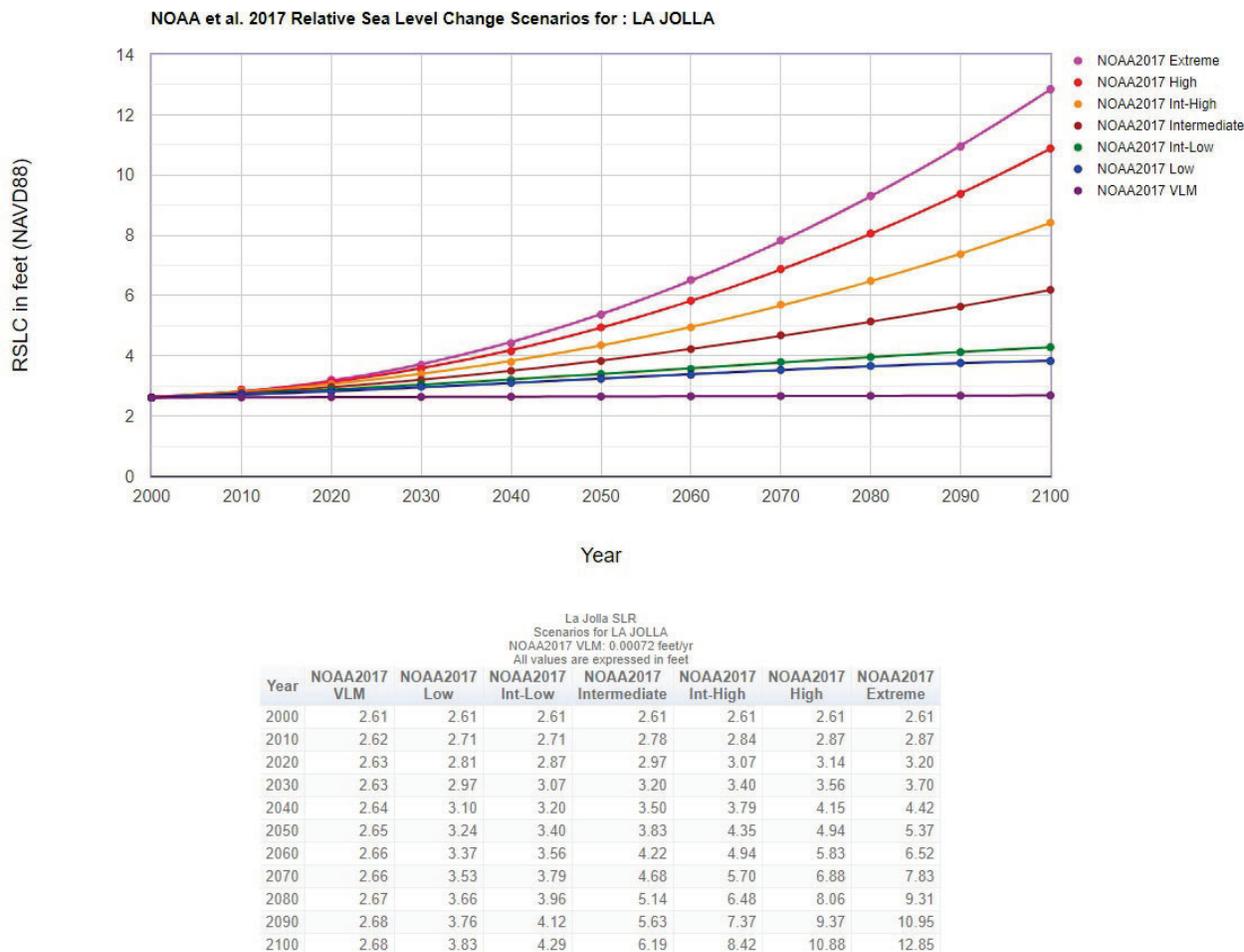
Figure 6. NOAA 2021 SLR projections for La Jolla.

NOAA also provides plots of the most current SLR model projections (best available science) over time starting in the year 2000. Figure 6, is the model projections taken from NOAA, which is more current SLR science and better SLR science than the 2018 COPC Guidance. To determine which model is accurately predicting SLR, the data for La Jolla can be either plotted onto the curves or estimated from the table below the curves. The model that is most accurate now should be considered the “best available science” SLR model for the project, at this time.

Recognizing that in the year 2000 the SLR zero line is 2.61 feet, and using the current La Jolla SLR data (trends), La Jolla SLR should be (2.61 + 0.21 feet) 2.82 feet in the year 2030. Looking at the table in Figure 6 for the year 2030 (~8.5 years from now) reveals that La Jolla SLR is tracking below the NOAA 2017 Low SLR model curve. The Low model predicts a SLR rise total in the year 2100 of about 1.22 feet.

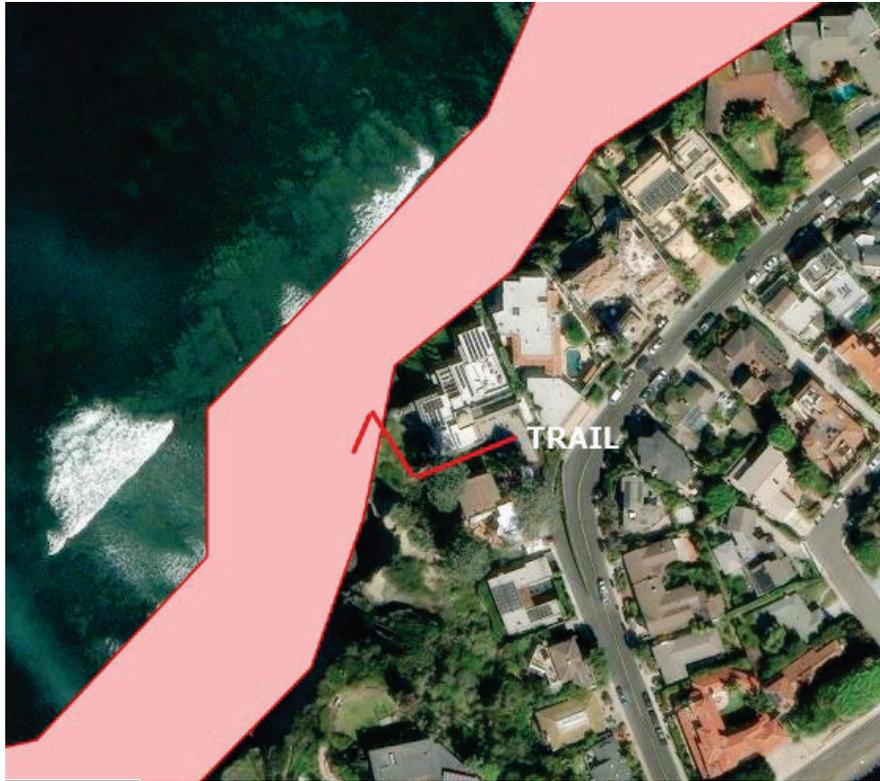
Figure 6. CalOES site tsunami map on Google Earth overlay.

The site is adjacent to the Pacific Ocean, which would allow for both near field (Channel Island faults) and far field (Alaska and Japan faults) generated tsunami to approach the site. The State of California (2009) shows that the lower portion of the coastal trail is within the limit of a tsunami inundation zone. However, the limit of the tsunami zone does not reach the location of the proposed cabana as shown in Figure 6. It should be advised that the site is mapped within the limits of the California Office of Emergency Services tsunami inundation map, La Jolla Quadrangle (State of California 2009). The tsunami inundation maps are very specific as to their use. Their use is for evacuation planning only. The limitation on the use of these maps is clearly stated in the **PURPOSE OF THIS MAP** on every quadrangle of California coastline. In addition, the following two paragraphs were taken from the CalOES Local Planning Guidance on Tsunami Response concerning the use of the tsunami inundation maps.
