REPORT OF GEOLOGIC FAULT INVESTIGATION

Proposed Lee/DeGuzman Residence
1855 Spindrift Drive
La Jolla, California

JOB NO. 22-13755

07 July 2023

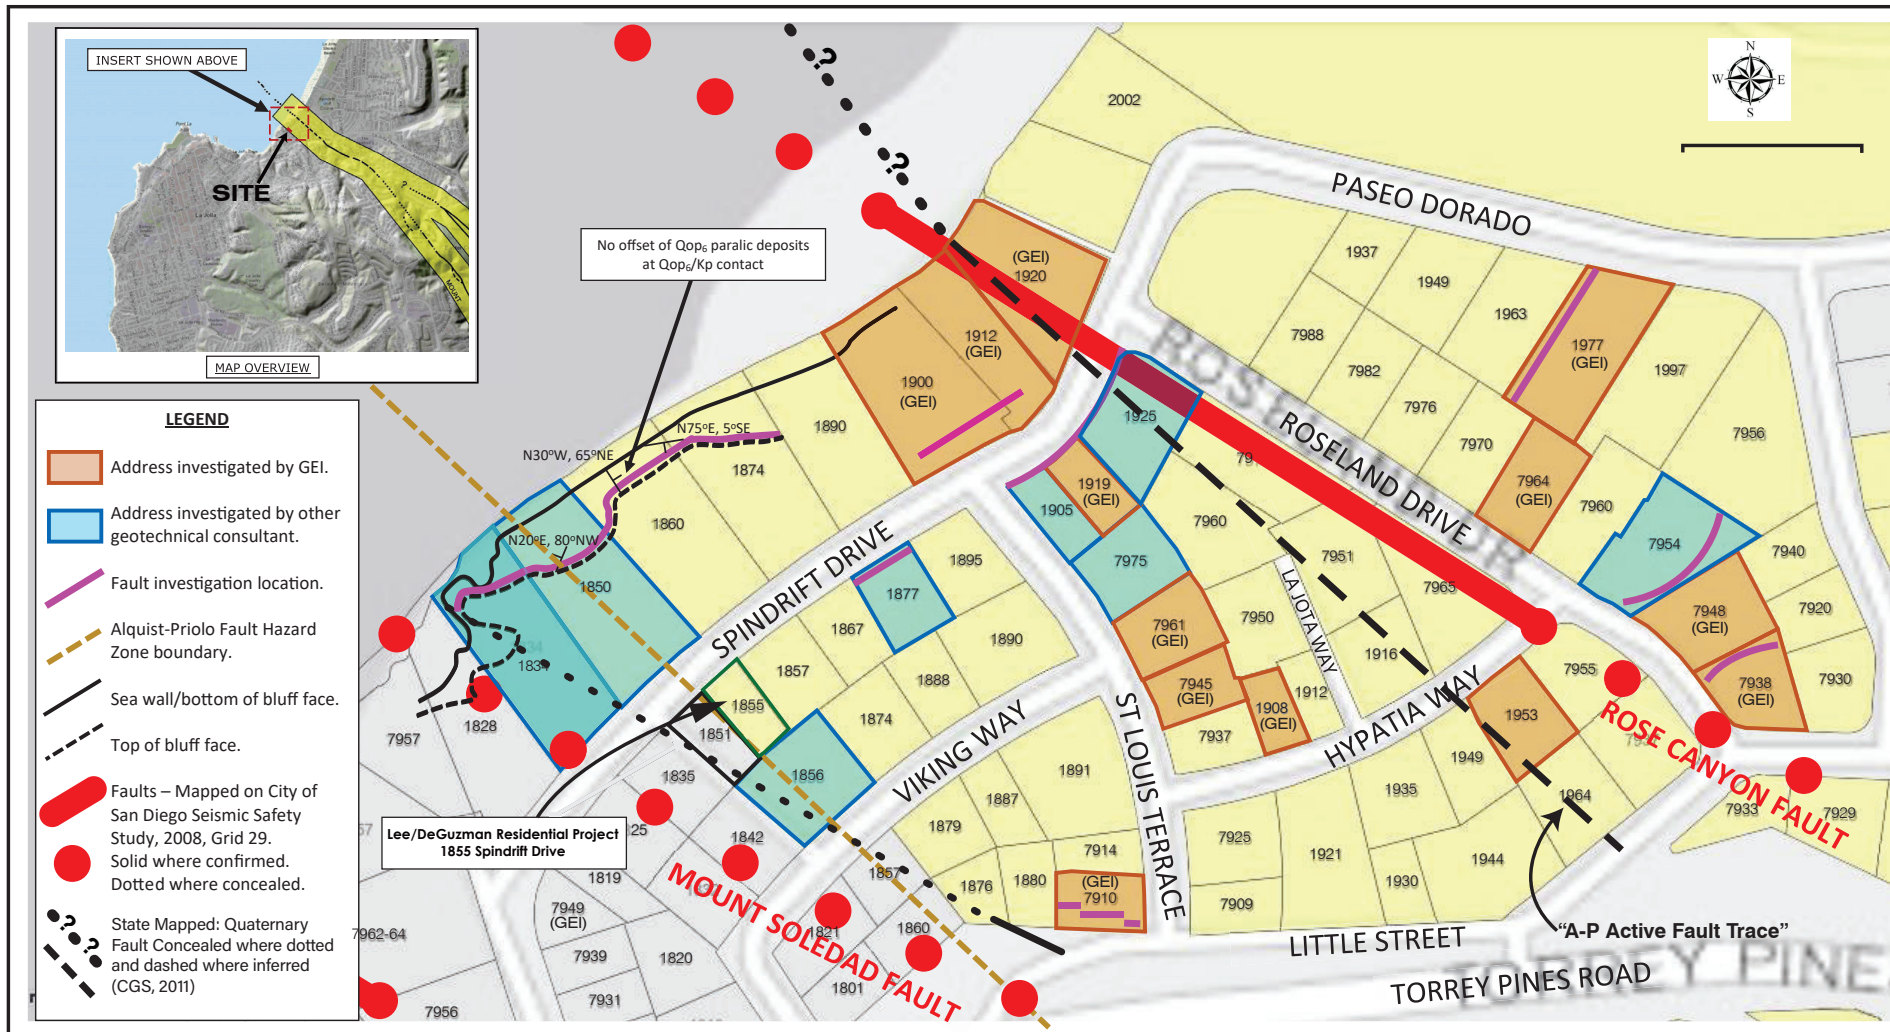
Figure No. IVb
Job No. 22-13755
GEI Geotechnical Exploration, Inc.
June 2023

PRIOR INVESTIGATION LOCATIONS ON EXPANDED ALQUIST-PRIOLO MAP
