November 18, 2019

**Letter Report**

Ms. Darlene Walter  
SeaWorld Parks and Entertainment  
500 SeaWorld Drive  
San Diego, California 92109

Subject: 2019 Sewer Capacity Study Update

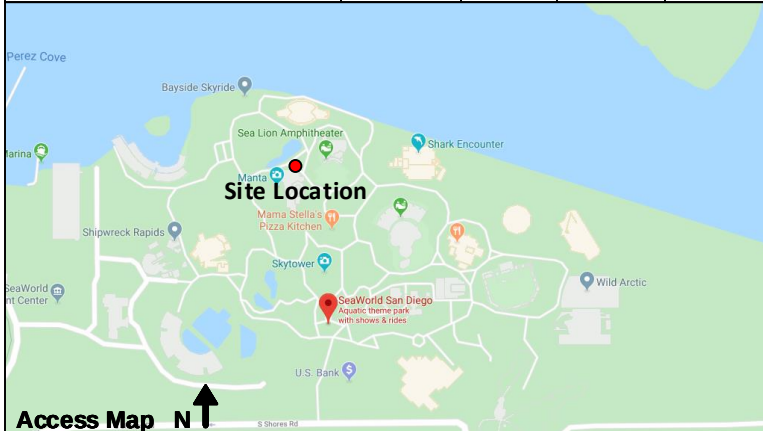
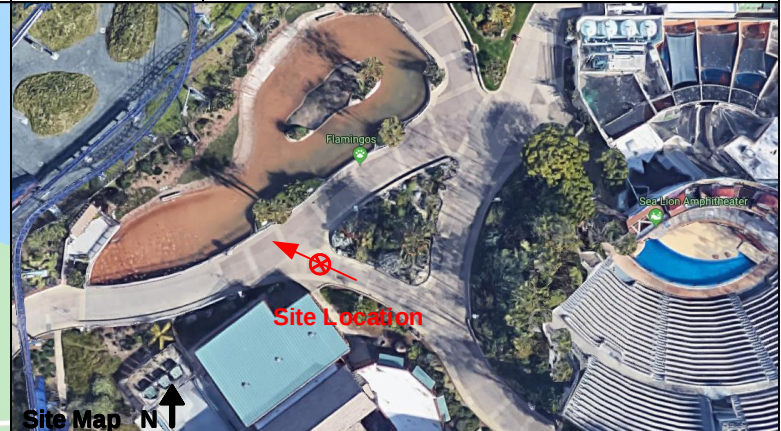
| Investigation Information: | | | | Manhole Information: | | | |
|---|--|---|--|---|---|---|---|
| <b>Site Hydraulics:</b> Low flow with slow moving velocity through manhole | | | | <b>Manhole Material / Condition:</b> Concrete Good | | | |
| <b>Upstream Input: (L/S,P/S)</b> | | N/A | | <b>Pipe Material / Condition:</b> Clay / N/A | | | |

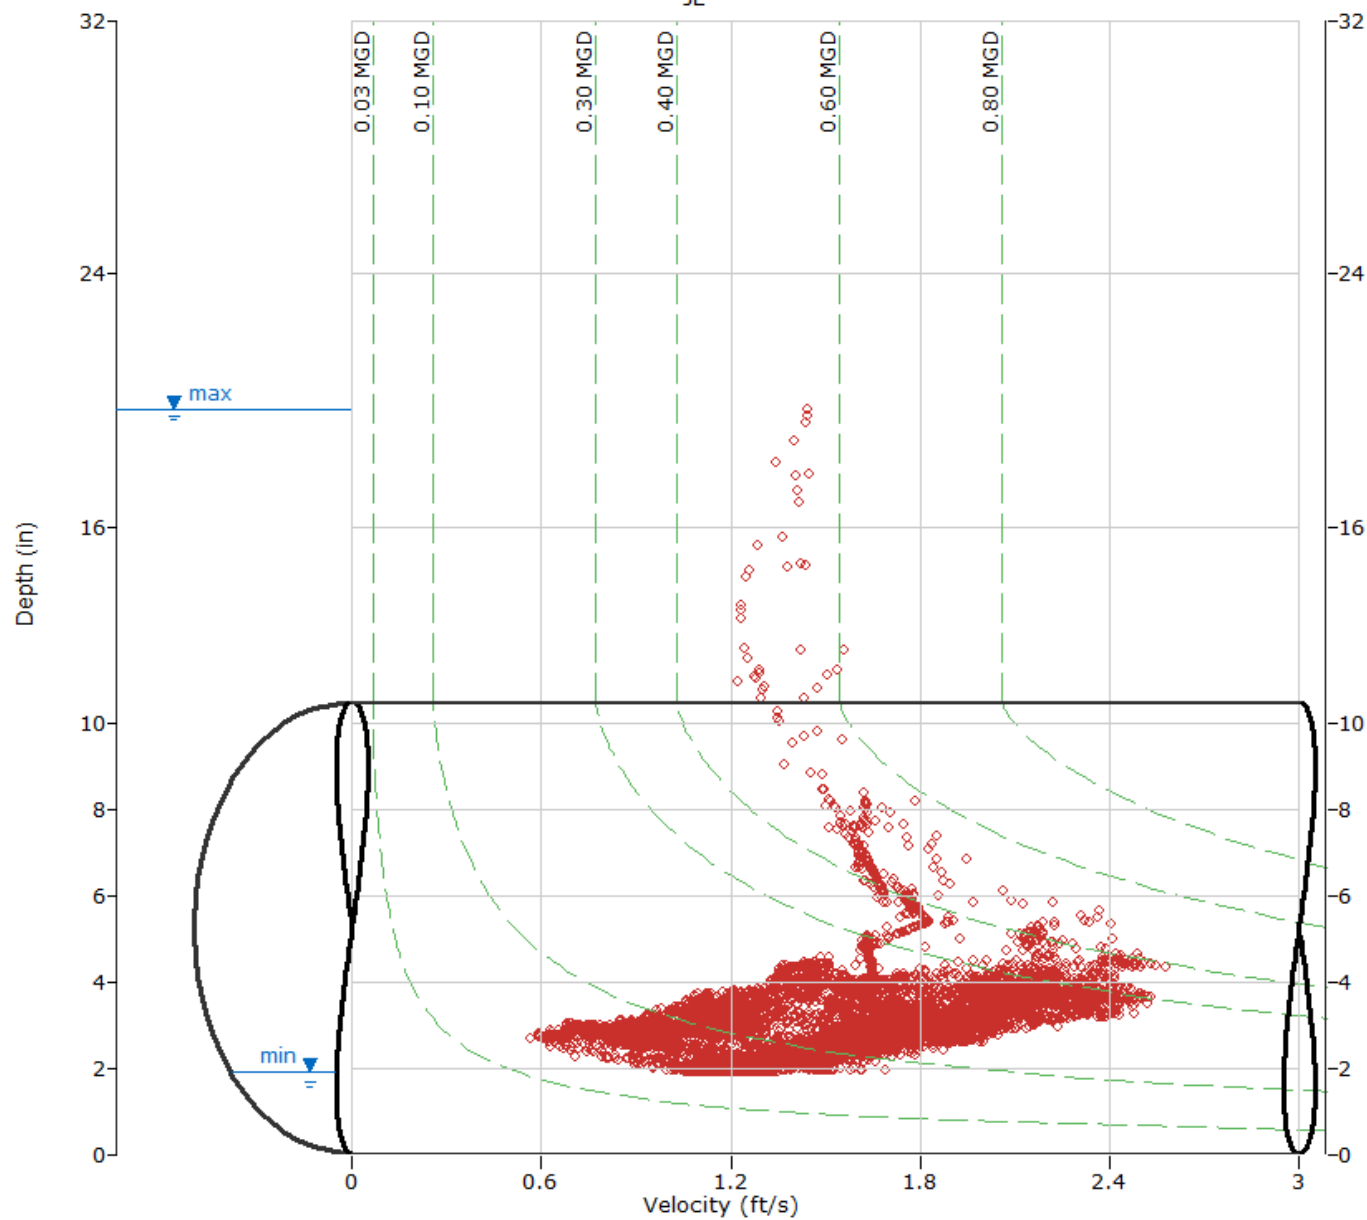
Site JL functioned under normal conditions during the period Wednesday, October 2, 2019 to Tuesday, October 8, 2019. Surge conditions were experienced at this location. Review of the Scattergraph shows that both free flow and backwater conditions were recorded during the study period.

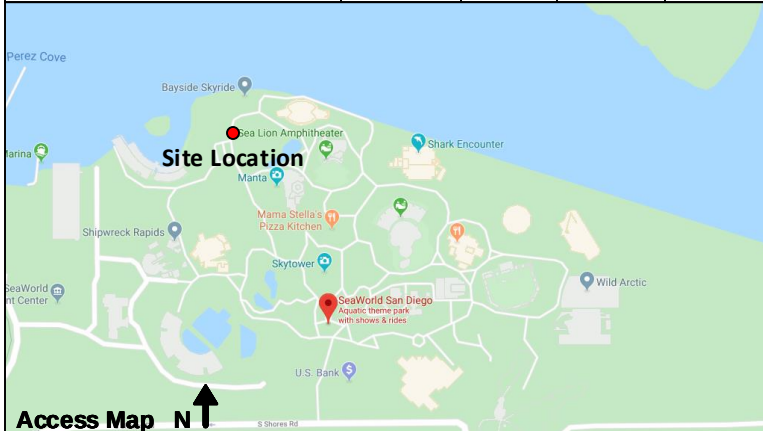
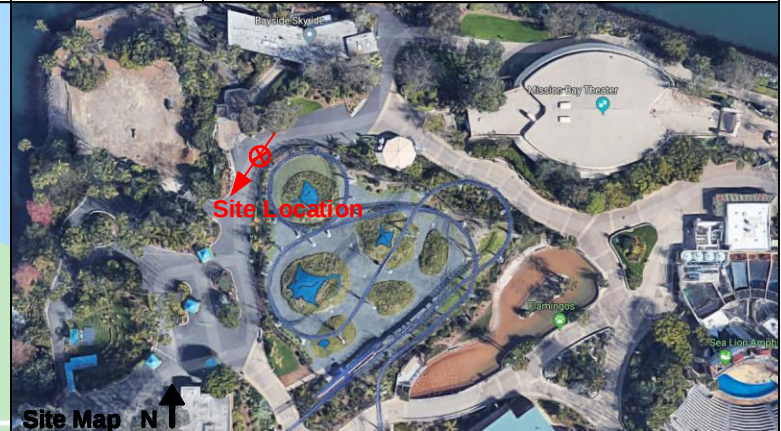
| Investigation Information: | | | | Manhole Information: | | | |
|---|--|---|---|---|--|---|---|
| <b>Site Hydraulics:</b> Low flow with scouring velocity through manhole | | | | <b>Manhole Material / Condition:</b> Concrete Good | | | |
| <b>Upstream Input: (L/S,P/S)</b> | | N/A | | <b>Pipe Material / Condition:</b> Clay / OK | | | |

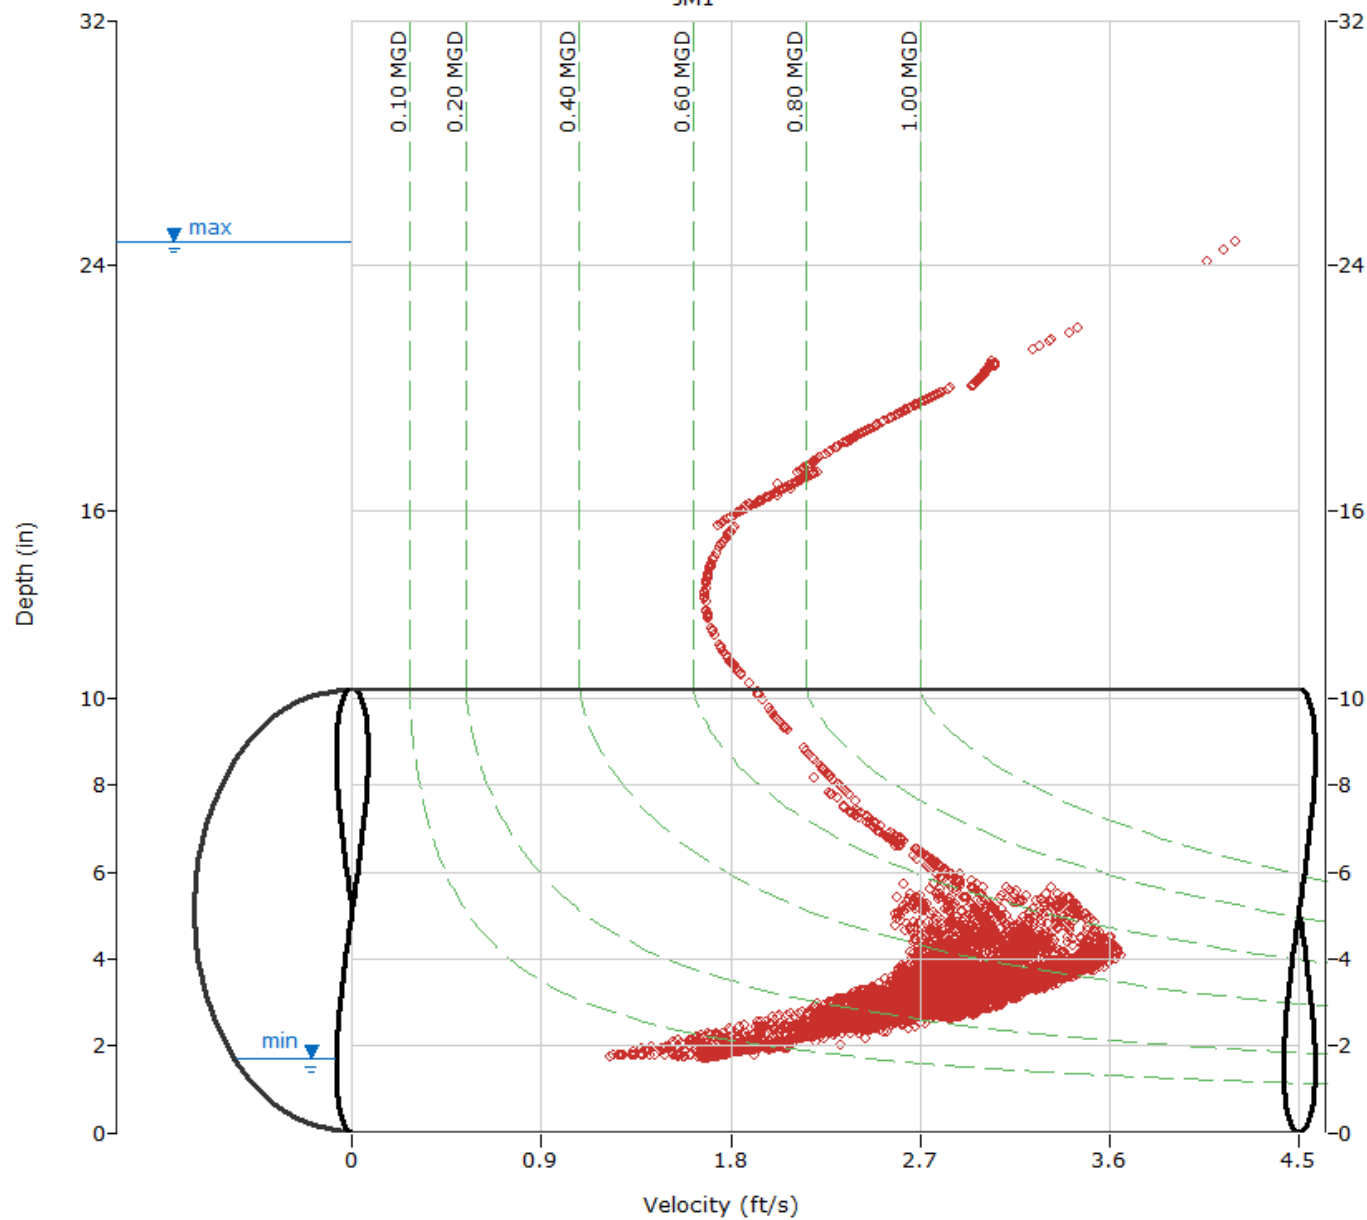
Site JM1 functioned under normal conditions during the period Wednesday, October 2, 2019 to Tuesday, October 8, 2019. Surcharge conditions were experienced at this location. Review of the Scattergraph shows that both free flow and backwater conditions were recorded during the study period.

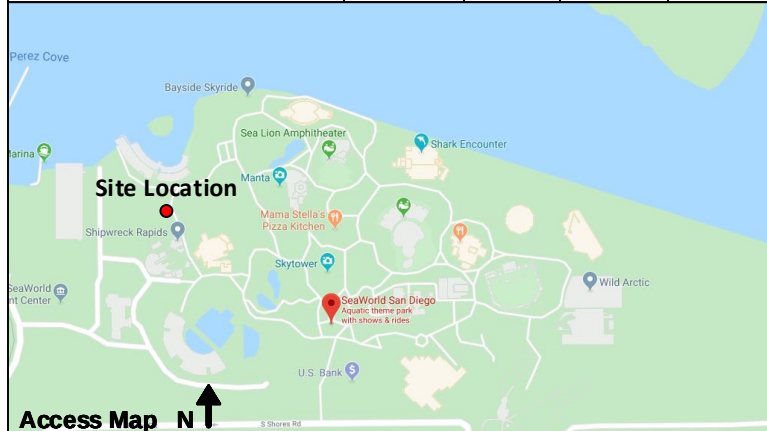
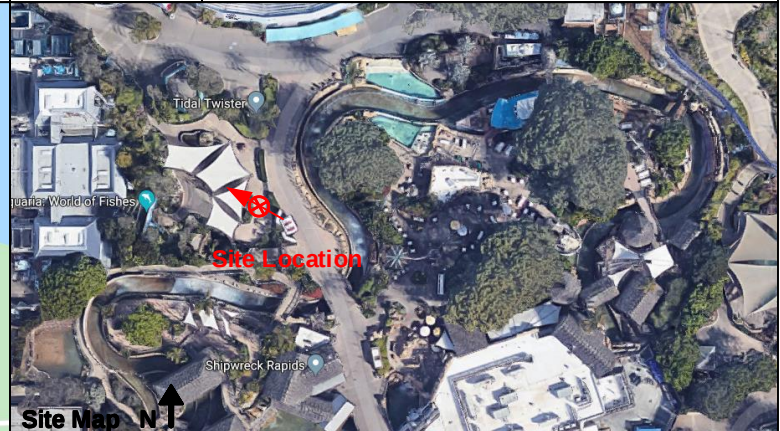
| Investigation Information: | | | | Manhole Information: | | | |
|---|--|---|---|---|--|---|---|
| <b>Site Hydraulics:</b> Low stagnant flow through manhole | | | | <b>Manhole Material / Condition:</b> Concrete Good | | | |
| <b>Upstream Input: (L/S,P/S)</b> | | N/A | | <b>Pipe Material / Condition:</b> Clay / OK | | | |

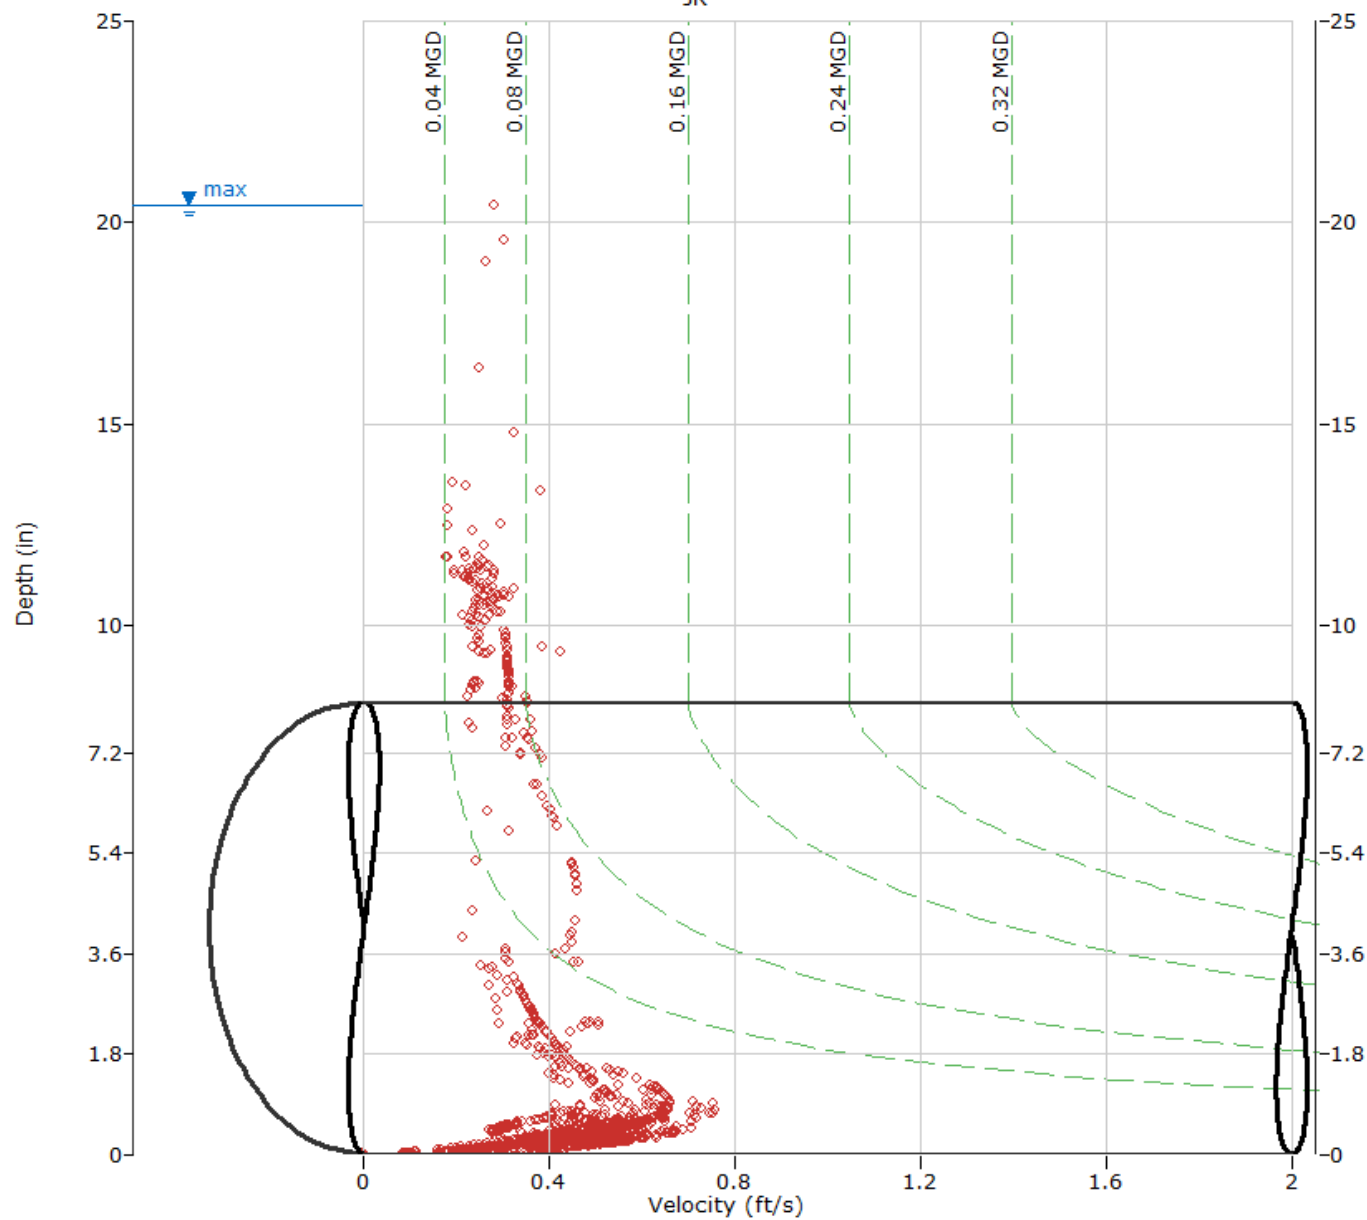
Site JR functioned under normal conditions during the period Wednesday, October 2, 2019 to Tuesday, October 8, 2019. Surge conditions were experienced at this location. Review of the Scattergraph shows that both free flow and backwater conditions were recorded during the study period.

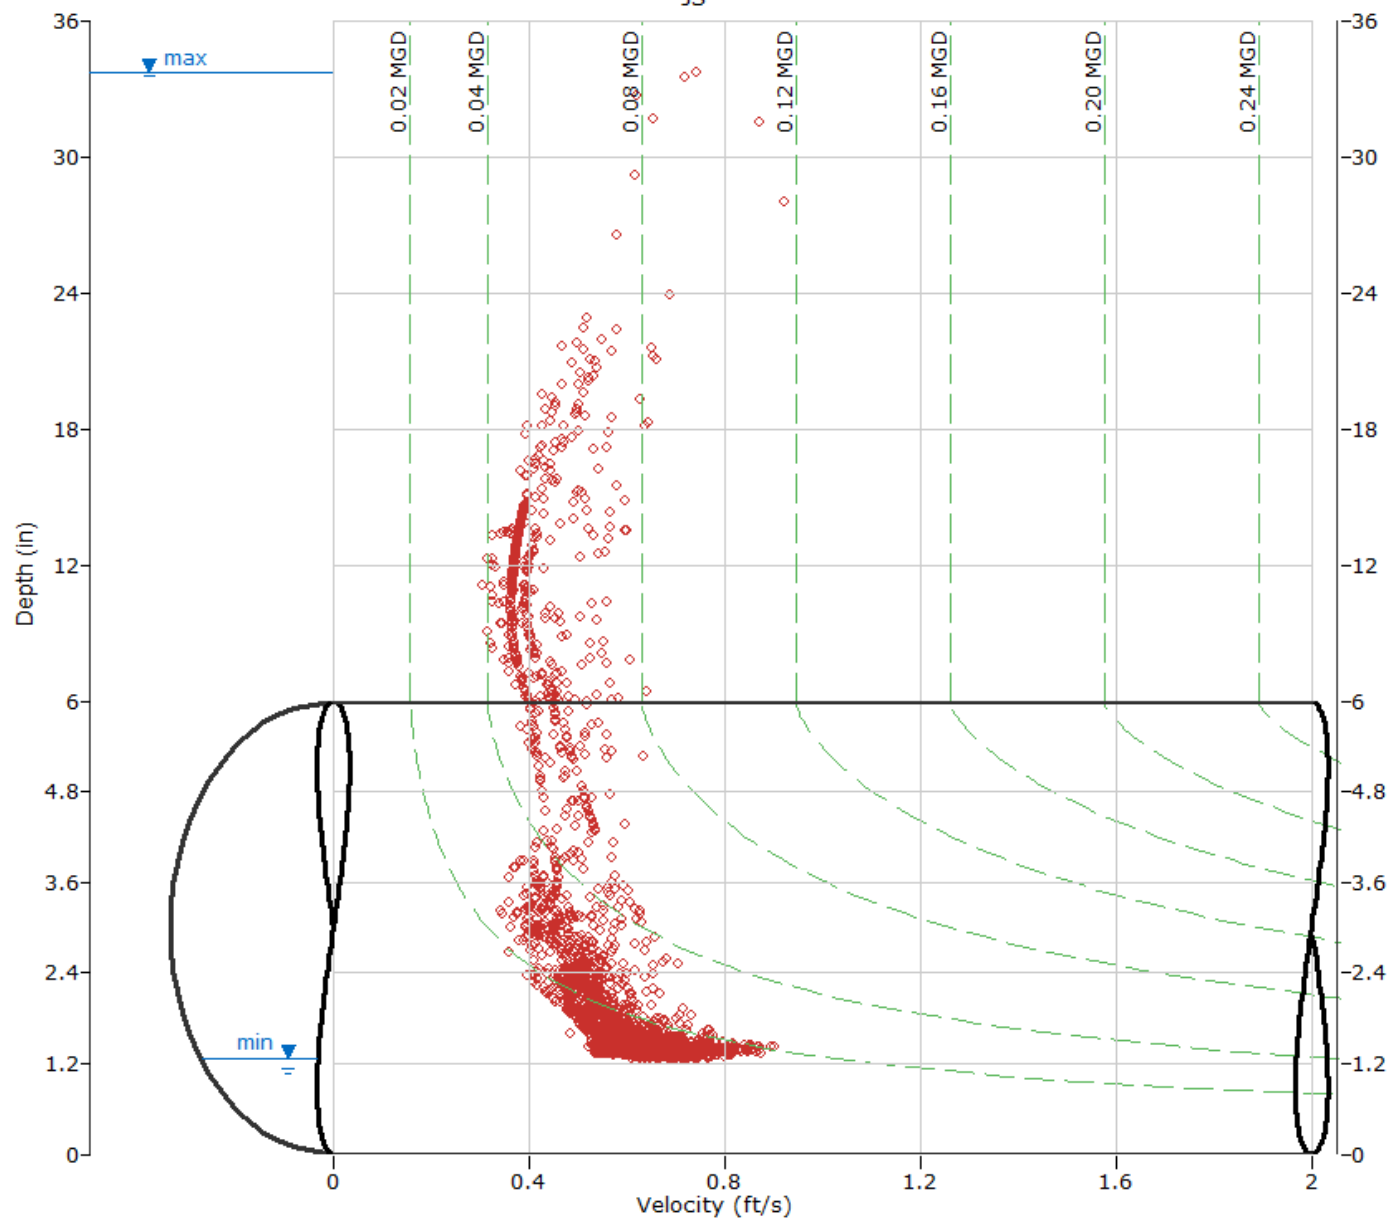
Site JS functioned under normal conditions during the period Wednesday, October 2, 2019 to Tuesday, October 8, 2019. Surge conditions were experienced at this location. Review of the Scattergraph shows that both free flow and backwater conditions were recorded during the study period.
