UPDATED HAZARDOUS MATERIAL TECHNICAL STUDY

Otay Mesa Community Plan Update San Diego, California

Project No. 09721-06-02
October 11, 2012

Subject: OTAY MESA COMMUNITY PLAN UPDATE
SAN DIEGO, CALIFORNIA
UPDATED HAZARDOUS MATERIALS TECHNICAL STUDY

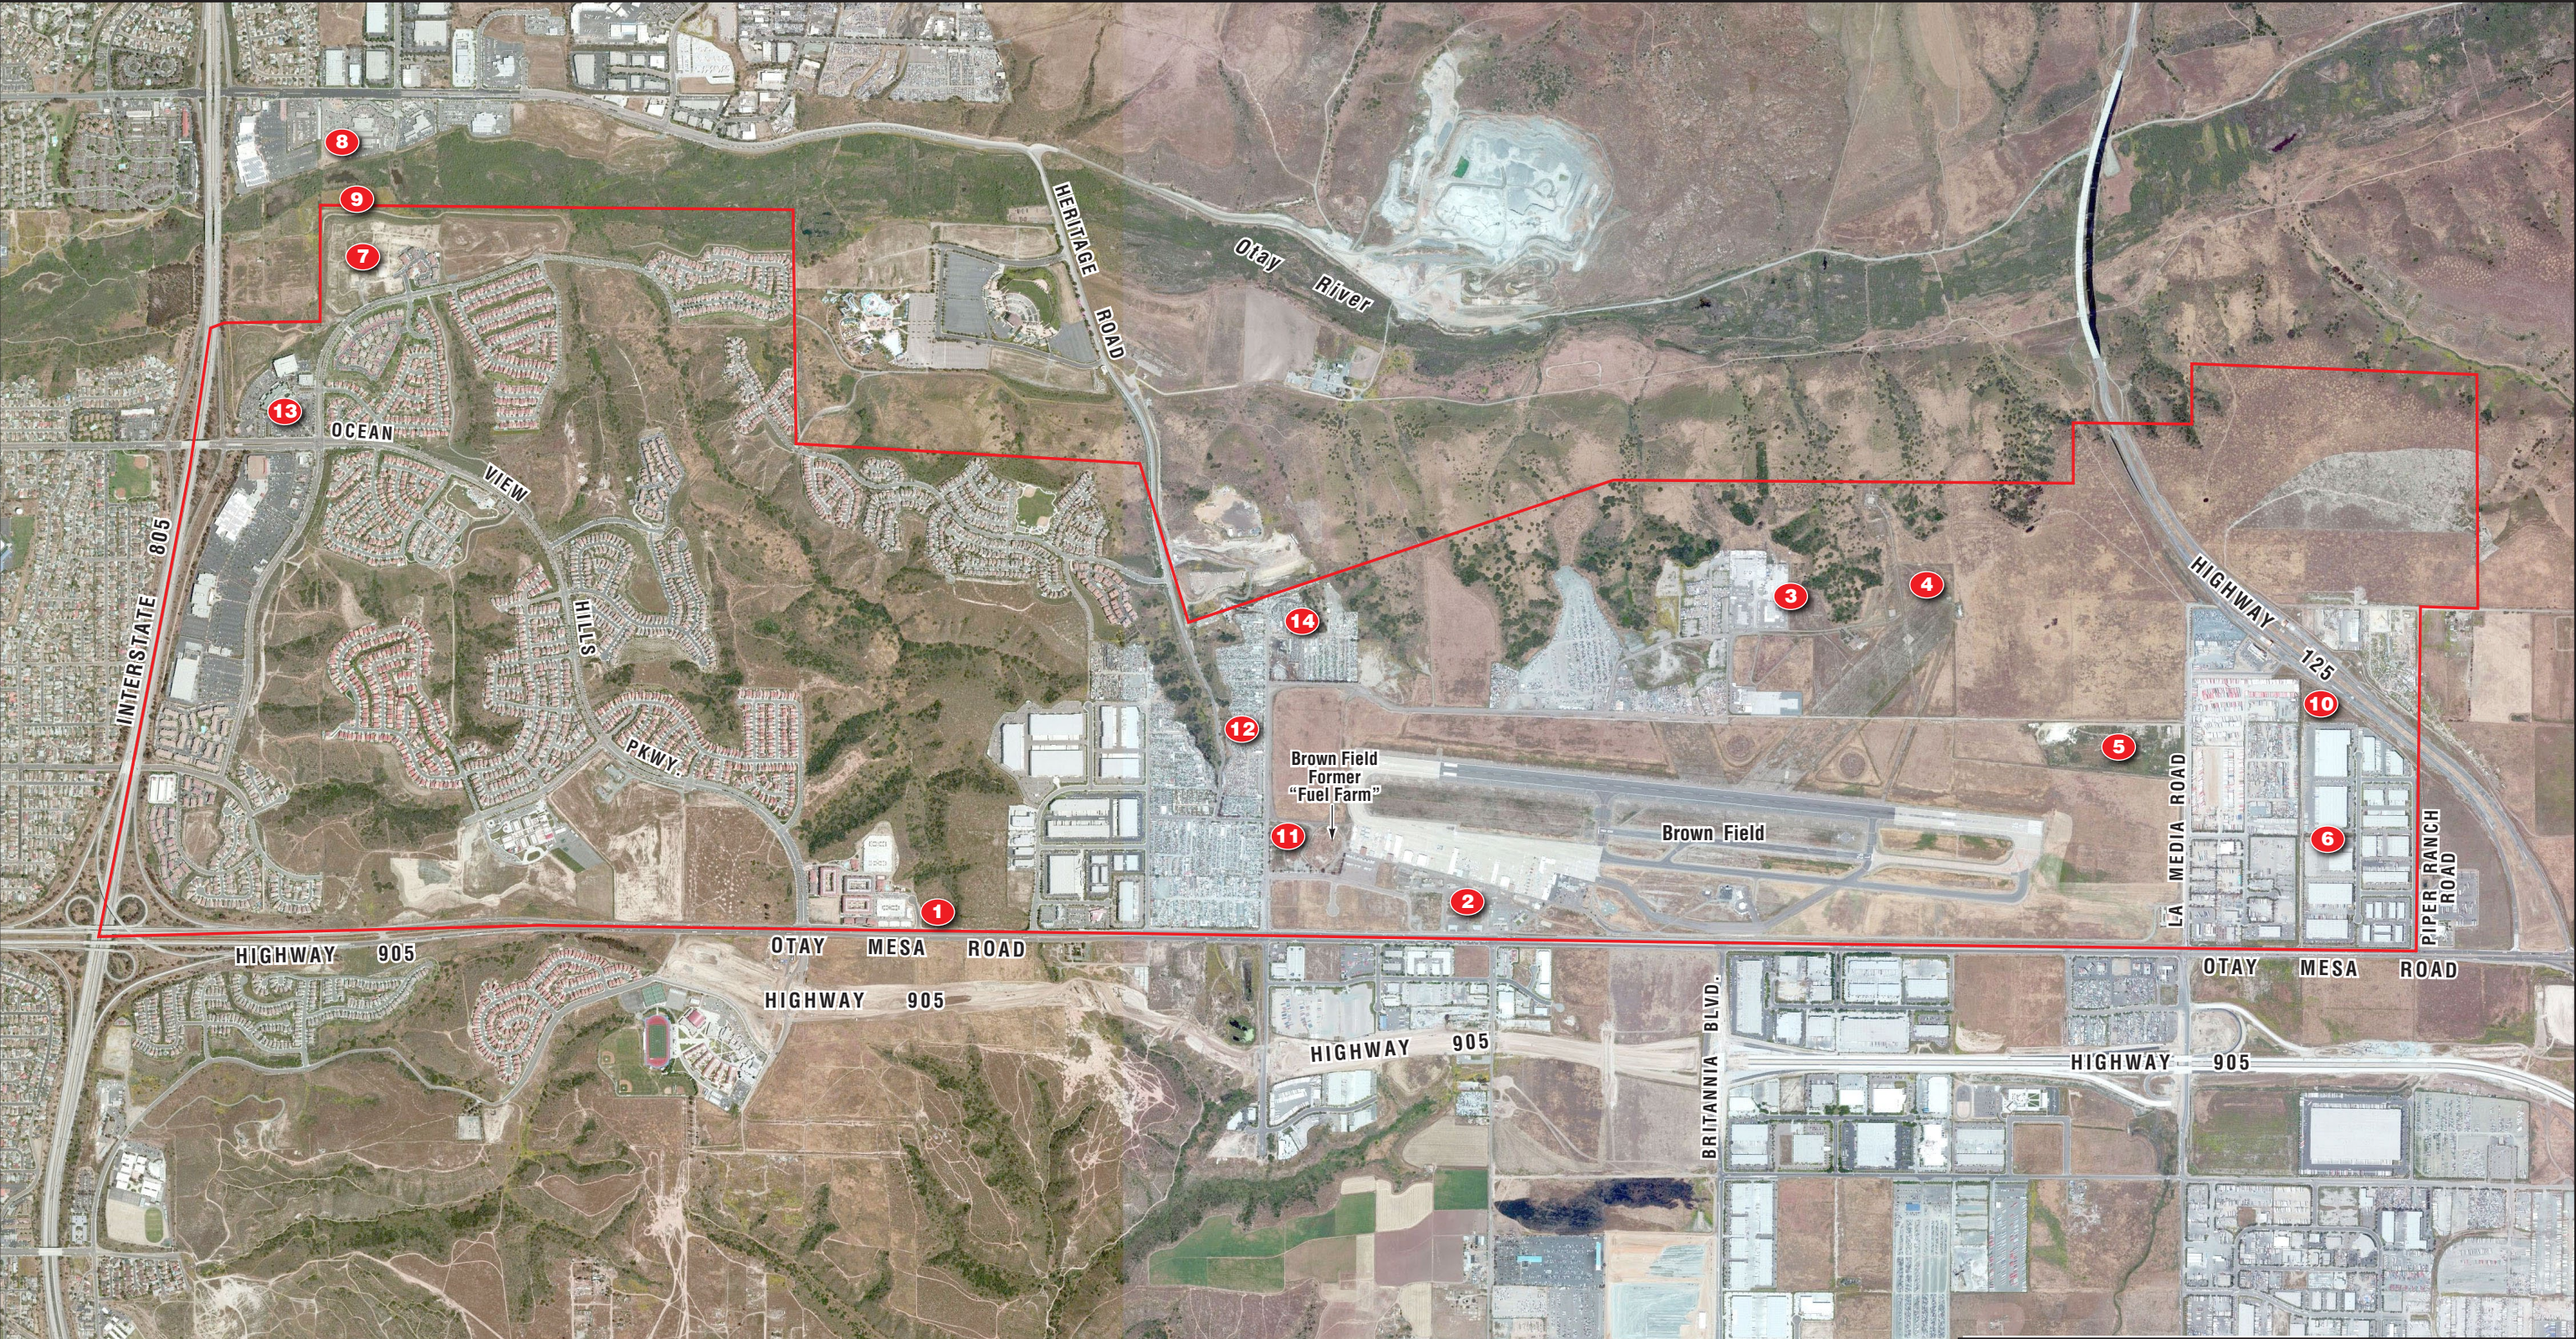
09721-06-02	October 2012	Figure 3-1
-------------	--------------	------------

Fourteen properties/facilities of potential environmental concern were identified in Area 1 or within 1/8-mile of the boundaries of Area 1. The approximate locations of these properties/facilities (Map IDs 1 through 14) are depicted on Figure 3-1, and additional information for each property/facility from the sources listed in Section 3.2 follows below.

The remaining 10 cases were open and/or reportedly involved contamination of groundwater. The 10 cases pertain to UST fuel releases in the western portion of the Brown Field operations area, predominately in the area of the former fuel farm (Figure 3-1). Depth to groundwater in this area of Brown Field is estimated to be 200 feet; however, areas of perched groundwater have been encountered at shallower depths. A detailed summary of the nature and status of each of these cases was included in our 2007 HMTS. An updated summary of each case from review of information on GeoTracker is summarized in the following table.

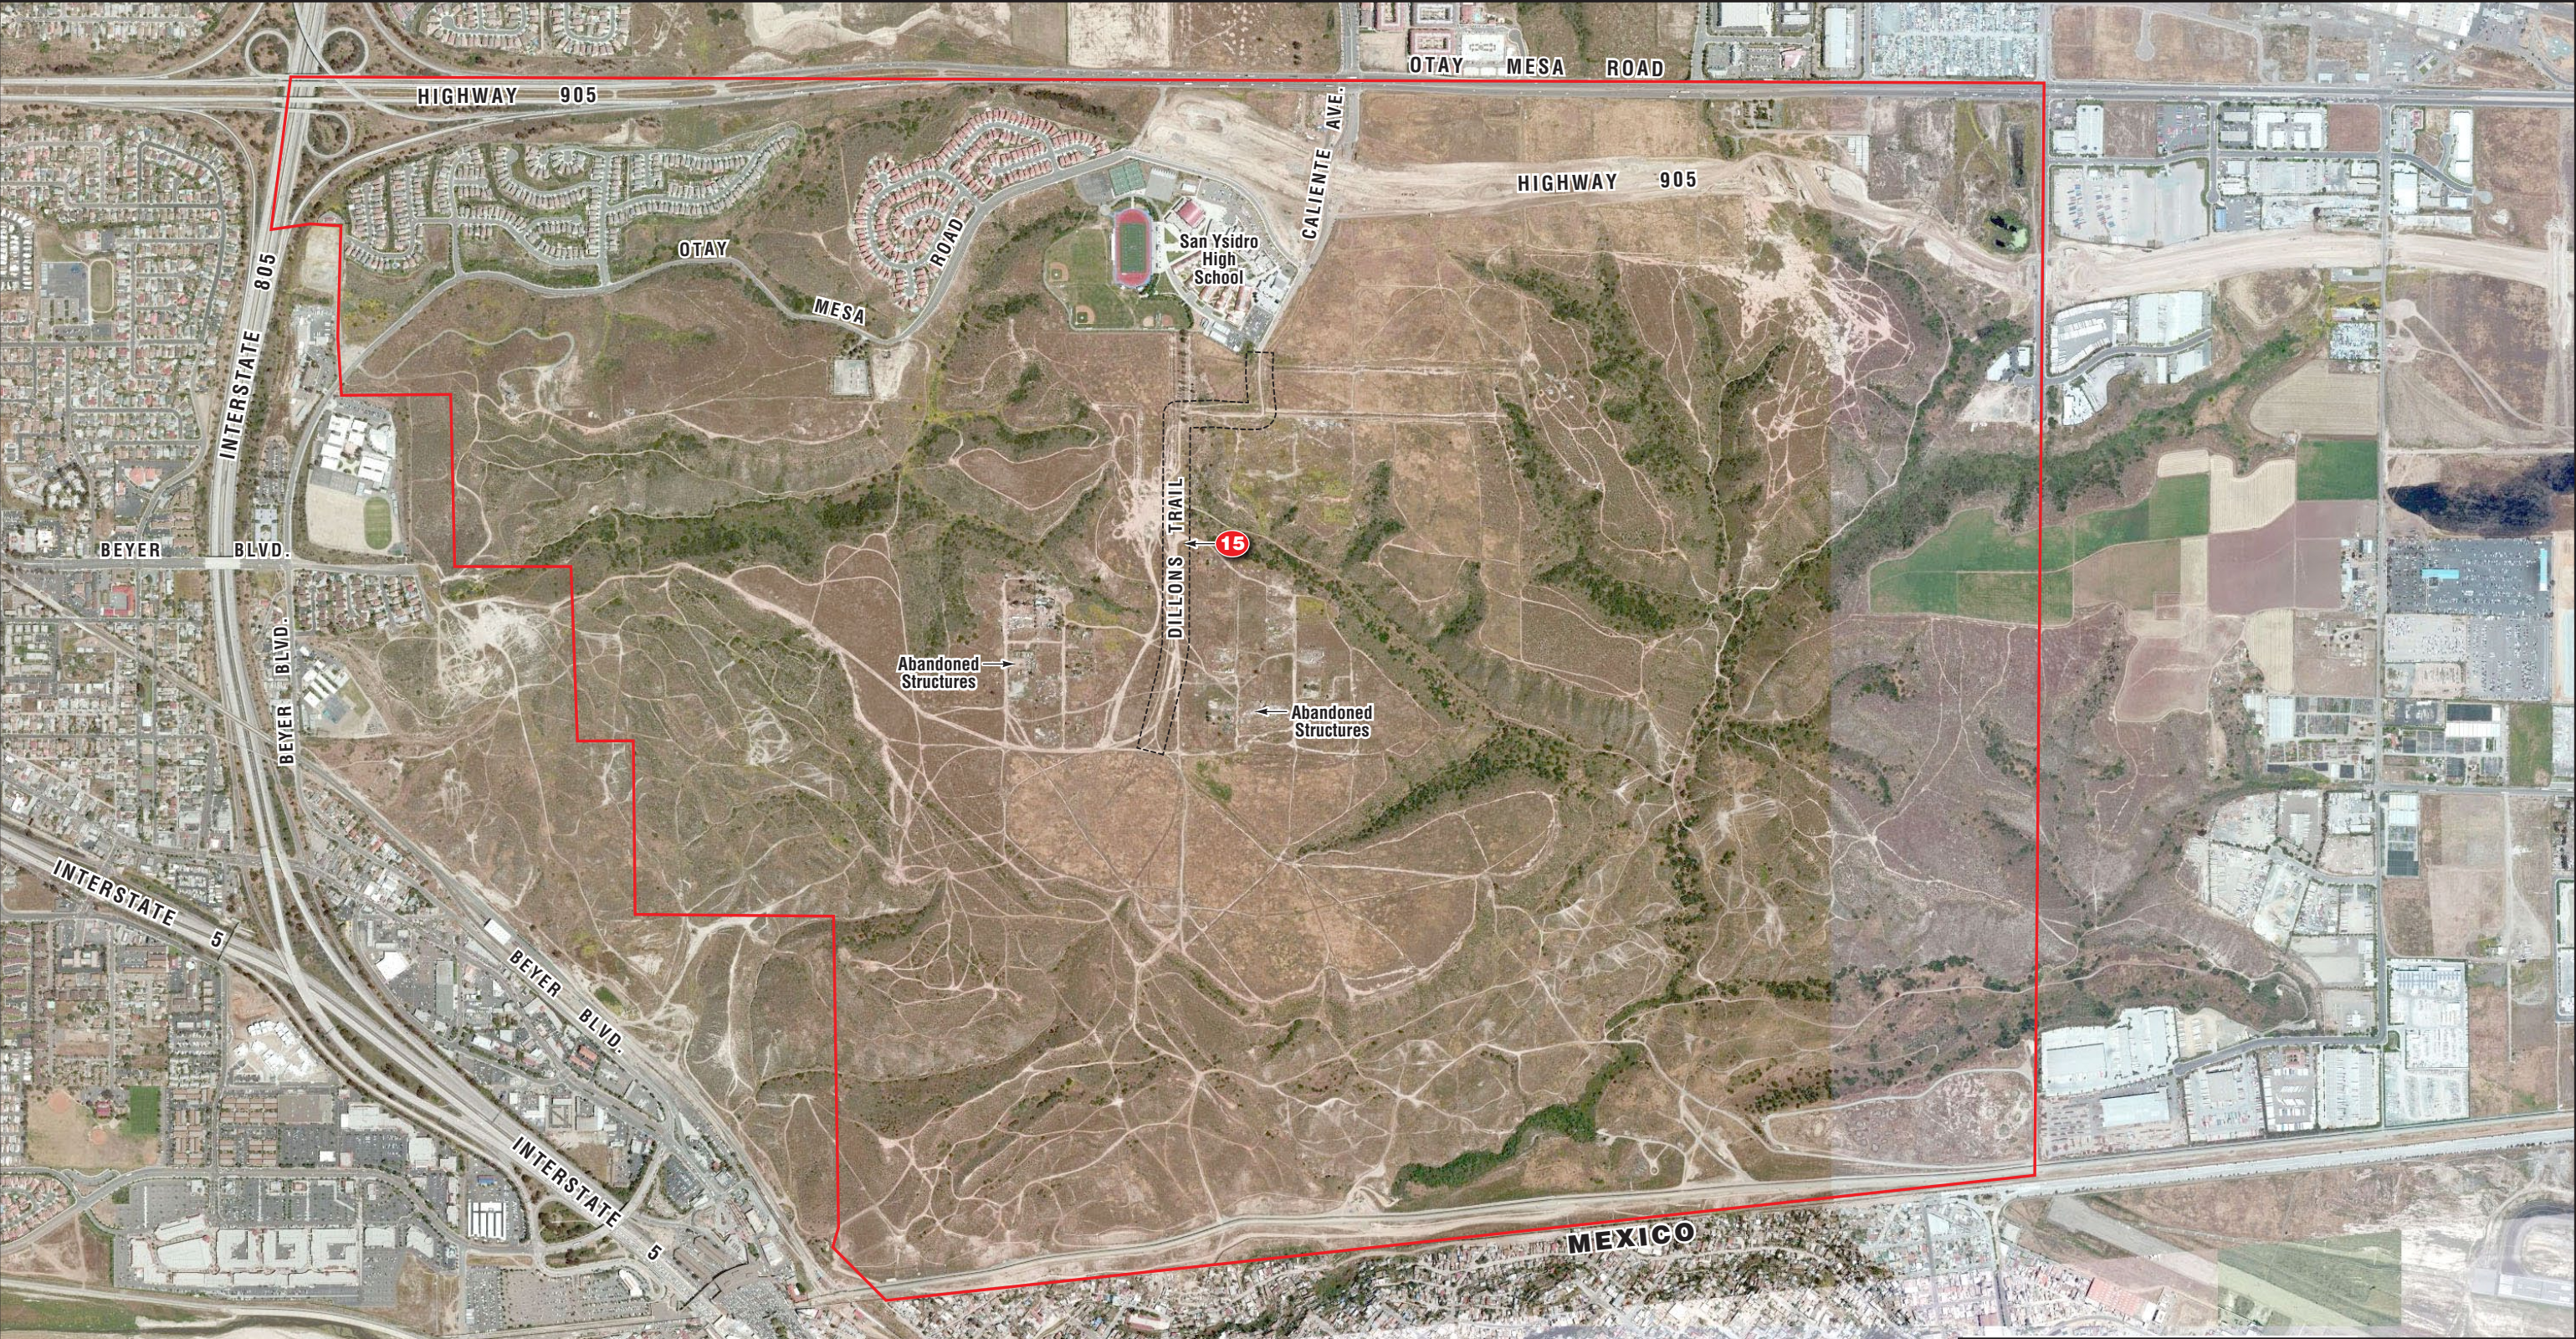
Figure 3-2

One property of potential environmental concern was identified in Area 2 or within ¼-mile of the boundaries of Area 2. The approximate location of this property (Map ID 15) is depicted on Figure 3-2. This section summarizes additional information for this property from the sources described in Section 3.2.

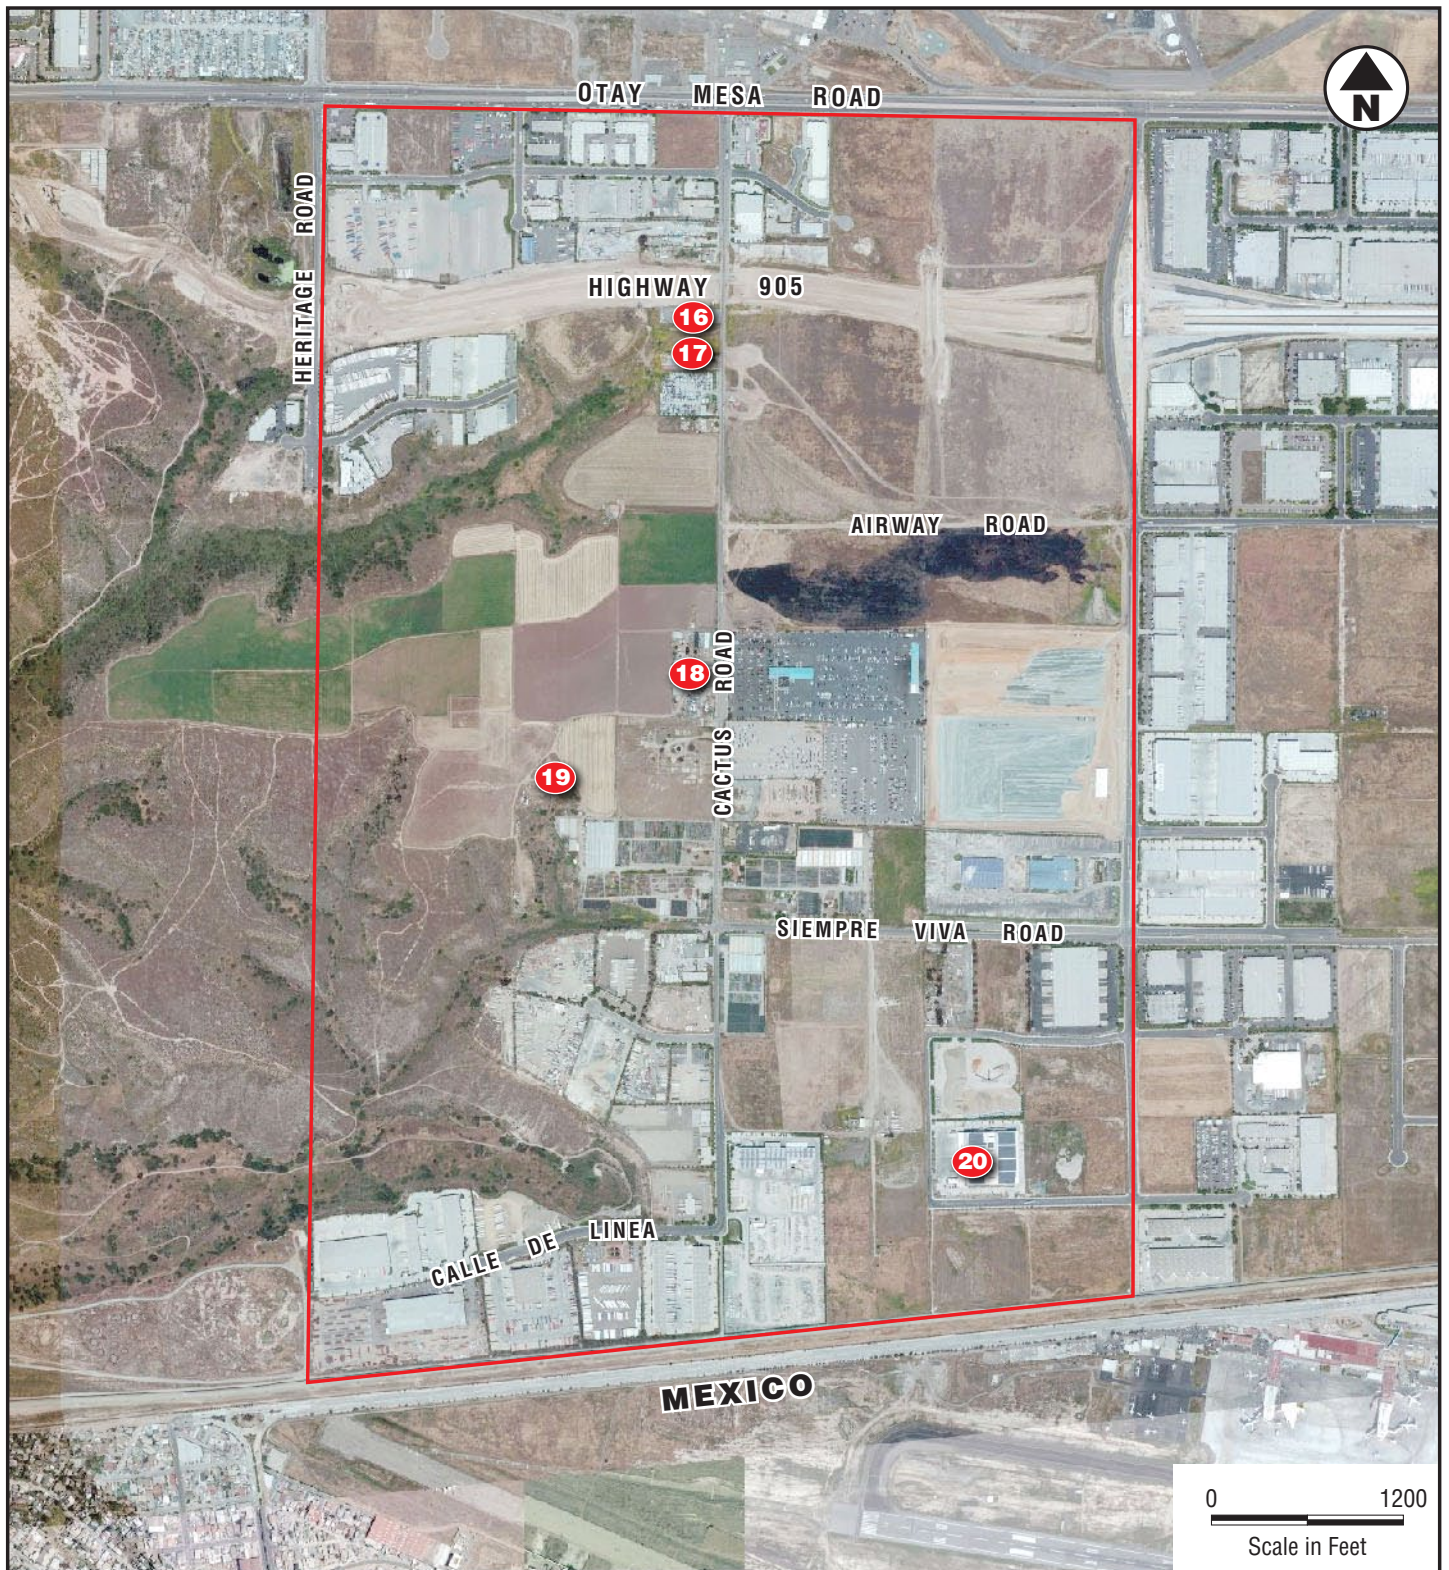
Figure 3-3

Five properties/facilities of potential environmental concern were identified in Area 3. The approximate locations of these properties/facilities (Map IDs 16 through 20) are depicted on Figure 3-3, and additional information for each property/facility from the sources listed in Section 3.2 follows below.

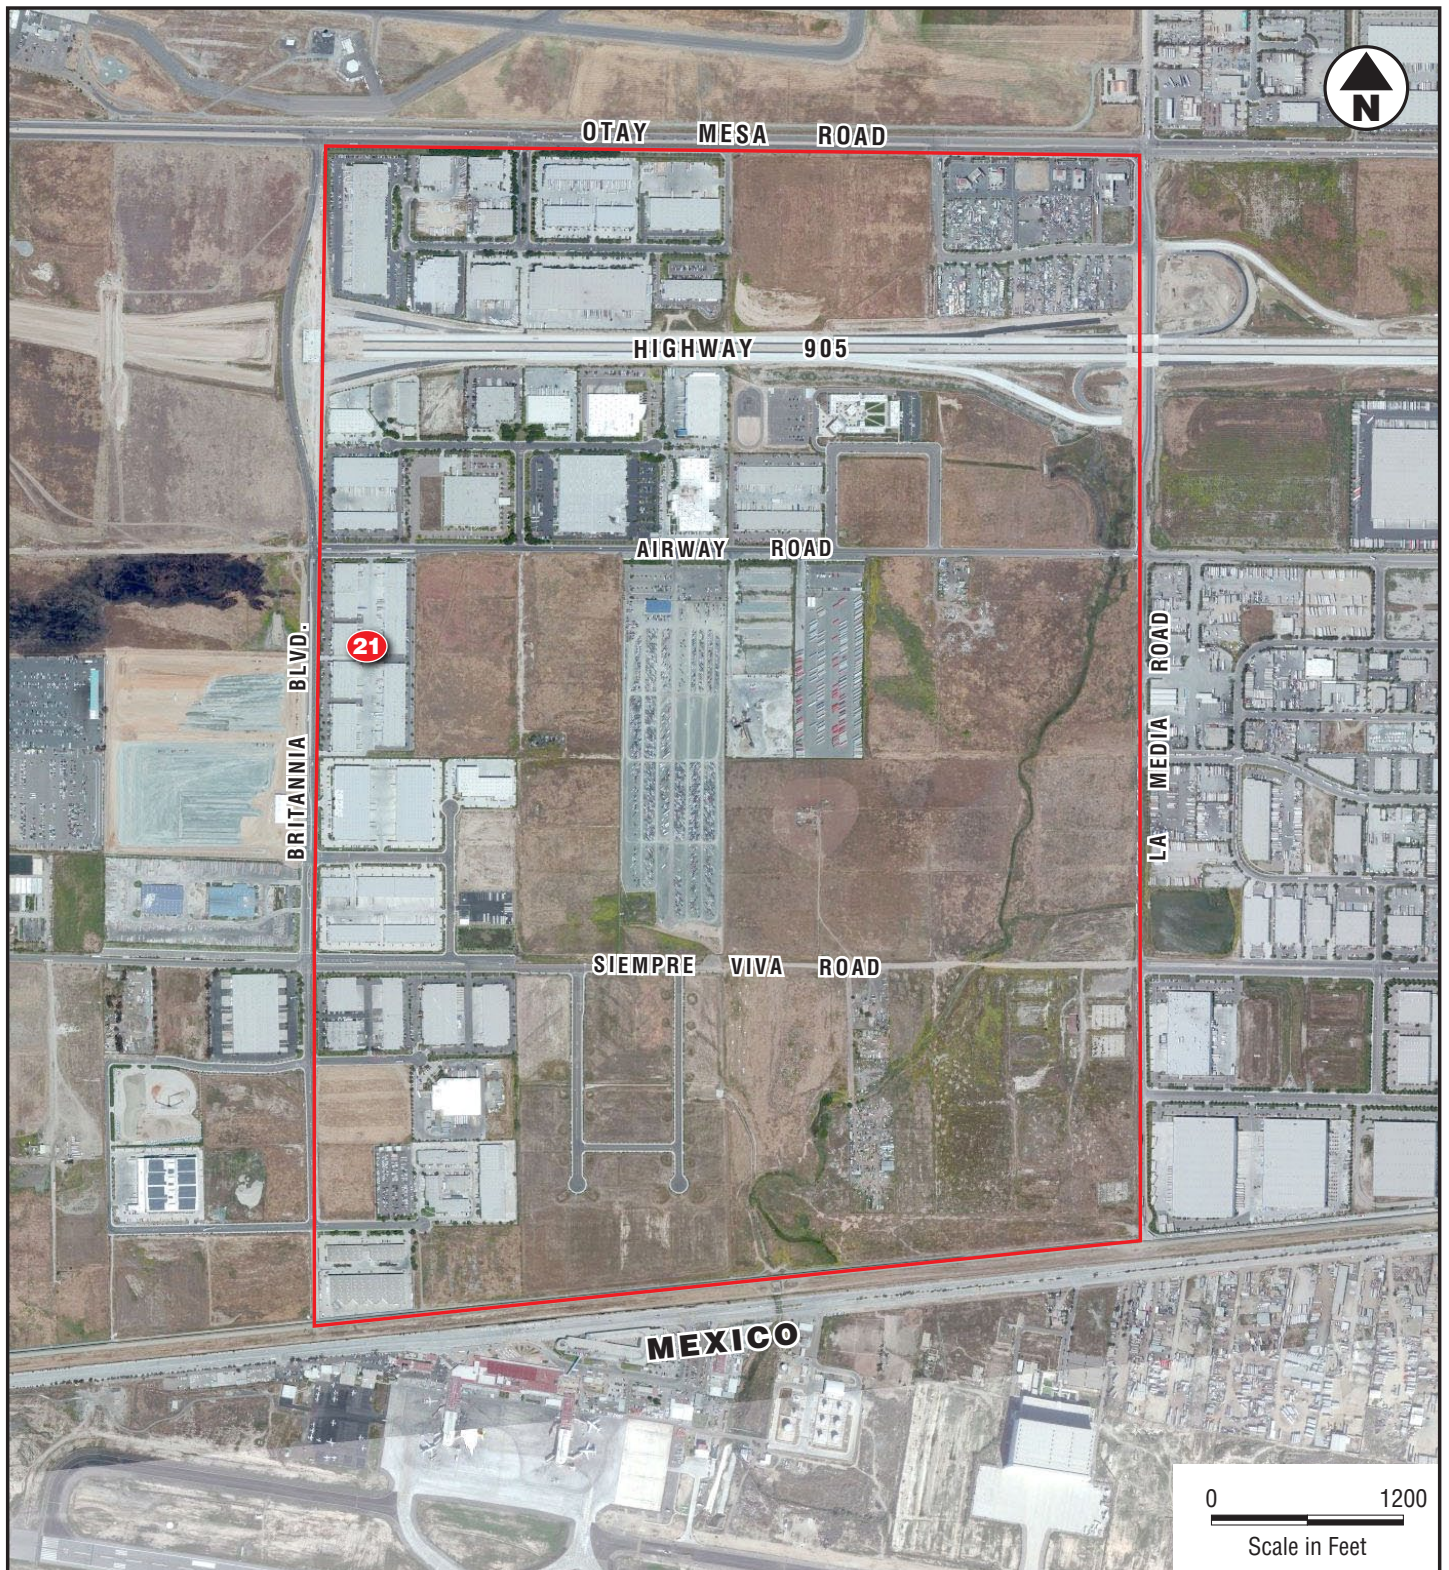
Figure 3-4

One property of potential environmental concern was identified in Area 4. The approximate location of this property (Map ID 21) is depicted on Figure 3-4. This section summarizes additional information for this property from the sources listed in Section 3.2.

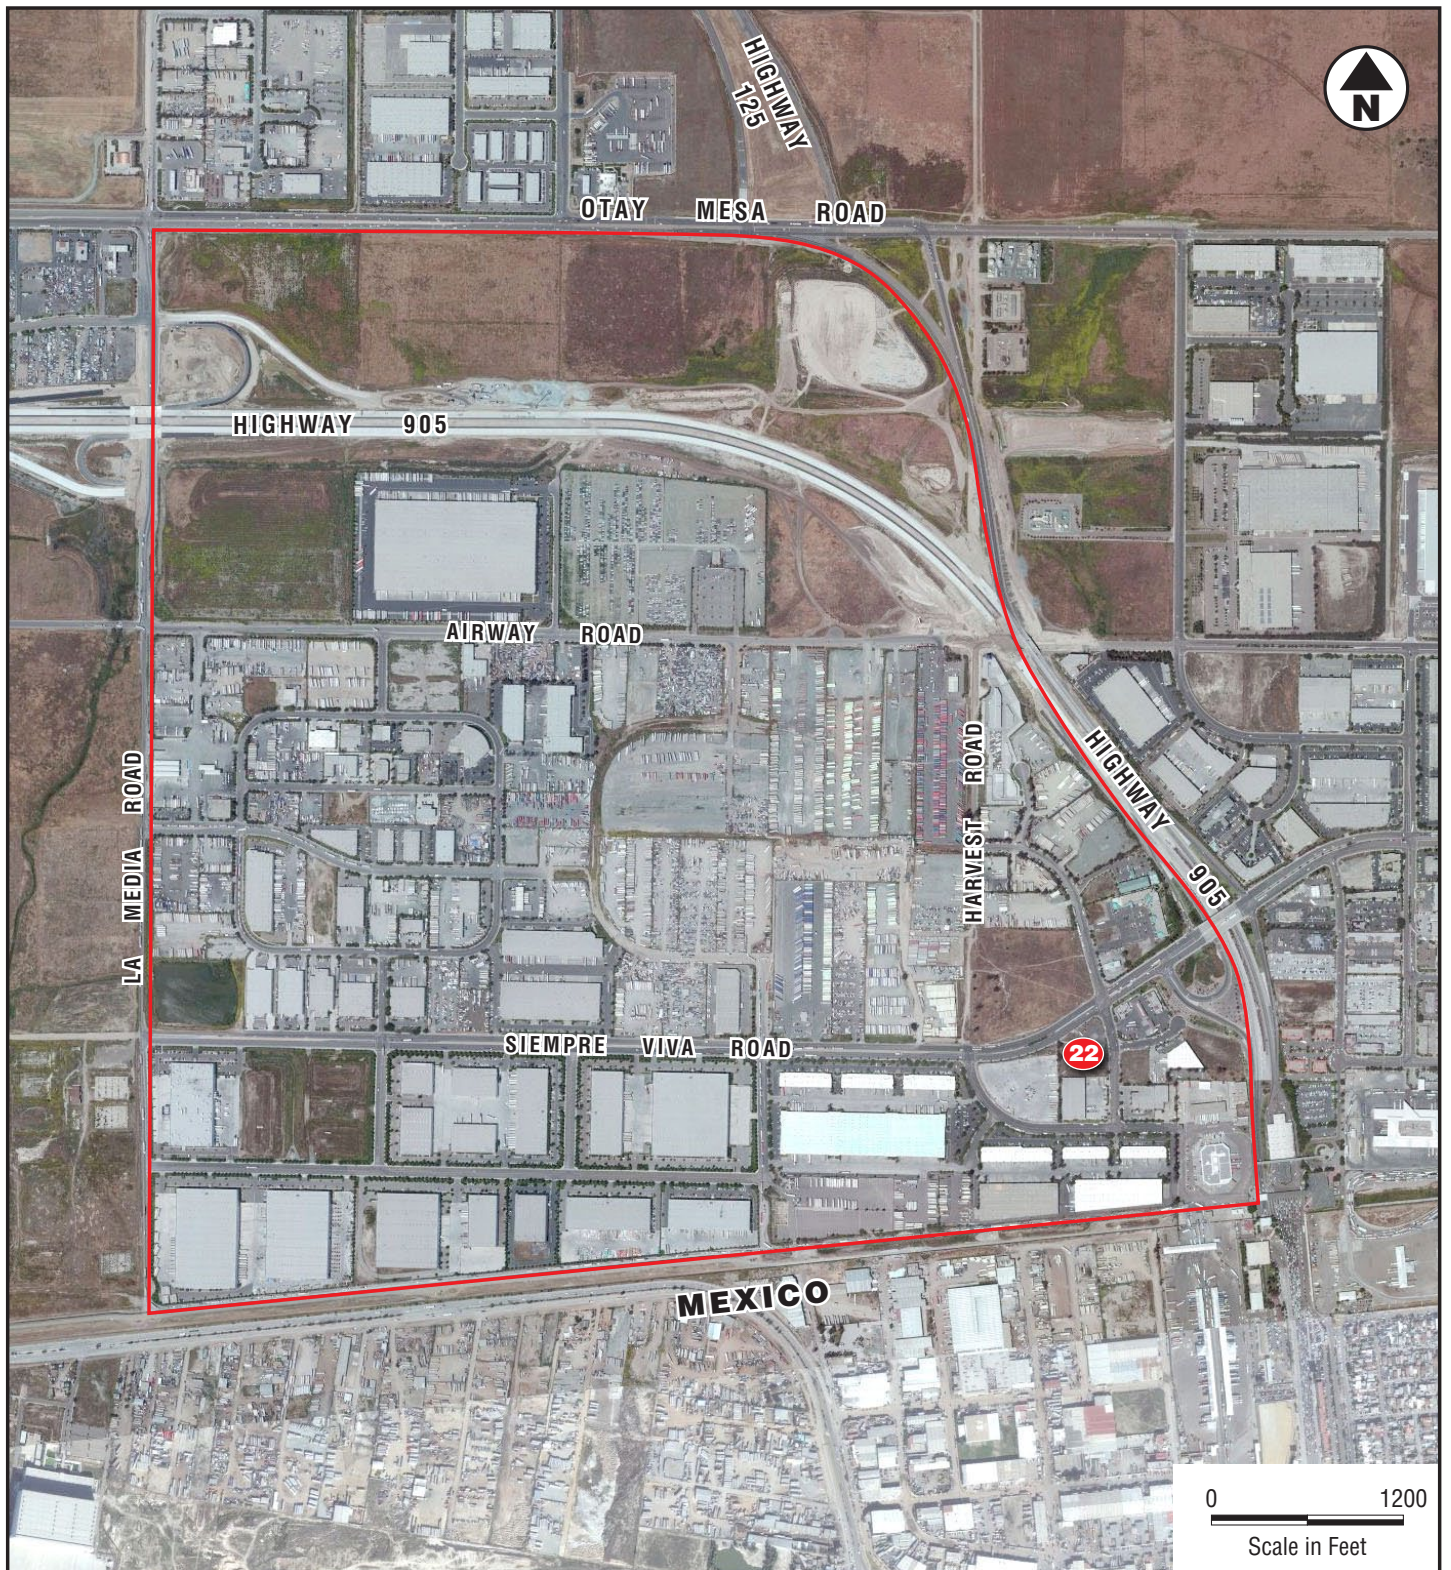
Figure 3-5

Area 5 is bounded by Otay Mesa Road to the north, the US-Mexico international border to the south, Highway 905 to the east, and La Media Road to the west (Figure 3-5). The southern and central portions of Area 5 are predominantly developed with commercial/light-industrial improvements. Commercial developments occupy the western corner of Highway 905 and Siempre Viva Road. The northern portion of Area 5 is predominately undeveloped land.

One property of potential environmental concern was identified in Area 5 or offsite within ¼-mile of the boundaries of Area 5. The approximate location of this property (Map ID 22) is depicted on Figure 3-5. This section summarizes additional information for this property from the sources described in Section 3.2.
