SUBJECT: RESPONSE TO 1<sup>ST</sup> PLANCHECK COMMENTS ON THE DRAFT MASTER MAINTENANCE PROGRAM (MMP) MAP 70 AND 76 AUBURN CREEK CHANNEL INDIVIDUAL WATER QUALITY ASSESSMENT (IWQA) REPORT DATED MARCH 30, 2017 (RICK ENGINEERING COMPANY JOB NUMBER 17204-L)

## INDIVIDUAL WATER QUALITY ASSESSMENT REPORT

**Site Name/Facility:** Auburn Creek Channel  
**Master Program Map No.:** Maps 70 and 76  
**Date:** March 30, 2017; Revised April 28, 2017  
**Civil Engineer (name, company, phone number):** Jayne Janda-Timba  
Rick Engineering Company  
5620 Friars Road  
San Diego, California 92110  
(619) 688-1448  
**Register Civil Engineer Number & Expiration Date (place stamp here):** RCE # 70649  
Exp. 06/2017

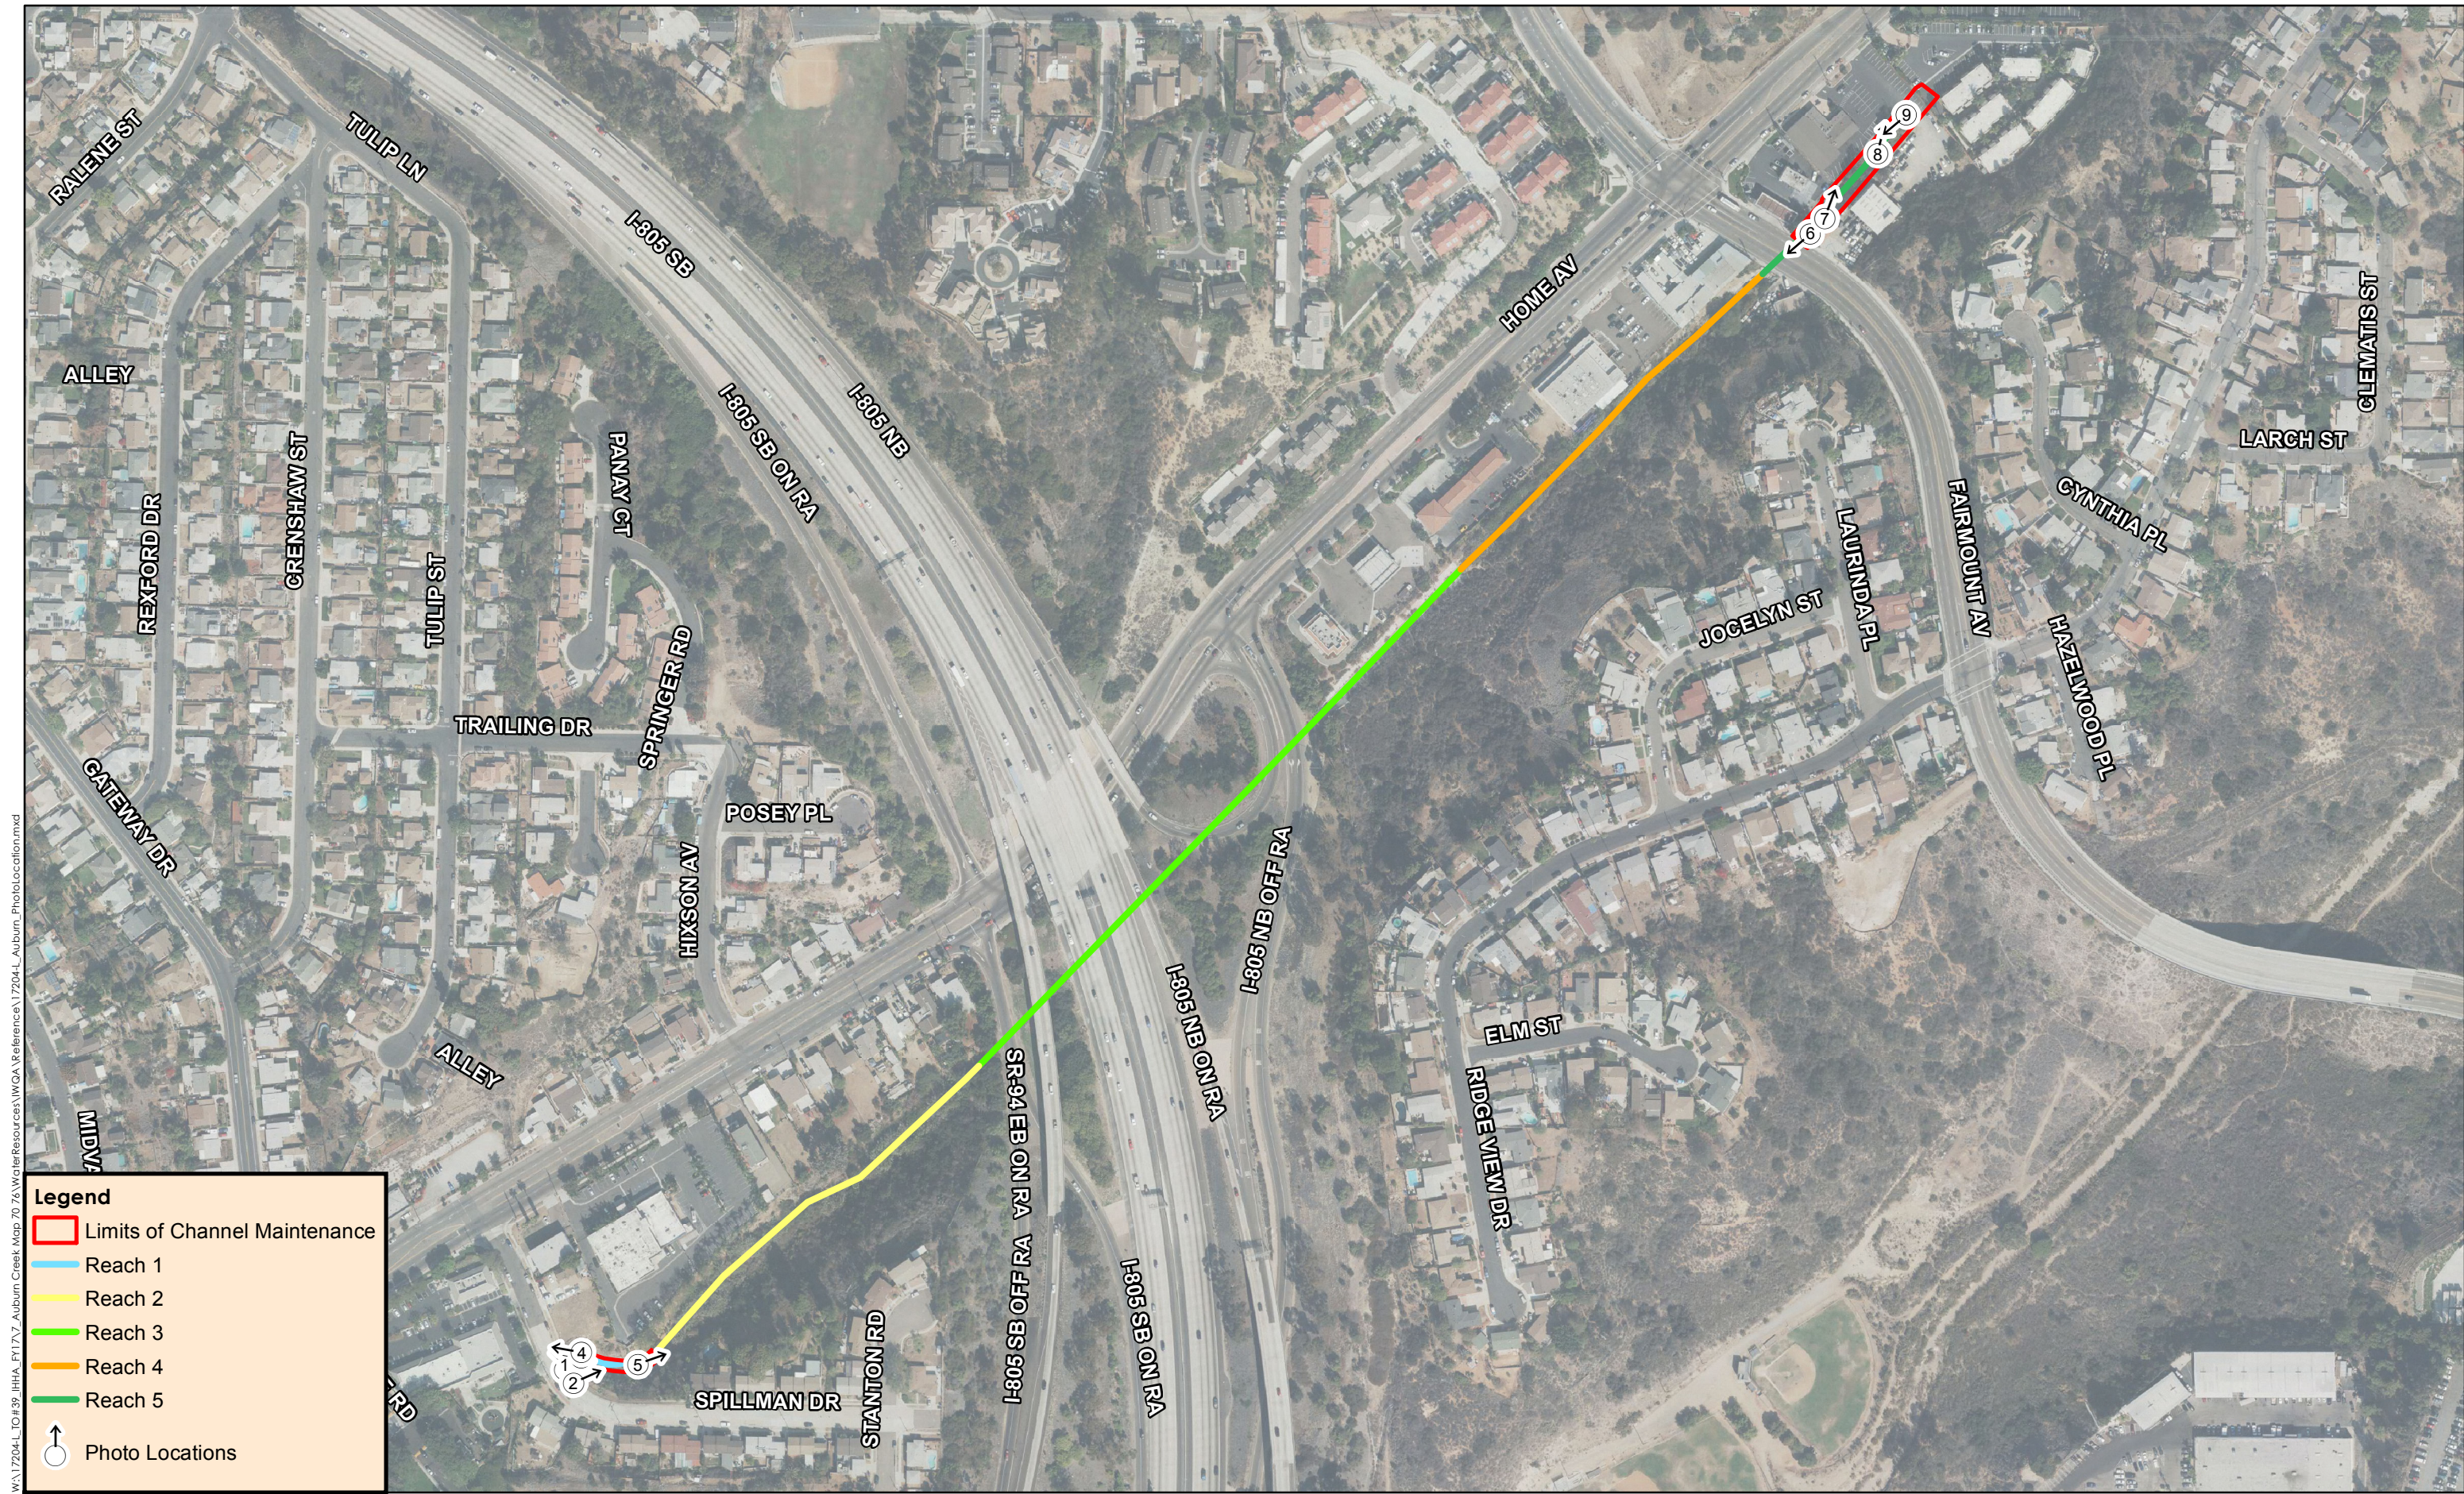
Site visits were conducted on November 10, 2016 and February 3, 2017 to determine if dry weather flows exist. No dry weather flows were observed on either date. See site photos attached and Figure 5 – Photo Locations Map for photos showing no dry weather flows. The field observation activities (described below) established that there are no negative water quality impacts associated with channel maintenance due to no dry weather flows in the channel, pursuant to the SOP. For this reason, sediment sampling activities are unnecessary, and would only serve to prove that channel maintenance has a greater positive impact on water quality than leaving the vegetation and sediment in place.
