101 ASH STREET

BUILDING CONDITION ASSESSMENT

FINAL REPORT

PREPARED BY KITCHELL

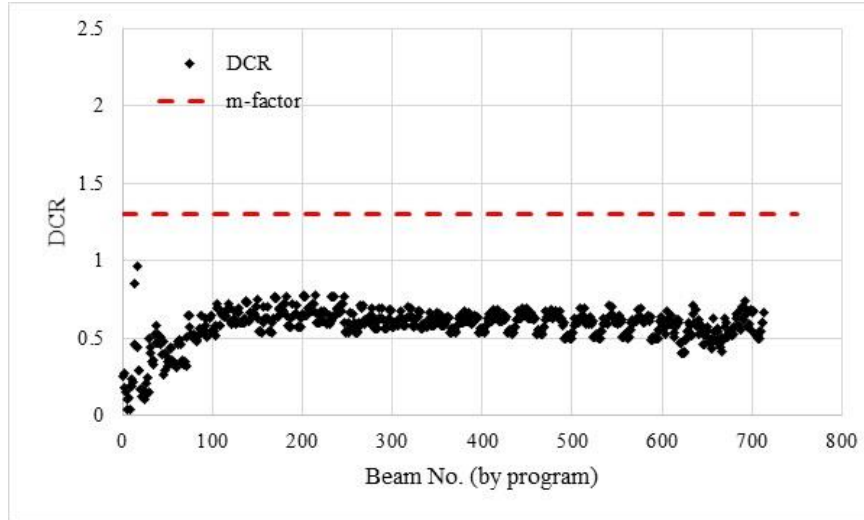
Figure 7. Performance of beams (connections), existing BSE 1E

Figure 7 presents the performance of connections at BSE-1E. Note the following:

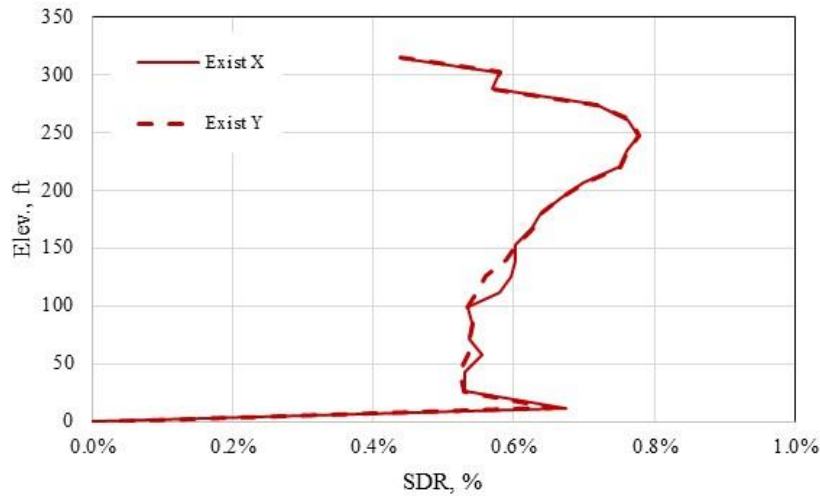
Figure 9. SDR, existing BSE 1E

Figure 9 presents SDR. Note that the maximum drift ratio is less than 0.8% and thus cladding damage is not anticipated.

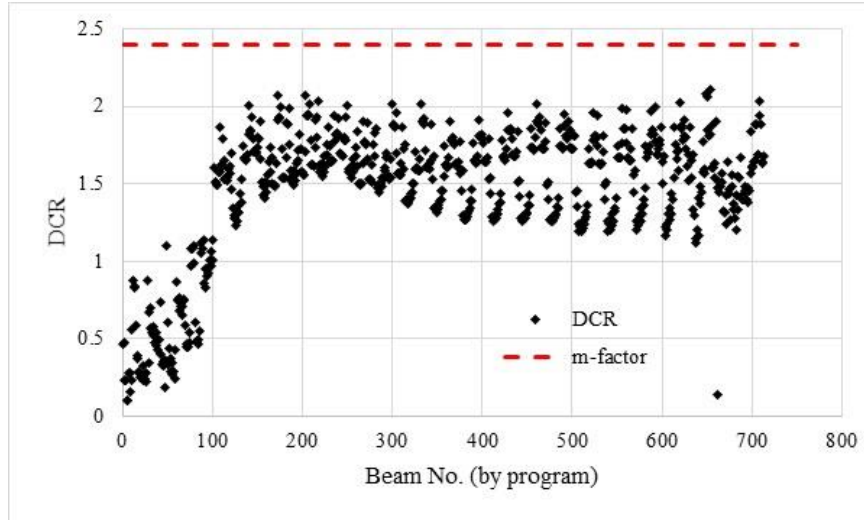
Figure 11. Performance of beams (connections), existing BSE 2E

Figure 11 presents the performance of connections at BSE-2E. Note the following:

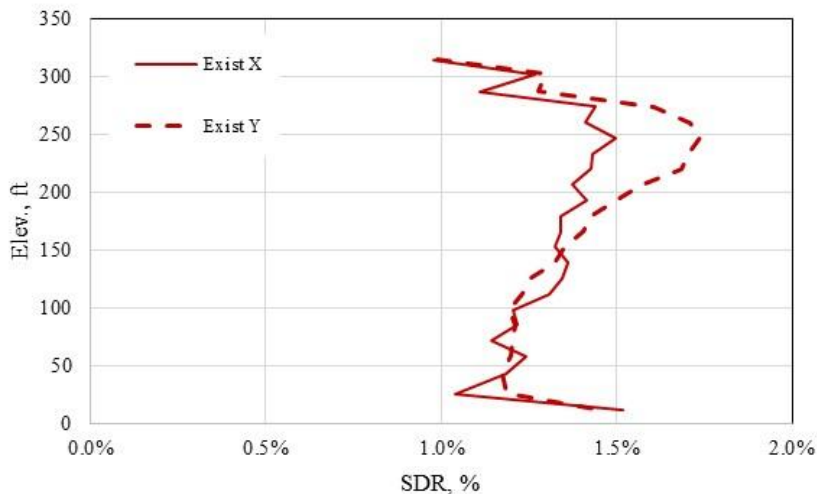
Figure 13. SDR, existing BSE 2E

Figure 13 presents SDR. Note that the drift ratio exceeds 1.2% along the building height for a number of levels and as such cladding damage is expected. Figure 14 presents the peak floor acceleration (PFA) along the building height. Note that the high PFA at the upper levels could result in damage to the cladding

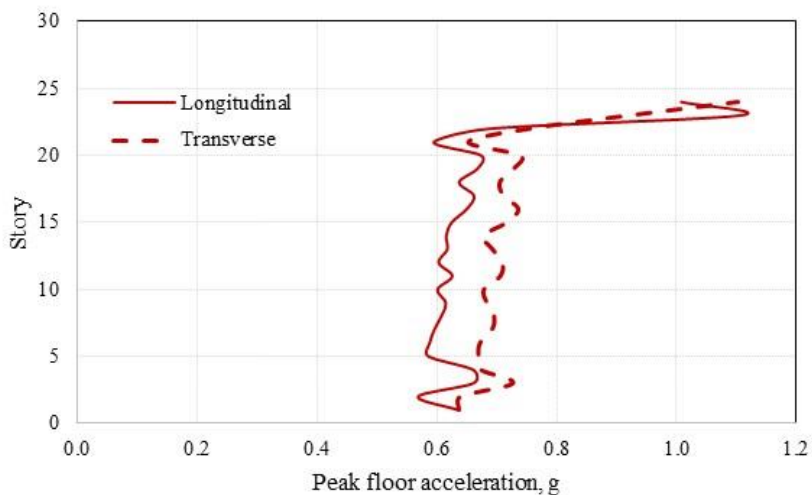
Figure 14. Peak floor accelerations, existing BSE 2E

anchorage and other acceleration-sensitive nonstructural components such as the items located at the mechanical level.

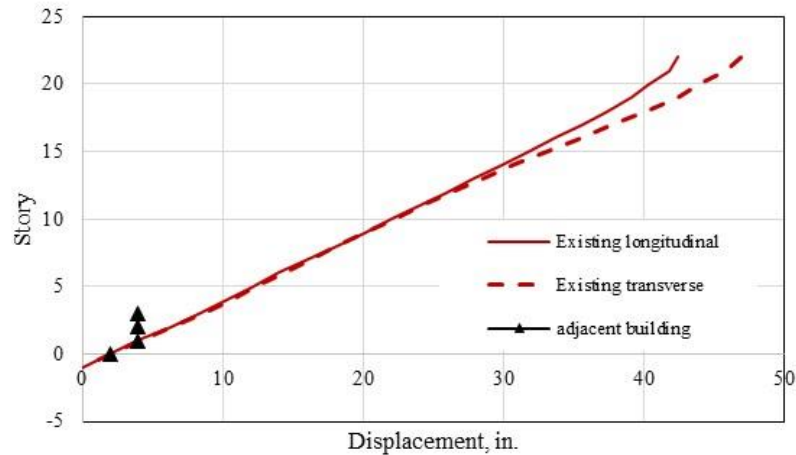
Figure 15. Floor displacements, existing BSE 2E

Figure 15 presents the computed floor displacements. Note that the seismic gap provided is not adequate and thus pounding is expected.

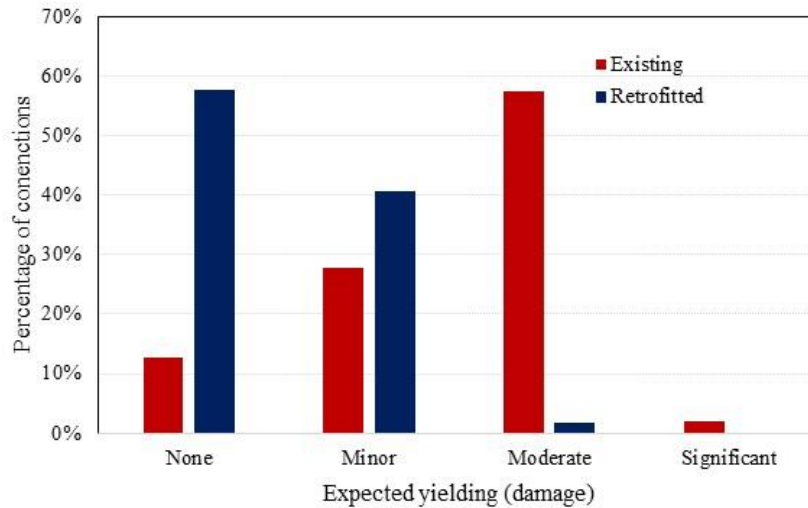
Figure 21. Expected level of connection damage, BSE 2E

Figure 21 presents the expected level of damage (yielding) in beam-to-column connections at BSE 2E. Note that the addition of seismic dampers reduced the expected yielding (damage) level in connections by a large amount and resulting in an essentially elastic behavior.

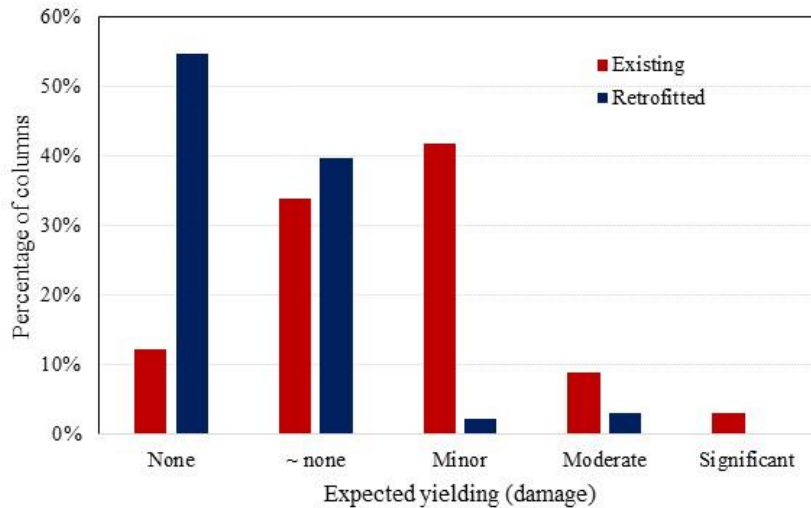
Figure 23. Expected level of column damage, BSE 2E

Figure 23 presents the expected level of damage (yielding) in columns at BSE 2E. Note that the addition of seismic dampers reduced the expected yielding (damage) level in columns by a large amount. For example, the number of columns expected to moderate to significant yielding (damage) has decreased by a factor of 3.

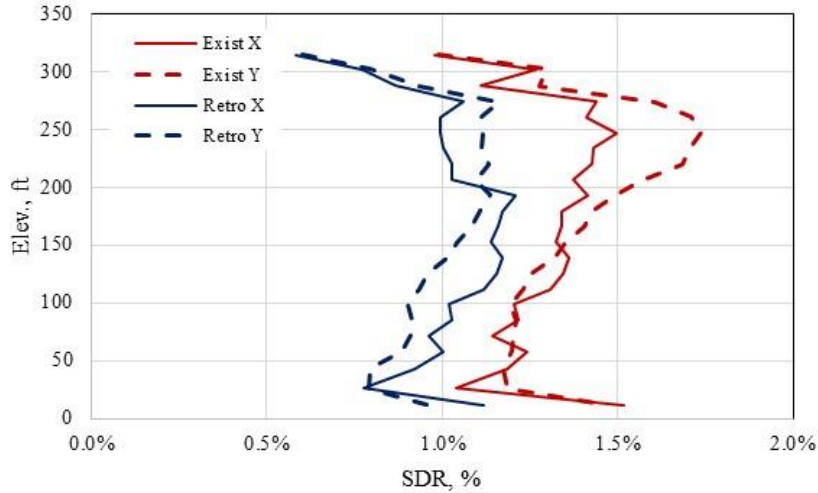
Figure 24. SDR, retrofitted BSE 2E

Figure 24 presents SDR for existing and retrofitted buildings. Note that the drift ratios are reduced by an average of approximately 30% and for the retrofitted building, the maximum SDR is 1.2%. In other words, cladding damage has been mitigated. Figure 25 presents PFA along the building height for existing and retrofitting structures. Note that the PFA is reduced by close to 50%. The reduced PFA will mitigate damage to cladding anchorage and other nonstructural components.

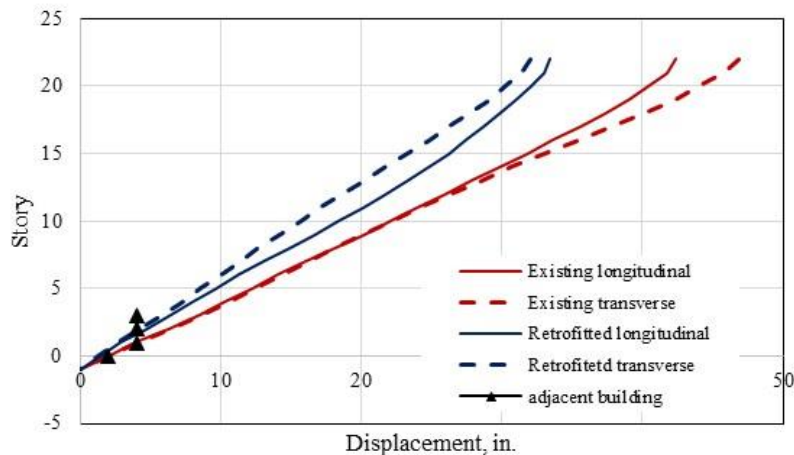
Figure 26. Floor displacements, retrofitted BSE 2E

Figure 26 presents the computed floor displacements for the existing and retrofitted structures. Note that for the retrofitted structure, the pounding is unlikely to court at ground level and below. Pounding could still occur at the above floors but its impact is reduced by the damper retrofit and could be mitigated by enlarging the seismic gap.
